# BRIDGE INSPECTION REPORT

INSPECTION TYPE: Routine Inspection

COUNTY TRANSYLVANIA BRIDGE NUMBER 870046 INSPECTION CYCLE 2 YRS

ROUTE NC215 ACROSS NORTH FORK FR. BROAD RVR M.P. 0

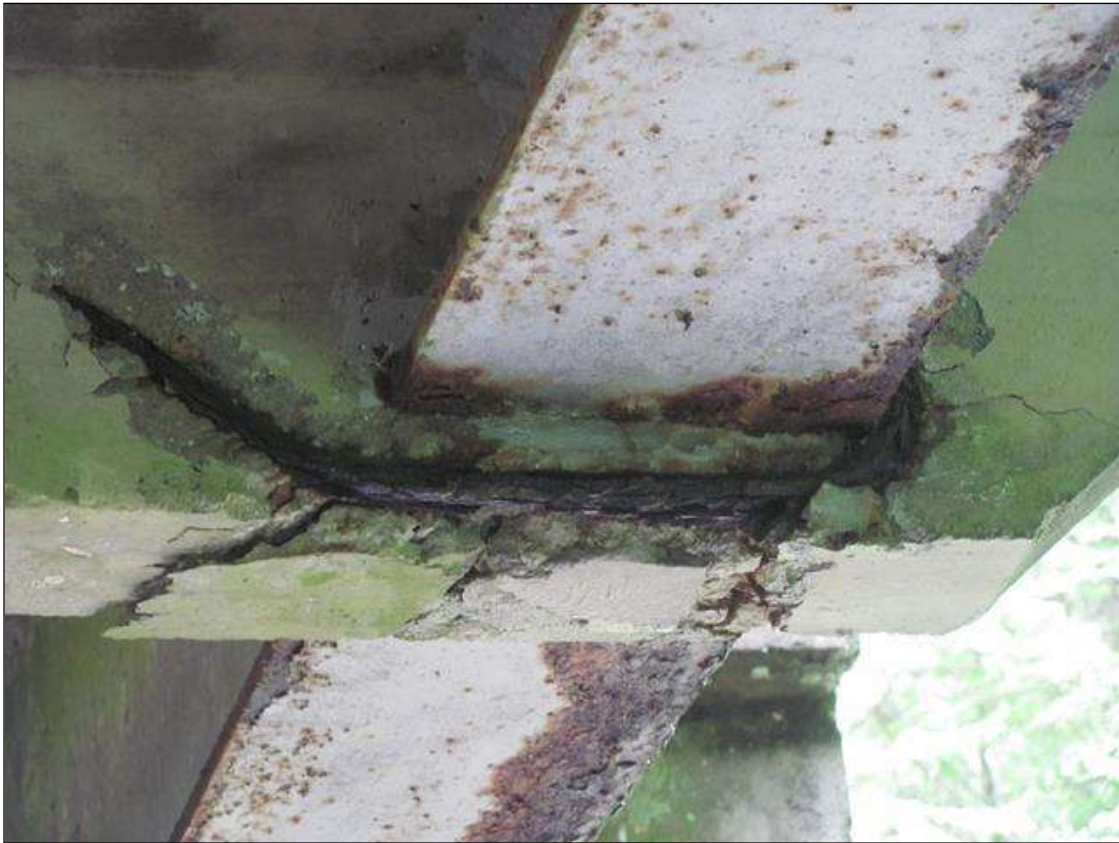
| Bridge I&A Form 1(82)H<br>State of North Carolina<br>Dept. of Transportation<br>Division of Highways | | <h1 style="text-align: center;">FIELD INSPECTION REPORT</h1> <h2 style="text-align: center;"><u>Bridge Inspection &amp; Analysis</u></h2> | |
|---|---|---|--|
| 12 | F | CRACK AND SEPARATION OF INTERMEDIATE DIAPHRAGM BELOW BEAM #1, 20 FEET FROM ABUTMENT 2.<br>(2) INTERMEDIATE DIAPHRAGMS BROKEN OFF AND SEPARATED FROM BEAM #4.<br>HAIRLINE CRACKING IN ALL DIAPHRAGMS.<br>CRACKING AND SPALLING IN RANDOM DIAPHRAGMS IN THE AREA BENEATH BEAMS #1, #4 WITH RUSTED AND DETERIORATED REINFORCING BARS EXPOSED. | |

CRACKING, SPALLING, SEPERATION WITH REBAR EXPOSURE AT INTERIOR DIAPHRAGM #4 / BEAM #1

| MMS Code | Description of Function | Unit | Quantity | Remarks | Est. Cost |
|---|---|---|---|---|---|
| 3306 | Maintain Concrete Superstructure Components | SF | 50 | CRACKING AND SPALLING IN INERIOR DIAPHRAGMS. DETERIORATION IN THE END CURTAIN WALLS AT ABUTMENT 2. | |

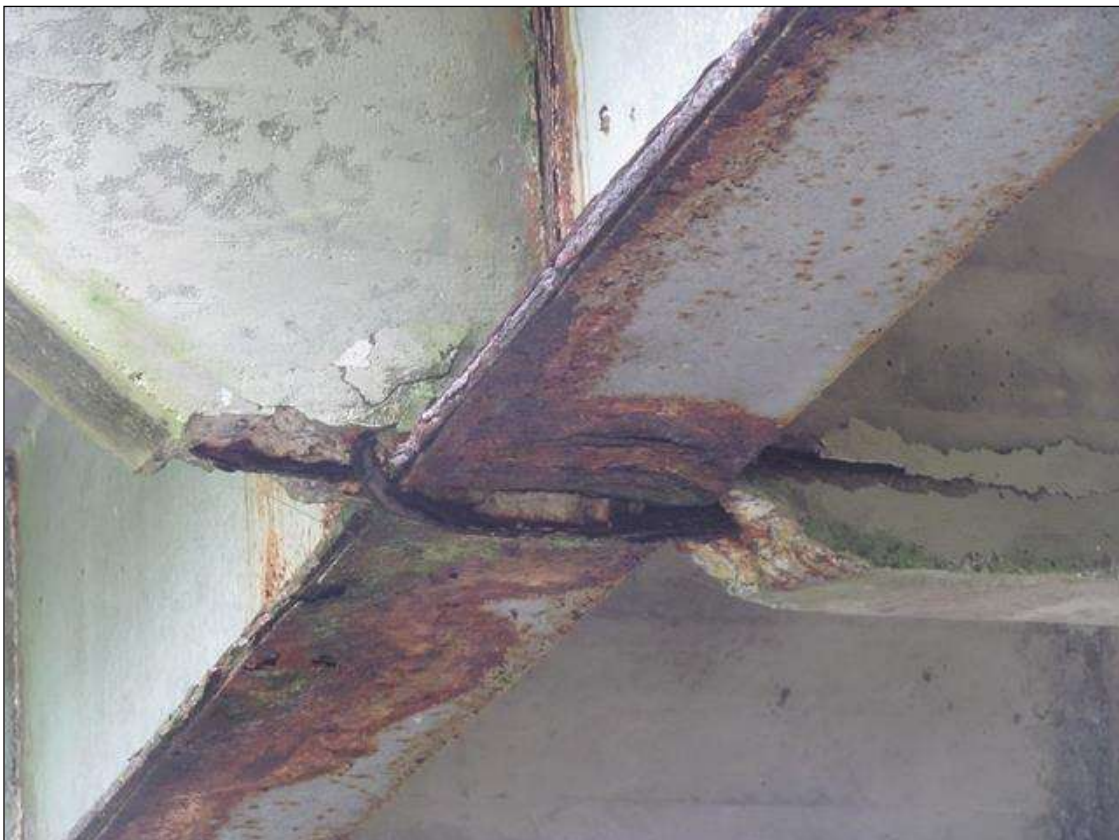
SPALL WITH REBAR EXPOSURE AT INTERIOR DIAPHRAGM #4 / BEAM #4

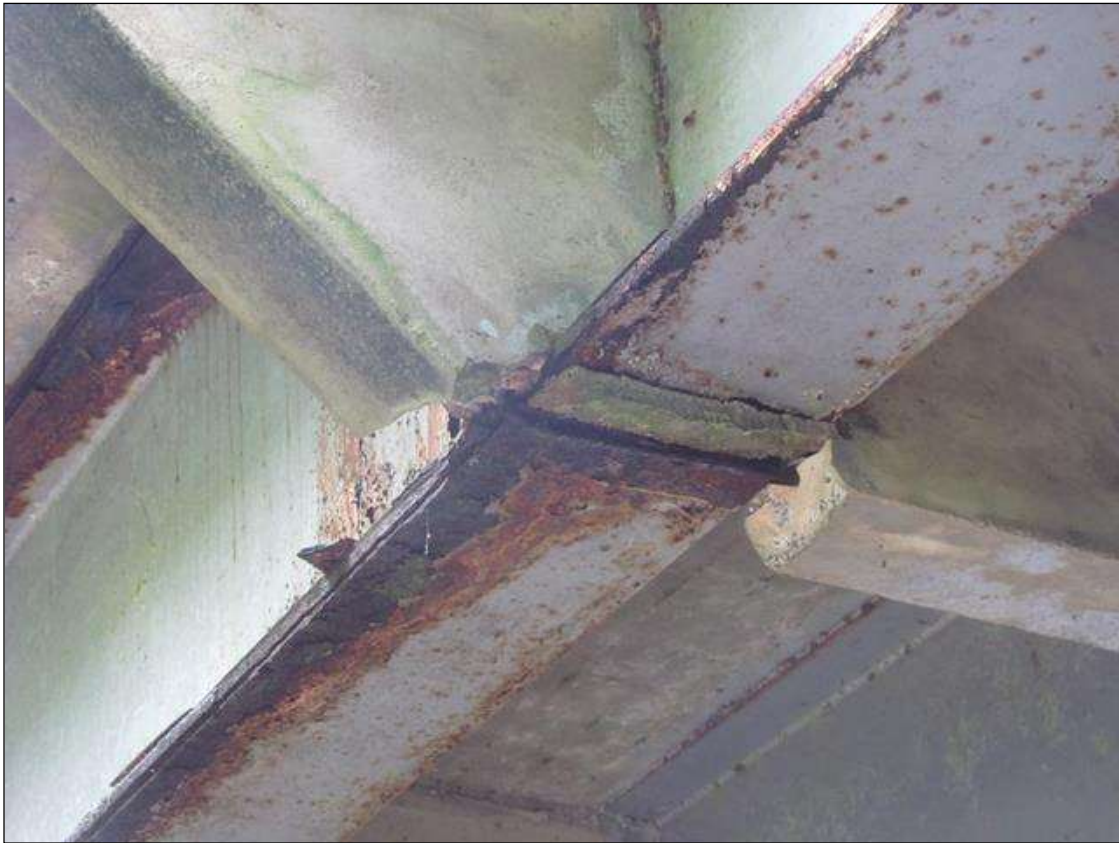
SPALL WITH REBAR EXPOSURE AT INTERIOR DIAPHRAGM #5 / BEAM #4

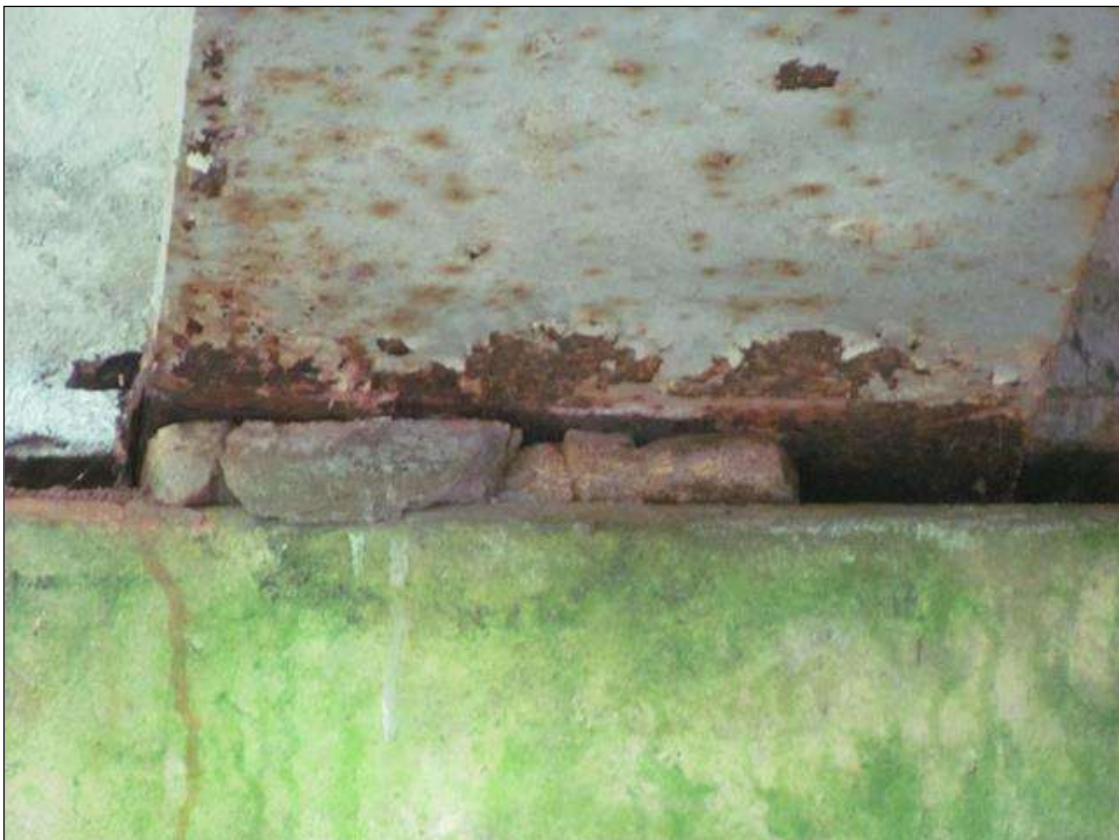
| Bridge I&A Form 1(82)H<br>State of North Carolina<br>Dept. of Transportation<br>Division of Highways | | <h1 style="text-align: center;">FIELD INSPECTION REPORT</h1> <h2 style="text-align: center;"><u>Bridge Inspection &amp; Analysis</u></h2> | |
|---|---|---|--|
| 15 | F | DETERIORATION BENEATH BEAM #4 AT ABUTMENT 1 WITH A 10 TO 15 PERCENT BEARING AREA LOSS. DETERIORATION BENEATH BEAMS #1, #4 AT END BENT 2, BUT NO BEARING AREA LOSS (SEE PHOTOS). A PRIORITY MAINTENANCE HAS BEEN REQUESTED FOR THESE CONDITIONS. | |

CONDITIONS FOUND TO BEARING ASSEMBLY AT BEAM #4 / END BENT 1

| MMS Code | Description of Function | Unit | Quantity | Remarks | Est. Cost |
|---|---|---|---|---|---|
| 3334 | Bridge Bearings | EA | 1 | DETERIORATION BENEATH BEAM 4 AT ABUTMENT 1 WITH A 10 TO 15 PERCENT BEARING AREA LOSS | |

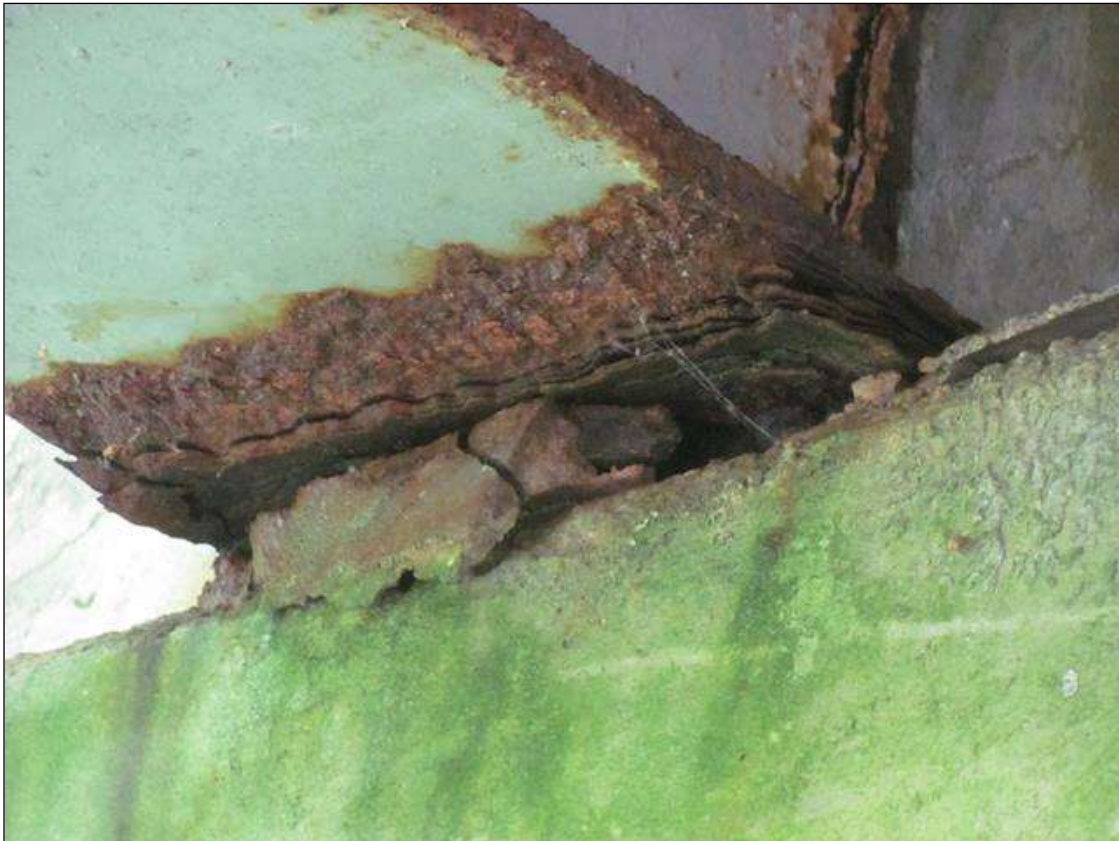
CONDITIONS FOUND TO BEARING ASSEMBLY AT BEAM #1 / END BENT 2

| MMS Code | Description of Function | Unit | Quantity | Remarks | Est. Cost |
|---|---|---|---|---|---|
| 3334 | Bridge Bearings | EA | 1 | DETERIORATION BENEATH BEAM 1 AT END BENT 2 , BUT NO BEARING AREA LOSS | |

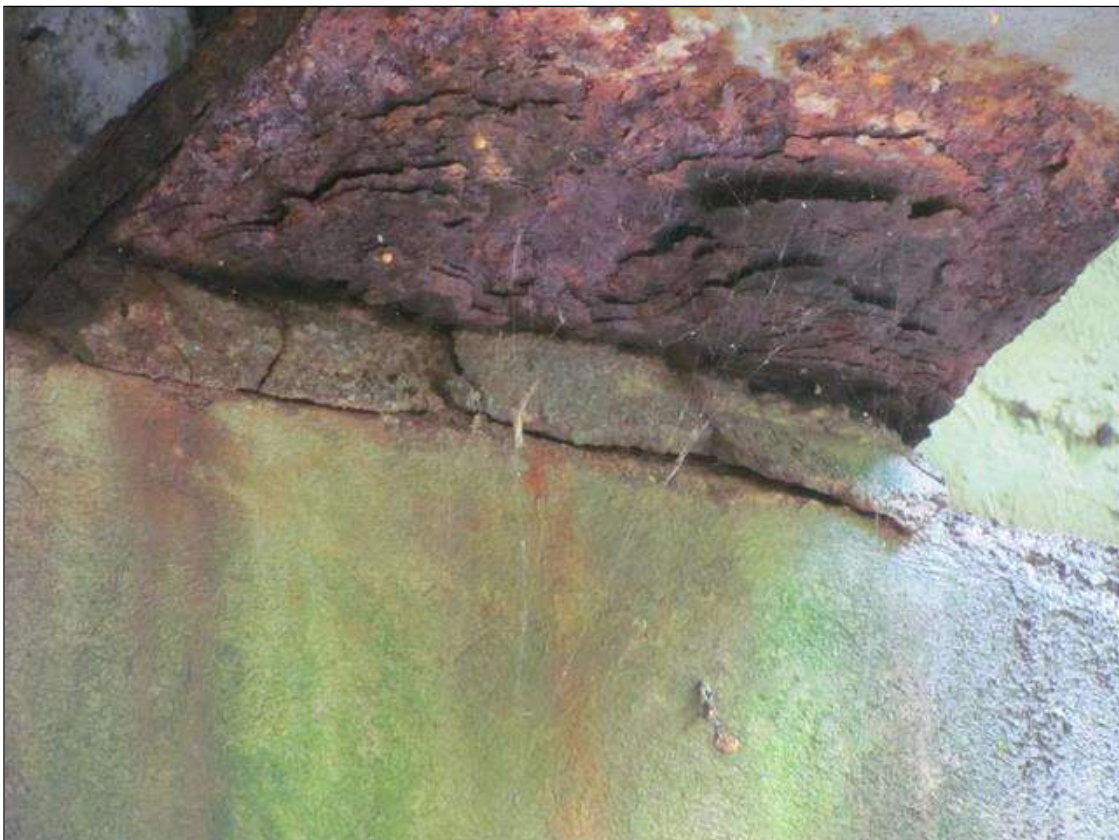
CONDITIONS FOUND TO BEARING ASSEMBLY AT BEAM #4 / END BENT 2

| MMS Code | Description of Function | Unit | Quantity | Remarks | Est. Cost |
|---|---|---|---|---|---|
| 3334 | Bridge Bearings | EA | 1 | DETERIORATION BENEATH BEAM 4 AT END BENT 2 , BUT NO BEARING AREA LOSS | |

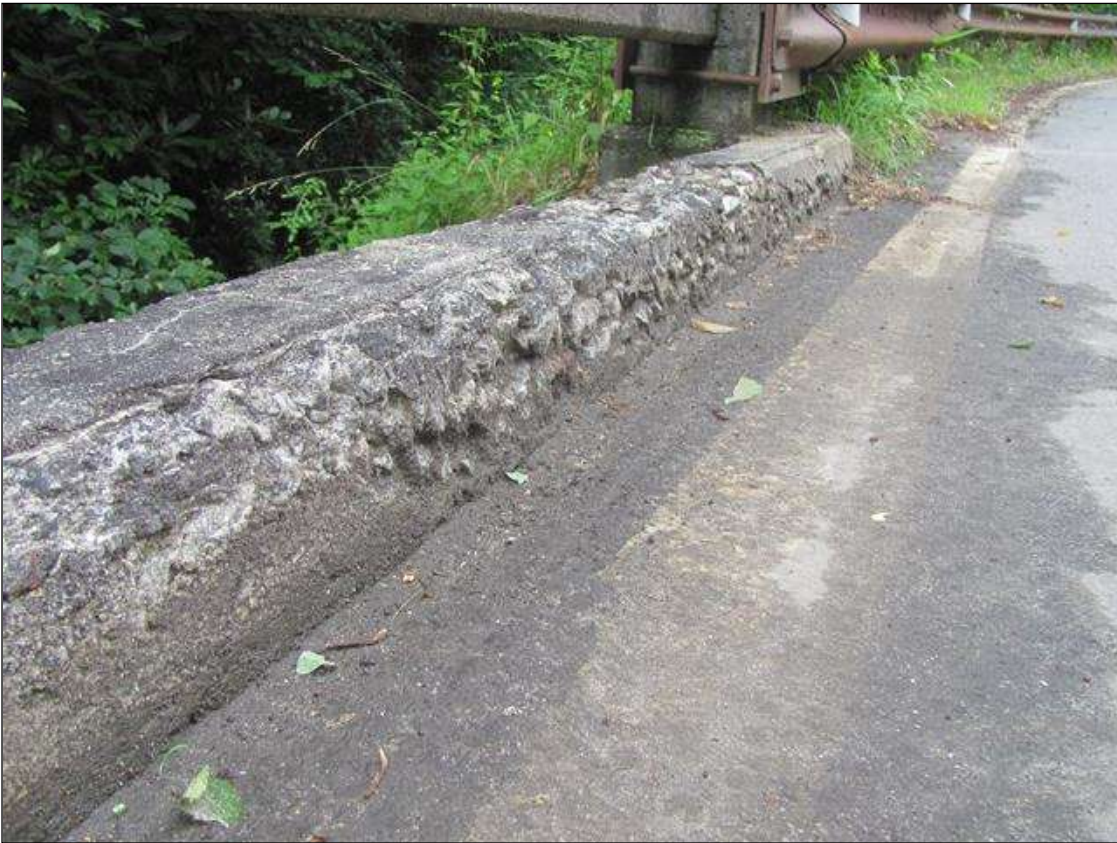
| Bridge I&A Form 1(82)H<br>State of North Carolina<br>Dept. of Transportation<br>Division of Highways | | <h1 style="text-align: center;">FIELD INSPECTION REPORT</h1> <h2 style="text-align: center;"><u>Bridge Inspection &amp; Analysis</u></h2> | |
|---|---|---|--|
| 4 | F | 5 FT. LONG AREA OF HEAVILY WEATHERED CONCRETE TO DOWNSTREAM CURB AT ABUTMENT 2.<br>5 FT. X 8 IN. X 8 IN. SPALL WITH EXPOSED REINFORCING IN UPSTREAM CURB AT MID-SPAN; SIMILAR AT ABUTMENT 2 AND 12 FEET FROM ABUTMENT 2. | |

SPALLING / DETERIORATION THROUGHOUT CONCRETE CURB AT BASE OF LEFT BRIDGE RAIL

| MMS Code | Description of Function | Unit | Quantity | Remarks | Est. Cost |
|---|---|---|---|---|---|
| 3318 | Maint to Concrete Handrail | LF | 102 | DAMAGE TO POST #4 OF THE LEFT RAIL. DETERIORATION IN THE CURBS. | |

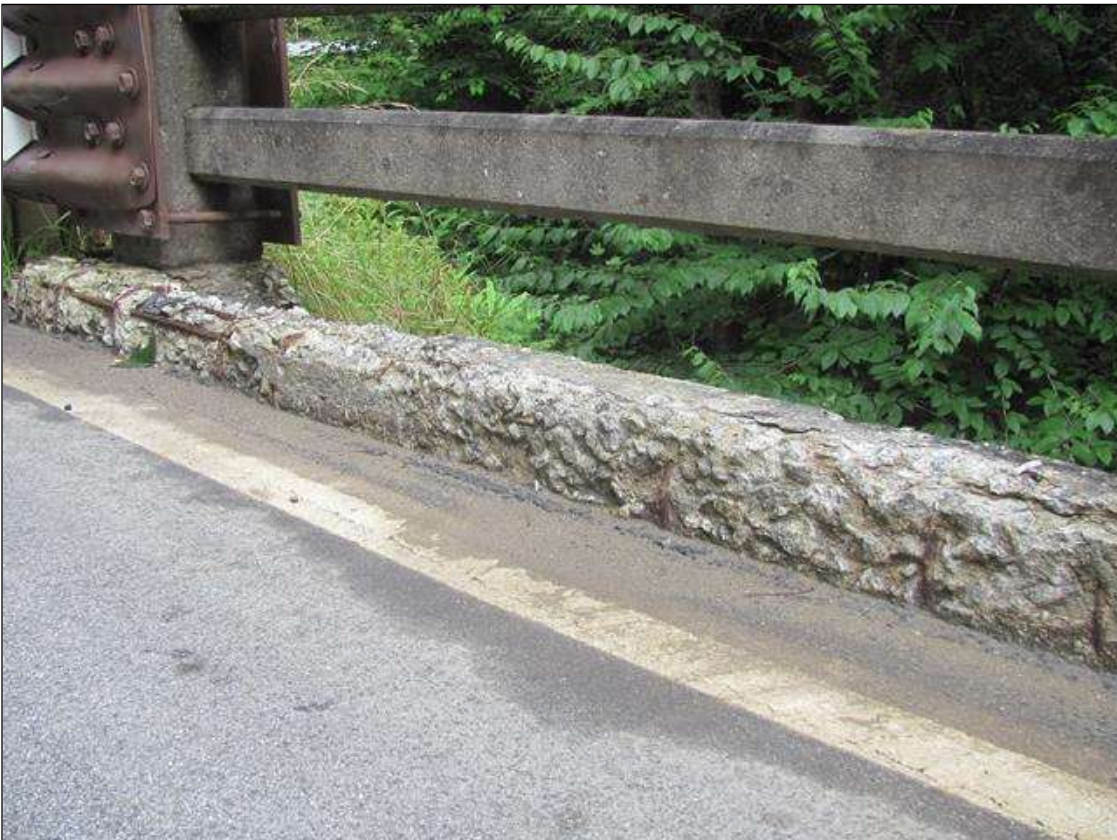
SPALLING / DETERIORATION WITH REBAR EXPOSURE THROUGHOUT CONCRETE CURB AT BASE OF RIGHT BRIDGE RAIL

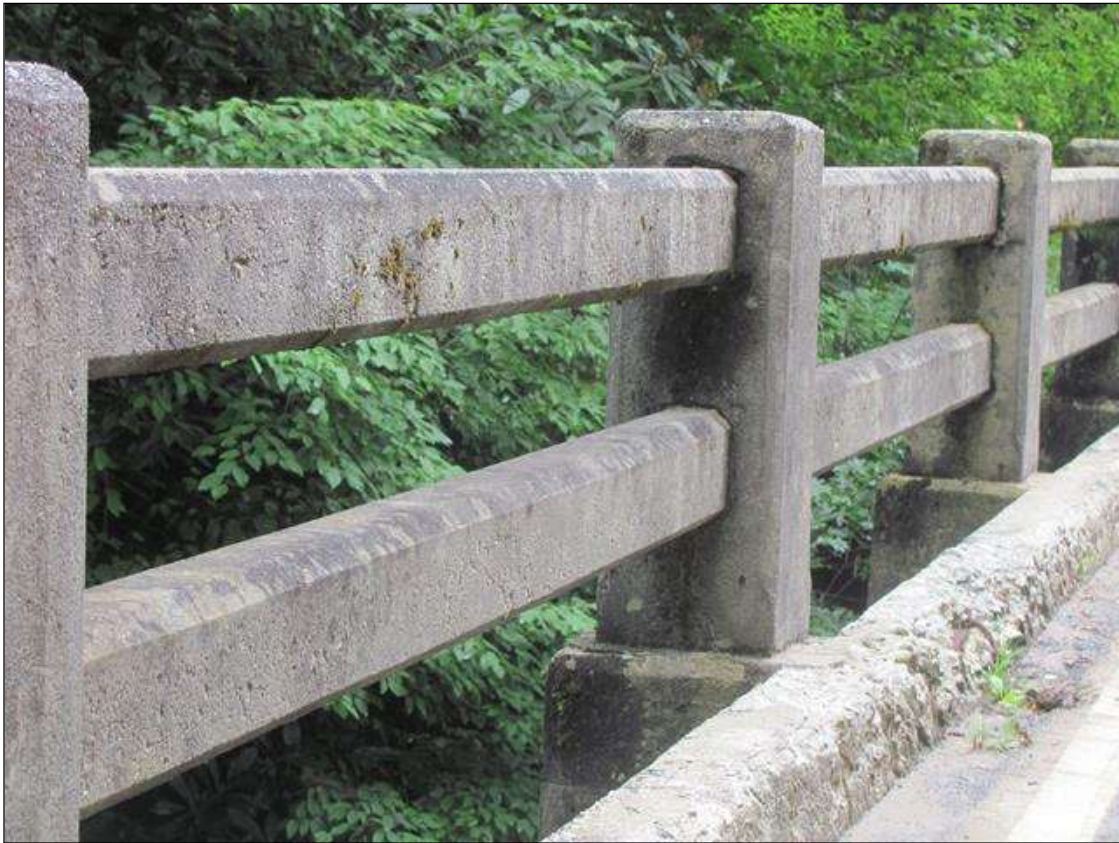
REP OF WEATHERING / SCALING OF CONCRETE BRIDGE RAILS (LEFT BRIDGE RAIL)

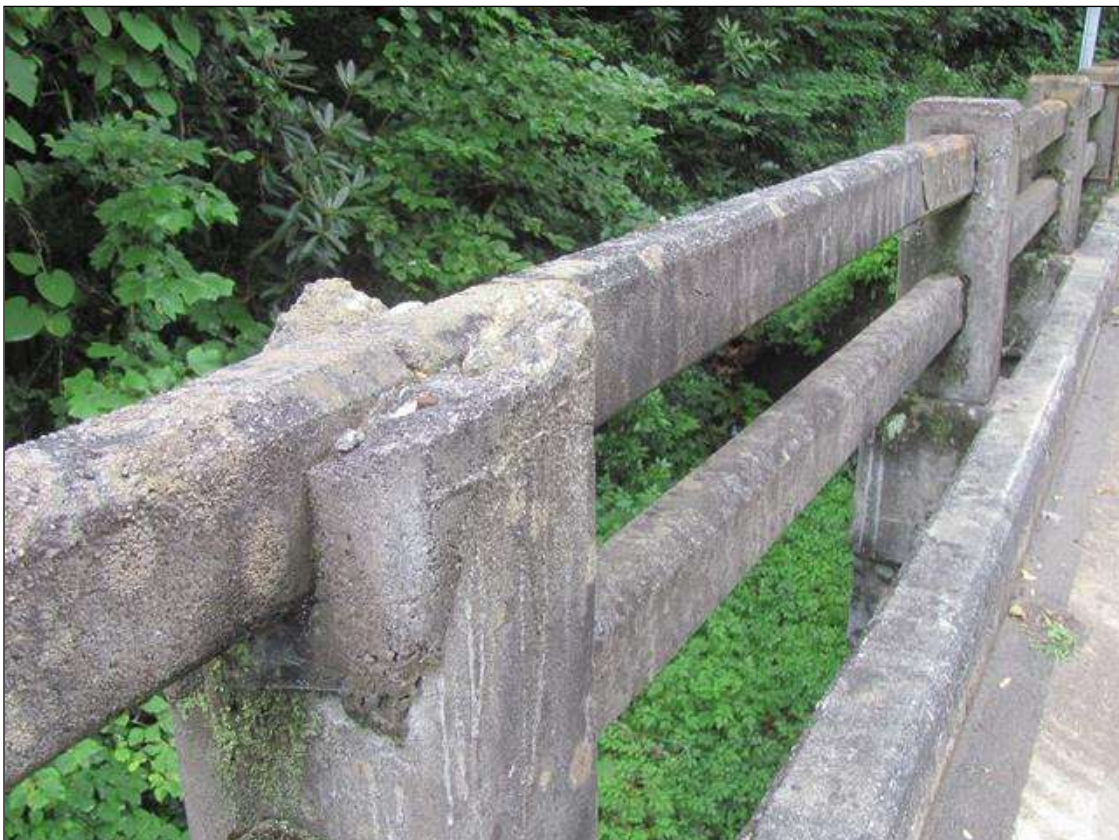
| Bridge I&A Form 1(82)H<br>State of North Carolina<br>Dept. of Transportation<br>Division of Highways | | <h1 style="text-align: center;">FIELD INSPECTION REPORT</h1> <h2 style="text-align: center;"><u>Bridge Inspection &amp; Analysis</u></h2> | |
|---|---|---|--|
| 3a | P | TOP 3" OF RAIL POST #4 AT DOWNSTREAM END HAS BROKEN OFF.<br>WEATHERING AND SCALING OF UPSTREAM RAIL, TYPICAL THROUGHOUT.<br>POST #4, #5 OF RIGHT RAIL AND POST #4 OF LEFT RAIL - THE CONCRETE BASE HAS DETERIORATED AWAY (SEE PHOTOS). A PRIORITY MAINTENANCE HAS BEEN REQUESTED FOR THESE CONDITIONS. | |

CONDITIONS FOUND AT LEFT RAIL POST #4

| MMS Code | Description of Function | Unit | Quantity | Remarks | Est. Cost |
|---|---|---|---|---|---|
| 3318 | Maint to Concrete Handrail | LF | 2 | THE CONCRETE BASE HAS DETERIORATED AWAY POST 4 LEFT RAIL | |

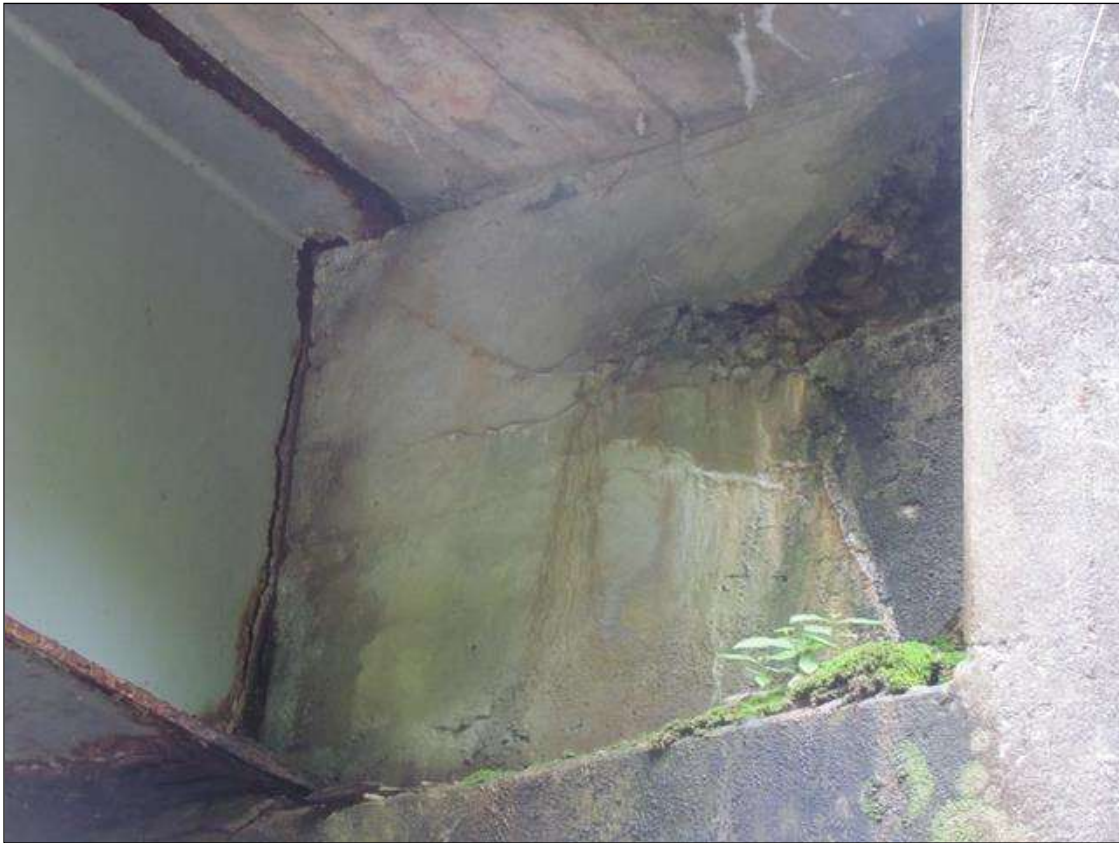
| Bridge I&A Form 1(82)H<br>State of North Carolina<br>Dept. of Transportation<br>Division of Highways | | <h1 style="text-align: center;">FIELD INSPECTION REPORT</h1> <h2 style="text-align: center;"><u>Bridge Inspection &amp; Analysis</u></h2> | |
|---|---|---|--|
| 13 | F | 2 FT. X 6 IN. X 3 IN. SPALL IN ABUTMENT 2 CURTAIN WALL OUTSIDE OF BEAM #4. | |

SPALLING / CRACKING AT END BENT 2 CURTAIN WALL / OUTSIDE OF BEAM #4

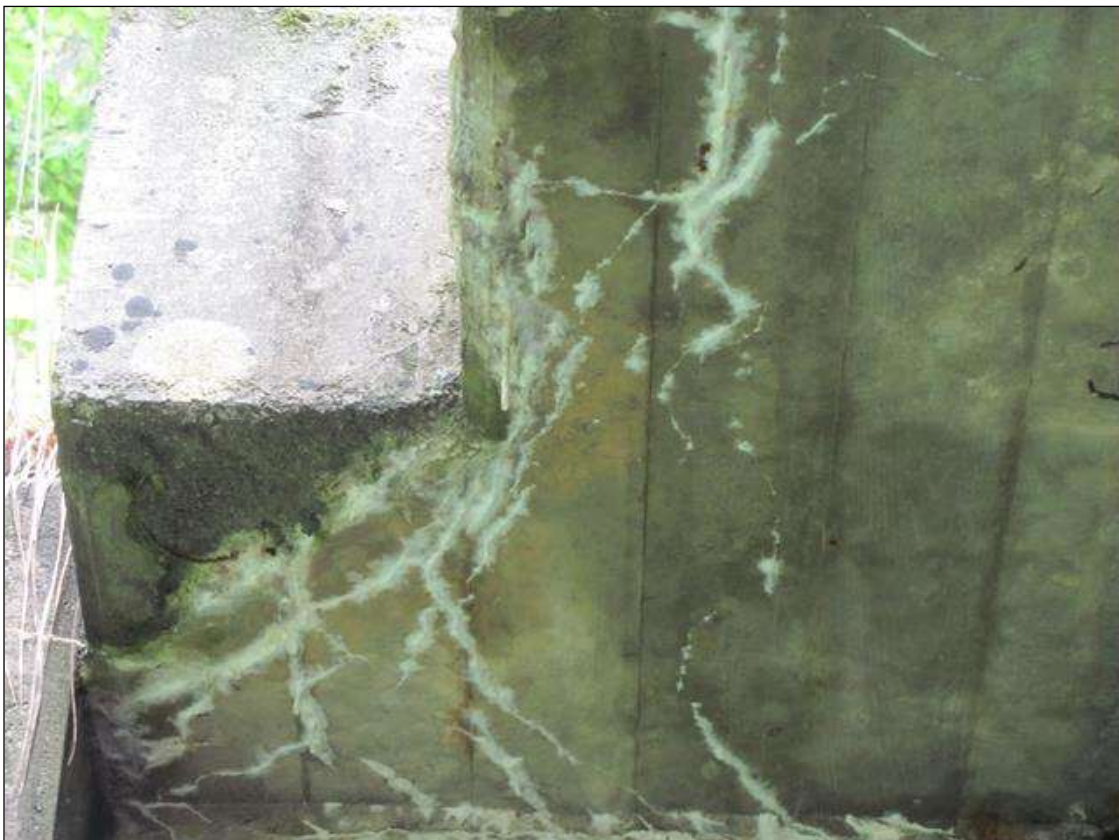
CRACKING WITH EFFLORESCENCE TO DOWNSTREAM OVERHANG / END BENT 2

| MMS Code | Description of Function | Unit | Quantity | Remarks | Est. Cost |
|---|---|---|---|---|---|
| 3326 | Maintain Concrete Deck | SF | 98 | DETERIORATION IN THE OVERHANGS. | |

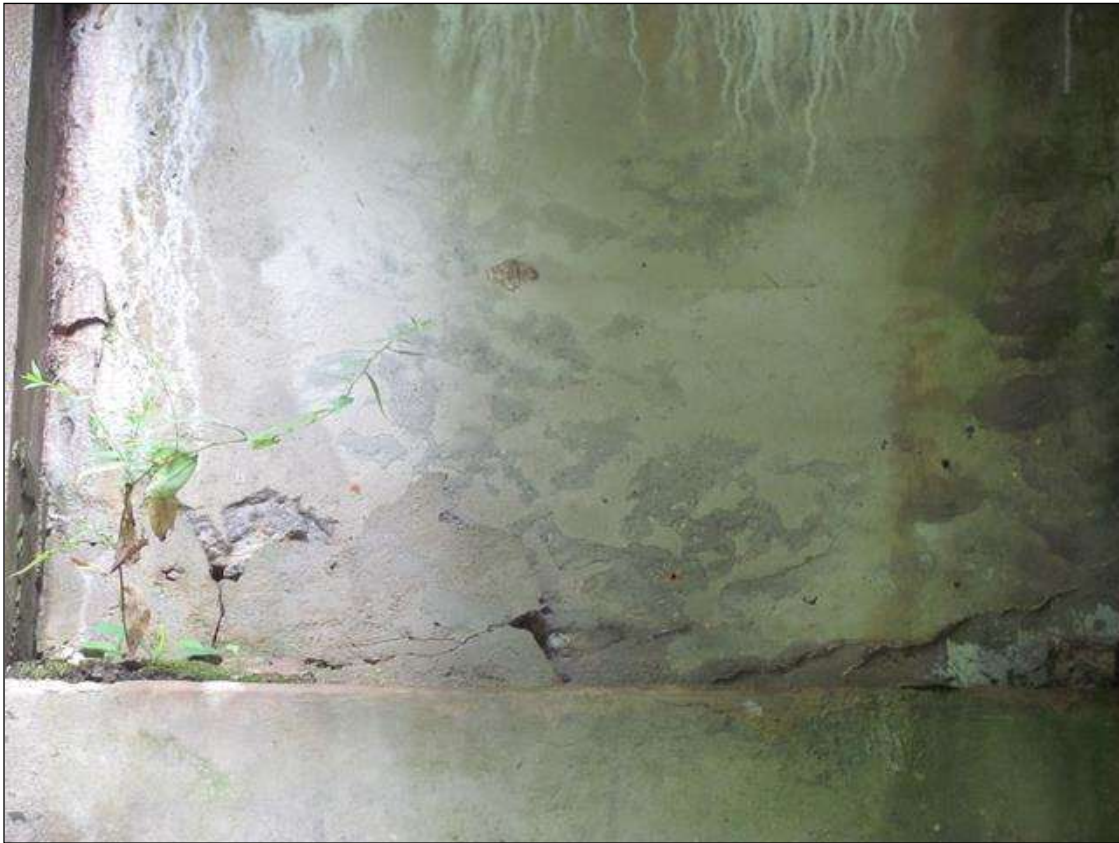
SPALLING / CRACKING AT END BENT 1 CURTAIN WALL / OUTSIDE OF BEAM #1

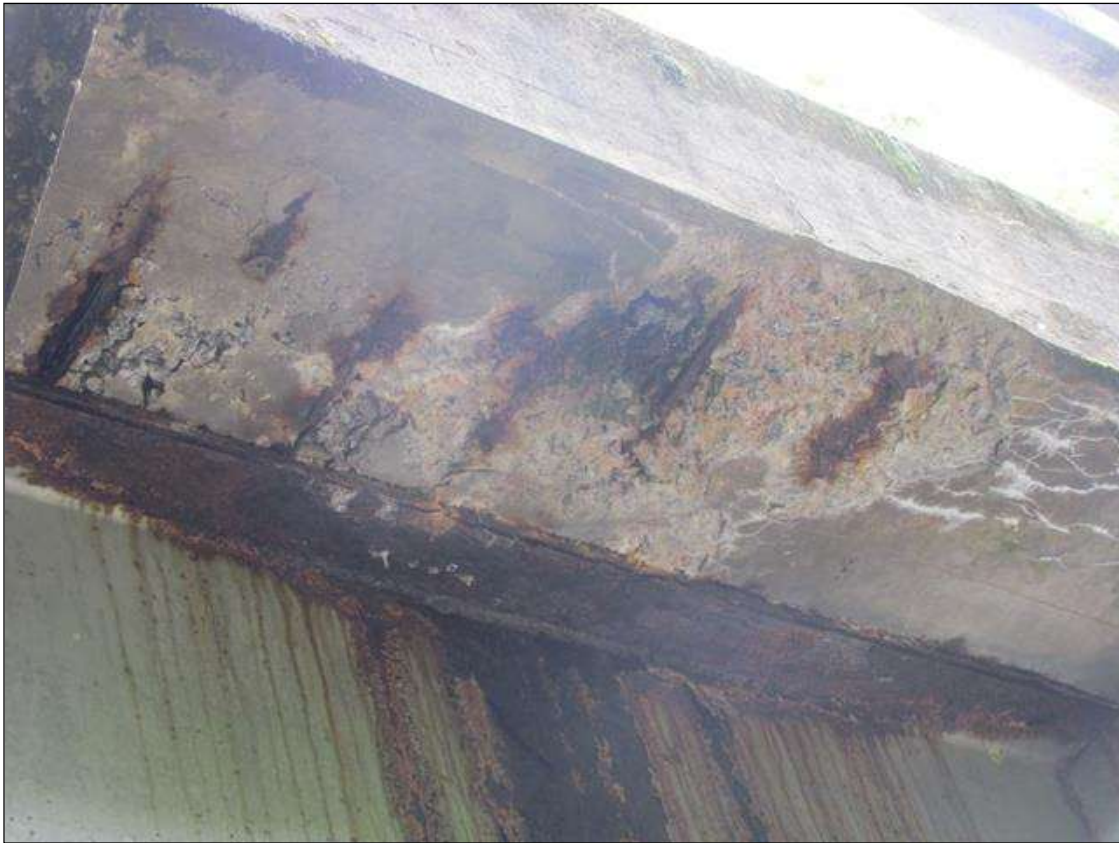
SPALLING WITH REBAR EXPOSURE TO DOWNSTREAM OVERHANG AT DECK DRAIN / MID-SPAN

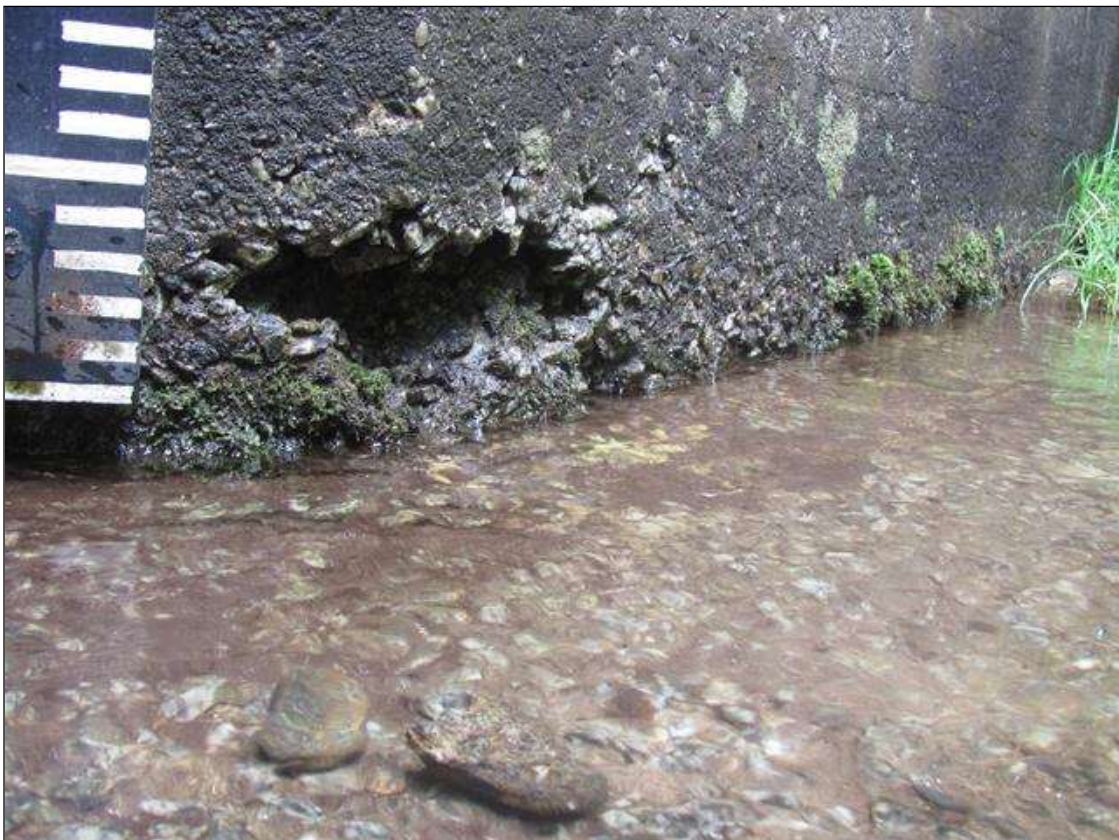
DETERIORATION AT BASE OF END BENT 2 / NORTH EAST WINGWALL
