# BRIDGE INSPECTION REPORT

INSPECTION TYPE: Routine Inspection

COUNTY TRANSYLVANIA BRIDGE NUMBER 870073 INSPECTION CYCLE 2 YRS  
N. FORK FRENCH BROAD RVR.  
ROUTE NC215 ACROSS N.FORK FRENCH BROAD RVR. M.P. 0

INSPECTION DATE 07/22/2014

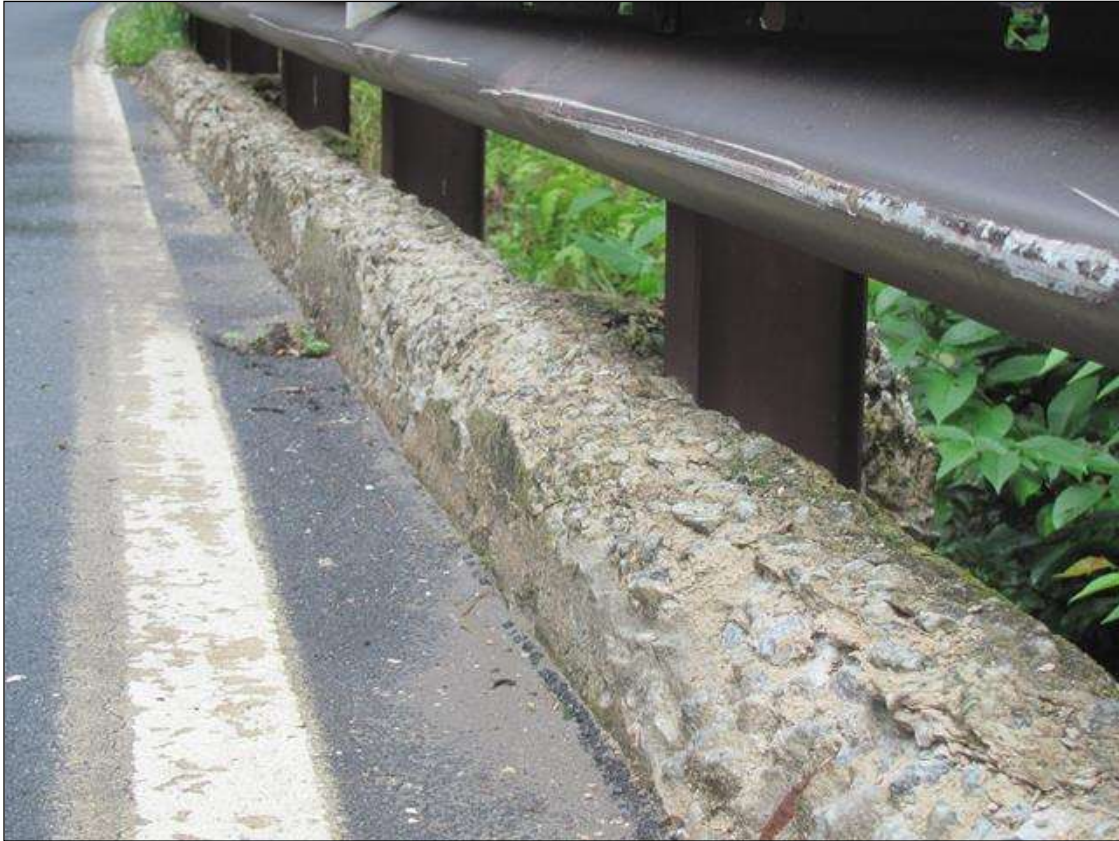
| Bridge I&A Form 1(82)H<br>State of North Carolina<br>Dept. of Transportation<br>Division of Highways | | <h1>FIELD INSPECTION REPORT</h1> <h2><u>Bridge Inspection &amp; Analysis</u></h2> | |
|---|---|---|--|
| 4 | F | UPSTREAM CONCRETE CURB IS WEATHERED AND SPALLED ALONG FULL LENGTH.<br>4 FT. X 8 IN. X 8 IN. SPALL WITH EXPOSED REINFORCING IN SOUTH END OF DOWNSTREAM CURB.<br>5 FT. X 8 IN. X 8 IN. SPALL AT NORTH END OF DOWNSTREAM CURB. | |

SPALLING / DETERIORATION THROUGHOUT CONCRETE CURB AT BASE OF RIGHT BRIDGE RAIL

| MMS Code | Description of Function | Unit | Quantity | Remarks | Est. Cost |
|---|---|---|---|---|---|
| 3318 | Maint to Concrete Handrail | LF | 71 | DETERIORATION IN THE CURBS. | |

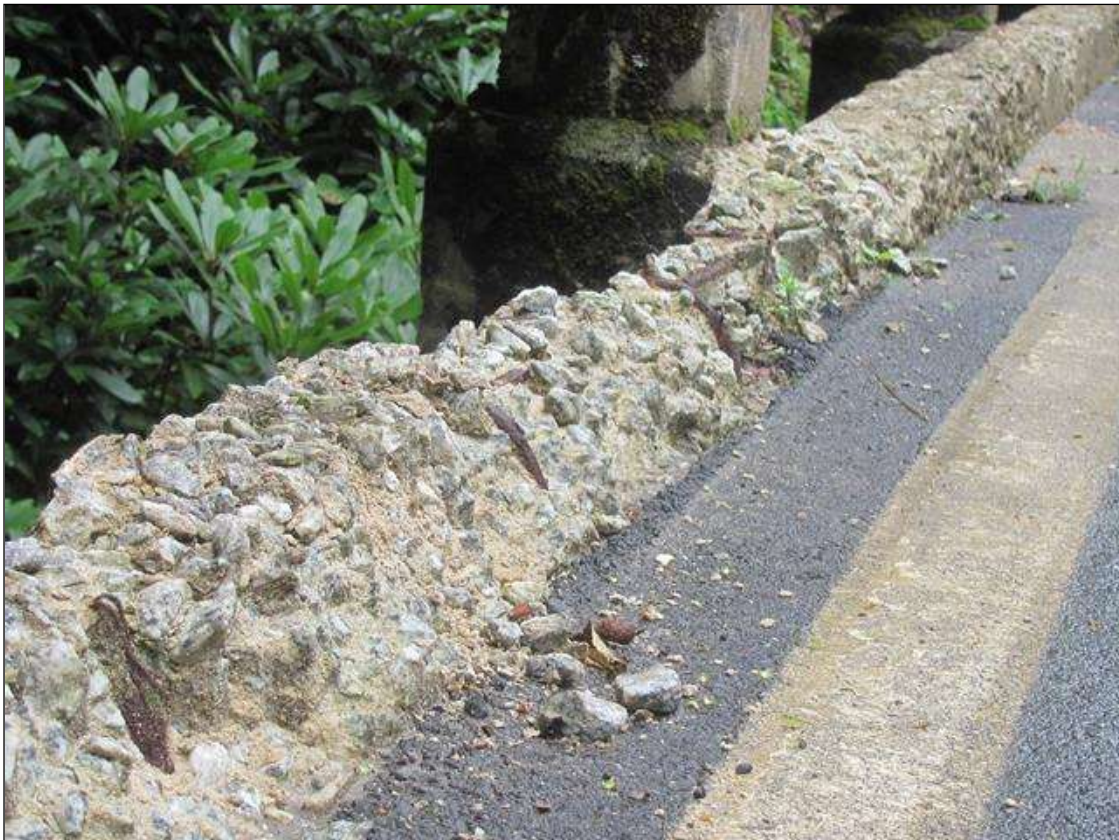
SPALLING / DETERIORATION WITH REBAR EXPOSURE THROUGHOUT CONCRETE CURB AT BASE OF LEFT BRIDGE RAIL

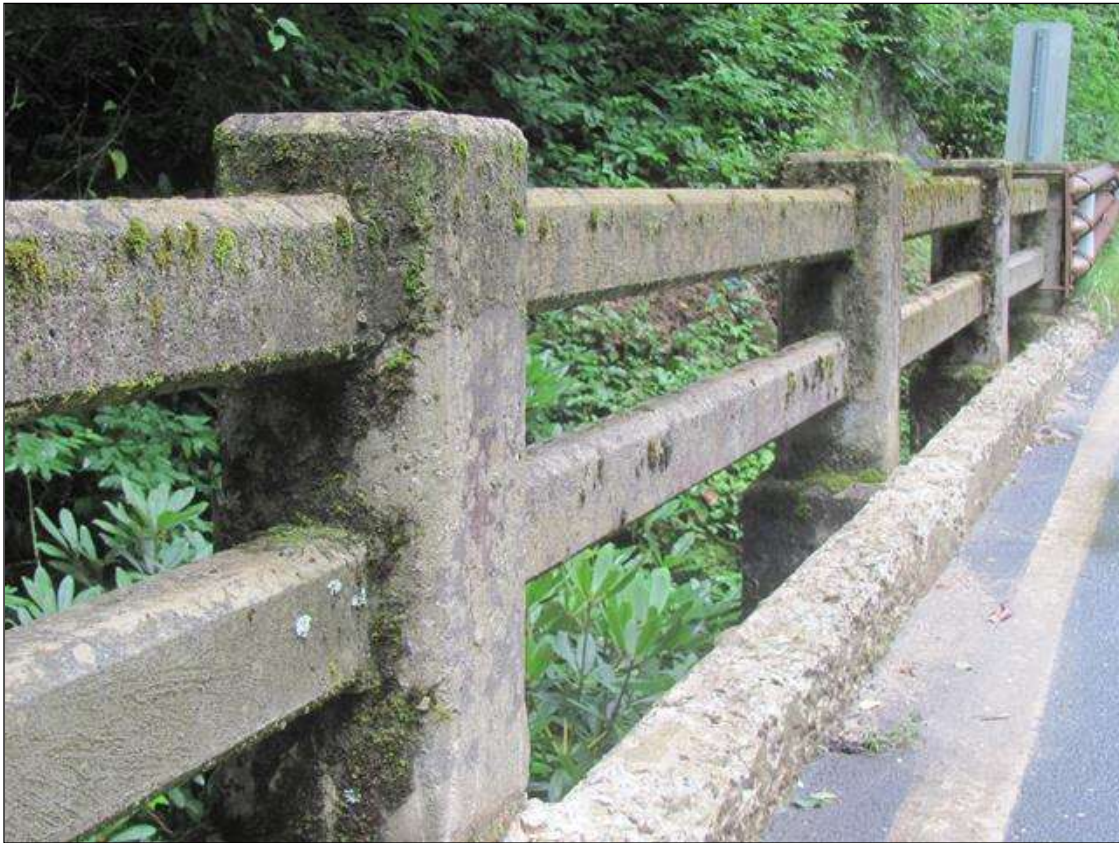
| Bridge I&A Form 1(82)H<br>State of North Carolina<br>Dept. of Transportation<br>Division of Highways | | <h1>FIELD INSPECTION REPORT</h1> <h2><u>Bridge Inspection &amp; Analysis</u></h2> | |
|---|---|---|--|
| 3a | F | DOWNSTREAM RAIL POST ATTACHMENT IS DELAMINATED WITH HAIRLINE CRACKS AND EFFLORESCENCE; SIMILAR AT ALL ATTACHMENTS.<br>WEATHERING AND SCALING OF CONCRETE RAILS WITH AREAS OF DELAMINATION AND VEGETATION GROWTH. | |

REP OF WEATHERING / SCALING AT LEFT BRIDGE RAIL

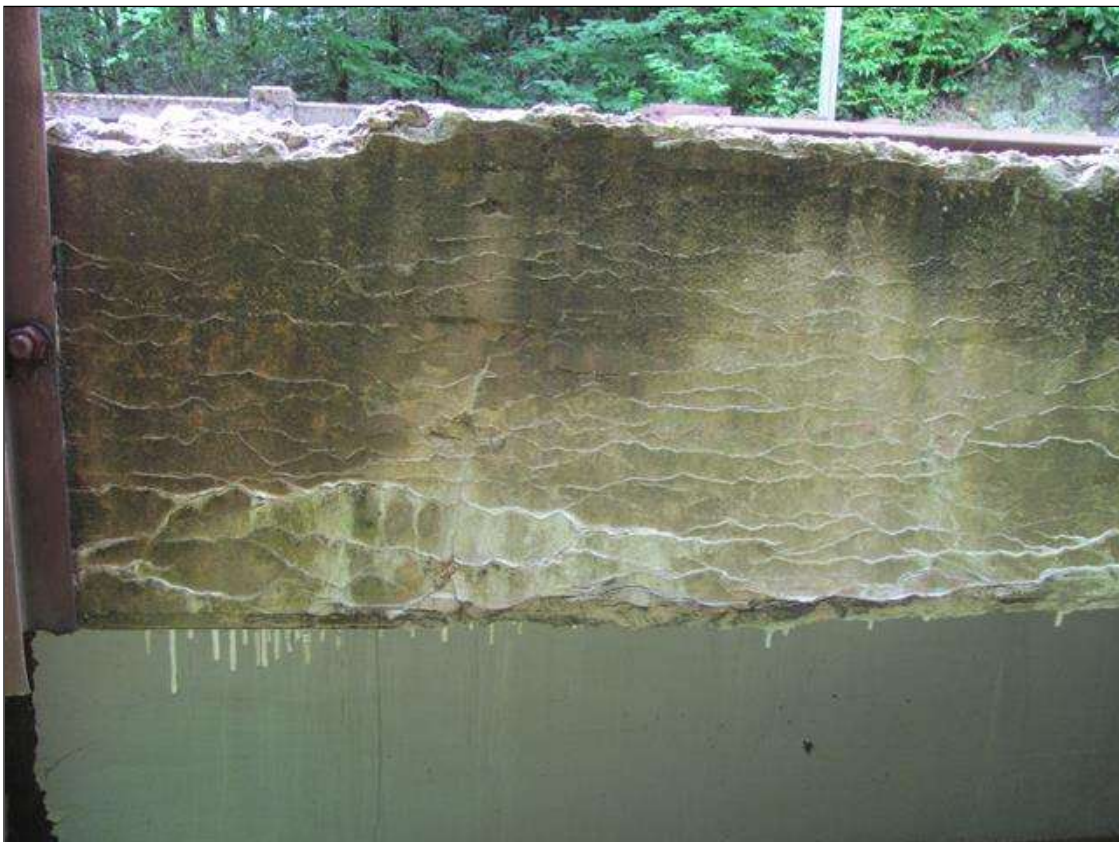
REP OF DELAMINATION, MAP CRACKING, EFFLORESCENCE AT UPSTREAM EDGE OF CONCRETE DECK

| MMS Code | Description of Function | Unit | Quantity | Remarks | Est. Cost |
|---|---|---|---|---|---|
| 3326 | Maintain Concrete Deck | SF | 164 | DETERIORATION IN THE OVERHANGS. | |

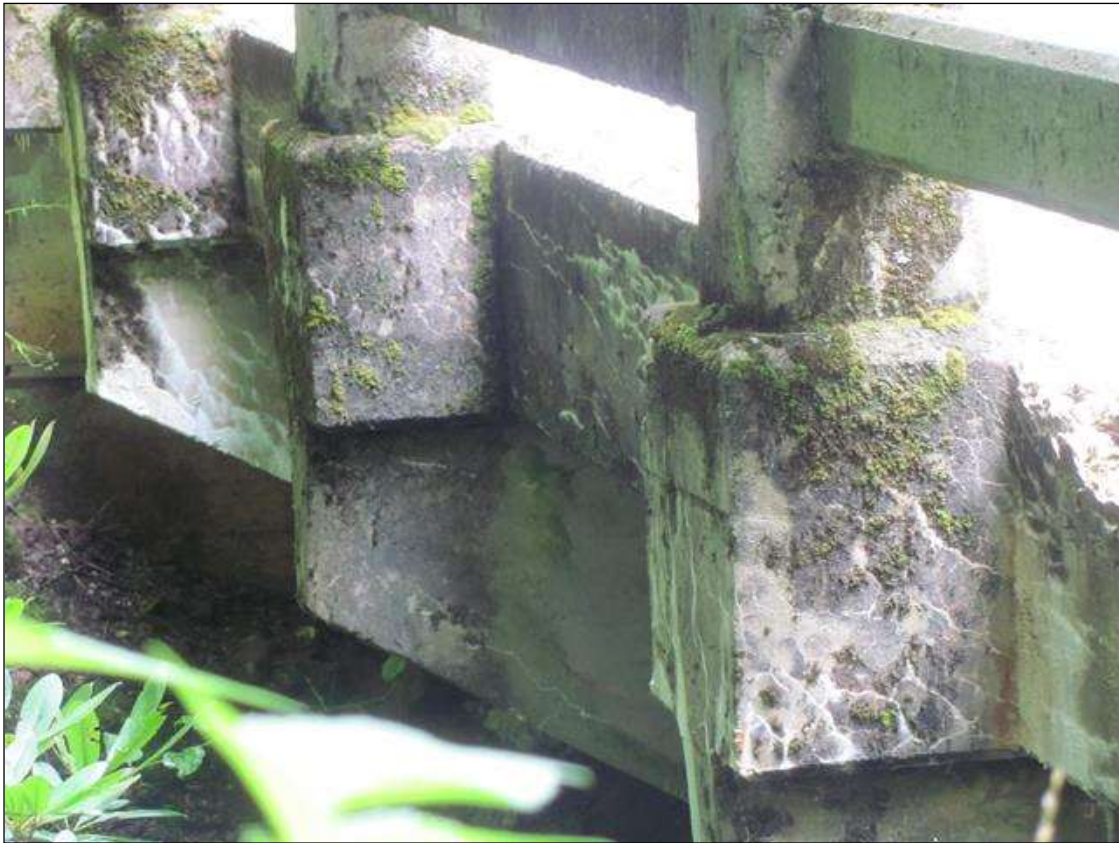
REP OF DELAMINATION, CRACKING, EFFLORESCENCE AT BRIDGE RAIL ATTACHMENTS (LEFT BRIDGE RAIL SHOWN)

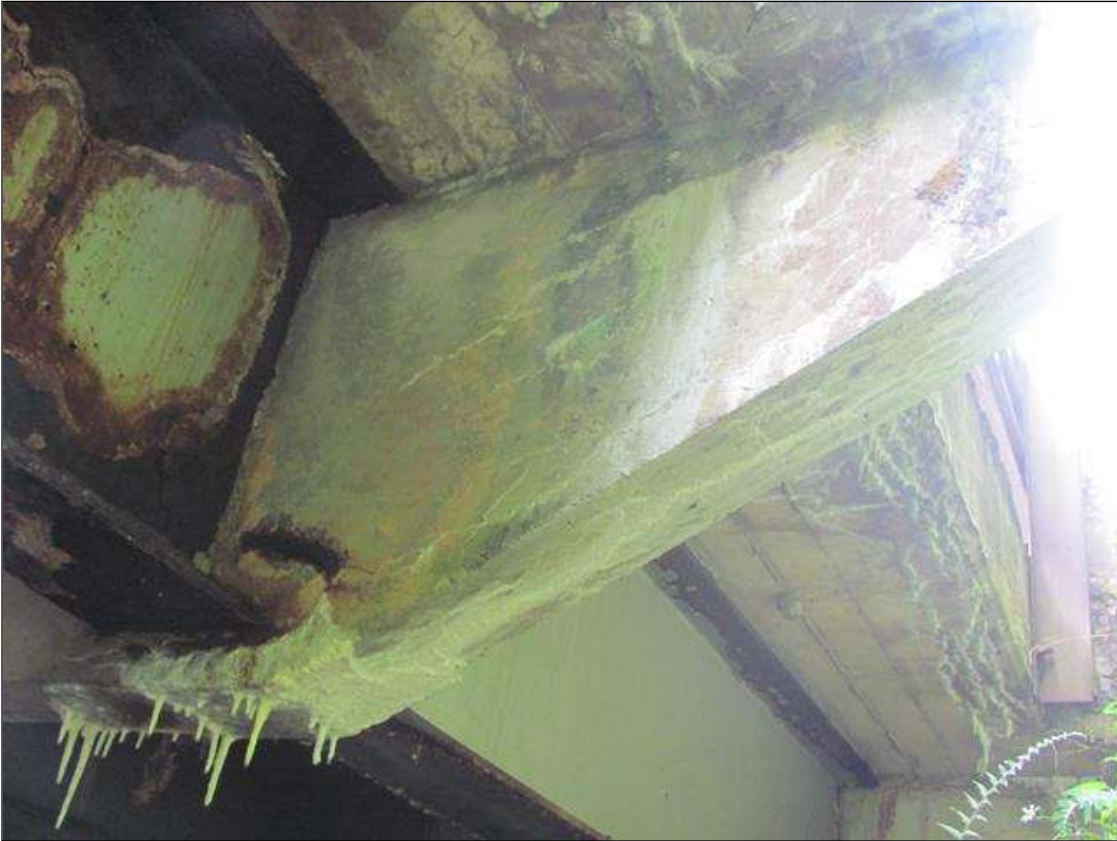
CRACKS WITH EFFLORESCENCE AT UNDERSIDE OF INTERIOR DIAPHRAGM / BEAM #4 / 10' FROM END BENT  
2

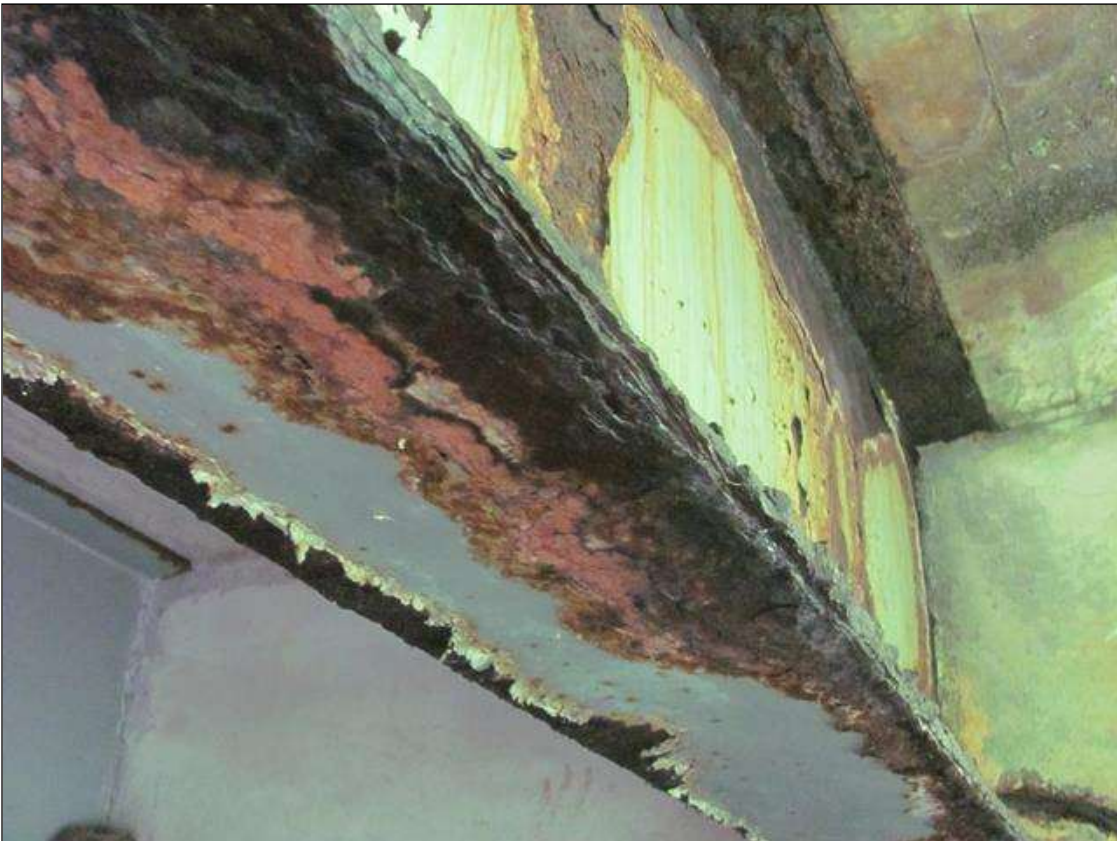
| Bridge I&A Form 1(82)H<br>State of North Carolina<br>Dept. of Transportation<br>Division of Highways | | <h1>FIELD INSPECTION REPORT</h1> <h2><u>Bridge Inspection &amp; Analysis</u></h2> | |
|---|---|---|--|
| 10 | F | RUST SCALE WITH UP TO 3/16 IN. SECTION LOSS OF BOTTOM FLANGE, FULL LENGTH OF GIRDER 4.<br>RUST SCALE WITH 1/8 IN. SECTION LOSS IN TOP FLANGE OF GIRDER 1, FULL LENGTH.<br>SURFACE RUST AND PAINT PEELING ON ALL INTERIOR GIRDER FLANGES; TYPICAL THROUGHOUT. | |

REP OF RUST AND LOSS TO BEAMS (BEAM #4)

| MMS Code | Description of Function | Unit | Quantity | Remarks | Est. Cost |
|---|---|---|---|---|---|
| 5603 | Partial Cleaning and Painting of Structural Steel | SF | 955 | RUST AND LOSS TO BEAMS. | |

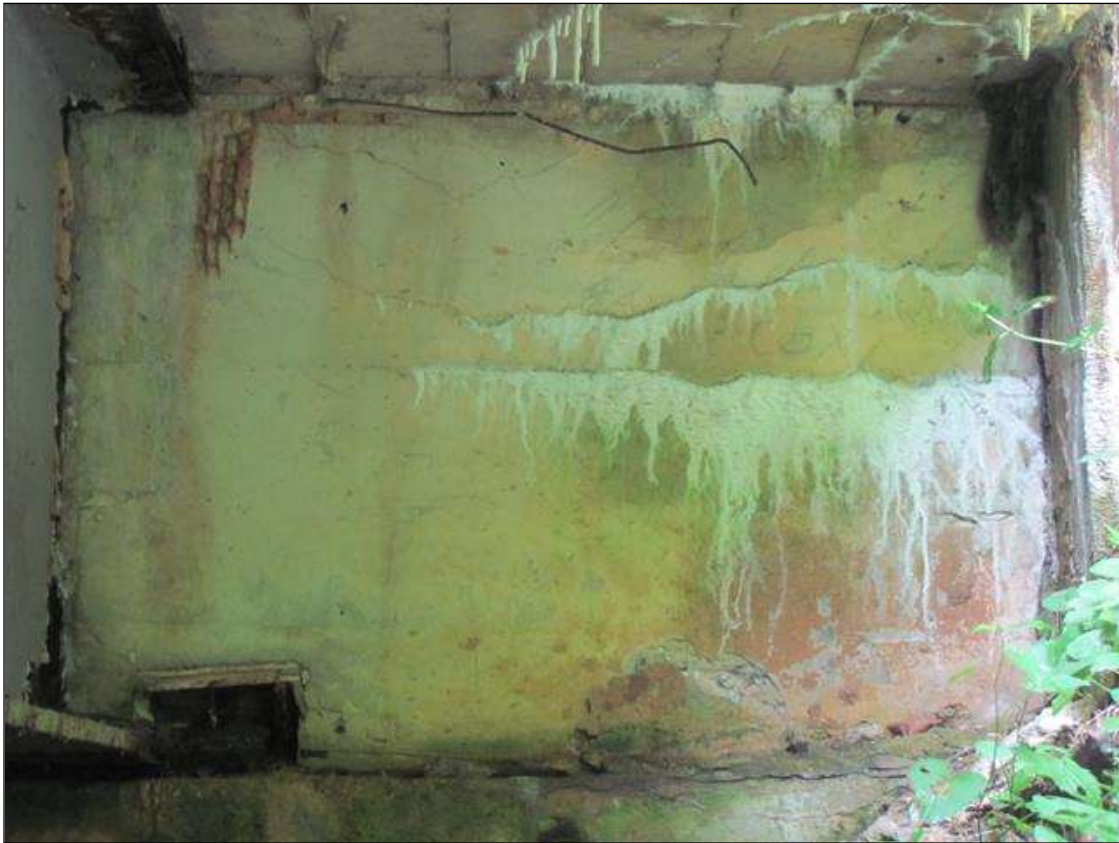
HORIZONTAL CRACKS WITH EFFLORESCENCE AT END BENT 2 CURTAIN WALL / OUTSIDE OF BEAM #4

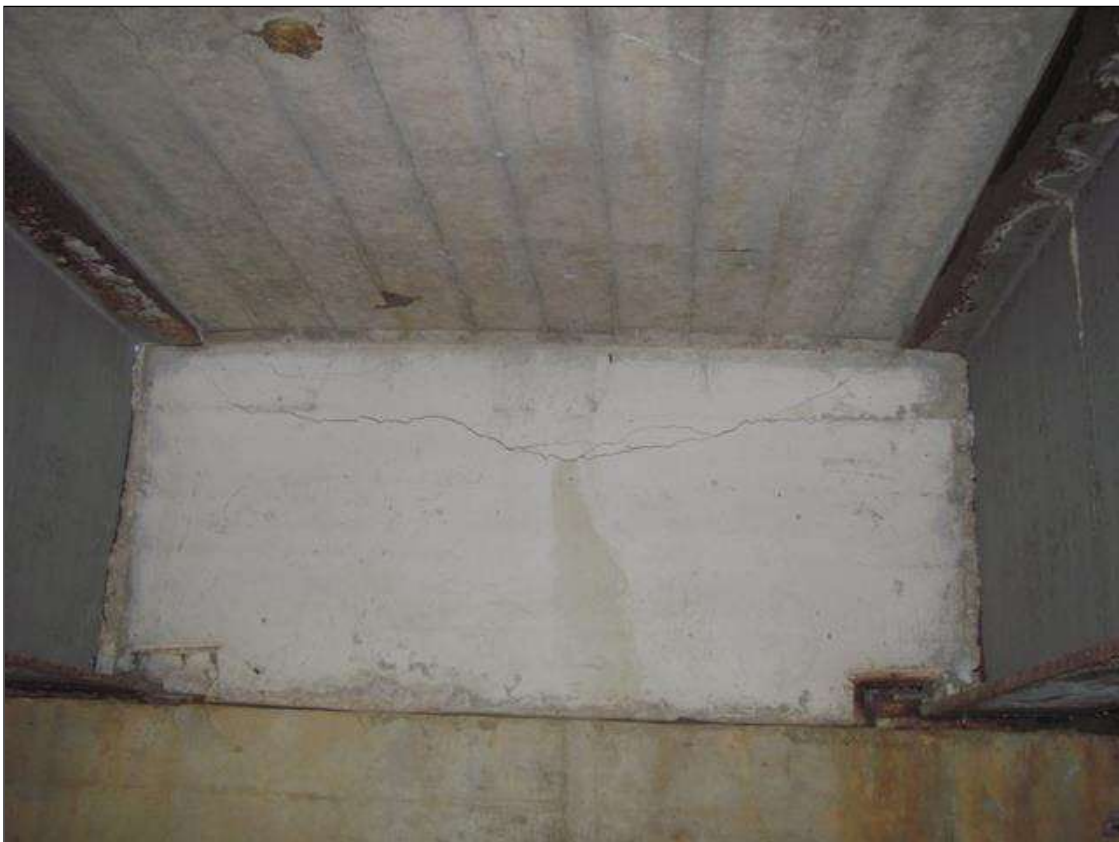
| Bridge I&A Form 1(82)H<br>State of North Carolina<br>Dept. of Transportation<br>Division of Highways | | <b>FIELD INSPECTION REPORT</b><br><u>Bridge Inspection &amp; Analysis</u> | |
|---|---|---|--|
| 13 | F | FULL WIDTH HORIZONTAL CRACK UP TO 1/ 8IN. ABUTMENT 2 CURTAINWALL IN ALL BAYS.<br>(2) 2 FT. HORIZONTAL HAIRLINE CRACKS WITH EFFLORESCENCE, OUTSIDE OF GIRDER 4 CURTAIN WALL AT ABUTMENT 2.<br>3 HORIZONTAL HAIRLINE CRACKS IN ABUTMENT 1 CURTAIN WALL WITH EFFLORESCENCE OUTSIDE OF GIRDER 4 | |

REP OF HORIZONTAL CRACKS IN END BENT 2 CURTAIL WALL (BAY #2)

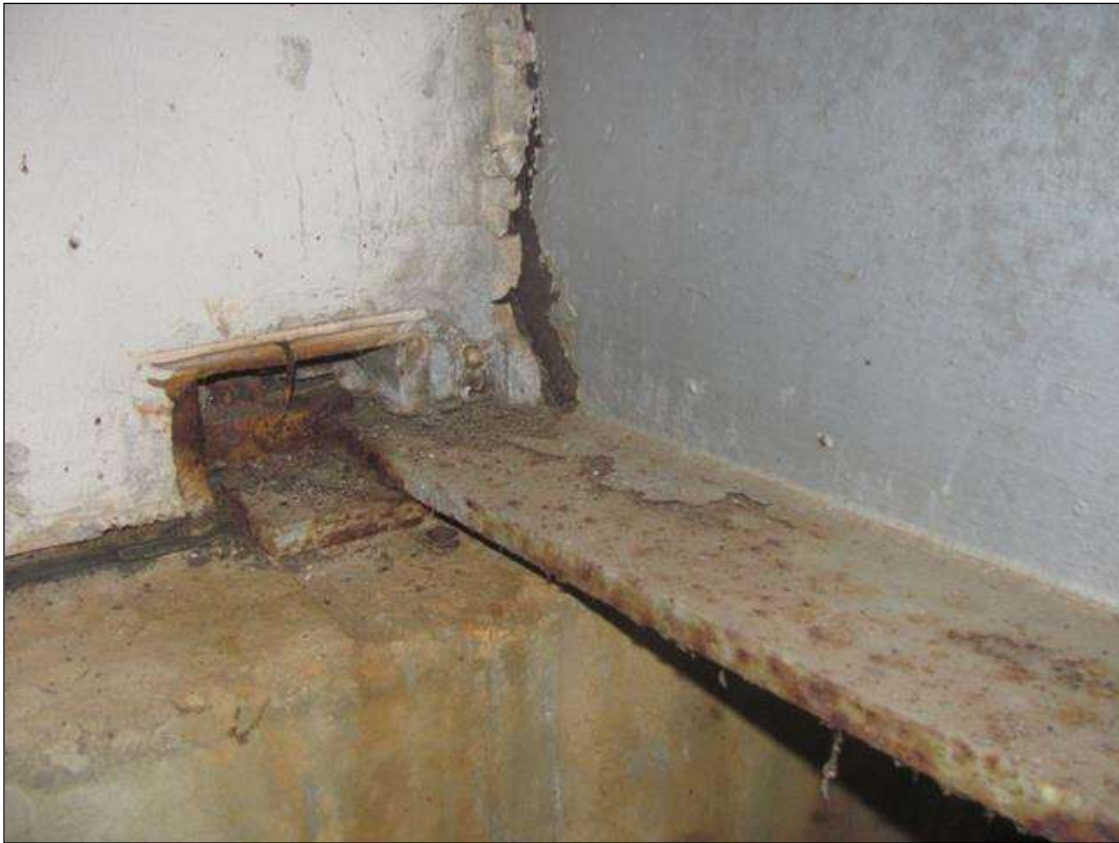
| Bridge I&A Form 1(82)H<br>State of North Carolina<br>Dept. of Transportation<br>Division of Highways | | <b>FIELD INSPECTION REPORT</b><br><u>Bridge Inspection &amp; Analysis</u> | |
|---|---|---|--|
| 15 | F | RUST SCALE WITH UP TO 3/16" SECTION LOSS AT BEARING OF GIRDER 3, ABUTMENT 2, ALL OTHER BEARINGS SIMILAR. | |

REP OF RUST AND LOSS TO BEARINGS (BEAM #3 / END BENT 2)

| MMS Code | Description of Function | Unit | Quantity | Remarks | Est. Cost |
|---|---|---|---|---|---|
| 3314 | Maintain Steel Superstructure Components | LF | 28 | RUST AND LOSS TO THE BEARING ASSEMBLIES. | |

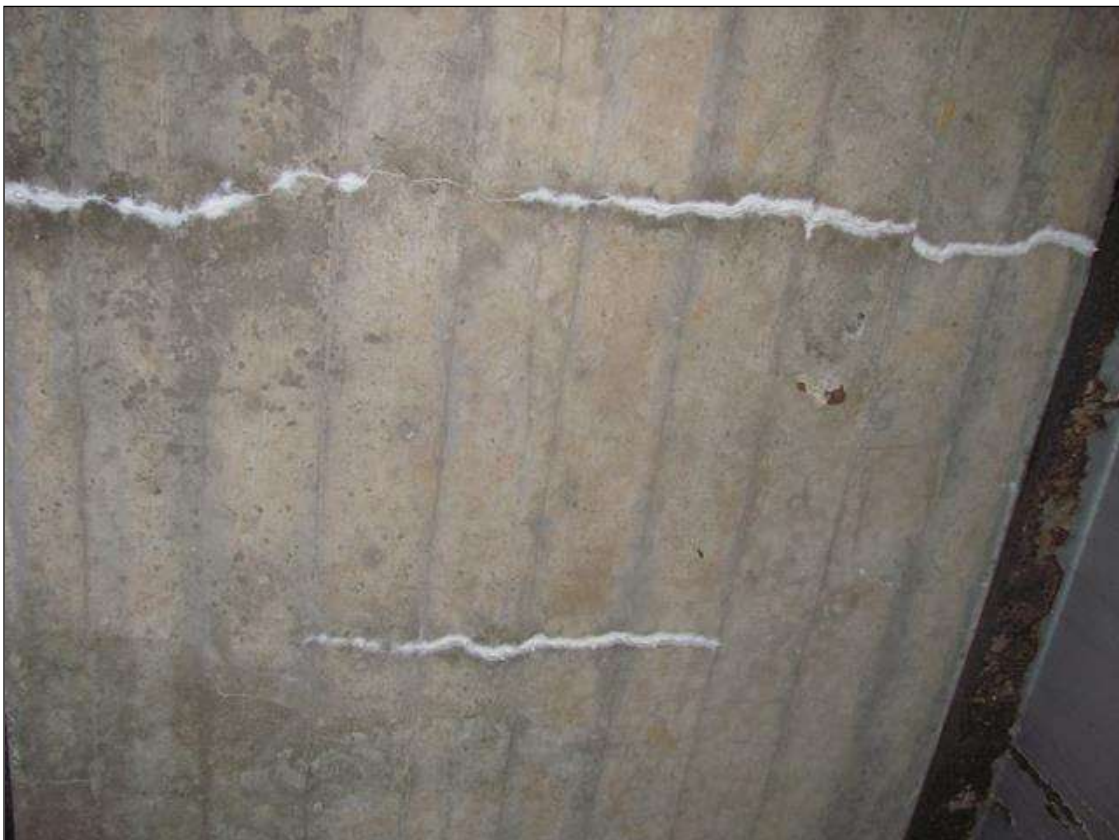
REP OF CRACKS WITH EFFLORESCENCE TO UNDERSIDE OF BRIDGE DECK (BAY #3)

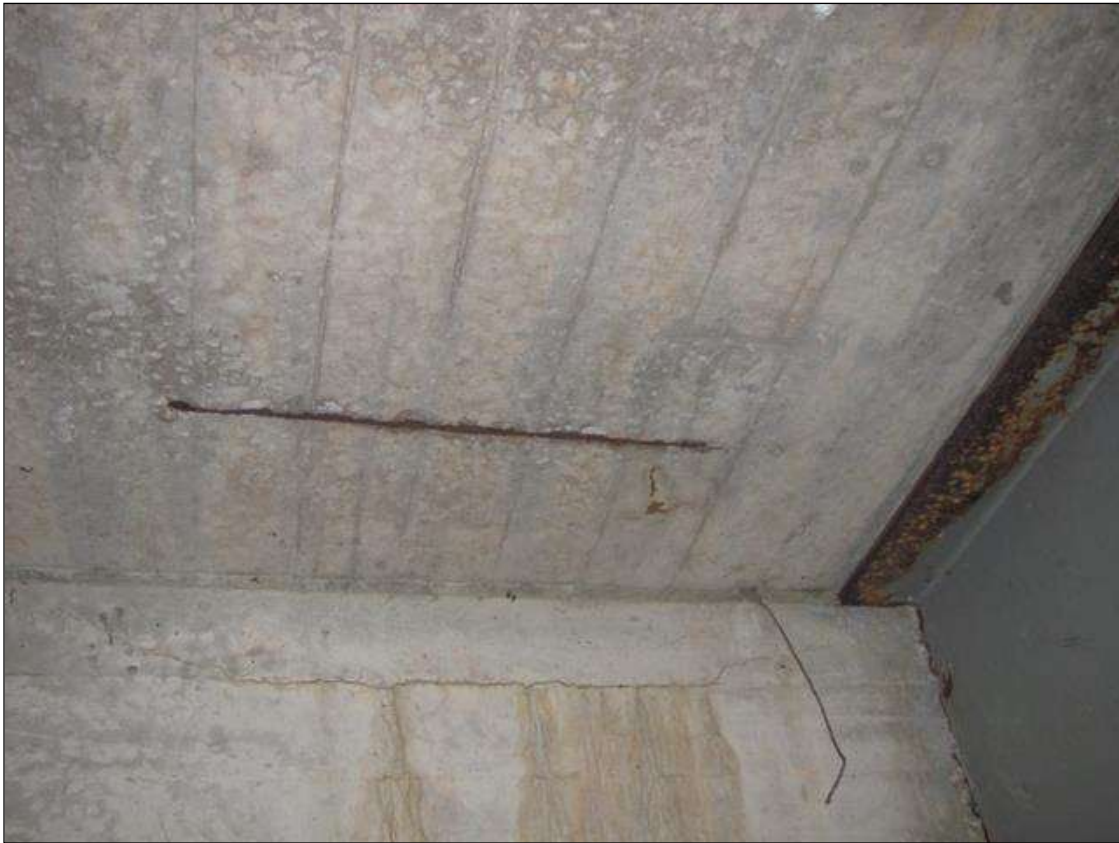
SPALL WITH REBAR EXPOSURE TO UNDERSIDE OF BRIDGE DECK / BAY #3 / END BENT 2

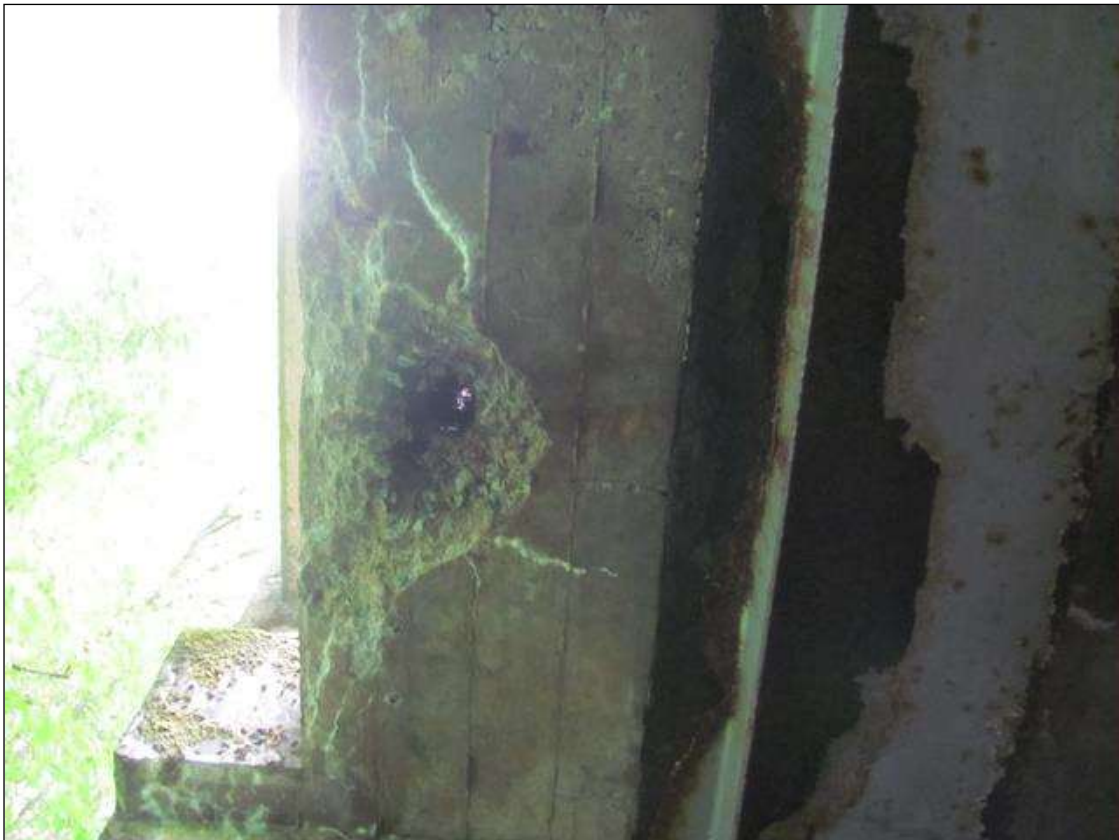
SPALLING WITH REBAR EXPOSURE TO DOWNSTREAM OVERHANG AT DECK DRAIN

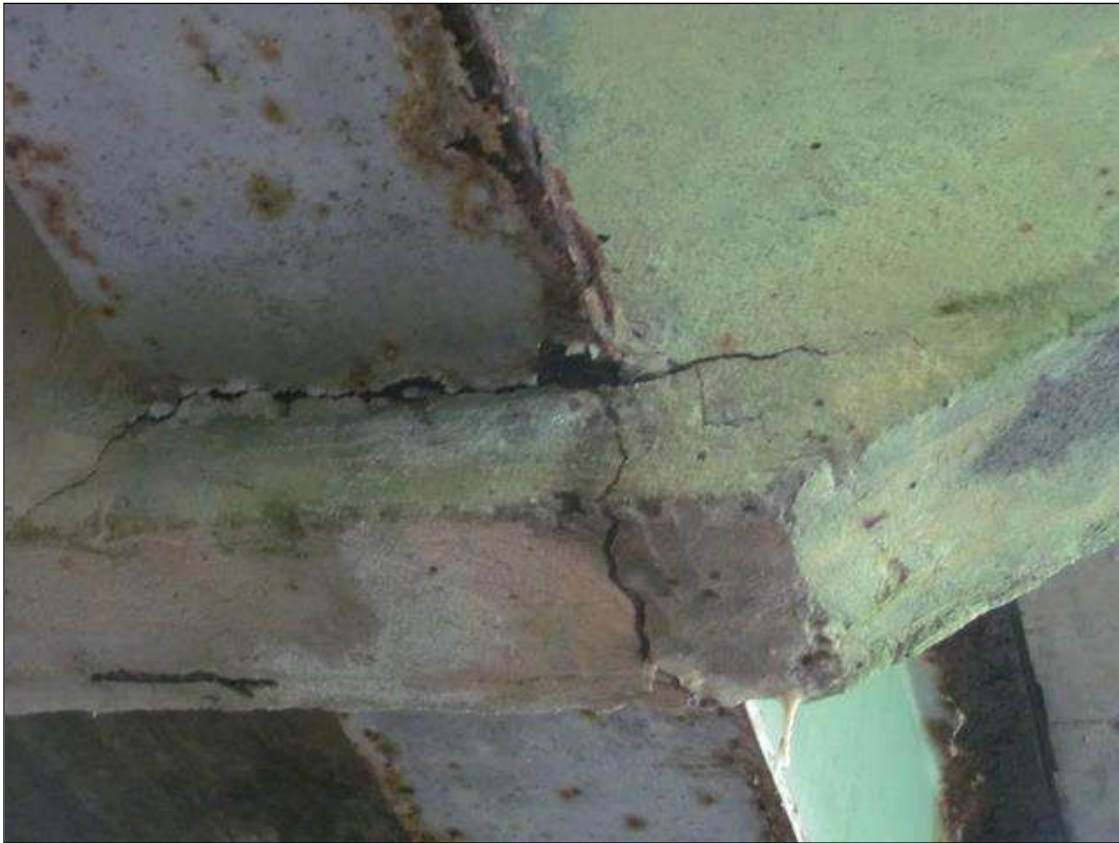
DELAMINATION TO INTERIOR DIAPHRAGM AT BEAM #1 / MID-SPAN

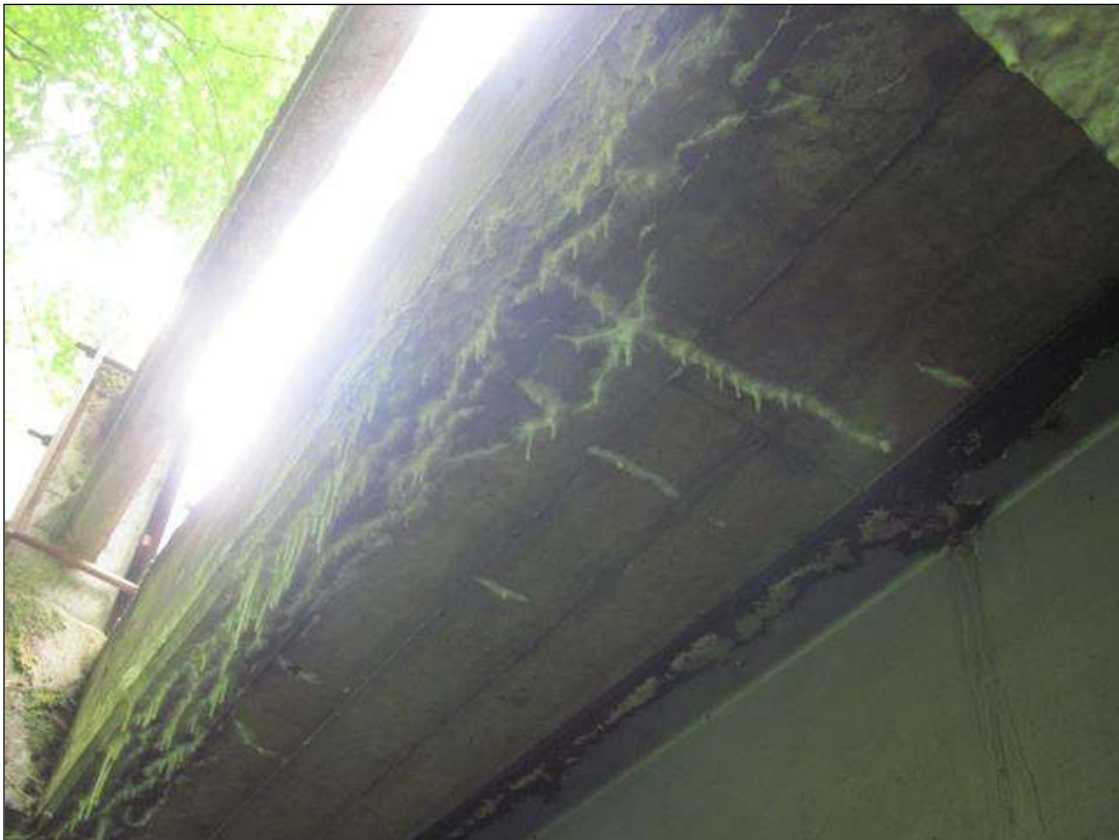
REP OF CRACKING WITH EFFLORESCENCE TO DOWNSTREAM OVERHANG

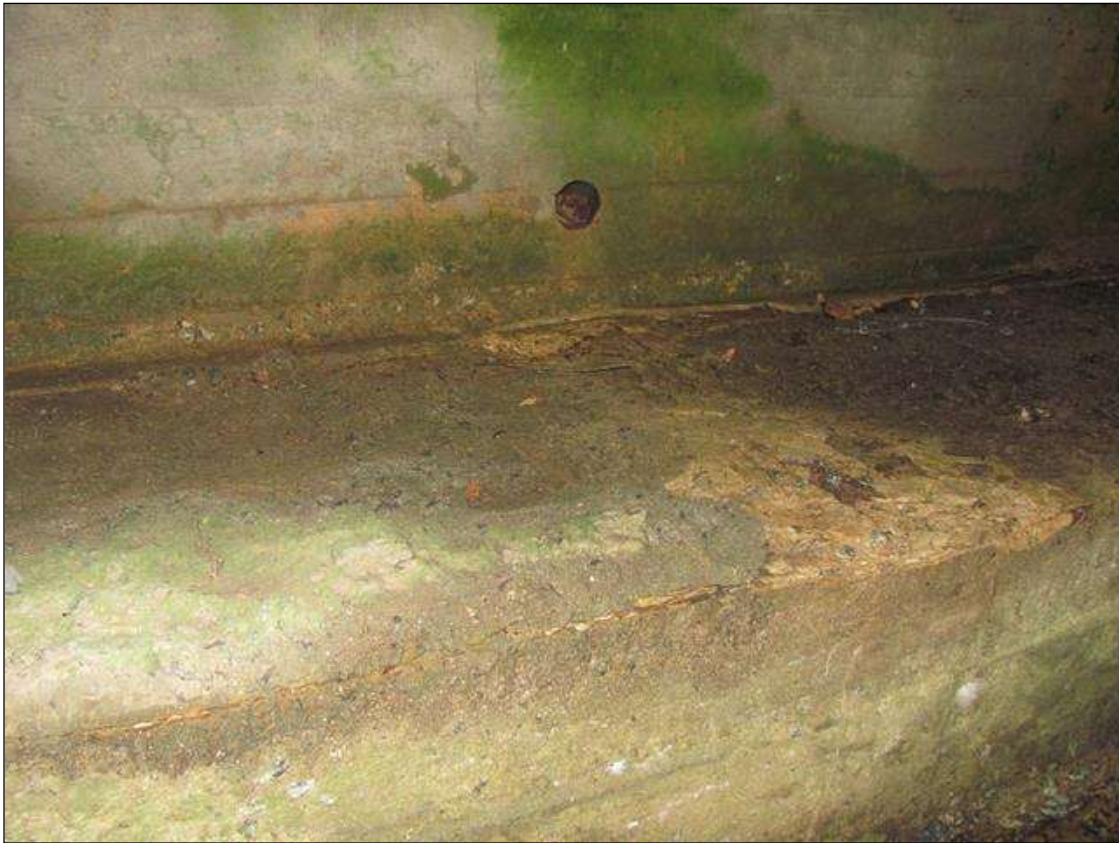
| Bridge I&A Form 1(82)H<br>State of North Carolina<br>Dept. of Transportation<br>Division of Highways | | <b>FIELD INSPECTION REPORT</b><br><u>Bridge Inspection &amp; Analysis</u> | |
|---|---|---|--|
| 36e | F | 4 FT. X 2 FT. X 2 FT. DETERIORATION OF CONCRETE SILL AT ABUTMENT 1.<br>UPSTREAM END OF ABUTMENT 1 SILL IS WEATHERED AND SPALLED.<br>END BENT 2 FOOTING IS NOT VISIBLE. | |

DETERIORATION / SPALLING AT END BENT 1 CONCRETE SILL

| MMS Code | Description of Function | Unit | Quantity | Remarks | Est. Cost |
|---|---|---|---|---|---|
| 3348 | Maintain Concrete Substructure Components | LF | 28 | DETERIORATION IN THE FOOTING AT ABUTMENT 1. VOIDS / UNDERMINING BENEATH THE FOOTING OF THE UPSTREAM WINGWALL AT ABUTMENT 1. | |

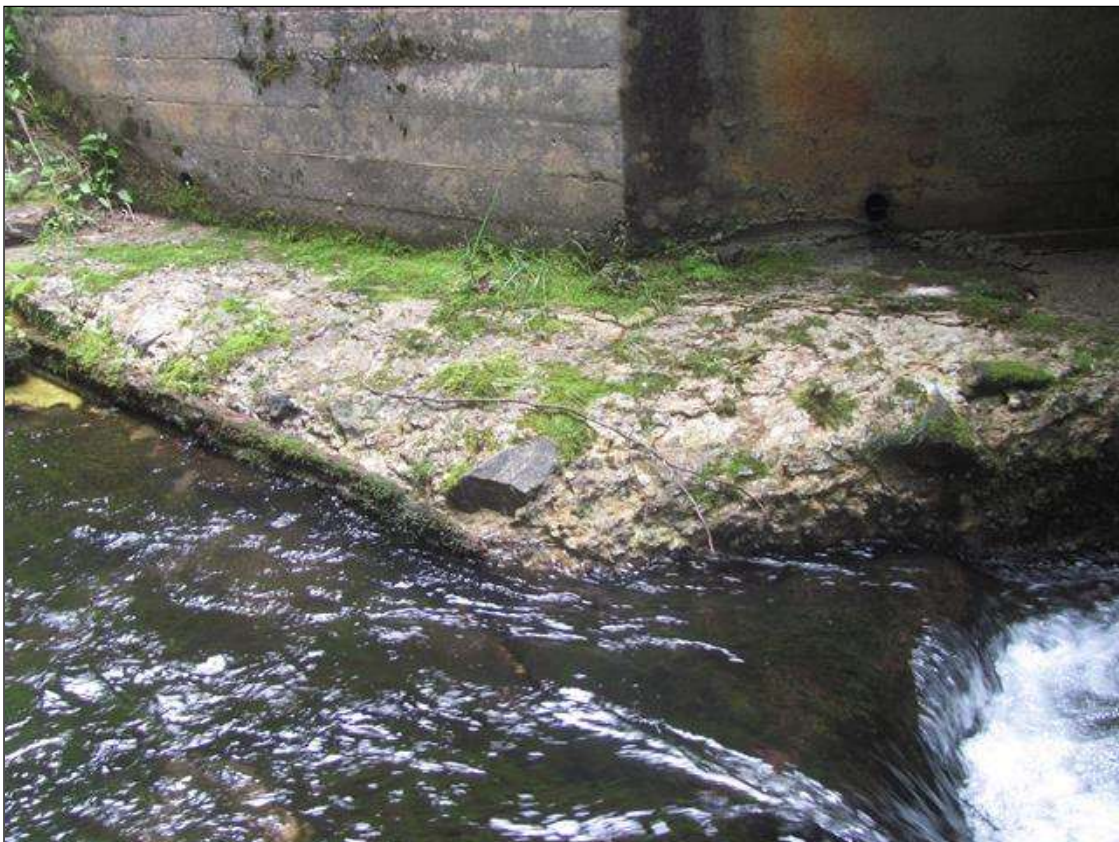
DETERIORATION / SPALLING AT UPSTREAM END OF END BENT 1 SILL

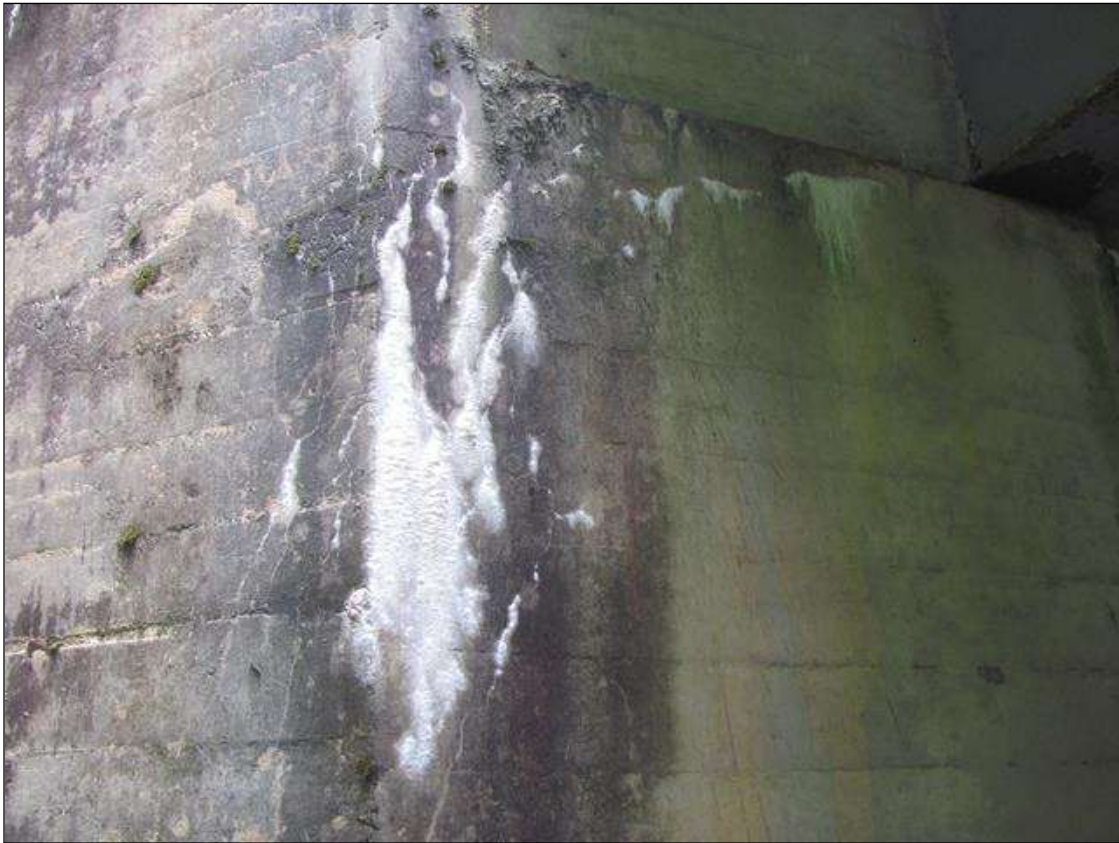
MAP CRACKING WITH EFFLORESCENCE AT END BENT 1 CURTAIN WALL / SOUTH EAST WINGWALL

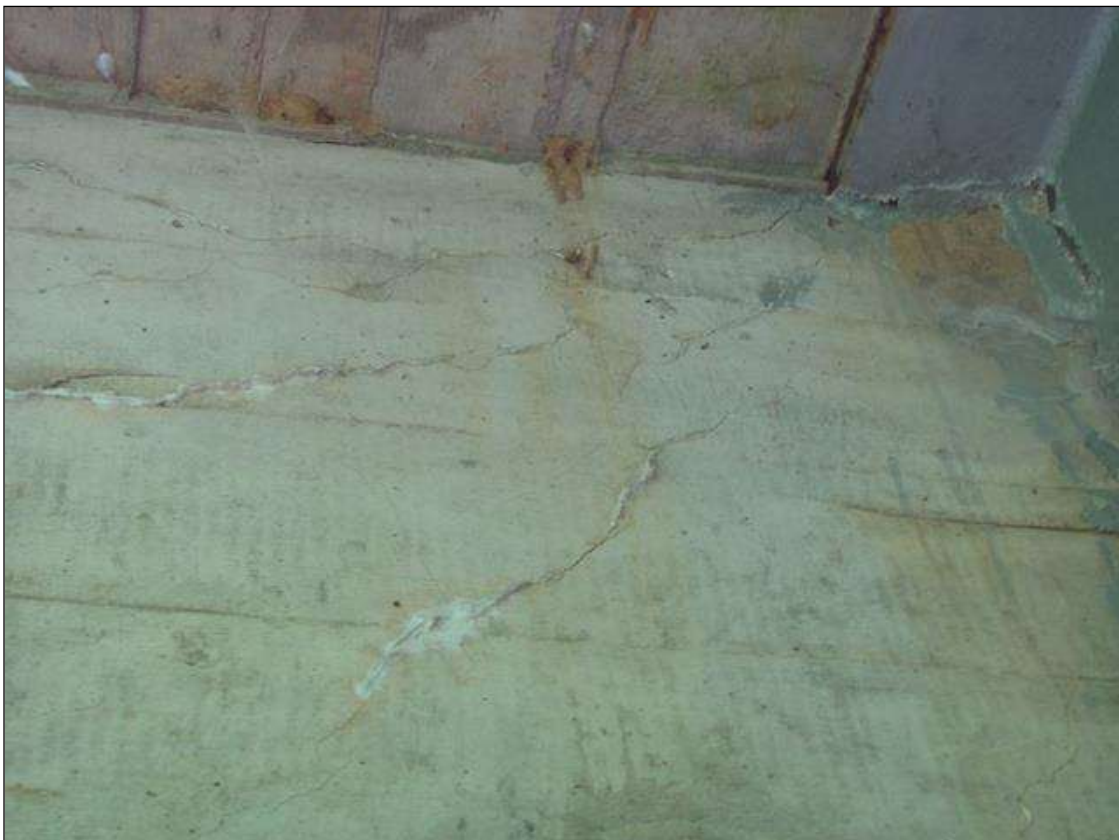
CRACKING WITH EFFLORESCENCE AT END BENT 1 CURTAIN WALL / OUTSIDE OF BEAM #4

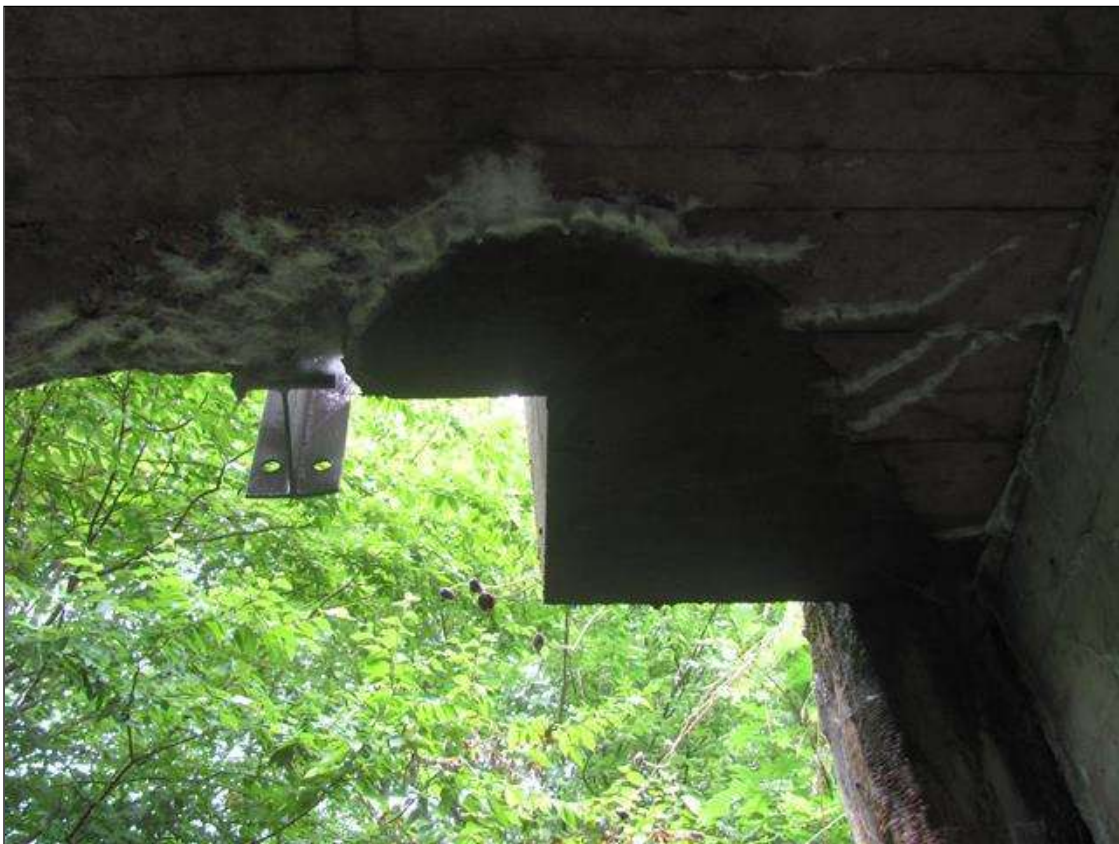
SPALLING WITH EFFLORESCENCE AT REPAIR AT UPSTREAM OVERHANG / END BENT 1

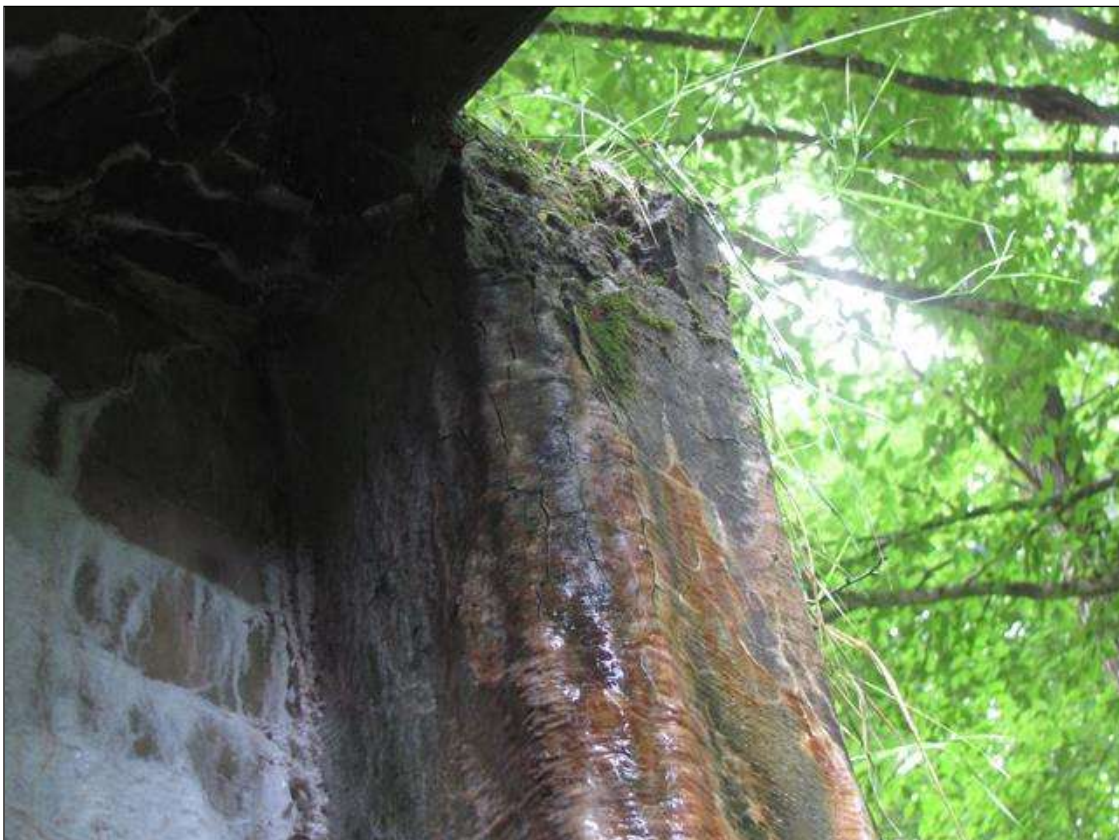
REP OF CONDITIONS FOUND AT TOP OF WING WALLS ADJACENT TO END BENT 1

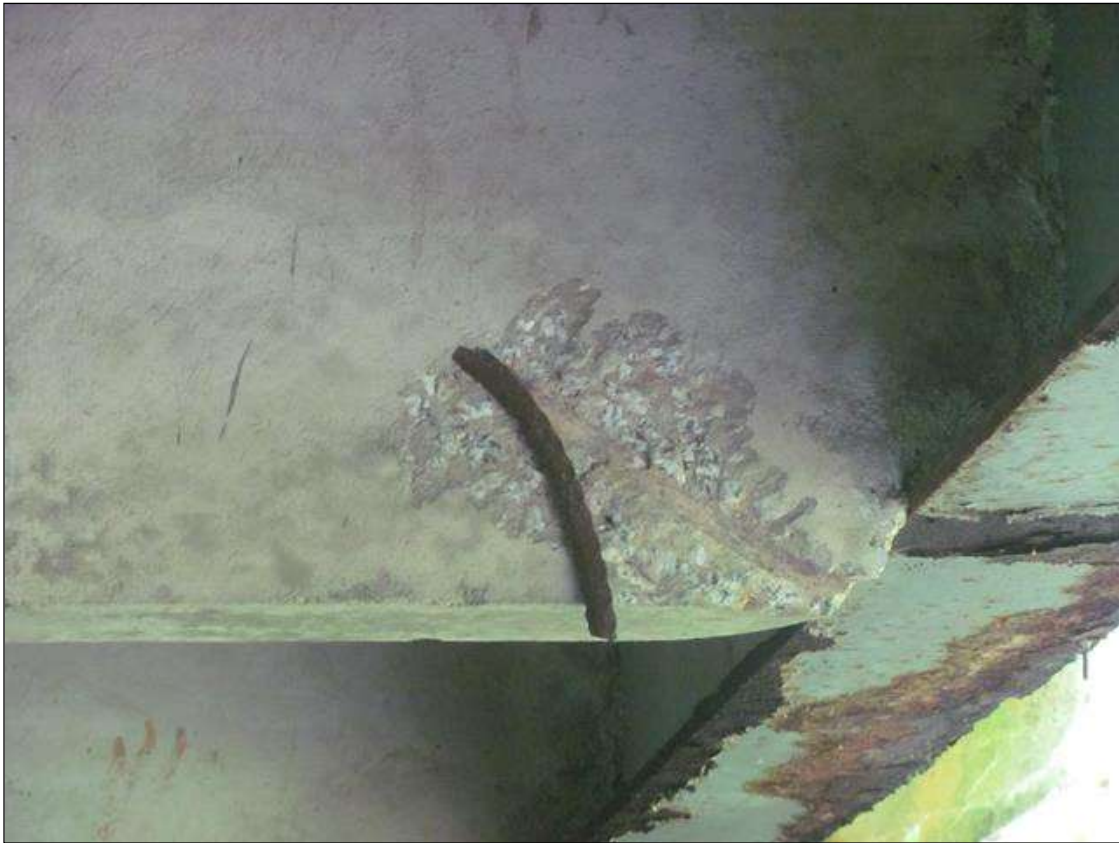
SPALL WITH REBAR EXPOSURE AT INTERIOR DIAPHRAGM / BAY #3 / MID-SPAN
