NC DEPARTMENT OF TRANSPORTATION  
DIVISION OF HIGHWAYS  
BRIDGE MANAGEMENT UNIT

# BRIDGE INSPECTION REPORT

INSPECTION TYPE: Routine Inspection

COUNTY COLUMBUS BRIDGE NUMBER 230013 INSPECTION CYCLE 2 YRS  
ROUTE NC410 ACROSS BEAVERDAM SWAMP M.P. 0

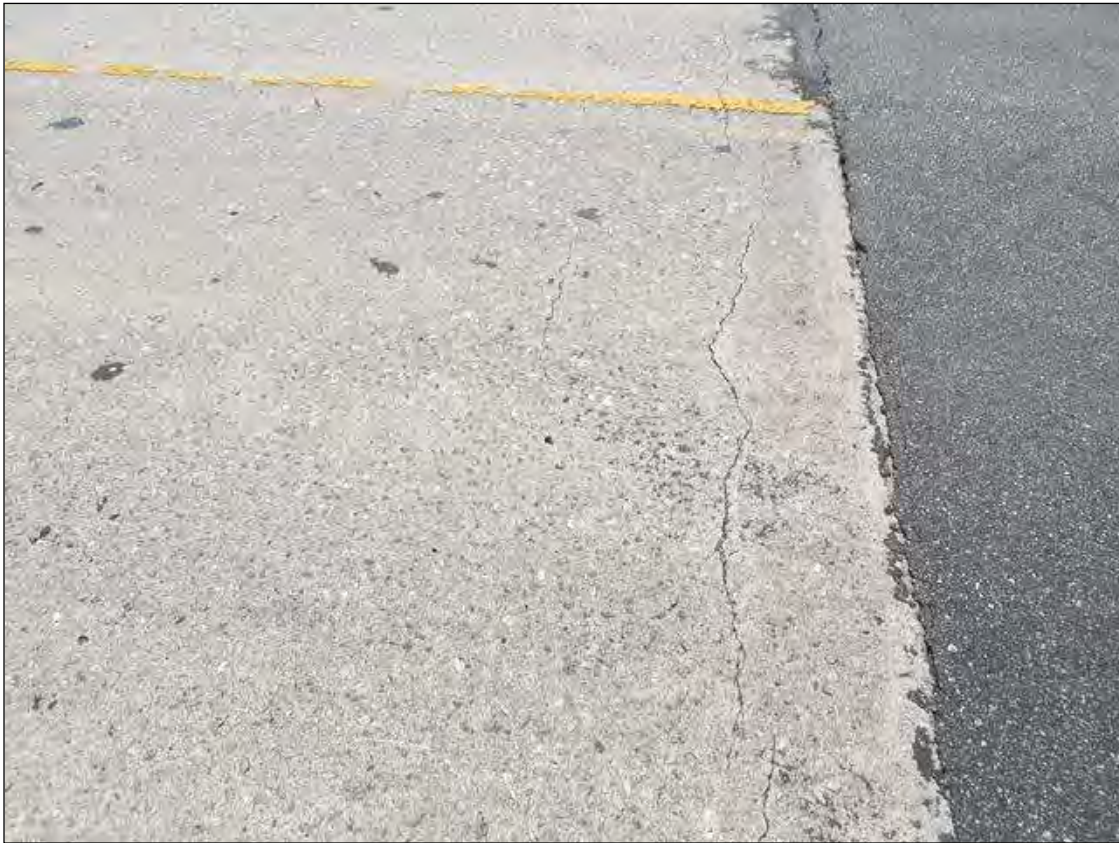
| Bridge I&A Form 1(82)H<br>State of North Carolina<br>Dept. of Transportation<br>Division of Highways | | <h1 style="text-align: center;">FIELD INSPECTION REPORT</h1> <p style="text-align: center;"><u>Bridge Inspection &amp; Analysis</u></p> | |
|---|---|---|--|
| 2a | F | <p>( RC DECK ) THERE IS A 1/16" TO 1/8" TRANSVERSE CRACK IN SPAN 1 DECK OVER END BENT 1 CURTAIN WALL. (PHOTO)</p> <p>THERE ARE DECK PATCHES IN BOTH SPANS OVER BENT 1 CRUTCHBENT PILES. (PHOTO)</p> <p>THERE IS A 1/8" TRANSVERSE CRACK IN SPAN 2 AT COLD JOINT. (PHOTO)</p> <p>THERE ARE 1/8" TRANSVERSE CRACKS IN SPAN 2 DECK AT 3' SPACINGS. (PHOTO)</p> <p>THE SPAN 2 DECK IS SCALING WITH EXPOSED AGGREGATE. (PHOTO)</p> <p>THERE IS A HAIRLINE DIAGONAL CRACK IN SPAN 2 DECK AT NORTHWEST CORNER, END BENT 2. (PHOTO)</p> <p>THERE IS A 1/16" TO 1/8" TRANSVERSE CRACK IN SPAN 2 DECK OVER END BENT 2 CURTAIN WALL. (PHOTO)</p> | |

1/16" TRANSVERSE CRACK IN SPAN 1 DECK OVER END BENT 1 CURTAIN WALL

| MMS Code | Description of Function | Unit | Quantity | Remarks | Est. Cost |
|---|---|---|---|---|---|
| 3326 | Maintain Concrete Deck | SF | 2 | CRACKING OVER END BENT CUTRAIN WALLS, CRACKS IN SPAN 2 DECK | |

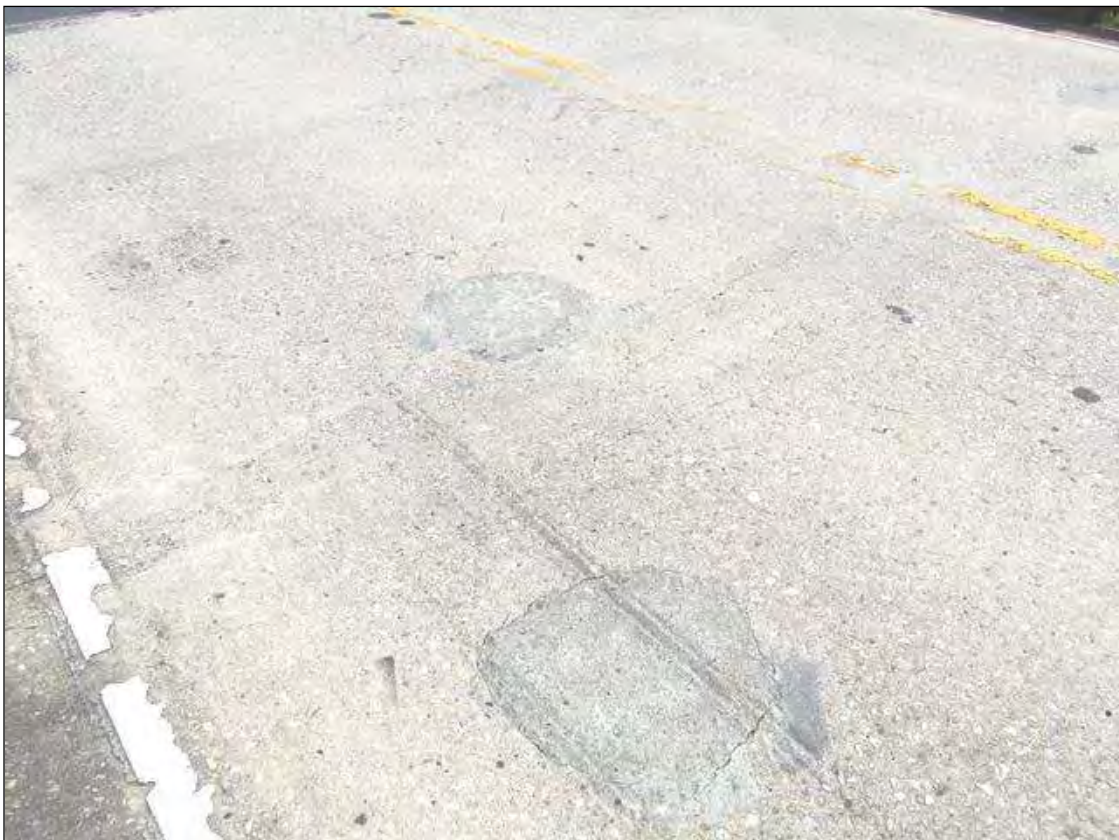
DECK PATCHES IN BOTH SPANS OVER BENT 1 CRUTCH PILES

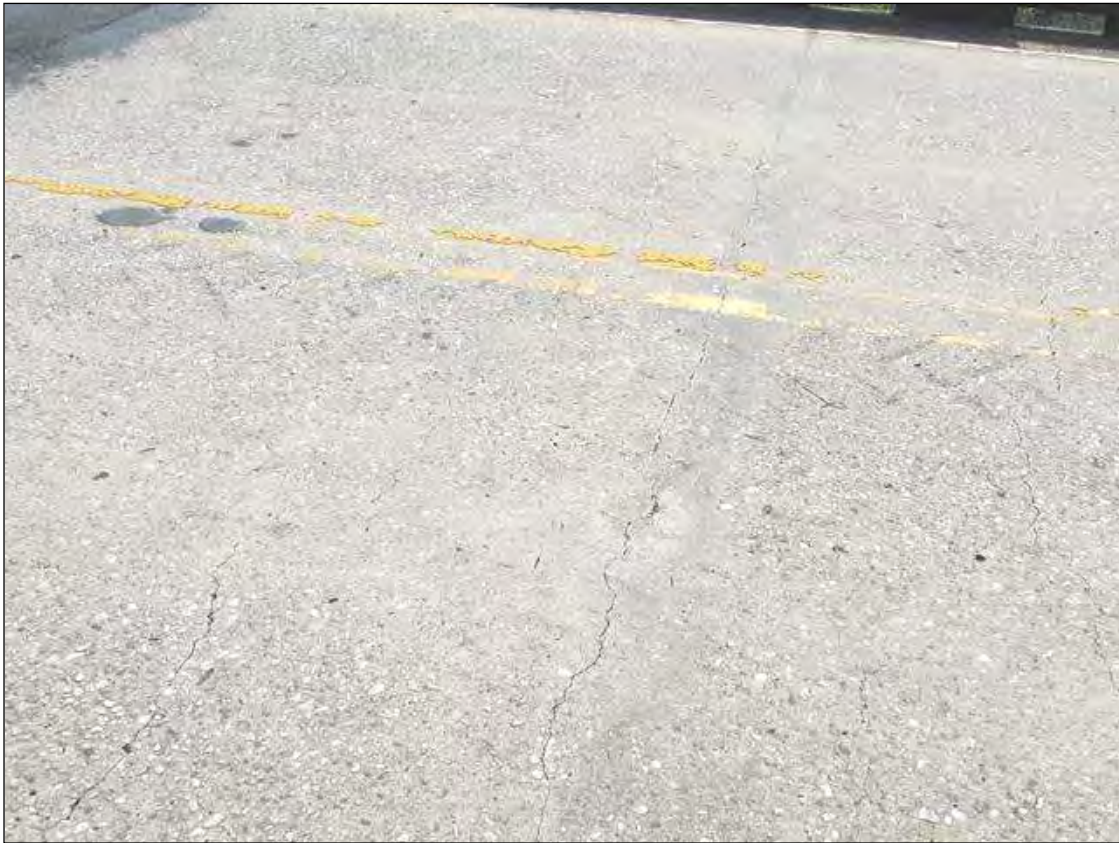
1/8" TRANSVERSE CRACK IN SPAN 2 AT COLD JOINT

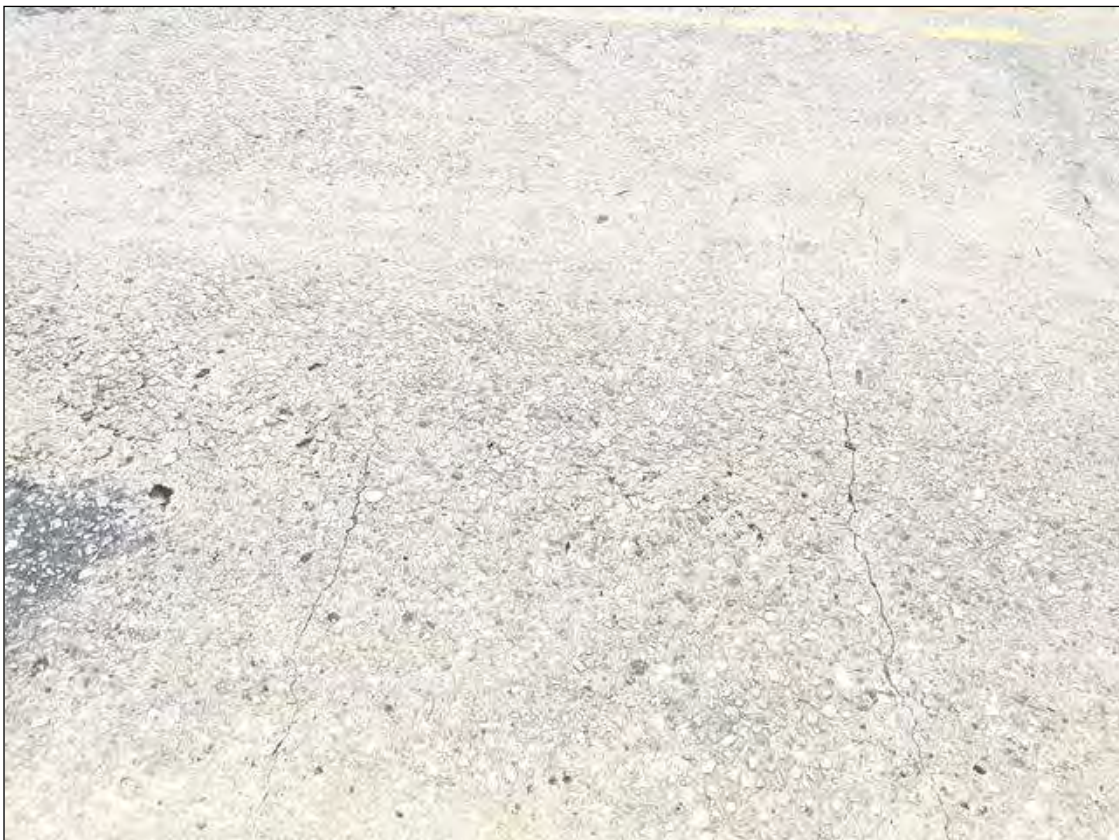
1/8" TRANSVERSE CRACKS IN SPAN 2 DECK AT 3' SPACINGS

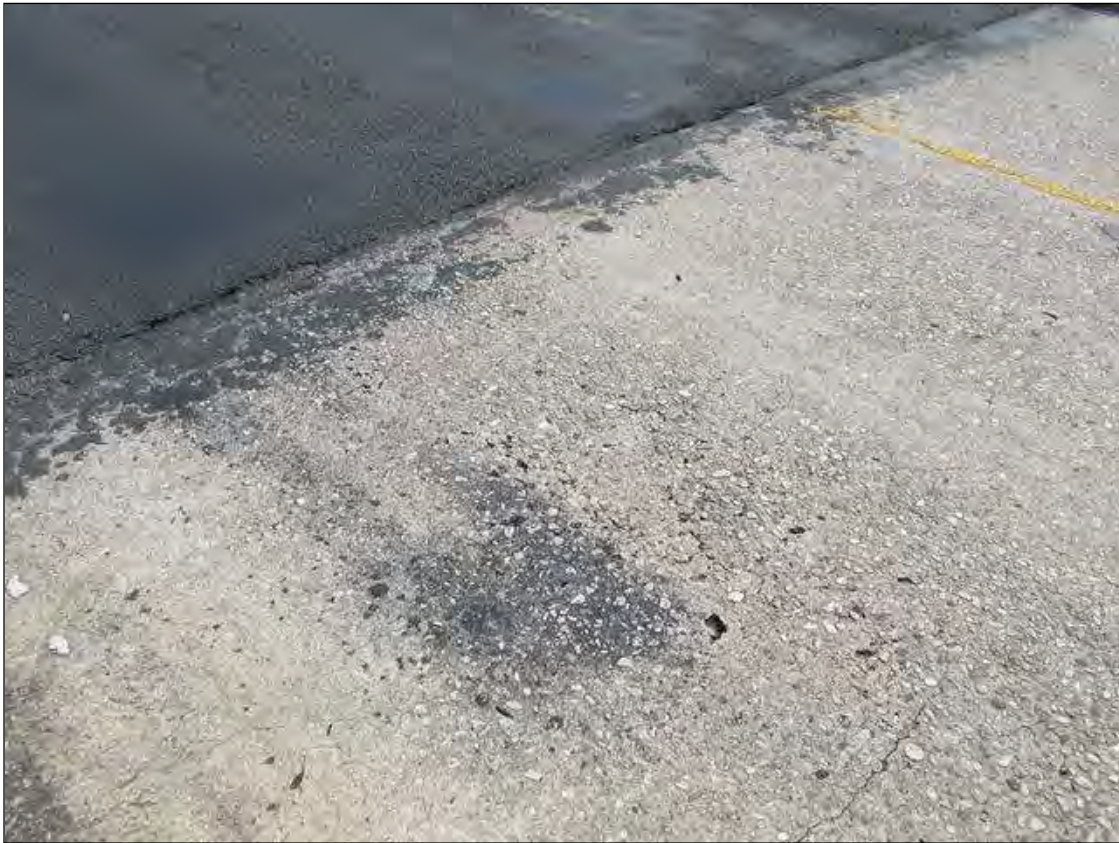
SPAN 2 DECK SCALING WITH EXPOSED AGGREGATE

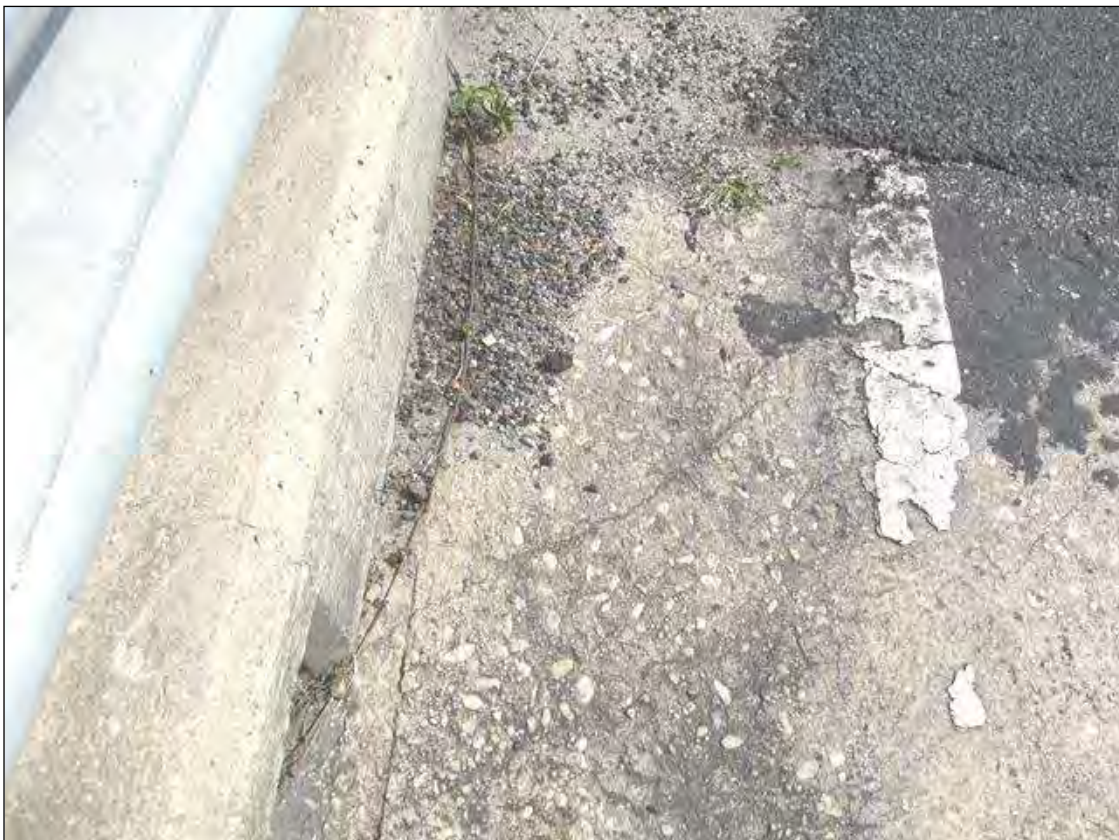
HAIRLINE DIAGONAL CRACK IN SPAN 2 DECK AT NORTHWEST CORNER , END BENT 2

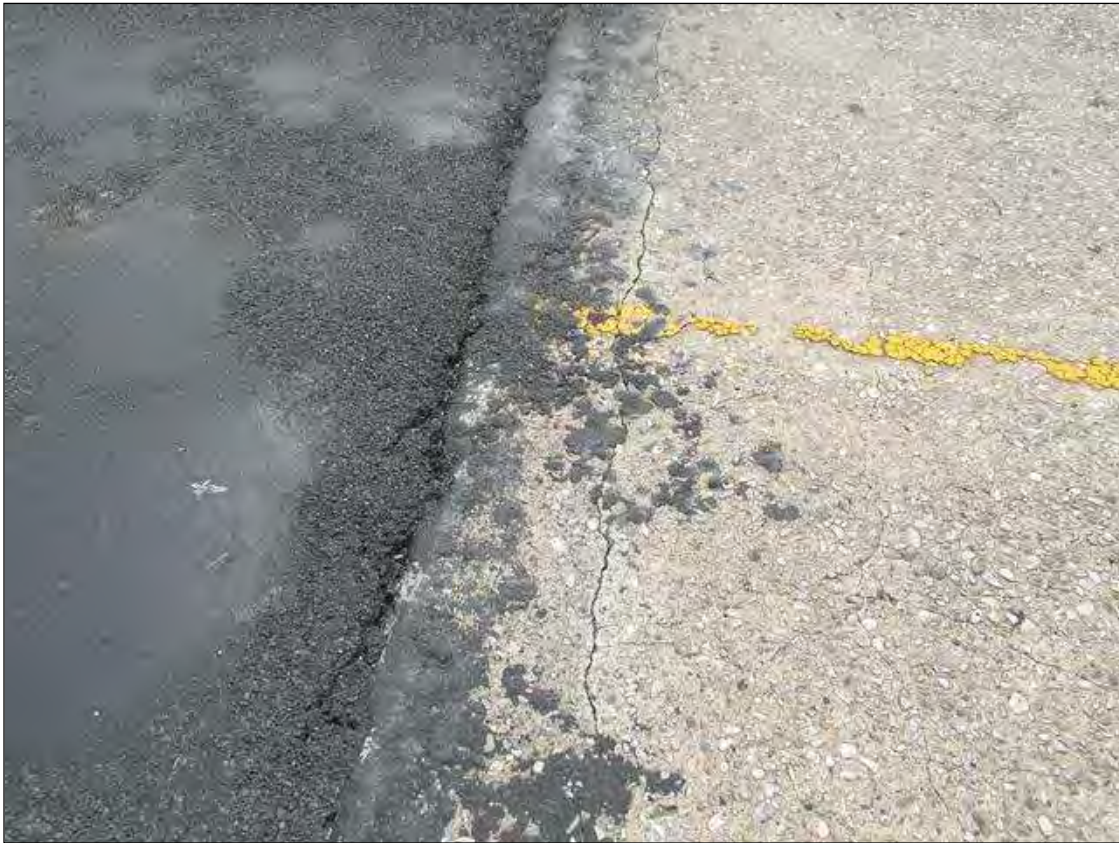
1/16" TO 1/8" TRANSVERSE CRACK IN SPAN 2 DECK OVER END BENT 2 CURTAIN WALL

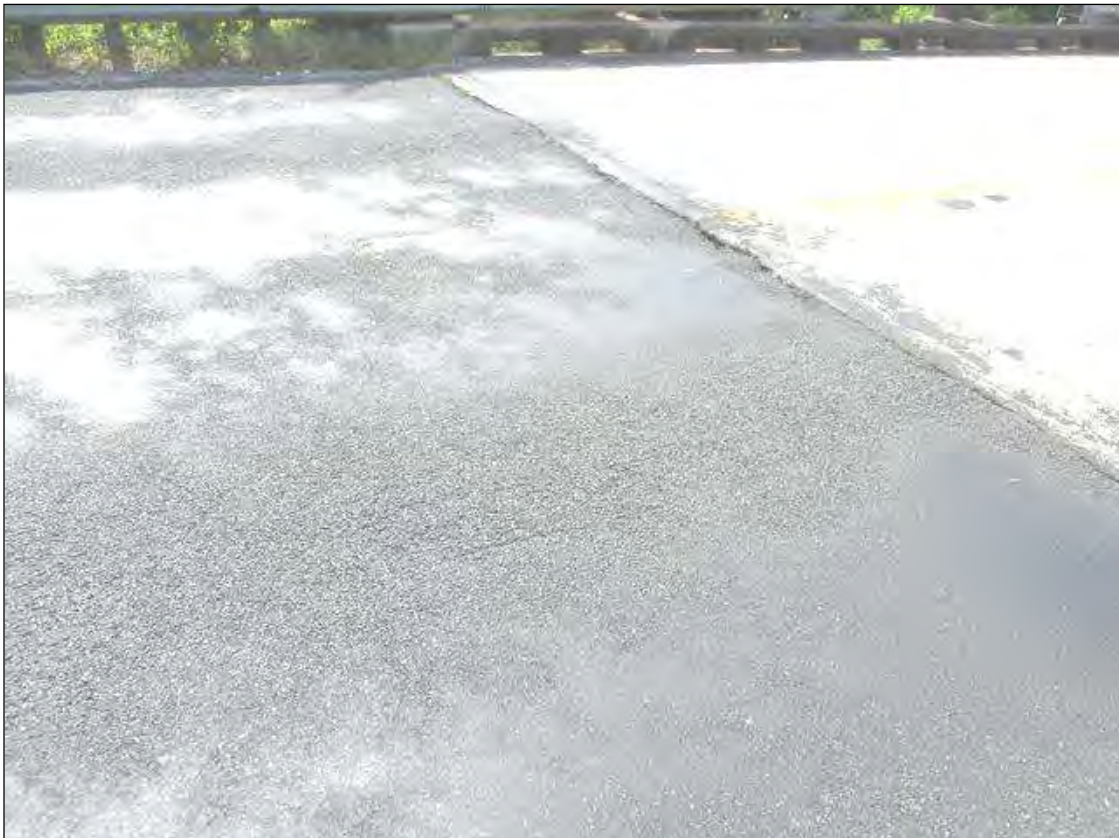
| Bridge I&A Form 1(82)H<br>State of North Carolina<br>Dept. of Transportation<br>Division of Highways | | <h1 style="text-align: center;">FIELD INSPECTION REPORT</h1> <p style="text-align: center;"><u>Bridge Inspection &amp; Analysis</u></p> | |
|---|---|---|--|
| 50 | F | ( APPROACH ROADWAY ) THE NORTH APPROACH IS CRACKED AND SETTLED UP TO 1". (PHOTO)<br><br>THERE IS A MISSING GUARDRAIL SPACER BLOCK IN SOUTHEAST CORNER. (PHOTO) | |

NORTH APPROACH ASPHALT WEARING SURFACE IS CRACKED AND SETTLED UP TO 1"

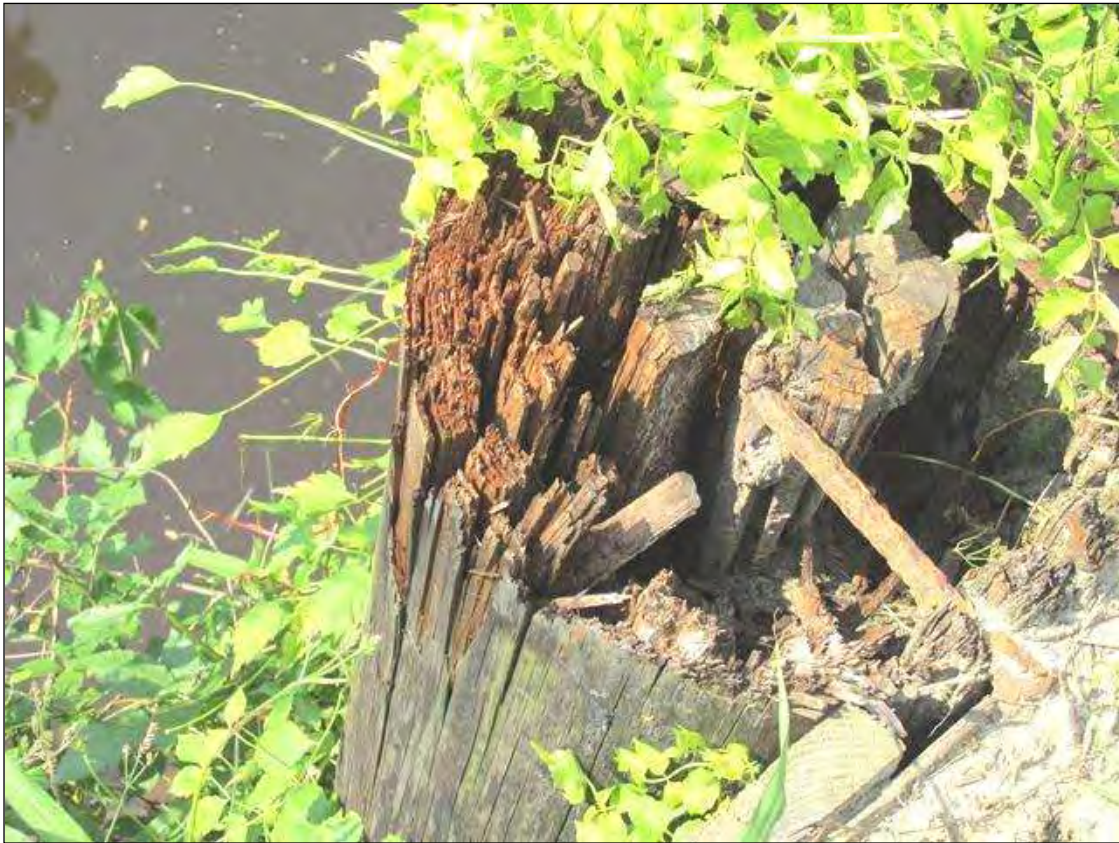
| Bridge I&A Form 1(82)H<br>State of North Carolina<br>Dept. of Transportation<br>Division of Highways | | <h1 style="text-align: center;">FIELD INSPECTION REPORT</h1> <p style="text-align: center;"><u>Bridge Inspection &amp; Analysis</u></p> | |
|---|---|---|--|
| 35c | G | SEE DIVERS UNDERWATER INSPECTION REPORT DATED 3/27/2013.<br>( TIMBER BULKHEADS ) THE TOP OF WINGWALL PILE IS DECAYED AT NORTHEAST CORNER. (PHOTO)<br><br>THERE IS A NEW TURNPILE IN NORTHEAST CORNER. (PHOTO) | |

TOP OF WINGWALL PILE DECAYED AT NORTHEAST CORNER

| MMS Code | Description of Function | Unit | Quantity | Remarks | Est. Cost |
|---|---|---|---|---|---|
| 3346 | Repair / Maintain Timber Wings & Blkhds | SF | 3 | TOP OF WINGWALL PILE DECAYED AT NORTHEAST CORNER | |

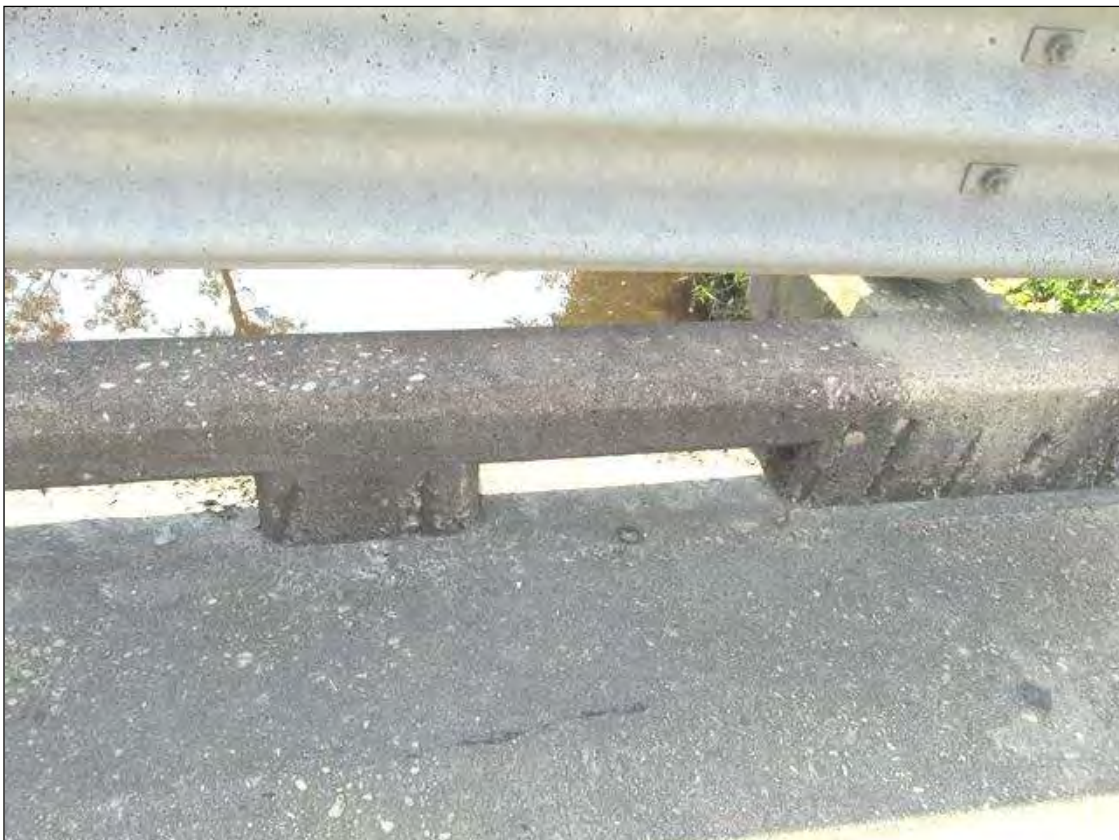
| Bridge I&A Form 1(82)H<br>State of North Carolina<br>Dept. of Transportation<br>Division of Highways | | <h1 style="text-align: center;">FIELD INSPECTION REPORT</h1> <p style="text-align: center;"><u>Bridge Inspection &amp; Analysis</u></p> | |
|---|---|---|--|
| 4 | F | ( CONC CURBS ) THERE ARE SURFACE SPALLS WITH EXPOSED STEEL IN RIGHT CURB AT SPAN 1. THE LEFT CURB IS SIMILAR. (PHOTO) | |

SURFACE SPALLS WITH EXPOSED REBAR IN RIGHT CURB AT SPAN 1, LEFT CURB IS SIMILAR

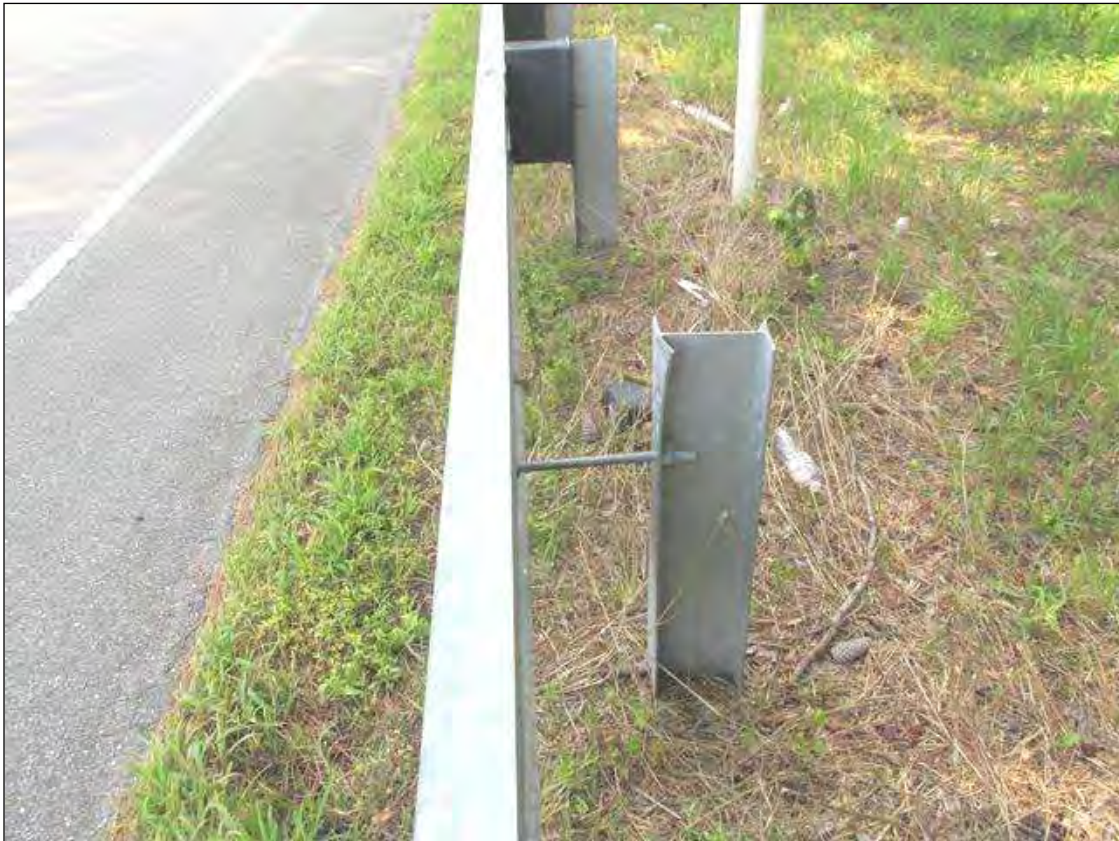
MISSING GUARDRAIL SPACER BLOCK IN SOUTHEAST CORNER

| MMS Code | Description of Function | Unit | Quantity | Remarks | Est. Cost |
|---|---|---|---|---|---|
| 3120 | Repair/Maintain Barriers | LF | 1 | MISSING GUARDRAIL SPACER BLOCK IN SOUTHEAST CORNER | |

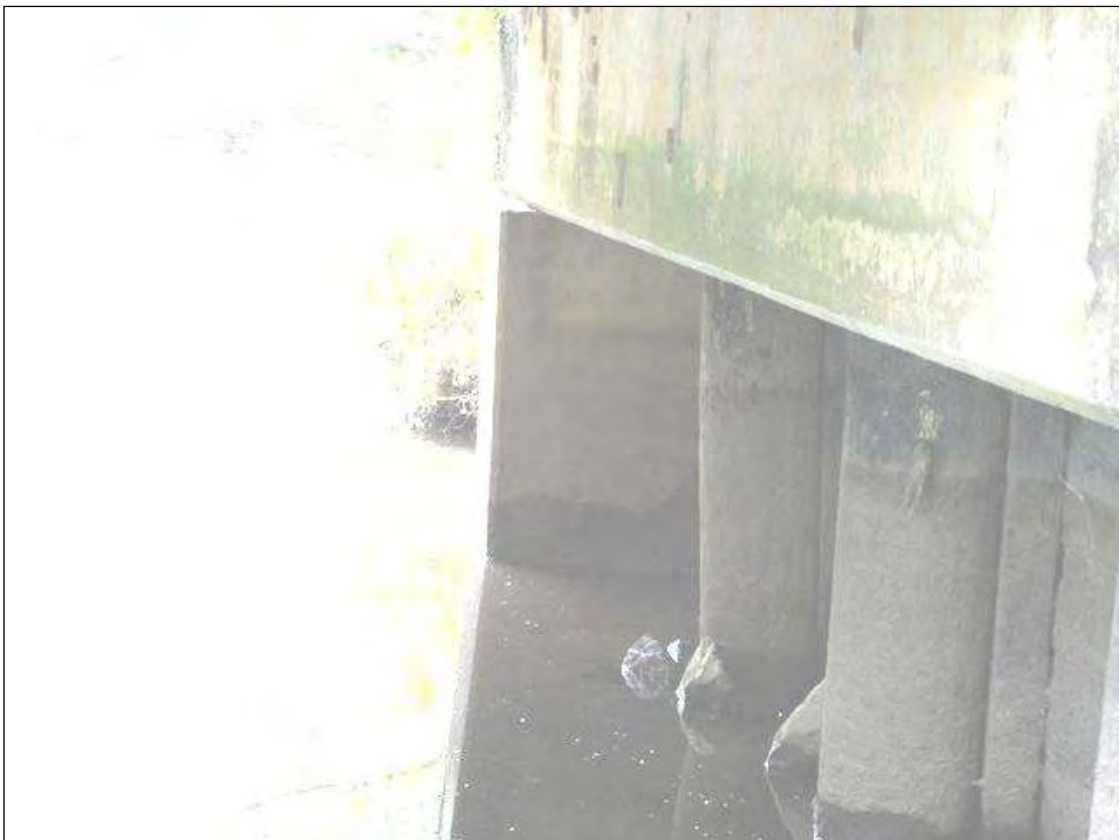
| Bridge I&A Form 1(82)H<br>State of North Carolina<br>Dept. of Transportation<br>Division of Highways | | <h1 style="text-align: center;">FIELD INSPECTION REPORT</h1> <p style="text-align: center;"><u>Bridge Inspection &amp; Analysis</u></p> | |
|---|---|---|--|
| 35b | F | ( TIMBER PILES ) ALL PILES HAVE FACIAL SOFTNESS AT WATERLINE.<br><br>END BENT 1 PILE 4 IS ENCASED. (PHOTO)<br><br>THERE ARE TIMBER CAP AND PILE CRUTCHBENTS AT BENT 1, BETWEEN EACH ORIGINAL PILE. (PHOTO) ALSO SEE SKETCH. | |

PILE 4 AT END BENT 1 IS ENCASED IN CONCRETE

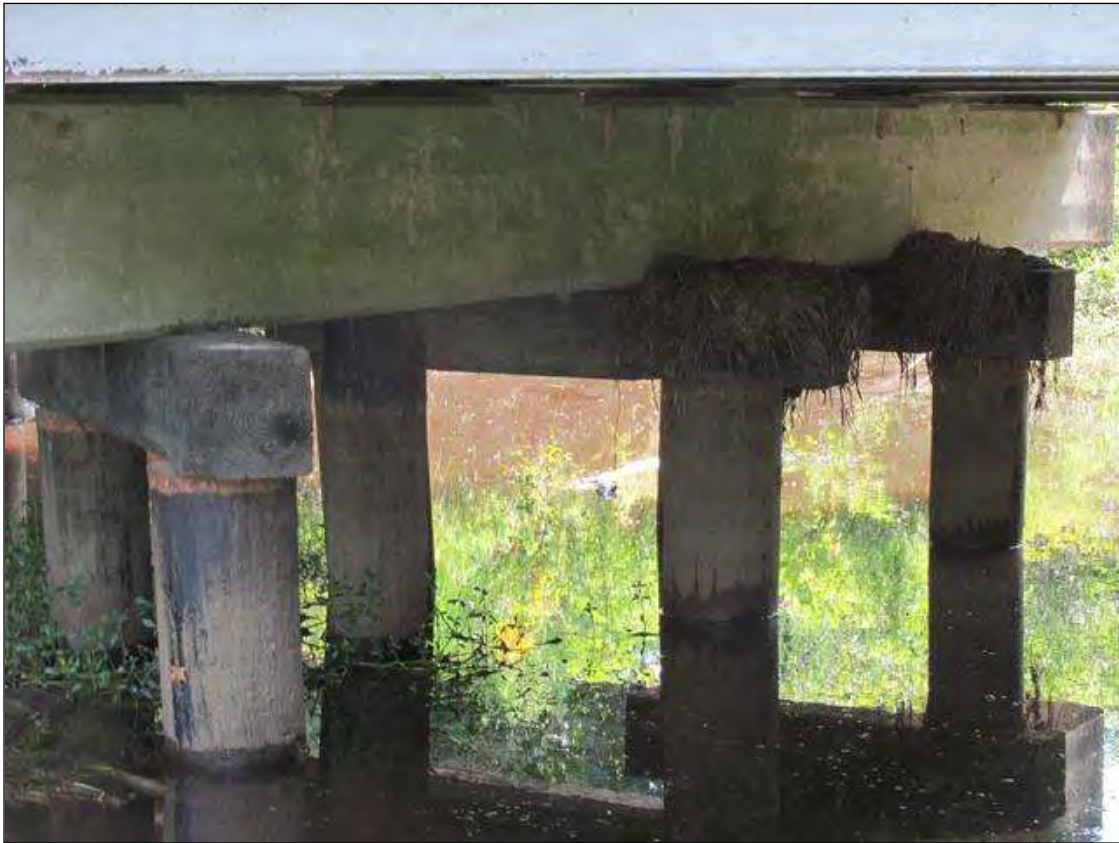
TIMBER CROSSCAP CRUTCHES AT BENT 1, BETWEEN EACH ORIGINAL PILE

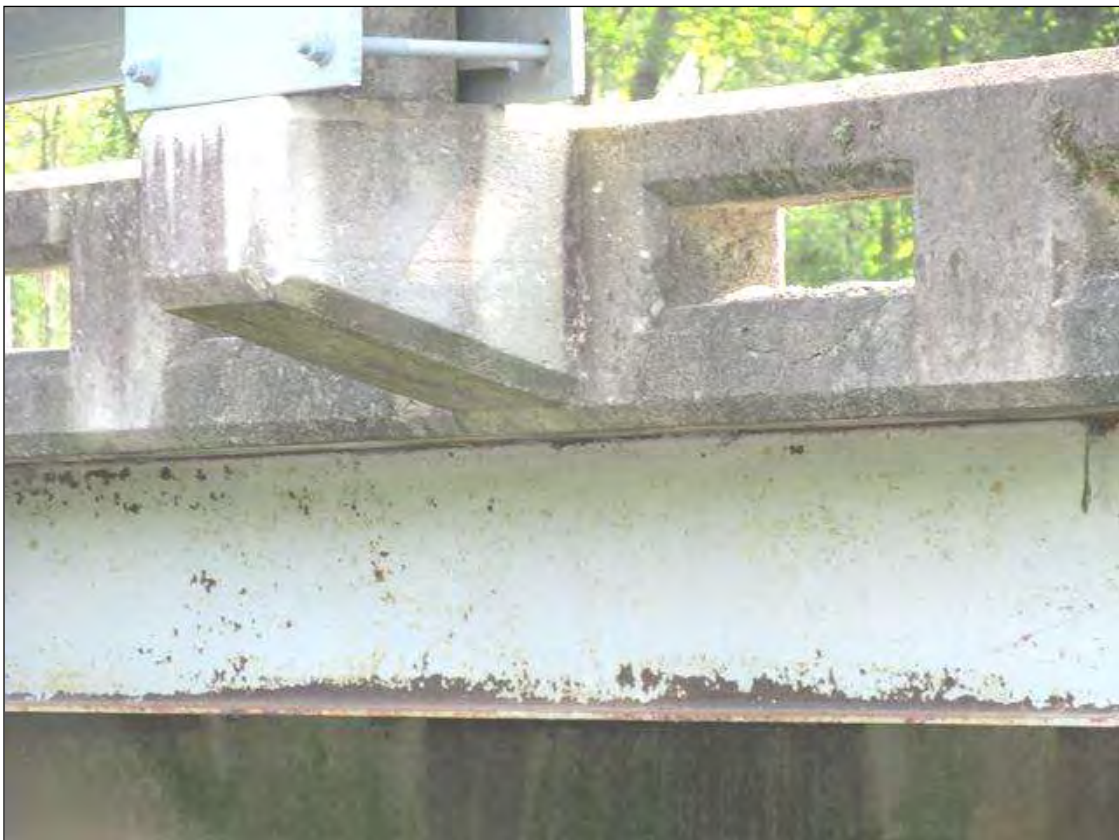
| Bridge I&A Form 1(82)H<br>State of North Carolina<br>Dept. of Transportation<br>Division of Highways | | <h1 style="text-align: center;">FIELD INSPECTION REPORT</h1> <p style="text-align: center;"><u>Bridge Inspection &amp; Analysis</u></p> | |
|---|---|---|--|
| 10 | F | <p>( STEEL BEAMS ) BEAM 6 IN SPAN 2 AT END BENT 2 BOTTOM FLANGE RUST WITH 1/8" SECTION LOSS X 2" LONG X 3/4" WIDE AT BEARING. BEAM 1 AT END BENT 1 AND END BENT 2 ARE SIMILAR.</p> <p>THERE IS SURFACE RUST ALONG END DIAPHRAGM CONNECTIONS AT MANY BEAMS AT BENT 1.</p> <p>THERE IS PAINT PEELING AND SURFACE RUST ON EXTERIOR BEAM 1 IN SPAN 2. (PHOTO)</p> | |

PAINT PEELING AND SURFACE RUST ON EXTERIOR BEAM 1 IN SPAN 2

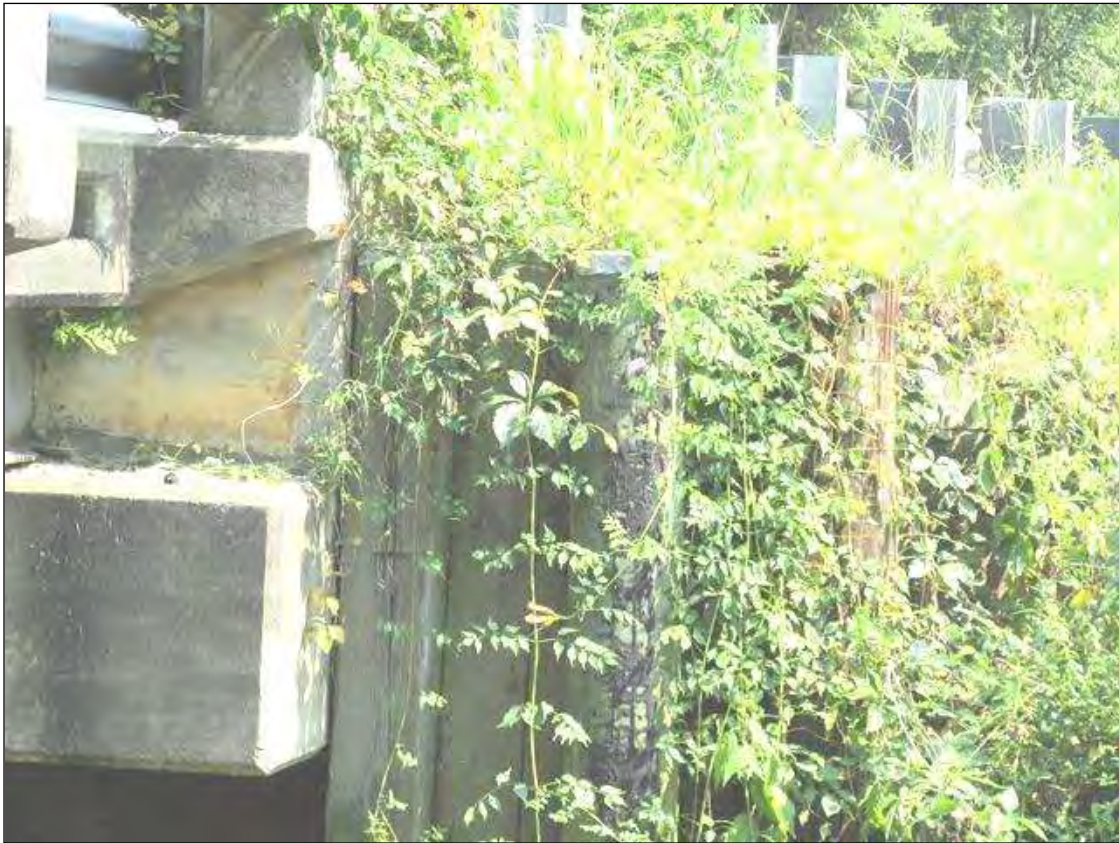
NEW TURNPILE IN NORTHEAST CORNER
