NC DEPARTMENT OF TRANSPORTATION  
DIVISION OF HIGHWAYS  
BRIDGE MANAGEMENT UNIT

# BRIDGE INSPECTION REPORT

INSPECTION TYPE: Routine Inspection

COUNTY COLUMBUS BRIDGE NUMBER 230118 INSPECTION CYCLE 2 YRS  
ROUTE SR1317 ACROSS GUM SWAMP M.P. 0

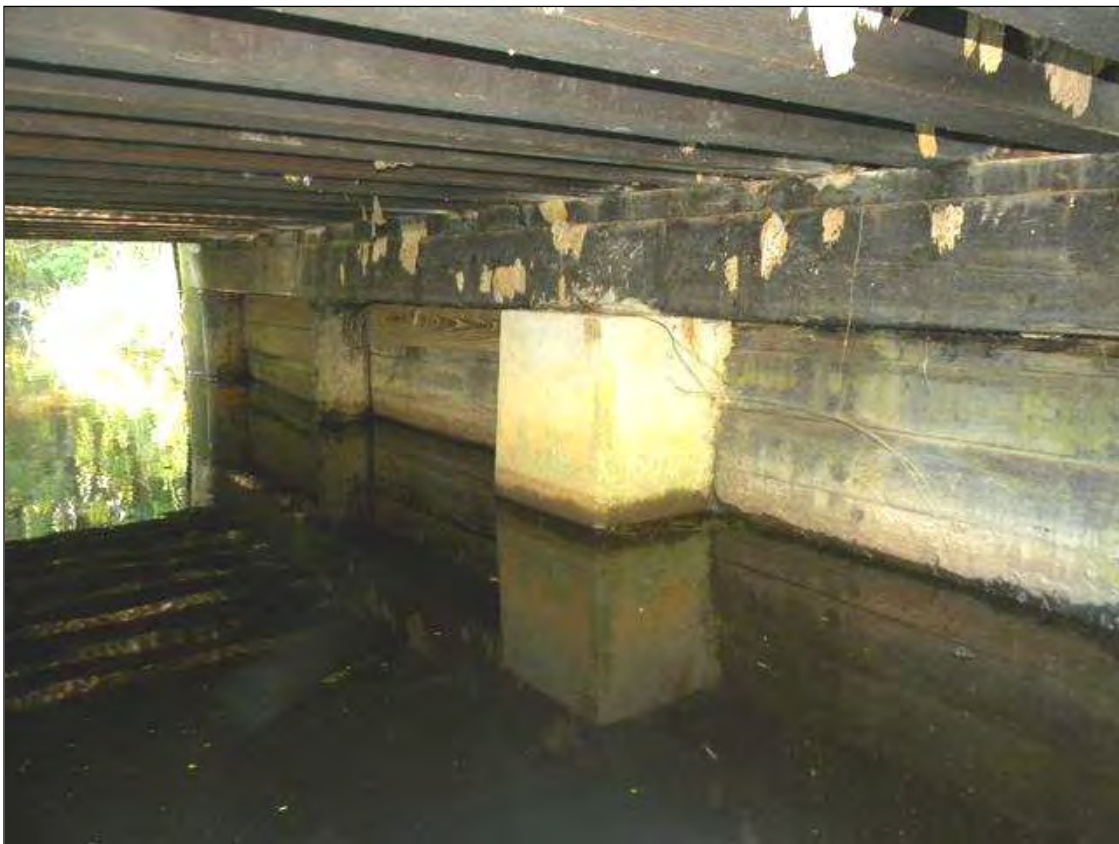
PILE 2 AT END BENT 1 ENCASED IN CONCRETE

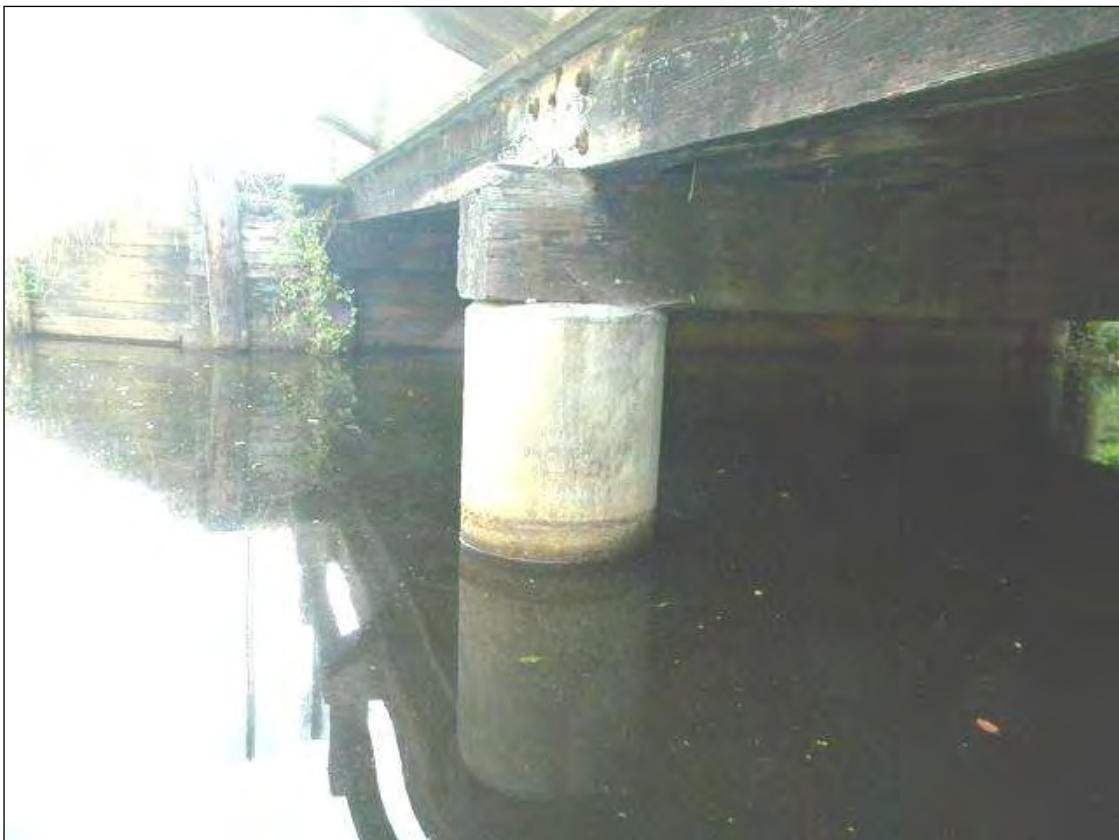
PILE 1 AT BENT 1 ENCASED IN CONCRETE

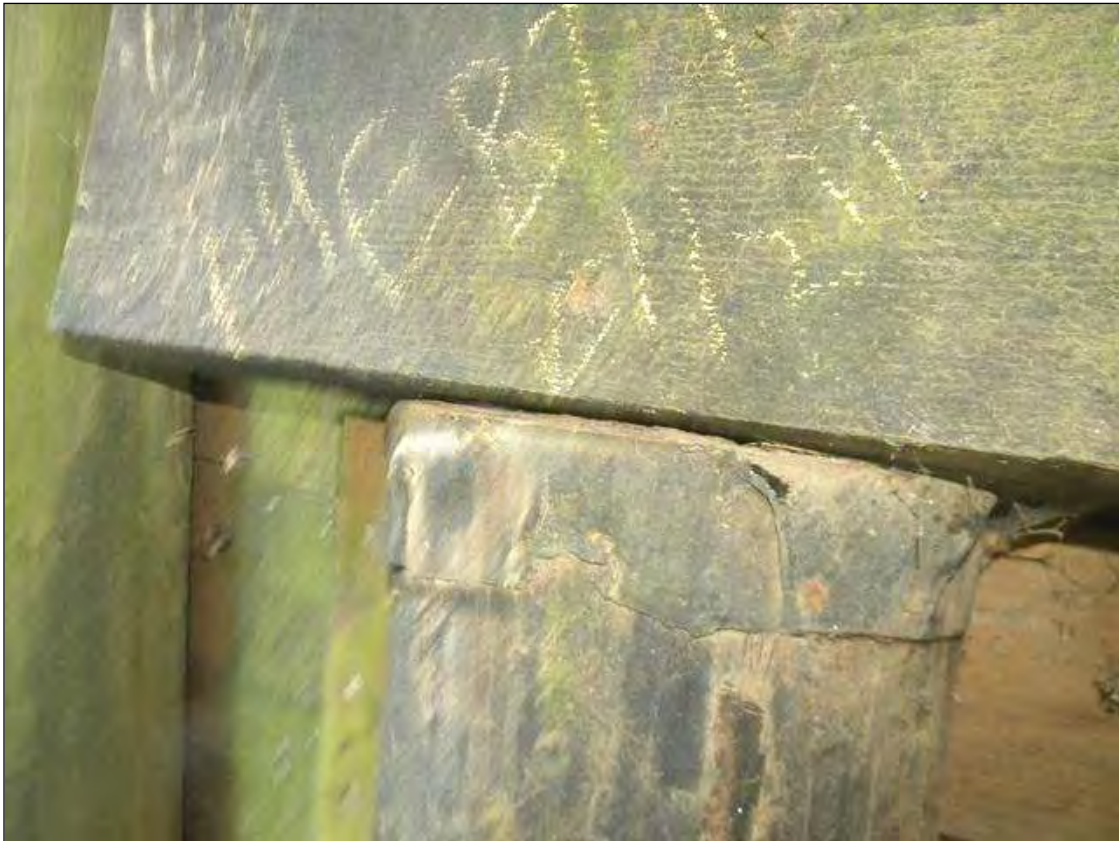
| <b>35a</b> | <b>F</b> | ( TIMBER CAPS ) THE END BENTS 1, AND 2 CAPS ARE ROLL BACK 1/2" AT PILE 4. (PHOTOS)<br><br>THE BENT 1 CAP IS DECAYED UP TO 11" DEEP AT THE TOP END PORTION AND A 5/16" TO 3/8" WIDE X 8" DEEP VERTICAL CRACK ON THE WEST END FACE. (PHOTO) | |

END BENT 1 CAP ROLLED BACK 1/2" AT PILE 4

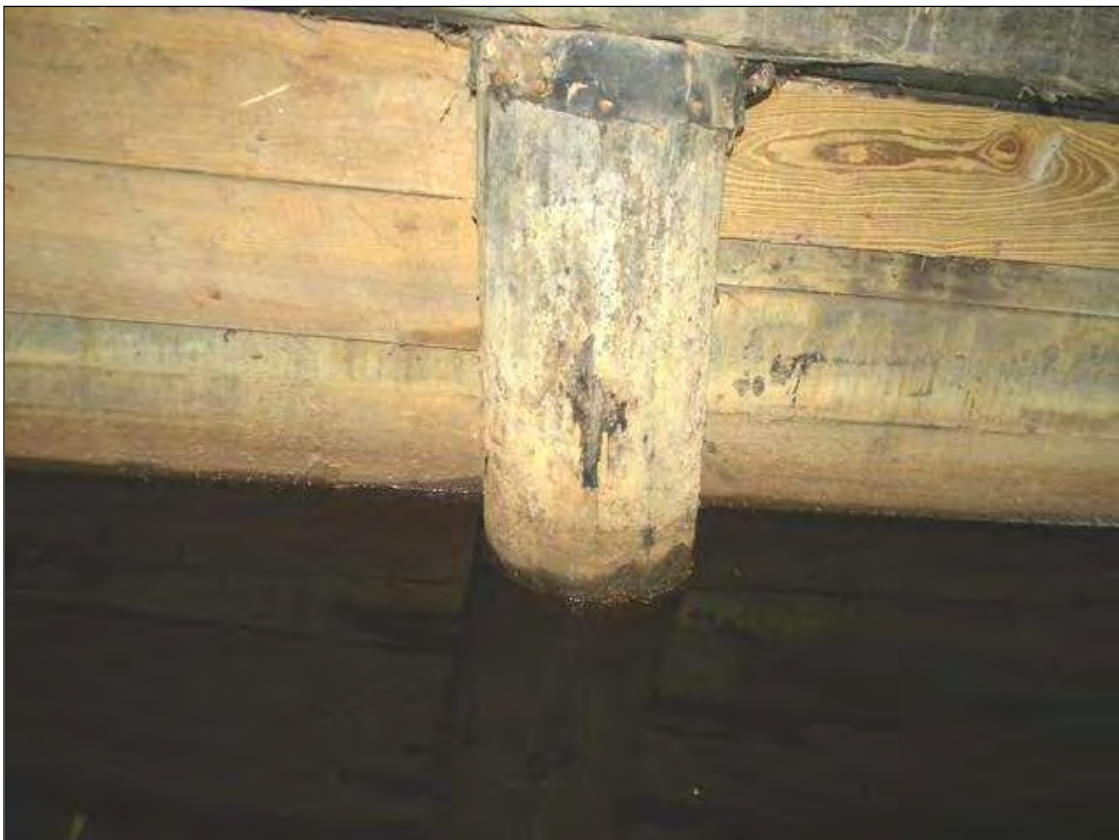
PILE 3 AT END BENT 1 SURFACE DECAYED

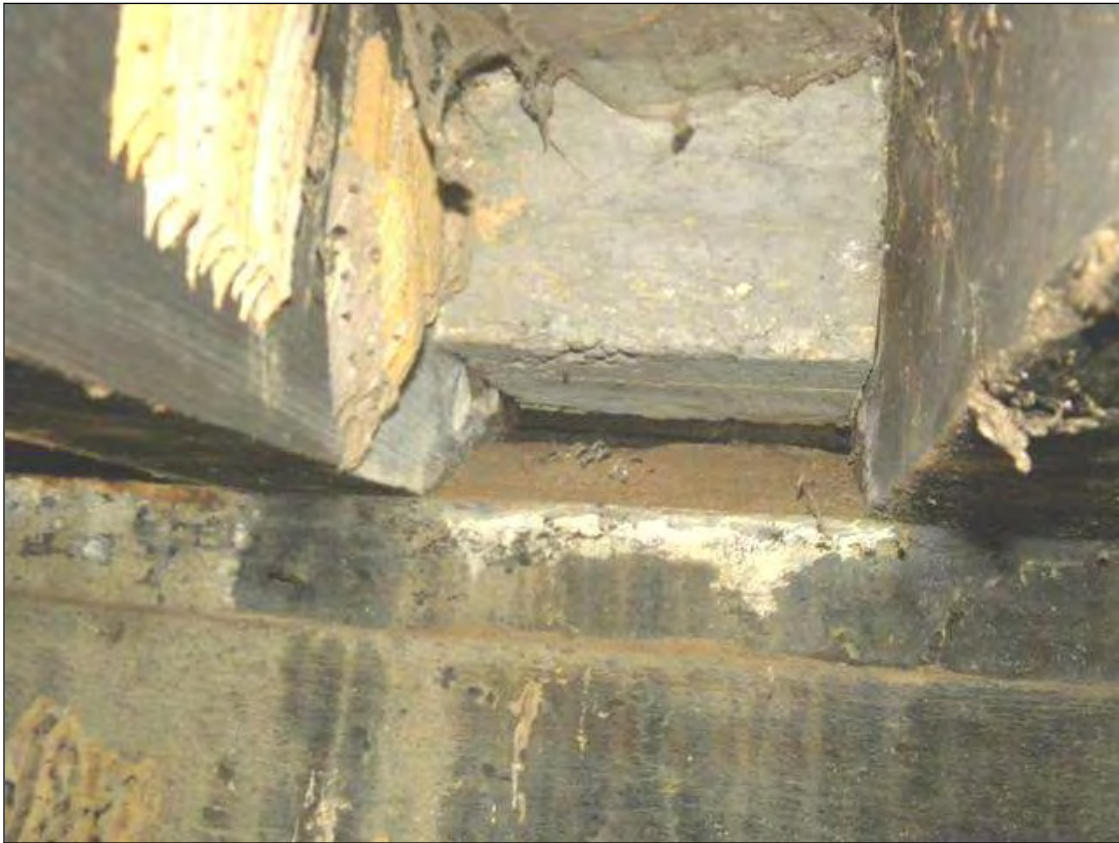
| Bridge I&A Form 1(82)H<br>State of North Carolina<br>Dept. of Transportation<br>Division of Highways | | <h1 style="text-align: center;">FIELD INSPECTION REPORT</h1> <p style="text-align: center;"><u>Bridge Inspection &amp; Analysis</u></p> | |
|---|---|---|--|
| 35c | F | ( TIMBER BULKHEADS )    THERE IS FILL LEAKAGE ON THE END BENT 1 CAP IN BAYS 13, 14, 15, 16, AND 17. (PHOTO)<br><br>THERE IS A NEW TURNPILE AT SOUTHEAST CORNER. (PHOTO)<br><br>THERE IS A NEW TURNPILE AT NORTHEAST CORNER. (PHOTO)<br><br>THERE ARE END SURFACE DECAYED WINGWALL BOARDS AT TOP PORTION IN NORTHWEST CORNER.<br><br>THERE IS A FULLY DECAYED WINGWALL PILE AT NORTHWEST CORNER. (PHOTO)<br><br>THERE IS A DECAYED BULKHEAD BOARD AT SOUTHWEST CORNER. (PHOTO) | |

FILL LEAKAGE ON END BENT 1 CAP IN BAYS 12 THRU 17

| MMS Code | Description of Function | Unit | Quantity | Remarks | Est. Cost |
|---|---|---|---|---|---|
| 3346 | Repair / Maintain Timber Wings & Blkhds | SF | 15 | FILL LEAKAGE ON END BENT 1 CAP IN BAYS 12 THRU 17 | |

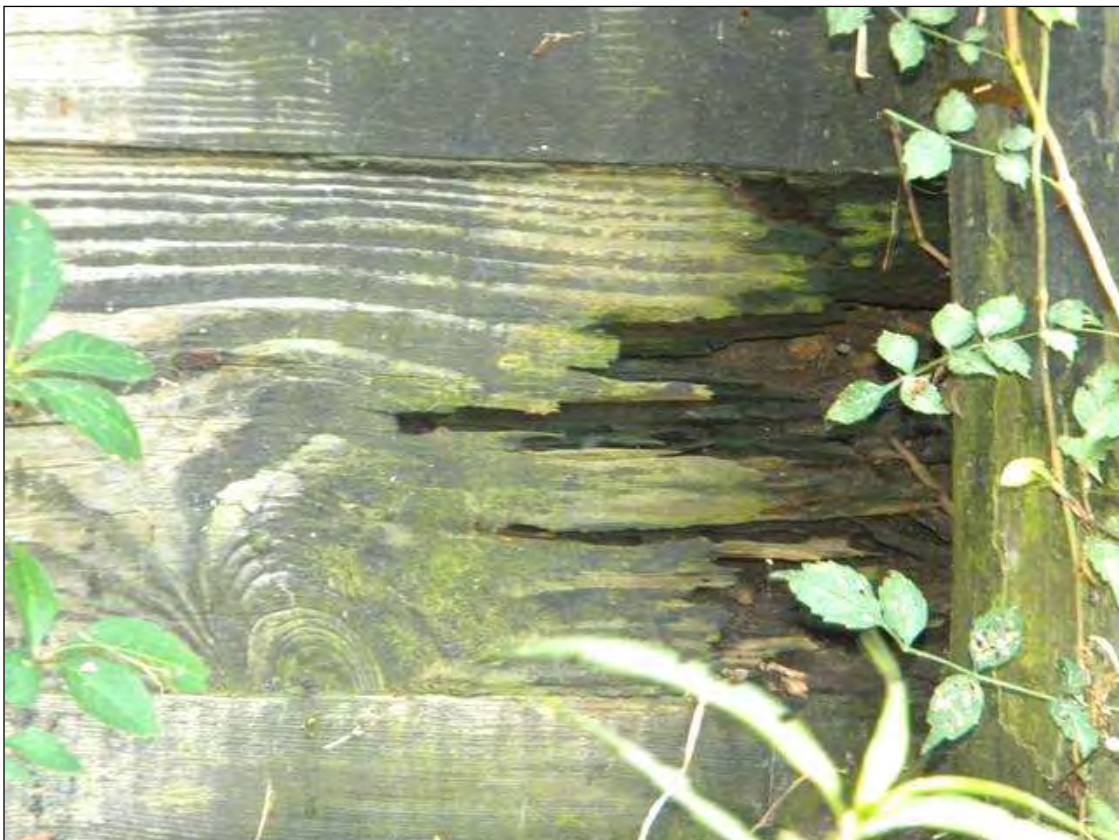
DECAYED BULKHEAD BOARD AT SOUTHWEST CORNER

| MMS Code | Description of Function | Unit | Quantity | Remarks | Est. Cost |
|---|---|---|---|---|---|
| 3346 | Repair / Maintain Timber Wings & Blkhds | SF | 6 | DECAYED BULKHEAD BOARD AT SOUTHWEST CORNER | |

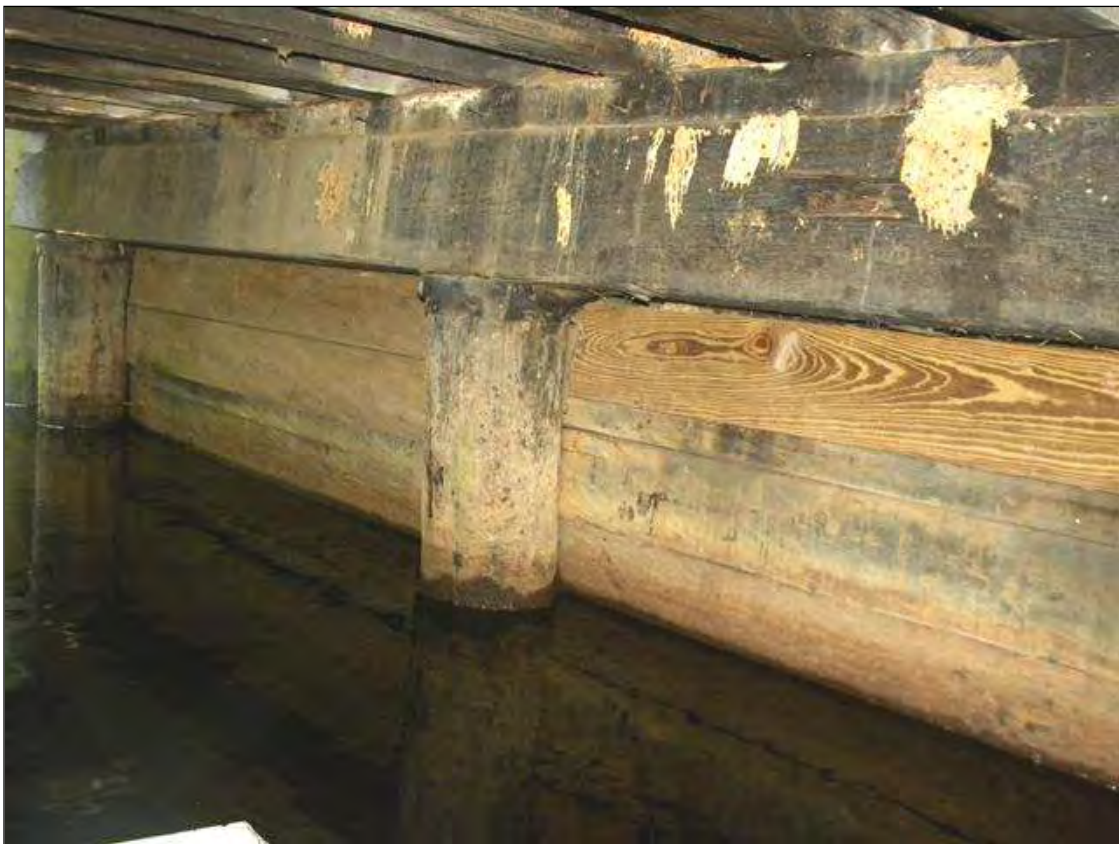
| Bridge I&A Form 1(82)H<br>State of North Carolina<br>Dept. of Transportation<br>Division of Highways | | <h1 style="text-align: center;">FIELD INSPECTION REPORT</h1> <p style="text-align: center;"><u>Bridge Inspection &amp; Analysis</u></p> | |
|---|---|---|--|
| 39 | G | THE END BENT 1 BULKHEAD WITH SCAB BOARDS BETWEEN PILES 2 AND 4. (PHOTO)<br>( SLOPE PROTECTION )   RIP RAP PLACED AT THE   NORTHEAST AND SOUTHEAST CORNERS. | |

END BENT 1 BULKHEAD WITH SCAB BOARDS BETWEEN PILES 2 AND 4

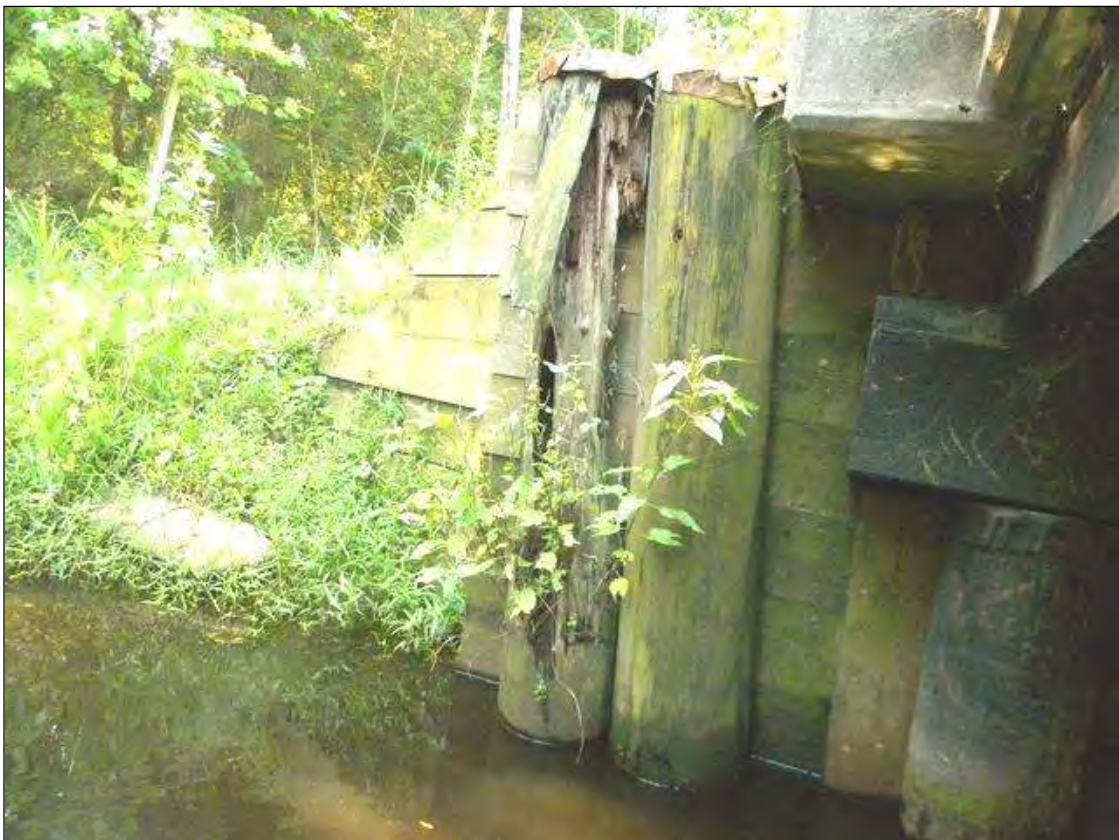
NEW TURNPILE AT SOUTHEAST CORNER

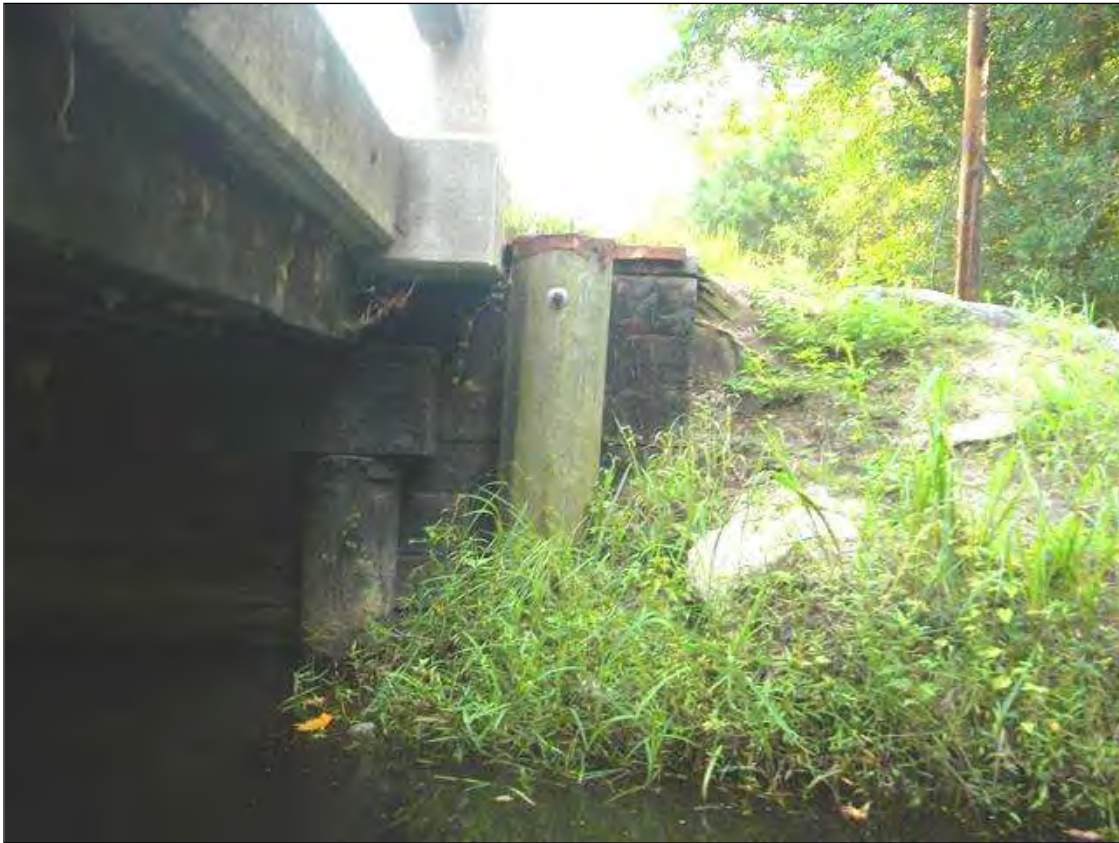
NEW TURNPILE AT NORTHEAST CORNER

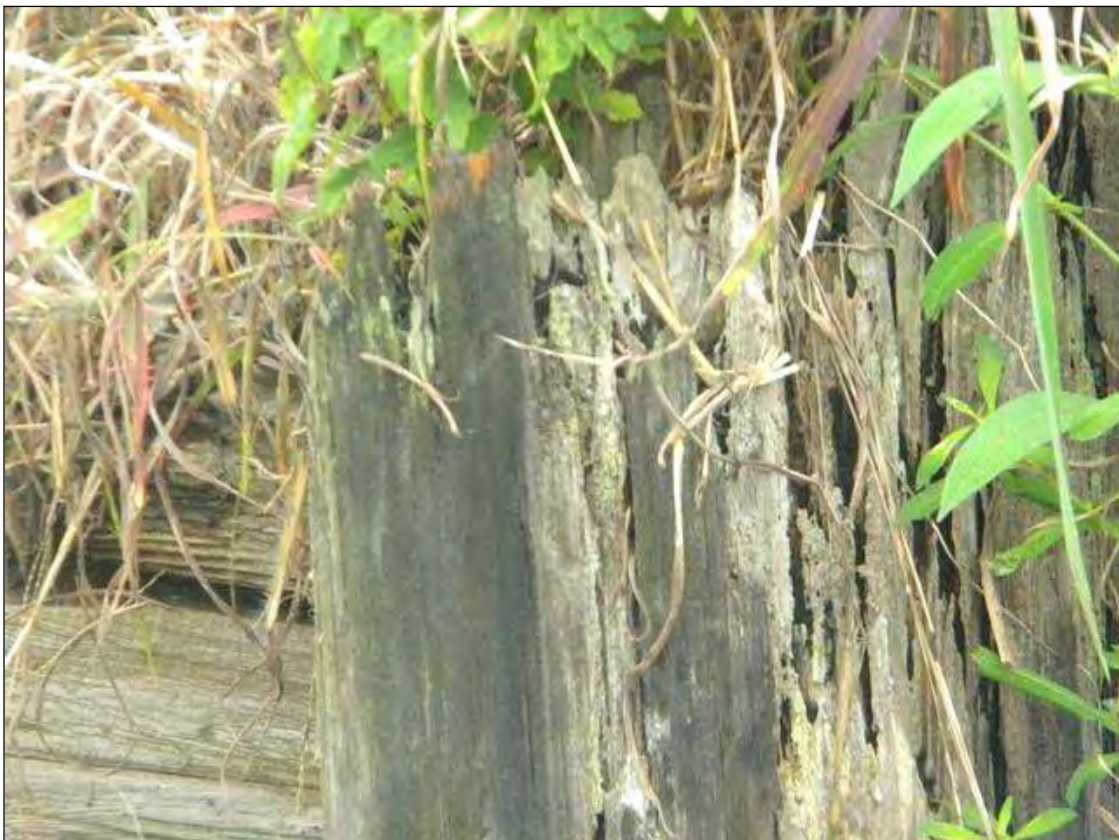
FULLY DECAYED WINGWALL PILE AT NORTHWEST CORNER

| MMS Code | Description of Function | Unit | Quantity | Remarks | Est. Cost |
|---|---|---|---|---|---|
| 3346 | Repair / Maintain Timber Wings & Blkhds | SF | 5 | FULLY DECAYED WINGWALL PILE AT NORTHWEST CORNER | |

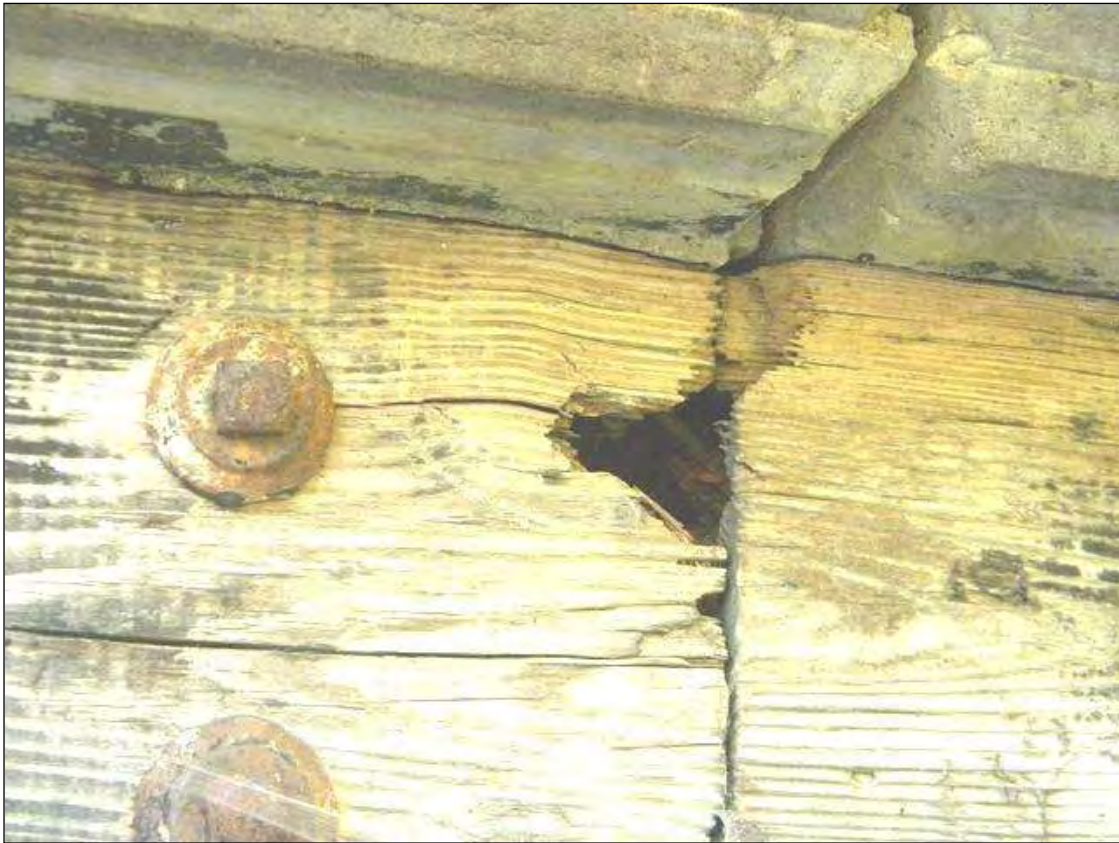
JOIST 1 IN SPAN 2 AT BENT 1 END DECAYED 2 1/2" HIGH X 2" WIDE X UP TO 3" DEEP

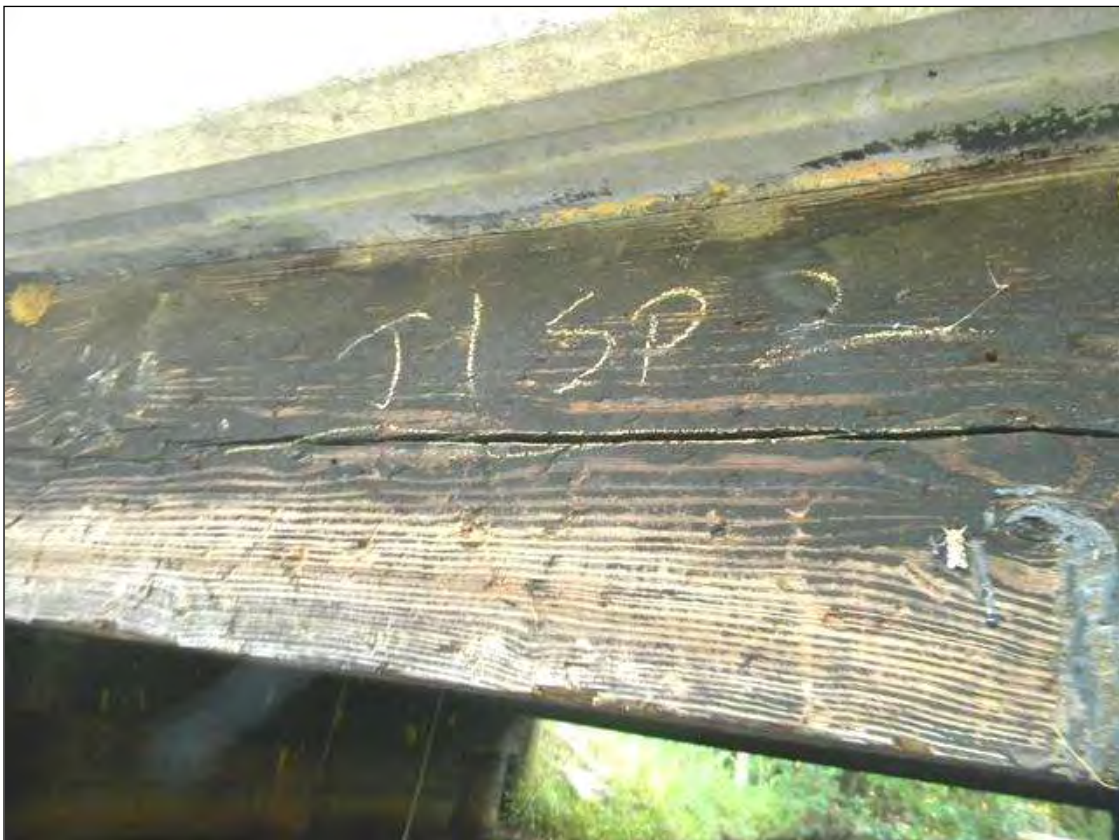
JOIST 1 IN SPAN 2 WITH 1/4" WIDE CHECKS

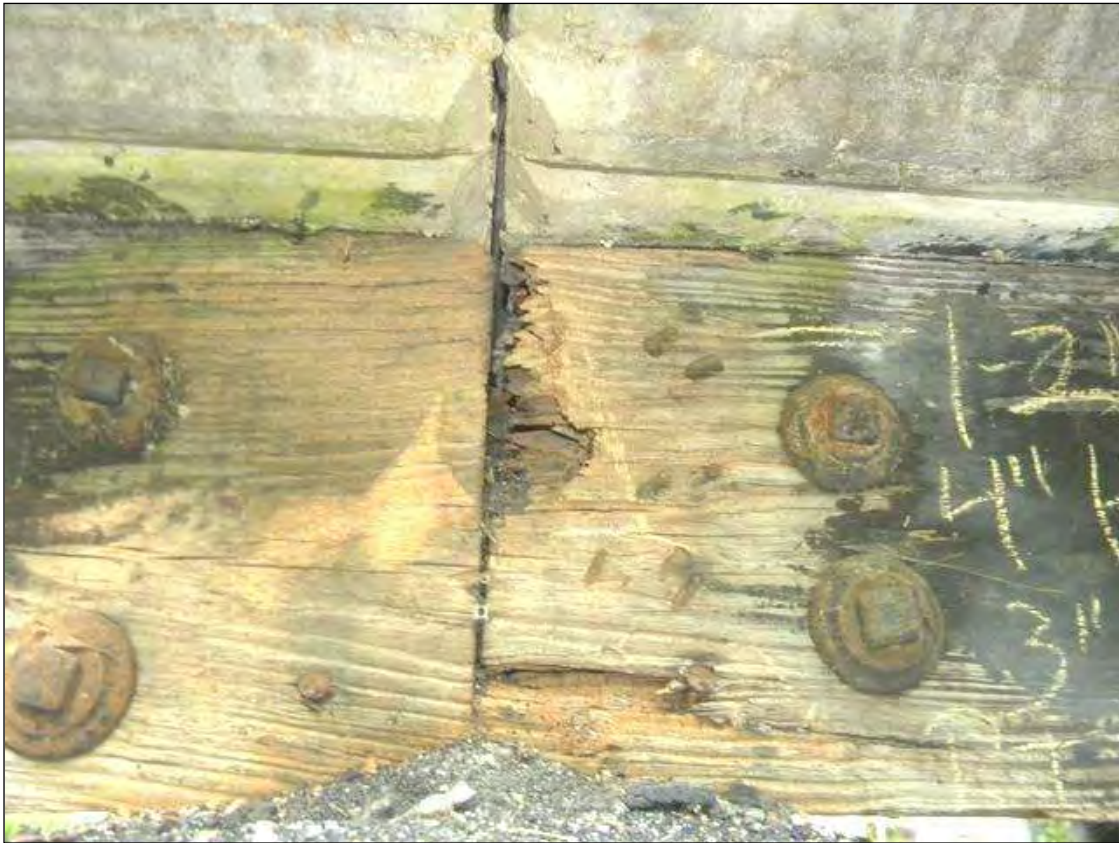
JOIST 19 IN SPAN 2 AT BENT 1 DECAYED 1" TO 2" WIDE X 4" HIGH X 3" DEEP

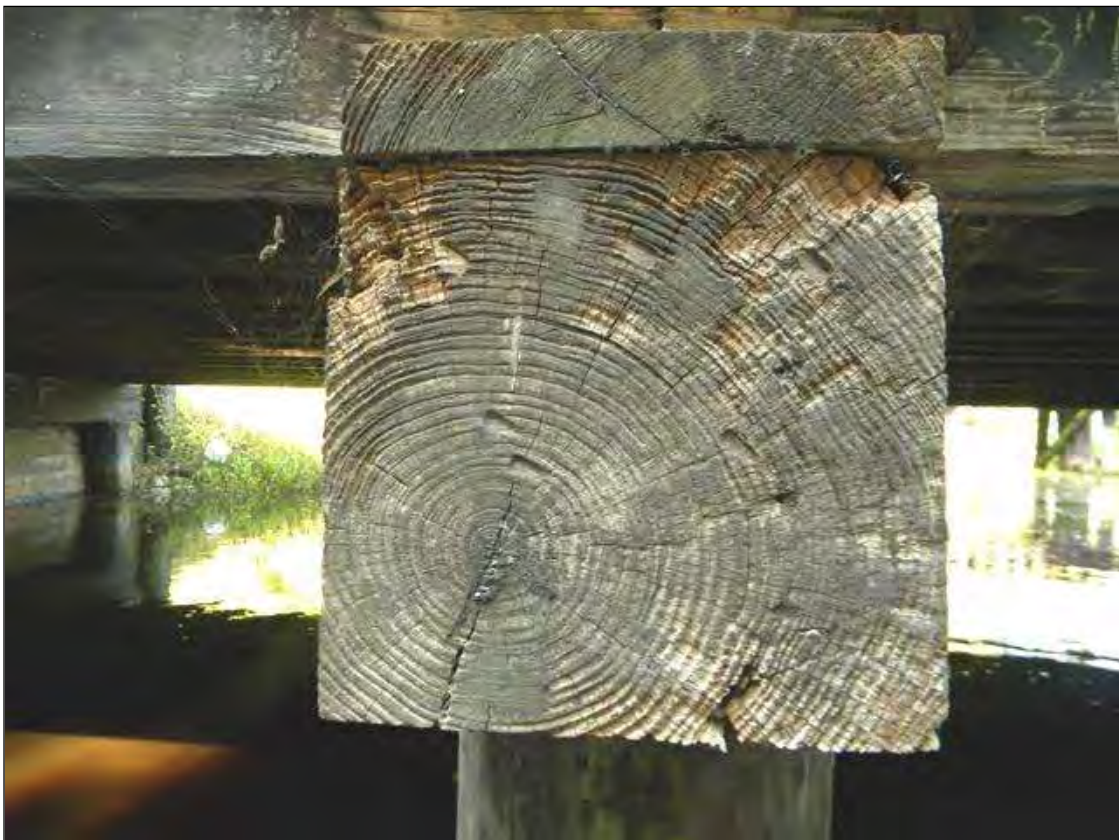
BENT 1 CAP AT EAST END IS SURFACE DECAYED

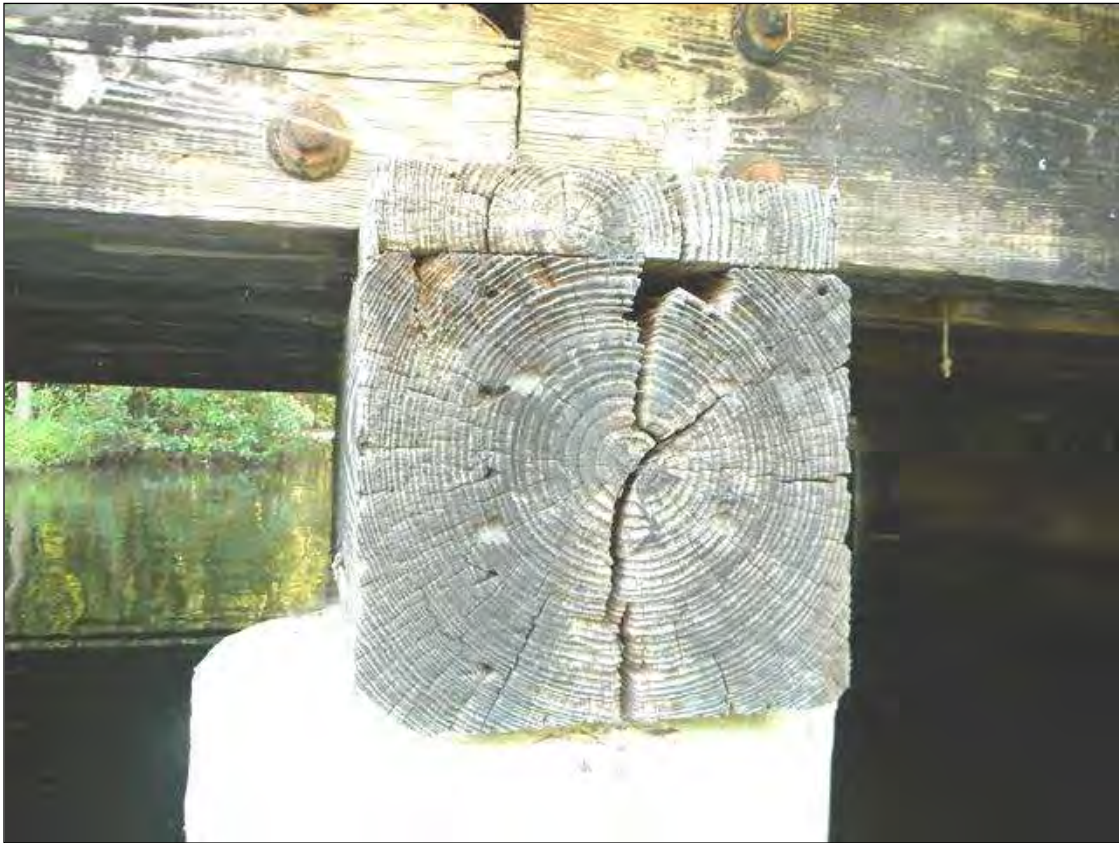
BENT 1 CAP WEST END IS DECAYED UP TO 11" DEEP AT TOP WITH A 5/16" TO 3/8" WIDE VERTICAL CRACK

| MMS Code | Description of Function | Unit | Quantity | Remarks | Est. Cost |
|---|---|---|---|---|---|
| 3344 | Repair / Replace Timber Substructure Components | LF | 1 | BENT 1 CAP WEST END IS DECAYED UP TO 11" DEEP AT TOP WITH A 5/16" TO 3/8" WIDE VERTICAL CRACK | |

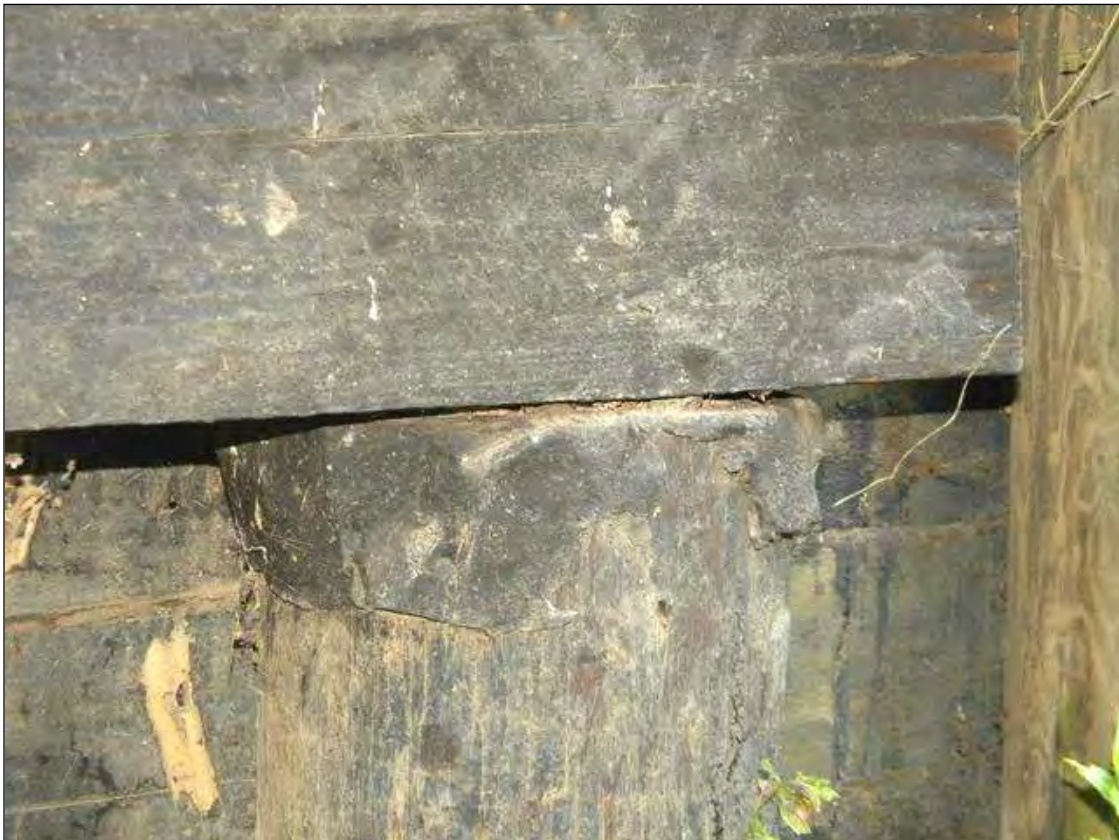
END BENT 2 CAP ROLLED BACK 1/2" AT PILE 4

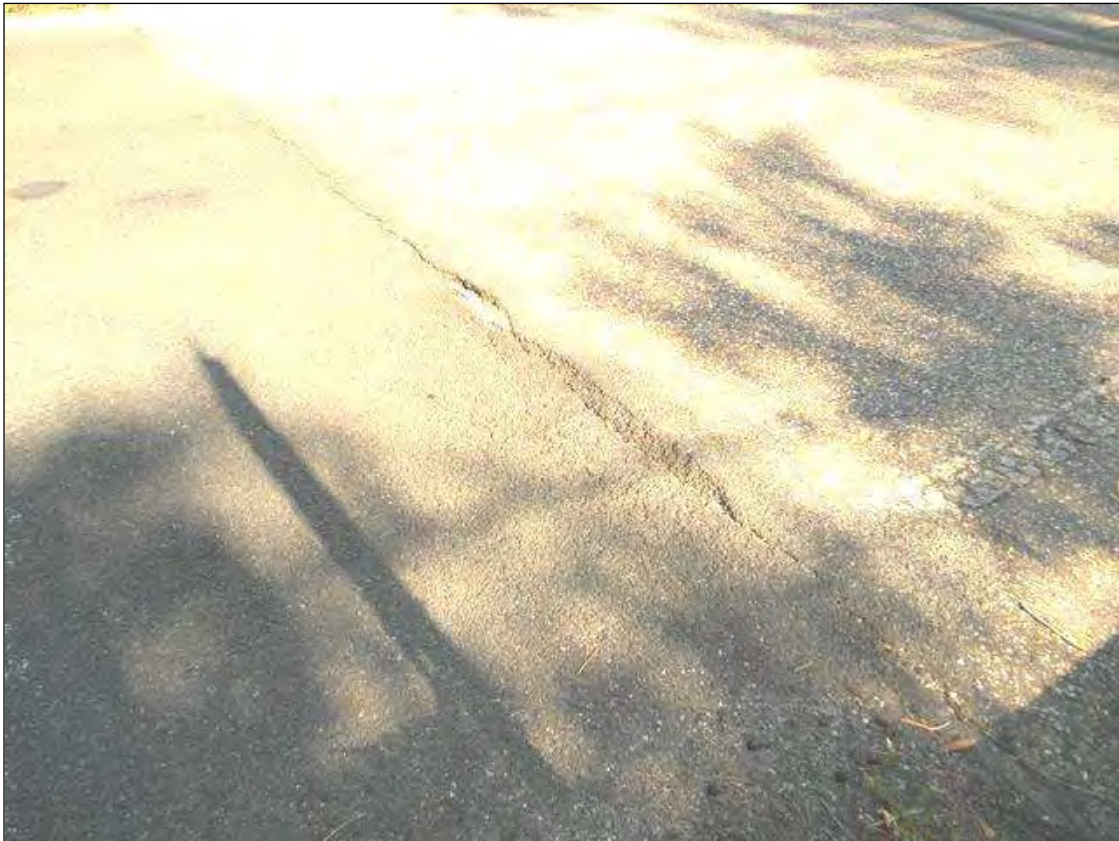
SOUTH APPROACH ASPHALT WEARING SURFACE SETTLED UP TO 1/2" IN THE NORTH BOUND LANE

| MMS Code | Description of Function | Unit | Quantity | Remarks | Est. Cost |
|---|---|---|---|---|---|
| 2816 | Asphalt Surface Repair or Replacement | SY | 3 | SOUTH APPROACH ASPHALT WEARING SURFACE SETTLED UP TO 1/2" IN THE NORTH BOUND LANE | |

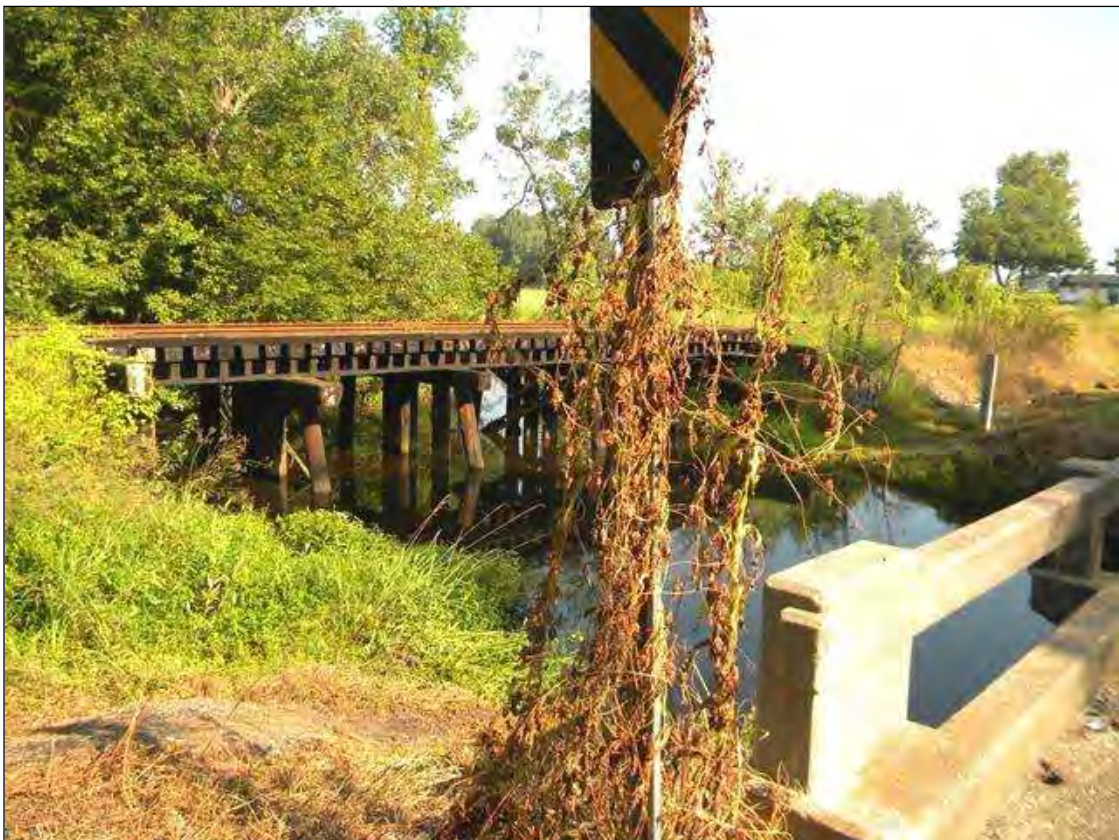
VEGETATION ON DELINEATOR AT SOUTHWEST CORNER

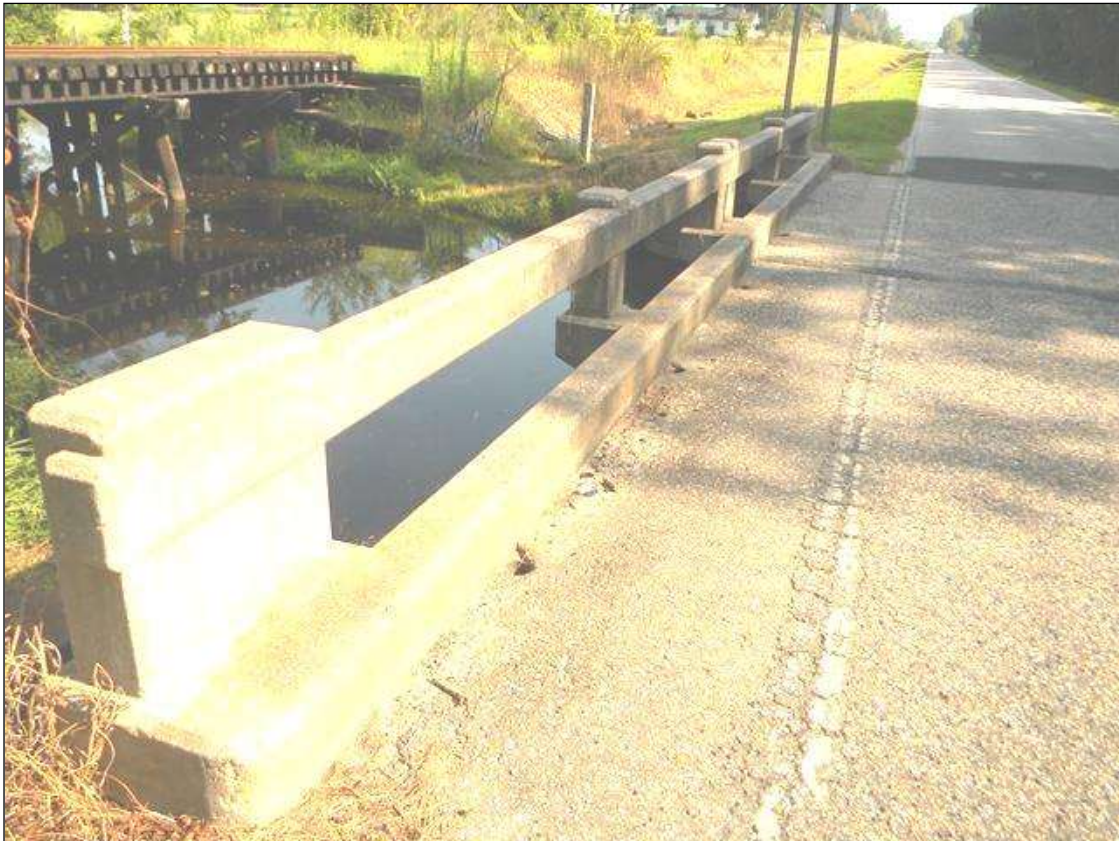
SCATTERED DEBRIS ALONG LEFT CURB

| MMS Code | Description of Function | Unit | Quantity | Remarks | Est. Cost |
|---|---|---|---|---|---|
| 3366 | Drift and Debris Removal | HR | 2 | SCATTERED DEBRIS ALONG LEFT CURB | |

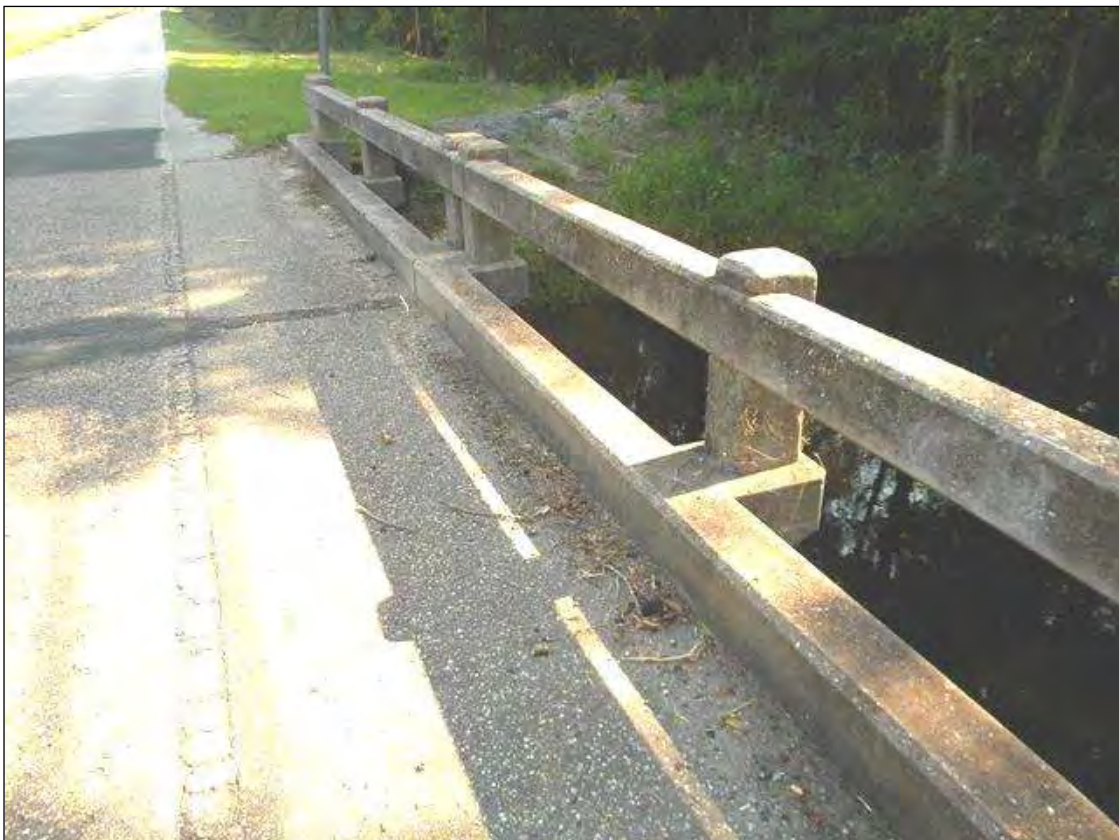
SCATTERED DEBRIS ALONG RIGHT CURB

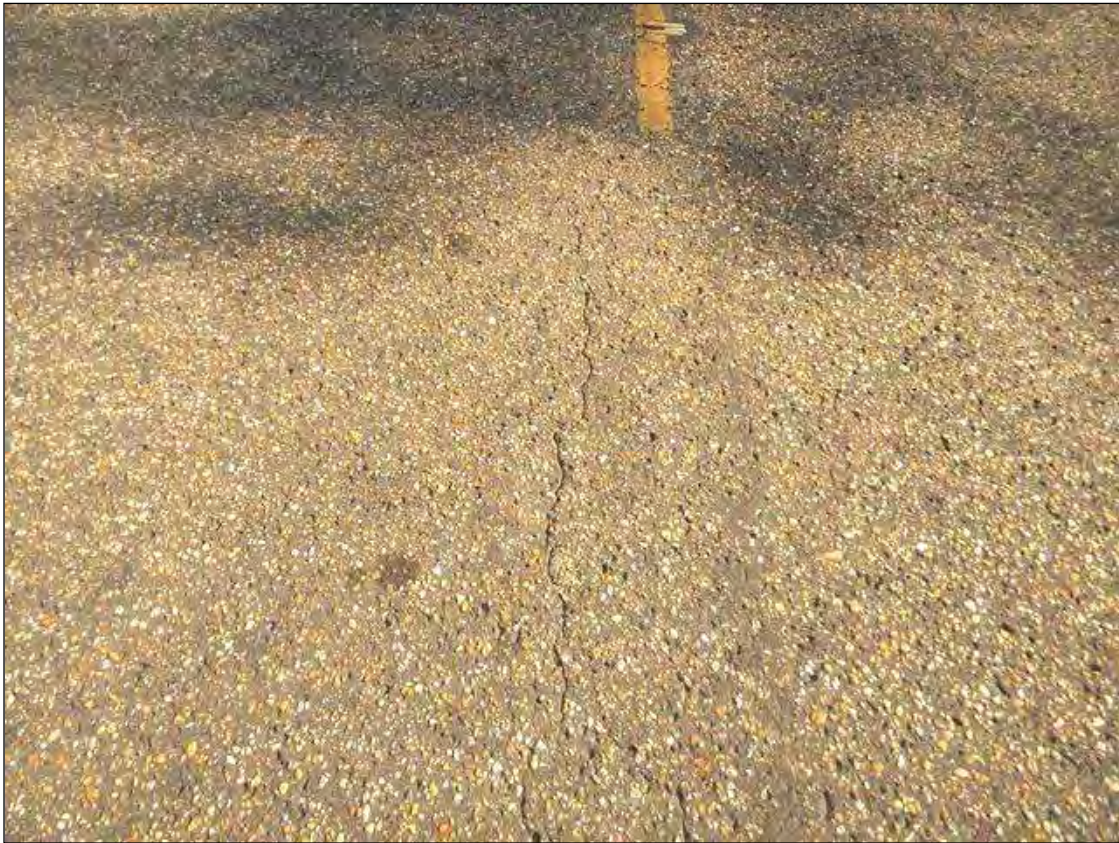
HAIRLINE TO 1/8" LONGITUDINAL CRACK IN SPAN 1 AT CENTERLINE

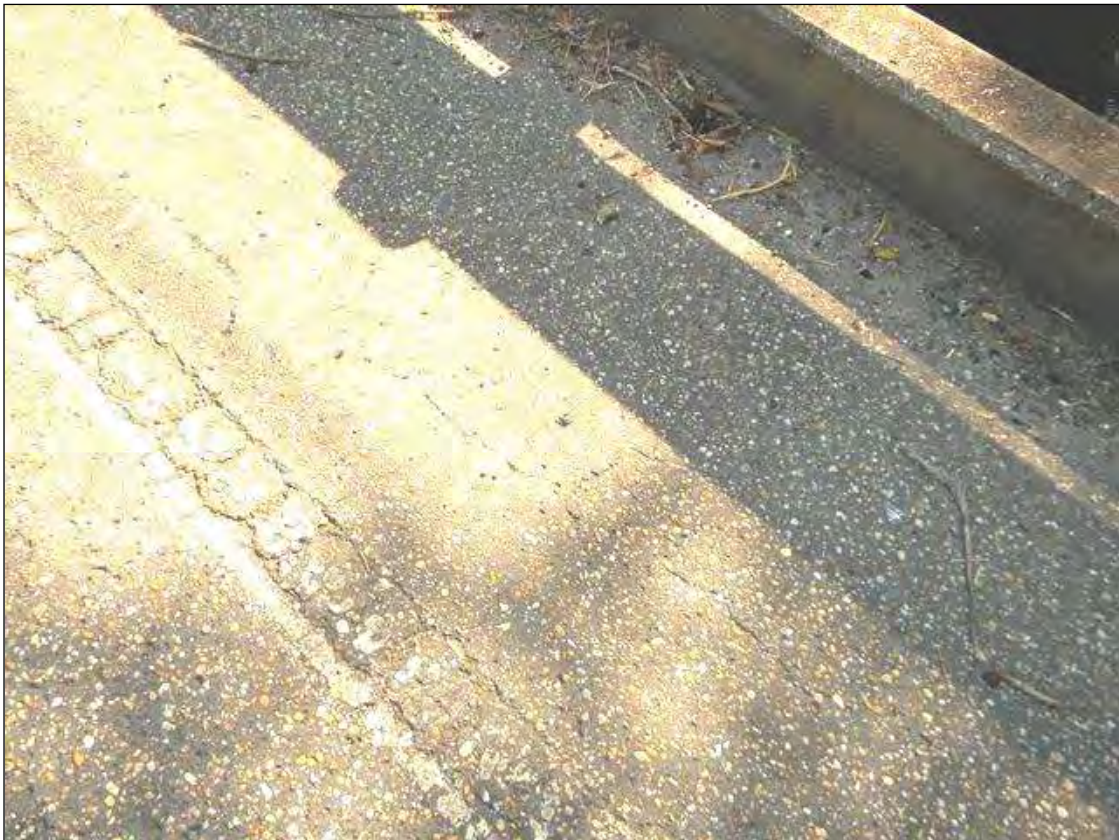
1/8" MAP CRACKING IN ASPHALT WEARING SURFACE AT SPAN 1 RIGHT SHOULDER

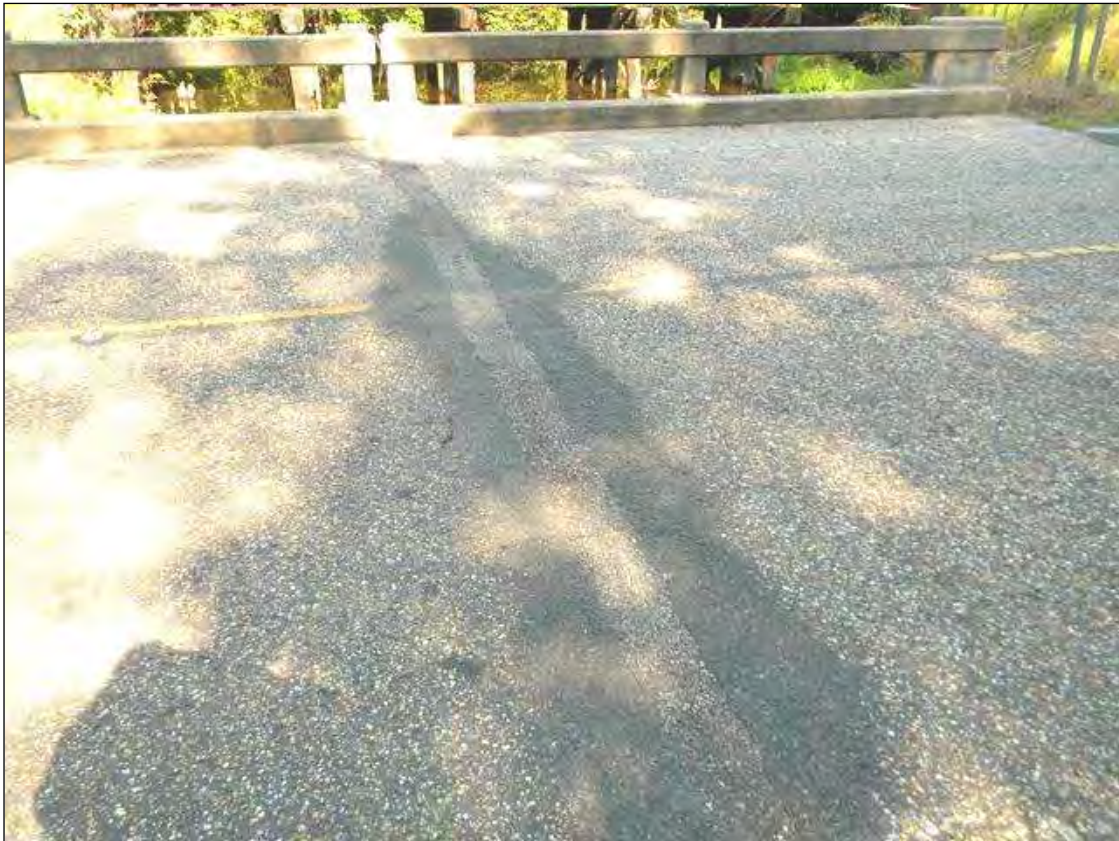
| <b>6d</b> | <b>G</b> | ( STANDARD JOINTS ) THE BENT 1 JOINT IS COVERED WITH ASPHALT WEARING SURFACE PATCH. (PHOTO) | |

BENT 1 STANDARD JOINT COVERED WITH ASPHALT WEARING SURFACE PATCH
