NC DEPARTMENT OF TRANSPORTATION  
DIVISION OF HIGHWAYS  
BRIDGE MANAGEMENT UNIT

# BRIDGE INSPECTION REPORT

INSPECTION TYPE: Routine Inspection

COUNTY COLUMBUS BRIDGE NUMBER 230118 INSPECTION CYCLE 2 YRS  
ROUTE SR1317 ACROSS GUM SWAMP M.P. 0

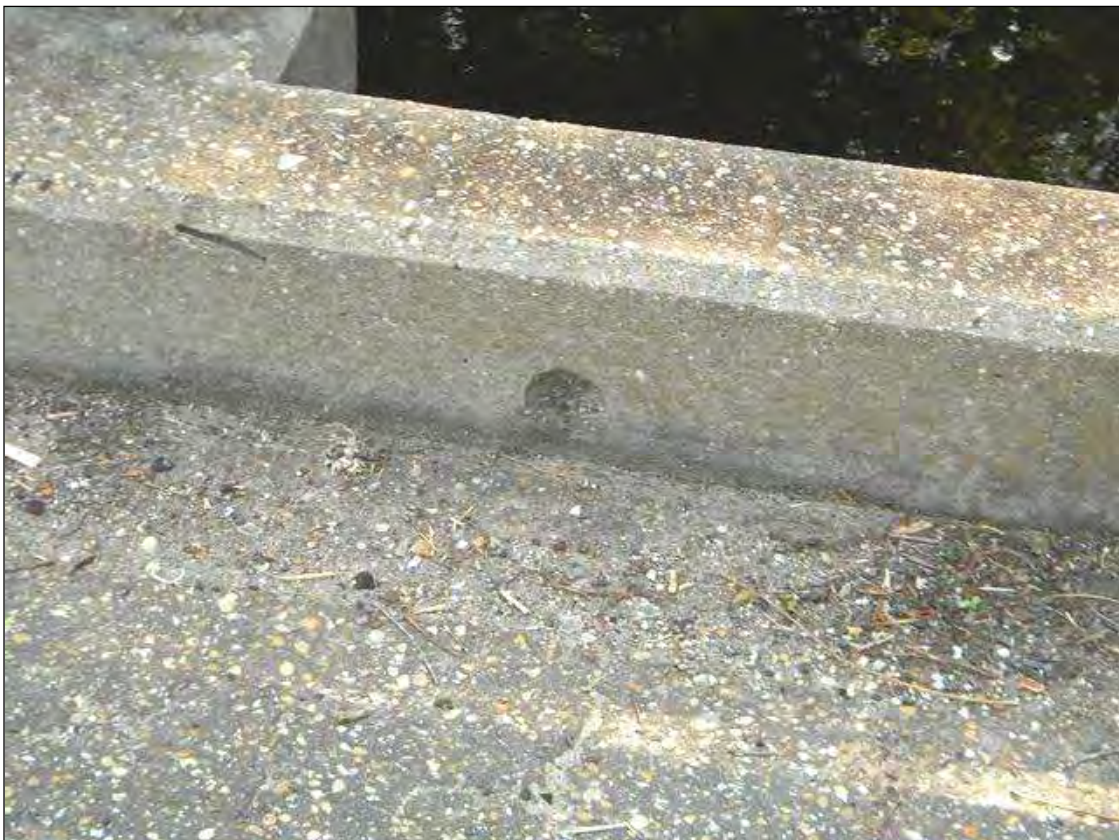
| <b>4</b> | <b>G</b> | ( CONC CURBS ) THE RIGHT CURB IN SPAN 1 HAS A SURFACE SPALL. (PHOTO) | |

SURFACE SPALL IN RIGHT CURB AT SPAN 1, NEAR BENT 1

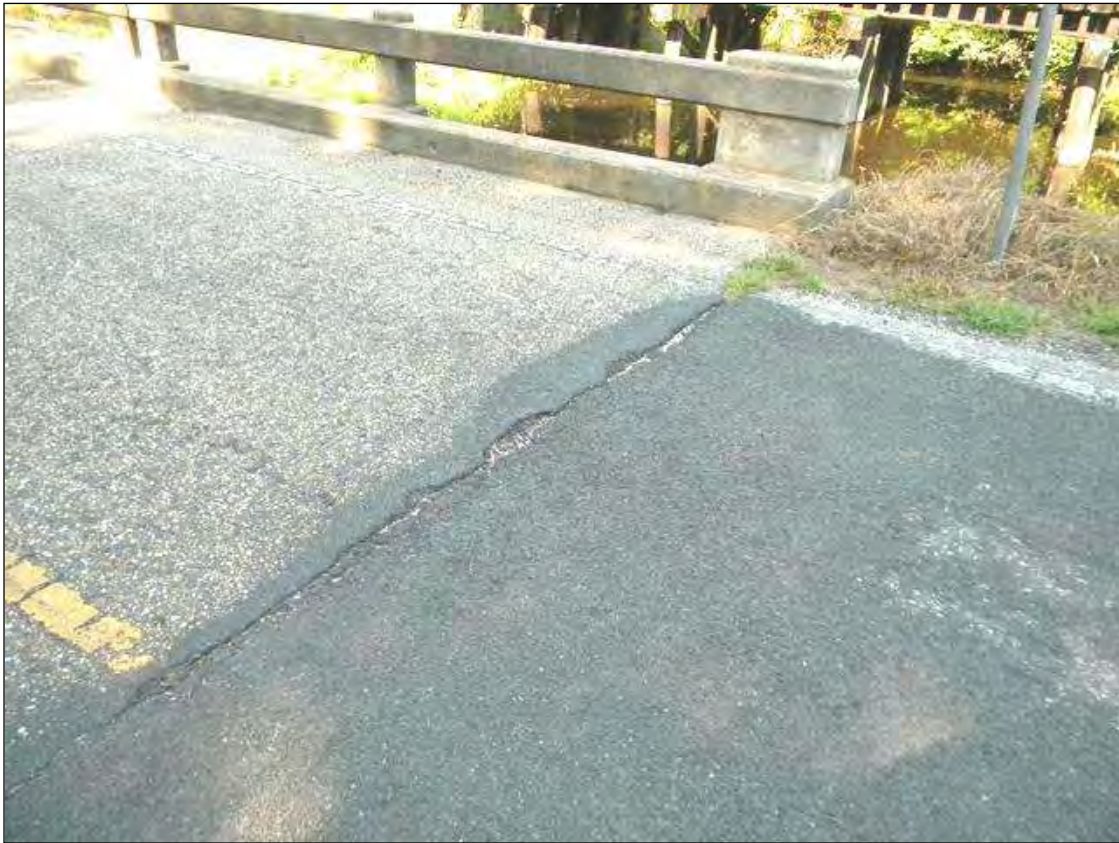
NORTH APPROACH ASPHALT WEARING SURFACE SETTLED UP TO 1/2" IN THE SOUTH BOUND LANE

| MMS Code | Description of Function | Unit | Quantity | Remarks | Est. Cost |
|---|---|---|---|---|---|
| 2816 | Asphalt Surface Repair or Replacement | SY | 3 | NORTH APPROACH ASPHALT WEARING SURFACE SETTLED UP TO 1/2" IN THE SOUTH BOUND LANE | |
