# BRIDGE INSPECTION REPORT

INSPECTION TYPE: Routine Inspection

COUNTY COLUMBUS BRIDGE NUMBER 230126 INSPECTION CYCLE 2 YRS  
ROUTE SR1005 ACROSS GUM SWAMP M.P. 0

INSPECTION DATE 07/16/2012

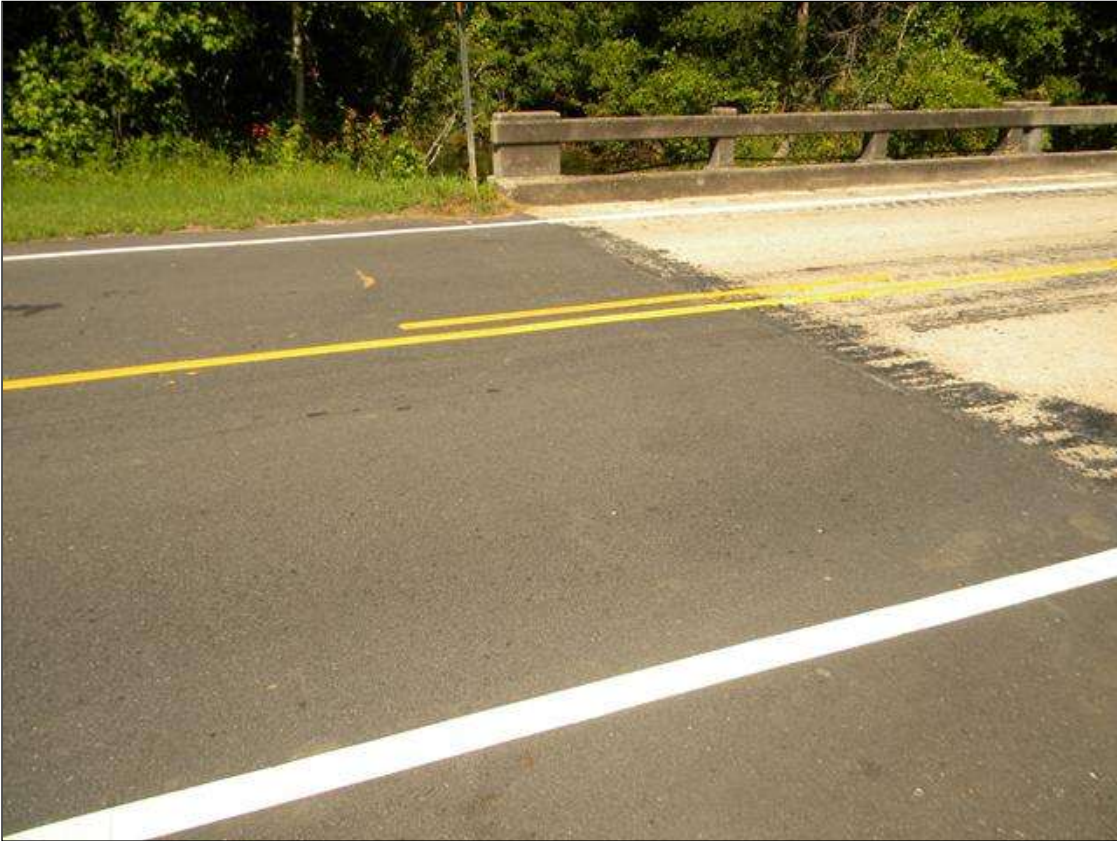
| Bridge I&A Form 1(82)H<br>State of North Carolina<br>Dept. of Transportation<br>Division of Highways | | <b>FIELD INSPECTION REPORT</b><br><u>Bridge Inspeccion &amp; Analysis</u> | |
|---|---|---|--|
| 50 | G | ( APPROACH ROADWAY ) BOTH APPROACHES HAVE BEEN RESURFACED. (PHOTOS) | |

SOUTH APPROACH ASPHALT WEARING SURFACE RESURFACED , NORTH APPROACH ASPHALT WEARING SURFACE SIMILAR

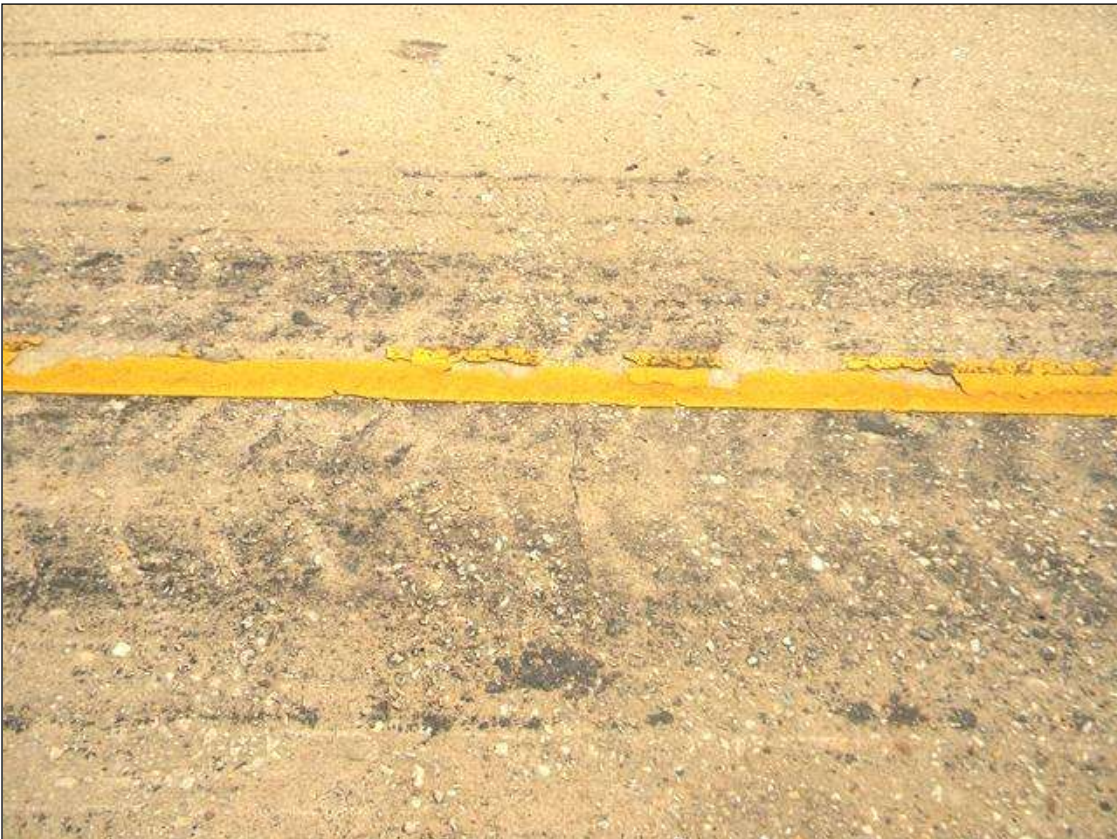
HAIRLINE TO 1/16" TRANSVERSE CRACK IN SPAN 1 DECK

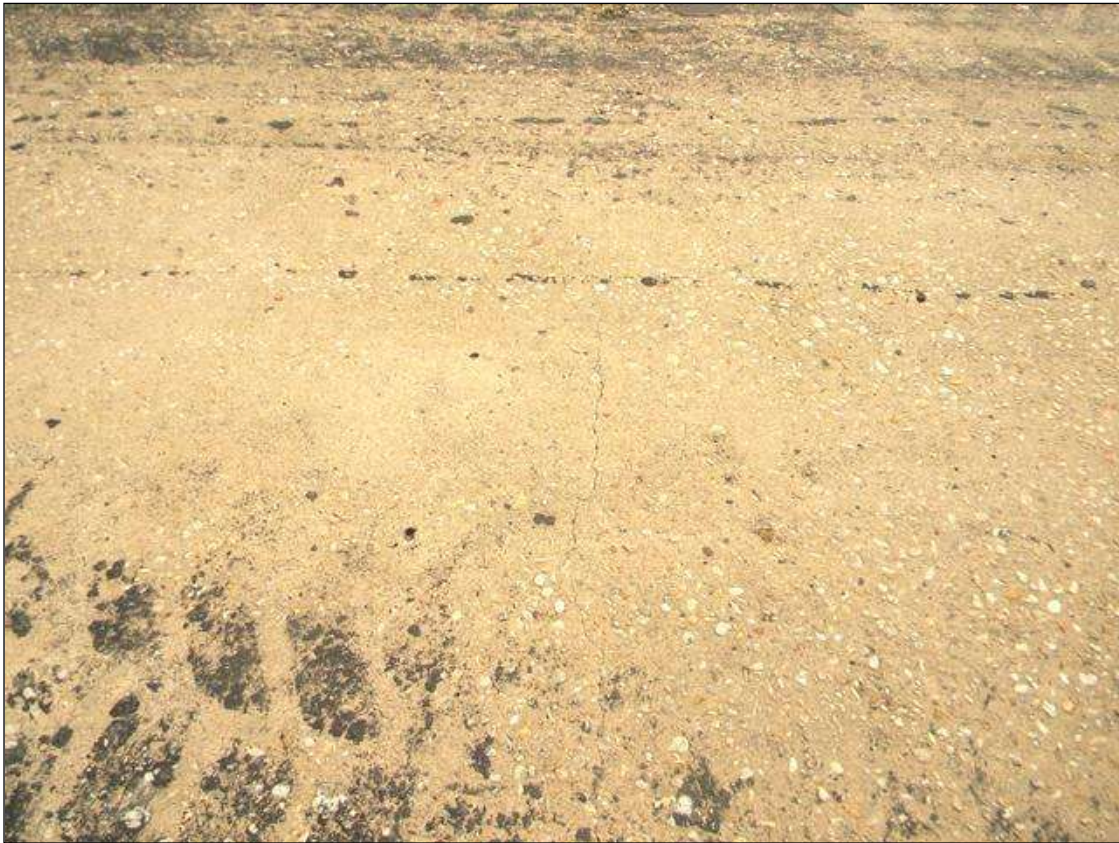
HAIRLINE TO 1/16" TRANSVERSE CRACK IN SPAN 2 SOUTH BOUND LANE

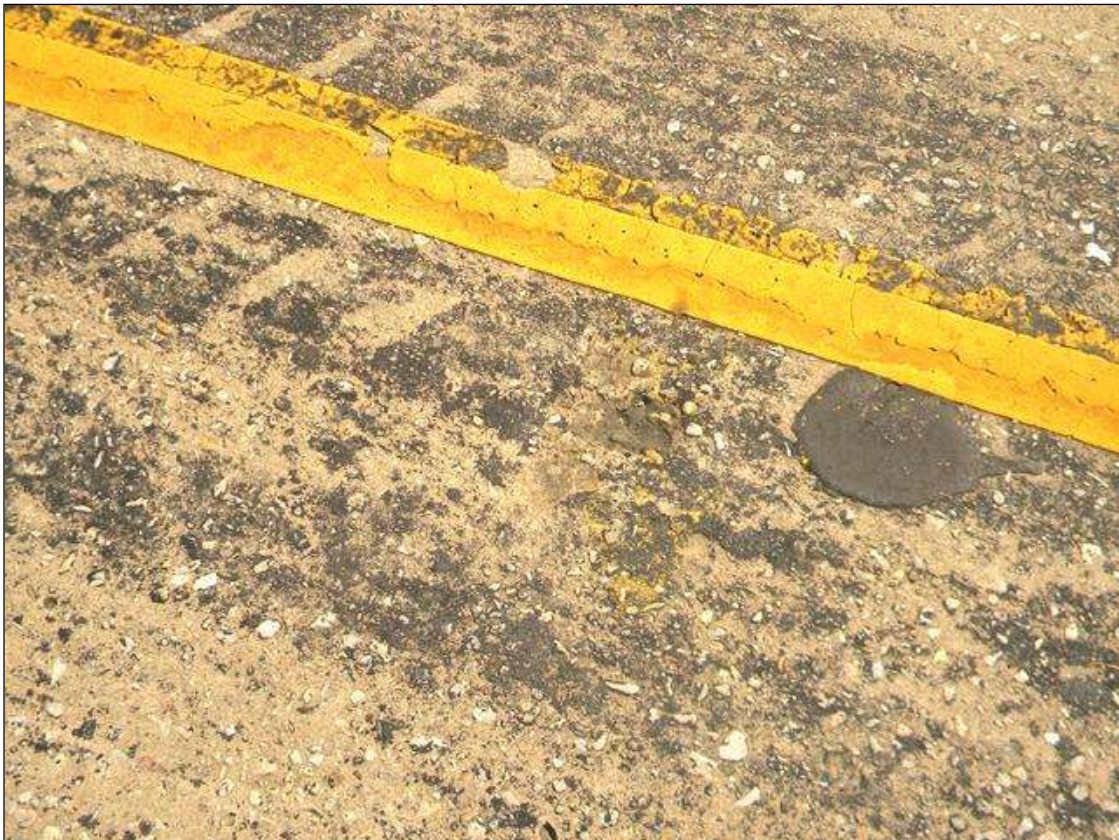
4" DIAMETER SURFACE SPALL IN SPAN 2 DECK NEAR CENTERLINE

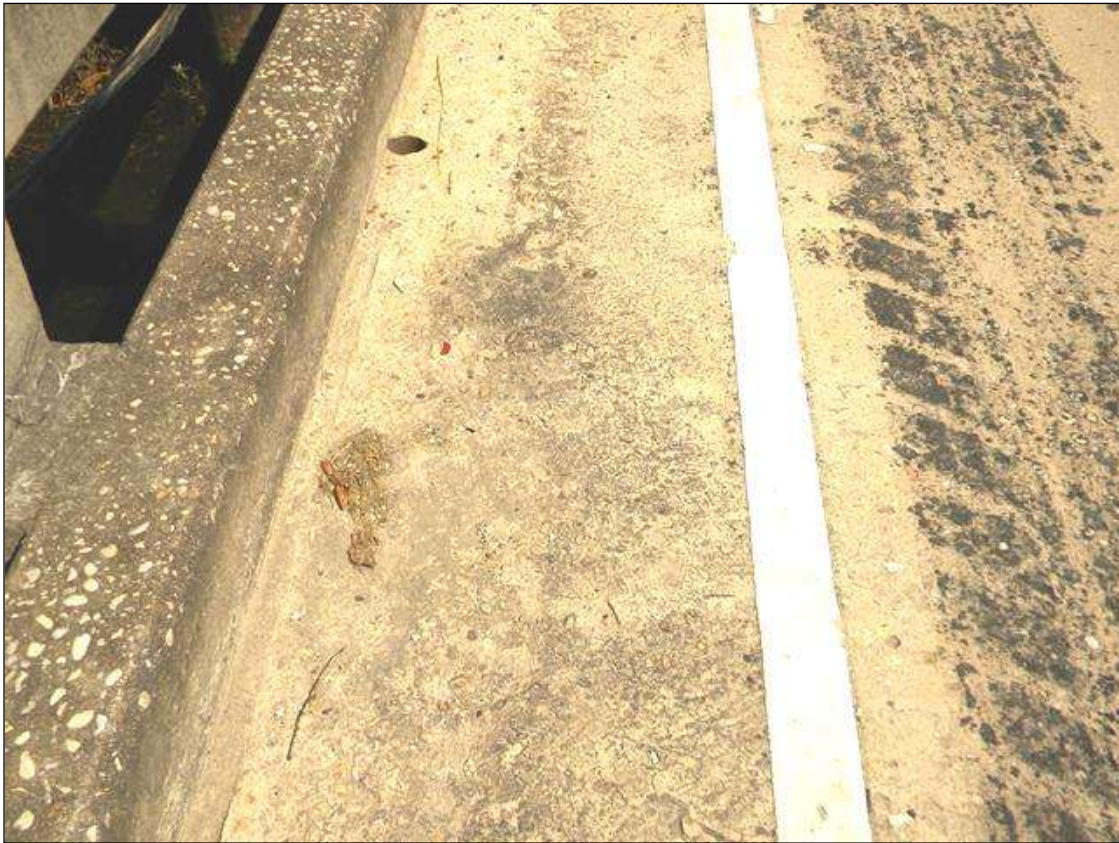
EXPOSED AGGREGATE IN ALL SPANS

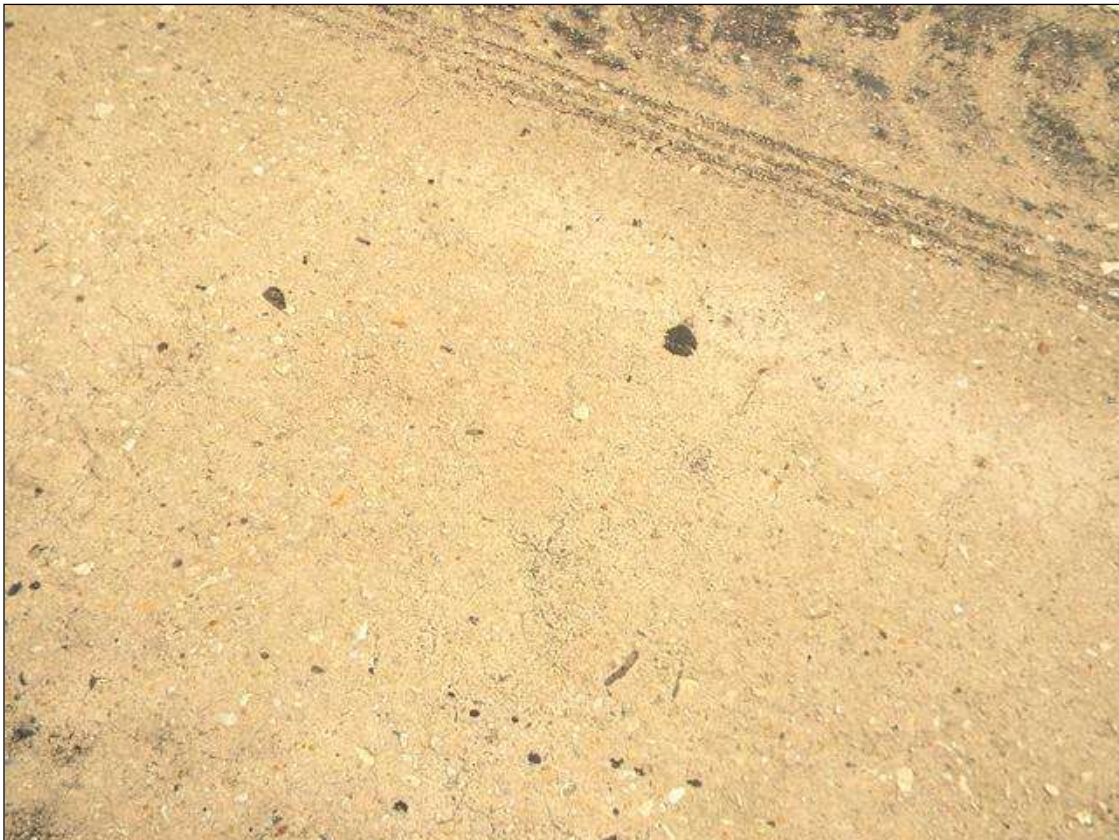
HAIRLINE MAP CRACKING IN SPAN 2 NORTH BOUND LANE

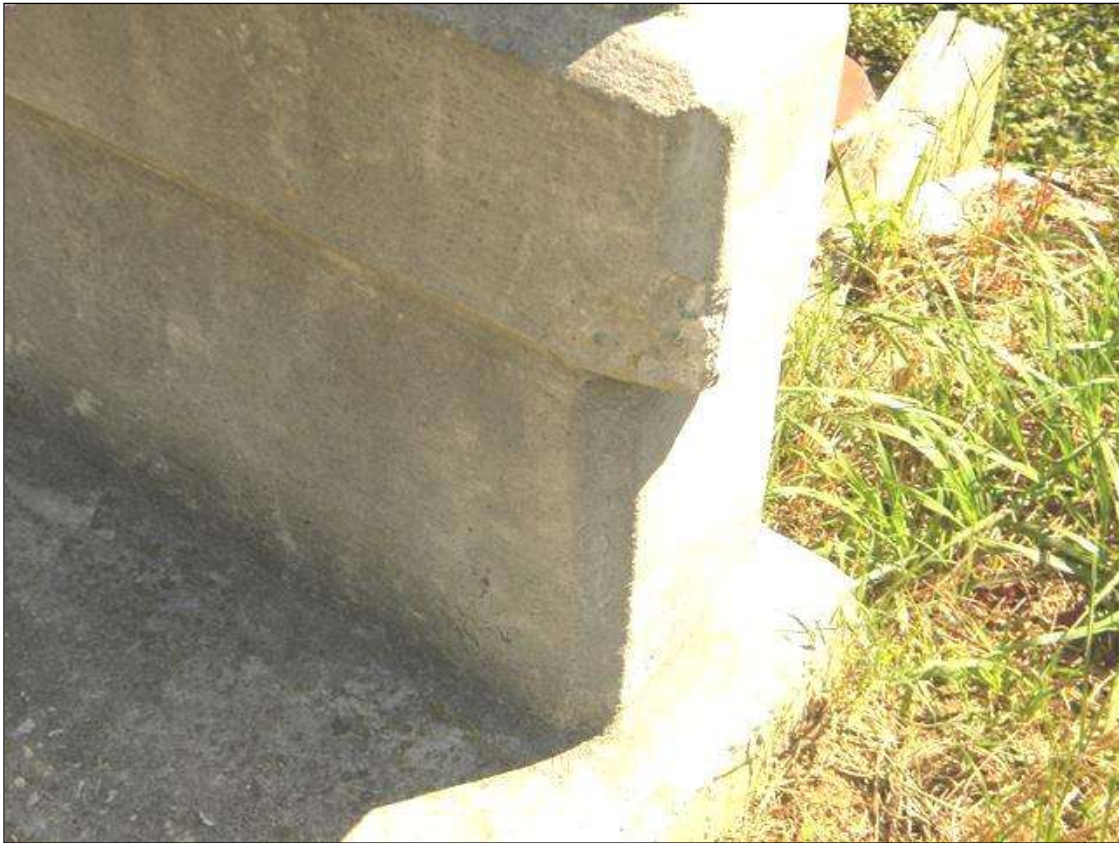
RAIL CHIP AT SOUTHEAST CORNER END POST

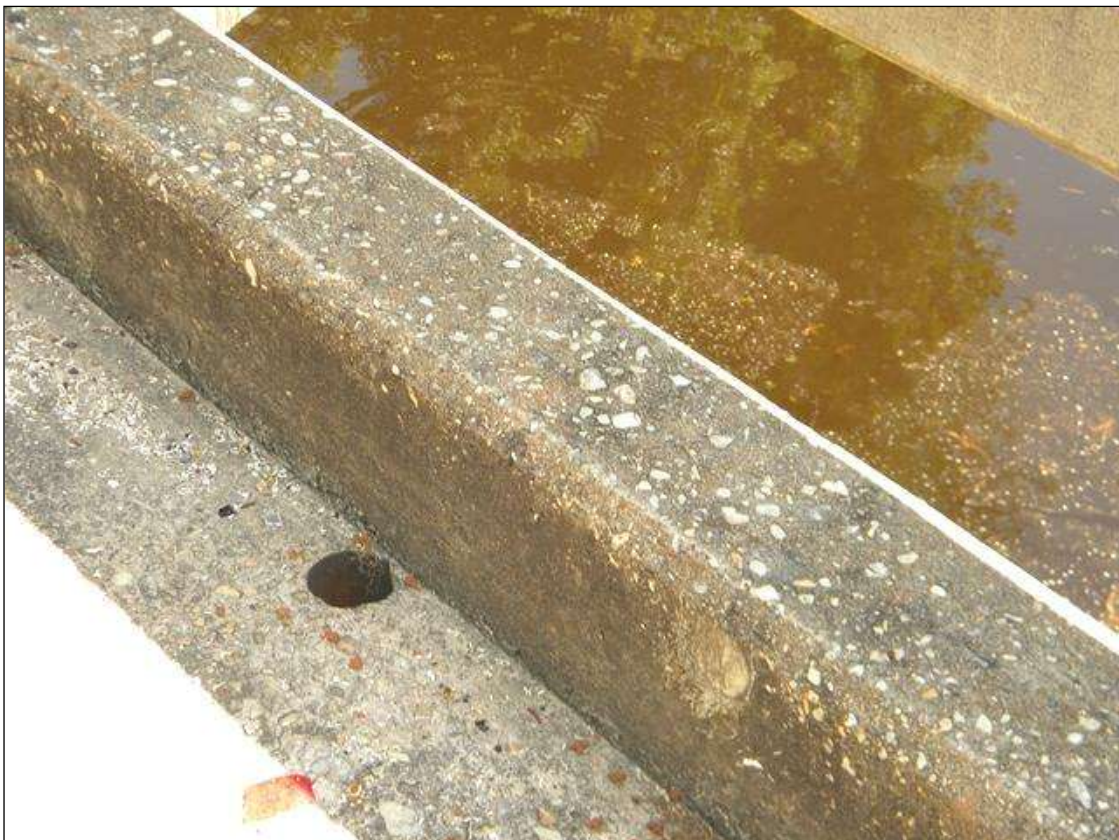
RIGHT CURB SCALING WITH EXPOSED AGGREGATE

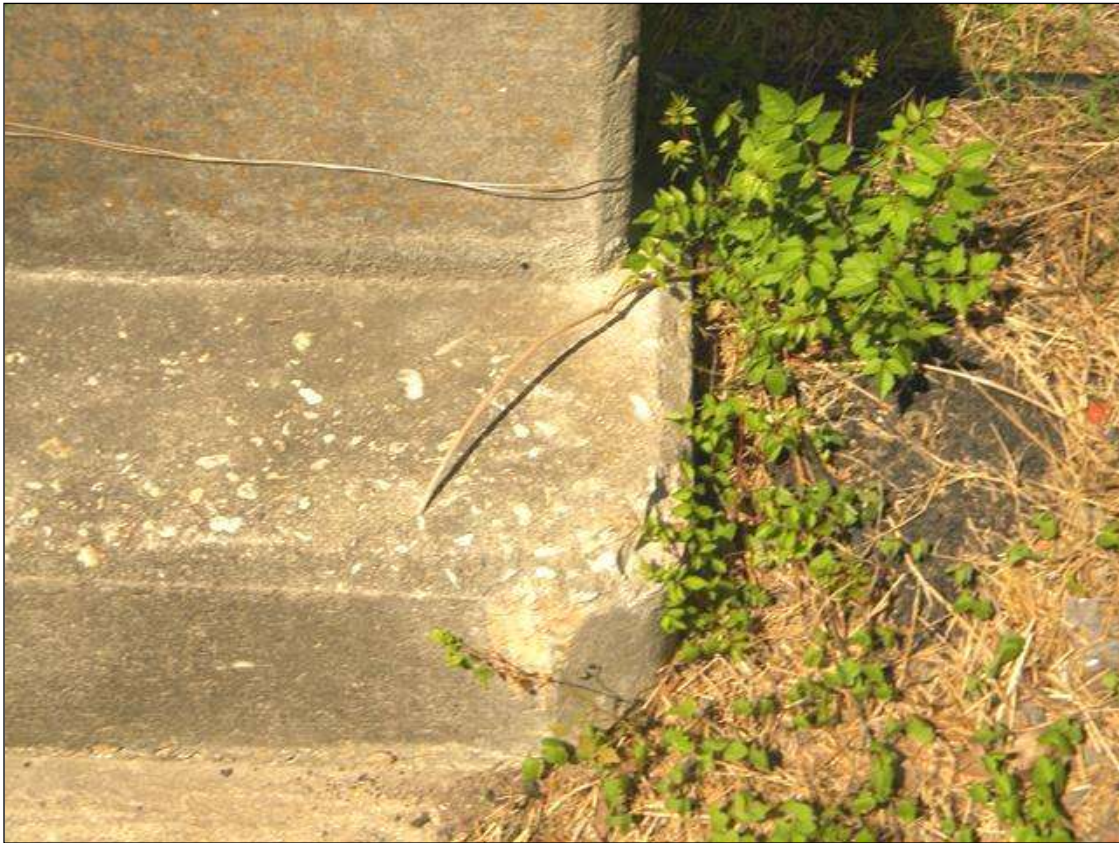
CURB SPALLED AT NORTHWEST CORNER

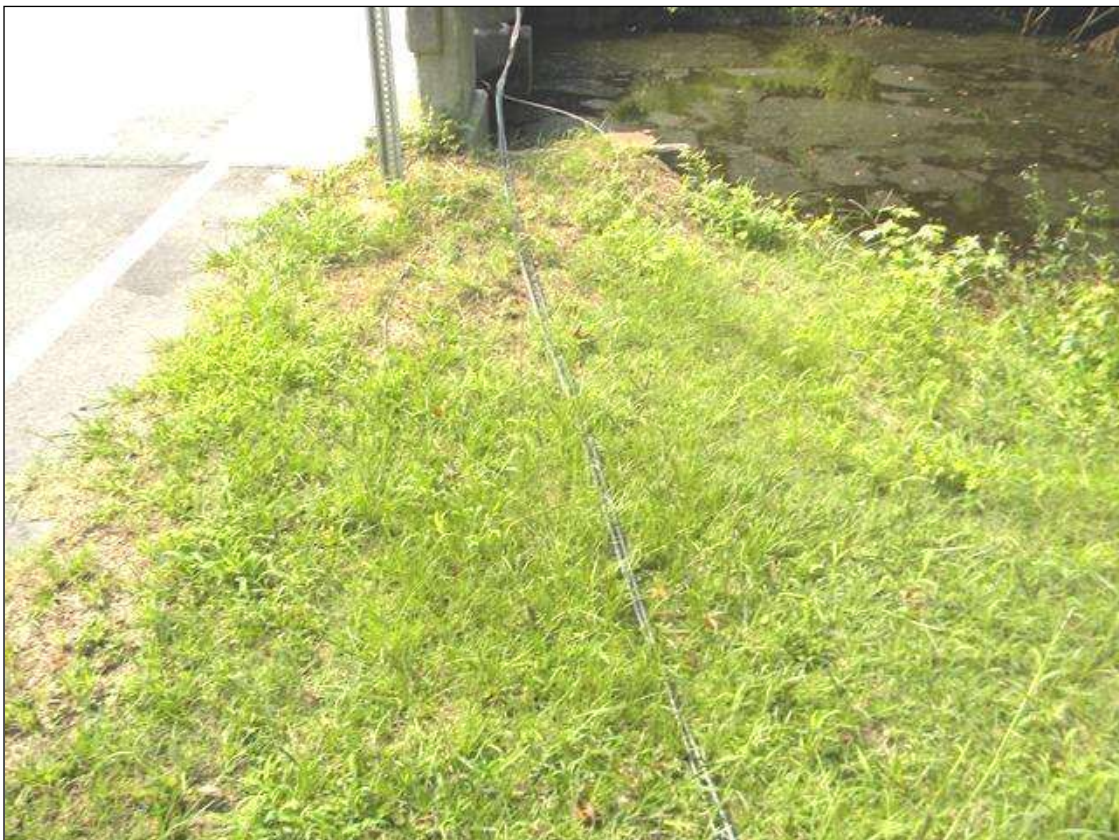
UTILITY ALONG SHOULDER AT NORTHWEST CORNER ( OWNER CENTURYLINK )

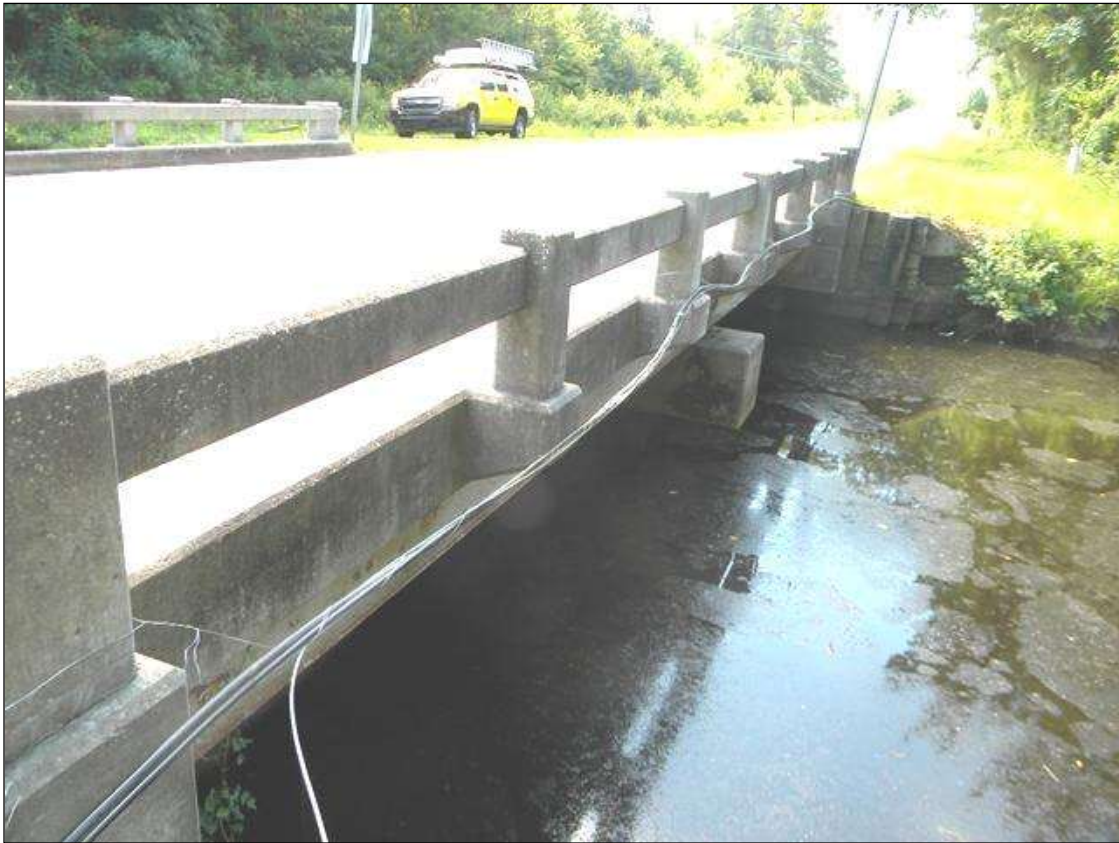
UTILITY ALONG WEST SIDE OF BRIDGE ( OWNER CENTURYLINK )

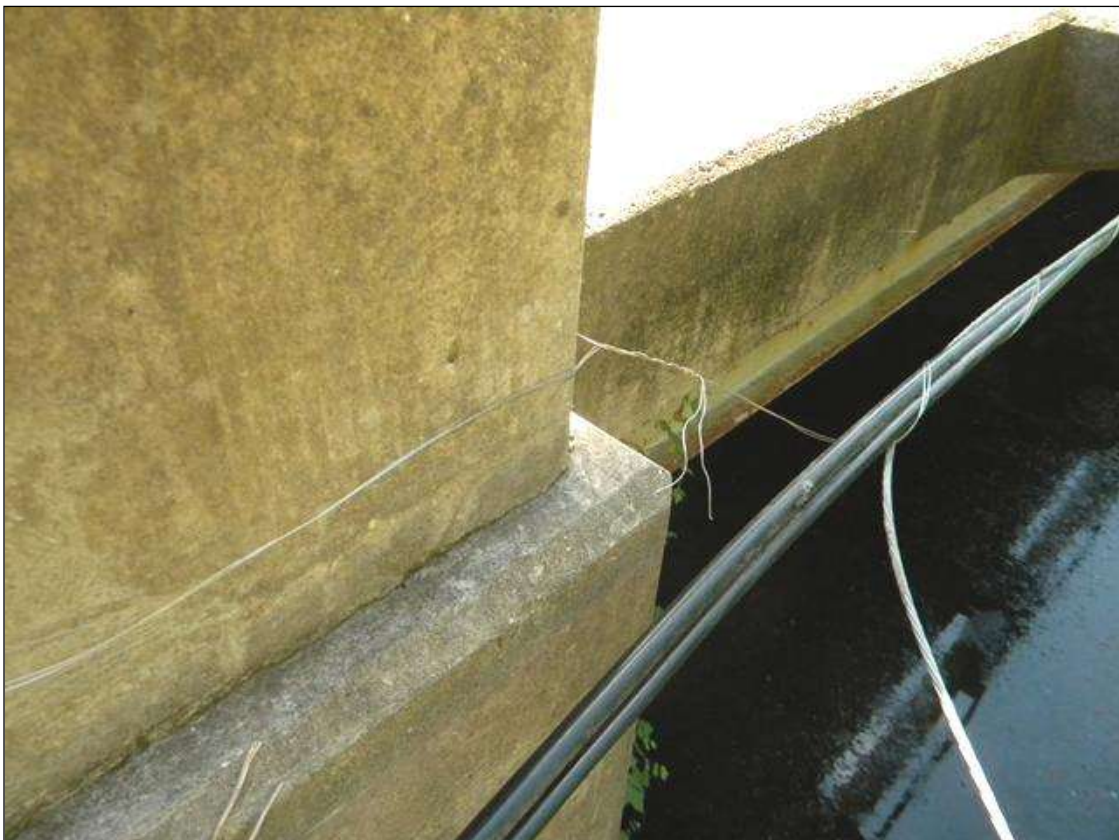
UTILITY ATTACHED TO WEST RAIL WITH SMALL WIRE ( OWNER CENTURYLINK )

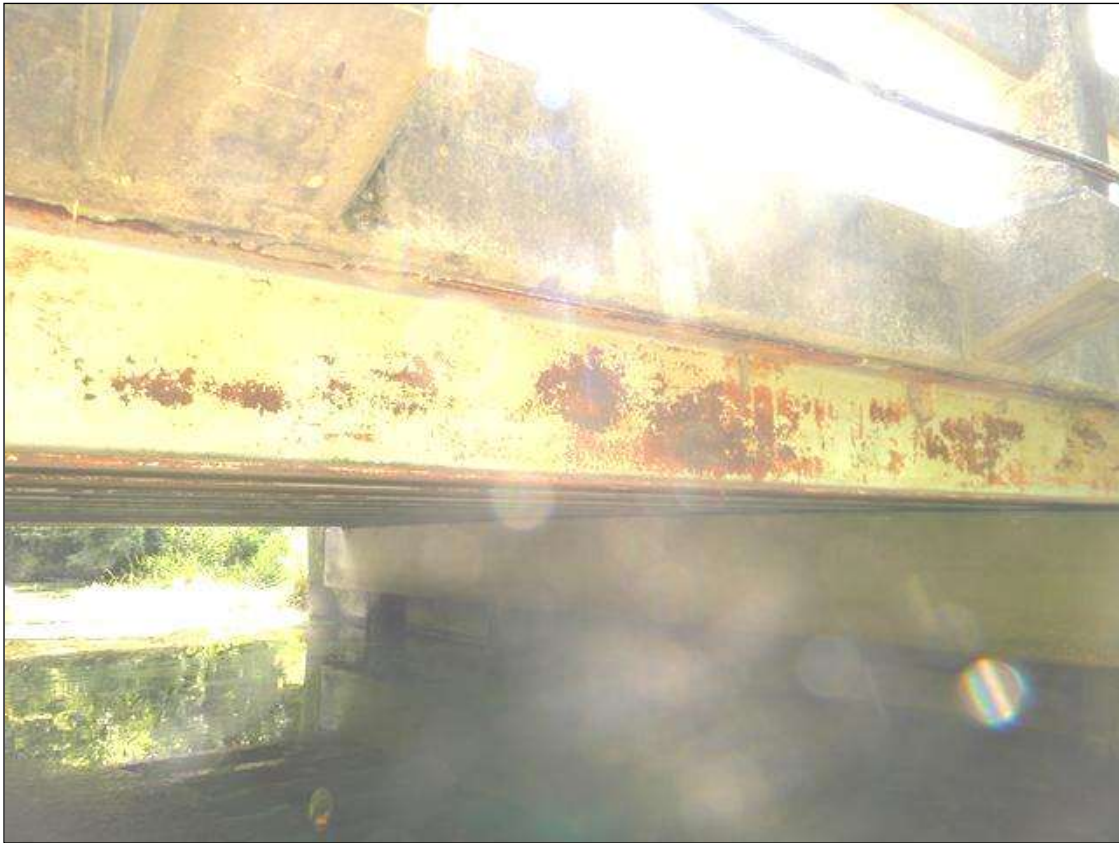
BEAM 1 EXTERIOR AT SPAN 1 WITH PAINT PEELING AND SURFACE RUST

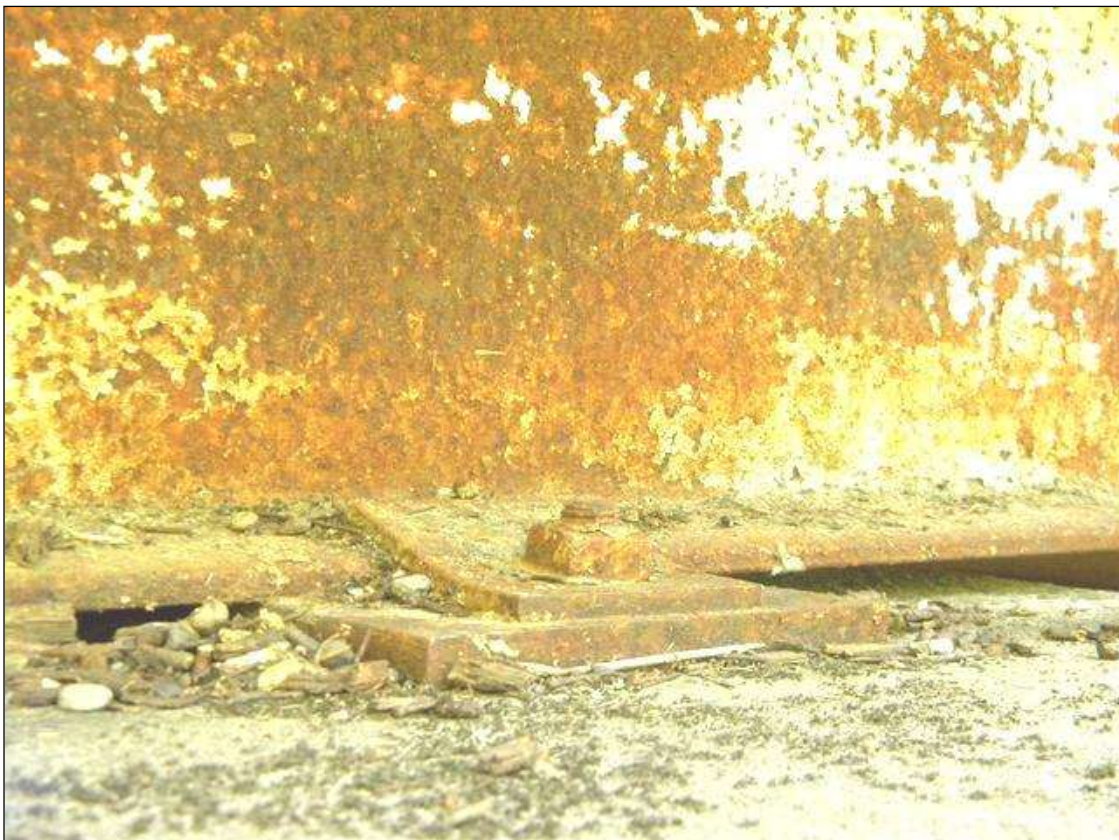
BEAM 1 BEARING AT BENT 1 WITH SURFACE RUST

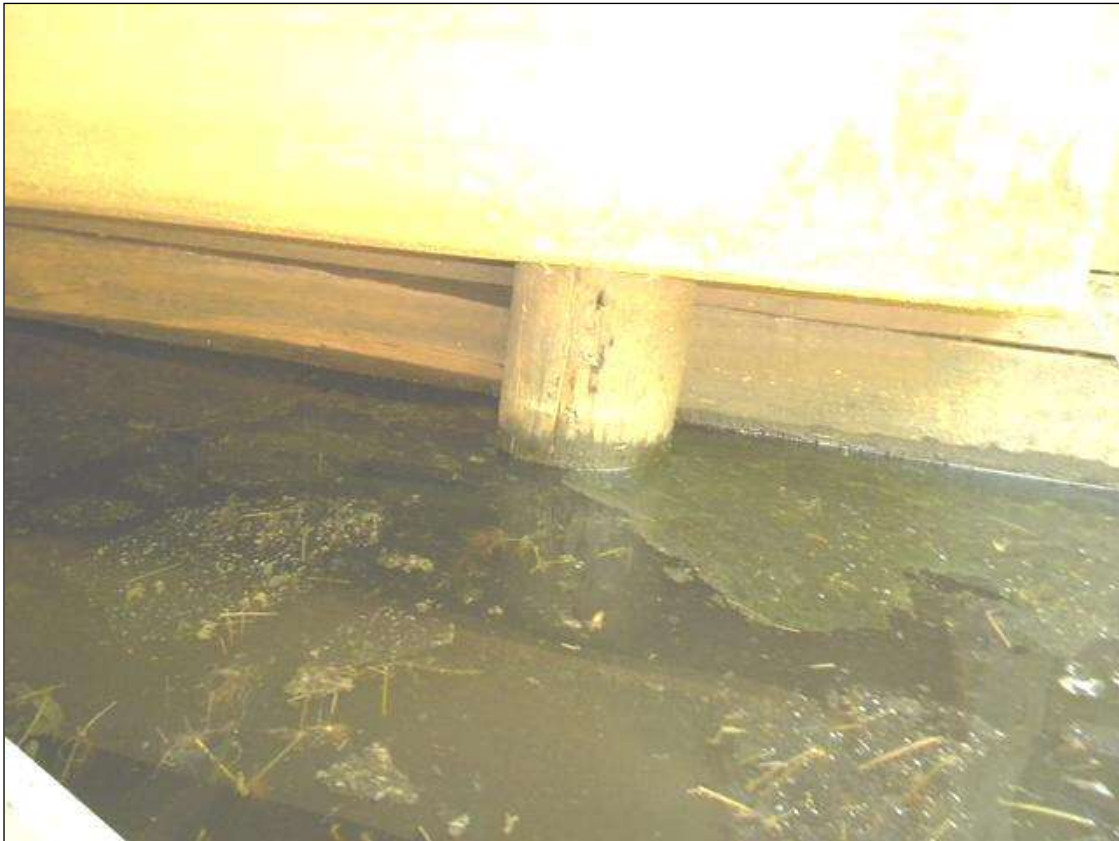
PILE 1 AT END BENT 1 SURFACE DECAYED

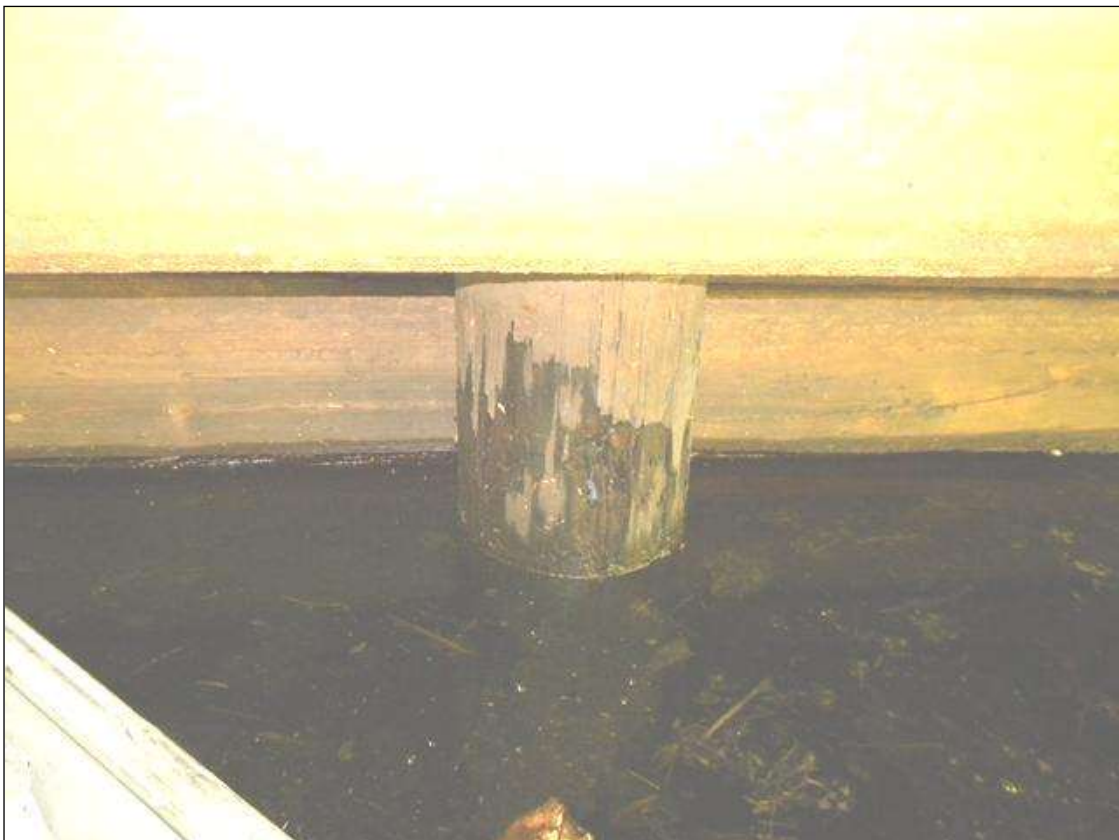
PILE 2 AT END BENT 1 DECAYED 8" HIGH X 10" WIDE X 2" DEEP

| MMS Code | Description of Function | Unit | Quantity | Remarks | Est. Cost |
|---|---|---|---|---|---|
| 3344 | Repair / Replace Timber Substructure Components | LF | 5 | PILE 2 AT END BENT 1 DECAYED 8" HIGH X 10" WIDE X 2" DEEP | |

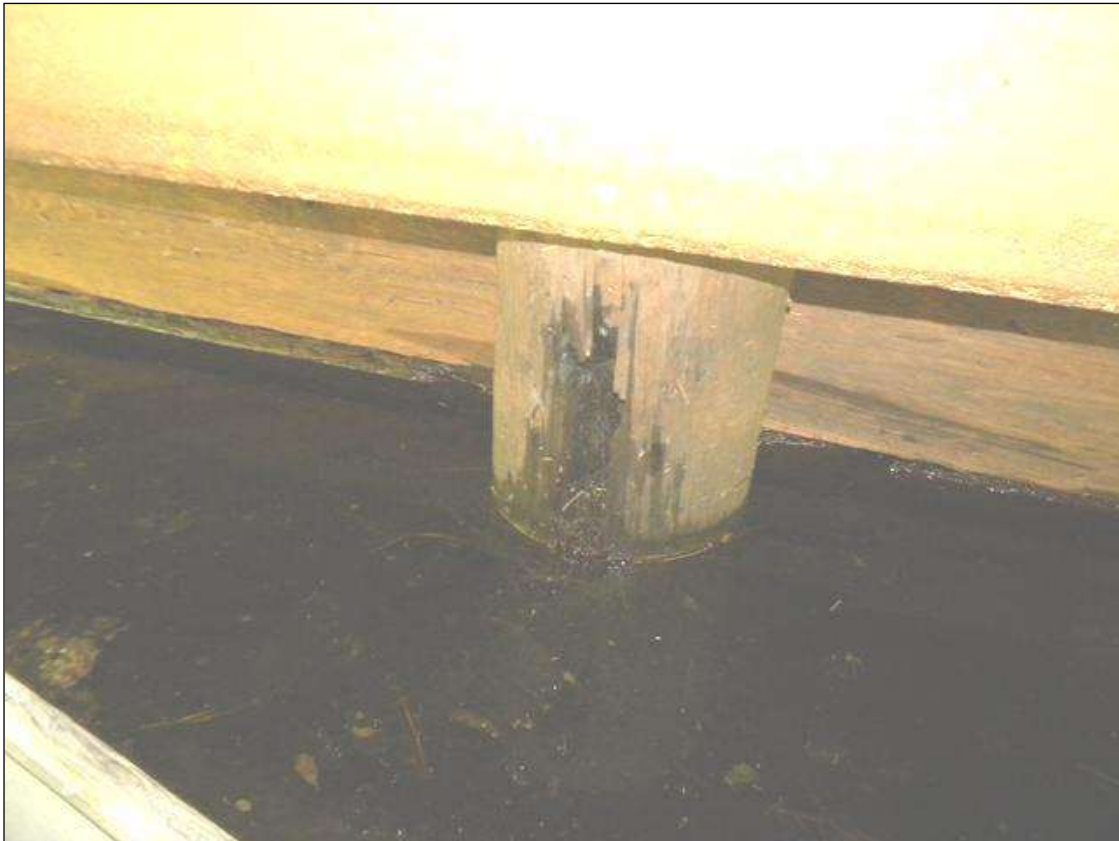
PILE 3 AT END BENT 1 DECAYED 9" HIGH X 3" WIDE X 2" DEEP

| MMS Code | Description of Function | Unit | Quantity | Remarks | Est. Cost |
|---|---|---|---|---|---|
| 3344 | Repair / Replace Timber Substructure Components | LF | 3 | PILE 3 AT END BENT 1 DECAYED 9" HIGH X 3" WIDE X 2" DEEP | |

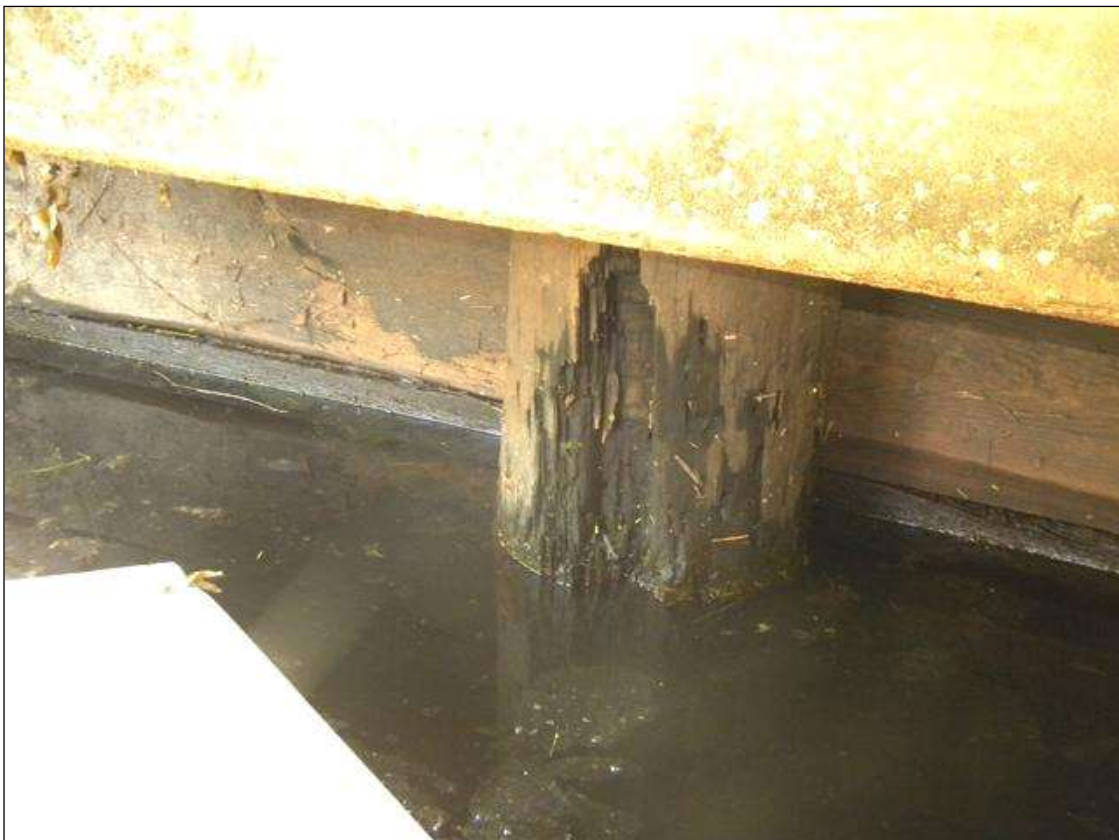
PILE 4 AT END BENT 1 DECAYED 7" WIDE X 14" HIGH X 2 1/2" DEEP

| MMS Code | Description of Function | Unit | Quantity | Remarks | Est. Cost |
|---|---|---|---|---|---|
| 3344 | Repair / Replace Timber Substructure Components | LF | 4 | PILE 4 AT END BENT 1 DECAYED 7" WIDE X 14" HIGH X 2 1/2" DEEP | |

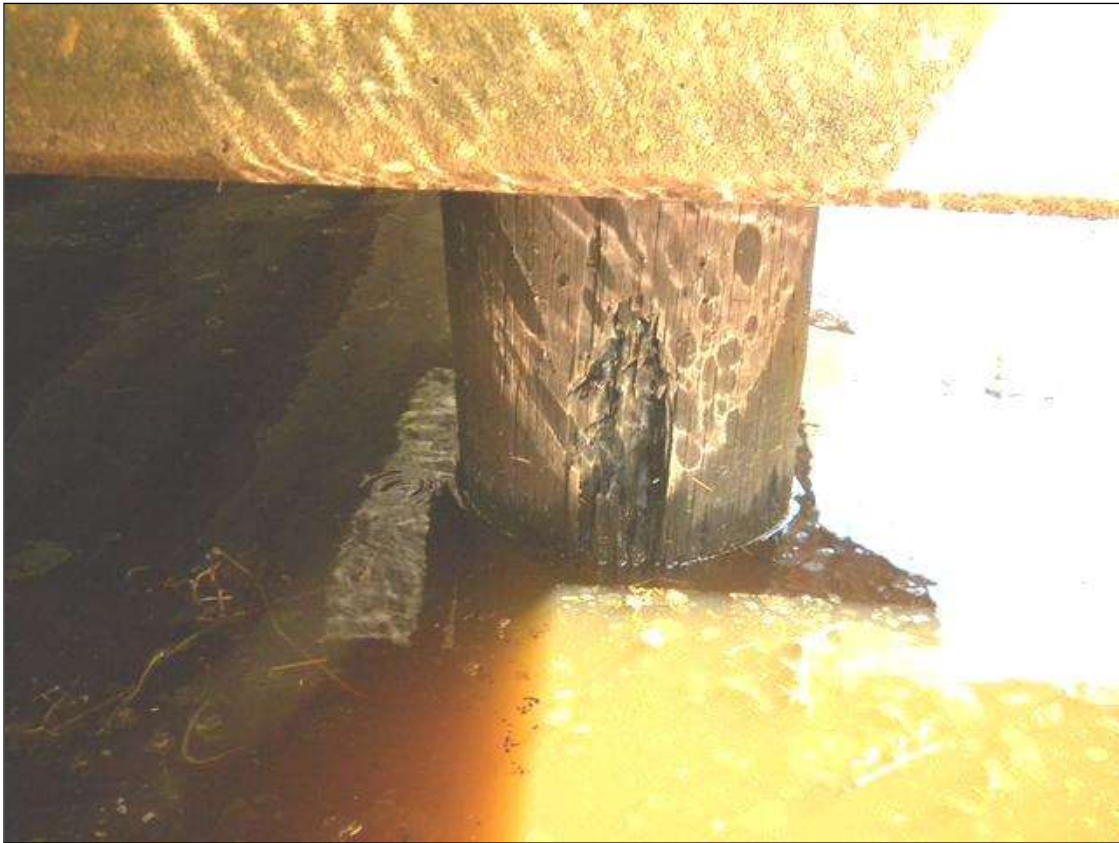
PILE 4 AT BENT 1 DECAYED 9" HIGH X 3" WIDE X 1" DEEP

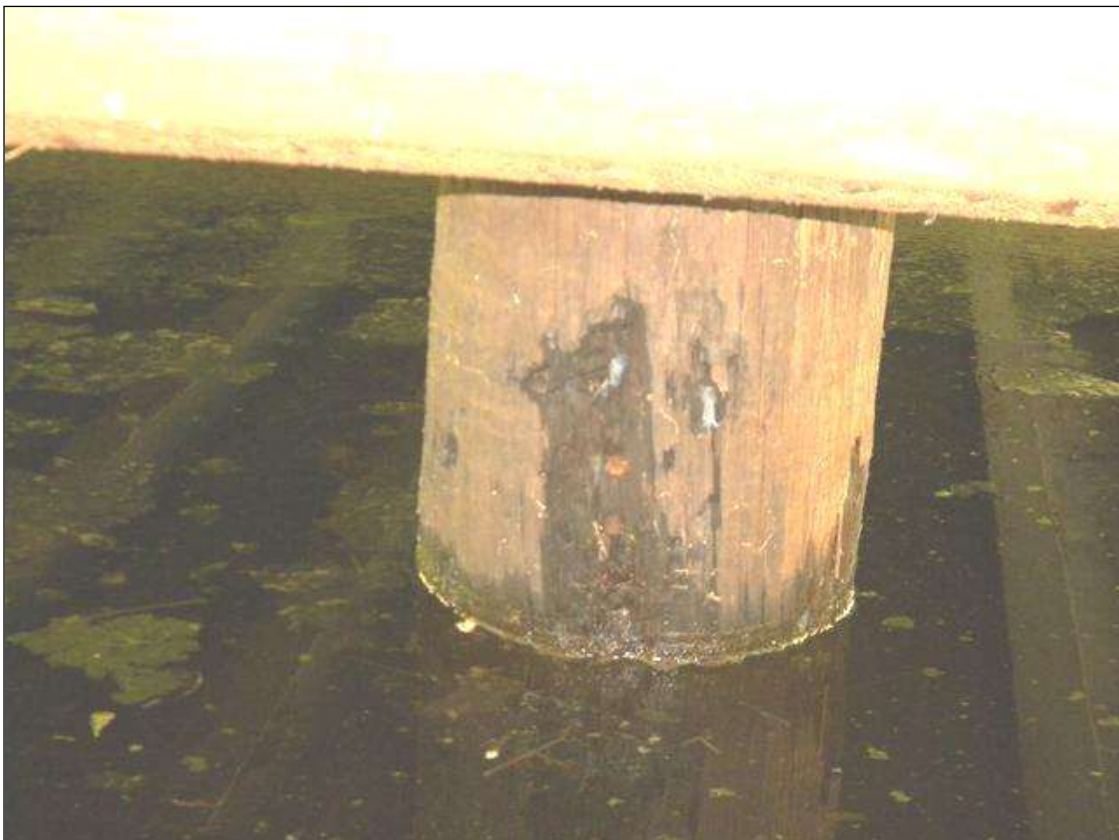
PILE 3 AT BENT 1 DECAYED 9" HIGH X 3 1/2" WIDE X 2" DEEP

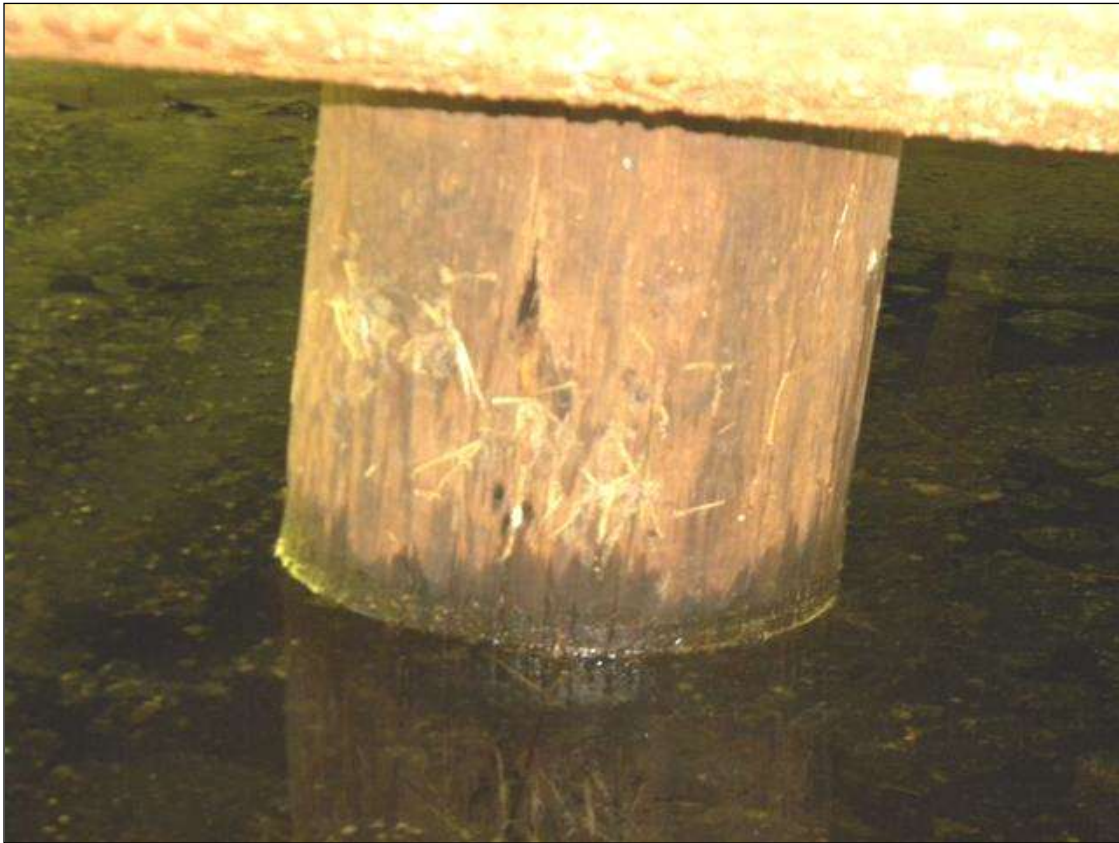
PILE 2 AT BENT 1 SURFACE DECAYED, SPAN 1 FACE

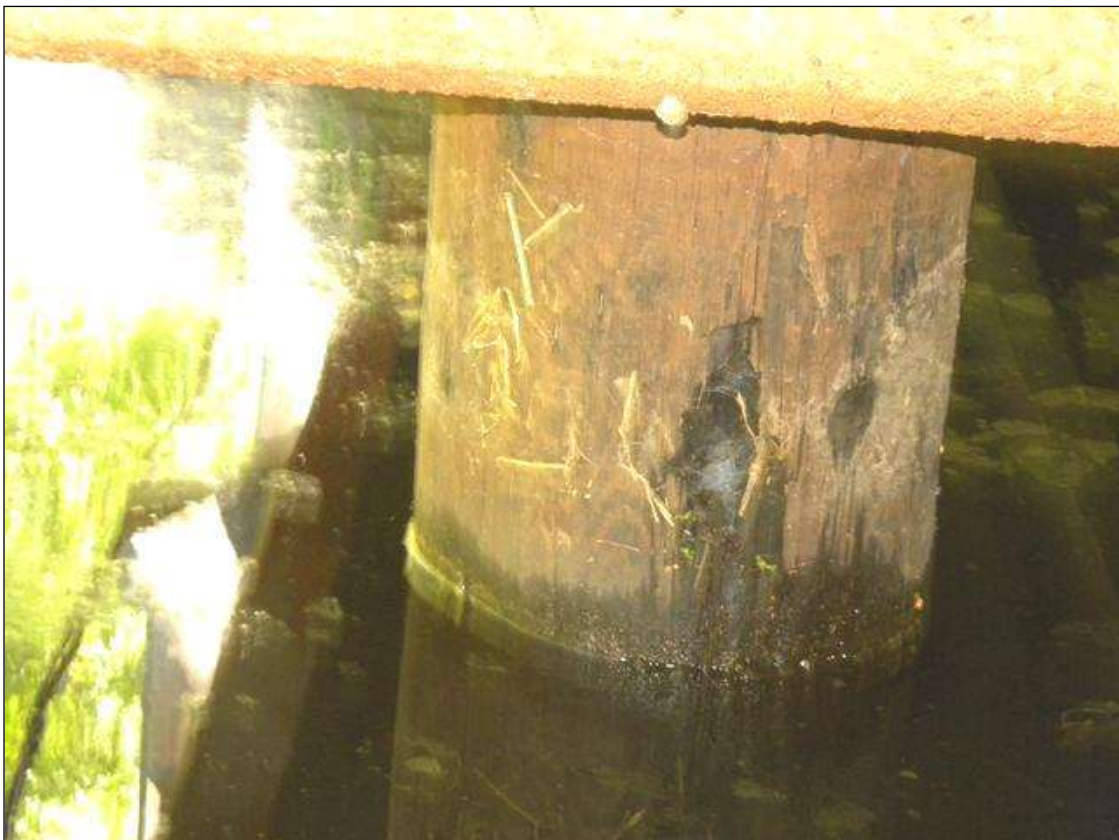
PILE 1 AT BENT 1 DECAYED 3" DIAMETER X 1" DEEP

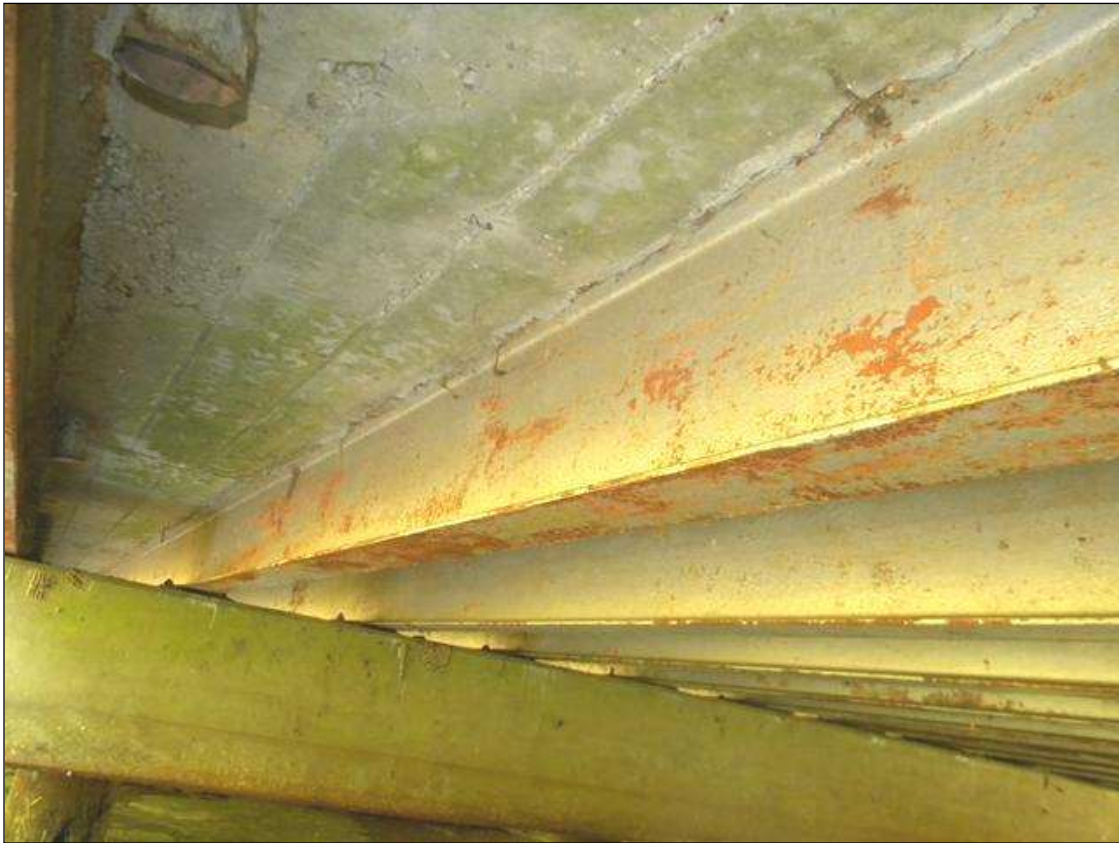
SPAN 1 UNDERSIDE WITH PAINT PEELING AND SURFACE RUST, SIMILAR IN SPAN 2

| MMS Code | Description of Function | Unit | Quantity | Remarks | Est. Cost |
|---|---|---|---|---|---|
| 3342 | Clean and Paint Structural Steel | SF | 1000 | SPAN 1 UNDERSIDE WITH PAINT PEELING AND SURFACE RUST, SIMILAR IN SPAN 2 | |

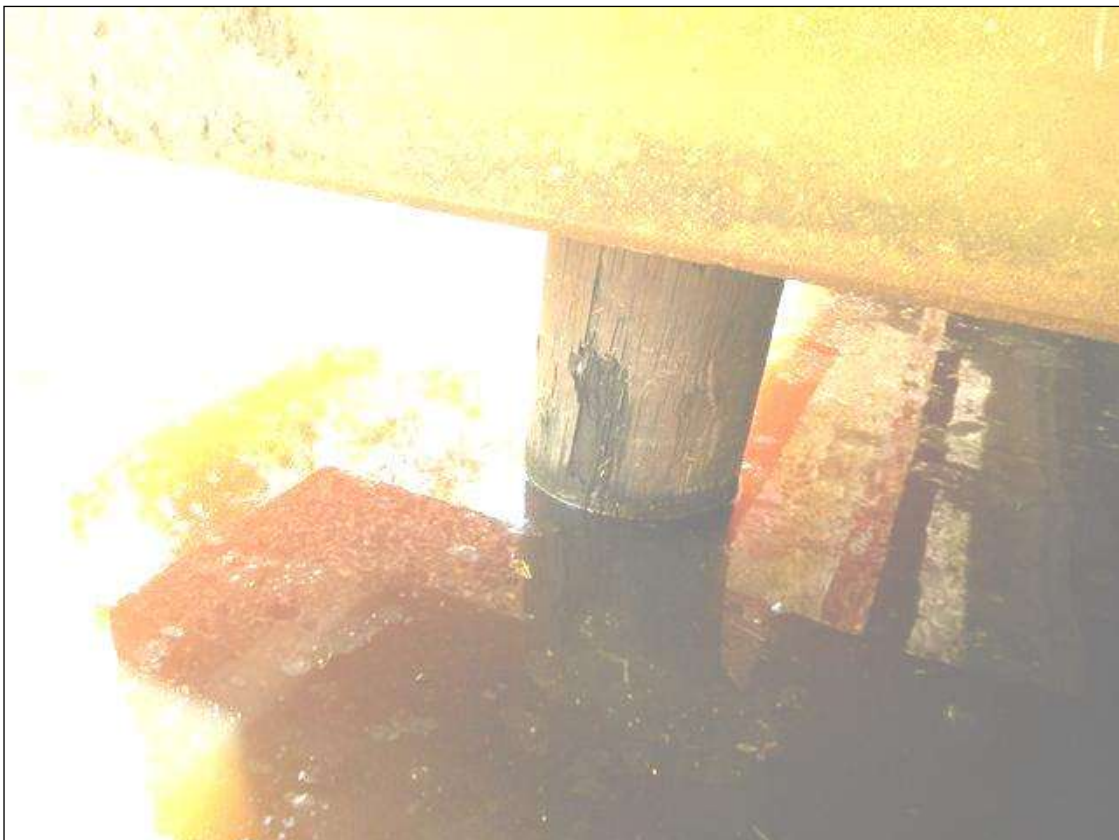
PILE 4 AT BENT 1 SPAN 2 FACE DECAYED 5" HIGH X 3" WIDE X 1" DEEP
