# BRIDGE INSPECTION REPORT

INSPECTION TYPE: Routine Inspection

COUNTY COLUMBUS BRIDGE NUMBER 230126 INSPECTION CYCLE 2 YRS  
ROUTE SR1005 ACROSS GUM SWAMP M.P. 0

INSPECTION DATE 07/16/2012

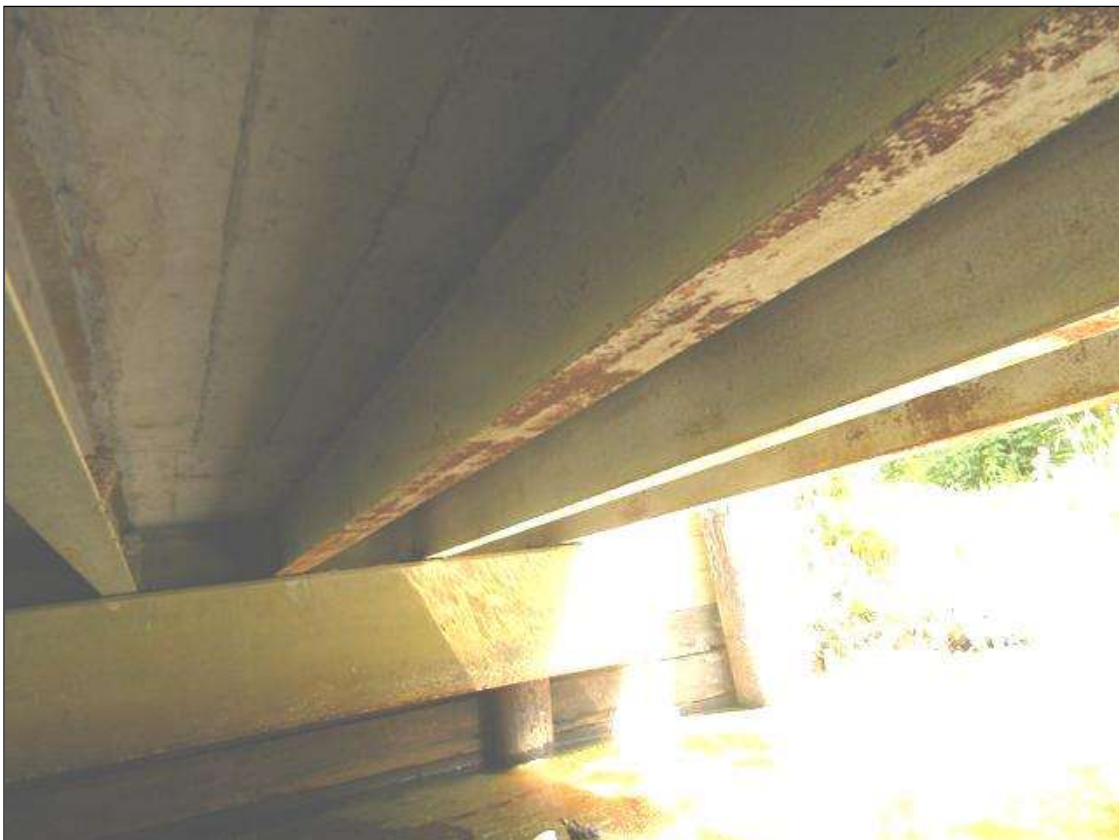
SPAN 2 UNDERSIDE WITH PAINT PEELING AND SURFACE RUST

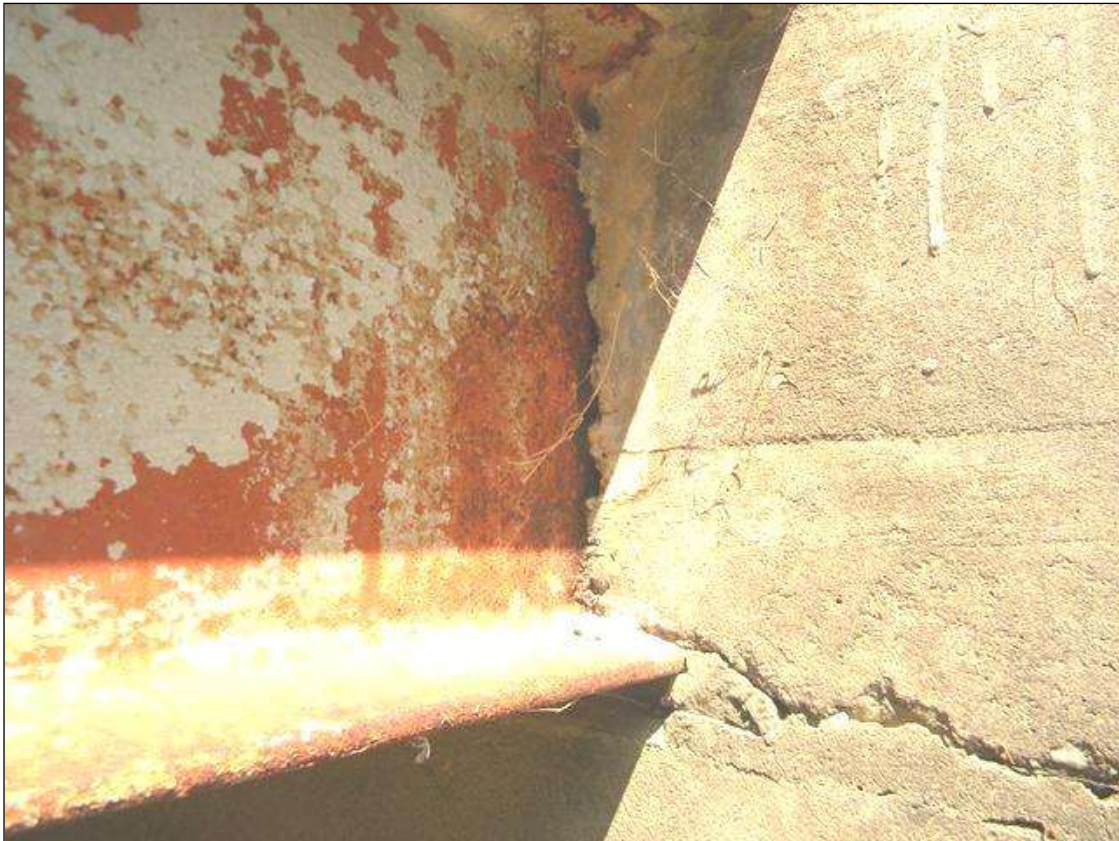
UP TO 1/8" SECTION LOSS IN WEB AT END DIAPHRAGM ON BEAM 12 AT END BENT 2

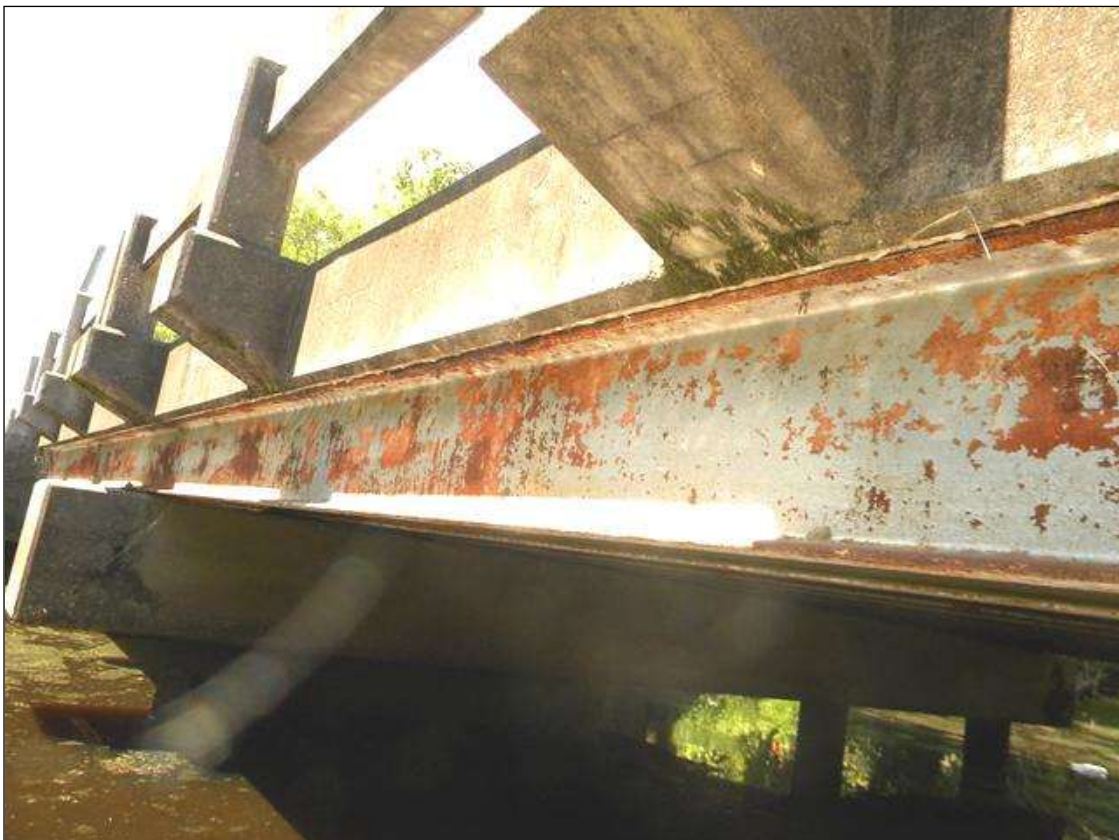
BEAM 12 EXTERIOR WITH PAINT PEELING AND RUST

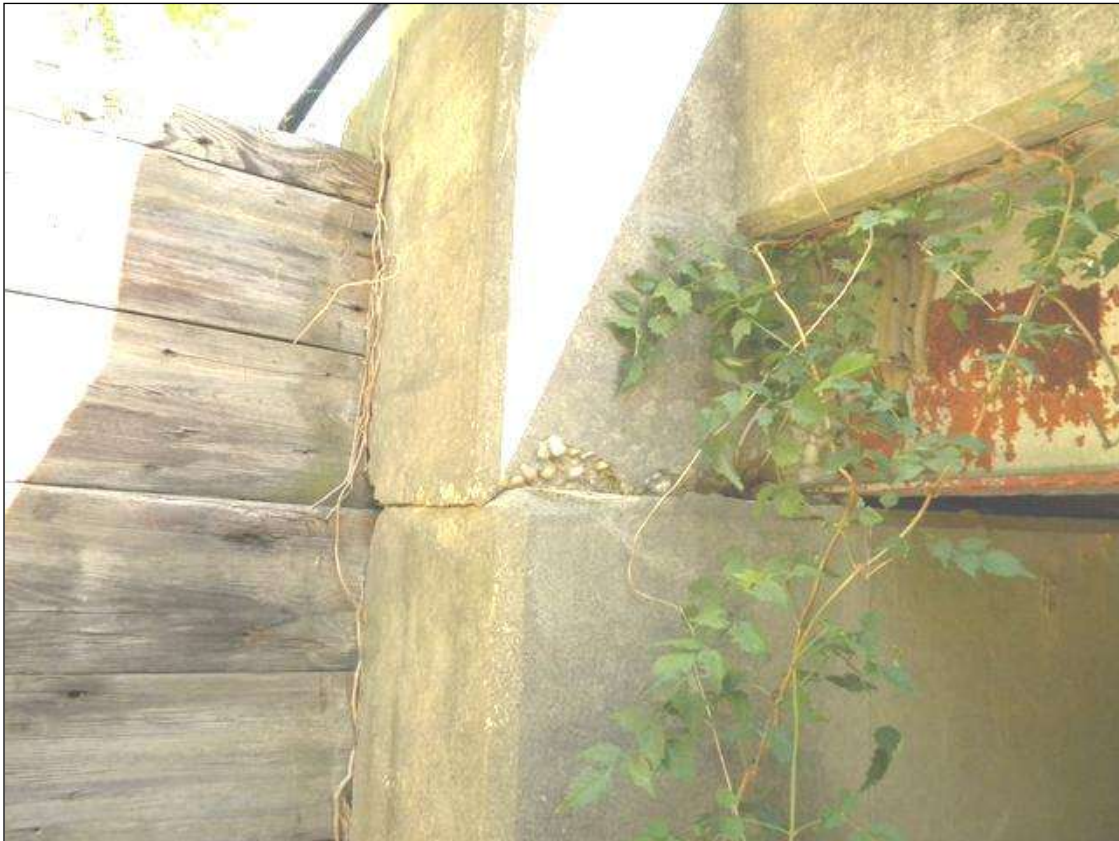
EXTERIOR CURTAIN WALL SURFACE SPALLED AT NORTHWEST CORNER

| MMS Code | Description of Function | Unit | Quantity | Remarks | Est. Cost |
|---|---|---|---|---|---|
| 3348 | Maintain Concrete Substructure Components | LF | 1 | EXTERIOR CURTAIN WALL SURFACE SPALLED AT NORTHWEST CORNER | |

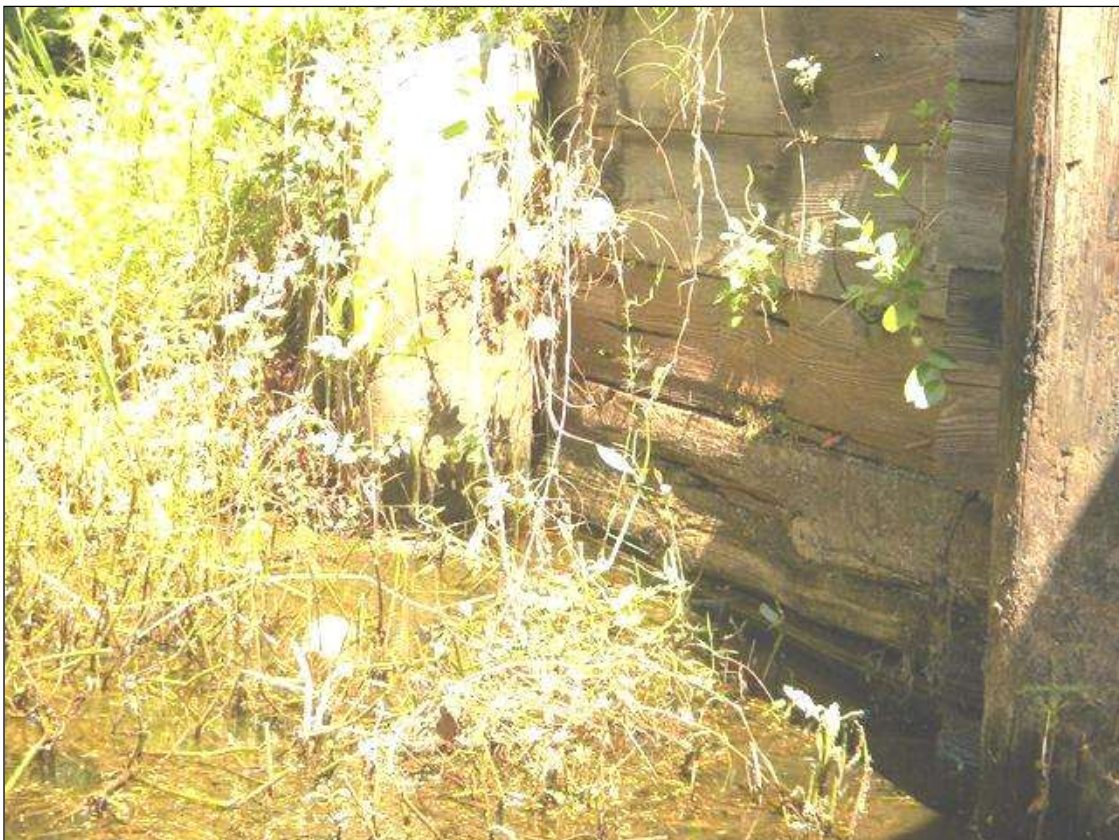
DECAYED WINGWALL BOARDS AT NORTHWEST CORNER

| MMS Code | Description of Function | Unit | Quantity | Remarks | Est. Cost |
|---|---|---|---|---|---|
| 3346 | Repair / Maintain Timber Wings & Blkhds | SF | 5 | DECAYED WINGWALL BOARDS AT NORTHWEST CORNER | |

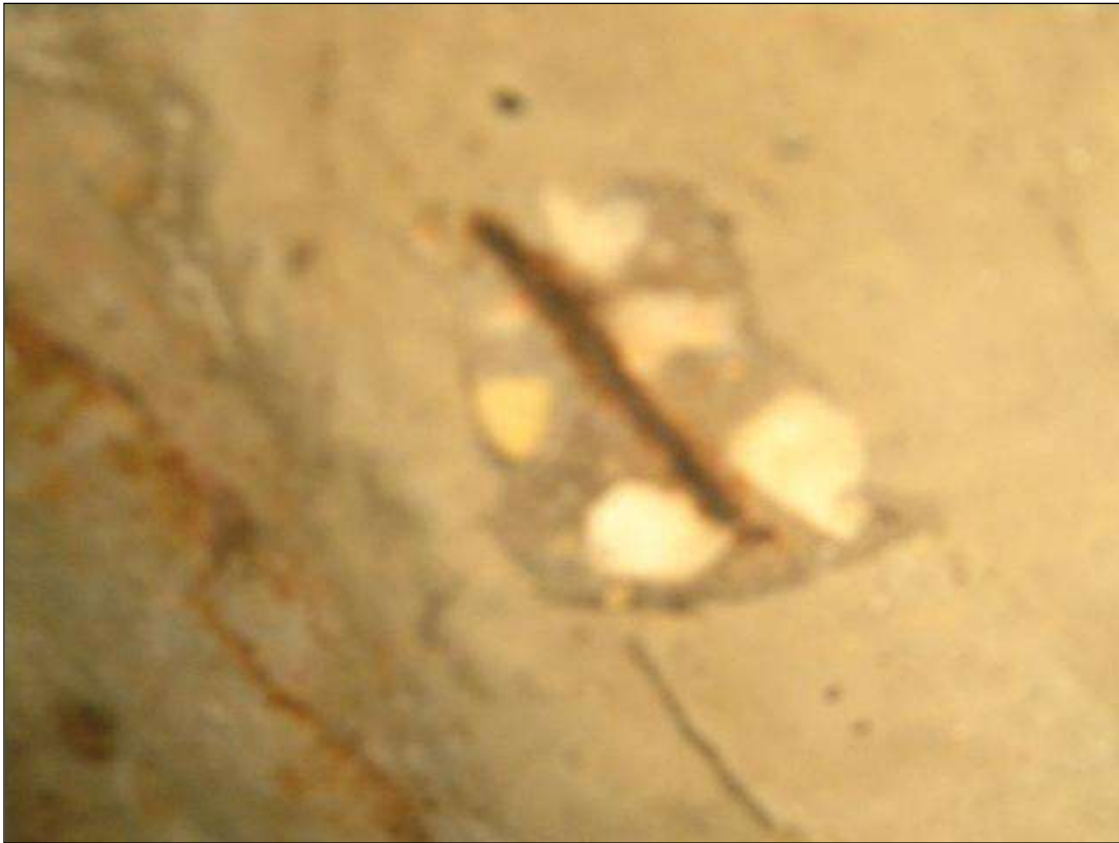
SURFACE SPALL WITH EXPOSED STEEL AT SPAN 1 UNDERSIDE IN BAY 11

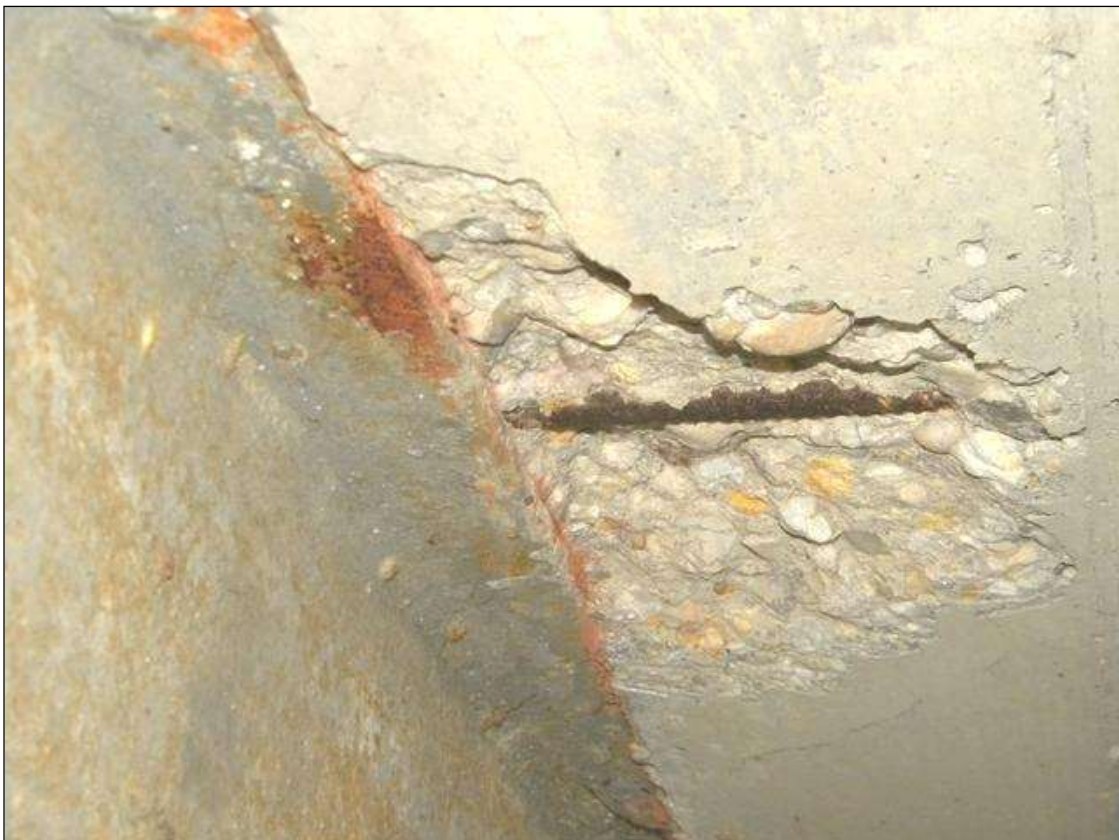
DECK UNDERSIDE SPALLED WITH EXPOSED STEEL OVER BENT 1 IN BAY 6

| MMS Code | Description of Function | Unit | Quantity | Remarks | Est. Cost |
|---|---|---|---|---|---|
| 3326 | Maintain Concrete Deck | SF | 1 | DECK UNDERSIDE SPALLED WITH EXPOSED STEEL OVER BENT 1 IN BAY 6 | |

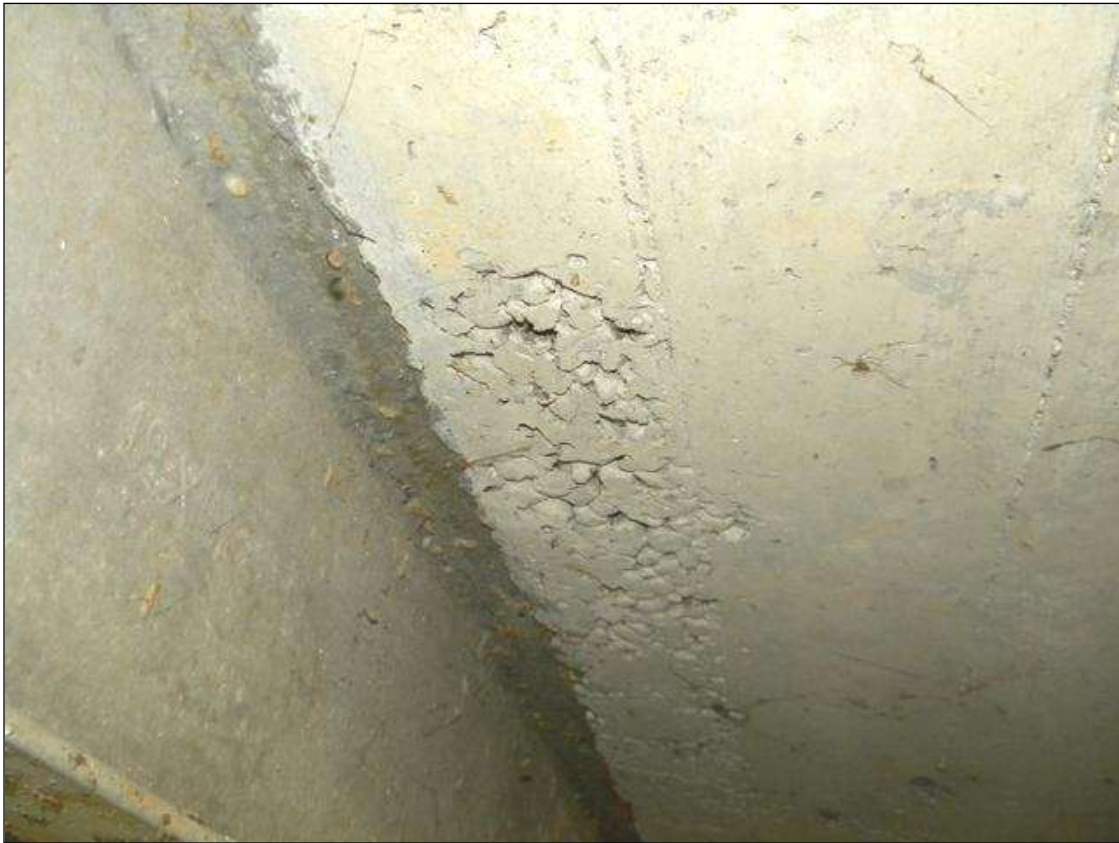
DECK UNDERSIDE HONEYCOMB IN BAY 8 , SPAN 1 ( SIMILAR IN OTHER BAYS )

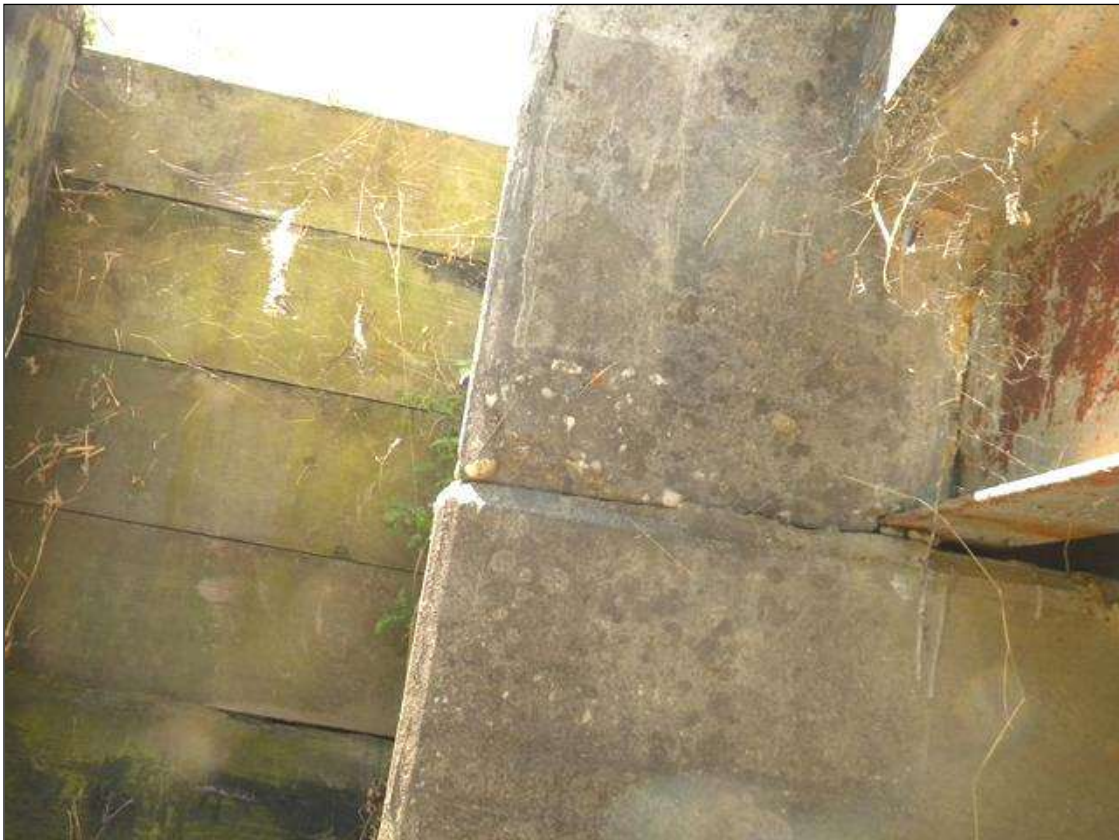
SOUTHEAST CORNER EXTERIOR CURTAIN WALL SURFACE SPALLED
