NC DEPARTMENT OF TRANSPORTATION  
DIVISION OF HIGHWAYS  
BRIDGE MANAGEMENT UNIT

# BRIDGE INSPECTION REPORT

COUNTY COLUMBUS BRIDGE NUMBER 230167 INSPECTION CYCLE 2 YRS  
ROUTE SR1379 ACROSS GAPWAY SWAMP M.P. 0

INSPECTION DATE 07/22/2013

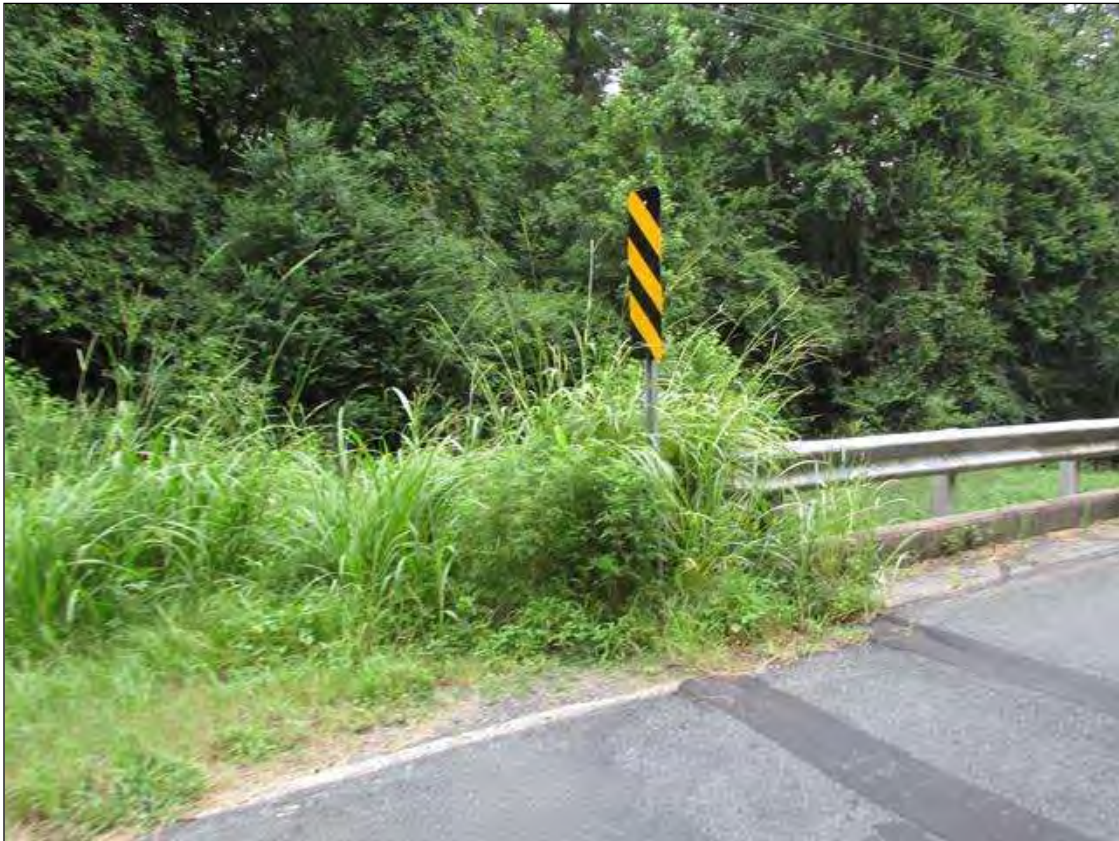
VEGETATION OVER RAIL AT NORTHWEST CORNER

| MMS Code | Description of Function | Unit | Quantity | Remarks | Est. Cost |
|---|---|---|---|---|---|
| 2910 | Manual Brush and Tree Control | LF | 10 | VEGETATION OVER RAIL AT NORTHWEST CORNER | |

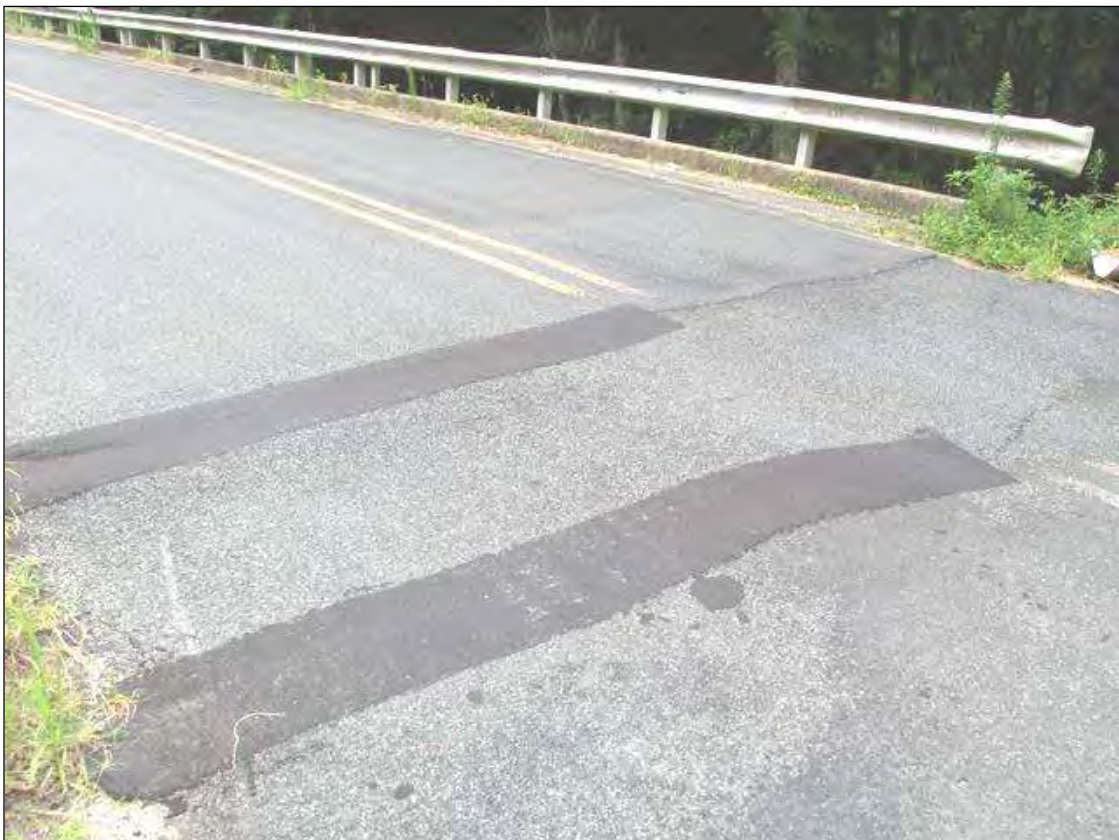
| Bridge I&A Form 1(82)H<br>State of North Carolina<br>Dept. of Transportation<br>Division of Highways | | <h2 style="text-align: center;">FIELD INSPECTION REPORT</h2> <p style="text-align: center;"><u>Bridge Inspeccion &amp; Analysis</u></p> | |
|---|---|---|--|
| 50 | F | ( APPROACH ROADWAY ) THE WEST APPROACH ASPHALT WEARING SURFACE CRACKS ARE PATCHED , SETTLED 1" IN BOTH LANES. (PHOTO)<br><br>EAST APPROACH ASPHALT WEARING SURFACE IS SETTLED UP TO 1". (PHOTO) | |

WEST APPROACH ASPHALT WEARING SURFACE IS PATCHED , SETTLED 1" IN BOTH LANES

| MMS Code | Description of Function | Unit | Quantity | Remarks | Est. Cost |
|---|---|---|---|---|---|
| 2816 | Asphalt Surface Repair or Replacement | SY | 2 | WEST APPROACH ASPHALT WEARING SURFACE IS PATCHED , SETTLED 1" IN BOTH LANES | |

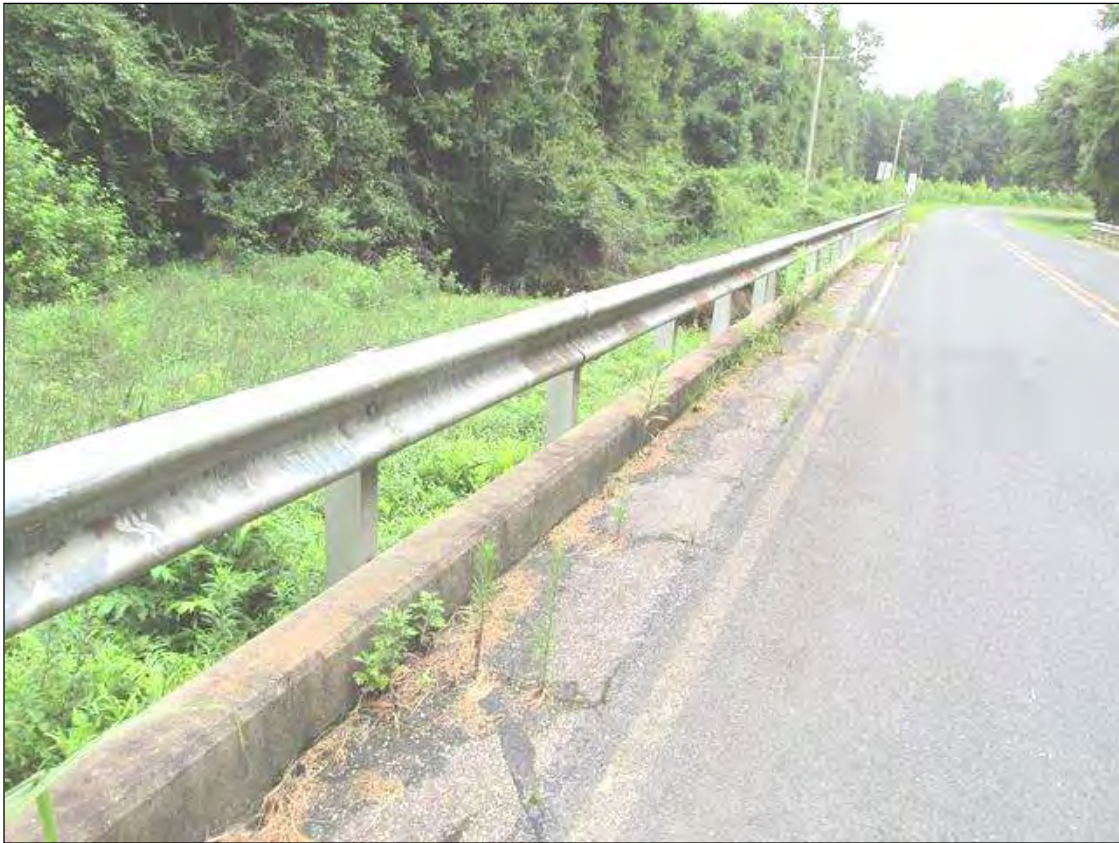
| Bridge I&A Form 1(82)H<br>State of North Carolina<br>Dept. of Transportation<br>Division of Highways | | <h1 style="text-align: center;">FIELD INSPECTION REPORT</h1> <p style="text-align: center;"><u>Bridge Inspection &amp; Analysis</u></p> | |
|---|---|---|--|
| 7 | F | ( DECK DEBRIS )    THERE IS SCATTERED VEGETATION ALONG BOTH CURBS. (PHOTOS) | |

SCATTERED VEGETATION ALONG LEFT CURB

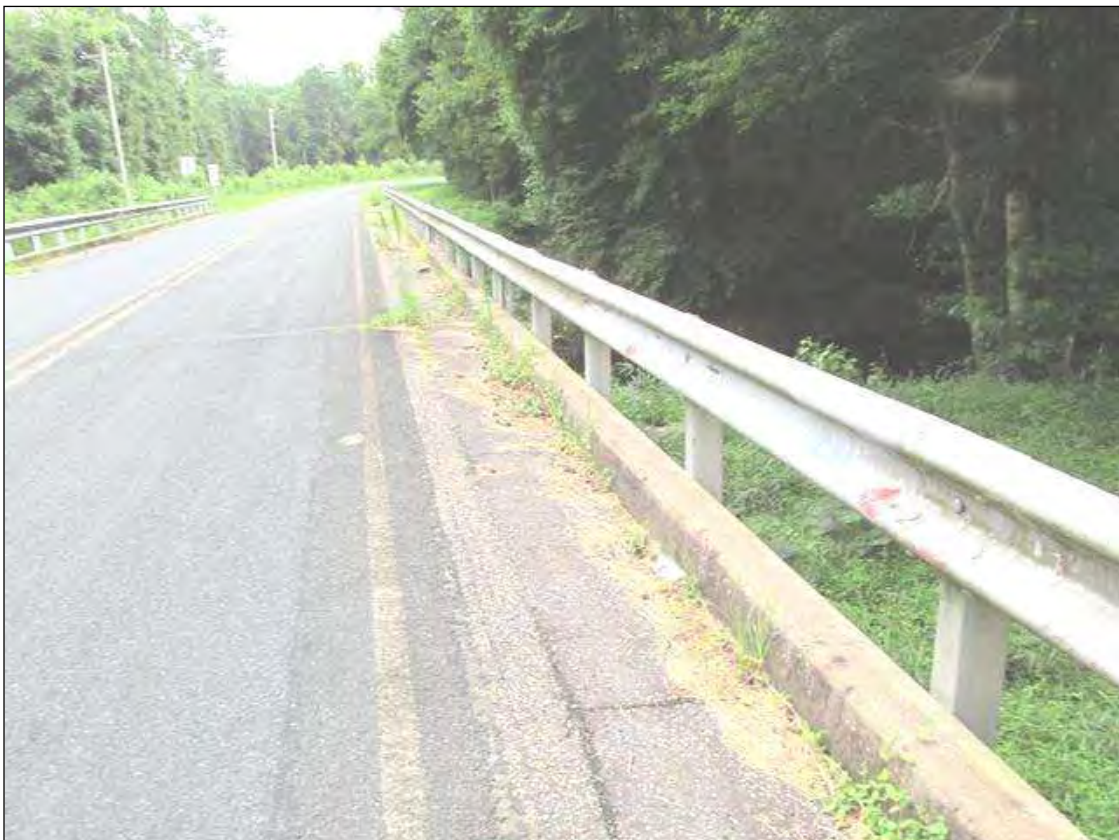
SCATTERED VEGETATION ALONG RIGHT CURB

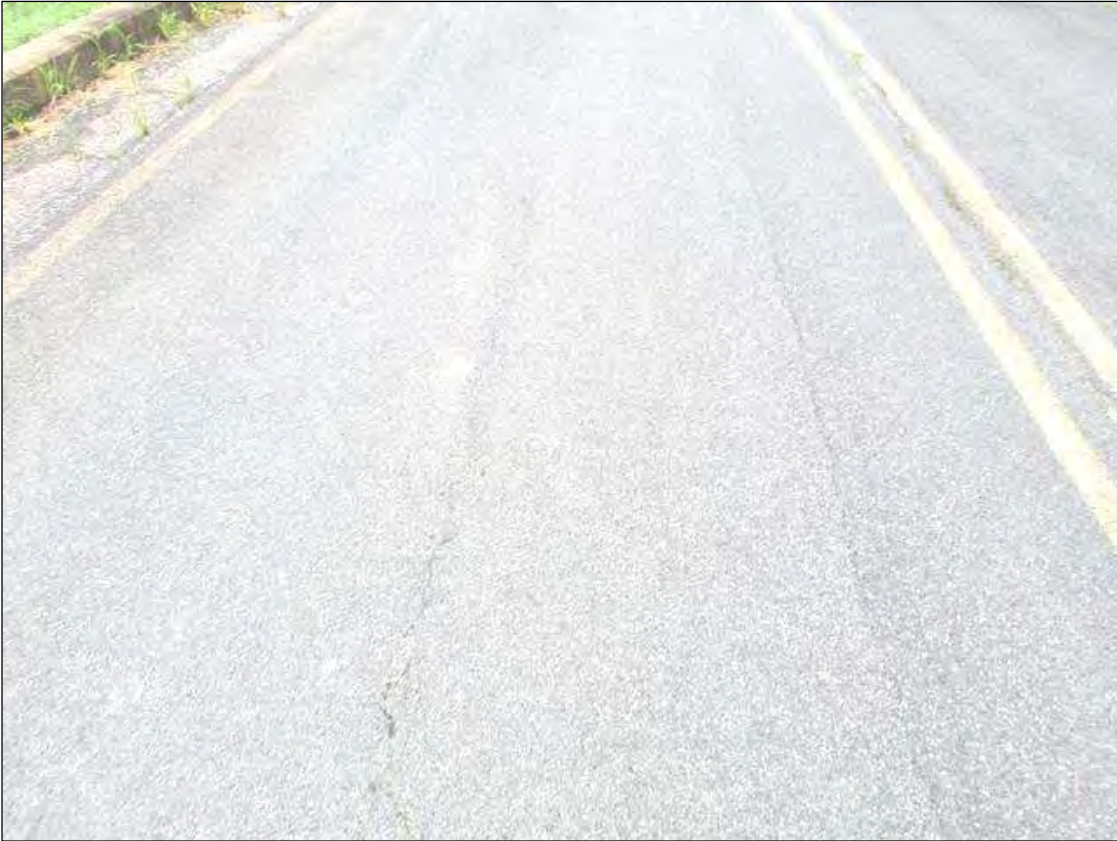
1/16" LONGITUDINAL CRACKS IN SPAN 1 WEST BOUND LANE ASPHALT WEARING SURFACE

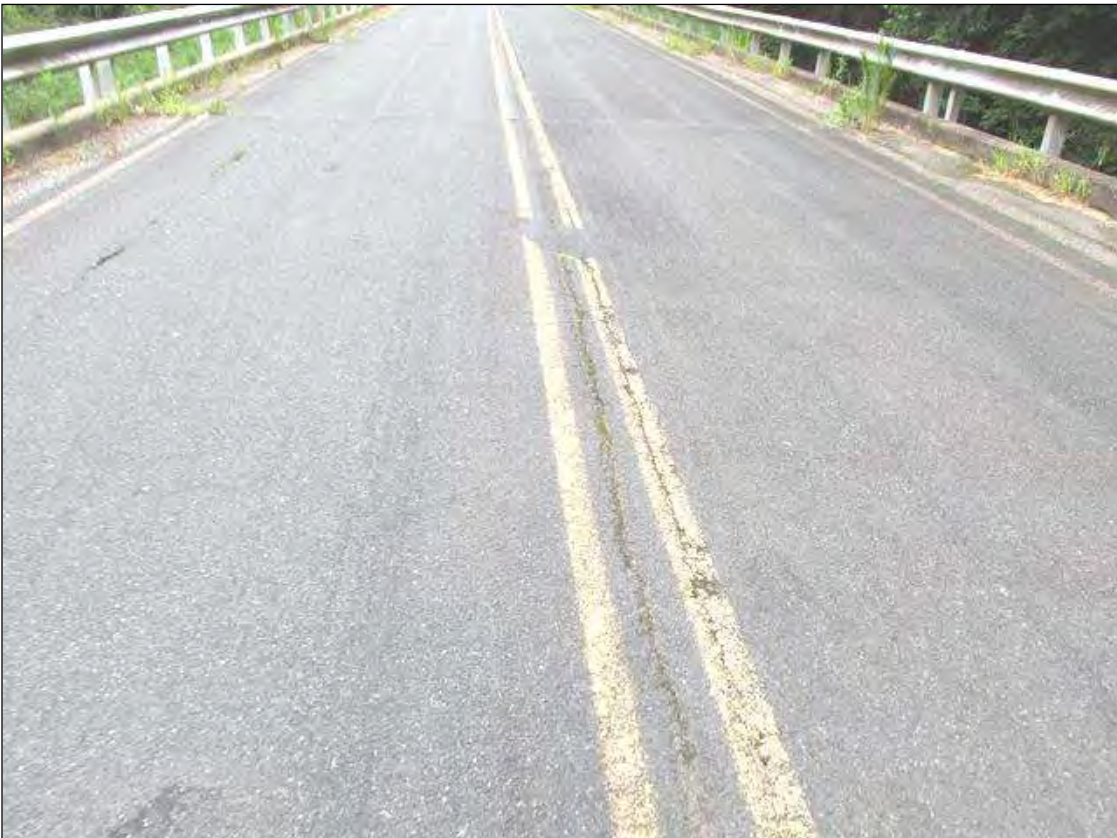
| Bridge I&A Form 1(82)H<br>State of North Carolina<br>Dept. of Transportation<br>Division of Highways | | <h1 style="text-align: center;">FIELD INSPECTION REPORT</h1> <p style="text-align: center;"><u>Bridge Inspection &amp; Analysis</u></p> | |
|---|---|---|--|
| 1 | F | <p>( ASPHALT WEARING SURFACE )    THERE ARE UP TO 1/4" LONGITUDINAL CRACKS AT CENTERLINE IN ALL SPANS WITH UP TO 2" DEEP RAVELING AREAS IN SPANS 2 AND 4 UP TO 4' LONG X 4" WIDE. (PHOTOS)</p> <p>THERE ARE 1/16" LONGITUDINAL CRACKS IN SPAN 1 WEST BOUND LANE ASPHALT WEARING SURFACE. (PHOTO)</p> <p>THERE IS A 1/4" TRANSVERSE CRACK IN ASPHALT WEARING SURFACE OVER BENT 1. THIS IS SIMILAR OVER ALL JOINTS. (PHOTO)</p> <p>THE ASPHALT WEARING SURFACE IS SPALLING OVER CHANNELS IN SPAN 2 WEST BOUND LANE. (PHOTO)</p> <p>THE ASPHALT WEARING SURFACE IS CRACKED OVER BENT 2 JOINT. (PHOTO)</p> <p>THE ASPHALT WEARING SURFACE IS SPALLING AT CENTERLINE IN SPAN 4. (PHOTO)</p> | |

1/4" LONGITUDINAL CRACK AT CENTERLINE UP TO 2" DEEP IN ALL SPANS

| MMS Code | Description of Function | Unit | Quantity | Remarks | Est. Cost |
|---|---|---|---|---|---|
| 2816 | Asphalt Surface Repair or Replacement | SY | 3 | 1/4" LONGITUDINAL CRACK AT CENTERLINE UP TO 2" DEEP IN ALL SPANS | |

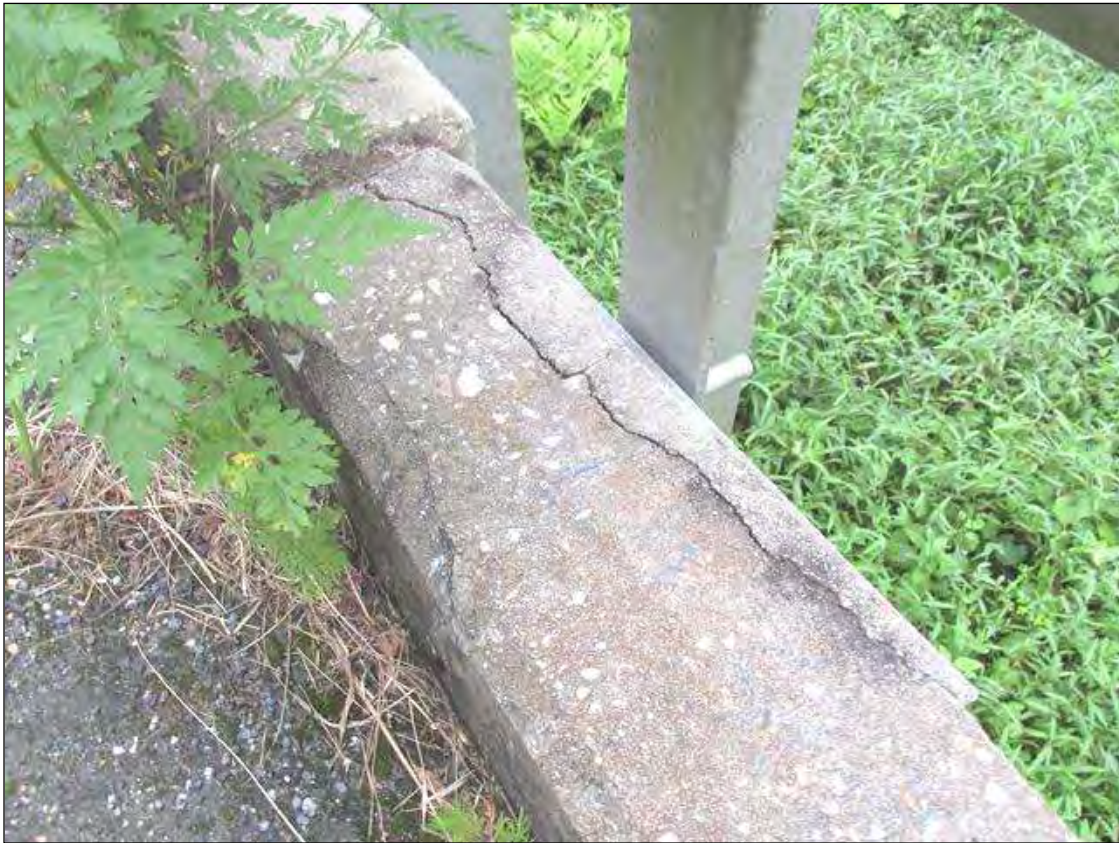
| Bridge I&A Form 1(82)H<br>State of North Carolina<br>Dept. of Transportation<br>Division of Highways | | <h1 style="text-align: center;">FIELD INSPECTION REPORT</h1> <p style="text-align: center;"><u>Bridge Inspection &amp; Analysis</u></p> | |
|---|---|---|--|
| 4 | F | <p>( CURBS )    THE LEFT CURB IN SPAN 2 AT BENT 1 HAS A 1/8" LONGITUDINAL CRACK WITH DELAMINATION. (PHOTO)</p> <p>THERE ARE HAIRLINE RANDOM CRACKS THROUGHOUT BOTH CURBS.</p> | |

1/8" LONGITUDINAL CRACK AND DELAMINATED LEFT CURB IN SPAN 2 AT BENT 1

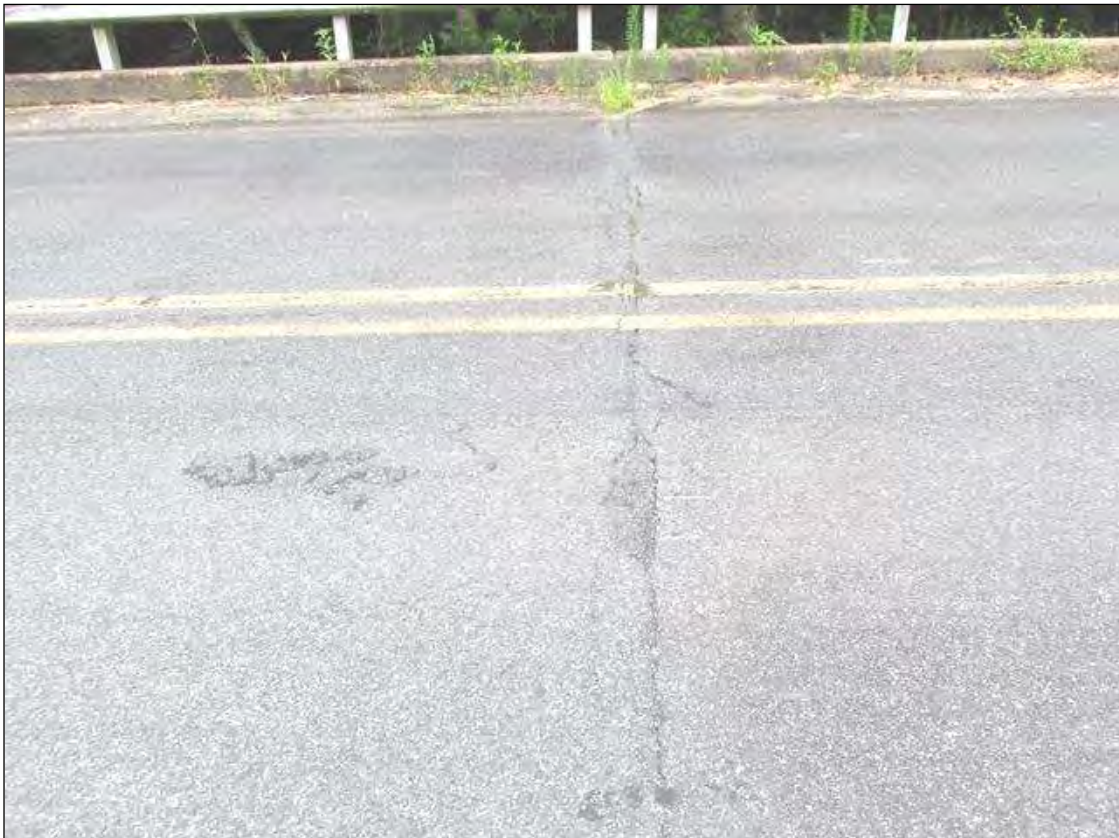
| Bridge I&A Form 1(82)H<br>State of North Carolina<br>Dept. of Transportation<br>Division of Highways | | <h1 style="text-align: center;">FIELD INSPECTION REPORT</h1> <p style="text-align: center;"><u>Bridge Inspection &amp; Analysis</u></p> | |
|---|---|---|--|
| 6d | F | ( STANDARD JOINTS )    THE ASPHALT WEARING SURFACE IS CRACKED UP TO 1/4" OVER ALL JOINTS. (PHOTO) | |

1/4" TRANSVERSE CRACK IN ASPHALT WEARING SURFACE OVER BENT 1, SIMILAR OVER ALL JOINTS

| MMS Code | Description of Function | Unit | Quantity | Remarks | Est. Cost |
|---|---|---|---|---|---|
| 2816 | Asphalt Surface Repair or Replacement | SY | 4 | 1/4" TRANSVERSE CRACK IN ASPHALT WEARING SURFACE OVER BENT 1, SIMILAR OVER ALL JOINTS | |

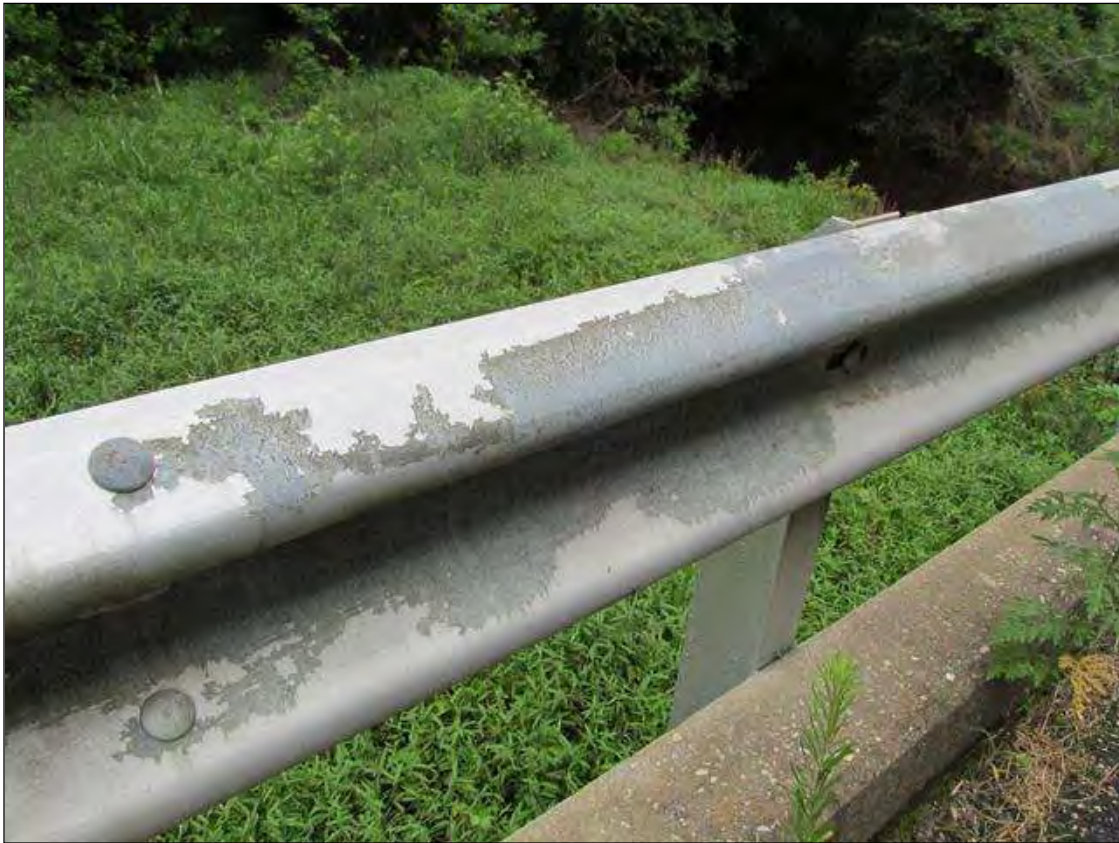
| Bridge I&A Form 1(82)H<br>State of North Carolina<br>Dept. of Transportation<br>Division of Highways | | <h1 style="text-align: center;">FIELD INSPECTION REPORT</h1> <p style="text-align: center;"><u>Bridge Inspection &amp; Analysis</u></p> | |
|---|---|---|--|
| 3d | F | <p>( STEEL RAILS )    THE LEFT RAIL PAINT PEELING IN ALL SPANS. THIS IS SIMILAR ON RIGHT RAIL. (PHOTO)</p> <p>THERE ARE SIGNS OF MILDEW ON BOTH RAILS.</p> | |

PAINT PEELING ON LEFT RAIL IN ALL SPANS, RIGHT RAIL IS SIMILAR

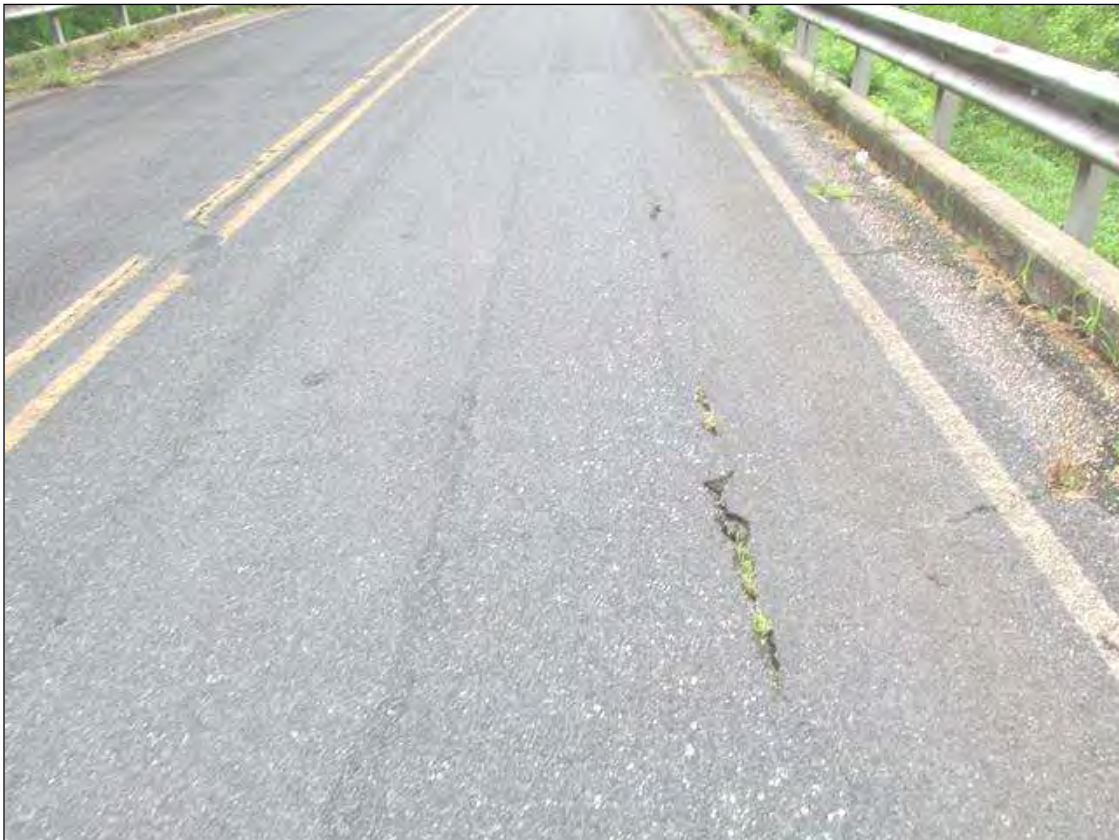
ASPHALT WEARING SURFACE SPALLING OVER CHANNELS IN SPAN 2 WEST BOUND LANE

| MMS Code | Description of Function | Unit | Quantity | Remarks | Est. Cost |
|---|---|---|---|---|---|
| 2816 | Asphalt Surface Repair or Replacement | SY | 2 | ASPHALT WEARING SURFACE SPALLING OVER CHANNELS IN SPAN 2 WEST BOUND LANE | |

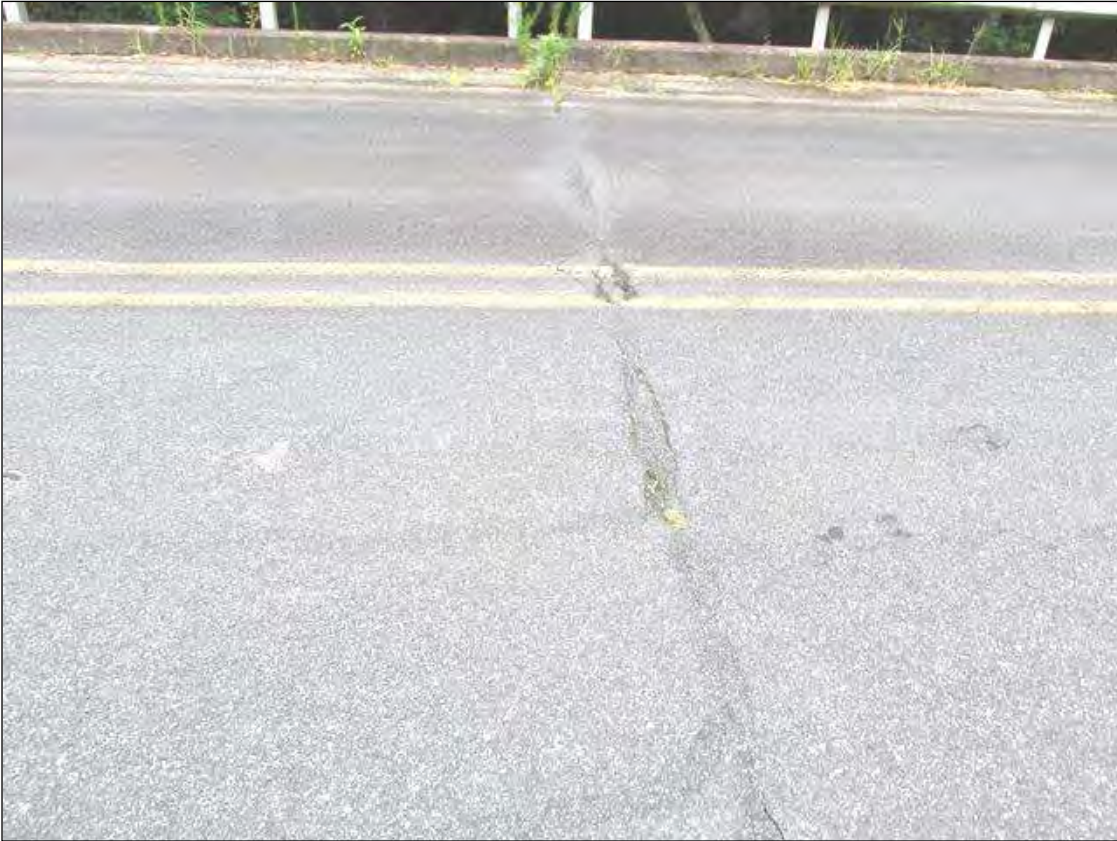
ASPHALT WEARING SURFACE CRACKED OVER BENT 2 JOINT

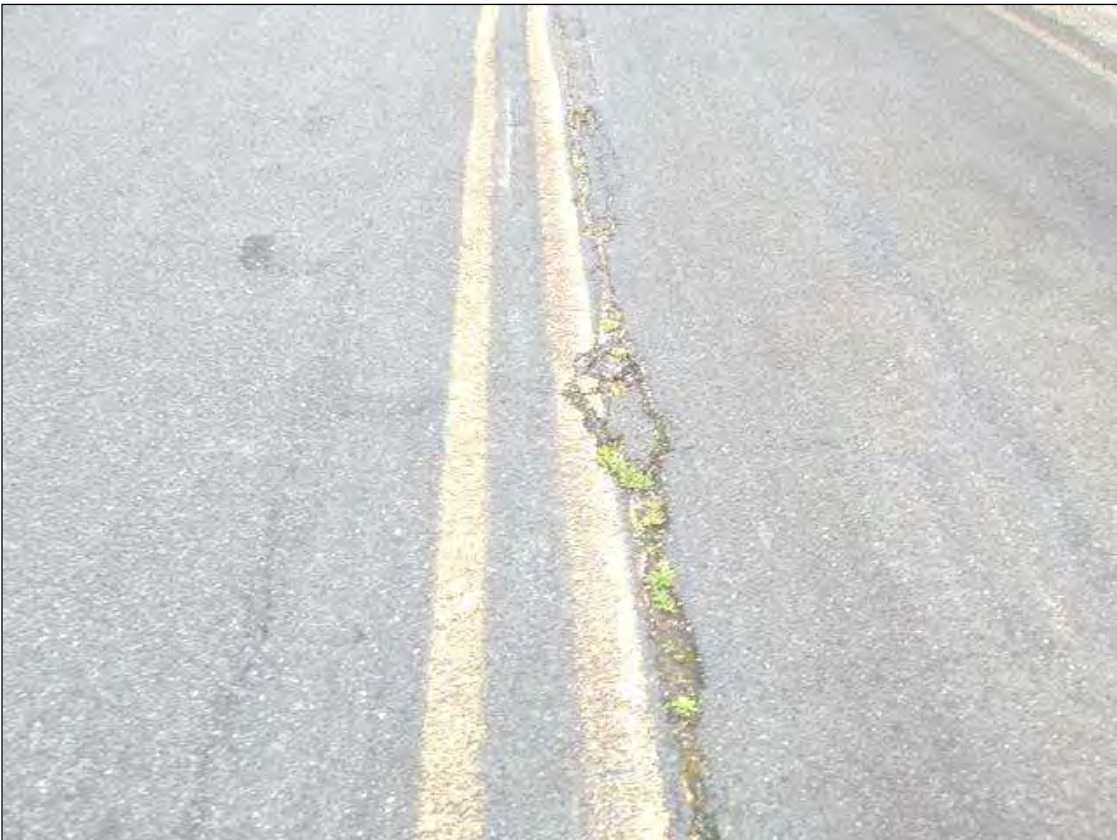
ASPHALT WEARING SURFACE SPALLING AT CENTERLINE IN SPAN 4

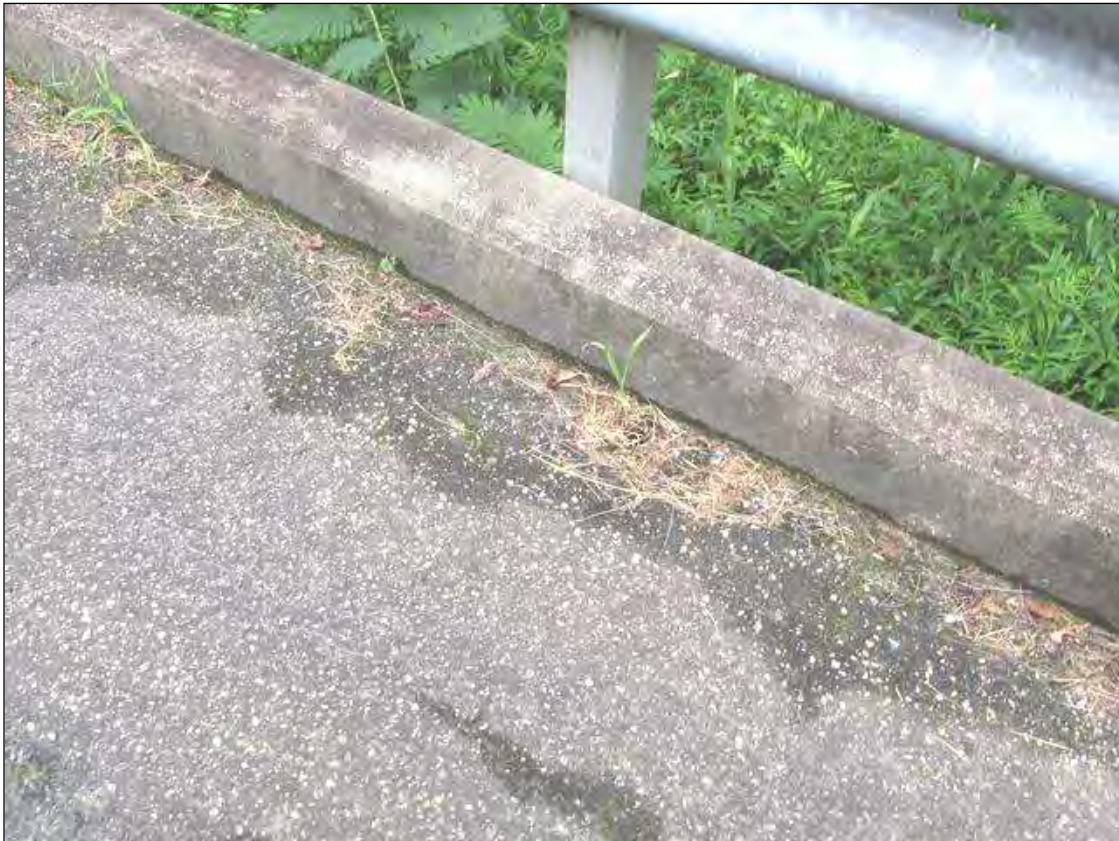
| Bridge I&A Form 1(82)H<br>State of North Carolina<br>Dept. of Transportation<br>Division of Highways | | <h2 style="text-align: center;">FIELD INSPECTION REPORT</h2> <p style="text-align: center;"><u>Bridge Inspeccion &amp; Analysis</u></p> | |
|---|---|---|--|
| 16 | F | ( DRAINAGE SYSTEM ) THERE IS A BLOCKED DECK DRAIN ALONG RIGHT CURB IN SPAN 5. (PHOTO) | |

BLOCKED DECK DRAIN ALONG RIGHT CURB IN SPAN 5

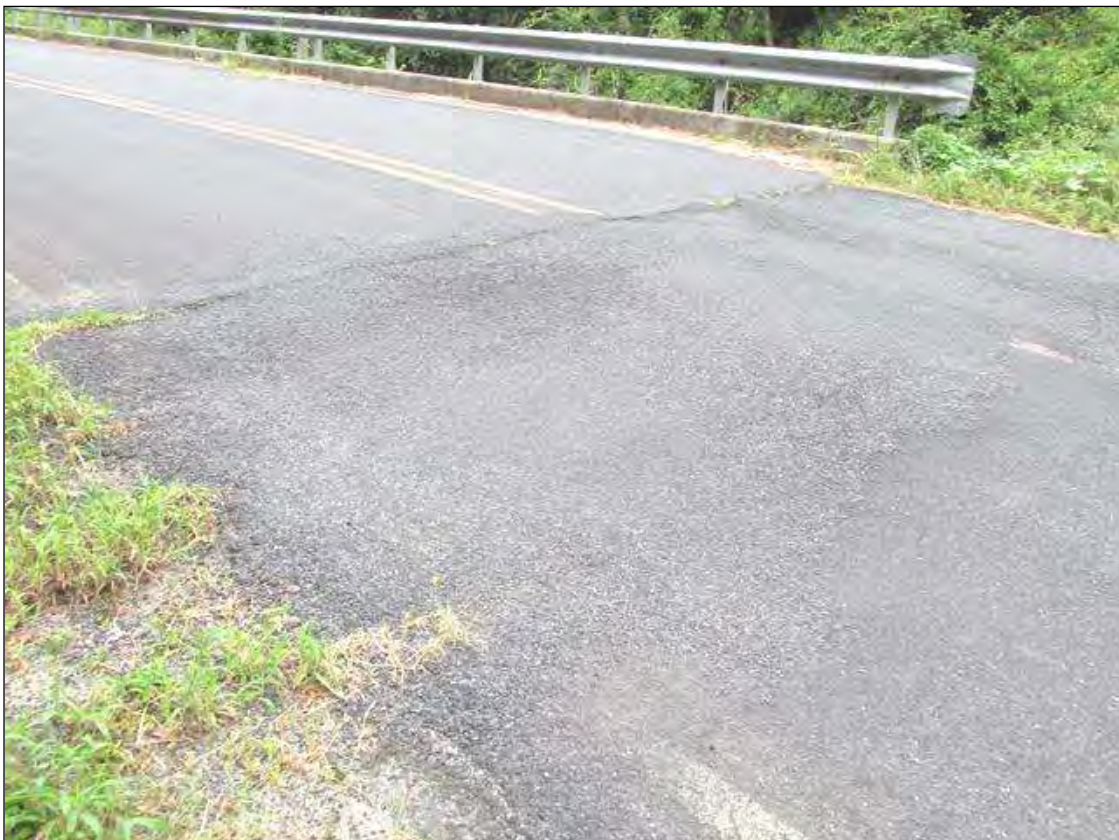
EAST APPROACH ASPHALT WEARING SURFACE IS SETTLED UP TO 1"

| MMS Code | Description of Function | Unit | Quantity | Remarks | Est. Cost |
|---|---|---|---|---|---|
| 2816 | Asphalt Surface Repair or Replacement | SY | 2 | EAST APPROACH ASPHALT WEARING SURFACE IS SETTLED UP TO 1" | |

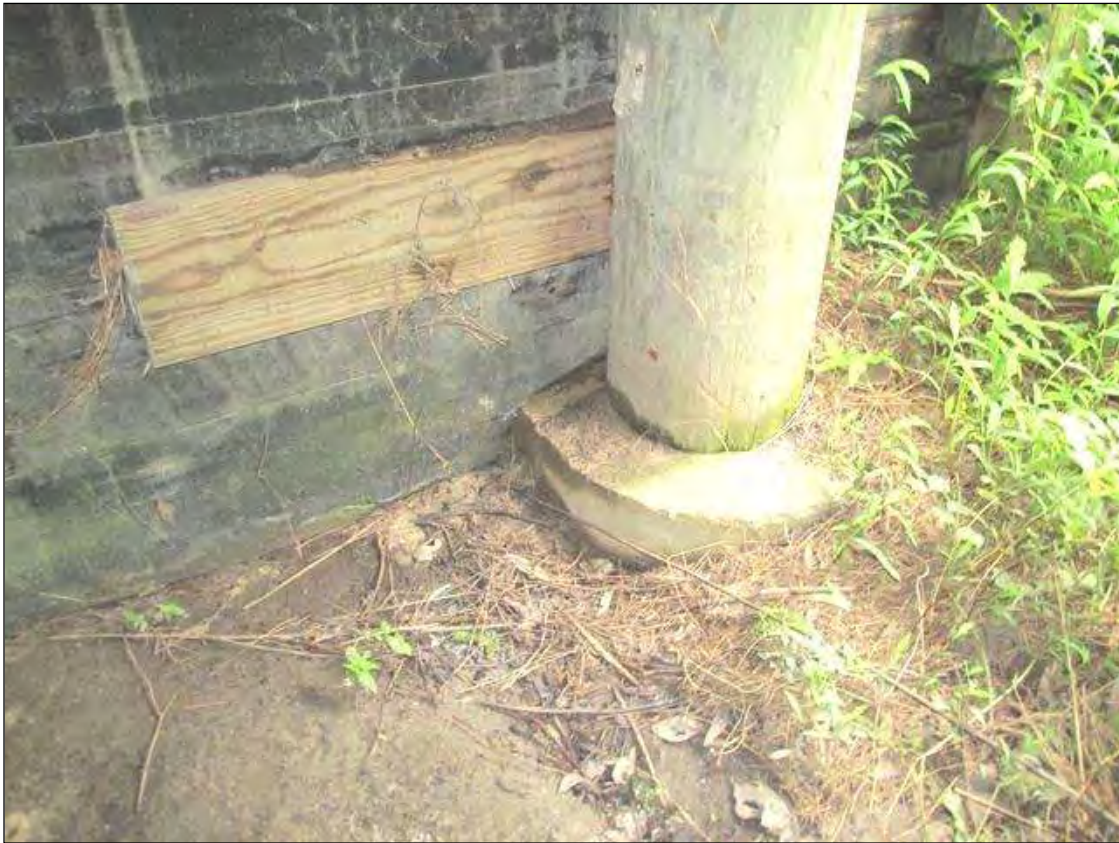
Some piles are encased with concrete.

PILE 1 AT END BENT 1 ENCASED IN CONCRETE

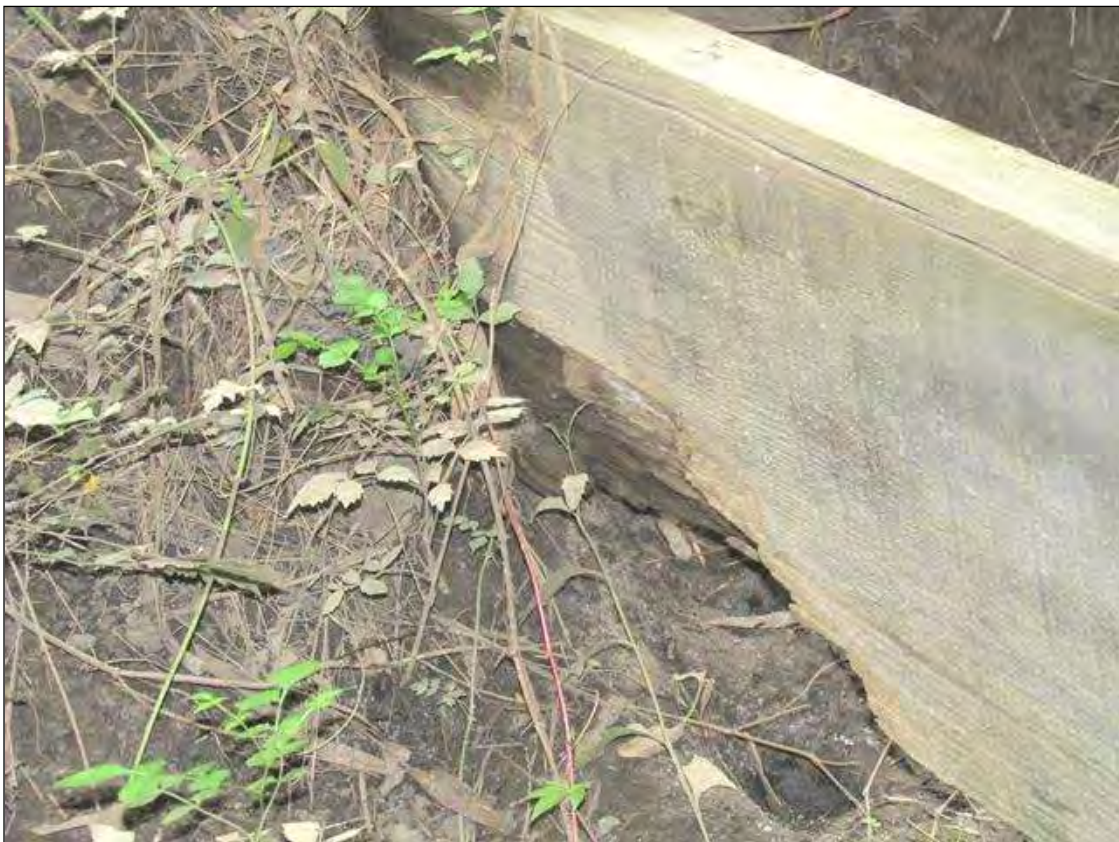
DECAYED TIMBER CROSSBRACING AT BENT 1 PILE 1

| MMS Code | Description of Function | Unit | Quantity | Remarks | Est. Cost |
|---|---|---|---|---|---|
| 3344 | Repair / Replace Timber Substructure Components | LF | 10 | DECAYED TIMBER CROSSBRACING AT BENT 1 PILE 1 | |

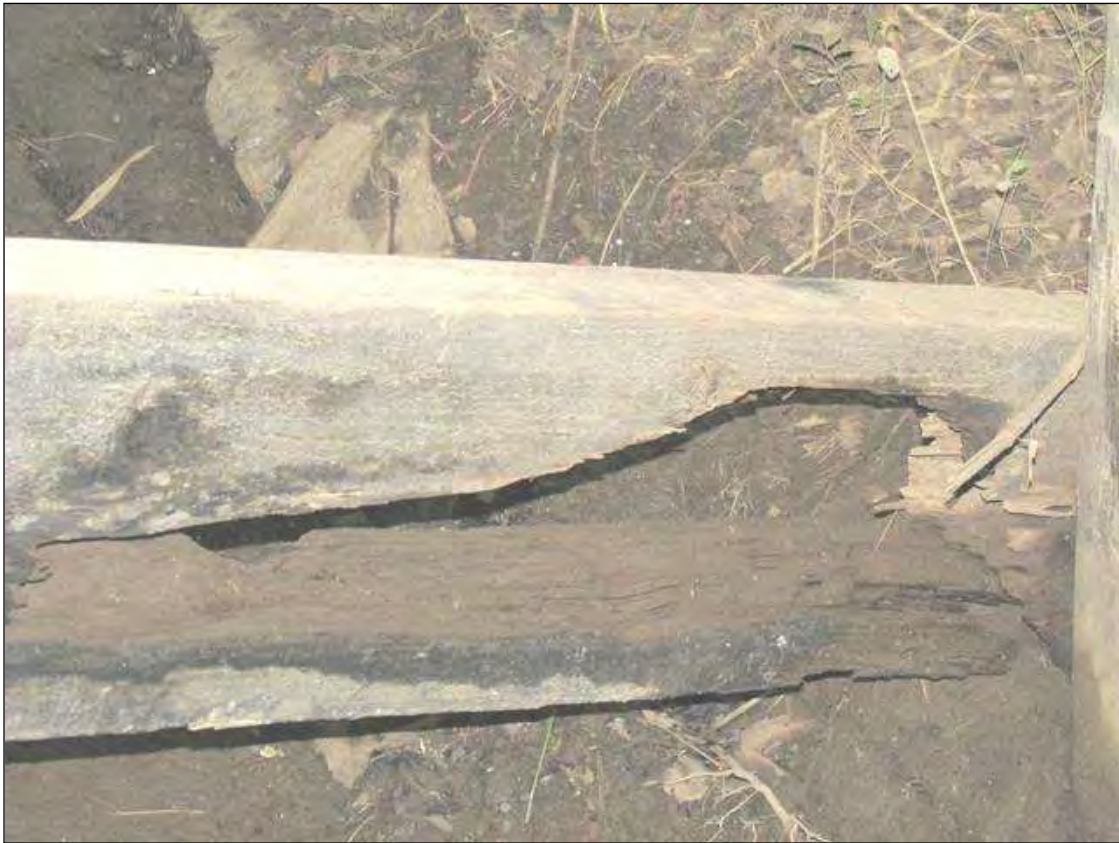
DECAYED TIMBER CROSSBRACING AT BENT 1 SPAN 2 AT PILE 5

| MMS Code | Description of Function | Unit | Quantity | Remarks | Est. Cost |
|---|---|---|---|---|---|
| 3344 | Repair / Replace Timber Substructure Components | LF | 10 | DECAYED TIMBER CROSSBRACING AT BENT 1 SPAN 2 AT PILE 5 | |

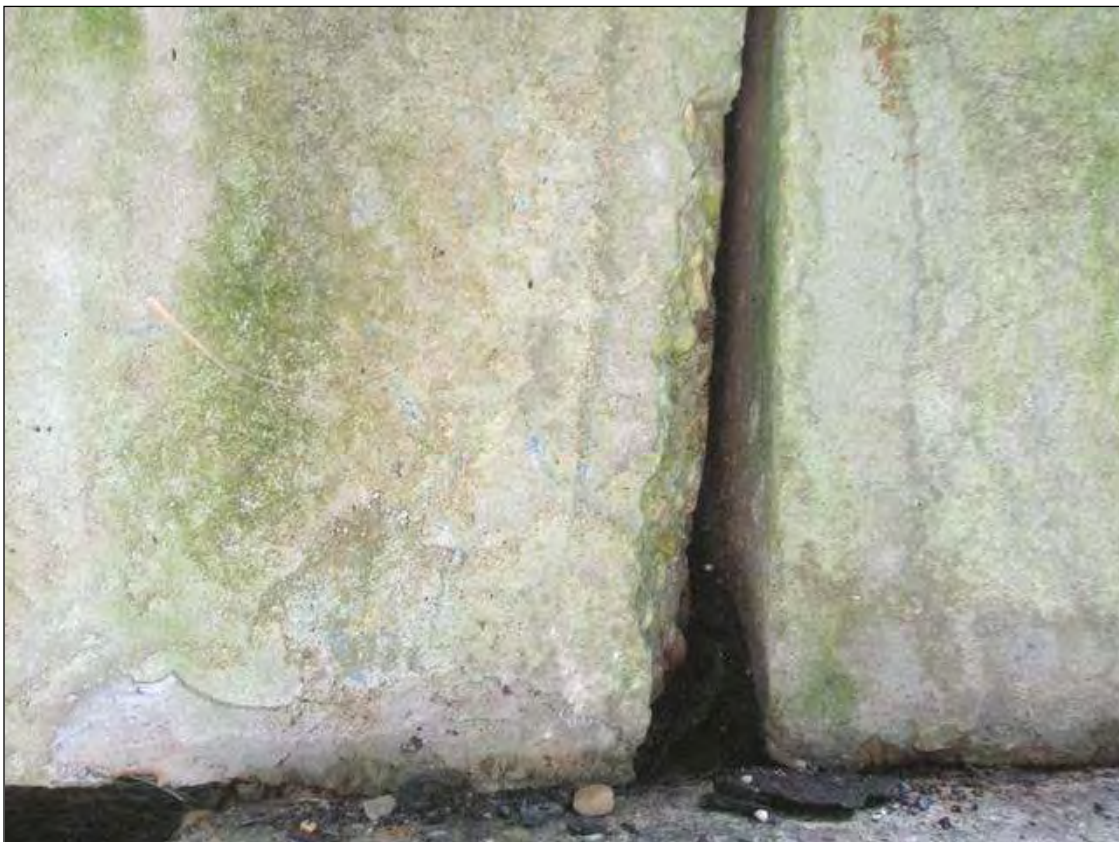
CHANNEL 10 EXTERIOR RIGHT LEG SURFACE SPALLED AT BENT 1, SPAN 1

| MMS Code | Description of Function | Unit | Quantity | Remarks | Est. Cost |
|---|---|---|---|---|---|
| 3306 | Maintain Concrete Superstructure Components | SF | 1 | CHANNEL 10 EXTERIOR RIGHT LEG SURFACE SPALLED AT BENT 1, SPAN 1 | |

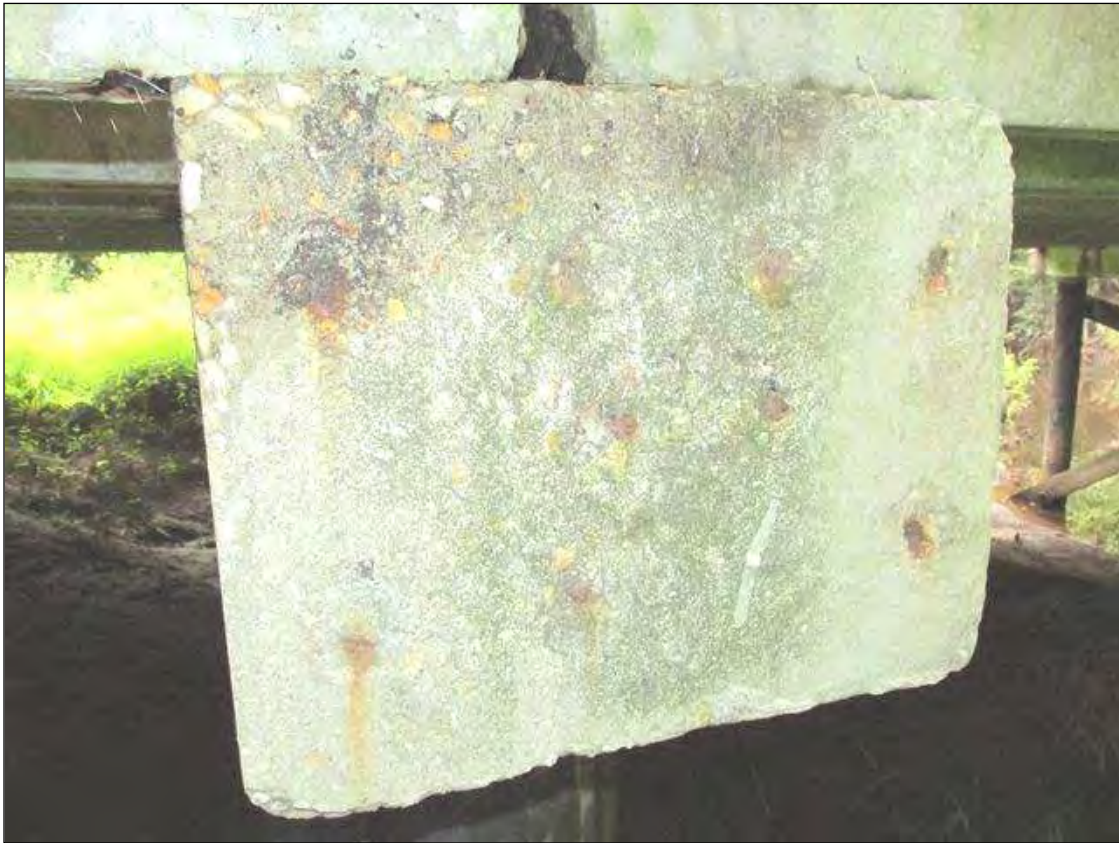
| Bridge I&A Form 1(82)H<br>State of North Carolina<br>Dept. of Transportation<br>Division of Highways | | <h2 style="text-align: center;">FIELD INSPECTION REPORT</h2> <p style="text-align: center;"><u>Bridge Inspeccion &amp; Analysis</u></p> | |
|---|---|---|--|
| 36a | F | ( PPC CAPS ) THERE ARE EXPOSED CABLE ENDS AT SOUTH END OF BENT 1. ALL CAP ENDS ARE SIMILAR. (PHOTO)<br><br>THERE ARE STAINS ON CAPS DUE TO JOINT LEAKAGE. | |

EXPOSED CABLE ENDS AT SOUTH END OF BENT 1 CAP, SIMILAR IN BOTH ENDS OF ALL CAPS

| MMS Code | Description of Function | Unit | Quantity | Remarks | Est. Cost |
|---|---|---|---|---|---|
| 3348 | Maintain Concrete Substructure Components | LF | 8 | EXPOSED CABLE ENDS AT SOUTH END OF BENT 1 CAP, SIMILAR IN BOTH ENDS OF ALL CAPS | |

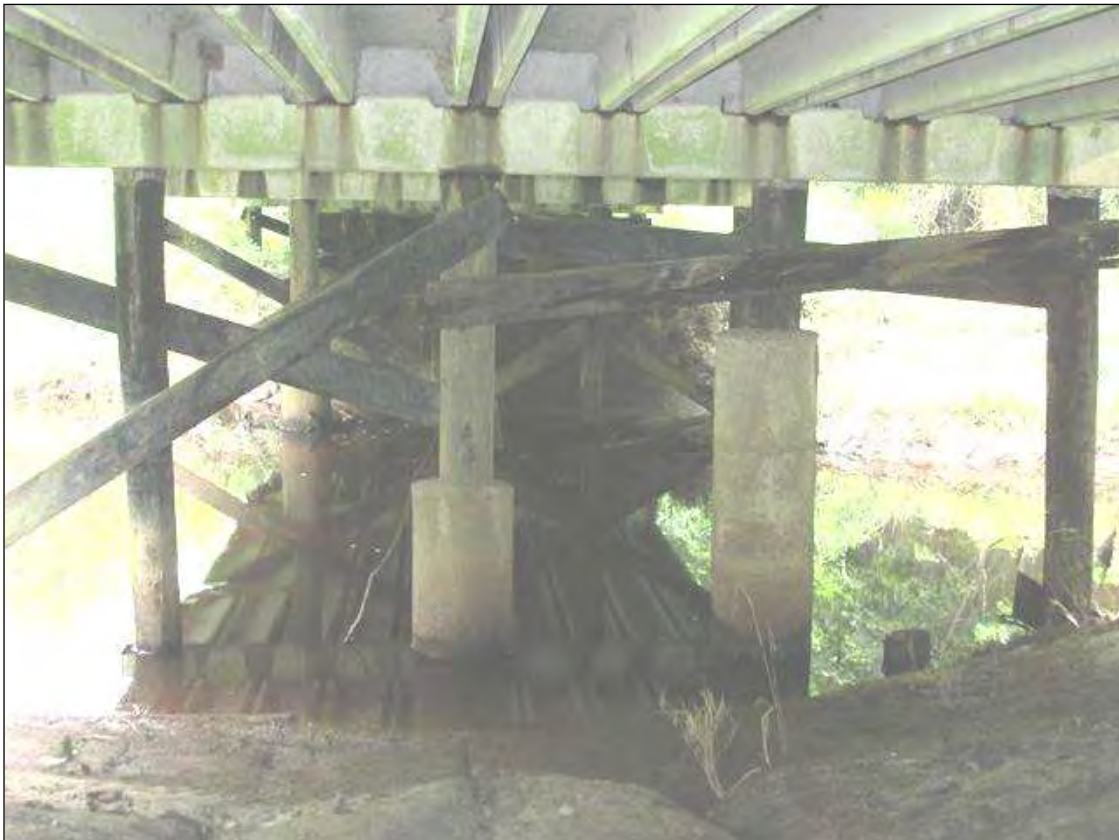
PILES 3 AND 4 AT BENT 2 ENCASED

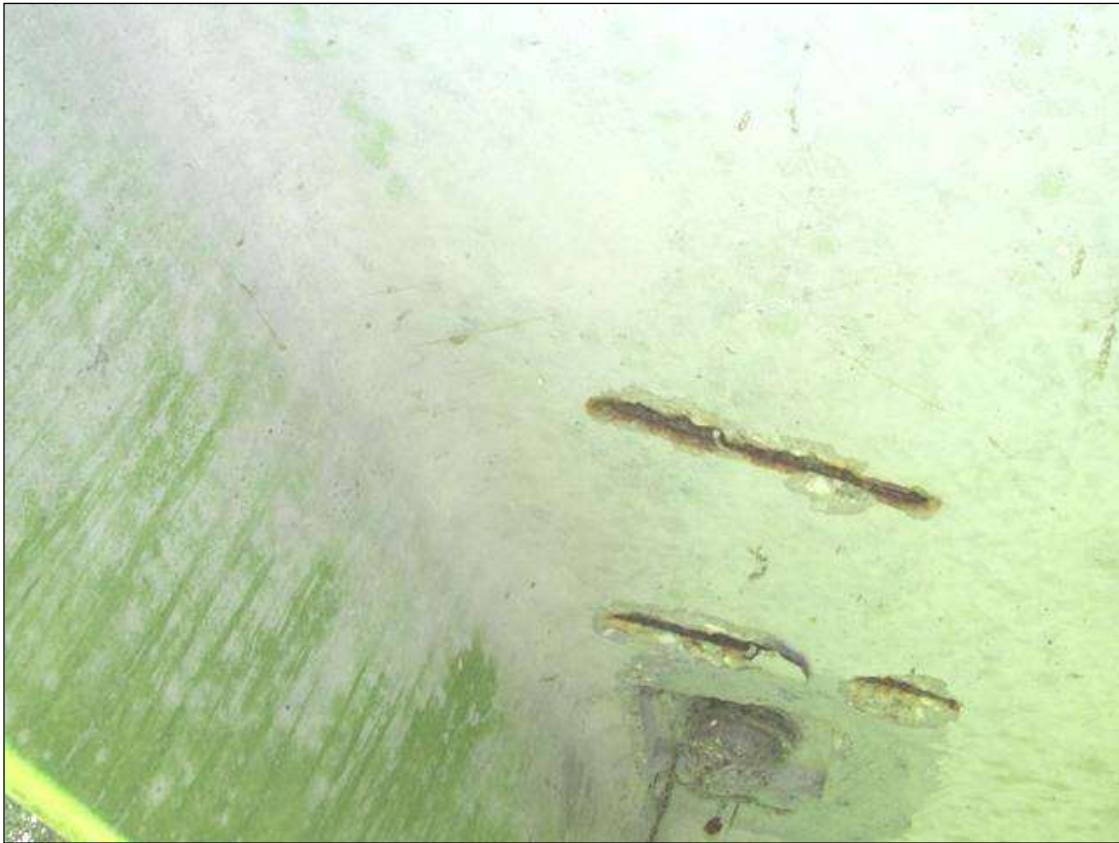
THREE SURFACE SPALLS WITH EXPOSED REBAR IN SPAN 2 CHANNEL 1

| MMS Code | Description of Function | Unit | Quantity | Remarks | Est. Cost |
|---|---|---|---|---|---|
| 3306 | Maintain Concrete Superstructure Components | SF | 2 | THREE SURFACE SPALLS WITH EXPOSED REBAR IN SPAN 2 CHANNEL 1 | |

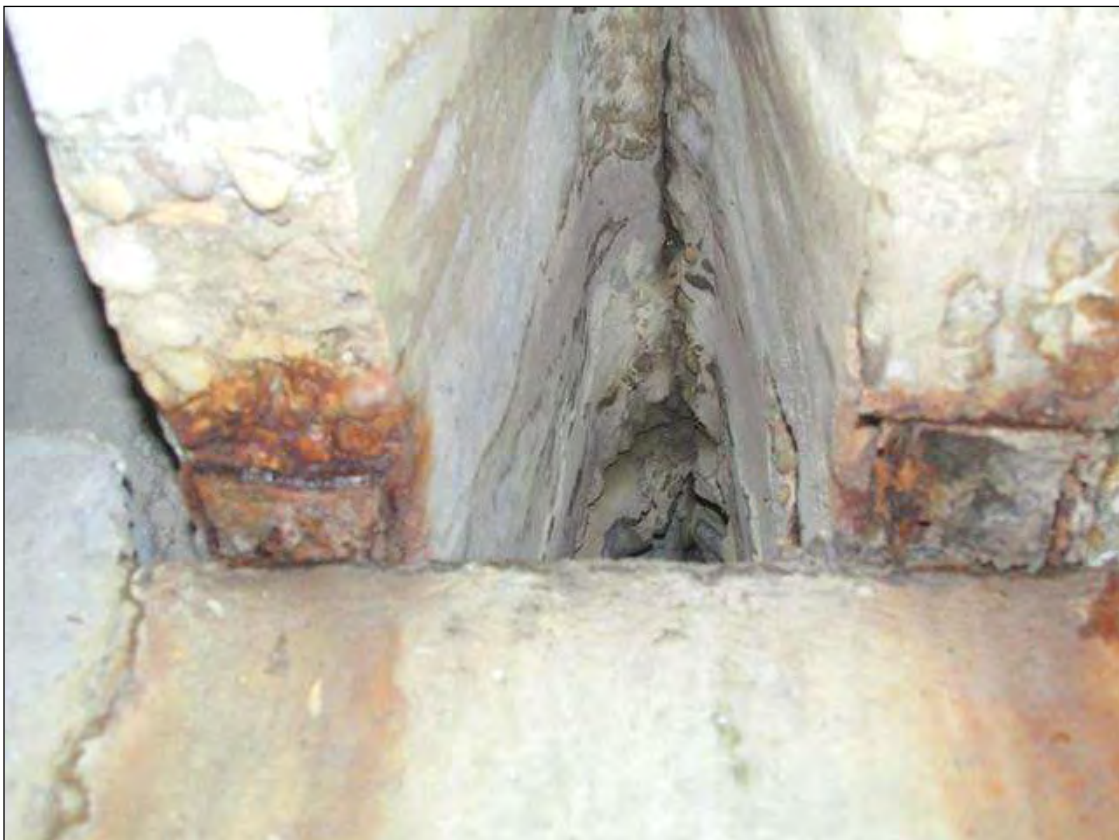
| Bridge I&A Form 1(82)H<br>State of North Carolina<br>Dept. of Transportation<br>Division of Highways | | <h2 style="text-align: center;">FIELD INSPECTION REPORT</h2> <p style="text-align: center;"><u>Bridge Inspeccion &amp; Analysis</u></p> | |
|---|---|---|--|
| 15 | F | ( BEARING ASSEMBLIES ) THE BEARING PLATES AT BENT 1 ARE RUSTED AND PITTING UP TO 1/8". ALL BEARINGS ARE SIMILAR. (PHOTO) | |

BEARING PLATES AT BENT 1 RUSTED AND PITTING UP TO 1/8", ALL BEARINGS ARE SIMILAR
