NC DEPARTMENT OF TRANSPORTATION  
DIVISION OF HIGHWAYS  
BRIDGE MANAGEMENT UNIT

# BRIDGE INSPECTION REPORT

COUNTY COLUMBUS BRIDGE NUMBER 230167 INSPECTION CYCLE 2 YRS  
ROUTE SR1379 ACROSS GAPWAY SWAMP M.P. 0

INSPECTION DATE 07/22/2013

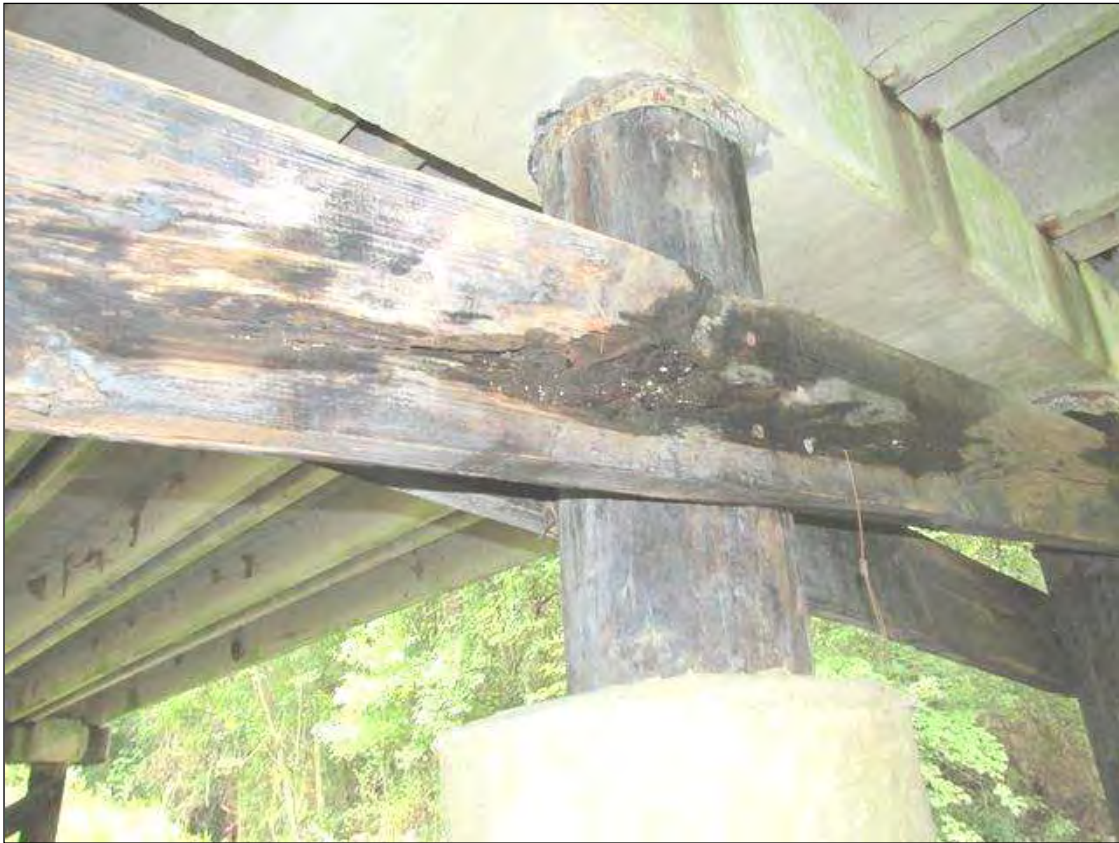
BENT 2 TIMBER CROSSBRACING IS DECAYED AT PILE 4

| MMS Code | Description of Function | Unit | Quantity | Remarks | Est. Cost |
|---|---|---|---|---|---|
| 3344 | Repair / Replace Timber Substructure Components | LF | 10 | BENT 2 TIMBER CROSSBRACING IS DECAYED AT PILE 4 | |

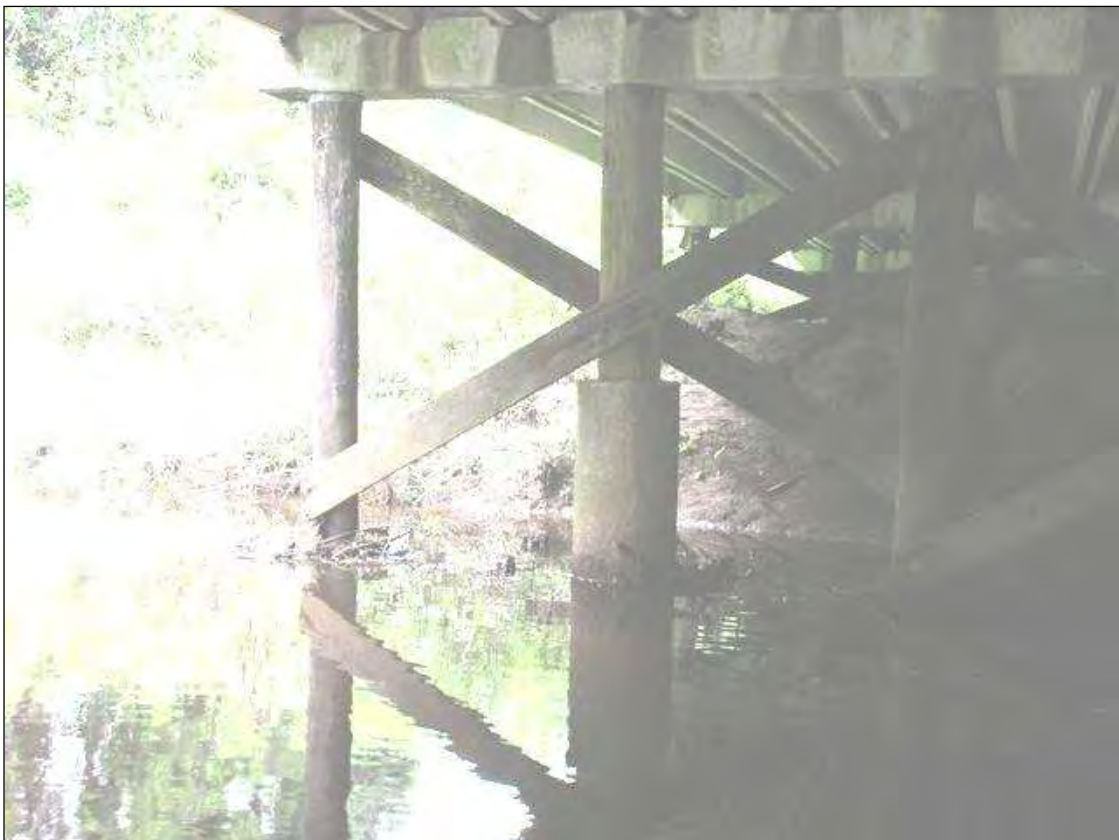
PILE 2 AT BENT 3 ENCASED

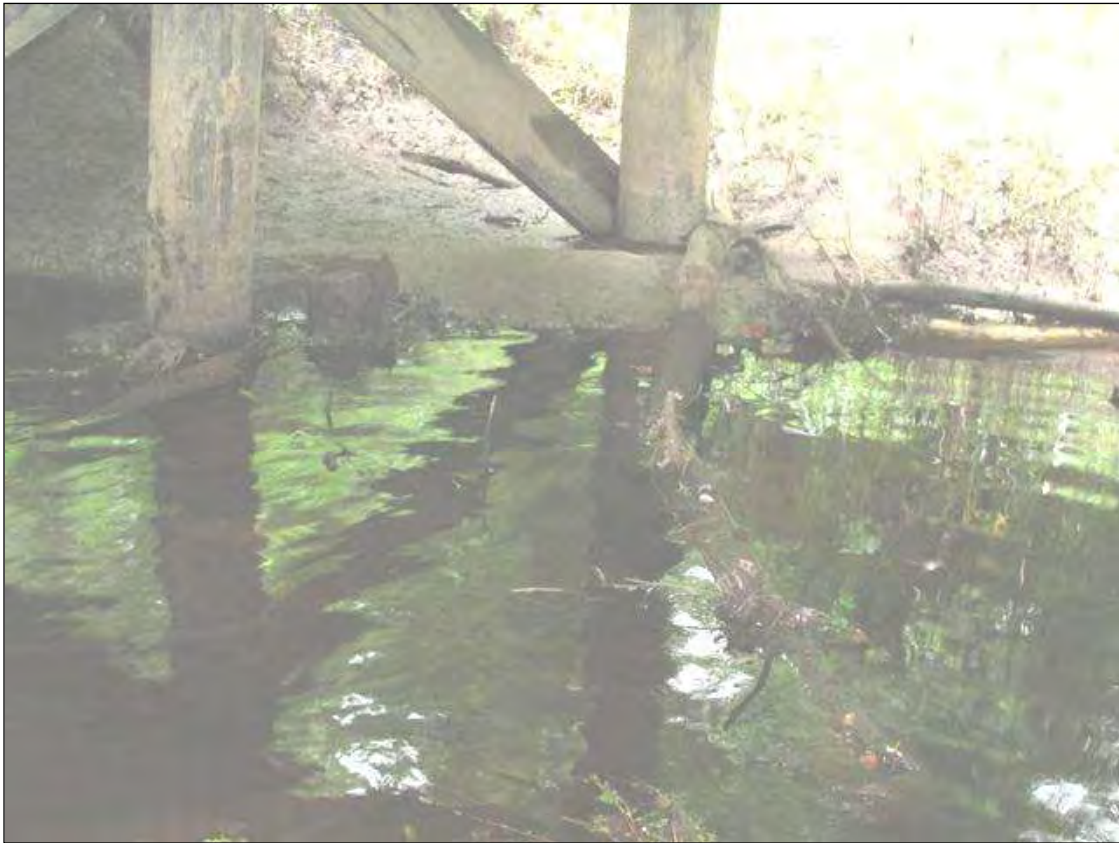
| Bridge I&A Form 1(82)H<br>State of North Carolina<br>Dept. of Transportation<br>Division of Highways | | <h2 style="text-align: center;">FIELD INSPECTION REPORT</h2> <p style="text-align: center;"><u>Bridge Inspeccion &amp; Analysis</u></p> | |
|---|---|---|--|
| 41 | F | ( DRIFT ) THERE IS DRIFT IN SPAN 3 AT BENT 3. (PHOTO) | |

DRIFT IN SPAN 3 AT BENT 3

| MMS Code | Description of Function | Unit | Quantity | Remarks | Est. Cost |
|---|---|---|---|---|---|
| 3366 | Drift and Debris Removal | HR | 3 | DRIFT IN SPAN 3 AT BENT 3 | |

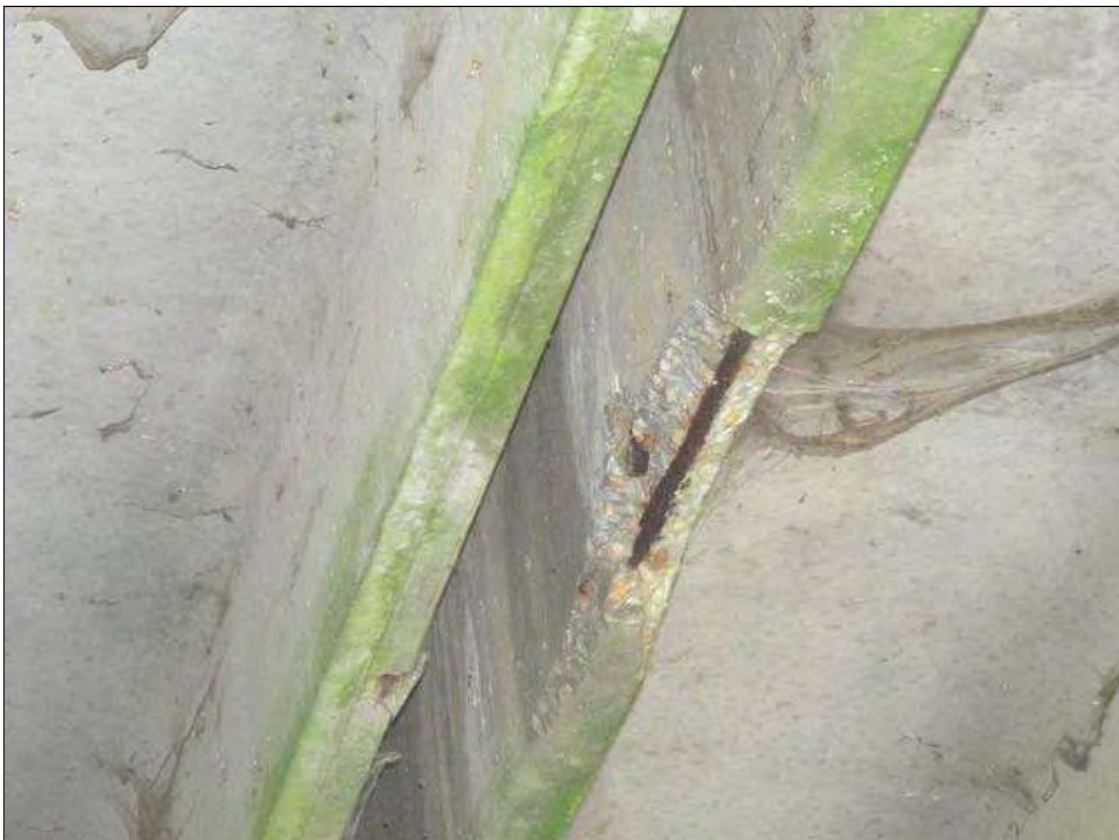
CHANNEL 3 IN SPAN 3 RIGHT LEG SPALLED 14" LONG X 2" HIGH WITH EXPOSED CABLE AT MID SPAN

| MMS Code | Description of Function | Unit | Quantity | Remarks | Est. Cost |
|---|---|---|---|---|---|
| 3306 | Maintain Concrete Superstructure Components | SF | 2 | CHANNEL 3 IN SPAN 3 RIGHT LEG SPALLED 14" LONG X 2" HIGH WITH EXPOSED REBAR AT MID SPAN | |

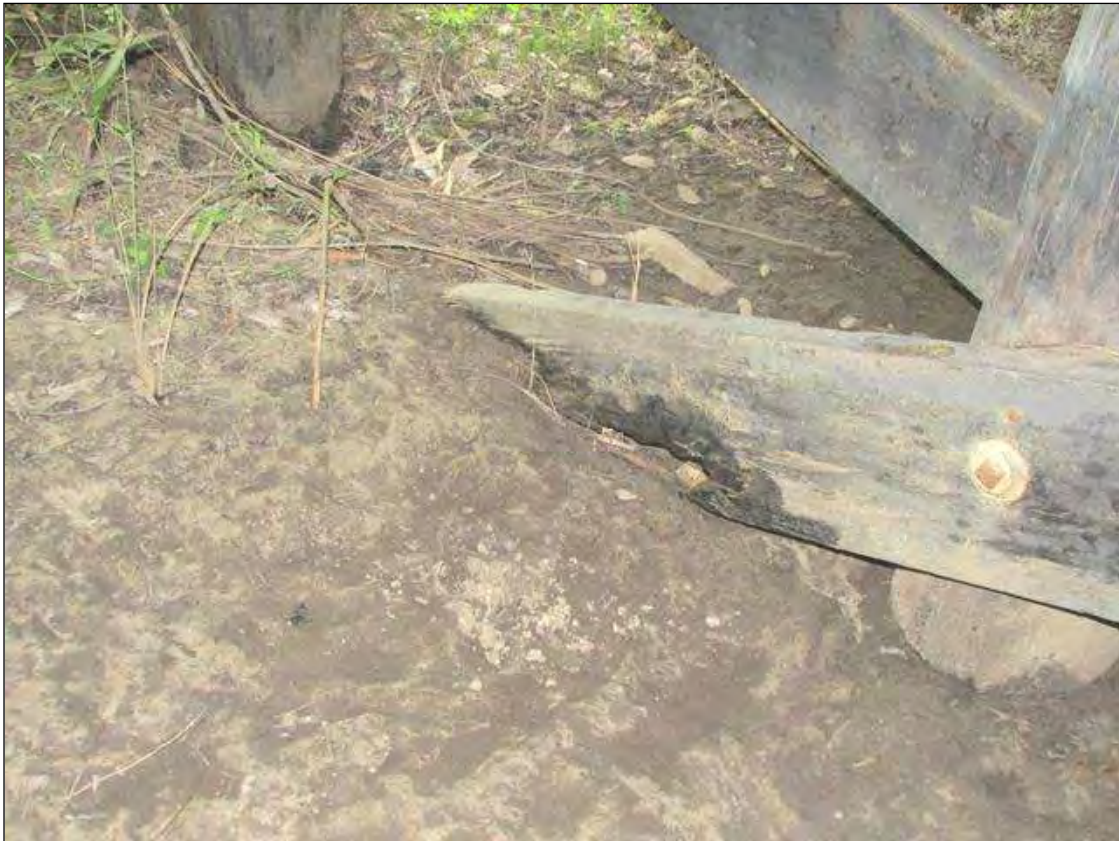
DECAYED TIMBER CROSSBRACING AT BENT 4 BETWEEN PILES 1 AND 2

| MMS Code | Description of Function | Unit | Quantity | Remarks | Est. Cost |
|---|---|---|---|---|---|
| 3344 | Repair / Replace Timber Substructure Components | LF | 10 | DECAYED TIMBER CROSSBRACING AT BENT 4 BETWEEN PILES 1 AND 2 | |

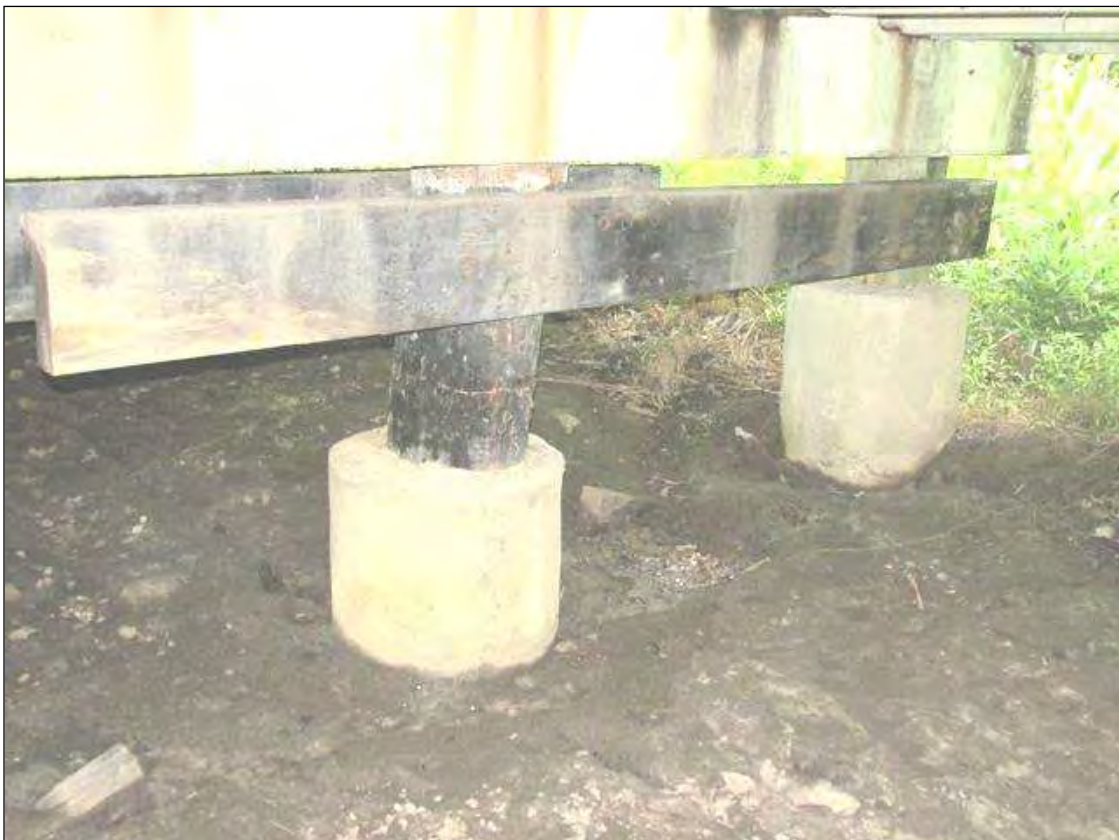
PILES 4 AND 5 ENCASED AT BENT 4

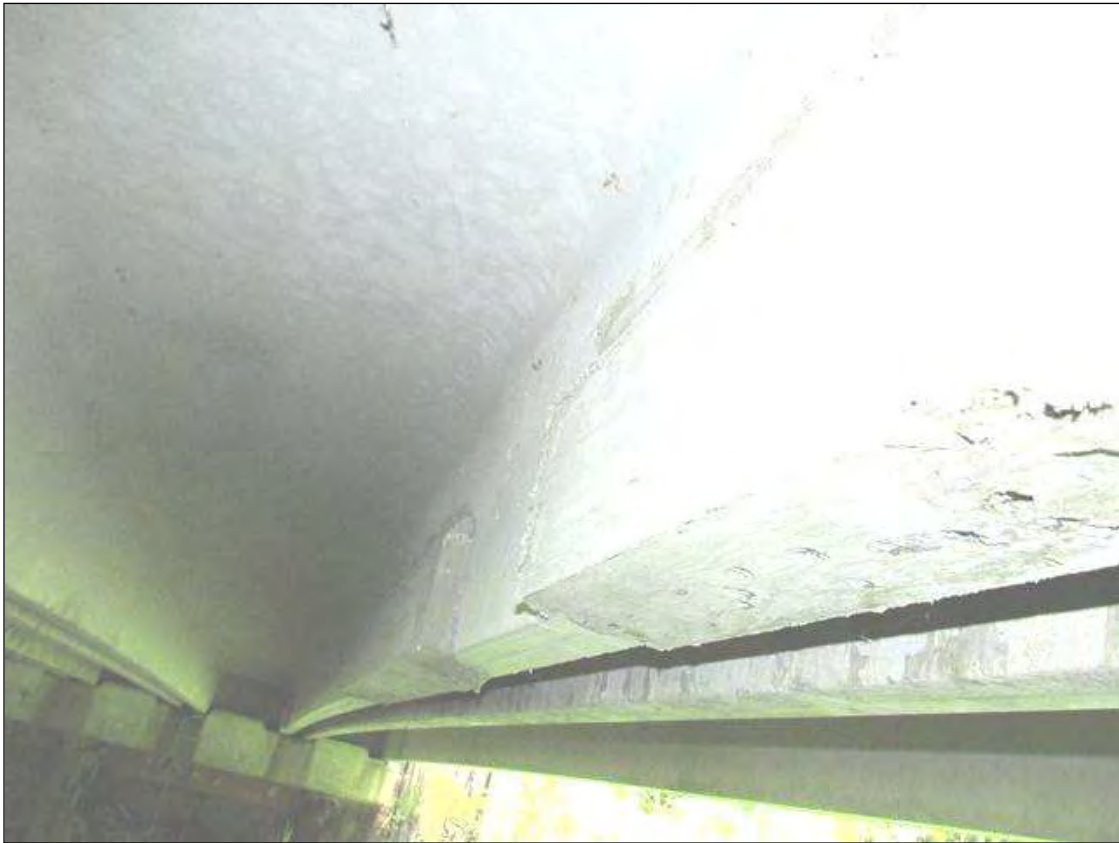
SIMILAR CHANNEL REPAIRS IN SPAN 5

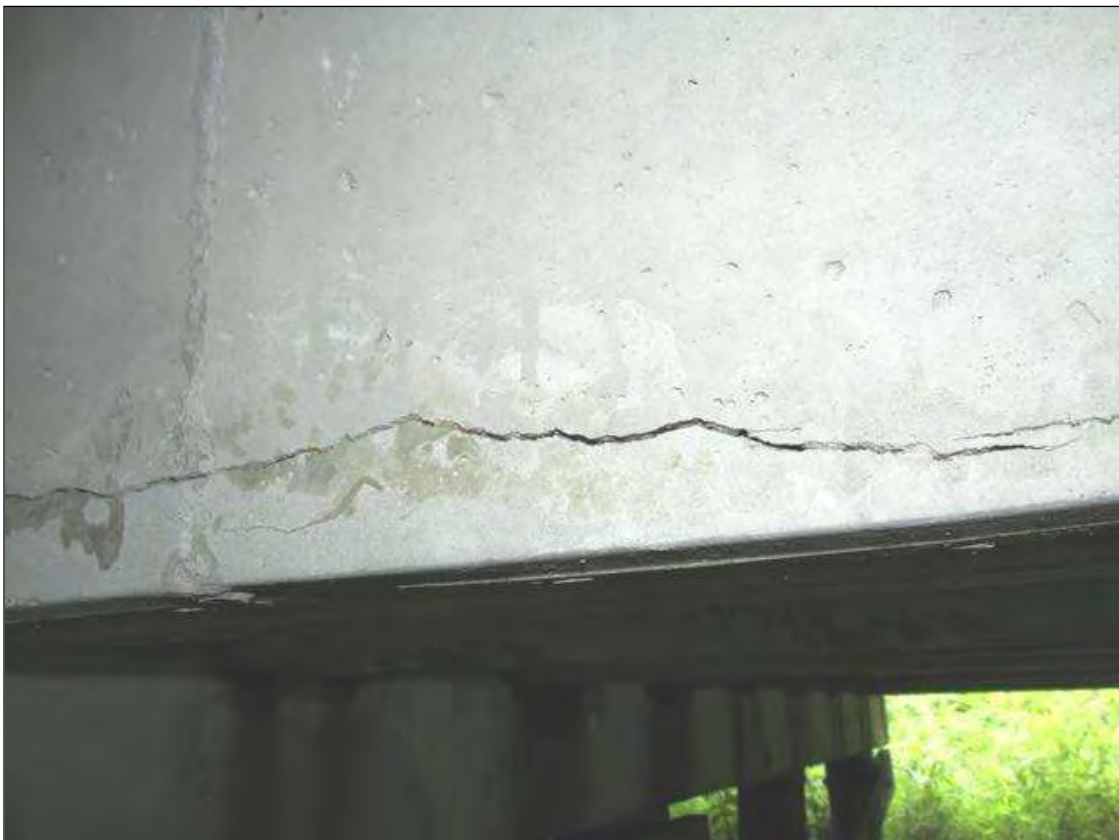
CHANNEL 9 IN SPAN 5 HAS A 1/8" X 3' LONG CRACK IN LEFT LEG 3' FROM BENT 4

| MMS Code | Description of Function | Unit | Quantity | Remarks | Est. Cost |
|---|---|---|---|---|---|
| 3306 | Maintain Concrete Superstructure Components | SF | 3 | CHANNEL 9 IN SPAN 5 HAS A 1/8" X 3' LONG CRACK IN LEFT LEG 3' FROM BENT 4 | |

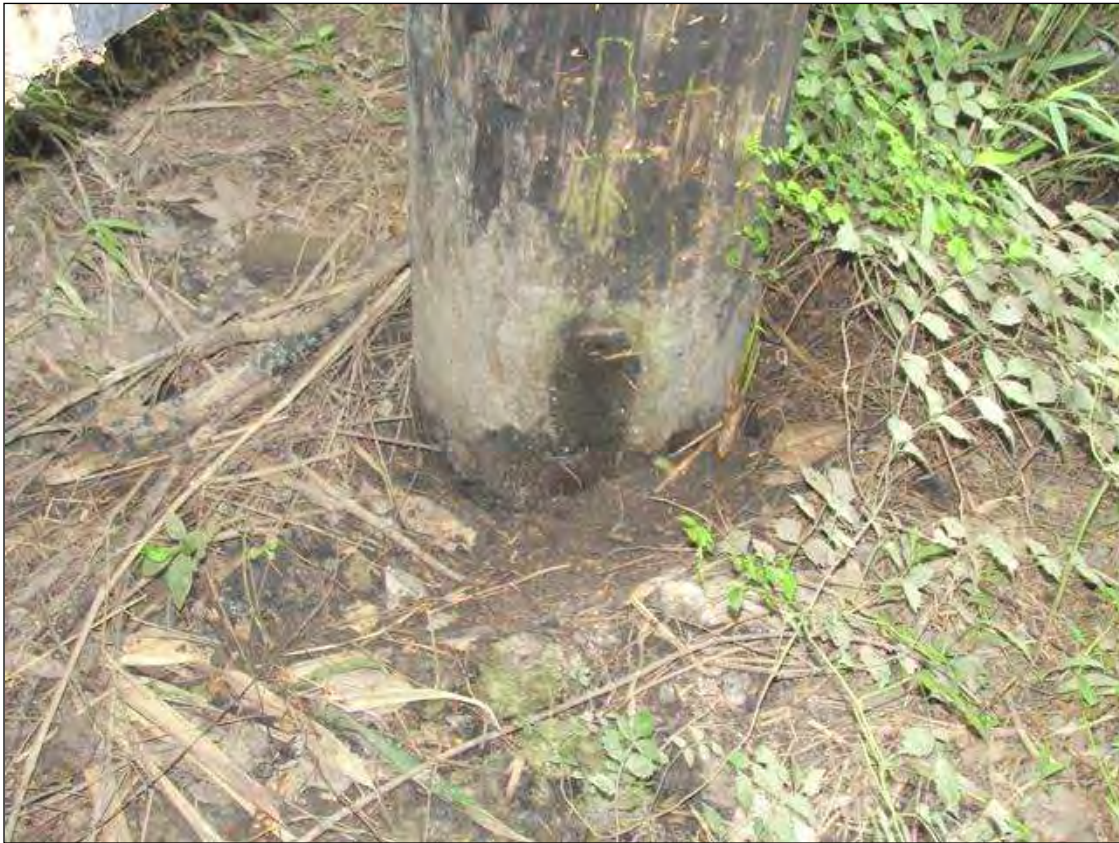
PILE 1 AT BENT 4, SPAN 5 FACE IS SURFACE DECAYED AT GROUND LINE

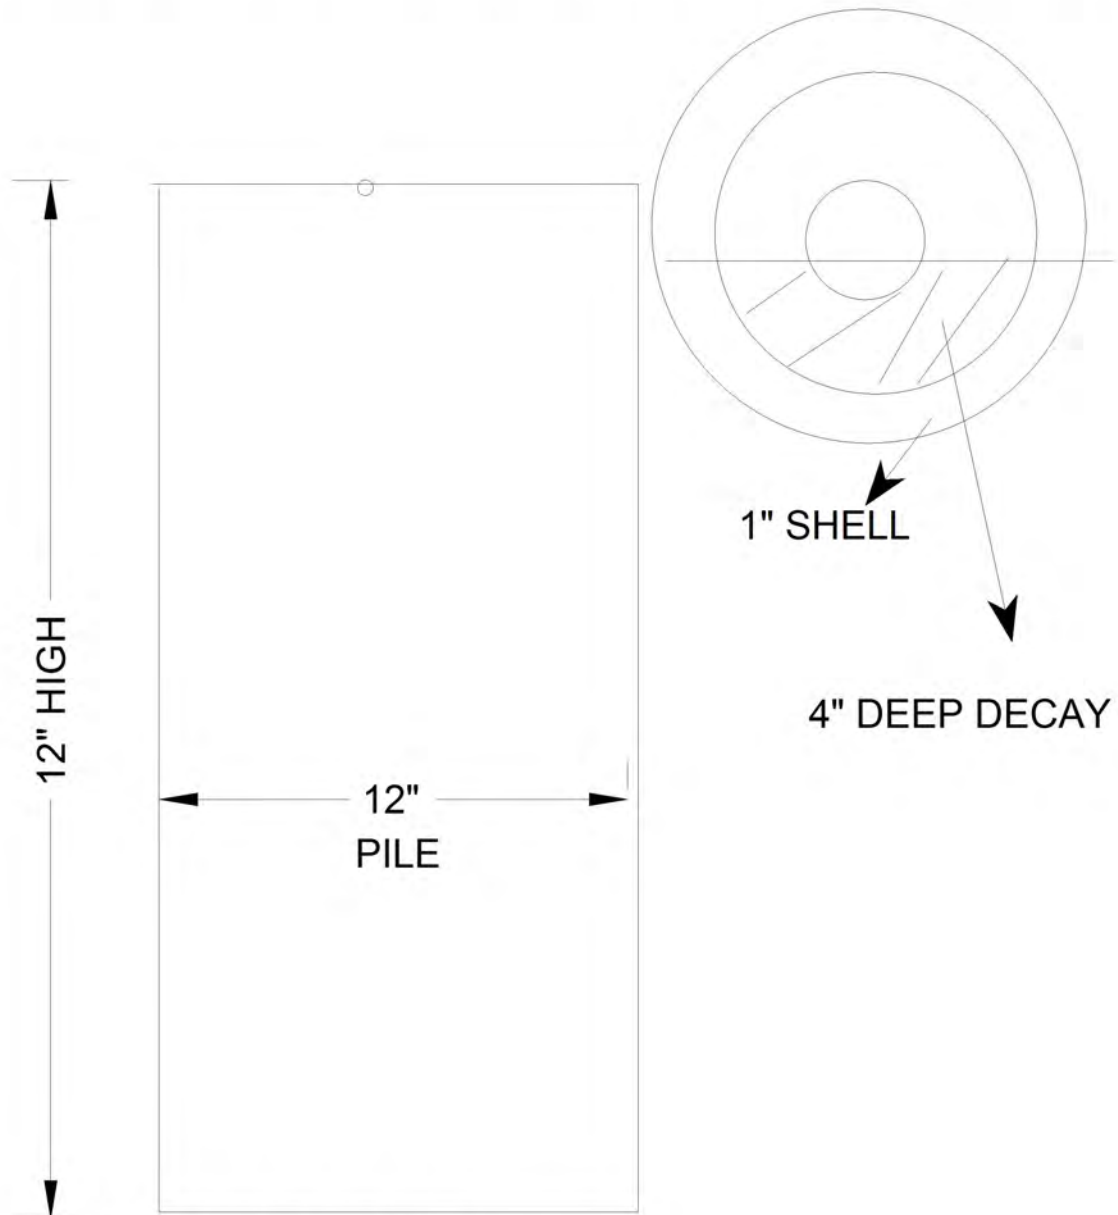
DECAY SKETCH

PILE 4 , BENT 4 DECAYED AREAS 12" HIGH X 1/2 CIRCUMFERENCE

THERE IS NO CHANGE SINCE LAST INSPECTION  
MEASUREMENTS VERIFIED BY RLK 7/22/13
