NC DEPARTMENT OF TRANSPORTATION  
DIVISION OF HIGHWAYS  
BRIDGE MANAGEMENT UNIT

# BRIDGE INSPECTION REPORT

INSPECTION TYPE: Routine Inspection

COUNTY COLUMBUS BRIDGE NUMBER 230171 INSPECTION CYCLE 2 YRS  
ROUTE SR1414 ACROSS DUNN SWAMP M.P. 0

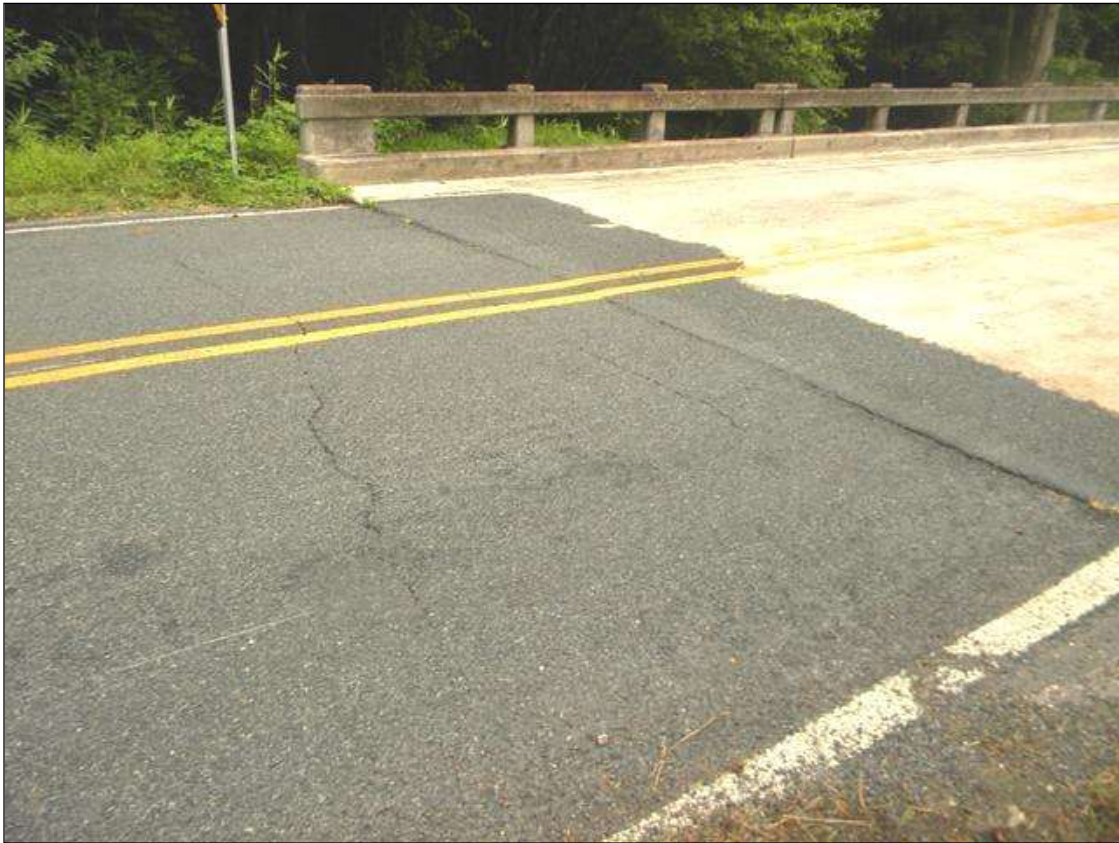
| <b>50</b> | <b>F</b> | ( APPROACH ROADWAYS ) THE ROADWAY HAS BEEN RESURFACED WITH ROCK AND TAR.<br><br>THE SOUTH APPROACH ASPHALT WEARING SURFACE IS CRACKED AND SETTLED UP TO 1". (PHOTO)<br><br>THE NORTH APPROACH ASPHALT WEARING SURFACE IS CRACKED AND SETTLED UP TO 1 1/4". (PHOTO) | |

SOUTH APPROACH ASPHALT WEARING SURFACE SETTLED UP TO 1"

| MMS Code | Description of Function | Unit | Quantity | Remarks | Est. Cost |
|---|---|---|---|---|---|
| 2816 | Asphalt Surface Repair or Replacement | SY | 3 | SOUTH APPROACH ASPHALT WEARING SURFACE SETTLED UP TO 1" | |

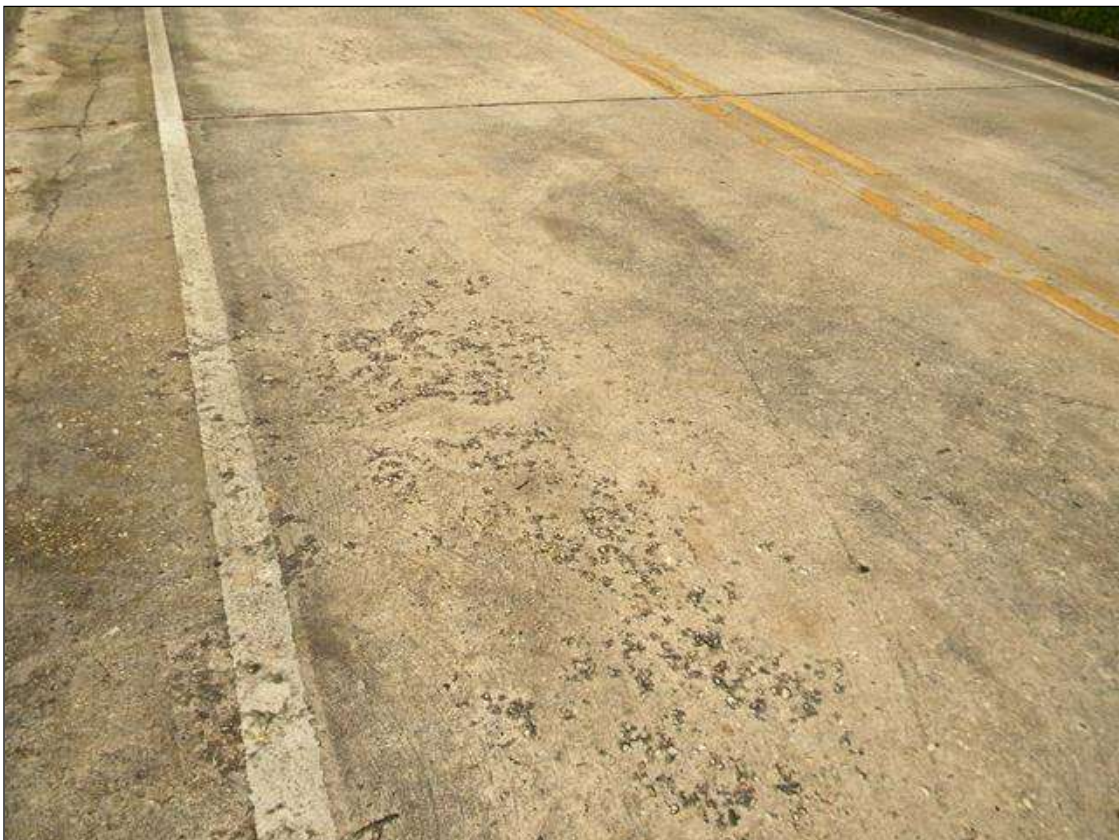
| Bridge I&A Form 1(82)H<br>State of North Carolina<br>Dept. of Transportation<br>Division of Highways | | <h1 style="text-align: center;">FIELD INSPECTION REPORT</h1> <h2 style="text-align: center;"><u>Bridge Inspection &amp; Analysis</u></h2> | |
|---|---|---|--|
| 2a | F | ( RC DECK ) THE TOP SURFACE IS ROUGH AND WORN.<br><br>THERE IS SURFACE SCALING NOTED AT RANDOM. (PHOTOS)<br><br>THERE ARE A FEW TRANSVERSE CRACKS. (PHOTOS)<br><br>THERE IS 1/16" MAP CRACKING IN SPAN 1 DECK. (PHOTO)<br><br>THERE IS HAIRLINE TO 1/16" MAP CRACKING IN SPAN 3 NORTH BOUND LANE. (PHOTO)<br><br>SPAN 4 DECK 1/16" LONGITUDINAL CRACK IN SOUTH BOUND LANE. (PHOTO) | |

DECK SURFACE SCALING IN SPAN 1

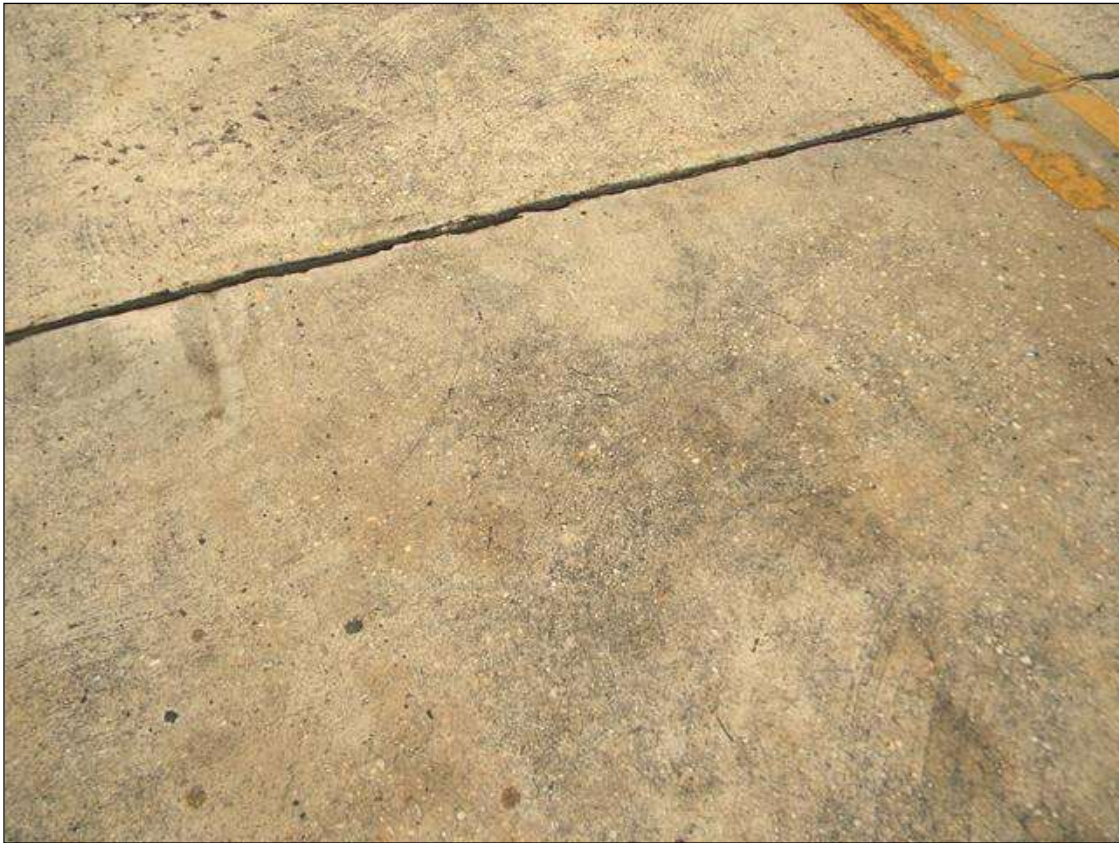
1/16" MAP CRACKING IN SPAN 1 DECK

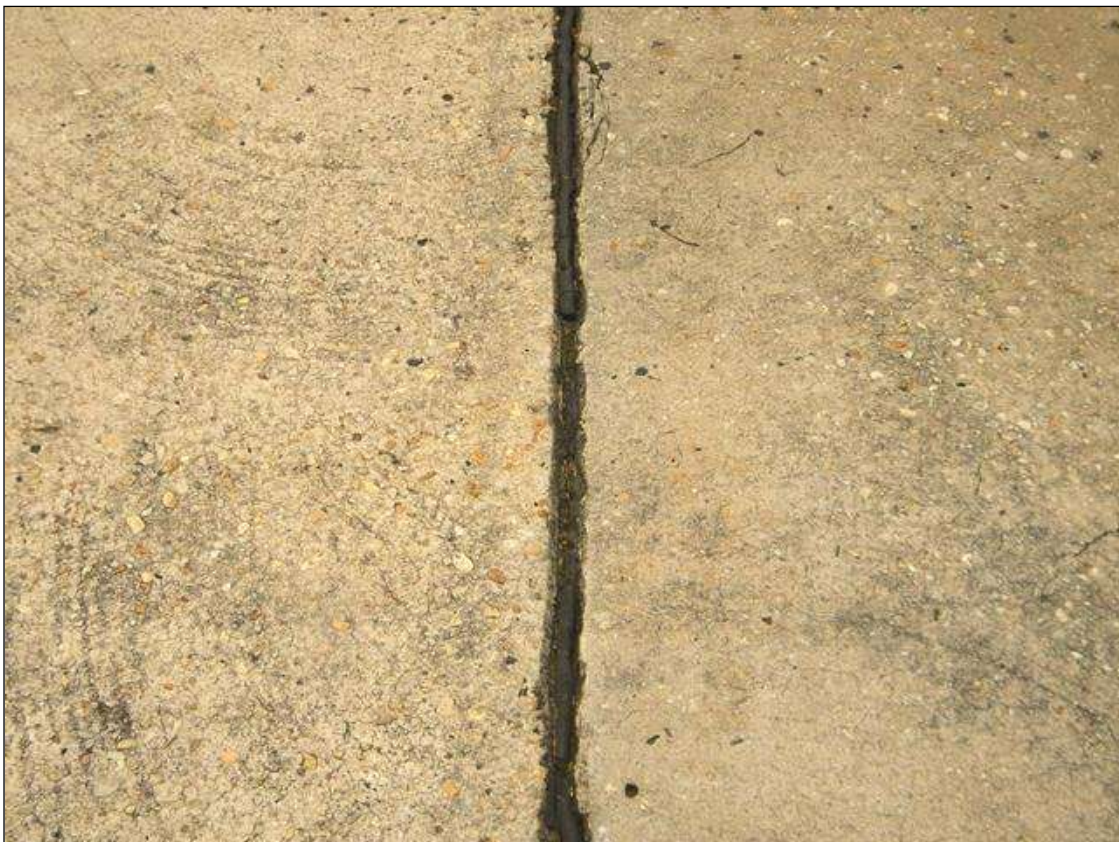
| Bridge I&A Form 1(82)H<br>State of North Carolina<br>Dept. of Transportation<br>Division of Highways | | <h1 style="text-align: center;">FIELD INSPECTION REPORT</h1> <h2 style="text-align: center;"><u>Bridge Inspection &amp; Analysis</u></h2> | |
|---|---|---|--|
| 6d | P | ( STANDARD JOINTS ) THERE ARE A FEW LOCATIONS ON THE UNDERSIDE THAT HAVE SIGNS OF LEAKAGE.<br><br>THE TOP SEAL IS DETERIORATED, CRACKED, SETTLED, AND LEAKING AT ALL STANDARD JOINTS. (PHOTOS) | |

BENT 1 STANDARD JOINT MATERIAL DETERIORATED, CRACKED, AND LEAKING ALL JOINTS ARE SIMILAR

| MMS Code | Description of Function | Unit | Quantity | Remarks | Est. Cost |
|---|---|---|---|---|---|
| 3310 | Maintenance/Repair/Replacement of Standard Bridge Expansion Joints | LF | 72 | BENT 1 STANDARD JOINT MATERIAL DETERIORATED, CRACKED, AND LEAKING ALL JOINTS ARE SIMILAR | |

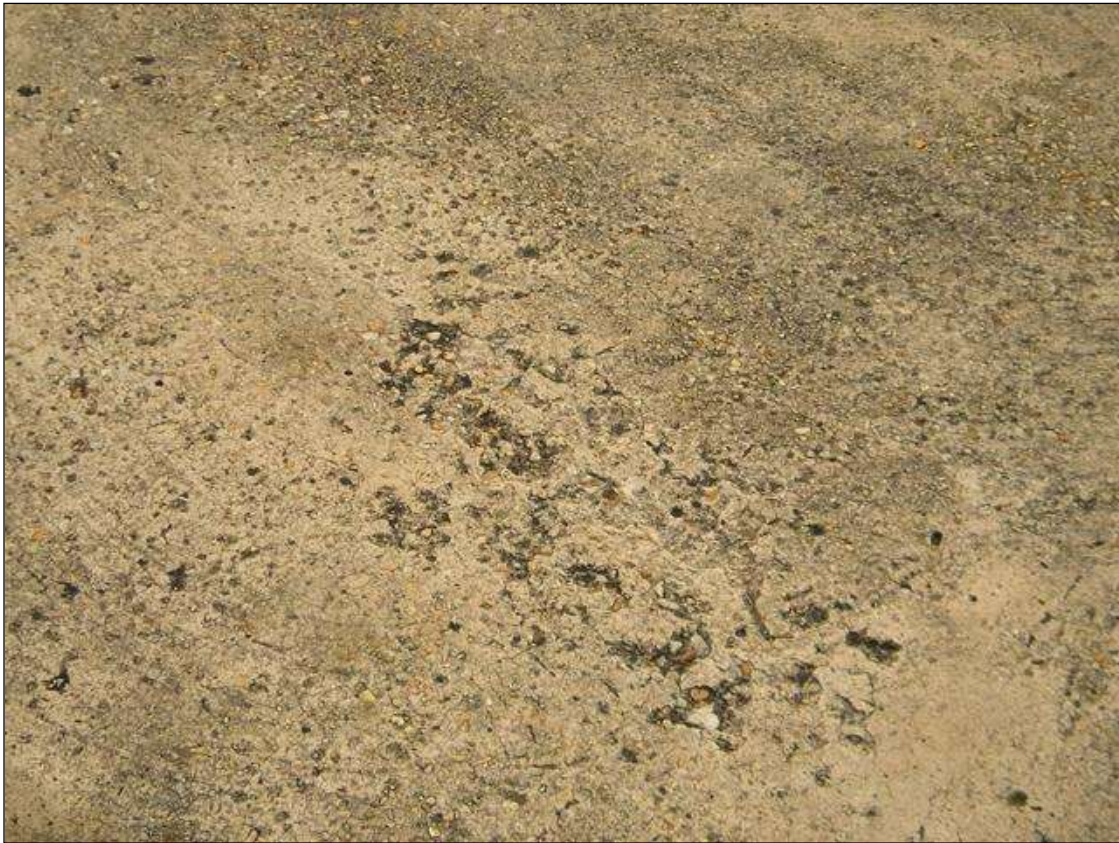
SURFACE SCALING IN SPAN 2 DECK

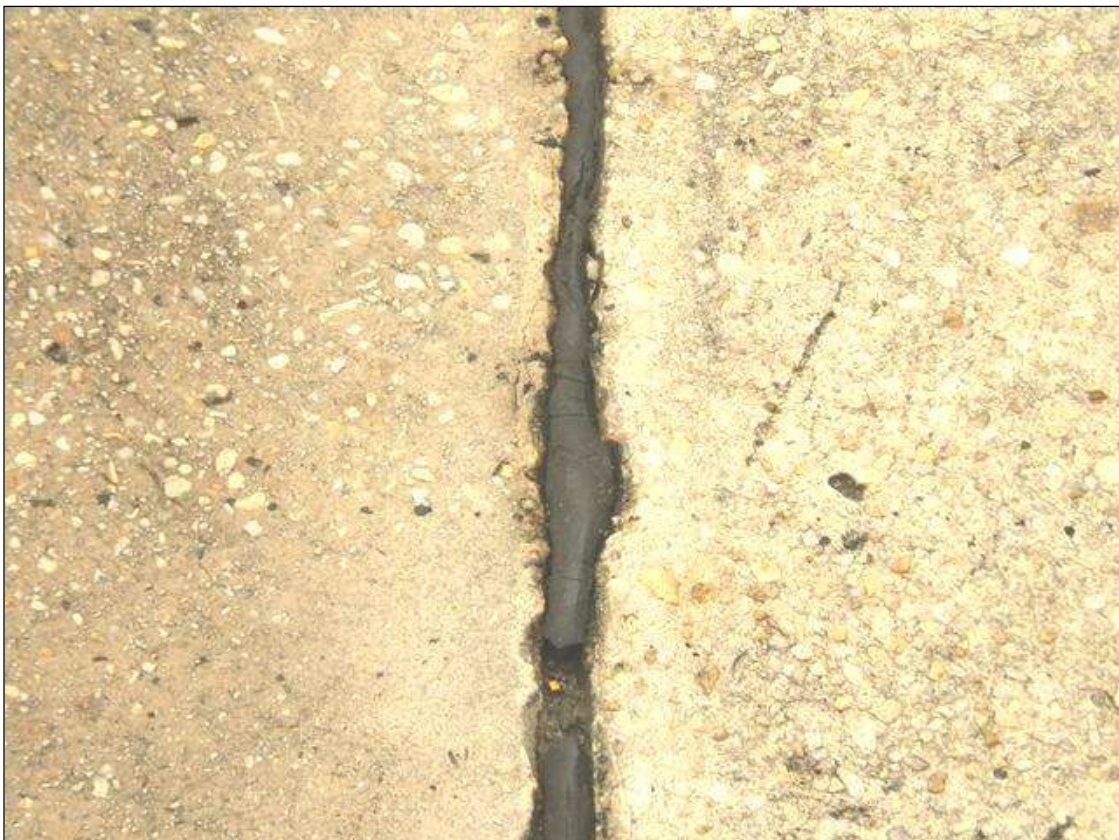
BENT 2 STANDARD JOINT DETERIORATED, SETTLING, AND LEAKING

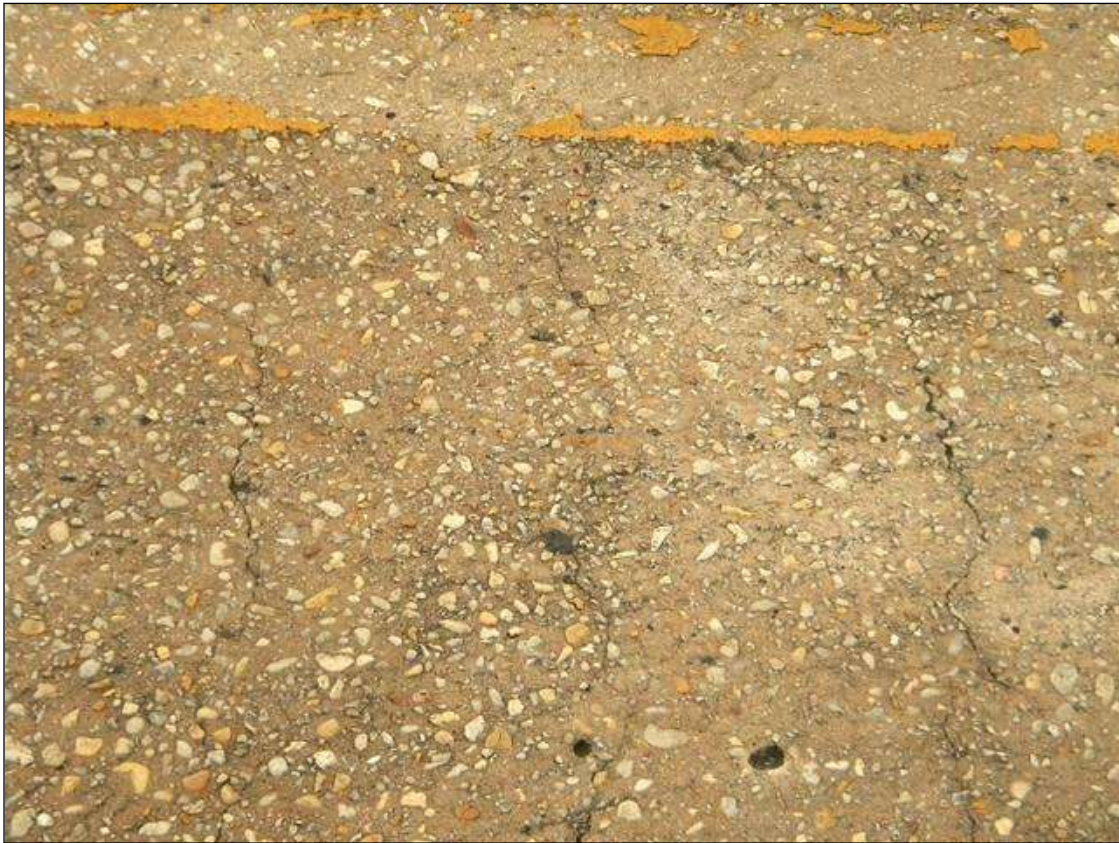
HAIRLINE TO 1/32" TRANSVERSE CRACKS IN SPAN 3 DECK

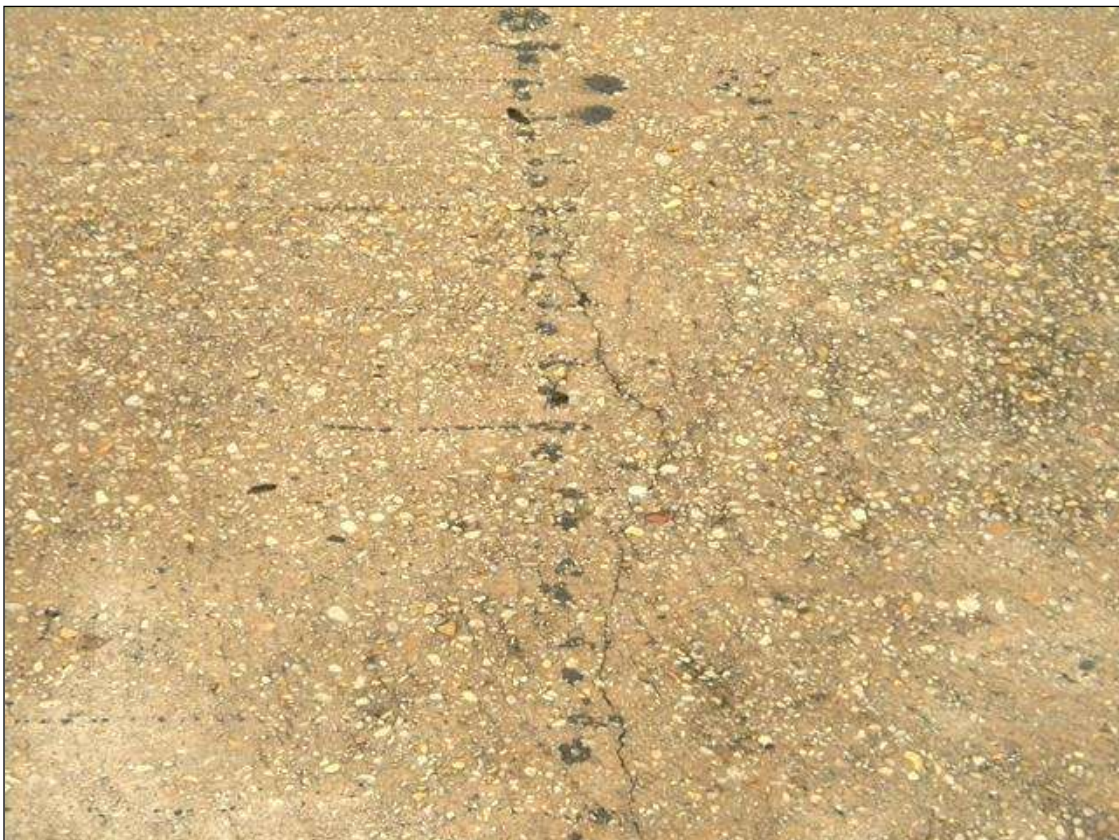
HAIRLINE TRANSVERSE CRACKS IN SPAN 3 SOUTH BOUND LANE

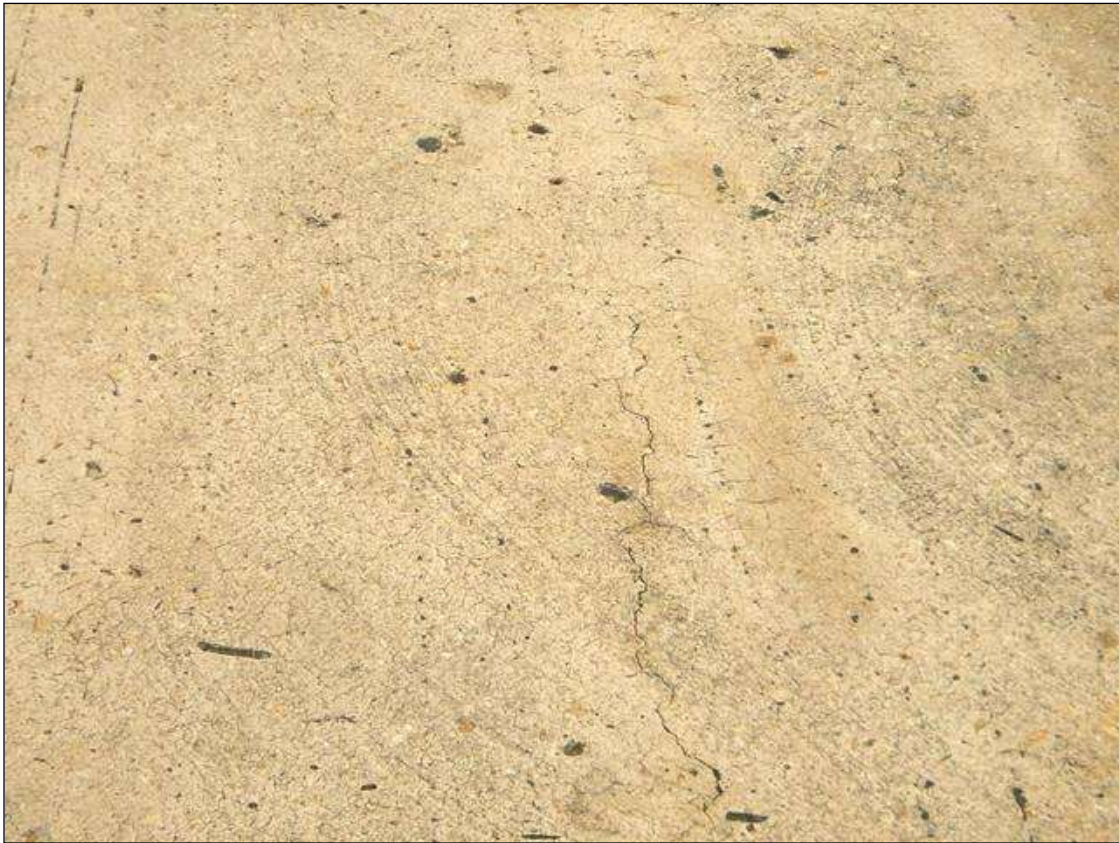
1/16" LONGITUDINAL CRACK IN SPAN 4 DECK IN THE SOUTH BOUND LANE

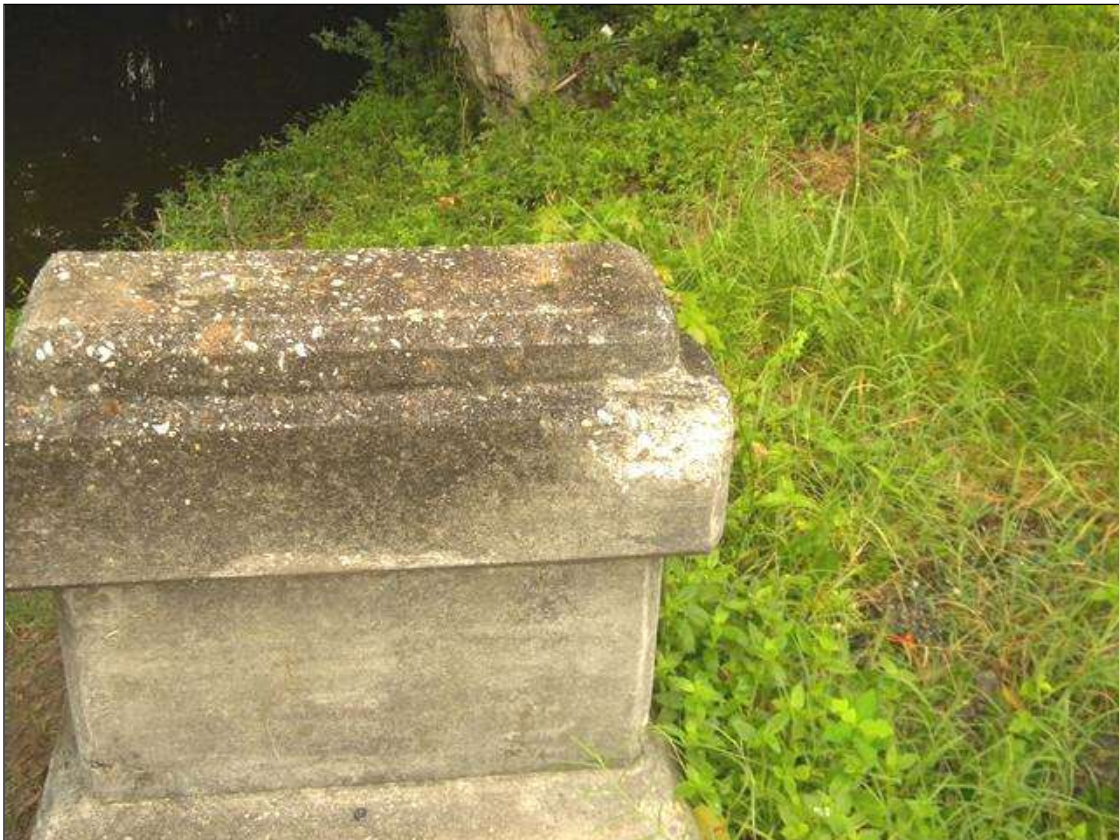
| Bridge I&A Form 1(82)H<br>State of North Carolina<br>Dept. of Transportation<br>Division of Highways | | <h1 style="text-align: center;">FIELD INSPECTION REPORT</h1> <h2 style="text-align: center;"><u>Bridge Inspection &amp; Analysis</u></h2> | |
|---|---|---|--|
| 3a | G | THERE IS HONEYCOMBING NOTED ON THE UNDERSIDE.<br>( RC RAILS ) THERE IS A CHIPPED AREA AT THE NORTHWEST CORNER. (PHOTO)<br><br>THERE IS A LEFT RAIL SPALL WITH EXPOSED STEEL SPAN 2 AT POST 2. (PHOTO) | |

LEFT RAIL END POST CHIPPED AT NORTHWEST CORNER

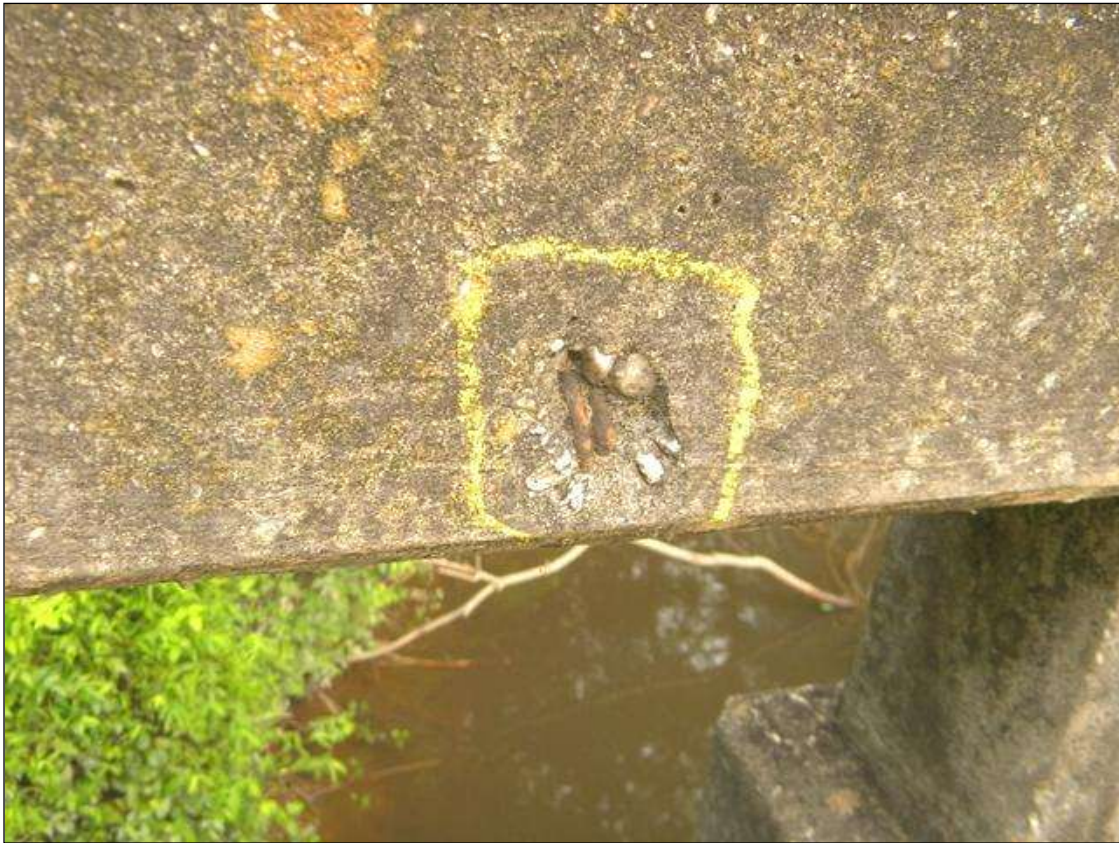
LEFT RAIL SURFACE SPALL WITH EXPOSED REBAR AT POST 2 IN SPAN 2

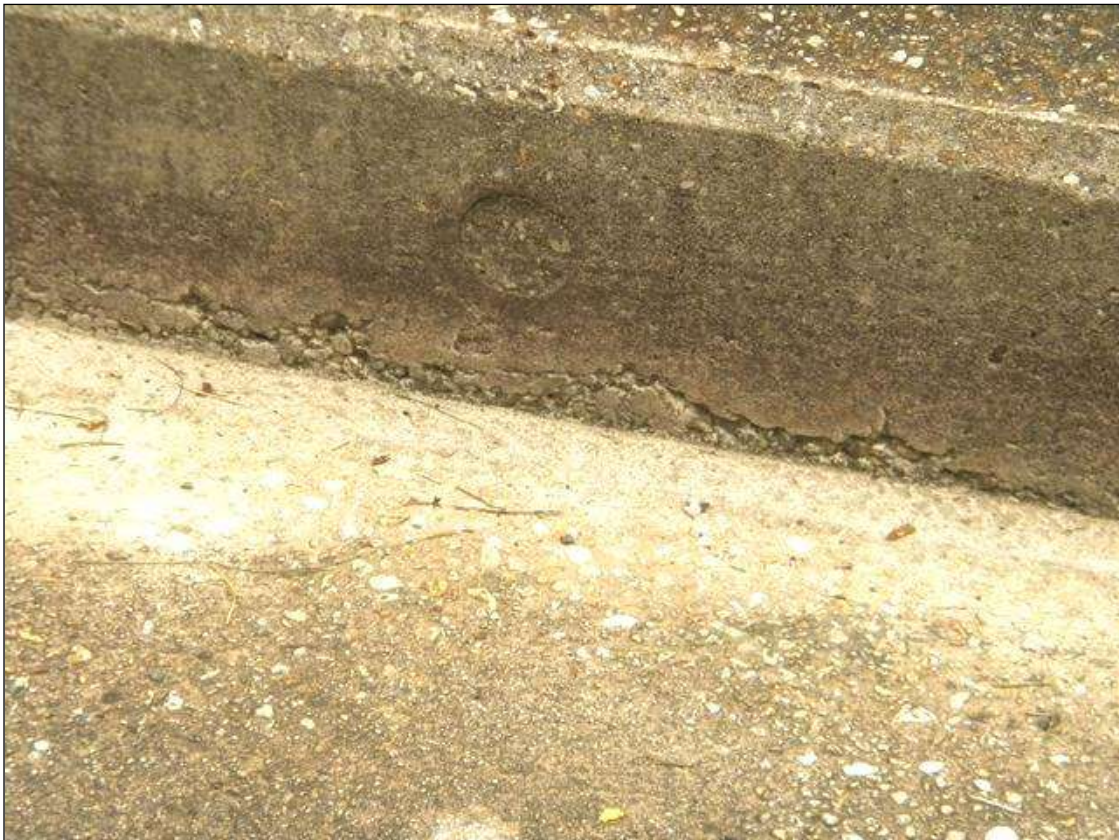
| Bridge I&A Form 1(82)H<br>State of North Carolina<br>Dept. of Transportation<br>Division of Highways | | <h1 style="text-align: center;">FIELD INSPECTION REPORT</h1> <h2 style="text-align: center;"><u>Bridge Inspection &amp; Analysis</u></h2> | |
|---|---|---|--|
| 4 | G | THERE IS A RAIL CHIP IN THE RIGHT RAIL BETWEEN POSTS 1 AND 2 IN SPAN 2.<br>( CONC CURBS ) THE RIGHT ( EAST ) CURB HAS A SHALLOW HONEYCOMB IN SPAN 3. (PHOTO) | |

RIGHT ( EAST ) CURB WITH SHALLOW HONEYCOMB IN SPAN 3

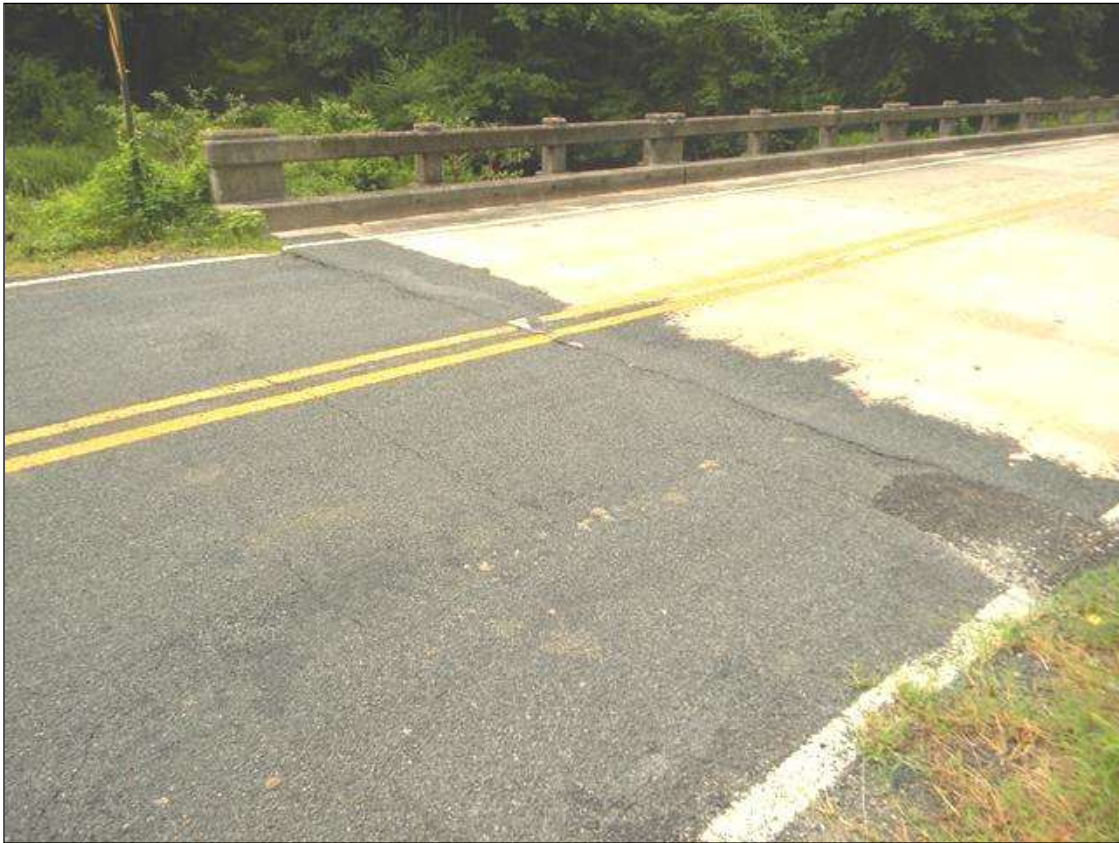
NORTH APPROACH ASPHALT WEARING SURFACE CRACKED AND SETTLED UP TO 1 1/4"

| MMS Code | Description of Function | Unit | Quantity | Remarks | Est. Cost |
|---|---|---|---|---|---|
| 2816 | Asphalt Surface Repair or Replacement | SY | 4 | NORTH APPROACH ASPHALT WEARING SURFACE CRACKED AND SETTLED UP TO 1 1/4" | |

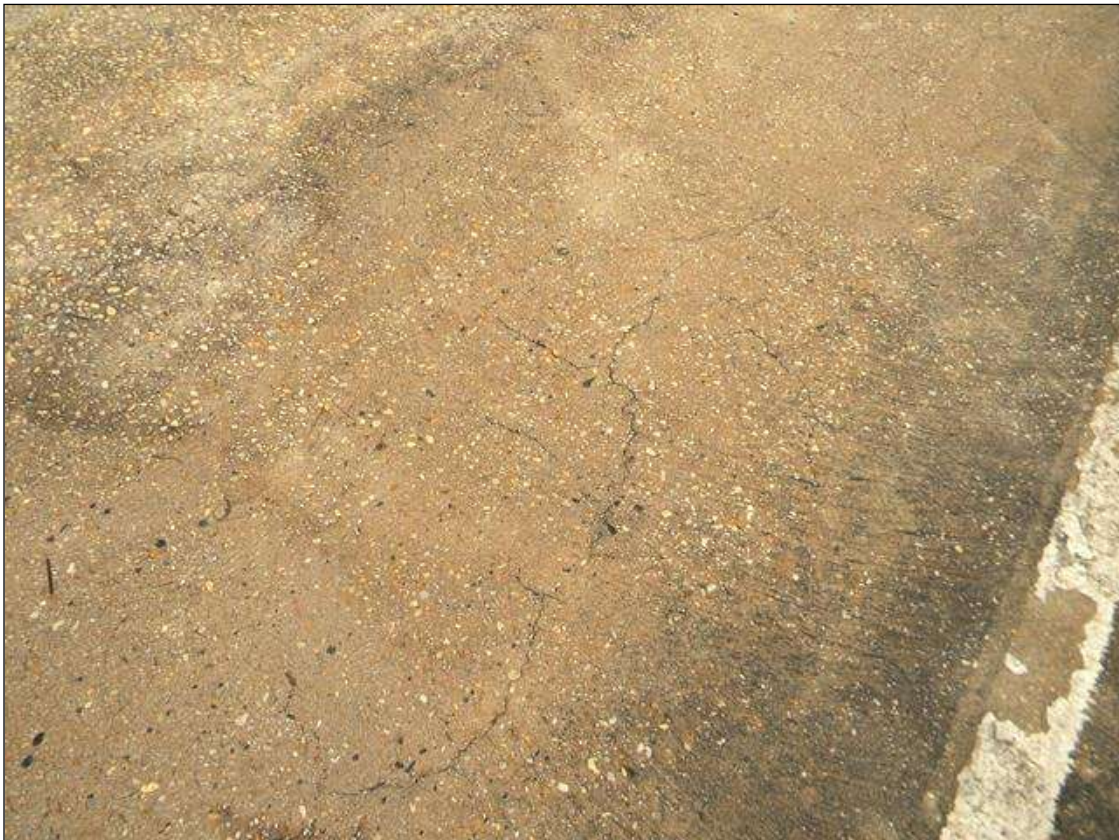
1/16" MAP CRACKING IN SPAN 3 NORTH BOUND LANE

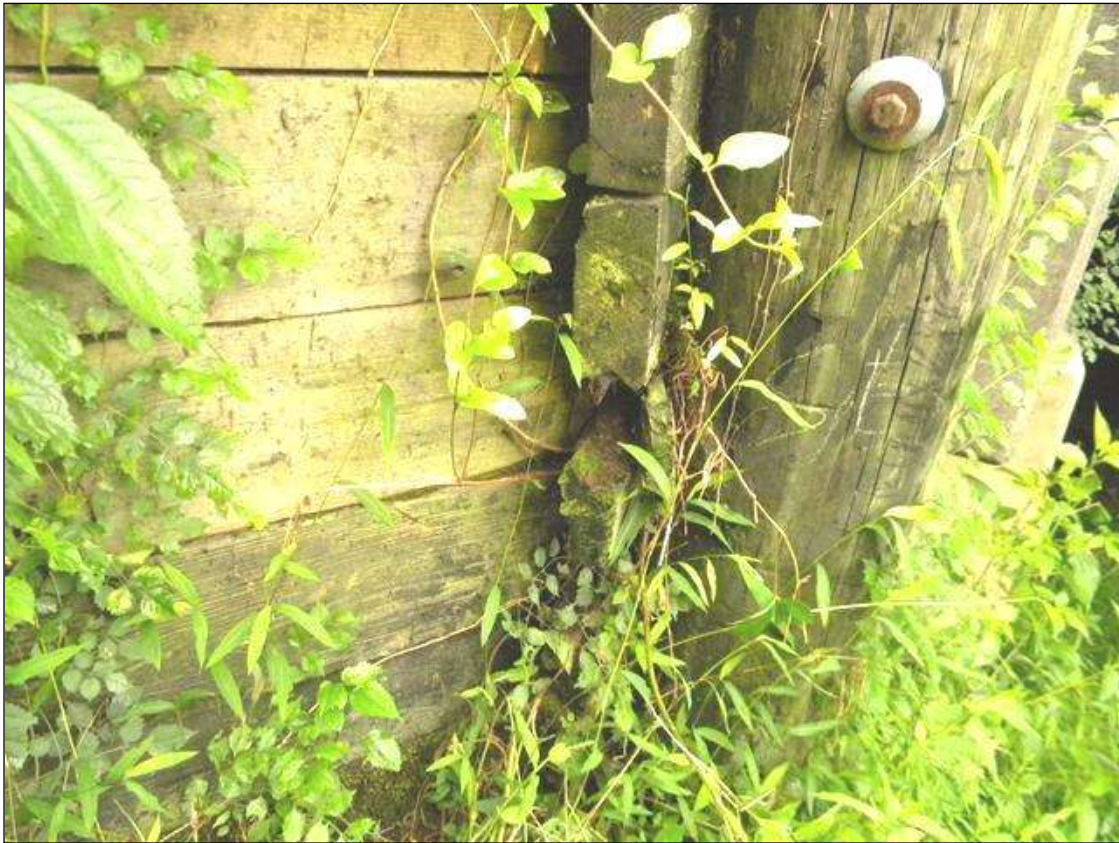
| <b>35c</b> | <b>F</b> | THERE ARE NO CROSSBRACING AT THE INTERIOR BENTS.<br>( TIMBER BULKHEADS AND WINGWALLS )        THERE IS FILL LEAKAGE ADJACENT TO PILE 2 AT END BENT 1. (PHOTO)<br><br>THE END BENT 2 BULKHEAD AT PILES 3 AND 4 HAS LEAKAGE OF FILL AND BOARDS ARE SOFT.<br><br>THE END BENT 2 BULKHEAD BETWEEN PILES 1 AND 2 HAVE AREAS THAT ARE SOFT AND DECAYED.<br><br>THERE IS A DECAYED EXTERIOR BULKHEAD BOARD AT THE SOUTHEAST CORNER. (PHOTO)<br><br>THERE IS A NEW TURNPILE AT SOUTHEAST CORNER. | |

END DECAYED EXTERIOR BULKHEAD BOARDS AT SOUTHEAST CORNER

| MMS Code | Description of Function | Unit | Quantity | Remarks | Est. Cost |
|---|---|---|---|---|---|
| 3346 | Repair / Maintain Timber Wings & Blkhds | SF | 4 | END DECAYED EXTERIOR BULKHEAD BOARDS AT SOUTHEAST CORNER | |

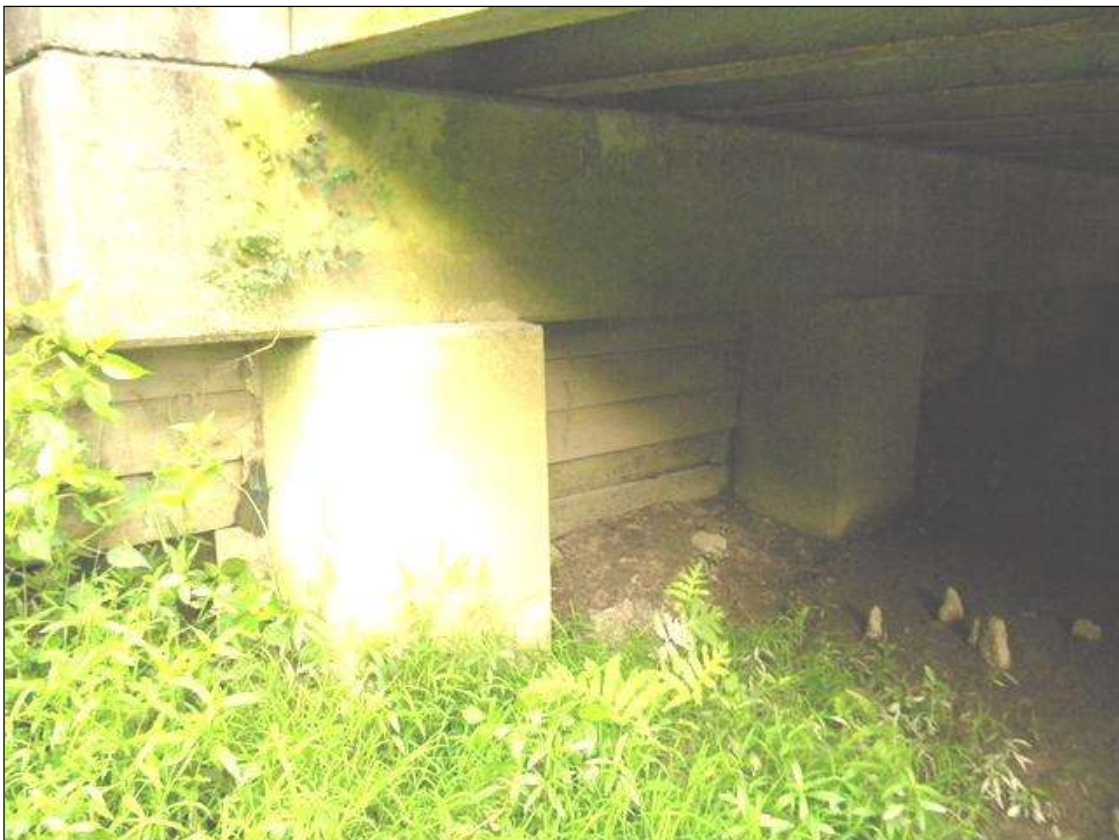
| <b>35b</b> | <b>F</b> | ( TIMBER PILES )    SOFT AND SATURATED AT THE LOWER PORTION.<br><br>THERE ARE A FEW PILES THAT HAVE SHALLOW DELAMINATION.<br><br>THERE ARE SEVERAL PILES ENCASED IN CONCRETE. (PHOTOS)<br><br>THEY ARE NOTED AT:<br><br>PILES 3, AND 4 AT END BENT 1;<br><br>PILE 2 AND 4 AT BENT 1;<br><br>PILE 4 AT BENT 2;<br><br>PILES 3, AND 4 AT BENT 3;<br><br>PILE 4 AT END BENT 2; | |

PILES 2 AND 4 ENCASED AT END BENT 1

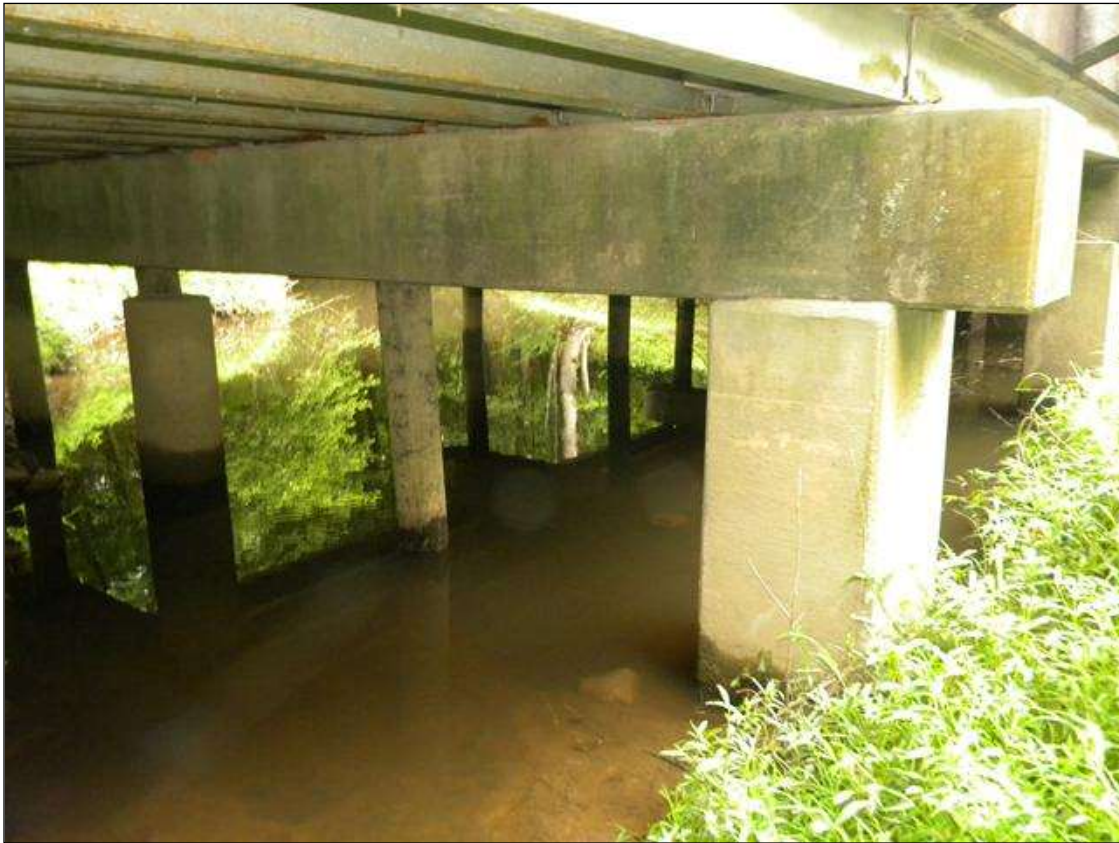
PILES 2 AND 4 ENCASED AT BENT 1

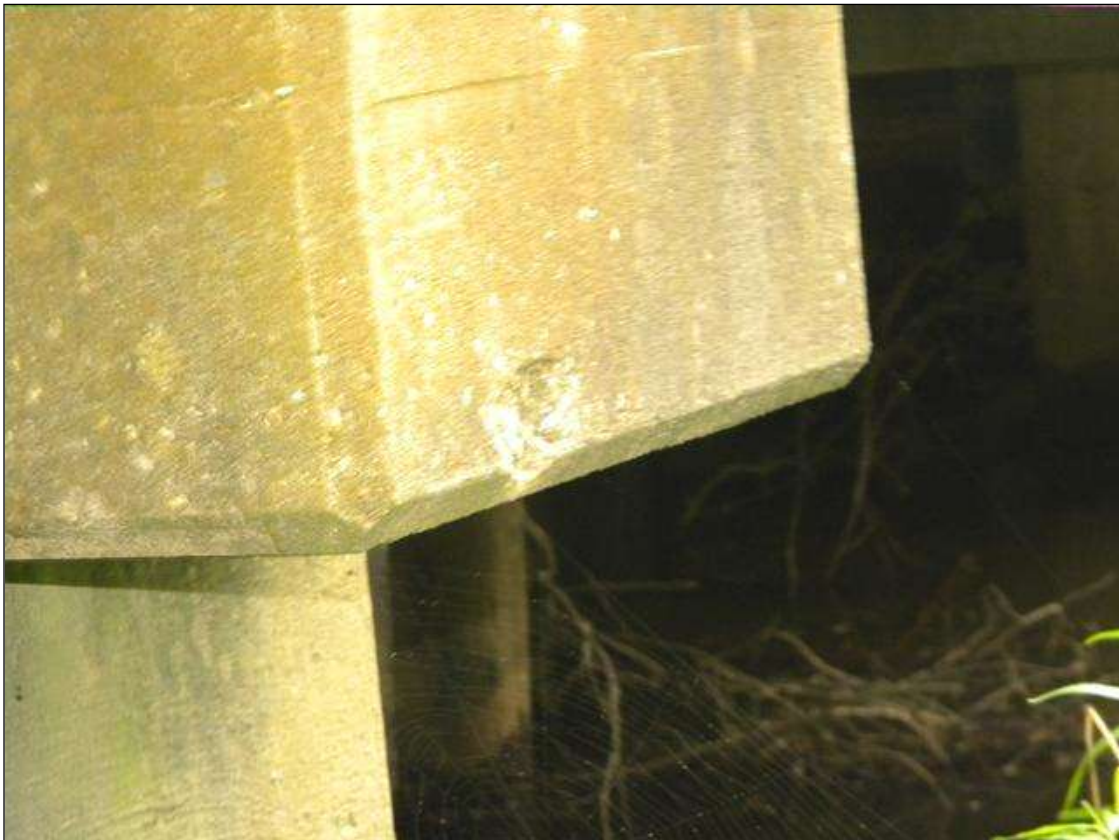
| <b>39</b> | <b>F</b> | THERE IS A SURFACE SPALL ON EAST END OF BENT 1 CAP. (PHOTO)<br>( SLOPE PROTECTION )    RIP RAP PLACED AT END BENT 2. | |

SURFACE SPALL ON EAST END OF BENT 1 CAP

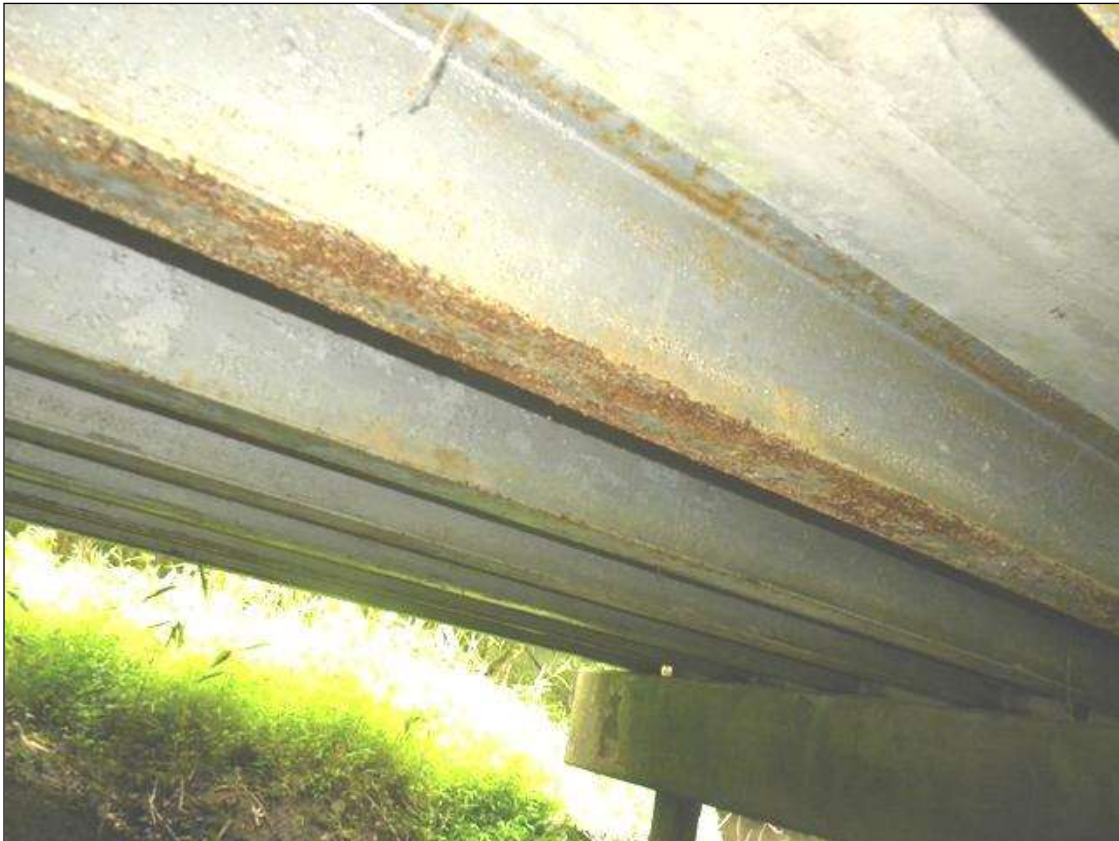
| Bridge I&A Form 1(82)H<br>State of North Carolina<br>Dept. of Transportation<br>Division of Highways | | <h1 style="text-align: center;">FIELD INSPECTION REPORT</h1> <h2 style="text-align: center;"><u>Bridge Inspection &amp; Analysis</u></h2> | |
|---|---|---|--|
| 52 | F | ( PAINT SYSTEM ) MOST BEAMS HAVE AREAS OF PEELING, SURFACE RUST AND SHALLOW PITTING AT THE BEARING AREAS. (PHOTOS) | |

SPAN 1 UNDERSIDE WITH PAINT PEELING AND SURFACE RUST, SIMILAR IN ALL SPANS

| MMS Code | Description of Function | Unit | Quantity | Remarks | Est. Cost |
|---|---|---|---|---|---|
| 3342 | Clean and Paint Structural Steel | SF | 1000 | SPAN 1 UNDERSIDE WITH PAINT PEELING AND SURFACE RUST, SIMILAR IN ALL SPANS | |

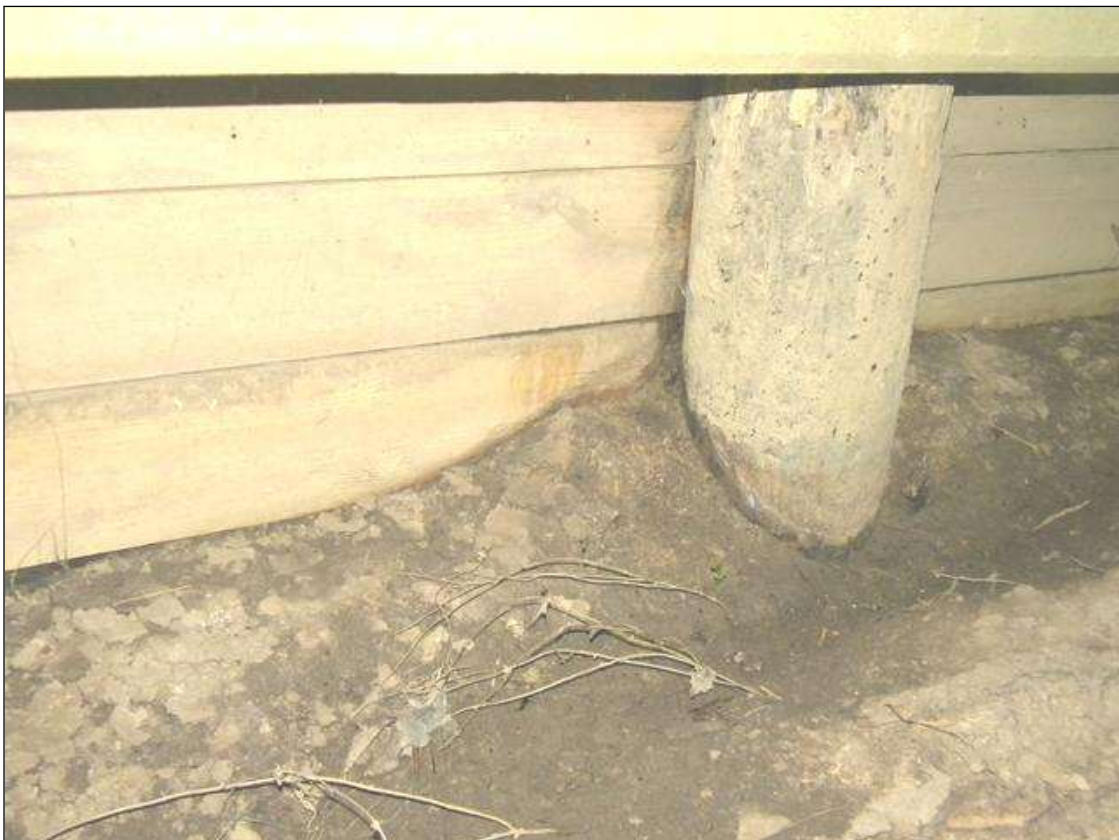
FILL LEAKAGE AT END BENT 1 BULKHEAD ALONG PILE 2

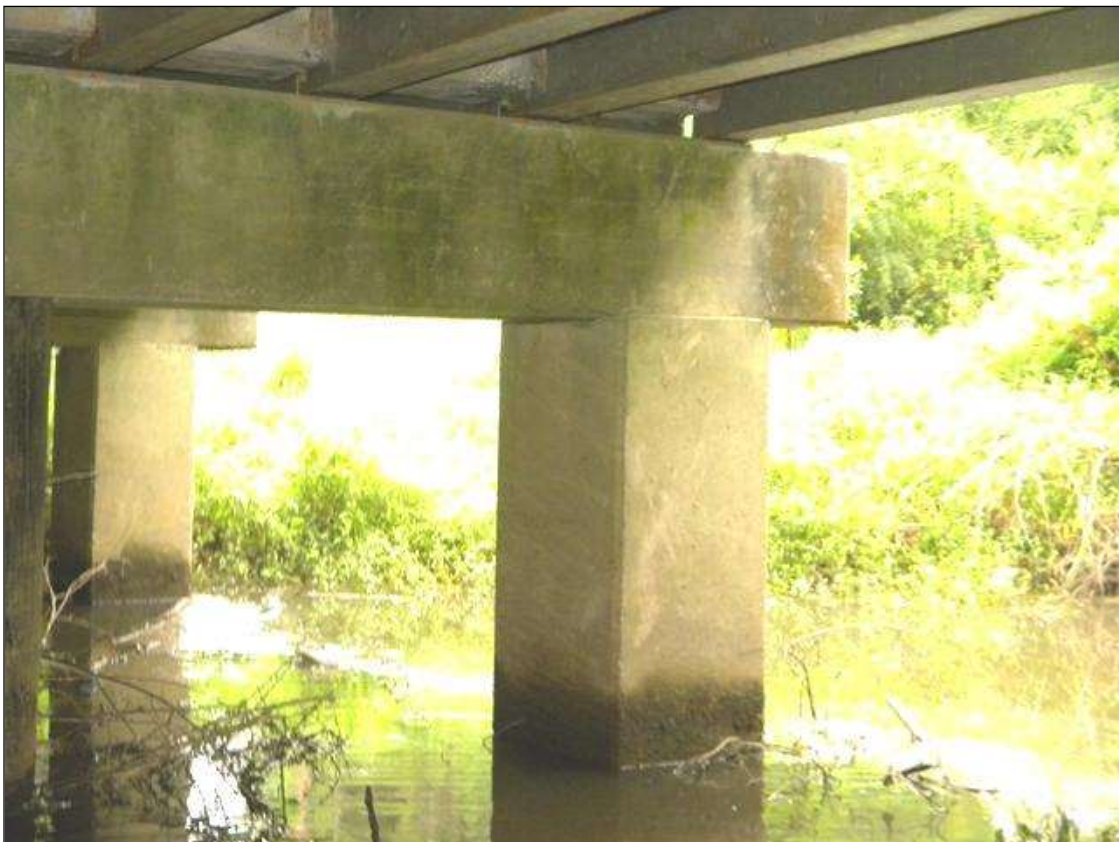
PILE 4 ENCASED AT BENT 2

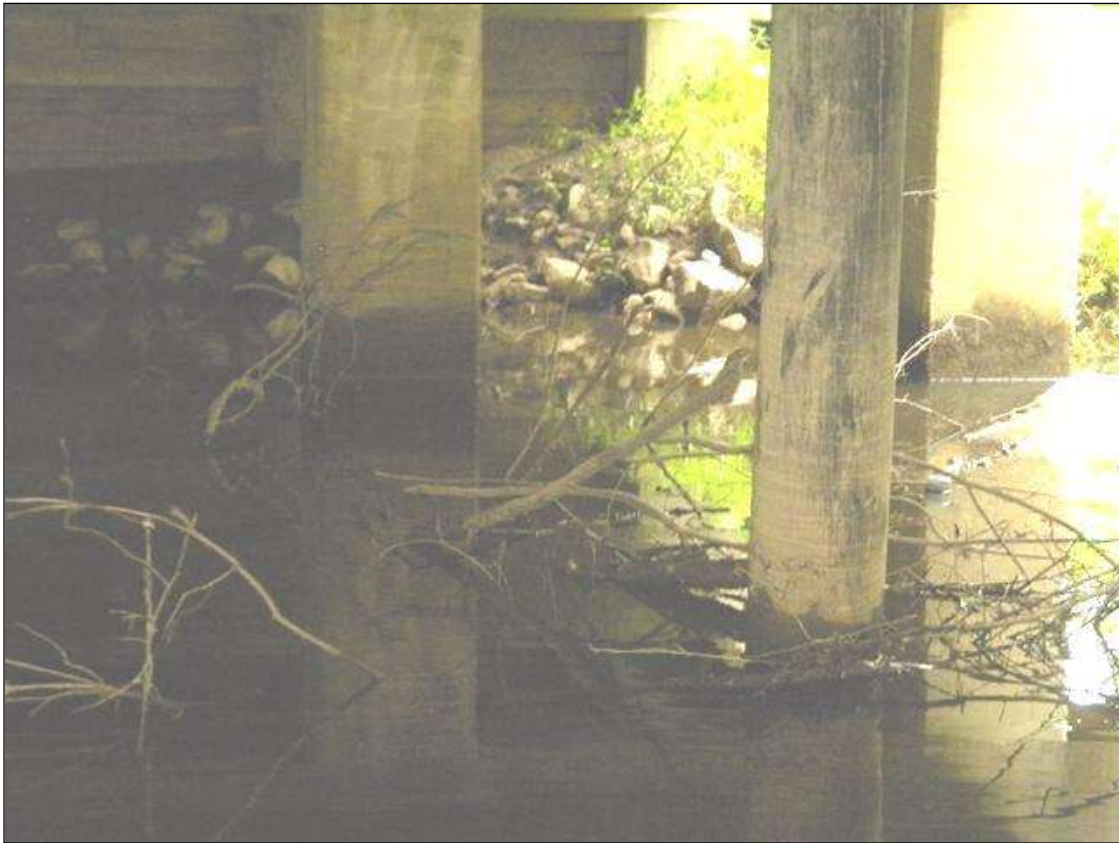
| <b>41</b> | <b>G</b> | ( DRIFT )    THERE IS DRIFT IN SPAN 3 AT BENT 2 PILE 3. (PHOTO) | |

DRIFT IN SPAN 3 AT BENT 2 PILE 3
