NC DEPARTMENT OF TRANSPORTATION  
DIVISION OF HIGHWAYS  
BRIDGE MANAGEMENT UNIT

# BRIDGE INSPECTION REPORT

INSPECTION TYPE: Routine Inspection

COUNTY COLUMBUS BRIDGE NUMBER 230171 INSPECTION CYCLE 2 YRS  
ROUTE SR1414 ACROSS DUNN SWAMP M.P. 0

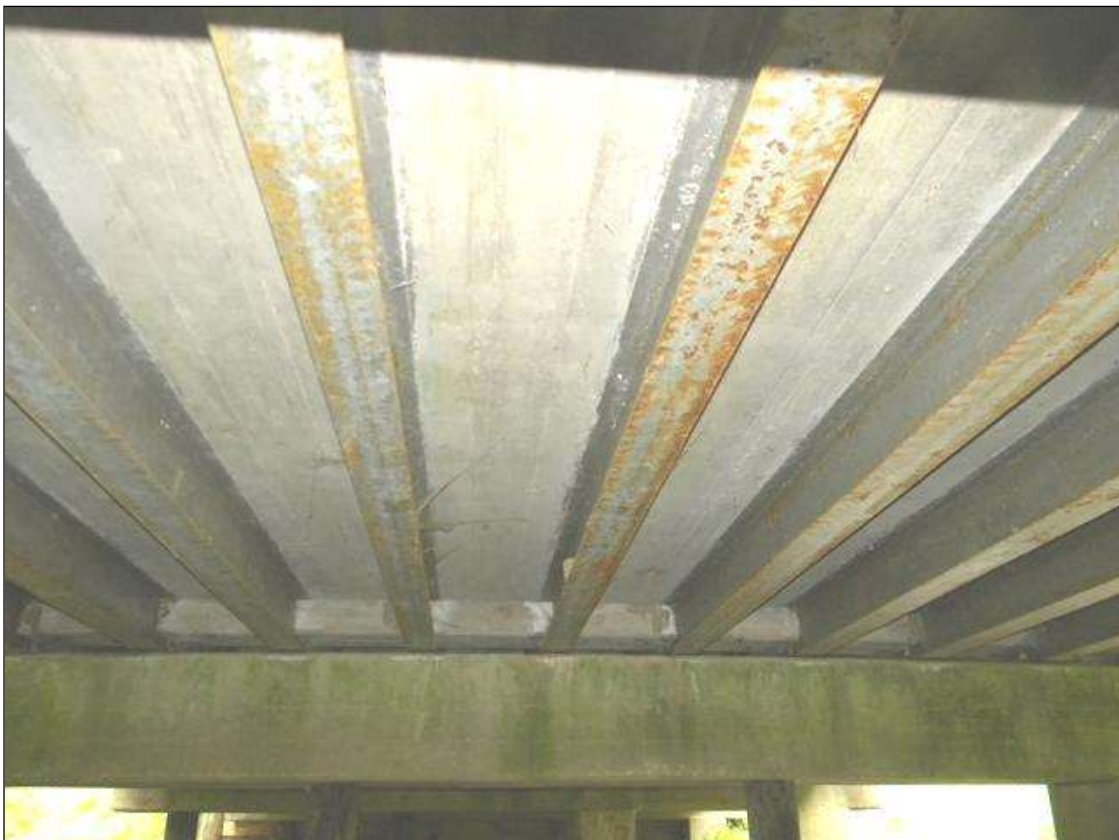
SPAN 2 UNDERSIDE WITH PAINT PEELING AND SURFACE RUST

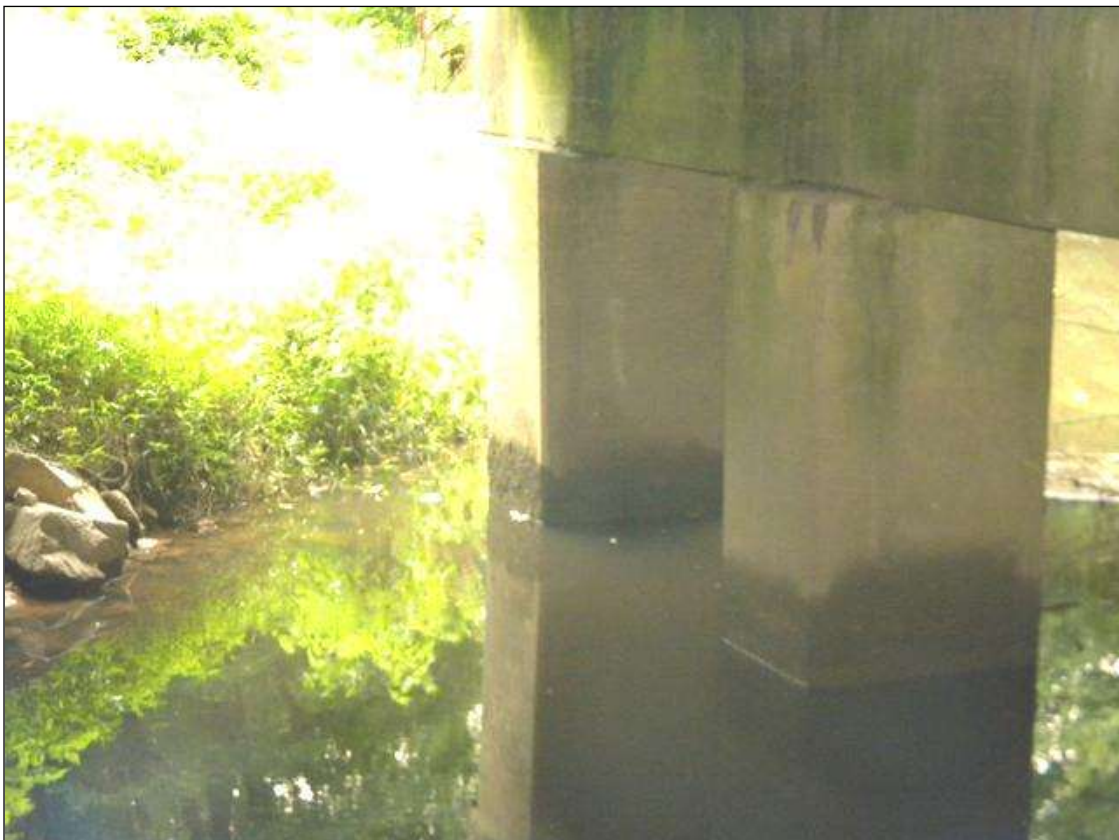
| <b>35b</b> | <b>F</b> | ( TIMBER PILES )    SOFT AND SATURATED AT THE LOWER PORTION.<br><br>THERE ARE A FEW PILES THAT HAVE SHALLOW DELAMINATION.<br><br>THERE ARE SEVERAL PILES ENCASED IN CONCRETE. (PHOTOS)<br><br>THEY ARE NOTED AT:<br><br>PILES 3, AND 4 AT END BENT 1;<br><br>PILE 2 AND 4 AT BENT 1;<br><br>PILE 4 AT BENT 2;<br><br>PILES 3, AND 4 AT BENT 3;<br><br>PILE 4 AT END BENT 2; | |

PILES 3 & 4 ENCASED AT BENT 3

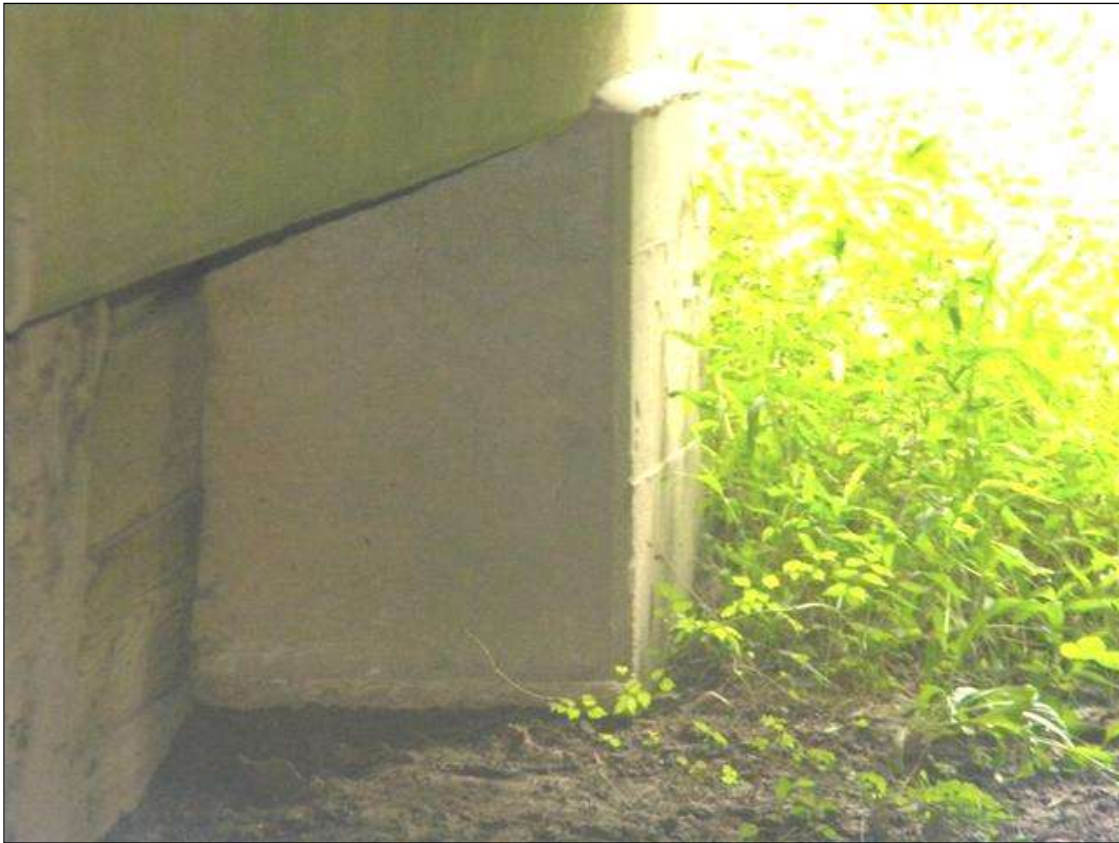
PILE 4 AT END BENT 2 ENCASED

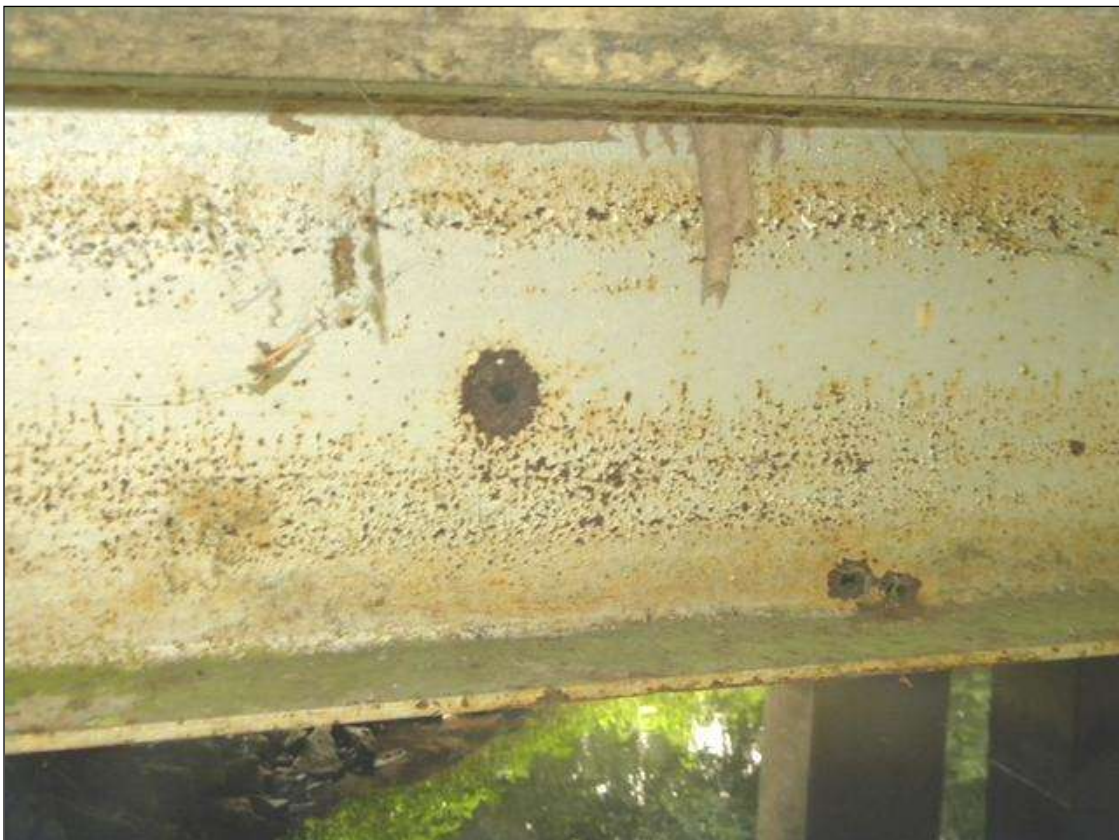
| Bridge I&A Form 1(82)H<br>State of North Carolina<br>Dept. of Transportation<br>Division of Highways | | <h1 style="text-align: center;">FIELD INSPECTION REPORT</h1> <h2 style="text-align: center;"><u>Bridge Inspection &amp; Analysis</u></h2> | |
|---|---|---|--|
| 10 | G | ( STEEL BEAMS ) THERE ARE THREE ( 3/8" DIAMETER ) BULLET HOLES IN BEAM 1 WEB AT SPAN 4. (PHOTO) SEE SKETCH. | |

BEAM 1 IN SPAN 4 HAS 3 BULLET HOLES IN WEB ( SEE SKETCH )

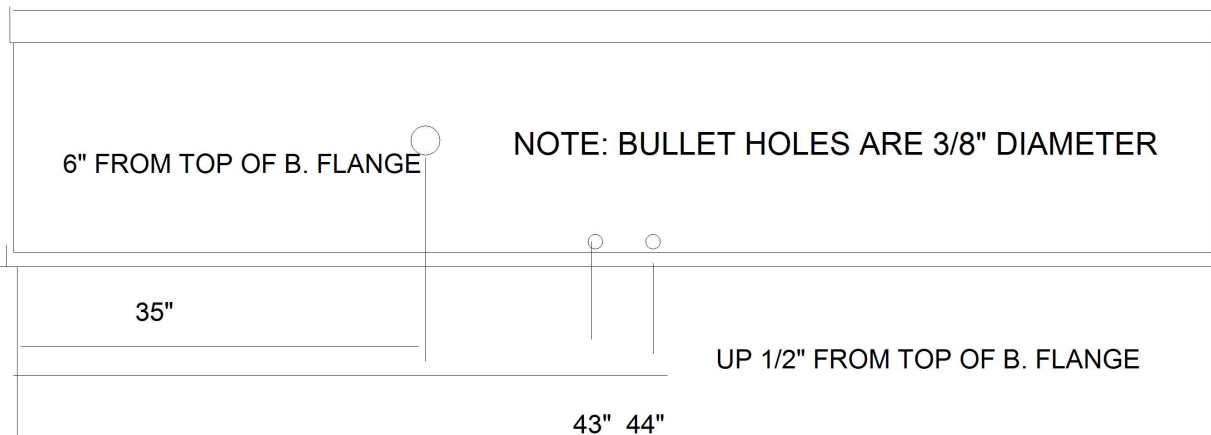
BEAM 1 IN SPAN 4

BULLET HOLES IN WEB
