NC DEPARTMENT OF TRANSPORTATION  
DIVISION OF HIGHWAYS  
BRIDGE MANAGEMENT UNIT

# BRIDGE INSPECTION REPORT

INSPECTION TYPE: Routine Inspection

COUNTY COLUMBUS BRIDGE NUMBER 230175 INSPECTION CYCLE 2 YRS  
ROUTE SR1504 ACROSS DUNN SWAMP M.P. 0

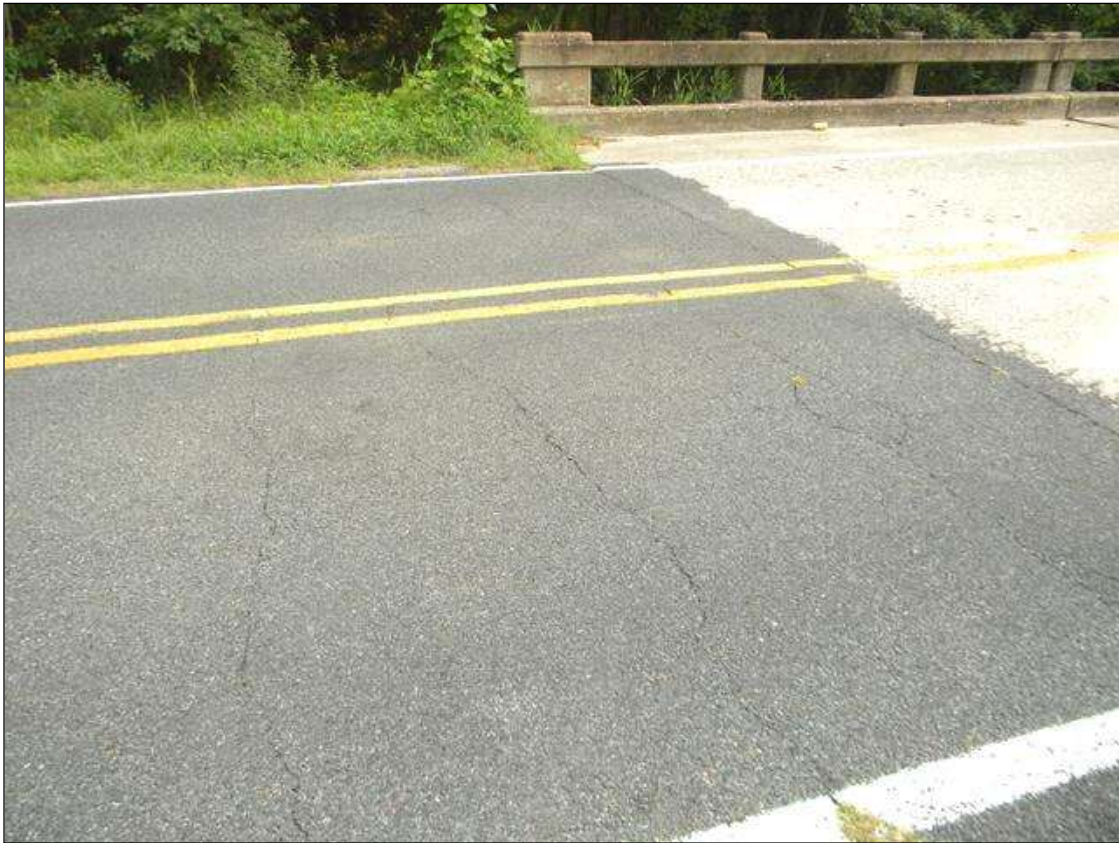
1/8" TRANSVERSE CRACKS IN WEST APPROACH ASPHALT WEARING SURFACE

| MMS Code | Description of Function | Unit | Quantity | Remarks | Est. Cost |
|---|---|---|---|---|---|
| 2816 | Asphalt Surface Repair or Replacement | SY | 2 | 1/8" TRANSVERSE CRACKS IN WEST APPROACH ASPHALT WEARING SURFACE | |

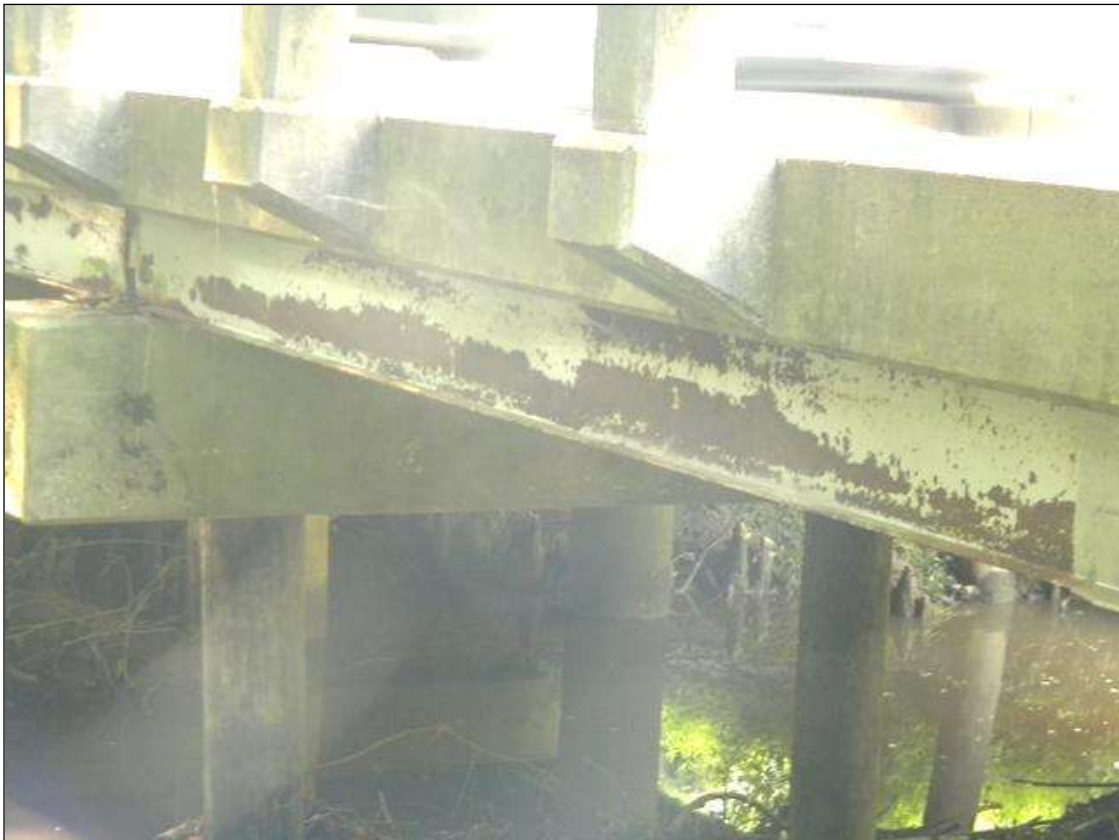
BEAM 1 EXTERIOR AT SPAN 2 WITH PAINT PEELING AND RUST, MANY OTHER BEAMS ARE SIMILAR

| MMS Code | Description of Function | Unit | Quantity | Remarks | Est. Cost |
|---|---|---|---|---|---|
| 3342 | Clean and Paint Structural Steel | SF | 1750 | BEAM 1 EXTERIOR AT SPAN 2 WITH PAINT PEELING AND RUST, MANY OTHER BEAMS SIMILAR | |

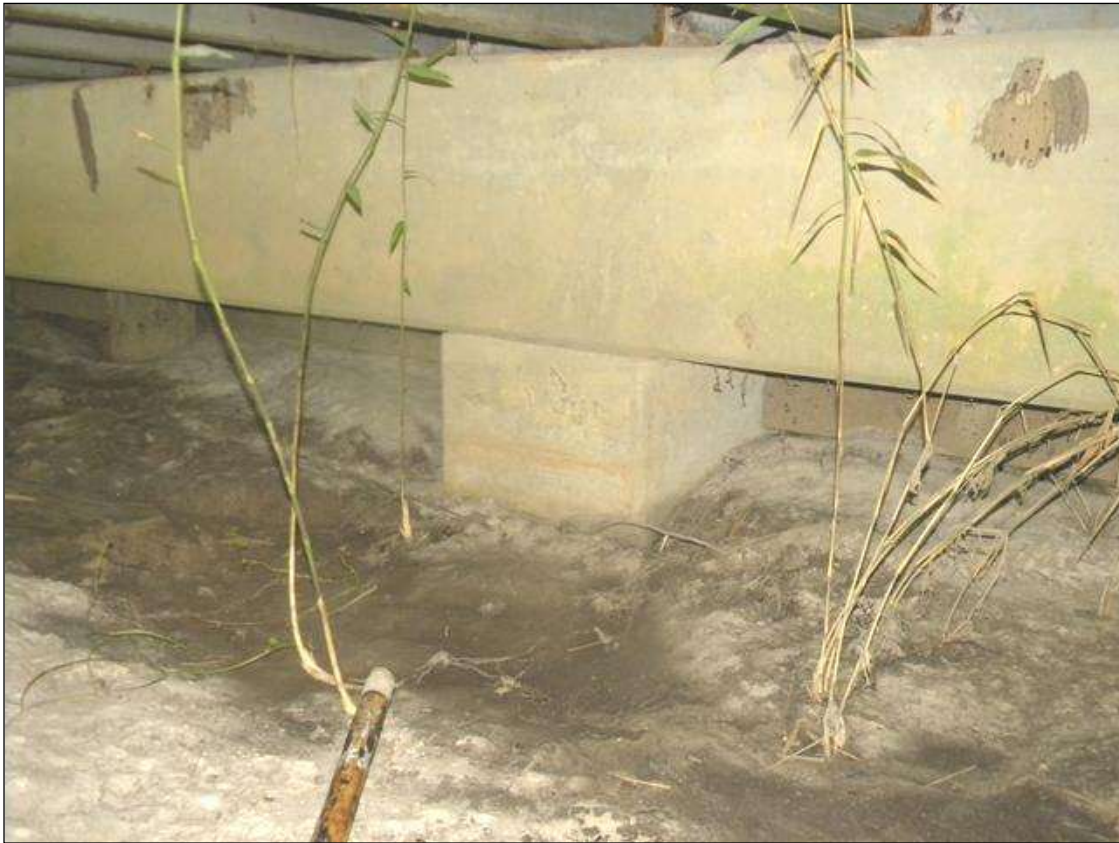
PILE 2 AT END BENT 1 ENCASED

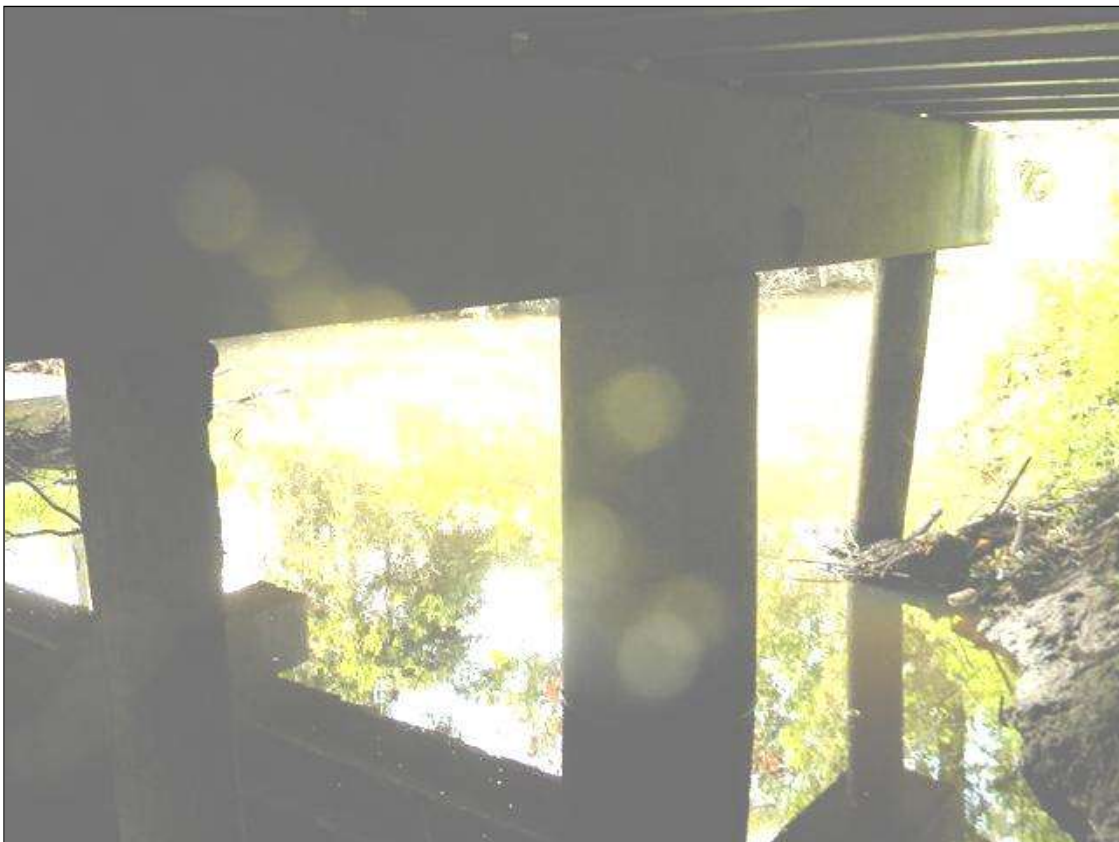
PILE 3 AT BENT 1 ENCASED

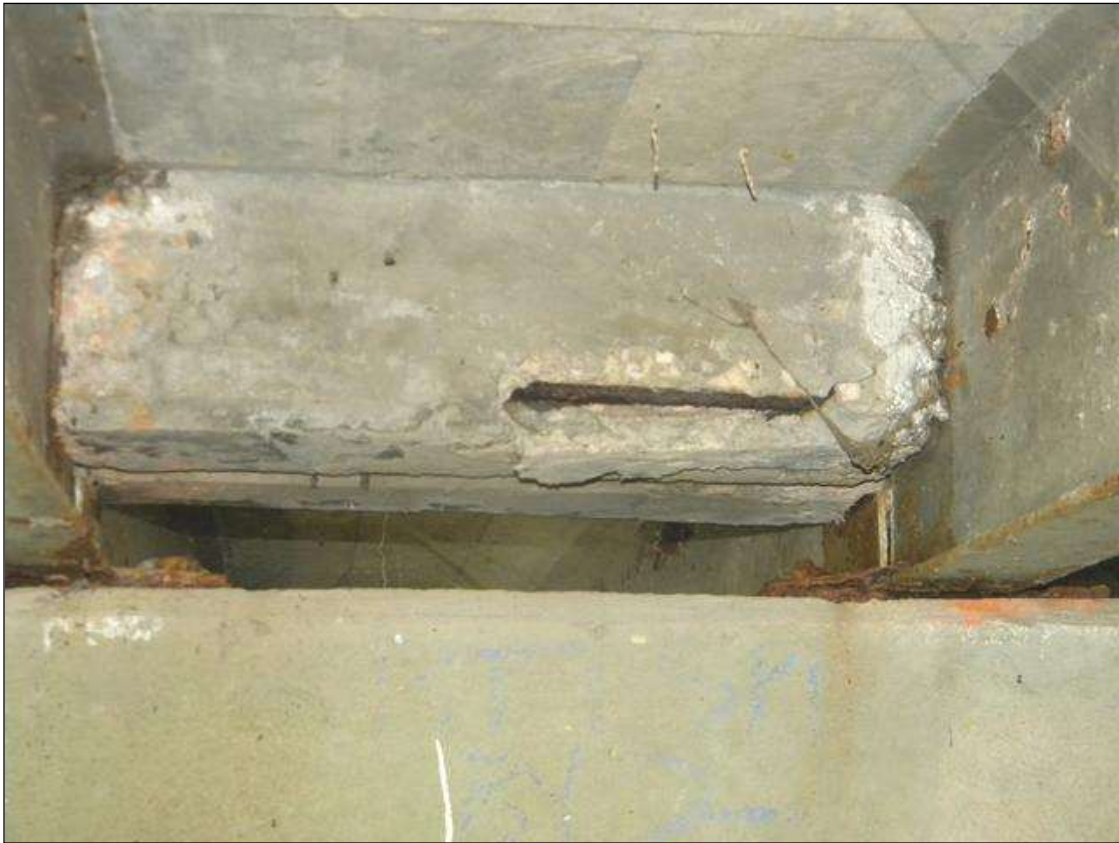
END DIAPHRAGM SPALLED WITH EXPOSED STEEL AT BENT 1, SPAN 1 AT BAY 2

| MMS Code | Description of Function | Unit | Quantity | Remarks | Est. Cost |
|---|---|---|---|---|---|
| 3306 | Maintain Concrete Superstructure Components | SF | 2 | END DIAPHRAGM SPALLED WITH EXPOSED STEEL AT BENT 1, SPAN 1 AT BAY 2 | |

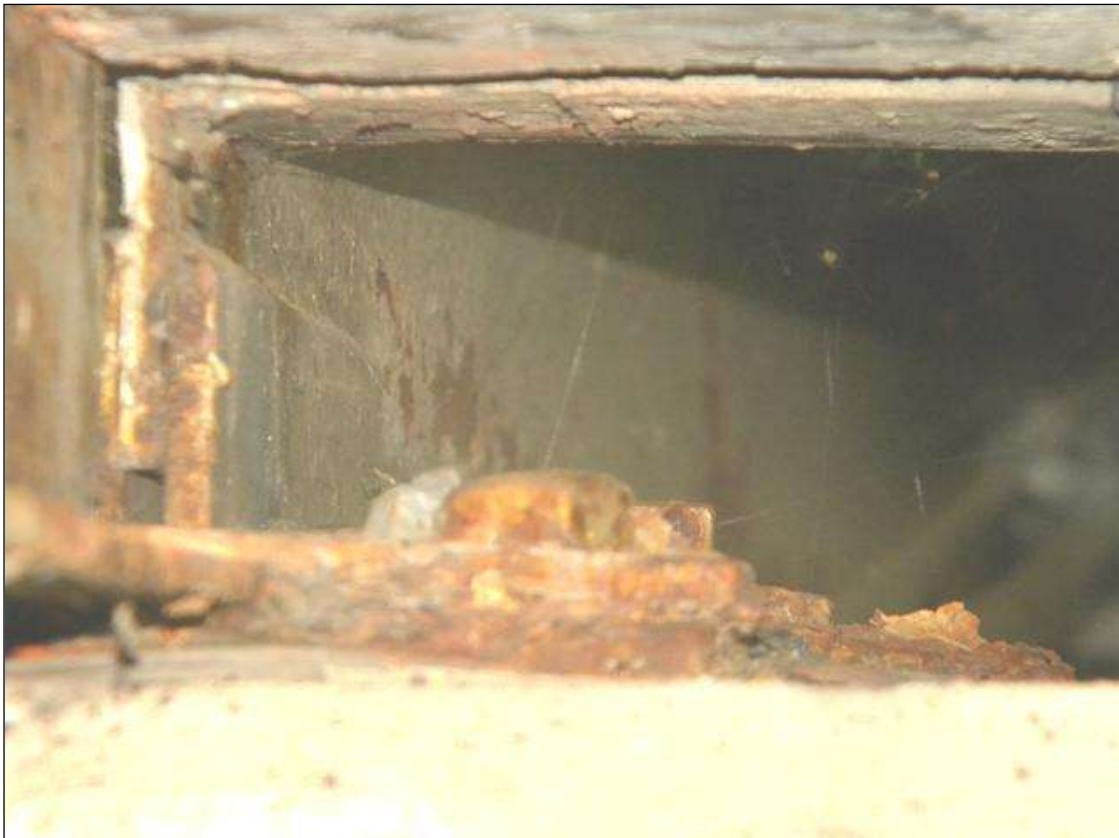
| 15 | F | ( BEARING ASSEMBLIES ) THE INTERIOR BENT BEARINGS HAVE RUST AND CORROSION.<br><br>BEAM 2 BEARING AT BENT 1, IN BAY 2 RUST AND SCALING. (PHOTO) ALL INTERIOR BEARINGS ARE SIMILAR. | |

BEAM 2 BEARING AT BENT 1, IN BAY 2 RUST AND SCALING, ALL INTERIOR BEARINGS ARE SIMILAR

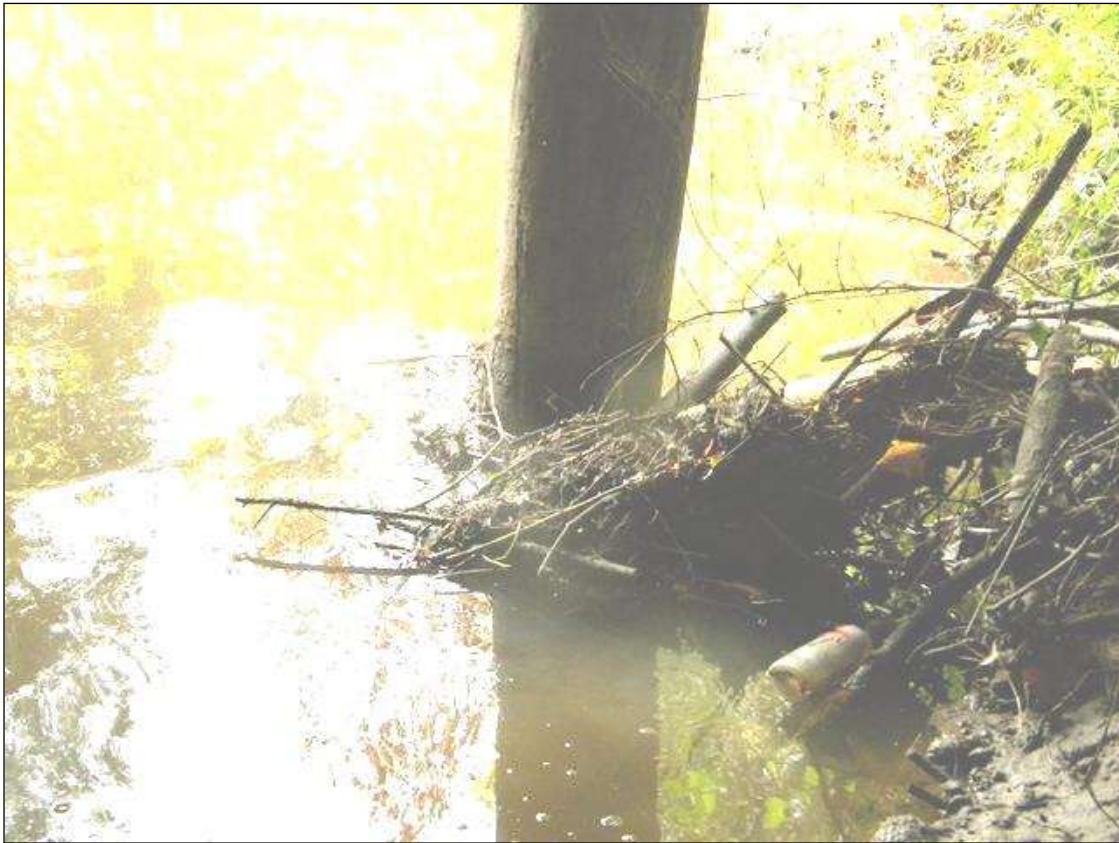
DRIFT AT PILE 4 OF BENT 1

| MMS Code | Description of Function | Unit | Quantity | Remarks | Est. Cost |
|---|---|---|---|---|---|
| 3366 | Drift and Debris Removal | HR | 1 | DRIFT AT PILE 4 OF BENT 1 | |

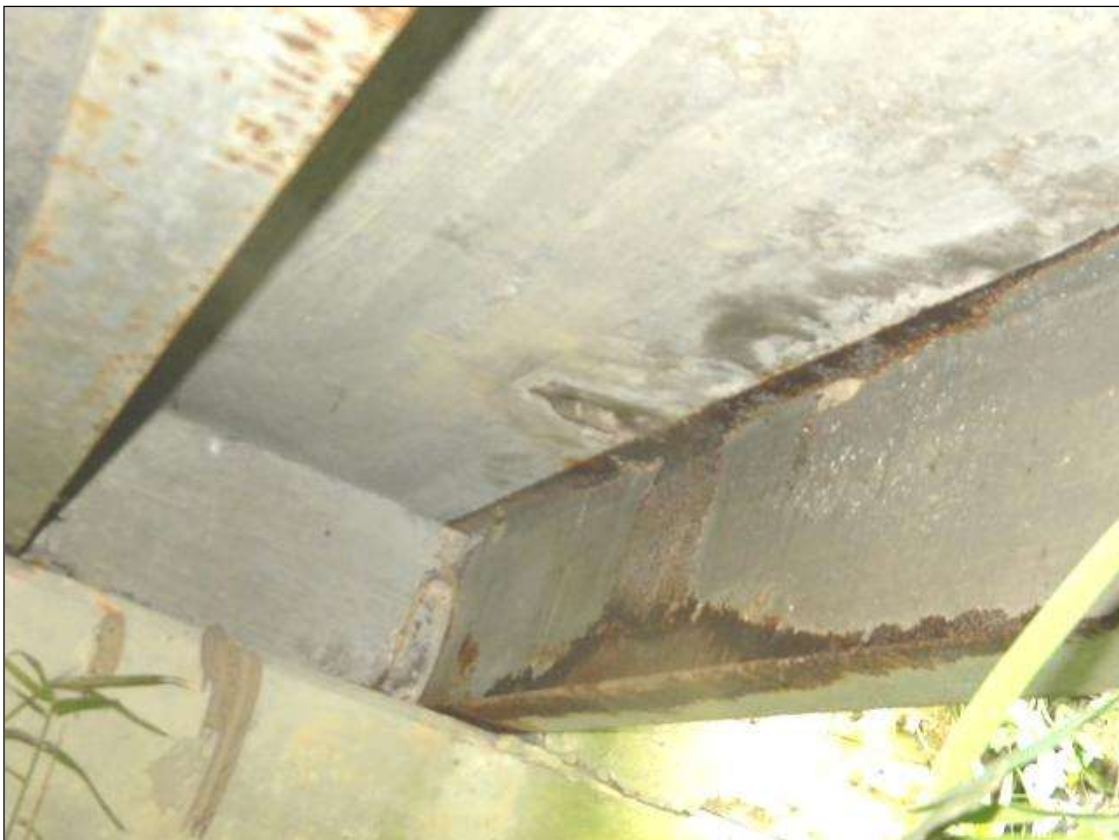
MISSING DRAIN DOWNSPOUT AT SPAN 1, BAY 1 AT END BENT 1

| MMS Code | Description of Function | Unit | Quantity | Remarks | Est. Cost |
|---|---|---|---|---|---|
| 3332 | Maint Drainage System - Bridge | LF | 1 | MISSING DRAIN DOWNSPOUT AT SPAN 1, BAY 1 AT END BENT 1 | |

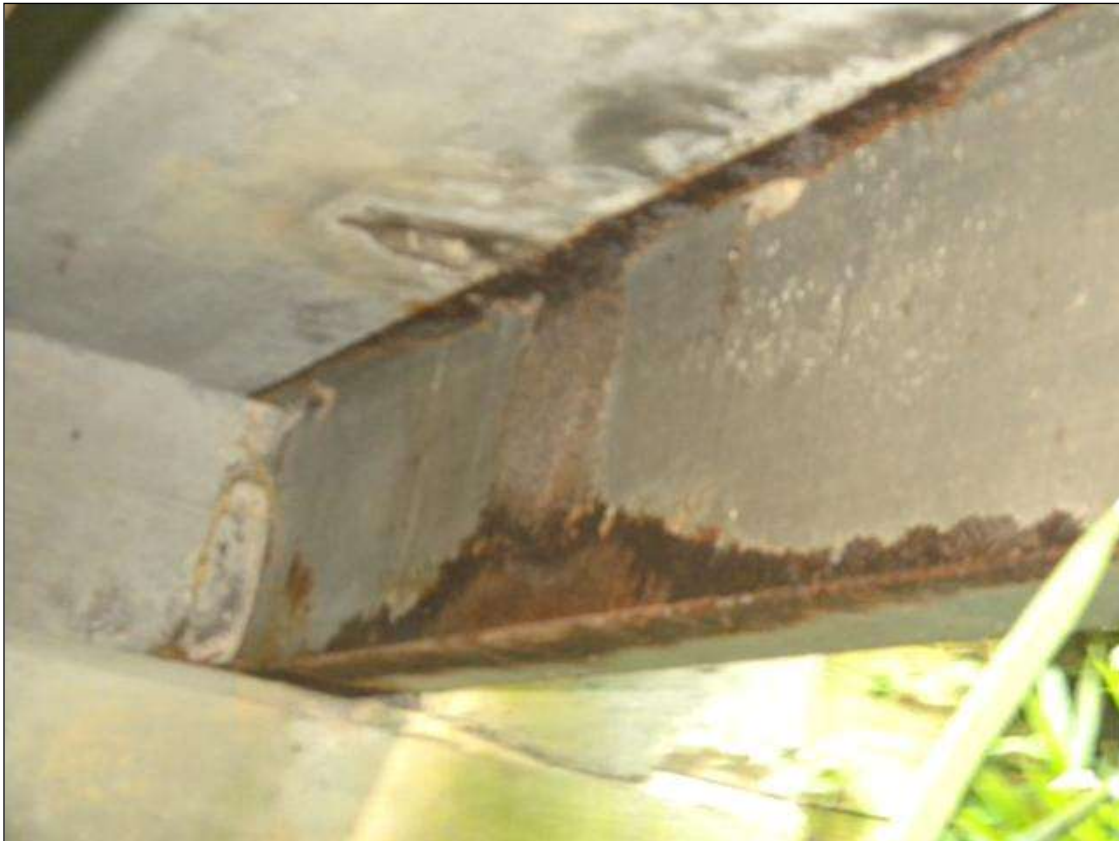
BEAM 1 IN SPAN 1 BAY 1 AT END BENT 1 PAINT PEELING AND RUST AT MISSING DOWNSPOUT

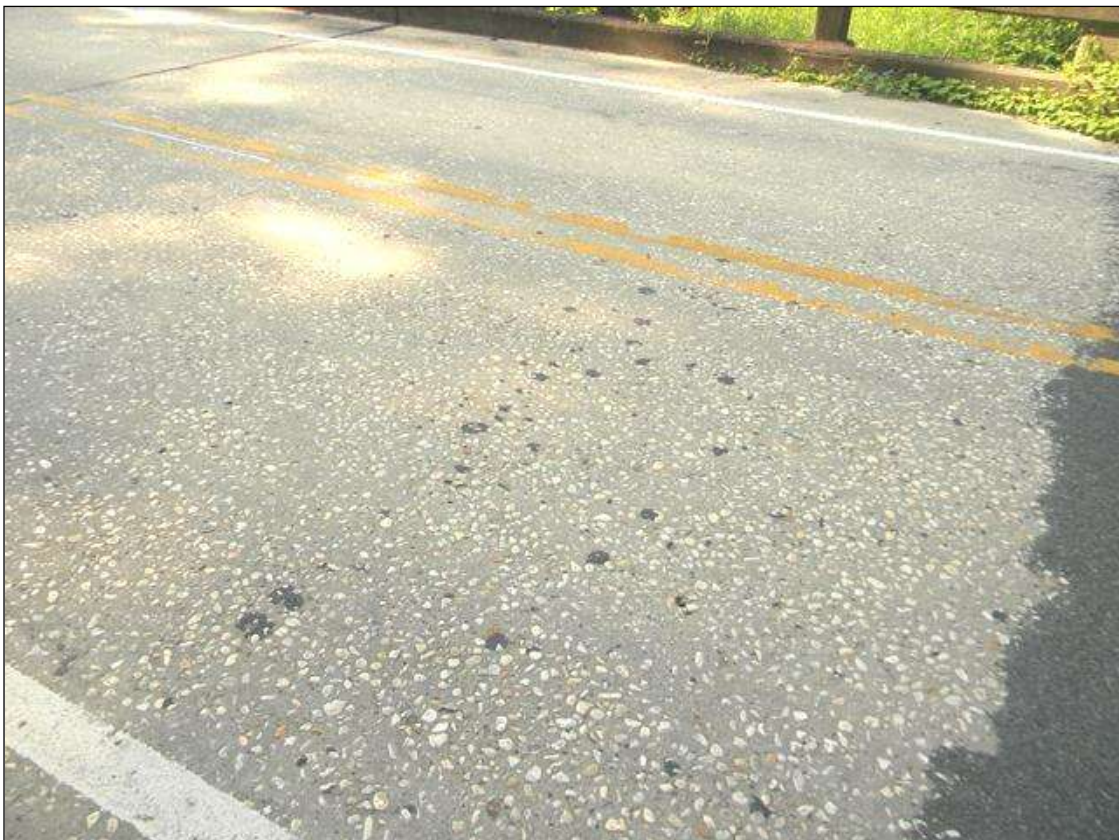
SPAN 1 DECK SCALING, ALL SPANS ARE SIMILAR

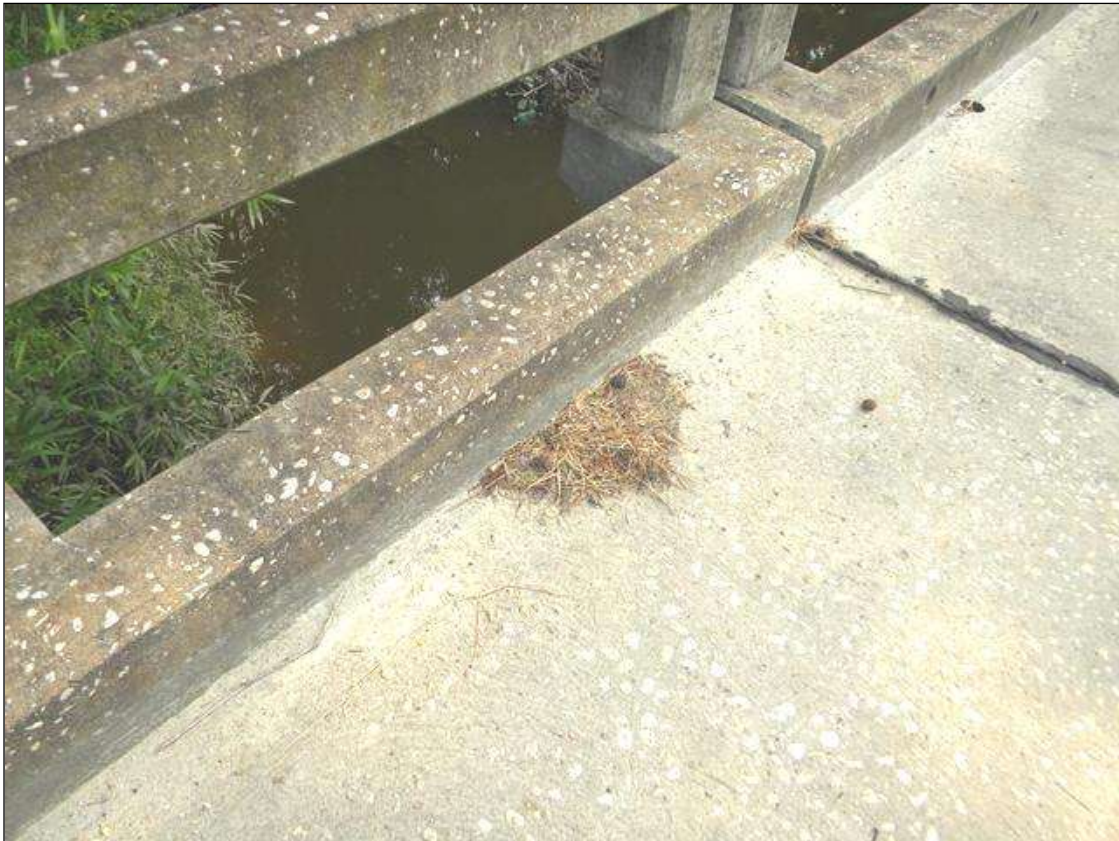
BLOCKED DECK DRAIN AT SPAN 1 ALONG LEFT CURB

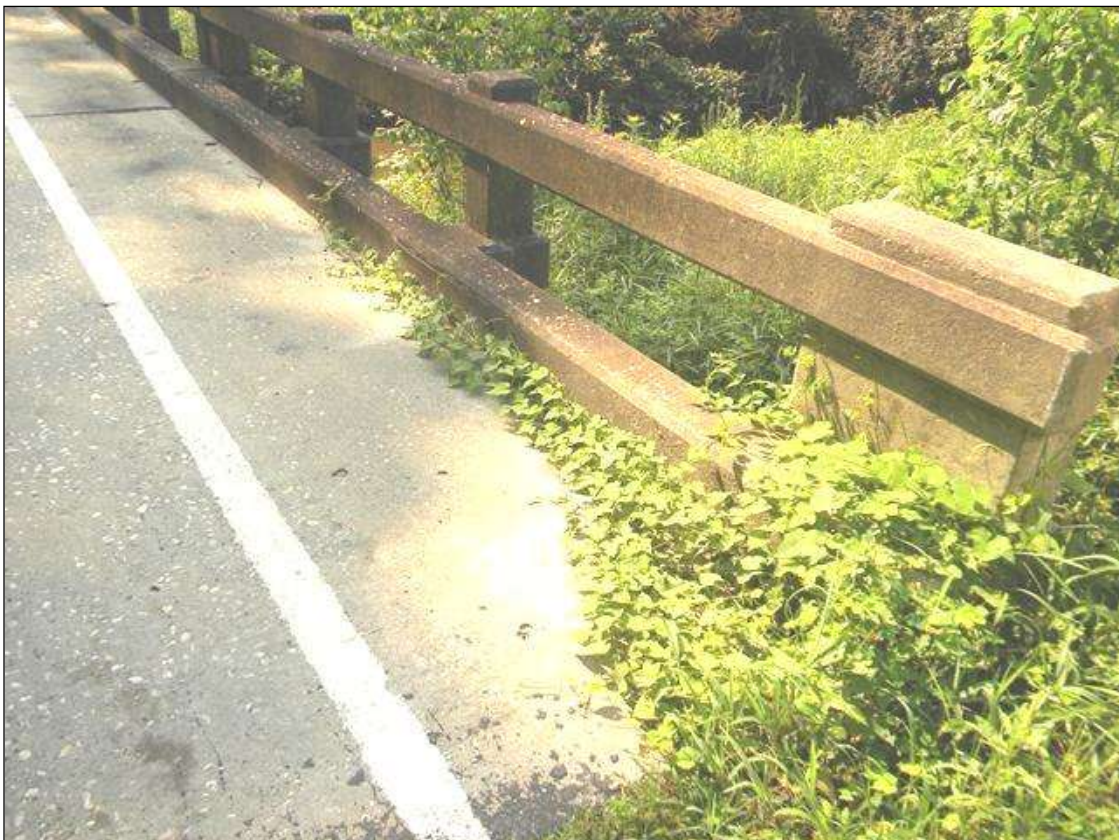
| <b>7</b> | <b>G</b> | ( DECK DEBRIS ) THERE IS VEGETATION ALONG RIGHT CURB IN SPAN 1. (PHOTO) | |

VEGETATION ALONG RIGHT CURB IN SPAN 1

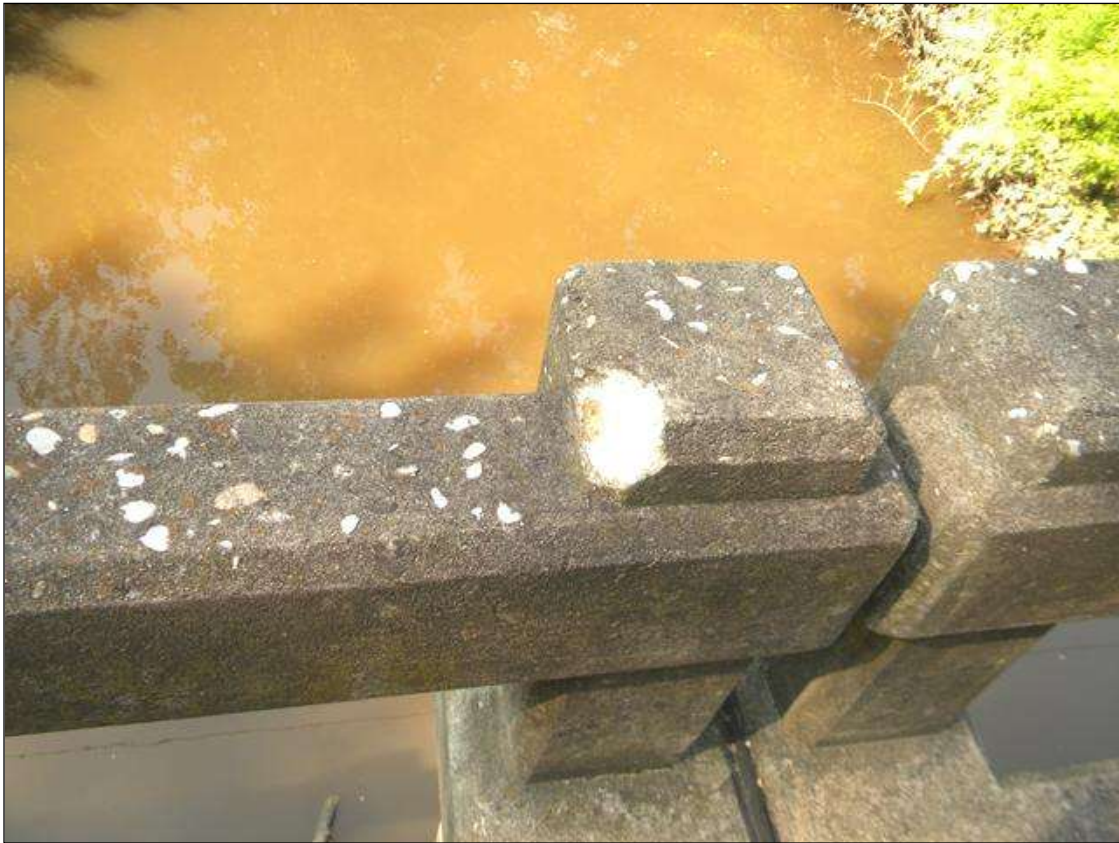
| <b>3a</b> | <b>G</b> | ( RC RAILING ) THE RIGHT RAIL POST 1 IS CHIPPED AT TOP IN SPAN 3 AT BENT 2. (PHOTO) | |

RIGHT RAIL POST 1 IS CHIPPED AT TOP IN SPAN 3 AT BENT 2

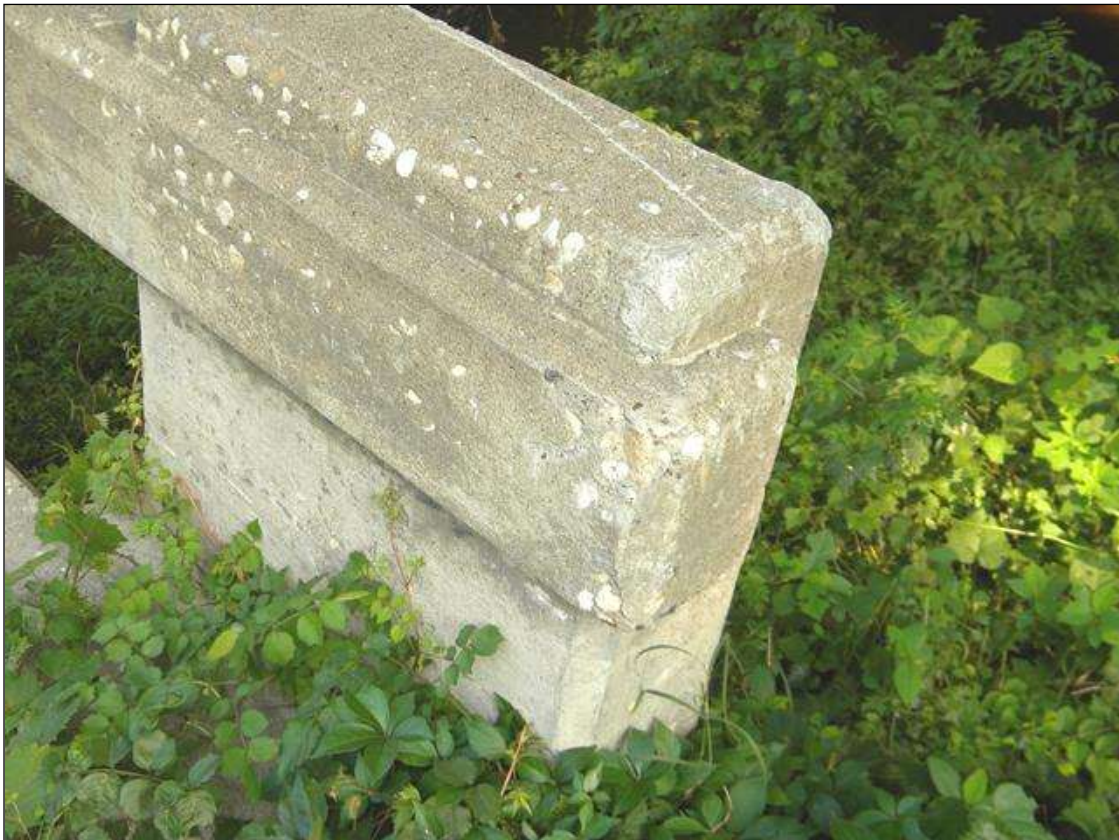
SURFACE SPALL IN RAIL END POST AT NORTHEAST CORNER

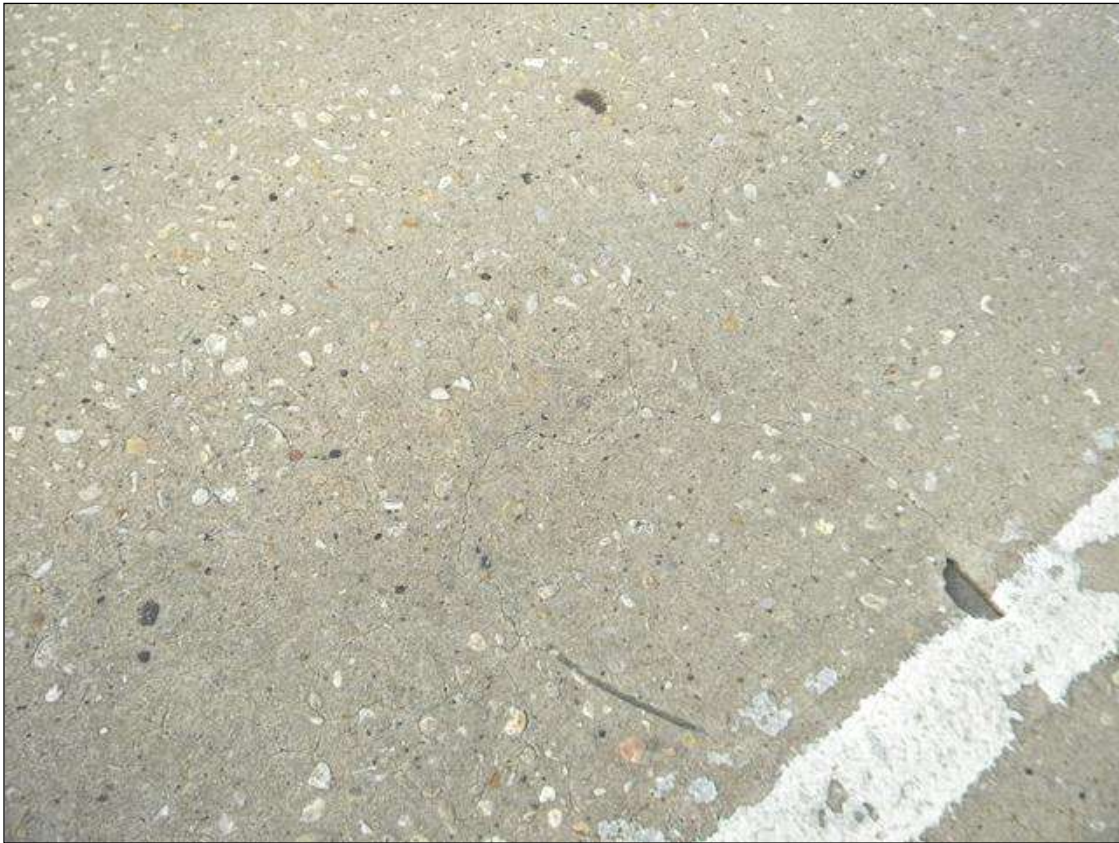
HAIRLINE MAP CRACKING IN SPAN 2 WEST BOUND LANE

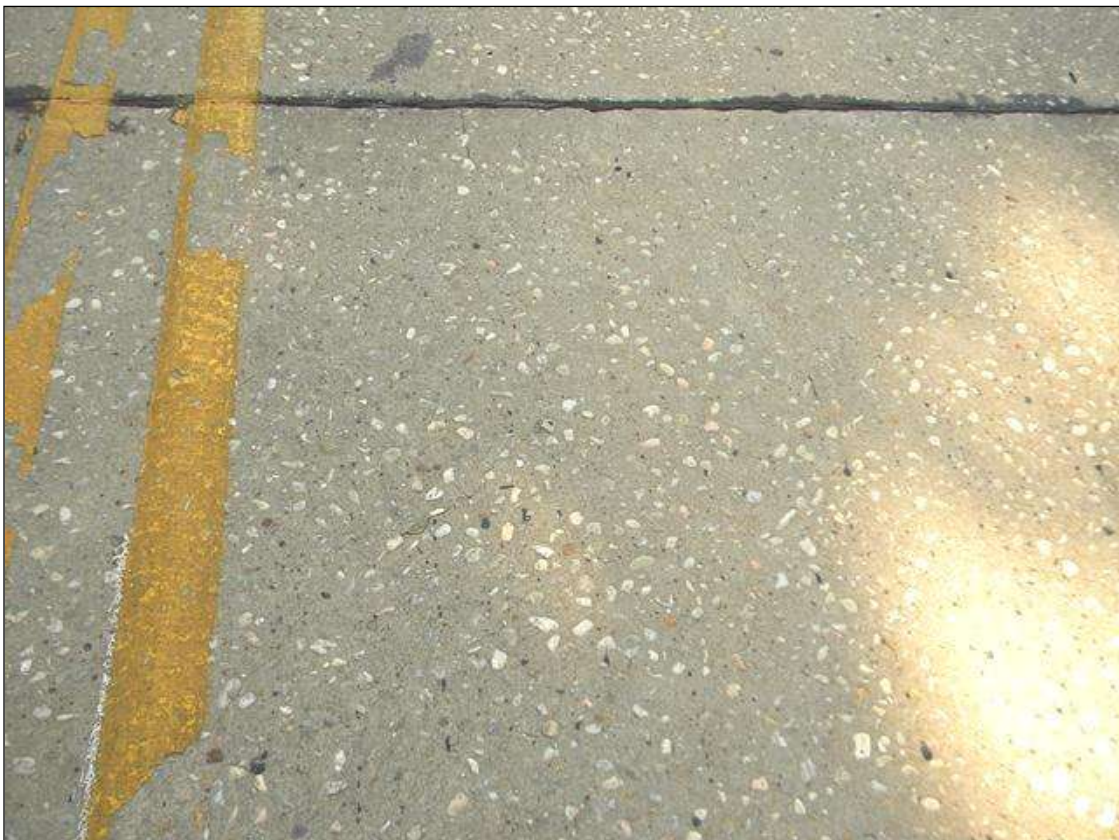
HAIRLINE LONGITUDINAL AND DIAGONAL CRACKS IN SPAN 2 EAST BOUND LANE

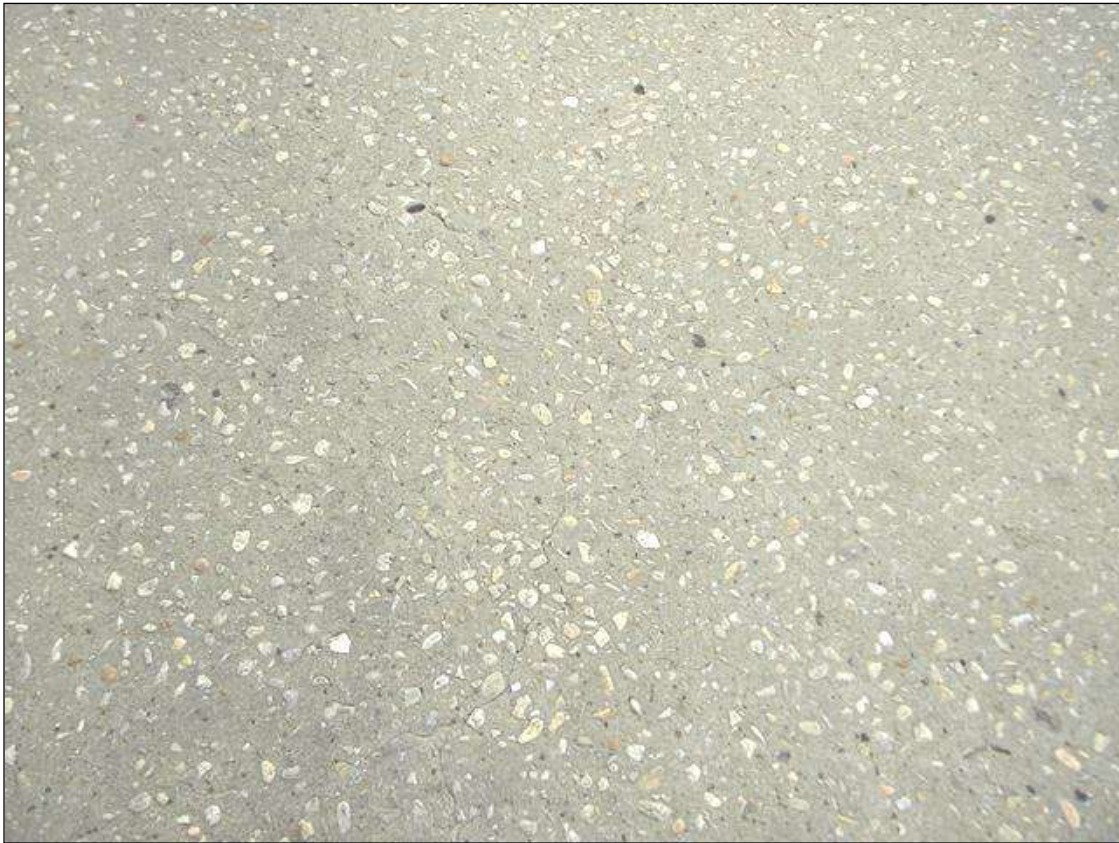
HAIRLINE MAP CRACKING IN SPAN 3 DECK

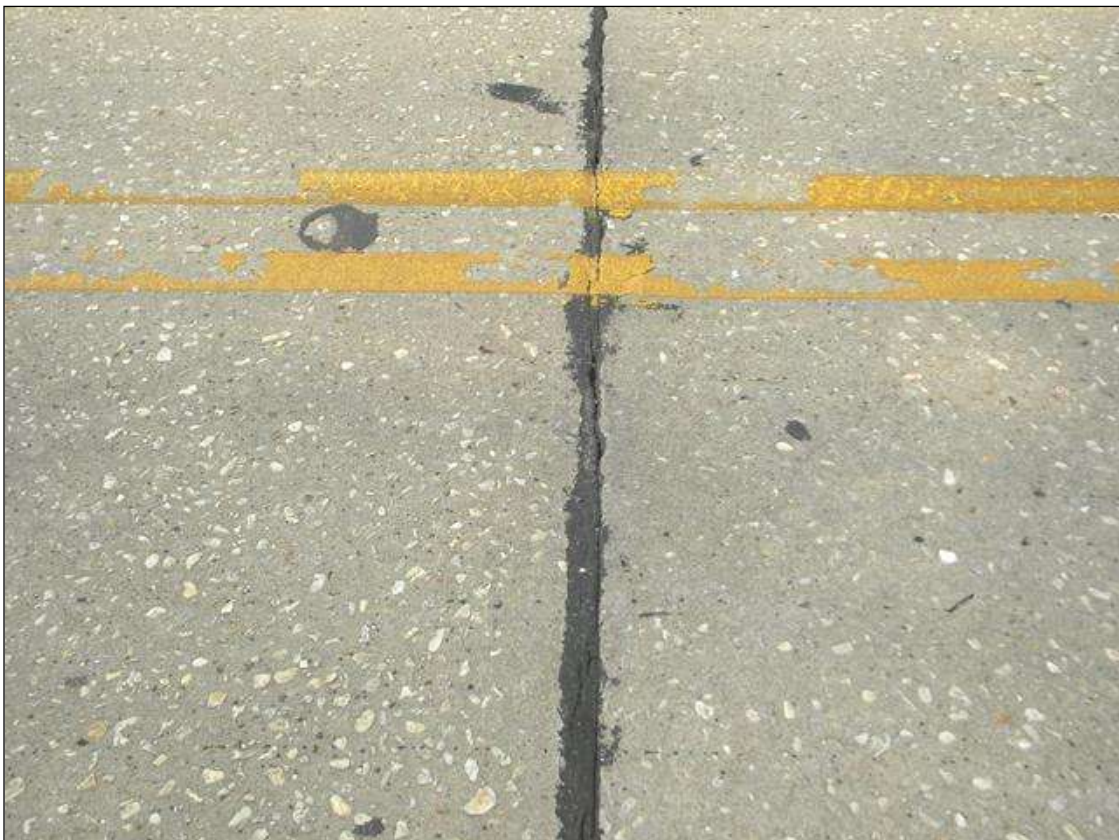
BENT 2 STANDARD JOINT SEAL CRACKED, SETTLING, AND LEAKING ( ALL JOINTS ARE SIMILAR )

| MMS Code | Description of Function | Unit | Quantity | Remarks | Est. Cost |
|---|---|---|---|---|---|
| 3310 | Maintenance/Repair/Replacement of Standard Bridge Expansion Joints | LF | 72 | BENT 2 STANDARD JOINT SEAL CRACKED, SETTLING, AND LEAKING ( ALL JOINTS ARE SIMILAR ) | |

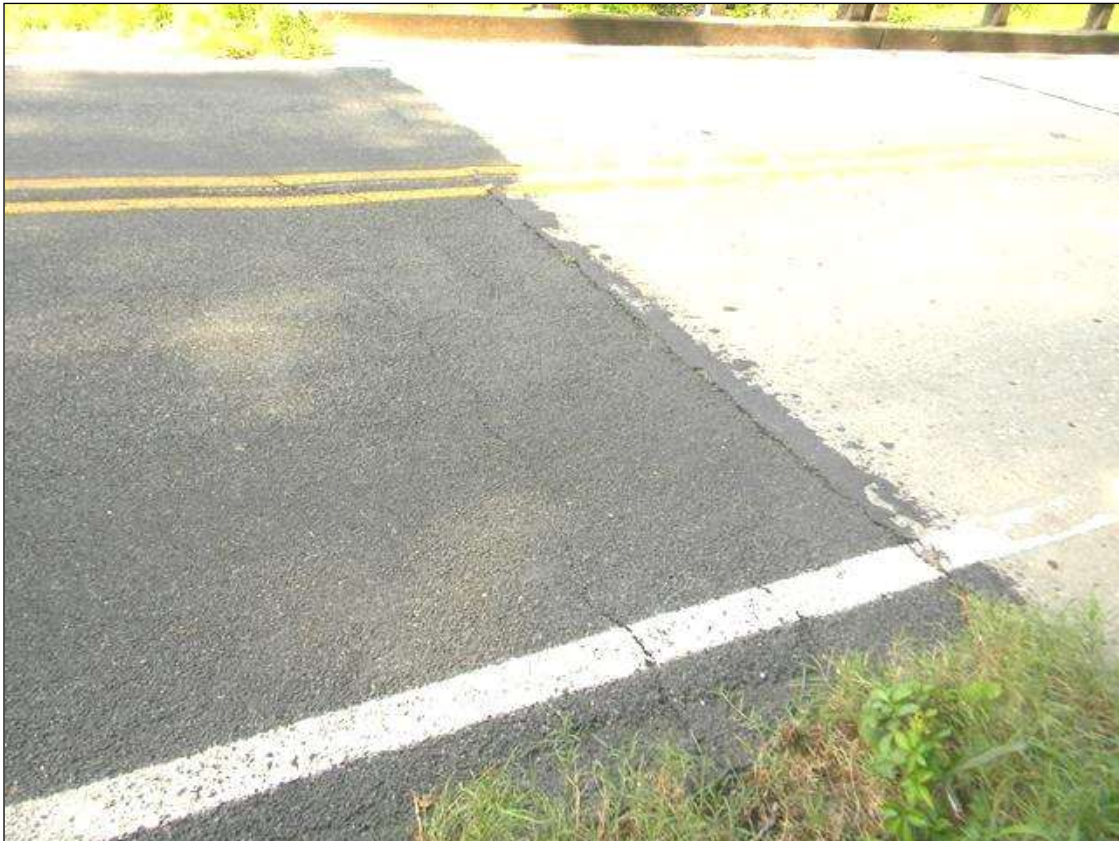
EAST APPROACH ASPHALT WEARING SURFACE SETTLED UP TO 1/2" IN WEST BOUND LANE

| MMS Code | Description of Function | Unit | Quantity | Remarks | Est. Cost |
|---|---|---|---|---|---|
| 2816 | Asphalt Surface Repair or Replacement | SY | 3 | EAST APPROACH ASPHALT WEARING SURFACE SETTLED UP TO 1/2" IN WEST BOUND LANE | |

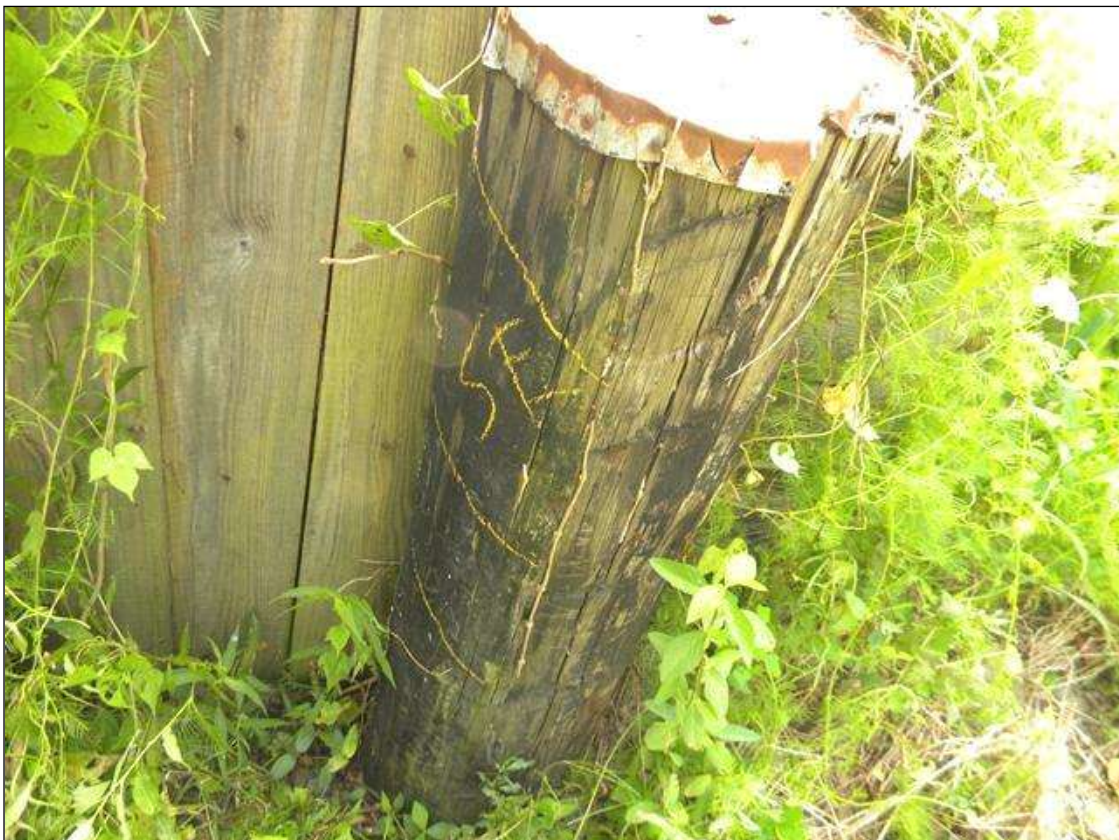
TURNPILE AT SOUTHEAST CORNER HOLLOW

| MMS Code | Description of Function | Unit | Quantity | Remarks | Est. Cost |
|---|---|---|---|---|---|
| 3346 | Repair / Maintain Timber Wings & Blkhds | SF | 8 | TURNPILE AT SOUTHEAST CORNER HOLLOW | |

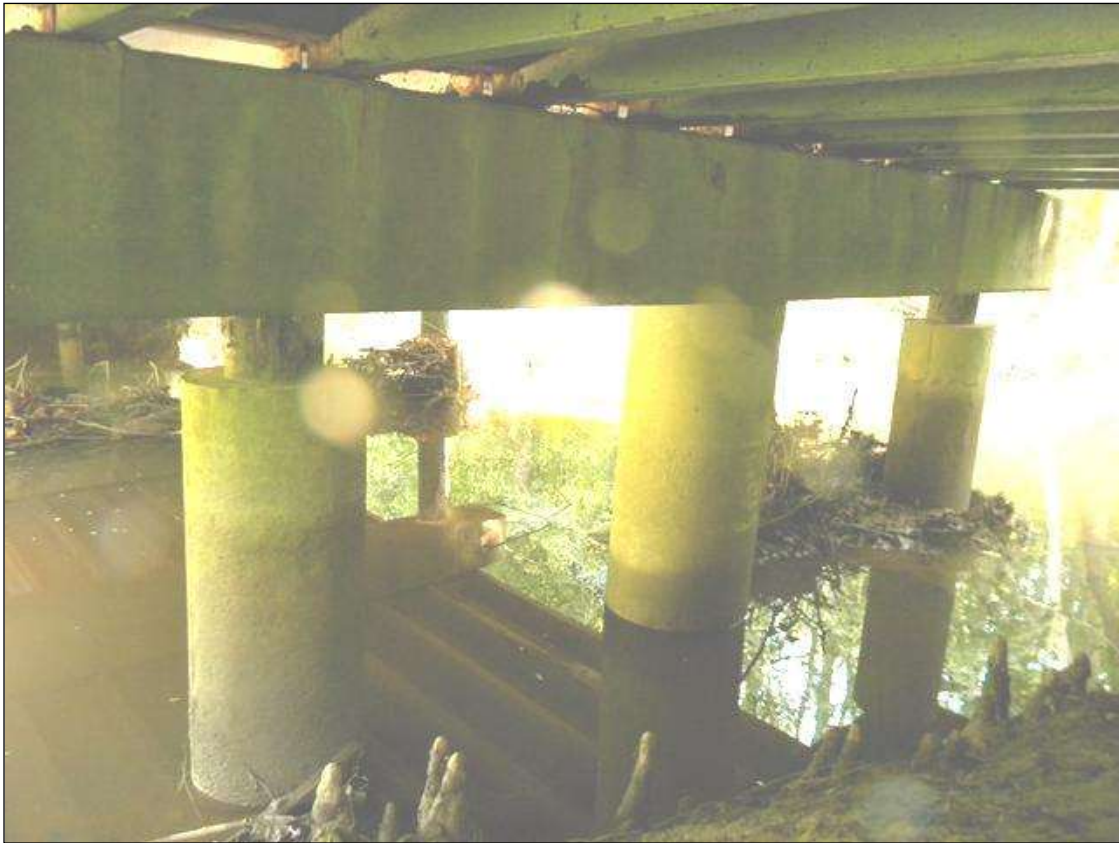
PILES 1, 2, AND 3 ENCASED AT BENT 3

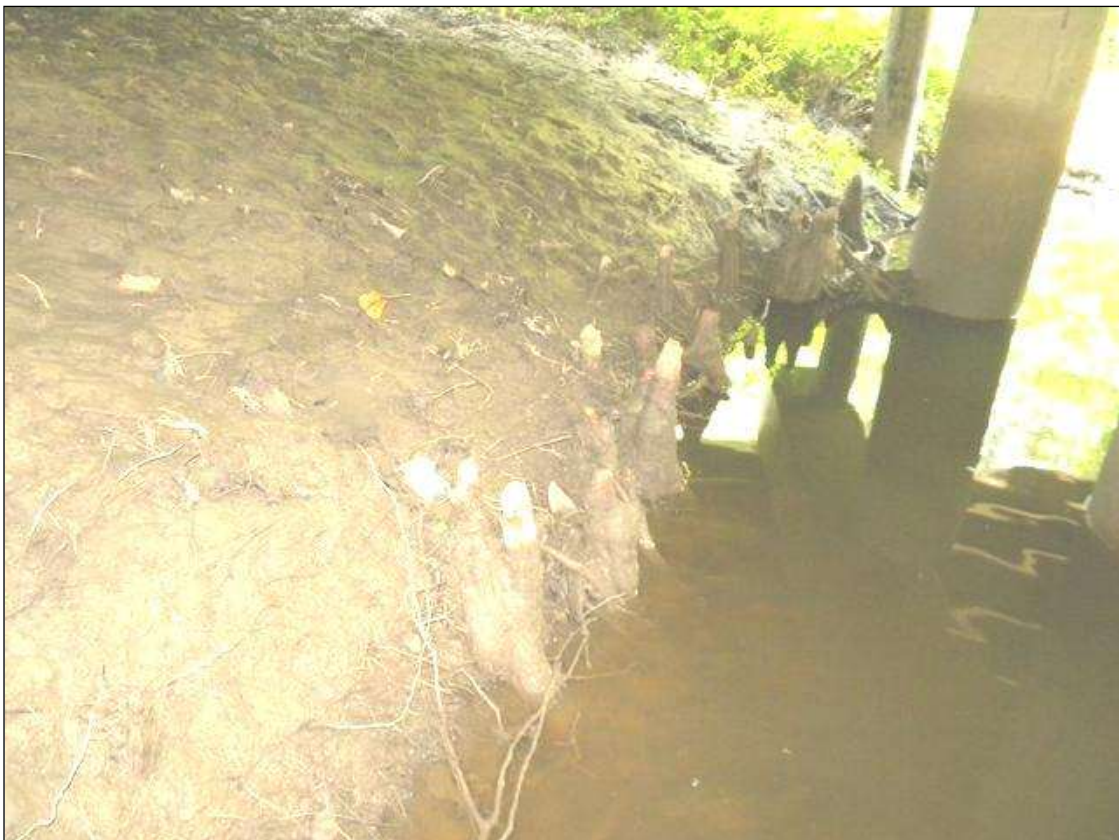
LATERAL BANK EROSION IN SPAN 4

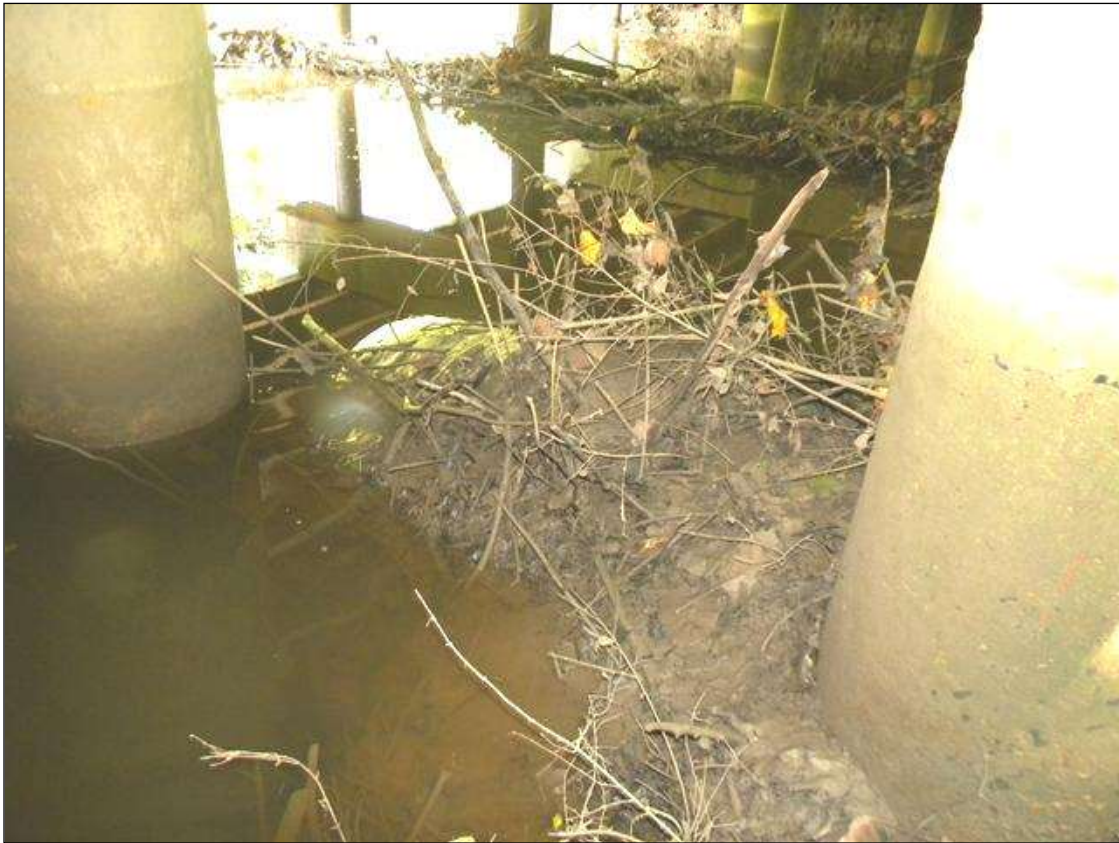
DRIFT AND SILT ALONG PILE 1 AT BENT 3
