NC DEPARTMENT OF TRANSPORTATION  
DIVISION OF HIGHWAYS  
BRIDGE MANAGEMENT UNIT

# BRIDGE INSPECTION REPORT

INSPECTION TYPE: Routine Inspection

COUNTY COLUMBUS BRIDGE NUMBER 230175 INSPECTION CYCLE 2 YRS  
ROUTE SR1504 ACROSS DUNN SWAMP M.P. 0

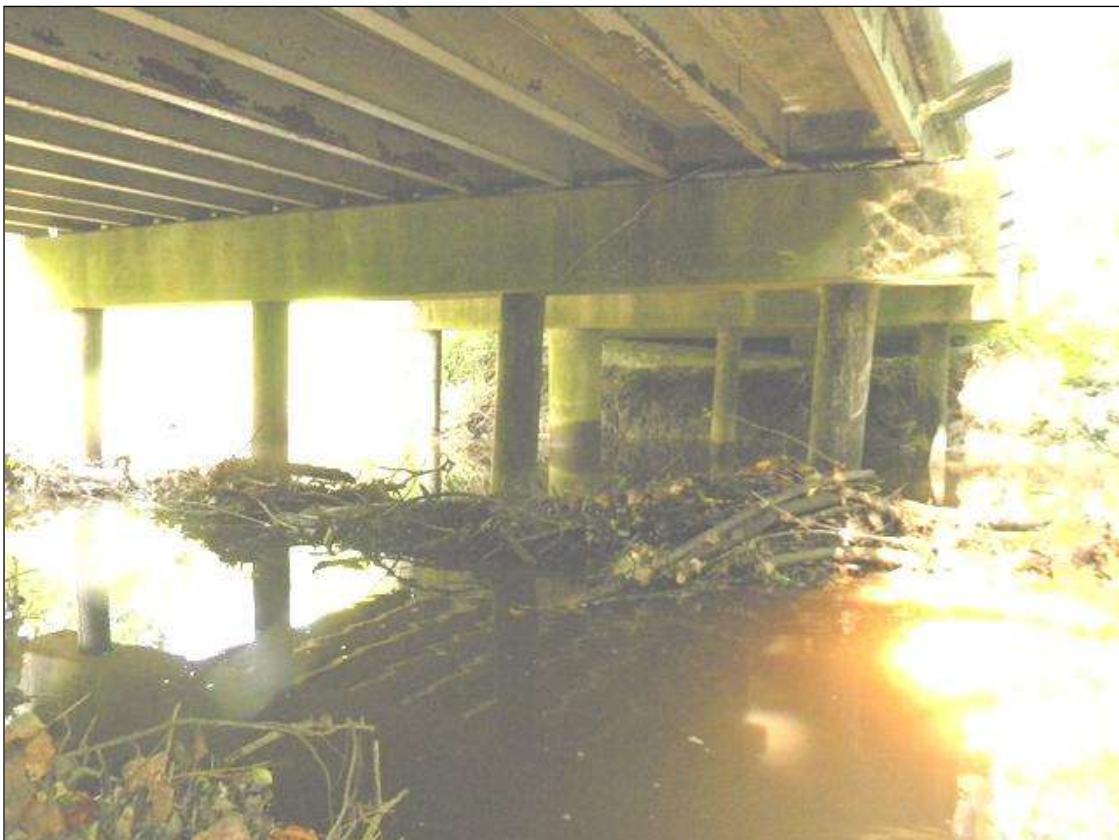
DRIFT ALONG BENT 2, SPAN 3 SIDE

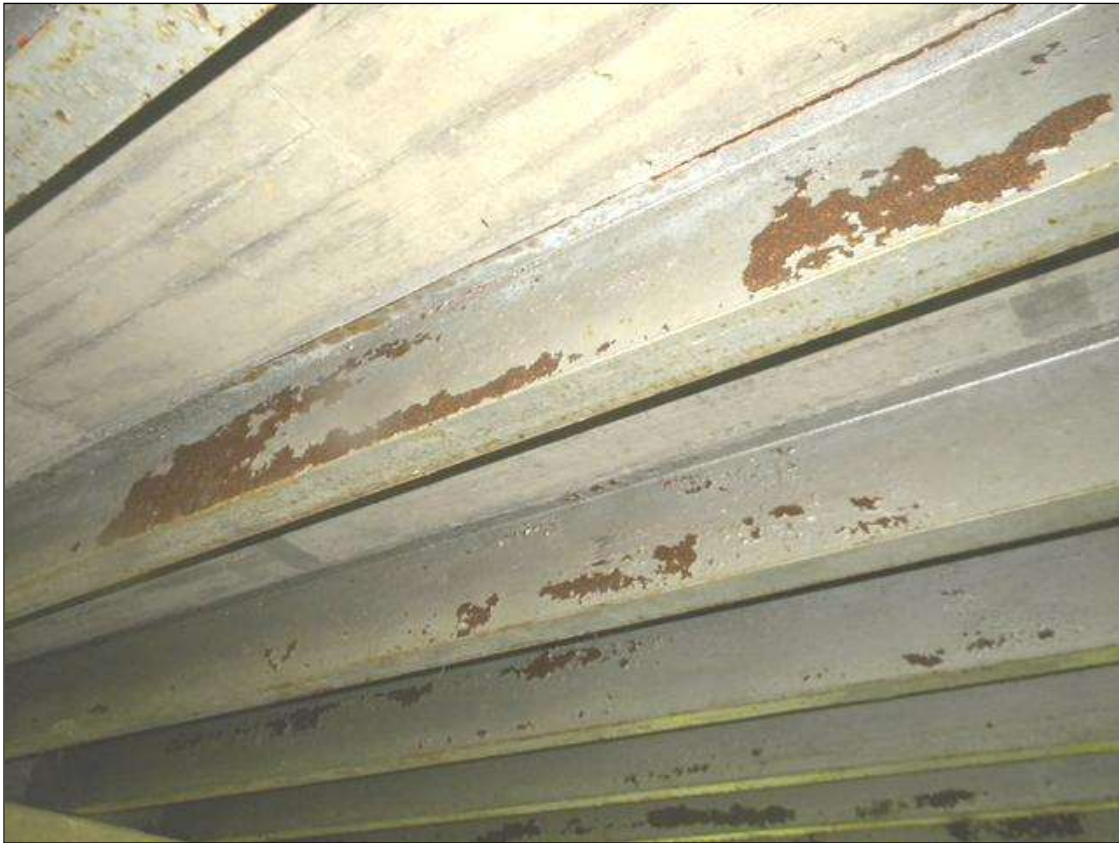
SPAN 4 UNDERSIDE, WITH PAINT PEELING AND SURFACE RUST

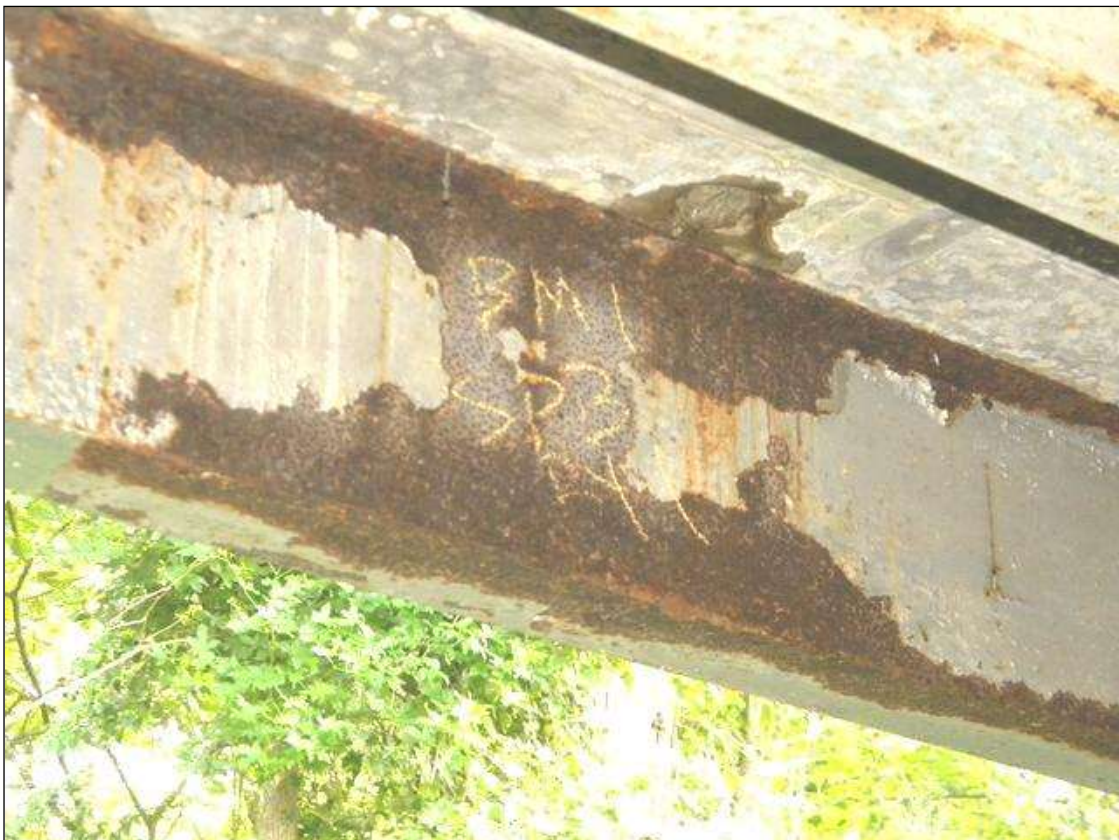
BEAM 1 IN SPAN 4 BAY 1 PAINT PEELING AND RUST WITH 1/16" PITTING NEAR MISSING DRAIN DOWNSPOUT

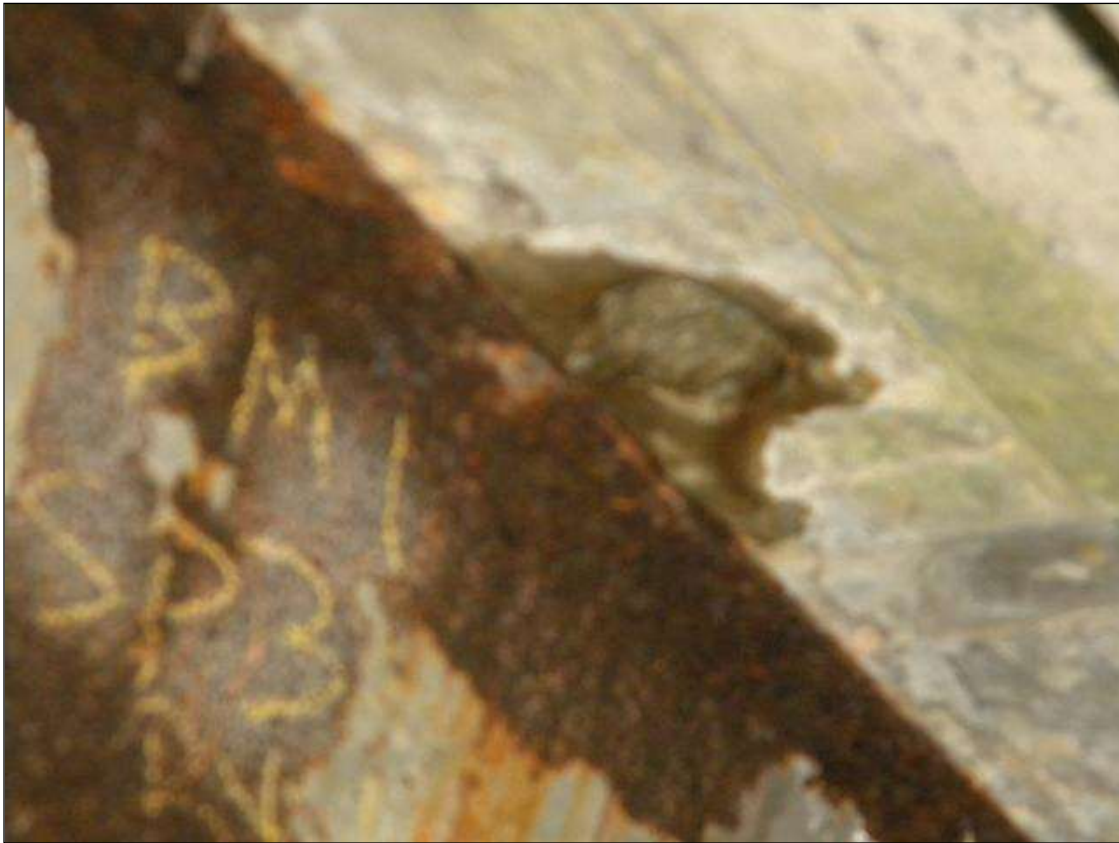
MISSING DRAIN DOWNSPOUT IN SPAN 4 BAY 1

| MMS Code | Description of Function | Unit | Quantity | Remarks | Est. Cost |
|---|---|---|---|---|---|
| 3332 | Maint Drainage System - Bridge | LF | 1 | MISSING DRAIN DOWNSPOUT IN SPAN 4 BAY 1 | |

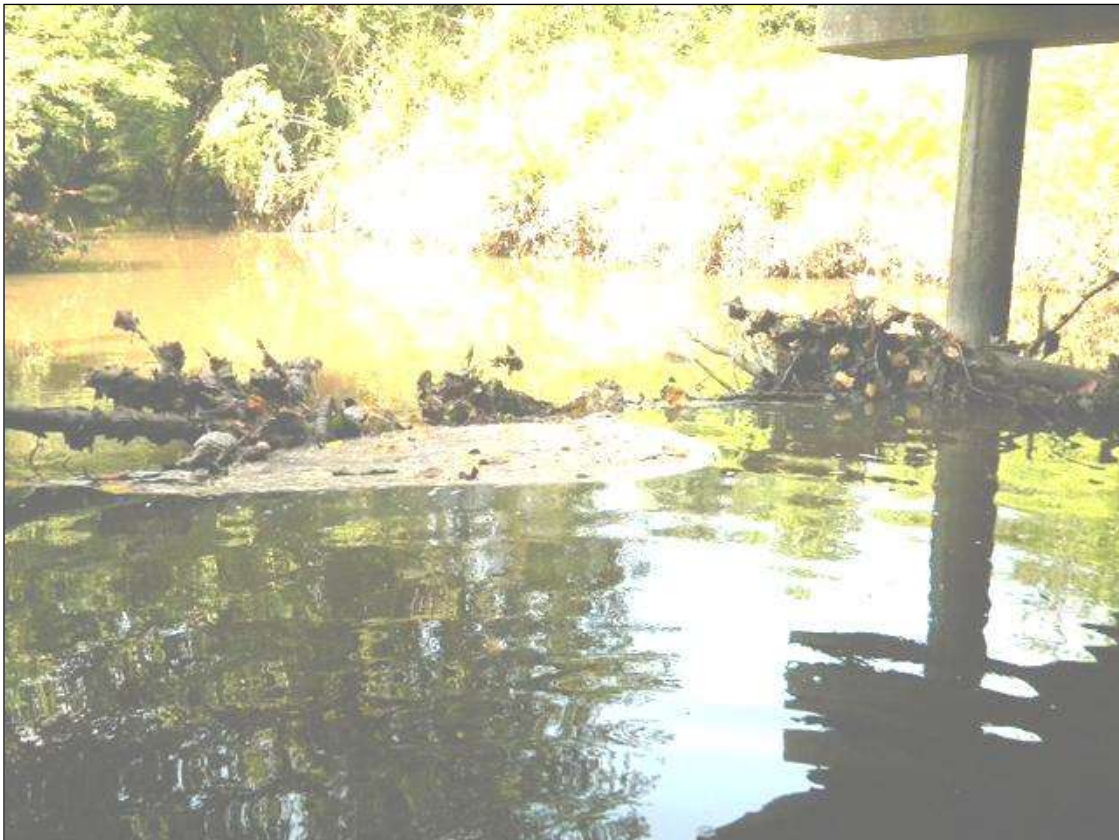
DRIFT DOWNSTREAM SOUTH IN SPAN 3

| MMS Code | Description of Function | Unit | Quantity | Remarks | Est. Cost |
|---|---|---|---|---|---|
| 3366 | Drift and Debris Removal | HR | 4 | DRIFT DOWNSTREAM SOUTH IN SPAN 3 | |

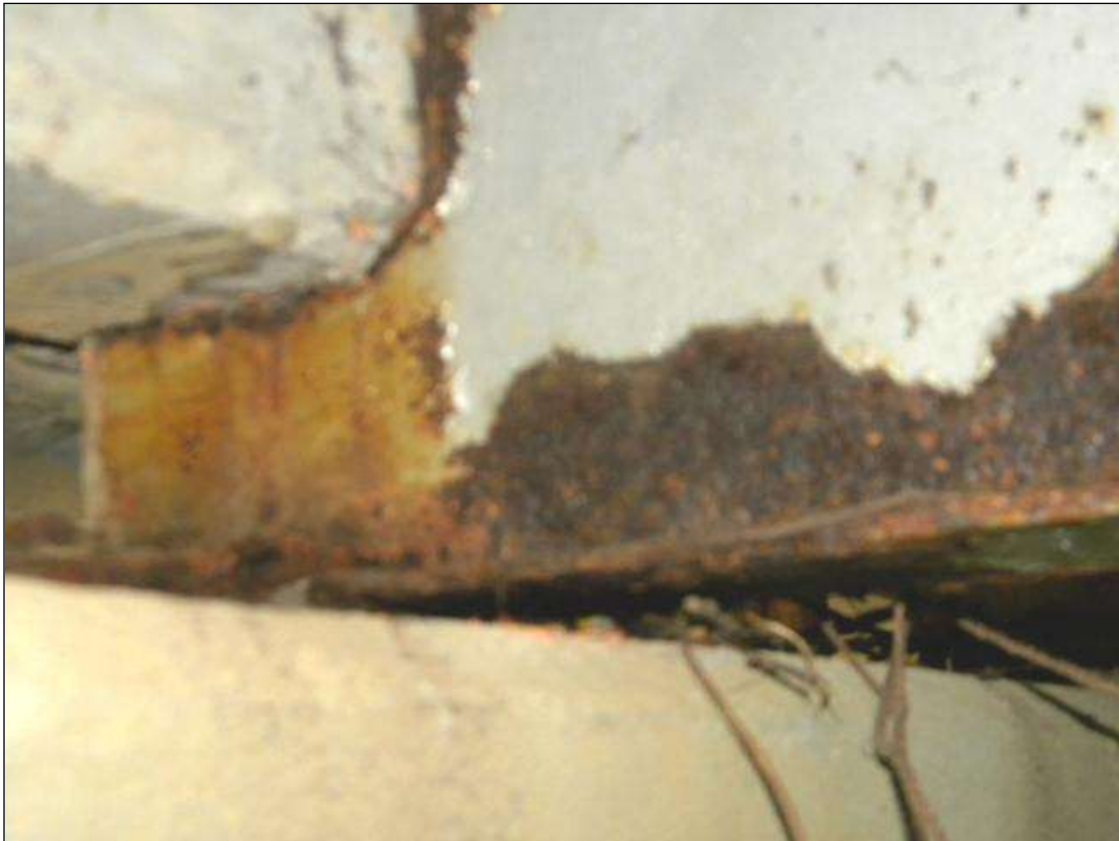
BEAM 7 IN SPAN 4 AT BENT 3 SECTION LOSS WITH 1/8" REMAINING FROM BEARING OUT 2" TO 6" X 1" WIDE

| MMS Code | Description of Function | Unit | Quantity | Remarks | Est. Cost |
|---|---|---|---|---|---|
| 3314 | Maintain Steel Superstructure Components | LF | 2 | BEAM 7 IN SPAN 4 AT BENT 3 SECTION LOSS WITH 1/8" REMAINING FROM BEARING OUT 2" TO 6" X 1" WIDE | |

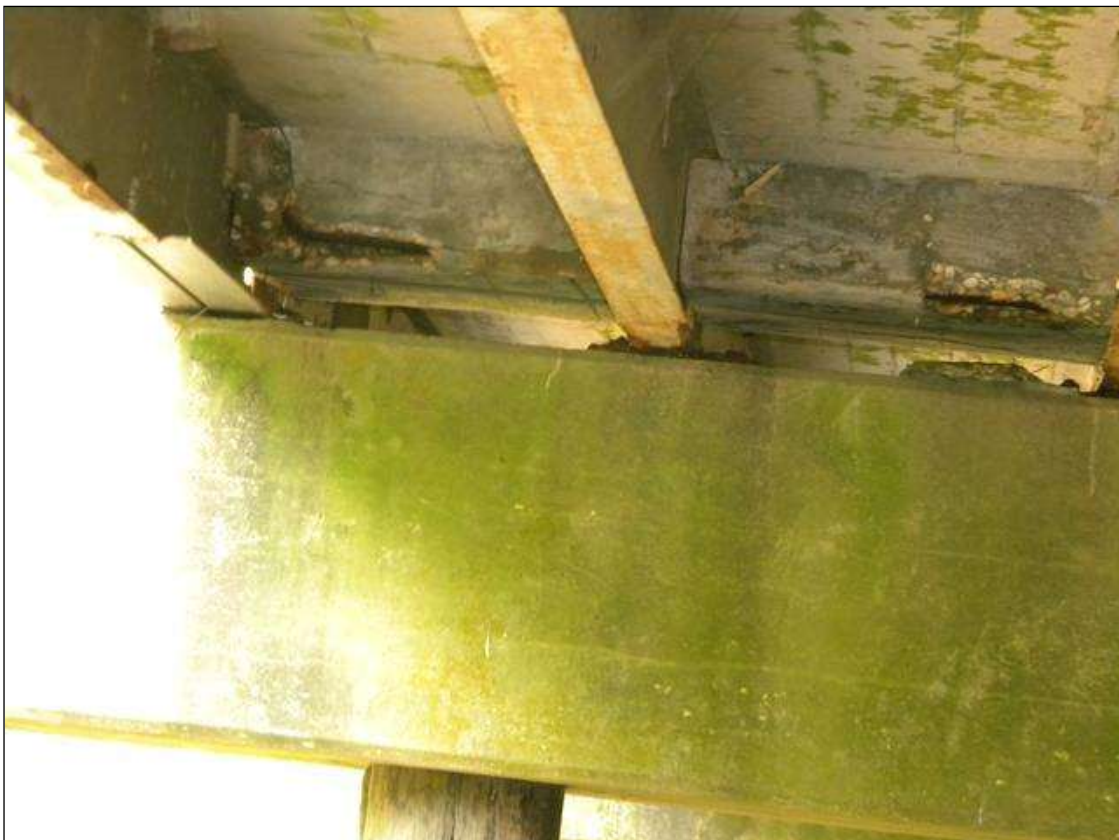
END DIAPHRAGM SPALLED WITH EXPOSED STEEL IN BAYS 10 & 11 AT BENT 2, SPAN 3

| MMS Code | Description of Function | Unit | Quantity | Remarks | Est. Cost |
|---|---|---|---|---|---|
| 3306 | Maintain Concrete Superstructure Components | SF | 3 | END DIAPHRAGM SPALLED WITH EXPOSED STEEL IN BAYS 10 & 11 AT BENT 2, SPAN 3 | |

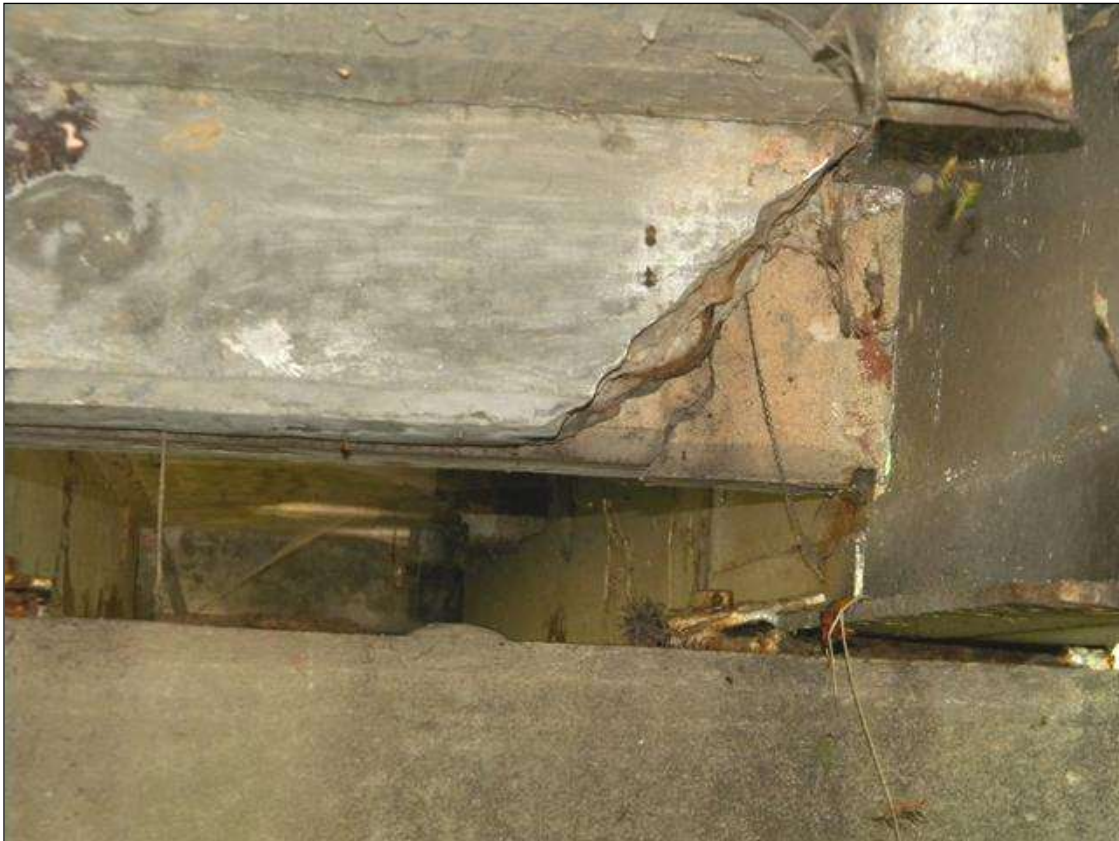
END DIAPHRAGM WITH SECTION LOSS AT BENT 3, SPAN 4 IN BAY 1

| MMS Code | Description of Function | Unit | Quantity | Remarks | Est. Cost |
|---|---|---|---|---|---|
| 3306 | Maintain Concrete Superstructure Components | SF | 1 | END DIAPHRAGM WITH SECTION LOSS AT BENT 3, SPAN 4 IN BAY 1 | |

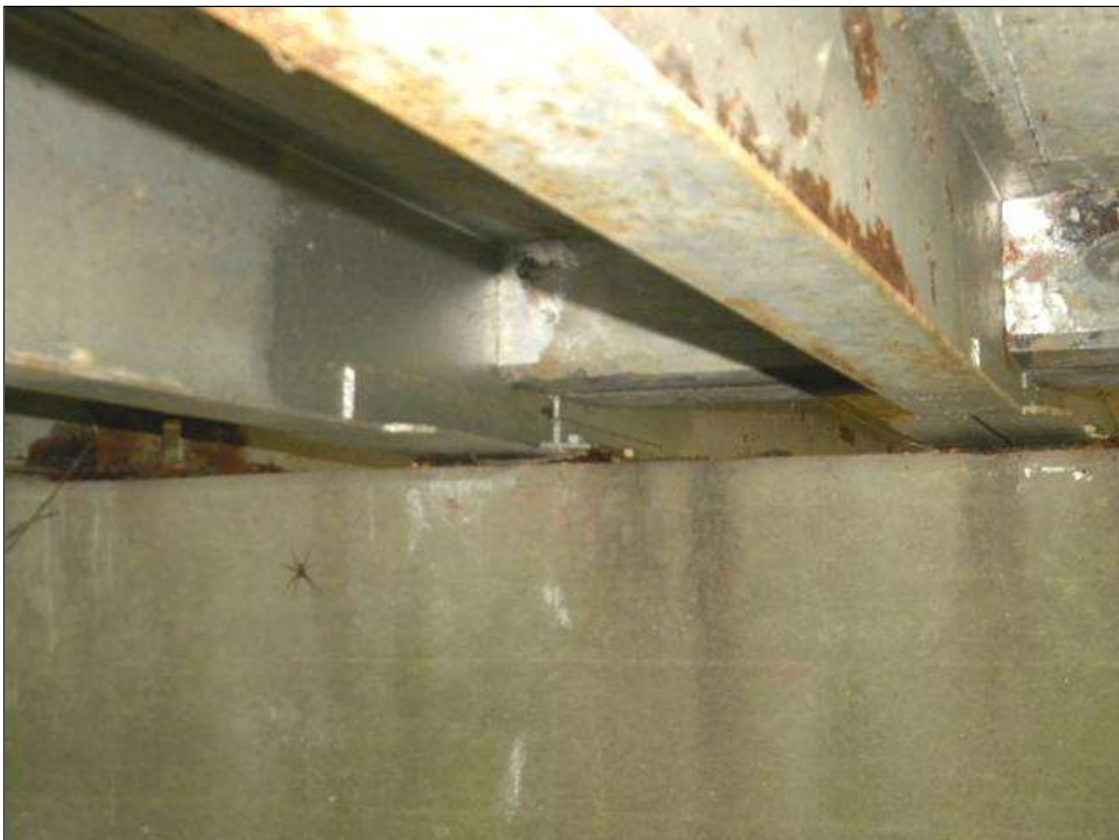
BEAMS 1,2,AND 3 SIMILAR REPAIRS AT BENT 3, IN SPAN 4

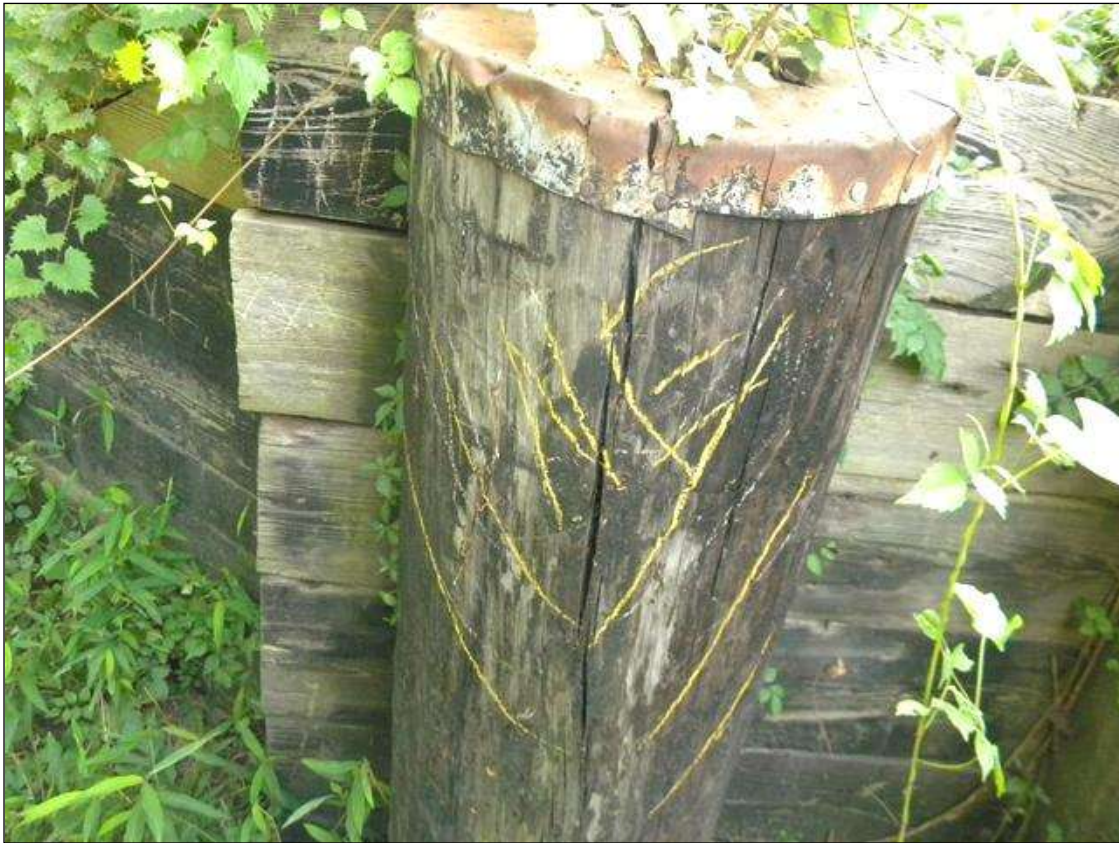
NORTHEAST CORNER TURNPILE HOLLOW AND INFESTED WITH ANTS

| MMS Code | Description of Function | Unit | Quantity | Remarks | Est. Cost |
|---|---|---|---|---|---|
| 3346 | Repair / Maintain Timber Wings & Blkhds | SF | 8 | NORTHEAST CORNER TURNPILE HOLLOW AND INFESTED WITH ANTS | |

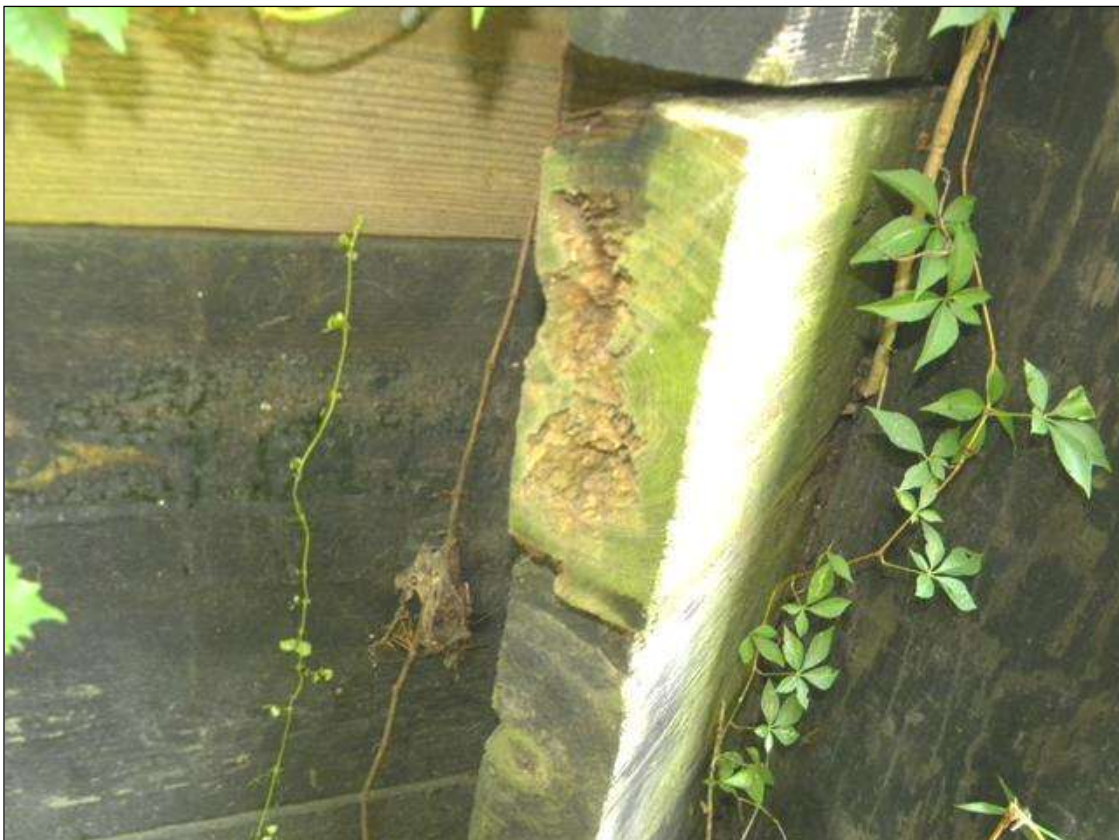
END DECAYED EXTERIOR BULKHEAD BOARD AT NORTHEAST CORNER

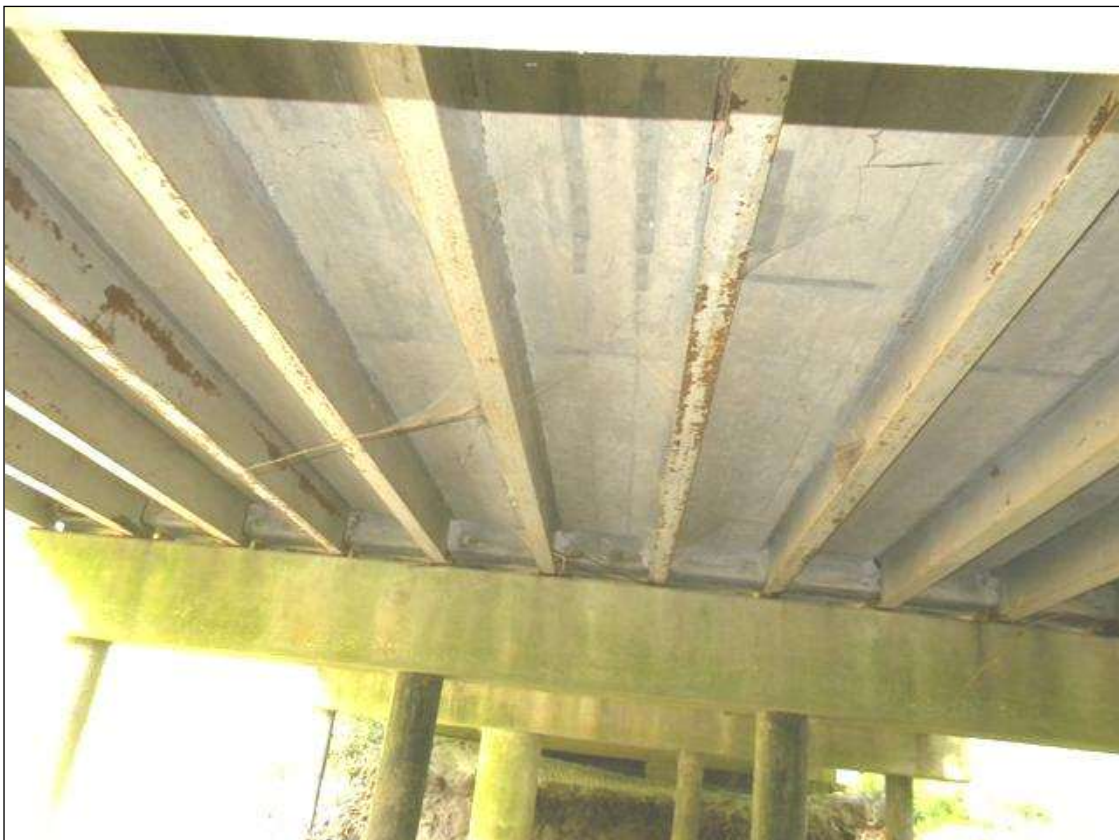
SPAN 3 UNDERSIDE, ALL SPANS ARE SIMILAR
