# BRIDGE INSPECTION REPORT

INSPECTION TYPE: Routine Inspection

COUNTY COLUMBUS BRIDGE NUMBER 230308 INSPECTION CYCLE 2 YRS  
ROUTE SR1005 ACROSS CREEK M.P. 0

INSPECTION DATE 01/15/2013

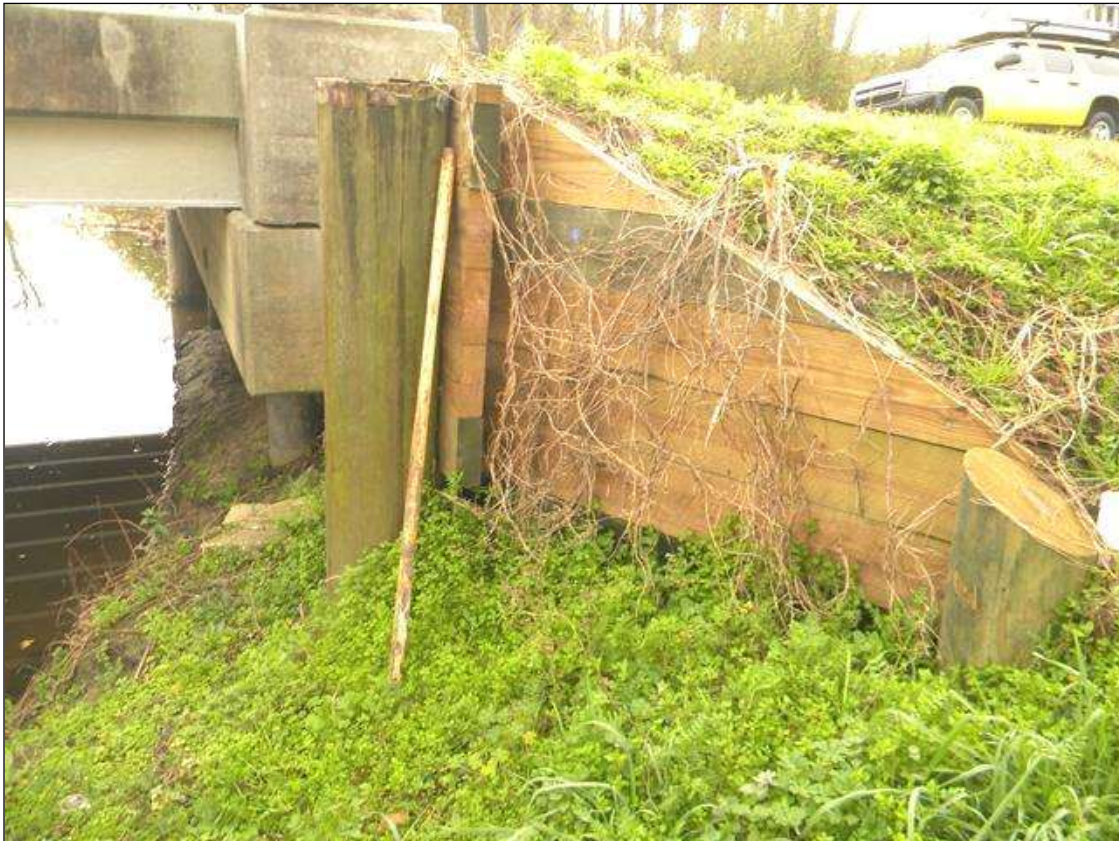
| <b>35c</b> | <b>G</b> | ( TIMBER BULKHEADS ) NEW WINGWALL AND WING PILES AT SOUTHWEST CORNER. (PHOTO)<br><br>NEW WINGWALL AND WING PILES AT NORTHWEST CORNER. (PHOTO)<br><br>END BENT 1 BULKHEAD REPAIRS AT SOUTHEAST CORNER. (PHOTO)<br><br>WINGWALL REPAIRS AT SOUTHEAST CORNER. (PHOTO)<br><br>END BENT 2 BULKHEAD BOARDS REPAIRED. (PHOTO) | |

NEW WINGWALL AND WING PILES AT SOUTHWEST CORNER

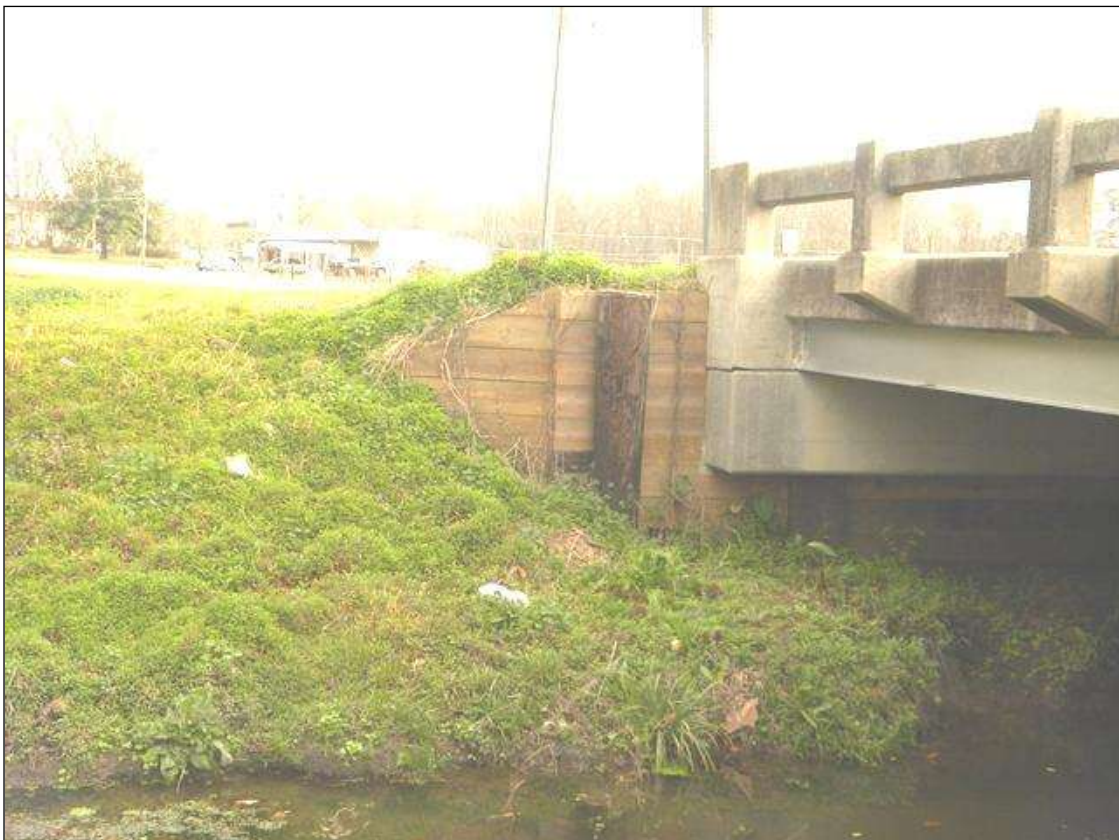
NEW WINGWALL AND WING PILES AT NORTHWEST CORNER

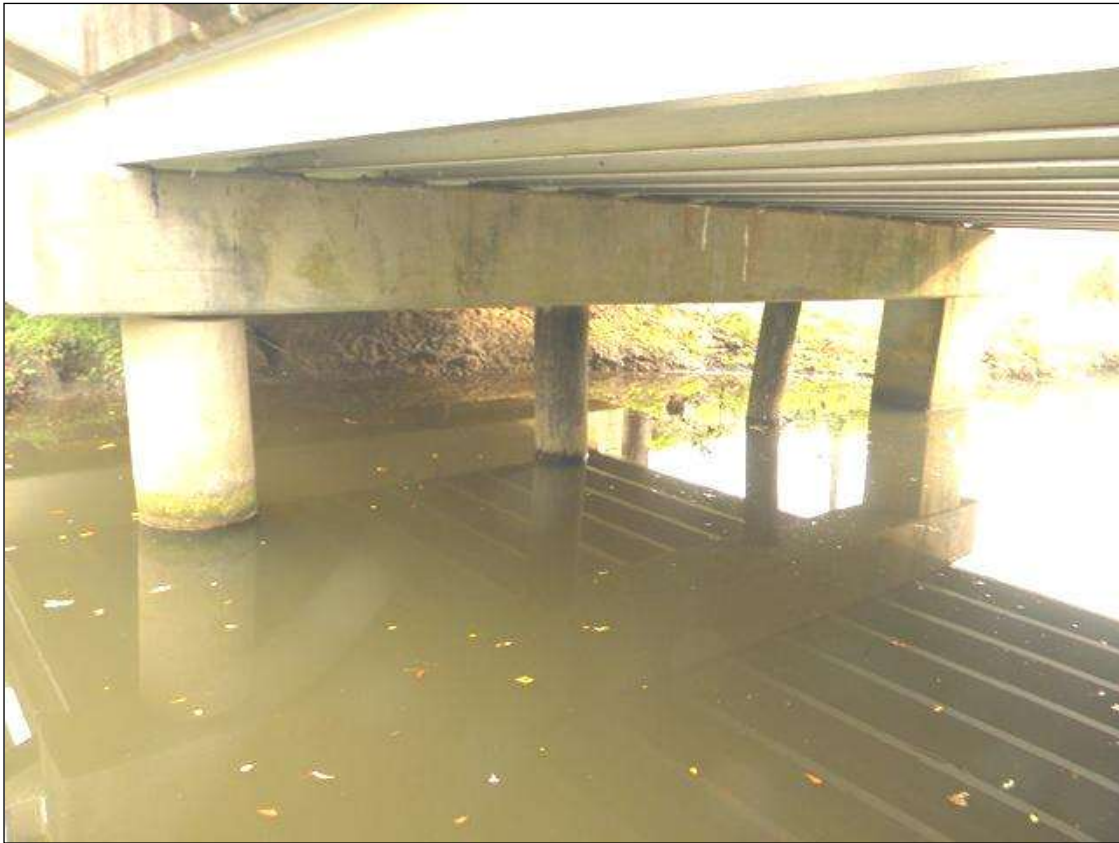
| Bridge I&A Form 1(82)H<br>State of North Carolina<br>Dept. of Transportation<br>Division of Highways | | <b>FIELD INSPECTION REPORT</b><br><u>Bridge Inspection &amp; Analysis</u> | |
|---|---|---|--|
| 35b | F | ( TIMBER PILES ) PILES 2, AND 3 AT BENT 1 HAVE BEEN DRIVEN OUT OF PLUMB.<br><br>PILES 1, AND 4 ARE ENCASED IN CONCRETE AT BENT 1. (PHOTO)<br><br>PILE 4 AT END BENT 1 ENCASED IN CONCRETE. (PHOTO) | |

BENT 1 PILES 1 AND 4 ENCASED IN CONCRETE

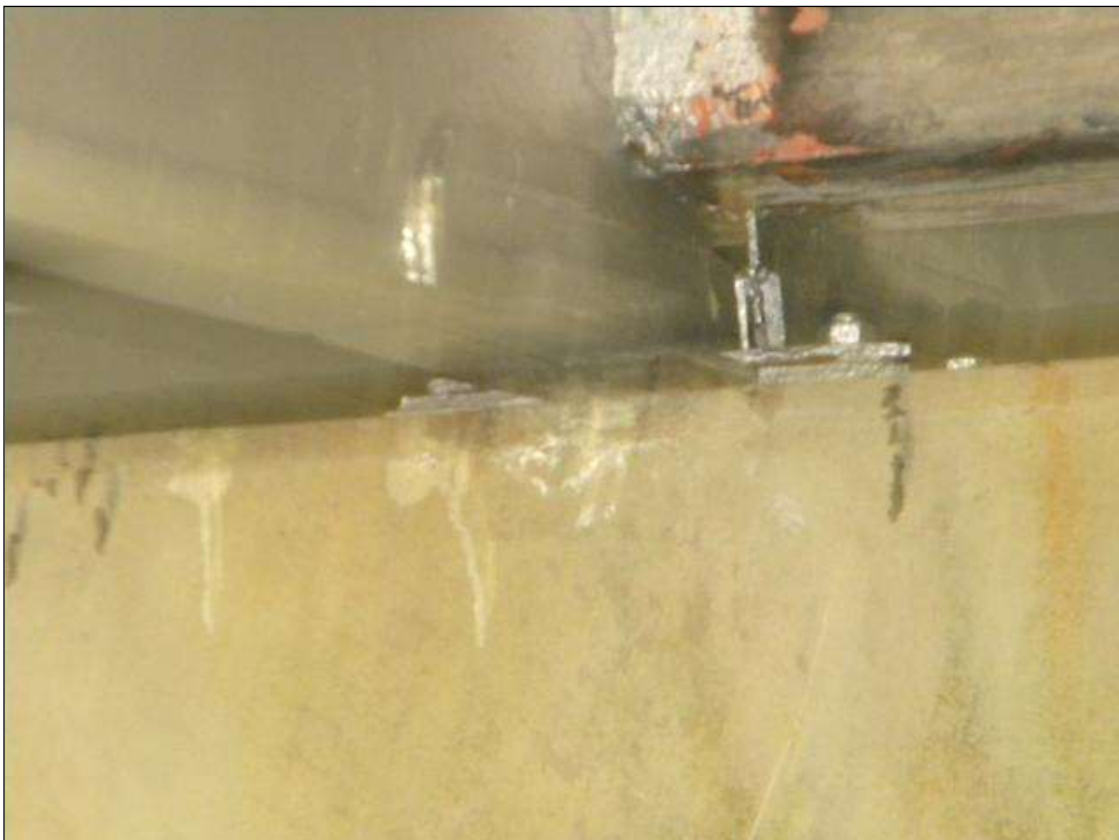
| Bridge I&A Form 1(82)H<br>State of North Carolina<br>Dept. of Transportation<br>Division of Highways | | <b>FIELD INSPECTION REPORT</b><br><u>Bridge Inspection &amp; Analysis</u> | |
|---|---|---|--|
| 10 | G | ( STEEL BEAMS ) THE BEAMS HAVE BEEN PAINTED SINCE LAST INSPECTION. (PHOTOS)<br><br>BEAM ENDS REPAIRED AND PAINTED AT BENT 1. ALL BEAMS ARE SIMILAR. (PHOTO) | |

BEAM ENDS REPAIRED AND PAINTED AT BENT 1, ALL BEAMS ARE SIMILAR

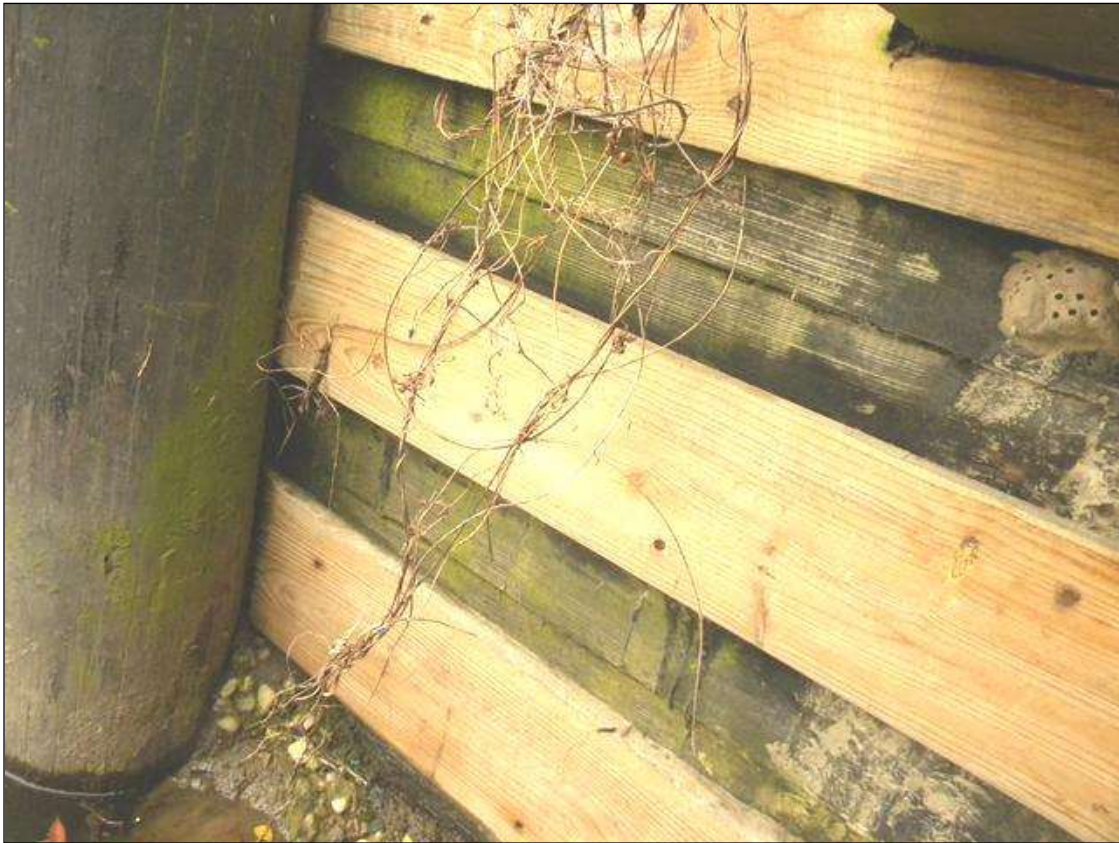
END BENT 1 BULKHEAD REPAIRS AT SOUTHEAST CORNER

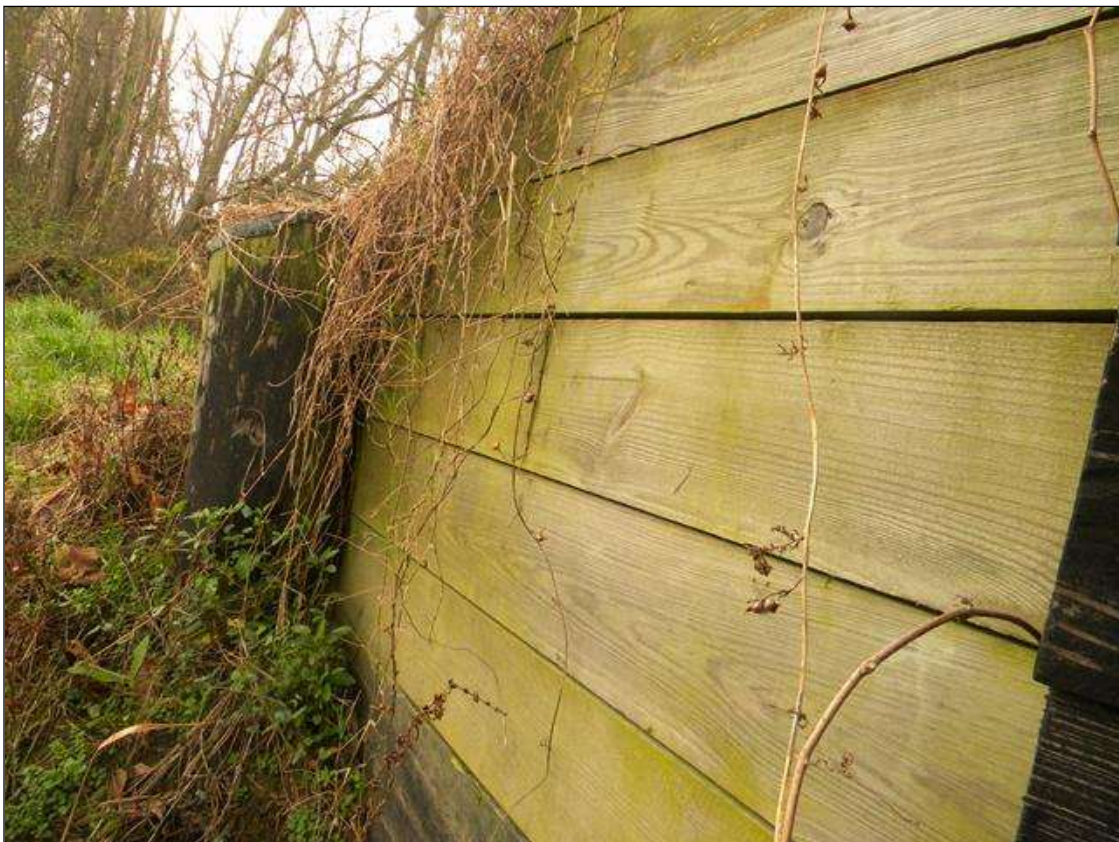
WINGWALL REPAIRS AT SOUTHEAST CORNER

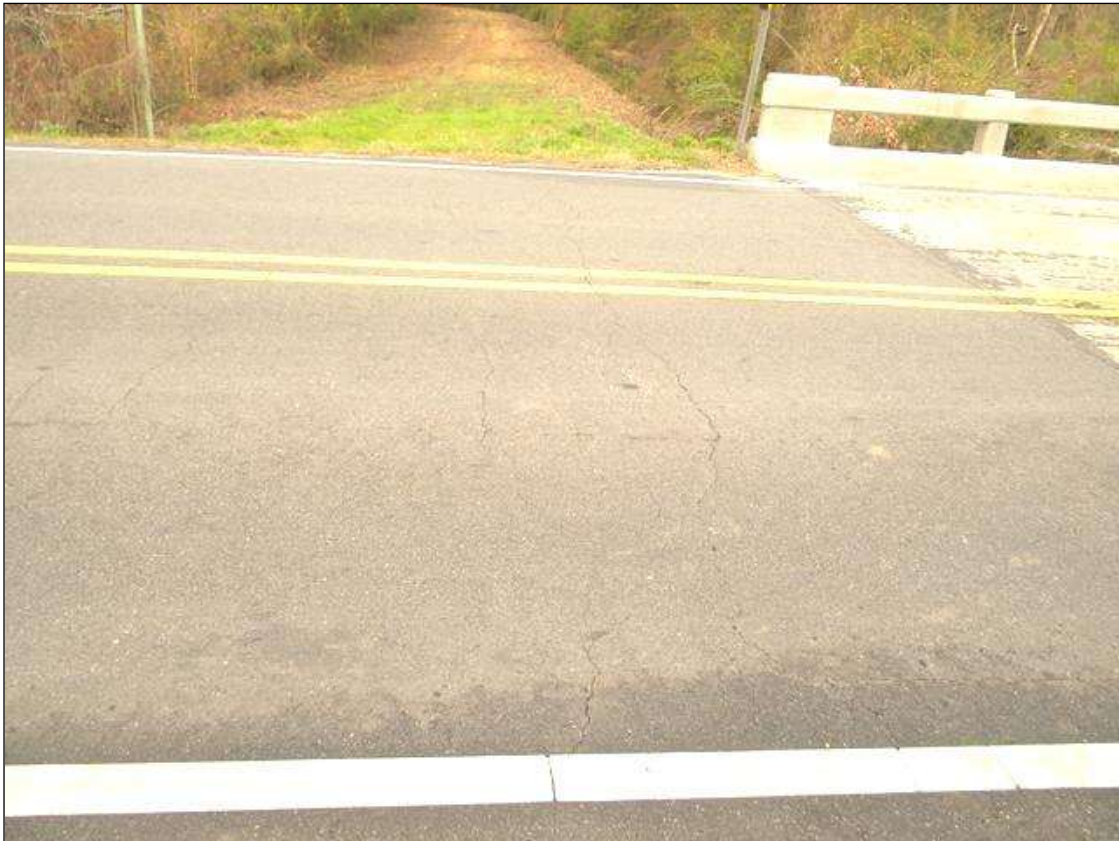
| <b>50</b> | <b>F</b> | ( APPROACH ROADWAYS ) THERE ARE HAIRLINE TO 1/16" TRANSVERSE CRACKS IN BOTH APPROACHES, WITH NO SETTLEMENT AT THIS TIME. (PHOTOS) | |

HAIRLINE TO 1/16" TRANSVERSE CRACKS IN SOUTH APPROACH ASPHALT WEARING SURFACE

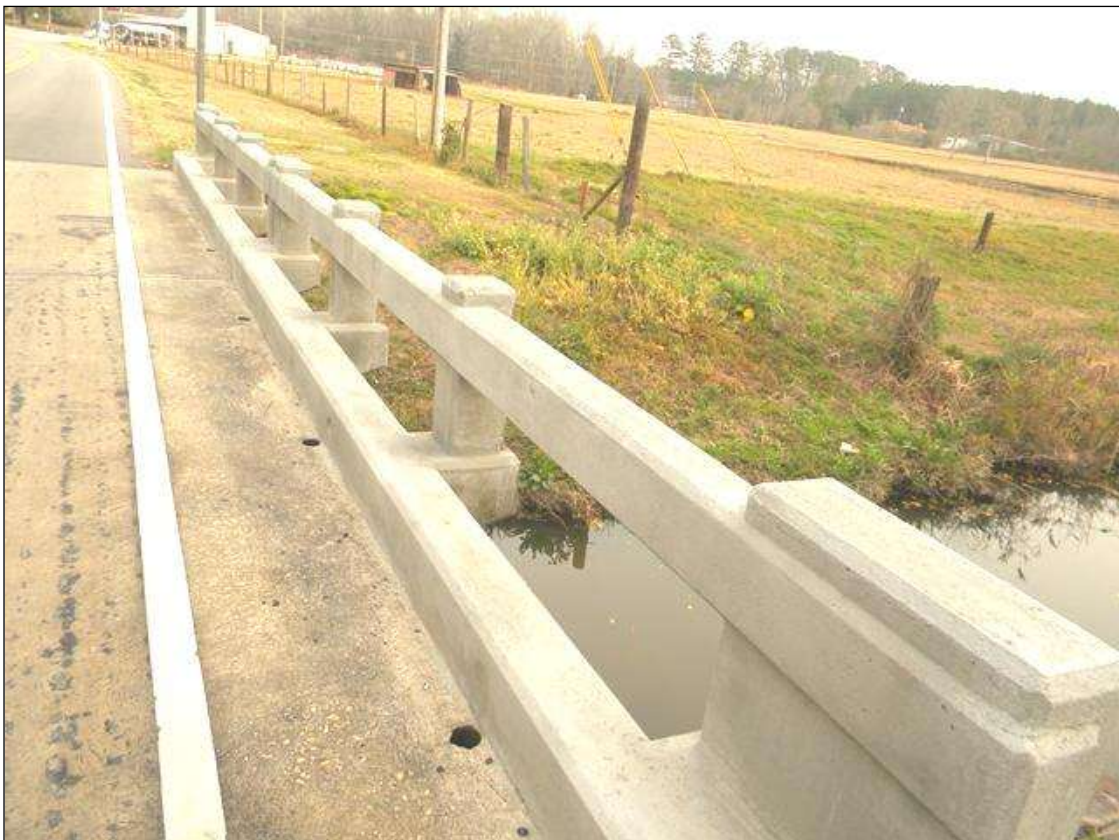
| Bridge I&A Form 1(82)H<br>State of North Carolina<br>Dept. of Transportation<br>Division of Highways | | <b>FIELD INSPECTION REPORT</b><br><u>Bridge Inspection &amp; Analysis</u> | |
|---|---|---|--|
| 3a | G | ( RC RAILS ) BOTH RAILS HAVE BEEN REPAIRED. (PHOTO) | |

BOTH RAILS HAVE BEEN REPAIRED

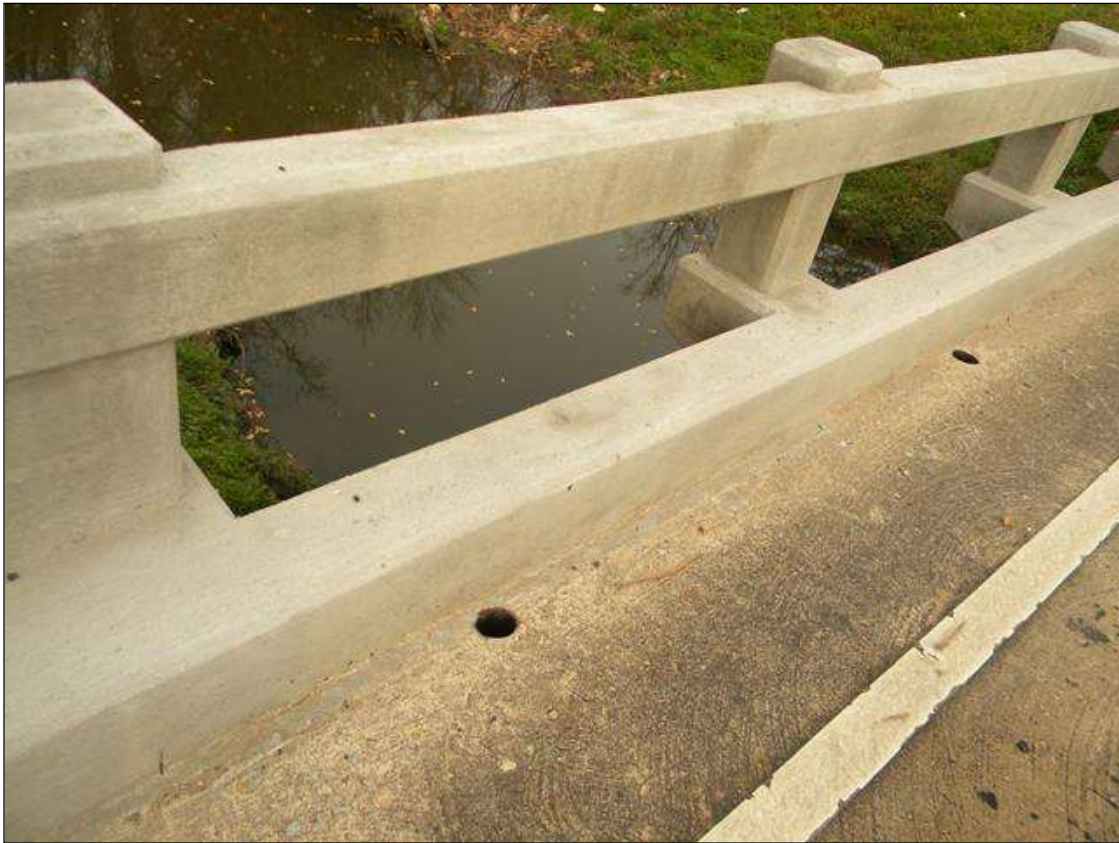
BOTH CURBS HAVE BEEN REPAIRED

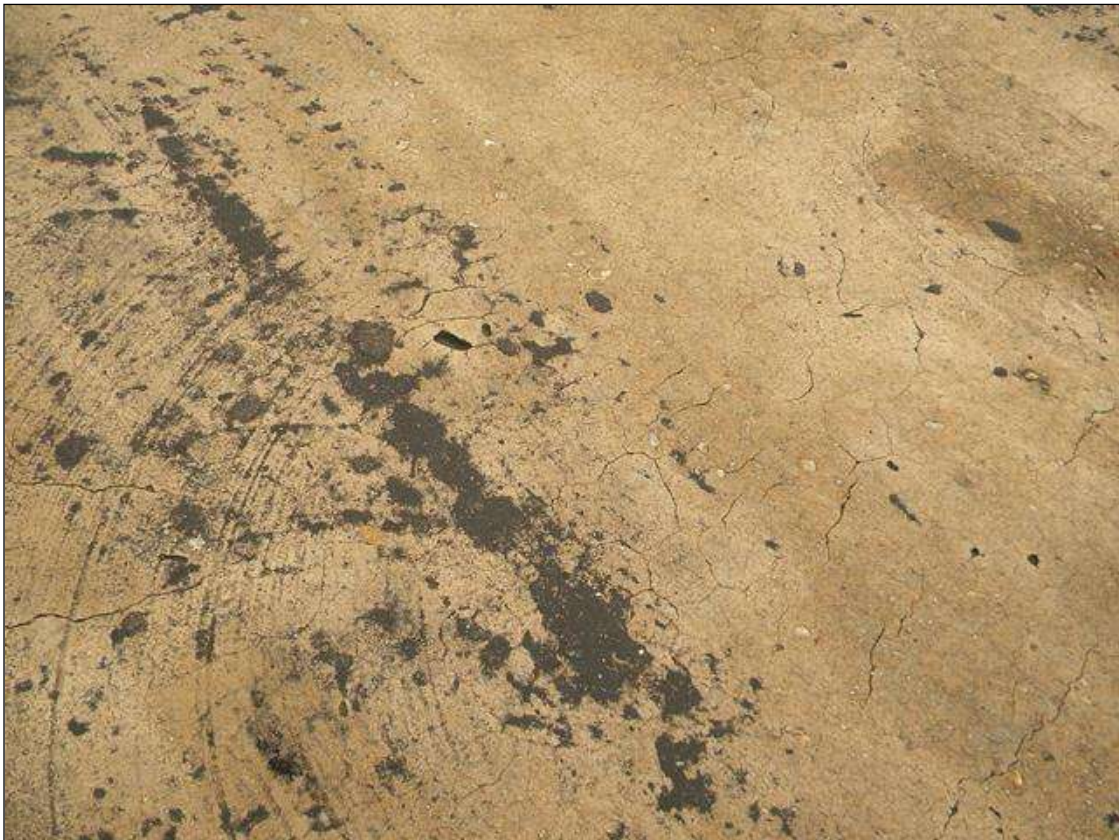
| Bridge I&A Form 1(82)H<br>State of North Carolina<br>Dept. of Transportation<br>Division of Highways | | <b>FIELD INSPECTION REPORT</b><br><u>Bridge Inspection &amp; Analysis</u> | |
|---|---|---|--|
| 2a | F | ( RC DECK ) THERE IS 1/16" MAP CRACKING AND POP OUTS IN SPAN 1 DECK. (PHOTO)<br><br>THERE IS ALSO 1/16" TRANSVERSE CRACK AND MAP CRACKING IN SPAN 1 NORTH BOUND LANE. (PHOTO)<br><br>THERE IS CRACKING NOTED IN SPAN 2 DECK AT SOUTH BOUND LANE. (PHOTO)<br><br>THERE IS A TRANSVERSE CRACK IN SPAN 2 DECK. (PHOTO)<br><br>THERE ARE RANDOM AGGREGATE POPOUTS AND SCALING IN BOTH SPANS UP TO 1/2" DEEP. (PHOTO) | |

1/16" MAP CRACKING WITH POPOUTS IN SPAN 1 DECK

| MMS Code | Description of Function | Unit | Quantity | Remarks | Est. Cost |
|---|---|---|---|---|---|
| 3326 | Maintain Concrete Deck | SF | 3 | CRACKING IN DECK, WITH SURFACE 1/2" DEEP POPOUTS AT RANDOM | |

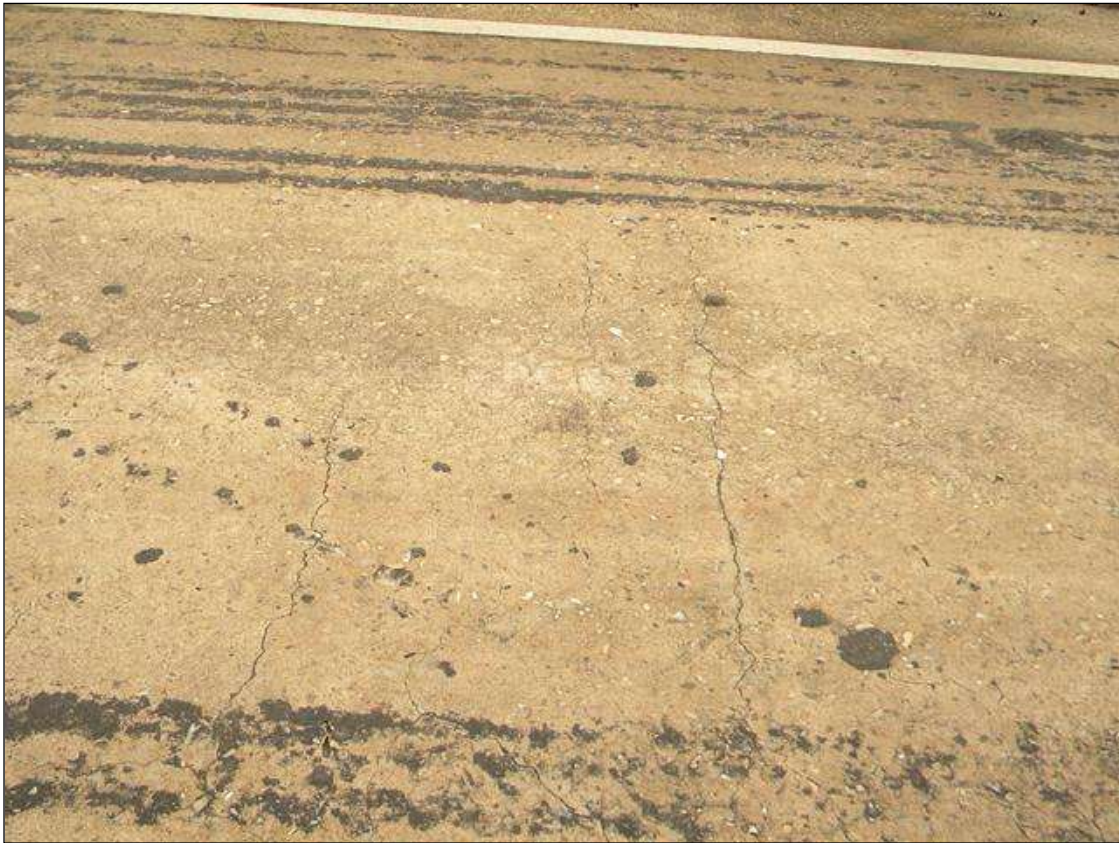
1/16" TRANSVERSE CRACK AND MAP CRACKING IN SPAN 1 NORTH BOUND LANE

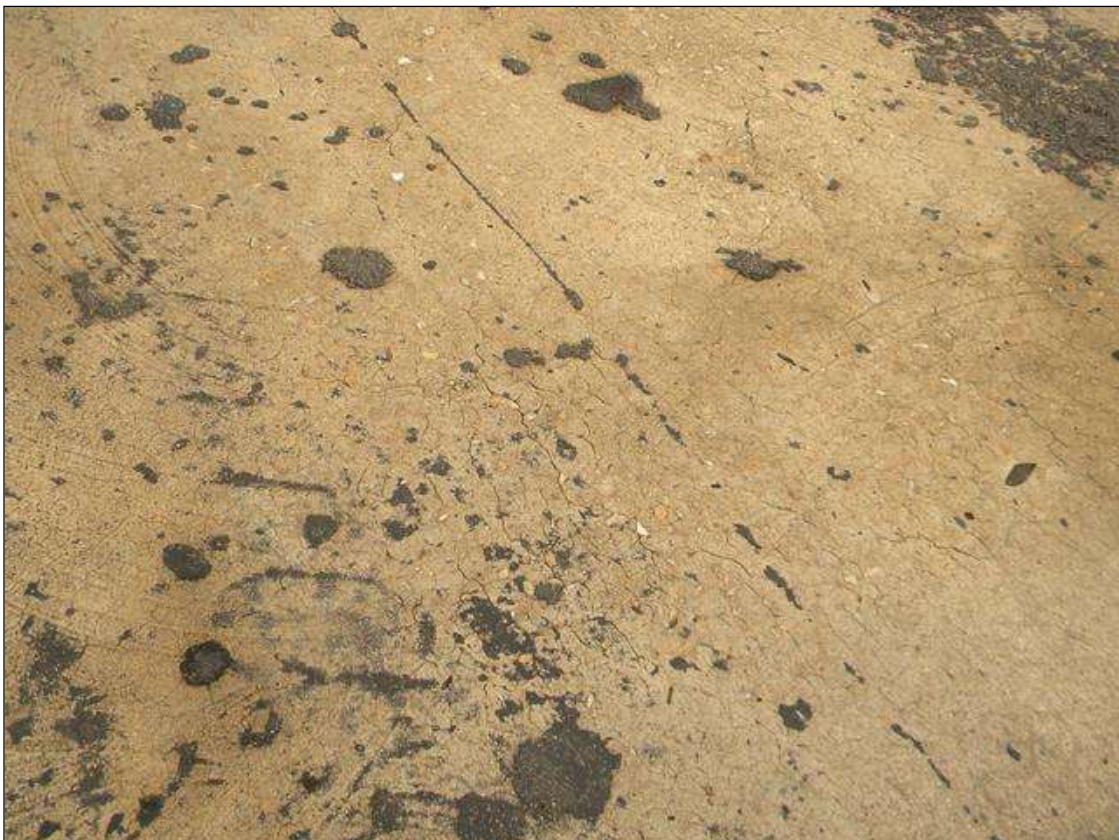
CRACKING IN SPAN 2 SOUTH BOUND LANE

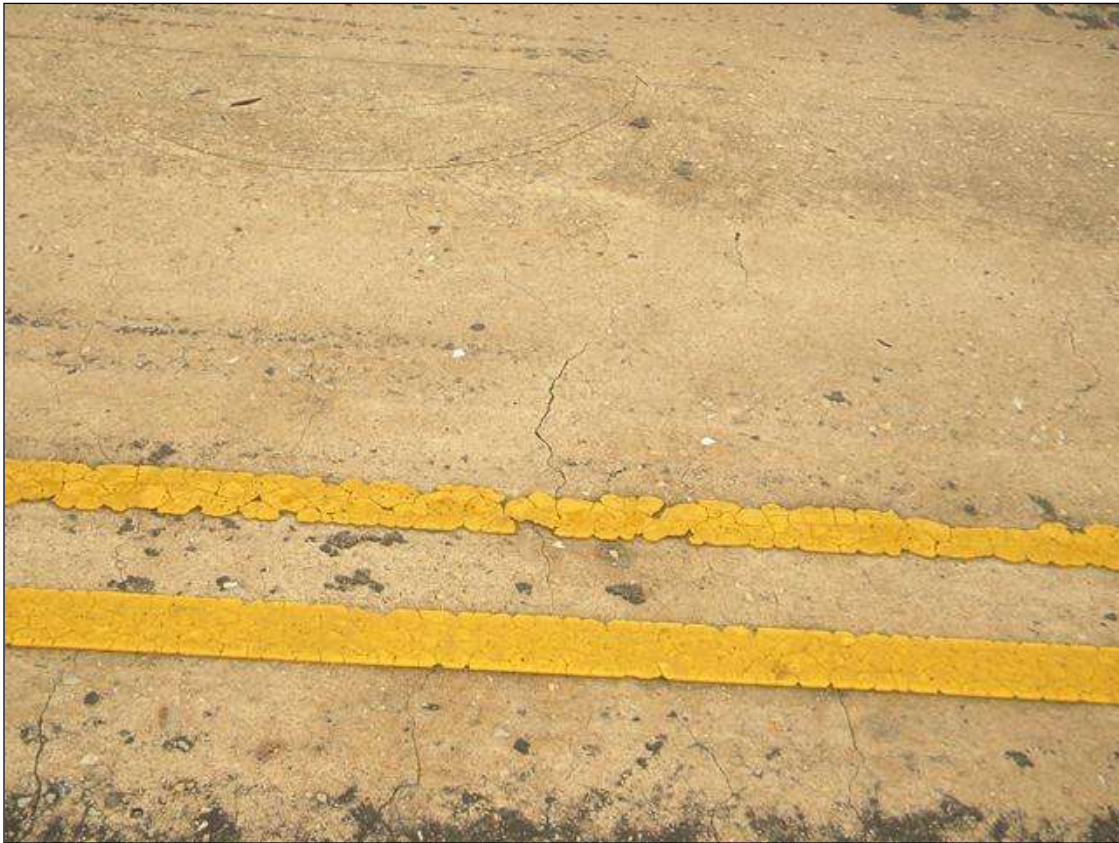
TRANSVERSE CRACK IN SPAN 2 DECK

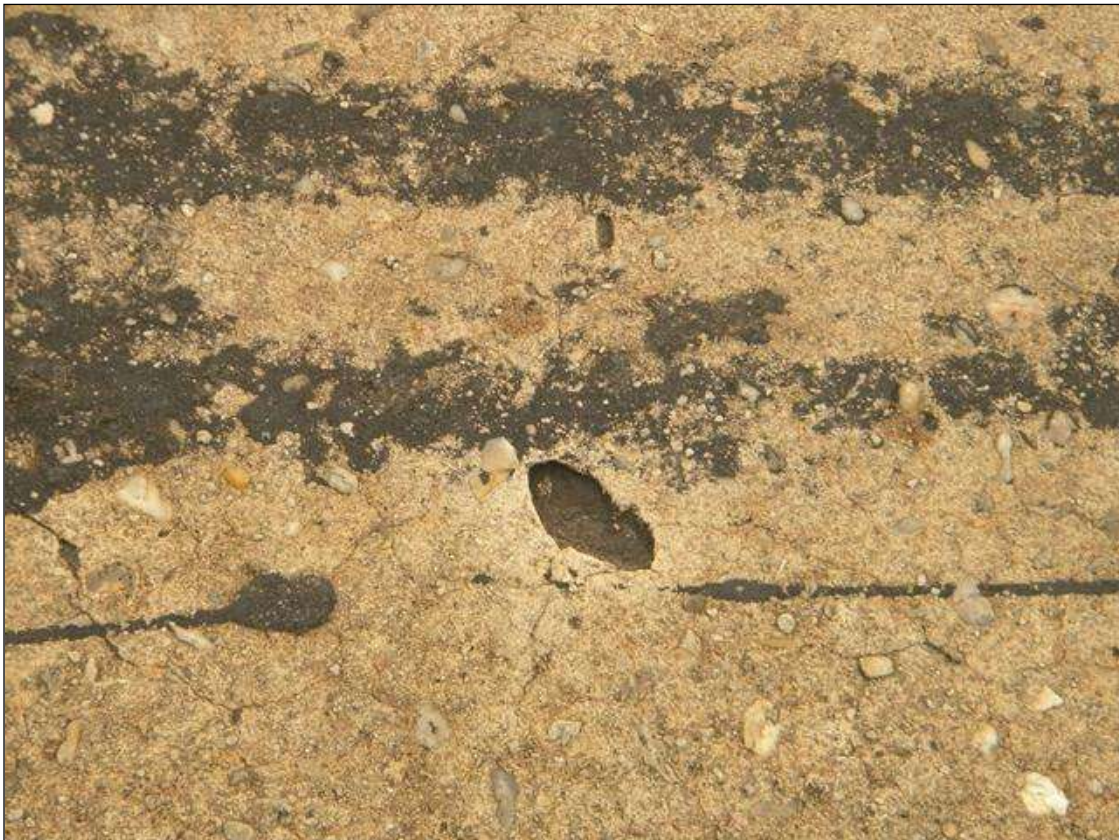
RANDOM SURFACE POPOUTS IN SPAN 2 DECK UP TO 1/2" DEEP

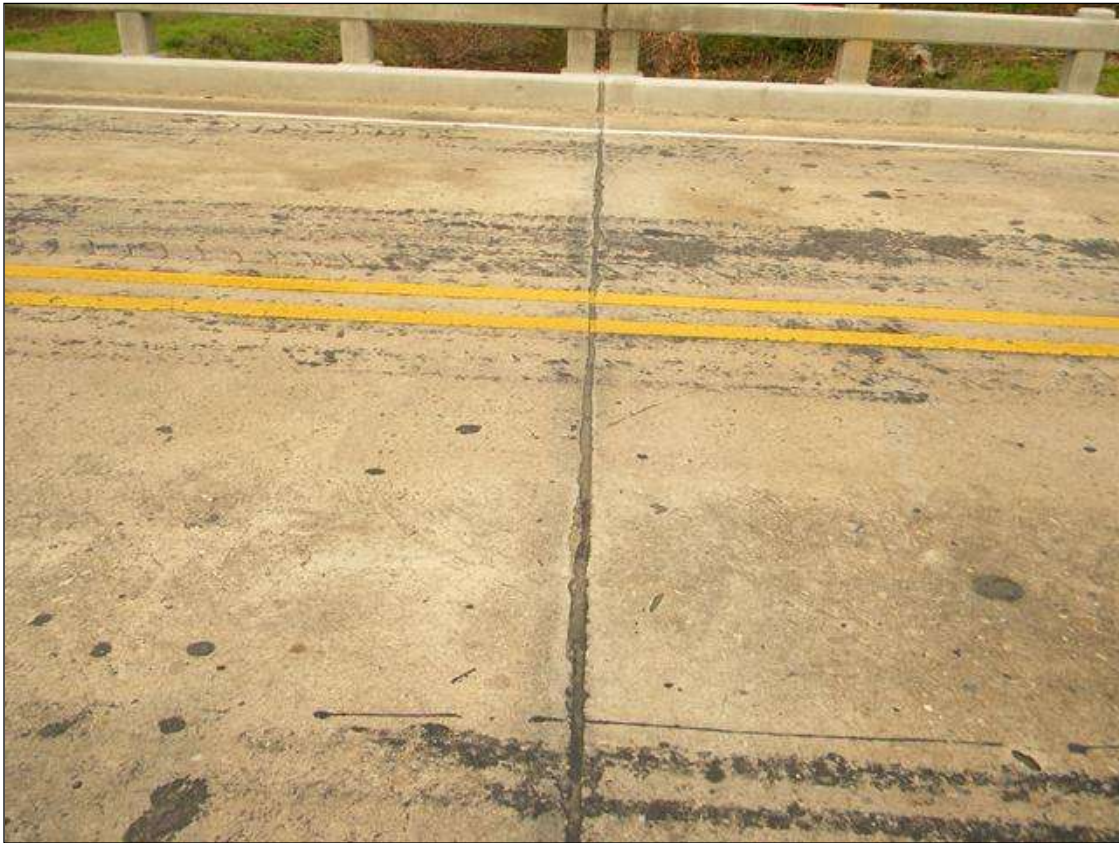
| Bridge I&A Form 1(82)H<br>State of North Carolina<br>Dept. of Transportation<br>Division of Highways | | <b>FIELD INSPECTION REPORT</b><br><u>Bridge Inspection &amp; Analysis</u> | |
|---|---|---|--|
| 6d | G | ( STANDARD JOINT ) BENT 1 STANDARD JOINT SEALED. (PHOTO) | |

BENT 1 STANDARD JOINT SEALED

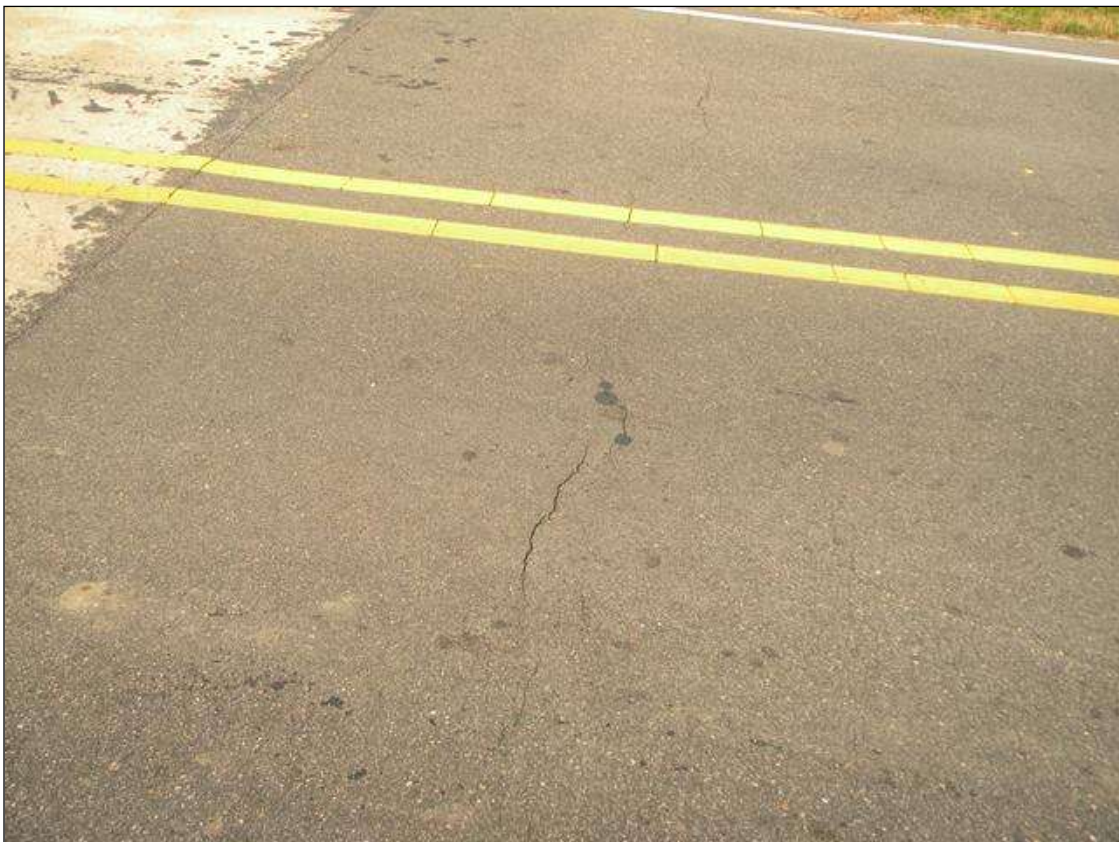
HAIRLINE TO 1/16" TRANSVERSE CRACKS IN NORTH APPROACH ASPHALT WEARING SURFACE

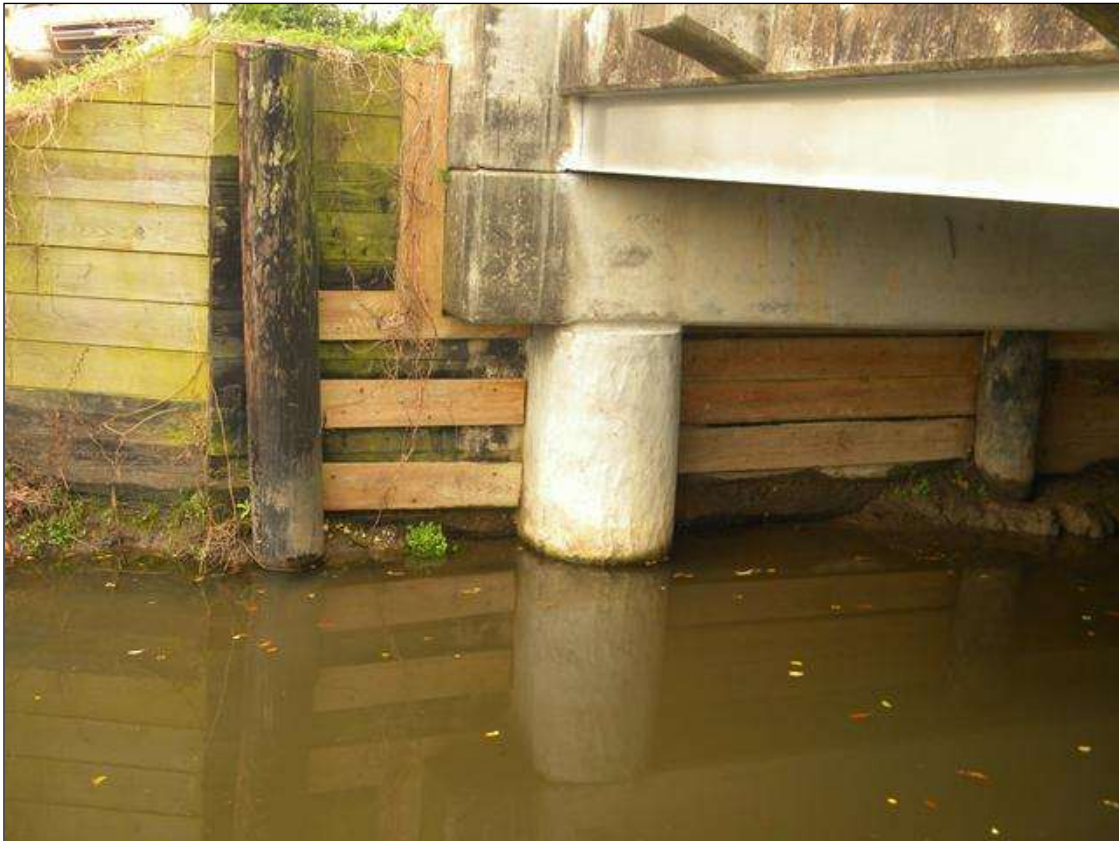
PILE 4 AT END BENT 1 ENCASED IN CONCRETE

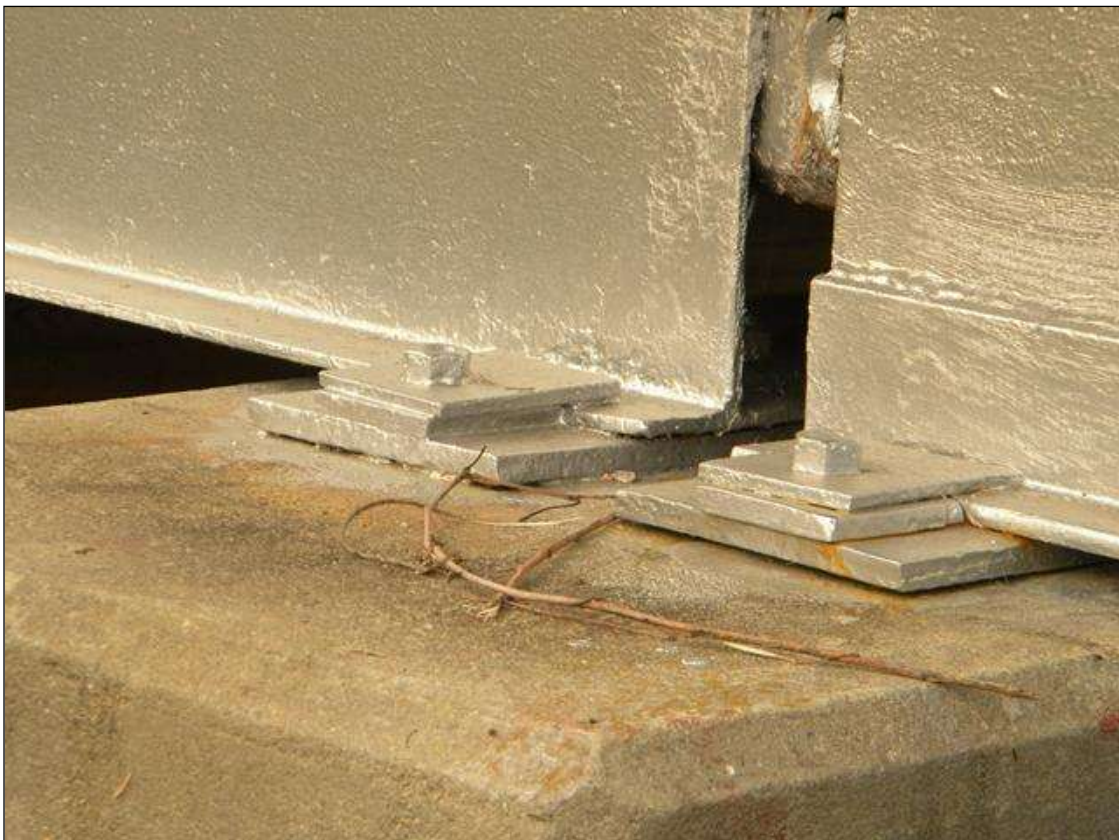
| Bridge I&A Form 1(82)H<br>State of North Carolina<br>Dept. of Transportation<br>Division of Highways | | <b>FIELD INSPECTION REPORT</b><br><u>Bridge Inspection &amp; Analysis</u> | |
|---|---|---|--|
| 15 | G | ( BEARING ASSEMBLIES ) THE BEARINGS HAVE BEEN PAINTED SINCE LAST INSPECTION.<br><br>BEAM 12 BEARINGS AT BENT 1 FRESH PAINT. ALL BEARINGS ARE SIMILAR. (PHOTO) | |

BEAM 12 BEARINGS AT BENT 1 FRESH PAINT, ALL BEARINGS ARE SIMILAR

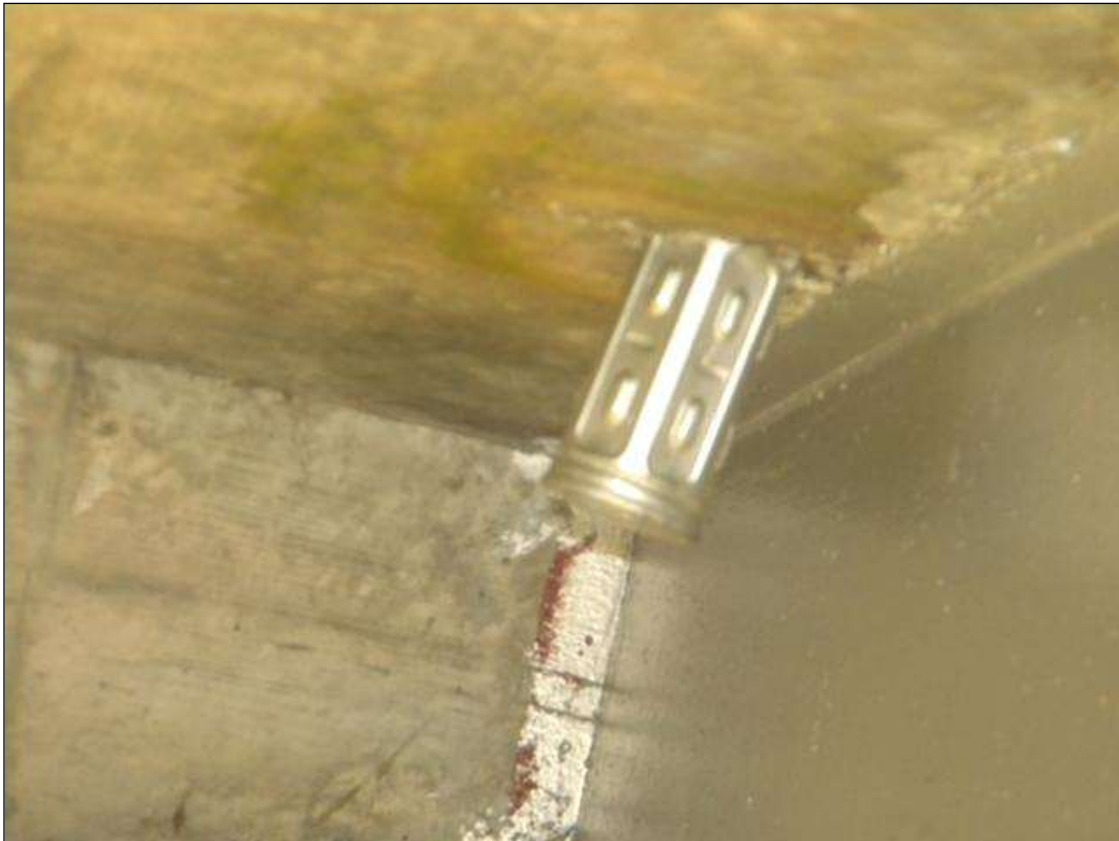
| Bridge I&A Form 1(82)H<br>State of North Carolina<br>Dept. of Transportation<br>Division of Highways | | <b>FIELD INSPECTION REPORT</b><br><u>Bridge Inspection &amp; Analysis</u> | |
|---|---|---|--|
| 16 | G | ( DRAINAGE SYSTEM ) THE LAST DECK DRAIN IN SPAN 2 RIGHT SIDE HAS BEEN REPAIRED. (PHOTO) | |

SPAN 2 RIGHT DRAIN DOWNSPOUT REPAIRED

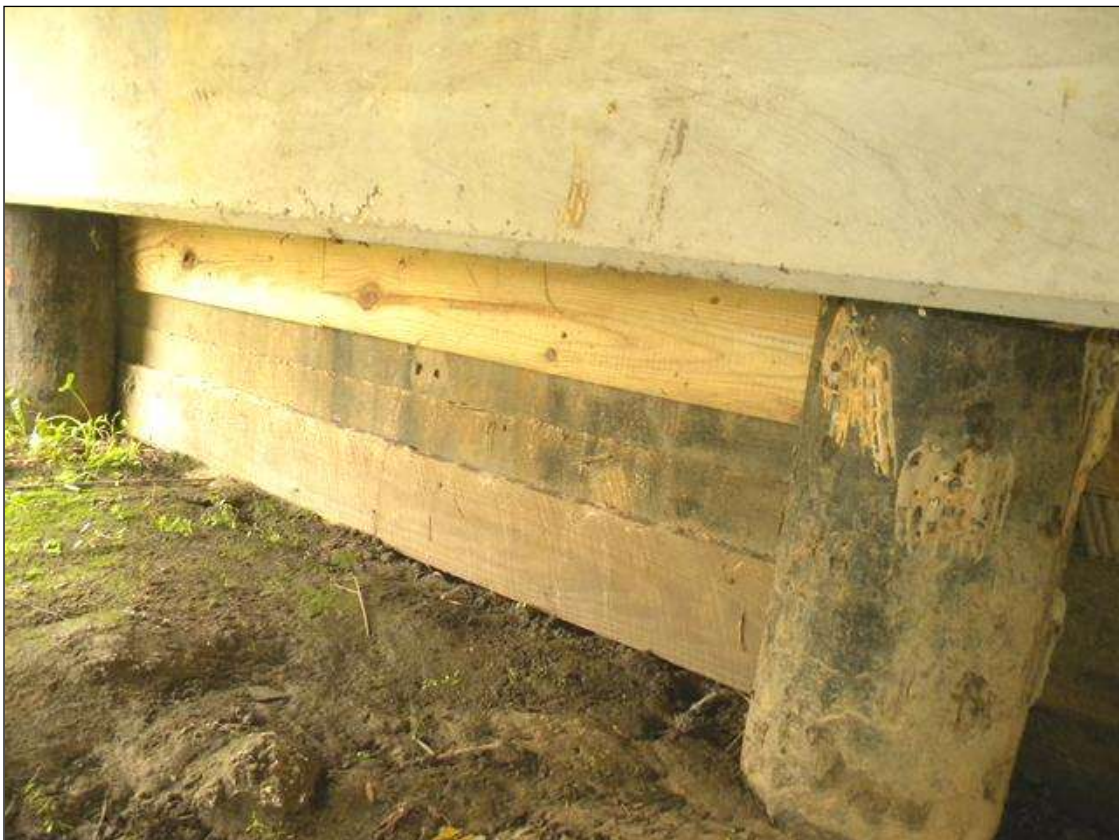
END BENT 2 BULKHEAD BOARDS REPAIRED

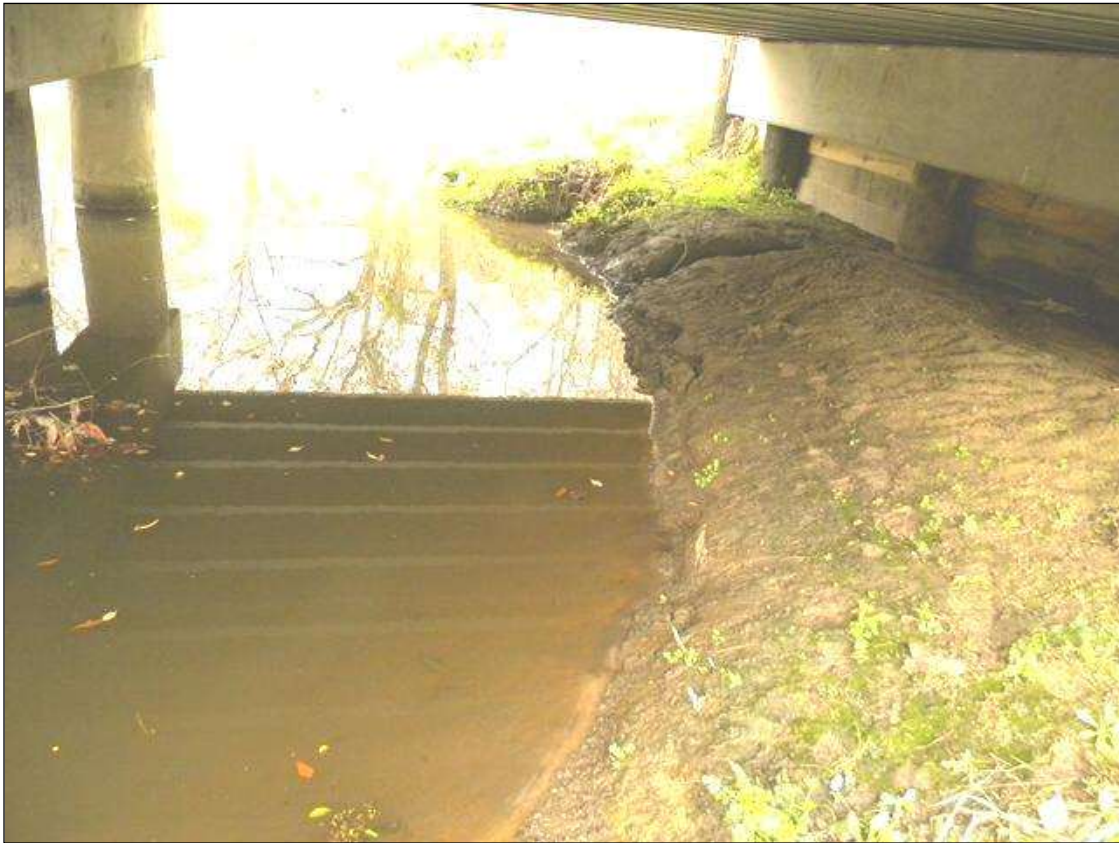
| <b>45c</b> | <b>F</b> | ( SCOUR ) THERE IS LATERAL BANK EROSION IN SPAN 2. (PHOTO)<br><br>THERE IS LATERAL BANK EROSION IN SPAN 1 AT END BENT 1. | |

LATERAL BANK EROSION IN SPAN 2 AT END BENT 2

| MMS Code | Description of Function | Unit | Quantity | Remarks | Est. Cost |
|---|---|---|---|---|---|
| 3352 | Maint Slope Protection | SF | 30 | LATERAL BANK EROSION IN SPAN 2 AT END BENT 2 | |

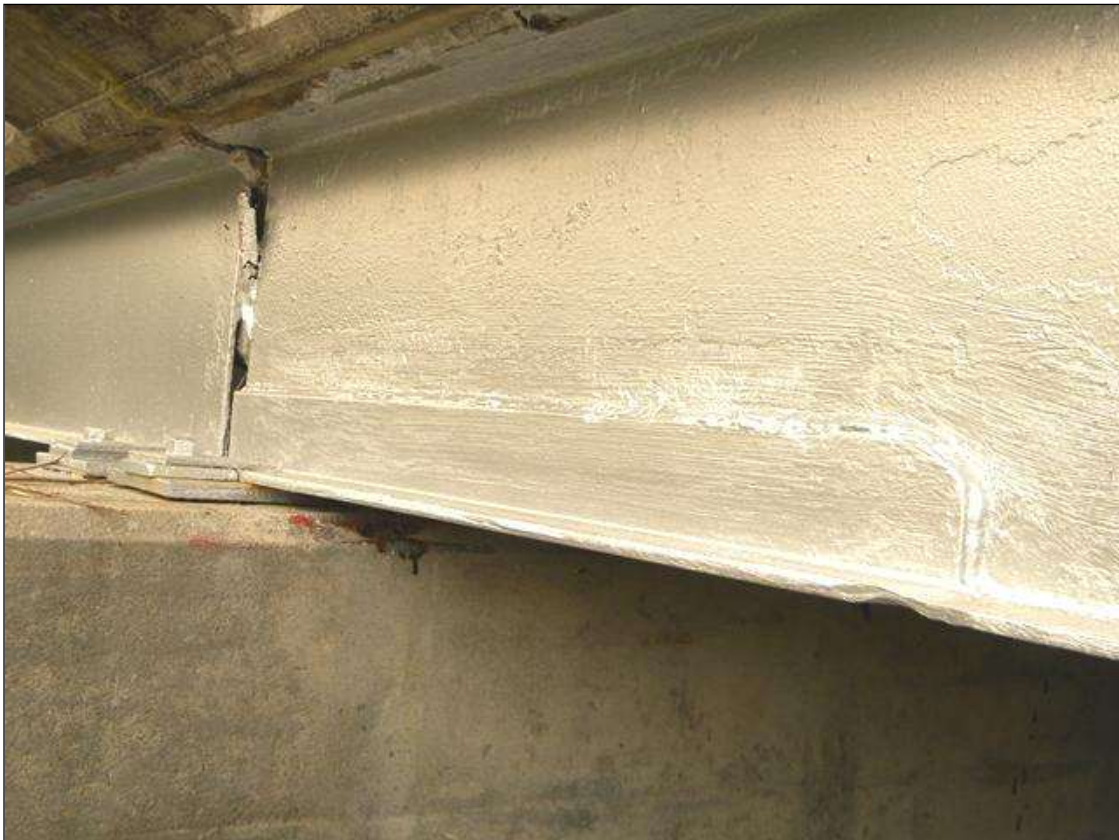
| Bridge I&A Form 1(82)H<br>State of North Carolina<br>Dept. of Transportation<br>Division of Highways | | <b>FIELD INSPECTION REPORT</b><br><u>Bridge Inspection &amp; Analysis</u> | |
|---|---|---|--|
| 10A | NO | BEAM 12 IN SPAN 2 AT BENT 1 HAS SIMILAR REPAIRS. (PHOTO)<br>( CURVED GIRDERS ) NO CURVED GIRDERS. | |

BEAM 12, SPAN 2 AT BENT 1 IS A SIMILAR REPAIR

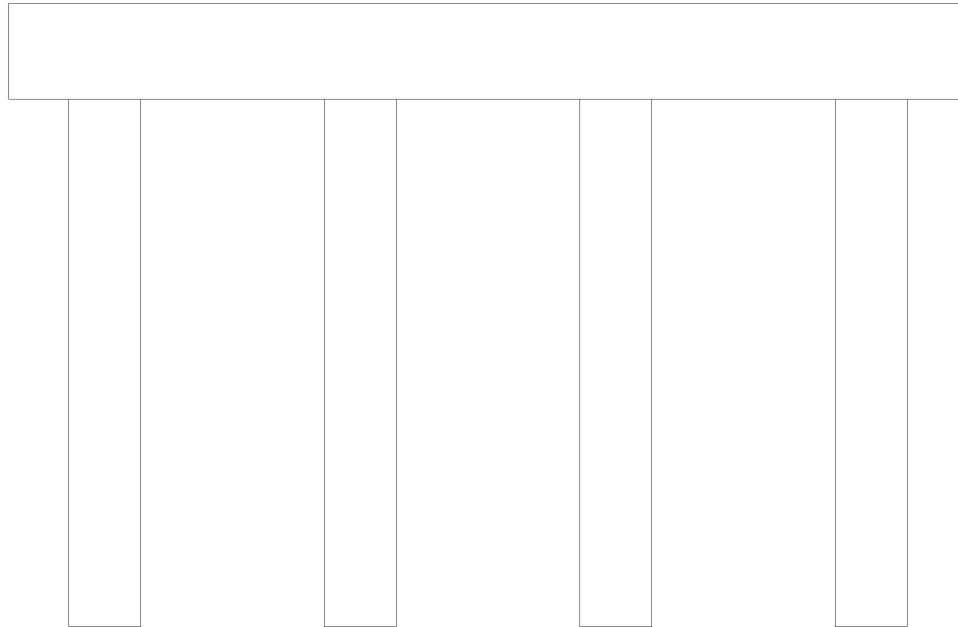
PILE 4 AT EBT1 IS ENCASED IN CONCRETE
