# BRIDGE INSPECTION REPORT

INSPECTION TYPE: Routine Inspection

COUNTY COLUMBUS BRIDGE NUMBER 230308 INSPECTION CYCLE 2 YRS  
ROUTE SR1005 ACROSS CREEK M.P. 0

INSPECTION DATE 01/15/2013

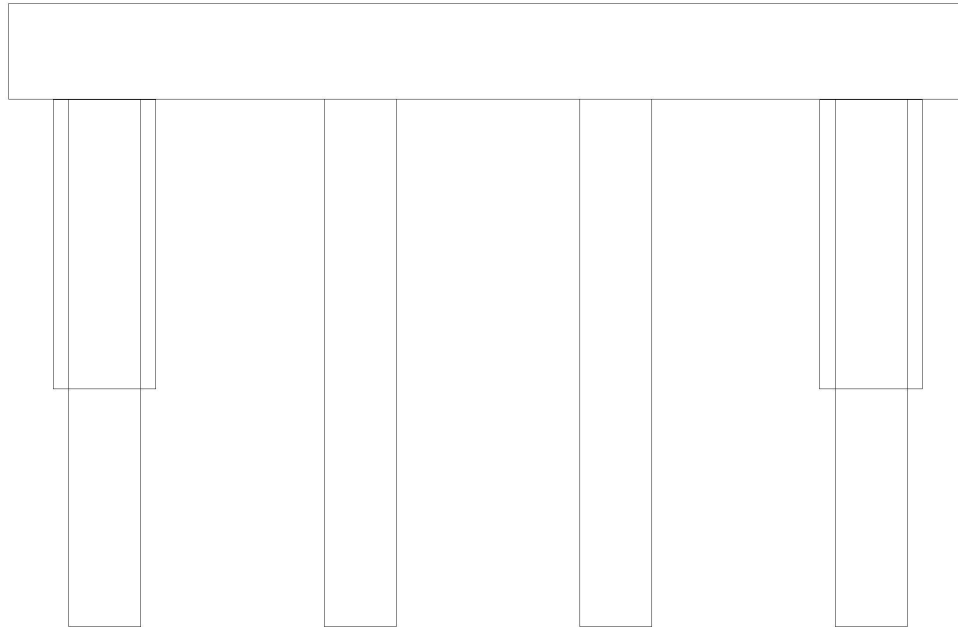
2 FT DIAMETER RC JACKET PILE 1

2 FT x 2.5 FT RC JACKET AT PILE 4
