NC DEPARTMENT OF TRANSPORTATION  
DIVISION OF HIGHWAYS  
BRIDGE MANAGEMENT UNIT

# BRIDGE INSPECTION REPORT

COUNTY GUILFORD BRIDGE NUMBER 400189 INSPECTION CYCLE 2 YRS  
ROUTE SR2719 ACROSS PRONG REEDY FORK M.P. 0

INSPECTION DATE 06/04/2014

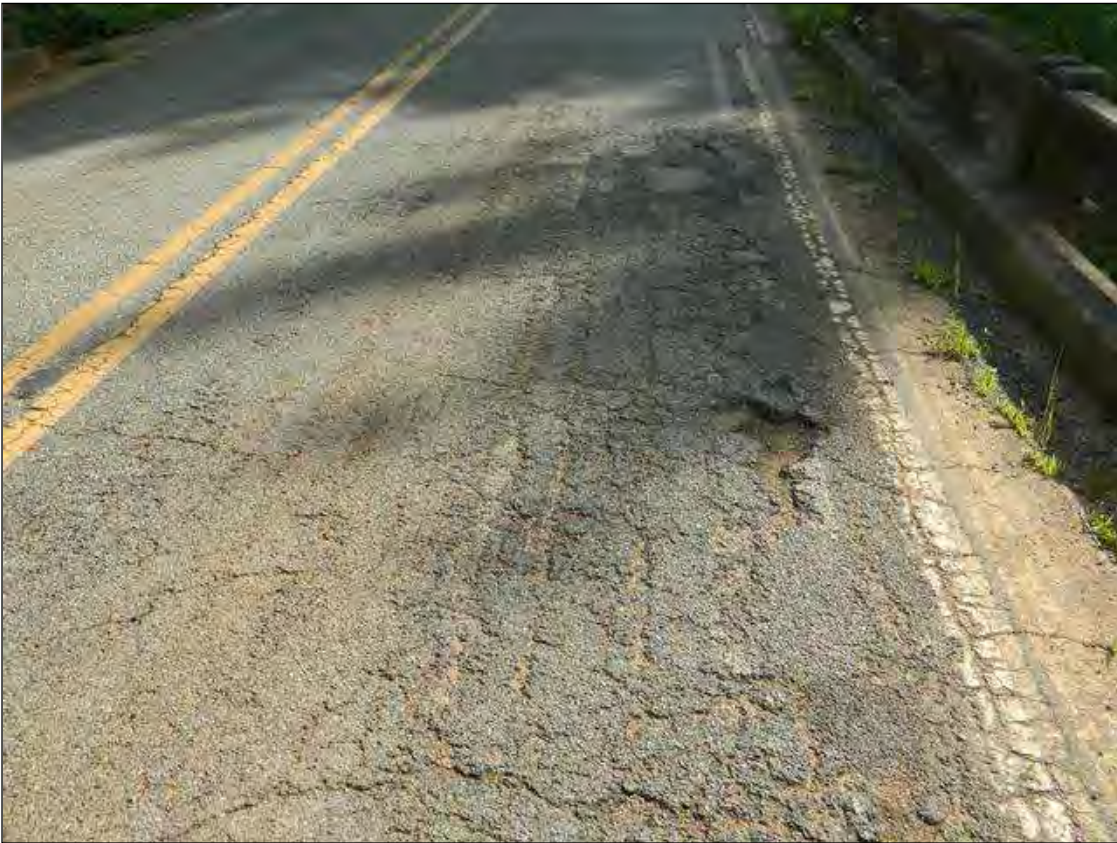
| 1 | P | WEARING SURFACE ..... POTHOLES IN RANDOM AREAS ALONG LENGTH. | |
| | | CRACKED AND BEGINING TO BREAK-UP ALONG LENGTH. | |

ASPHALT WEARING SURFACE HAS POTHOLES AND CRACKING ALONG LENGTH

| MMS Code | Description of Function | Unit | Quantity | Remarks | Est. Cost |
|---|---|---|---|---|---|
| 2816 | Asphalt Surface Repair or Replacement | SY | 15 | WEARING SURFACE ..... POTHOLES IN RANDOM AREAS ALONG LENGTH.<br><br>CRACKED AND BEGINING TO BREAK-UP ALONG LENGTH.<br><br>NO WEARING SURFACE ALONG CURBS AT DRAIN HOLES . | |

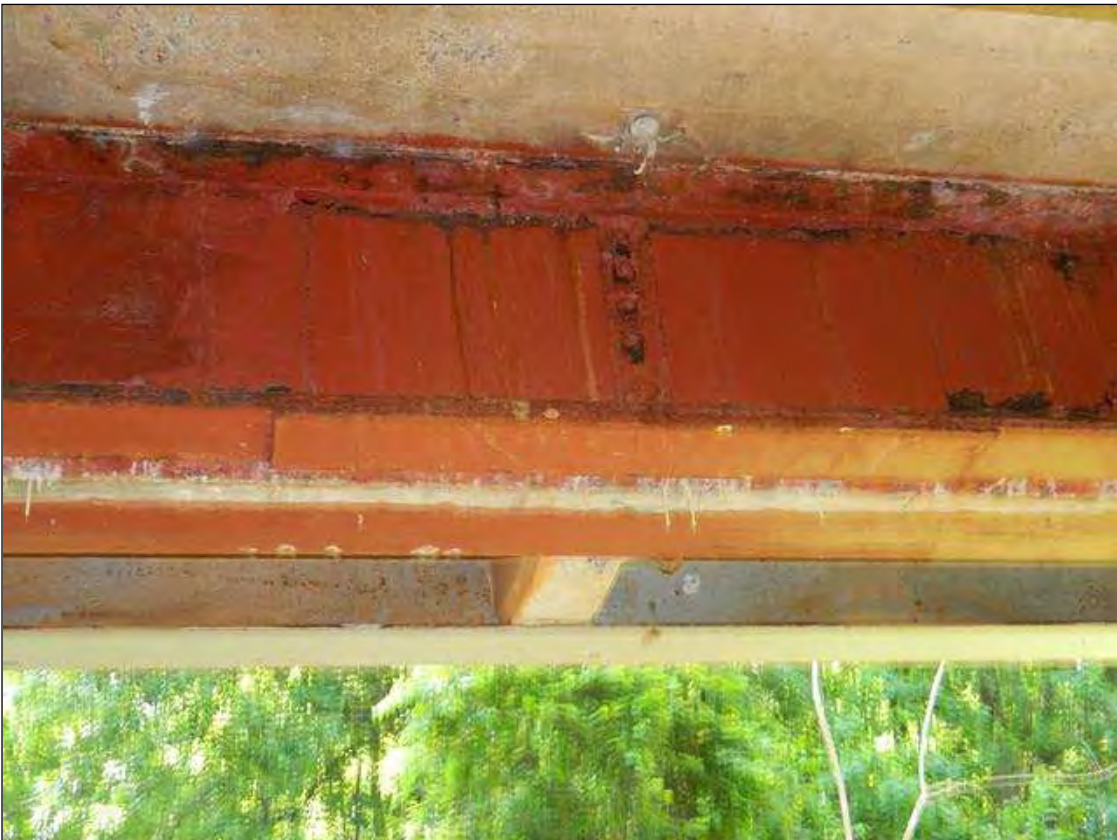
TEMPORARY REPAIR, BEAM 8 PLATED ALONG BOTTOM AND WEB IN SPOTS ALONG LENGTH

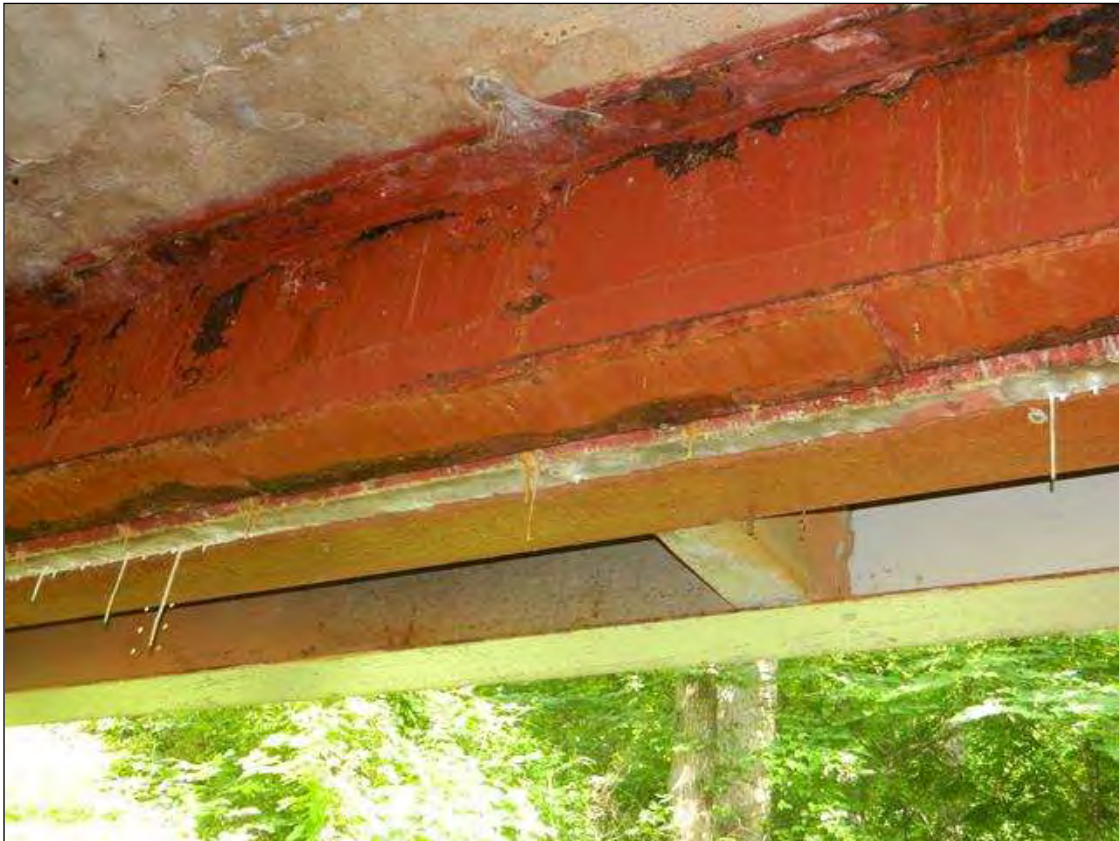
TEMPORARY REPAIR, BEAM 3 PLATED ALONG BOTTOM AND WEB IN SPOTS ALONG LENGTH

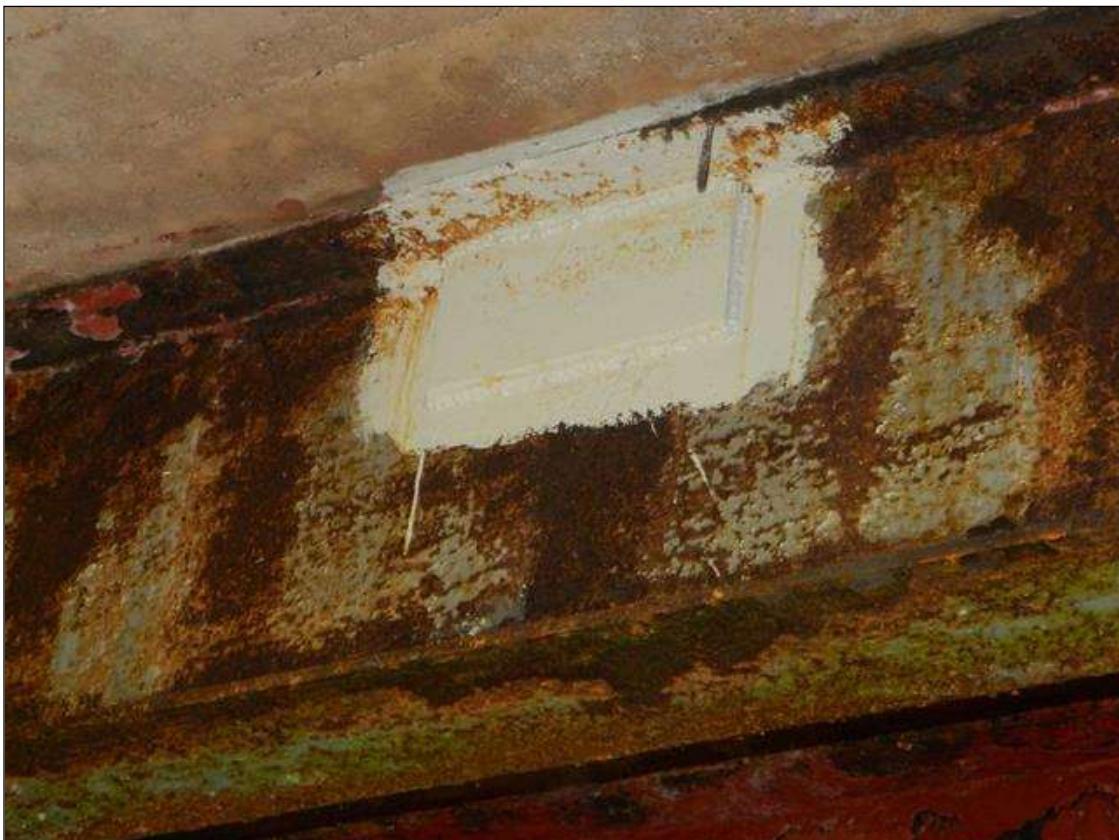
TEMPORARY REPAIR, BEAM 4 PLATED ON RIGHT SIDE OF WEB NEAR MIDSPAN

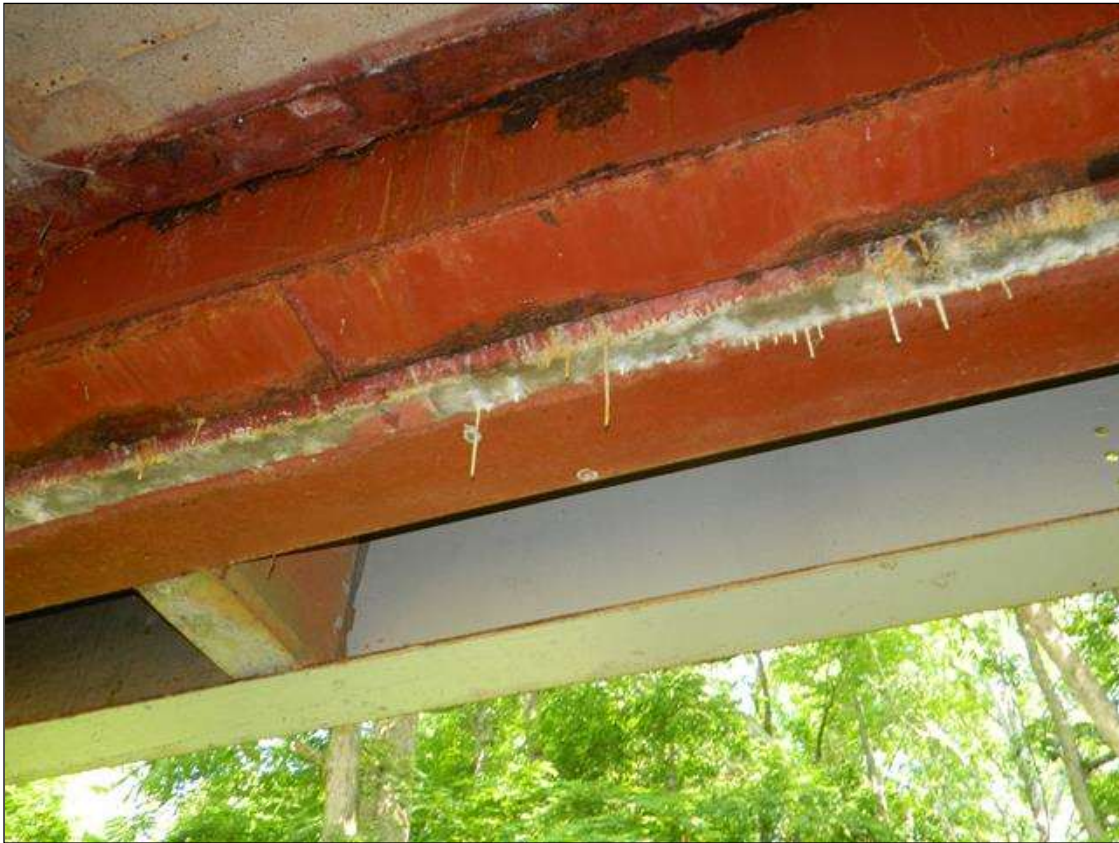
BETWEEN BEAMS 2 AND 3 THERE IS EFFLORESCENCE LEAKING ALONG CONSTRUCTION JOINT, SIMILAR AT BEAMS 8 AND 9

| MMS Code | Description of Function | Unit | Quantity | Remarks | Est. Cost |
|---|---|---|---|---|---|
| 3326 | Maintain Concrete Deck | SF | 100 | DECK....UNDERSIDE HAS EFFLORESCENCE LEAKING ALONG C-JTS IN BAYS 2 AND 8 FROM END TO END .<br><br>1 TV CRACK UP TO 1/16" IN BAY 7 NEAR MID-SPAN . | |

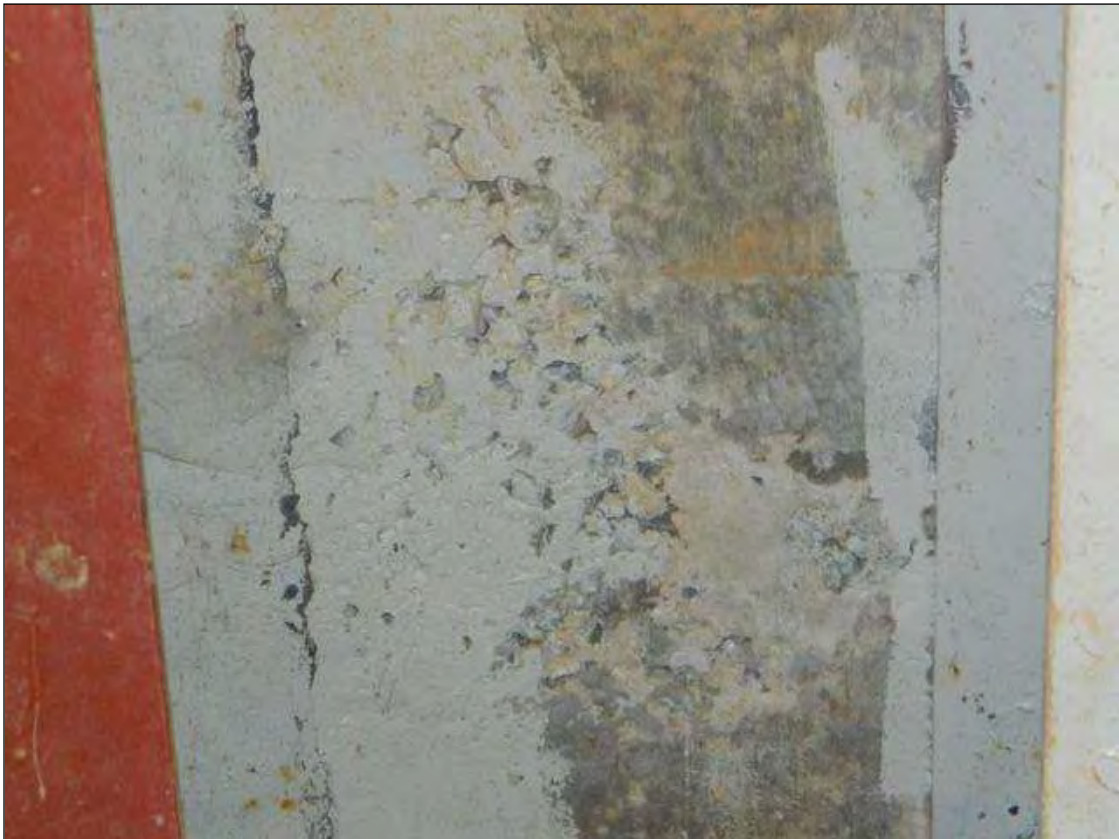
UNDERSIDE OF DECK IN BAY 8, 4' FROM ABUTMENT 2 HAS 1/4" DEEP HONEYCOMBING 1' X 1' AREA

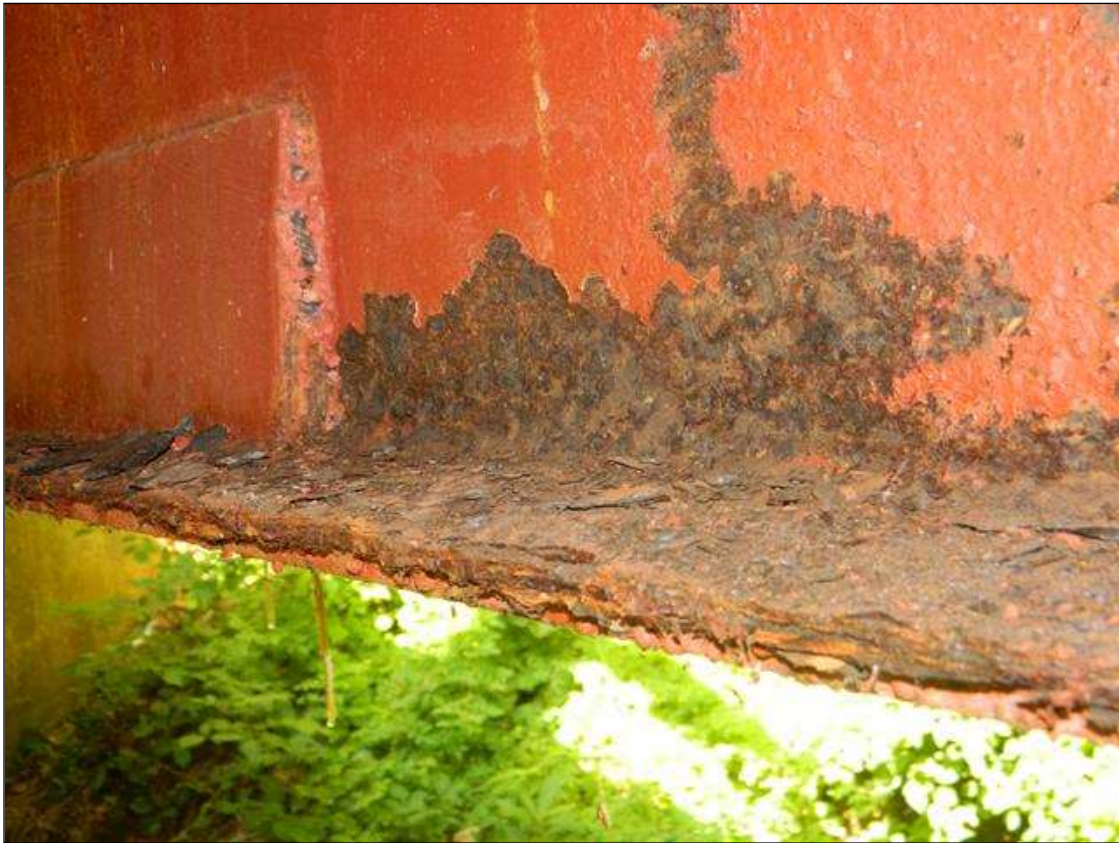
PRIORITY MAINT., BEAM 3, RIGHT SIDE, 12' FROM ABUTMENT 2 HAS SECTION LOSS 1/8" DEEP X 4" HIGH X 1' LONG ALONG THE LOWER WEB

| MMS Code | Description of Function | Unit | Quantity | Remarks | Est. Cost |
|---|---|---|---|---|---|
| 3314 | Maintain Steel Superstructure Components | LF | 25 | PRIORITY MAINT., BEAM 3, RIGHT SIDE, 12' FROM ABUTMENT 2 HAS SECTION LOSS 1/16 to 1/8" DEEP X 4" HIGH X 1' LONG ALONG THE LOWER WEB. BEAM 3, RIGHT SIDE OF WEB AT DIAPHRAGM 1 HAS 1/16 TO 1/8" SECTION LOSS ALONG DIAPHRAGM CONNECTION TO WEB. RIGHT SIDE HAS 1/16" TO 1/8" SECTION LOSS ALONG THE UPPER WEB UP TO 2" HIGH IN A 25' LONG AREA STARTING AT ABUTMENT 1 CAP. | |

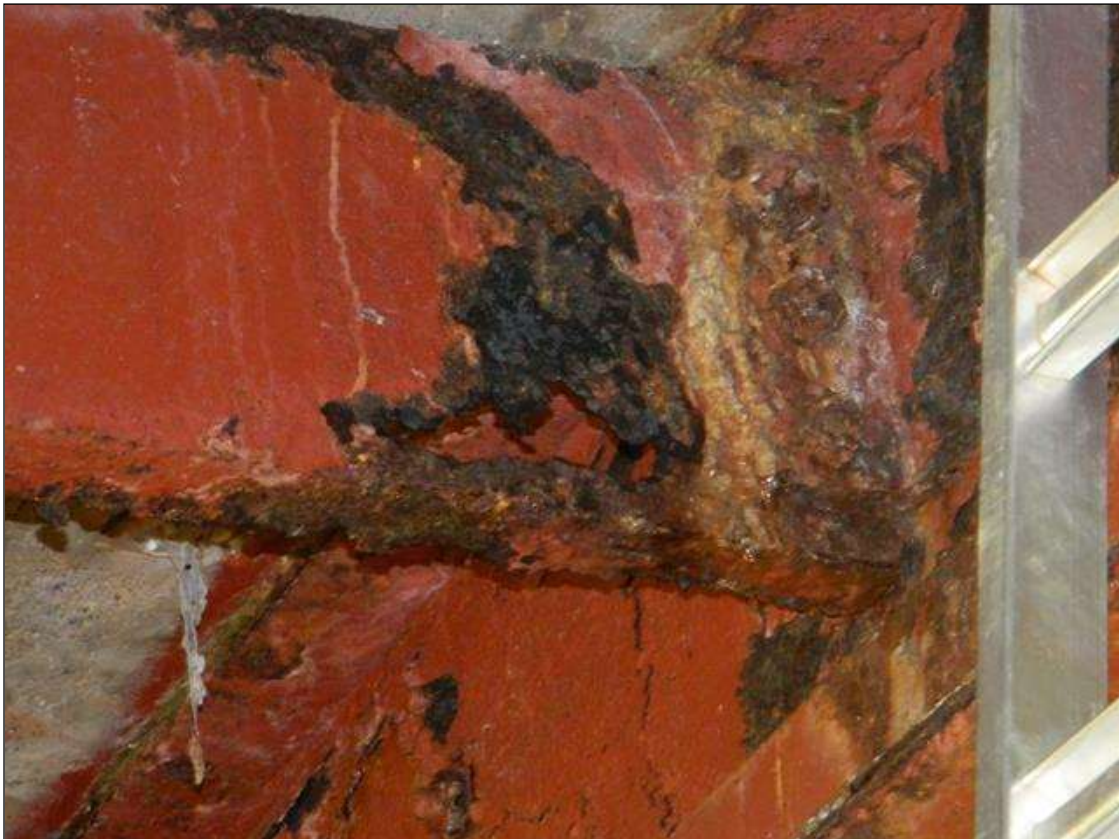
PRIORITY MAINT., BAY 3, DIAPHRAGM 1 HAS A 5" LONG X 2" HIGH HOLE IN WEB

| MMS Code | Description of Function | Unit | Quantity | Remarks | Est. Cost |
|---|---|---|---|---|---|
| 3314 | Maintain Steel Superstructure Components | LF | 1 | PRIORITY MAINT., BAY 3, DIAPHRAGM 1 HAS A 5" LONG X 2" HIGH HOLE IN LOWER WEB | |

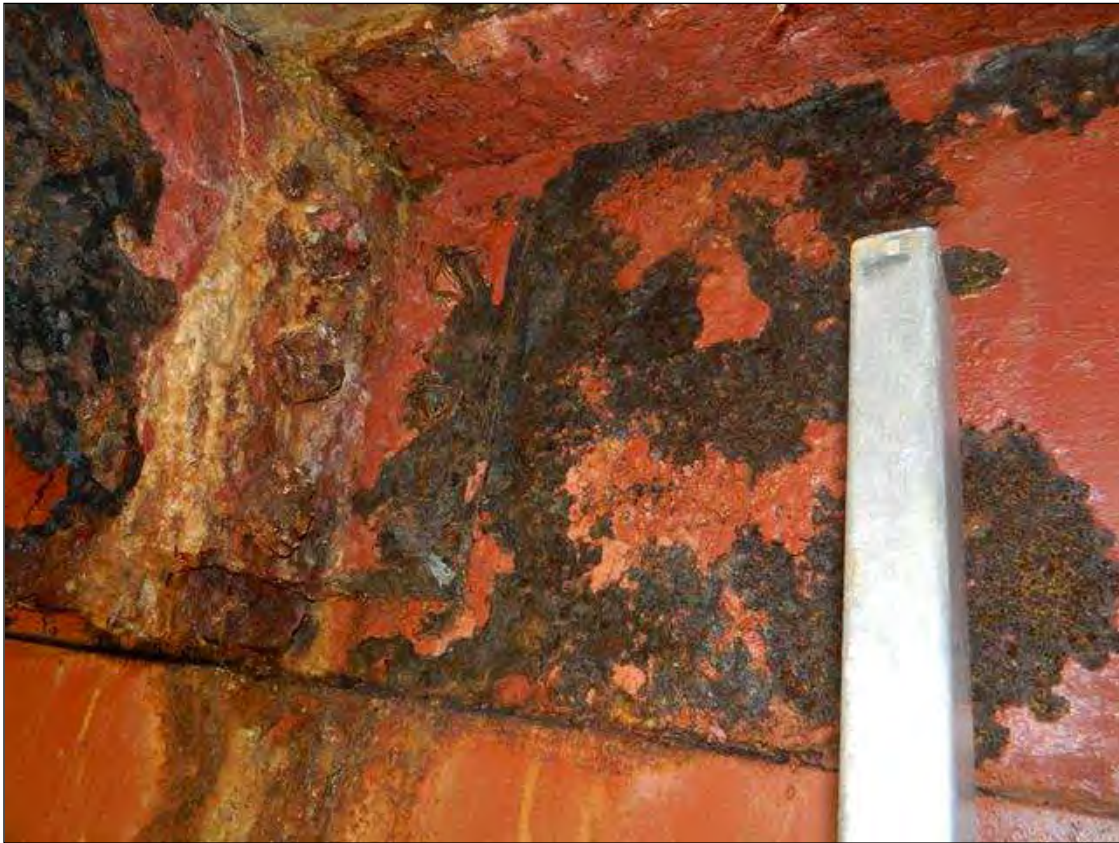
PRIORITY MAINT., BEAM 3, RIGHT SIDE OF WEB AT DIAPHRAGM 1 HAS 1/16 TO 1/8" SECTION LOSS ALONG DIAPHRAGM CONNECTION TO WEB.

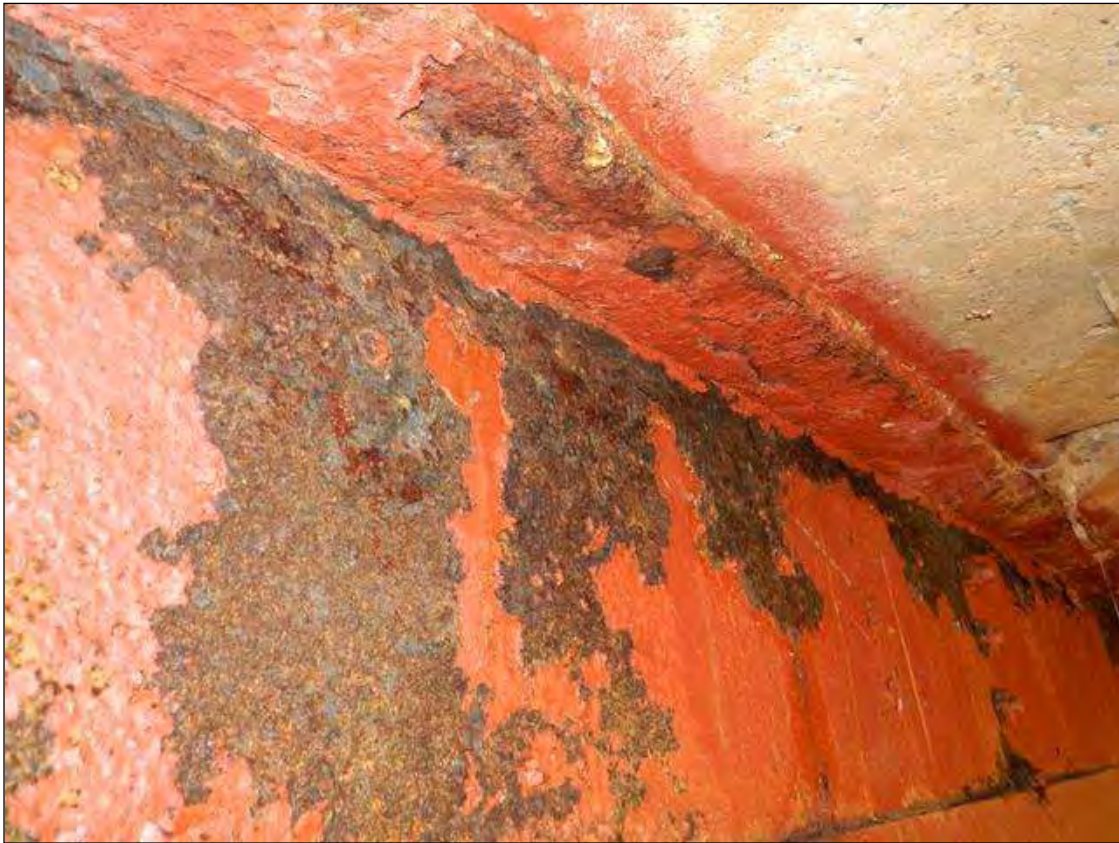
PRIORITY MAINT., BEAM 3, RIGHT SIDE ON TOP OF WEB HAS 1/16" TO 1/8" SECTION LOSS IN A 6' AREA NEAR MIDSPAN.

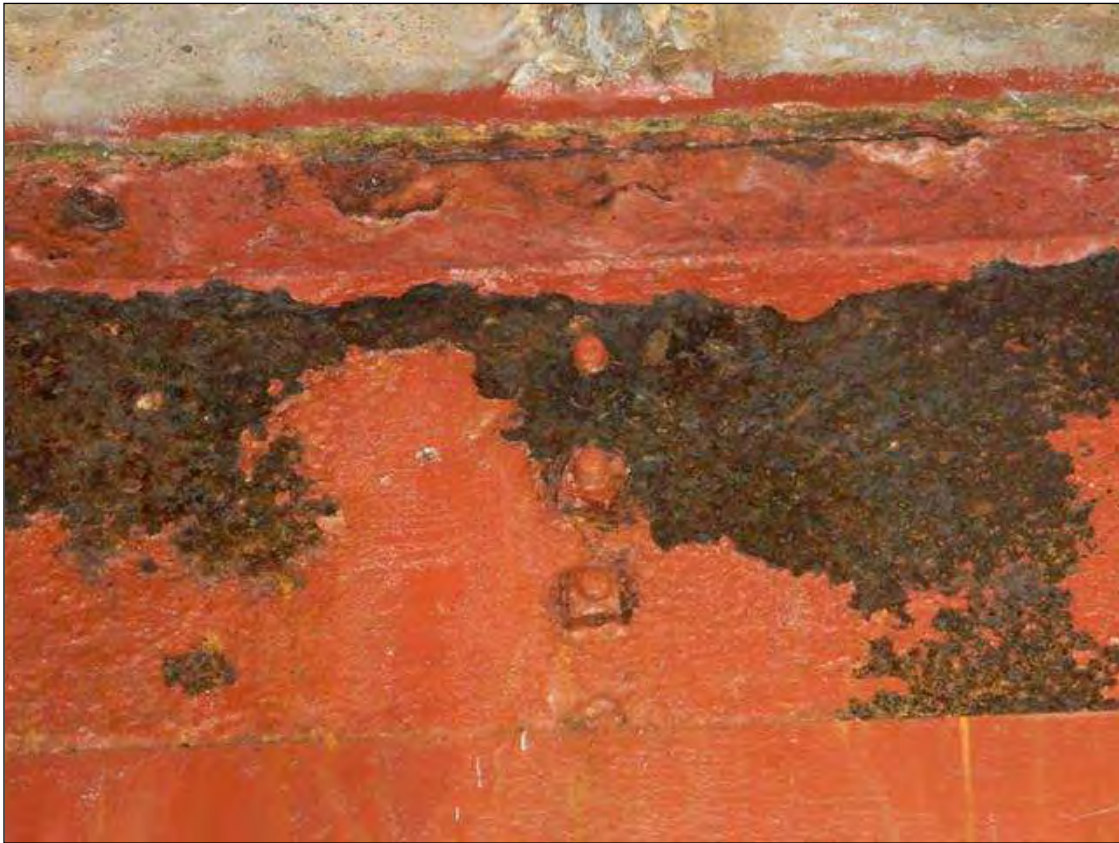
PRIORITY MAINT., BEAM 3, RIGHT SIDE HAS 1/16" TO 1/8" SECTION LOSS ALONG THE UPPER WEB UP TO 2" HIGH IN A 25' LONG AREA STARTING AT ABUTMENT 1 CAP.

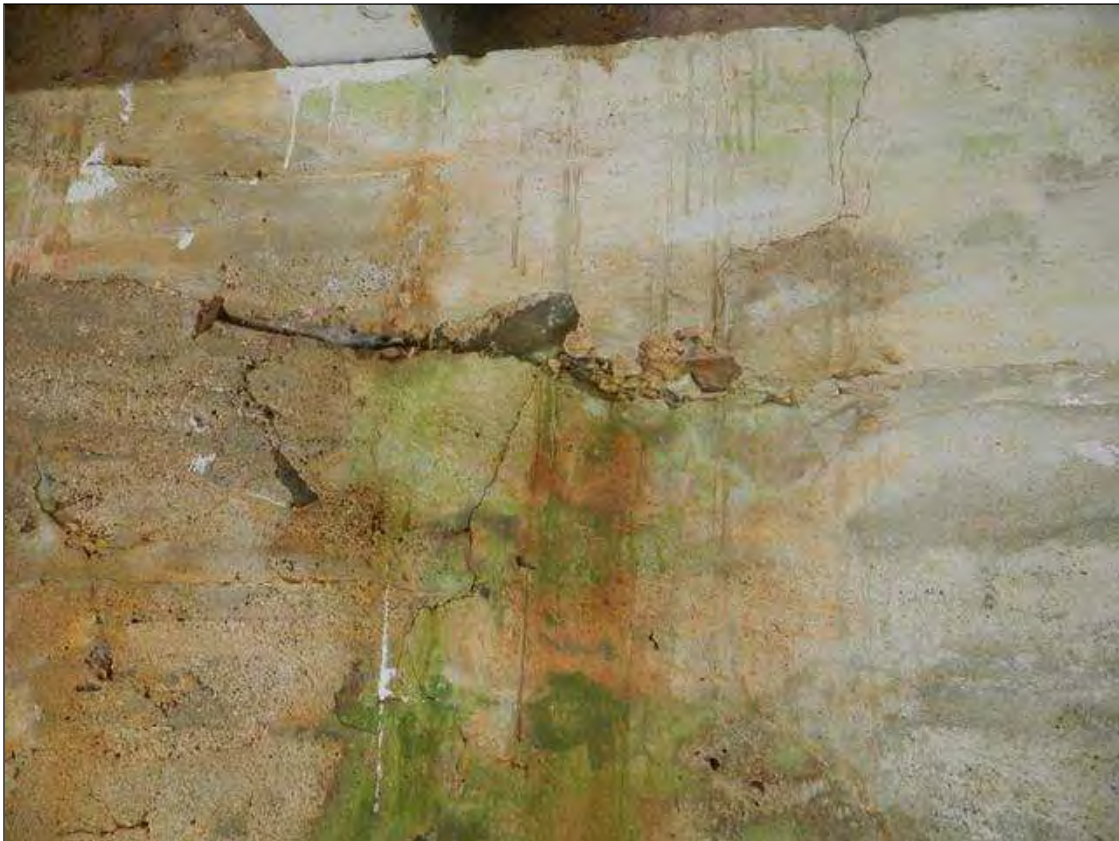
| Bridge I&A Form 1(82)H<br>State of North Carolina<br>Dept. of Transportation<br>Division of Highways | | <h1 style="text-align: center;">FIELD INSPECTION REPORT</h1> <p style="text-align: center;"><u>Bridge Inspeccion &amp; Analysis</u></p> | |
|---|---|---|--|
| 36a | F | CAPS ..... BOTH ABUTMENTS HAVE SCATTERED H/L CRACKS UP TO 2 1/2 INCH HONEYCOMBING ALONG RUBBLE MASONRY SECTION . | |

ABUTMENT 1 HAS ISOLATED PITTING AND HONEYCOMBING

| MMS Code | Description of Function | Unit | Quantity | Remarks | Est. Cost |
|---|---|---|---|---|---|
| 3348 | Maintain Concrete Substructure Components | LF | 50 | BOTH ABUTMENTS HAVE SCATTERED H/L CRACKS UP TO 2 1/2 INCH HONEYCOMBING ALONG RUBBLE MASONRY SECTION . | |

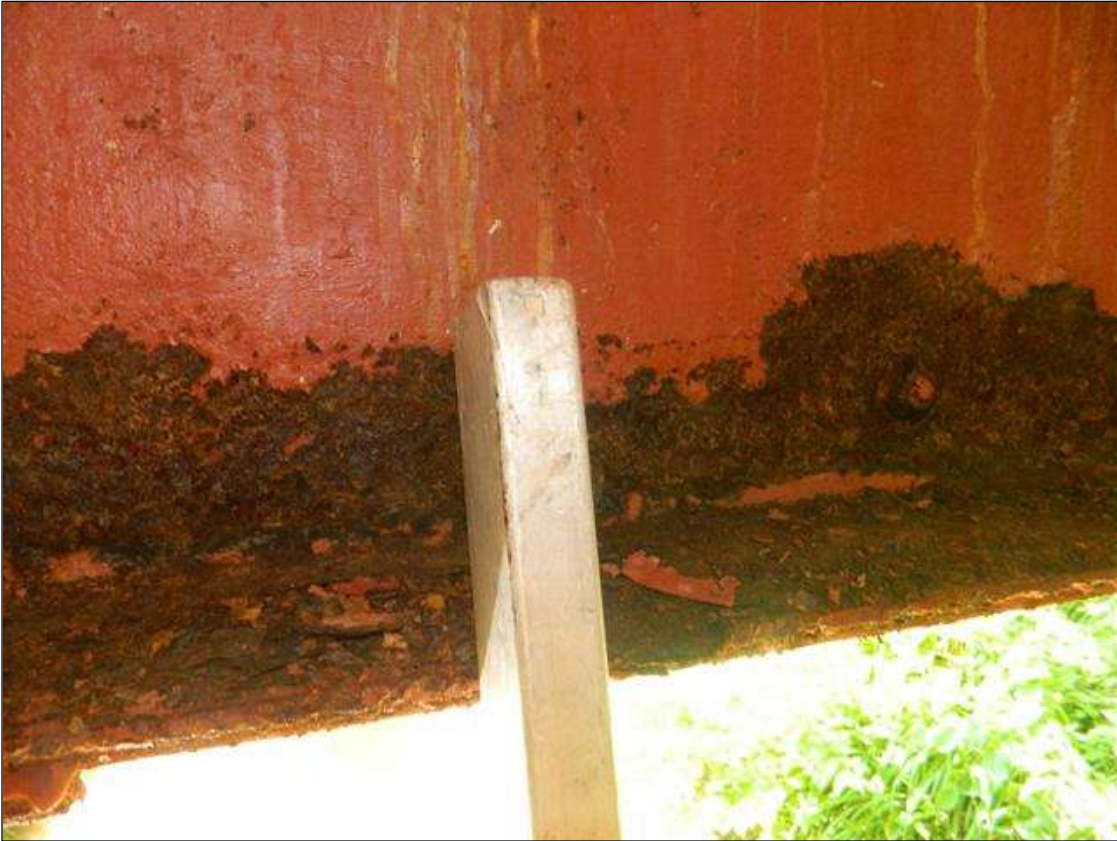
PRIORITY MAINT., BEAM 8, LEFT SIDE 12' OUT FROM ABUTMENT 1, HAS 2' LONG X 4" HIGH AREA OF 1/8" SECTION LOSS

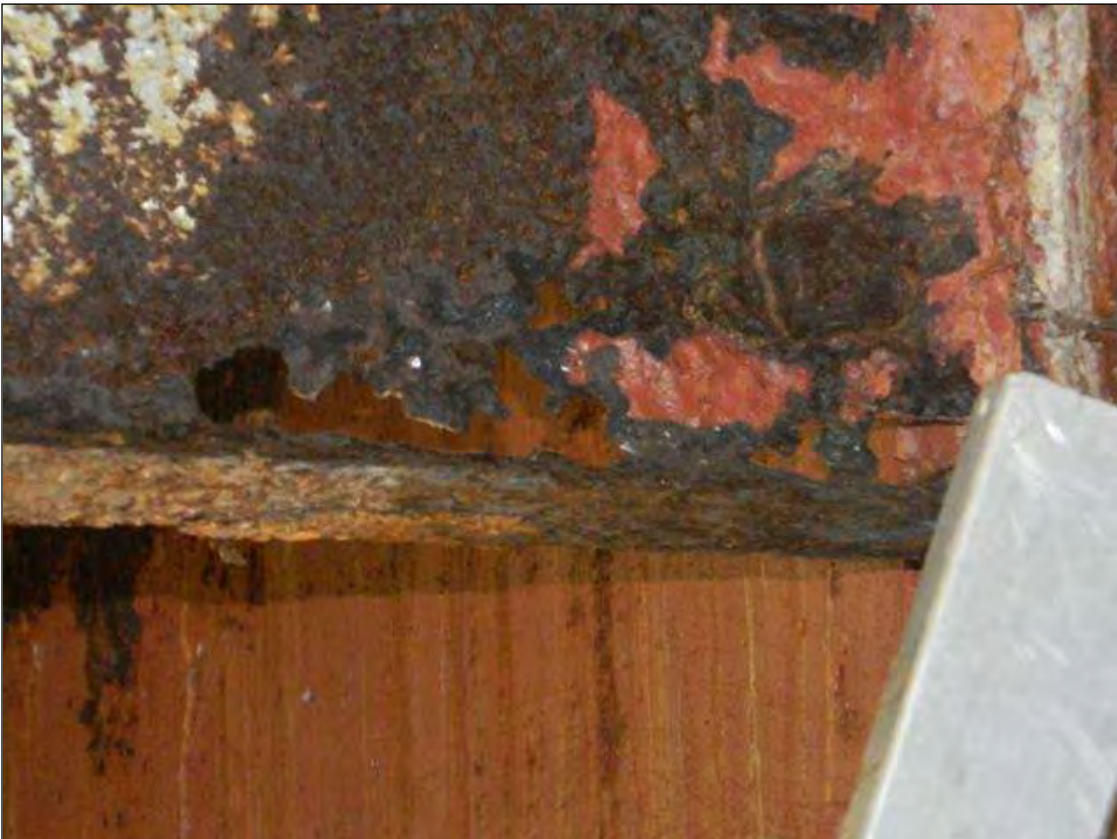
PRIORITY MAINT., BAY 7, DIAPHRAGM 1 HAS 6" LONG X 1 1/2" HIGH HOLE

| MMS Code | Description of Function | Unit | Quantity | Remarks | Est. Cost |
|---|---|---|---|---|---|
| 3314 | Maintain Steel Superstructure Components | LF | 1 | PRIORITY MAINT., BAY 7, DIAPHRAGM 1 HAS 6" LONG X 1 1/2" HIGH HOLE | |

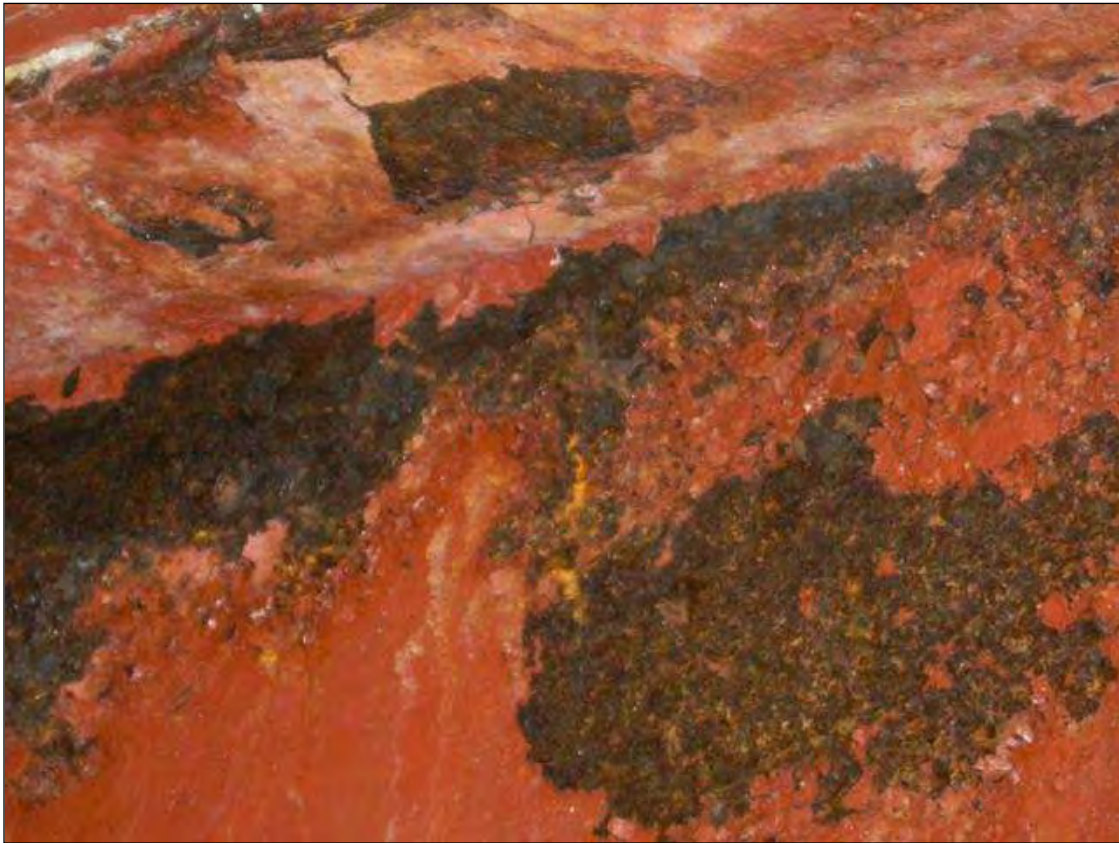
PRIORITY MAINT., BEAM 8 HAS 1/16 TO 1/8" SECT. LOSS IN A 2" HIGH X 2' LONG AREA ON LEFT SIDE ALONG TOP OF WEB 8' OUT FROM ABUTMENT 1,

| MMS Code | Description of Function | Unit | Quantity | Remarks | Est. Cost |
|---|---|---|---|---|---|
| 3314 | Maintain Steel Superstructure Components | LF | 5 | PRIORITY MAINT., BEAM 8 HAS 1/16 TO 1/8" SECT. LOSS IN A 2" HIGH X 2' LONG AREA ON LEFT SIDE ALONG TOP OF WEB 8' OUT FROM ABUTMENT 1. ALSO HAS 1/16 TO 1/8" SECT. LOSS IN A 3' LONG X 3" HIGH AREA ON LEFT SIDE ALONG LOWER WEB 8' OUT FROM ABUTMENT 1. | |

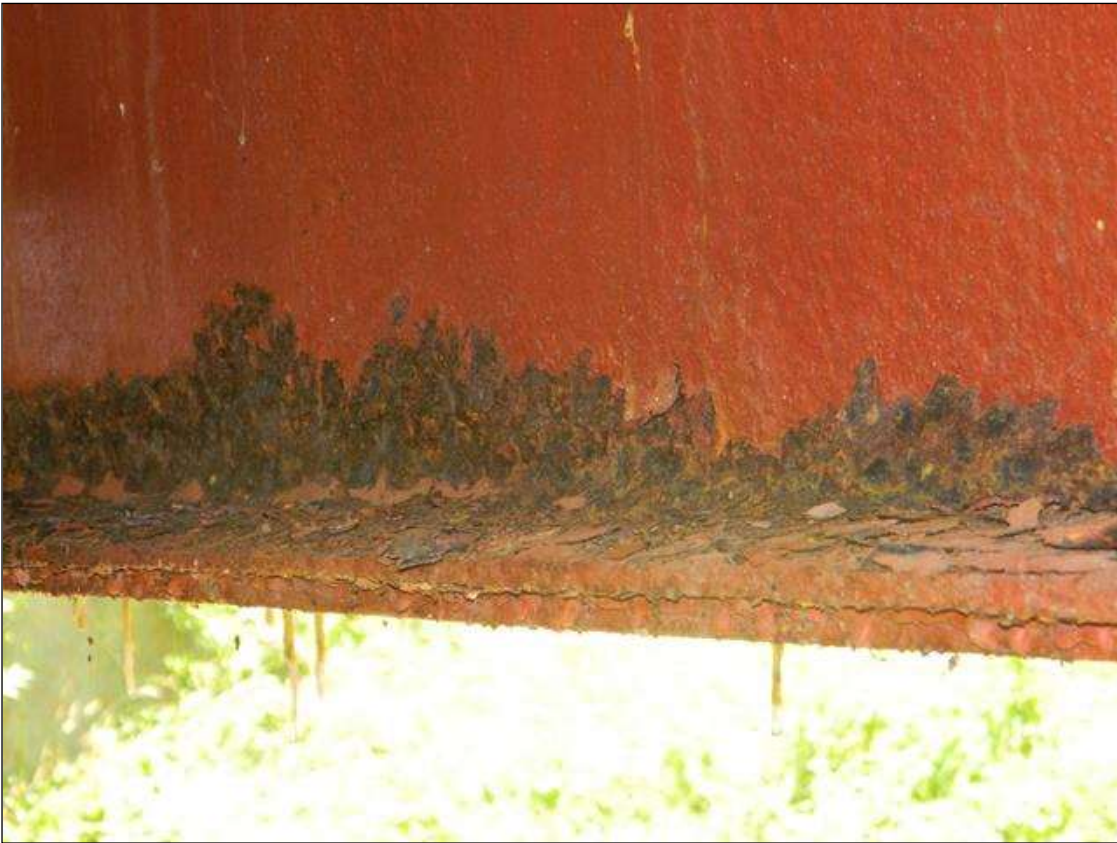
PRIORITY MAINT., BEAM 8, HAS 1/16 TO 1/8" SECT. LOSS IN A 3' LONG X 3" HIGH AREA ON LEFT SIDE ALONG LOWER WEB 8' OUT FROM ABUTMENT 1.

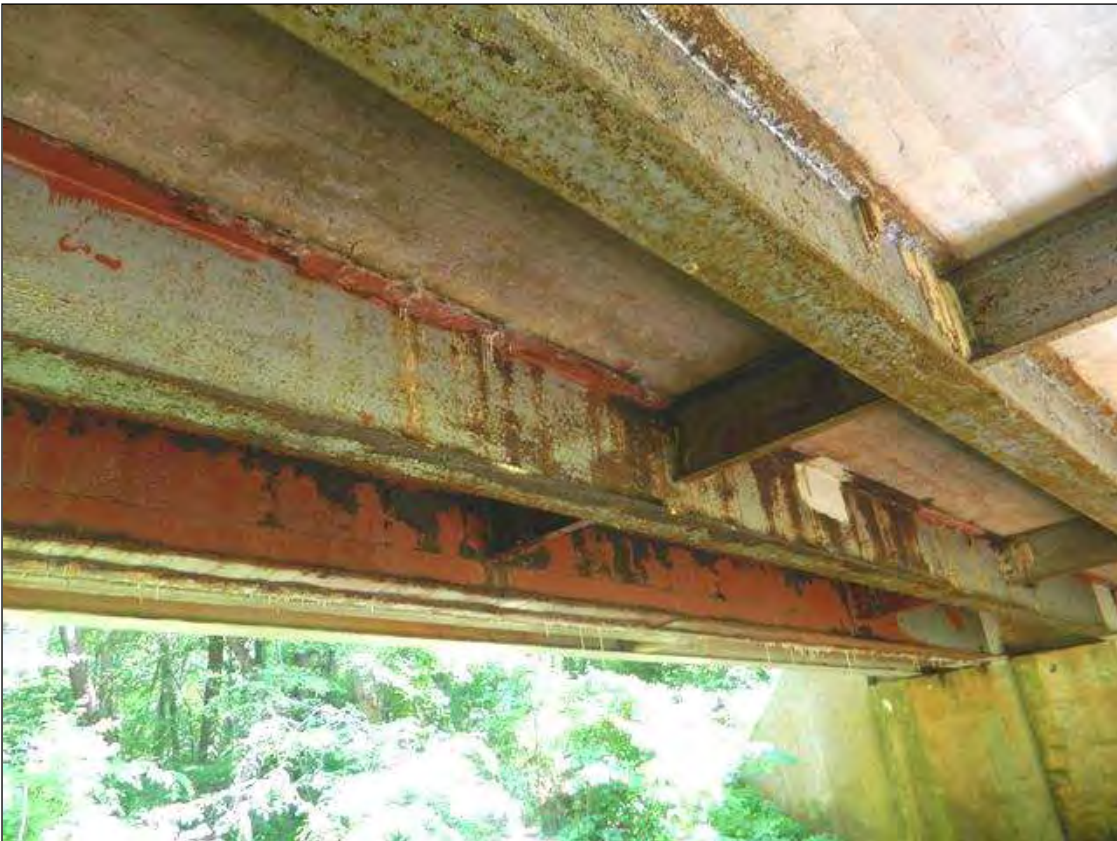
BEAM 4 HAS SURFACE RUST AND 1/32" SECTION LOSS IN SPOTS ALONG LENGTH

| MMS Code | Description of Function | Unit | Quantity | Remarks | Est. Cost |
|---|---|---|---|---|---|
| 3314 | Maintain Steel Superstructure Components | LF | 20 | BEAM 4 HAS SURFACE RUST AND UP TO 1/32 INCH SECTION LOSS ALONG TOP FLANGE , | |

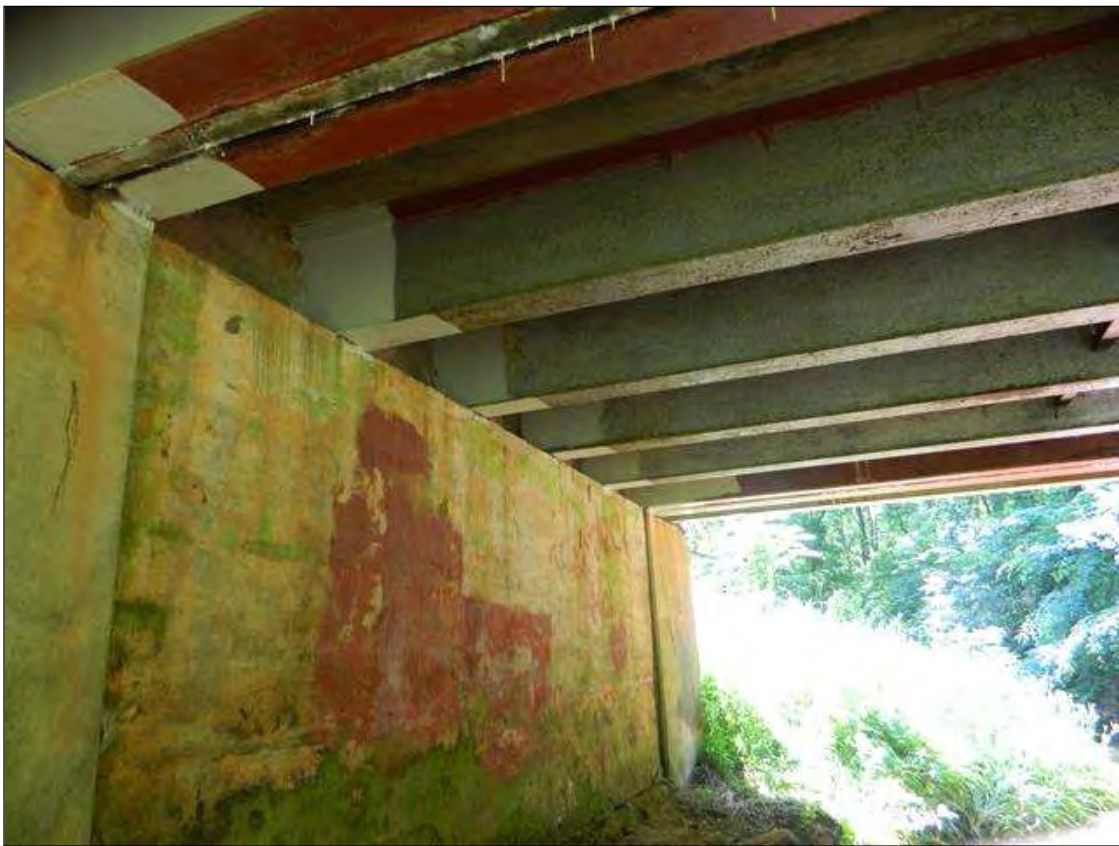
ALL BEAM ENDS HAVE BEEN PAINTED
