# BRIDGE INSPECTION REPORT

INSPECTION TYPE: Routine Inspection

COUNTY GUILFORD BRIDGE NUMBER 400271 INSPECTION CYCLE 2 YRS  
ROUTE SR3343 ACROSS STINKING QUARTER CREEK M.P. 0

INSPECTION DATE 02/20/2013

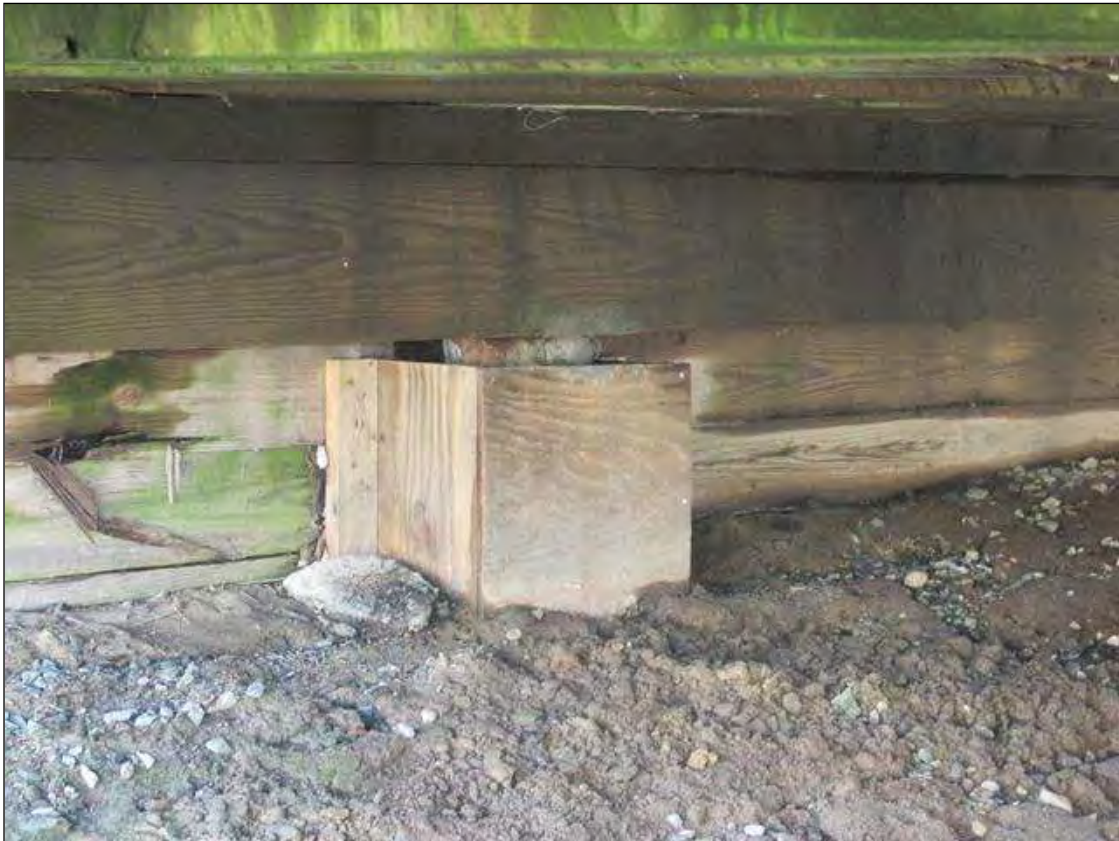
TEMP. REPAIR, PILE 2 @ ABUTMENT 2

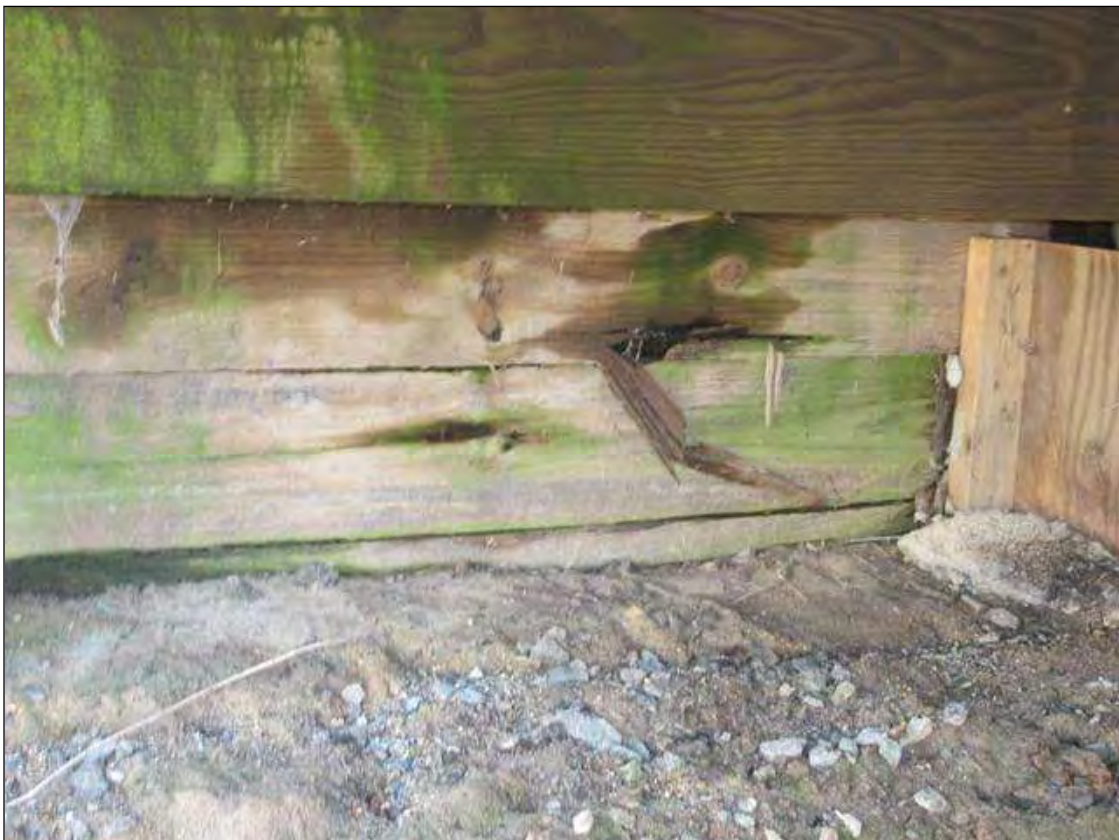
| Bridge I&A Form 1(82)H<br>State of North Carolina<br>Dept. of Transportation<br>Division of Highways | | <h1>FIELD INSPECTION REPORT</h1> <p><u>Bridge Inspeccion &amp; Analysis</u></p> | |
|---|---|---|--|
| 35c | F | TEMP. REPAIR, ABUTMENT 1, PILE 4 ABU 2 PILE 2<br>BULKHEADS .....ABUTMENT 2 BULKHEAD HAS 1 BOARD DECAYED BETWEEN PILES 1 AND 2.<br><br>ABUTMENT 1, RIGHT WINGWALL HAS 1 BOARD DECAYED | |

ABUTMENT 2 BULKHEAD HAS 1 BOARD DECAYED BETWEEN PILES 1 AND 2.

| MMS Code | Description of Function | Unit | Quantity | Remarks | Est. Cost |
|---|---|---|---|---|---|
| 3346 | Repair / Maintain Timber Wings & Blkhds | SF | 50 | BULKHEADS .....ABUTMENT 2 BULKHEAD HAS 1 BOARD DECAYED BETWEEN PILES 1 AND 2.<br>ABUTMENT 1, RIGHT WINGWALL HAS 1 BOARD DECAYED | |

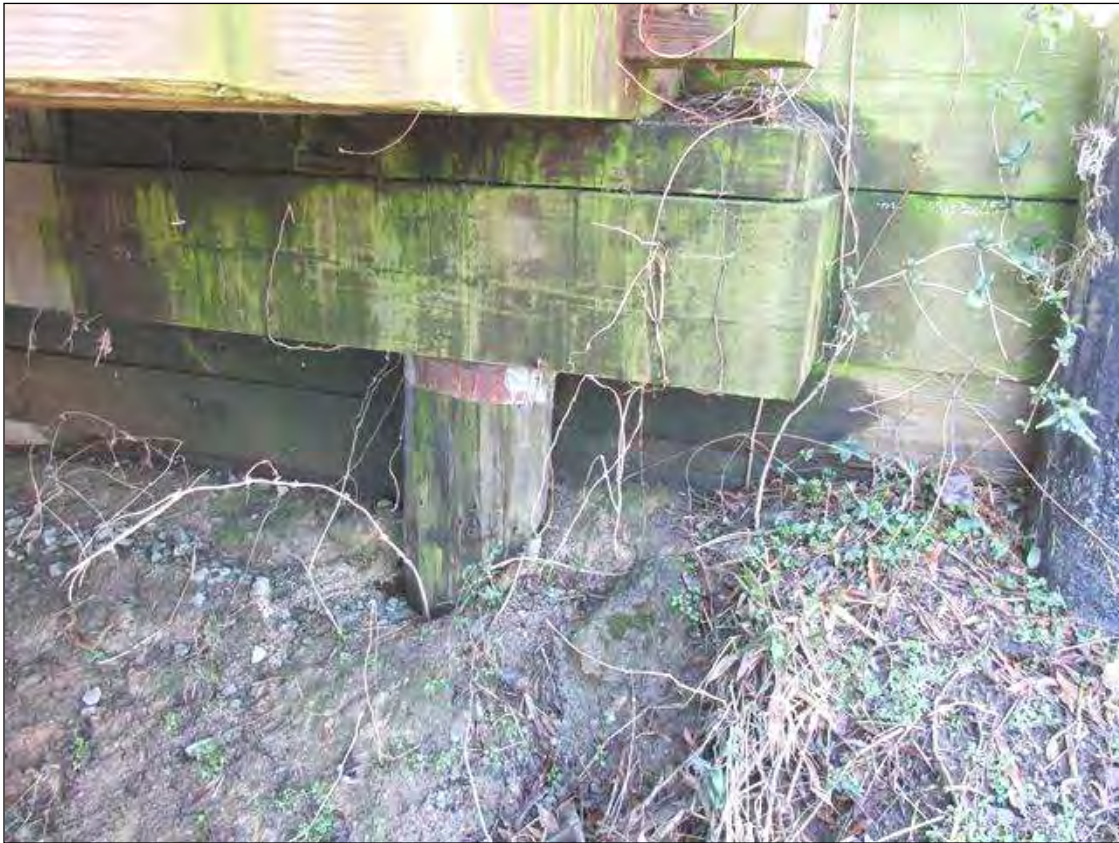
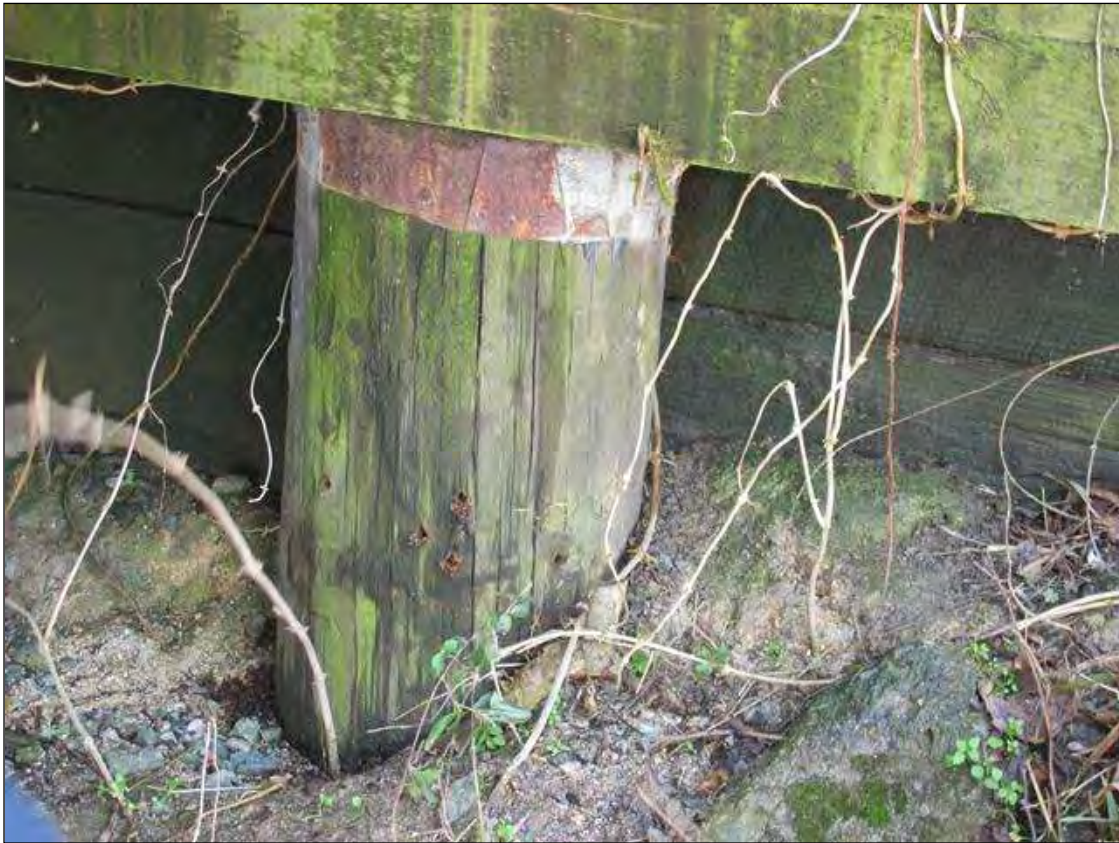
| Bridge I&A Form 1(82)H<br>State of North Carolina<br>Dept. of Transportation<br>Division of Highways | | <h1>FIELD INSPECTION REPORT</h1> <p><u>Bridge Inspeccion &amp; Analysis</u></p> | |
|---|---|---|--|
| 35b | F | PILES.....<br>PRIORITY MAINT. PILE 1 @ ABUTMENT 1 IS DECAYED UP TO 3" DEEP INSIDE A 1" SOLID SHELL AROUND 50% OF DIAMETER FROM GROUNDLINE TO CAP.<br><br>PILE 2 @ PIER 1 HAS UP TO 1" DEEP DECAY ON THE EAST FACE FROM WATERLINE UP 1' HIGH.<br><br>PILE 4 @ PIER 1 HAS UP TO 1" DEEP DECAY ON THE EAST FACE FROM WATERLINE UP 1' H<br><br>ABUTMENT 1, PILE 2 IS DECAYED AT GROUNDLINE ON FACE UP TO 1" DEEP AND SOFT ON EXTERIOR.<br><br>ABUTMENT 1, PILE 3 IS DECAYED 1/2" DEEP X 3" HIGH FROM FACE TO LEFT SIDE. AREA IS 5" FROM GROUNDLINE.<br><br>PIERS 1 AND 2 , PILES 1 AND 4 DELAMINATED IN SPOTS.<br><br>ALL PILES WEATHER CRACKING AND SOFT ON EXTERIOR. | |

PRIORITY MAINT. PILE 1 @ ABUTMENT 1 IS DECAYED UP TO 3" DEEP INSIDE A 1" SOLID SHELL AROUND 50% OF DIAMETER FROM GROUNDLINE TO CAP.

| 61 | YES | PRIORITY MAINTENANCE FOR PILE 1 IN ABU 1 | |

| MMS Code | Description of Function | Unit | Quantity | Remarks | Est. Cost |
|---|---|---|---|---|---|
| 3344 | Repair / Replace Timber Substructure Components | LF | <i>2' TSC</i><br><i>3/18/13</i> | PRIORITY MAINT. PILE 1 @ ABUTMENT 1 IS DECAYED UP TO 3" DEEP INSIDE A 1" SOLID SHELL AROUND 50% OF DIAMETER FROM GROUNDLINE TO CAP. | |

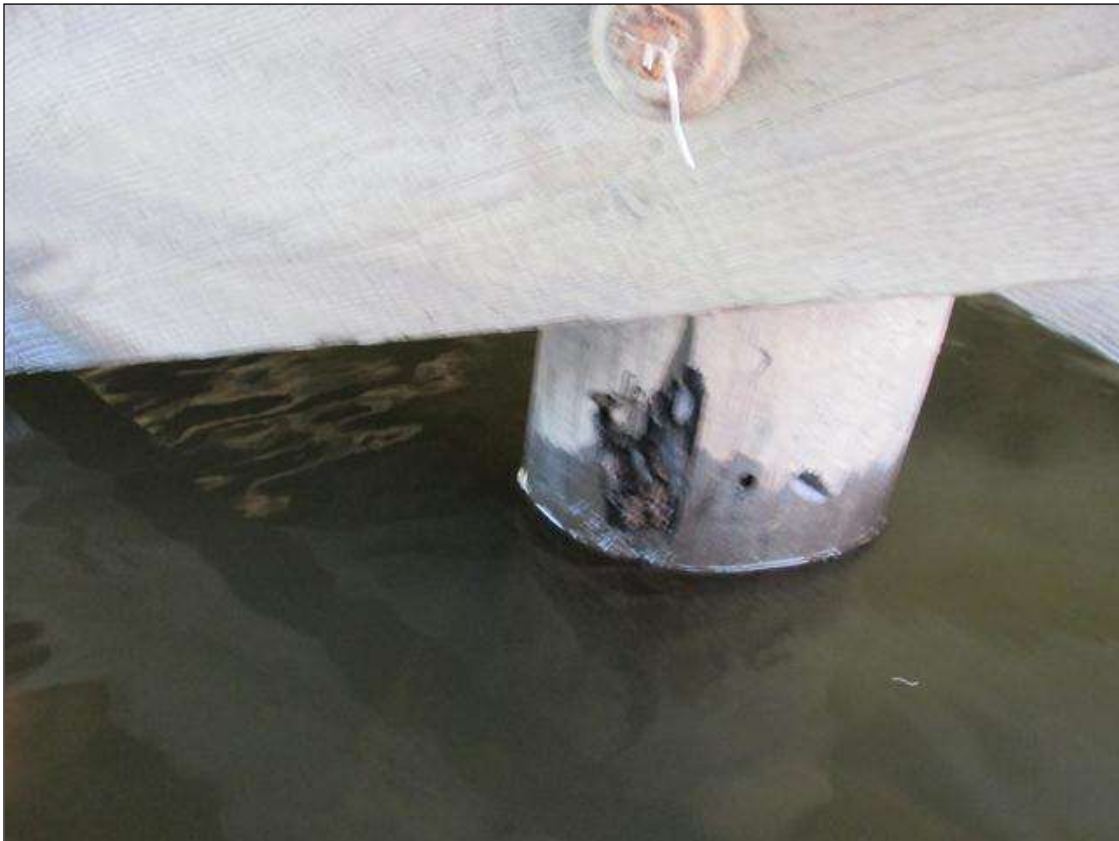
PILE 2 @ PIER 1 HAS UP TO 1" DEEP DECAY ON THE EAST FACE FROM WATERLINE UP 1' HIGH.

| MMS Code | Description of Function | Unit | Quantity | Remarks | Est. Cost |
|---|---|---|---|---|---|
| 3344 | Repair / Replace Timber Substructure Components | LF | 20 | PILE 2 @ PIER 1 HAS UP TO 1" DEEP DECAY ON THE EAST FACE FROM WATERLINE UP 1' HIGH.<br>PILE 4 @ PIER 1 HAS UP TO 1" DEEP DECAY ON THE EAST FACE FROM WATERLINE UP 1' H<br>ABUTMENT 1, PILE 2 IS DECAYED AT GROUNDLINE ON FACE UP TO 1" DEEP AND SOFT ON EXTERIOR.<br>ABUTMENT 1, PILE 3 IS DECAYED 1/2" DEEP X 3" HIGH FROM FACE TO LEFT SIDE. AREA IS 5" FROM GROUNDLINE. | |

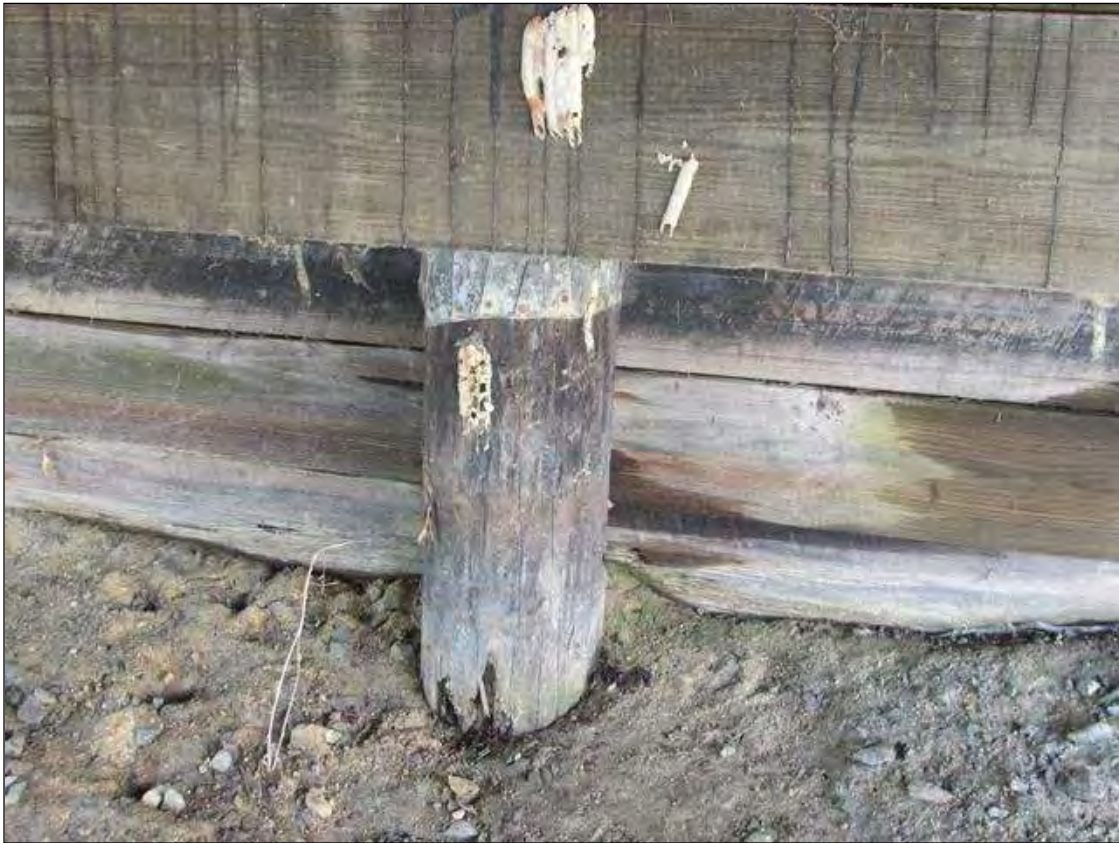
PILE 2 @ ABUTMENT 1 IS DECAYED AT GROUNDLINE ON FACE UP TO 1" DEEP AND SOFT ON EXTERIOR.

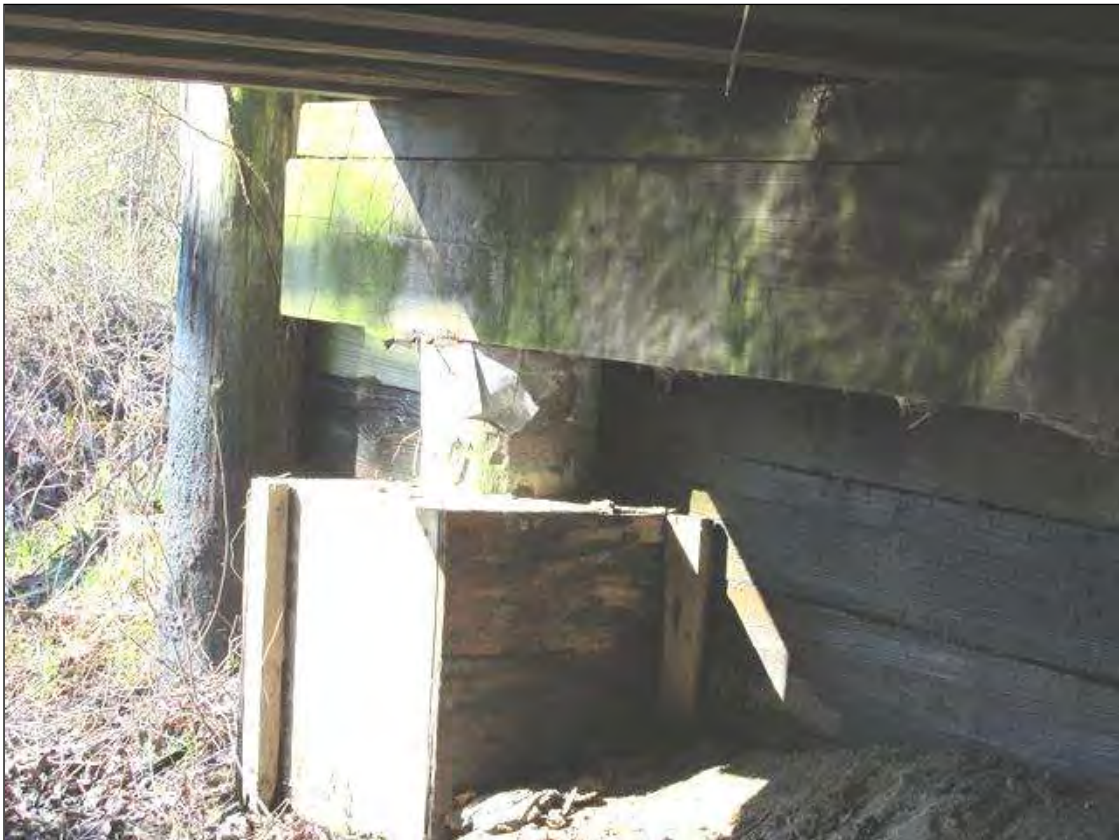
TEMP. REPAIR, PILE 4 @ ABUTMENT 1

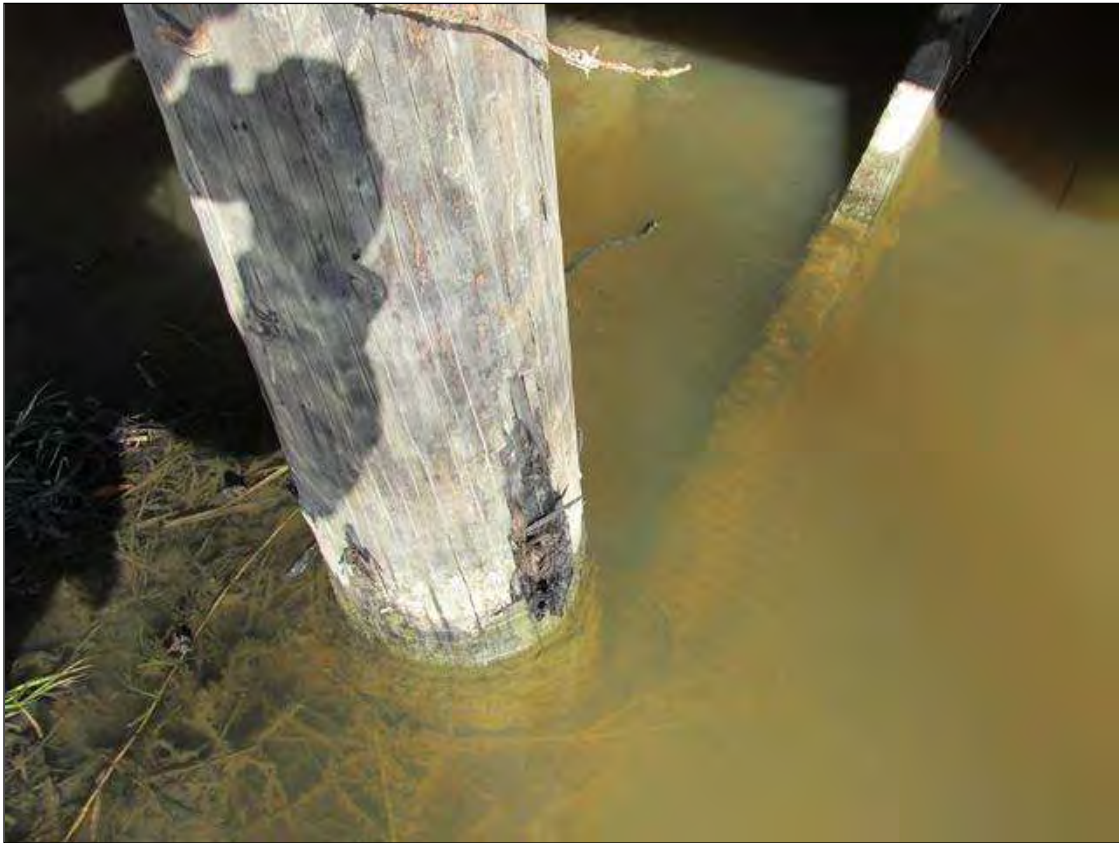
PILE 4 @ PIER 1 HAS UP TO 1" DEEP DECAY ON THE EAST FACE FROM WATERLINE UP 1' HIGH.

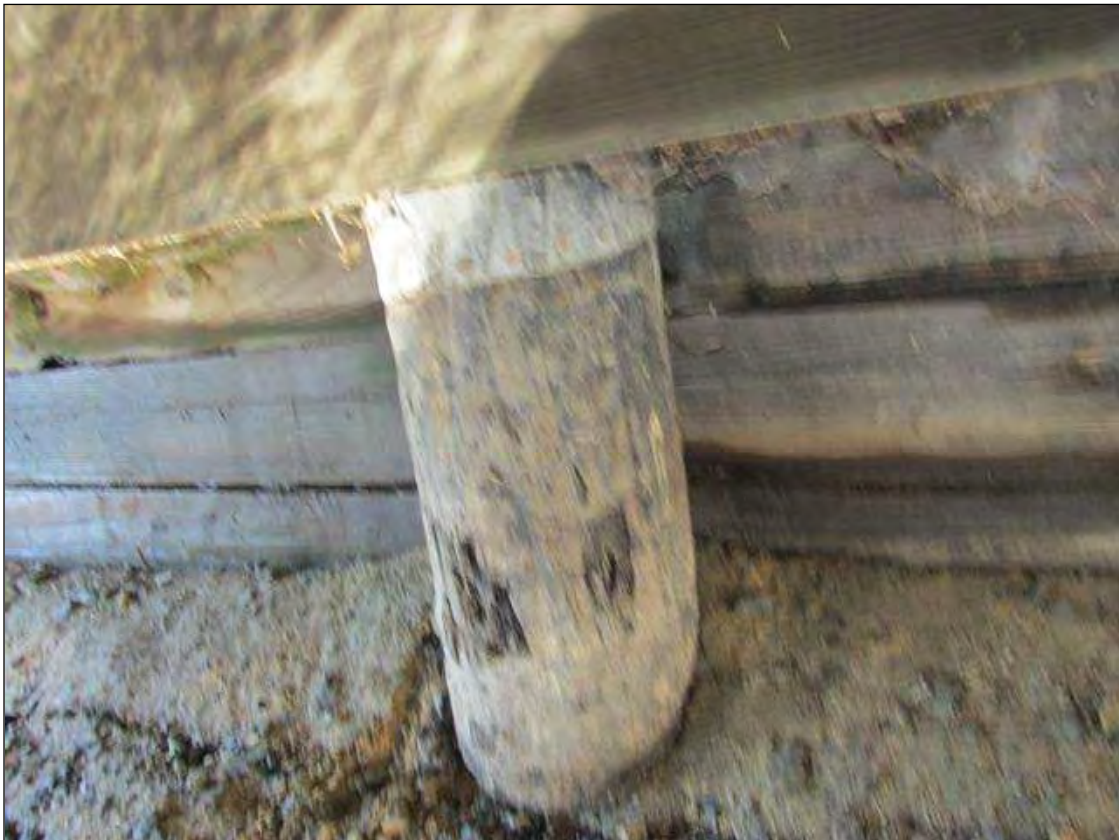
PILE 3 @ ABUTMENT 1 IS DECAYED 1/2" DEEP X 3" HIGH FROM FACE TO LEFT SIDE. AREA IS 5" FROM GROUNDLINE.

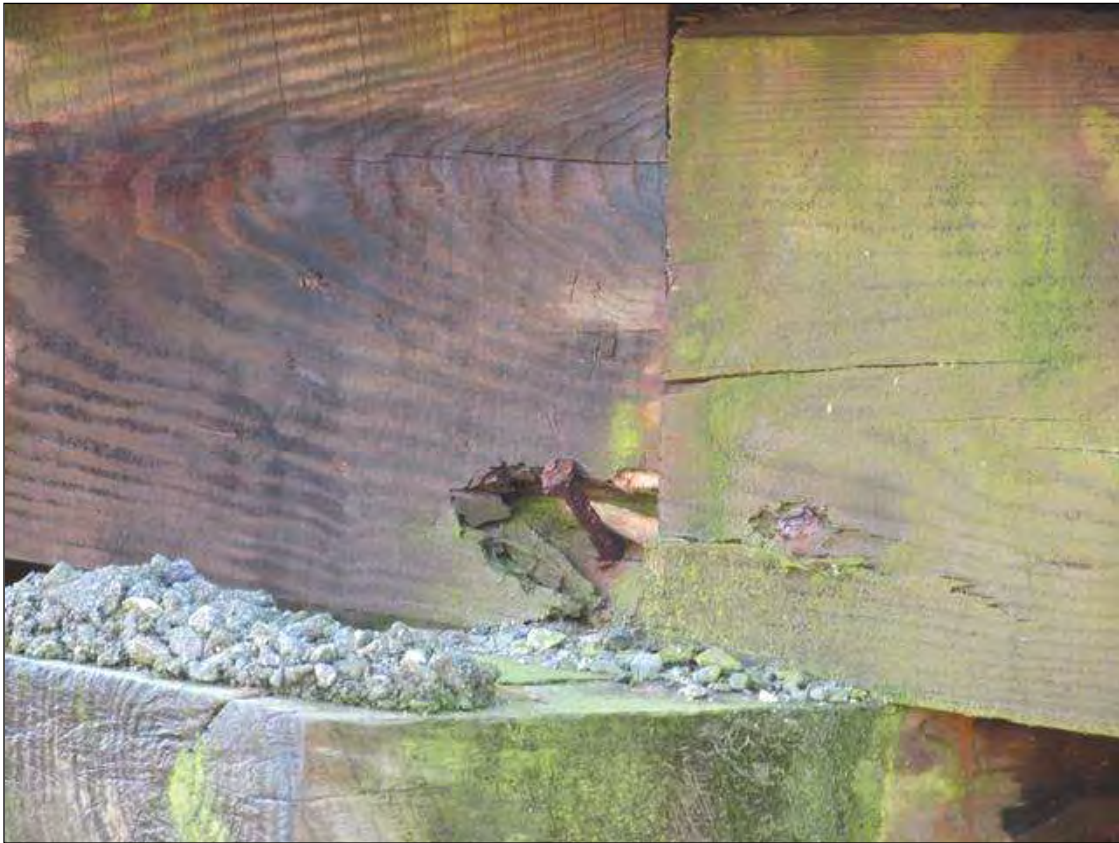
| Bridge I&A Form 1(82)H<br>State of North Carolina<br>Dept. of Transportation<br>Division of Highways | | <h1>FIELD INSPECTION REPORT</h1> <p><u>Bridge Inspeccion &amp; Analysis</u></p> | |
|---|---|---|--|
| 11 | F | JOISTS ..... JOIST 1 IN SPAN 2 AT PIER 1 DECAYING ALONG BOTTOM AND SIDE 1" DEEP WHERE NAIL WAS DRIVEN. | |

JOIST 1 IN SPAN 2 AT PIER 1 DECAYING ALONG BOTTOM AND SIDE 1" DEEP WHERE NAIL WAS DRIVEN.

| MMS Code | Description of Function | Unit | Quantity | Remarks | Est. Cost |
|---|---|---|---|---|---|
| 3304 | Maintain/Replace Timber Superstructure Components | LF | 2 | JOISTS ..... JOIST 1 IN SPAN 2 AT PIER 1 DECAYING ALONG BOTTOM AND SIDE 1" DEEP WHERE NAIL WAS DRIVEN. | |

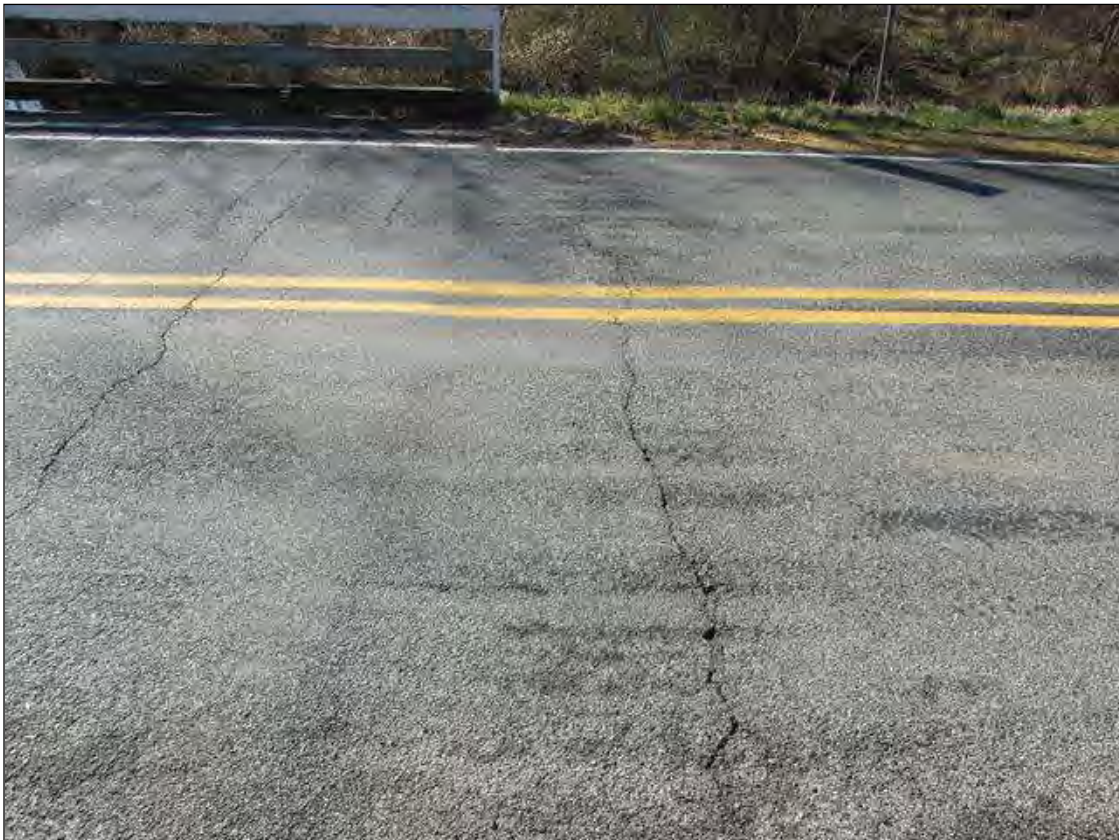
| 50 | F | APPROACHES ..WEST APPROACH CRACKED AND SETTLED 1/2 INCH.<br>EAST APPROACH SETTLED 1/2 INCH. | |

WEST APPROACH CRACKED AND SETTLED 1/2 INCH. EAST SIMILAR

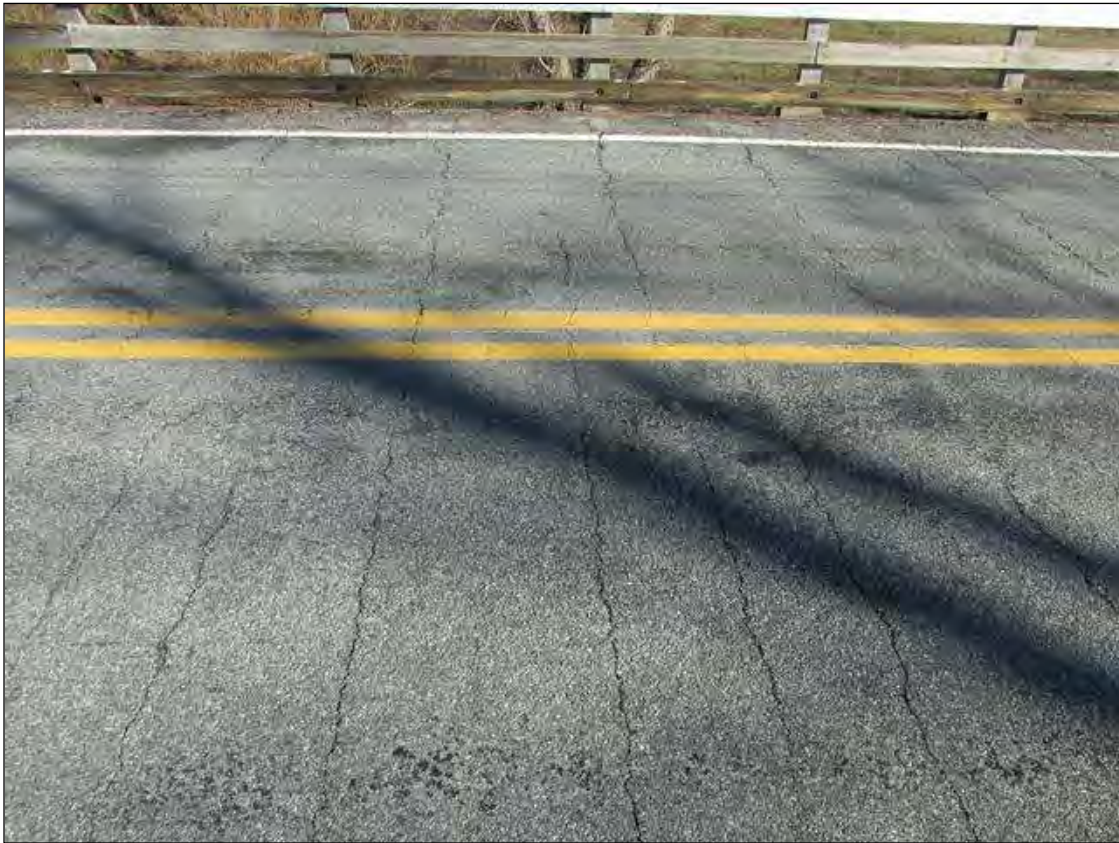
| Bridge I&A Form 1(82)H<br>State of North Carolina<br>Dept. of Transportation<br>Division of Highways | | <h1>FIELD INSPECTION REPORT</h1> <p><u>Bridge Inspeccion &amp; Analysis</u></p> | |
|---|---|---|--|
| | | SPAN 3 WEARING SURFACE CRACKED ALONG EACH FLOORBOARD AND OPENING TO 1/4 INCH. | |

AWS IS CRACKED ALONG FLOORING

| MMS Code | Description of Function | Unit | Quantity | Remarks | Est. Cost |
|---|---|---|---|---|---|
| 2816 | Asphalt Surface Repair or Replacement | SY | 5 | WEARING SURFACE IN SPAN 1 HAS TRANSVERSE CRACKS SCATTERED OPENING TO 1/4 INCH. SPAN 2 SIMILAR.<br>SPAN 3 WEARING SURFACE CRACKED ALONG EACH FLOORBOARD AND OPENING TO 1/4 INCH. | |

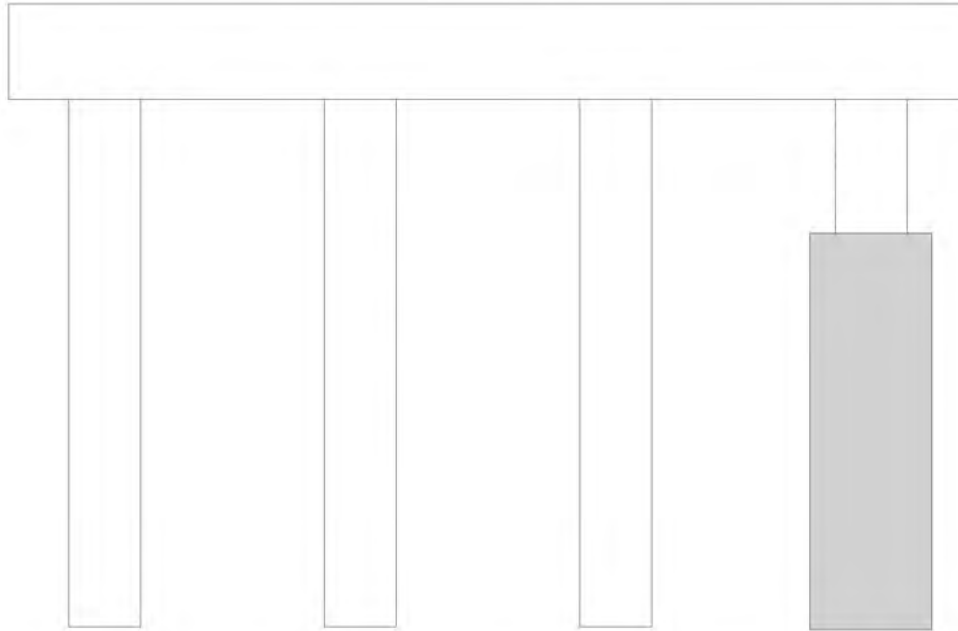
| Abutment # | 1 | | |

PILE 4 IS A TEMPORARY REPAIR WITH A CONCRETE COLLAR.
