# BRIDGE INSPECTION REPORT

INSPECTION TYPE: Routine Inspection

BRIDGE NUMBER 670077

ROUTE SR1113

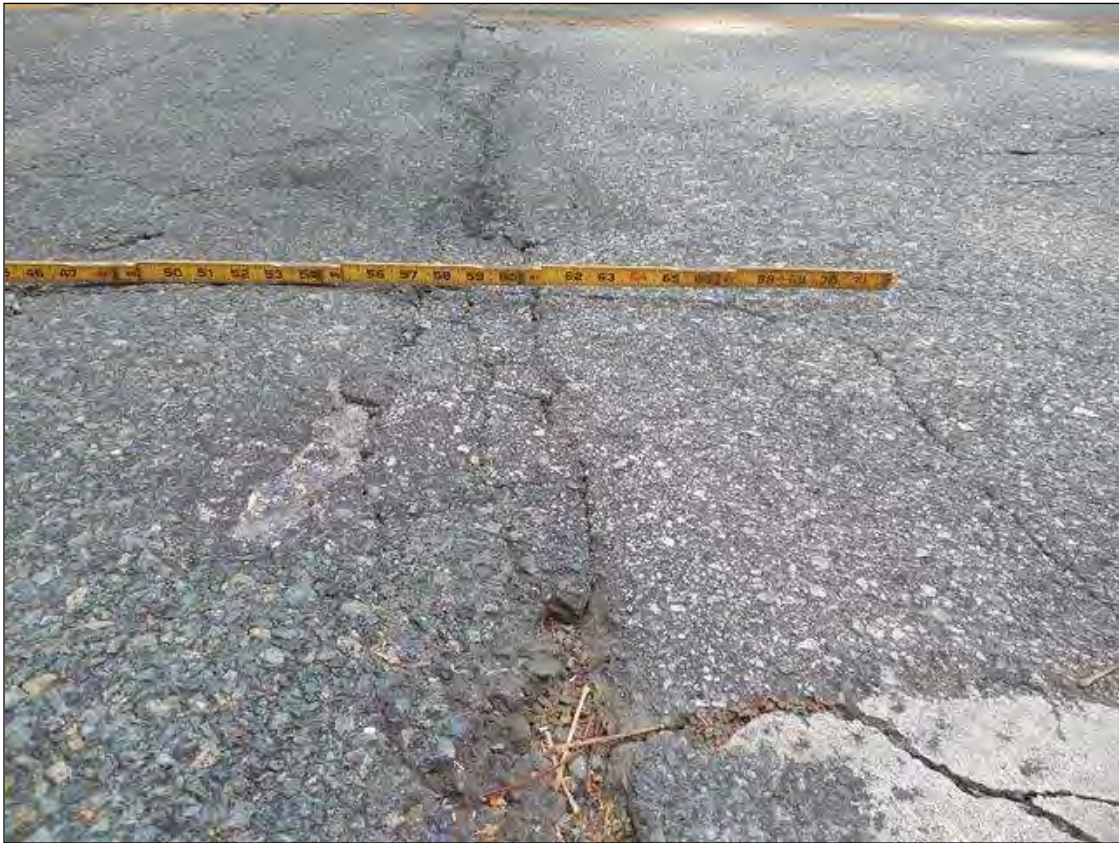
| Bridge I&A Form 1(82)H<br>State of North Carolina<br>Dept. of Transportation<br>Division of Highways | | <h1>FIELD INSPECTION REPORT</h1> <p><u>Bridge Inspection &amp; Analysis</u></p> | |
|---|---|---|--|
| 50 | F | BOTH APPROACHES CRACKED AND SETTLED, 1" TO 1-3/4" AT FILL FACE. | |

SETTLEMENT AND CRACKING ON WEST END APPROACH

| MMS Code | Description of Function | Unit | Quantity | Remarks | Est. Cost |
|---|---|---|---|---|---|
| 2816 | Asphalt Surface Repair or Replacement | SY | 40 | APPROACHES CRACKED AND SETTLED | |

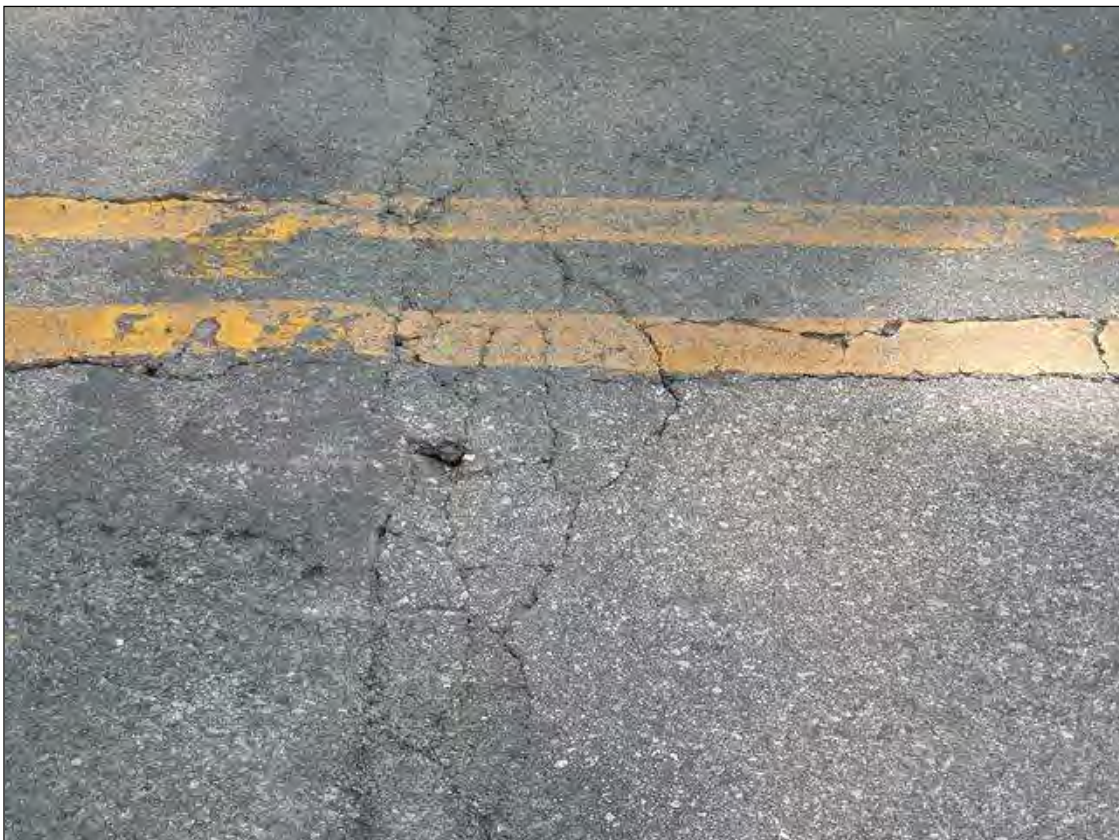
| Bridge I&A Form 1(82)H<br>State of North Carolina<br>Dept. of Transportation<br>Division of Highways | | <h1>FIELD INSPECTION REPORT</h1> <p><u>Bridge Inspection &amp; Analysis</u></p> | |
|---|---|---|--|
| 1 | F | AWS HEAVILY CRACKED ALONG TIMBER DECKING EDGES, UP TO 1/2"WIDE. SEVERAL PATCHED AREAS ALONG CENTERLINE. | |

WEAR SURFACE CRACKING AT END BENT 1

| MMS Code | Description of Function | Unit | Quantity | Remarks | Est. Cost |
|---|---|---|---|---|---|
| 2816 | Asphalt Surface Repair or Replacement | SY | 100 | AWS CRACKING ON DECK | |

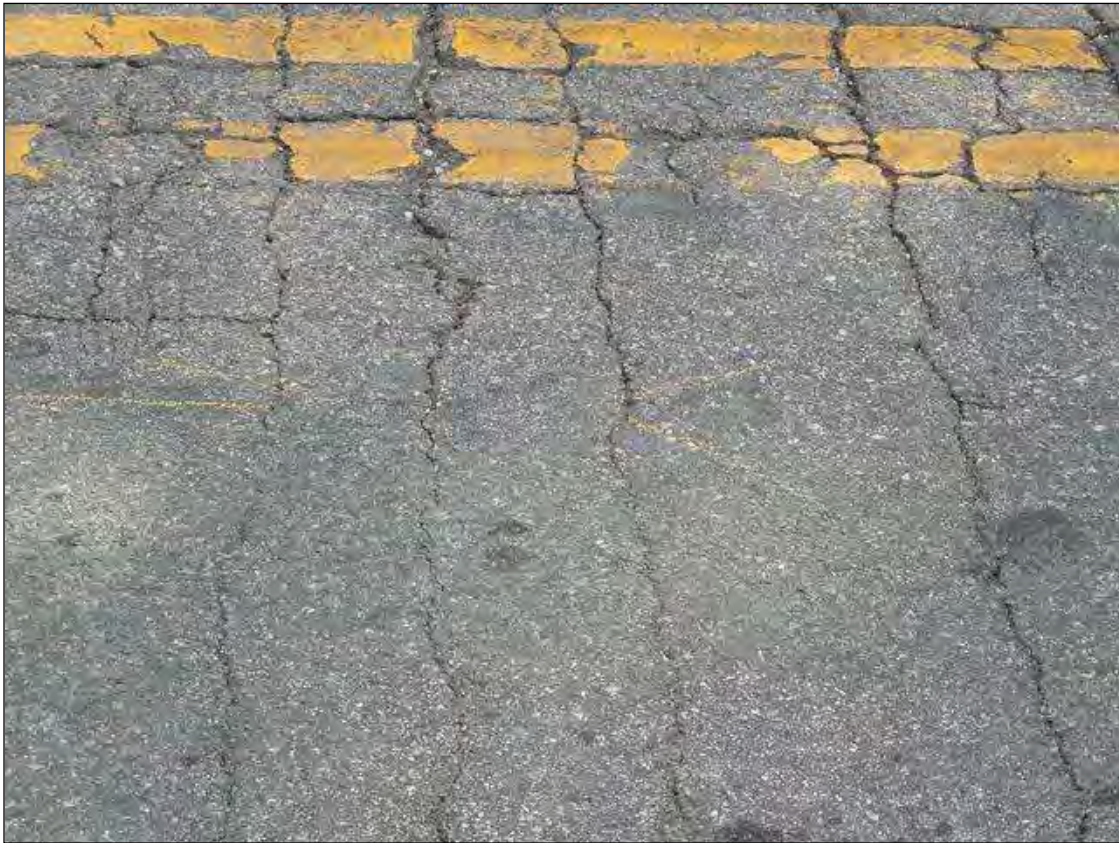
WEAR SURFACE CRACKING ON DECK AT TIMBER DECKING BOARD JOINTS

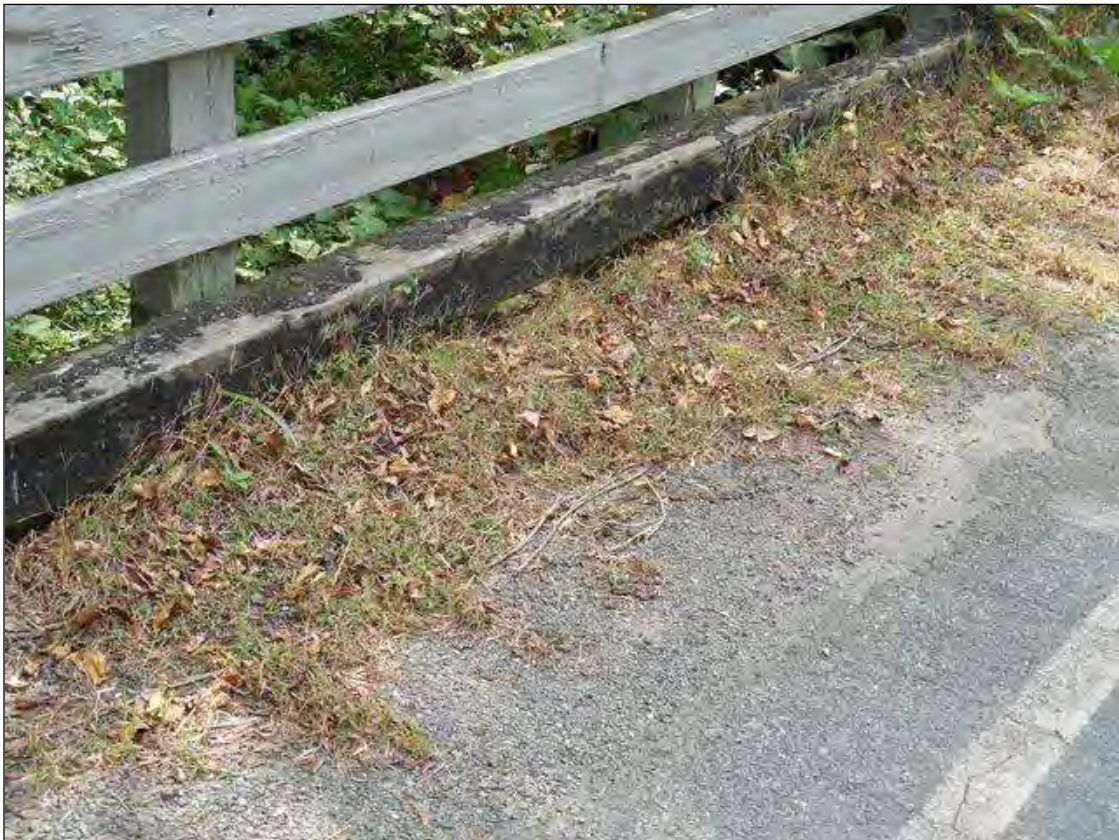
| Bridge I&A Form 1(82)H<br>State of North Carolina<br>Dept. of Transportation<br>Division of Highways | | <h1>FIELD INSPECTION REPORT</h1> <p><u>Bridge Inspection &amp; Analysis</u></p> | |
|---|---|---|--|
| 7 | F | DIRT AND DEBRIS BUILD UP ALONG SCUPPERS. | |

VEGETATION AND DEBRIS ON DECK

| MMS Code | Description of Function | Unit | Quantity | Remarks | Est. Cost |
|---|---|---|---|---|---|
| 3376 | Clean/Wash Bridge Decks | SF | 300 | DEBRIS BUILD UP ALONG DECK EDGES | |

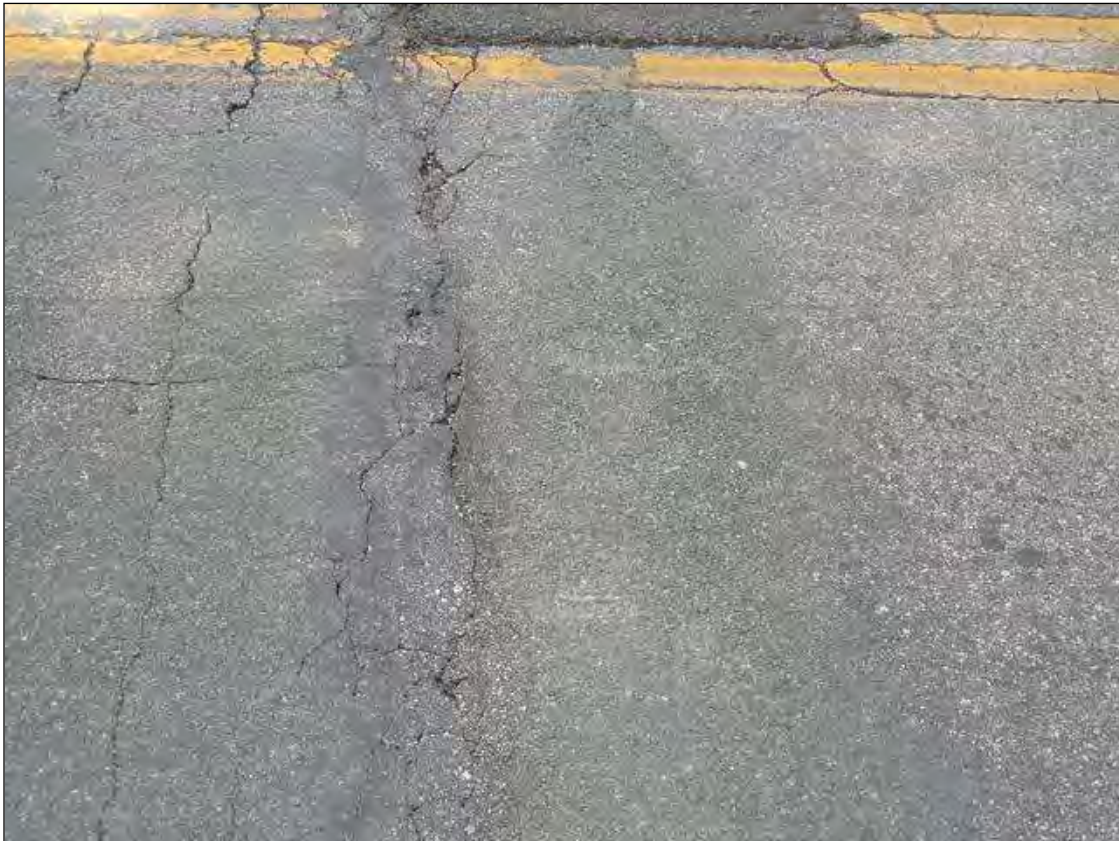
WEAR SURFACE CRACKING AT END BENT 2

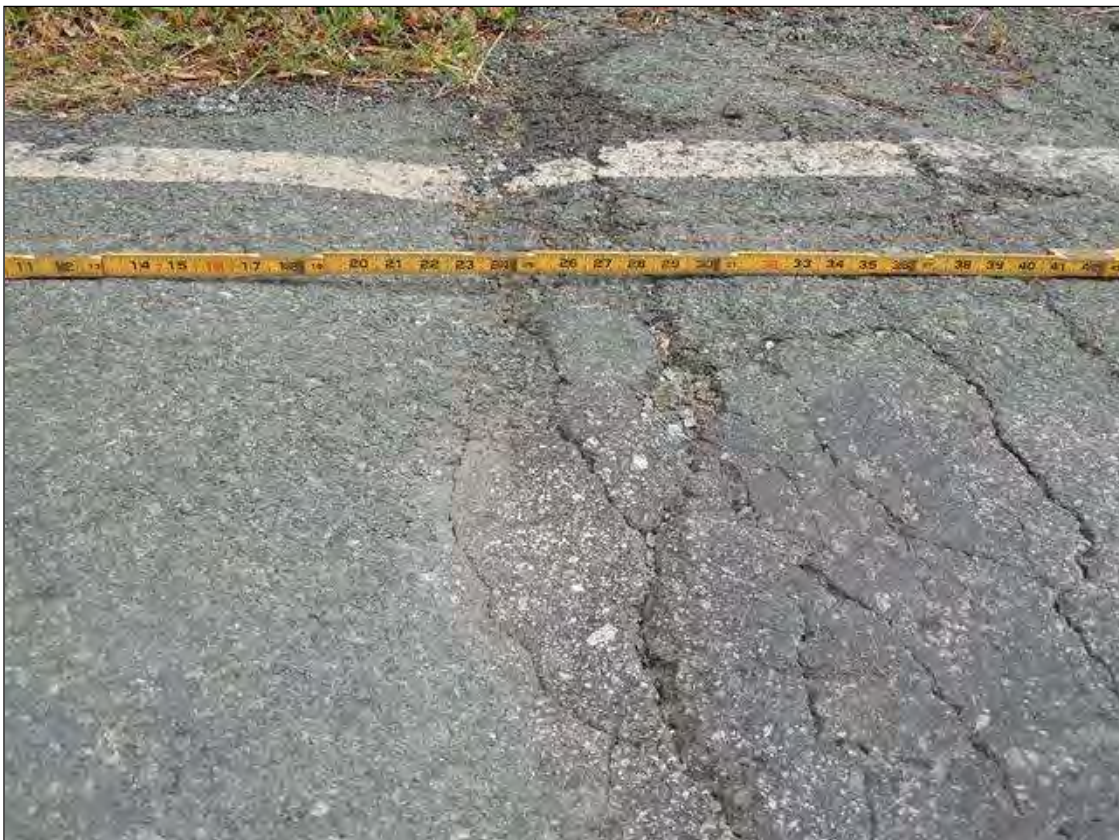
SETTLEMENT ON EAST END APPROACH

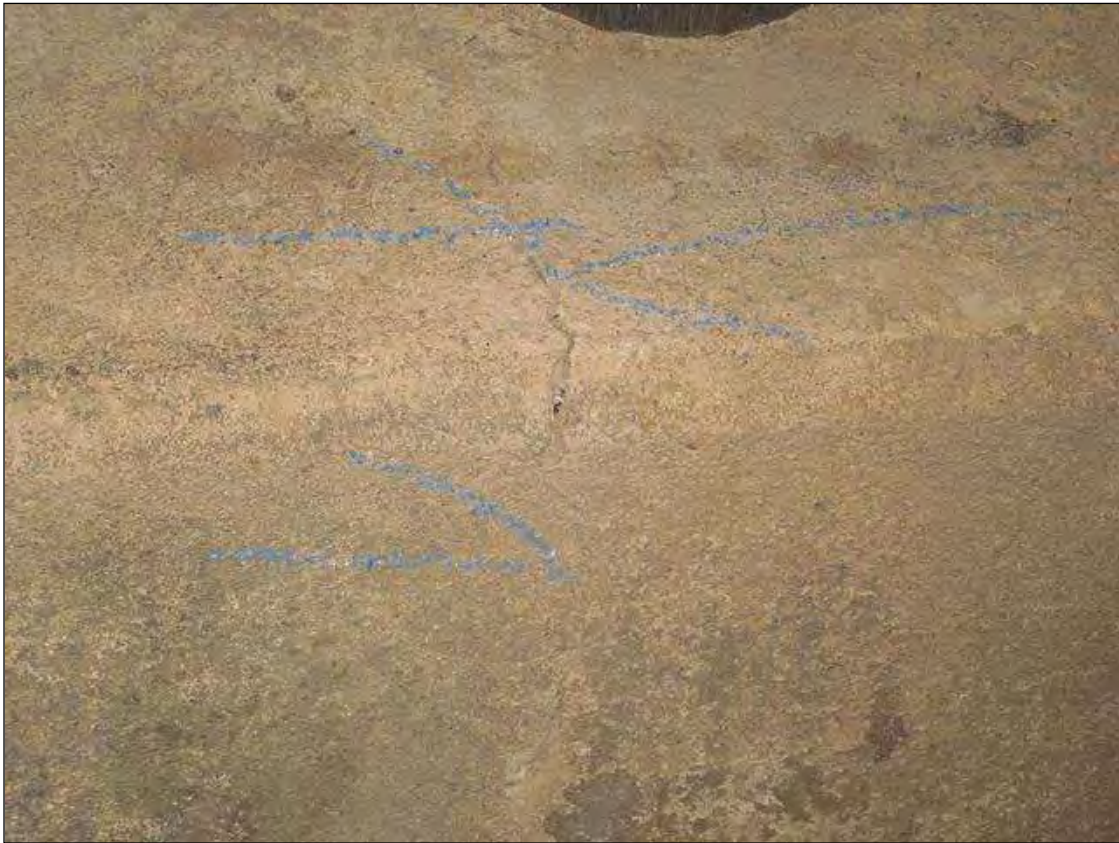
| Bridge I&A Form 1(82)H<br>State of North Carolina<br>Dept. of Transportation<br>Division of Highways | | <h1>FIELD INSPECTION REPORT</h1> <p><u>Bridge Inspection &amp; Analysis</u></p> | |
|---|---|---|--|
| 36e | F | FULL HEIGHT CRACKING RUNNING OFF TIMBER PILES AT END BENTS. CRACKS ARE UP TO 1/4"WIDE. END BENT CRACK AT PILE 6, END BENT 2 CRACK AT PILE 5. | |

CRACKING ON FOOTER AT END BENT 1 UNDER PILE 6

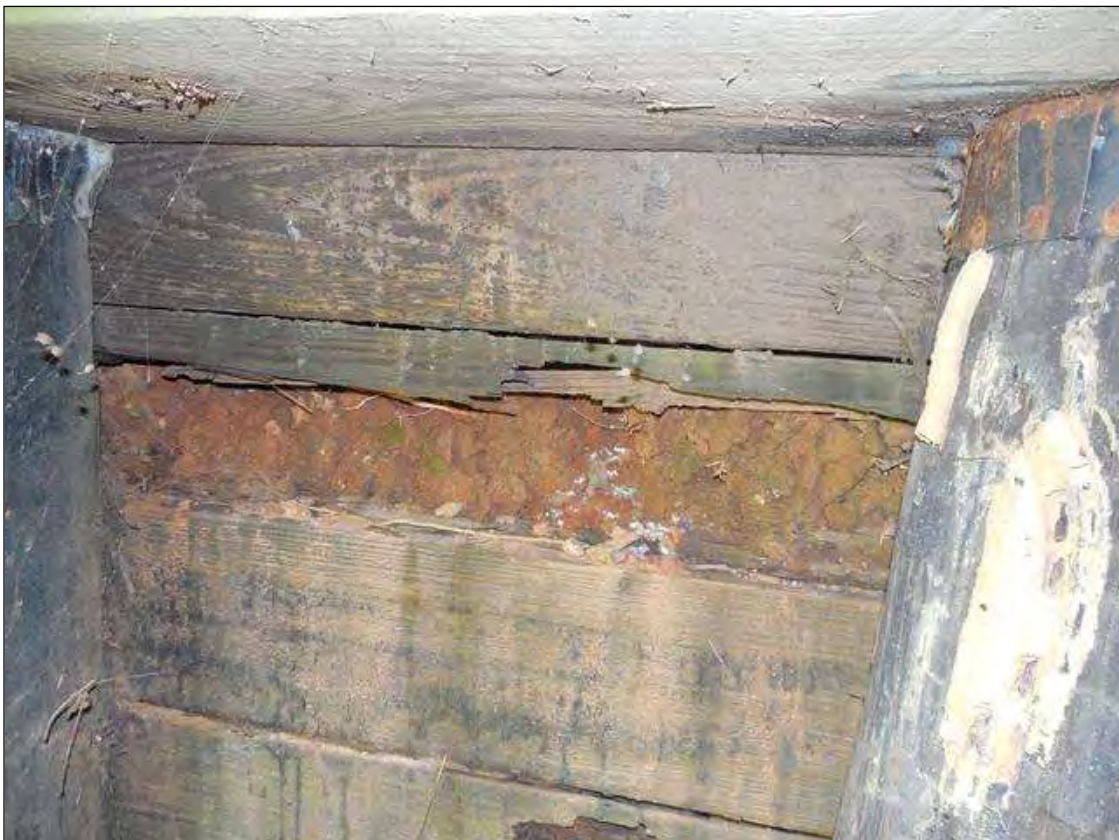
| Bridge I&A Form 1(82)H<br>State of North Carolina<br>Dept. of Transportation<br>Division of Highways | | <h1>FIELD INSPECTION REPORT</h1> <p><u>Bridge Inspection &amp; Analysis</u></p> | |
|---|---|---|--|
| 35c | P | TIMBERS SHOWING DECAY FULL THICKNESS ALONG FILL TO BE EXPOSED. END BENT 1 DECAY IS AROUND PILE 5 TO OUTSIDE WING, WING POST HAVE FULL DEPTH DECAY ALONG BASE AT CONCRETE FOOTING. END BENT 2 HAS BACKWALL DECAY AROUND PILE 1 EXTENDING OVER TO PILE 2, FULL THICKNESS. | |

DECAY ON BULKHEAD AT END BENT 2 BETWEEN PILES 1 AND 2

| MMS Code | Description of Function | Unit | Quantity | Remarks | Est. Cost |
|---|---|---|---|---|---|
| 3346 | Repair / Maintain Timber Wings & Blkhs | SF | 90 | BULKHEAD AND WING TIMBERS SHOWING DECAY | |

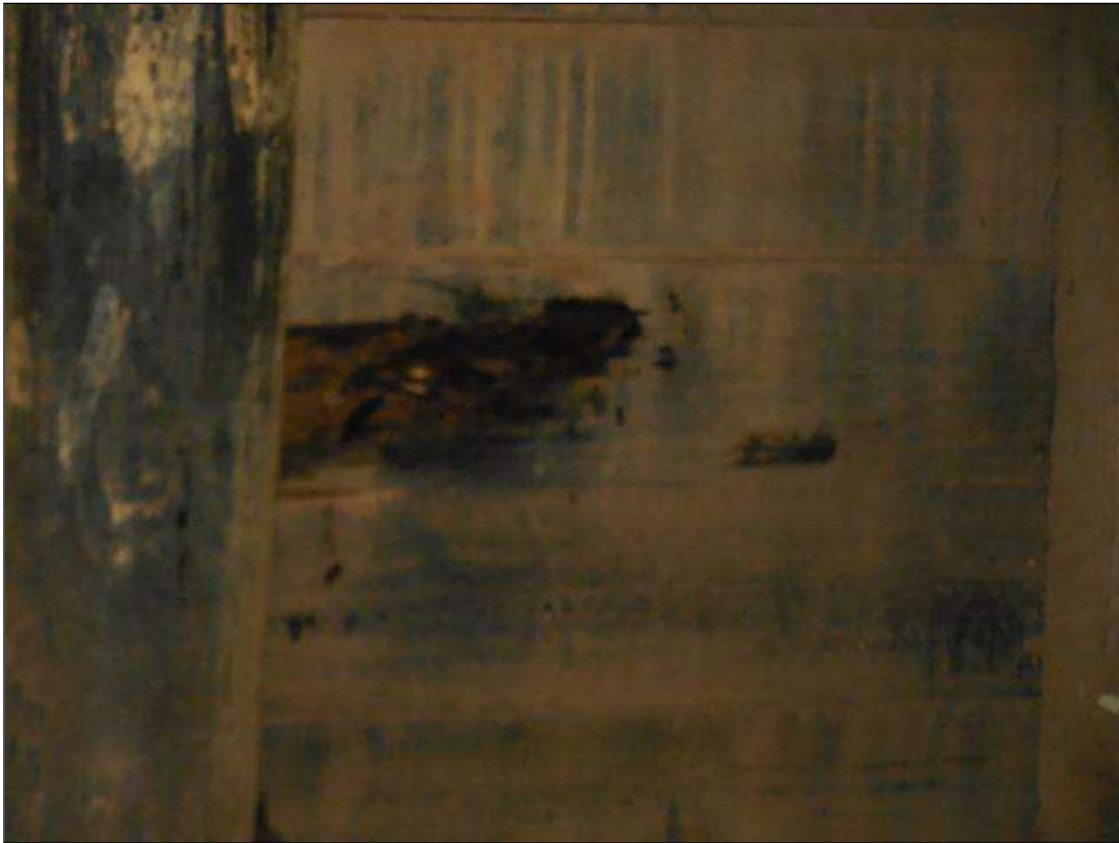
DECAY ON BULKHEAD AT END BENT 1 BEHIND PILE 6

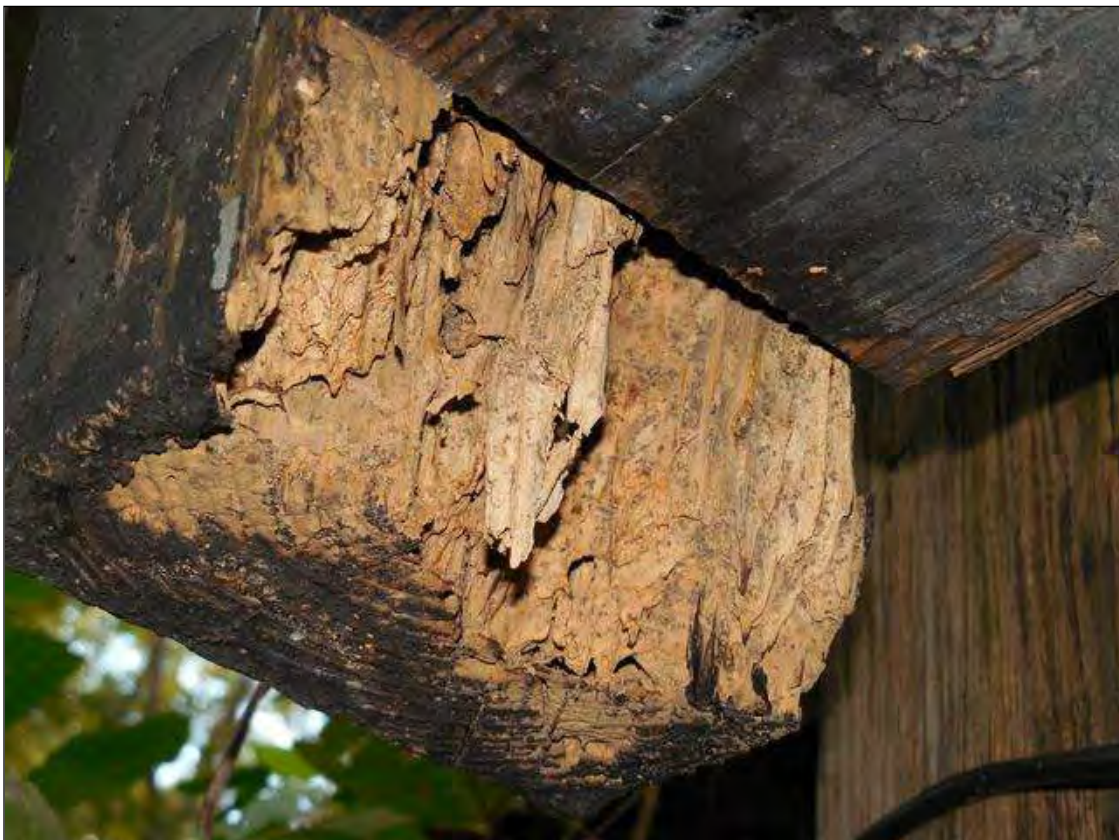
| Bridge I&A Form 1(82)H<br>State of North Carolina<br>Dept. of Transportation<br>Division of Highways | | <h1>FIELD INSPECTION REPORT</h1> <p><u>Bridge Inspection &amp; Analysis</u></p> | |
|---|---|---|--|
| 3b | F | TIMBERS WEATHERED AND SPLIT, TOP BOARD LOOSE IN SPOTS. TIMBER RAIL POST ARE SPLIT WITH DECAY ALONG BOTTOM PORTIONS, RAILS TIGHT AT THIS TIME. | |

DECAY ON BOTTOM OF RAIL POST THROUGHOUT

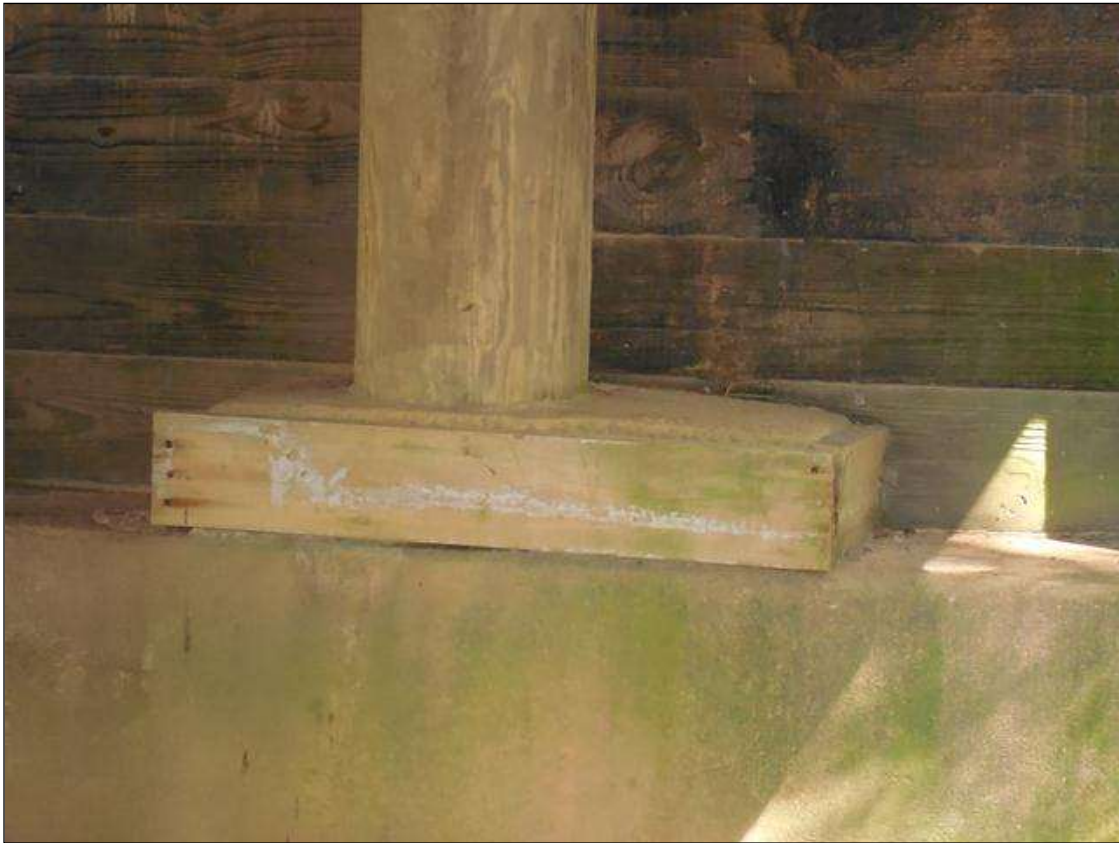
Some piles have been supplemented and some have been encased with concrete  
*Temporary Repair*

TEMPORARY REPAIRS ON PILES 3 AND 6 AT END BENT 2
