NC DEPARTMENT OF TRANSPORTATION  
DIVISION OF HIGHWAYS  
BRIDGE MANAGEMENT UNIT

# BRIDGE INSPECTION REPORT

INSPECTION TYPE: Routine Inspection - Contract

COUNTY ROWAN BRIDGE NUMBER 790149 INSPECTION CYCLE 0 YRS  
ROUTE SR2132 ACROSS N.PRONG OF CHURCH M.P. 0

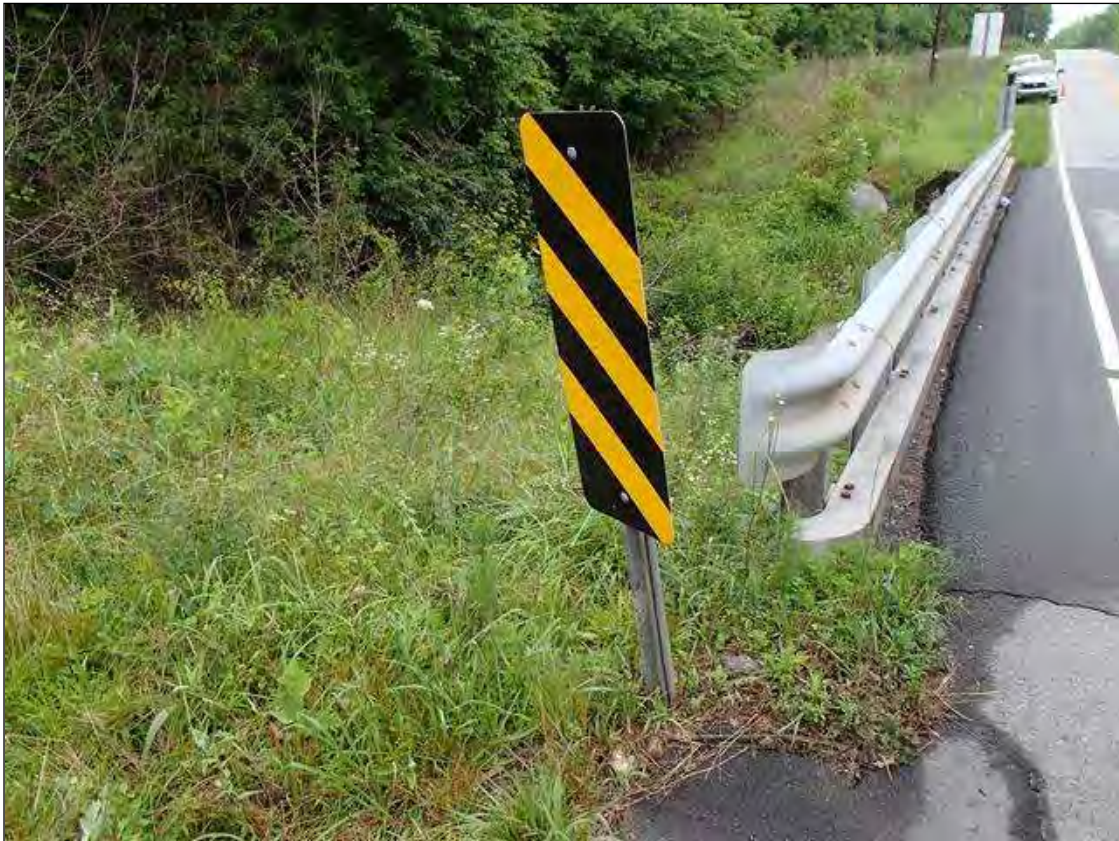
DELINEATOR SIGN TWISTED AT SOUTH APPROACH

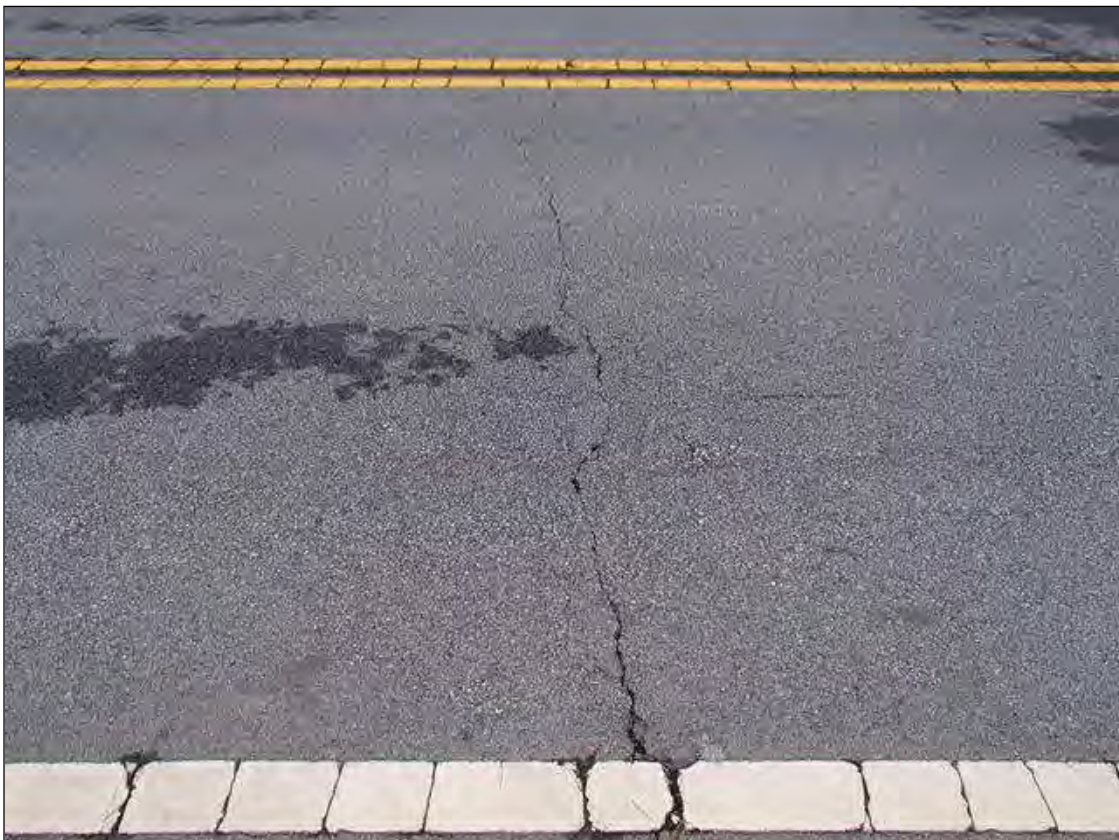
ASPHALT AT NORTH APPROACH: TRANSVERSE CRACKING UP TO 1/8" WIDE

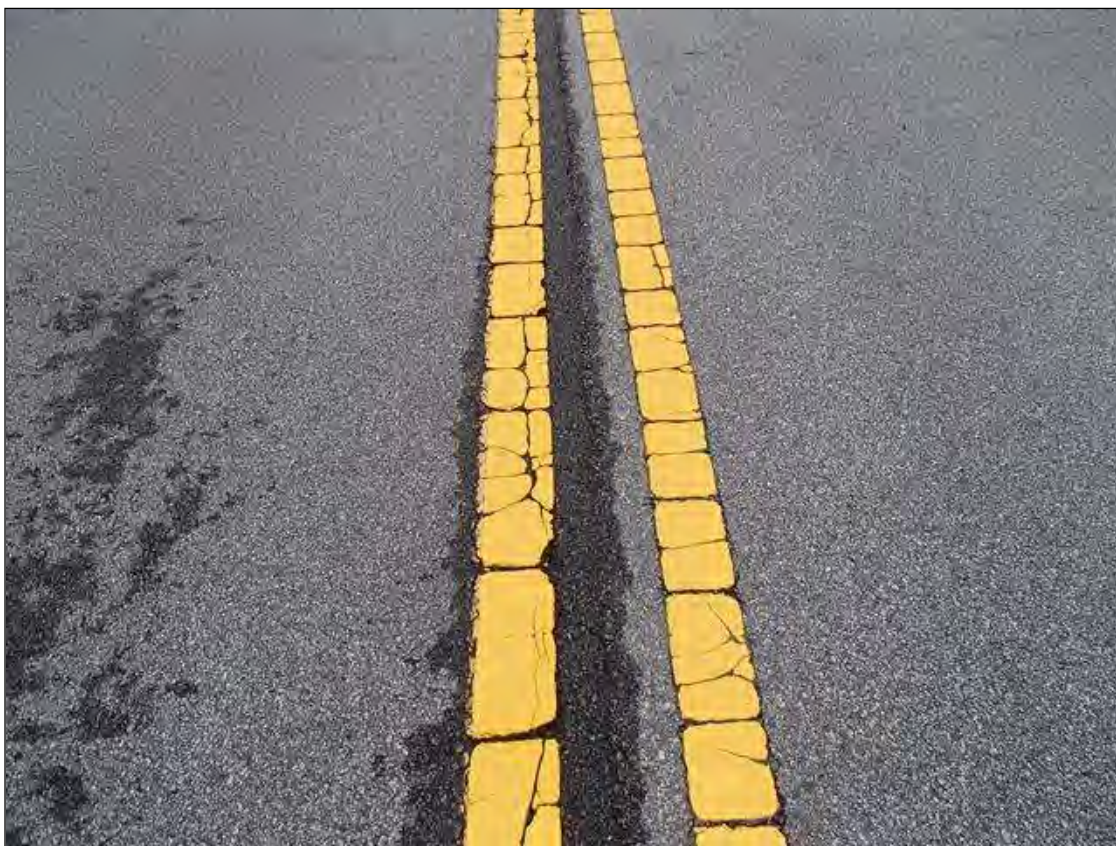
ASPHALT AT NORTH APPROACH: LONGITUDINAL CRACKING UP TO 1/8" WIDE

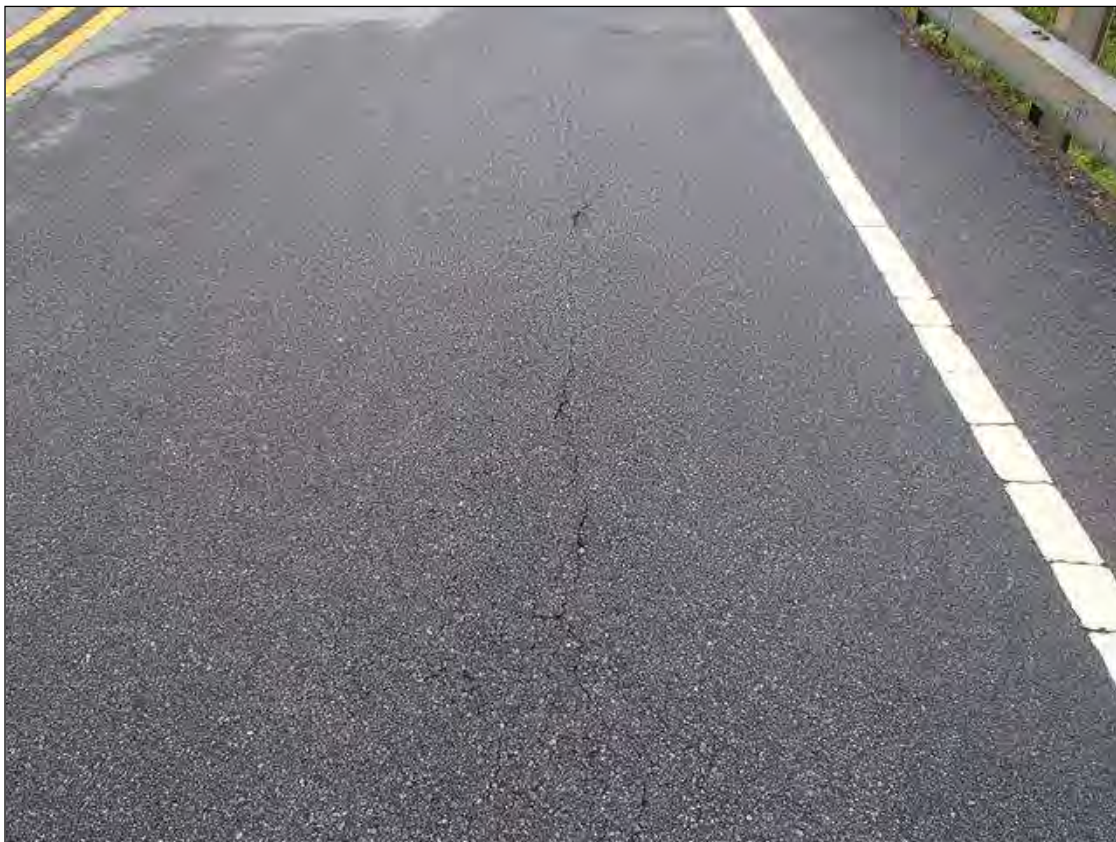
ASPHALT WEARING SURFACE SPAN 3: LONGITUDINAL CRACKING UP TO 1/8" WIDE (SIMILAR ALL SPANS)

| MMS Code | Description of Function | Unit | Quantity | Remarks | Est. Cost |
|---|---|---|---|---|---|
| 2816 | Asphalt Surface Repair or Replacement | SY | 160 | CRACKING IN ASPHALT WEARING SURFACE ALL SPANS | |

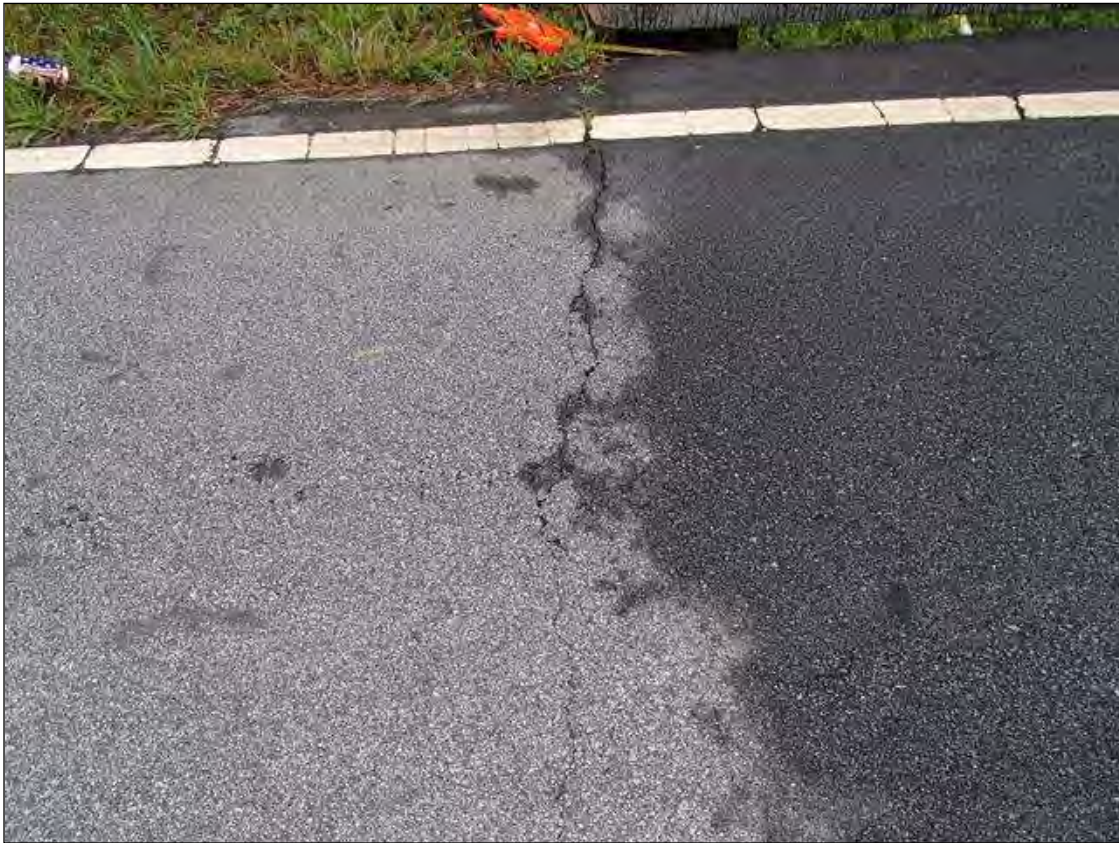
ASPHALT WEARING SURFACE OVER BENT 2: TRANSVERSE CRACKING UP TO 1/4" WIDE OVER JOINT  
(SIMILAR AT JOINT OVER BENT 1)

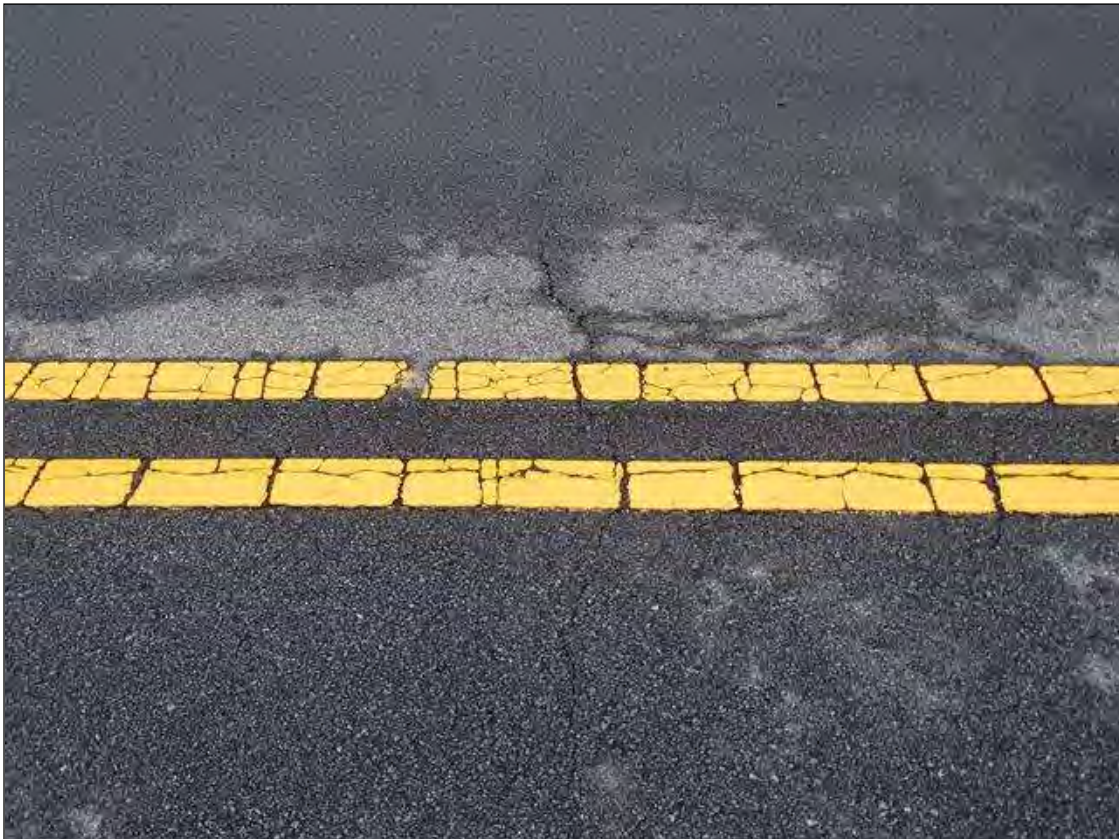
ASPHALT WEARING SURFACE SPAN 3: TRANSVERSE CRACKING AT MID SPAN UP TO 1/8" WIDE

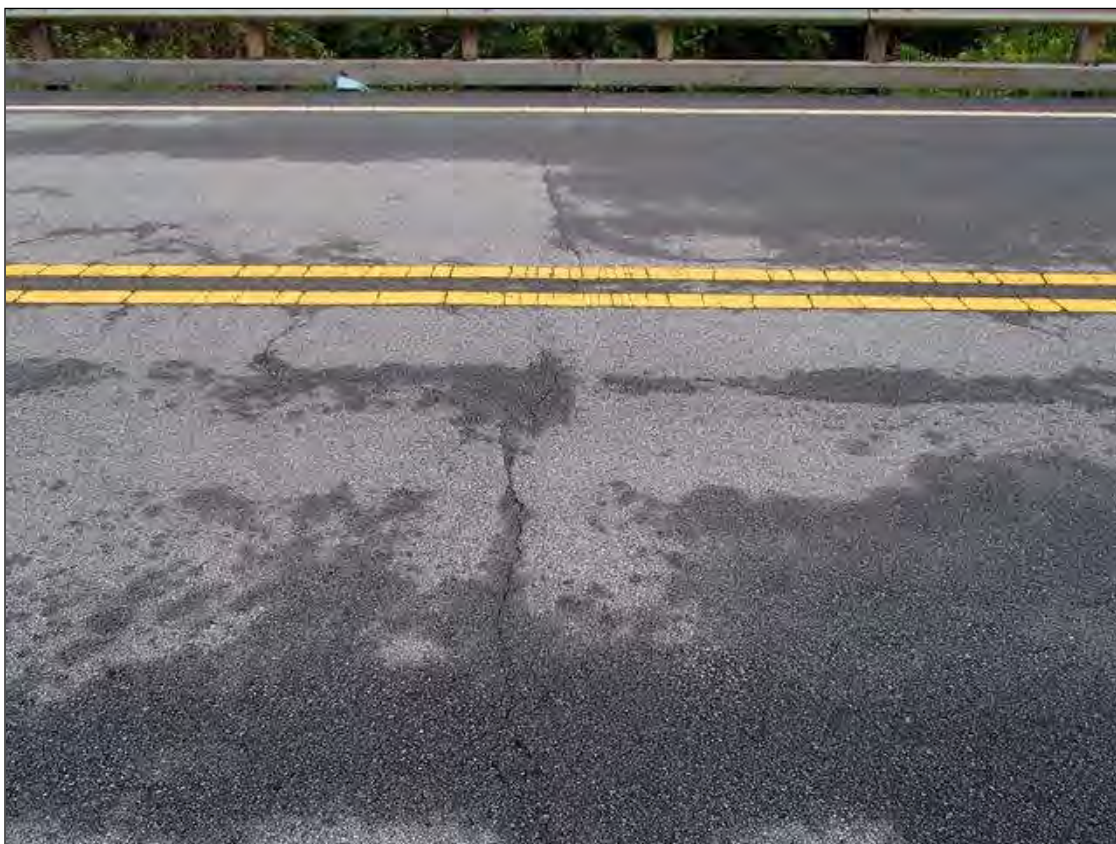
ASPHALT WEARING SURFACE OVER JOINT AT BENT 2: TRANSVERSE CRACKING UP TO 1/8" WIDE

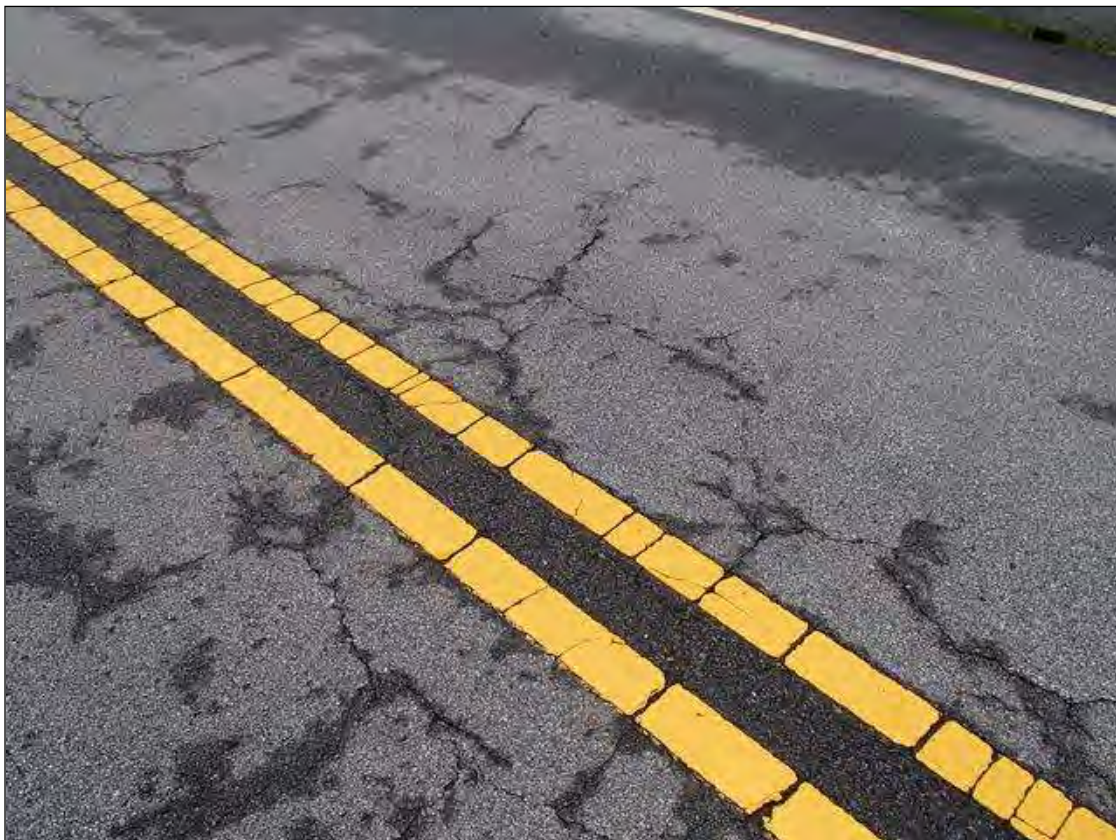
ASPHALT WEARING SURFACE SPAN 2: MAP CRACKING UP TO 1/4" WIDE (SIMILAR ALL SPANS)

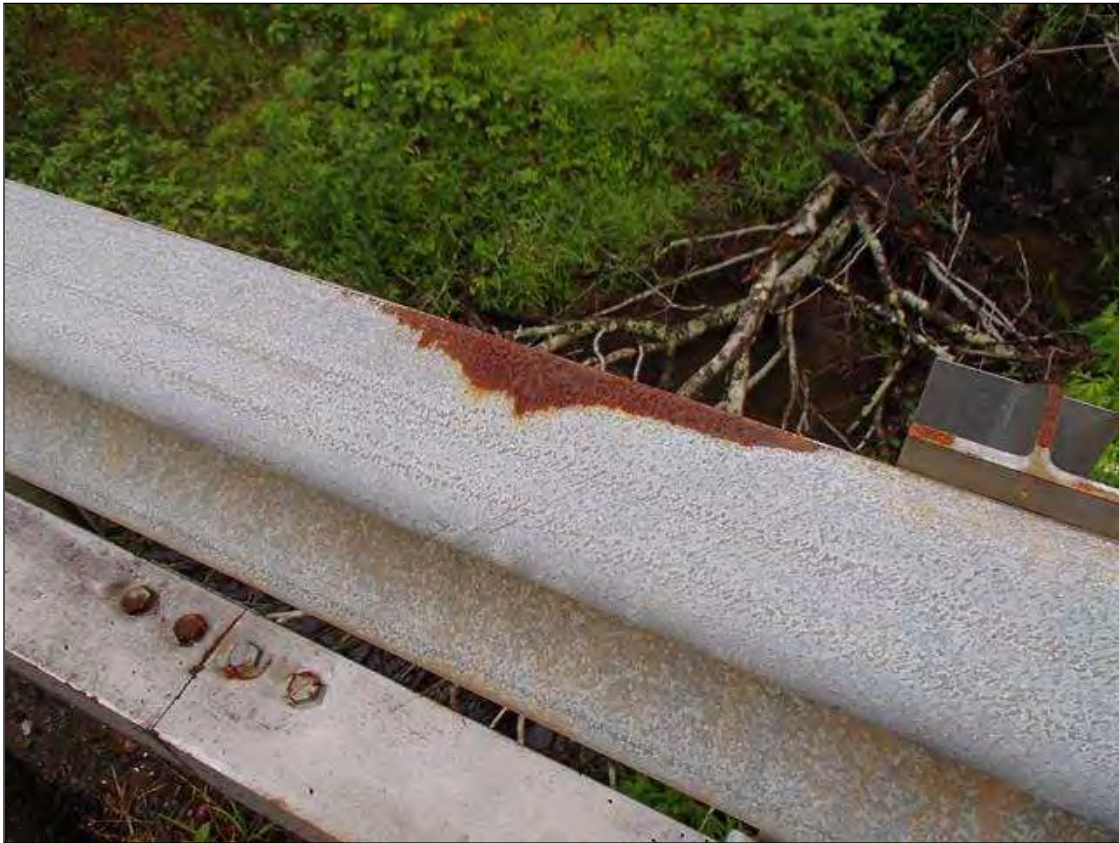
LEFT SIDE RAIL SPAN 3: CORROSION ON TOP FACE

| MMS Code | Description of Function | Unit | Quantity | Remarks | Est. Cost |
|---|---|---|---|---|---|
| 3322 | Maint to Steel Handrail | LF | 120 | IMPACT DAMAGE AT NORTHEAST CORNER AND CORROSION ON RAIL AND CURB SIMILAR BOTH SIDES | |

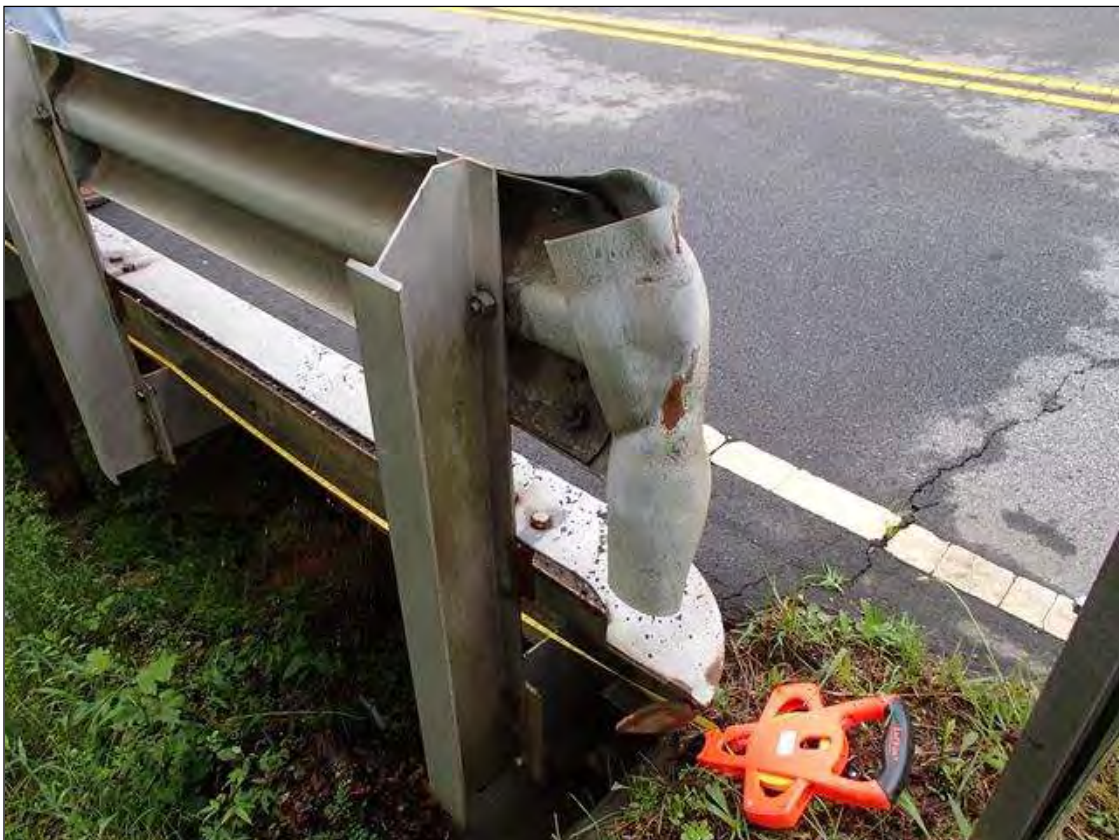
RIGHT SIDE RAIL END SECTION NORTHEAST CORNER: IMPACT DAMAGE

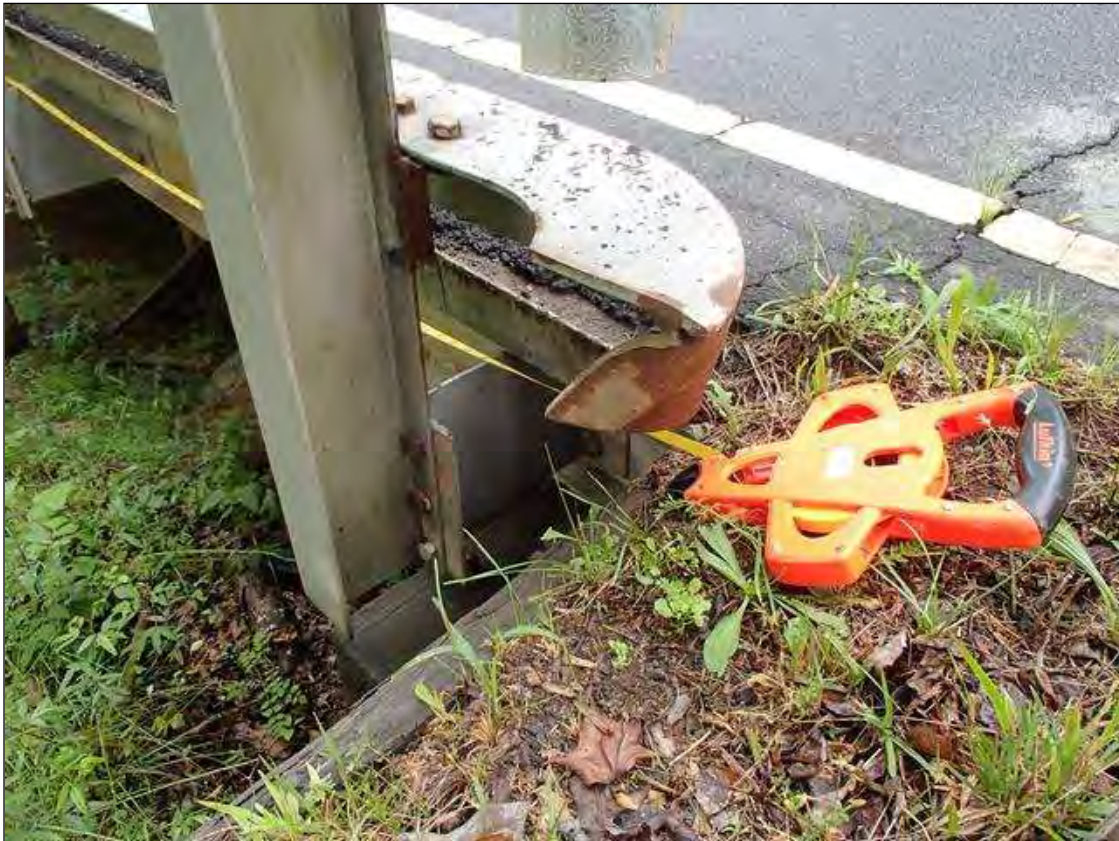
RIGHT SIDE CURB NORTHEAST CORNER: IMPACT DAMAGE

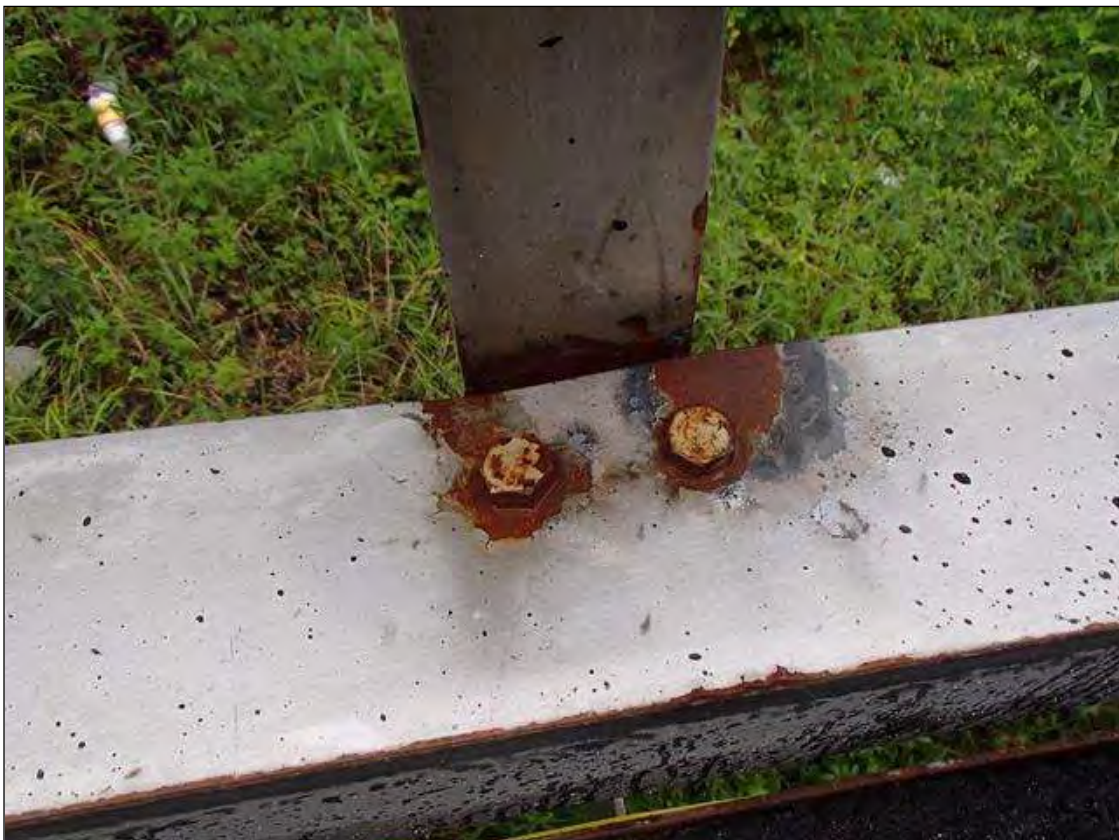
RIGHT SIDE CURB SPAN 3: CORROSION ON TOP FACE AT CONNECTION BOLTS (SIMILAR THROUGHOUT)

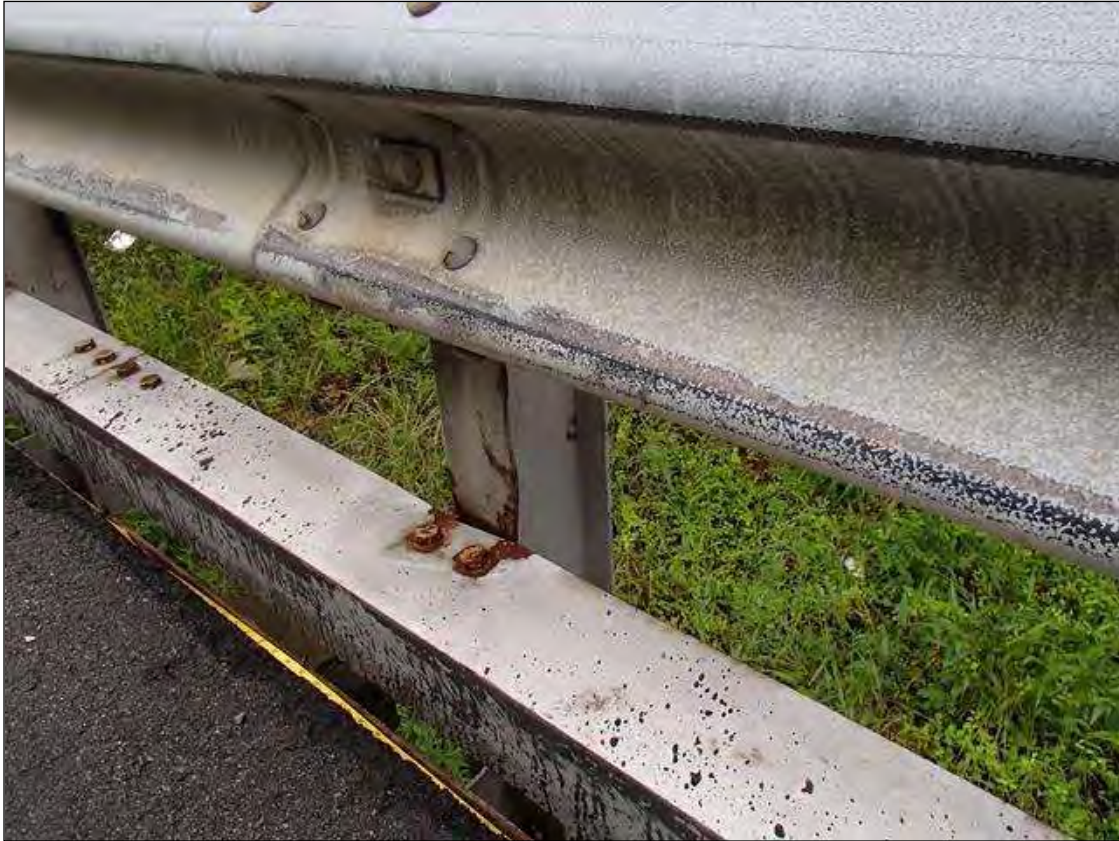
RIGHT SIDE RAIL POST SPAN 2 AT BENT 2: DAMAGE ADJACENT TO TOP OF CURB

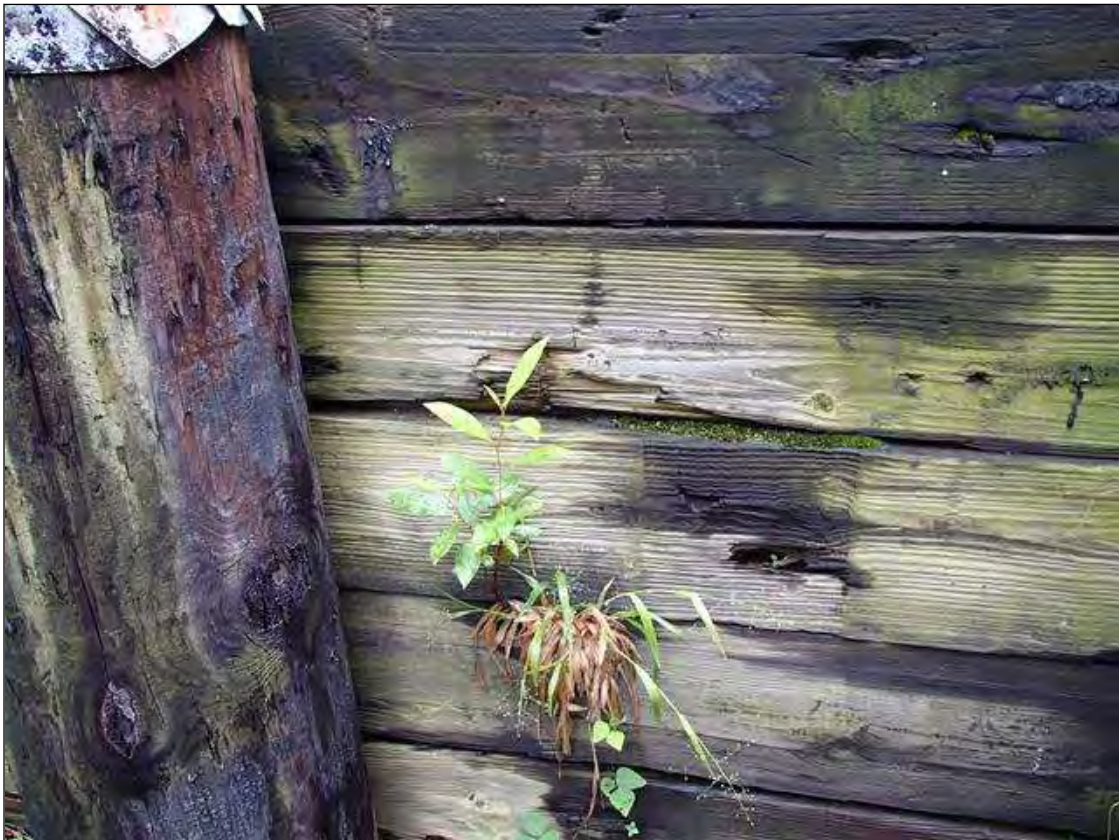
BULKHEAD EXTENSION AT EAST END OF ABUTMENT 1: AREA OF SPLINTERING AND MISSING SECTION ON BOTTOM OF MIDDLE BOARD

| MMS Code | Description of Function | Unit | Quantity | Remarks | Est. Cost |
|---|---|---|---|---|---|
| 3346 | Repair / Maintain Timber Wings & Blkhds | SF | 20 | THERE ARE SEVERAL AREAS OF DECAY ON THE BULKHEADS AT BOTH ABUTMENTS, LOOSE BOARDS AT SOME OF THE WINGWALLS IN DECAY WITH PENETRATION ON THE END OF SEVERAL BOARDS AT THE BULKHEAD EXTENSION'S AT BOTH ABUTMENTS | |

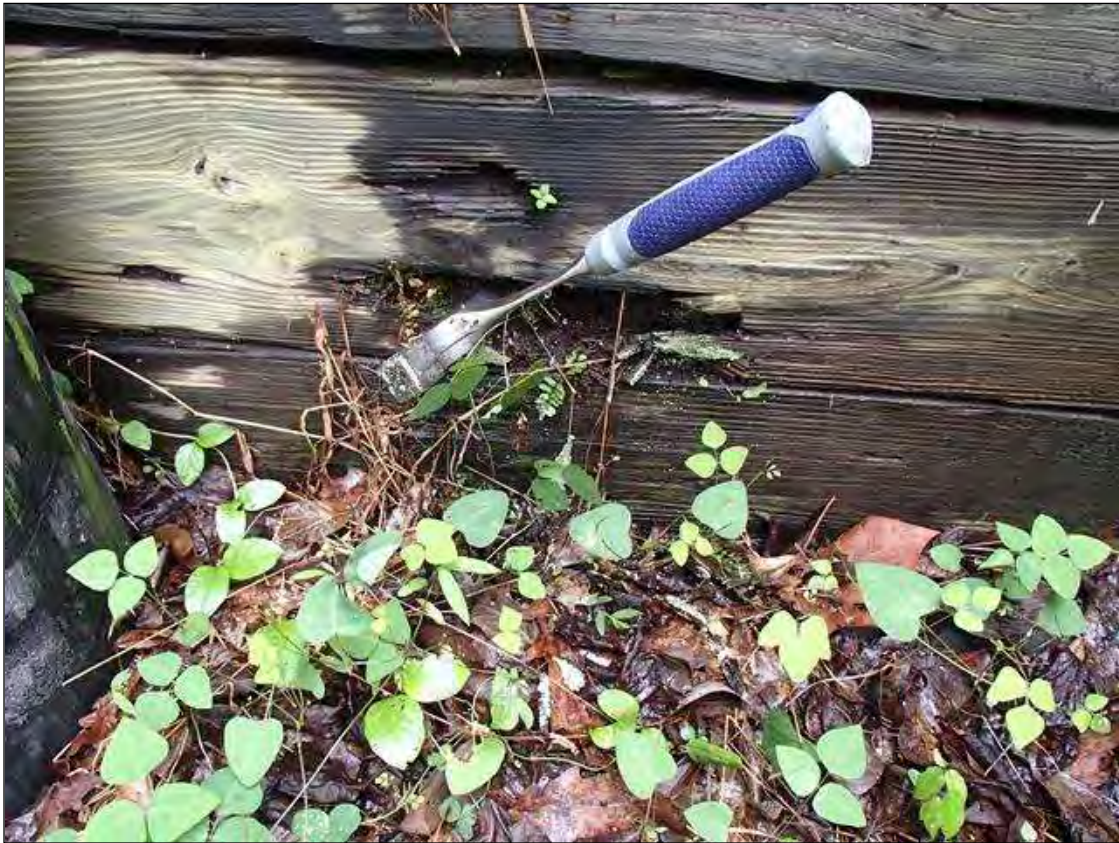
BULKHEAD EXTENSION AT EAST END ABUTMENT 1: AREA OF DECAY 18 " X 2 " X 3"

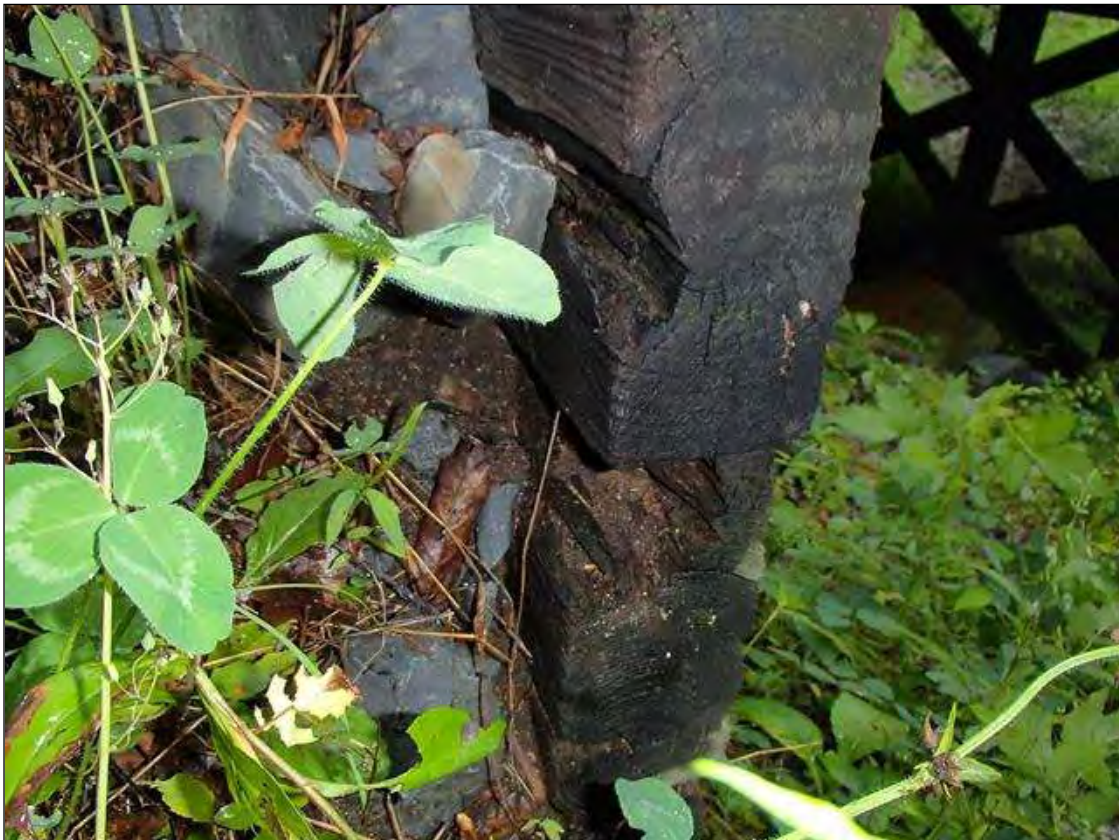
BULKHEAD EXTENSION AT SOUTHEAST CORNER: DECAY ON END OF BOARDS WITH UP TO 8 INCHES PENETRATION

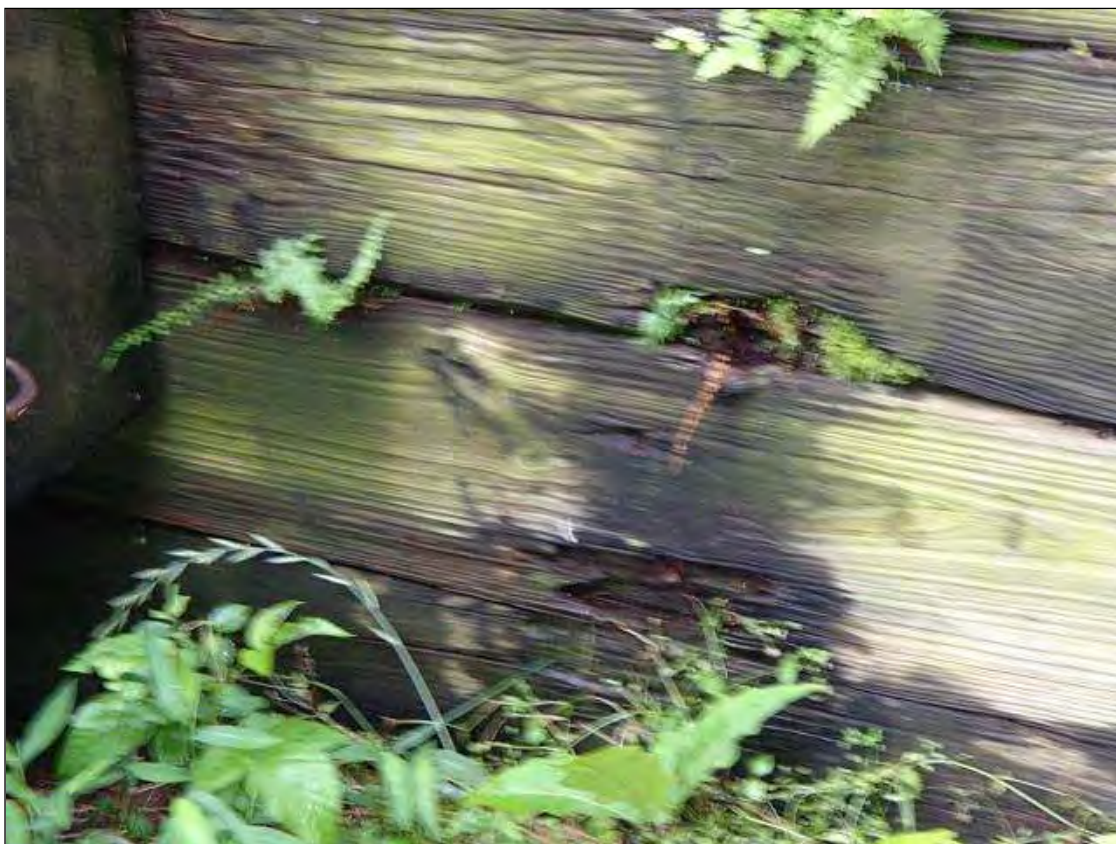
BULKHEAD EXTENSION AT SOUTHWEST CORNER: 2 AREAS OF DECAY UP TO 6" X 3" X 2"

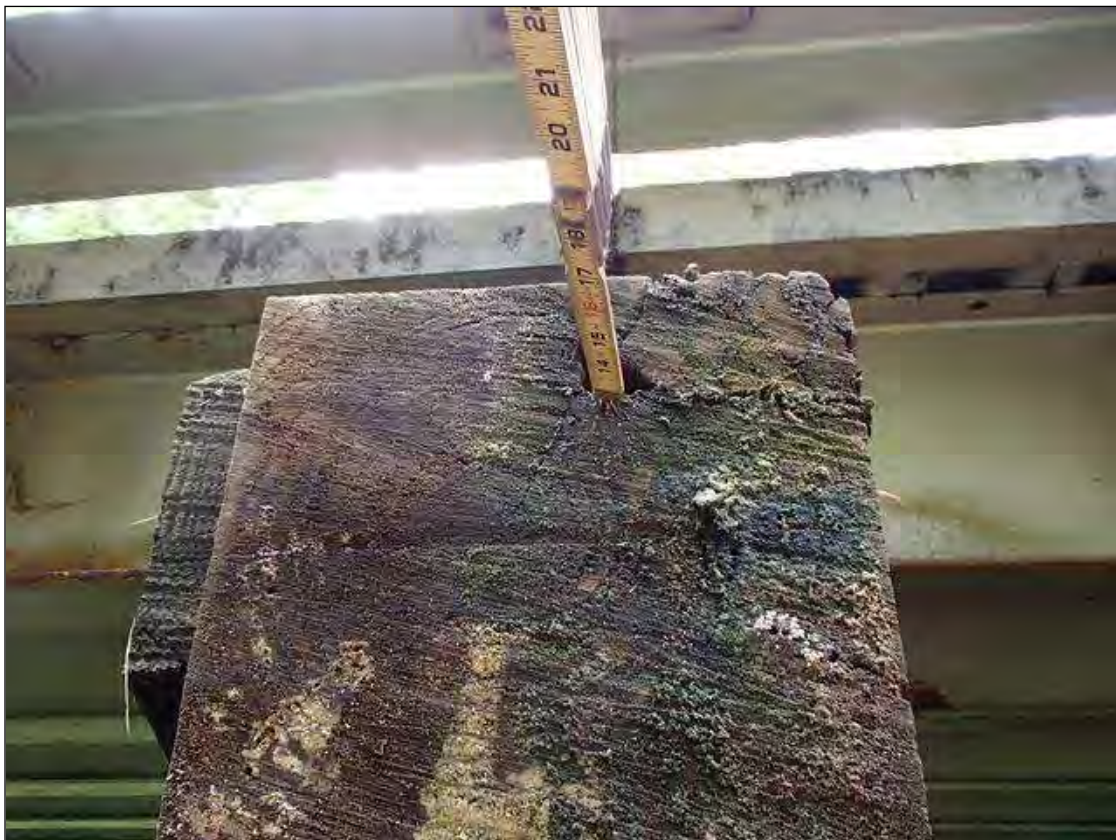
TIMBER CAP AT BENT 1 WEST END: AREA OF DECAY 2" X 2" WITH 13" PENETRATION

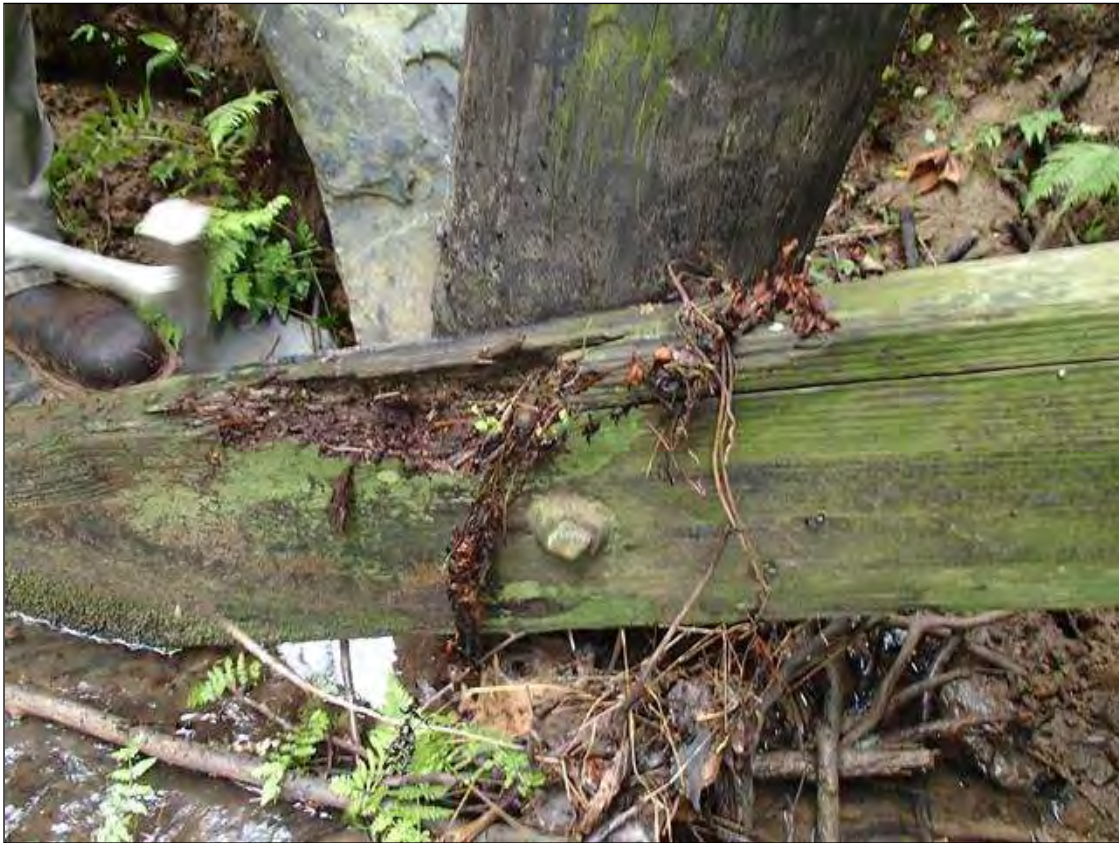
CROSS BRACE AT BOTTOM OF PILE 5 AT BENT 1: AREA OF DECAY ON TOP OF BOARD 18 " X 3 " X 3"

| MMS Code | Description of Function | Unit | Quantity | Remarks | Est. Cost |
|---|---|---|---|---|---|
| 3304 | Maintain/Replace Timber Superstructure Components | LF | 2 | THERE IS AN AREA OF DECAY ON CROSS BRACE AT THE BOTTOM OF PILE 5 AT BENT 1 | |

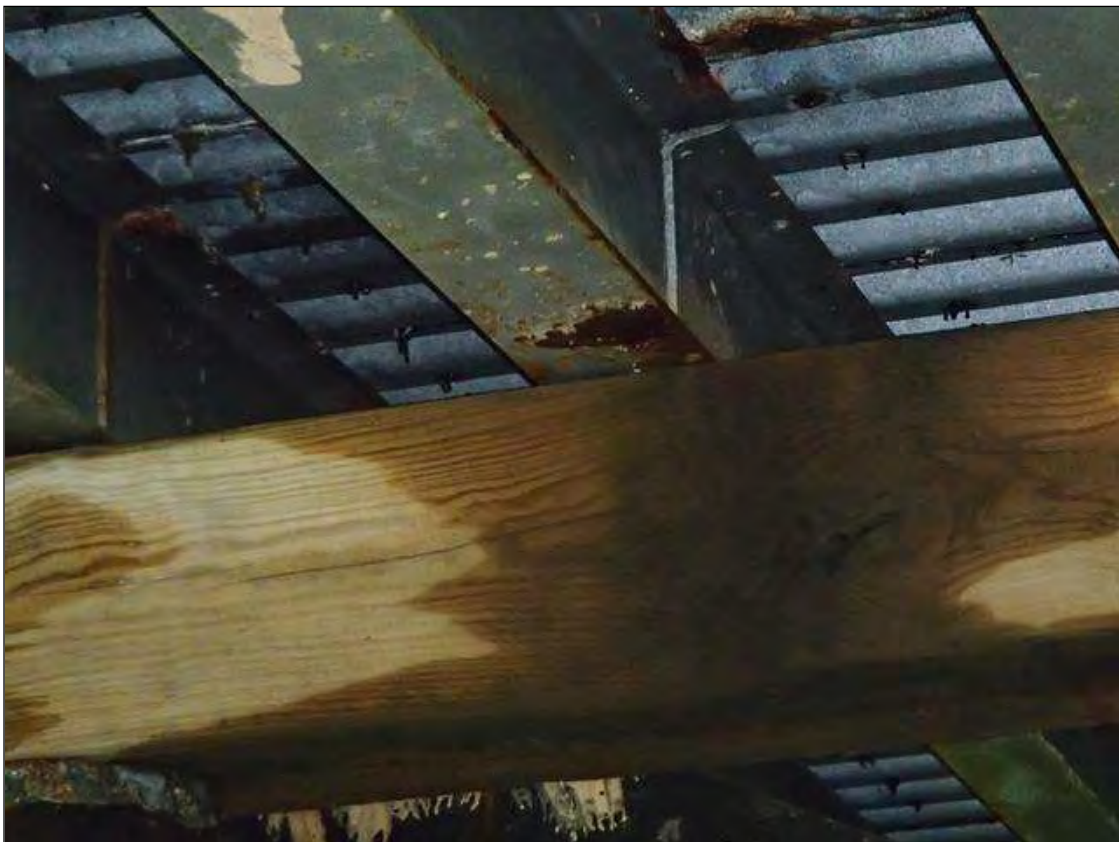
BEAM 5 AT BENT 2 SPAN 2: PAINT LOSS AND CORROSION ON BOTTOM FLANGE (SIMILAR SEVERAL LOCATIONS THROUGHOUT)

| MMS Code | Description of Function | Unit | Quantity | Remarks | Est. Cost |
|---|---|---|---|---|---|
| 5603 | Partial Cleaning and Painting of Structural Steel | SF | 500 | SEVERAL AREAS OF CORROSION AND PAINT LOSS ON BEAMS | |

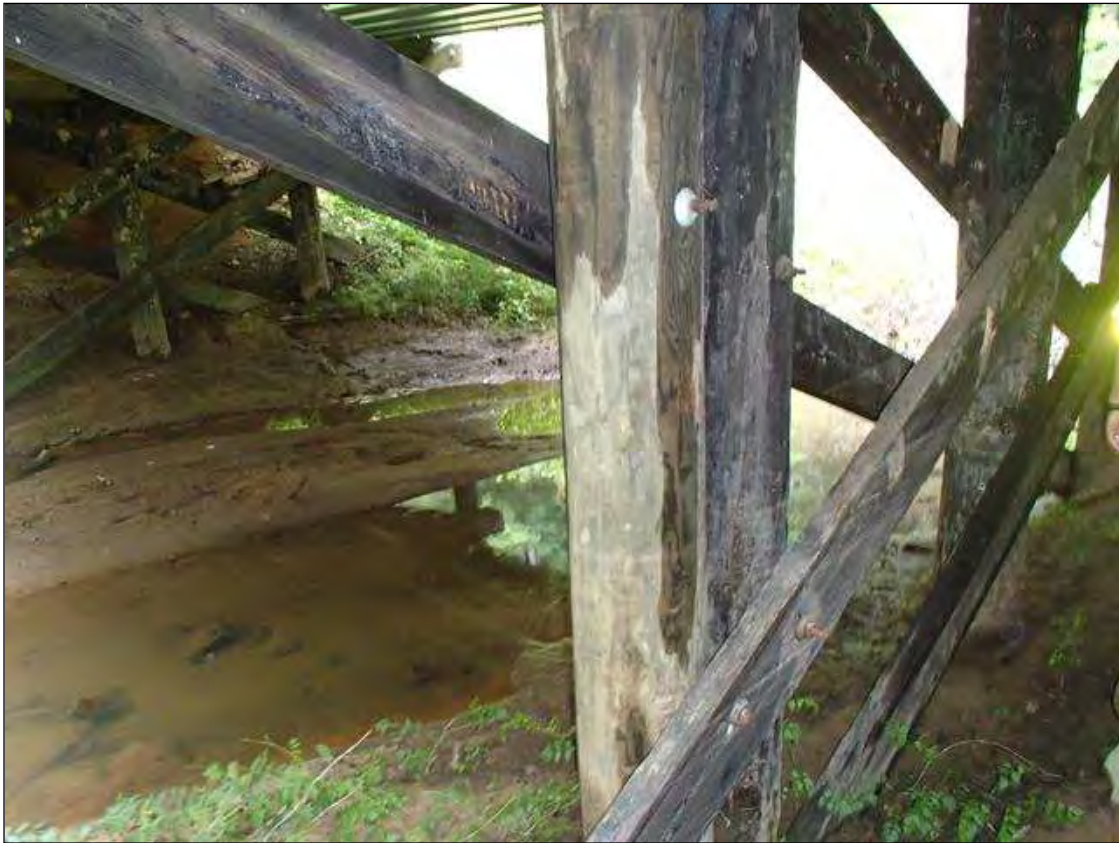
Pile 4 at Int. bent 2 supplemented.  
Temporary Repair

PILE 5 AT BENT 2: PILE ADDED AS TEMPORARY REPAIR

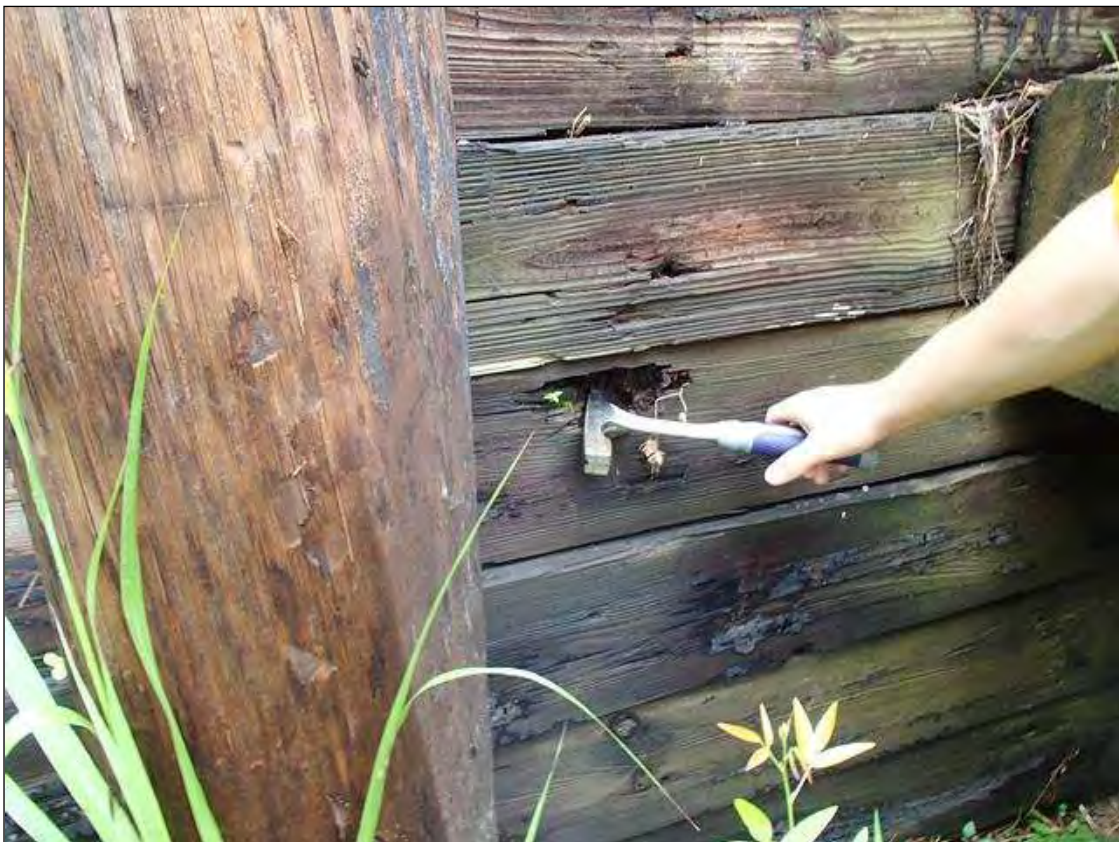
BULKHEAD AT NORTHWEST CORNER: AREA OF DECAY 6 " X 2 " X 3"

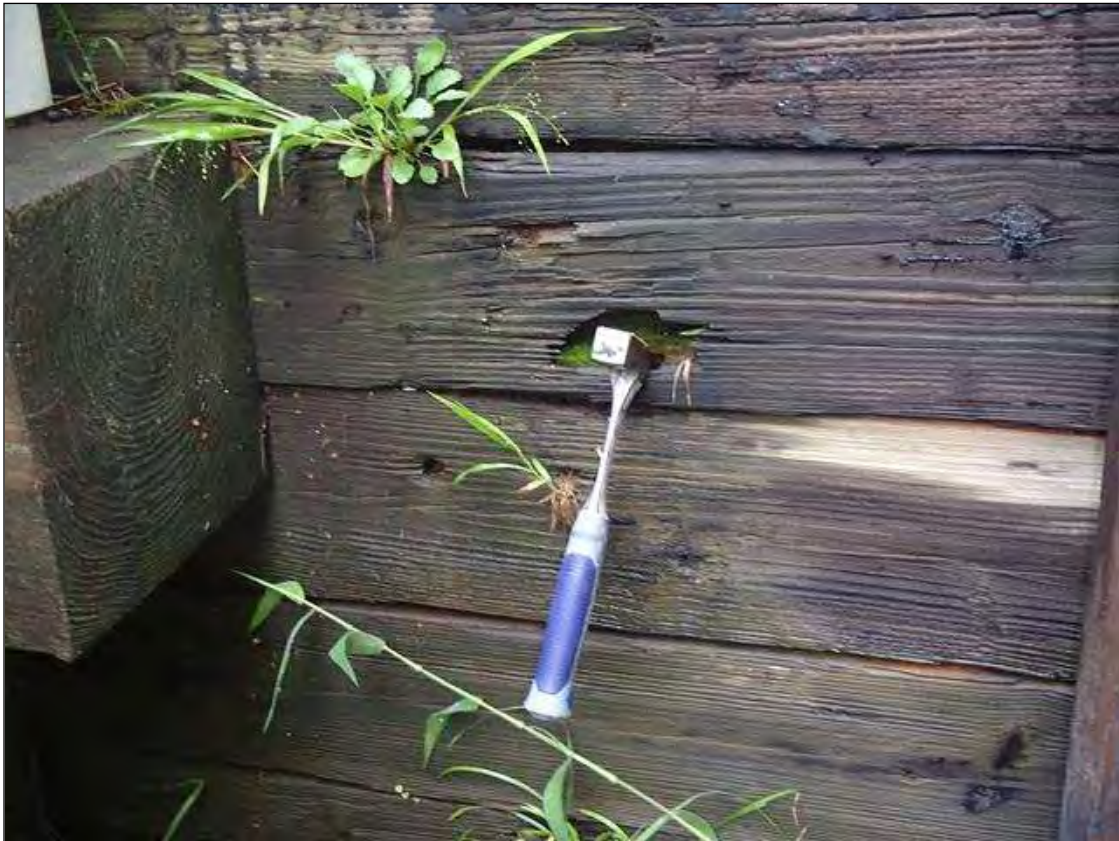
BULKHEAD AT NORTHEAST CORNER: AREA OF DECAY 4 " X 2 " X 2"
