NC DEPARTMENT OF TRANSPORTATION  
DIVISION OF HIGHWAYS  
BRIDGE MANAGEMENT UNIT

# BRIDGE INSPECTION REPORT

INSPECTION TYPE: Routine Inspection - Contract

COUNTY ROWAN BRIDGE NUMBER 790149 INSPECTION CYCLE 0 YRS  
ROUTE SR2132 ACROSS N.PRONG OF CHURCH M.P. 0

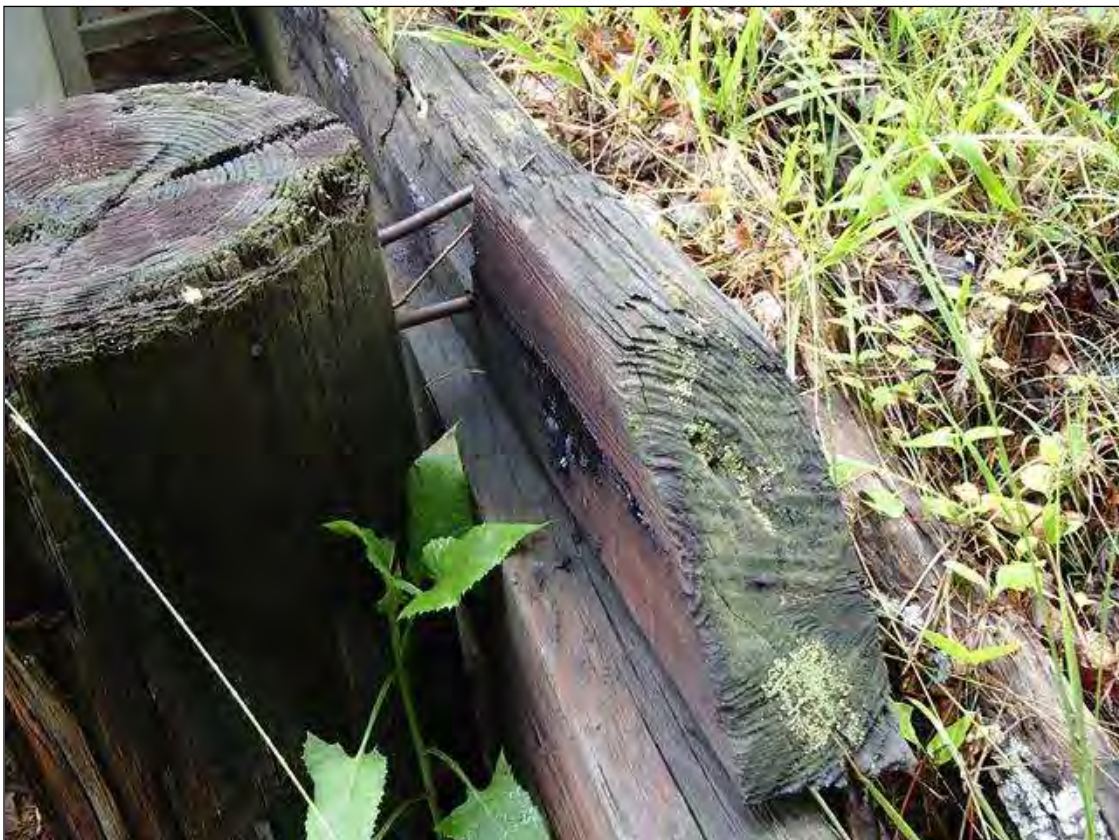
BULKHEAD EXTENSION AT NORTHEAST CORNER TOP BOARD LOOSE AND DISPLACED FROM POST

| MMS Code | Description of Function | Unit | Quantity | Remarks | Est. Cost |
|---|---|---|---|---|---|
| 3346 | Repair / Maintain Timber Wings & Blkhds | SF | 20 | THERE ARE SEVERAL AREAS OF DECAY ON THE BULKHEADS AT BOTH ABUTMENTS, LOOSE BOARDS AT SOME OF THE WINGWALLS IN DECAY WITH PENETRATION ON THE END OF SEVERAL BOARDS AT THE BULKHEAD EXTENSION'S AT BOTH ABUTMENTS | |

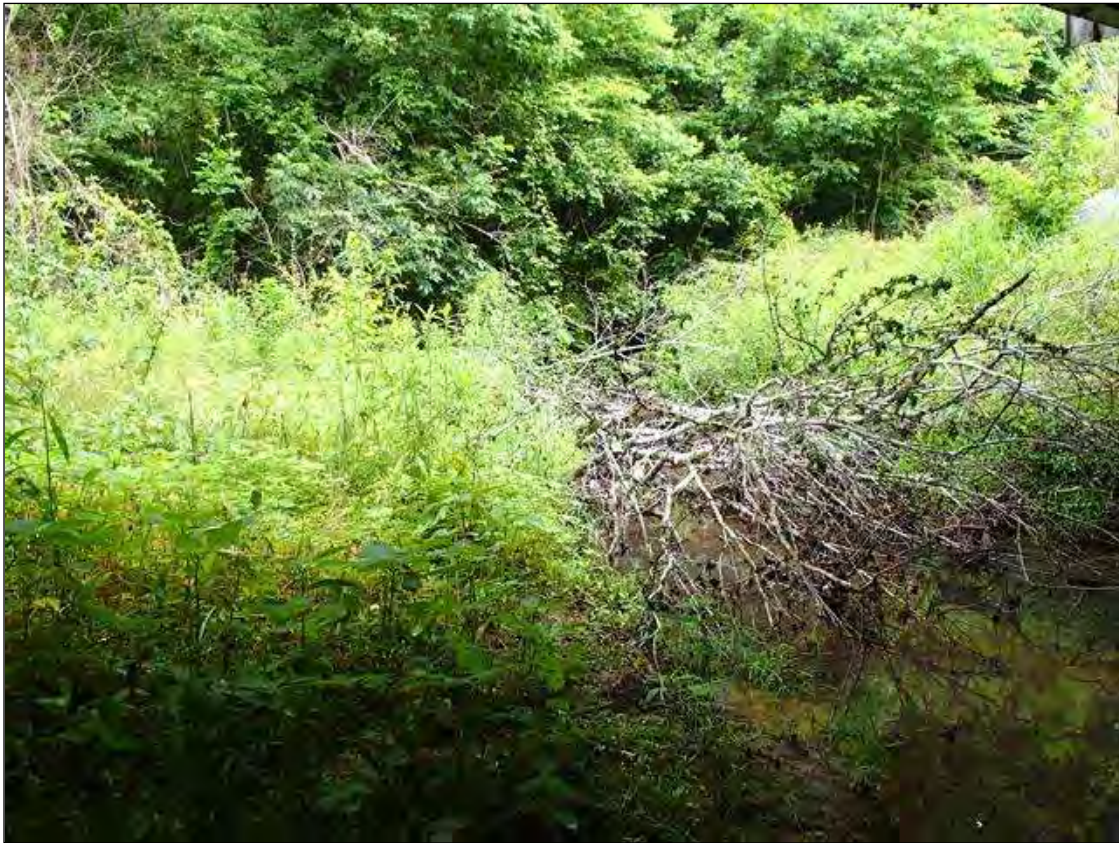
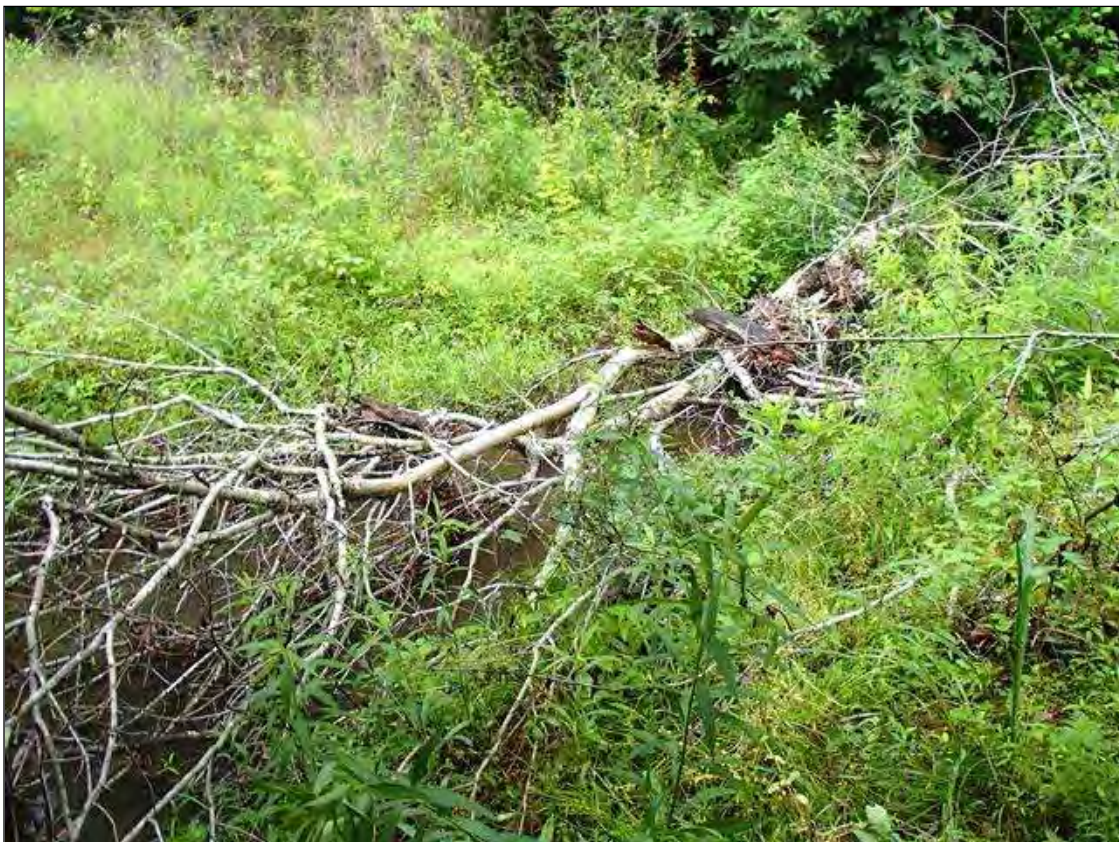
| 41 | F | DRIFT<br><br>THERE IS A LARGE TREE IN THE MIDDLE OF THE UPSTREAM CHANNEL<br>- | |

DRIFT IN UPSTREAM CHANNEL

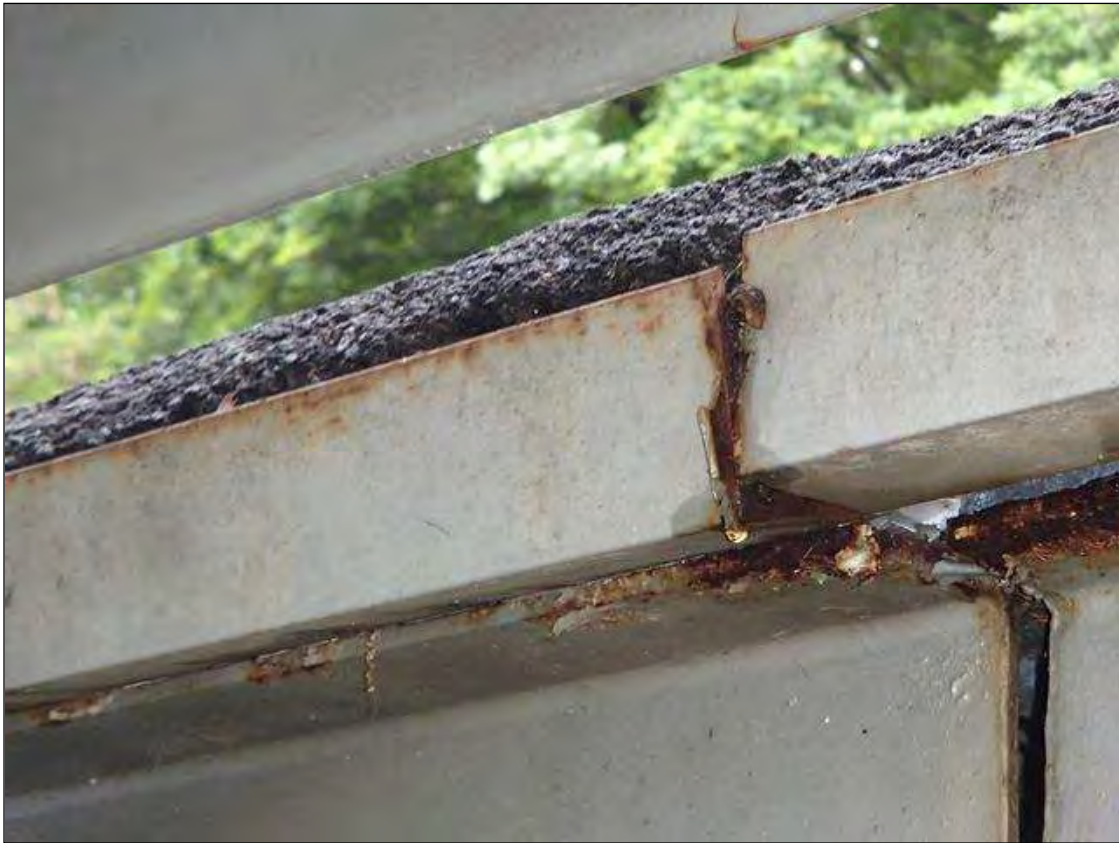
DECK PLANKING SUPPORT ANGLE ON RIGHT SIDE AT BENT 2 DISPLACED
