# BRIDGE INSPECTION REPORT

INSPECTION TYPE: Routine Inspection - Contract

COUNTY ROWAN BRIDGE NUMBER 790353 INSPECTION CYCLE 0 YRS  
ROUTE SR1349 ACROSS CREEK M.P. 0

INSPECTION DATE 06/13/2014

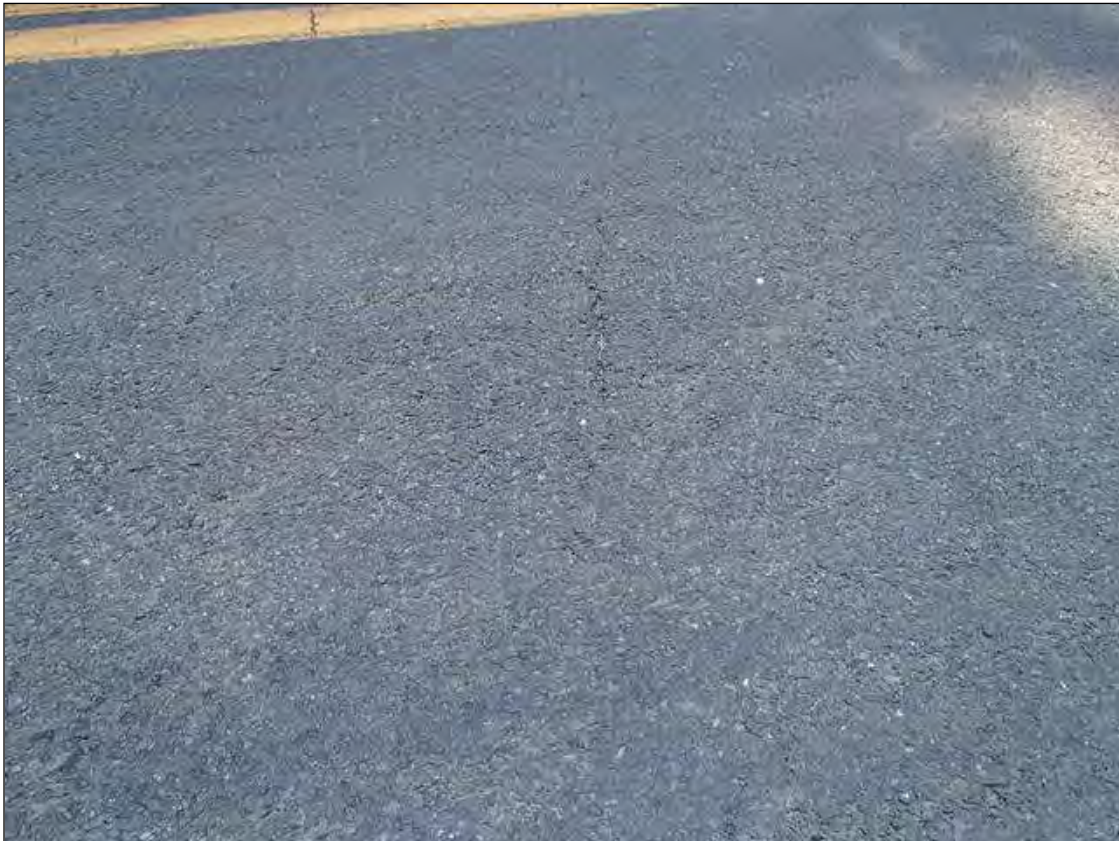
ASPHALT AT NORTH APPROACH: TRANSVERSE CRACKING UP TO 1/8" WIDE

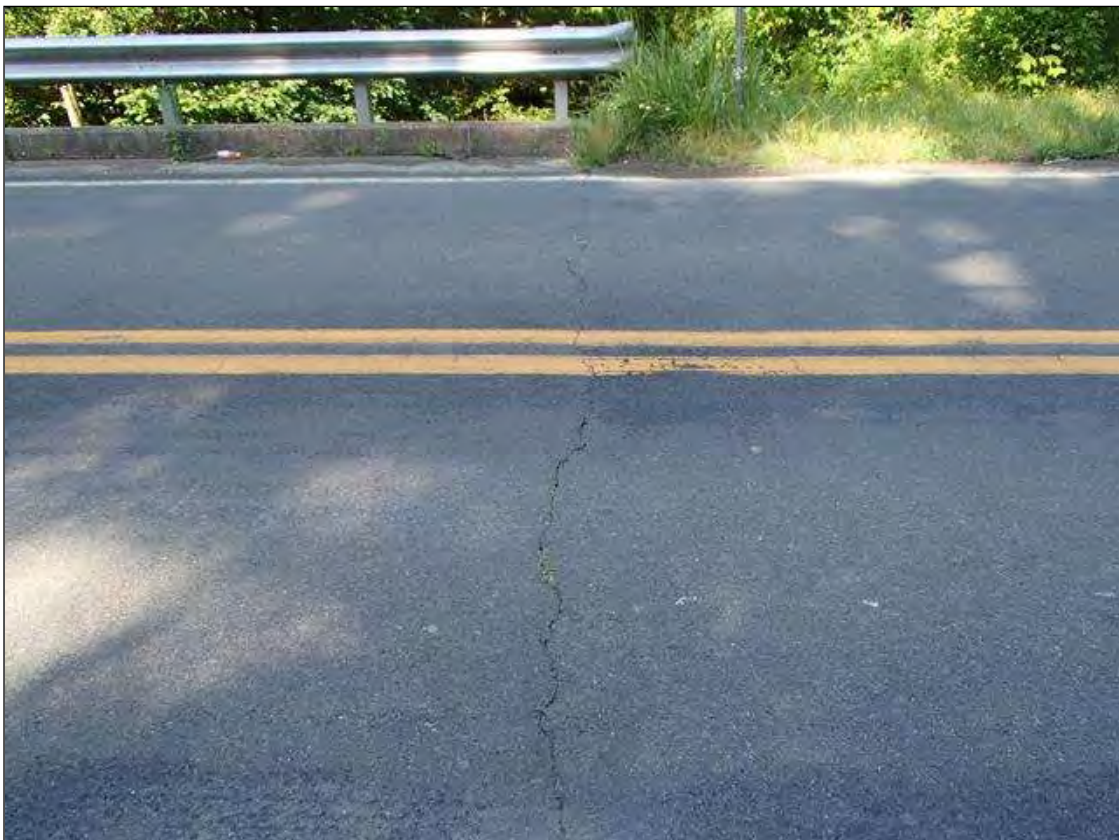
ASPHALT AT NORTH APPROACH: TRANSVERSE CRACKING UP TO 1/8" WIDE ALONG JOINT AT ABUTMENT 2

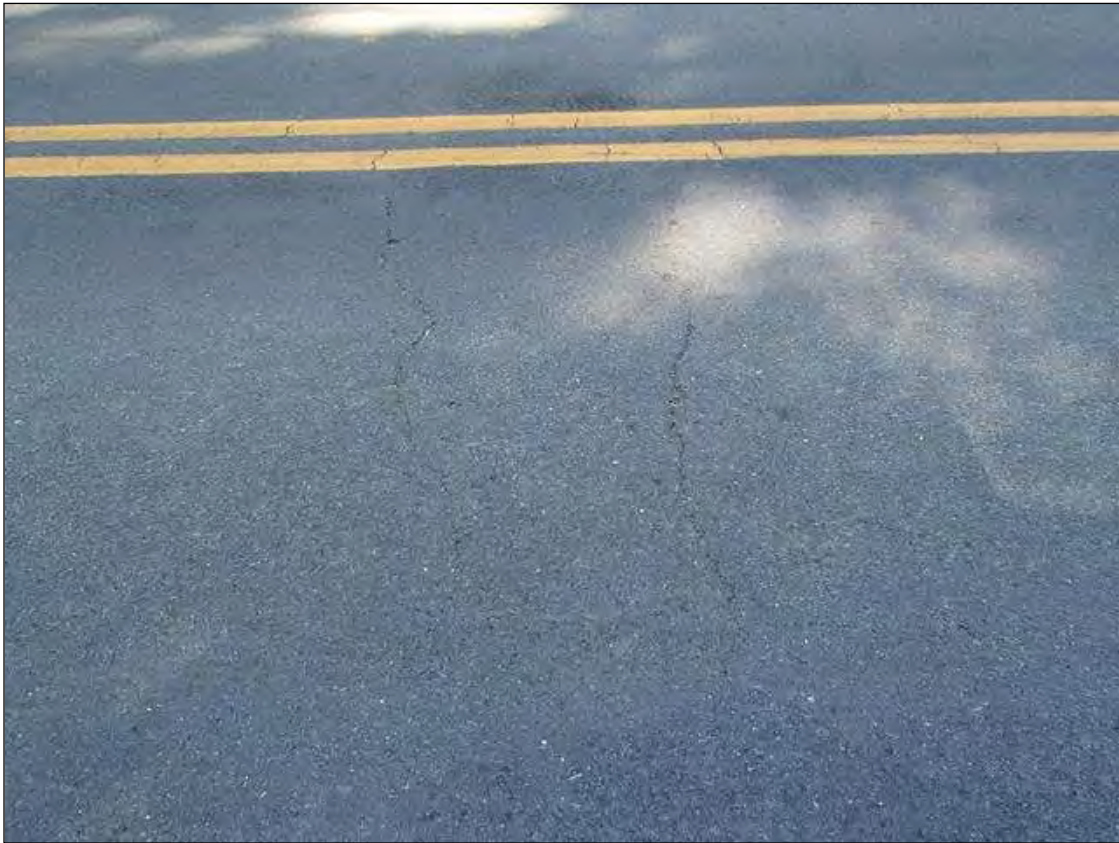
ASPHALT AT SOUTH APPROACH: TRANSVERSE CRACKING UP TO 1/4" WIDE

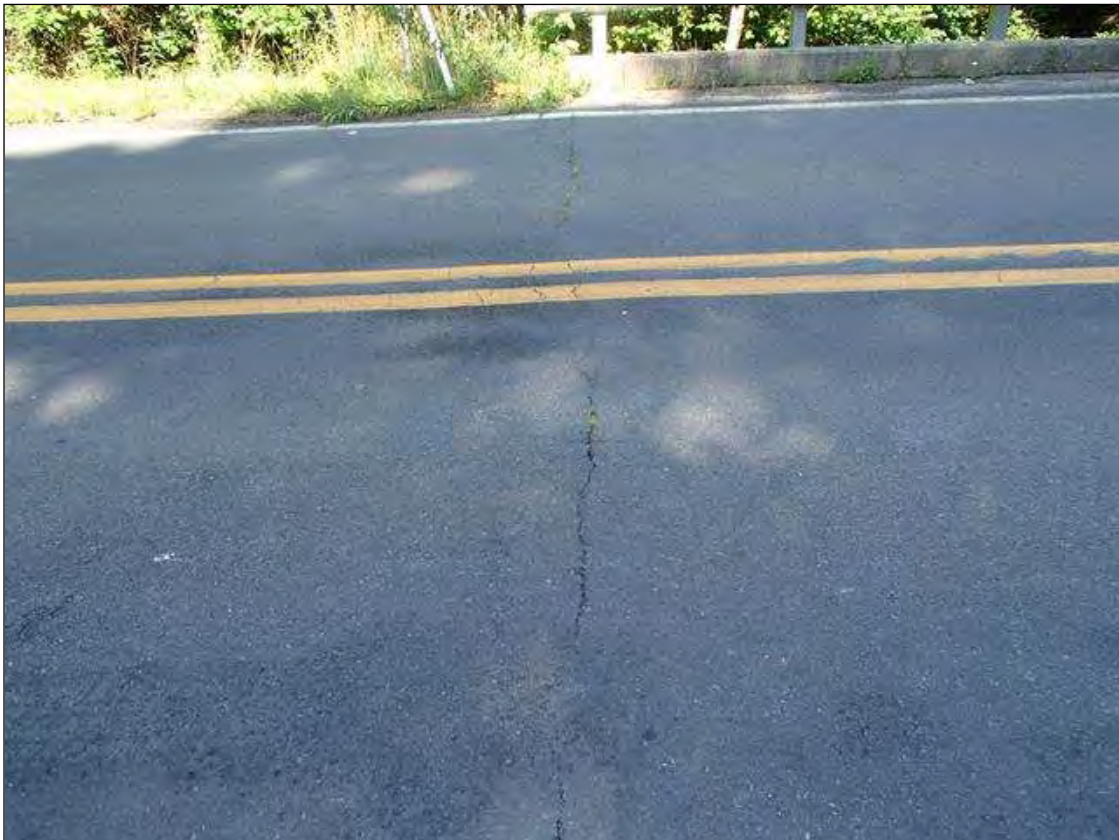
ASPHALT AT SOUTH APPROACH: TRANSVERSE CRACKING UP TO 1/4" WIDE ALONG JOINT AT ABUTMENT 1

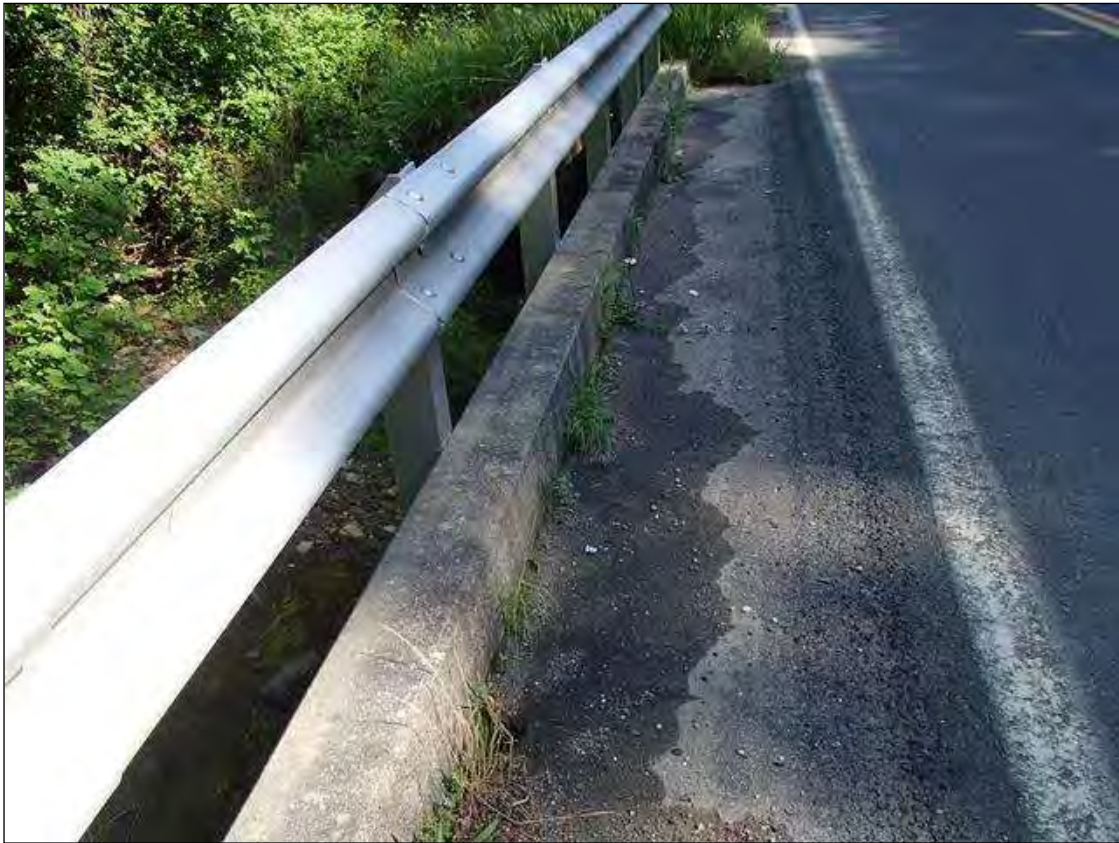
| Bridge I&A Form 1(82)H<br>State of North Carolina<br>Dept. of Transportation<br>Division of Highways | | <h1 style="text-align: center;">FIELD INSPECTION REPORT</h1> <p style="text-align: center;"><u>Bridge Inspection &amp; Analysis</u></p> | |
|---|---|---|--|
| | | THERE IS AN ACCUMULATION OF DIRT AND VEGETATION ALONG BOTH GUTTER LINES | |

DEBRIS ALONG LEFT SIDE GUTTER LINE

| MMS Code | Description of Function | Unit | Quantity | Remarks | Est. Cost |
|---|---|---|---|---|---|
| 3376 | Clean/Wash Bridge Decks | SF | 50 | DEBRIS AND VEGETATION ALONG BOTH GUTTER LINES | |

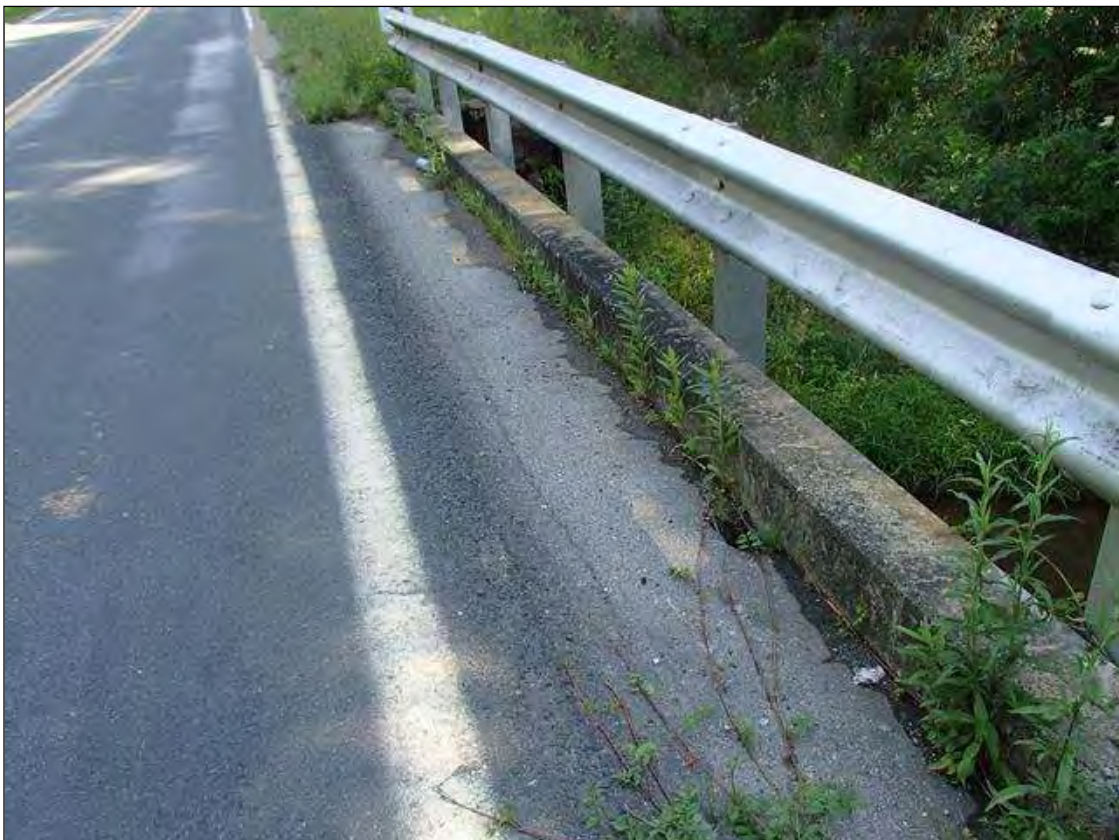
DEBRIS ALONG RIGHT SIDE GUTTER LINE

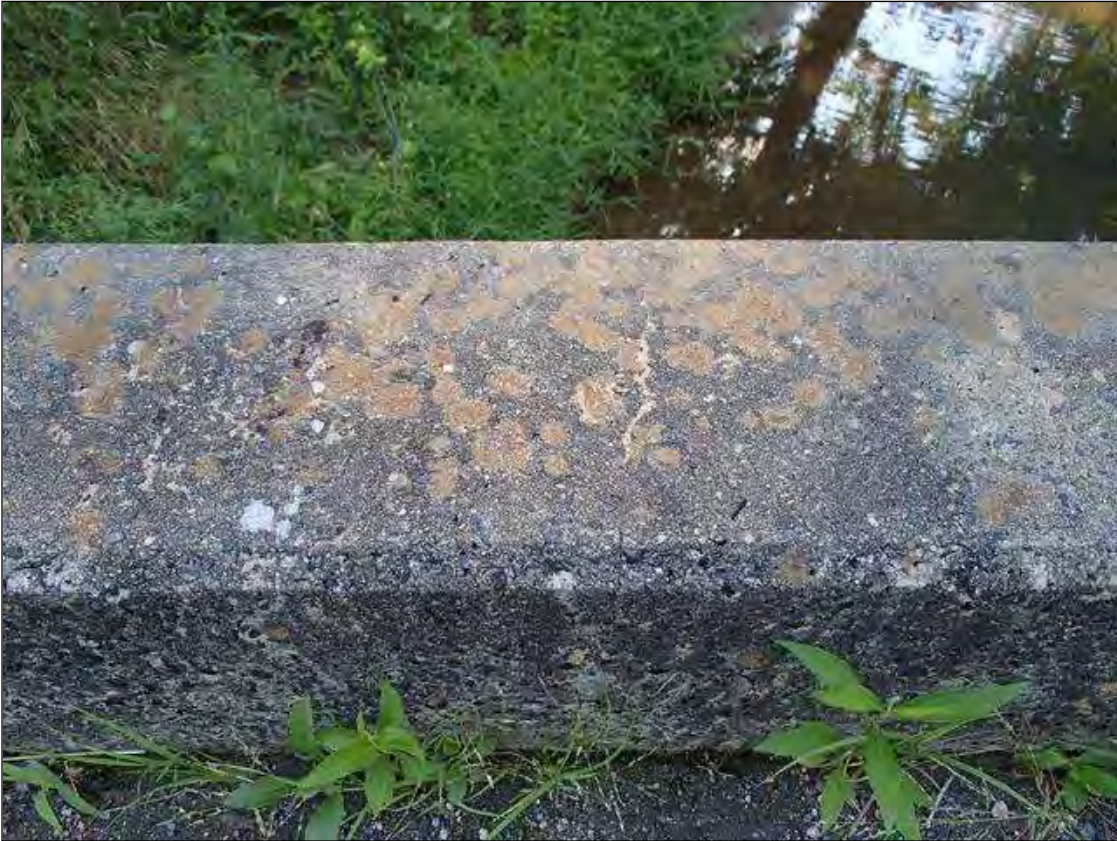
RIGHT SIDE CURB: TRANSVERSE CRACKING UP TO 1/64" WIDE (SIMILAR SEVERAL LOCATIONS THROUGHOUT)

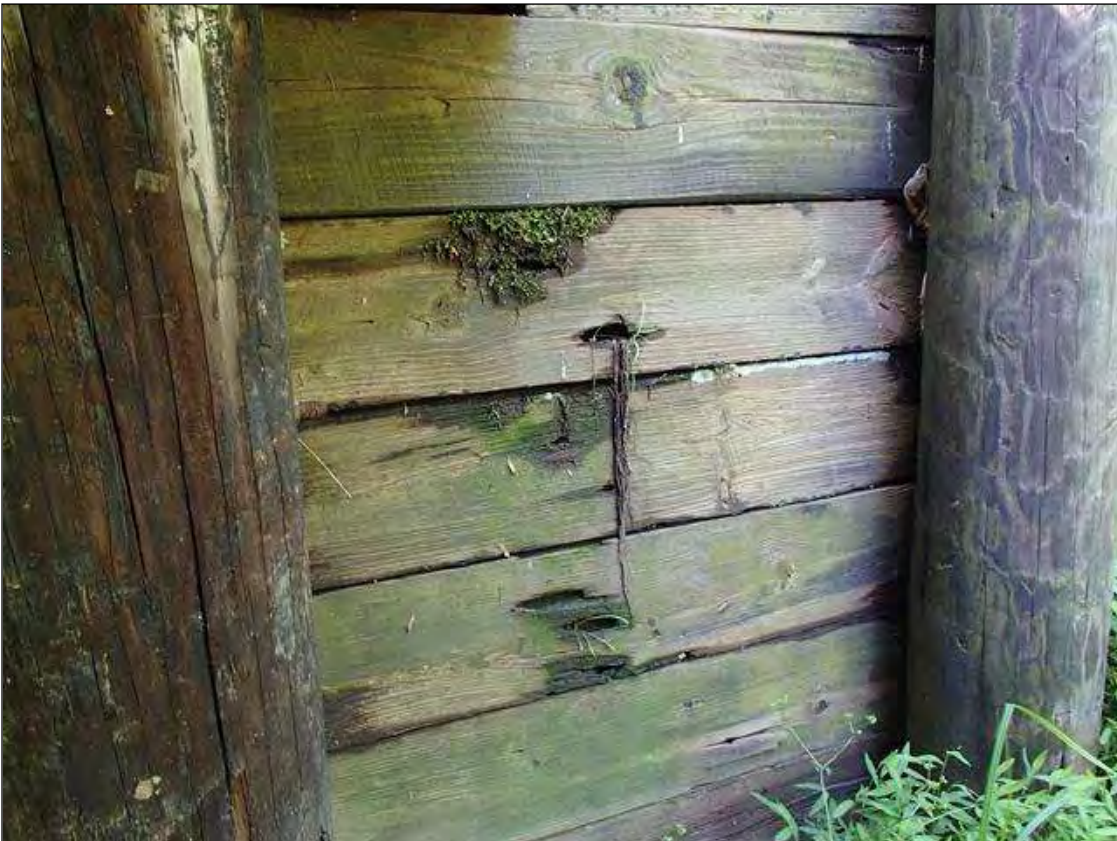
BULKHEAD EXTENSION AT WEST END OF ABUTMENT 1: SEVERAL AREAS OF DECAY UP TO 8 " X 4 " X 3"

| MMS Code | Description of Function | Unit | Quantity | Remarks | Est. Cost |
|---|---|---|---|---|---|
| 3346 | Repair / Maintain Timber Wings & Blkhds | SF | 60 | NUMEROUS AREAS OF DECAY ON BULKHEADS AT BOTH ABUTMENTS AND ALL 4 WINGWALLS | |

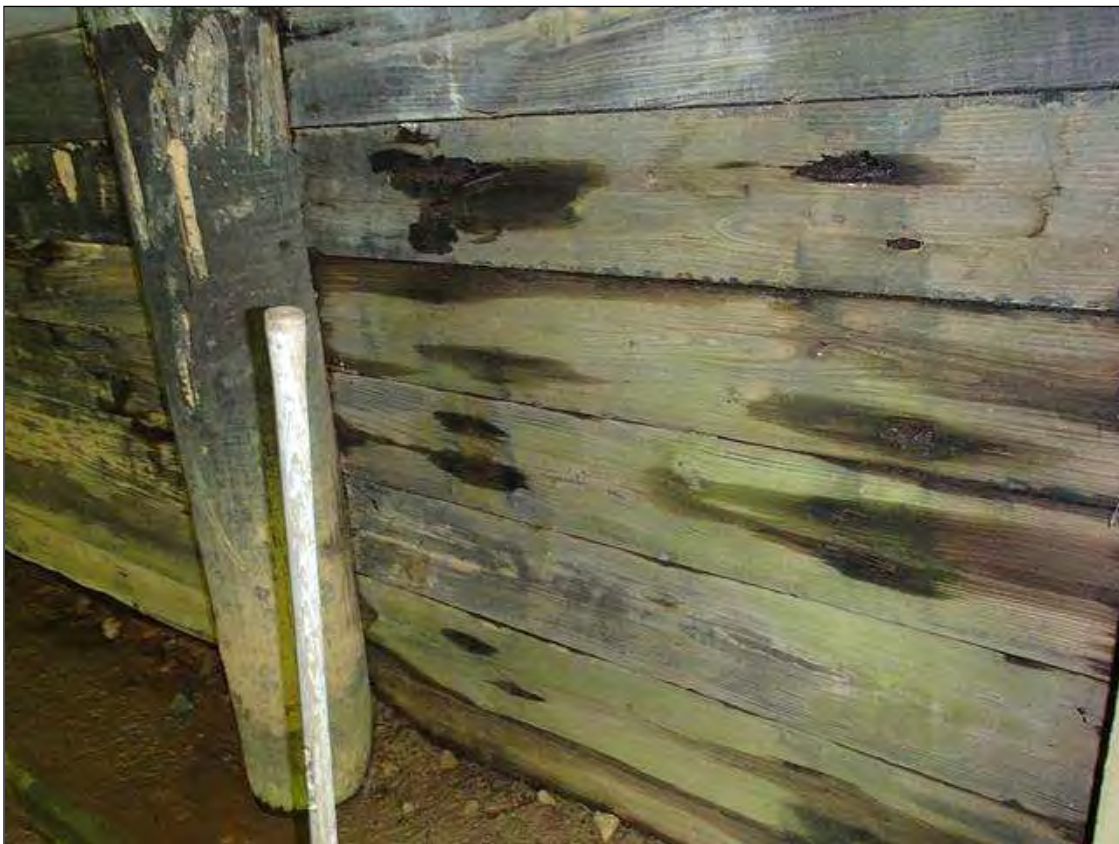
BULKHEAD AT ABUTMENT 1 BAY 1: SEVERAL AREAS OF DECAY UP TO 12 " X 4 " X 3"

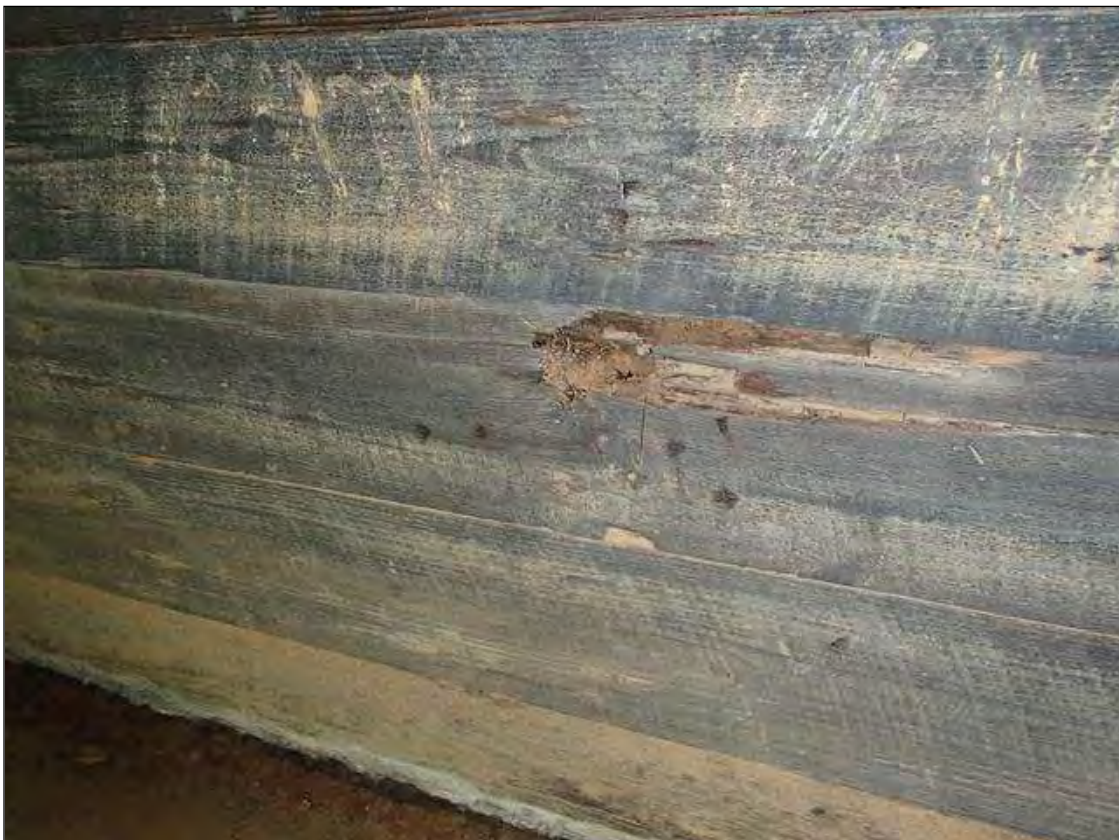
BULKHEAD AT ABUTMENT 1 BAY 3: AREA OF DECAY 18 " X 3 " X 3"

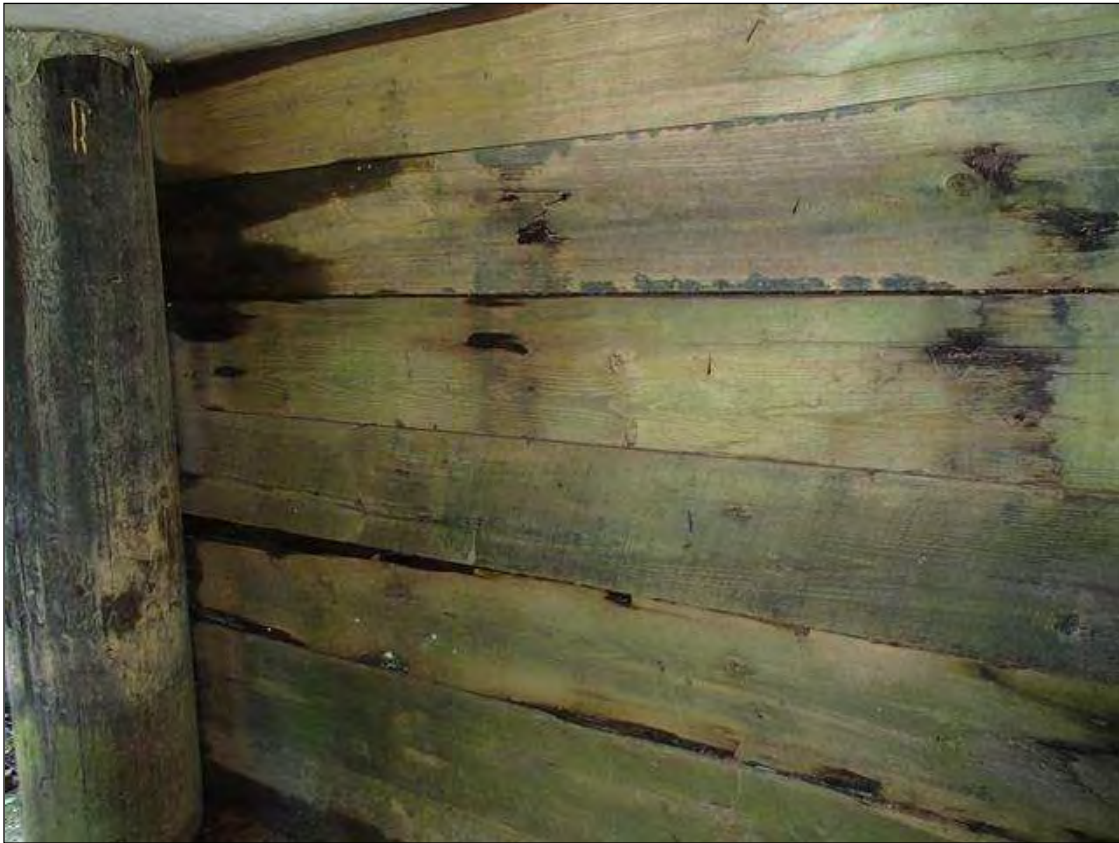
BULKHEAD AT ABUTMENT 1 BAY 4: SEVERAL AREAS OF DECAY UP TO 36 " X 2 " X 3"

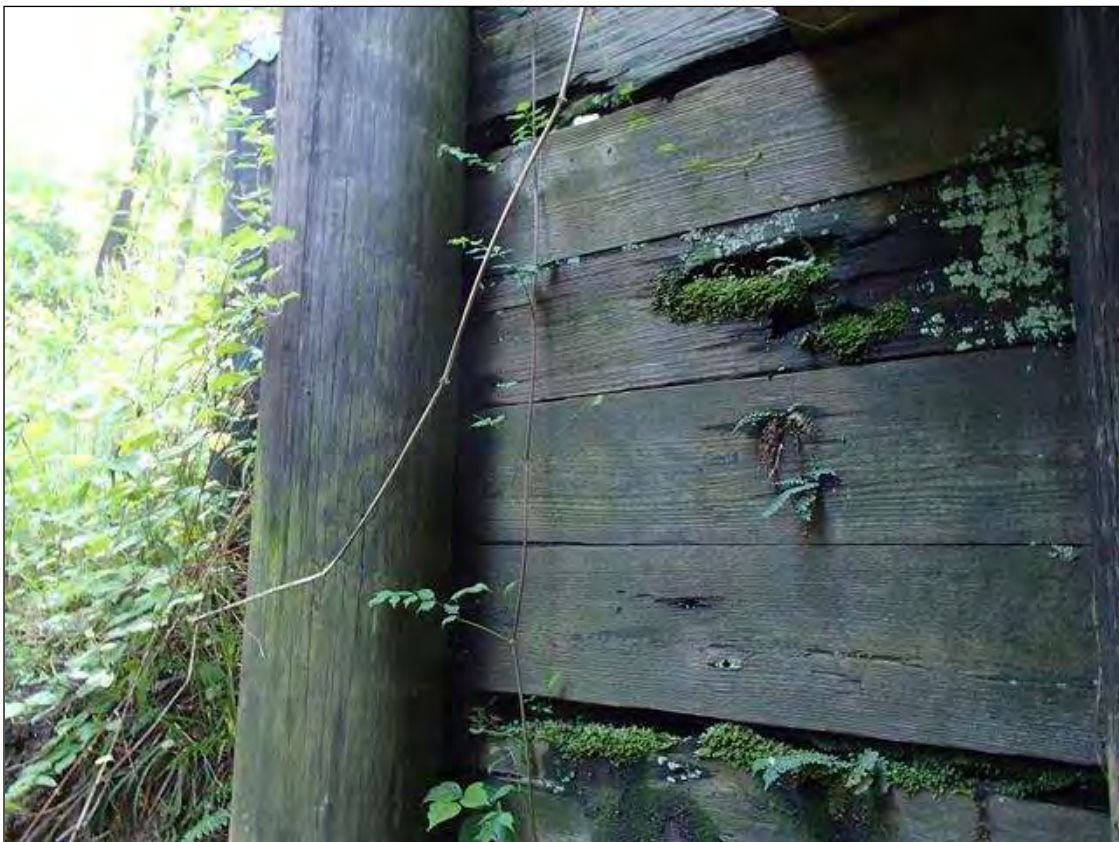
BULKHEAD EXTENSION AT EAST END OF ABUTMENT 1: SEVERAL AREAS OF DECAY UP TO 36 " X 8 " X 3"

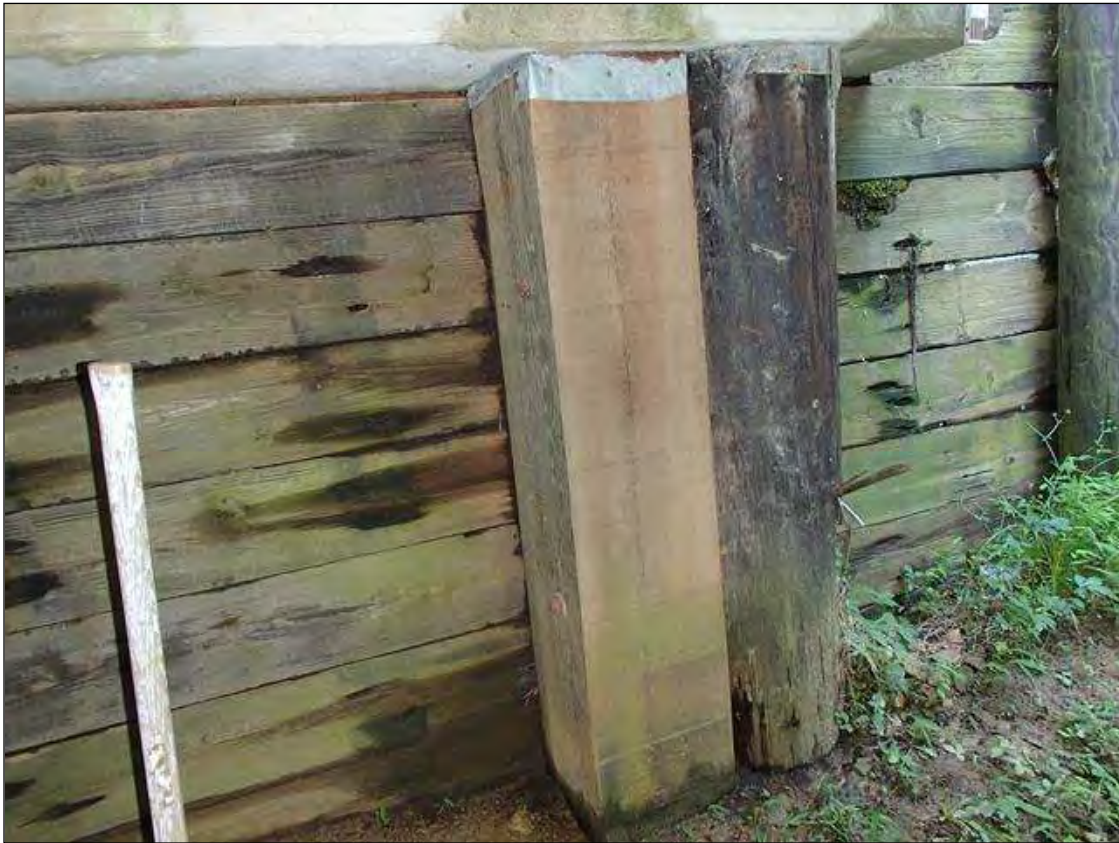
Pile 2 @ Abut. 1 & Pile 4 @ Abut. 2 have been supplemented.

| Bridge I&A Form 1(82)H<br>State of North Carolina<br>Dept. of Transportation<br>Division of Highways | | <h1 style="text-align: center;">FIELD INSPECTION REPORT</h1> <p style="text-align: center;"><u>Bridge Inspection &amp; Analysis</u></p> | |
|---|---|---|--|
| | | PILE 2 AT ABUTMENT 1: NEW PILE ADJACENT PILE 1 | |

PILE 2 AT ABUTMENT 1: NEW PILE

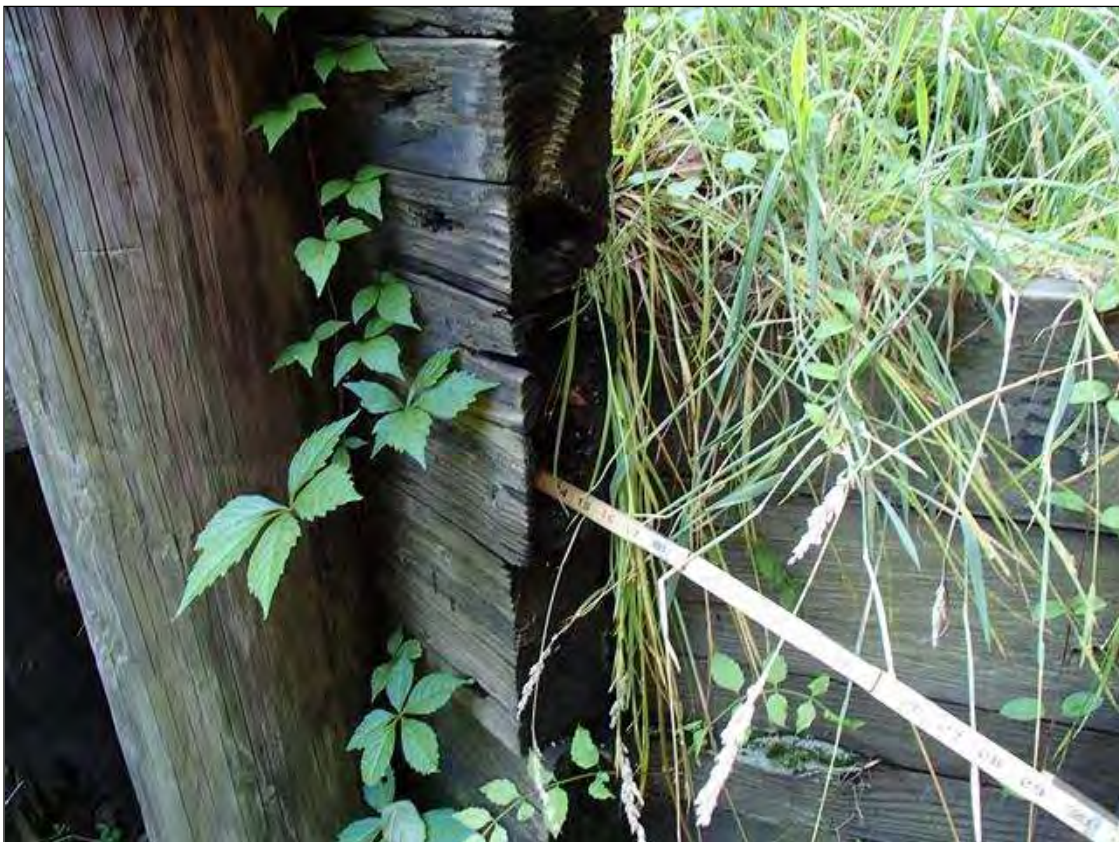
BULKHEAD BOARDS WEST END OF ABUTMENT 1: DECAY ON END OF SEVERAL BOARDS WITH PENETRATION UP TO 16"

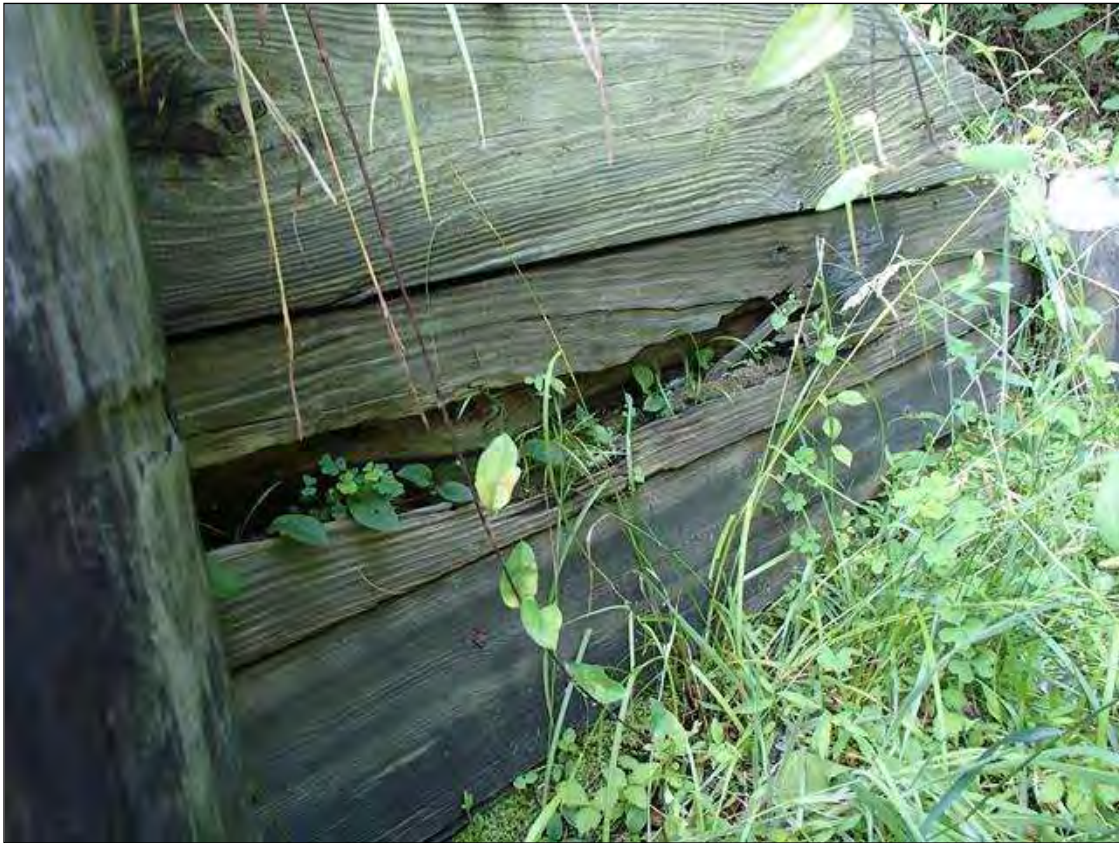
WINGWALL AT SOUTHWEST CORNER: AREA OF DECAY 36 " X 4 " X 4 "

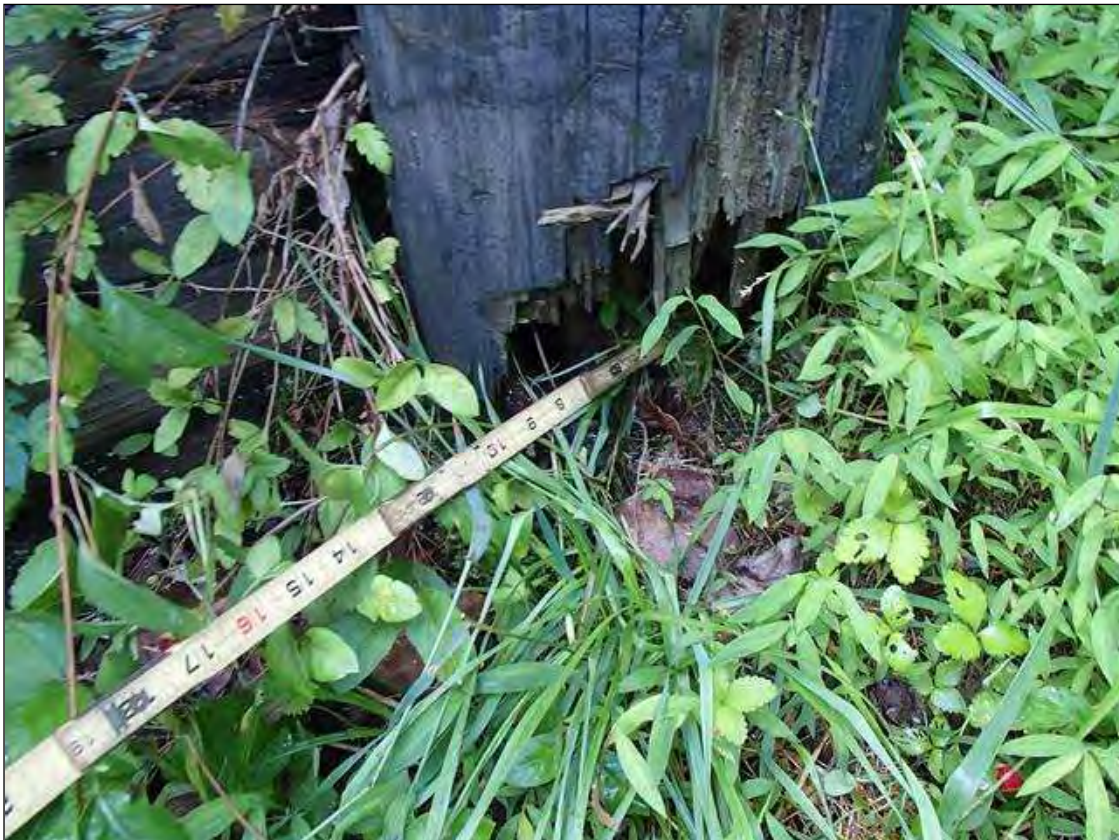
| Bridge I&A Form 1(82)H<br>State of North Carolina<br>Dept. of Transportation<br>Division of Highways | | <h1 style="text-align: center;">FIELD INSPECTION REPORT</h1> <p style="text-align: center;"><u>Bridge Inspection &amp; Analysis</u></p> | |
|---|---|---|--|
| | | WINGWALL PILE AT SOUTHWEST CORNER: AREA OF DECAY AT BOTTOM OF PILE 6 " X 6 " X 6" (MIDDLE CORE OF PILE GONE) | |

WINGWALL PILE AT SOUTHWEST CORNER: AREA OF DECAY AT BOTTOM OF PILE 6 " X 6 " X 6 " (MIDDLE CORE OF PILE GONE)

| MMS Code | Description of Function | Unit | Quantity | Remarks | Est. Cost |
|---|---|---|---|---|---|
| 3344 | Repair / Replace Timber Substructure Components | LF | 1 | THE WINGWALL PILE AT SOUTHWEST CORNER HAS AN AREA OF DECAY AT BOTTOM OF PILE 6 " X 6 " X 6" THE MIDDLE CORE OF PILE GONE. | |

| MMS Code | MMS Description | Quantity |
|---|---|---|
| THE WINGWALL PILE AT SOUTHWEST CORNER HAS AN AREA OF DECAY AT BOTTOM OF PILE 6 " X 6 " X 6" THE MIDDLE CORE OF PILE GONE. | | |

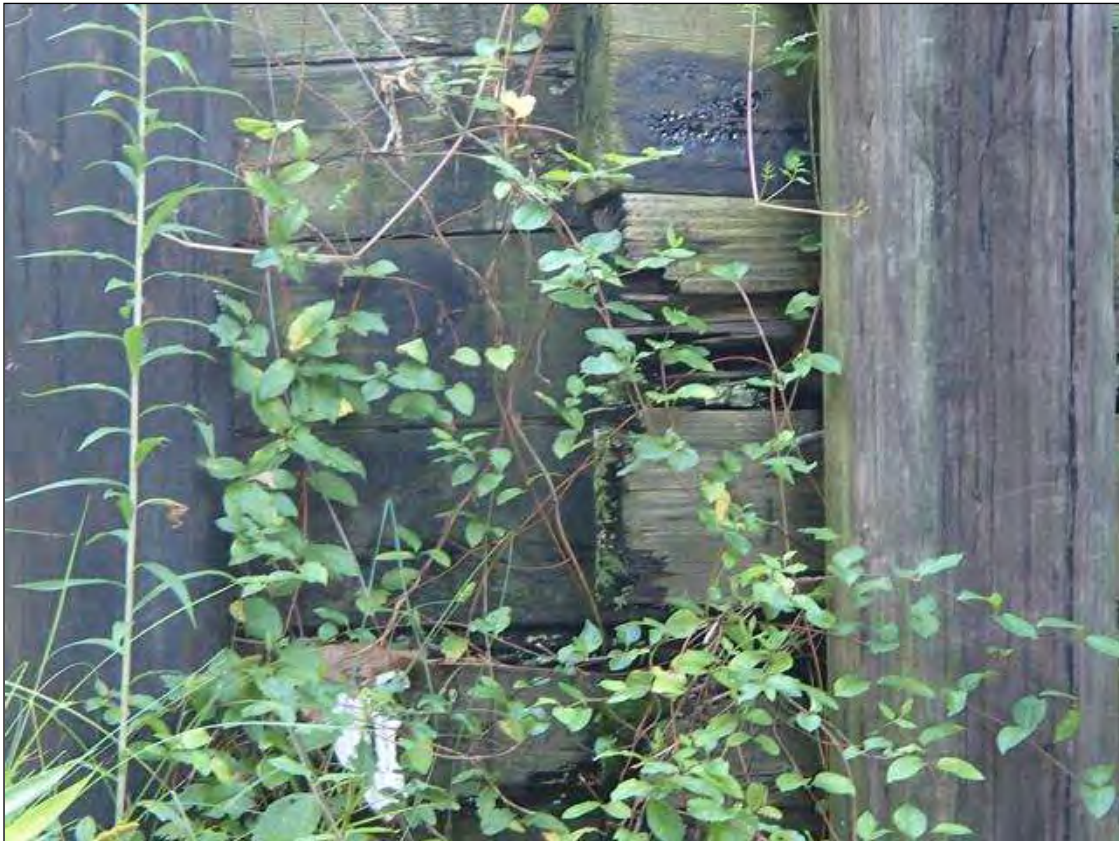
BULKHEAD BOARDS AT EAST END OF ABUTMENT 1: DECAY ON END OF SEVERAL BOARDS WITH PENETRATION UP TO 24"

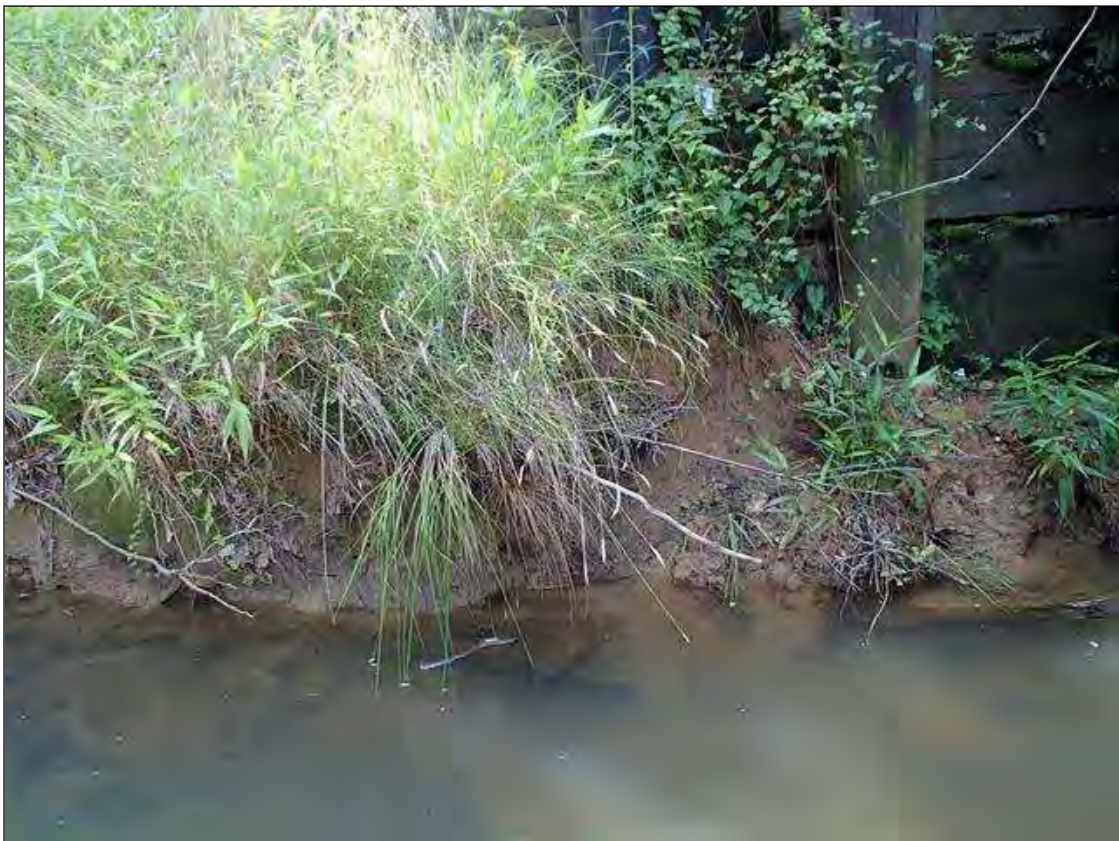
| 45a | F | <p>WATERWAY</p> <p>THERE IS AN AREA OF BANK EROSION AT EAST END OF ABUTMENT 1 FOOTING IS NOT EXPOSED.</p> <p>-</p> | |

BANK EROSION AT EAST END OF ABUTMENT 1

| MMS Code | Description of Function | Unit | Quantity | Remarks | Est. Cost |
|---|---|---|---|---|---|
| 3352 | Maint Slope Protection | SF | 150 | AREA OF EROSION AT EAST END OF ABUTMENT 1 AND SOUTH BANK OF EAST CHANNEL | |

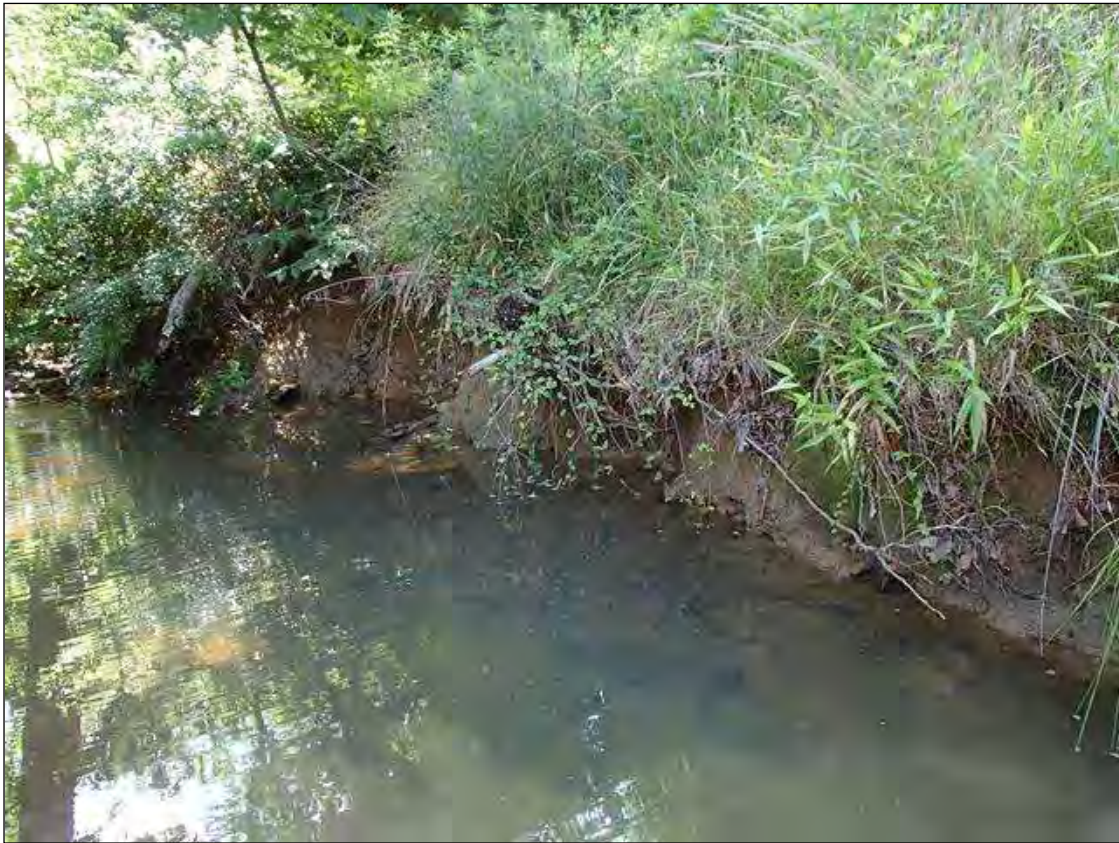
| 45d | F | CHANNEL SLOPE PROTECTION<br><br>THERE IS AN AREA OF BANK EROSION ON THE SOUTH SIDE OF THE EAST CHANNEL<br><br>THE UPPER PORTIONS OF THE BANKS BOTH UPSTREAM AND DOWNSTREAM HAVE GOOD VEGETATION.<br>-- | |

BANK EROSION ON THE SOUTH SIDE THE EAST CHANNEL

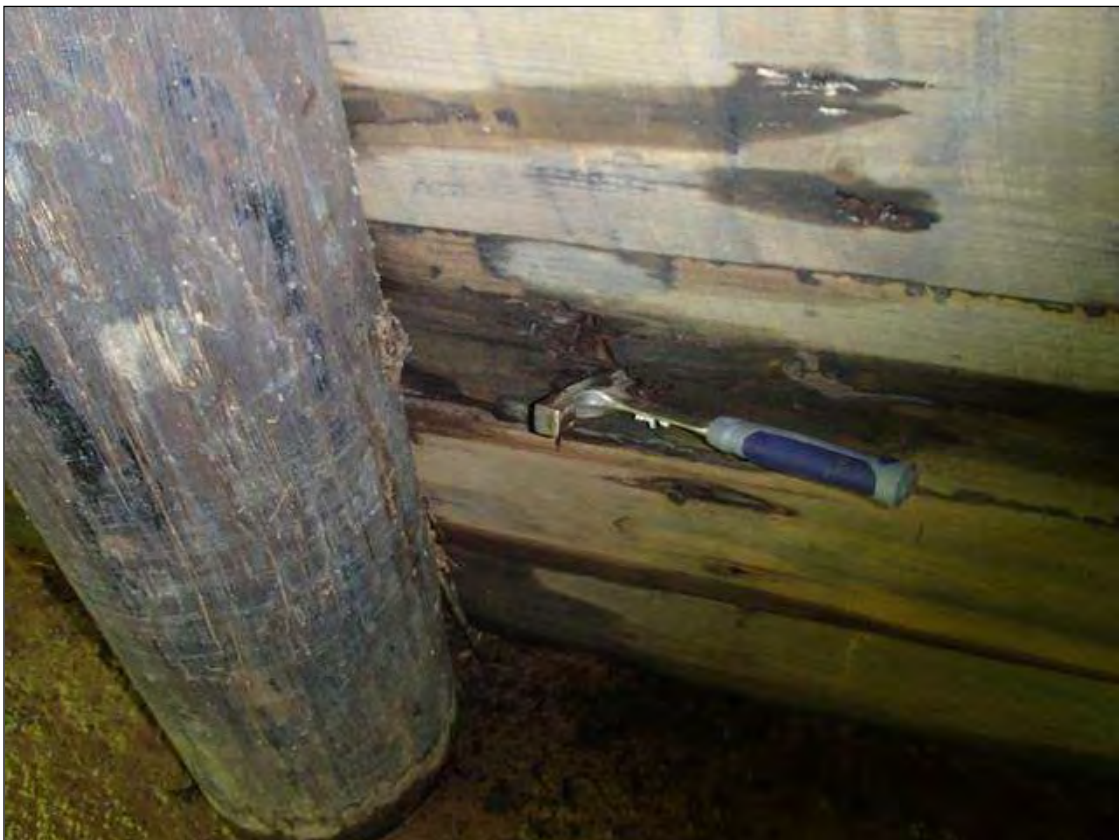
BULKHEAD AT ABUTMENT 2 BAY 2: AREA OF DECAY 12 " X 8 " X 4" ADJACENT TO PILE 2

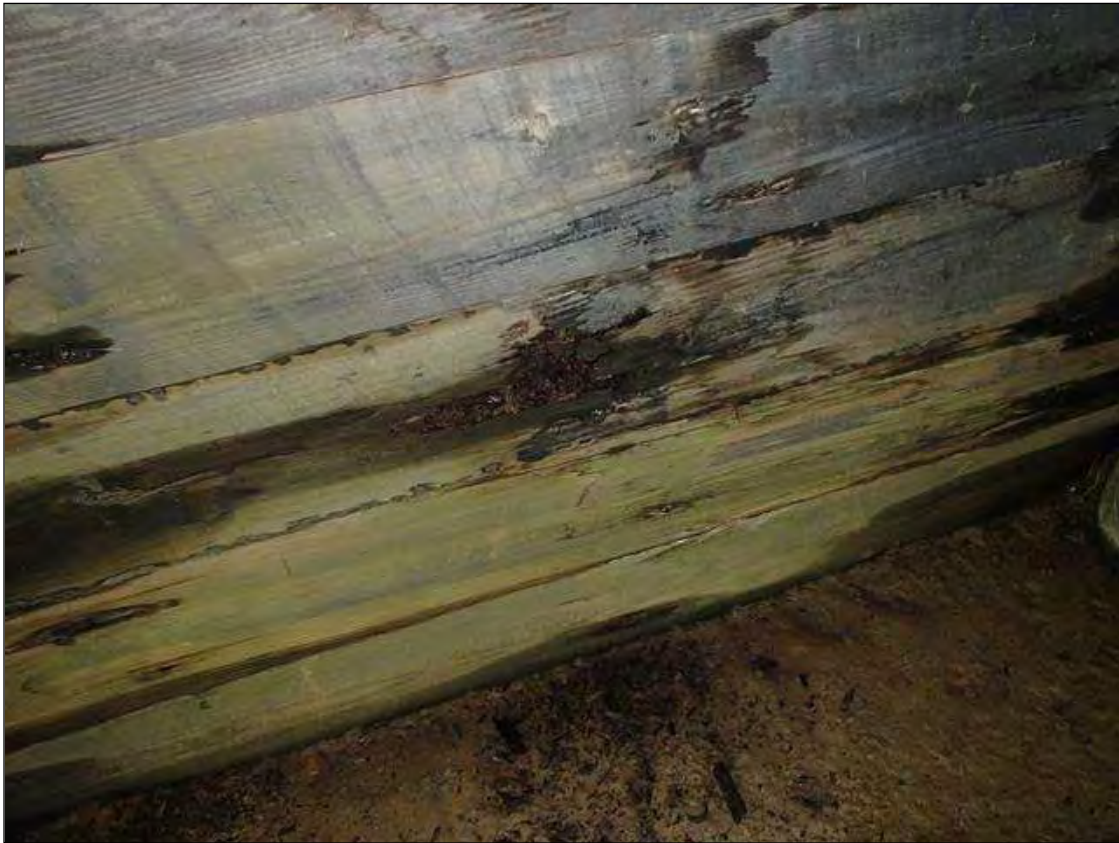
BULKHEAD AT ABUTMENT 2 BAY 2: AREA OF DECAY 14 " X 8 " X 4"

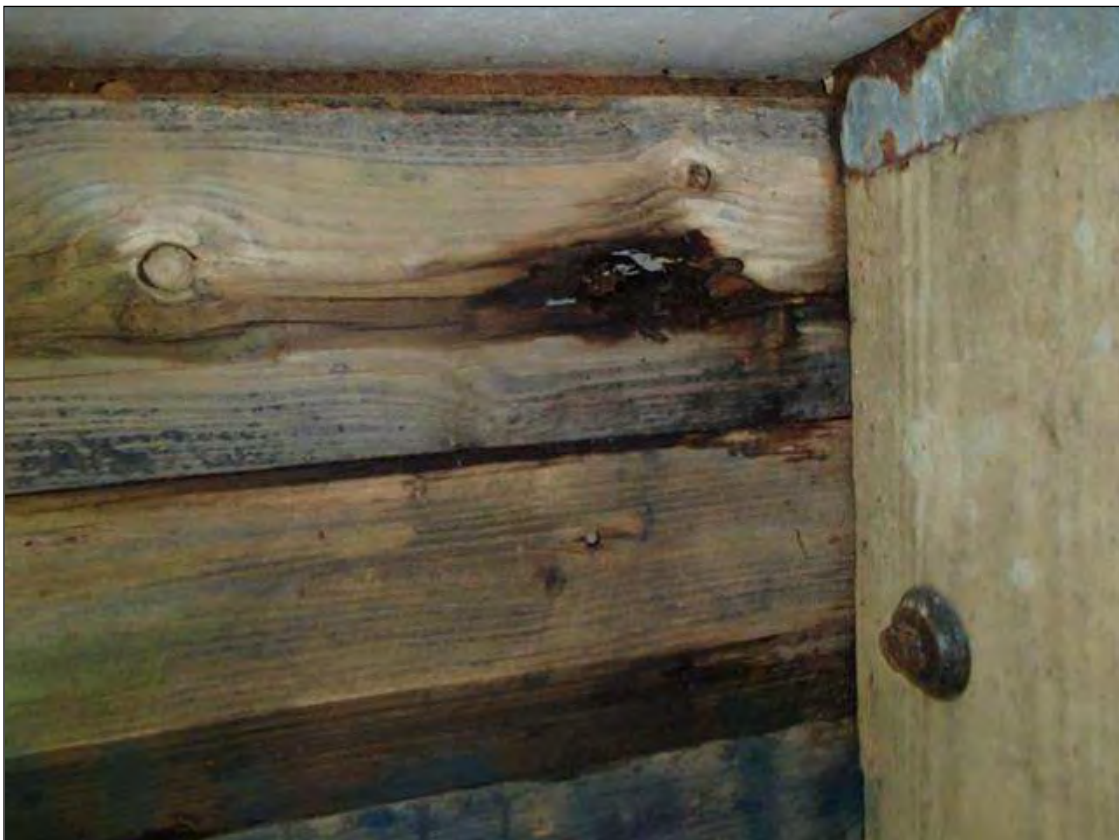
BULKHEAD AT ABUTMENT 2 BAY 3: AREA OF DECAY 4 " X 2 " X 3" ADJACENT TO PILE 4

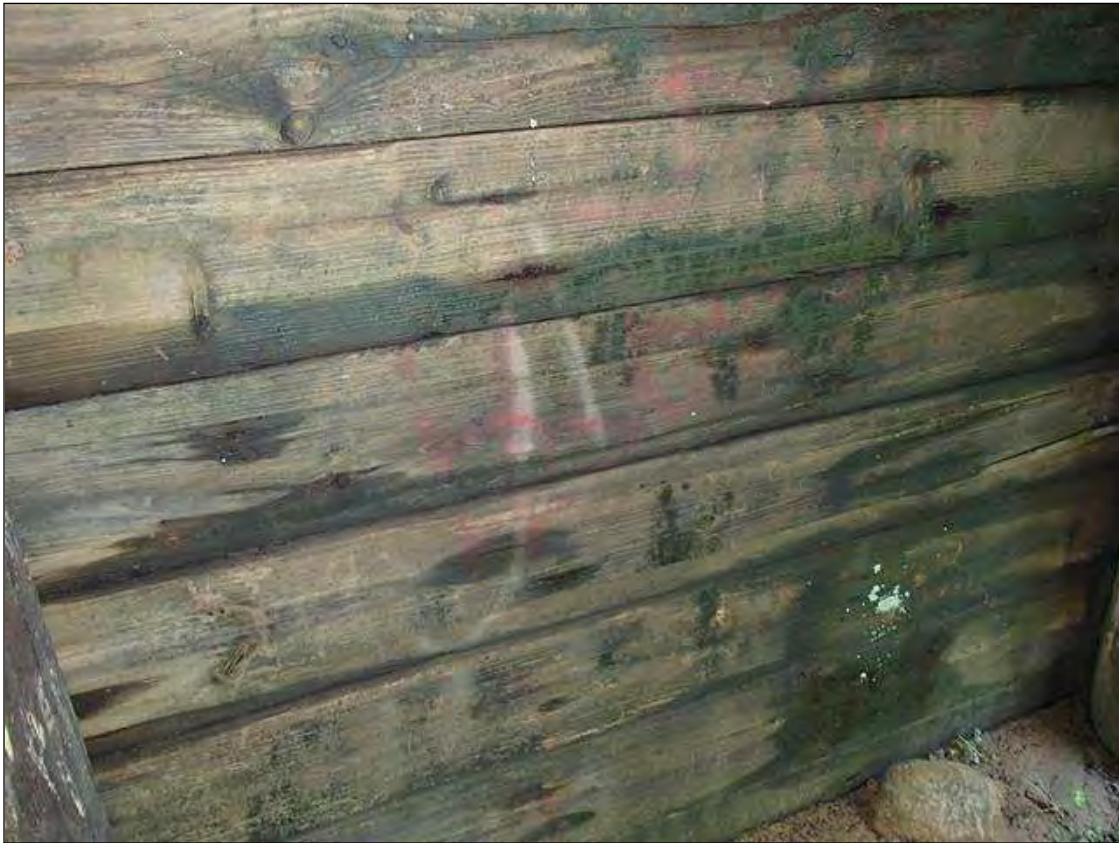
BULKHEAD AT ABUTMENT 2 BAY 4: SEVERAL AREAS OF DECAY UP TO 3 " X 2 " X 2"
