# BRIDGE INSPECTION REPORT

INSPECTION TYPE: Routine Inspection - Contract

COUNTY ROWAN BRIDGE NUMBER 790353 INSPECTION CYCLE 0 YRS  
ROUTE SR1349 ACROSS CREEK M.P. 0

INSPECTION DATE 06/13/2014

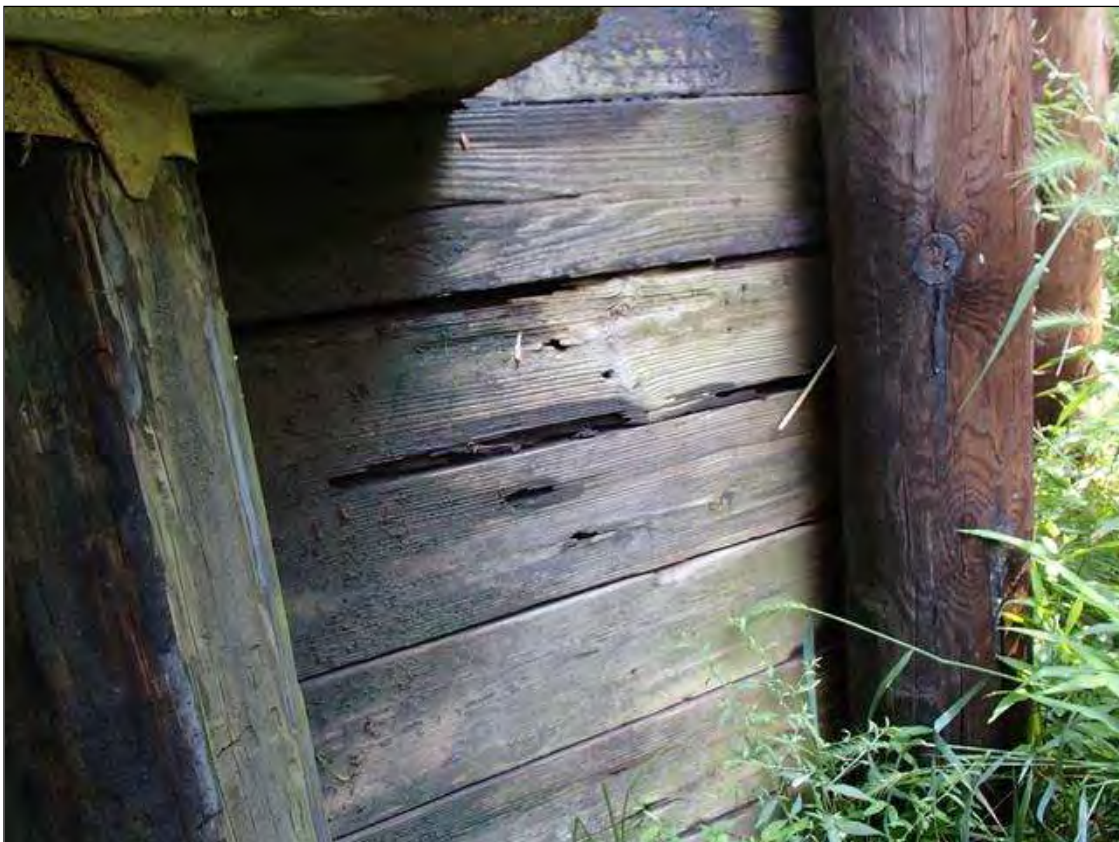
BULKHEAD EXTENSION AT EAST END OF ABUTMENT 2: SEVERAL AREAS OF DECAY UP TO 36 " X 2 " X 2"

| MMS Code | Description of Function | Unit | Quantity | Remarks | Est. Cost |
|---|---|---|---|---|---|
| 3346 | Repair / Maintain Timber Wings & Blkhds | SF | 60 | NUMEROUS AREAS OF DECAY ON BULKHEADS AT BOTH ABUTMENTS AND ALL 4 WINGWALLS | |

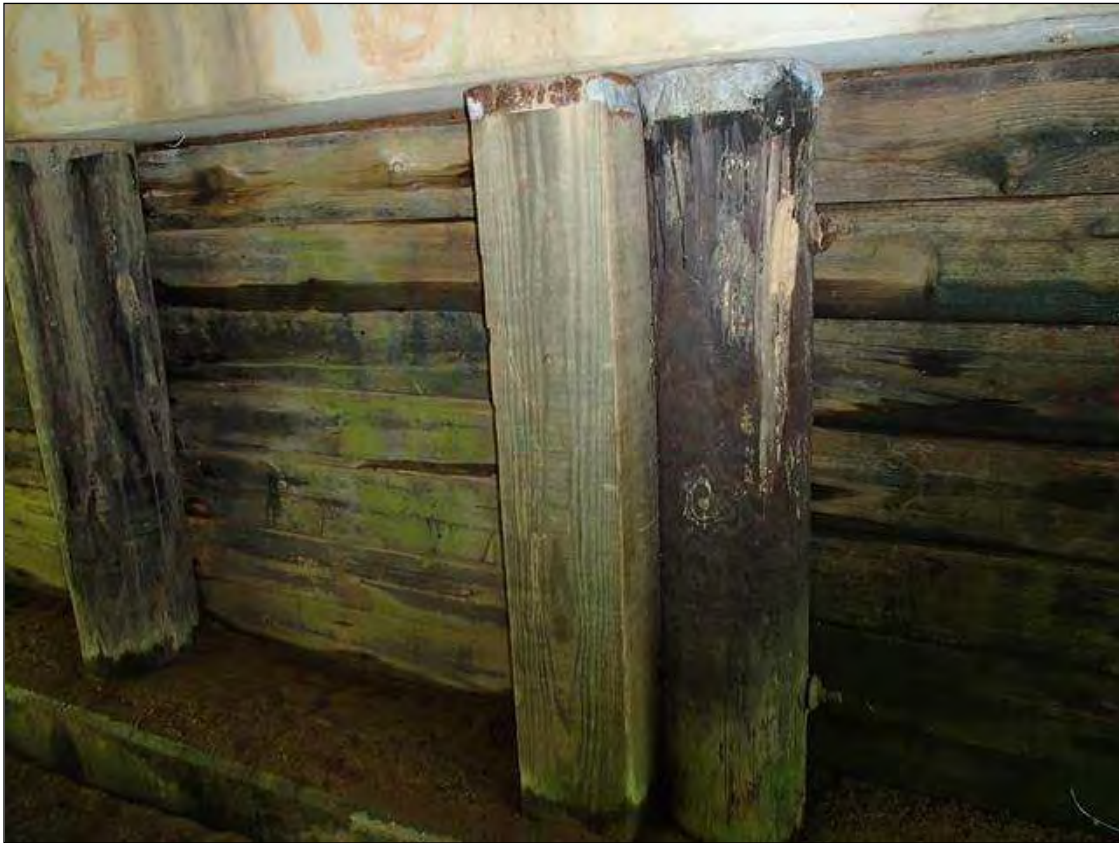
Pile 2 @ Abut. 1 & Pile 4 @ Abut. 2 have been supplemented.

| Bridge I&A Form 1(82)H<br>State of North Carolina<br>Dept. of Transportation<br>Division of Highways | | <h1 style="text-align: center;">FIELD INSPECTION REPORT</h1> <p style="text-align: center;"><u>Bridge Inspection &amp; Analysis</u></p> | |
|---|---|---|--|
| | | PILE 4 AT ABUTMENT 2: NEW PILE ADJACENT TO PILE 5 | |

PILE 4 AT ABUTMENT 2: NEW PILE

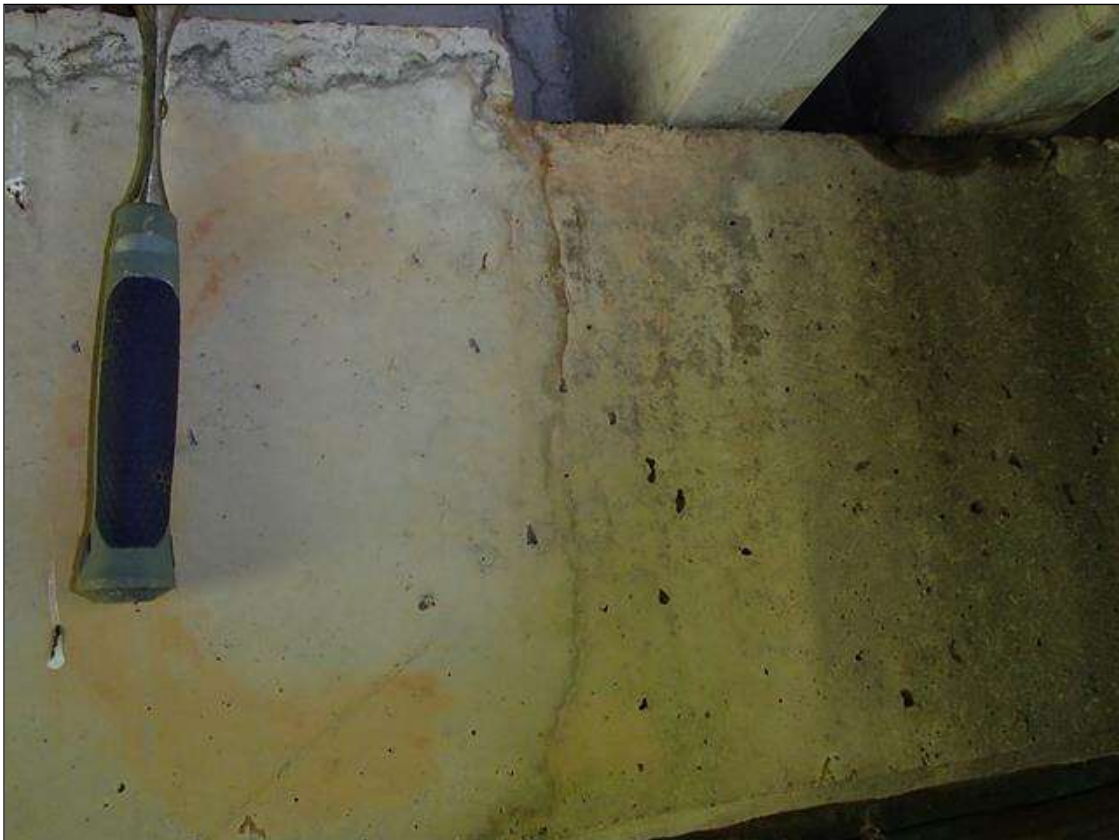
ABUTMENT 2 UNDER BEAM 8: VERTICAL CRACKING UP TO 1/64" WIDE (SIMILAR SEVERAL LOCATIONS)

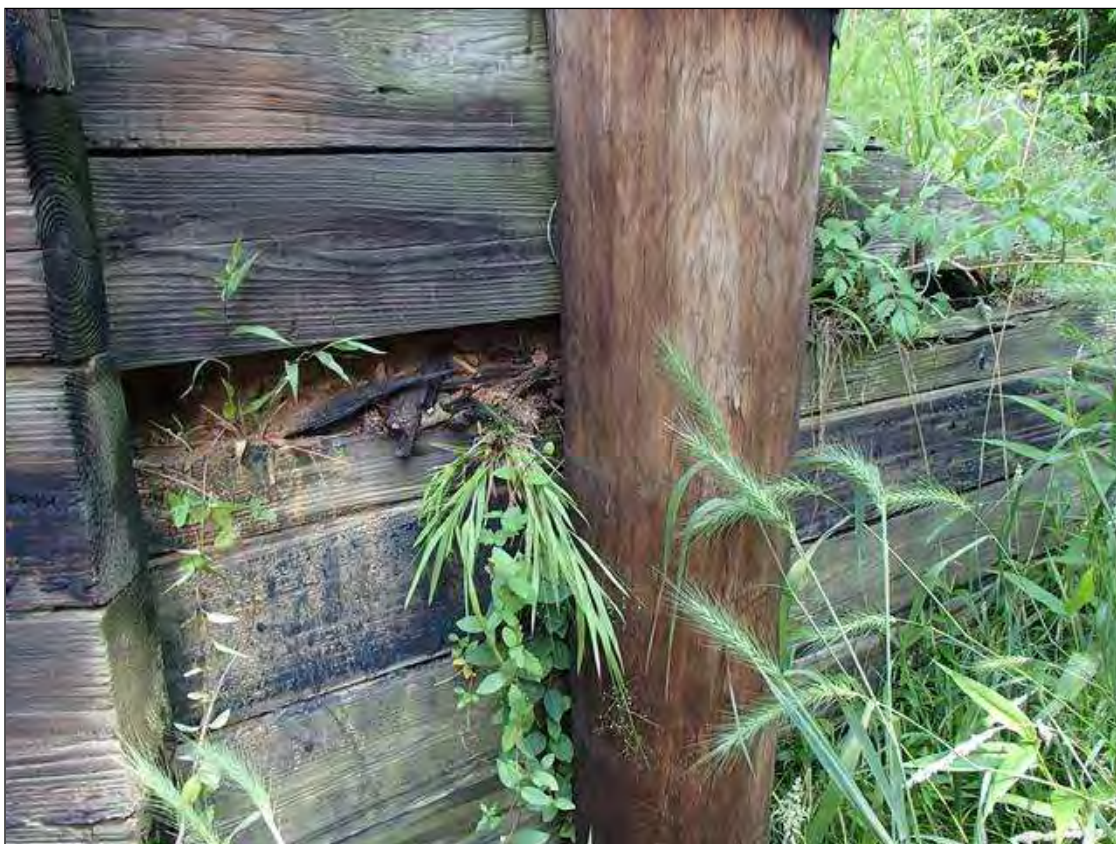
WINGWALL AT NORTHEAST CORNER: AREA OF HEAVY DECAY 60 " X 8 " X 6"

| MMS Code | Description of Function | Unit | Quantity | Remarks | Est. Cost |
|---|---|---|---|---|---|
| 3346 | Repair / Maintain Timber Wings & Blkhds | SF | 5 | THE MIDDLE BOARD AT THE NORTHEAST WINGWALL HAS AN AREA OF HEAVY DECAY UP TO 60 " X 8 " X 6". A LARGE SECTION OF BOARD IS COMPLETELY MISSING AND DIRT IS SEEPING IN AT THIS LOCATION. THE END SECTION OF BOARD HAS INTERNAL DECAY THROUGHOUT. | |

| MMS Code | MMS Description | Quantity |
|---|---|---|
| THE MIDDLE BOARD AT THE NORTHEAST WINGWALL HAS AN AREA OF HEAVY DECAY UP TO 60 " X 8 " X 6". A LARGE SECTION OF BOARD IS COMPLETELY MISSING AND DIRT IS SEEPING IN AT THIS LOCATION. THE END SECTION OF BOARD HAS INTERNAL DECAY THROUGHOUT. | | |

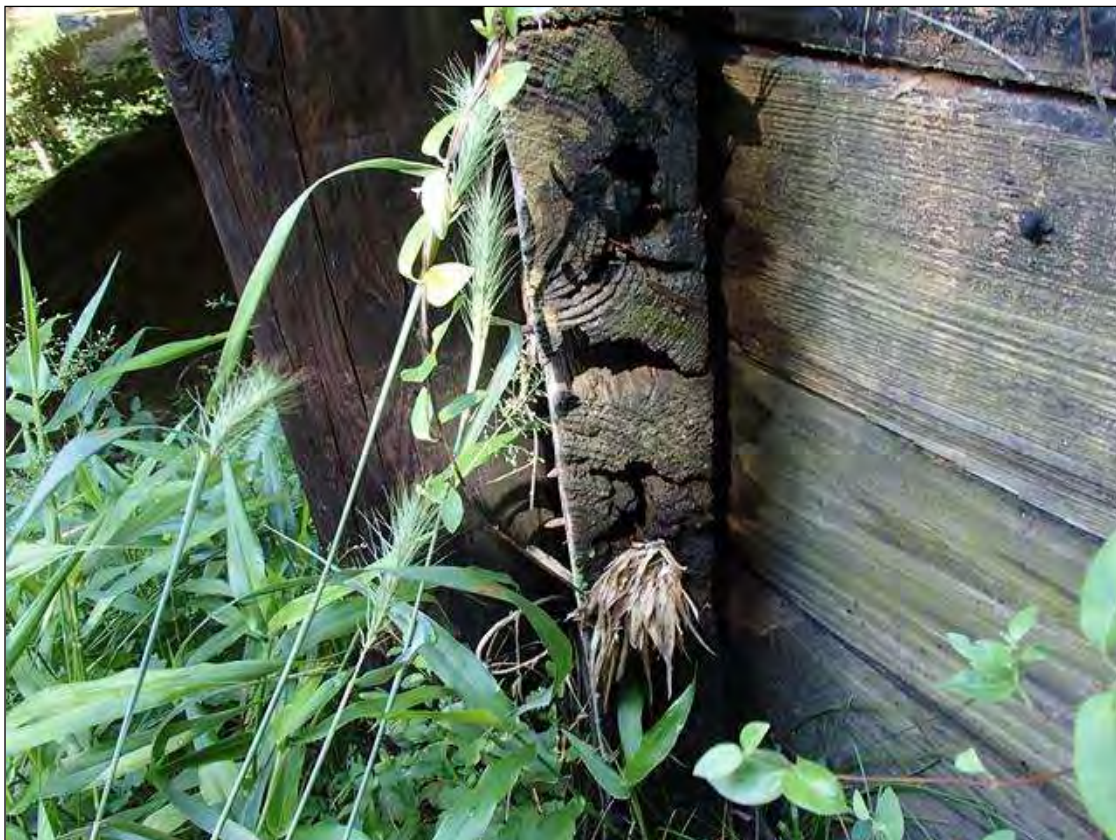
BULKHEAD EXTENSION EAST END OF THE ABUTMENT 2: DECAY ON END OF BOARDS WITH PENETRATION UP TO 12"

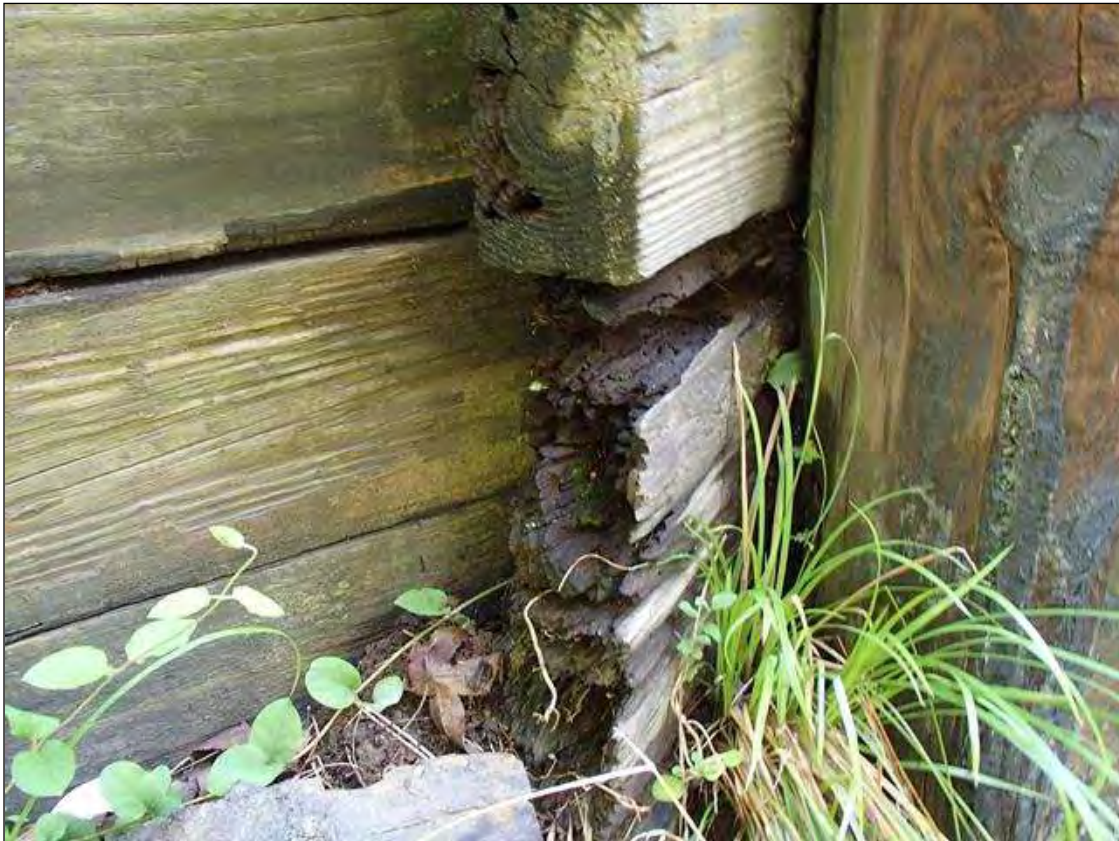
BULKHEAD EXTENSION WEST END OF ABUTMENT 2: DECAY ON END OF BOARDS WITH PENETRATION UP TO 18"

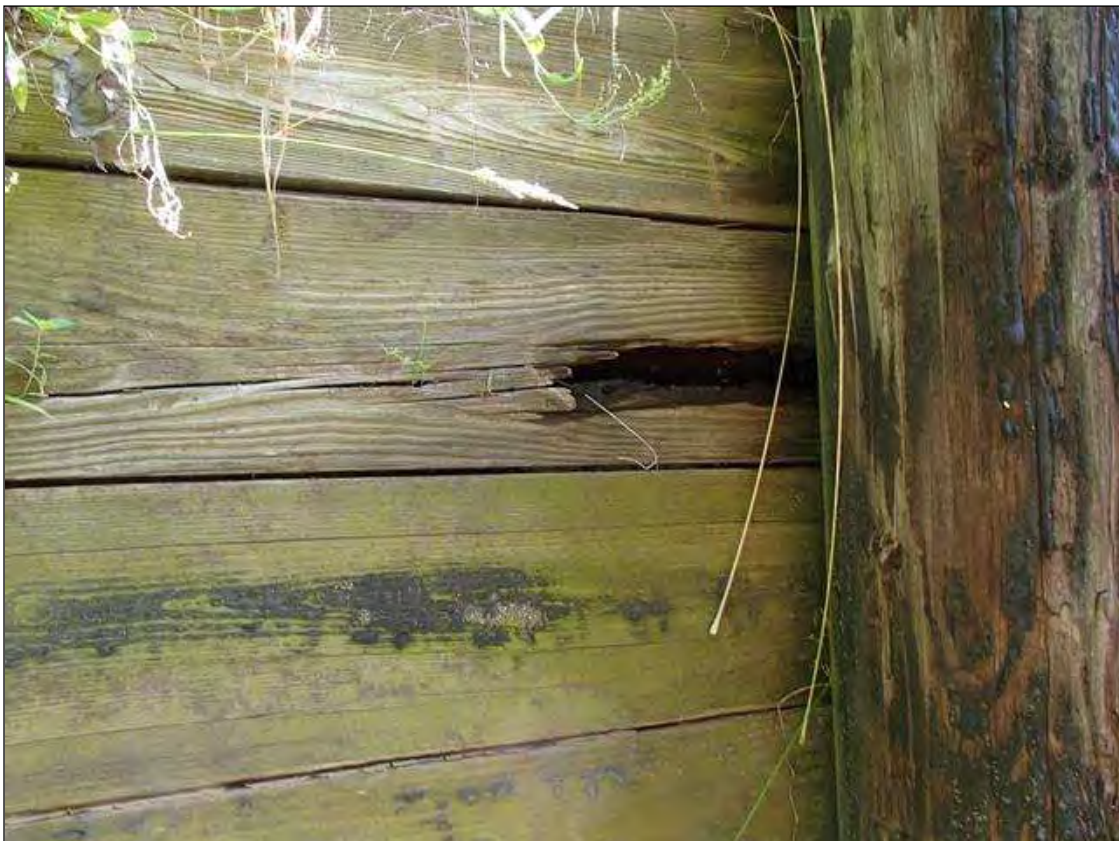
WINGWALL NORTHWEST CORNER: AREA OF DECAY UP TO 24 " X 2 " X 2"

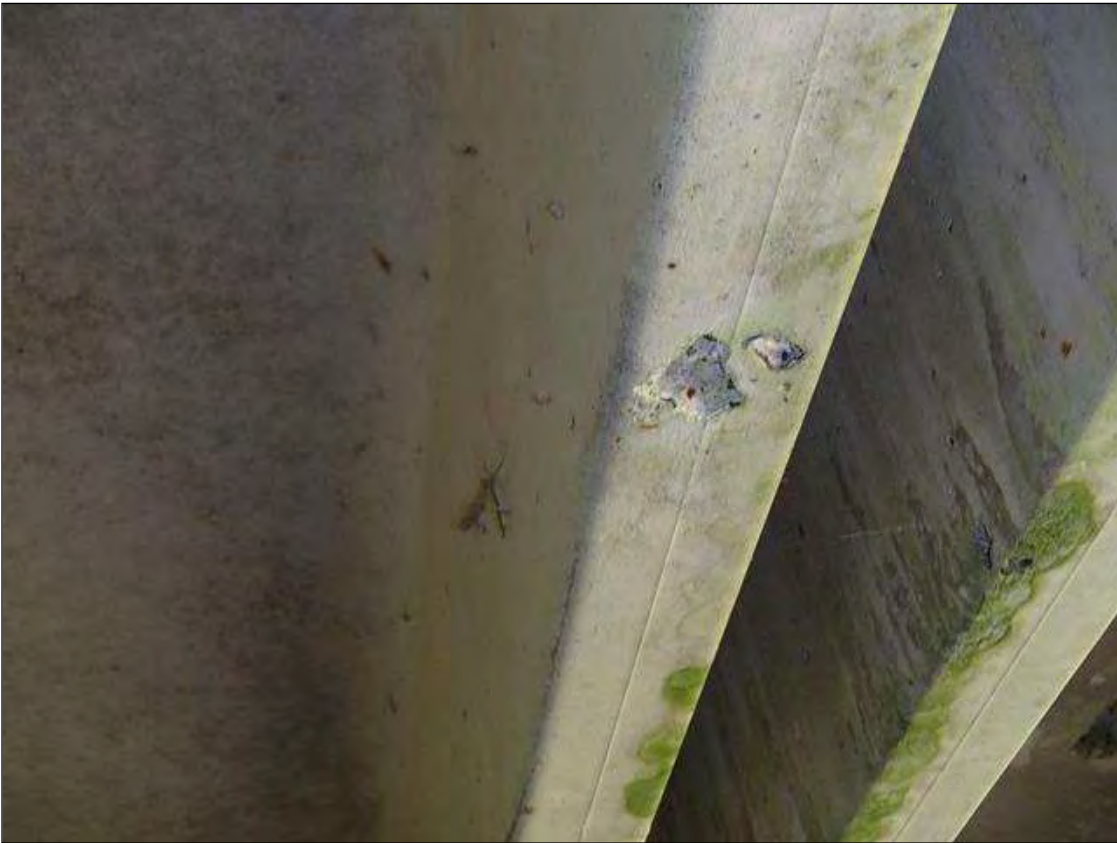
| Bridge I&A Form 1(82)H<br>State of North Carolina<br>Dept. of Transportation<br>Division of Highways | | <h1 style="text-align: center;">FIELD INSPECTION REPORT</h1> <p style="text-align: center;"><u>Bridge Inspection &amp; Analysis</u></p> | |
|---|---|---|--|
| | | BEAM 2 LEFT LEG MID SPAN: POP OUT SPALL ON BOTTOM SURFACE (SIMILAR SEVERAL LOCATIONS) | |

BEAM 2 LEFT LEG MID SPAN: POP OUT SPALL ON BOTTOM SURFACE (SIMILAR SEVERAL LOCATIONS)

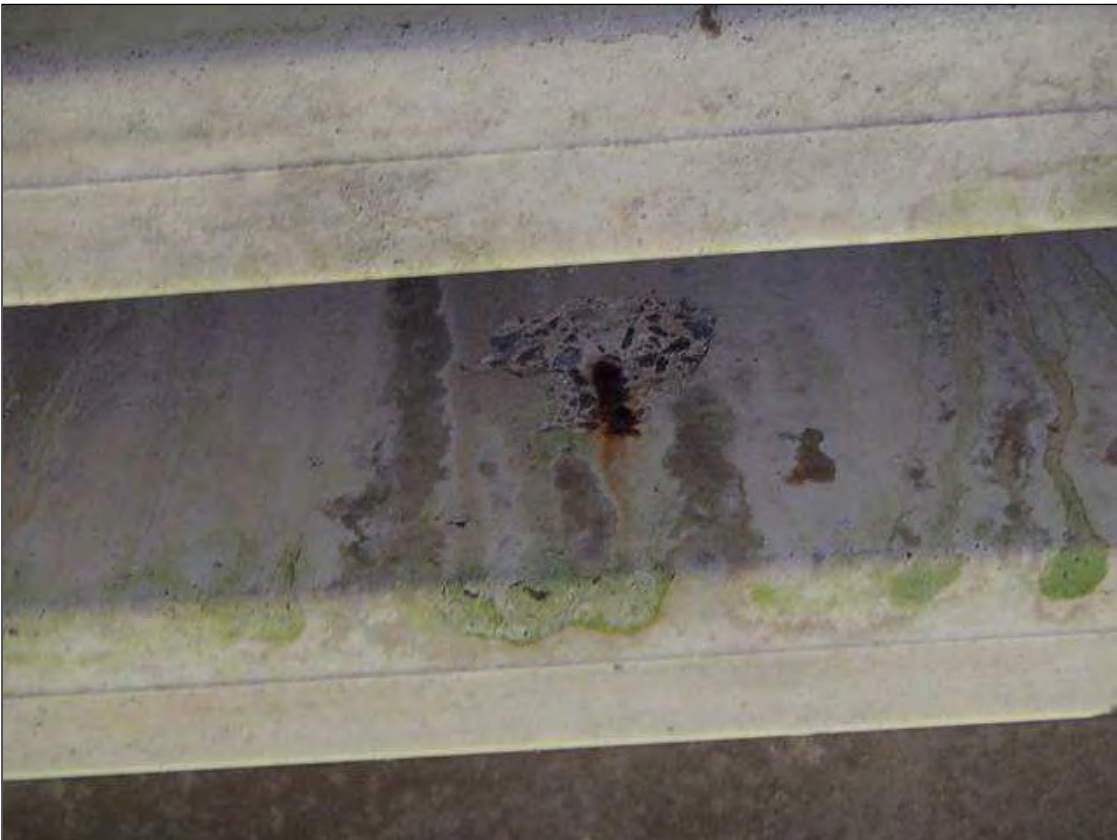
| Bridge I&A Form 1(82)H<br>State of North Carolina<br>Dept. of Transportation<br>Division of Highways | | <h1 style="text-align: center;">FIELD INSPECTION REPORT</h1> <p style="text-align: center;"><u>Bridge Inspection &amp; Analysis</u></p> | |
|---|---|---|--|
| | | BEAM 1 RIGHT LEG 7 FEET FROM ABUTMENT 1: SPALL WITH EXPOSED REBAR ON EAST FACE 3 " X 2 " X 1/2" | |

BEAM 1 RIGHT LEG 7 FEET FROM ABUTMENT 1: SPALL WITH EXPOSED REBAR ON EAST FACE 3" X 2" X 1/2"

| MMS Code | Description of Function | Unit | Quantity | Remarks | Est. Cost |
|---|---|---|---|---|---|
| 3306 | Maintain Concrete Superstructure Components | SF | 2 | SPALLS WITH EXPOSED REBAR ON BEAM 1 | |

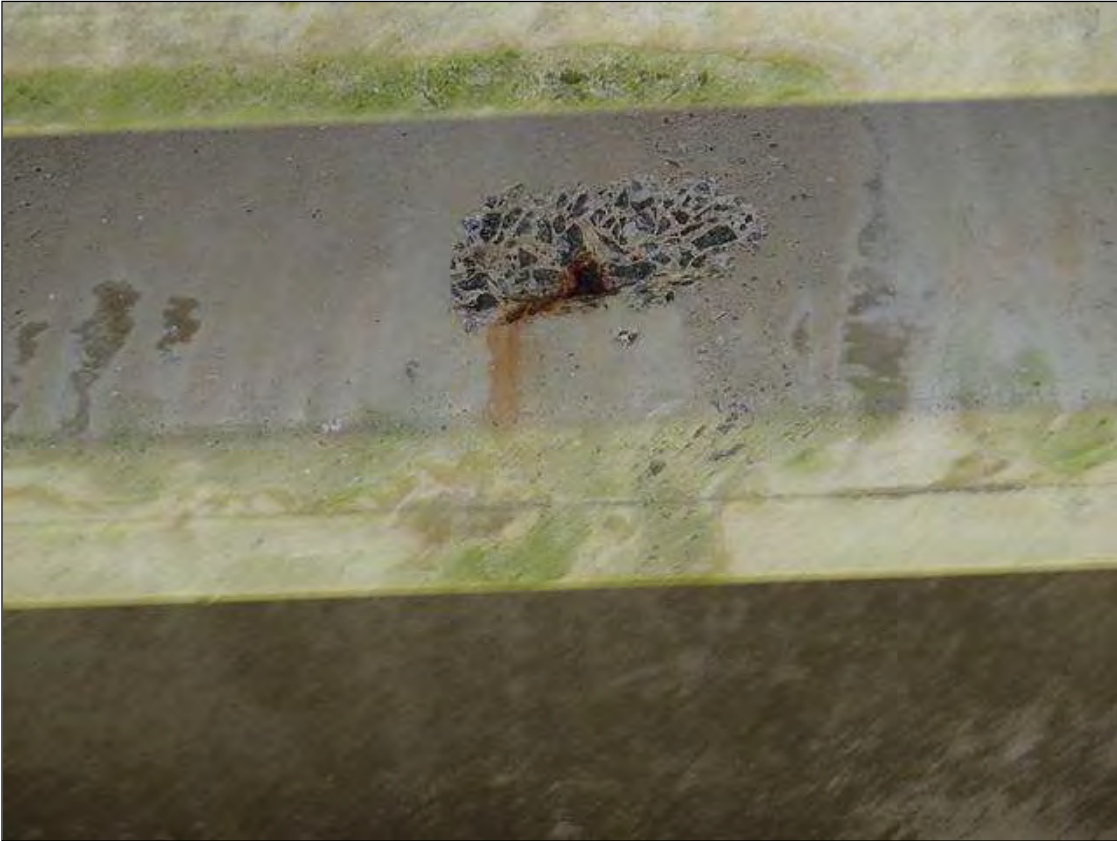
| Bridge I&A Form 1(82)H<br>State of North Carolina<br>Dept. of Transportation<br>Division of Highways | | <h1 style="text-align: center;">FIELD INSPECTION REPORT</h1> <p style="text-align: center;"><u>Bridge Inspection &amp; Analysis</u></p> | |
|---|---|---|--|
| | | BEAM 1 RIGHT LEG 6 FEET FROM ABUTMENT 1: SPALL WITH EXPOSED REBAR ON EAST FACE 3 " X 3 " X 1/2" | |

BEAM 1 RIGHT LEG 6 FEET FROM ABUTMENT 1: SPALL WITH EXPOSED REBAR ON EAST FACE 3 " X 3 " X 1/2"

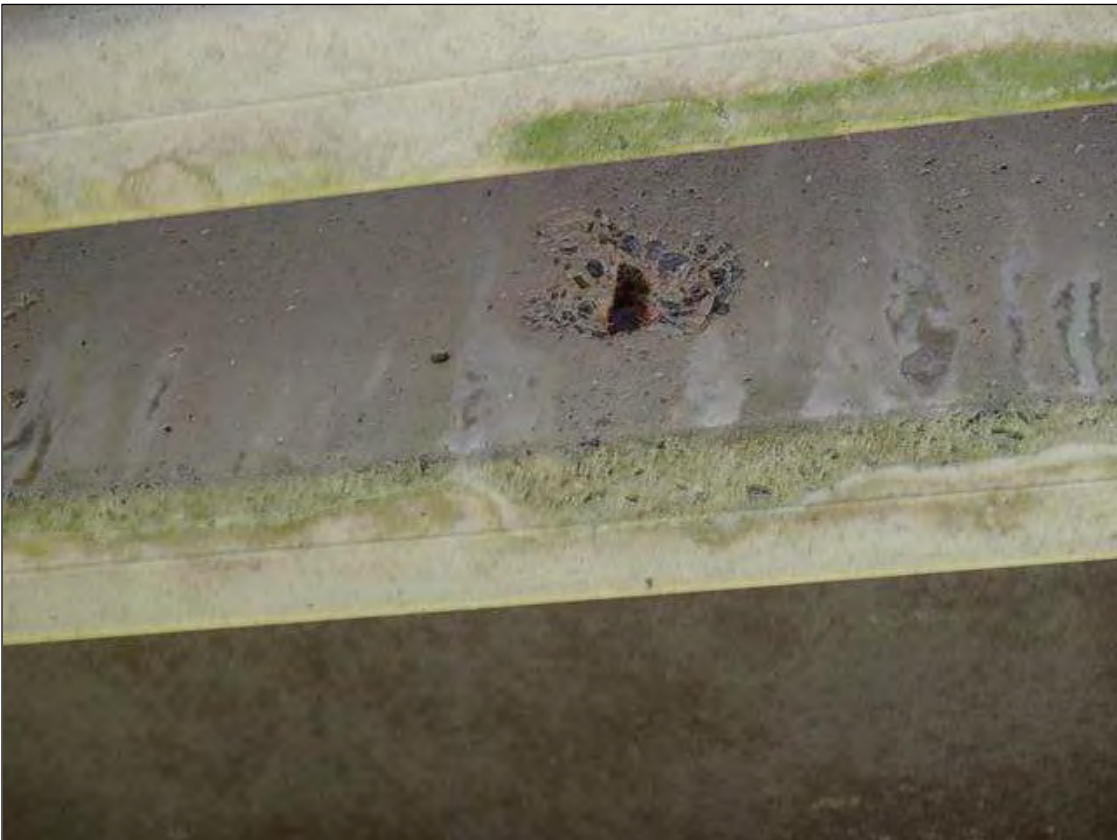
| Bridge I&A Form 1(82)H<br>State of North Carolina<br>Dept. of Transportation<br>Division of Highways | | <h1 style="text-align: center;">FIELD INSPECTION REPORT</h1> <p style="text-align: center;"><u>Bridge Inspection &amp; Analysis</u></p> | |
|---|---|---|--|
| | | BEAM 1 RIGHT LEG 5 FEET FROM ABUTMENT 1: SPALL WITH EXPOSED REBAR 2 " X 2 " X 1/2" | |

BEAM 1 RIGHT LEG 5 FEET FROM ABUTMENT 1: SPALL WITH EXPOSED REBAR 2 " X 2 " X 1/2"
