NC DEPARTMENT OF TRANSPORTATION  
DIVISION OF HIGHWAYS  
STRUCTURE MANAGEMENT UNIT

## Structure Safety Report

### Routine Element Inspection

COUNTY: BLADEN STRUCTURE NUMBER: 080011 FREQUENCY: 24 MONTHS

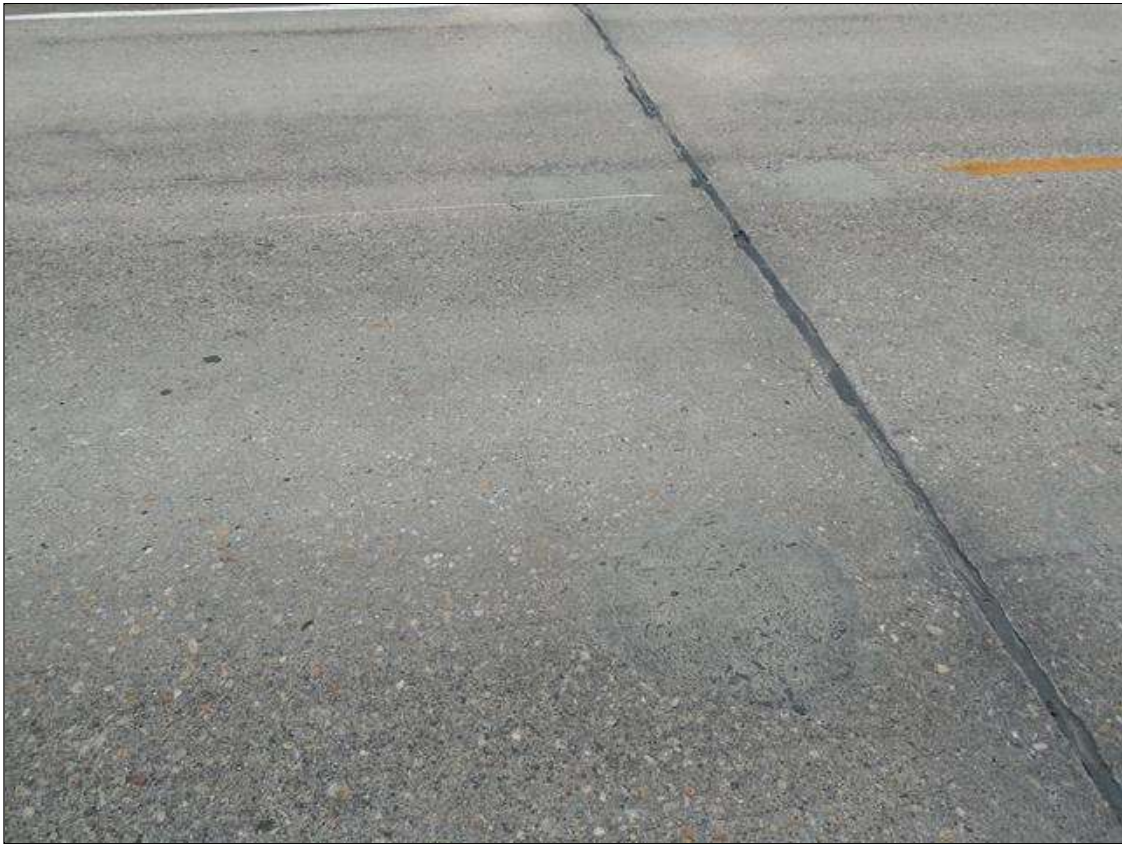
Span 4 Deck: 3 Square Feet of Delamination/Spall/Patched Area: Delaminated. Spall 1 in. or less deep or 6 in. or less in diameter. Patched area that is sound. 2 - 16" DIAMETER PATCHES AT BENT 3 JOINT ( OVER CRUTCH PILES )

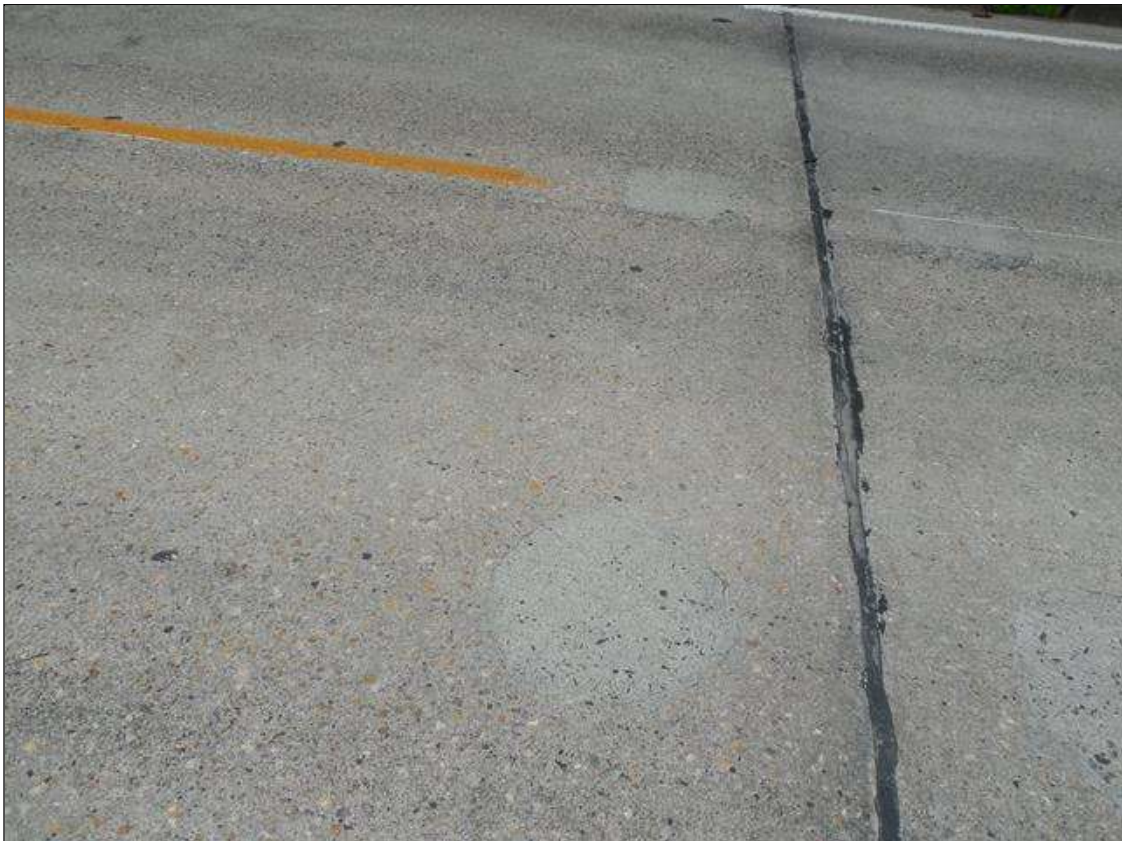
Span 3 Deck: 3 Square Feet of Delamination/Spall/Patched Area: Delaminated. Spall 1 in. or less deep or 6 in. or less in diameter. Patched area that is sound. 2 - 16" DIAMETER PATCHES AT BENT 3 ( OVER CRUTCH PILES )

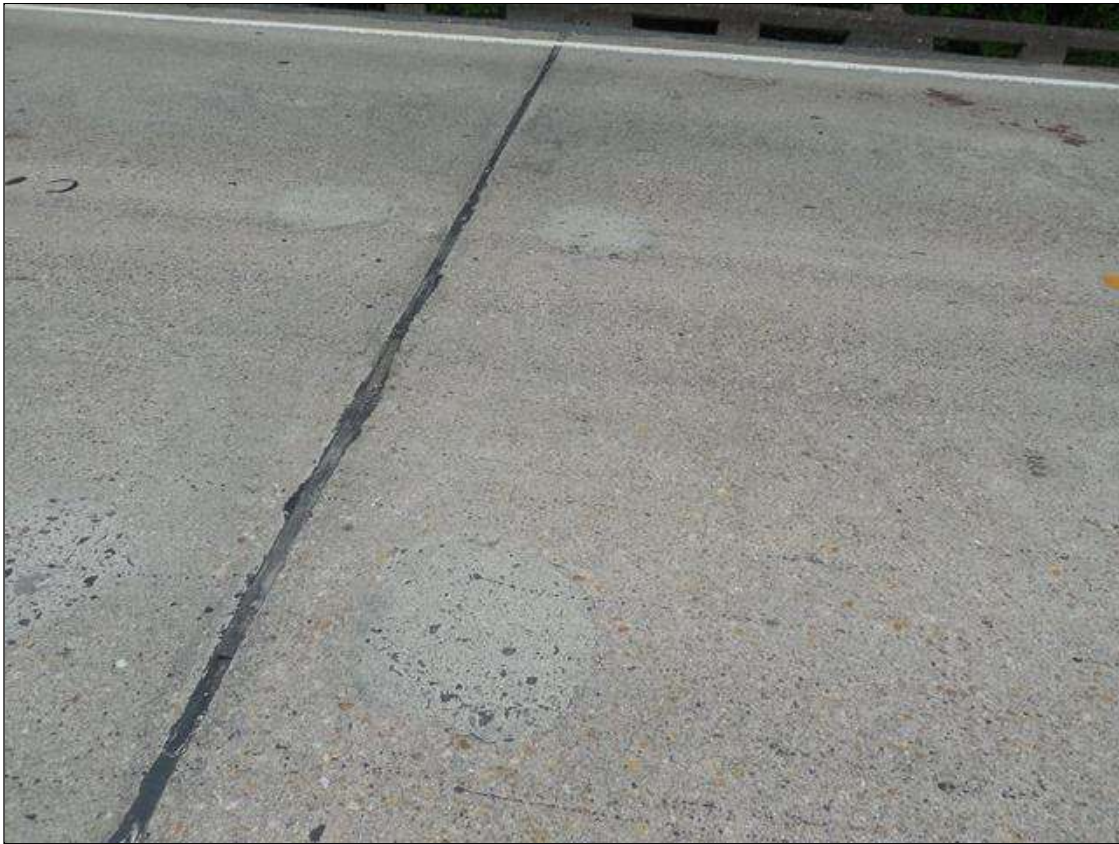
Span 3 Deck: 5 Square Feet of Delamination/Spall/Patched Area: Delaminated. Spall 1 in. or less deep or 6 in. or less in diameter. Patched area that is sound. 3 - 16" DIAMETER PATCHES AT BENT 2 JOINT ( OVER CRUTCH PILES )

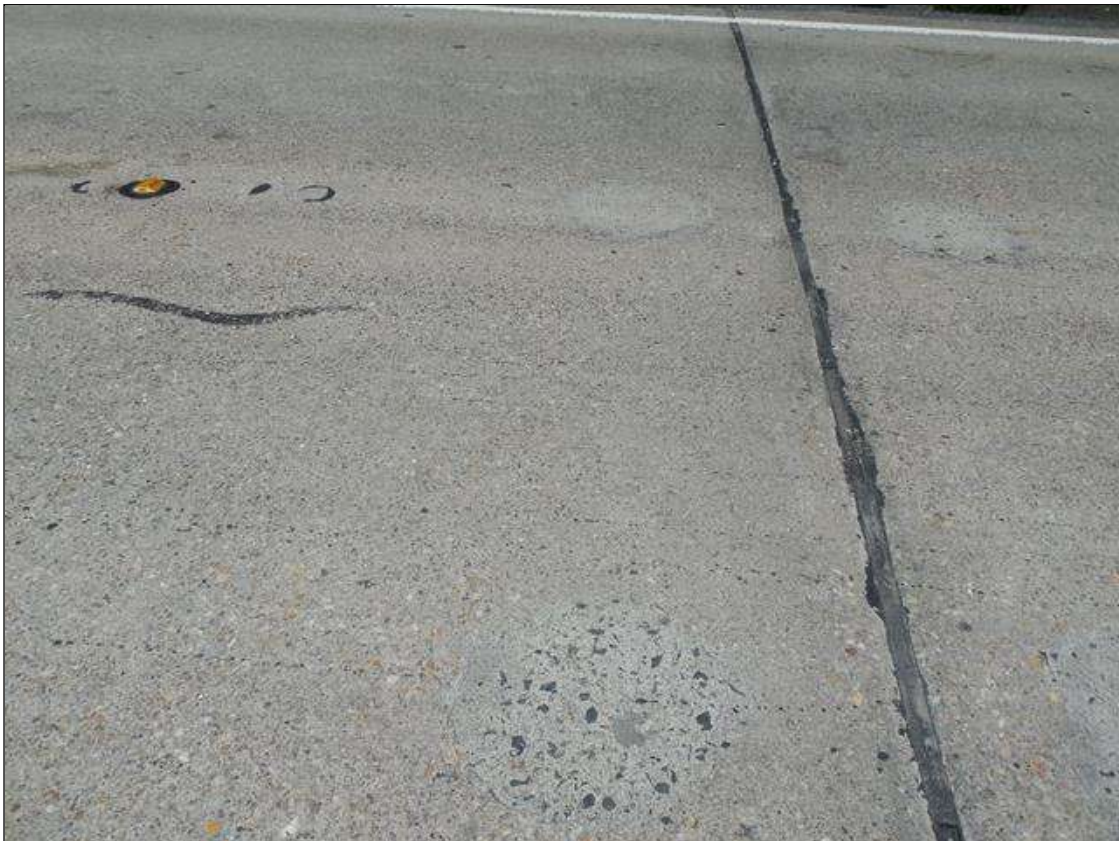
Span 2 Deck: 5 Square Feet of Delamination/Spall/Patched Area: Delaminated. Spall 1 in. or less deep or 6 in. or less in diameter. Patched area that is sound. 3 - 16" DIAMETER PATCHES AT BENT 1 ( OVER CRUTCH PILES )

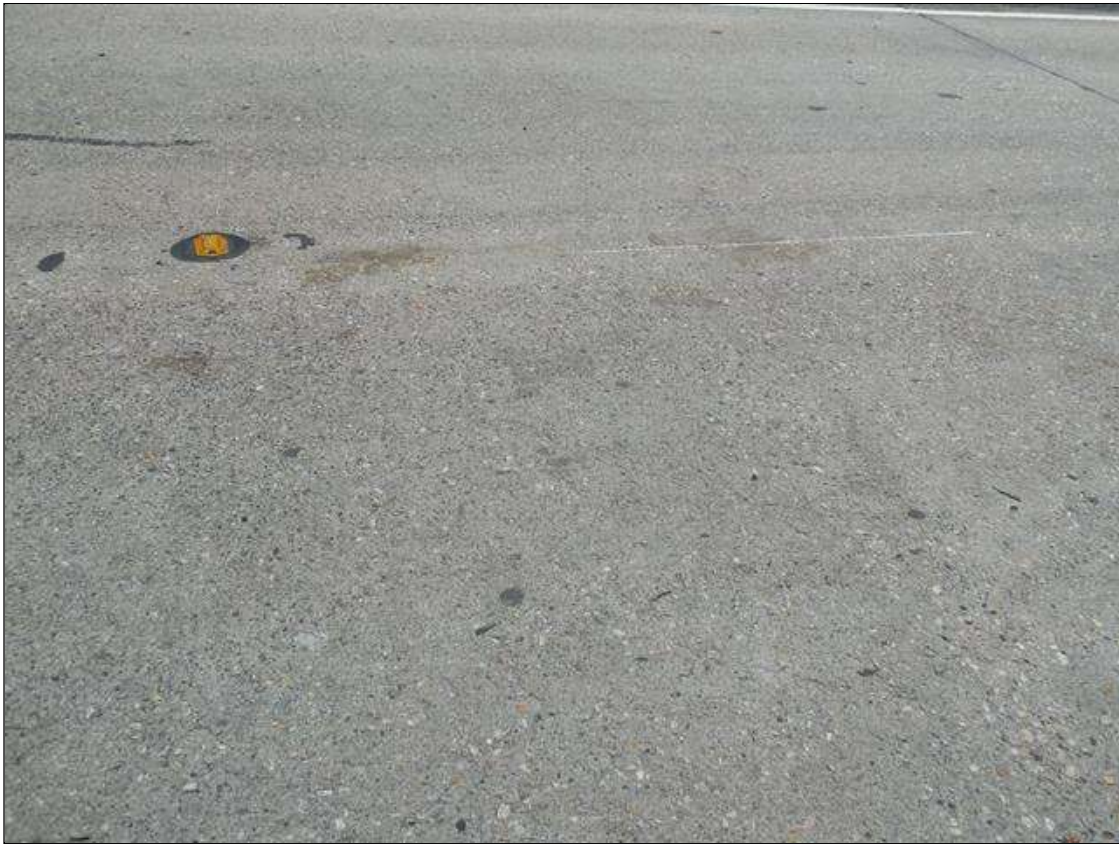
Span 2 Deck: 300 Square Feet of Abrasion/Wear (PSC/RC): Abrasion or wearing has exposed coarse aggregate but the aggregate remains secure in the concrete. SCALING WITH EXPOSED AGGREGATE

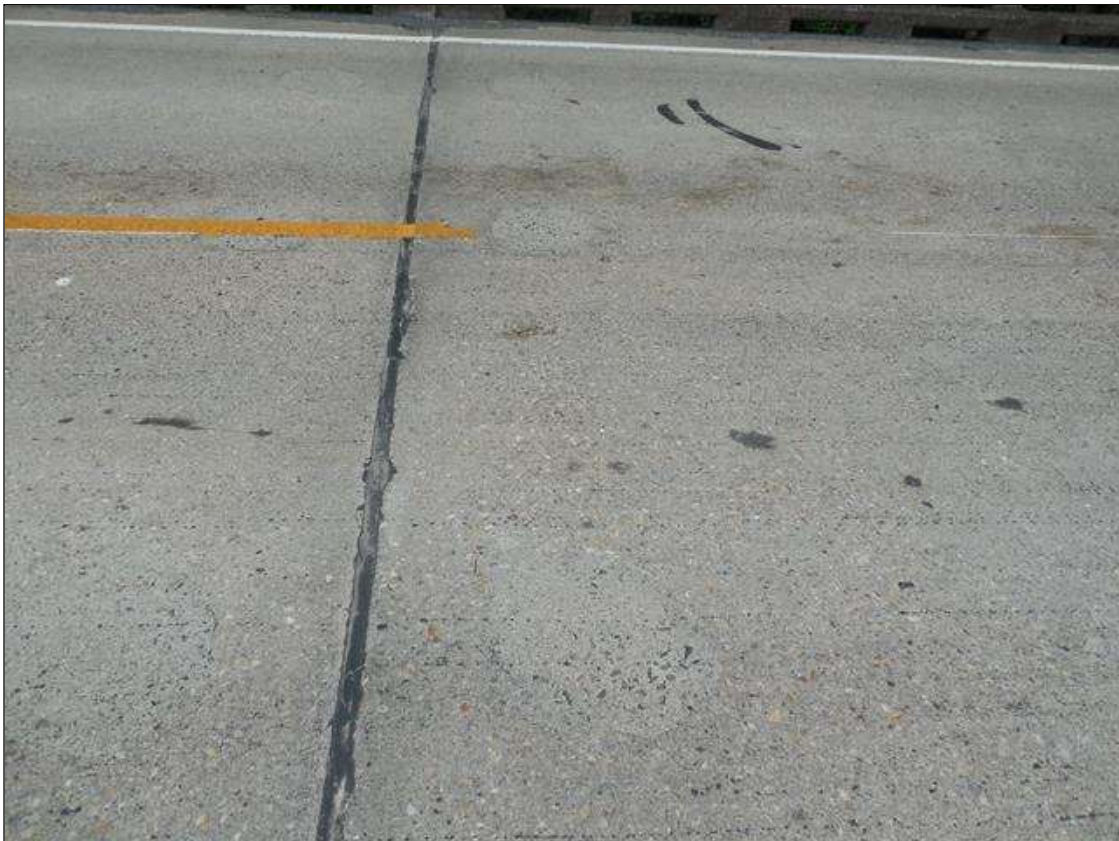
Span 2 Deck: 5 Square Feet of Delamination/Spall/Patched Area: Delaminated. Spall 1 in. or less deep or 6 in. or less in diameter. Patched area that is sound. 3 - 16" DIAMETER PATCHES AT BENT 1 ( OVER CRUTCH PILES )

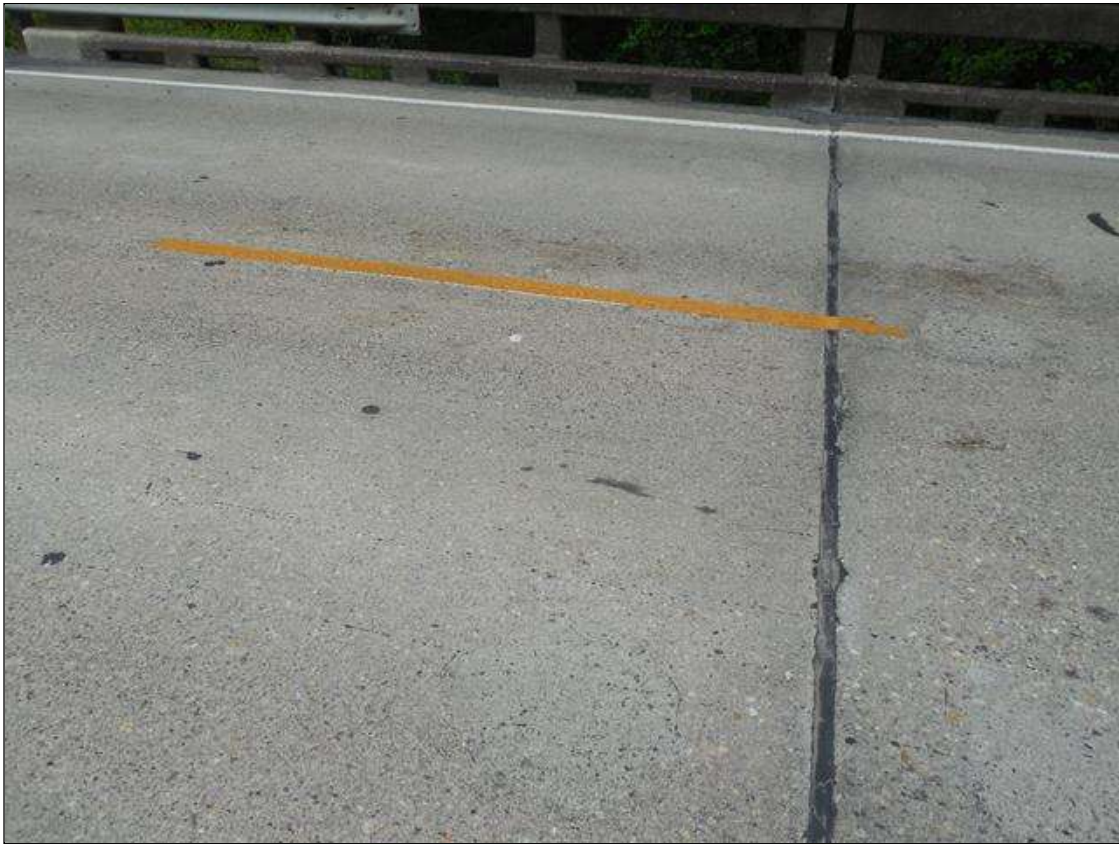
Span 1 Deck: 5 Square Feet of Delamination/Spall/Patched Area: Delaminated. Spall 1 in. or less deep or 6 in. or less in diameter. Patched area that is sound. 3 - 16" DIAMETER PATCHES AT BENT 1 ( OVER CRUTCH PILES )

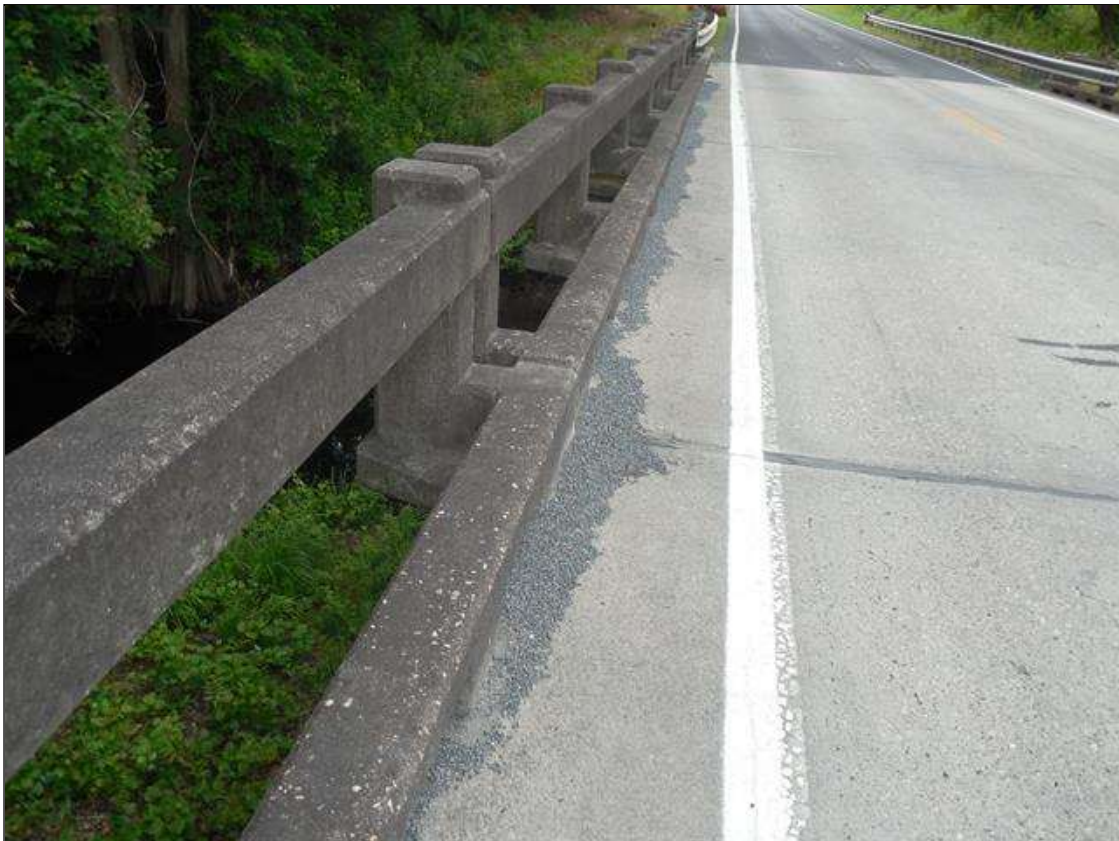
GRAVEL ALONG LEFT CURB

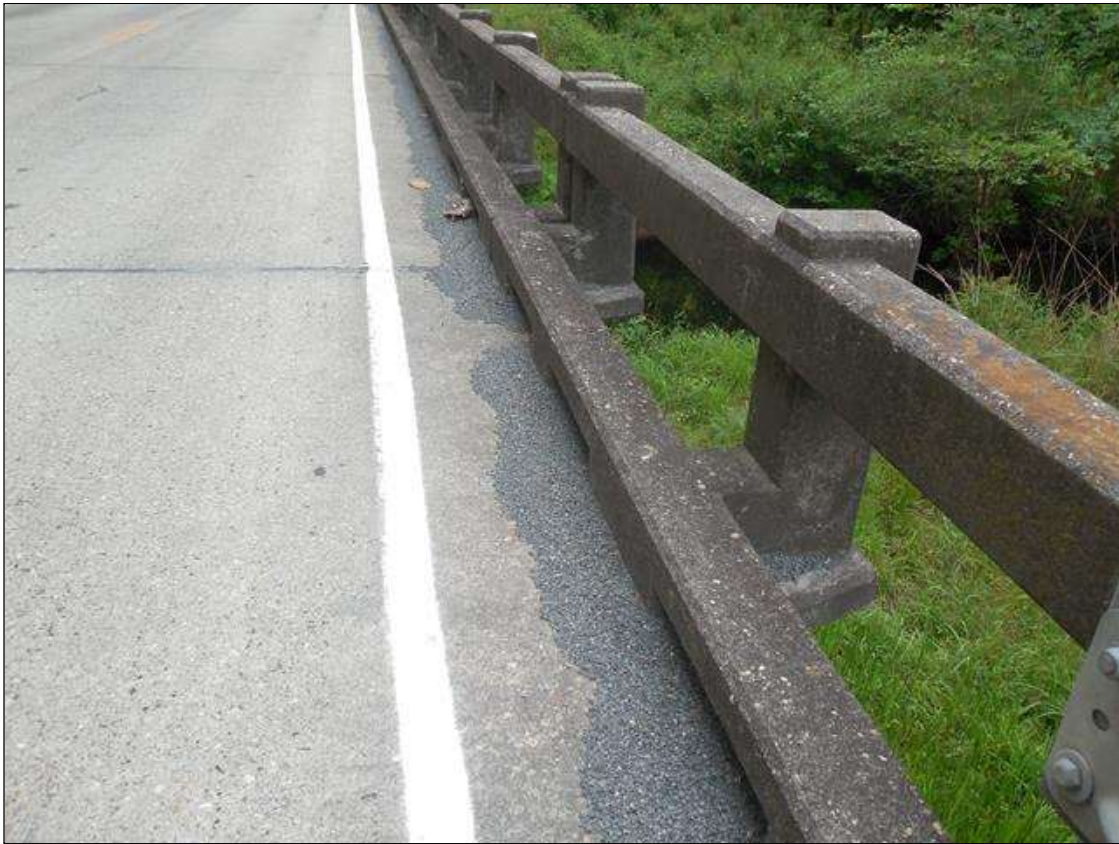
GRAVEL ALONG RIGHT CURB

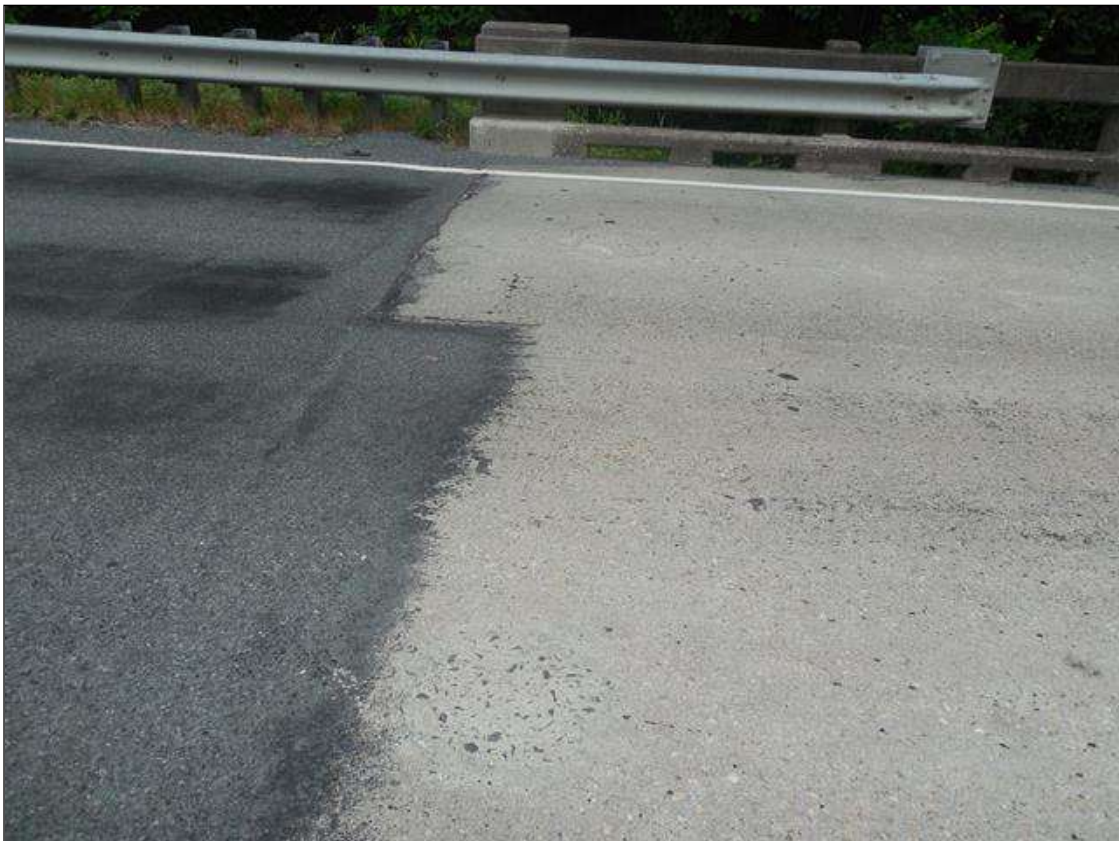
Span 1 Deck: 3 Square Feet of Delamination/Spall/Patched Area: Delaminated. Spall 1 in. or less deep or 6 in. or less in diameter. Patched area that is sound. 2 - 16" DIAMETER PATCHES AT END BENT 1 ( OVER CRUTCH PILES )

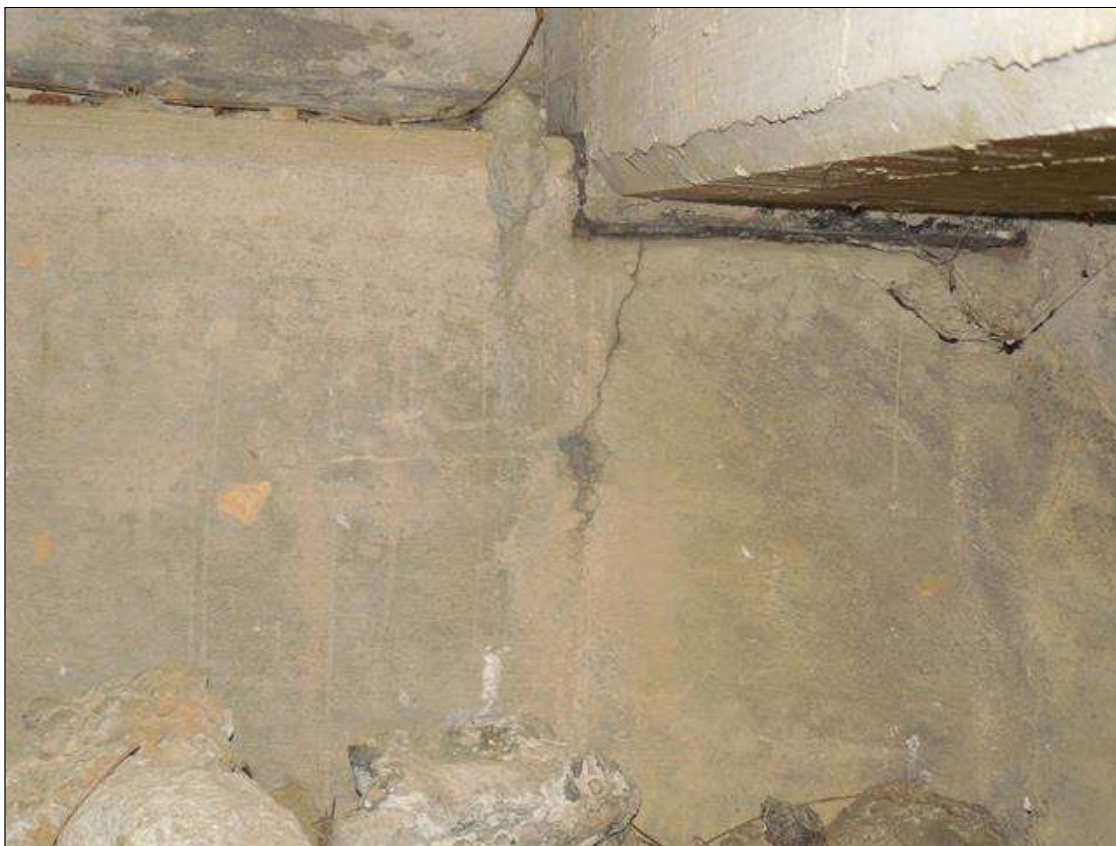
END BENT PILES NOT VISIBLE DUE TO RIP RAP AND SOIL SLOPE  
1 Feet of Cracking (RC and Other): Width greater than 0.05 in. or spacing of less than 1 ft. 1/16" WIDE VERTICAL CRACK UNDER GIRDER 3

End Bent 1 Cap : 1 Feet of Cracking (RC and Other): Width greater than 0.05 in. or spacing of less than 1 ft. 1/16"  
WIDE VERTICAL CRACK UNDER GIRDER 3

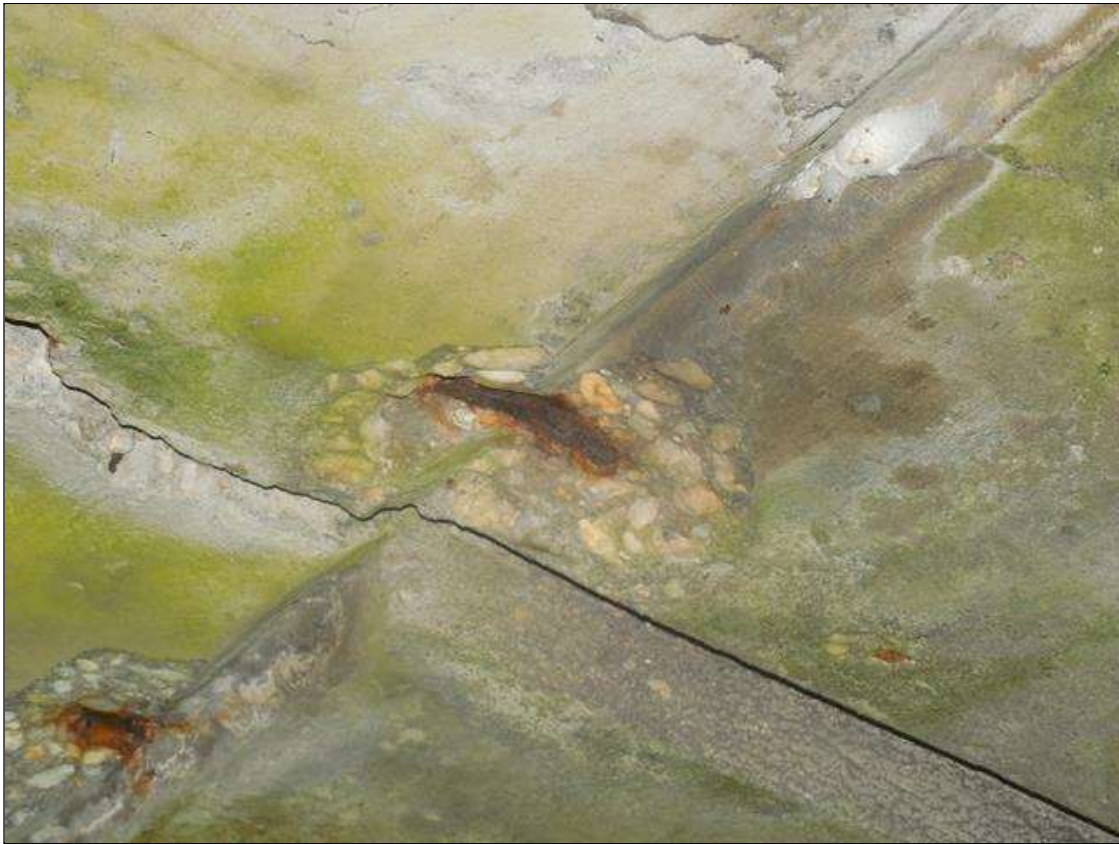
Span 1 Deck: 1 Square Feet of Delamination/Spall/Patched Area: Delaminated. Spall 1 in. or less deep or 6 in. or less in diameter. Patched area that is sound. SPALL 6" DIAMETER X 1" DEEP WITH 3" EXPOSED REBAR IN RIGHT OVERHANG AT BENT 1

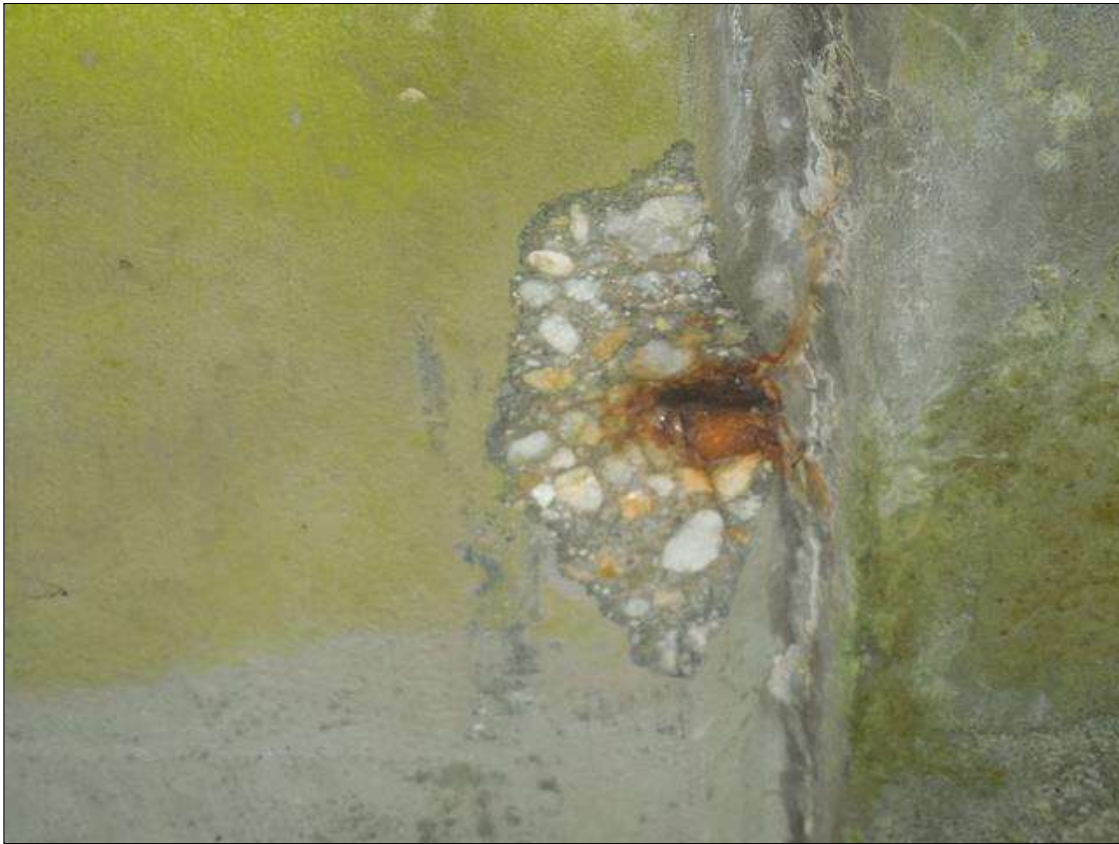
Span 2 Deck: 1 Square Feet of Delamination/Spall/Patched Area: Delaminated. Spall 1 in. or less deep or 6 in. or less in diameter. Patched area that is sound. SPALL 4" DIAMETER X 1" DEEP IN RIGHT OVERHANG AT BENT 1

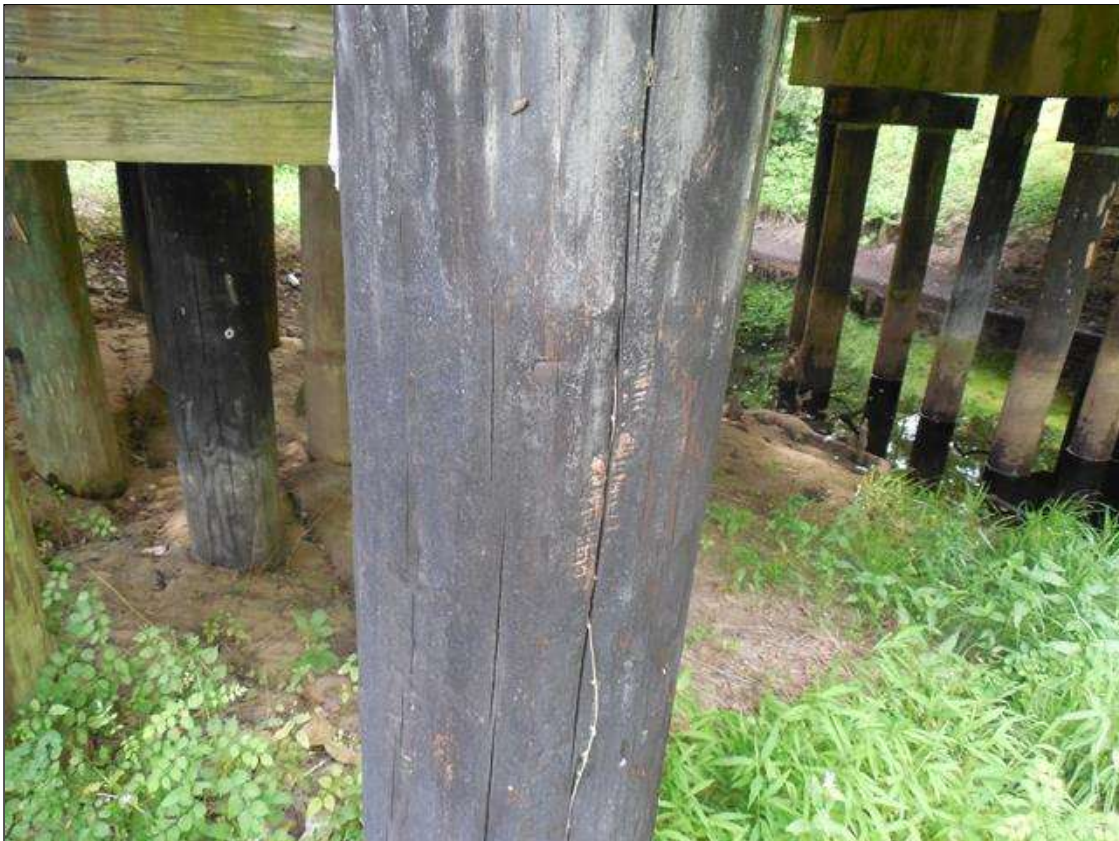
Bent 1 Pile 4: 1 Each of Check/Shake: Penetrates 5%-50% of the thickness of the member and not in the tension zone.  
1/8" VERTICAL CHECKS

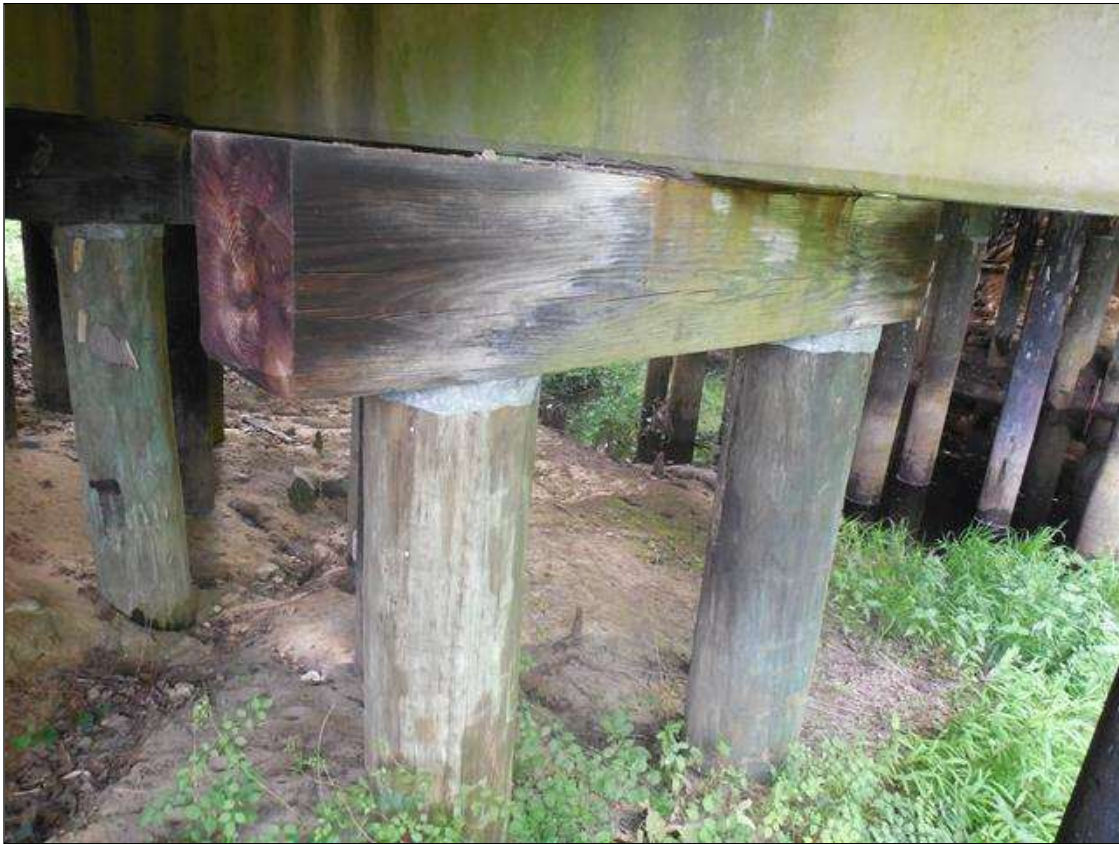
TIMBER CROSS CAP CRUTCH BETWEEN PILES 3 AND 4 AT BENT 1, SIMILAR BETWEEN ALL ORIGINAL PILES AT ALL INTERIOR BENTS ( SHORED STRUCTURE )

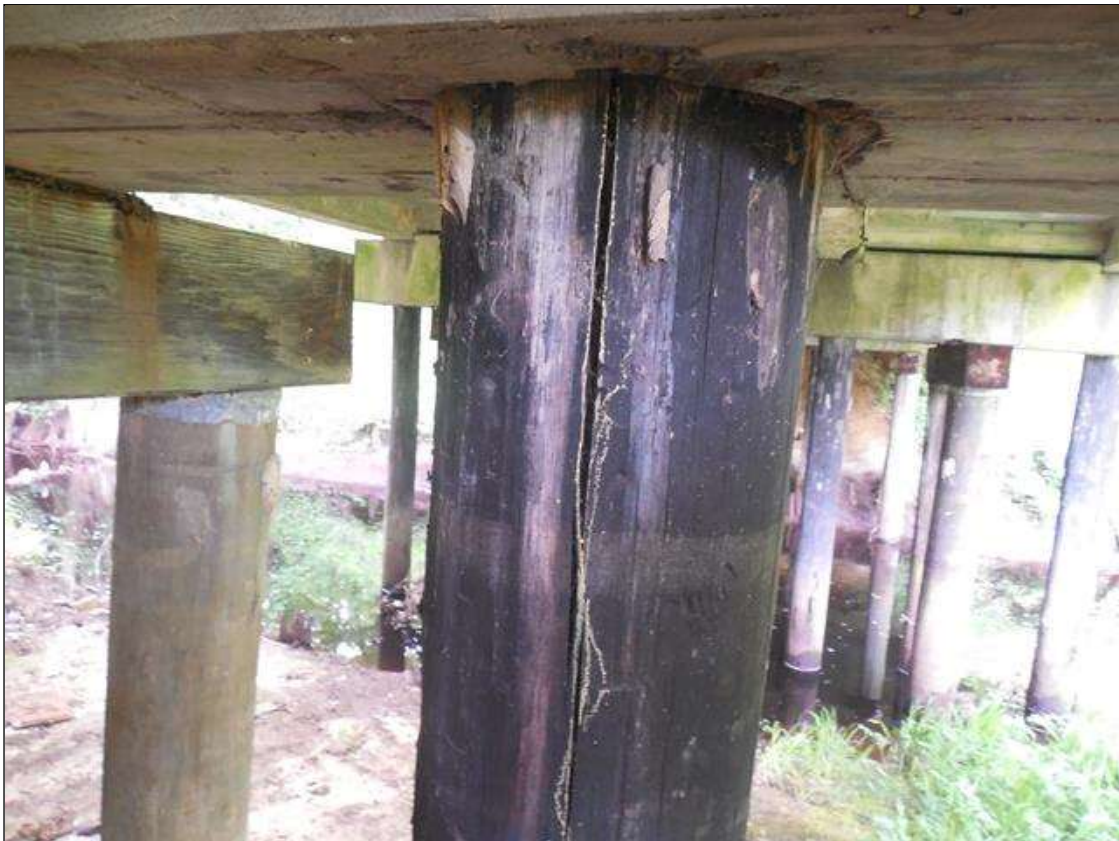
Bent 1 Pile 3: 1 Each of Check/Shake: Penetrates 5%-50% of the thickness of the member and not in the tension zone.  
2' HIGH X 1/4" WIDE X 1 1/2" DEEP VERTICAL CHECK ON SPAN 1 FACE

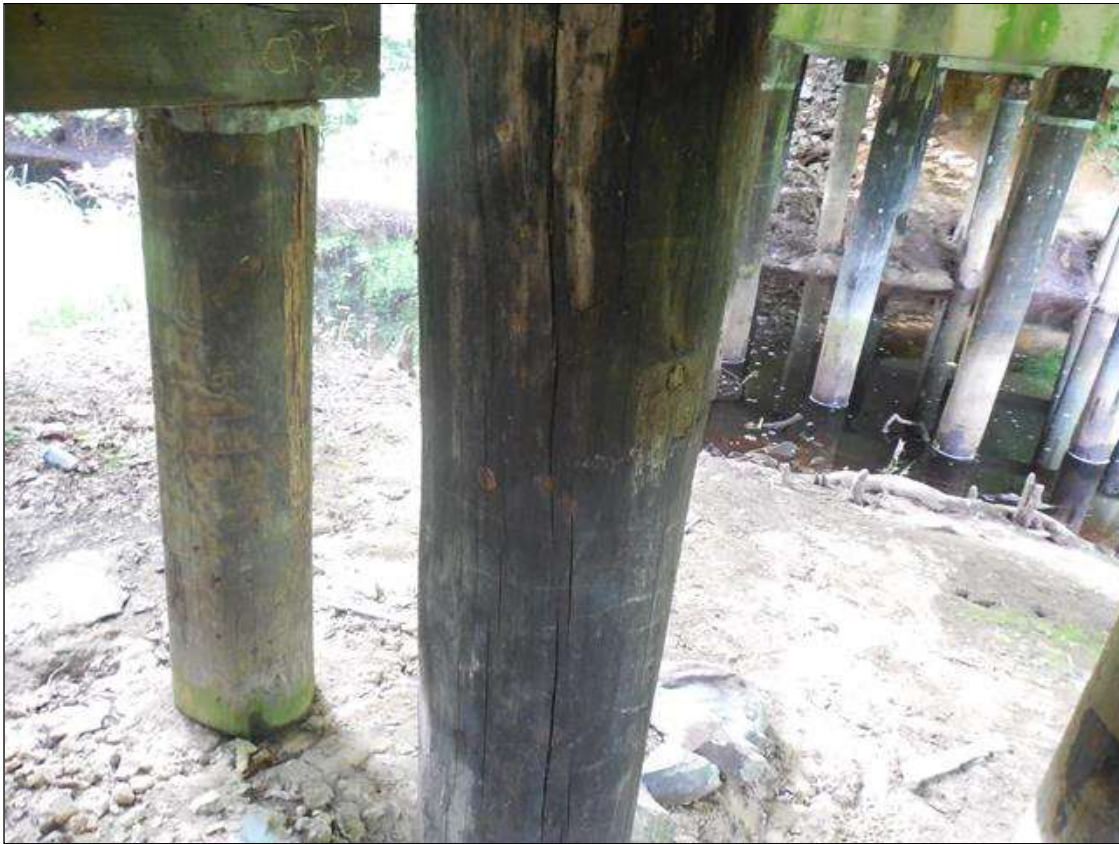
Bent 1 Pile 2: 1 Each of Check/Shake: Penetrates 5%-50% of the thickness of the member and not in the tension zone.  
1/8" WIDE X 3/4" DEEP VERTICAL CHECKS

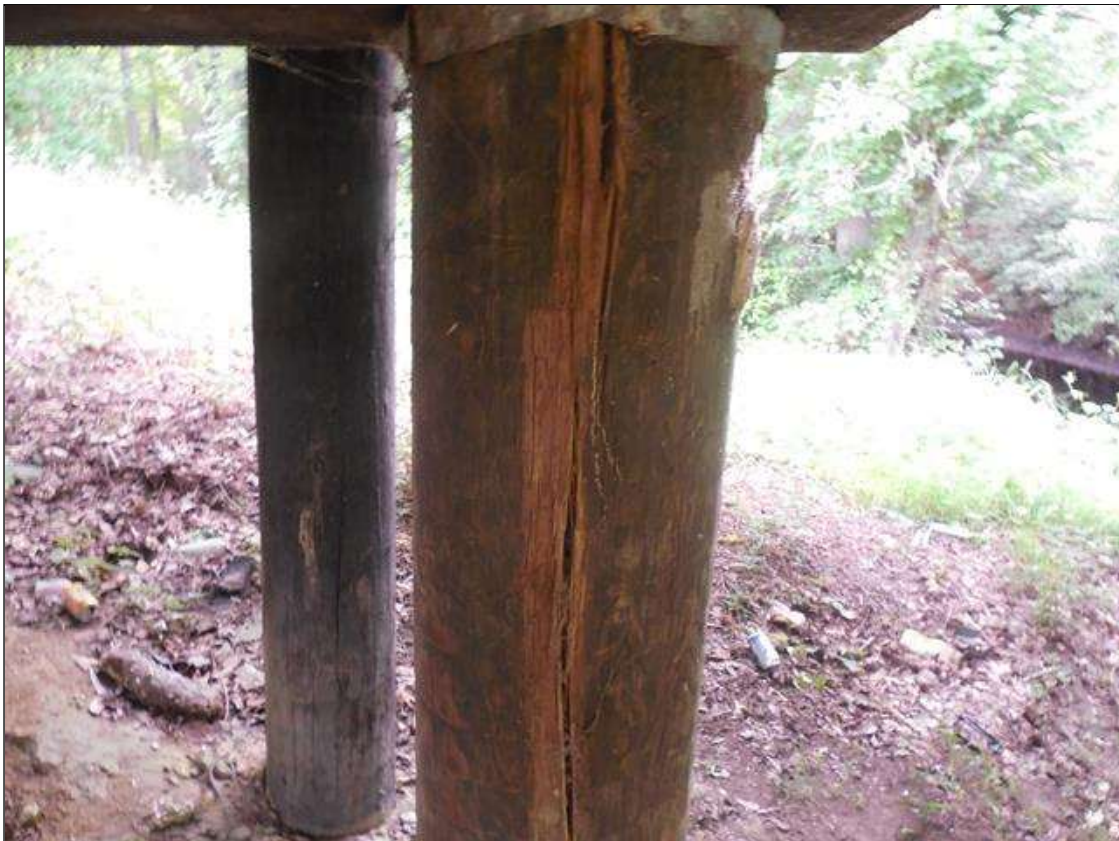
TIMBER CROSS CAP CRUTCH  
1 Each of Check/Shake: Penetrates 5%-50% of the thickenss of the member and not in the tension zone. 1/8" WIDE X 3/4" DEEP VERTICAL CHECKS  
1 Each of Check/Shake: Penetrates 5%-50% of the thickenss of the member and not in the tension zone. PILE 2 SPAN 2 CRUTCH PILE 1/2" WIDE X 2" DEEP X 4' HIGH VERTICAL CRACK

Bent 1 Pile 2: 1 Each of Check/Shake: Penetrates 5%-50% of the thickness of the member and not in the tension zone.  
PILE 2 SPAN 2 CRUTCH PILE 1/2" WIDE X 2" DEEP X 4' HIGH VERTICAL CRACK

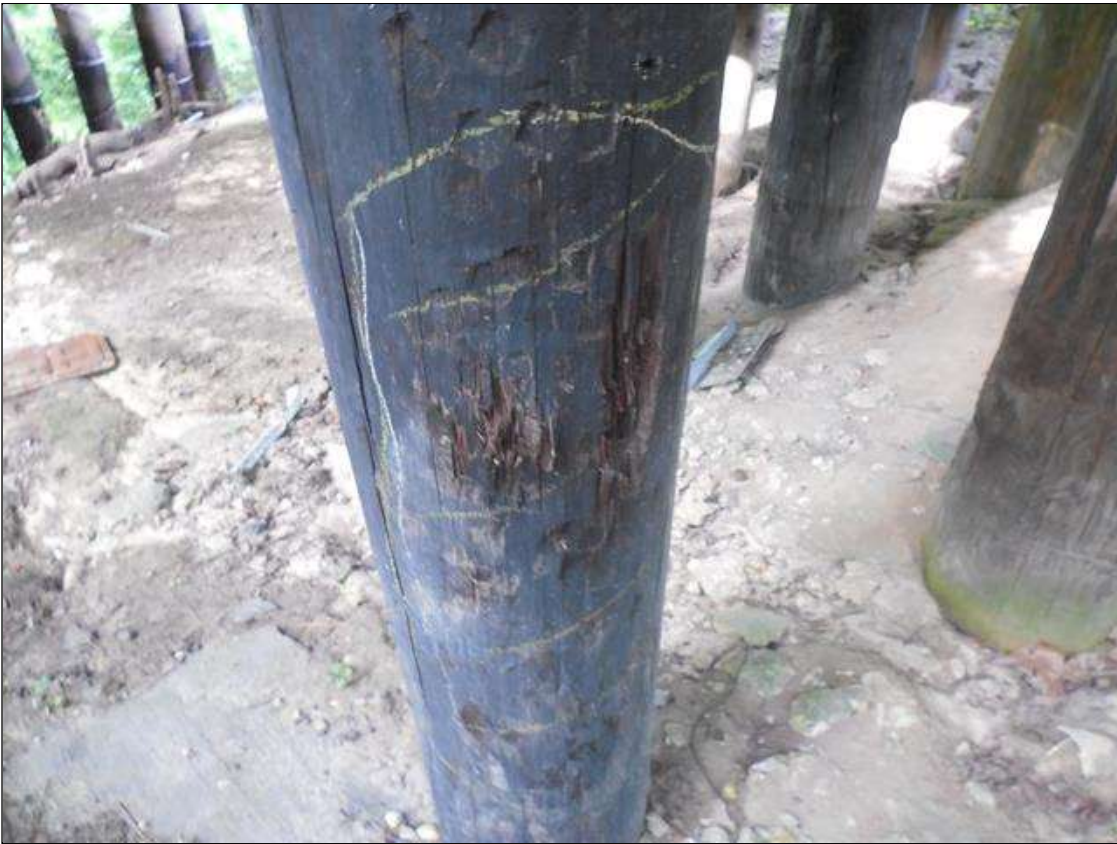
1 Each of Decay/Section Loss: Affects less than 10% of the member section SURFACE DECAYED 12" HIGH X 12" WIDE X 1" DEEP AND DELAMINATED 2' HIGH X 8" WIDE

Bent 1 Pile 1: 1 Each of Decay/Section Loss: Affects less than 10% of the member section SURFACE DECAYED 12" HIGH X 12" WIDE X 1" DEEP AND DELAMINATED 2' HIGH X 8" WIDE

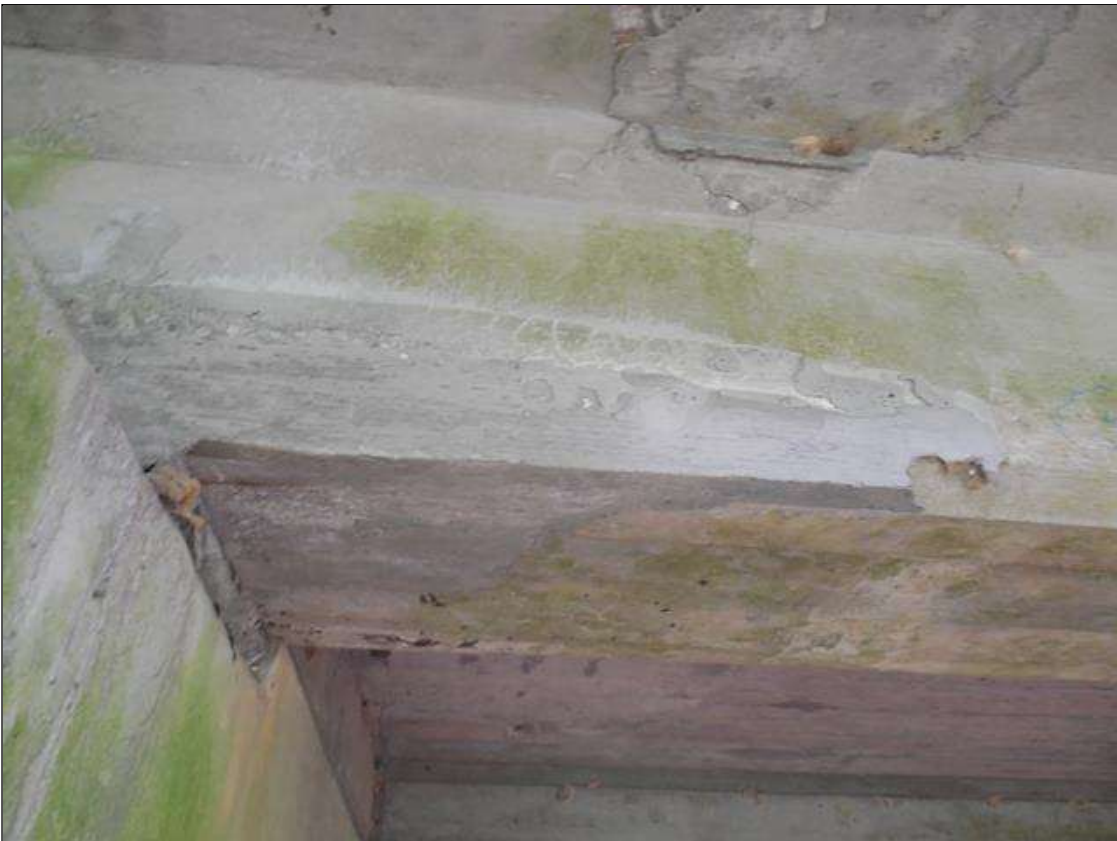
2 Feet of Delamination/Spall/Patched Area: Delaminated. Spall 1 in. or less deep or 6 in. or less in diameter. Patched area that is sound. PATCH AT BENT 1

Span 1 Beam 1: 2 Feet of Delamination/Spall/Patched Area: Delaminated. Spall 1 in. or less deep or 6 in. or less in diameter. Patched area that is sound. PATCH AT BENT 1

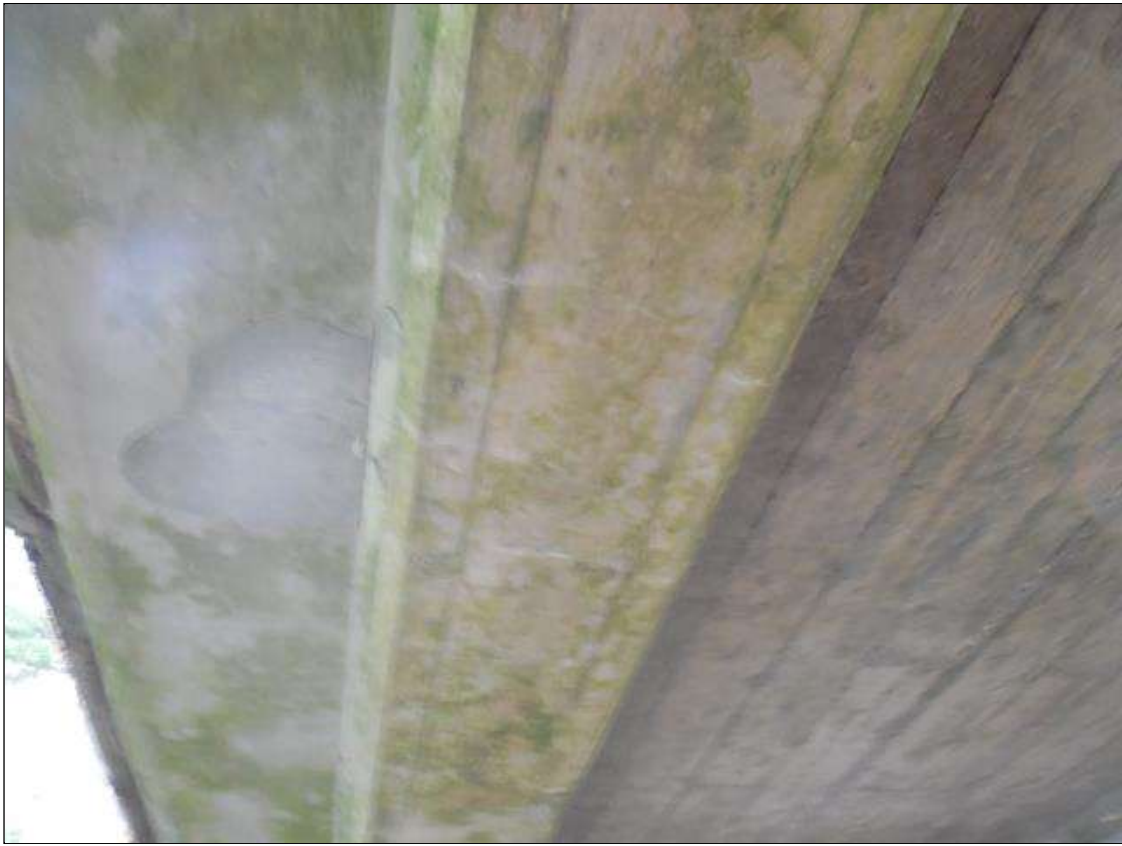
3 Feet of Cracking (RC and Other): Width greater than 0.05 in. or spacing of less than 1 ft. HAIRLINE TRANSVERSE CRACKS WITH EFFLORESCENCE AT 6" SPACING IN GIRDER UNDERSIDE

Span 2 Beam 1: 3 Feet of Cracking (RC and Other): Width greater than 0.05 in. or spacing of less than 1 ft. HAIRLINE TRANSVERSE CRACKS WITH EFFLO AT 6" SPACING IN GIRDER UNDERSIDE

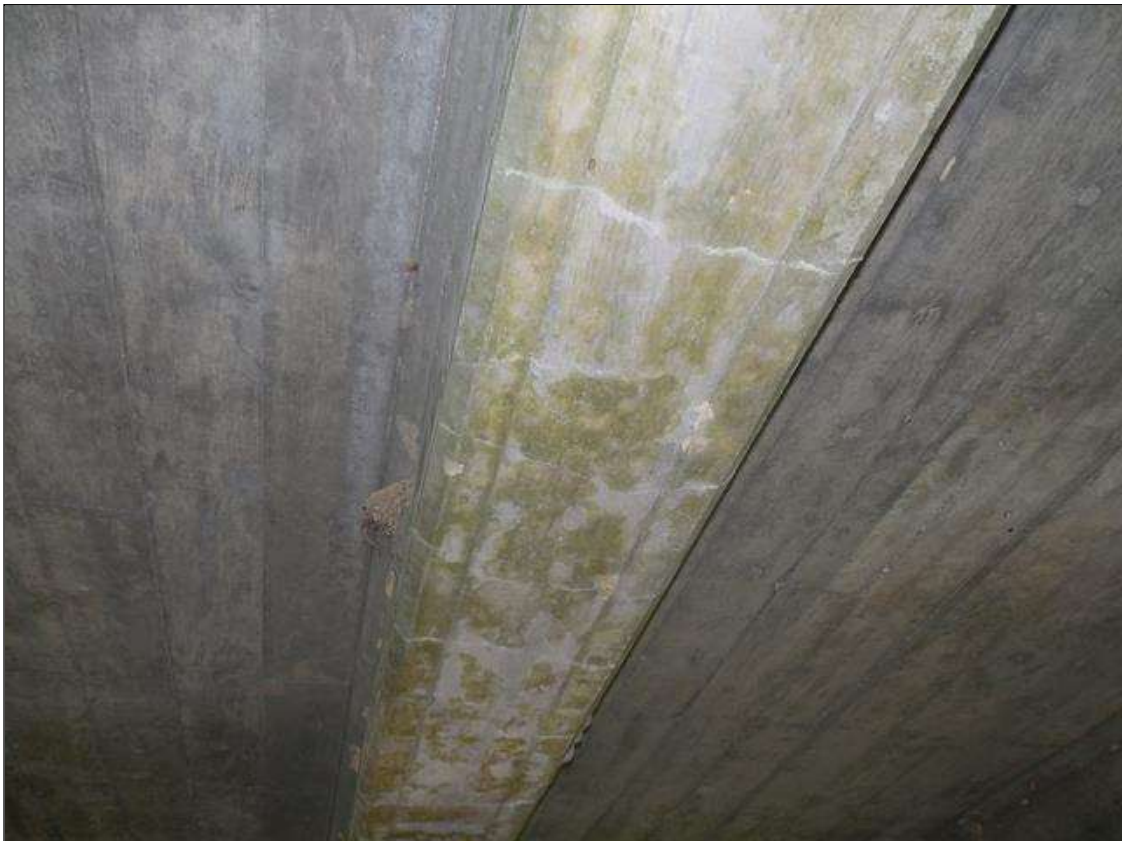
14 Feet of Cracking (RC and Other): Width greater than 0.05 in. or spacing of less than 1 ft. HAIRLINE TRANSVERSE CRACKS IN GIRDER UNDERSIDE AT 6" TO 1' SPACING

Span 2 Beam 2: 14 Feet of Cracking (RC and Other): Width greater than 0.05 in. or spacing of less than 1 ft. HAIRLINE TRANSVERSE CRACKS IN GIRDER UNDERSIDE AT 6" TO 1' SPACING

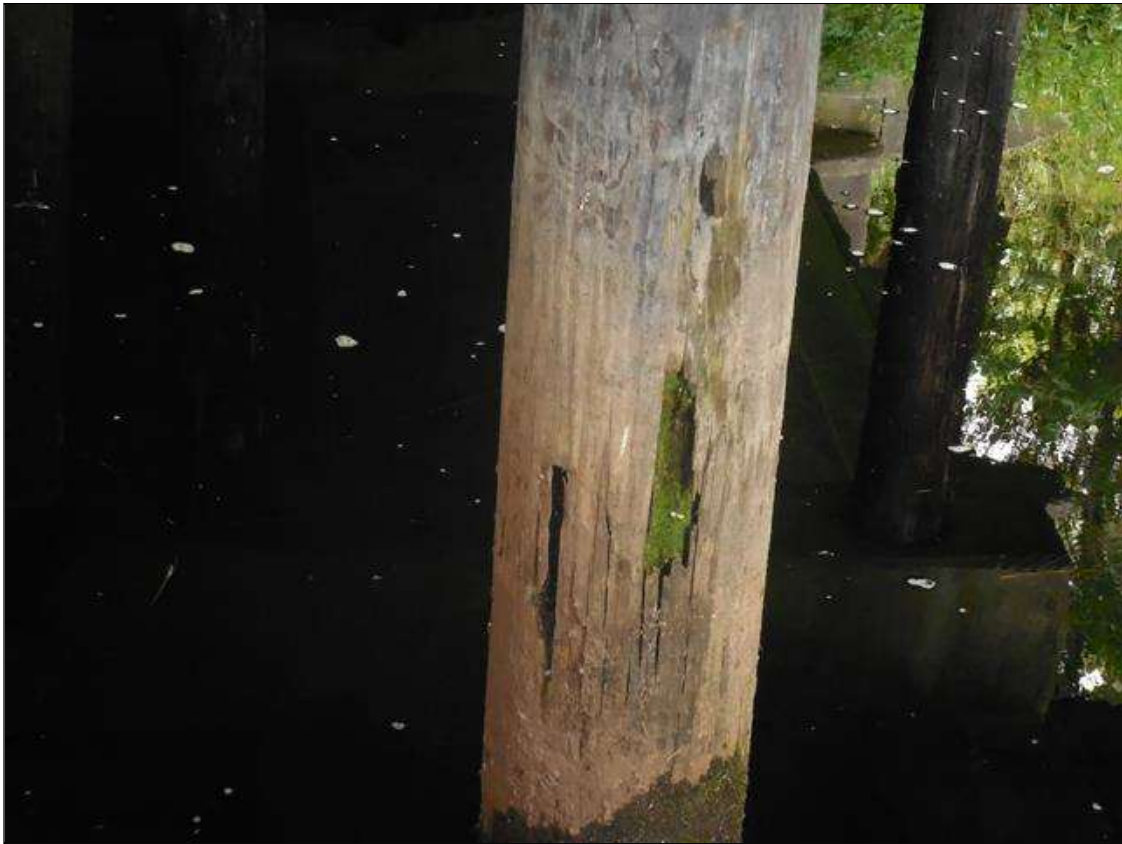
1 Each of Decay/Section Loss: Affects less than 10% of the member section DECAYED 2' HIGH X 10" WIDE X 2 1/2" DEEP

Bent 2 Pile 5: 1 Each of Decay/Section Loss: Affects less than 10% of the member section DECAYED 2' HIGH X 10" WIDE X 2 1/2" DEEP
