NC DEPARTMENT OF TRANSPORTATION  
DIVISION OF HIGHWAYS  
STRUCTURE MANAGEMENT UNIT

## Structure Safety Report

### Routine Element Inspection

COUNTY: BLADEN STRUCTURE NUMBER: 080011 FREQUENCY: 24 MONTHS

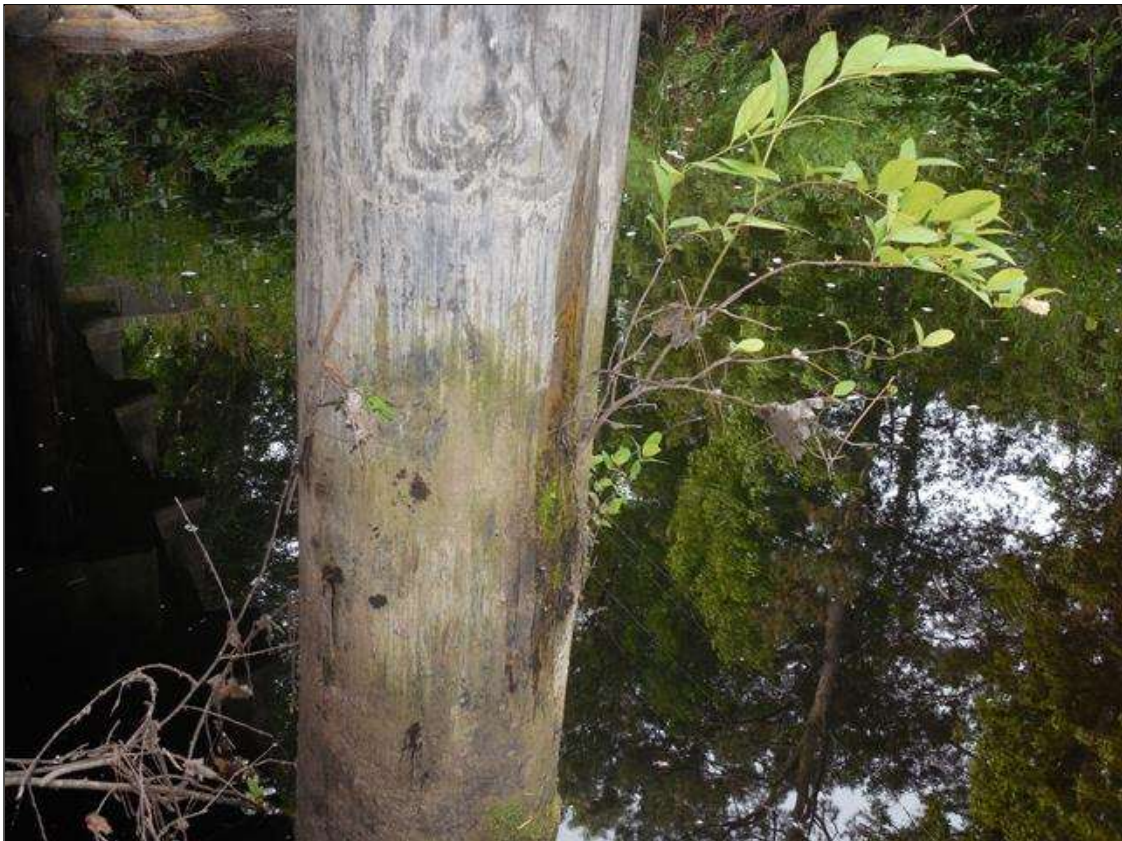
1 Each of Decay/Section Loss: Affects less than 10% of the member section DECAYED 2' HIGH X 6" WIDE X 1" DEEP WITH VEGETATION

Bent 2 Pile 7: 1 Each of Decay/Section Loss: Affects less than 10% of the member section DECAYED 2' HIGH X 6" WIDE X 1" DEEP WITH VEGETATION

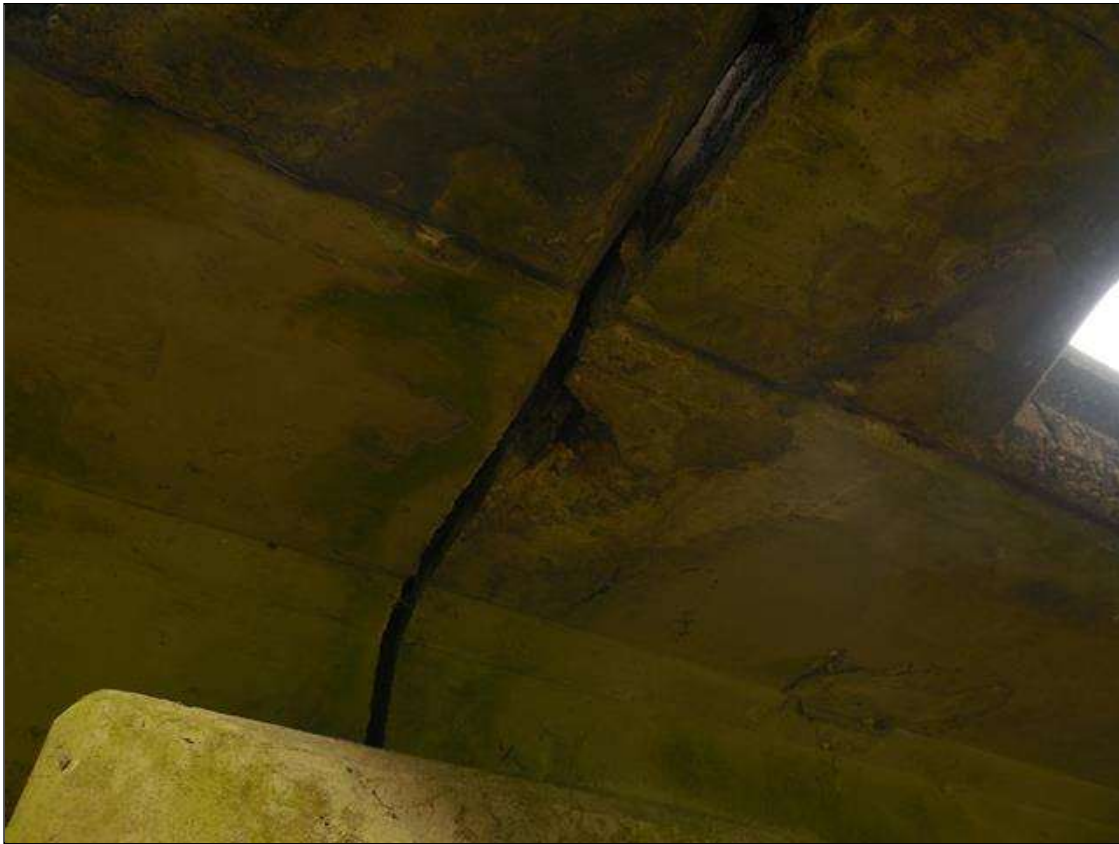
250 Square Feet of Abrasion/Wear (PSC/RC): Abrasion or wearing has exposed coarse aggregate but the aggregate remains secure in the concrete. SCALING WITH EXPOSED AGGREGATE  
 5 Square Feet of Delamination/Spall/Patched Area: Delaminated. Spall 1 in. or less deep or 6 in. or less in diameter. Patched area that is sound. 3 - 16" DIAMETER PATCHES AT BENT 1 ( OVER CRUTCH PILES )  
 3 Square Feet of Delamination/Spall/Patched Area: Delaminated. Spall 1 in. or less deep or 6 in. or less in diameter. Patched area that is sound. 2 - 16" DIAMETER PATCHES AT END BENT 1 ( OVER CRUTCH PILES )  
 1 Square Feet of Delamination/Spall/Patched Area: Delaminated. Spall 1 in. or less deep or 6 in. or less in diameter. Patched area that is sound. SPALL 6" DIAMETER X 1" DEEP WITH 3" EXPOSED REBAR IN RIGHT OVERHANG AT BENT 1  
 1 Square Feet of Delamination/Spall/Patched Area: Spall greater than 1 in. deep or greater than 6 in. diameter. Patched area that is unsound or showing distress. Does not warrant structural review. LEFT DECK OVERHANG SPALL 6" WIDE X 4" LONG X 3" DEEP WITH 2" EXPOSED REBAR AT BENT 1

Span 1 Deck: 1 Square Feet of Delamination/Spall/Patched Area: Spall greater than 1 in. deep or greater than 6 in. diameter. Patched area that is unsound or showing distress. Does not warrant structural review. LEFT DECK OVERHANG SPALL 6" WIDE X 4" LONG X 3" DEEP WITH 2" EXPOSED REBAR AT BENT 1

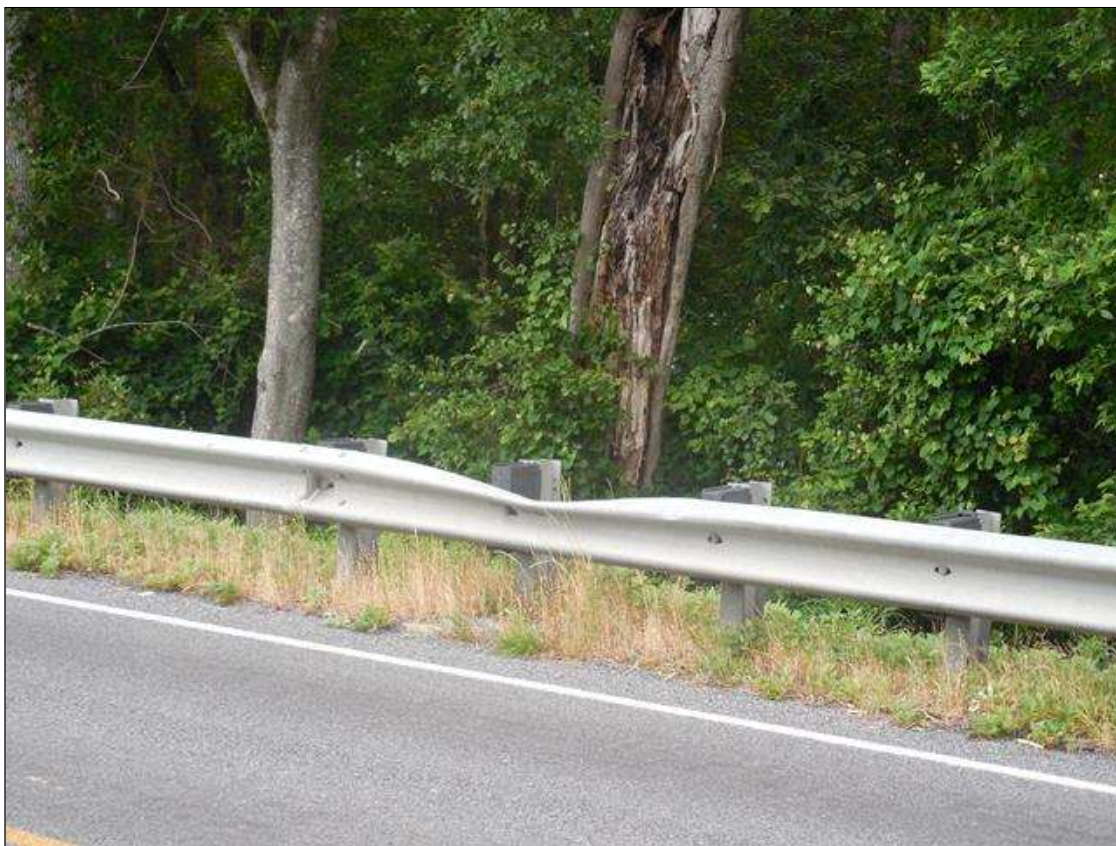
Details DAMAGED GUARDRAIL AT NORTHWEST CORNER ( 5 FT. MAINTENANCE )

DAMAGED GUARDRAIL AT NORTHWEST CORNER

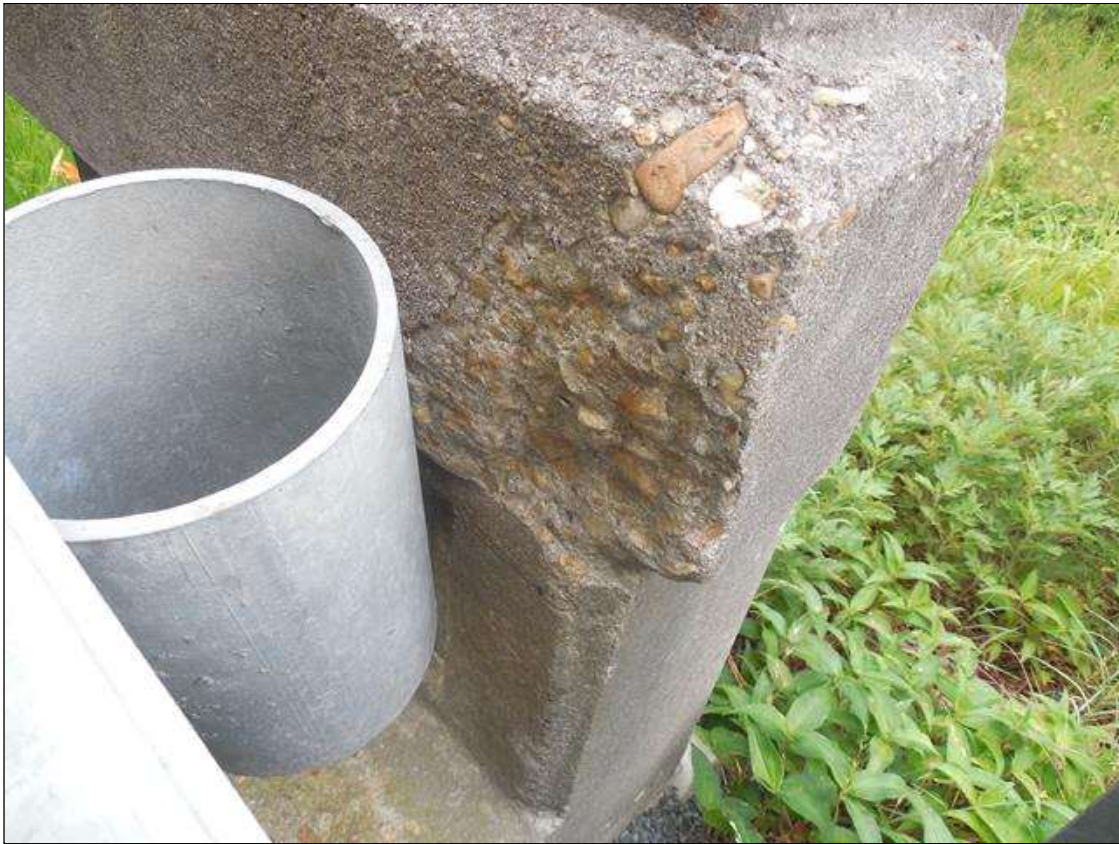
1 Feet of Delamination/Spall/Patched Area: Spall greater than 1 in. deep or greater than 6 in. diameter. Patched area that is unsound or showing distress. Does not warrant structural review. RAIL END POST SPALL 10" HIGH X 8" WIDE X 2" DEEP AT SOUTHWEST CORNER

Span 1 Right Bridge Rail: 1 Feet of Delamination/Spall/Patched Area: Spall greater than 1 in. deep or greater than 6 in. diameter. Patched area that is unsound or showing distress. Does not warrant structural review. RAIL END POST SPALL 10" HIGH X 8" WIDE X 2" DEEP AT SOUTHWEST CORNER

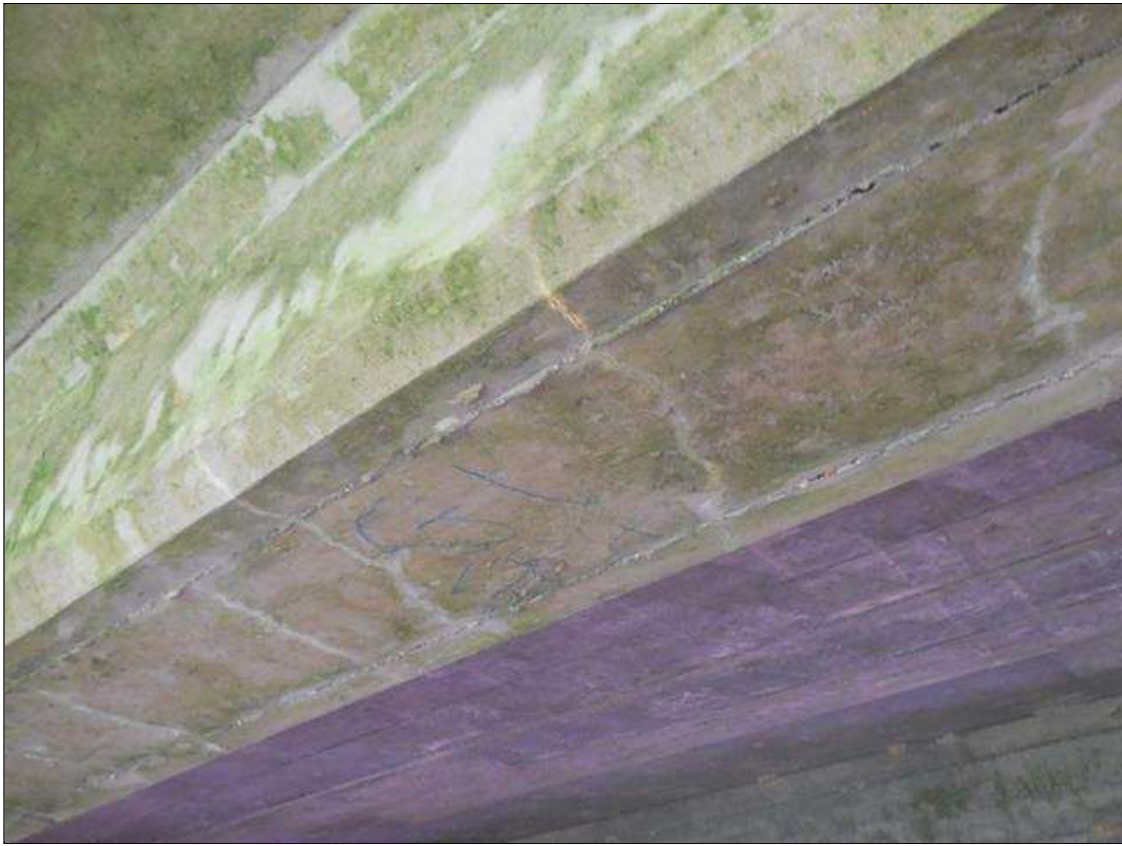
12 Feet of Cracking (RC and Other): Width greater than 0.05 in. or spacing of less than 1 ft. HAIRLINE TRANSVERSE CRACKS AT 6" TO 1' SPACING

Span 4 Beam 1: 12 Feet of Cracking (RC and Other): Width greater than 0.05 in. or spacing of less than 1 ft.  
HAIRLINE TRANSVERSE CRACKS AT 6" TO 1' SPACING

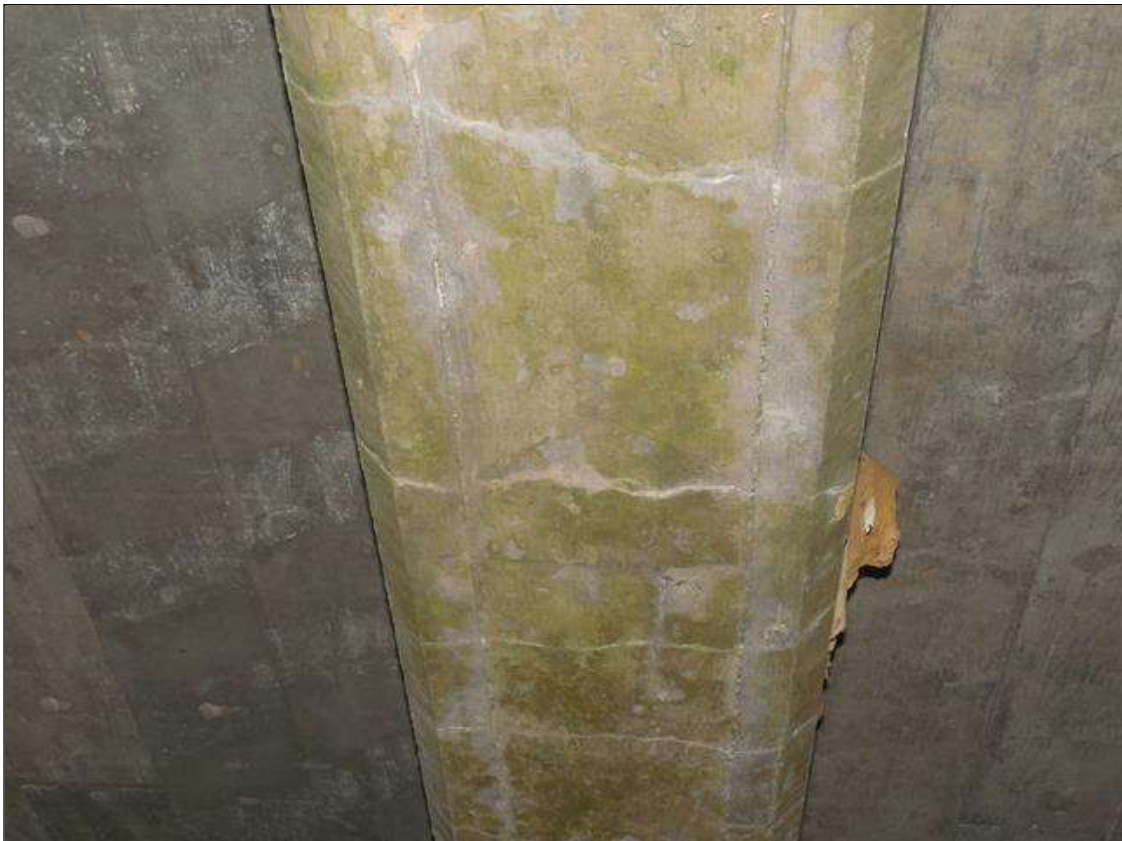
19 Feet of Cracking (RC and Other): Width greater than 0.05 in. or spacing of less than 1 ft. HAIRLINE TRANSVERSE CRACKS AT 6" TO 1' SPACING

Span 4 Beam 2: 19 Feet of Cracking (RC and Other): Width greater than 0.05 in. or spacing of less than 1 ft.  
HAIRLINE TRANSVERSE CRACKS AT 6" TO 1' SPACING

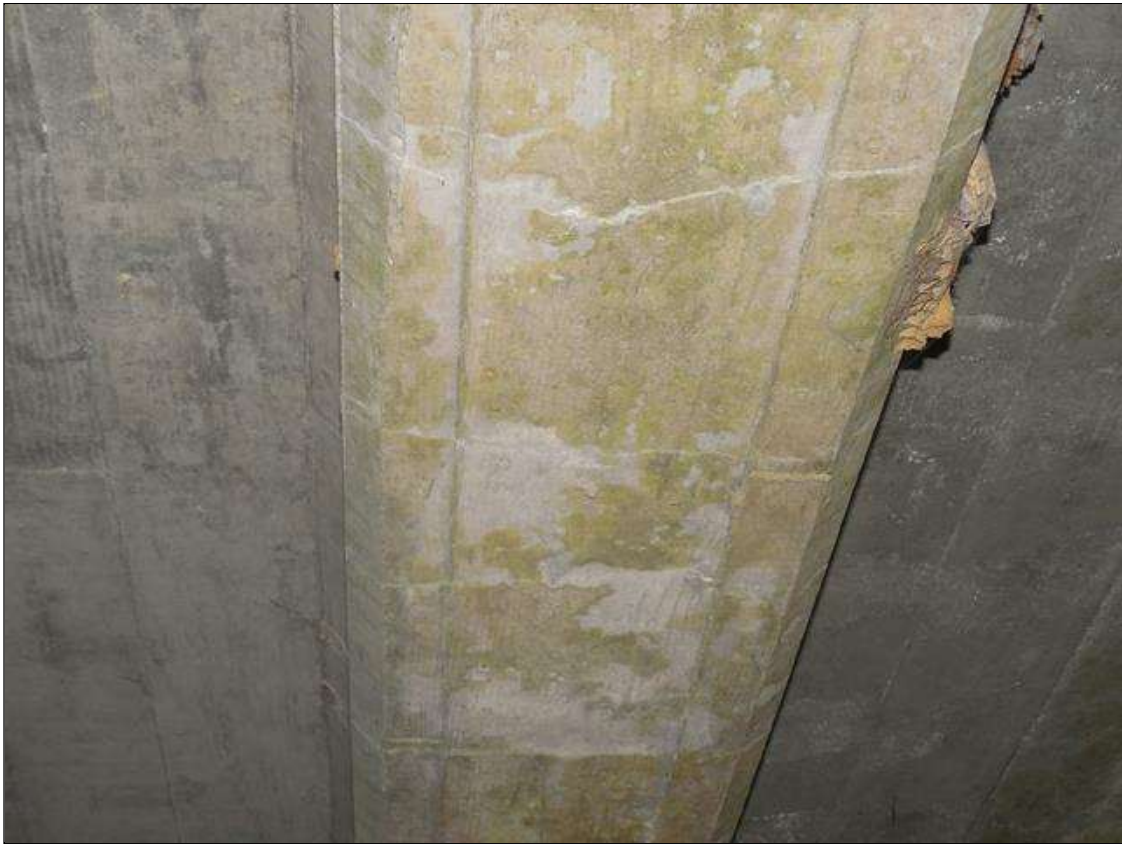
17 Feet of Cracking (RC and Other): Width greater than 0.05 in. or spacing of less than 1 ft. HAIRLINE TRANSVERSE CRACKS AT 6" TO 1' SPACING

Span 4 Beam 3: 17 Feet of Cracking (RC and Other): Width greater than 0.05 in. or spacing of less than 1 ft. HAIRLINE TRANSVERSE CRACKS AT 6" TO 1' SPACING

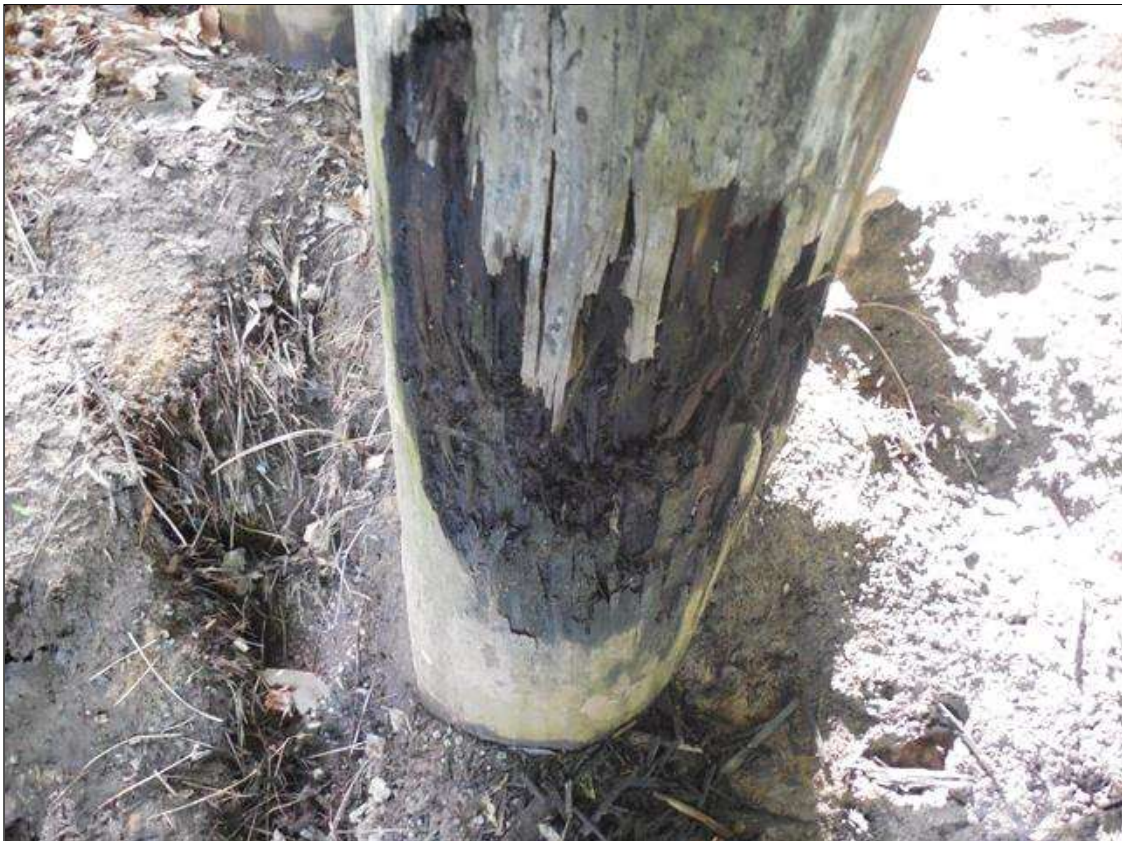
1 Each of Decay/Section Loss: Affects less than 10% of the member section DECAYED 2' HIGH X 16" WIDE X 2 1/2" DEEP

Bent 3 Pile 3: 1 Each of Decay/Section Loss: Affects less than 10% of the member section DECAYED 2' HIGH X 16" WIDE X 2 1/2" DEEP

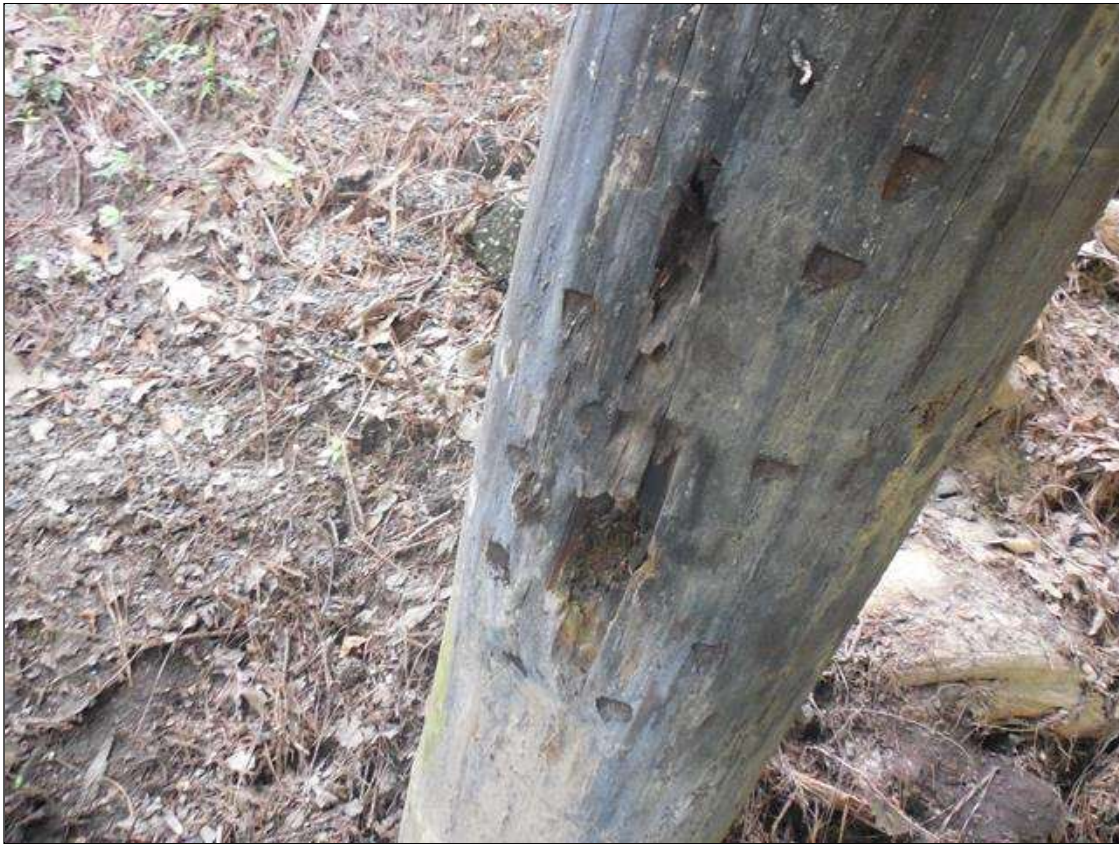
1 Each of Decay/Section Loss: Affects less than 10% of the member section DECAYED 14" HIGH X 4" WIDE X 1 1/2" DEEP ON SPAN 3 FACE

Bent 3 Pile 1: 1 Each of Decay/Section Loss: Affects less than 10% of the member section DECAYED 14" HIGH X 4" WIDE X 1 1/2" DEEP ON SPAN 3 FACE

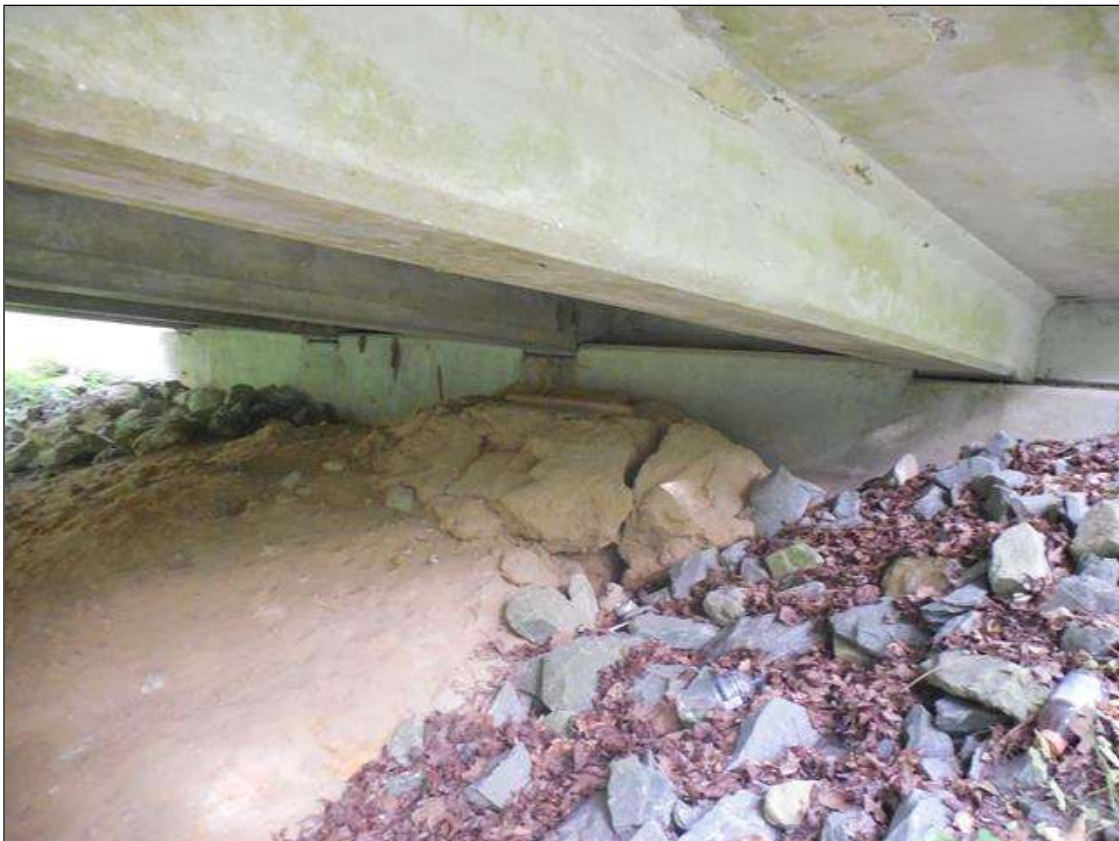
END BENT 1, PILES AND CRUTCH PILES NOT VISIBLE

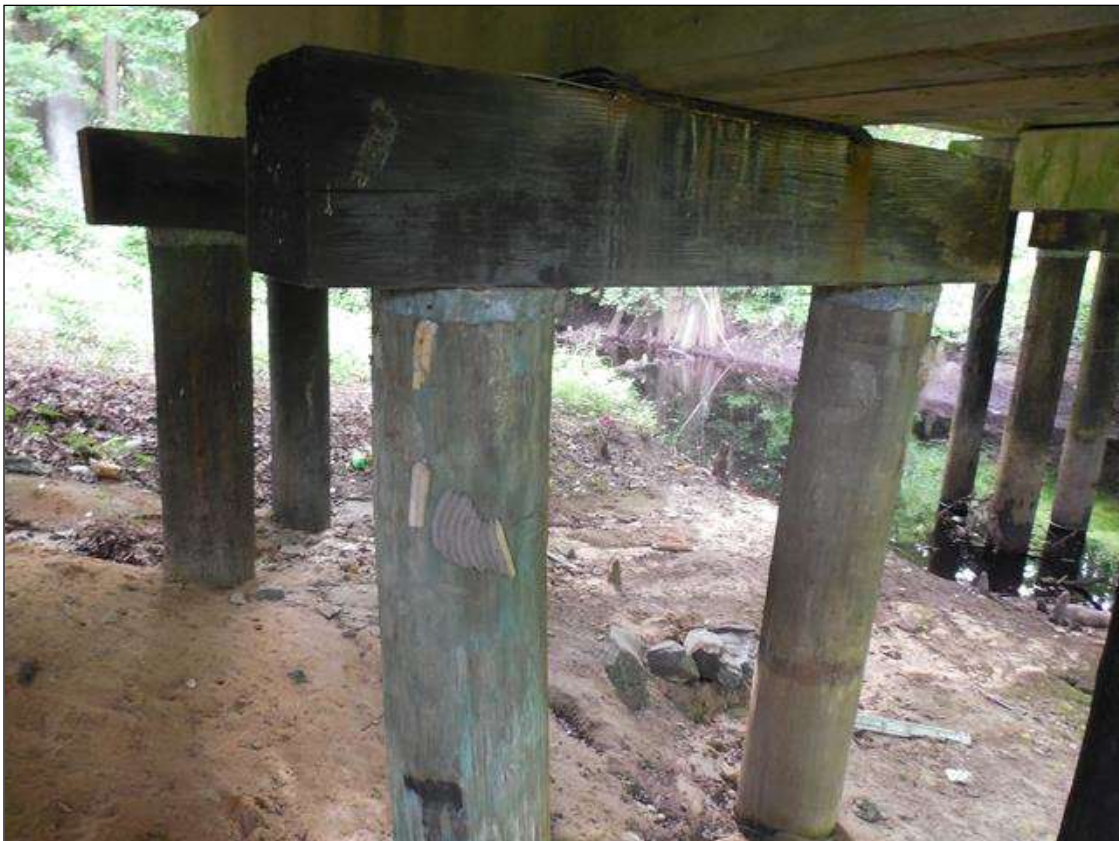
TIMBER CRUTCH BETWEEN PILES 2 AND 3 AT BENT 1 ( SHORED STRUCTURE ) SIMILAR AT ALL INTERIOR BENTS

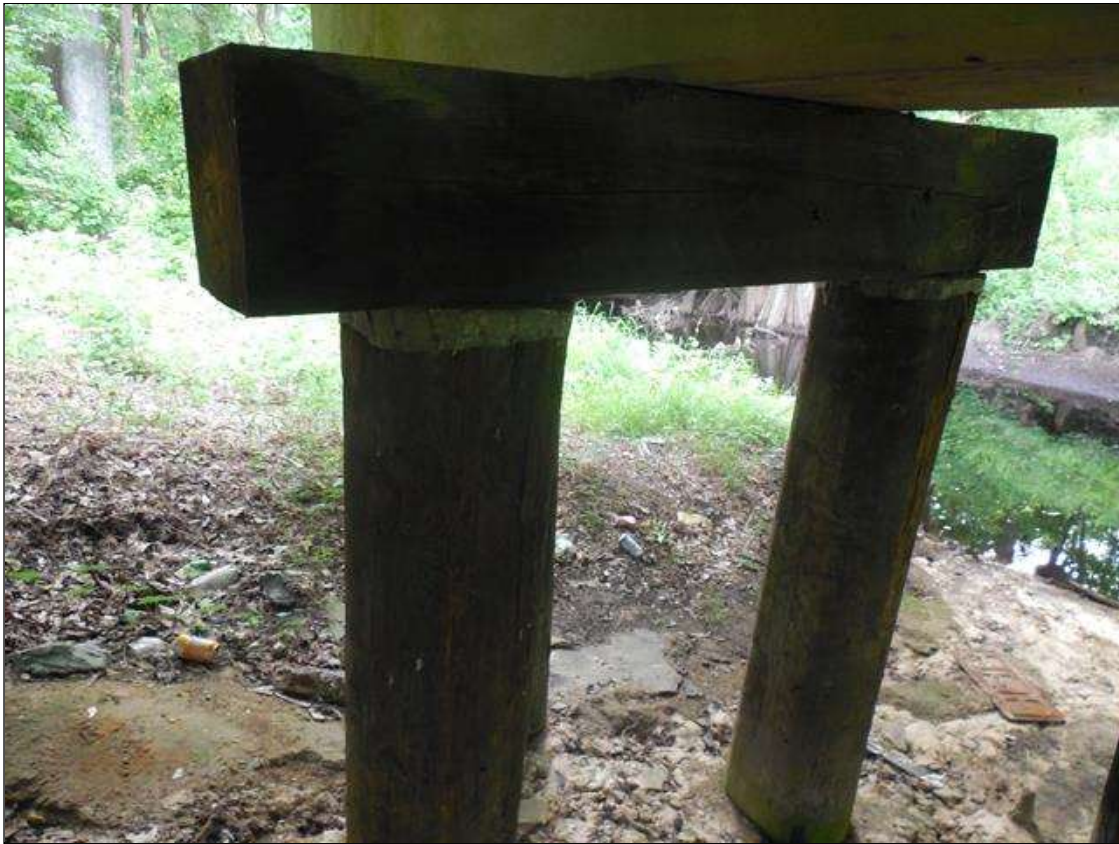
TIMBER CRUTCH AT BENT 1 BETWEEN ORIGINAL PILES 1 AND 2 , ( SHORED STRUCTURE ) SIMILAR AT ALL INTERIOR BENTS

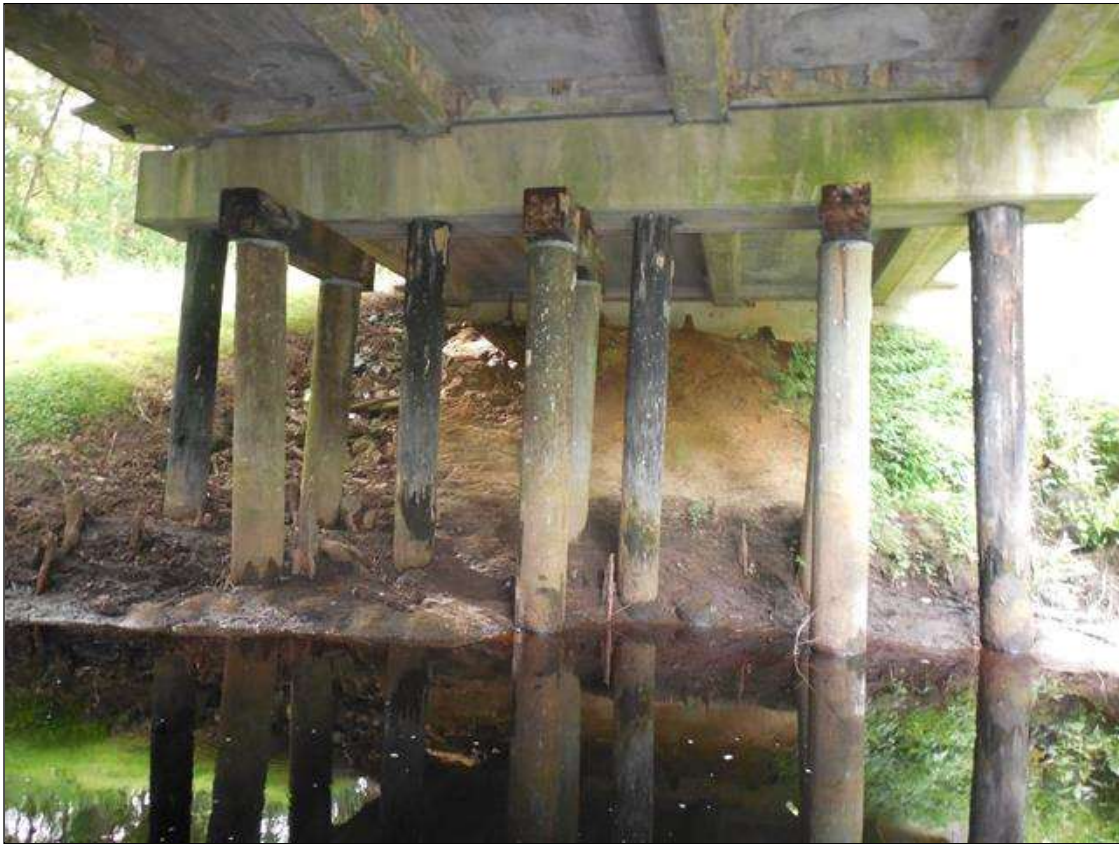
BENT 3 WITH TIMBER CROSS CAP CRUTES ( SHORED STRUCTURE )
