NC DEPARTMENT OF TRANSPORTATION  
DIVISION OF HIGHWAYS  
STRUCTURE MANAGEMENT UNIT

## Structure Safety Report

### Routine Element Inspection

COUNTY: BLADEN STRUCTURE NUMBER: 080032 FREQUENCY: 24 MONTHS  
FACILITY CARRIED: SR1700 MILE POST: \_\_\_\_\_  
LOCATION: 0.2 MI.N.JCT.SR1708  
FEATURE INTERSECTED: HAMMOND CREEK  
LATITUDE: 34° 34' 43.41" LONGITUDE: 78° 35' 30.81"  
SUPERSTRUCTURE: PRESTRESSED CONCRETE CHANNELS, STD.BMD-13  
SUBSTRUCTURE: E.BTS&BTS:PRESTR.CONC.CAPS ON TIM.PILES@5"6CTS  
SPANS: 1@30"6,1@30",1@30"6  
☐ FRACTURE CRITICAL ☒ TEMPORARY SHORING ☐ SCOUR CRITICAL ☐ SCOUR PLAN OF ACTION  
PRESENT CONDITION: Fair INSPECTION DATE: 06/02/2015  
POSTED SV: 22 POSTED TTST: 25  
OTHER SIGNS PRESENT: 3 DELINEATORS

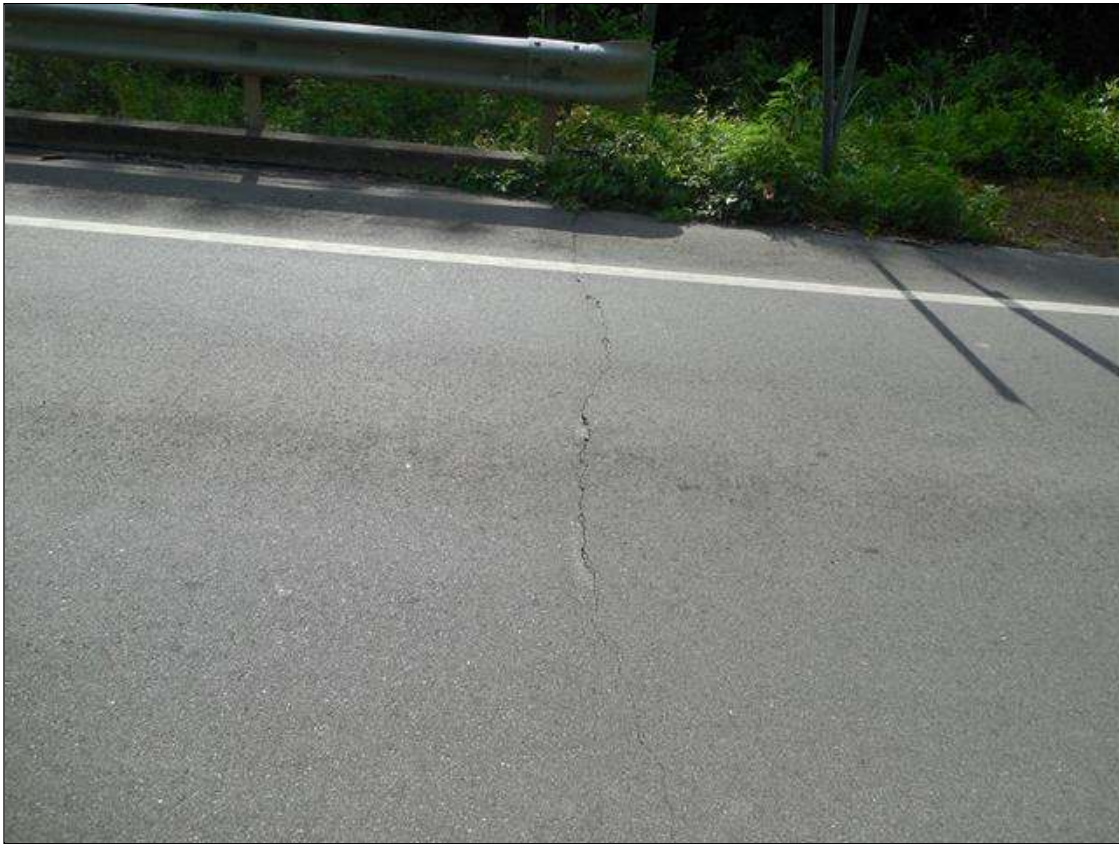
12 Square Feet of Crack (Wearing Surface): Width of more than 0.05 in. or spacing of less than 1.0 ft. 1/8" WIDE  
TRANSVERSE CRACK OVER END BENT 1 IN NORTH BOUND LANE

Span 1 Wearing Surface: 12 Square Feet of Crack (Wearing Surface): Width of more than 0.05 in. or spacing of less than 1.0 ft. 1/8" WIDE TRANSVERSE CRACK OVER END BENT 1 IN NORTH BOUND LANE

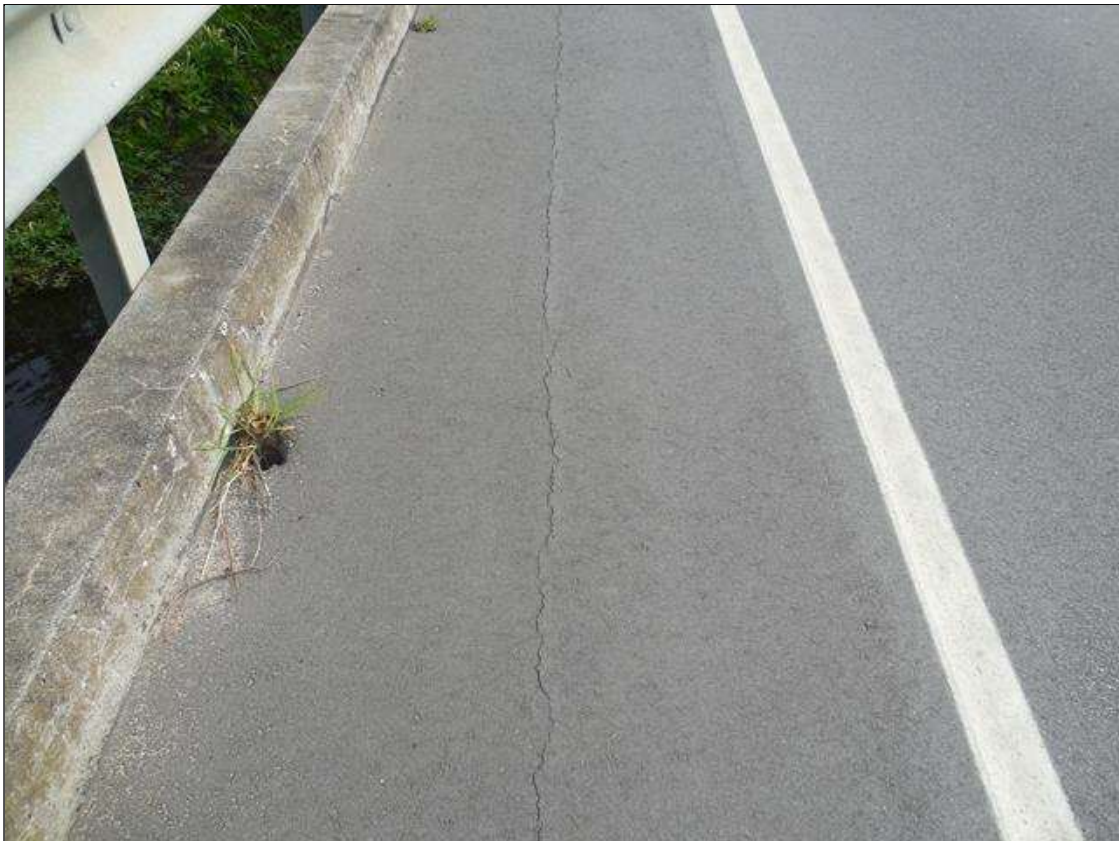
20 Square Feet of Crack (Wearing Surface): Width of more than 0.05 in. or spacing of less than 1.0 ft. 1/8" LONGITUDINAL  
CRACK IN LEFT SHOULDER

Span 2 Wearing Surface: 20 Square Feet of Crack (Wearing Surface): Width of more than 0.05 in. or spacing of less than 1.0 ft. 1/8" LONGITUDINAL CRACK IN LEFT SHOULDER

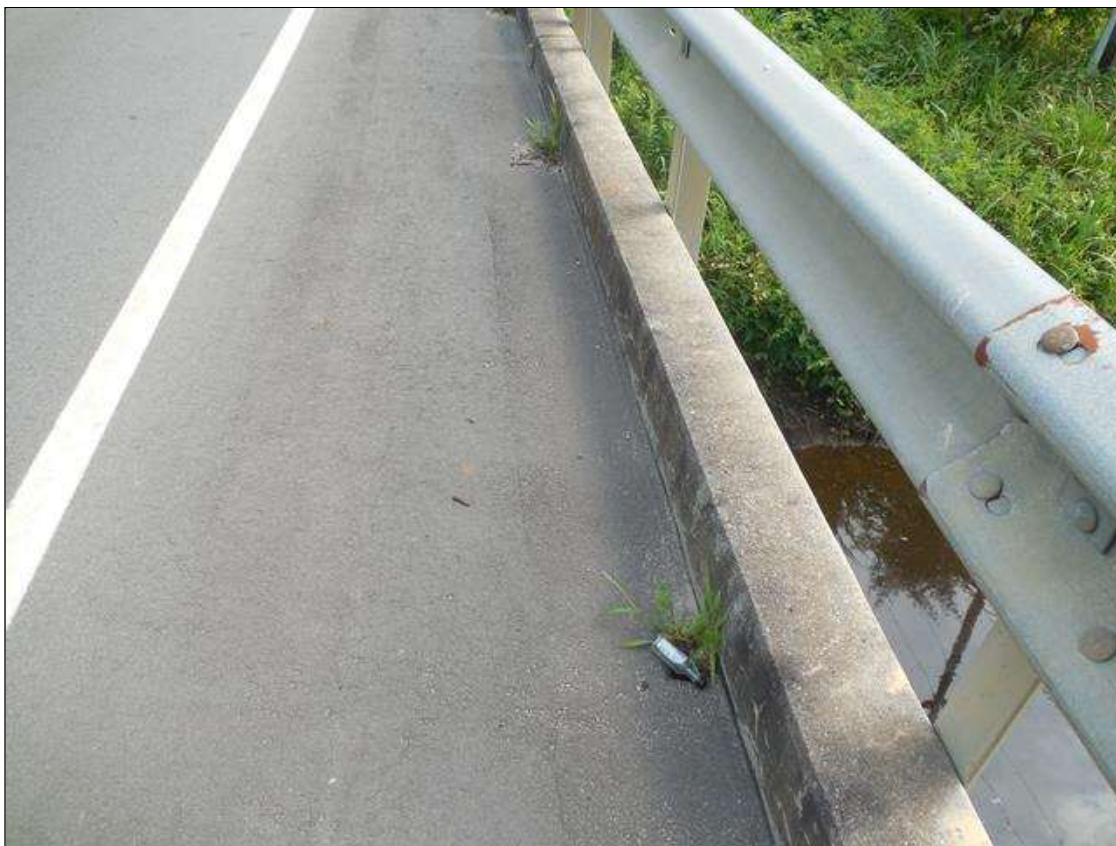
RIGHT SIDE DRAINS BLOCKED BY VEGETATION

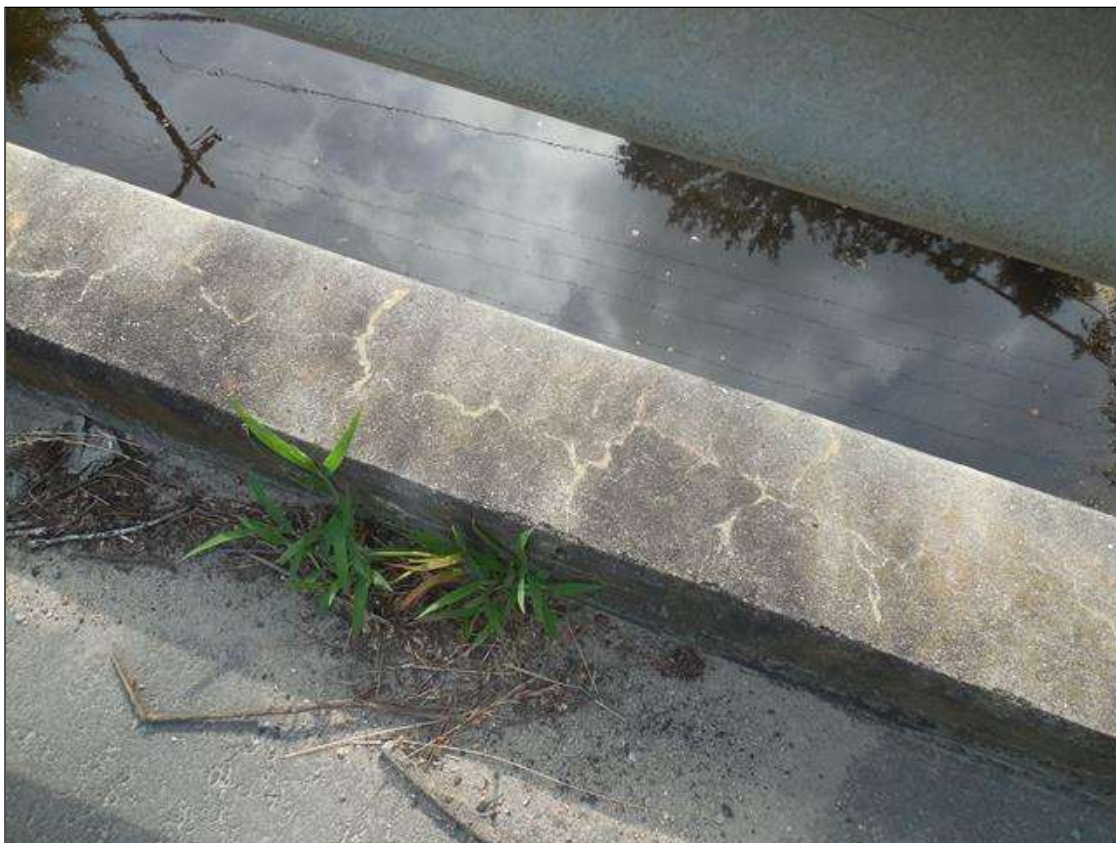
SPAN 2 RIGHT CURB 10' HAIRLINE MAP CRACKING 10' MAINTENANCE

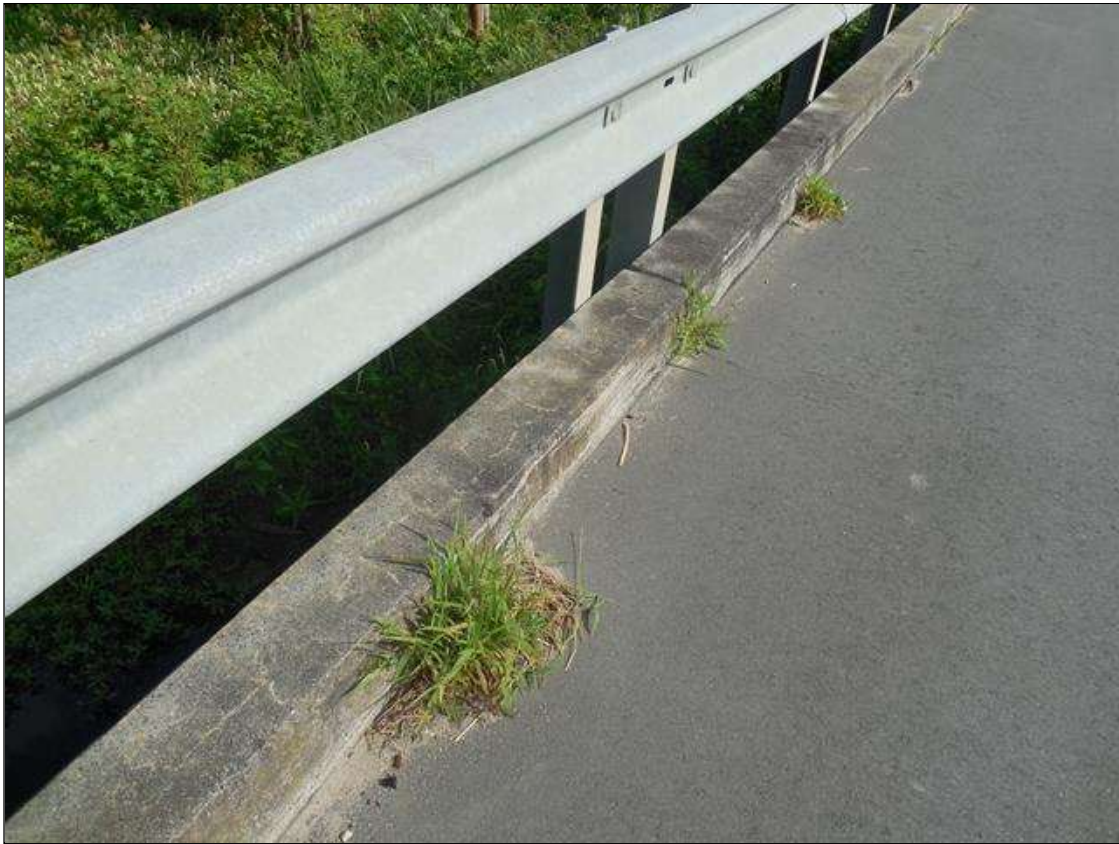
LEFT CURB DRAINS BLOCKED BY VEGETATION

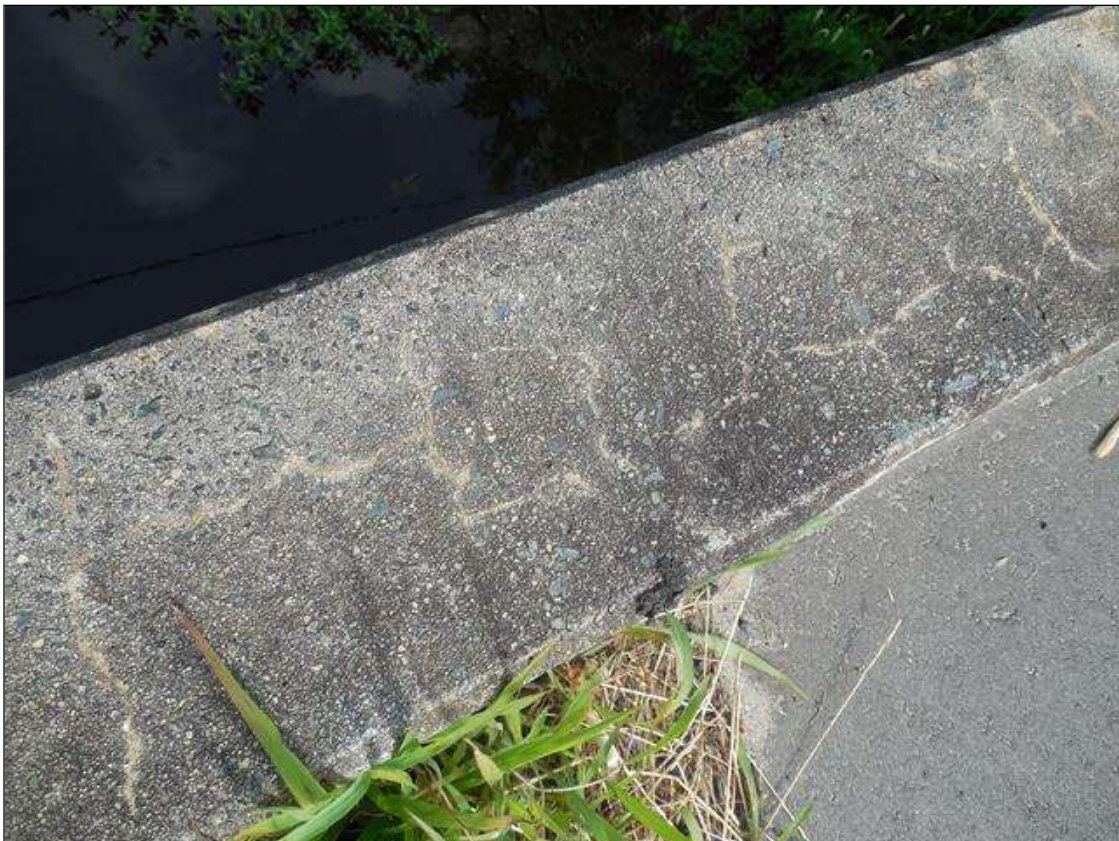
SPAN 2 LEFT CURB HAS 20' HAIRLINE MAP CRACKING 20 FT. MAINTENANCE

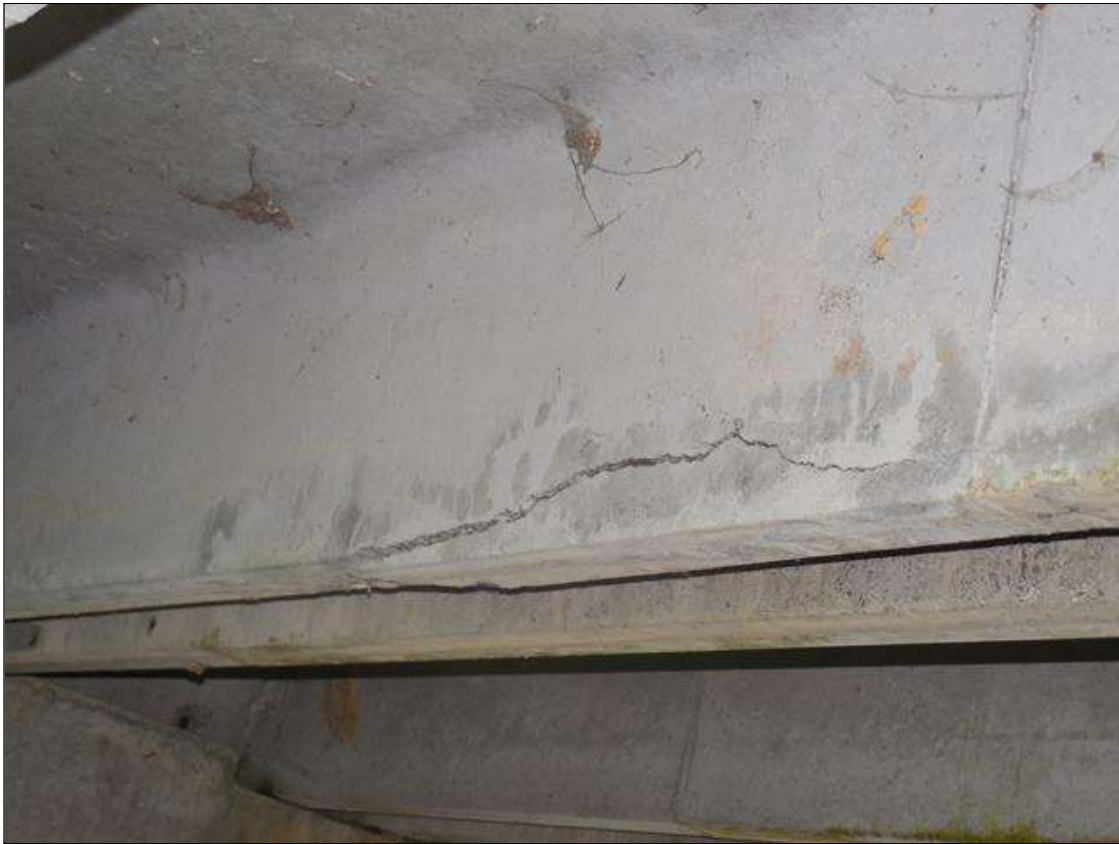
5 Feet of Delamination/Spall/Patched Area: Spall greater than 1 in. deep or greater than 6 in. diameter. Patched area that is unsound or showing distress. Does not warrant structural review. RIGHT LEG CRACKED, SPALLED 2' LONG X 3" HIGH AT 10' FROM BENT 1 PM ISSUED

Span 1 Channel/Slab 6: 5 Feet of Delamination/Spall/Patched Area: Spall greater than 1 in. deep or greater than 6 in. diameter. Patched area that is unsound or showing distress. Does not warrant structural review. RIGHT LEG CRACKED, SPALLED 2' LONG X 3" HIGH AT 10' FROM BENT 1 PM ISSUED

| MMS Code | Description of Function | Unit | Quantity | Remarks | Est. Cost |
|---|---|---|---|---|---|
| 3306 | Maintain Concrete Superstructure Components | SF | 2 | CHANNEL 6 IN SPAN 1 RIGHT LEG CRACKED , SPALLED 2' LONG X 3" HIGH AT 10' FROM BENT 1 CAP | |

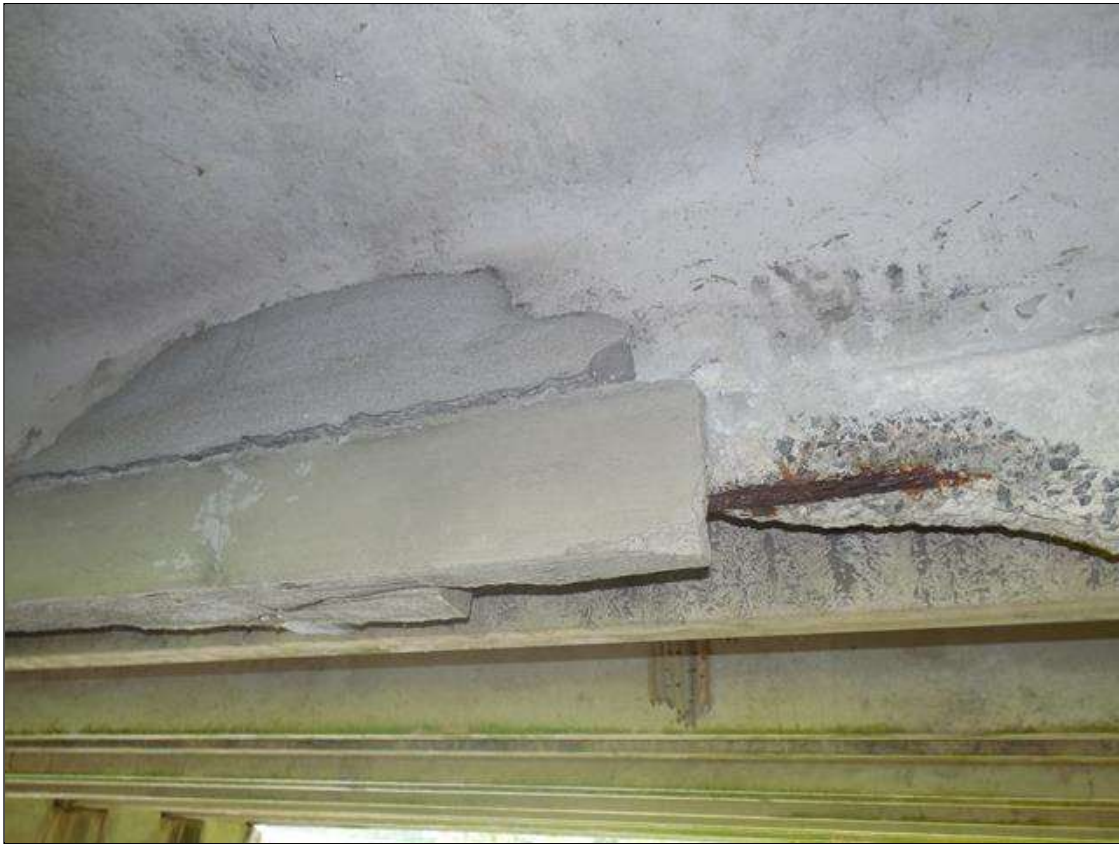
1 Feet of Delamination/Spall/Patched Area: Spall greater than 1 in. deep or greater than 6 in. diameter. Patched area that is unsound or showing distress. Does not warrant structural review. RIGHT LEG SPALL 12" LONG X 4" HIGH WITH 8" EXPOSED PRESTRESS CABLE PM ISSUED

Span 1 Channel/Slab 6: 1 Feet of Delamination/Spall/Patched Area: Spall greater than 1 in. deep or greater than 6 in. diameter. Patched area that is unsound or showing distress. Does not warrant structural review. RIGHT LEG SPALL 12" LONG X 4" HIGH WITH 8" EXPOSED PRESTRESS CABLE PM ISSUED

| MMS Code | Description of Function | Unit | Quantity | Remarks | Est. Cost |
|---|---|---|---|---|---|
| 3306 | Maintain Concrete Superstructure Components | SF | 2 | SPAN 1 CHANNEL 6 RIGHT LEG SPALLED 12" LONG X 4" HIGH WITH EXPOSED PRESTRESS CABLE PM ISSUED | |

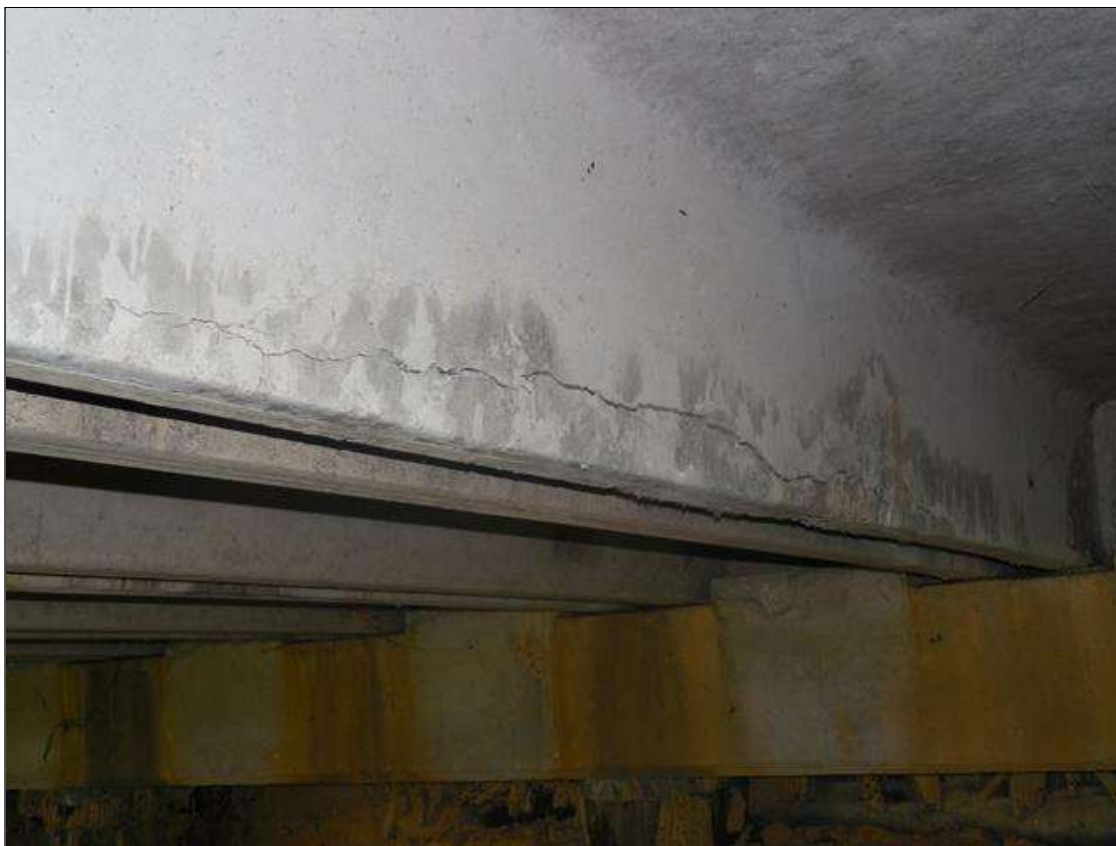
5 Feet of Cracking (PSC): Width greater than 0.009 in. or spacing less than 1 ft. 5' LONG X 1/4" CRACK IN RIGHT LEG AT 5' FROM END BENT 1 PM ISSUED

Span 1 Channel/Slab 6: 5 Feet of Cracking (PSC): Width greater than 0.009 in. or spacing less than 1 ft. 5' LONG X 1/4" CRACK IN RIGHT LEG AT 5' FROM END BENT 1 PM ISSUED

| MMS Code | Description of Function | Unit | Quantity | Remarks | Est. Cost |
|---|---|---|---|---|---|
| 3306 | Maintain Concrete Superstructure Components | SF | 5 | SPAN 1 CHANNEL 6 RIGHT LEG CRACKED 5' LONG X 1/4" WIDE AT 5' FROM END BENT 1 PM ISSUED | |

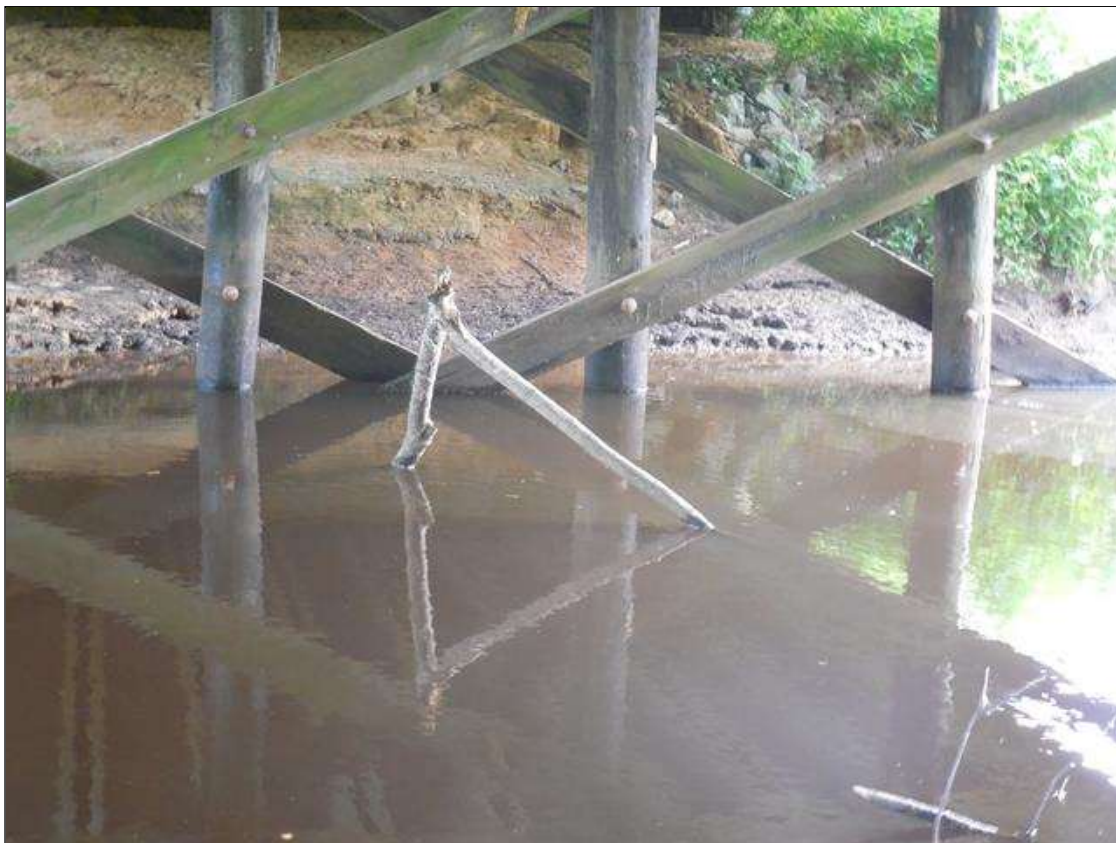
DRIFT IN SPAN 2

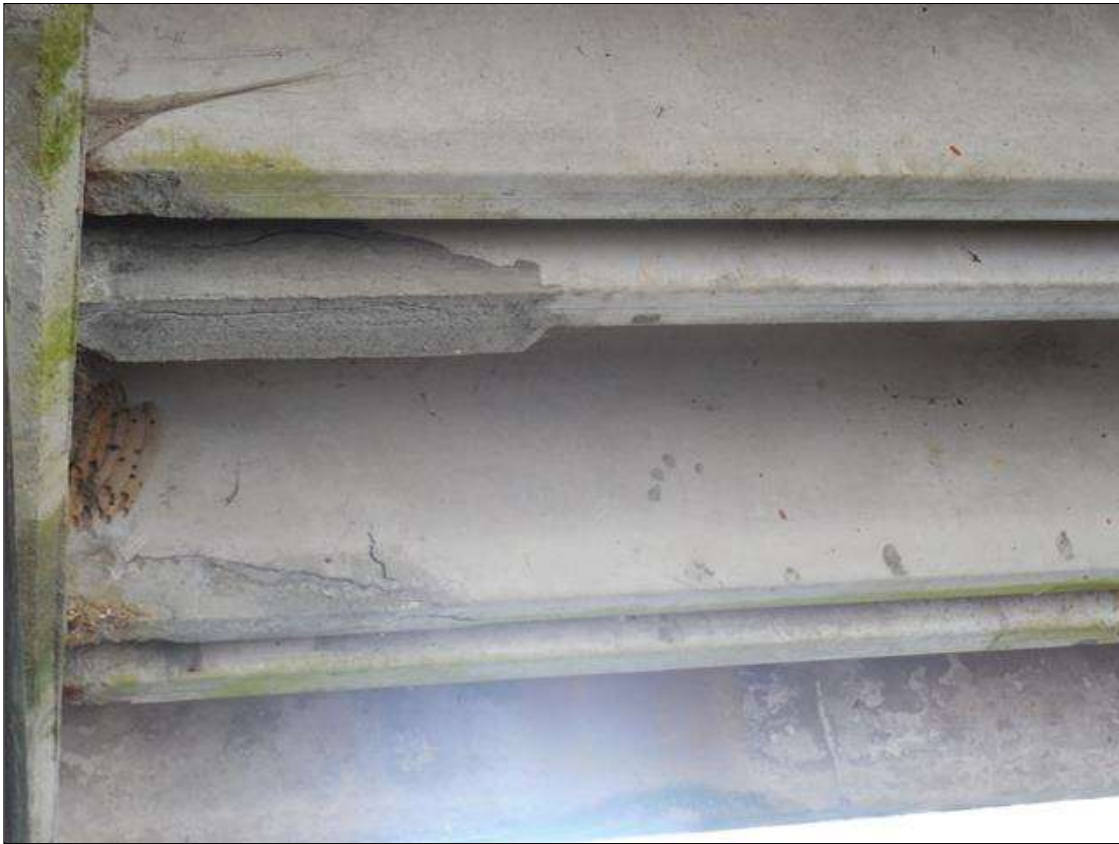
2 Feet of Delamination/Spall/Patched Area: Delaminated. Spall 1 in. or less deep or 6 in. or less in diameter. Patched area that is sound. PATCH ON RIGHT AND LEFT LEGS AT BENT 1

Span 2 Channel/Slab 2: 2 Feet of Delamination/Spall/Patched Area: Delaminated. Spall 1 in. or less deep or 6 in. or less in diameter. Patched area that is sound. PATCH ON RIGHT AND LEFT LEGS AT BENT 1

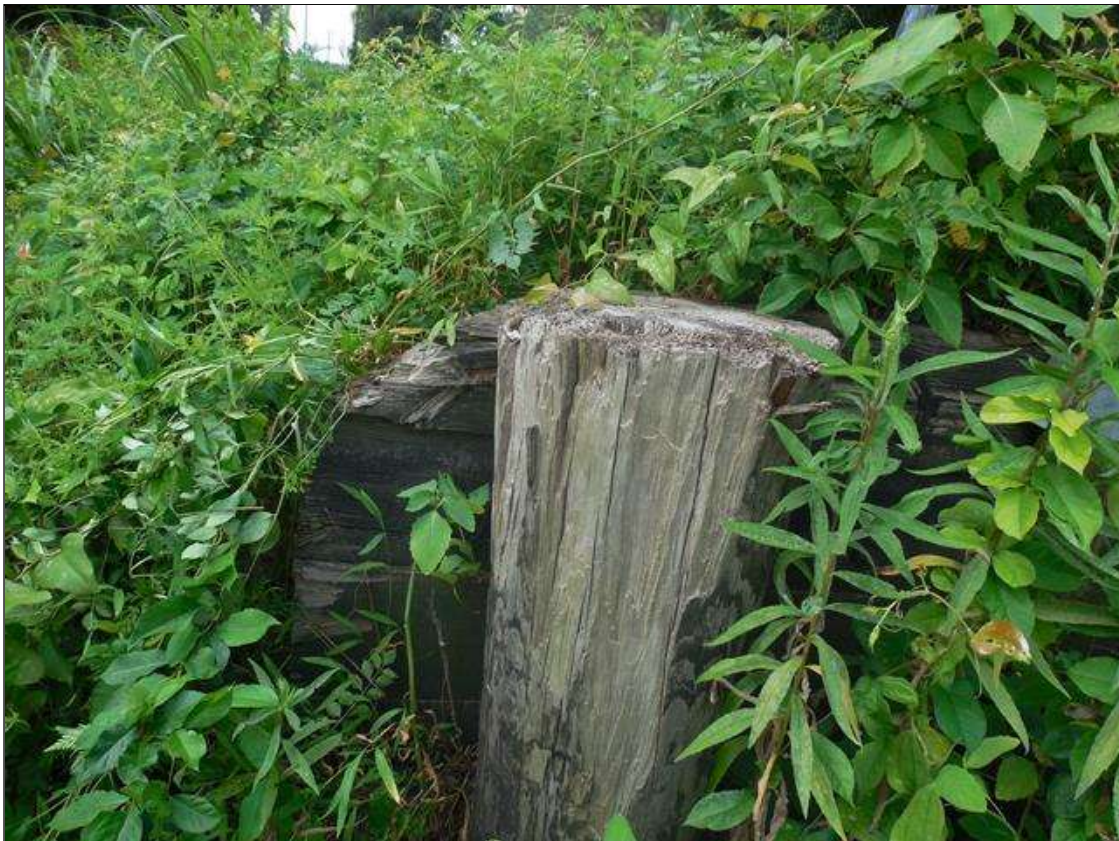
1 Feet of Decay/Section Loss: Affects less than 10% of the member section TURNPILE IN SOUTHEAST CORNER HAS SECTION LOSS 2' HIGH X 10" WIDE X 2" DEEP

End Bent 1 Abutment/Backwall : 1 Feet of Decay/Section Loss: Affects less than 10% of the member section  
TURNPILE IN SOUTHEAST CORNER HAS SECTION LOSS 2' HIGH X 10" WIDE X 2" DEEP

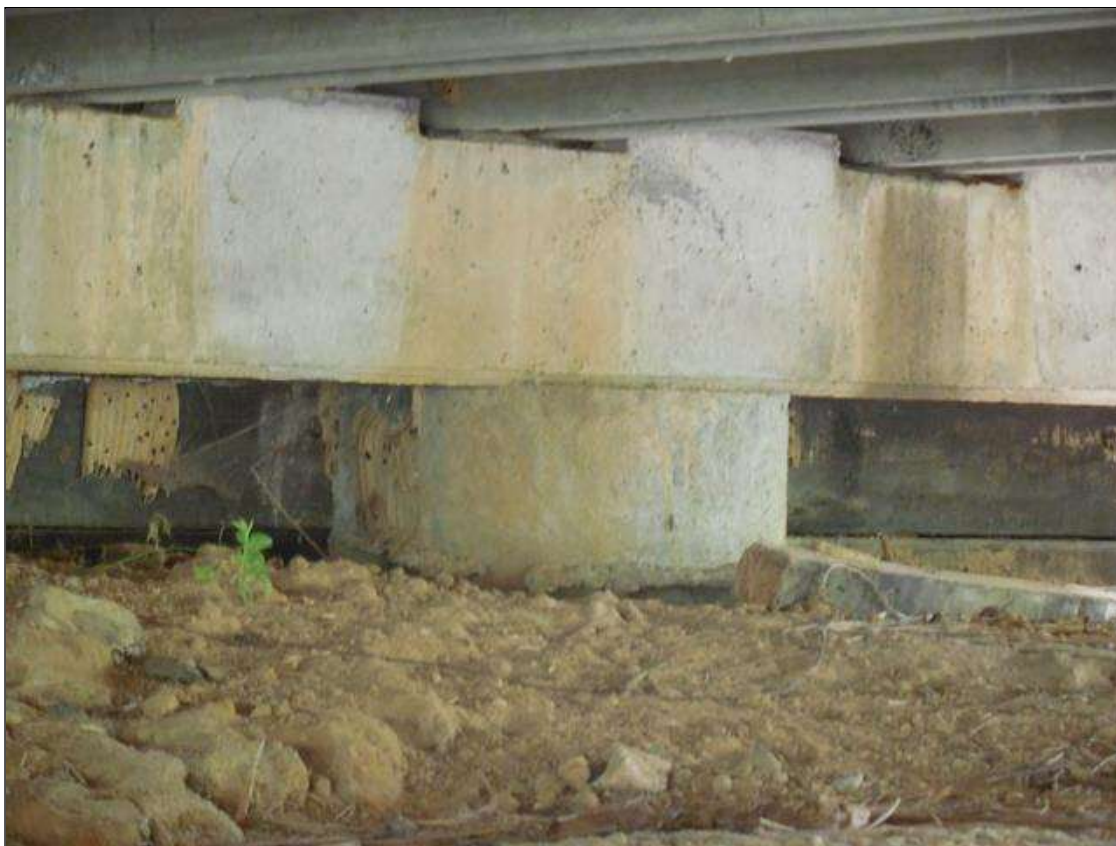
PILE 5 AT END BENT 2 ENCASED IN CONCRETE ( TEMPORARY REPAIR )

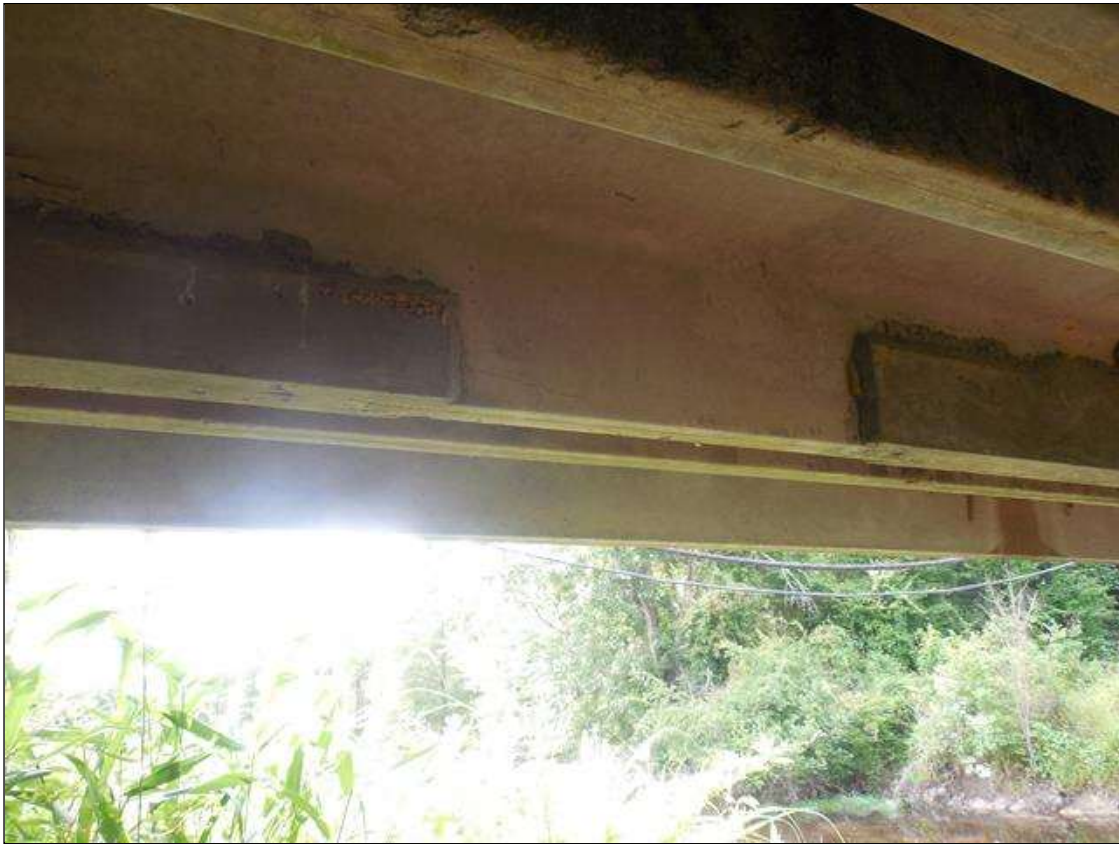
4 Feet of Delamination/Spall/Patched Area: Delaminated. Spall 1 in. or less deep or 6 in. or less in diameter. Patched area that is sound. 2 - 2' LONG PATCHES ON RIGHT LEG 1 AT MIDSPAN 1 AT 5' FROM BENT 2 ( TEMPORARY REPAIRS )

Span 3 Channel/Slab 11: 4 Feet of Delamination/Spall/Patched Area: Delaminated. Spall 1 in. or less deep or 6 in. or less in diameter. Patched area that is sound. 2 - 2' LONG PATCHES ON RIGHT LEG 1 AT MIDSPAN 1 AT 5' FROM BENT 2 ( TEMPORARY REPAIRS )

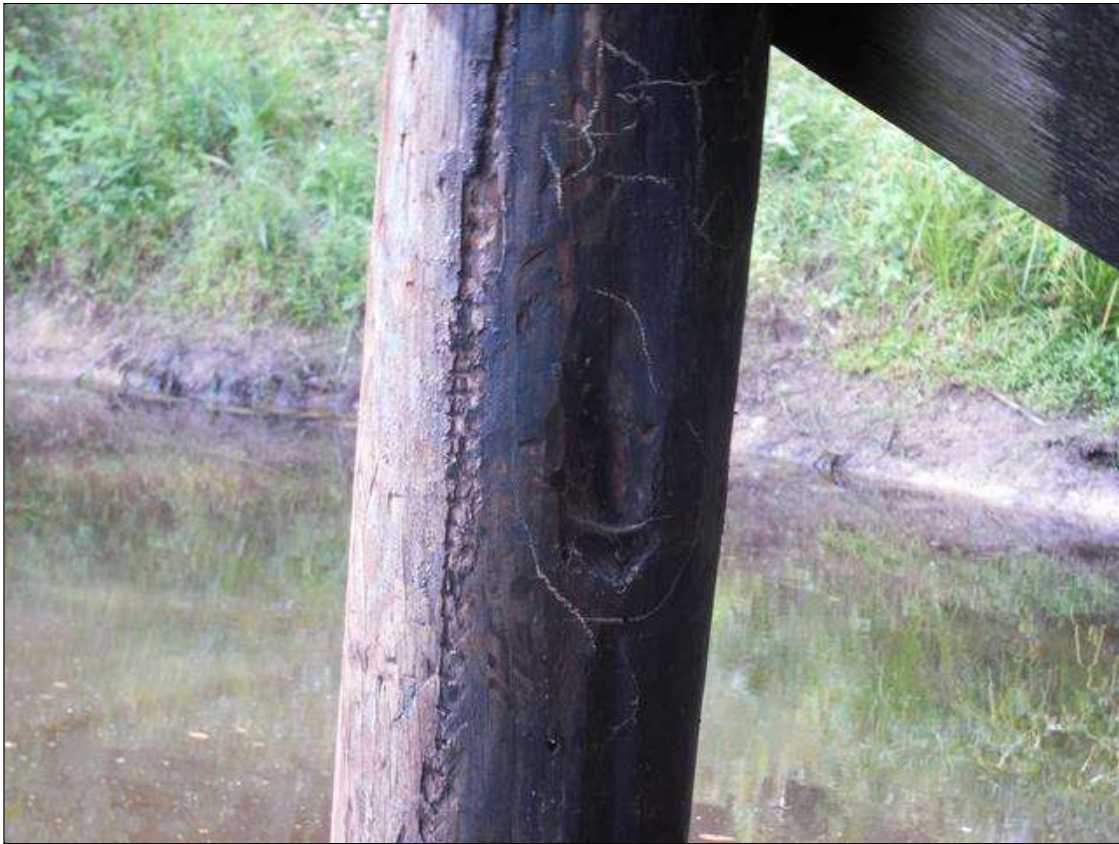
1 Each of Decay/Section Loss: Affects less than 10% of the member section DECAYED 8" HIGH X 3" WIDE X 1 1/2" DEEP AT 2' BELOW CAP ON SPAN 3 FACE

Bent 2 Pile 6: 1 Each of Decay/Section Loss: Affects less than 10% of the member section DECAYED 8" HIGH X 3" WIDE X 1 1/2" DEEP AT 2' BELOW CAP ON SPAN 3 FACE

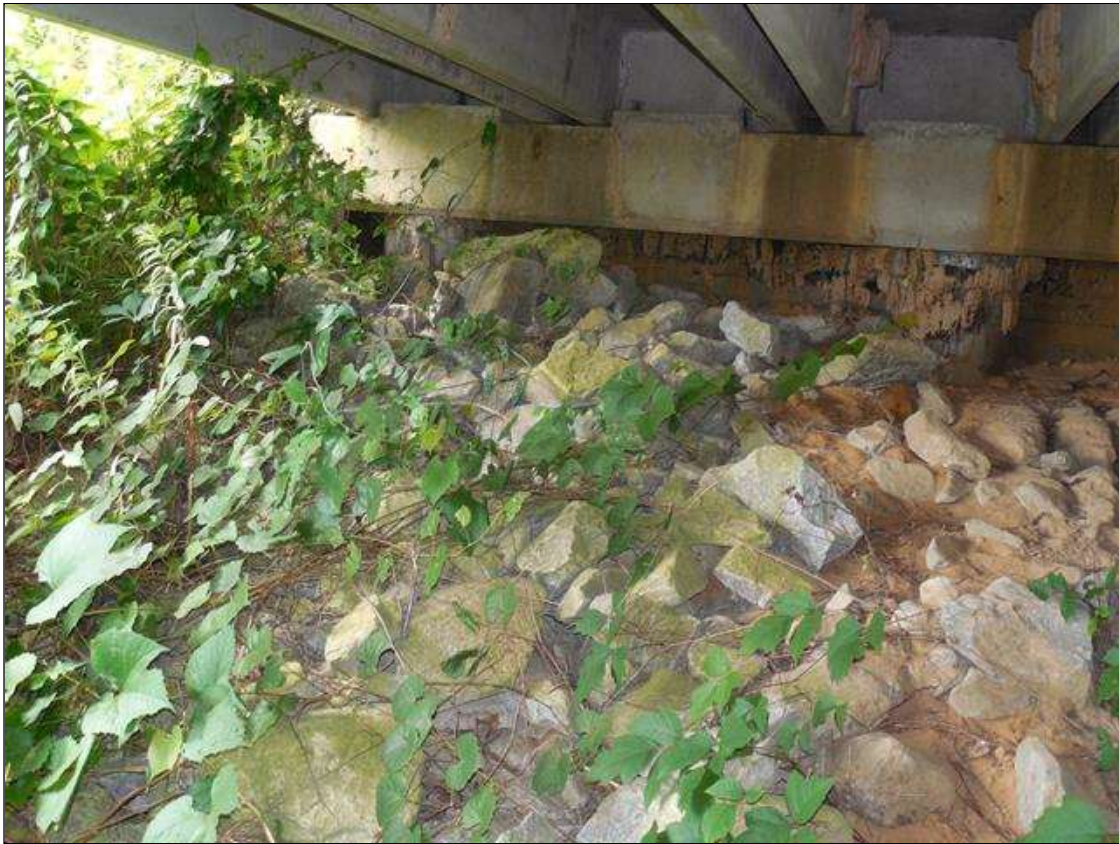
RIP RAP PLACED IN SPAN 1 AT END BENT 1 IN SOUTHEAST CORNER

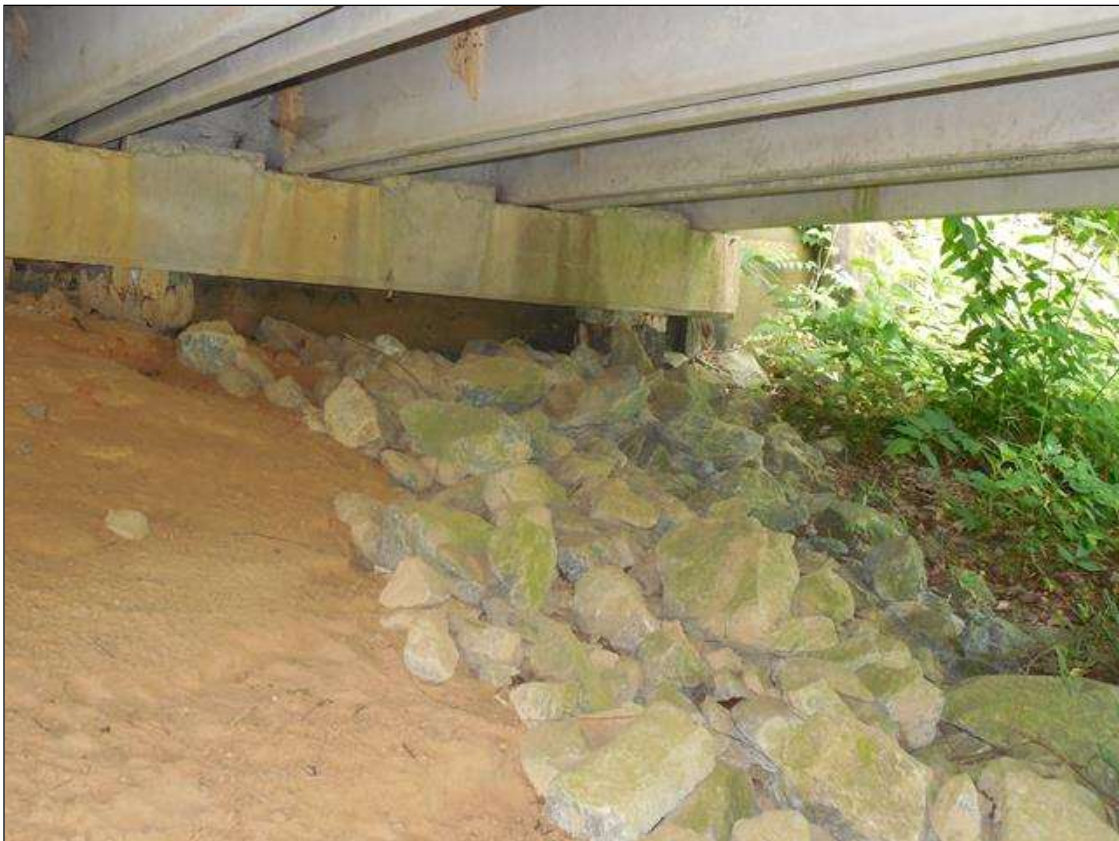
RIP RAP PLACED IN SPAN 1 AT END BENT 1 IN SOUTHWEST CORNER

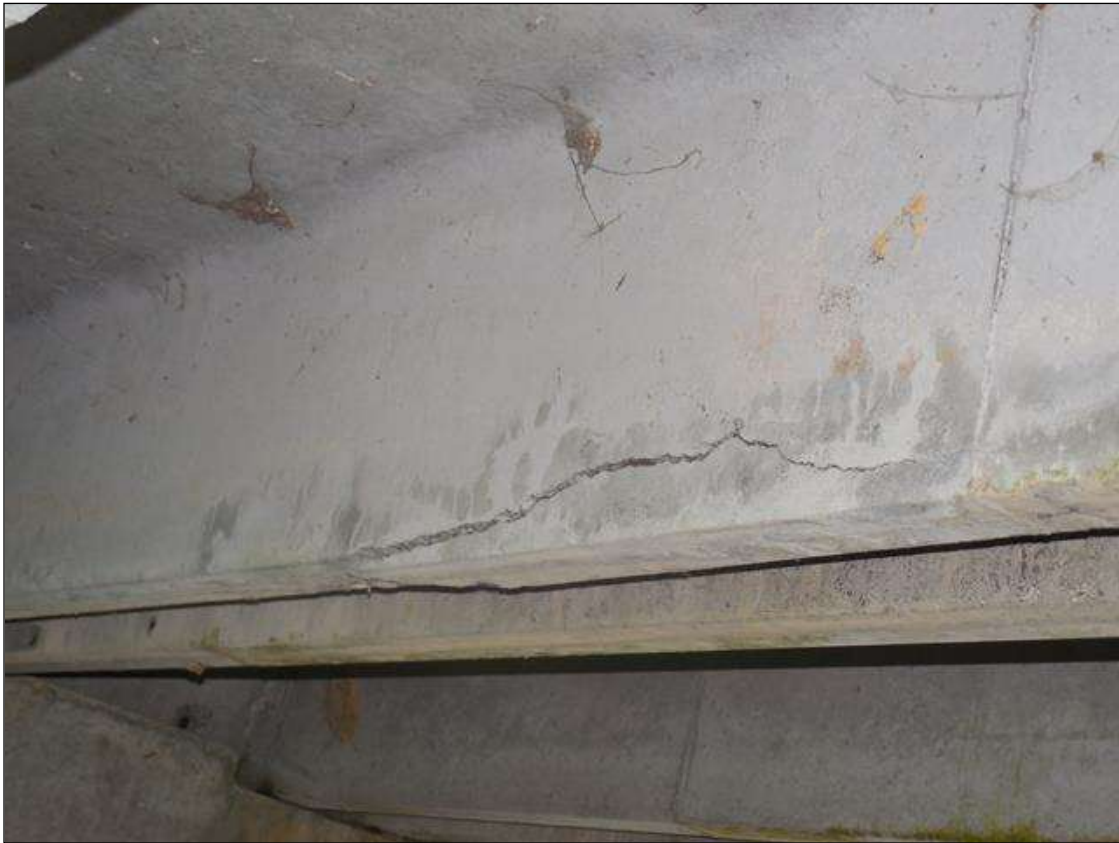
SPAN 1 CHANNEL 6 RIGHT LEG CRACKED, SPALLED 2' LONG X 3" HIGH AT 10' FROM BENT 1 CAP PM  
ISSUED

| MMS Code | MMS Description | Quantity |
|---|---|---|
| CHANNEL 6 IN SPAN 1 RIGHT LEG CRACKED , SPALLED 2' LONG X 3" HIGH AT 10' FROM BENT 1 CAP | | |

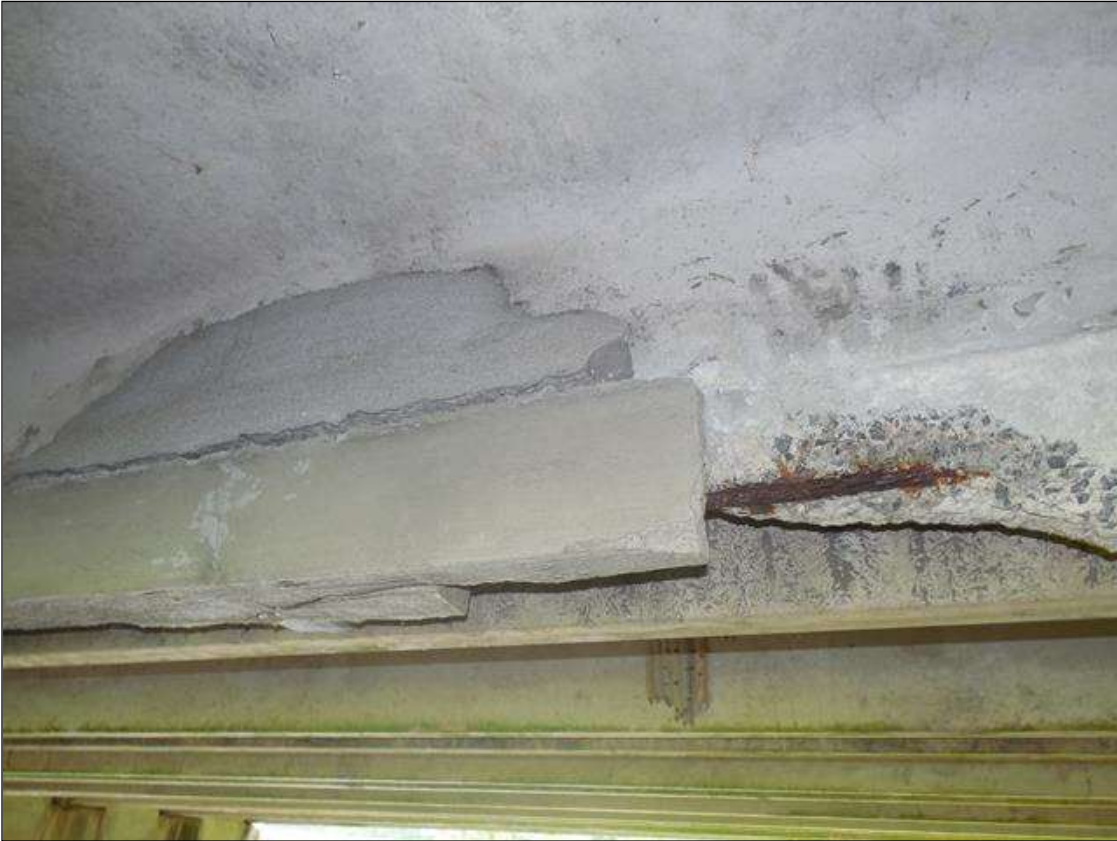
SPAN 1 CHANNEL 6 RIGHT LEG SPALLED 12" LONG X 4" HIGH WITH EXPOSED PRESTRESS CABLE PM ISSUED

| MMS Code | MMS Description | Quantity |
|---|---|---|
| SPAN 1 CHANNEL 6 RIGHT LEG SPALLED 12" LONG X 4" HIGH WITH EXPOSED PRESTRESS CABLE PM ISSUED | | |

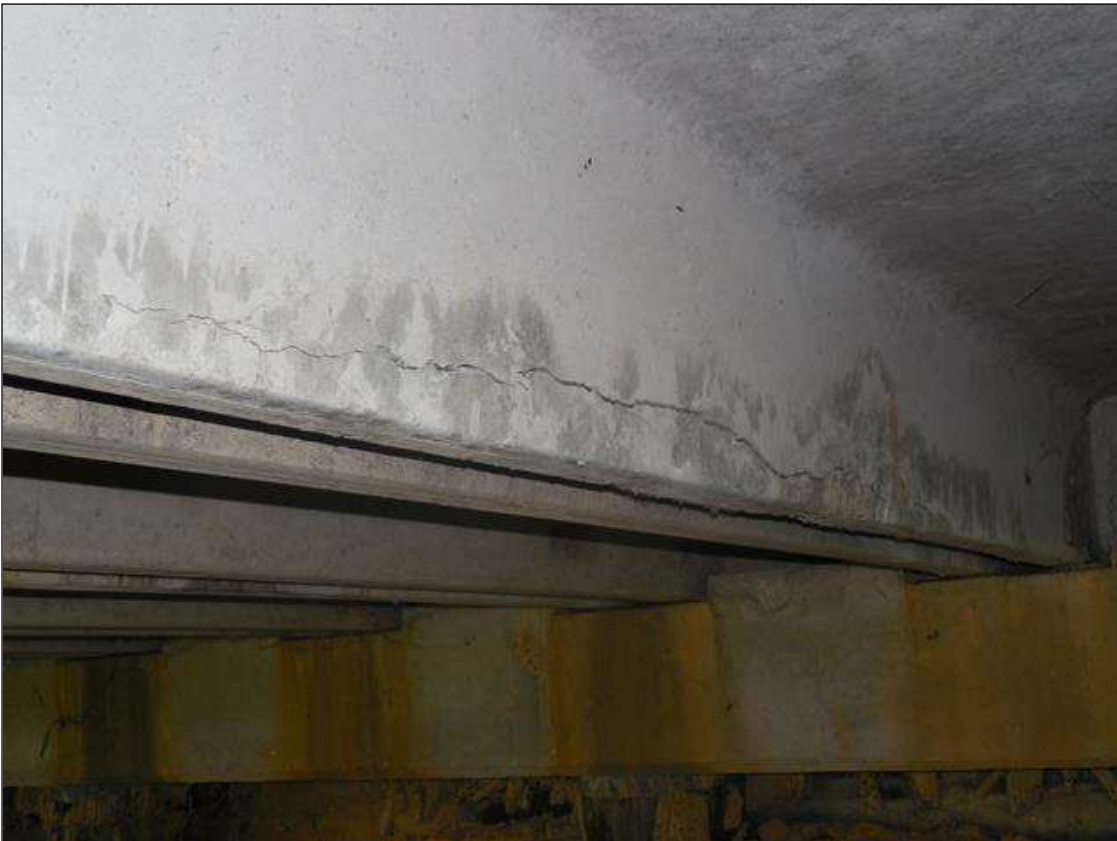
SPAN 1 CHANNEL 6 RIGHT LEG CRACKED 5' LONG X 1/4" WIDE AT 5' FROM END BENT 1 PM ISSUED

| MMS Code | MMS Description | Quantity |
|---|---|---|
| SPAN 1 CHANNEL 6 RIGHT LEG CRACKED 5' LONG X 1/4" WIDE AT 5' FROM END BENT 1 PM ISSUED | | |
