NC DEPARTMENT OF TRANSPORTATION  
DIVISION OF HIGHWAYS  
BRIDGE MANAGEMENT UNIT

# BRIDGE INSPECTION REPORT

INSPECTION TYPE: Routine Inspection

COUNTY CUMBERLAND BRIDGE NUMBER 250042 INSPECTION CYCLE 2 YRS  
ROUTE SR2030 ACROSS CREEK M.P. 0

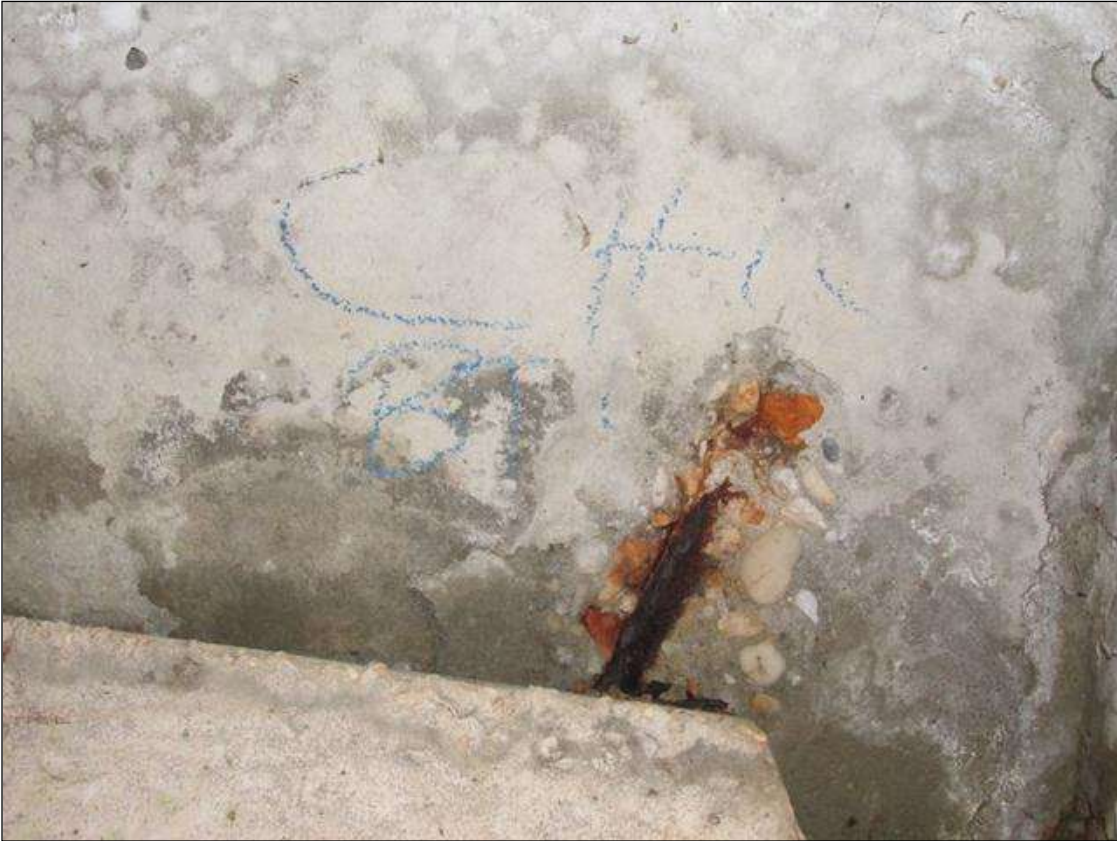
| Bridge I&A Form 1(82)H<br>State of North Carolina<br>Dept. of Transportation<br>Division of Highways | | <b>FIELD INSPECTION REPORT</b><br><u>Bridge Inspection &amp; Analysis</u> | |
|---|---|---|--|
| 13 | F | ( END DIAPHRAGMS ) THE END DIAPHRAGMS HAVE SPALLS AND EXPOSED REBAR AT SEVERAL LOCATIONS. (PHOTO) | |

BENT 1 END DIAPHRAGM SURFACE SPALLED WITH EXPOSED REBAR , SIMILAR AT SEVERAL LOCATIONS

| MMS Code | Description of Function | Unit | Quantity | Remarks | Est. Cost |
|---|---|---|---|---|---|
| 3306 | Maintain Concrete Superstructure Components | SF | 5 | BENT 1 END DIAPHRAGM SURFACE SPALLED WITH EXPOSED REBAR , SIMILAR AT SEVERAL LOCATIONS | |

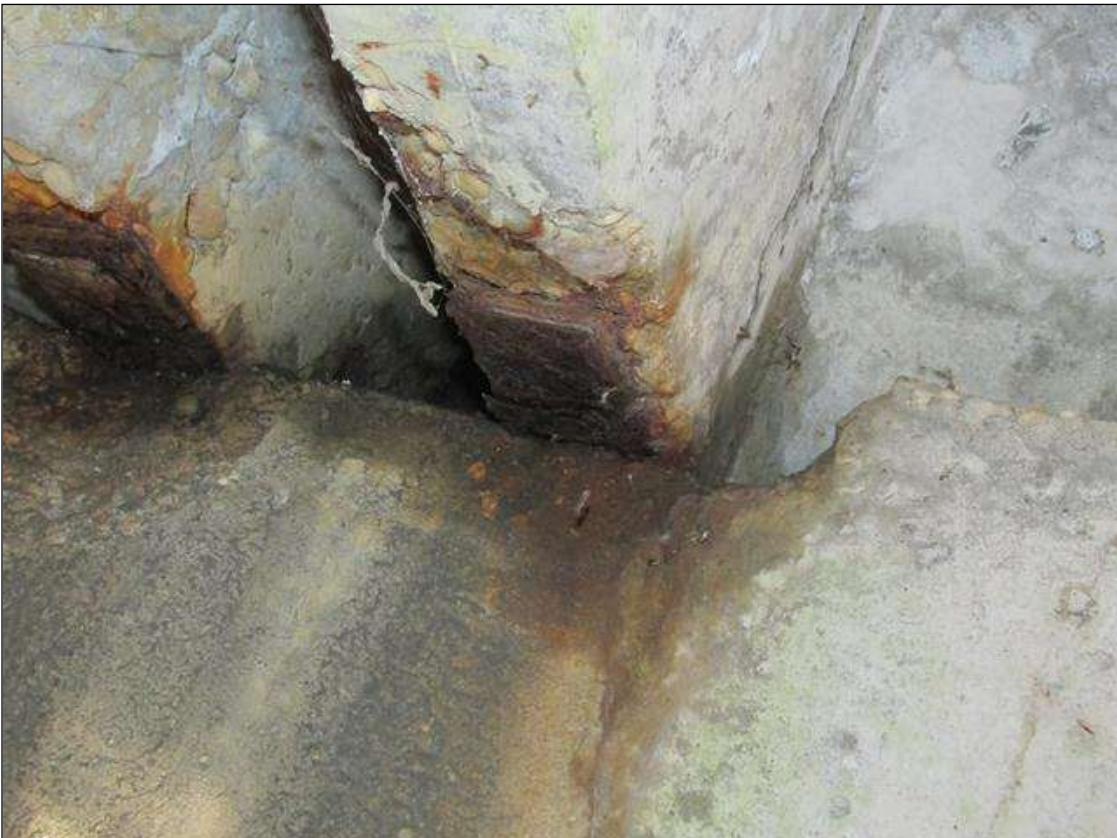
| Bridge I&A Form 1(82)H<br>State of North Carolina<br>Dept. of Transportation<br>Division of Highways | | <b>FIELD INSPECTION REPORT</b><br><u>Bridge Inspection &amp; Analysis</u> | |
|---|---|---|--|
| 15 | F | ( BEARING ASSEMBLIES ) THERE IS RUST WAS NOTED AT THE BEARING AREAS.<br><br>THERE IS A RUSTY BEARING PLATE AT CHANNEL 9 IN SPAN 1 AT BENT 1. ALL BEARINGS ARE SIMILAR. (PHOTO) | |

CHANNEL 9 BEARING PLATE WITH RUST IN SPAN 1 AT BENT 1, ALL BEARING PLATES ARE SIMILAR

| MMS Code | Description of Function | Unit | Quantity | Remarks | Est. Cost |
|---|---|---|---|---|---|
| 3342 | Clean and Paint Structural Steel | SF | 20 | CHANNEL 9 BEARING PLATE WITH RUST IN SPAN 1 AT BENT 1, ALL BEARING PLATES ARE SIMILAR | |

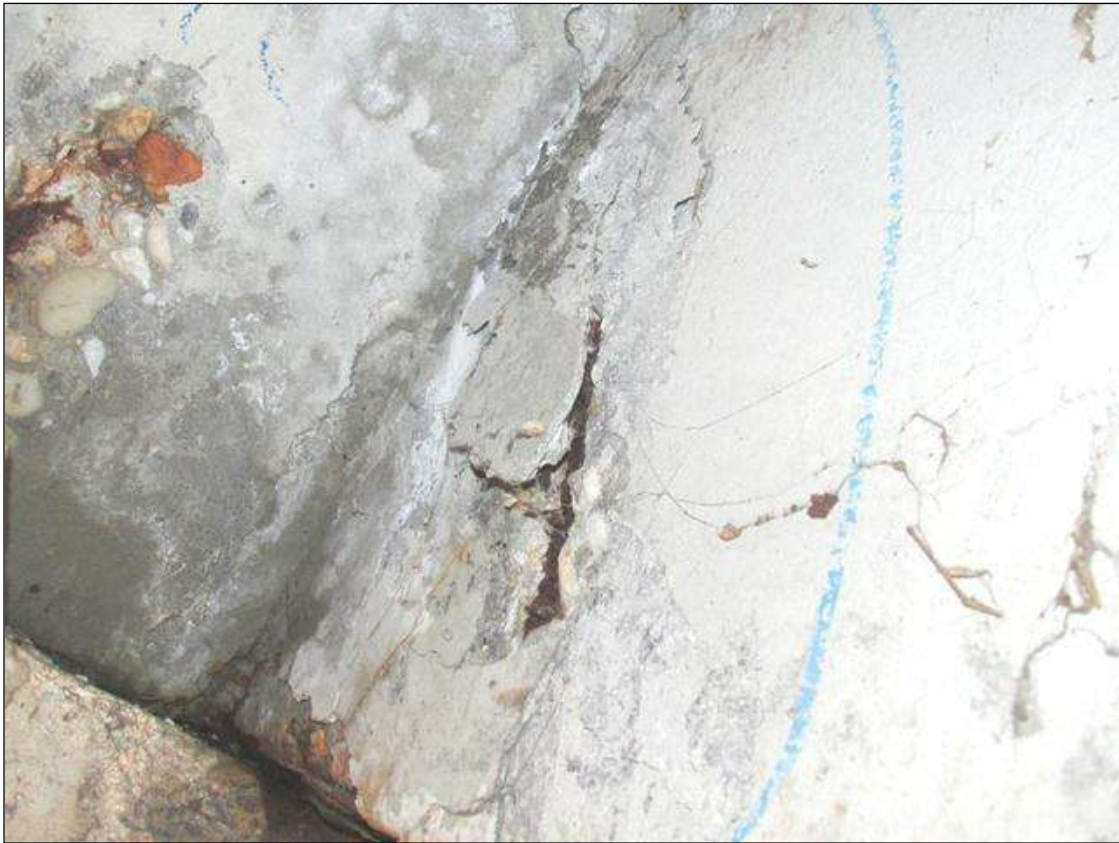
| Bridge I&A Form 1(82)H<br>State of North Carolina<br>Dept. of Transportation<br>Division of Highways | | <b>FIELD INSPECTION REPORT</b><br><u>Bridge Inspection &amp; Analysis</u> | |
|---|---|---|--|
| 10 | F | ( PPC CHANNELS ) THERE ARE SOME AREAS OF CRACKING ON THE LEFT LEG OF BEAM 10 AND AT OTHER RANDOM LOCATIONS. (PHOTO)<br><br>THERE ARE REPAIRS AT MID SPAN 1 CHANNELS 9 AND 10. (PHOTO) | |

CHANNEL 10 RIGHT LEG AT SPAN 1, BENT 1 IS CRACKED UP TO 1/16"

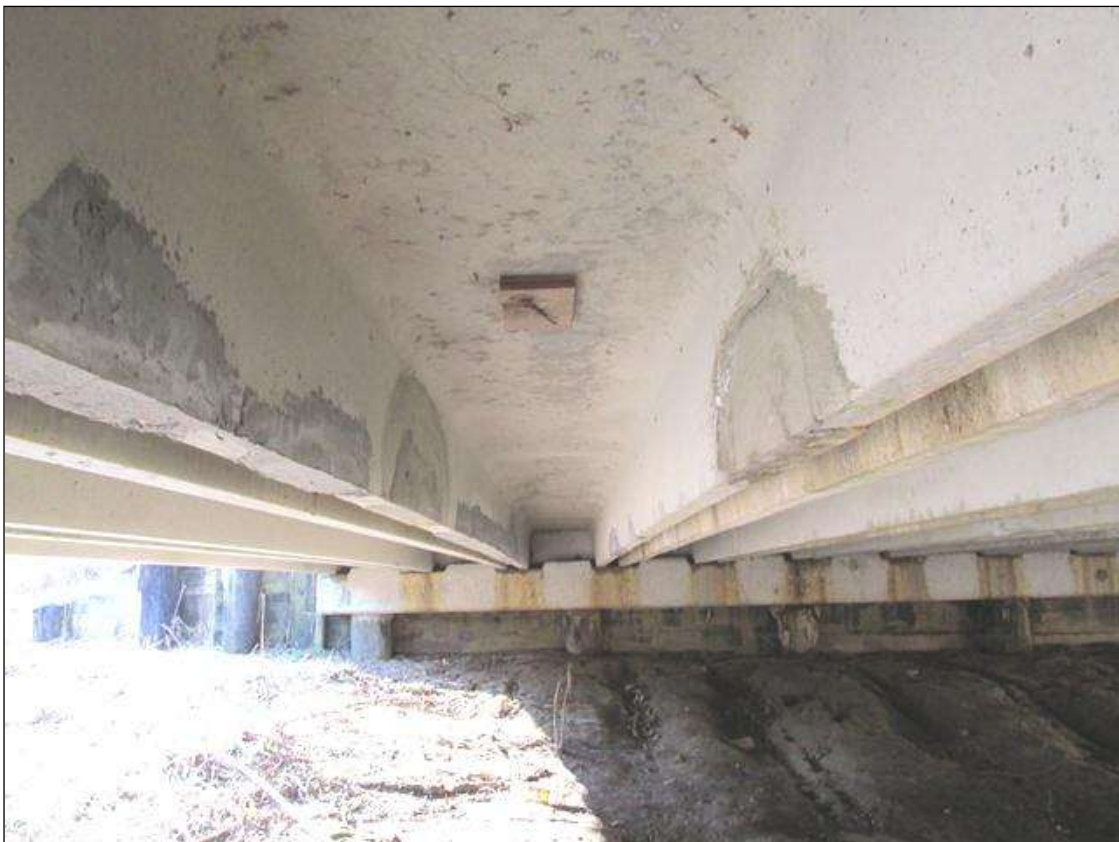
REPAIRS IN SPAN 1 AT MIDSPAN ON CHANNELS 9 AND 10

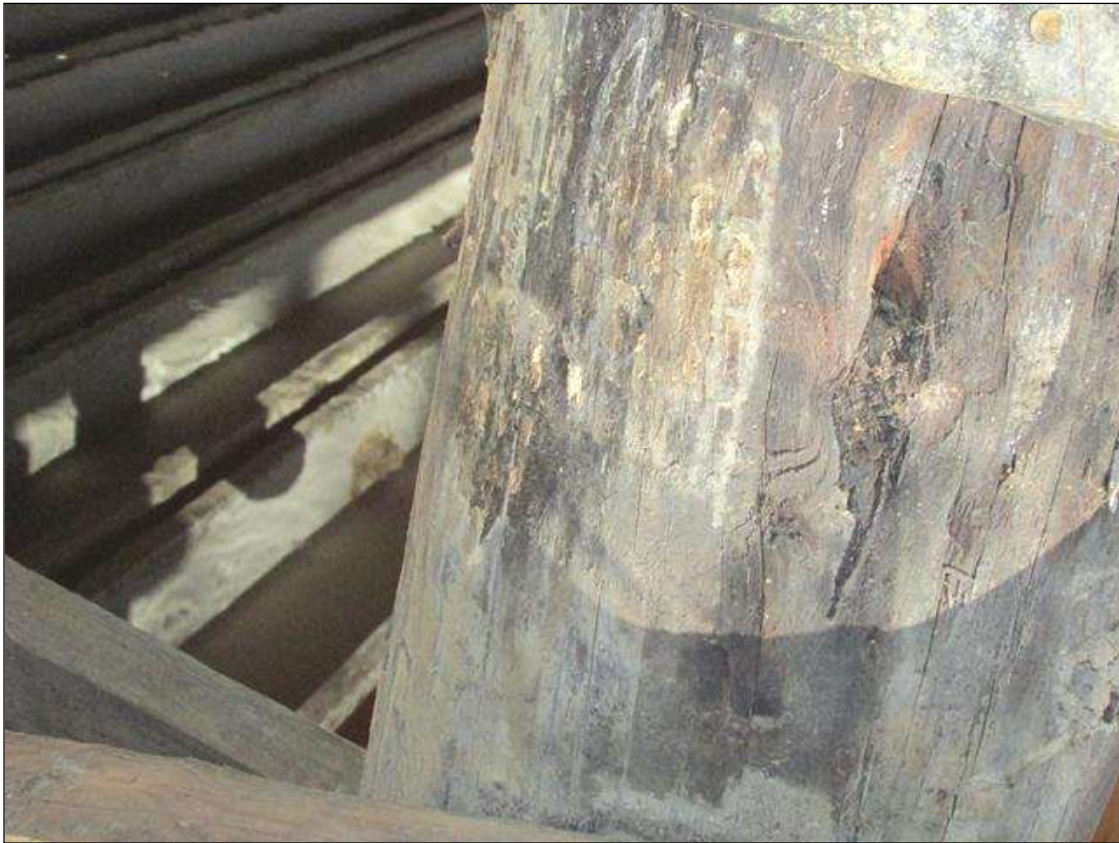
| <b>35b</b> | <b>F</b> | ( TIMBER PILES, AND CROSSBRACING ) THE PILES HAVE AREAS OF CHECKING ,AND FACIAL SOFTNESS AND DECAY. (PHOTO)<br><br>THERE IS AN AREA OF DECAY ON THE CROSSBRACE AT PILE 2 BENT 2 ON THE SPAN 2 SIDE. (PHOTO)<br><br>ALSO SEE DIVERS UNDERWATER REPORT DATED 3/19/2013. | |

BENT 1 PILES WITH HAIRLINE CHECKING

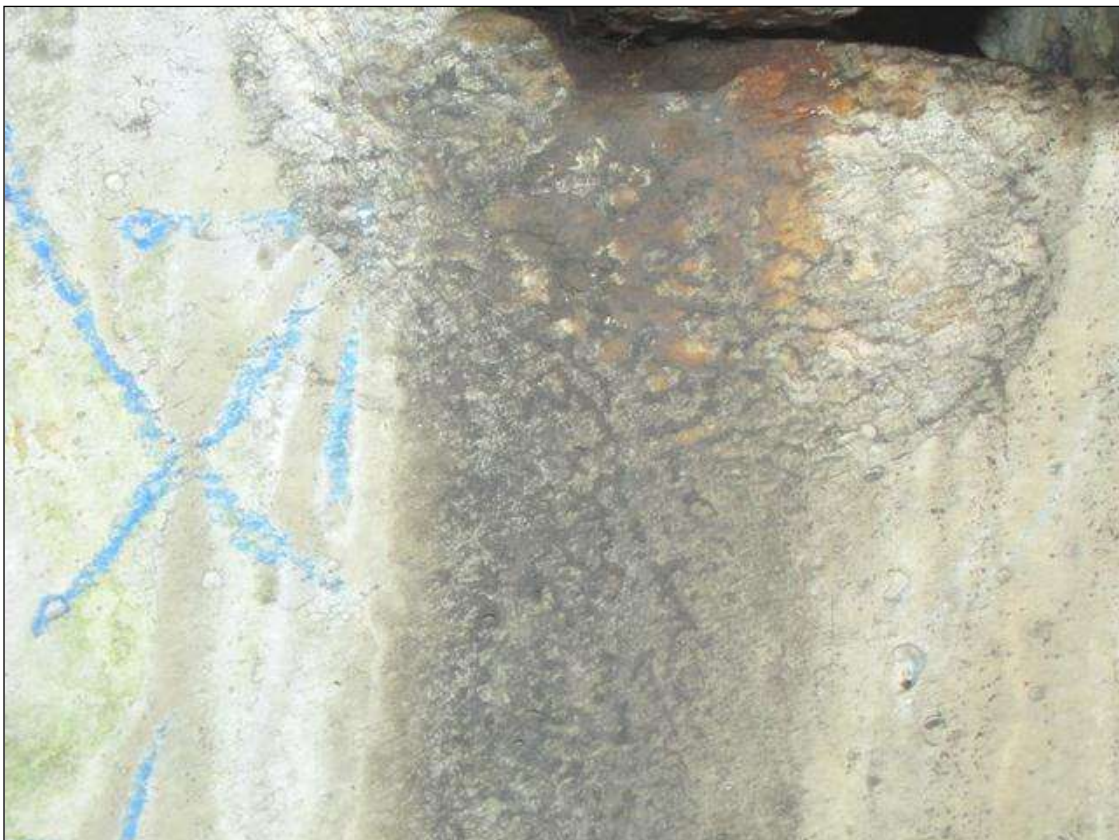
| <b>36a</b> | <b>G</b> | ( PPC CAPS ) BENT 1 CAP, SPAN 1 FACE IS SPALLED 4" DIAMETER X 1" DEEP UNDER CHANNEL 10. (PHOTO)<br><br>THERE ARE EXPOSED CABLE ENDS AT EAST END OF BENT 1 CAP. (PHOTO) ALL CAPS ARE SIMILAR. | |

BENT 1 CAP, SPAN 1 FACE IS SPALLED 4" DIAMETER X 1" DEEP UNDER CHANNEL 10

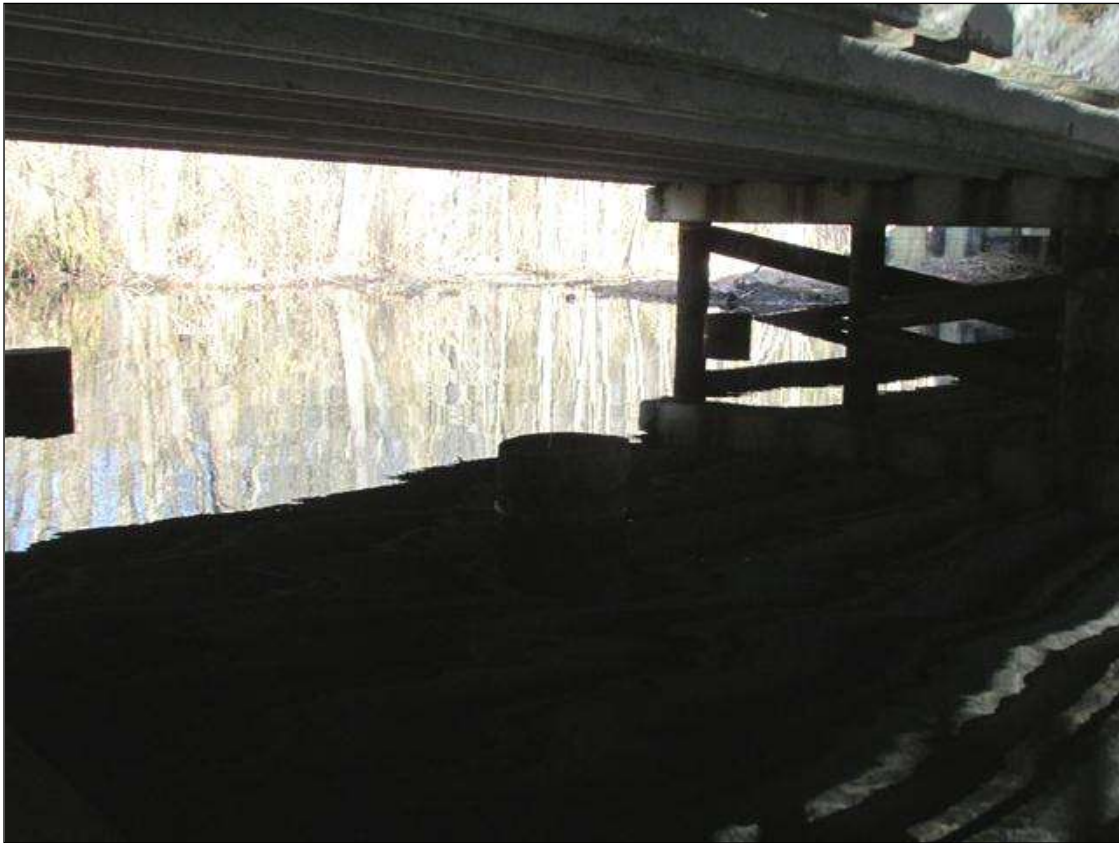
| <b>45a</b> | <b>G</b> | ( WATERWAY ) THERE ARE CUT OFF PILES IN SPAN 2. (PHOTO)<br><br>SEE DIVERS UNDERWATER REPORT DATED 3/19/2013. | |

CUT OFF PILES IN SPAN 2 WATERWAY

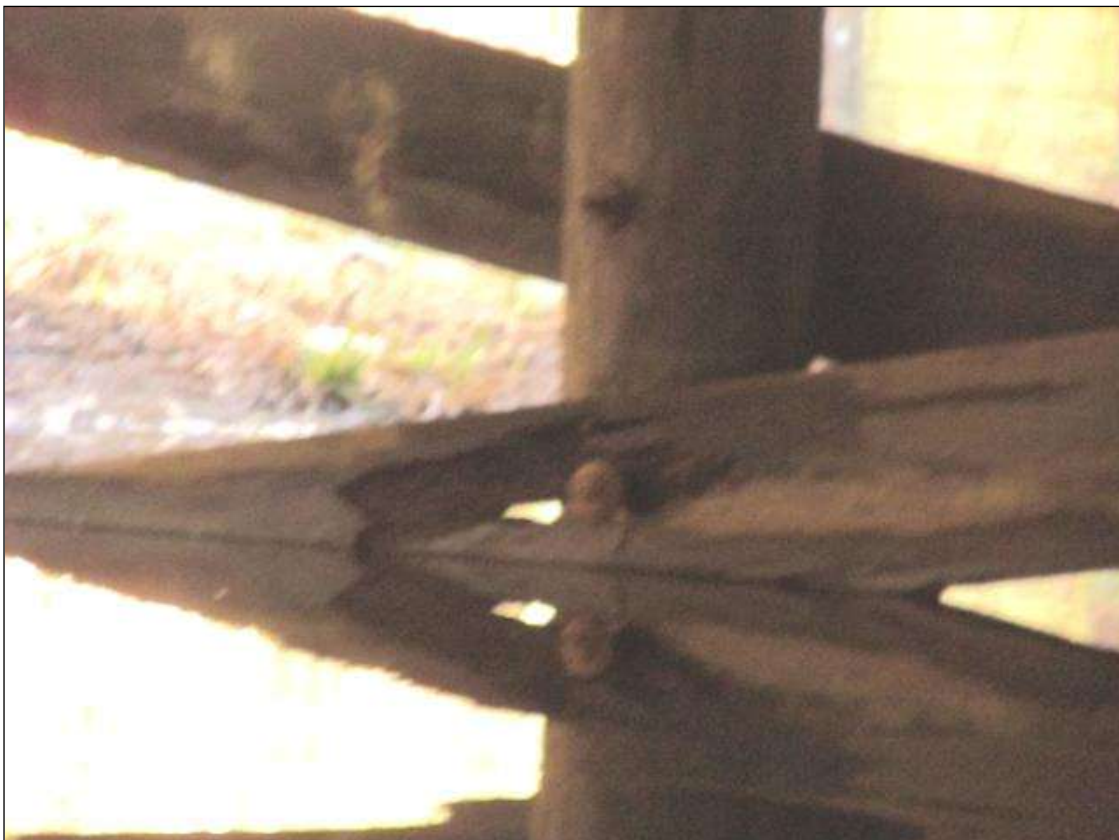
DECAYED CROSSBRACING AT BENT 2, SPAN 2 SIDE AT PILE 2

| MMS Code | Description of Function | Unit | Quantity | Remarks | Est. Cost |
|---|---|---|---|---|---|
| 3344 | Repair / Replace Timber Substructure Components | LF | 10 | DECAYED CROSSBRACING AT BENT 2, SPAN 2 SIDE AT PILE 2 | |

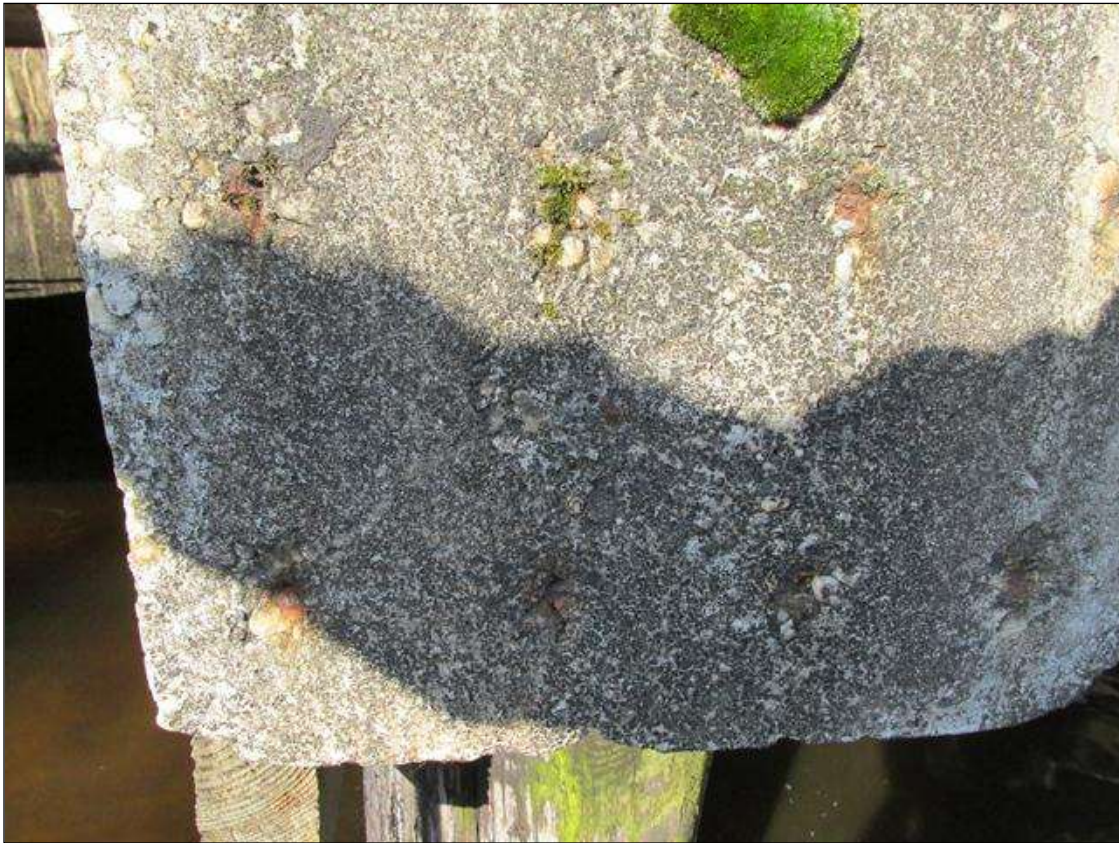
EXPOSED CABLE ENDS AT EAST END OF BENT 1 CAP, ALL CAPS ARE SIMILAR

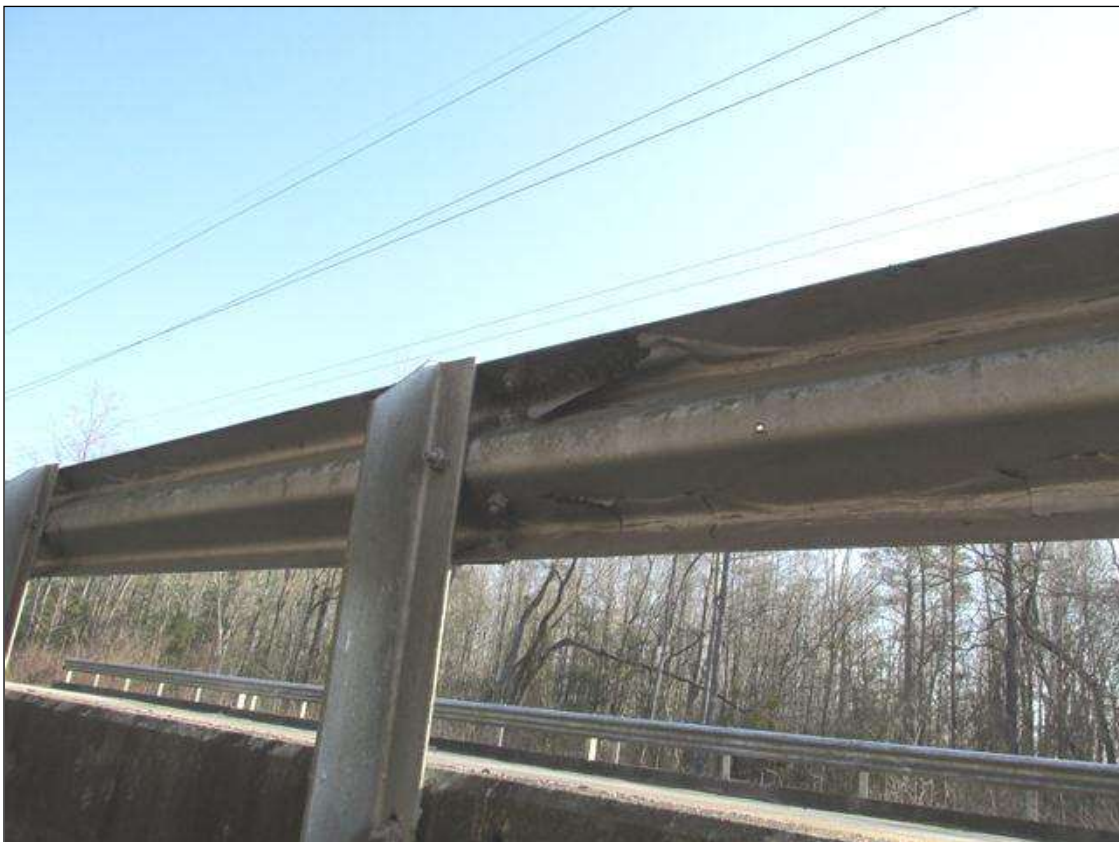
LEFT EXTERIOR RAIL HAS PAINT PEELING AT SPAN 1

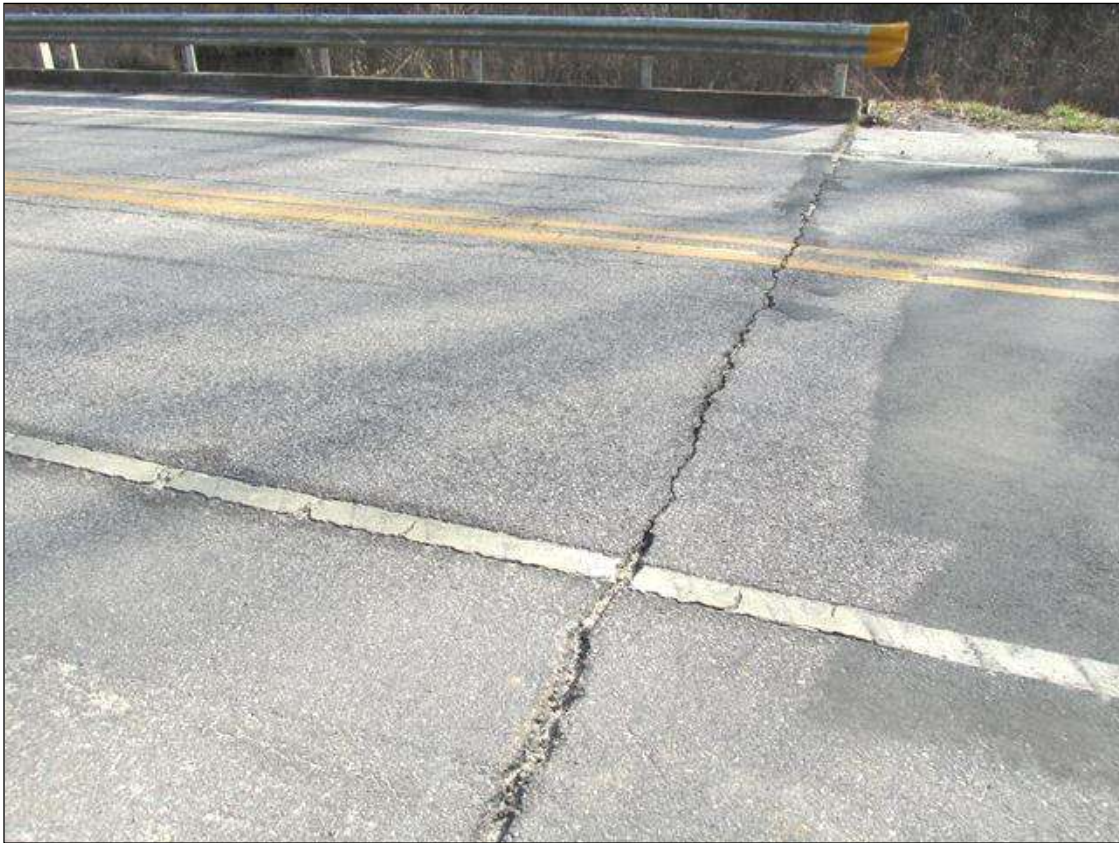
1/4" TRANSVERSE CRACK IN SOUTH APPROACH ASPHALT WEARING SURFACE OVER END BENT 1

| MMS Code | Description of Function | Unit | Quantity | Remarks | Est. Cost |
|---|---|---|---|---|---|
| 2816 | Asphalt Surface Repair or Replacement | SY | 2 | 1/4" TRANSVERSE CRACK IN SOUTH APPROACH ASPHALT WEARING SURFACE OVER END BENT 1 | |

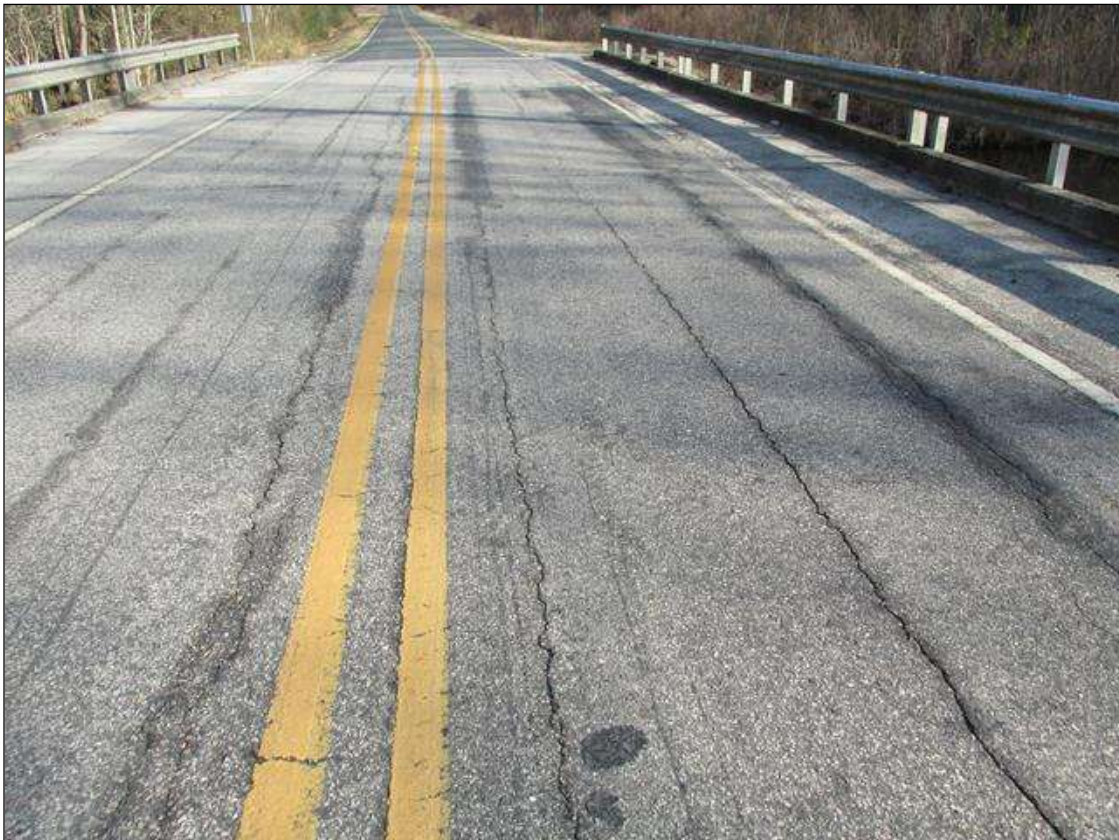
HAIRLINE TO 1/16" LONGITUDINAL CRACKS IN SPAN 1 ASPHALT WEARING SURFACE

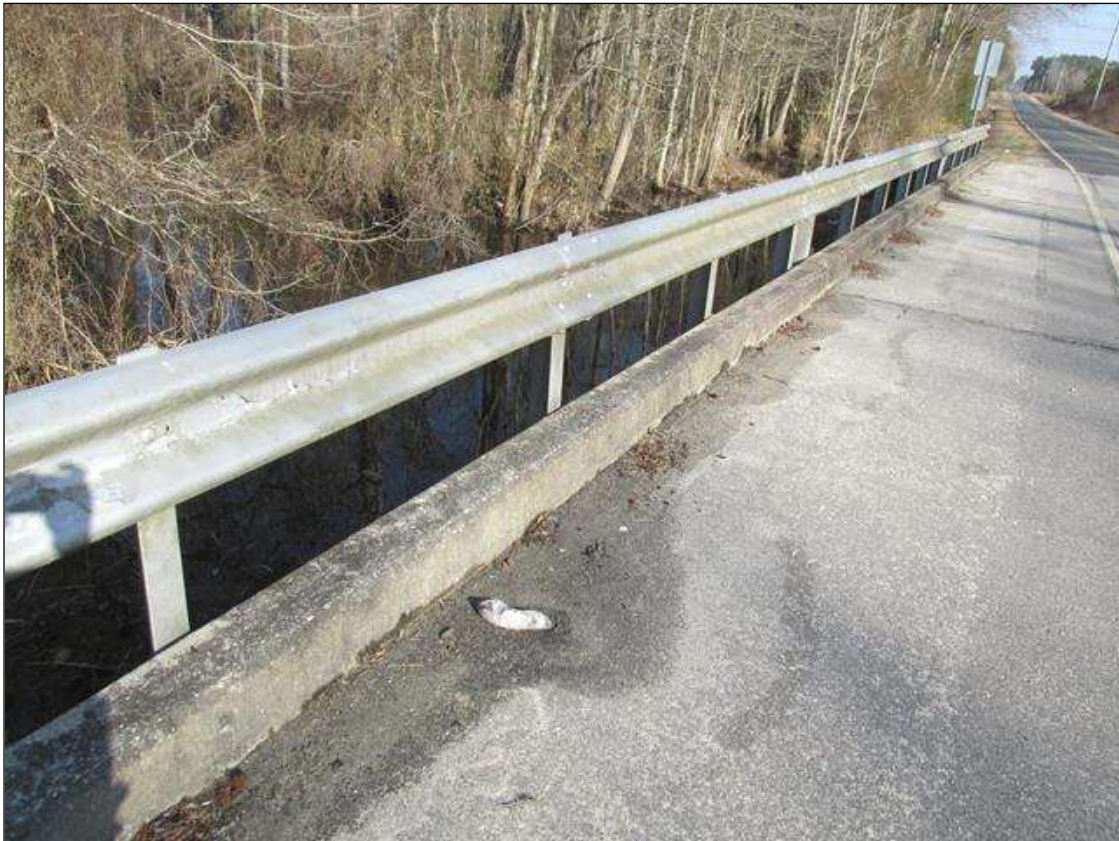
| Bridge I&A Form 1(82)H<br>State of North Carolina<br>Dept. of Transportation<br>Division of Highways | | <b>FIELD INSPECTION REPORT</b><br><u>Bridge Inspection &amp; Analysis</u> | |
|---|---|---|--|
| 7 | F | ( DECK DEBRIS ) THERE IS SCATTERED DEBRIS ALONG LEFT CURB. (PHOTO) | |

SCATTERED DEBRIS ALONG LEFT CURB

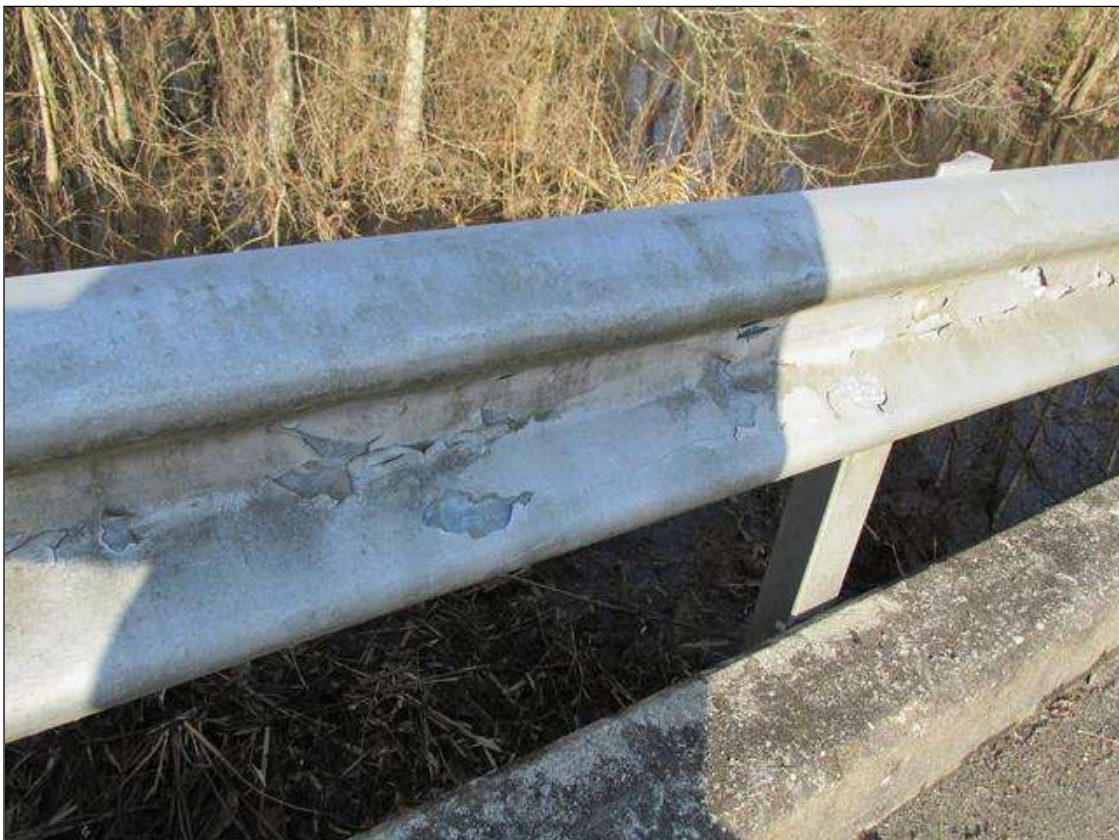
PAINT PEELING IN LEFT RAIL IN ALL SPANS

| MMS Code | Description of Function | Unit | Quantity | Remarks | Est. Cost |
|---|---|---|---|---|---|
| 3322 | Maint to Steel Handrail | LF | 88 | PAINT PEELING IN LEFT RAIL IN ALL SPANS | |

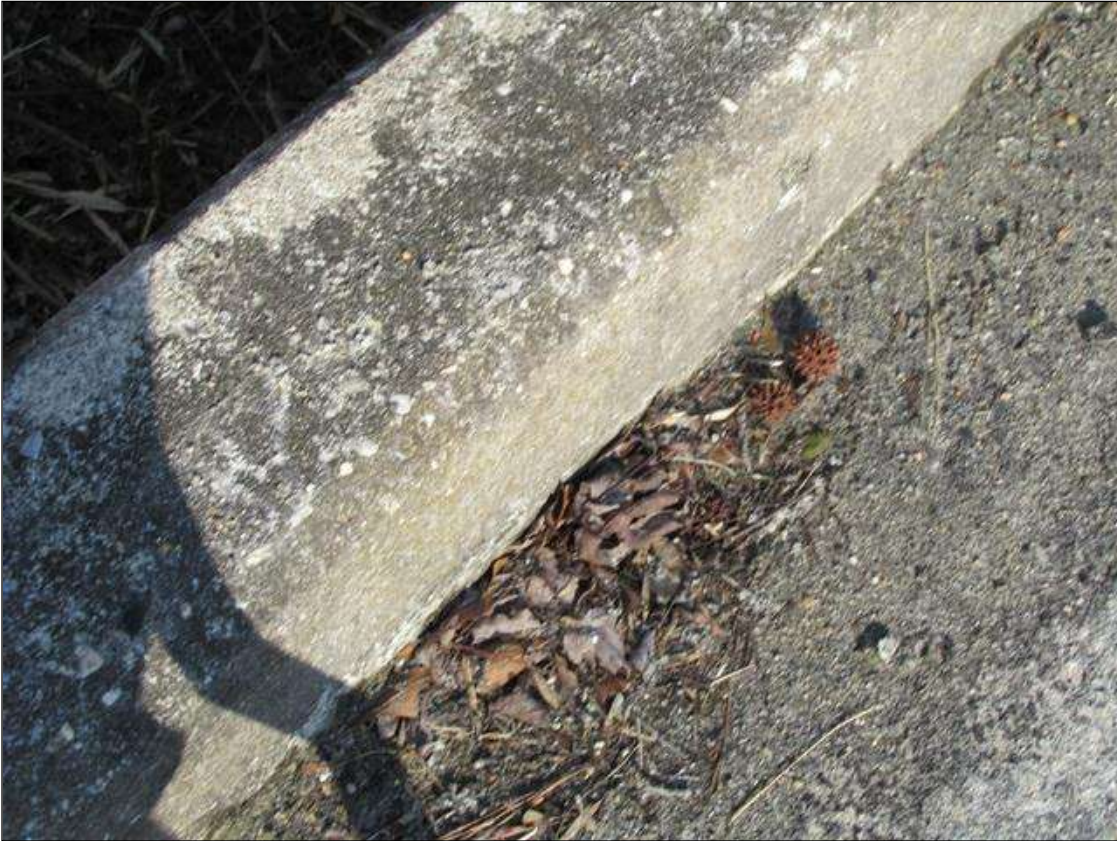
| Bridge I&A Form 1(82)H<br>State of North Carolina<br>Dept. of Transportation<br>Division of Highways | | <b>FIELD INSPECTION REPORT</b><br><u>Bridge Inspection &amp; Analysis</u> | |
|---|---|---|--|
| 16 | F | ( DRAINAGE SYSTEMS ) MOST OF THE DRAINS ARE BLOCKED WITH DEBRIS. (PHOTO) | |

MANY DECK DRAINS ARE BLOCKED BY DEBRIS

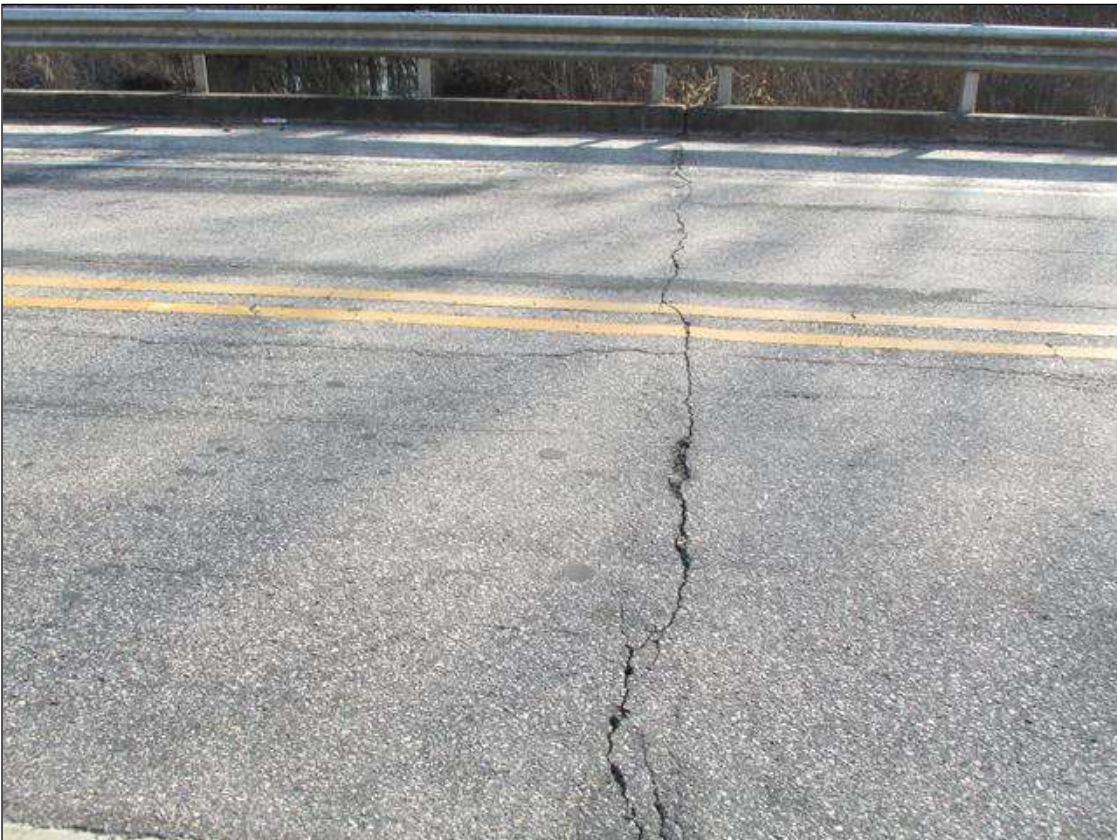
THERE IS A 3/16" TRANSVERSE CRACK IN ASPHALT WEARING SURFACE OVER BENT 1 JOINT

| MMS Code | Description of Function | Unit | Quantity | Remarks | Est. Cost |
|---|---|---|---|---|---|
| 2816 | Asphalt Surface Repair or Replacement | SY | 1 | THERE IS A 3/16" TRANSVERSE CRACK IN ASPHALT WEARING SURFACE OVER BENT 1 JOINT | |

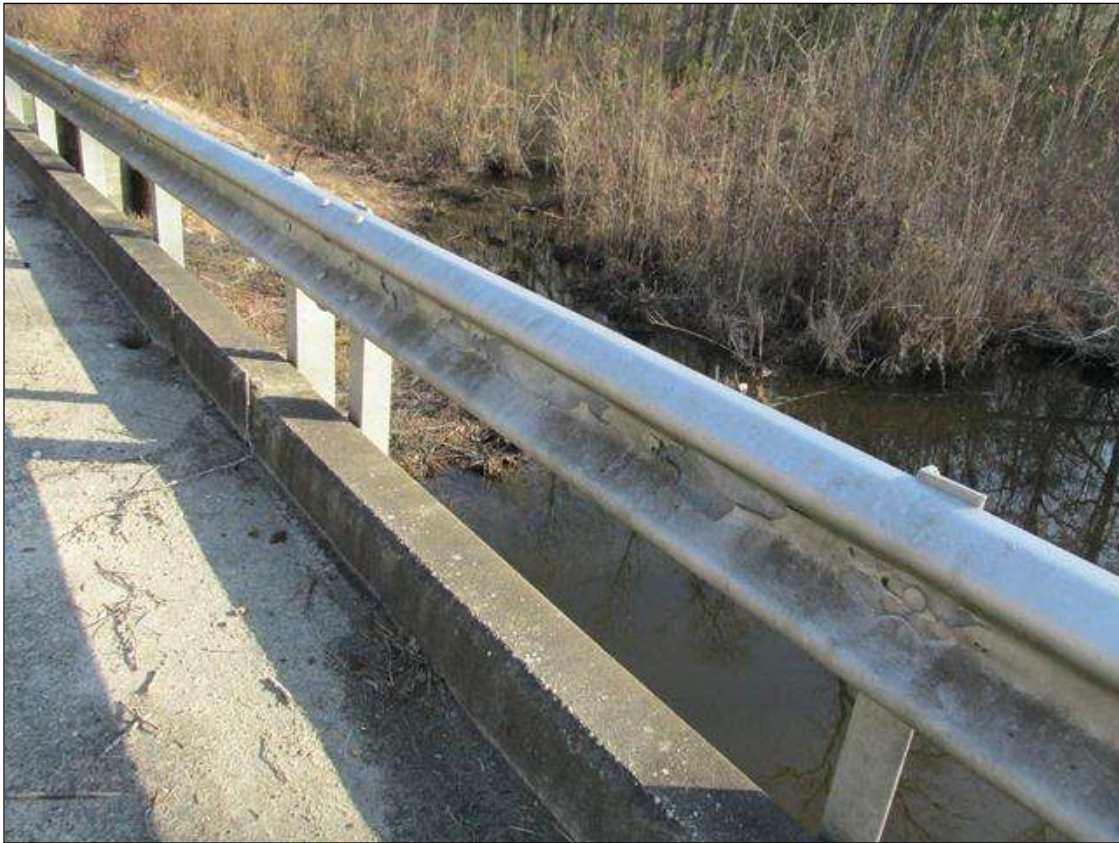
PAINT PEELING IN RIGHT RAIL AT ALL SPANS

| MMS Code | Description of Function | Unit | Quantity | Remarks | Est. Cost |
|---|---|---|---|---|---|
| 3322 | Maint to Steel Handrail | LF | 88 | PAINT PEELING IN RIGHT RAIL AT ALL SPANS | |

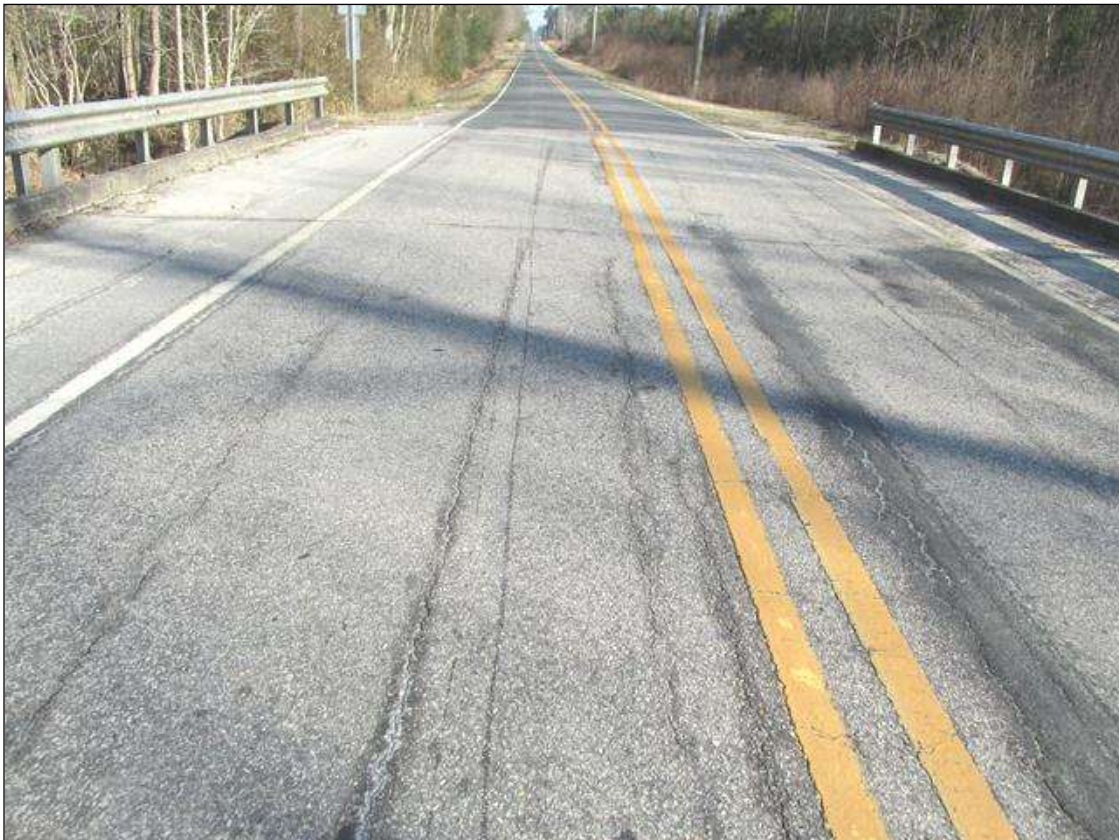
HAIRLINE TO 1/16" LONGITUDINAL CRACKS IN SPAN 2 ASPHALT WEARING SURFACE, ALL SPANS ARE SIMILAR

| MMS Code | Description of Function | Unit | Quantity | Remarks | Est. Cost |
|---|---|---|---|---|---|
| 2816 | Asphalt Surface Repair or Replacement | SY | 3 | HAIRLINE TO 1/16" LONGITUDINAL CRACKS IN SPAN 2 ASPHALT WEARING SURFACE, ALL SPANS ARE SIMILAR | |

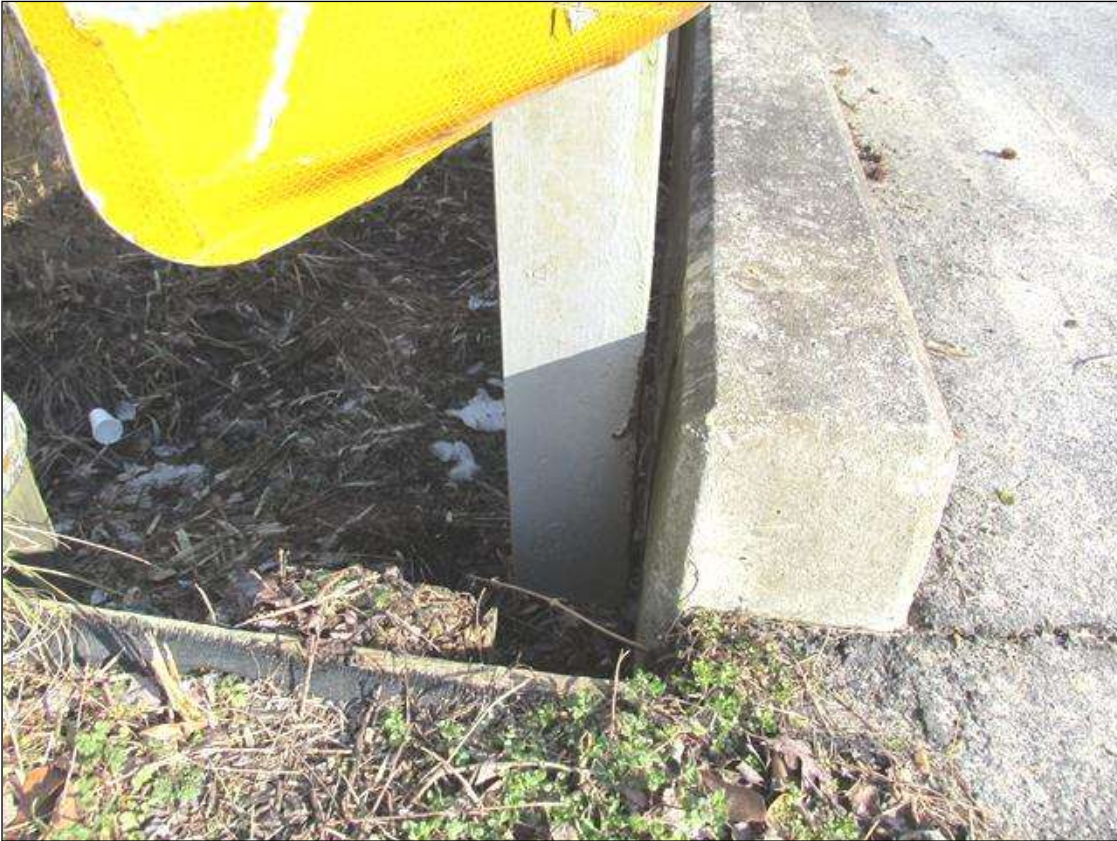
LEFT RAIL POSTS 1 AND 2 ARE LOOSE AT SOUTHWEST CORNER

| MMS Code | Description of Function | Unit | Quantity | Remarks | Est. Cost |
|---|---|---|---|---|---|
| 3322 | Maint to Steel Handrail | LF | 2 | LEFT RAIL POSTS 1 AND 2 ARE LOOSE AT SOUTHWEST CORNER | |

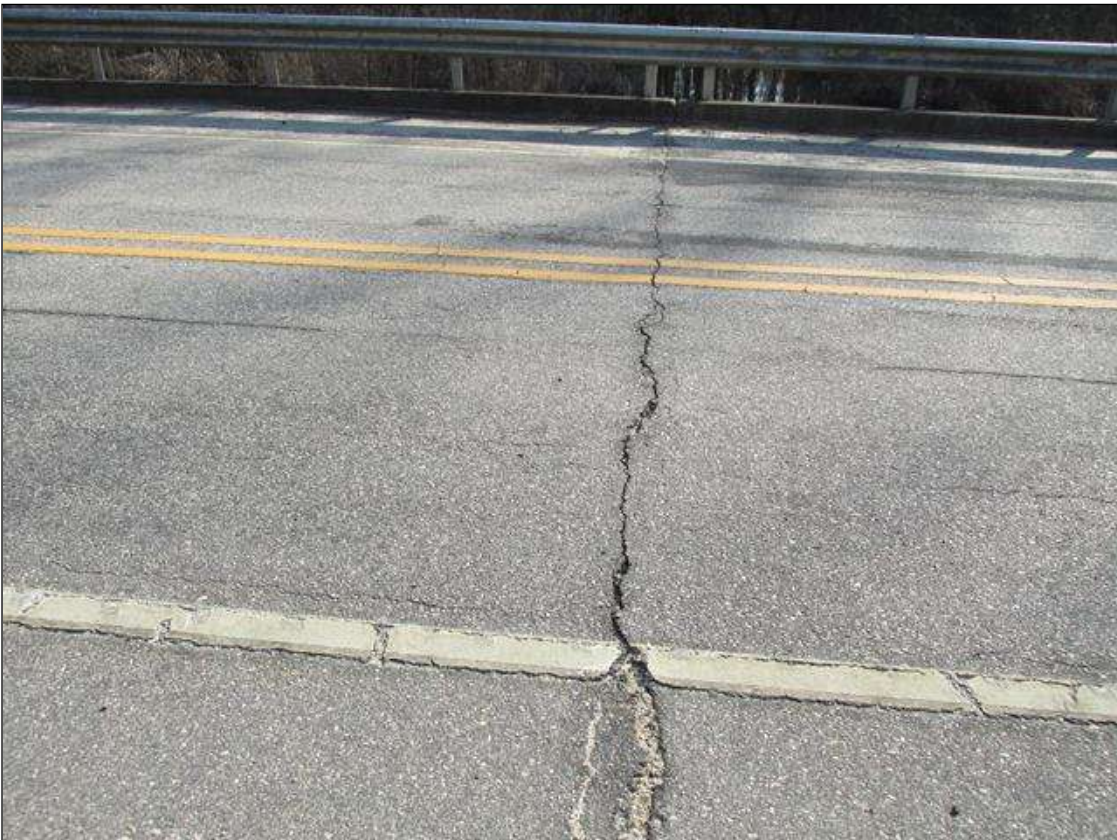
3/16" TO 1/2" TRANSVERSE CRACK IN ASPHALT WEARING SURFACE OVER BENT 2 JOINT

| MMS Code | Description of Function | Unit | Quantity | Remarks | Est. Cost |
|---|---|---|---|---|---|
| 2816 | Asphalt Surface Repair or Replacement | SY | 1 | 3/16" TO 1/2" TRANSVERSE CRACK IN ASPHALT WEARING SURFACE OVER BENT 2 JOINT | |

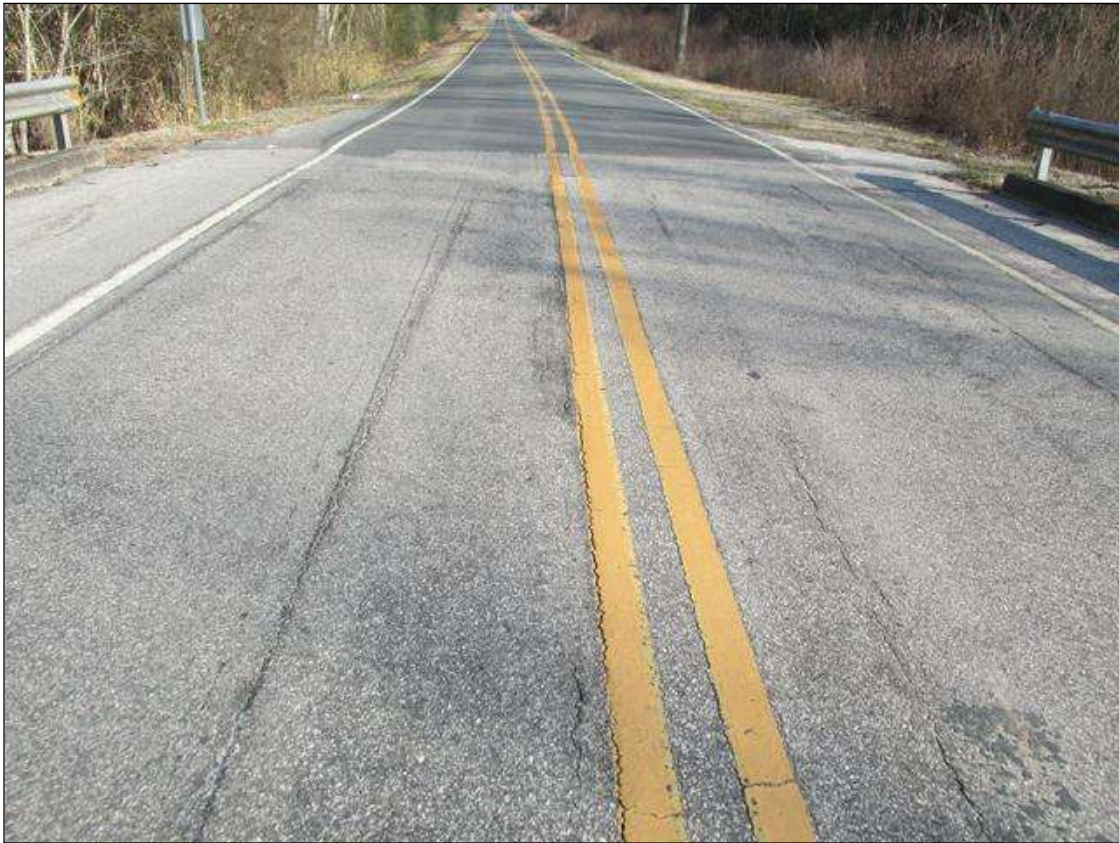
LONGITUDINAL CRACKS IN SPAN 3 ASPHALT WEARING SURFACE

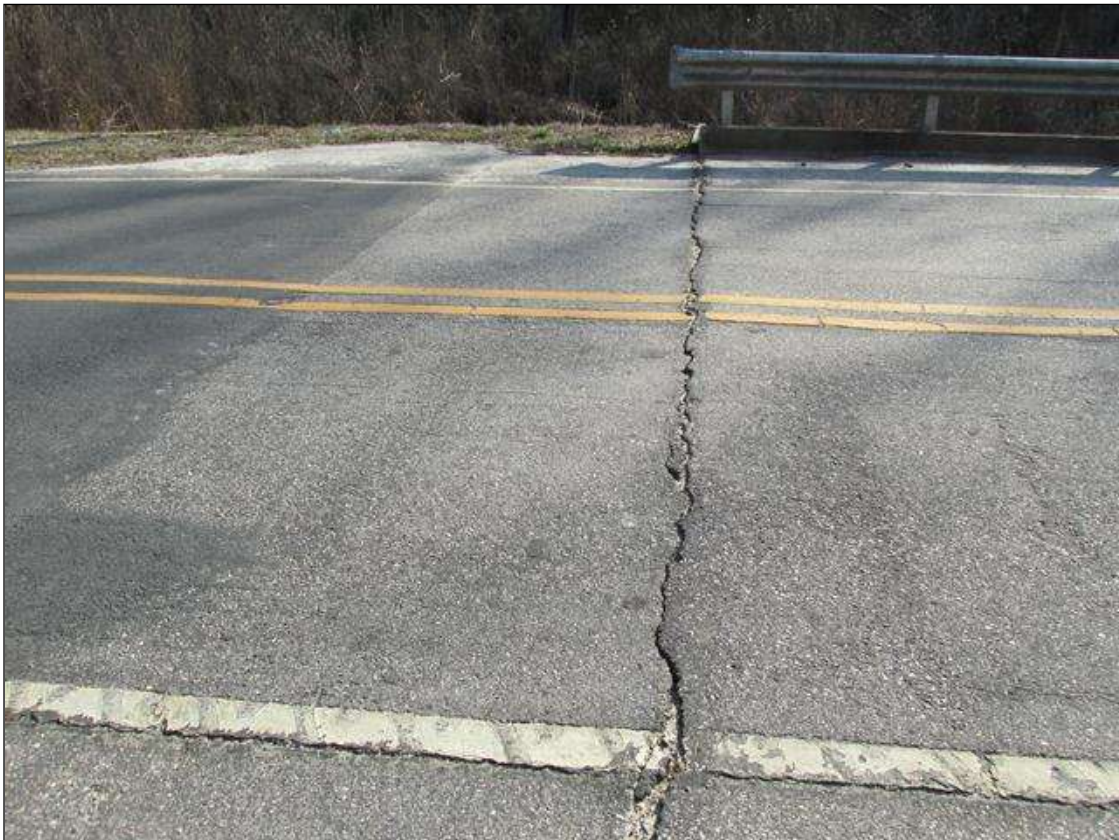
1/2" TRANSVERSE CRACK IN NORTH APPROACH ASPHALT WEARING SURFACE OVER END BENT 2

| MMS Code | Description of Function | Unit | Quantity | Remarks | Est. Cost |
|---|---|---|---|---|---|
| 2816 | Asphalt Surface Repair or Replacement | SY | 2 | 1/2" TRANSVERSE CRACK IN NORTH APPROACH ASPHALT WEARING SURFACE OVER END BENT 2 | |
