NC DEPARTMENT OF TRANSPORTATION  
DIVISION OF HIGHWAYS  
BRIDGE MANAGEMENT UNIT

# BRIDGE INSPECTION REPORT

INSPECTION TYPE: Routine Inspection

COUNTY CUMBERLAND BRIDGE NUMBER 250042 INSPECTION CYCLE 2 YRS  
ROUTE SR2030 ACROSS CREEK M.P. 0

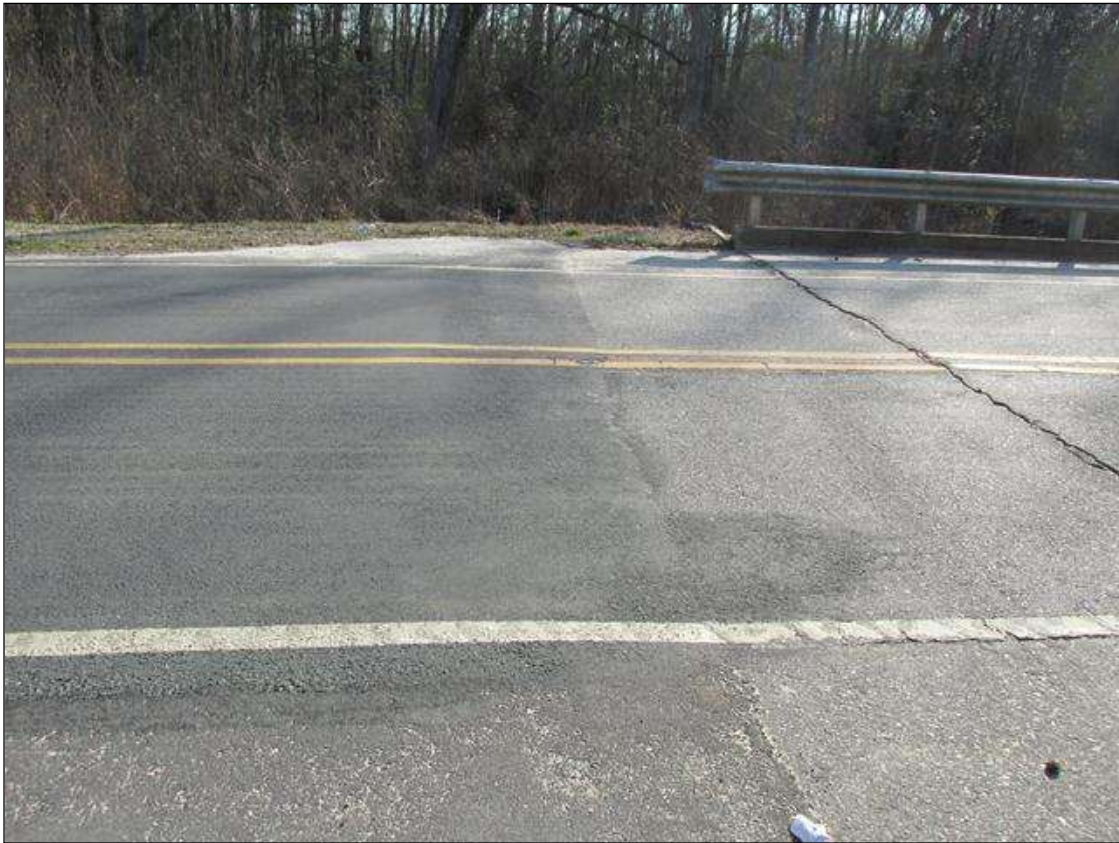
NORTH APPROACH ASPHALT WEARING SURFACE IS ROUGH AND UNEVEN

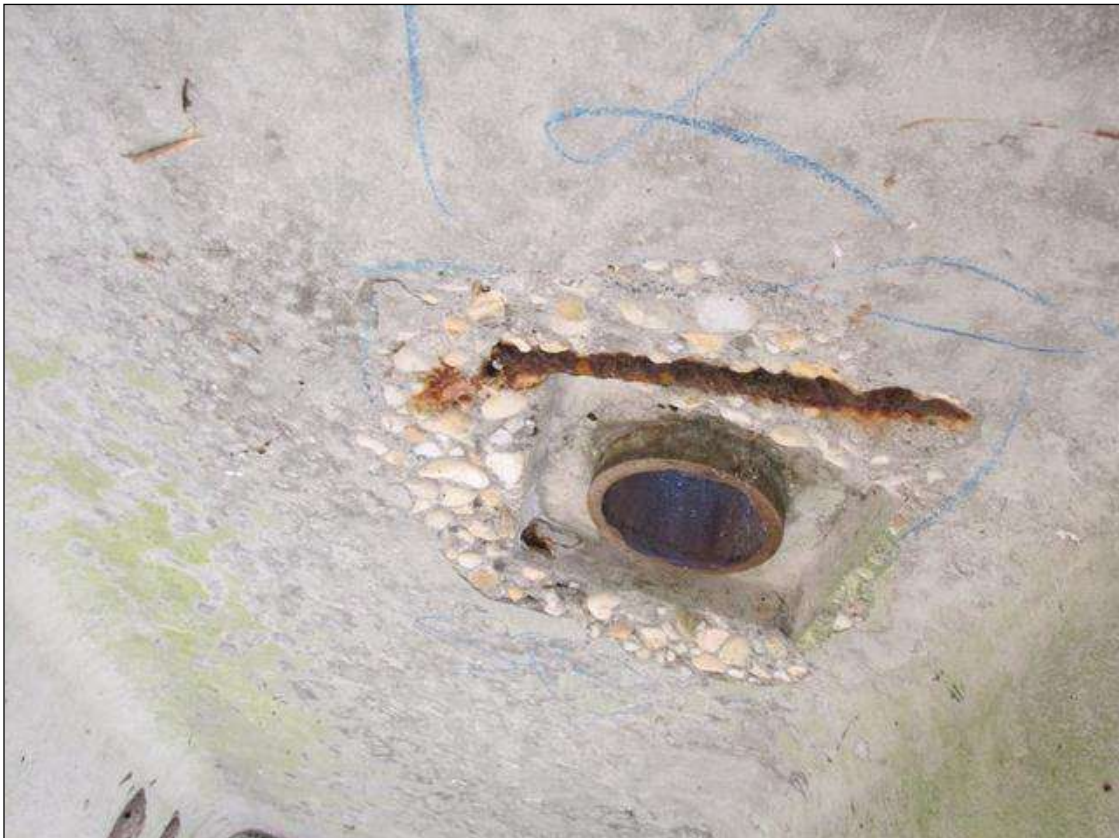
SURFACE SPALL 12" DIAMETER X 1/2" DEEP WITH 8" EXPOSED REBAR IN TOP OF CHANNEL 12 IN SPAN 3 AT  
END BENT 2 NEAR DRAIN

| MMS Code | Description of Function | Unit | Quantity | Remarks | Est. Cost |
|---|---|---|---|---|---|
| 3326 | Maintain Concrete Deck | SF | 1 | SURFACE SPALL 12" DIAMETER X 1/2" DEEP WITH 8" EXPOSED REBAR IN TOP OF CHANNEL 12 IN SPAN 3 AT END BENT 2 NEAR DRAIN | |

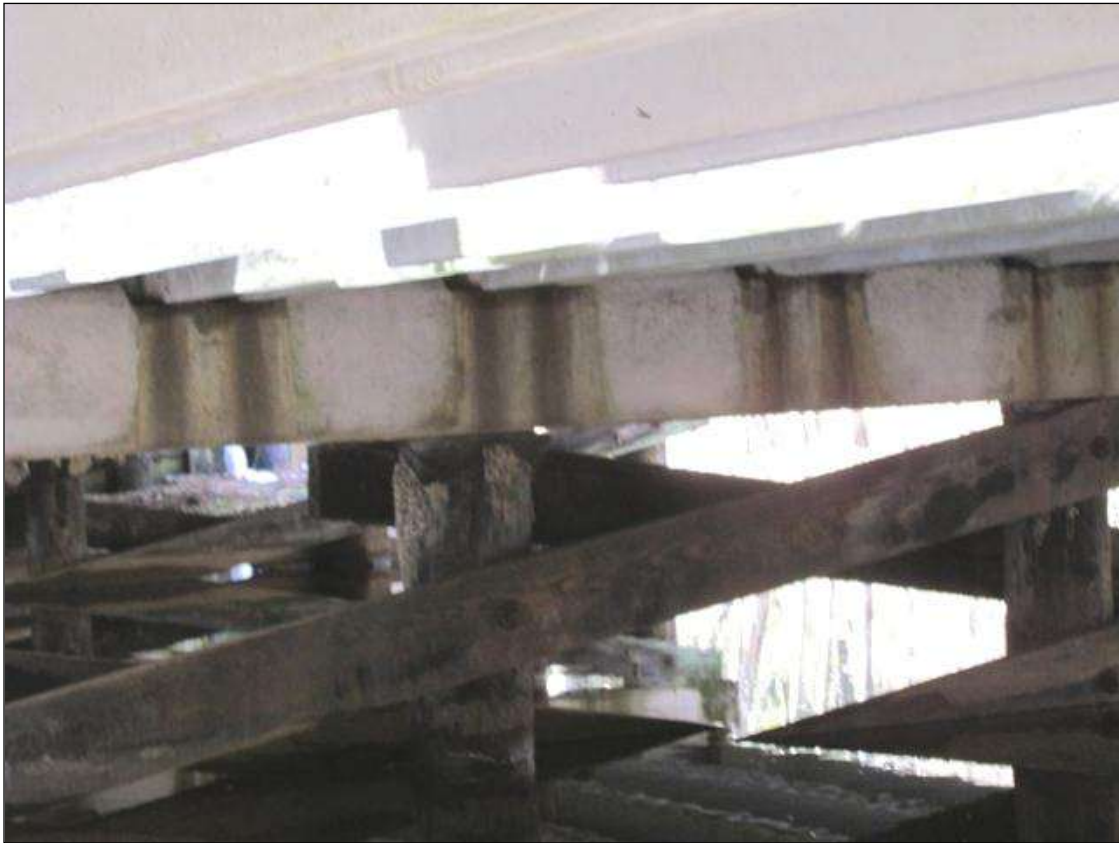
| Bridge I&A Form 1(82)H<br>State of North Carolina<br>Dept. of Transportation<br>Division of Highways | | <b>FIELD INSPECTION REPORT</b><br><u>Bridge Inspection &amp; Analysis</u> | |
|---|---|---|--|
| 6d | F | ( STANDARD JOINTS ) THE STANDARD JOINTS SHOWS EVIDENCE OF LEAKAGE ON THE INTERIOR BENT CAPS. (PHOTO) | |

BOTH STANDARD JOINTS EXHIBIT LEAKAGE ON CAPS
