NC DEPARTMENT OF TRANSPORTATION  
DIVISION OF HIGHWAYS  
BRIDGE MANAGEMENT UNIT

# BRIDGE INSPECTION REPORT

INSPECTION TYPE: Routine Inspection

COUNTY ROBESON BRIDGE NUMBER 770059 INSPECTION CYCLE 2 YRS  
ROUTE SR1924 ACROSS BIG MARSH SWAMP M.P. 0

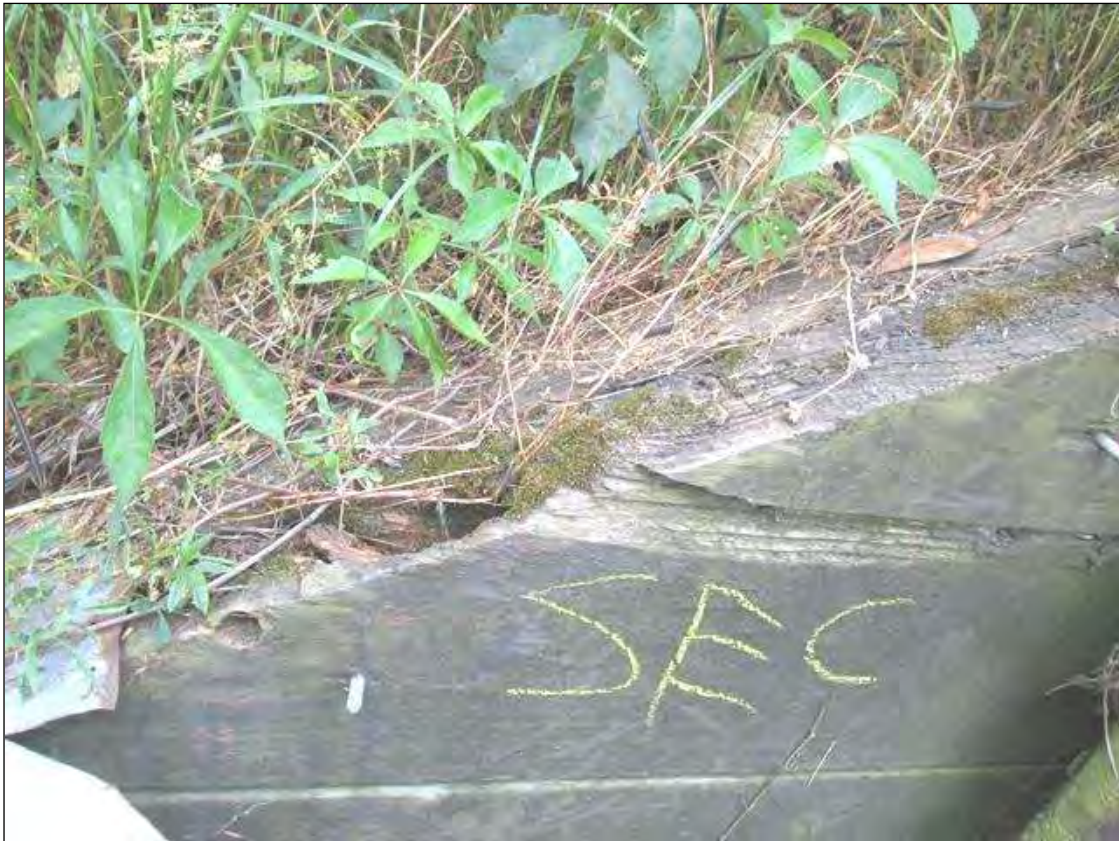
TOP WINGWALL BOARDS ARE SURFACE DECAYED AT SOUTHEAST CORNER

| MMS Code | Description of Function | Unit | Quantity | Remarks | Est. Cost |
|---|---|---|---|---|---|
| 3346 | Repair / Maintain Timber Wings & Blkhds | SF | 2 | TOP WINGWALL BOARDS ARE SURFACE DECAYED AT SOUTHEAST CORNER | |

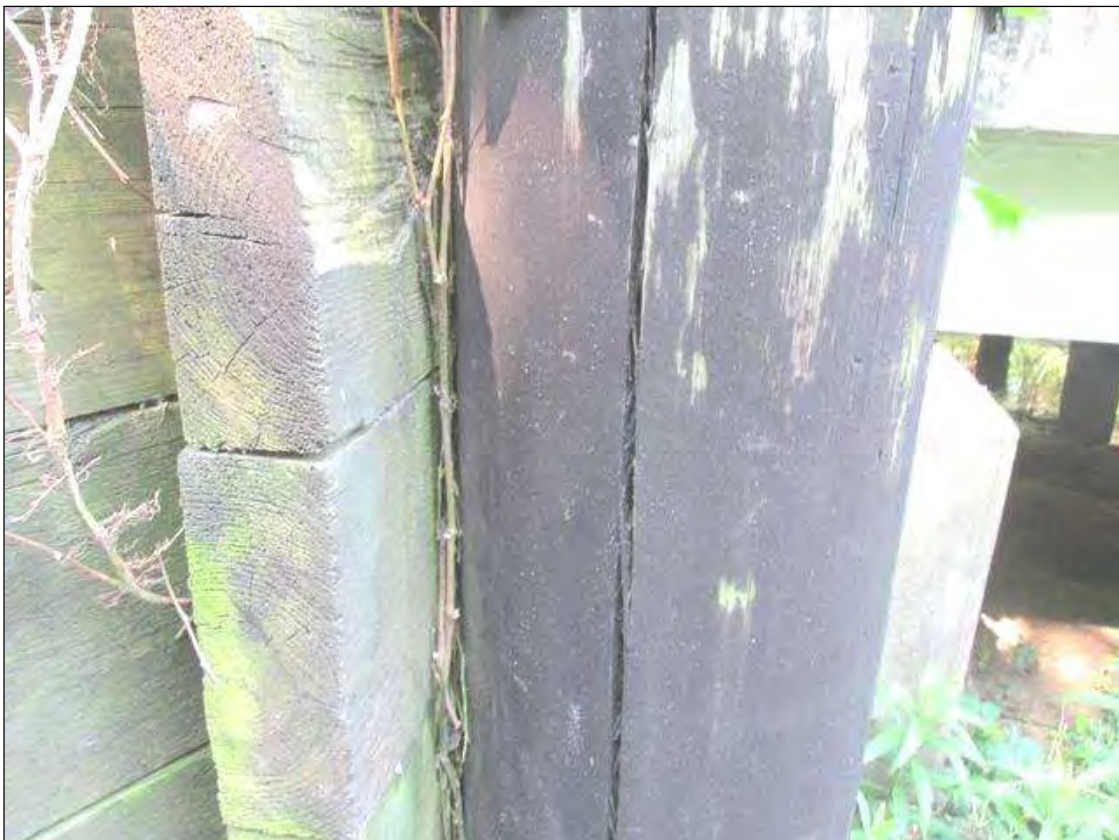
1/4" WIDE VERTICAL CHECK IN TURNPILE AT SOUTHEAST CORNER

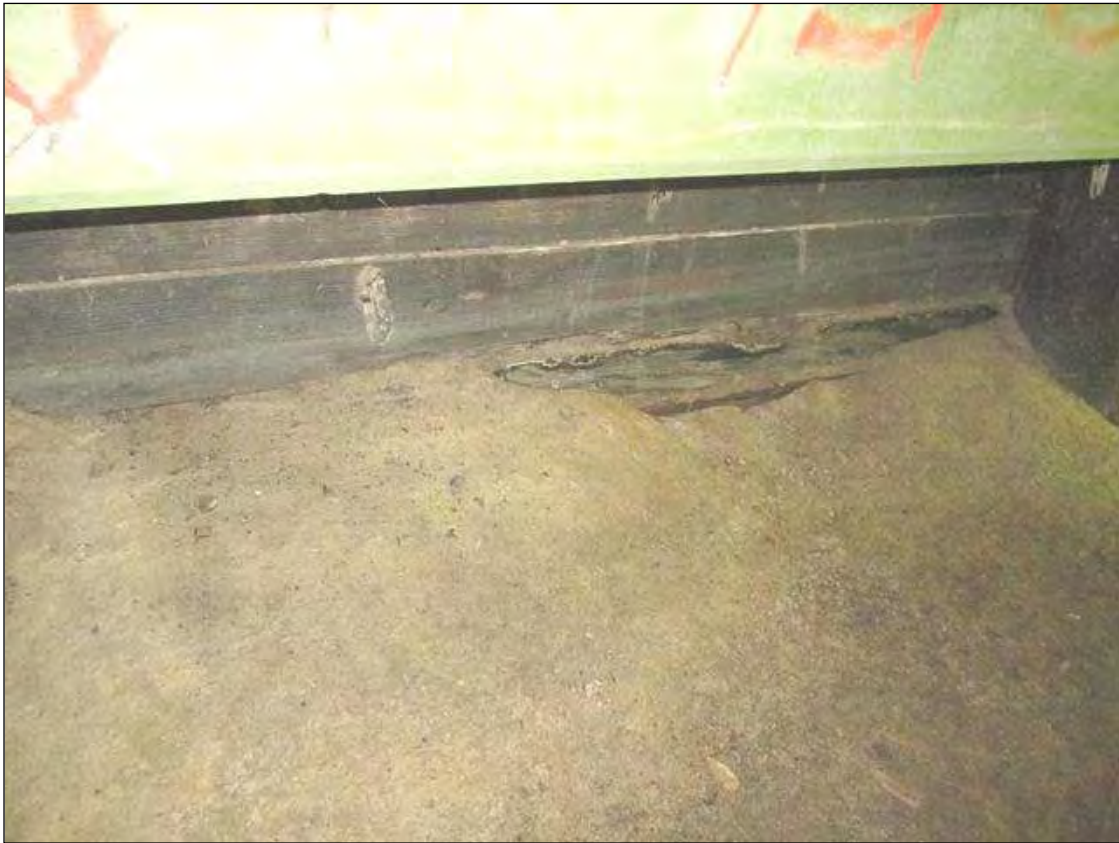
| Bridge I&A Form 1(82)H<br>State of North Carolina<br>Dept. of Transportation<br>Division of Highways | | <h1>FIELD INSPECTION REPORT</h1> <p><u>Bridge Inspection &amp; Analysis</u></p> | |
|---|---|---|--|
| 35c | F | <p>( TIMBER BULKHEAD AND WINGWALLS ) END BENT 1 BULKHEAD IS DECAYED WITH FILL LEAKAGE BETWEEN PILES 2 AND 3. (PHOTO) PM ISSUED.</p> <p>DECAYED EXTERIOR BULKHEAD BOARDS WITH EXPOSED FILL AT SOUTHWEST CORNER. (PHOTO) PM ISSUED.</p> <p>THE TOP WINGWALL BOARDS ARE SURFACE DECAYED AT SOUTHEAST CORNER. (PHOTO)</p> <p>THERE IS A 1/4" WIDE VERTICAL CHECK IN TURNPILE AT SOUTHEAST CORNER. (PHOTO)</p> <p>END BENT 1 BULKHEAD BOARD DECAYED BETWEEN PILES 3 AND 4, WITH NO FILL LEAKAGE. (PHOTO)</p> <p>NORTHWEST CORNER WINGWALL BOARD IS DECAYED. (PHOTO)</p> | |
| 61 | YES | <p>( PM ISSUED ) FOR DECAYED BULKHEAD AT END BENT 1 WITH FILL LEAKAGE, AND BEAM 12 IN SPAN 19 WITH SECTION LOSS.</p> | |

END BENT 1 BULKHEAD IS DECAYED WITH FILL LEAKAGE BETWEEN PILES 2 AND 3 PM ISSUED.

| MMS Code | Description of Function | Unit | Quantity | Remarks | Est. Cost |
|---|---|---|---|---|---|
| 3346 | Repair / Maintain Timber Wings & Blkhds | SF | <del>8</del> 8/19/14 | END BENT 1 BULKHEAD IS DECAYED WITH FILL LEAKAGE BETWEEN PILES 2 AND 3 | |

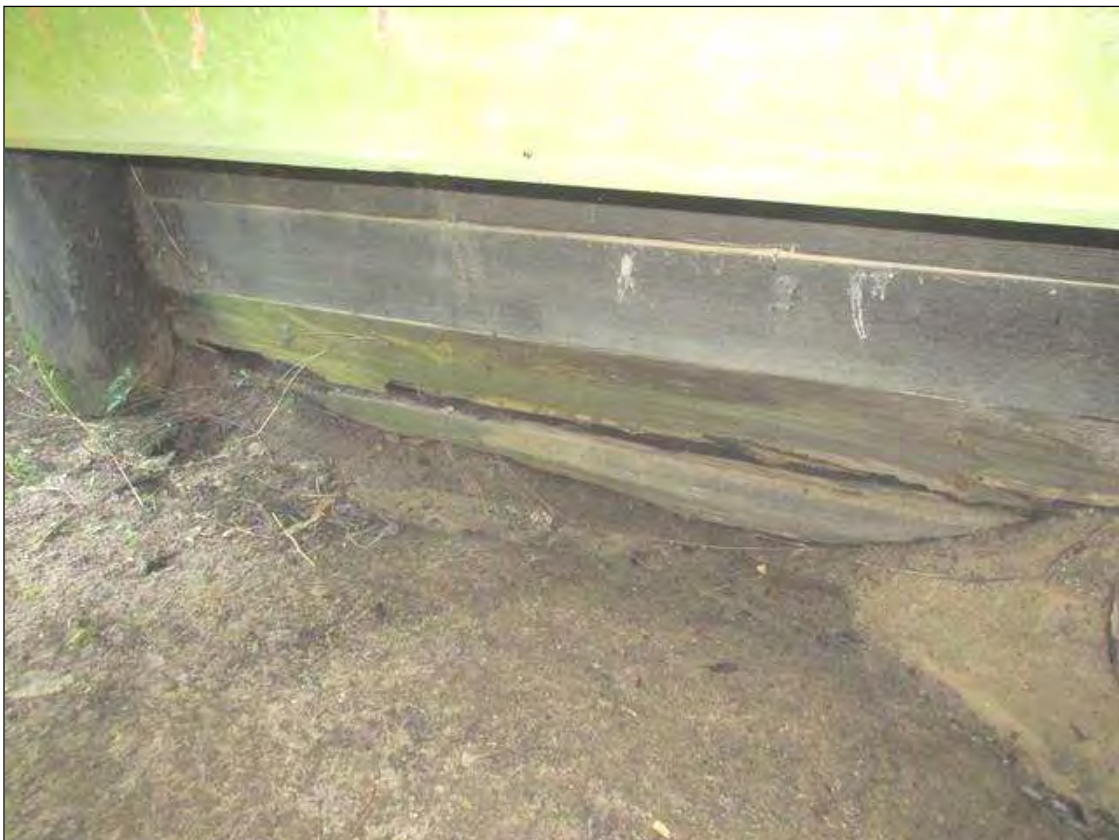
END BENT 1 BULKHEAD BOARD DECAYED BETWEEN PILES 3 AND 4, WITH NO FILL LEAKAGE

| MMS Code | Description of Function | Unit | Quantity | Remarks | Est. Cost |
|---|---|---|---|---|---|
| 3346 | Repair / Maintain Timber Wings & Blkhds | SF | 6 | END BENT 1 BULKHEAD BOARD DECAYED BETWEEN PILES 3 AND 4, WITH NO FILL LEAKAGE | |

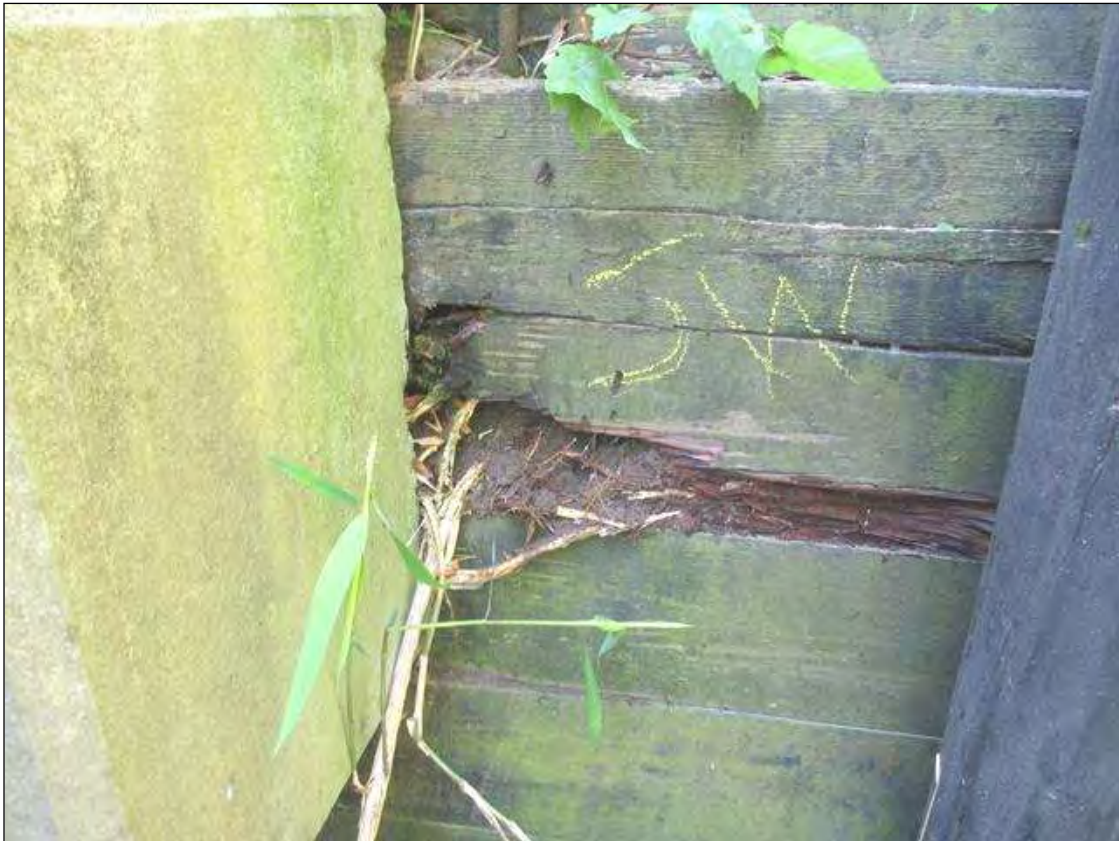
DECAYED EXTERIOR BULKHEAD BOARDS WITH EXPOSED FILL AT SOUTHWEST CORNER

| MMS Code | Description of Function | Unit | Quantity | Remarks | Est. Cost |
|---|---|---|---|---|---|
| 3346 | Repair / Maintain Timber Wings & Blkhds | SF | <del>8</del> TSE | DECAYED EXTERIOR BULKHEAD BOARDS WITH EXPOSED FILL AT SOUTHWEST CORNER | |

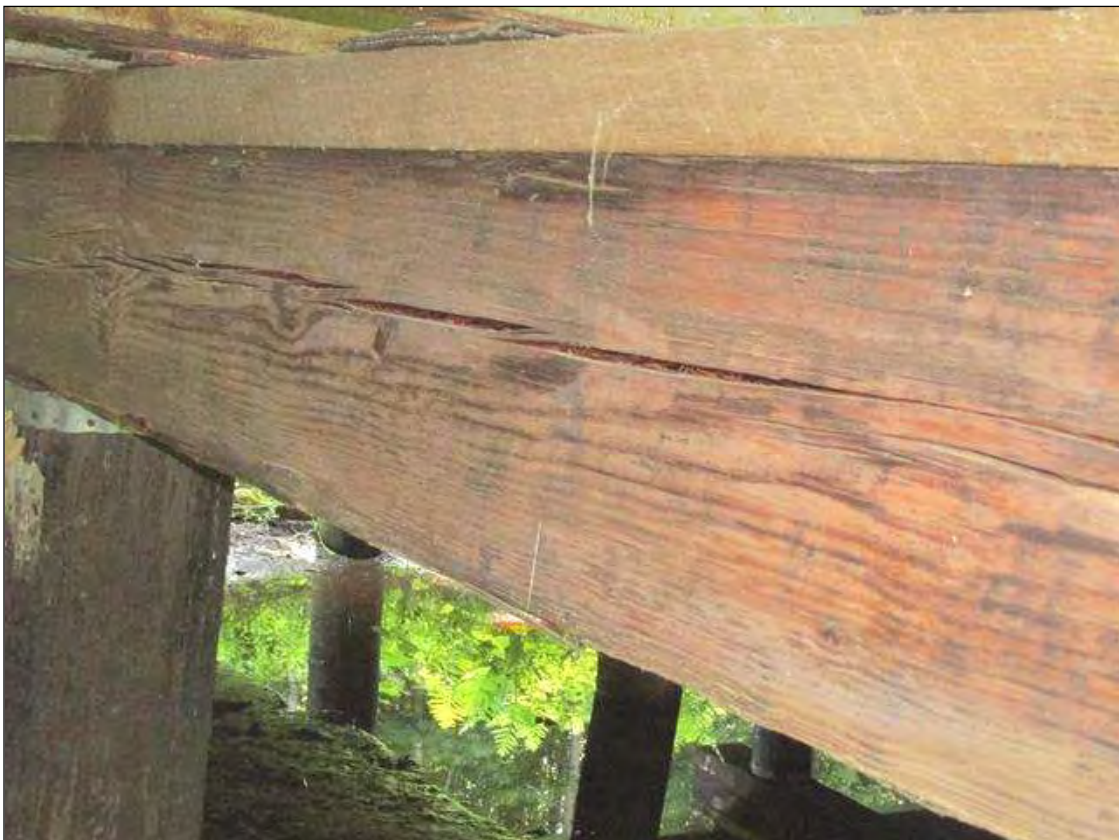
| Bridge I&A Form 1(82)H<br>State of North Carolina<br>Dept. of Transportation<br>Division of Highways | | <h1>FIELD INSPECTION REPORT</h1> <p><u>Bridge Inspeccion &amp; Analysis</u></p> | |
|---|---|---|--|
| | | PAINT PEELING AND RUST IN SPAN 19 BEAMS. ALL SPANS ARE SIMILAR. (PHOTO)<br>( TIMBER CAPS ) THERE ARE 3/16" CHECKS IN BENT 3 CAP ON SPAN 4 FACE. (PHOTO) | |

3/16" CHECKS ON BENT 3 TIMBER CAP, SPAN 4 FACE ( SIMILAR IN ALL TIMBER CAPS )

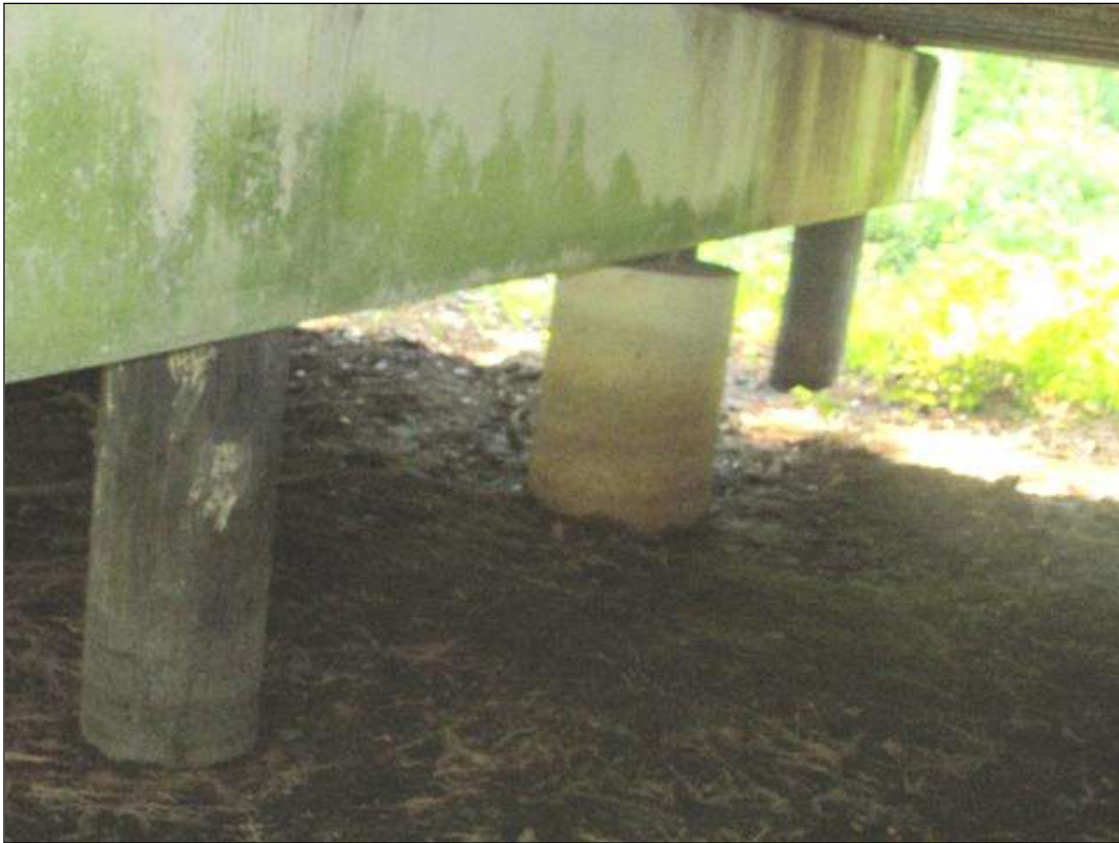
PILE 3 AT BENT 4 ENCASED, TEMP REPAIR

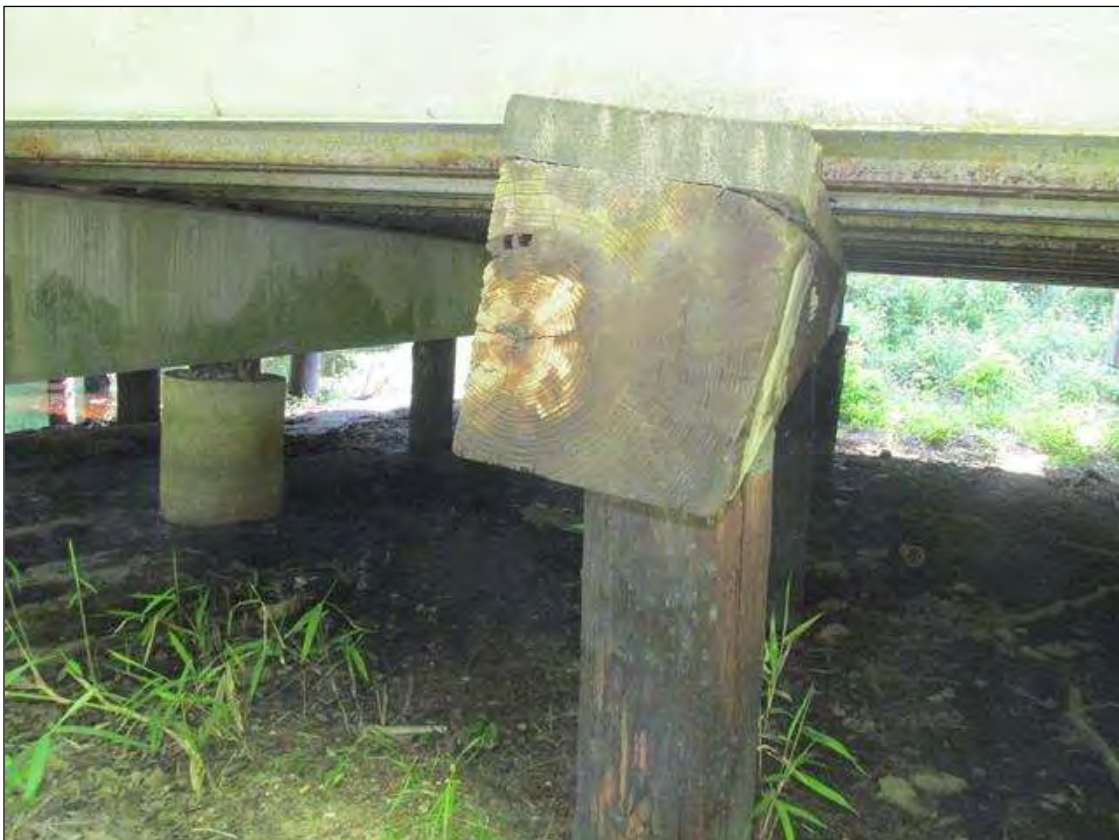
BENT 5 TIMBER CAP IS TWISTED 6" OUT OF PLUMB AT WEST END, WITH 1" CLEARANCE AT PILE 1 IN SPAN 6 FACE

| MMS Code | Description of Function | Unit | Quantity | Remarks | Est. Cost |
|---|---|---|---|---|---|
| 3344 | Repair / Replace Timber Substructure Components | LF | 26 | BENT 5 TIMBER CAP IS TWISTED 6" OUT OF PLUMB AT WEST END, WITH 1" CLEARANCE AT PILE 1 IN SPAN 6 FACE | |

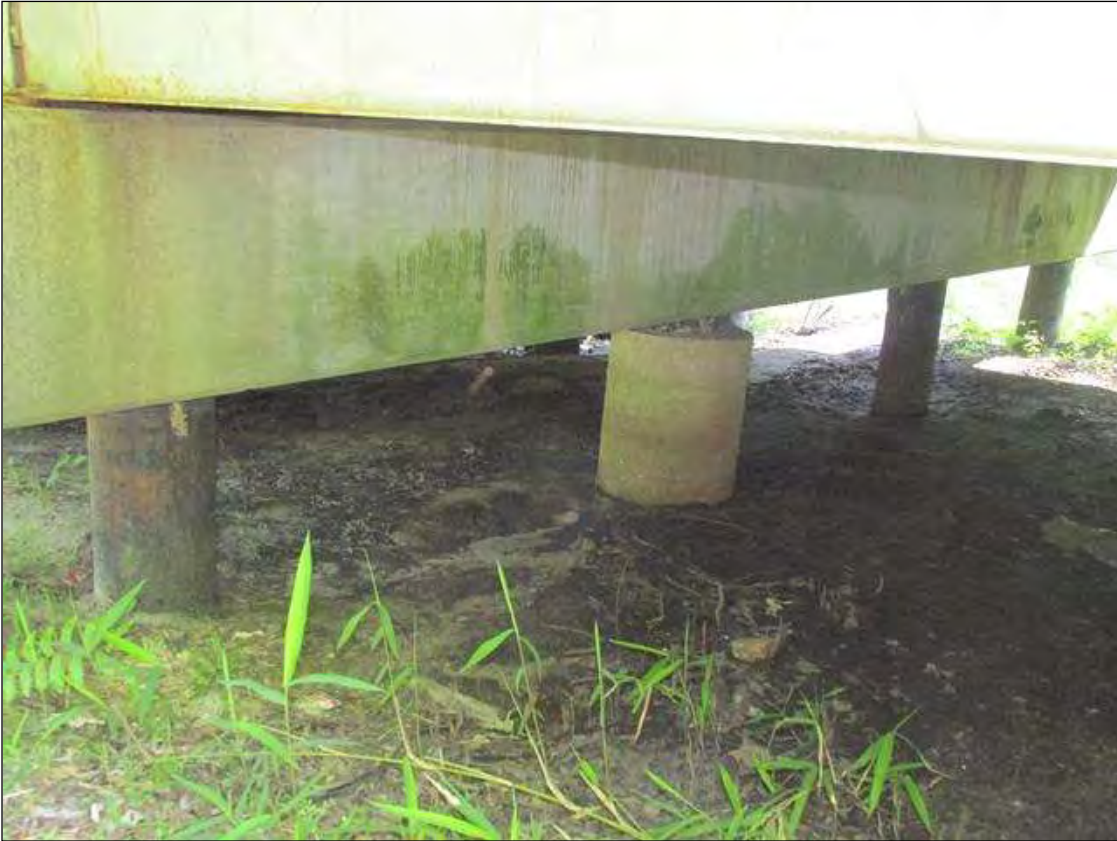
PILE 2 AT BENT 6 ENCASED, TEMP REPAIR

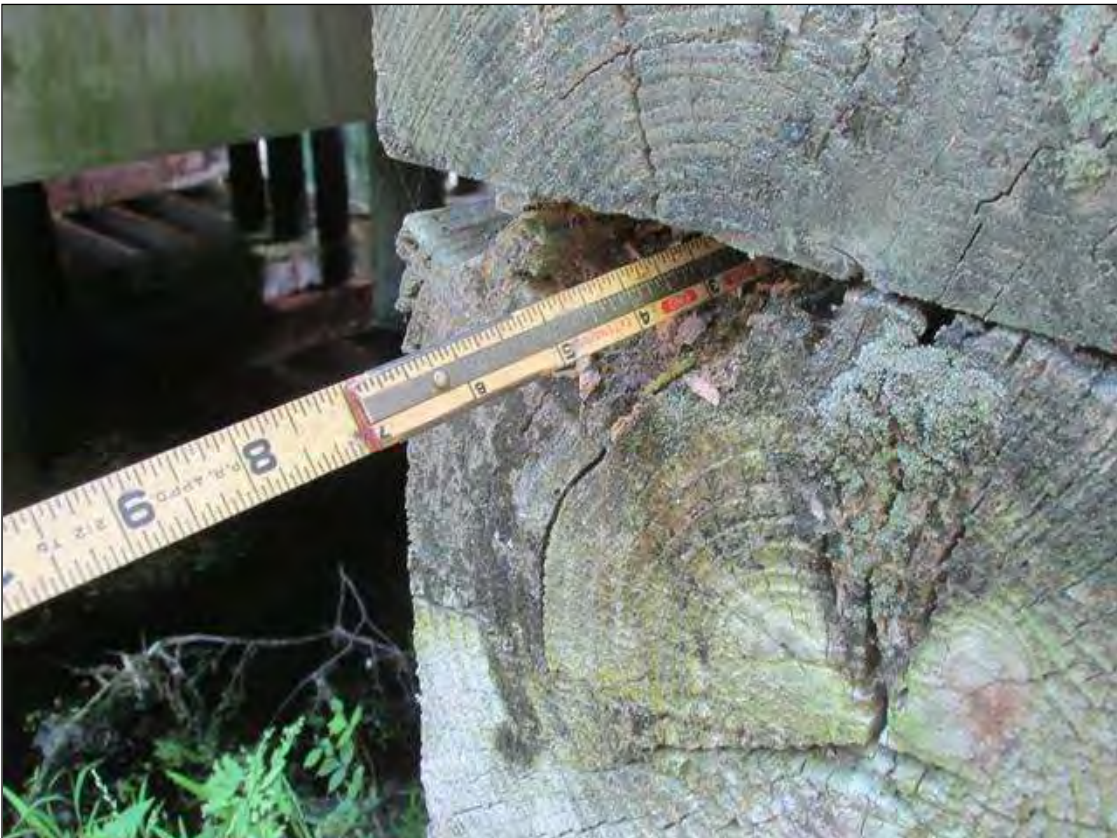
| Bridge I&A Form 1(82)H<br>State of North Carolina<br>Dept. of Transportation<br>Division of Highways | | <h1>FIELD INSPECTION REPORT</h1> <p><u>Bridge Inspeccion &amp; Analysis</u></p> | |
|---|---|---|--|
| | | BENT 7 TIMBER CAP WEST END IS DECAYED 3" WIDE X 2" HIGH X UP TO 4" DEEP. (PHOTO) | |

BENT 7 TIMBER CAP WEST END IS DECAYED 3" WIDE X 2" HIGH X UP TO 4" DEEP

| MMS Code | Description of Function | Unit | Quantity | Remarks | Est. Cost |
|---|---|---|---|---|---|
| 3344 | Repair / Replace Timber Substructure Components | LF | 1 | BENT 7 TIMBER CAP WEST END IS DECAYED 3" WIDE X 2" HIGH X UP TO 4" DEEP | |

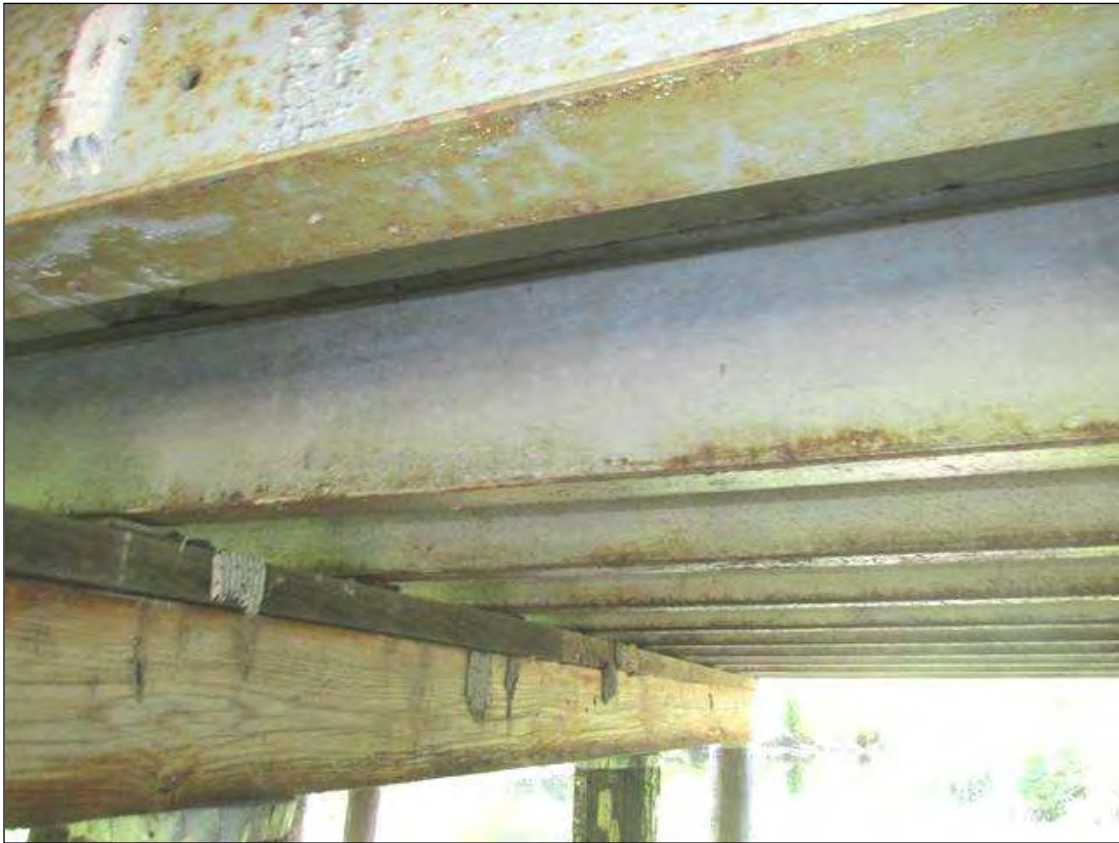
| Bridge I&A Form 1(82)H<br>State of North Carolina<br>Dept. of Transportation<br>Division of Highways | | <h1>FIELD INSPECTION REPORT</h1> <p><u>Bridge Inspeccion &amp; Analysis</u></p> | |
|---|---|---|--|
| 35a | F | THERE IS PAINT PEELING AND SURFACE RUST IN SPAN 7 BEAMS. ALL SPANS ARE SIMILAR. (PHOTO) | |

THERE IS PAINT PEELING AND SURFACE RUST IN SPAN 7 BEAMS, ALL SPANS ARE SIMILAR

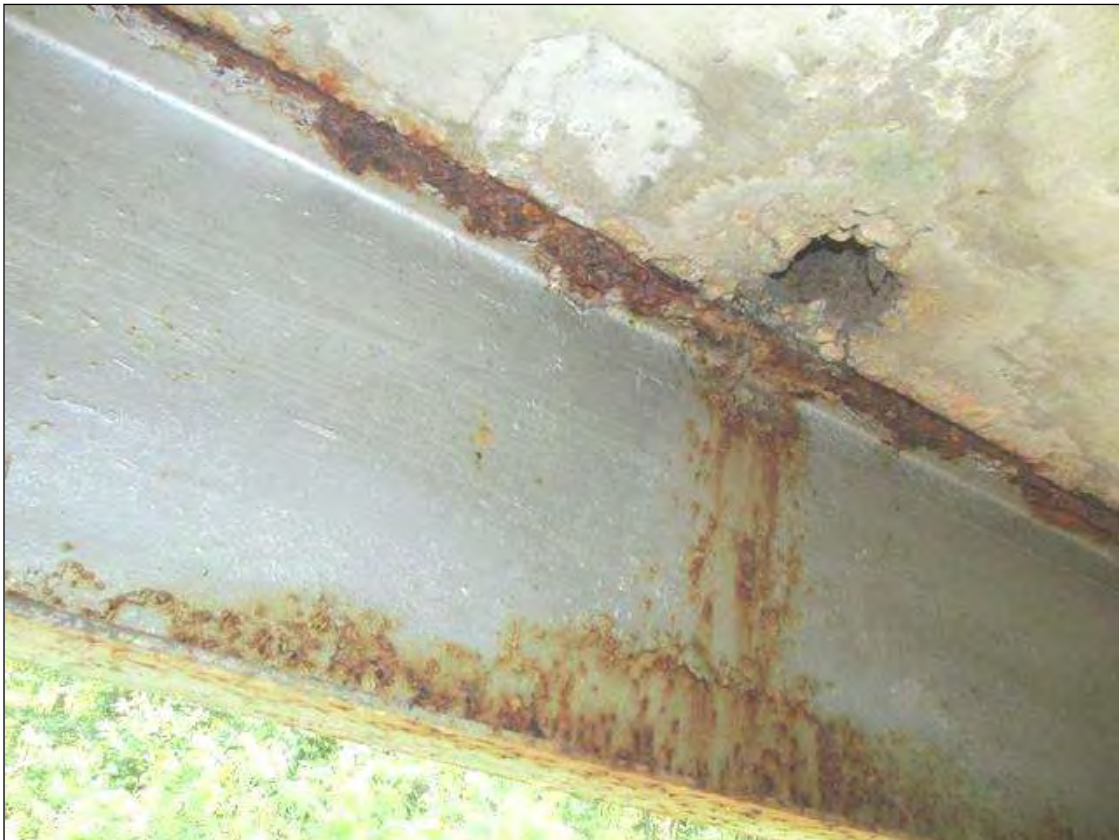
| Bridge I&A Form 1(82)H<br>State of North Carolina<br>Dept. of Transportation<br>Division of Highways | | <h1>FIELD INSPECTION REPORT</h1> <p><u>Bridge Inspeccion &amp; Analysis</u></p> | |
|---|---|---|--|
| | | BEAM 12 IN SPAN 7 BAY 11 SIDE HAS PAINT PEELING AND RUST WITH 1/16" SECTION LOSS IN TOP AND BOTTOM FLANGE AT DECK DRAIN. (PHOTO) | |

BEAM 12 IN SPAN 7 BAY 11 SIDE HAS PAINT PEELING AND RUST WITH 1/16" SECTION LOSS IN TOP AND BOTTOM FLANGE AT DECK DRAIN

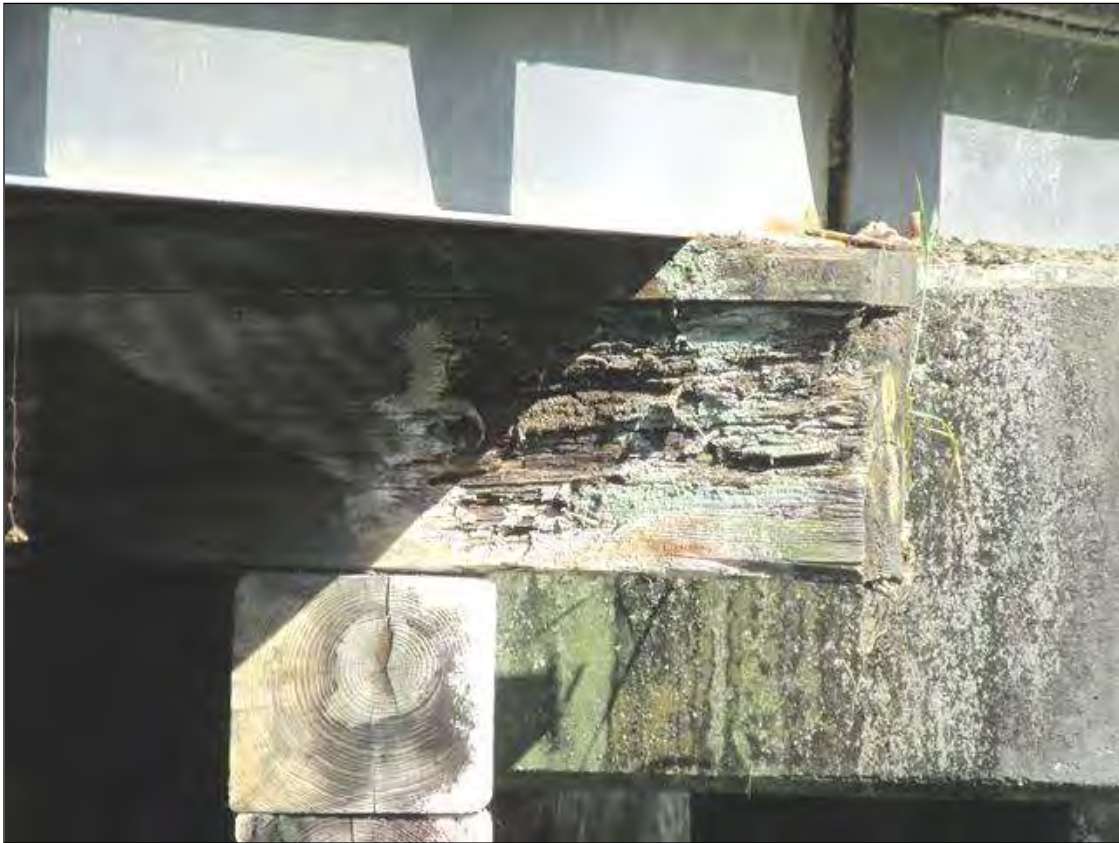
BENT 13 PILE 4 TIMBER CAP IS DECAYED 14" WIDE X 12" HIGH X 2" DEEP ( ALSO SEE BENT 13 CAP DECAY SKETCH )

| MMS Code | Description of Function | Unit | Quantity | Remarks | Est. Cost |
|---|---|---|---|---|---|
| 3344 | Repair / Replace Timber Substructure Components | LF | 2 | BENT 13 PILE 4 TIMBER CAP IS DECAYED 14" WIDE X 12" HIGH X 2" DEEP | |

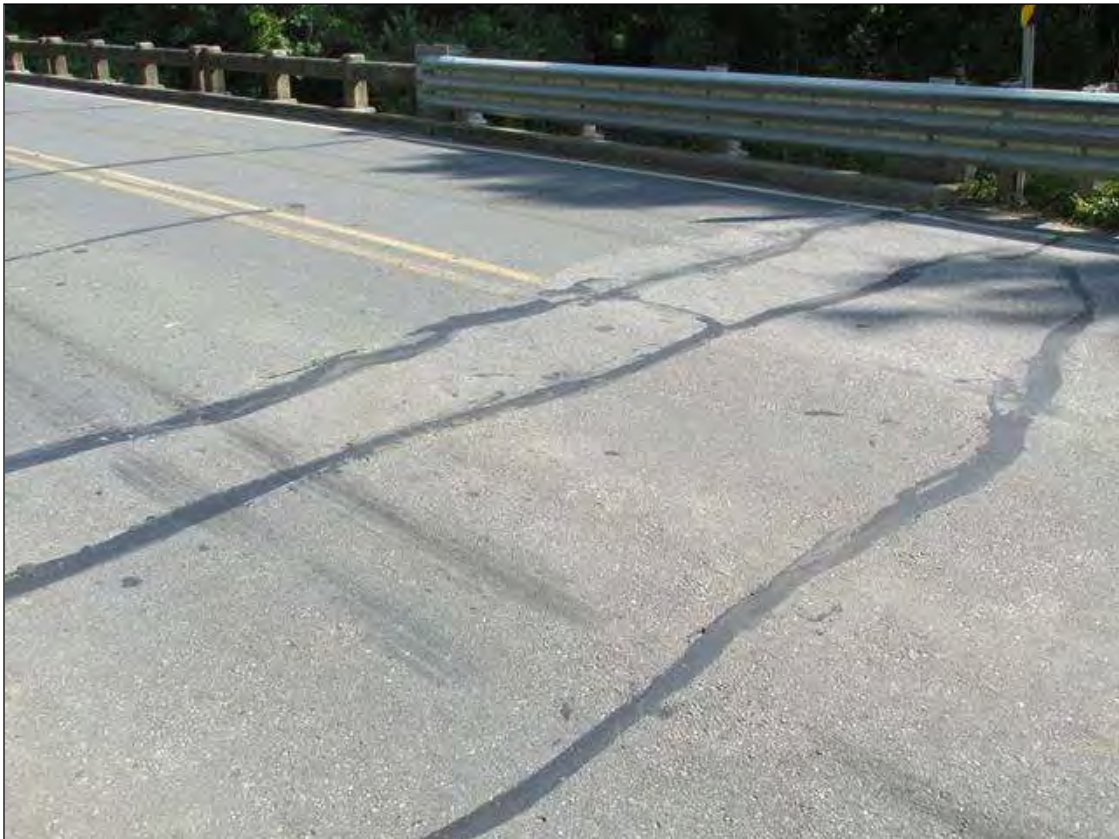
SEALED TRANSVERSE CRACKS IN SOUTH APPROACH ASPHALT WEARING SURFACE

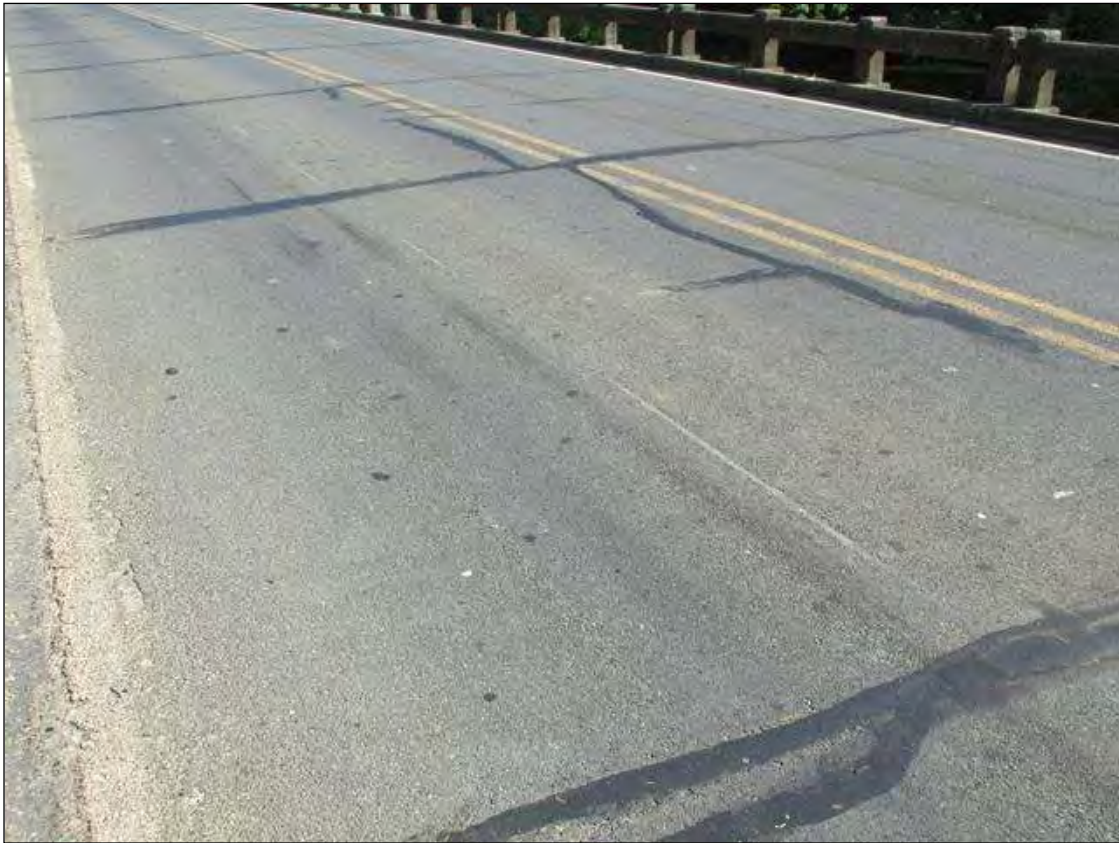
| 1 | F | ( ASPHALT WEARING SURFACE ) THERE ARE SEALED TRANSVERSE CRACKS OVER ORIGINAL BENTS. (PHOTO) | |

SEALED TRANSVERSE CRACKS OVER ORIGINAL BENTS

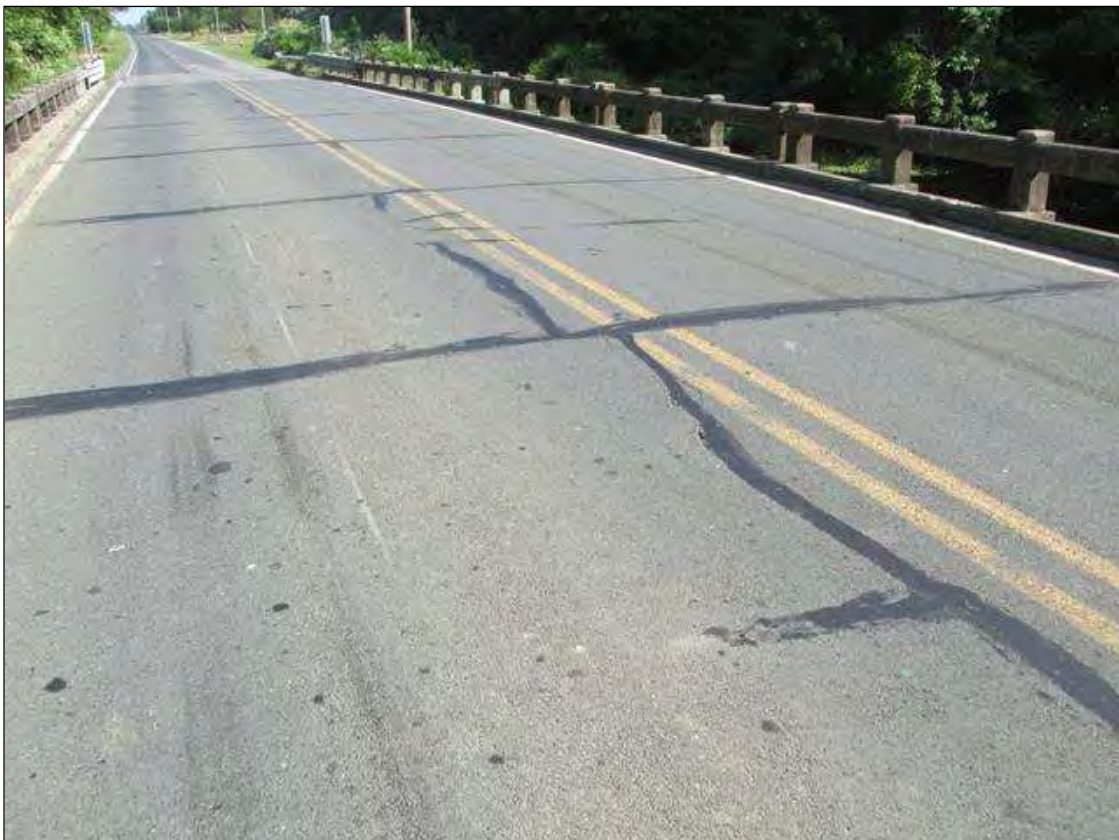
SEALED LONGITUDINAL CRACKS IN ALL SPANS

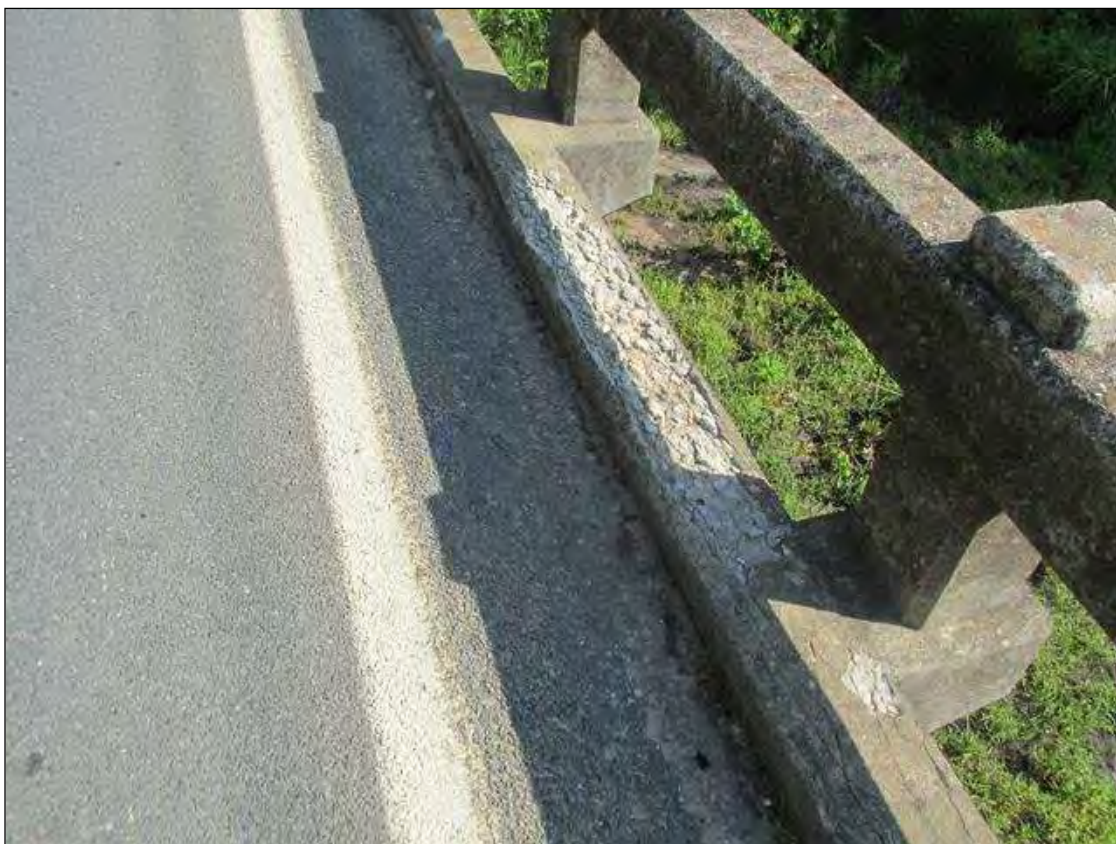
| 4 | F | ( CURBS ) THE RIGHT CURB IN SPANS 13 AND 14 IS DELAMINATED, SURFACE SPALLED 10' LONG X 8" WIDE X UP TO 2" DEEP. (PHOTO)<br><br>THE LEFT CURB IN SPAN 15 IS SURFACE SPALLED 16" LONG X 8" WIDE X 1" DEEP. (PHOTO) | |

RIGHT CURB IN SPANS 13 AND 14 IS DELAMINATED, SURFACE SPALLED 10' LONG X 8" WIDE X UP TO 2" DEEP

| MMS Code | Description of Function | Unit | Quantity | Remarks | Est. Cost |
|---|---|---|---|---|---|
| 3326 | Maintain Concrete Deck | SF | 10 | RIGHT CURB IN SPANS 13 AND 14 IS DELAMINATED, SURFACE SPALLED 10' LONG X 8" WIDE X UP TO 2" DEEP | |

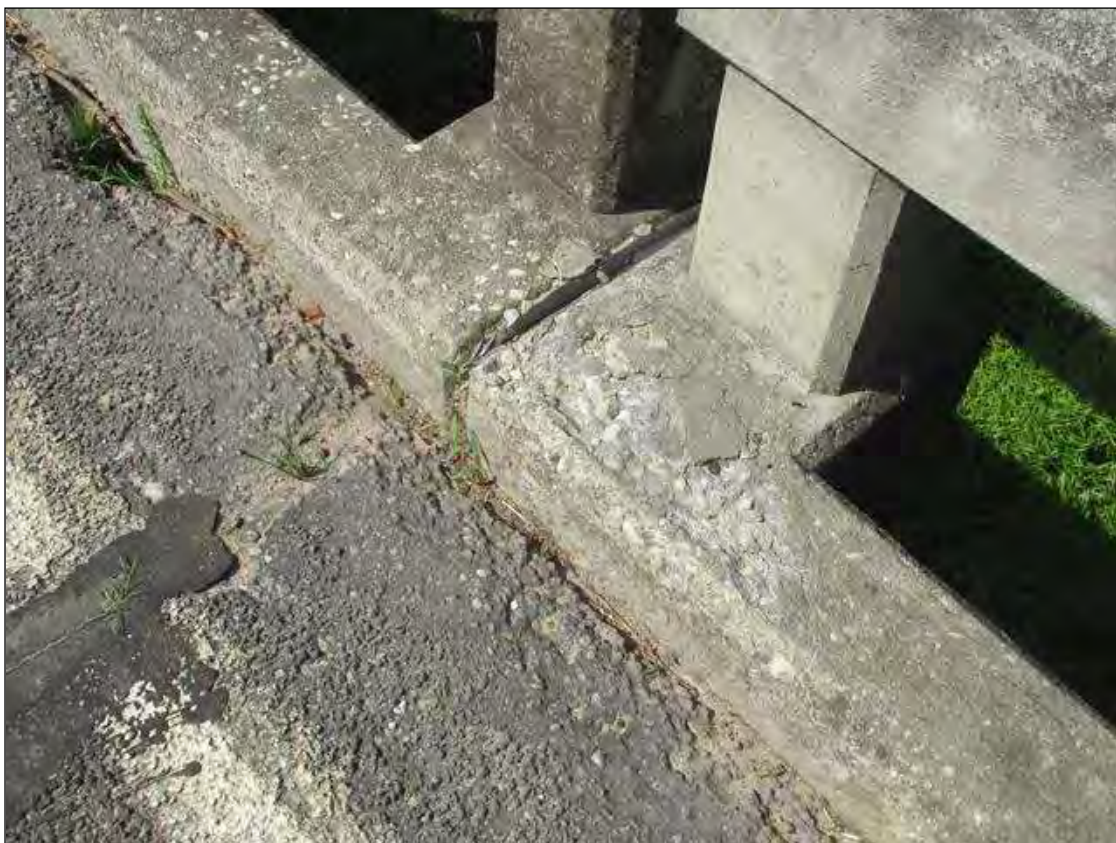
LEFT CURB IN SPAN 15 IS SURFACE SPALLED 16" LONG X 8" WIDE X 1" DEEP

| MMS Code | Description of Function | Unit | Quantity | Remarks | Est. Cost |
|---|---|---|---|---|---|
| 3326 | Maintain Concrete Deck | SF | 1 | LEFT CURB IN SPAN 15 IS SURFACE SPALLED 16" LONG X 8" WIDE X 1" DEEP | |

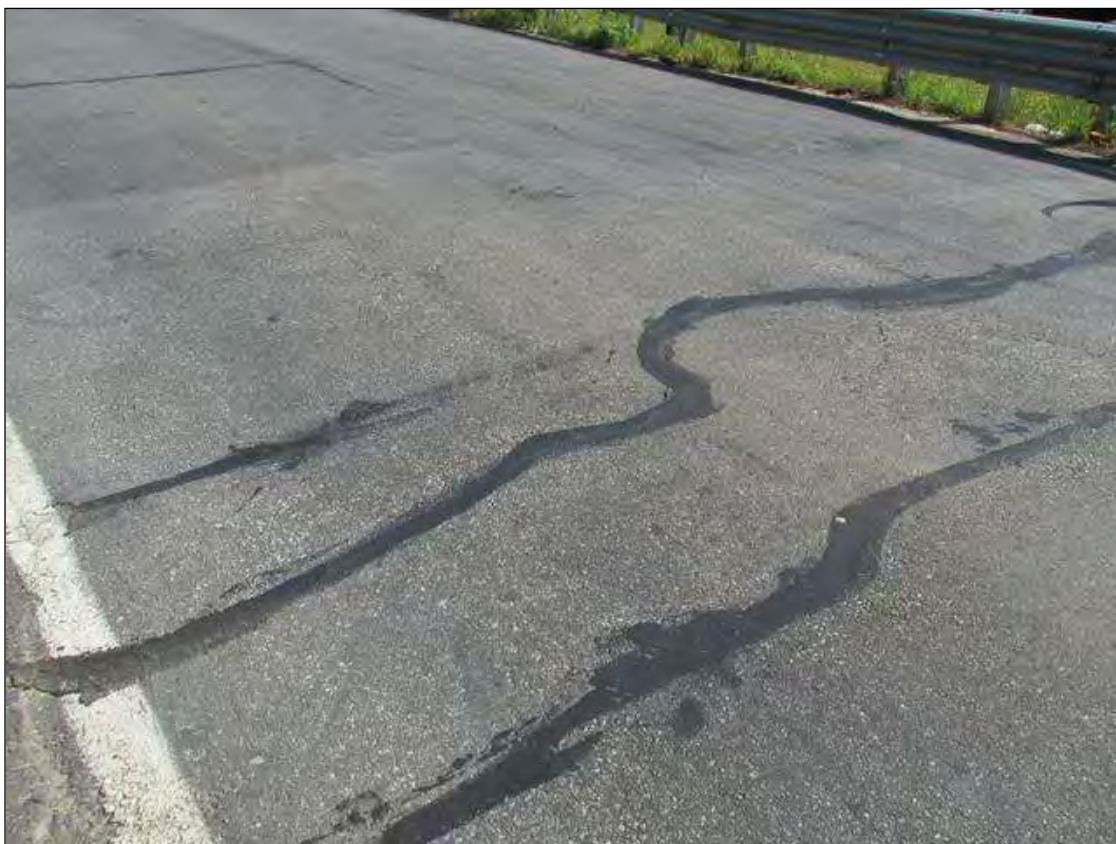
NORTH APPROACH ASPHALT WEARING SURFACE CRACKS ARE SEALED, ASPHALT WEARING SURFACE IS ROUGH AND UNEVEN

| MMS Code | Description of Function | Unit | Quantity | Remarks | Est. Cost |
|---|---|---|---|---|---|
| 2816 | Asphalt Surface Repair or Replacement | SY | 3 | NORTH APPROACH ASPHALT WEARING SURFACE CRACKS ARE SEALED, ASPHALT WEARING SURFACE IS ROUGH AND UNEVEN | |

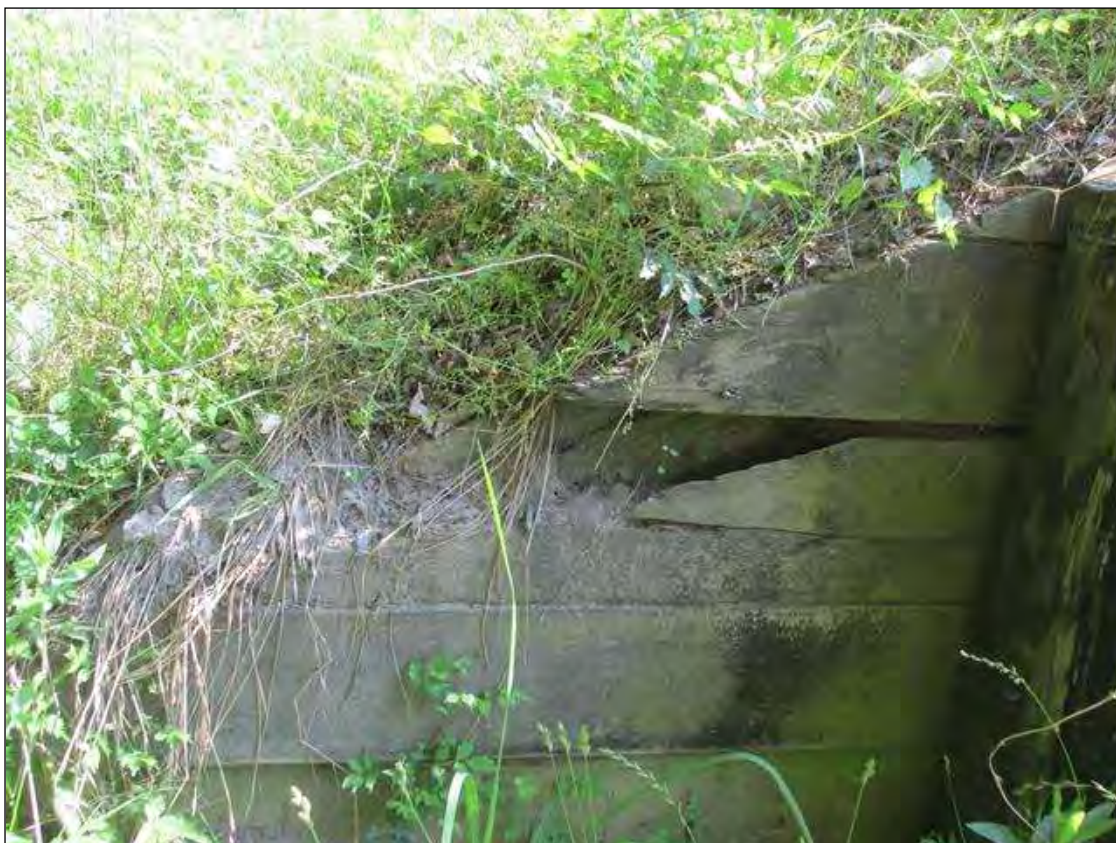
NORTHWEST CORNER WINGWALL BOARD IS DECAYED

| MMS Code | Description of Function | Unit | Quantity | Remarks | Est. Cost |
|---|---|---|---|---|---|
| 3346 | Repair / Maintain Timber Wings & Blkhds | SF | 3 | NORTHWEST CORNER WINGWALL BOARD IS DECAYED | |

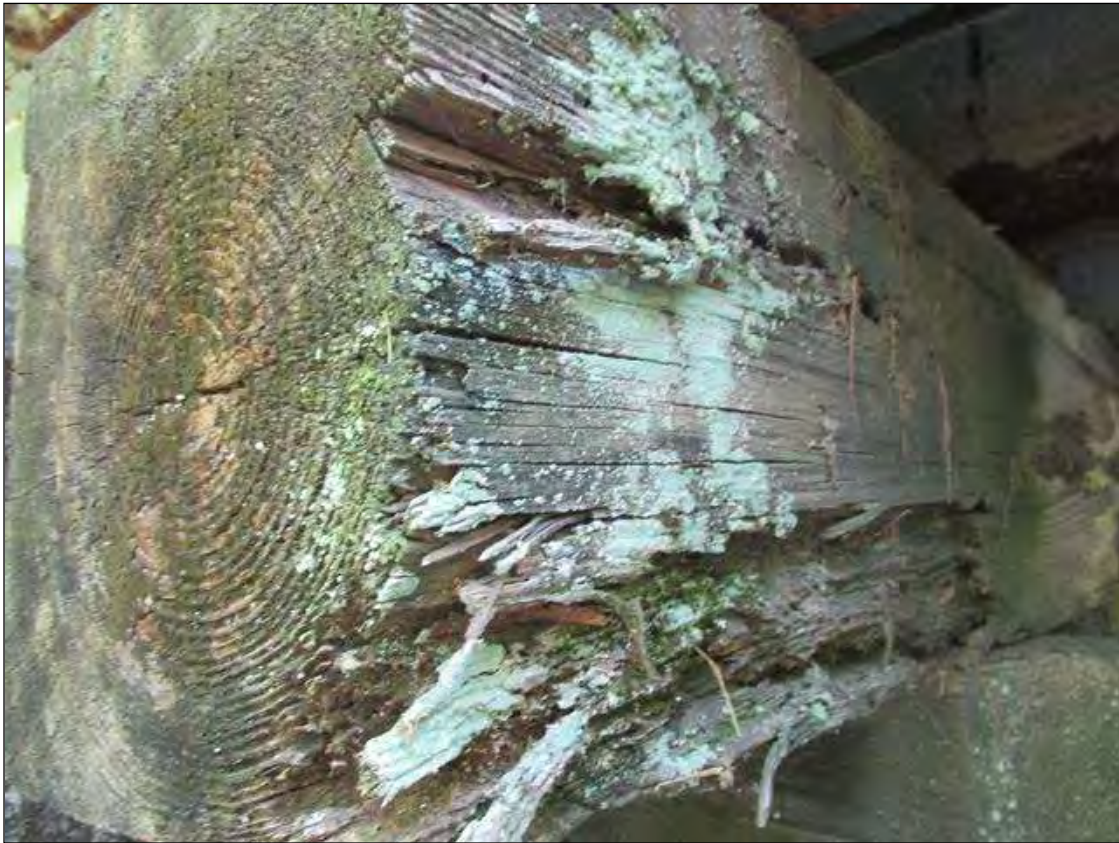
| Bridge I&A Form 1(82)H<br>State of North Carolina<br>Dept. of Transportation<br>Division of Highways | | <h1>FIELD INSPECTION REPORT</h1> <p><u>Bridge Inspeccion &amp; Analysis</u></p> | |
|---|---|---|--|
| BENT 14 TIMBER CAP IS DECAYED 2' LONG X 8" HIGH X 1" DEEP. (PHOTO) | | | |

BENT 14 TIMBER CAP IS DECAYED 2' LONG X 8" HIGH X 1" DEEP

| MMS Code | Description of Function | Unit | Quantity | Remarks | Est. Cost |
|---|---|---|---|---|---|
| 3344 | Repair / Replace Timber Substructure Components | LF | 2 | BENT 14 TIMBER CAP IS DECAYED 2' LONG X 8" HIGH X 1" DEEP | |

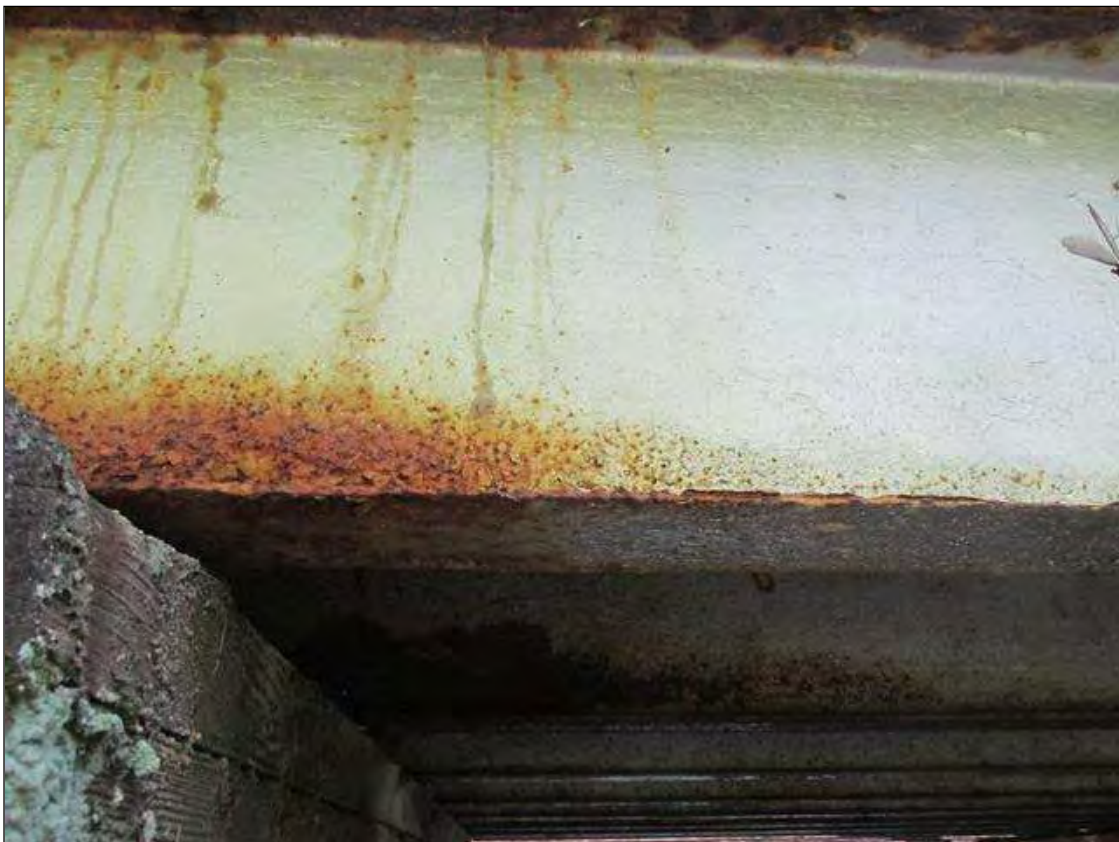
BEAM 1 AT BENT 14 HAS RUST WITH SECTION LOSS 2' LONG WITH 1/16" REMAINING ON BOTTOM FLANGE

| MMS Code | Description of Function | Unit | Quantity | Remarks | Est. Cost |
|---|---|---|---|---|---|
| 3314 | Maintain Steel Superstructure Components | LF | 2 | BEAM 1 AT BENT 14 HAS RUST WITH SECTION LOSS 2' LONG WITH 1/16" REMAINING ON BOTTOM FLANGE | |
