NC DEPARTMENT OF TRANSPORTATION  
DIVISION OF HIGHWAYS  
BRIDGE MANAGEMENT UNIT

# BRIDGE INSPECTION REPORT

INSPECTION TYPE: Routine Inspection

COUNTY ROBESON BRIDGE NUMBER 770059 INSPECTION CYCLE 2 YRS  
ROUTE SR1924 ACROSS BIG MARSH SWAMP M.P. 0

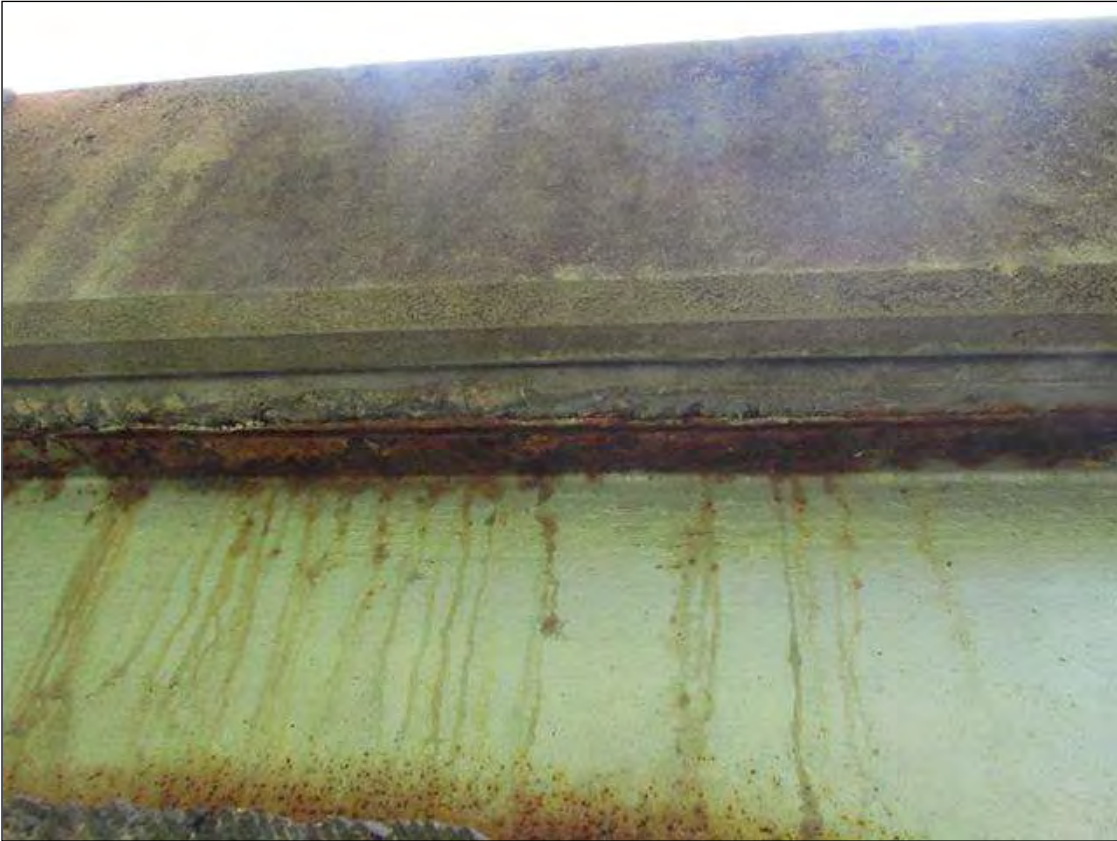
BEAM 1 TOP FLANGE AT BENT 14 HAS RUST AND UP TO 1/8" SECTION LOSS 3' LONG WITH 1/8" REMAINING

| MMS Code | Description of Function | Unit | Quantity | Remarks | Est. Cost |
|---|---|---|---|---|---|
| 3314 | Maintain Steel Superstructure Components | LF | 3 | BEAM 1 TOP FLANGE AT BENT 14 HAS RUST AND UP TO 1/8" SECTION LOSS 3' LONG WITH 1/8" REMAINING | |

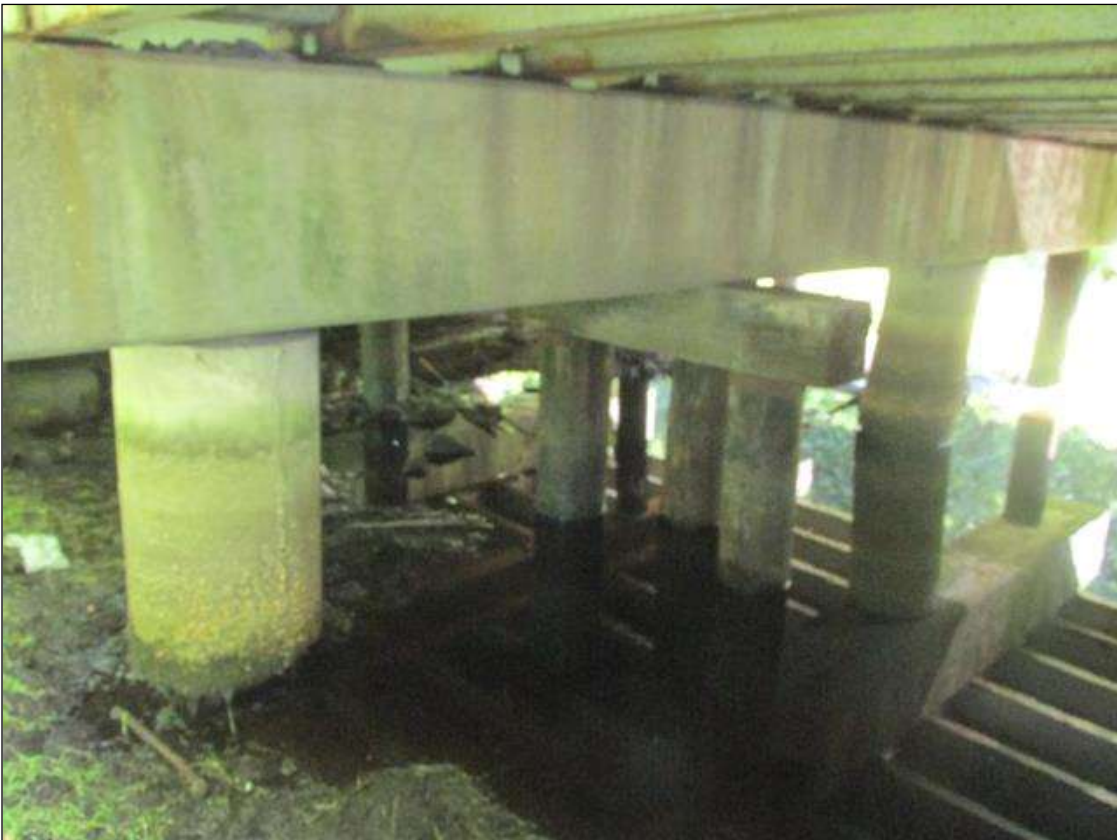
BENT 17 PILES 1 AND 3 ENCASED, TEMP REPAIRS

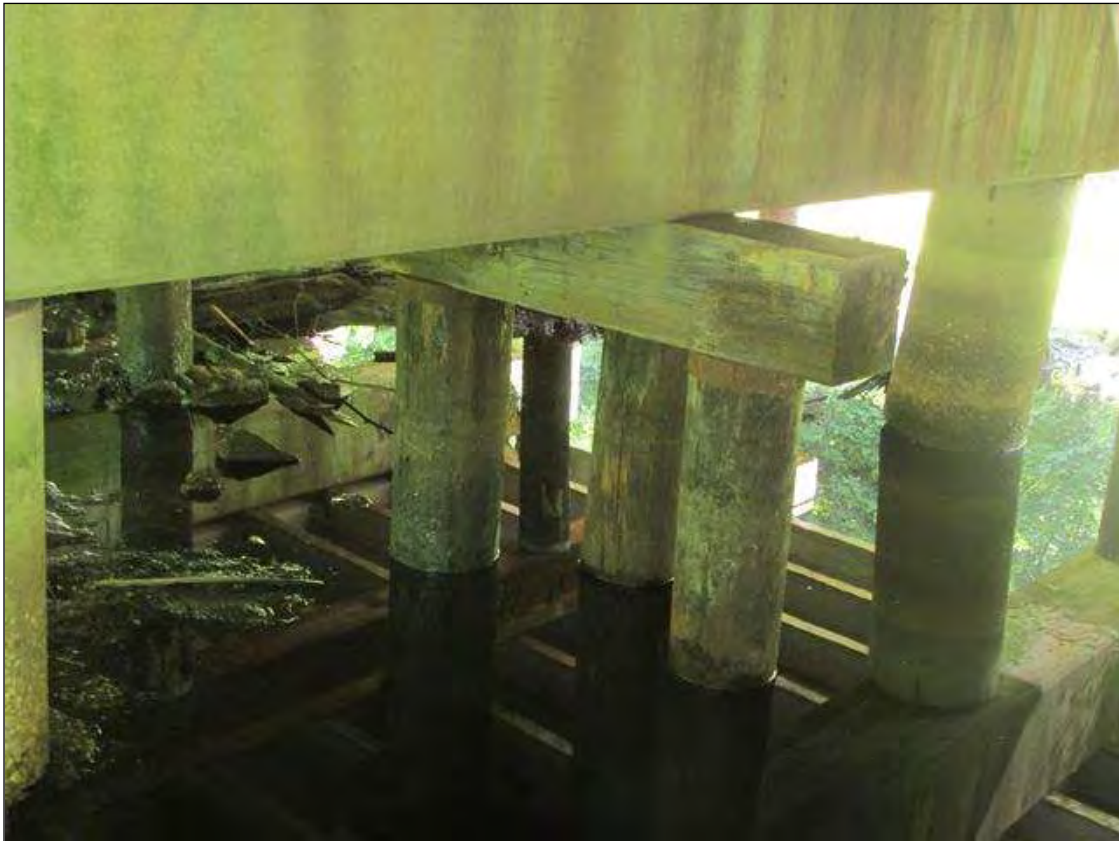
BENT 17 PILE 2 HAS TIMBER CROSSCAP CRUTCHBENT LEFT OF ORIGINAL PILE, TEMP REPAIR

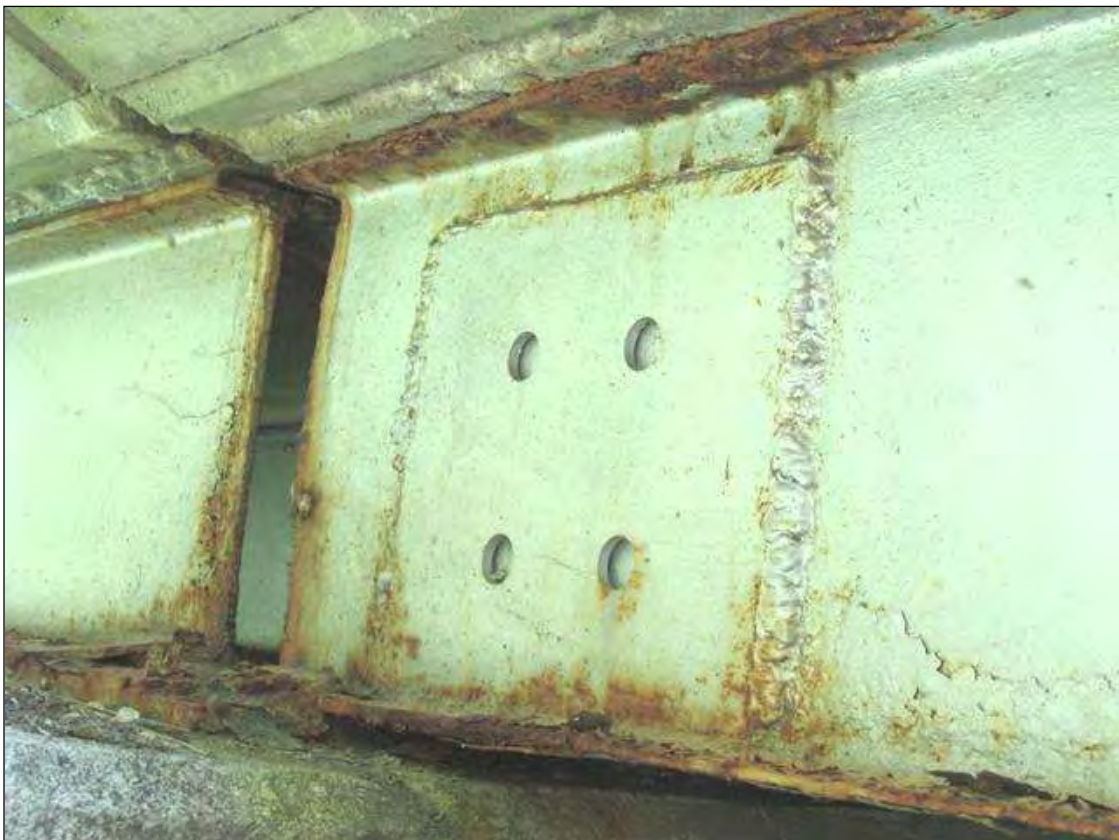
BEAM 1 AT BENT 17 TEMP REPAIR

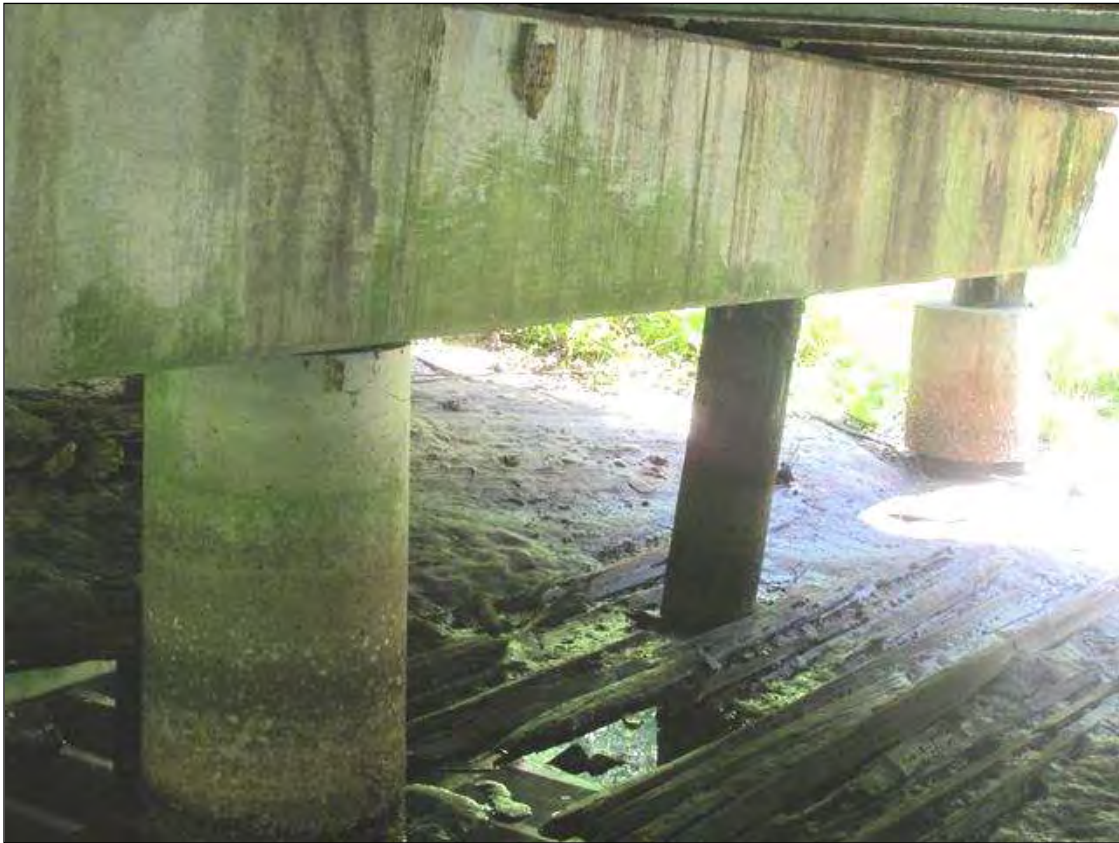
BENT 18 PILES 2 AND 4 ENCASED, TEMP REPAIR

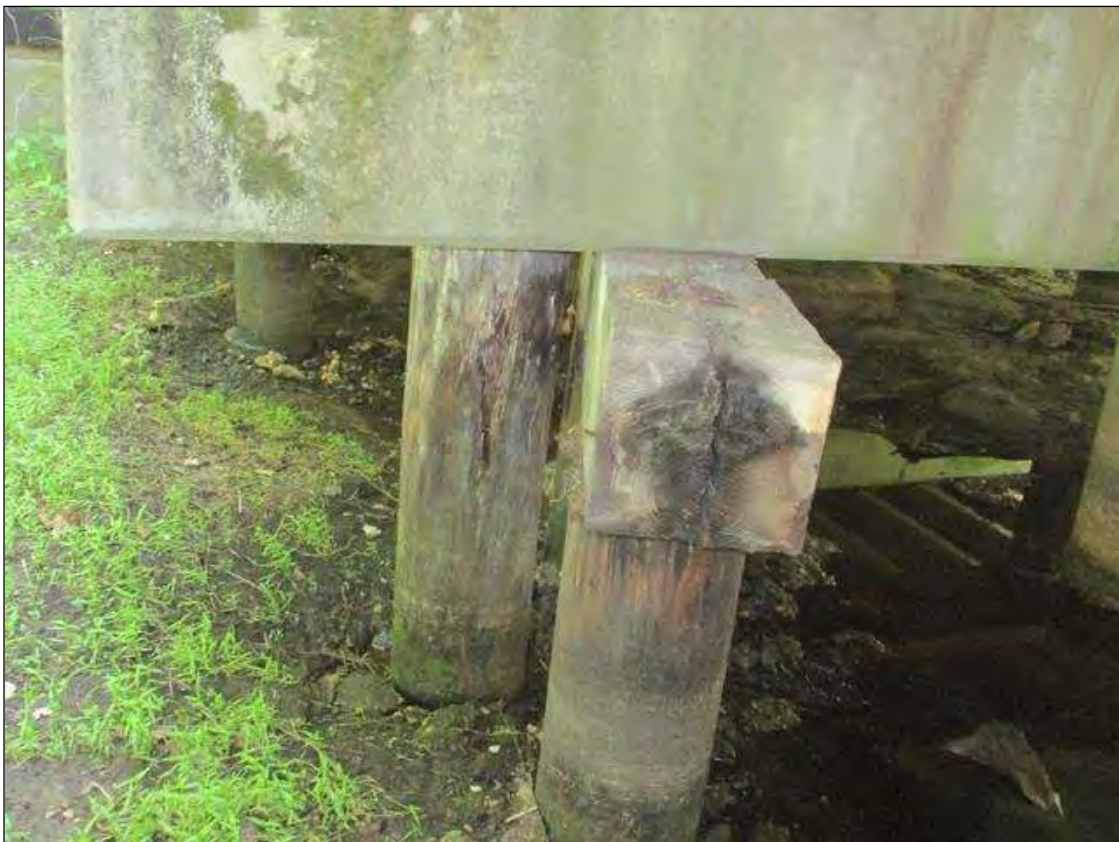
BENT 18 PILE 1 HAS TIMBER CROSSCAP CRUTCHBENT RIGHT OF ORIGINAL PILE, TEMP REPAIR

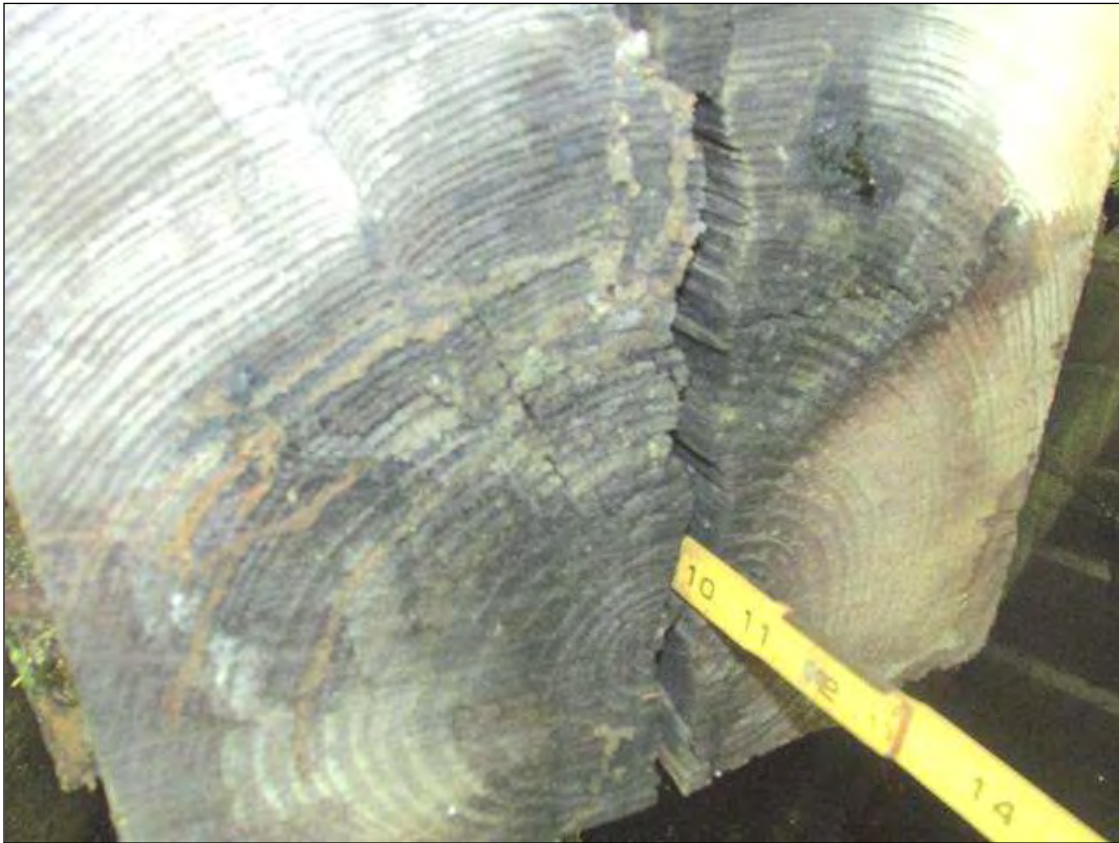
BENT 18 PILE 1 CRUTCHBENT CAP IS SPLIT 1/2" WIDE X 10" DEEP ON SOUTH END

| MMS Code | Description of Function | Unit | Quantity | Remarks | Est. Cost |
|---|---|---|---|---|---|
| 3344 | Repair / Replace Timber Substructure Components | LF | 6 | BENT 18 PILE 1 CRUTCH CAP IS SPLIT 1/2" WIDE X 10" DEEP ON SOUTH END | |

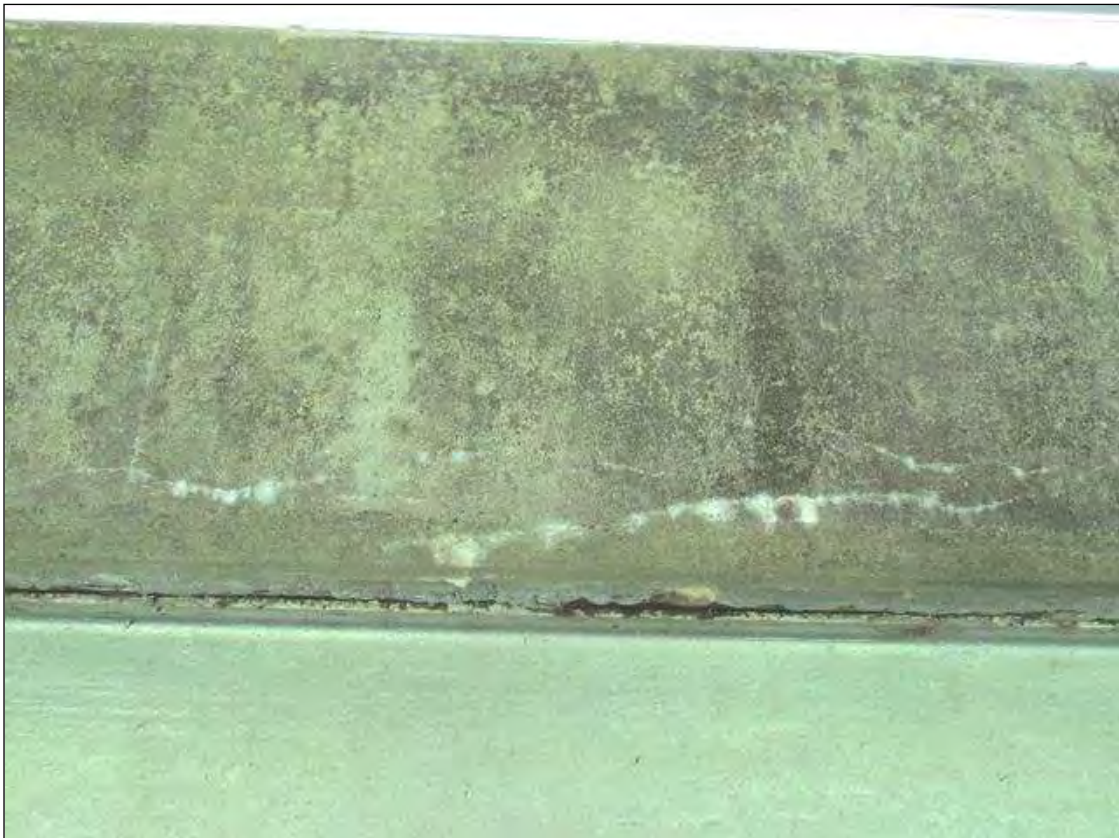
HAIRLINE HORIZONTAL CRACK WITH EFFLORESCENCE IN LEFT DECK OVERHANG AT BENT 19

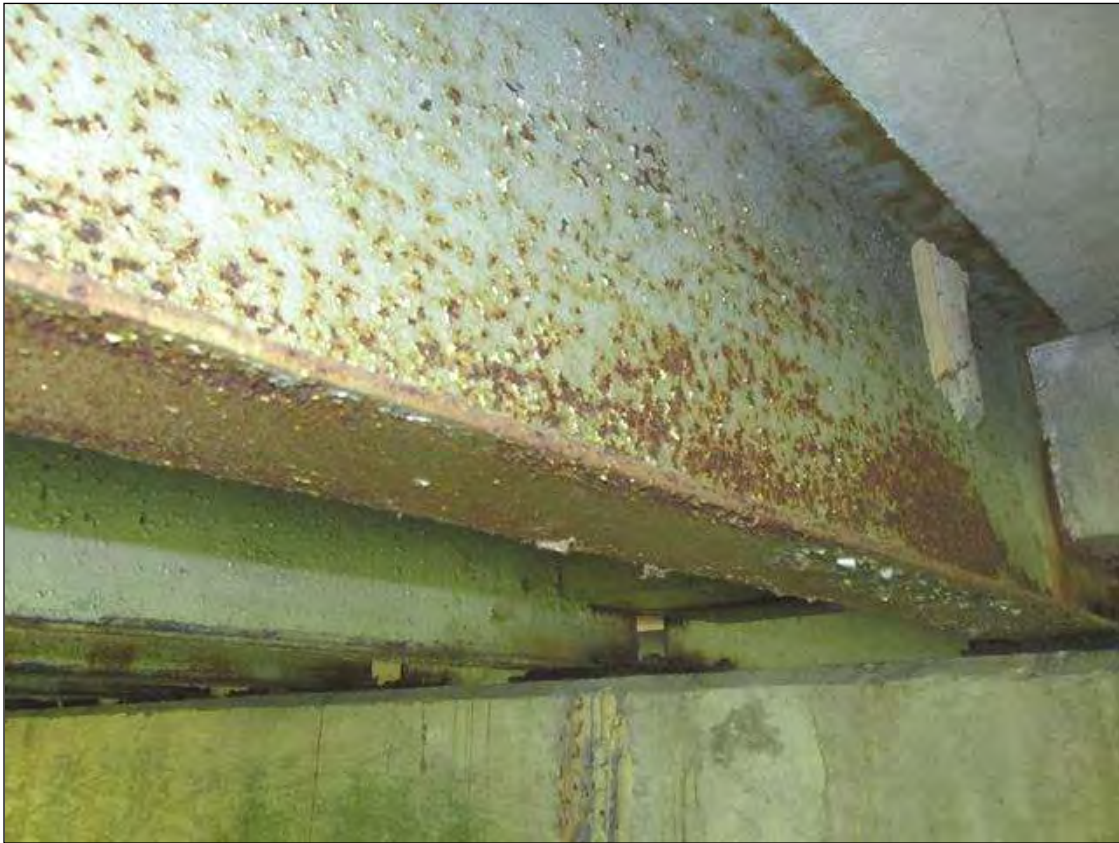
PAINT PEELING AND RUST IN SPAN 19 BEAMS, ALL SPANS ARE SIMILAR

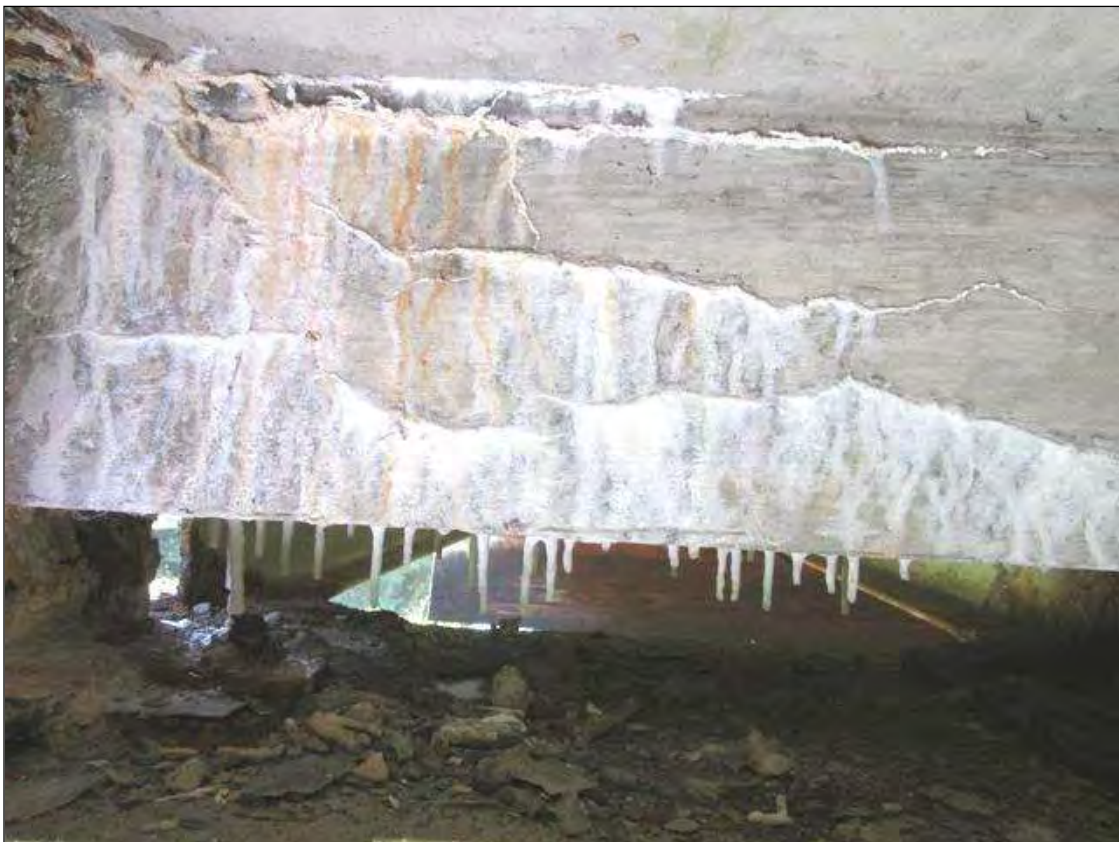
SPAN 19 BAY 11 END DIAPHRAGM HAS CRACKING WITH EFFLORESCENCE

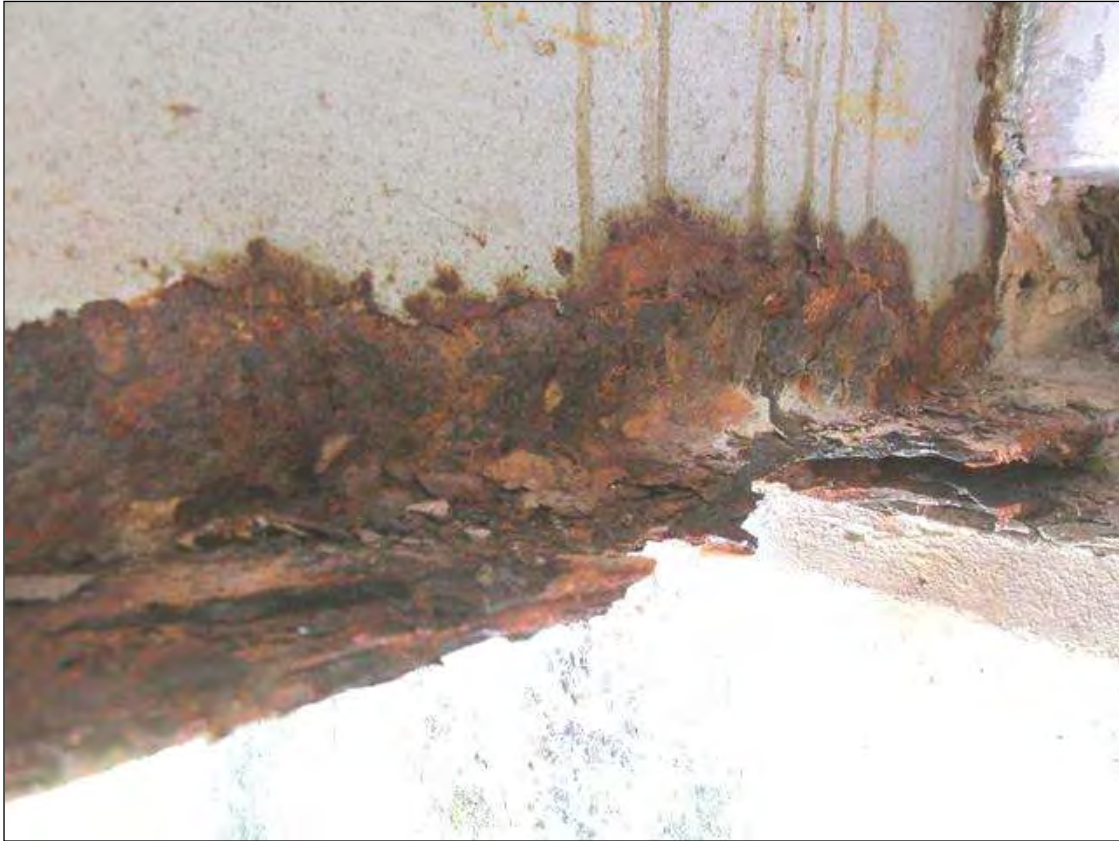
| 10 | F | <p>( STEEL BEAMS ) BEAM 12 BAY 11 SIDE AT SPAN 19 RUST , SECTION LOSS 6" L X 1 1/2" W AT 12" FROM BEAM END IN FLANGE, 1/8" LOSS IN WEB 12" L X UP TO 3" H. (PHOTO) PM ISSUED.</p> <p>BEAM 12 IN SPAN 7 BAY 11 SIDE HAS PAINT PEELING AND RUST WITH 1/16" SECTION LOSS IN TOP AND BOTTOM FLANGE AT DECK DRAIN. (PHOTO)</p> <p>BEAM 1 AT BENT 14 HAS RUST WITH SECTION LOSS 2' LONG WITH 1/16" REMAINING ON BOTTOM FLANGE. (PHOTO)</p> <p>BEAM 1 TOP FLANGE AT BENT 14 HAS RUST AND UP TO 1/8" SECTION LOSS 3' LONG WITH 1/8" REMAINING. (PHOTO)</p> <p>BEAM 1 AT BENT 17 TEMP REPAIR. (PHOTO)</p> <p>THE BOTTOM FLANGE RIGHT SIDE BEAM 12 AT BENT 16 HAS UP TO 1/8" SECTION LOSS 18" LONG.</p> <p>THE BOTTOM AND TOP FLANGE BEAM 11 BENT 5 RUSTING WITH 1/8" SECTION LOSS 20" LONG.</p> <p>BEAM 11 AT BENT 16, IN SPAN 17 SECTION LOSS IN BOTTOM FLANGE 2" LONG X 1" WIDE AT BEARING AREA.</p> <p>BEAM 12 AT BENT 16 IN SPAN 17 BAY 12 SIDE HAS UP TO 1/16" SECTION LOSS IN WEB, AND 1/8" BOTTOM FLANGE SECTION LOSS 18" LONG.</p> <p>BEAM 12 IN SPAN 8 AT BENT 9 RUST WITH SECTION LOSS IN BOTTOM FLANGE 6" FROM BEAM END OUT 2" LONG X 1" WIDE.</p> <p>BEAM 11 AT BENT 5 BOTH FLANGES RUSTED WITH 1/16" SECTION LOSS IN WEB, 1/8" LOSS IN FLANGES UP TO 18" LONG.</p> <p>BEAM 1 IN SPAN 13, AT BENT 13 BOTTOM FLANGE WITH SECTION LOSS UP TO KNIFES EDGE 20" LONG AT 3' FROM BENT 13.</p> <p>BEAM 12 SPAN 18 AT THE BOTTOM FLANGE IS DEFORMED IN 3 PLACES UP TO 3/4" HIGH X 2" LONG.</p> <p>BEAM 12 IN SPAN 14 HAS BEEN REPLACED.</p> <p>BEAM 1 AT BENT 18, SPAN 18 IS REPAIRED.</p> | |

| Bridge I&A Form 1(82)H<br>State of North Carolina<br>Dept. of Transportation<br>Division of Highways | | <h1>FIELD INSPECTION REPORT</h1> <p><u>Bridge Inspection &amp; Analysis</u></p> | |
|---|---|---|--|
| 61 | YES | <p>( PM ISSUED ) FOR DECAYED BULKHEAD AT END BENT 1 WITH FILL LEAKAGE, AND BEAM 12 IN SPAN 19 WITH SECTION LOSS.</p> | |

BEAM 12 BAY 11 SIDE AT SPAN 19 RUST , SECTION LOSS 6" L X 1 1/2" W AT 12" FROM BEAM END IN FLANGE,  
1/8" LOSS IN WEB 12" L X UP TO 3" H

| MMS Code | Description of Function | Unit | Quantity | Remarks | Est. Cost |
|---|---|---|---|---|---|
| 3314 | Maintain Steel Superstructure Components | LF | <del>2</del> TSE | BEAM 12 BAY 11 SIDE AT SPAN 19 RUST, SECTION LOSS 6" L X 1 1/2" W AT 12" FROM BEAM END IN FLANGE, 1/8" LOSS IN WEB 12" L X UP TO 3" H | |

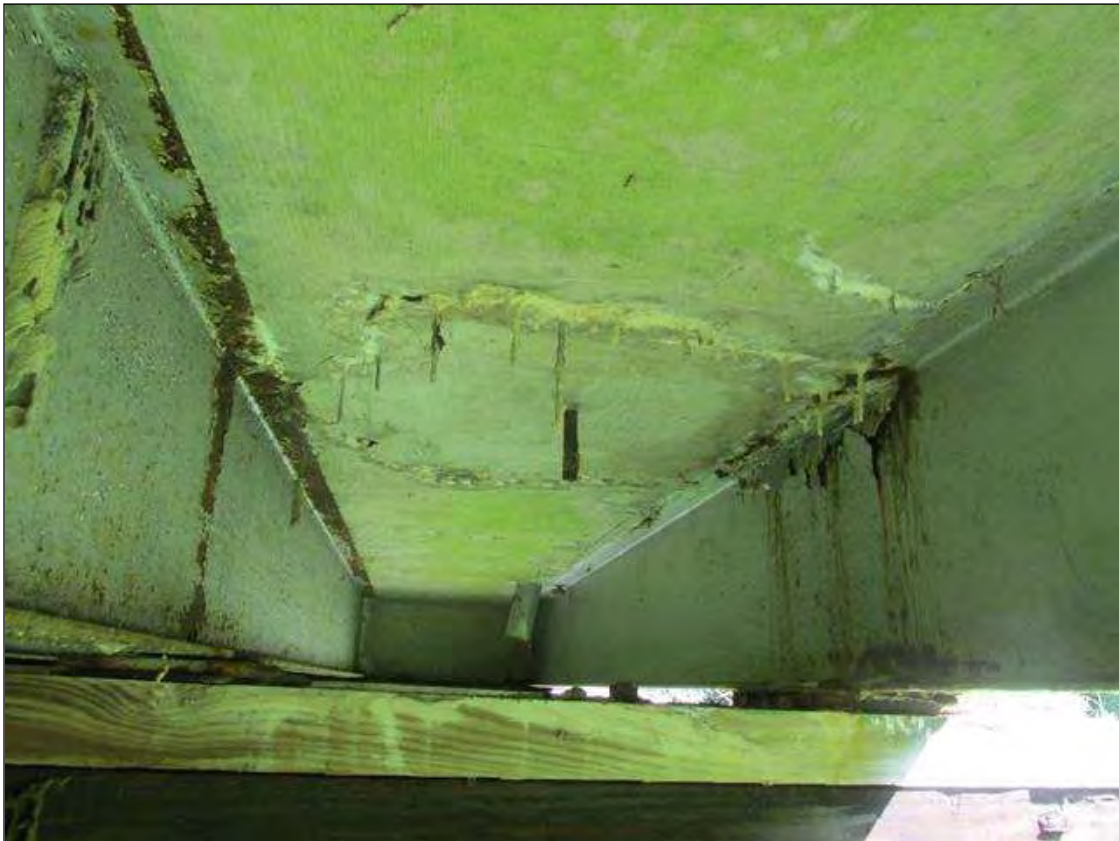
EFFLORESCENCE LEAKAGE IN DECK OVER BENT 19 PILE 4 PATCH

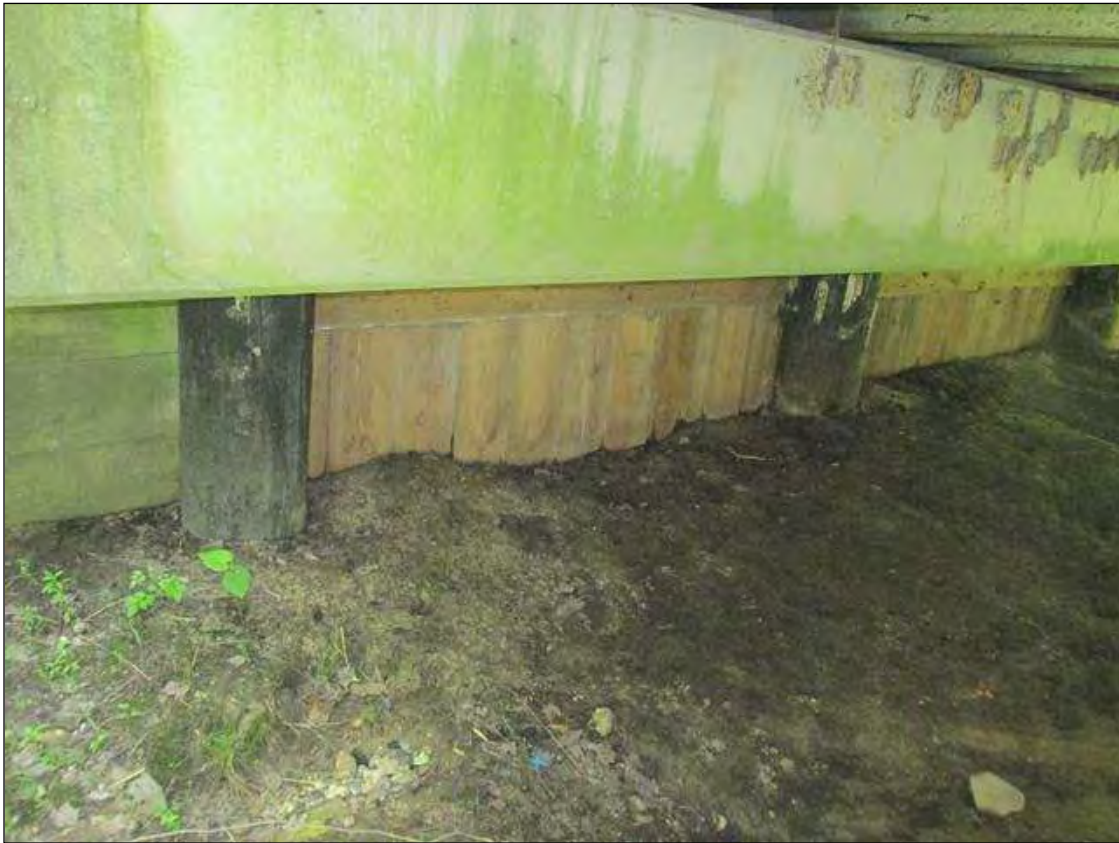
THERE ARE VERTICAL SCAB BOARDS AT END BENT 2 BULKHEAD

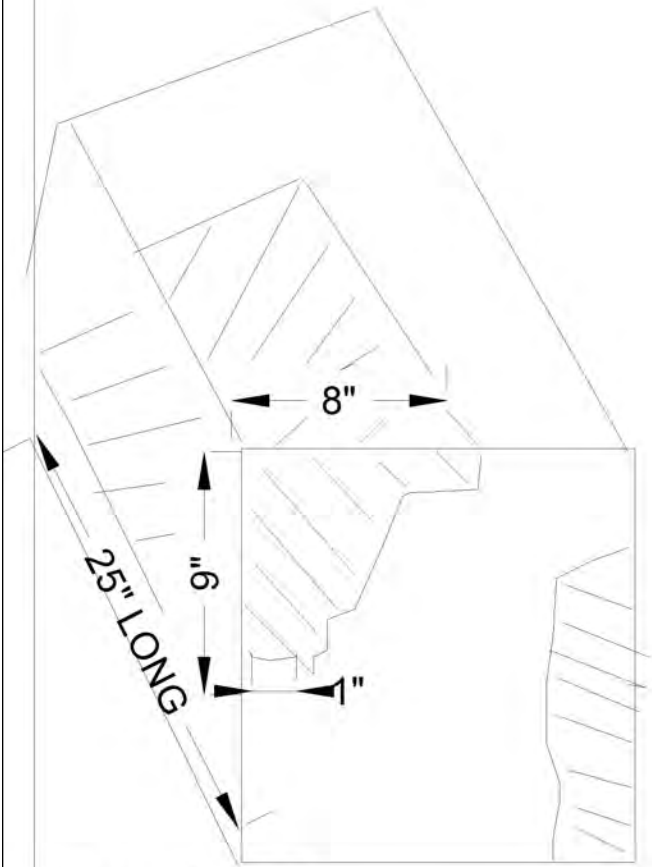
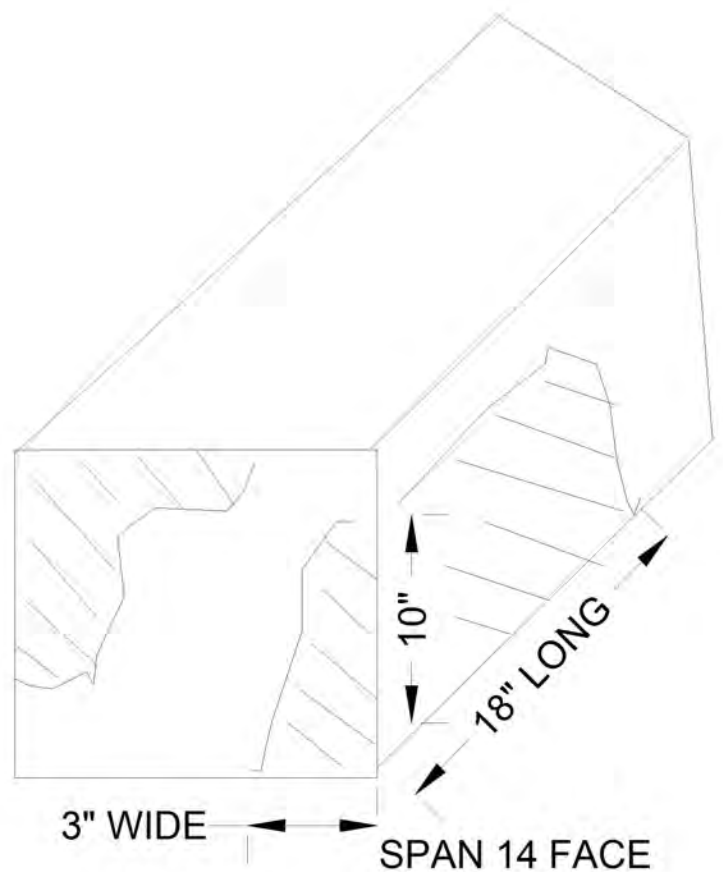
| Title | | Description | |
|---|---|---|---|
| BENT 13 CAP DECAY EAST END | | DECAYED SECTION | |

| Bridge I&A Form 1(82)H<br>State of North Carolina<br>Dept. of Transportation<br>Division of Highways | | <h1>FIELD INSPECTION REPORT</h1> <p><u>Bridge Inspeccion &amp; Analysis</u></p> | |
|---|---|---|--|
| | | THE BENT 13 TIMBER CAP IS DECAYED RIGHT END, SPAN 13 FACE 24" LONG X 9 1/2" HIGH X UP TO 8" WIDE. (PHOTO) ALSO SEE SKETCH. | |
| | | THE BENT 13 CAP AT LEFT END ON SPAN 13 FACE IS DECAYED 24" LONG X 8" HIGH X 1 1/2" DEEP. | |
| | | BENT 13 CAP, SPAN 14 FACE LEFT END IS DECAYED 5" HIGH X 22" LONG X 1 1/2" DEEP. | |
| | | THE BENT 13 CAP AT SOUTH END IS DECAYED. | |
