NC DEPARTMENT OF TRANSPORTATION  
DIVISION OF HIGHWAYS  
STRUCTURE MANAGEMENT UNIT

## Structure Safety Report

### Routine Element Inspection

COUNTY: ROBESON STRUCTURE NUMBER: 770135 FREQUENCY: 24 MONTHS

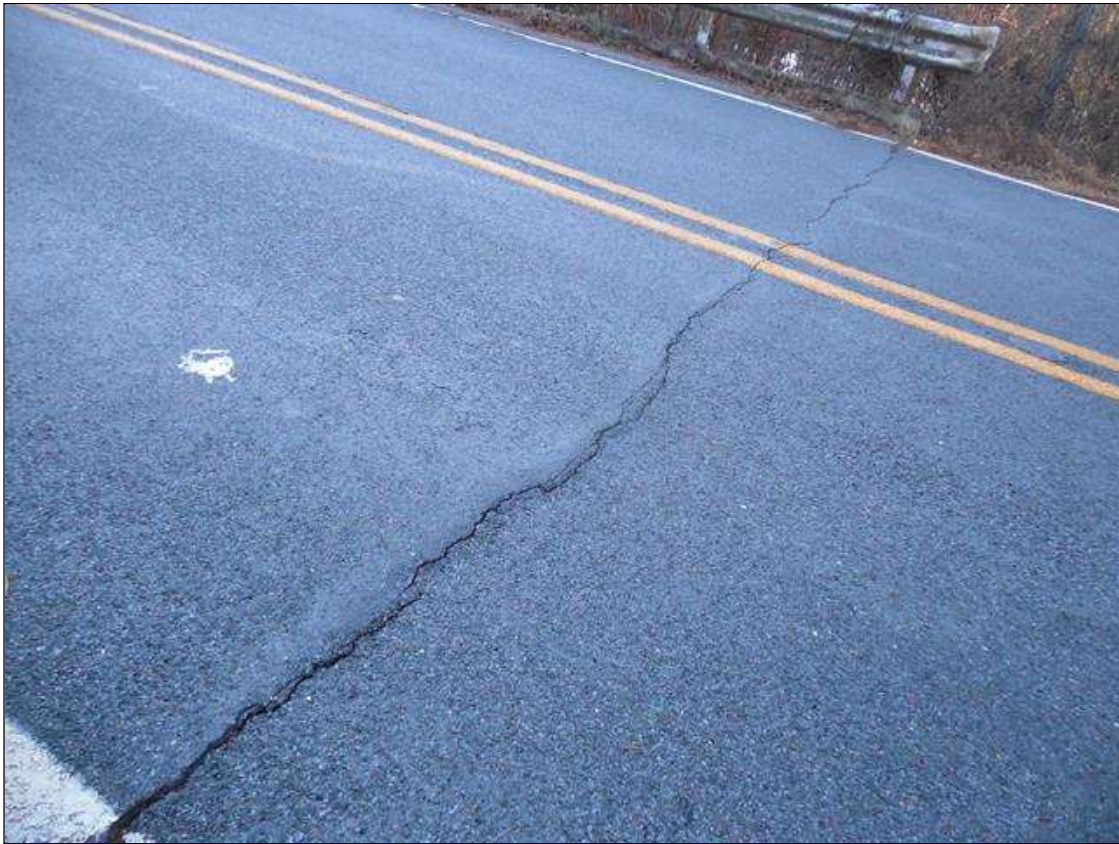
24 Square Feet of Crack (Wearing Surface): Width of more than 0.05 in. or spacing of less than 1.0 ft. 1/8" WIDE TRANSVERSE CRACK IN ASPHALT WEARING SURFACE OVER END BENT 1 WITH UP TO 1/2" SETTLEMENT  
80 Square Feet of Crack (Wearing Surface): Width of more than 0.05 in. or spacing of less than 1.0 ft. FOUR 20' LONG X 1/16" WIDE LONGITUDINAL CRACKS, 3 IN WEST BOUND LANE AND 1 IN EAST BOUND LANE AT CENTERLINE  
25 Square Feet of Crack (Wearing Surface): Width of more than 0.05 in. or spacing of less than 1.0 ft. 1/8" WIDE TRANSVERSE CRACK IN ASPHALT WEARING SURFACE OVER BENT 1

Span 1 Wearing Surface: 24 Square Feet of Crack (Wearing Surface): Width of more than 0.05 in. or spacing of less than 1.0 ft. 1/8" WIDE TRANSVERSE CRACK IN ASPHALT WEARING SURFACE OVER END BENT 1

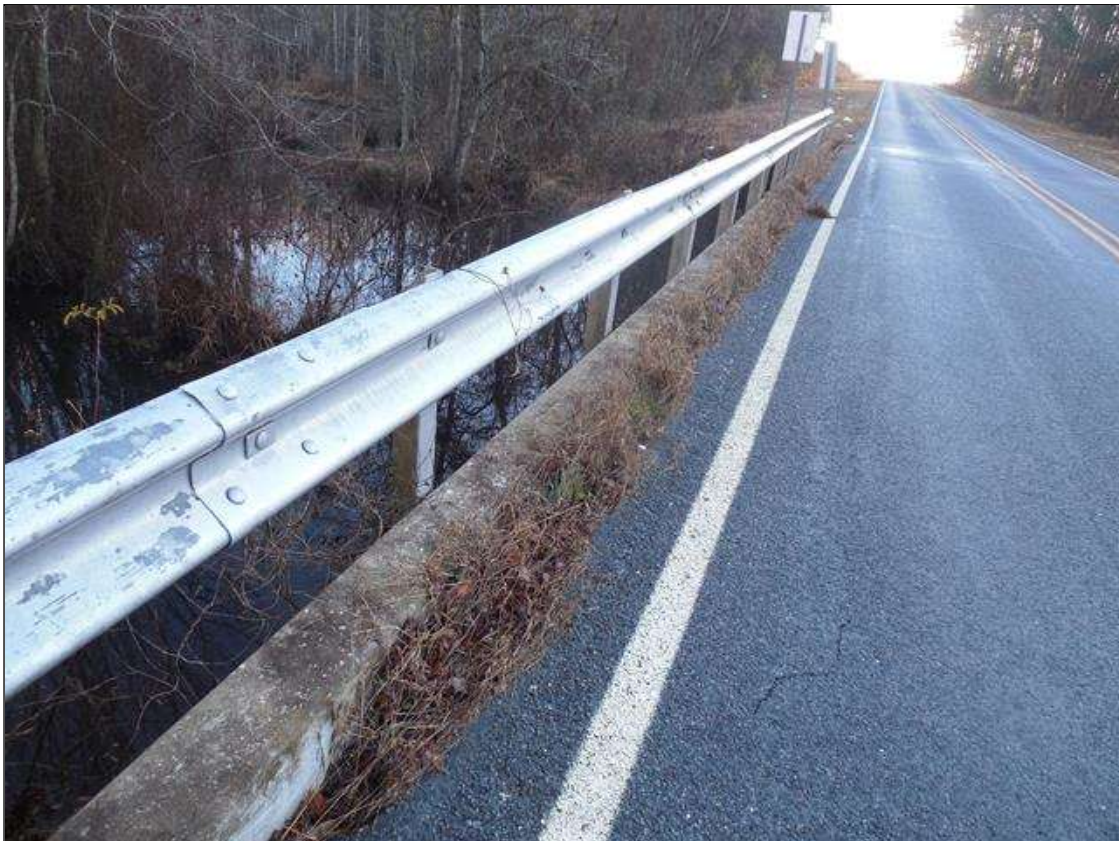
DEBRIS AND VEGETATION ALONG LEFT CURB

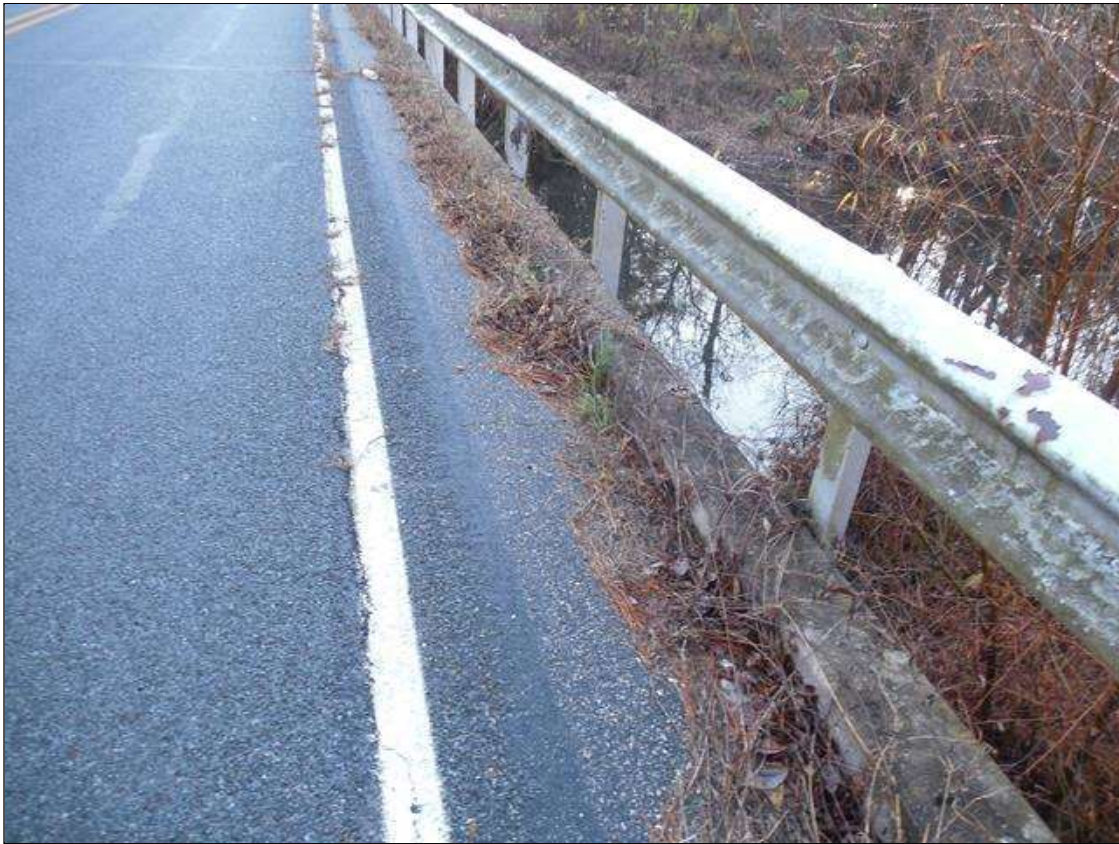
DEBRIS AND VEGETATION ALONG RIGHT CURB

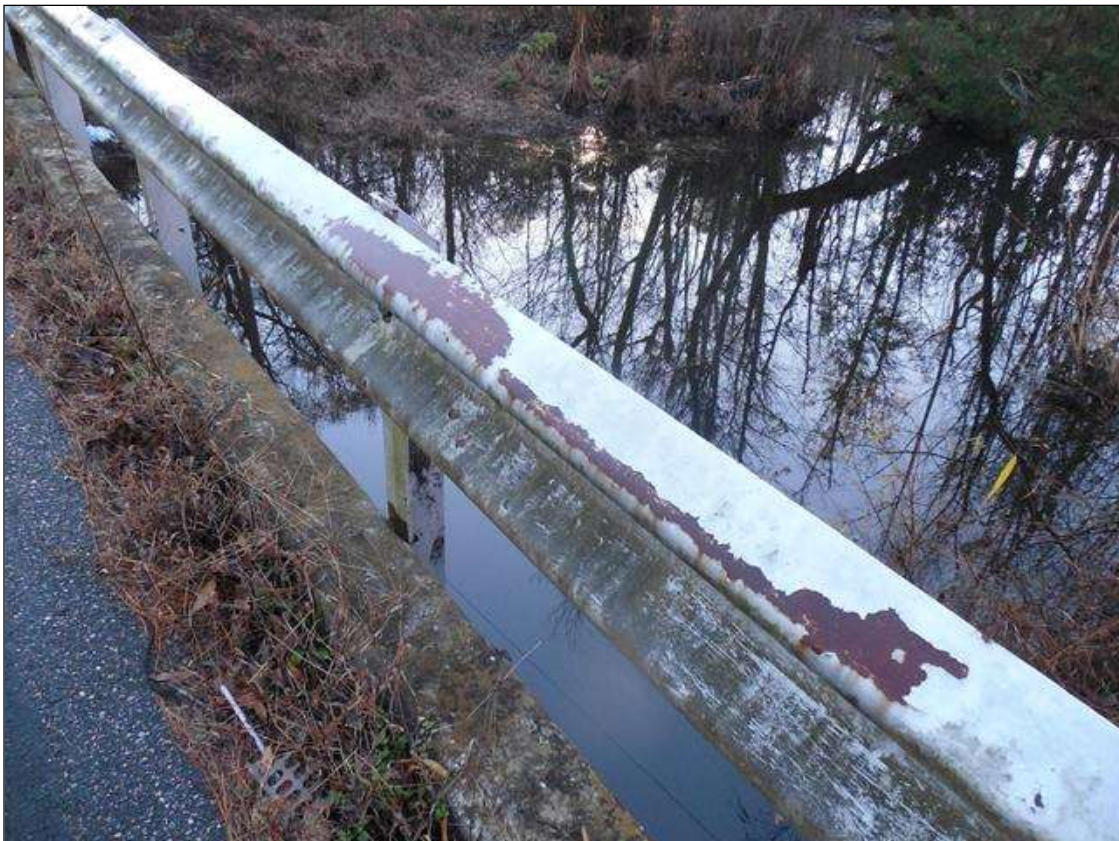
15 Square Feet of Peeling/Bubbling/Cracking (steel Protective Coatings): Finish coats only.

Span 1 Right Bridge Rail: 15 Square Feet of Peeling/Bubbling/Cracking (steel Protective Coatings): Finish coats only.

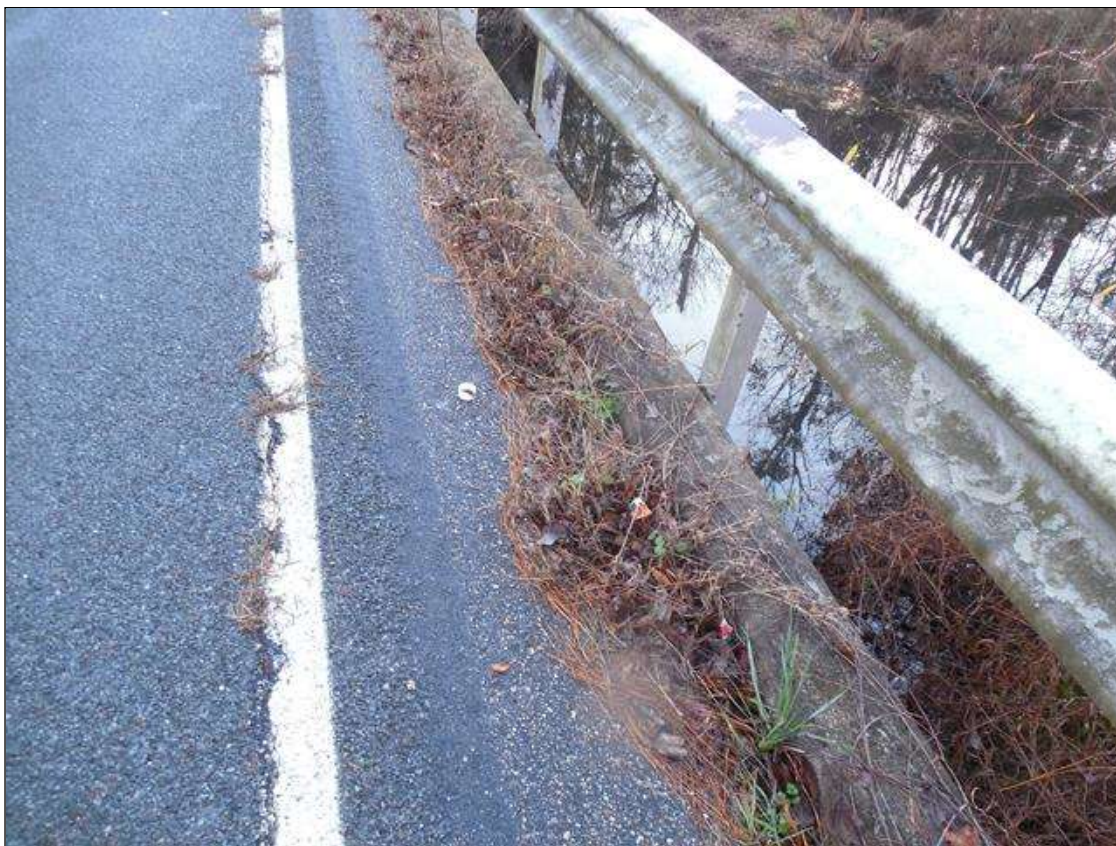
RIGHT SIDE DECK DRAINS BLOCKED BY DEBRIS

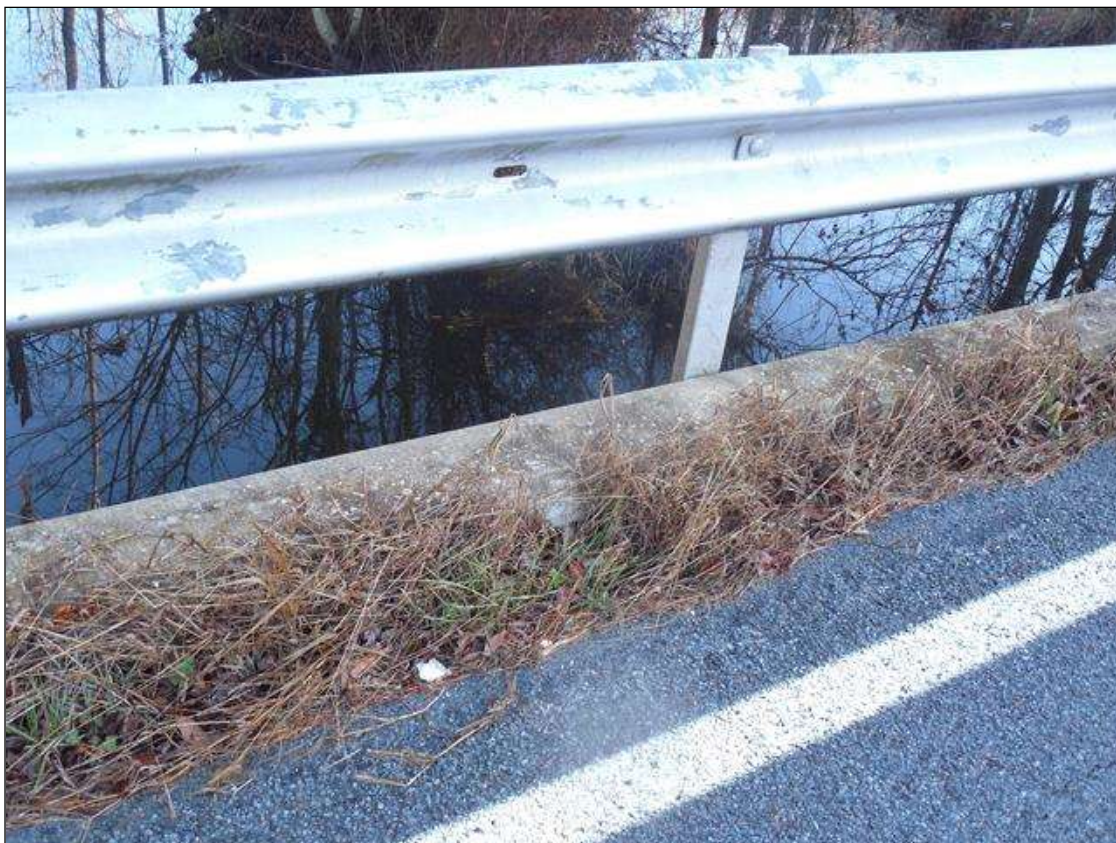
LEFT SIDE DECK DRAINS BLOCKED BY DEBRIS

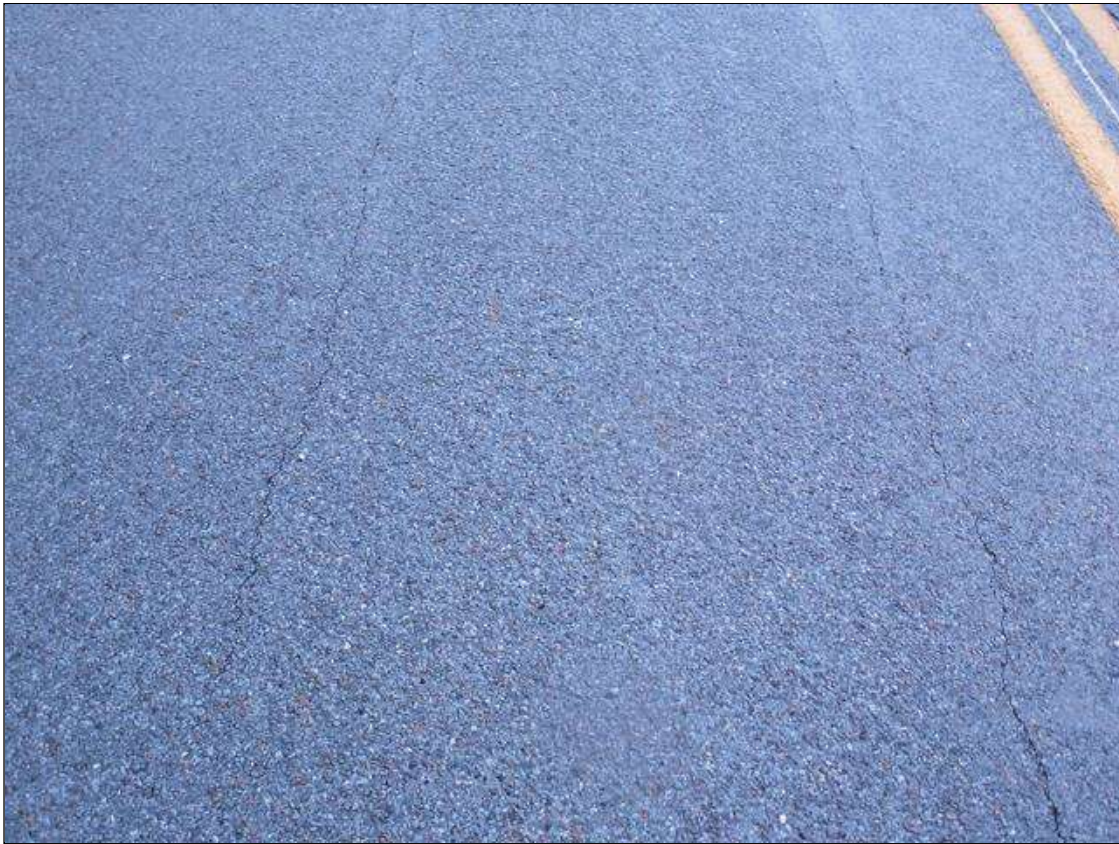
Span 1 Wearing Surface: 80 Square Feet of Crack (Wearing Surface): Width of more than 0.05 in. or spacing of less than 1.0 ft. FOUR 20' LONG X 1/16" WIDE LONGITUDINAL CRACKS, 3 IN WEST BOUND LANE AND 1 IN EAST BOUND LANE AT CENTERLINE

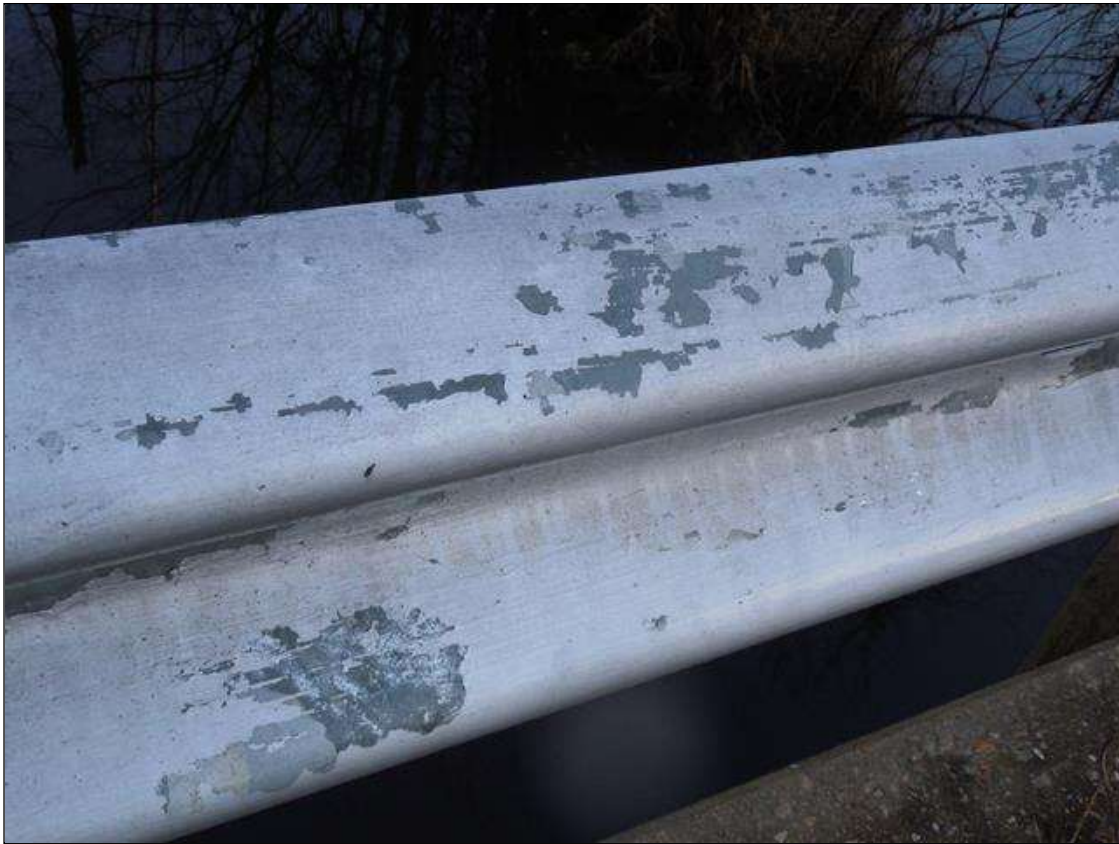
75 Square Feet of Peeling/Bubbling/Cracking (steel Protective Coatings): Finish and primer coats. PAINT PEELING IN RAIL

Span 1 Left Bridge Rail: 75 Square Feet of Peeling/Bubbling/Cracking (steel Protective Coatings): Finish and primer coats. PAINT PEELING IN RAIL

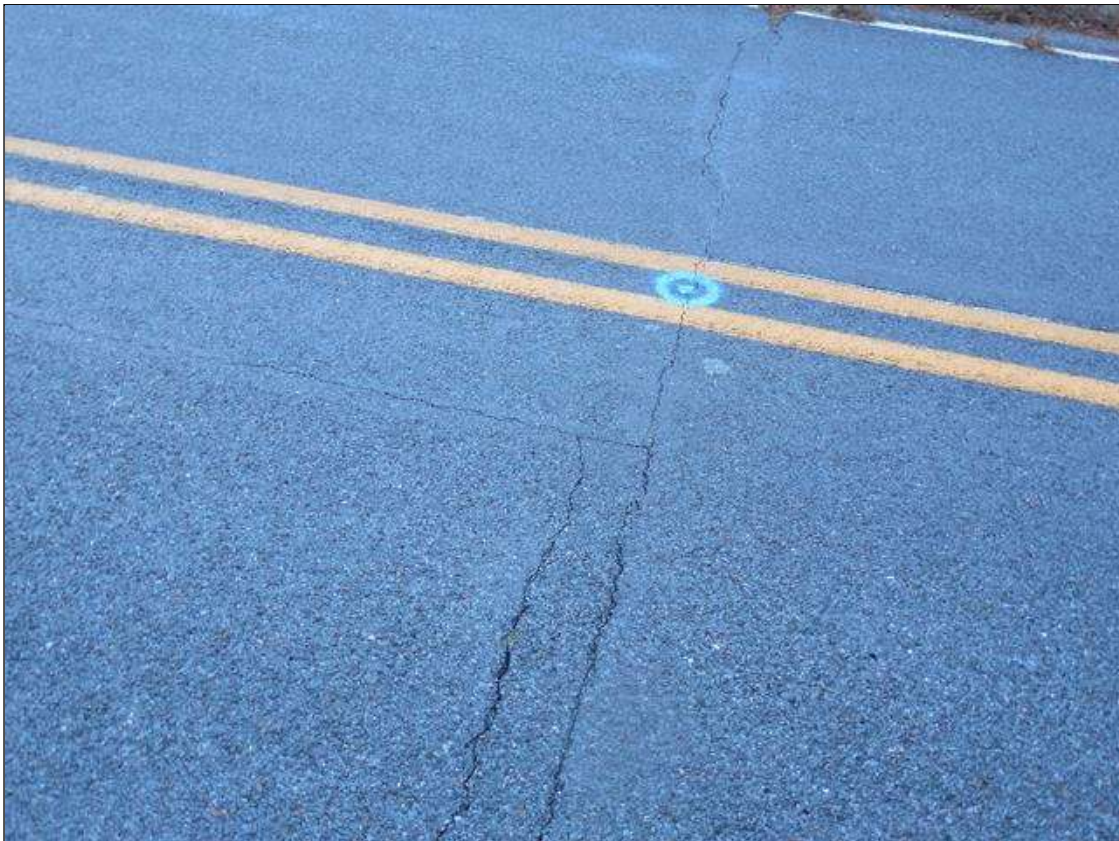
Span 1 Wearing Surface: 25 Square Feet of Crack (Wearing Surface): Width of more than 0.05 in. or spacing of less than 1.0 ft. 1/8" WIDE TRANSVERSE CRACK IN ASPHALT WEARING SURFACE OVER BENT 1

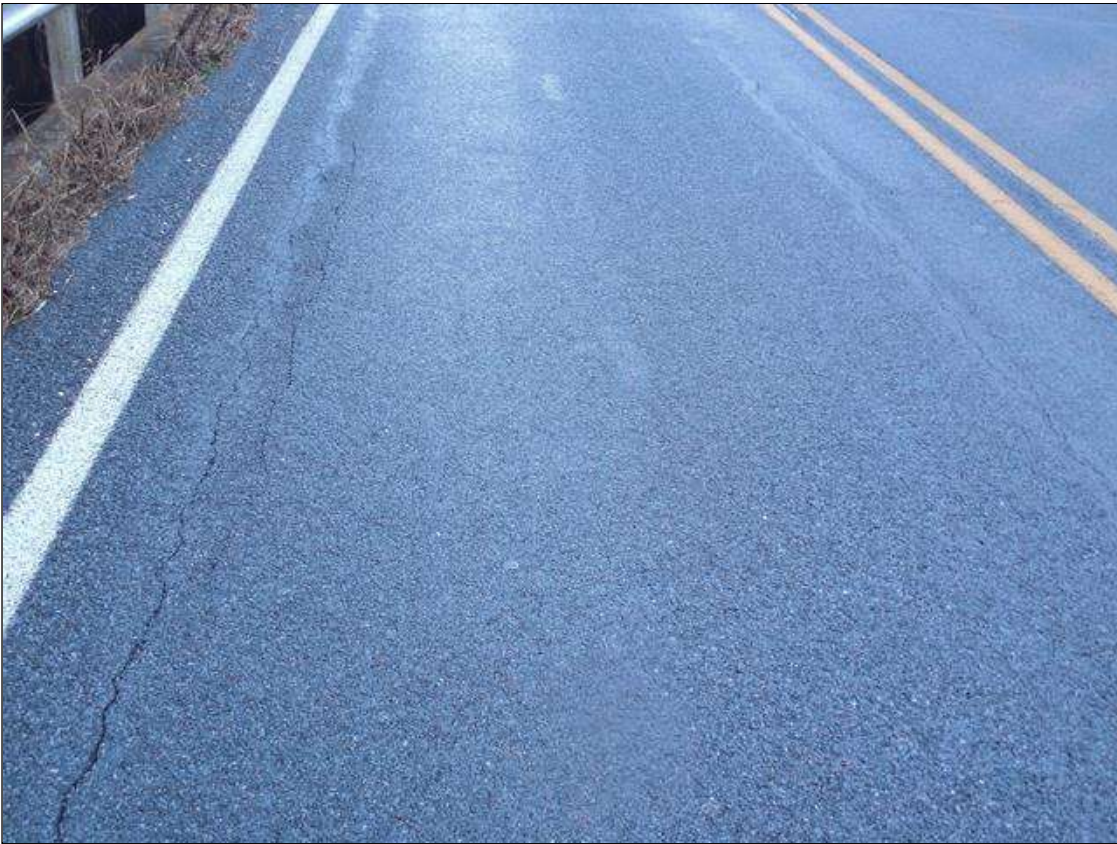
60 Square Feet of Crack (Wearing Surface): Width of more than 0.05 in. or spacing of less than 1.0 ft. TWO FULL SPAN LENGTH X 1/8" WIDE LONGITUDINAL CRACKS IN WEST BOUND LANE  
30 Square Feet of Crack (Wearing Surface): Width of more than 0.05 in. or spacing of less than 1.0 ft. 1/8" WIDE X 30' LONG LONGITUDINAL CRACK IN EAST BOUND LANE  
25 Square Feet of Crack (Wearing Surface): Width of more than 0.05 in. or spacing of less than 1.0 ft. 1/8" WIDE TRANSVERSE CRACK WITH 1/2" SETTLEMENT OVER END BENT 2

Span 2 Wearing Surface: 60 Square Feet of Crack (Wearing Surface): Width of more than 0.05 in. or spacing of less than 1.0 ft. TWO FULL SPAN LENGTH X 1/8" WIDE LONGITUDINAL CRACKS IN WEST BOUND LANE

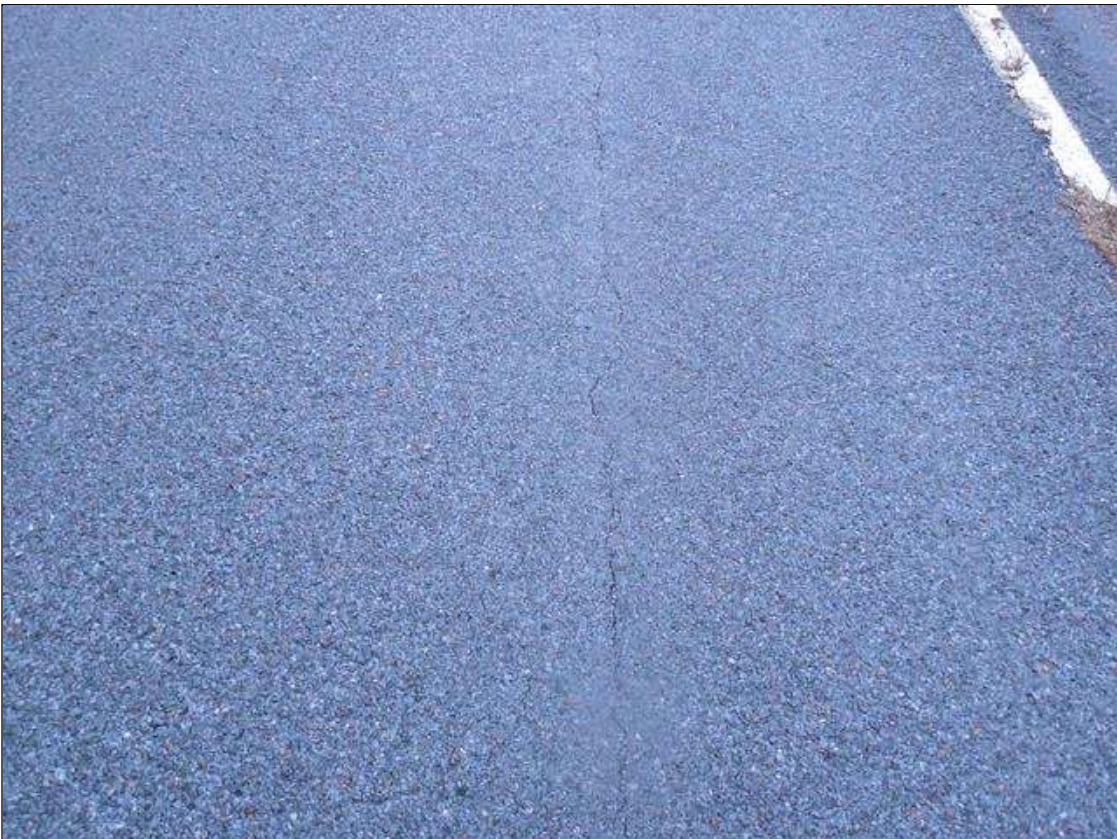
Span 2 Wearing Surface: 30 Square Feet of Crack (Wearing Surface): Width of more than 0.05 in. or spacing of less than 1.0 ft. 1/8" WIDE X 30' LONG LONGITUDINAL CRACK IN EAST BOUND LANE

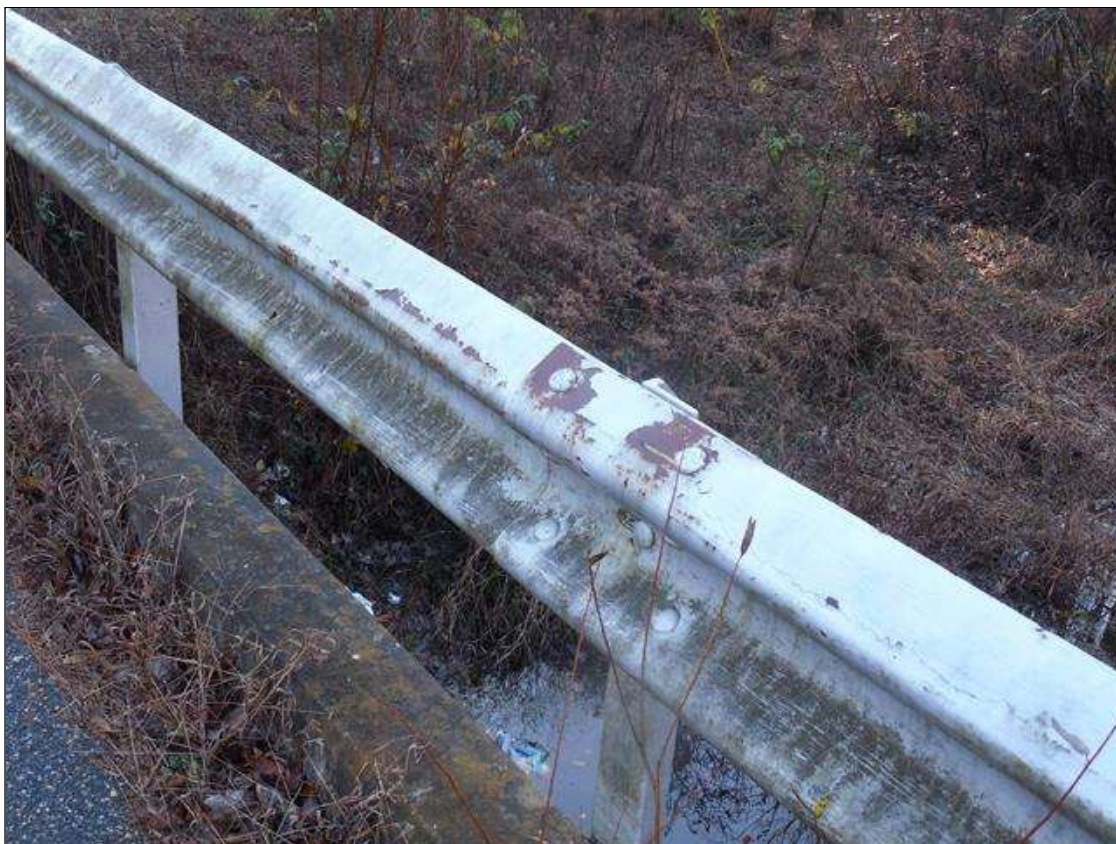
30 Square Feet of Peeling/Bubbling/Cracking (steel Protective Coatings): Finish and primer coats.

Span 2 Right Bridge Rail: 30 Square Feet of Peeling/Bubbling/Cracking (steel Protective Coatings): Finish and primer coats.

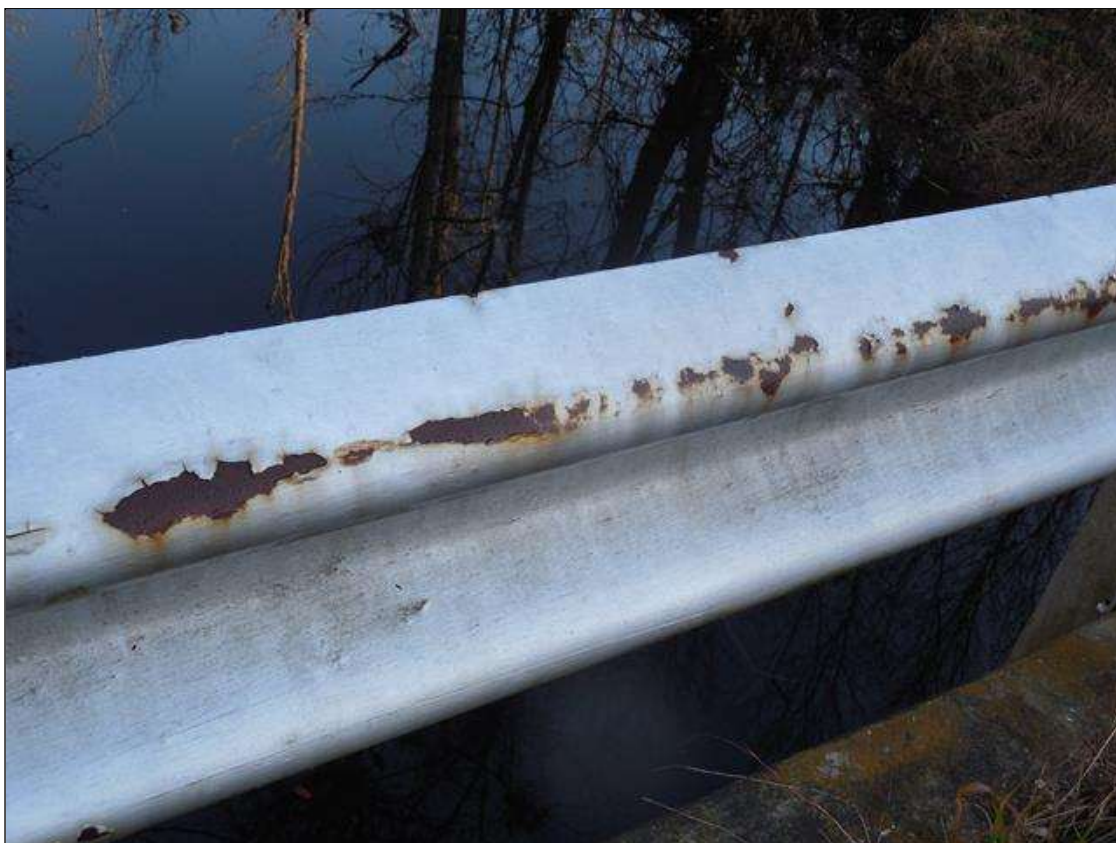
30 Square Feet of Peeling/Bubbling/Cracking (steel Protective Coatings): Finish and primer coats.

Span 2 Left Bridge Rail: 30 Square Feet of Peeling/Bubbling/Cracking (steel Protective Coatings): Finish and primer coats.

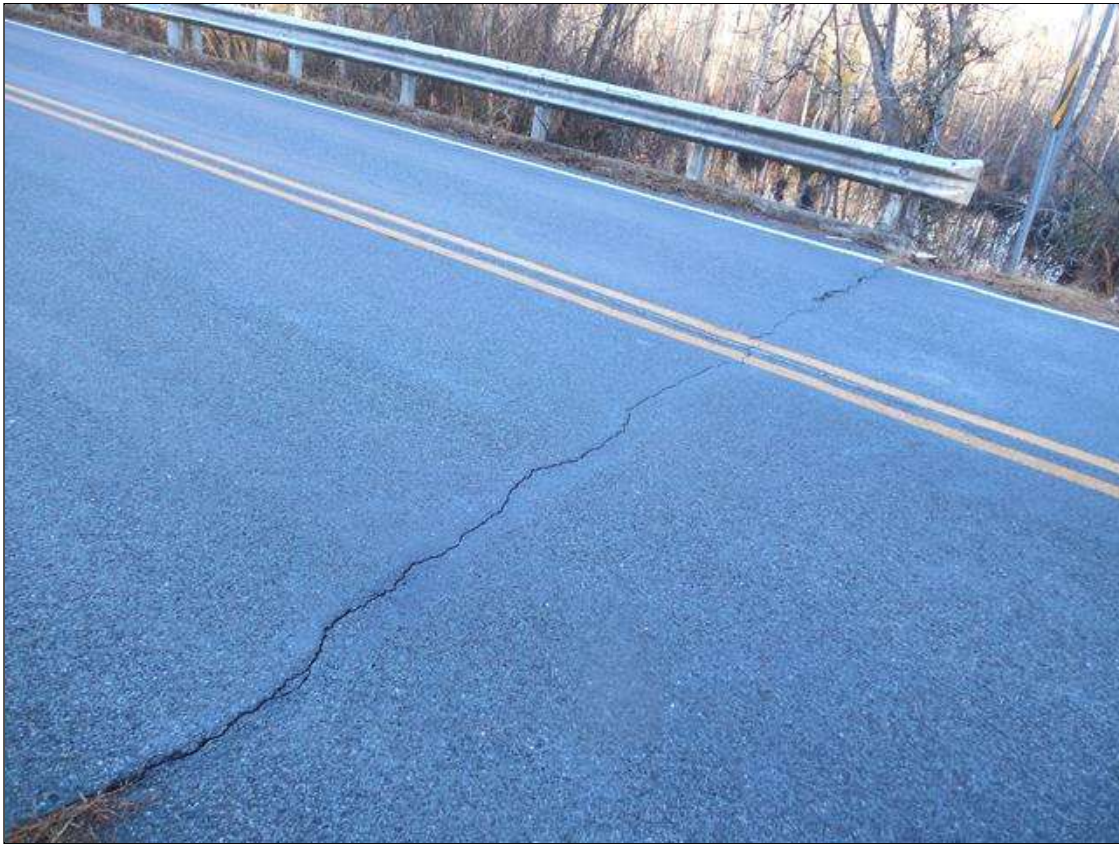
Span 2 Wearing Surface: 25 Square Feet of Crack (Wearing Surface): Width of more than 0.05 in. or spacing of less than 1.0 ft. 1/8" WIDE TRANSVERSE CRACK WITH 1/2" SETTLEMENT OVER END BENT 2

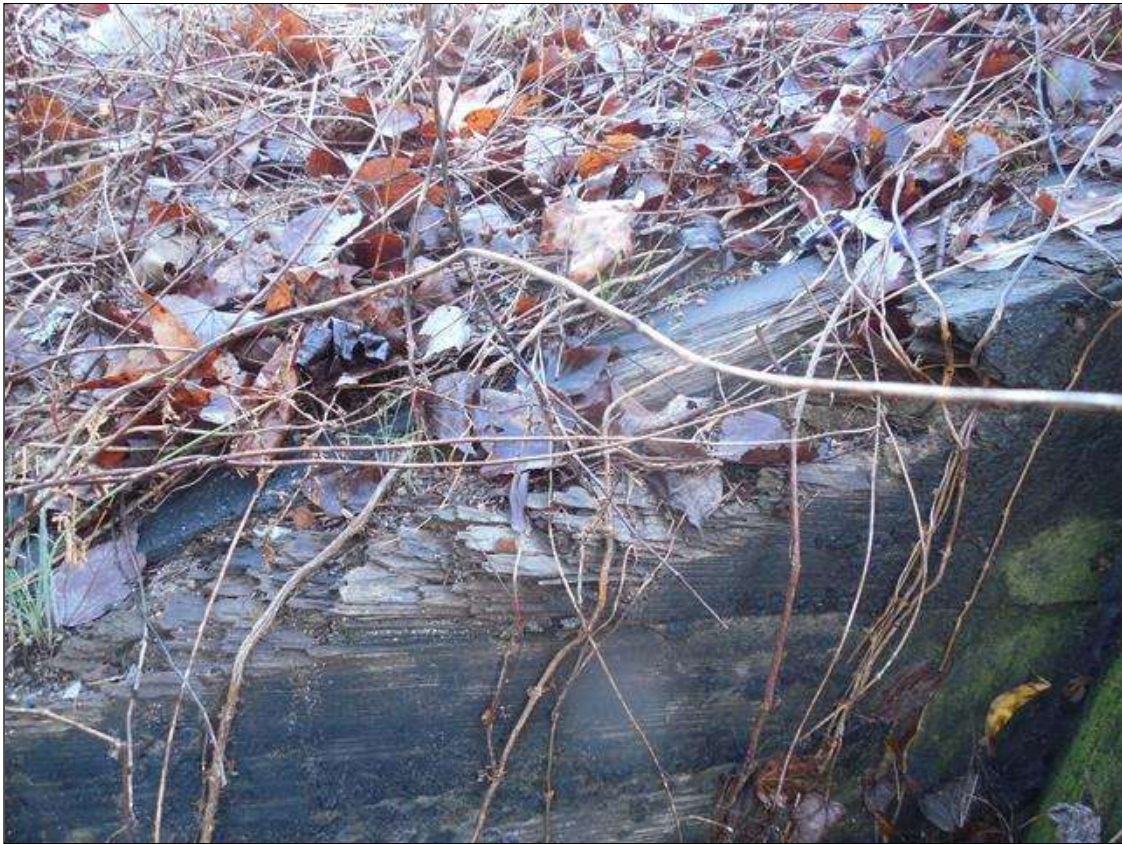
| Details | NORTHEAST CORNER TOP WINGWALL BOARD DECAYED 2' | | | | | |

NORTHEAST CORNER TOP WINGWALL BOARD DECAYED 2'

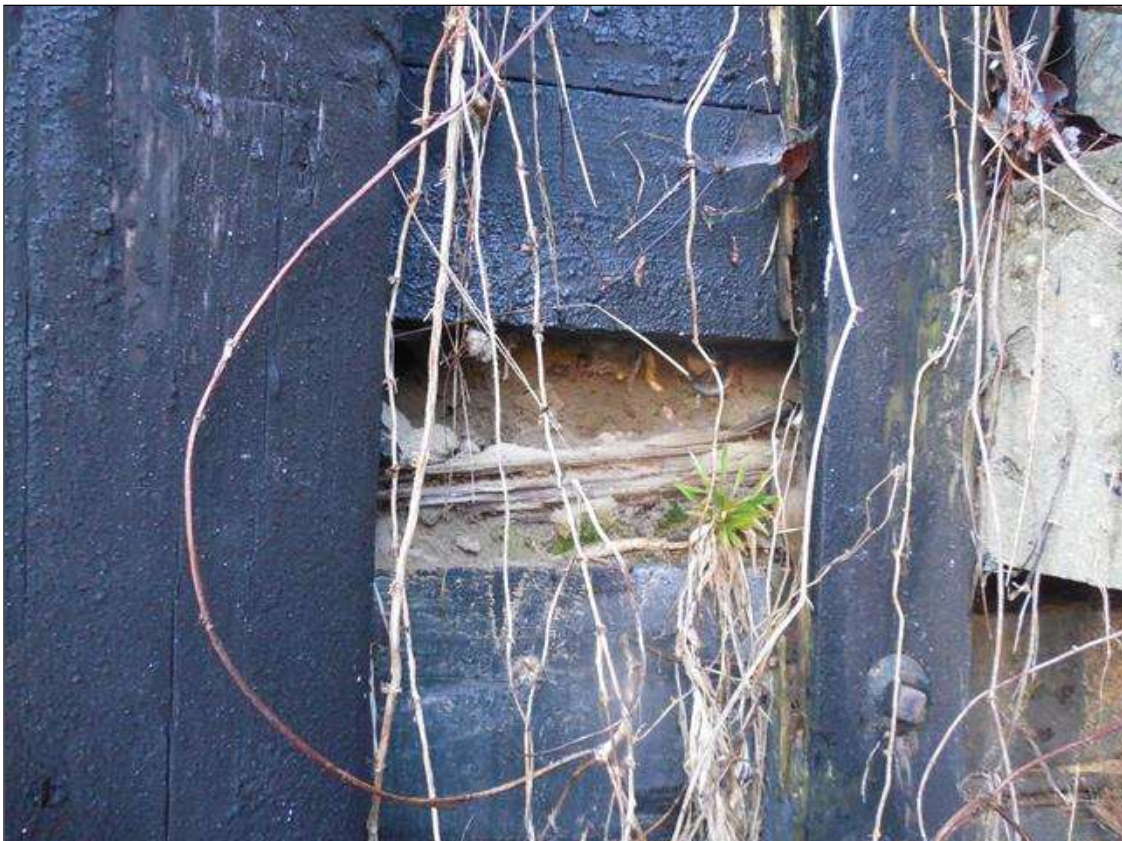
4 Feet of Decay/Section Loss: Affects 10% or more of the member but does not warrant structural review. DECAY WITH EXPOSED FILL ( PM ISSUED )

End Bent 2 Abutment/Backwall : 4 Feet of Decay/Section Loss: Affects 10% or more of the member but does not warrant structural review. DECAY WITH EXPOSED FILL ( PM ISSUED )

| MMS Code | Description of Function | Unit | Quantity | Remarks | Est. Cost |
|---|---|---|---|---|---|
| 3344 | Repair / Replace Timber Substructure Components | LF | 4 | END BENT 2 TIMBER ABUTMENT DECAY WITH FILL LEAKAGE 4 FT. , CAUSING EROSION / SETTLEMENT IN APPROACH SHOULDER ( PM ISSUED ) | |

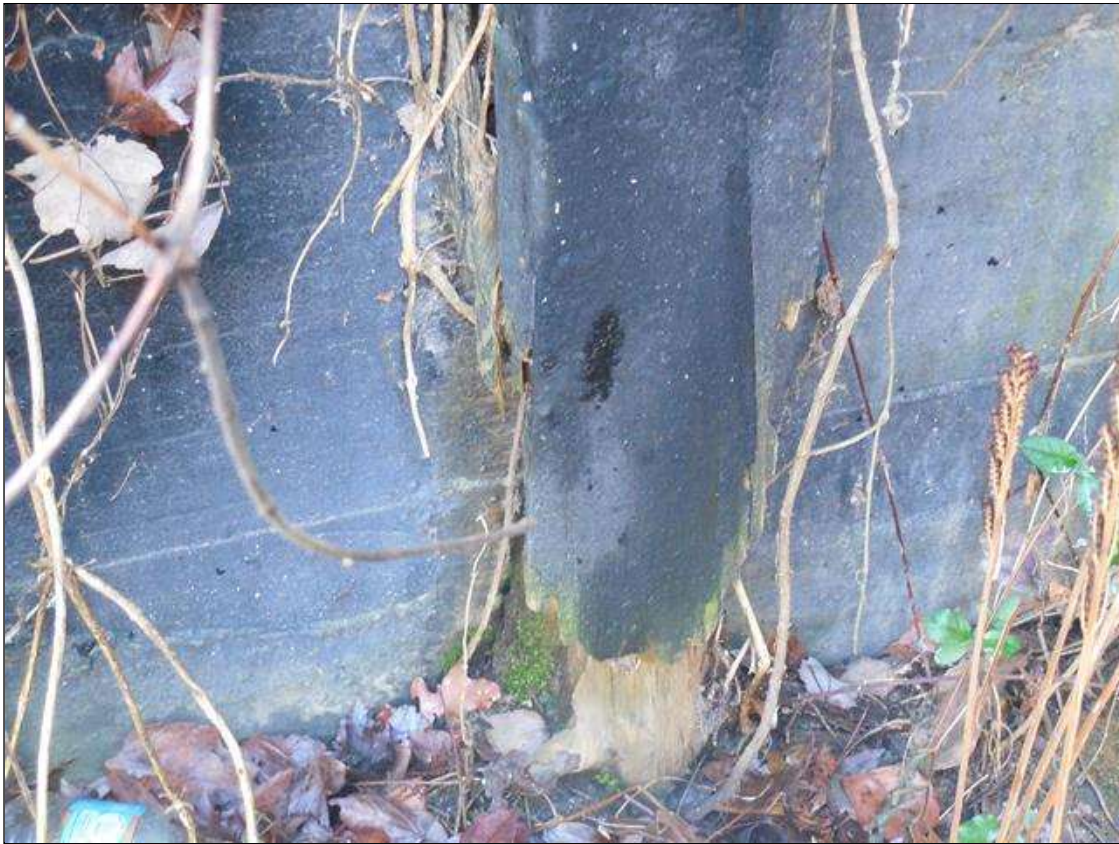
1 Feet of Decay/Section Loss: Affects 10% or more of the member but does not warrant structural review. ABUTMENT CLEAT DECAYED AT NORTHEAST CORNER

End Bent 2 Abutment/Backwall : 1 Feet of Decay/Section Loss: Affects 10% or more of the member but does not warrant structural review. ABUTMENT CLEAT DECAYED AT NORTHEAST CORNER

| MMS Code | Description of Function | Unit | Quantity | Remarks | Est. Cost |
|---|---|---|---|---|---|
| 3344 | Repair / Replace Timber Substructure Components | LF | 4 | END BENT 2 TIMBER ABUTMENT IS DECAYED 4' WITH FILL LEAKAGE AT NORTHEAST CORNER | |

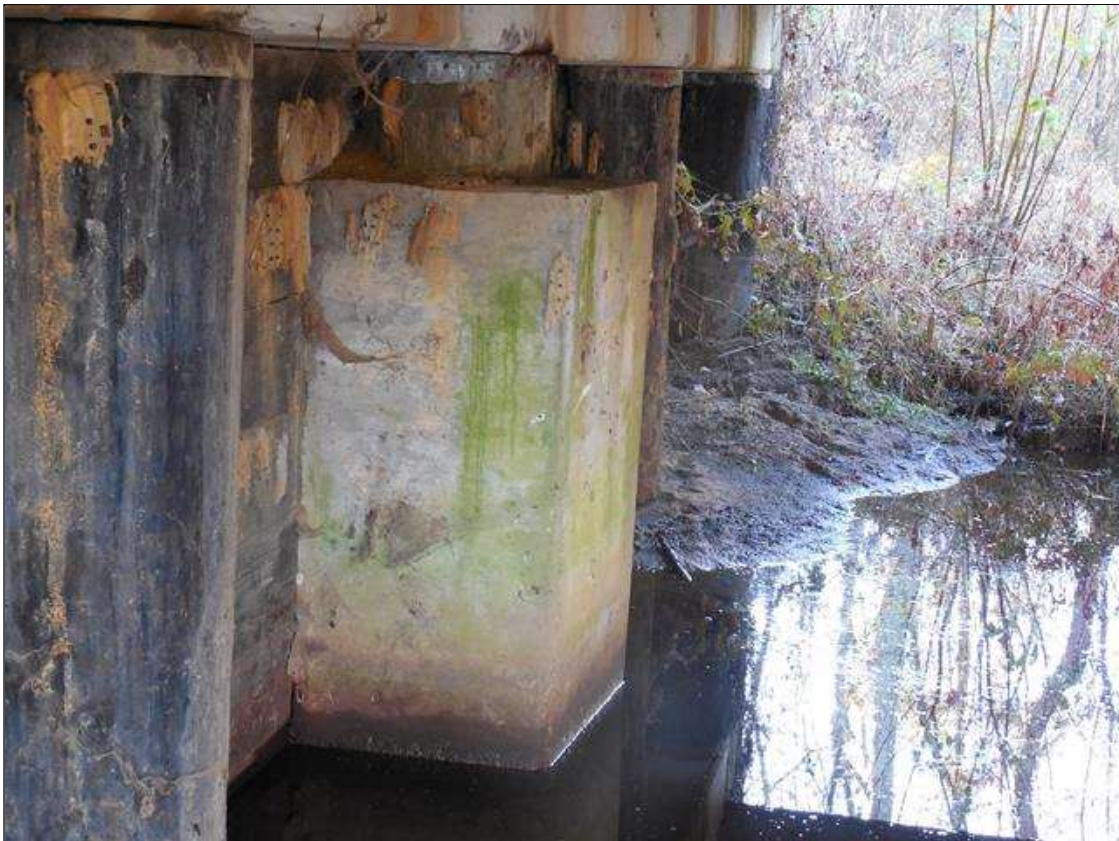
Pile 3 @ EBT. 2 Encased with Concrete.

| Details | END BENT 2 PILE 3 ENCASED ( TEMPORARY REPAIR ) | | | | | |

END BENT 2 PILE 3 ENCASED ( TEMPORARY REPAIR )

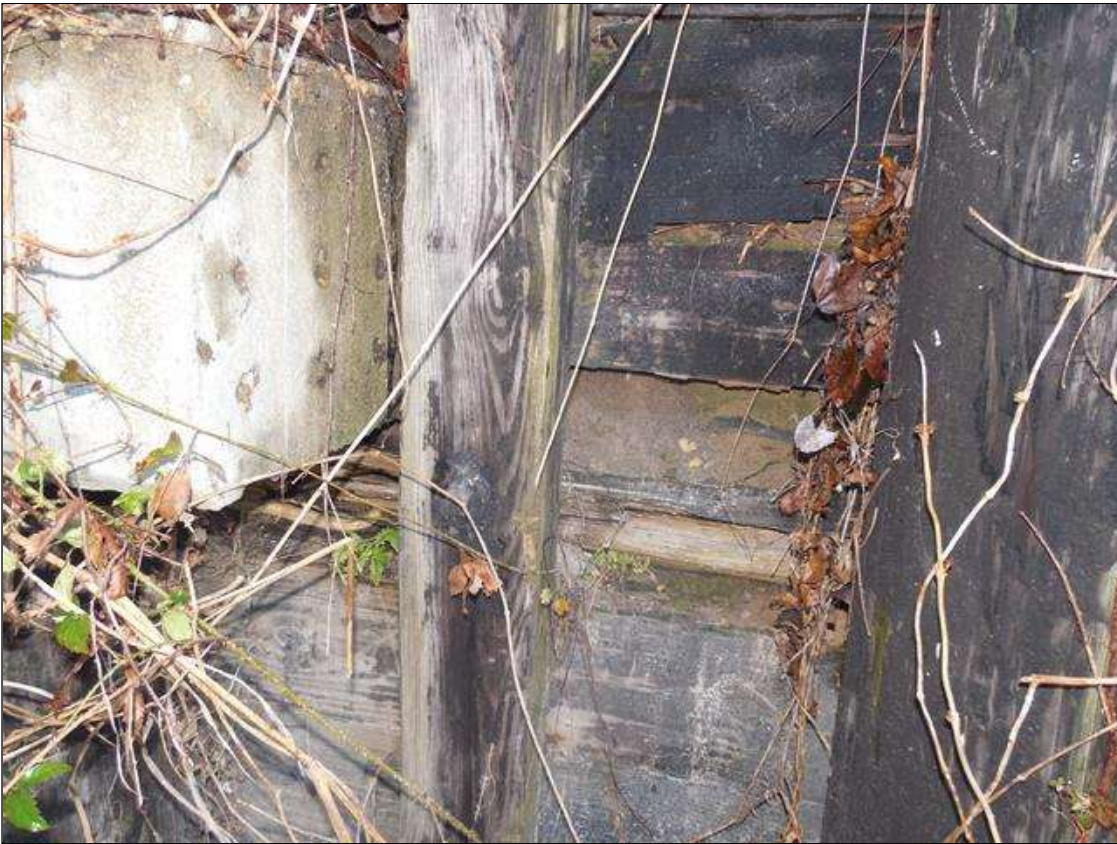
4 Feet of Decay/Section Loss: Affects 10% or more of the member but does not warrant structural review. DECAYED WITH FILL LEAKAGE AT SOUTHEAST CORNER ( PM ISSUED )

End Bent 2 Abutment/Backwall : 4 Feet of Decay/Section Loss: Affects 10% or more of the member but does not warrant structural review. DECAYED WITH FILL LEAKAGE AT SOUTHEAST CORNER ( PM ISSUED )

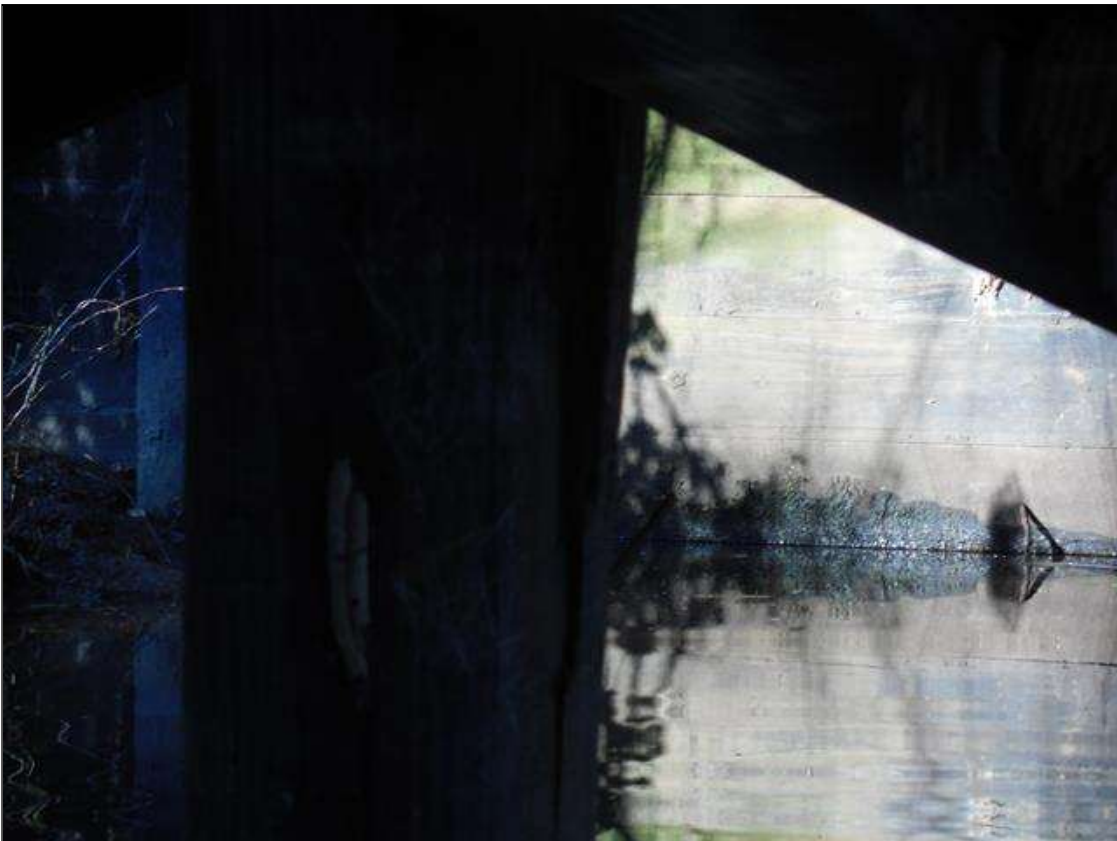
1 Each of Decay/Section Loss: Affects less than 10% of the member section PILE 3 DECAYED 2' H X 6" W X 2" D ON NORTH FACE

Bent 1 Pile 3: 1 Each of Decay/Section Loss: Affects less than 10% of the member section PILE 3 DECAYED 2' H X 6" W X 2" D ON NORTH FACE

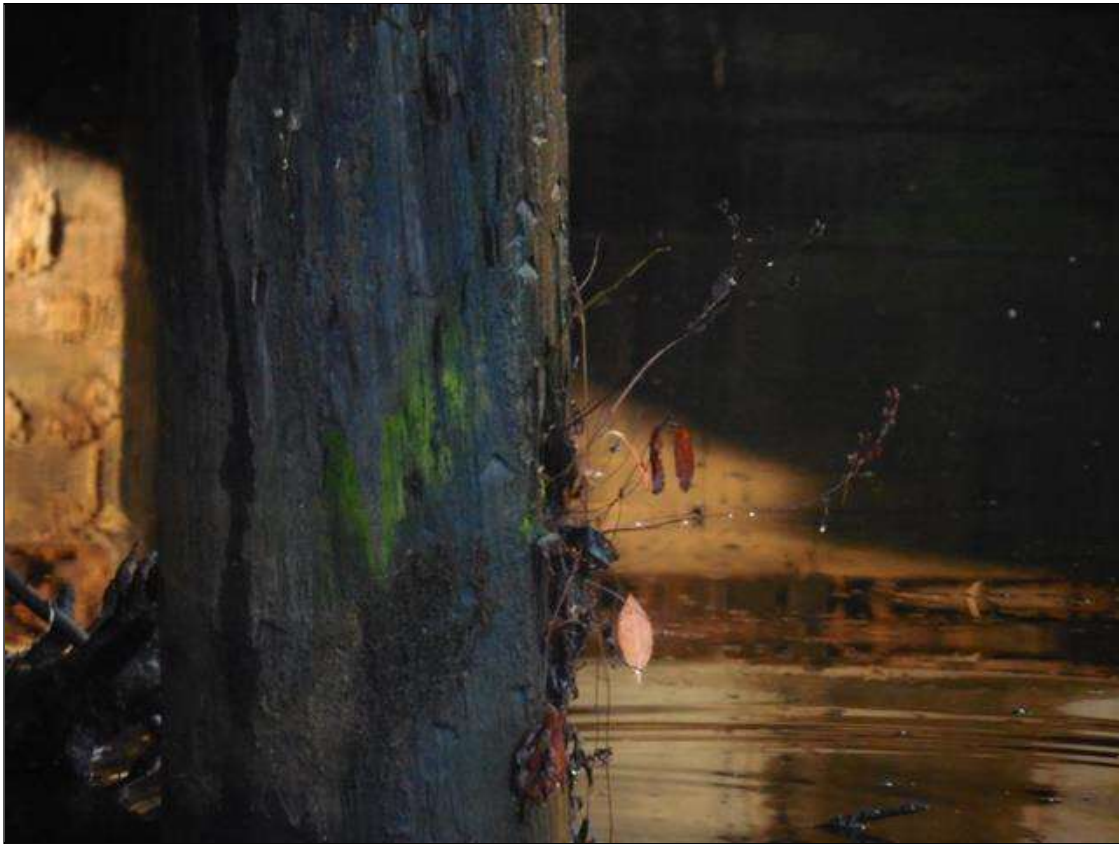
1 Each of Decay/Section Loss: Affects less than 10% of the member section DECAY 12" HIGH X 8" WIDE X 3" DEEP ON NORTH FACE

Bent 1 Pile 1: 1 Each of Decay/Section Loss: Affects less than 10% of the member section DECAY 12" HIGH X 8" WIDE X 3" DEEP ON NORTH FACE

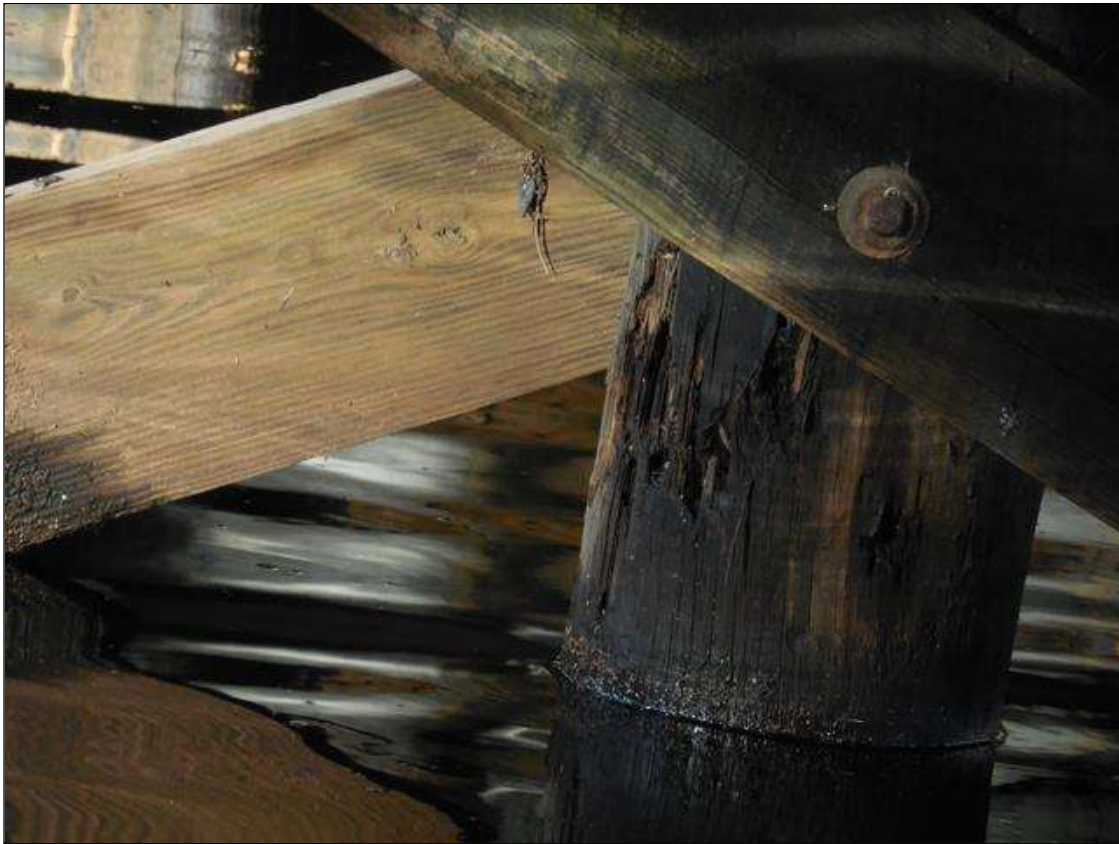
1 Each of Decay/Section Loss: Affects 10% or more of the member but does not warrant structural review. DELAMINATED 22" HIGH X 14" WIDE AND DECAYED 8" HIGH X 6" WIDE X 2" DEEP ON SOUTH FACE NEAR WATERLINE

Bent 1 Pile 4: 1 Each of Decay/Section Loss: Affects 10% or more of the member but does not warrant structural review. DELAMINATED 22" HIGH X 14" WIDE AND DECAYED 8" HIGH X 6" WIDE X 2" DEEP ON SOUTH FACE NEAR WATERLINE
