NC DEPARTMENT OF TRANSPORTATION  
DIVISION OF HIGHWAYS  
STRUCTURE MANAGEMENT UNIT

## Structure Safety Report

### Routine Element Inspection

COUNTY: ROBESON STRUCTURE NUMBER: 770135 FREQUENCY: 24 MONTHS

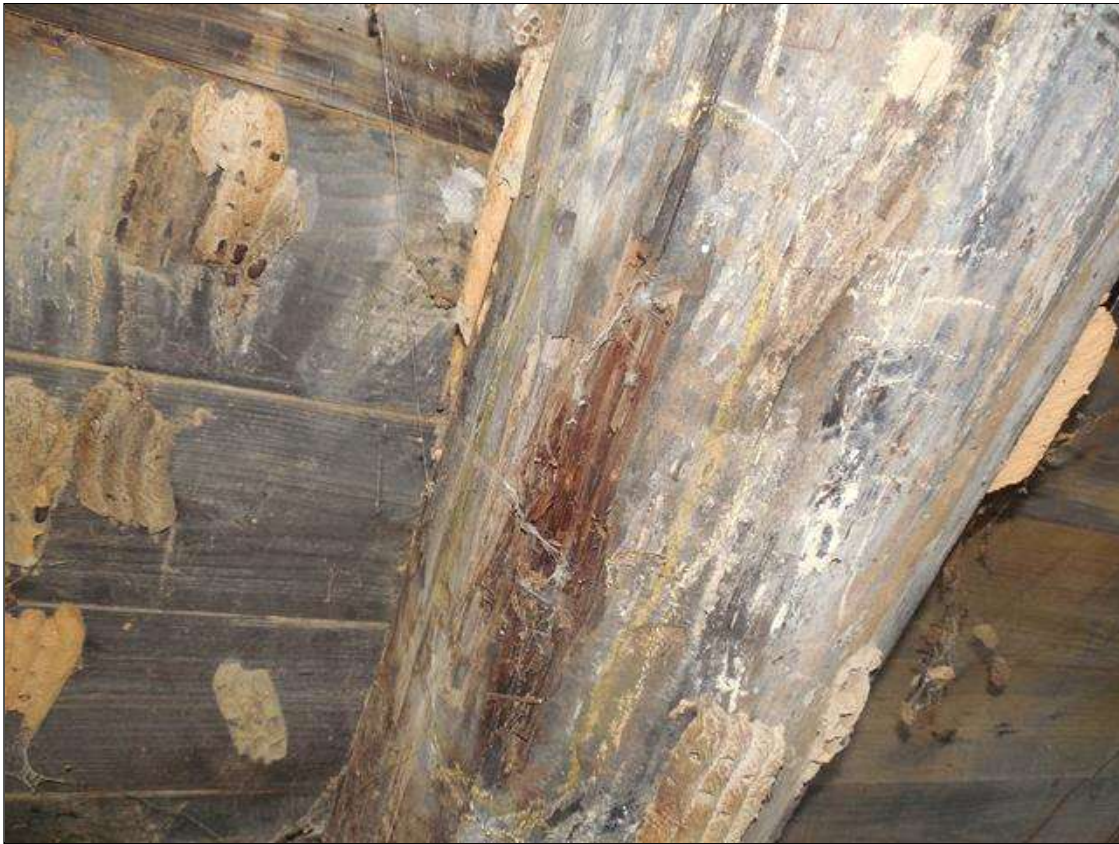
1 Each of Decay/Section Loss: Affects less than 10% of the member section DECAYED 14" HIGH X 5" WIDE X 1" DEEP

End Bent 2 Pile 4: 1 Each of Decay/Section Loss: Affects less than 10% of the member section DECAYED 14" HIGH X 5" WIDE X 1" DEEP

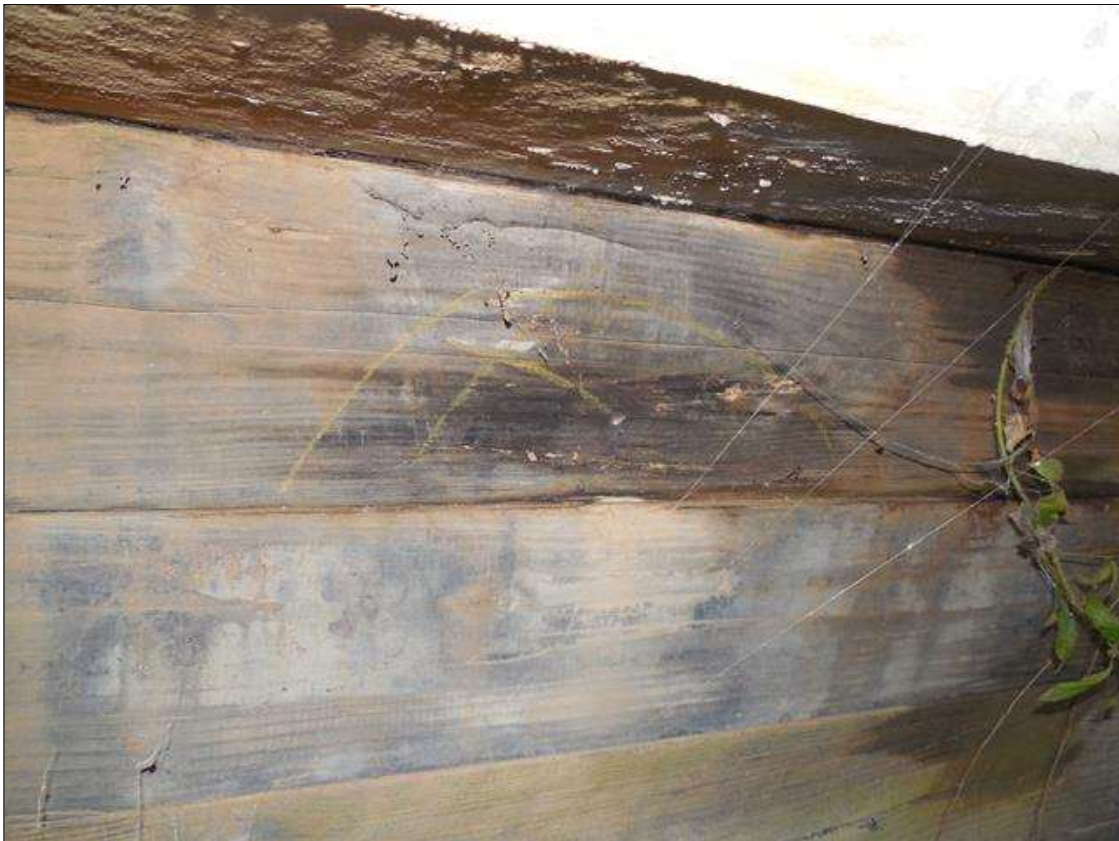
2 Feet of Decay/Section Loss: Affects less than 10% of the member section SURFACE DECAY BETWEEN PILES 4 AND 5

End Bent 2 Abutment/Backwall : 2 Feet of Decay/Section Loss: Affects less than 10% of the member section  
SURFACE DECAY BETWEEN PILES 4 AND 5

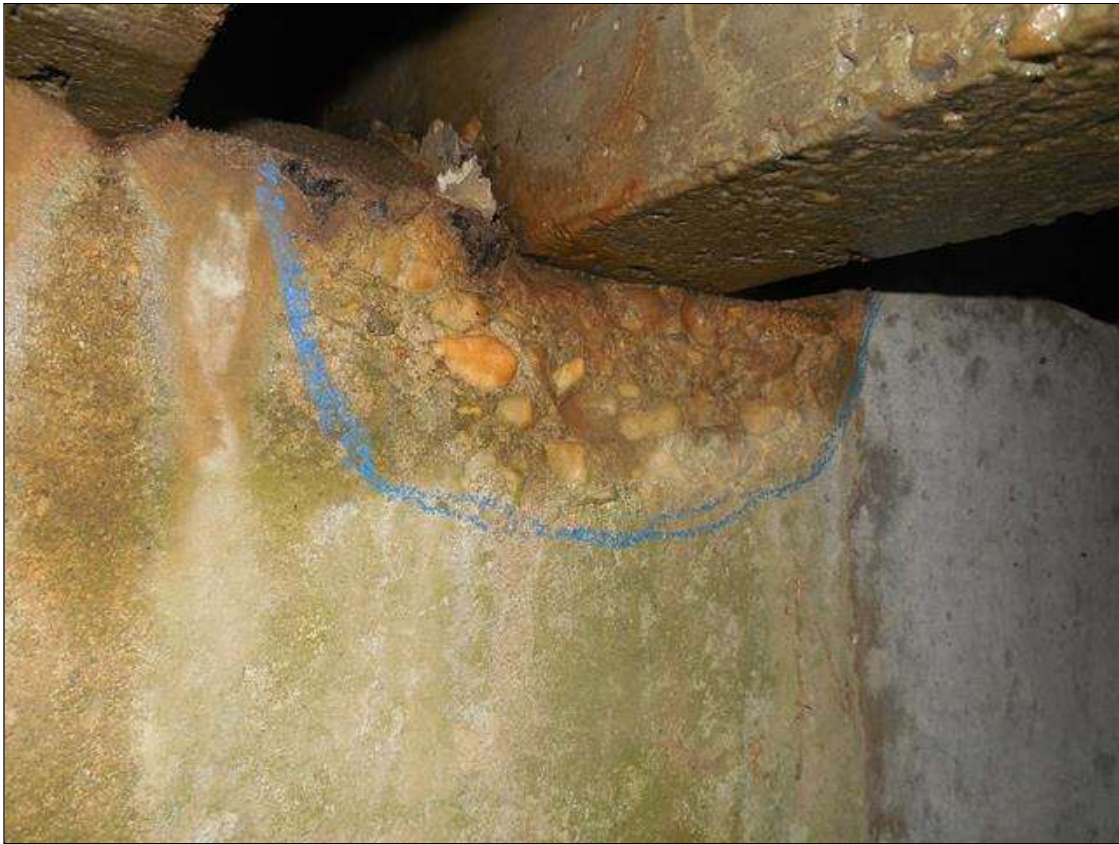
1 Feet of Delamination/Spall/Patched Area: Spall greater than 1 in. deep or greater than 6 in. diameter. Patched area that is unsound or showing distress. Does not warrant structural review. SPALL 8" WIDE X 4" HIGH X 1 1/2" DEEP UNDER CHANNEL 8 LEFT LEG

End Bent 2 Cap : 1 Feet of Delamination/Spall/Patched Area: Spall greater than 1 in. deep or greater than 6 in. diameter. Patched area that is unsound or showing distress. Does not warrant structural review. SPALL 8" WIDE X 4" HIGH X 1 1/2" DEEP UNDER CHANNEL 8 LEFT LEG

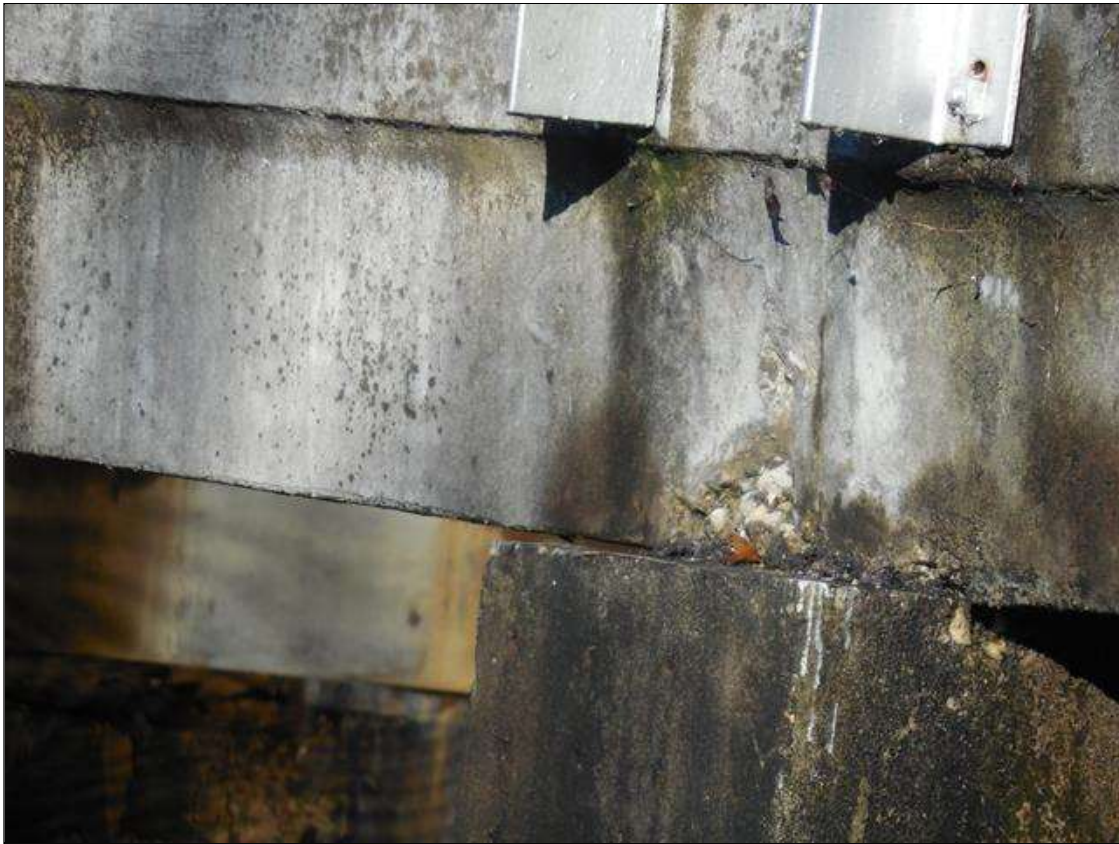
1 Feet of Delamination/Spall/Patched Area: Delaminated. Spall 1 in. or less deep or 6 in. or less in diameter. Patched area that is sound. SPALL 6" HIGH X 1" TO 8" WIDE X 3/4" DEEP AT BENT 1 END ON EXTERIOR FACE

Span 1 Channel/Slab 8: 1 Feet of Delamination/Spall/Patched Area: Delaminated. Spall 1 in. or less deep or 6 in. or less in diameter. Patched area that is sound. SPALL 6" HIGH X 1" TO 8" WIDE X 3/4" DEEP AT BENT 1 END ON EXTERIOR FACE

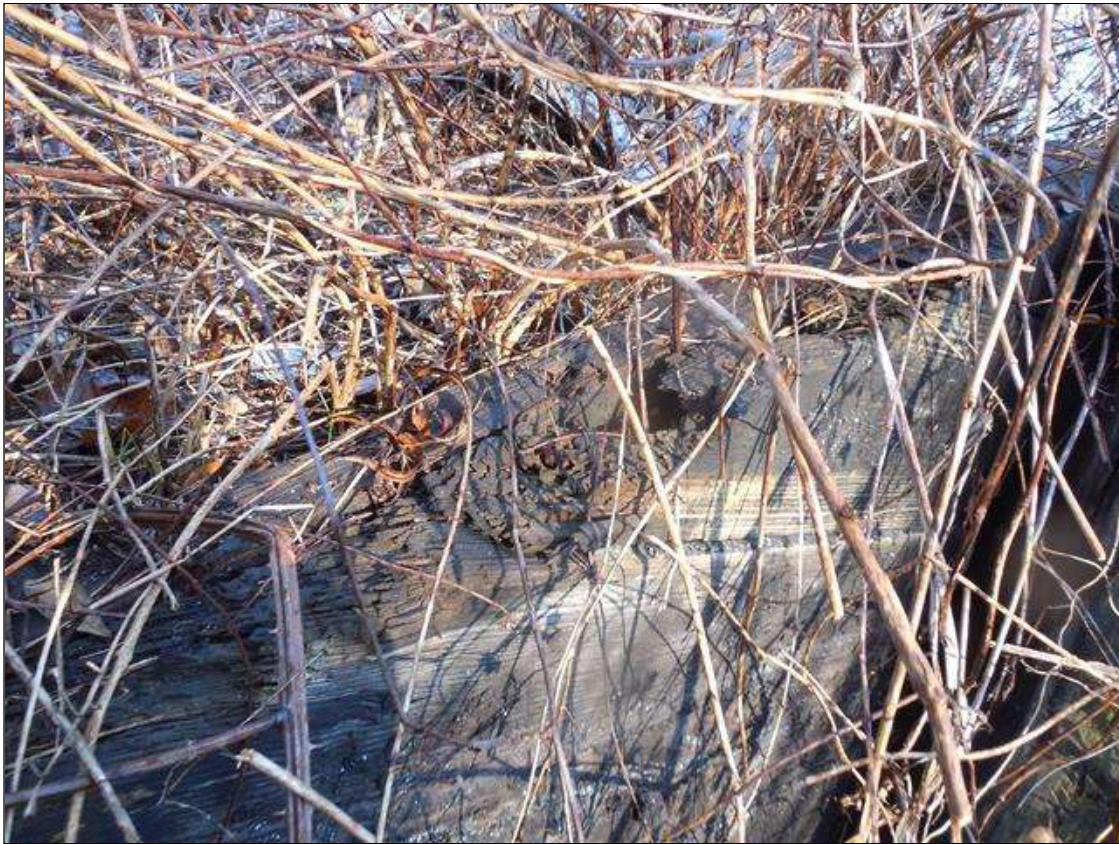
| | SOUTHWEST CORNER TOP WINGWALL BOARD DECAYED 2" | | | | | |

SOUTHWEST CORNER TOP WINGWALL BOARD DECAYED 2"

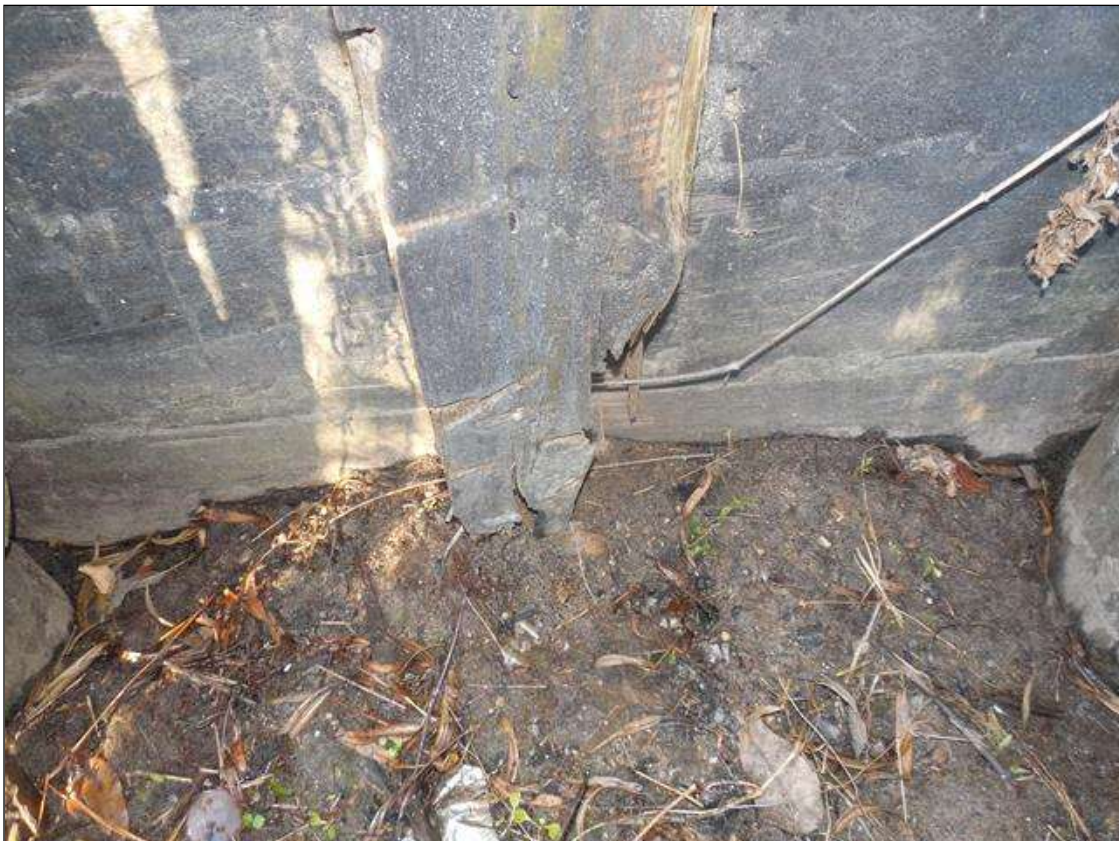
1 Feet of Decay/Section Loss: Affects less than 10% of the member section BULKHEAD CLEAT DECAYED AT SOUTHWEST CORNER

End Bent 1 Abutment/Backwall : 1 Feet of Decay/Section Loss: Affects less than 10% of the member section  
BULKHEAD CLEAT DECAYED AT SOUTHWEST CORNER

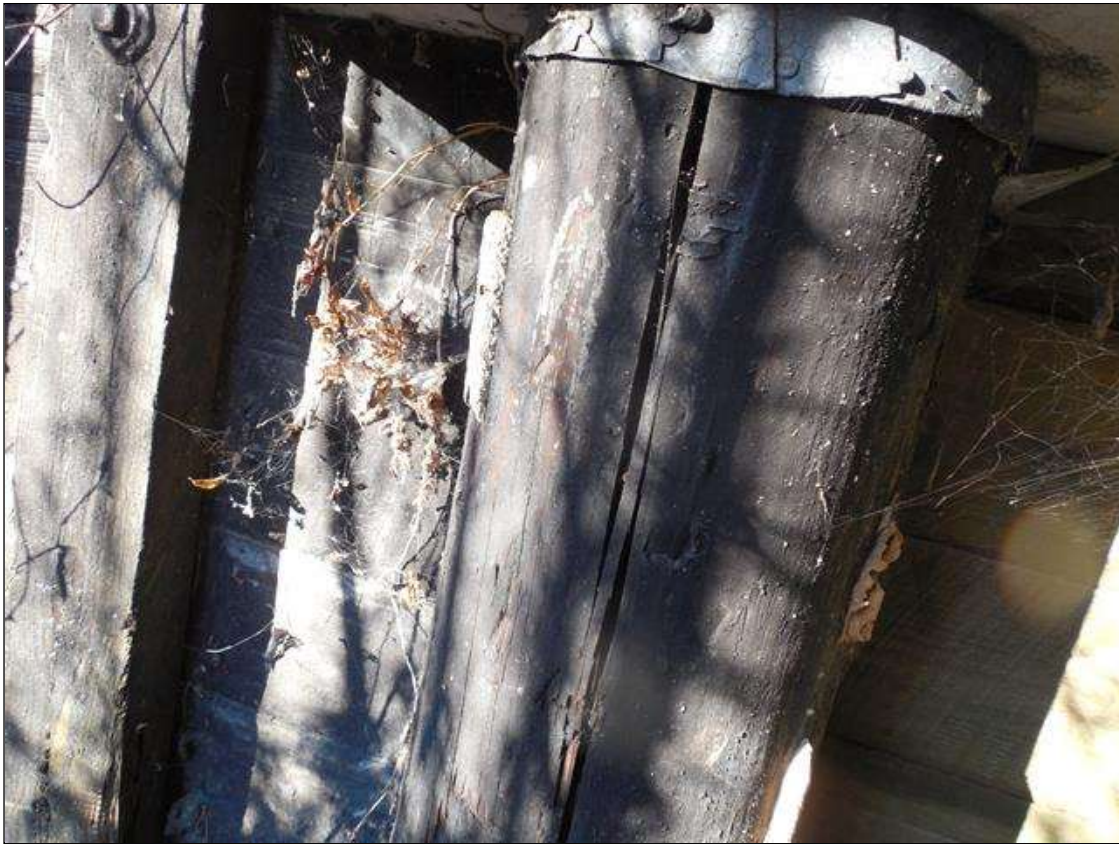
End Bent 1 Pile 5: 1 Each of Check/Shake: Penetrates 5%-50% of the thickness of the member and not in the tension zone. 3' HIGH X 1/4" WIDE X 1 1/2" DEEP VERTICAL CHECK

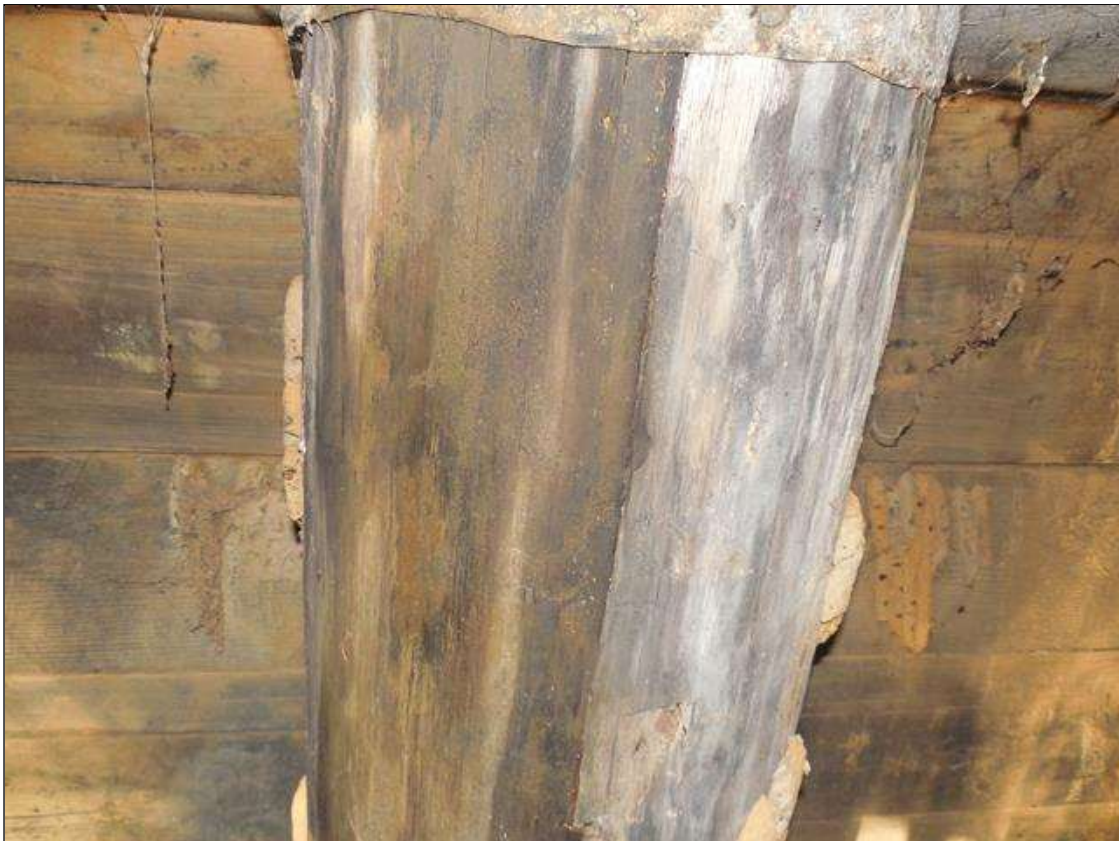
End Bent 1 Pile 4: 1 Each of Check/Shake: Penetrates 5%-50% of the thickness of the member and not in the tension zone. VERTICAL CHECK 3' HIGH X 1/8" WIDE X 3/4" DEEP

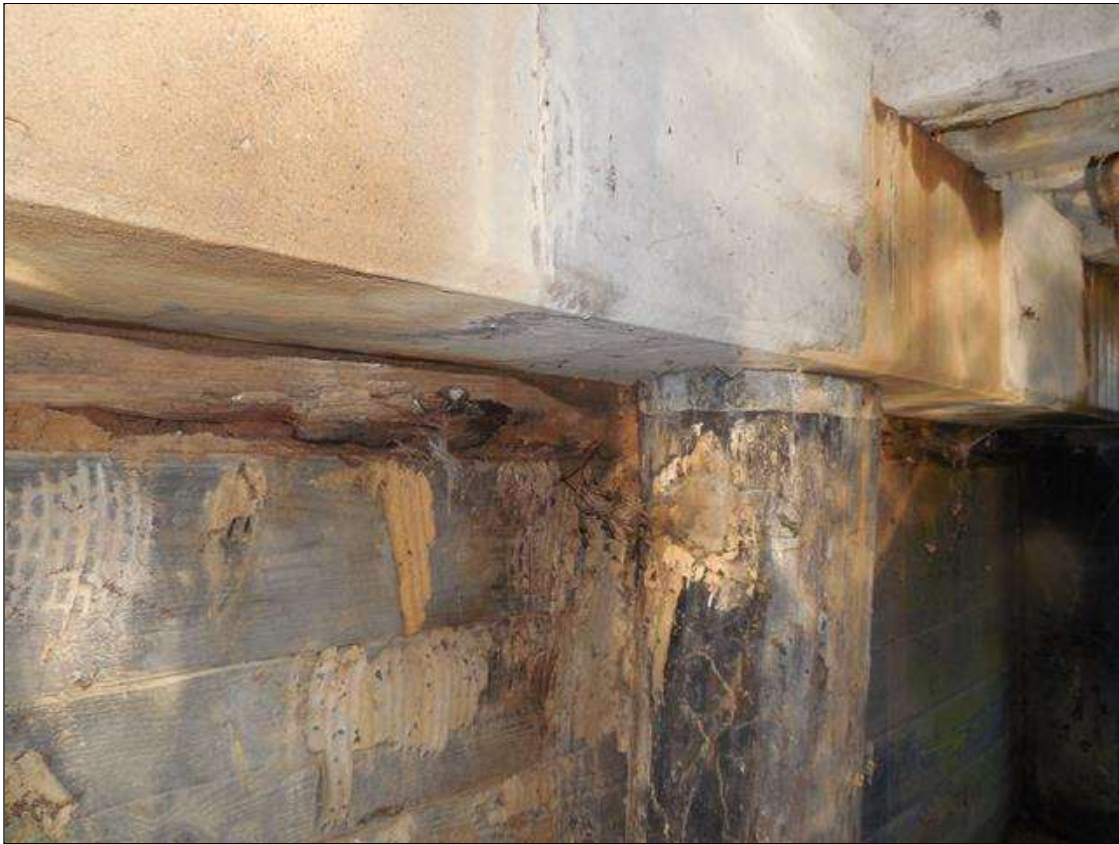
15 Feet of Decay/Section Loss: Affects 10% or more of the member but does not warrant structural review. ABUTMENT 1 TOP BOARD DECAYED WITH EXPOSED FILL FROM BETWEEN PILES 1 AND 2 TO NORTH END ( PM ISSUED )

End Bent 1 Abutment/Backwall : 15 Feet of Decay/Section Loss: Affects 10% or more of the member but does not warrant structural review. ABUTMENT 1 TOP BOARD DECAYED WITH EXPOSED FILL FROM BETWEEN PILES 1 AND 2 TO NORTH END ( PM ISSUED )

| MMS Code | Description of Function | Unit | Quantity | Remarks | Est. Cost |
|---|---|---|---|---|---|
| 3344 | Repair / Replace Timber Substructure Components | LF | 15 | END BENT 1 TIMBER ABUTMENT TOP BOARD DECAYED WITH FILL EXPOSED 15 FT. FROM BETWEEN PILES 1 AND 2 TO NORTH END ( PM ISSUED ) | |

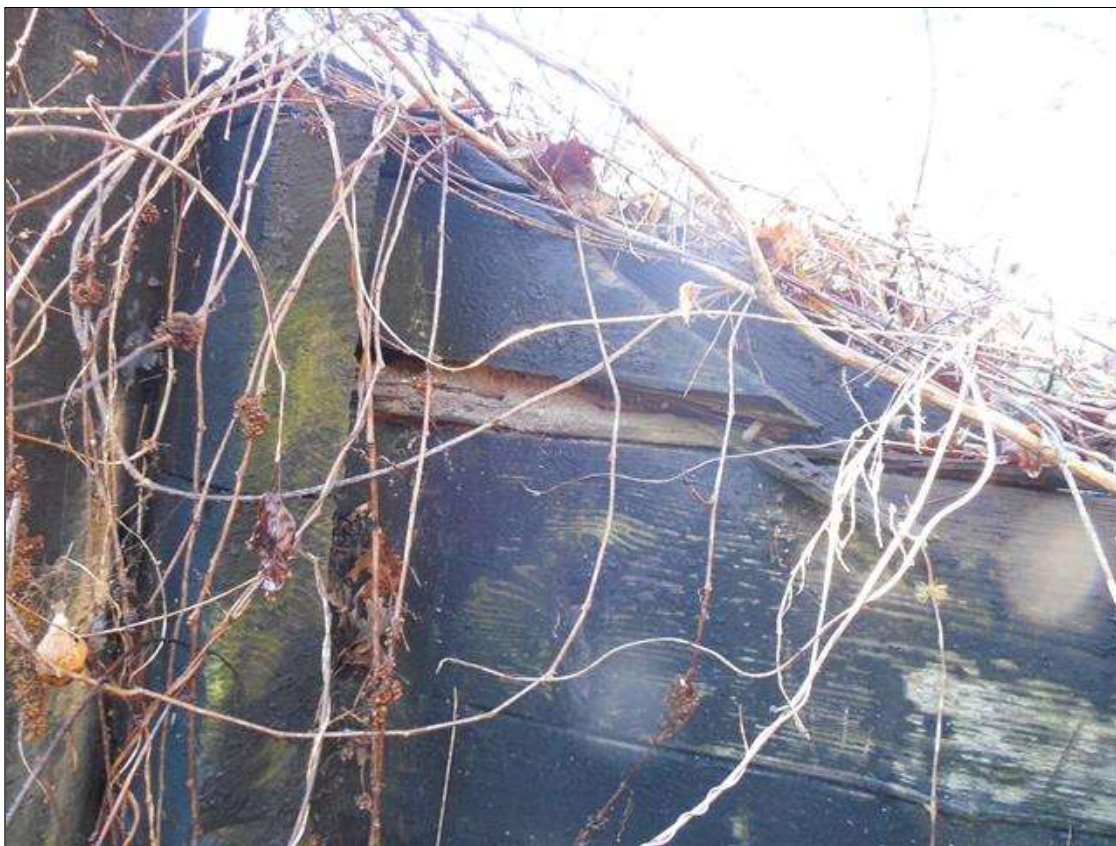
| | NORTHWEST CORNER TOP WINGWALL BOARD DECAYED 1' | | | | | |

NORTHWEST CORNER TOP WINGWALL BOARD DECAYED 1'

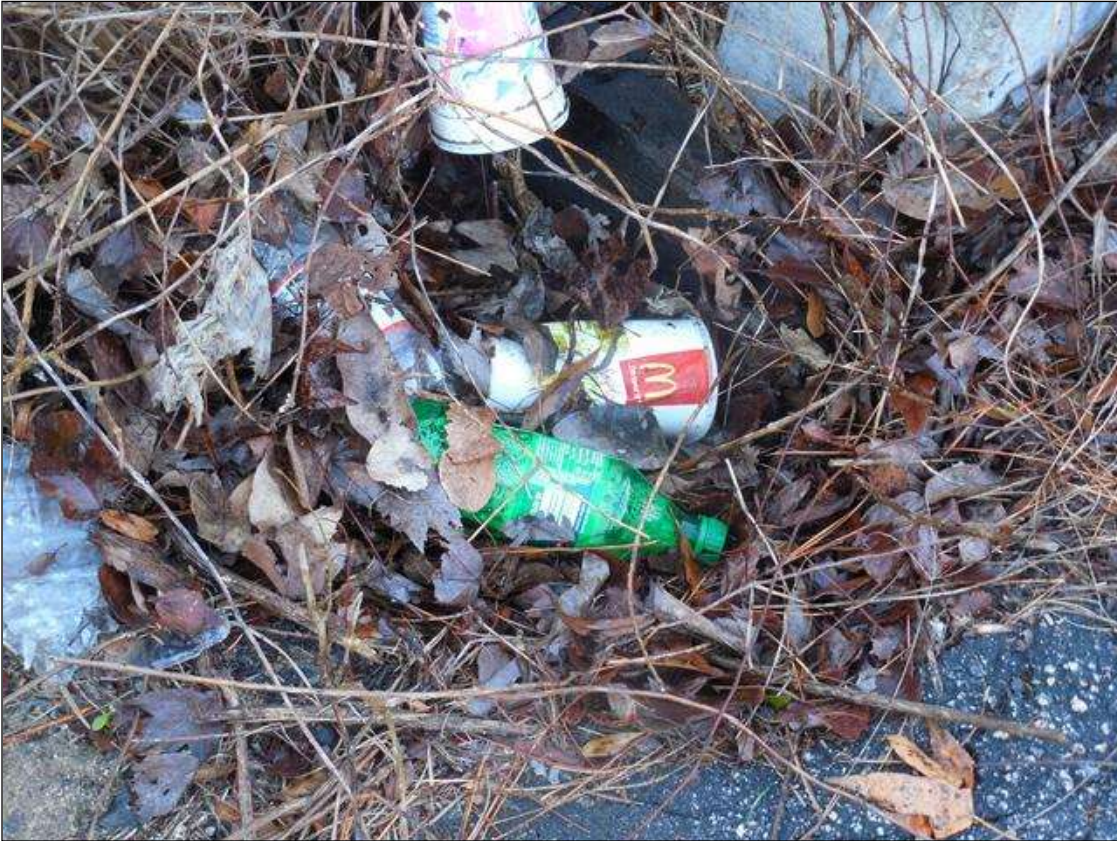
SOUTHEAST CORNER APPROACH SHOULDER SETTLED 1' DEEP X 1' WIDE X 2' LONG DUE TO END BENT 2 ABUTMENT FILL LEAKAGE ( PM ISSUED )

| MMS Code | Description of Function | Unit | Quantity | Remarks | Est. Cost |
|---|---|---|---|---|---|
| 3352 | Maint Slope Protection | SF | 3 | SOUTHEAST CORNER APPROACH SHOULDER SETTLED 1' DEEP X 1' WIDE X 2' LONG DUE TO END BENT 2 ABUTMENT FILL LEAKAGE ( PM ISSUED ) | |

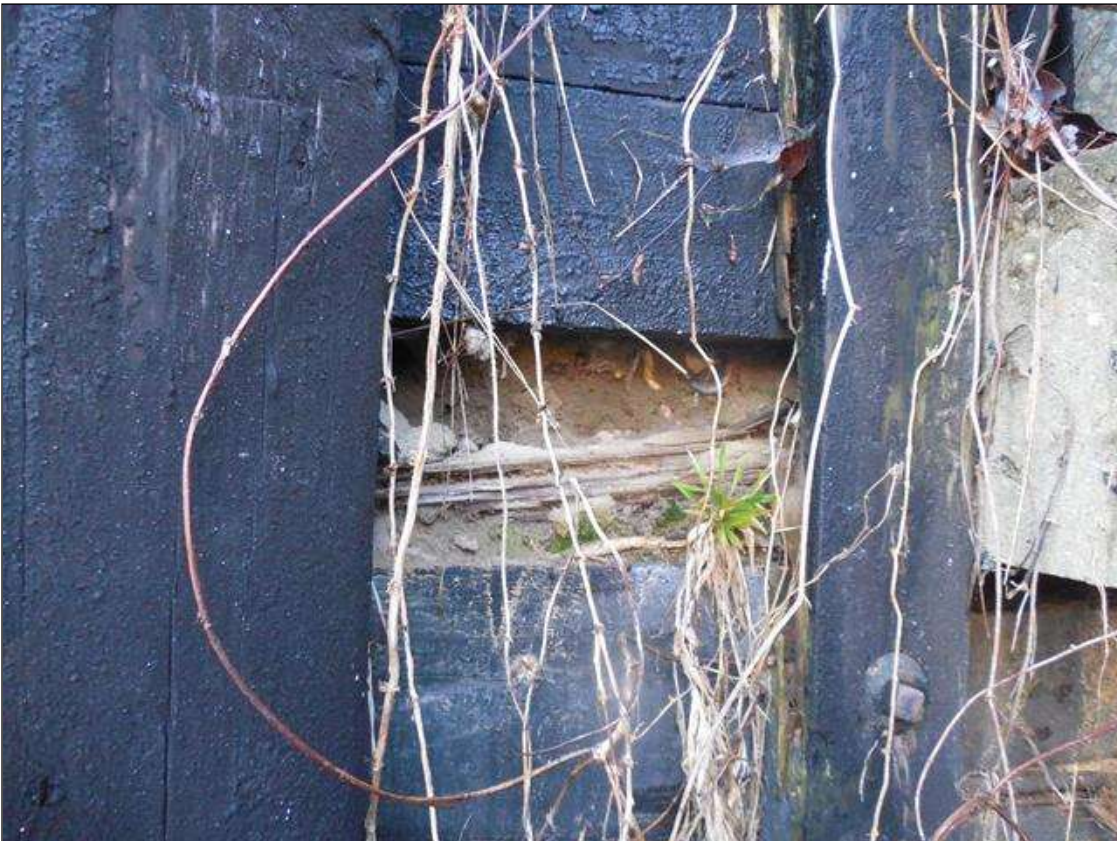
END BENT 2 TIMBER ABUTMENT IS DECAYED 4' WITH FILL LEAKAGE AT NORTHEAST CORNER

| MMS Code | Description of Function | Unit | Quantity | Remarks | Est. Cost |
|---|---|---|---|---|---|
| 3344 | Repair / Replace Timber Substructure Components | LF | 4 | END BENT 2 TIMBER ABUTMENT IS DECAYED 4' WITH FILL LEAKAGE AT NORTHEAST CORNER | |

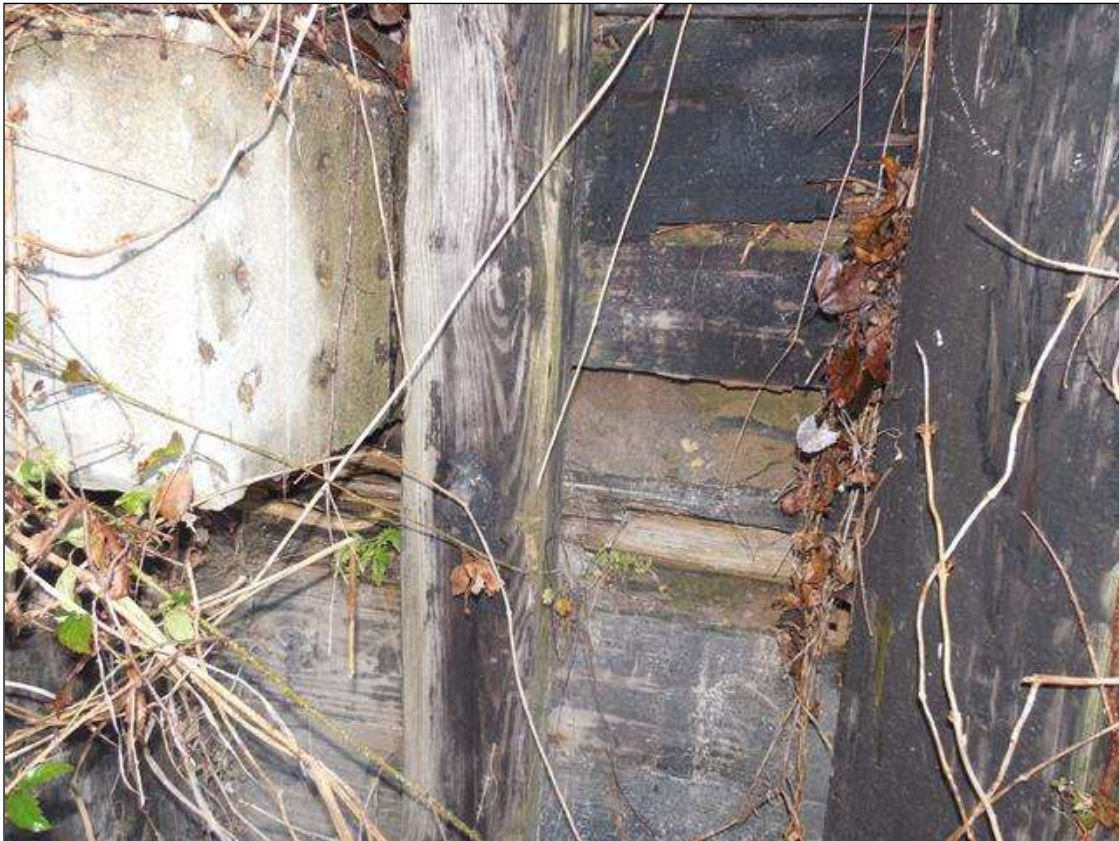
END BENT 2 TIMBER ABUTMENT DECAY WITH FILL LEAKAGE 4 FT. , CAUSING EROSION / SETTLEMENT IN  
APPROACH SHOULDER ( PM ISSUED )

| MMS Code | Description of Function | Unit | Quantity | Remarks | Est. Cost |
|---|---|---|---|---|---|
| 3344 | Repair / Replace Timber Substructure Components | LF | 4 | END BENT 2 TIMBER ABUTMENT DECAY WITH FILL LEAKAGE 4 FT. , CAUSING EROSION / SETTLEMENT IN APPROACH SHOULDER ( PM ISSUED ) | |

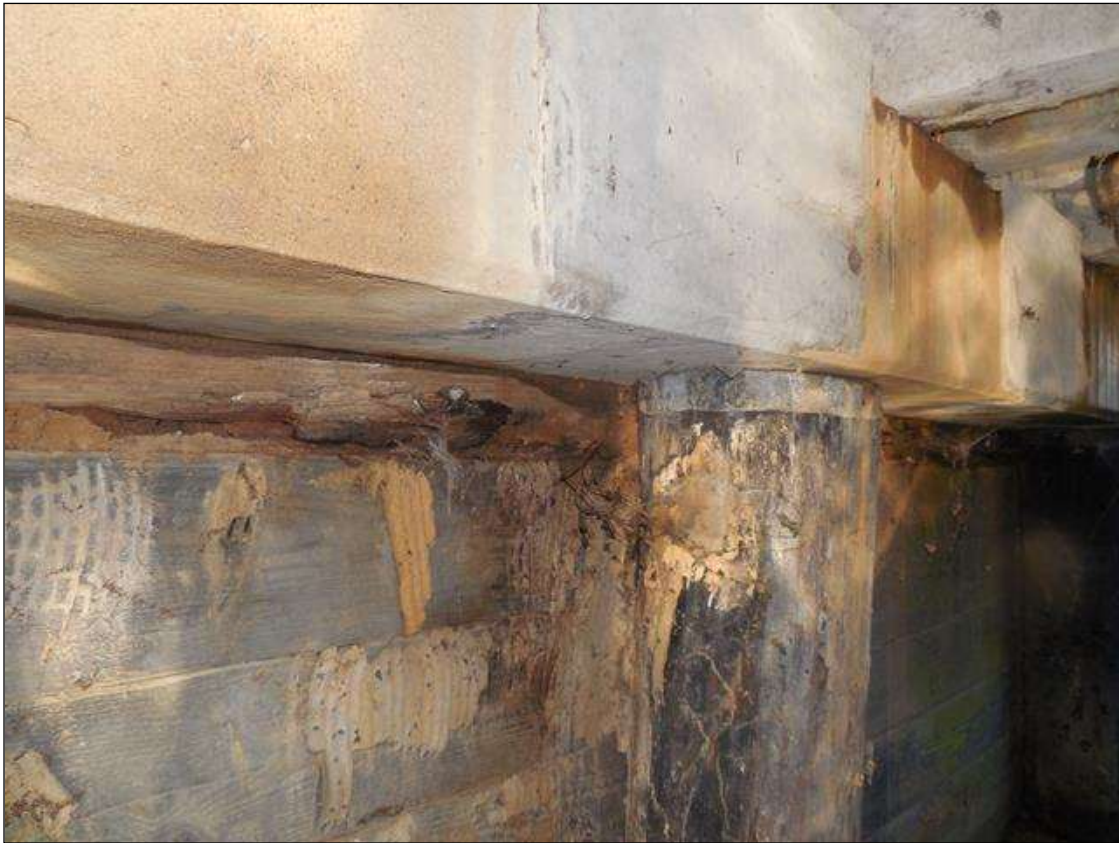
END BENT 1 TIMBER ABUTMENT TOP BOARD DECAYED WITH FILL EXPOSED 15 FT. FROM BETWEEN PILES 1 AND 2 TO NORTH END ( PM ISSUED )
