NC DEPARTMENT OF TRANSPORTATION  
DIVISION OF HIGHWAYS  
STRUCTURE MANAGEMENT UNIT

## Structure Safety Report

### Routine Element Inspection

COUNTY: ROBESON STRUCTURE NUMBER: 770172 FREQUENCY: 24 MONTHS

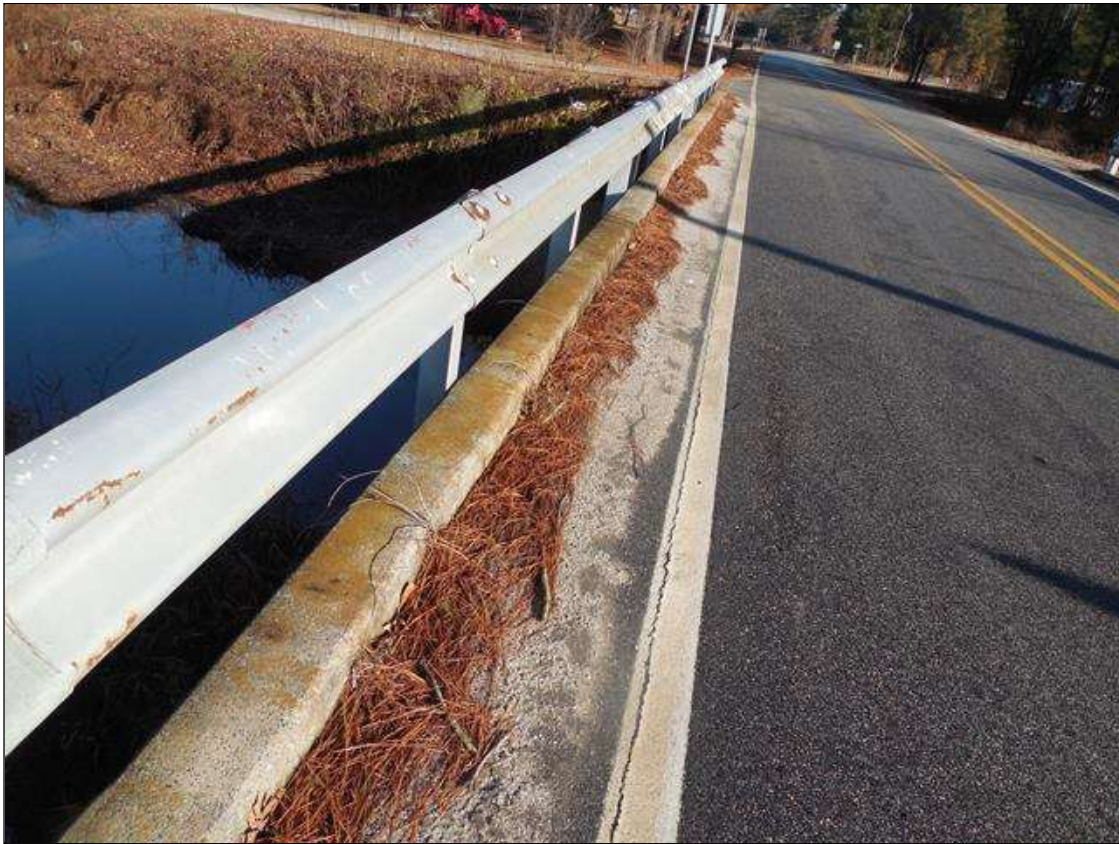
DEBRIS ALONG LEFT CURB

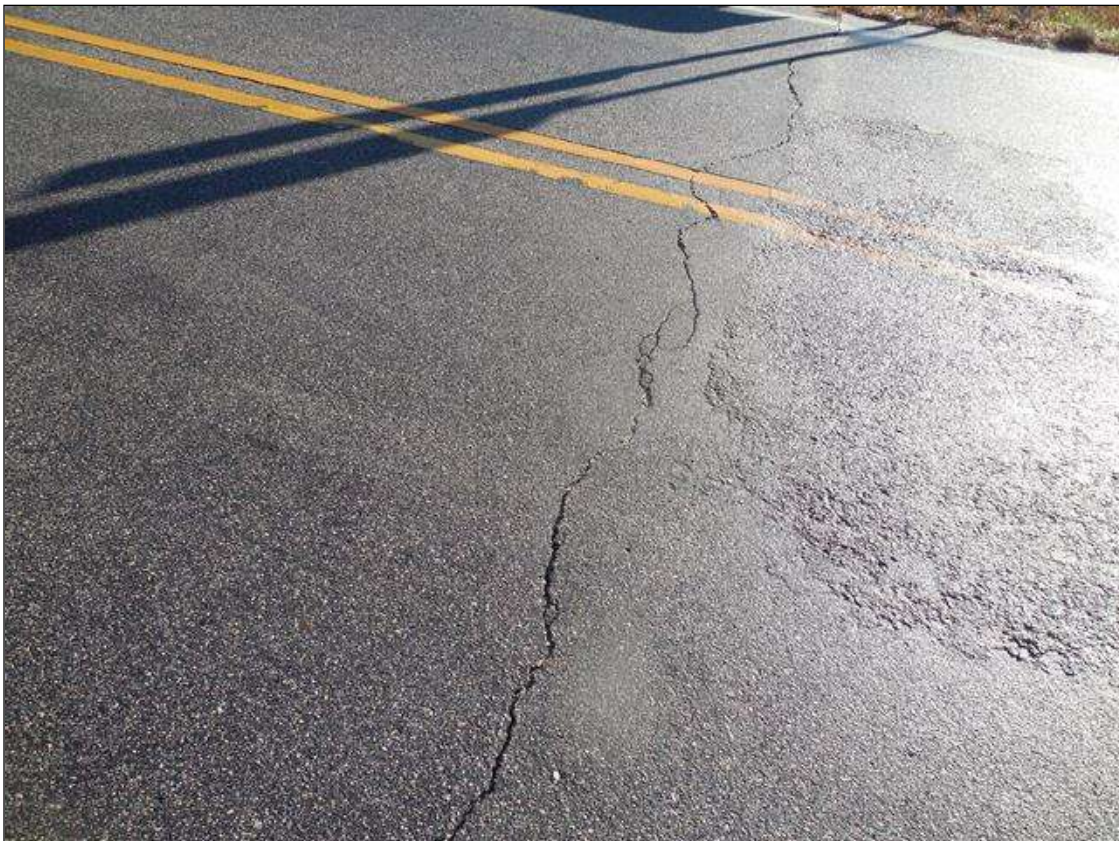
25 Square Feet of Crack (Wearing Surface): Width of more than 0.05 in. or spacing of less than 1.0 ft. 1/8" WIDE  
TRANSVERSE CRACK OVER END BENT 1

Span 1 Wearing Surface: 25 Square Feet of Crack (Wearing Surface): Width of more than 0.05 in. or spacing of less than 1.0 ft. 1/8" WIDE TRANSVERSE CRACK OVER END BENT 1

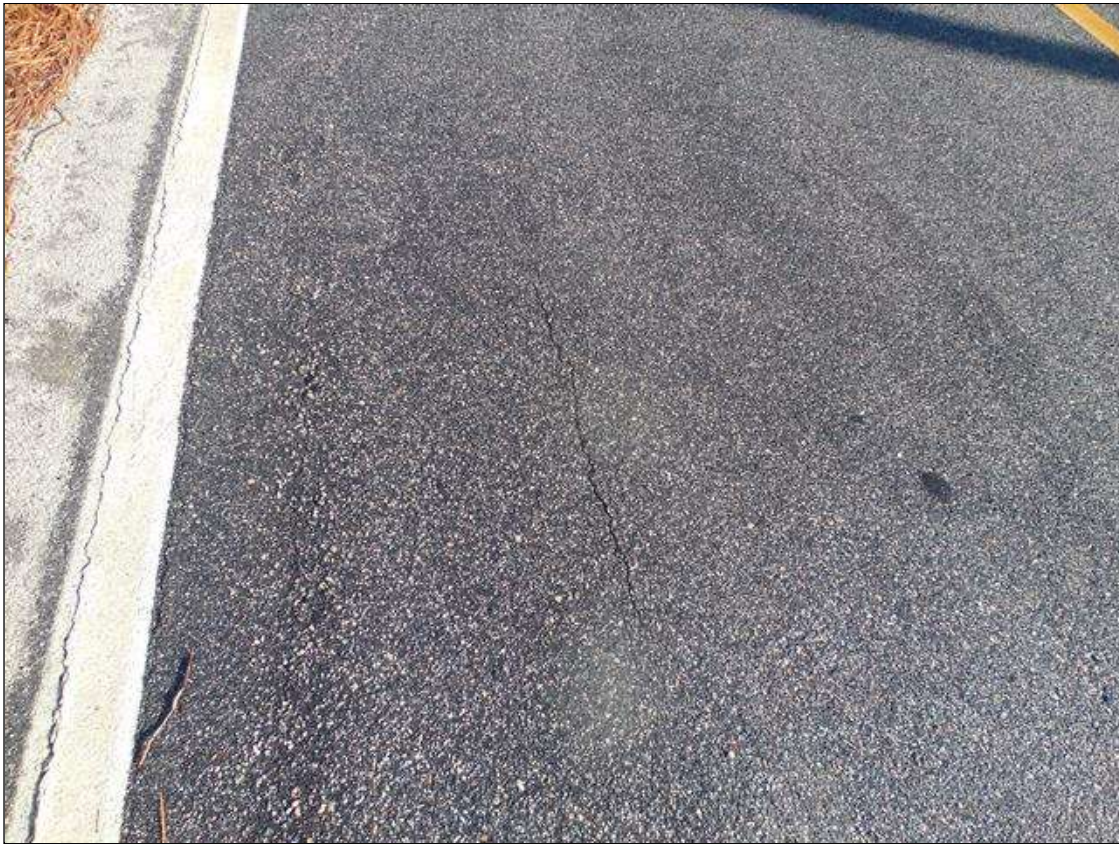
2 Square Feet of Crack (Wearing Surface): Width of more than 0.05 in. or spacing of less than 1.0 ft. 2' LONG X 1/8" WIDE  
LONGITUDINAL CRACK IN SOUTH BOUND LANE

Span 1 Wearing Surface: 2 Square Feet of Crack (Wearing Surface): Width of more than 0.05 in. or spacing of less than 1.0 ft. 2' LONG X 1/8" WIDE LONGITUDINAL CRACK IN SOUTH BOUND LANE

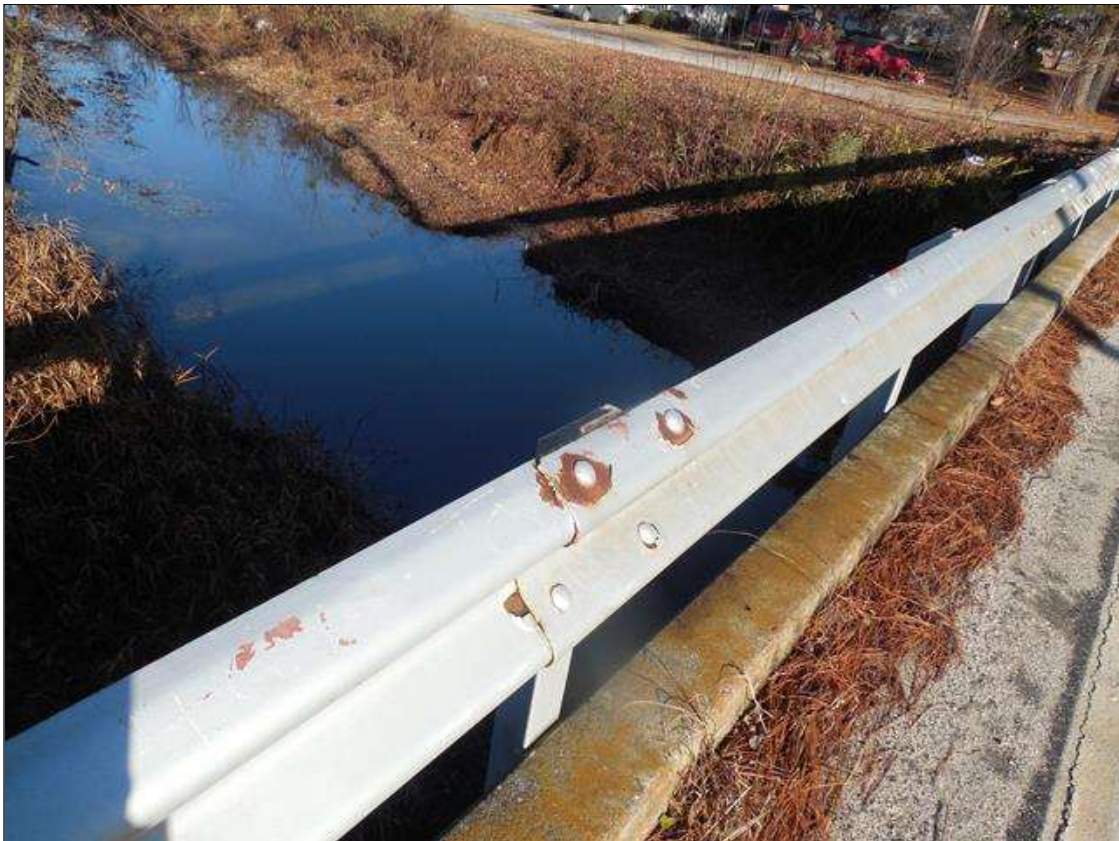
6 Square Feet of Peeling/Bubbling/Cracking (steel Protective Coatings): Finish and primer coats.

Span 1 Left Bridge Rail: 6 Square Feet of Peeling/Bubbling/Cracking (steel Protective Coatings): Finish and primer coats.

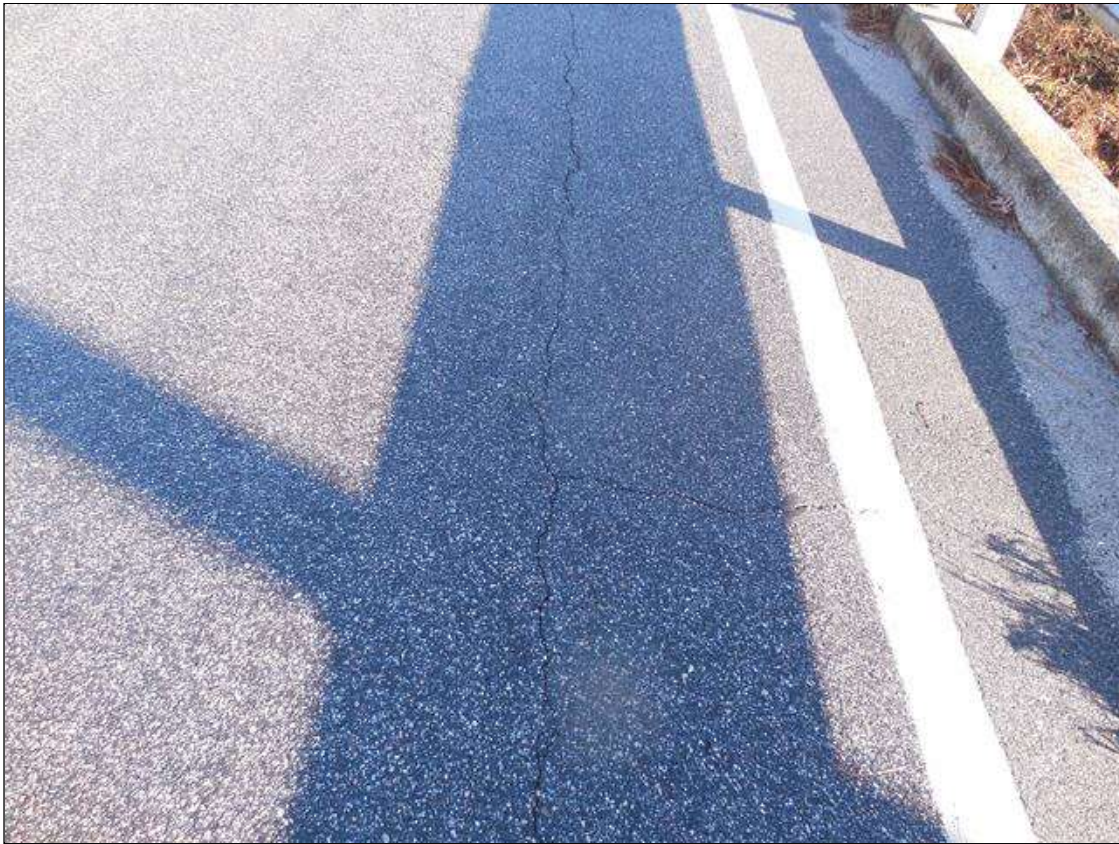
13 Square Feet of Crack (Wearing Surface): Width of more than 0.05 in. or spacing of less than 1.0 ft. 10' X 1/8" LONGITUDINAL CRACK AND 3' X 1/8" TRANSVERSE CRACK IN NORTH BOUND LANE

Span 1 Wearing Surface: 13 Square Feet of Crack (Wearing Surface): Width of more than 0.05 in. or spacing of less than 1.0 ft. 10' X 1/8" LONGITUDINAL CRACK AND 3' X 1/8" TRANSVERSE CRACK IN NORTH BOUND LANE

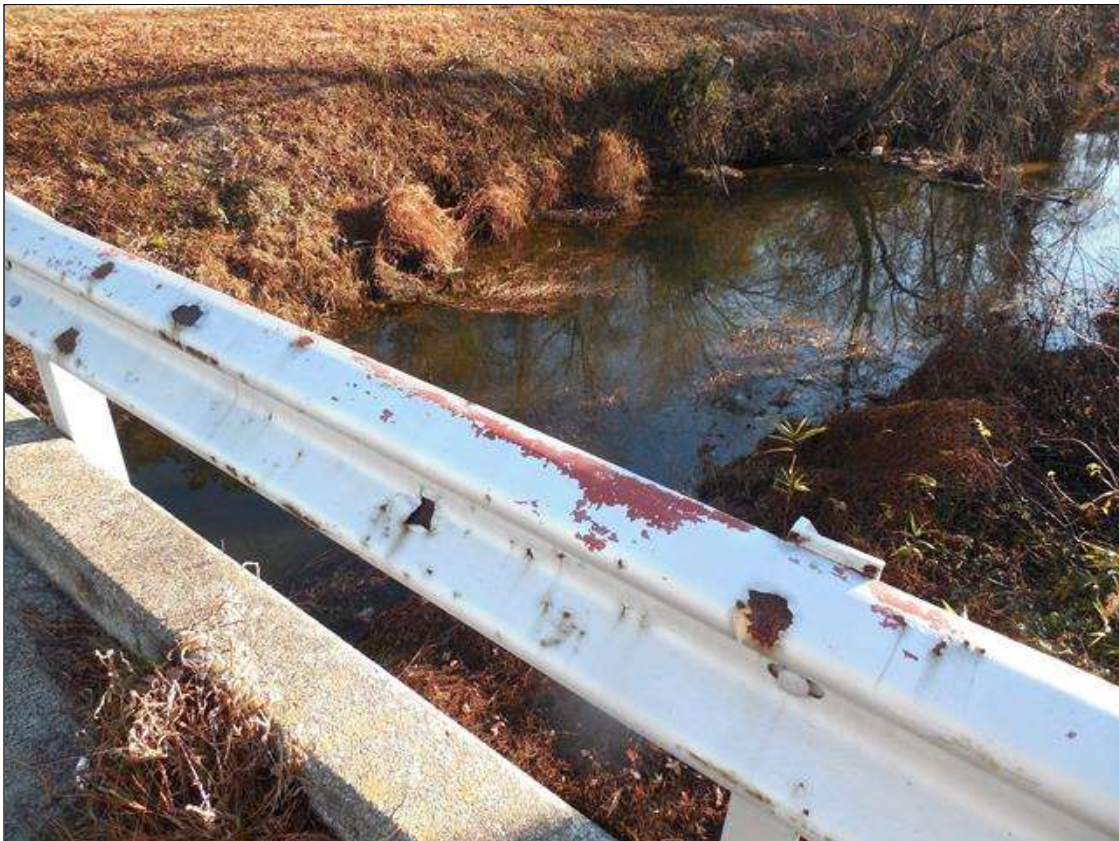
21 Square Feet of Peeling/Bubbling/Cracking (steel Protective Coatings): Finish and primer coats.

Span 1 Right Bridge Rail: 21 Square Feet of Peeling/Bubbling/Cracking (steel Protective Coatings): Finish and primer coats.

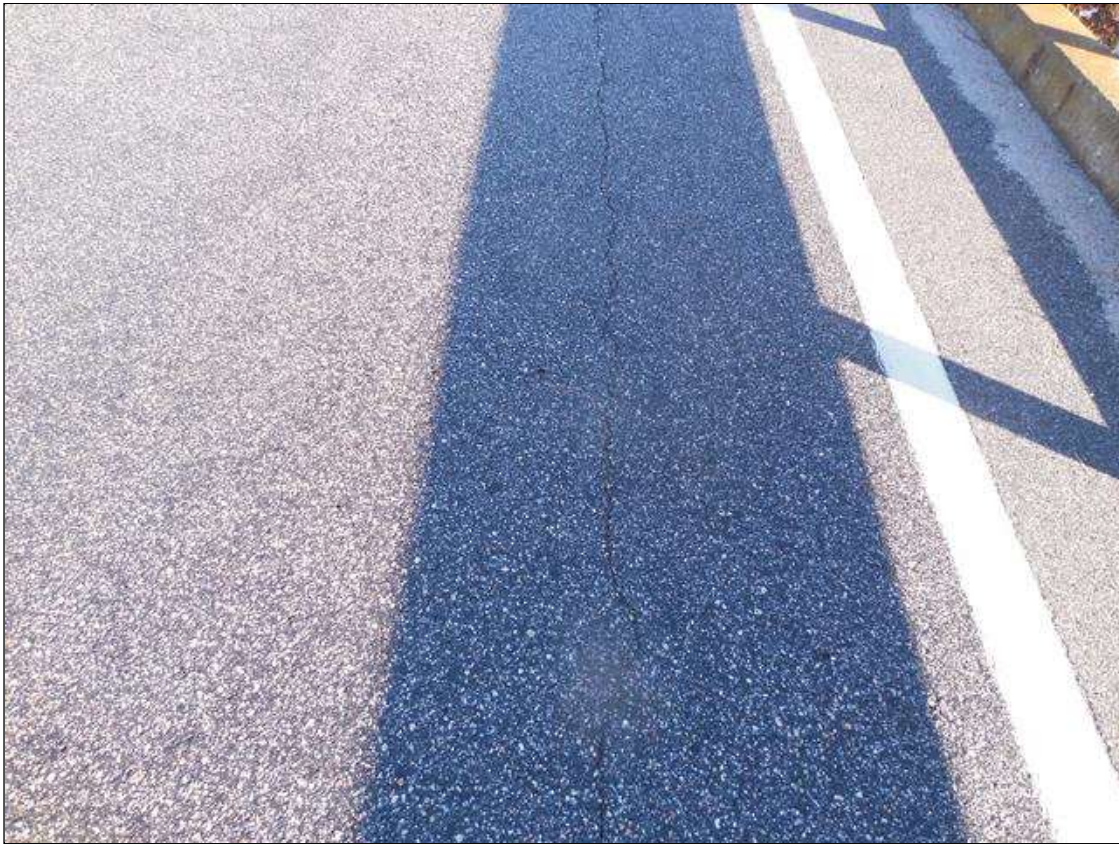
21 Square Feet of Crack (Wearing Surface): Width of more than 0.05 in. or spacing of less than 1.0 ft. 21' LONG X 1/8" WIDE  
LONGITUDINAL CRACK IN NORTH BOUND LANE

Span 2 Wearing Surface: 21 Square Feet of Crack (Wearing Surface): Width of more than 0.05 in. or spacing of less than 1.0 ft. 21' LONG X 1/8" WIDE LONGITUDINAL CRACK IN NORTH BOUND LANE

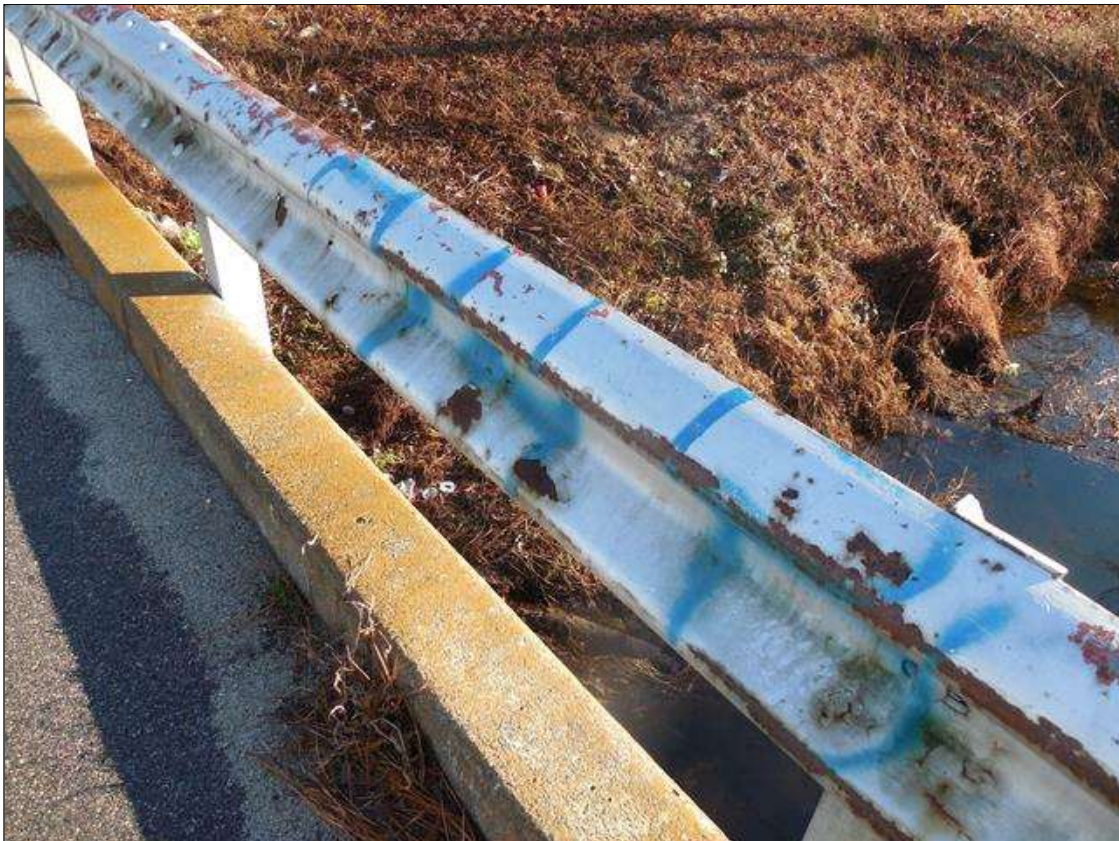
Span 2 Right Bridge Rail: 20 Square Feet of Peeling/Bubbling/Cracking (steel Protective Coatings): Finish and primer coats.

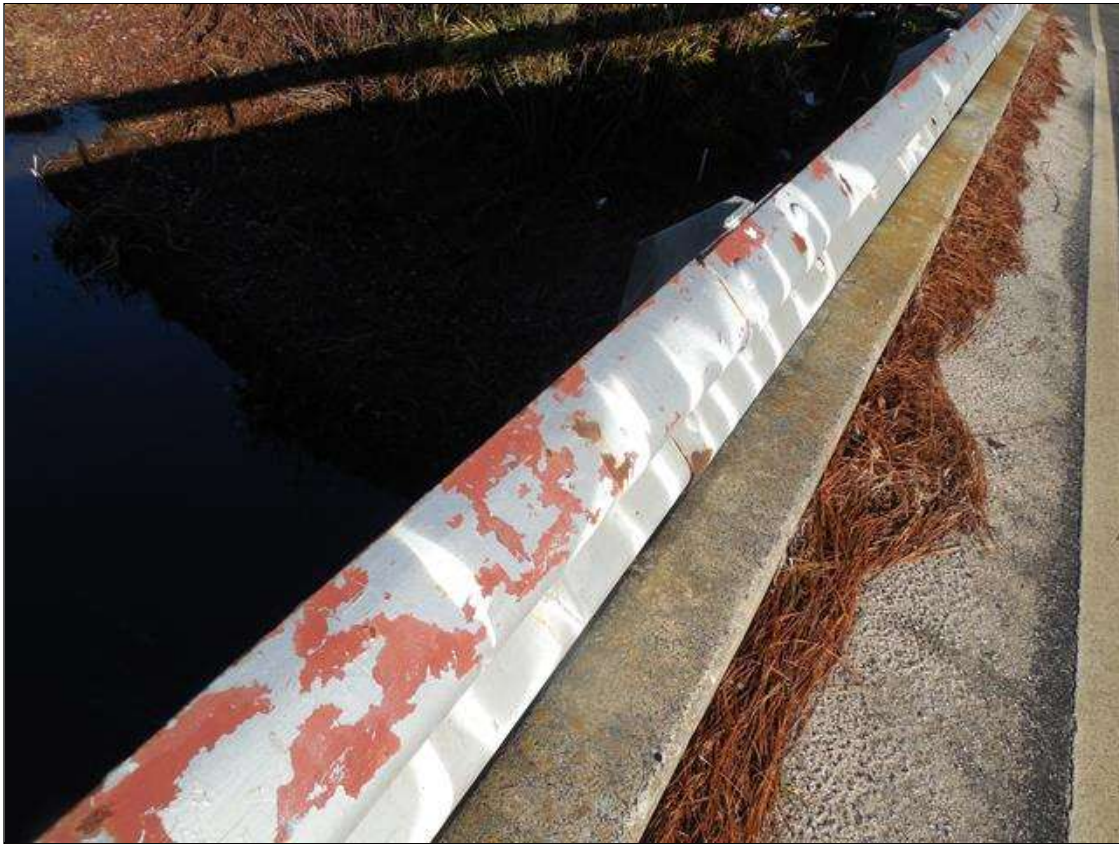
Span 2 Left Bridge Rail: 20 Square Feet of Peeling/Bubbling/Cracking (steel Protective Coatings): Finish and primer coats.

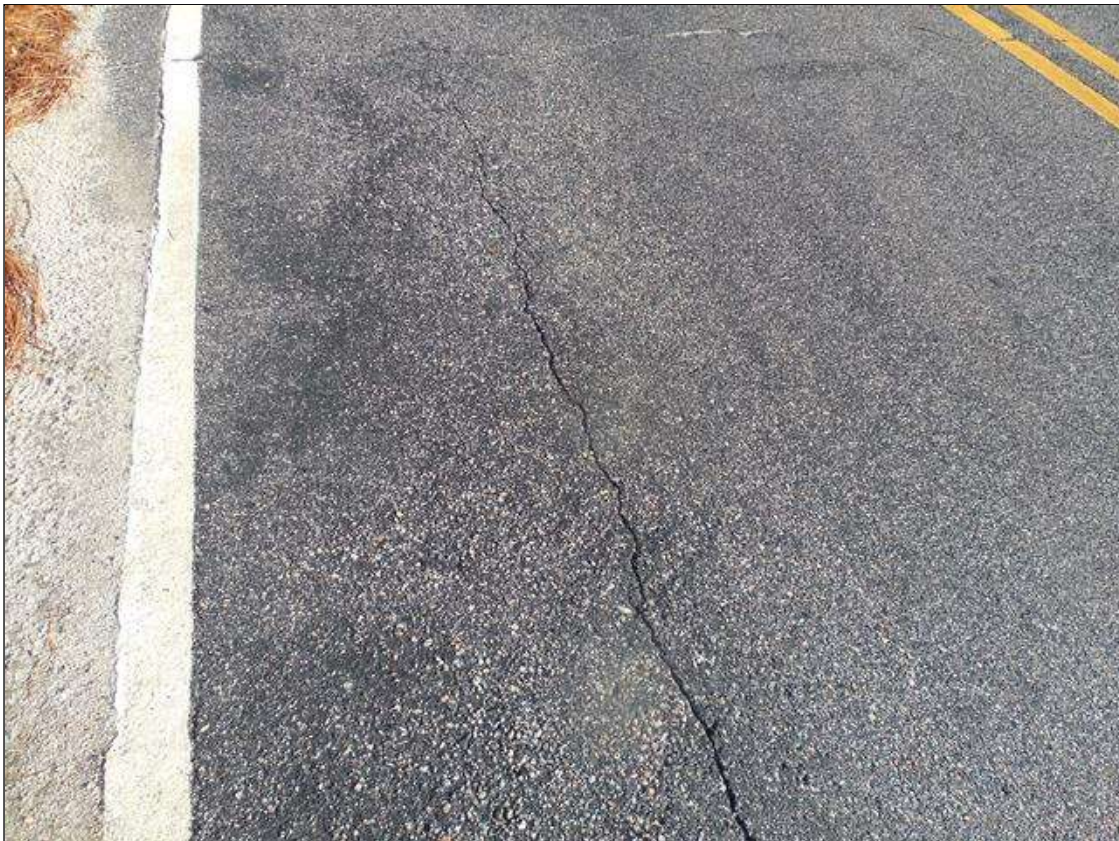
Span 3 Wearing Surface: 6 Square Feet of Crack (Wearing Surface): Width of more than 0.05 in. or spacing of less than 1.0 ft. 6' LONG X 3/16" WIDE LONGITUDINAL CRACK IN SOUTH BOUND LANE

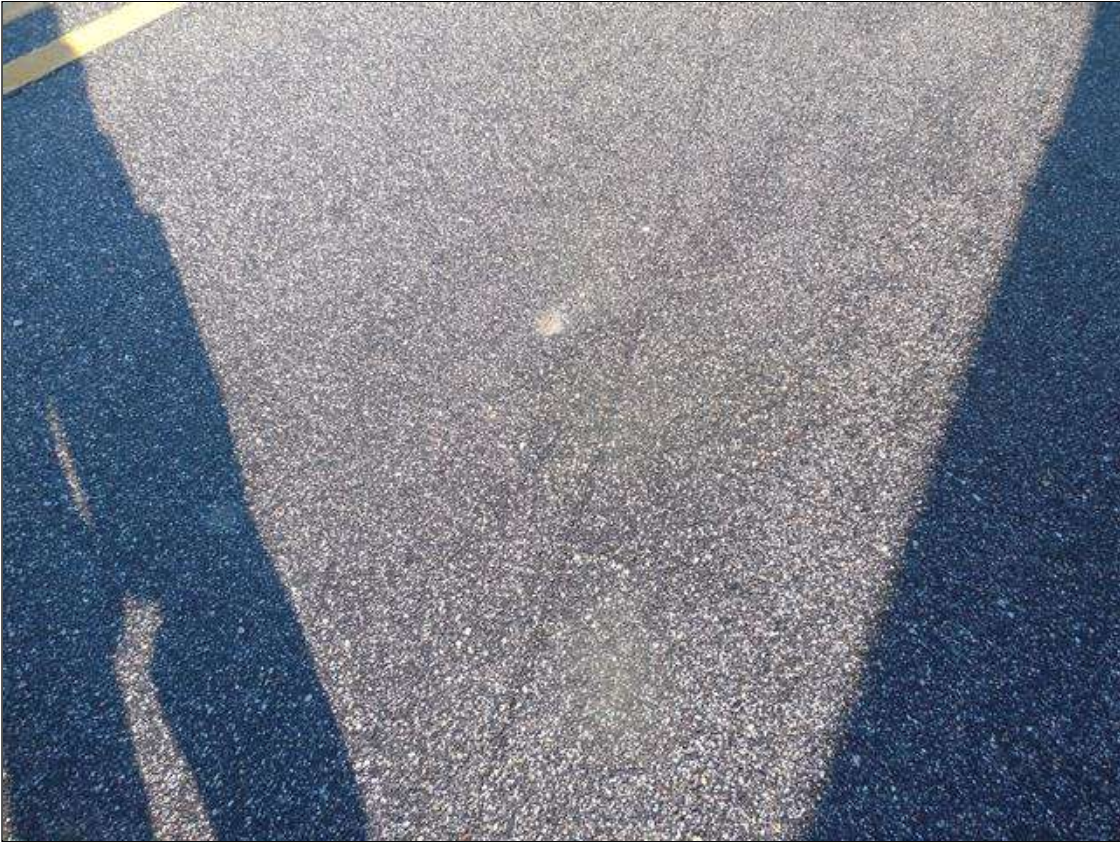
Span 3 Wearing Surface: 10 Square Feet of Crack (Wearing Surface): Width 0.012-0.05 in. or spacing of 1.0-3.0 ft.  
HAIRLINE X 10' LONG LONGITUDINAL CRACK IN NORTH BOUND LANE

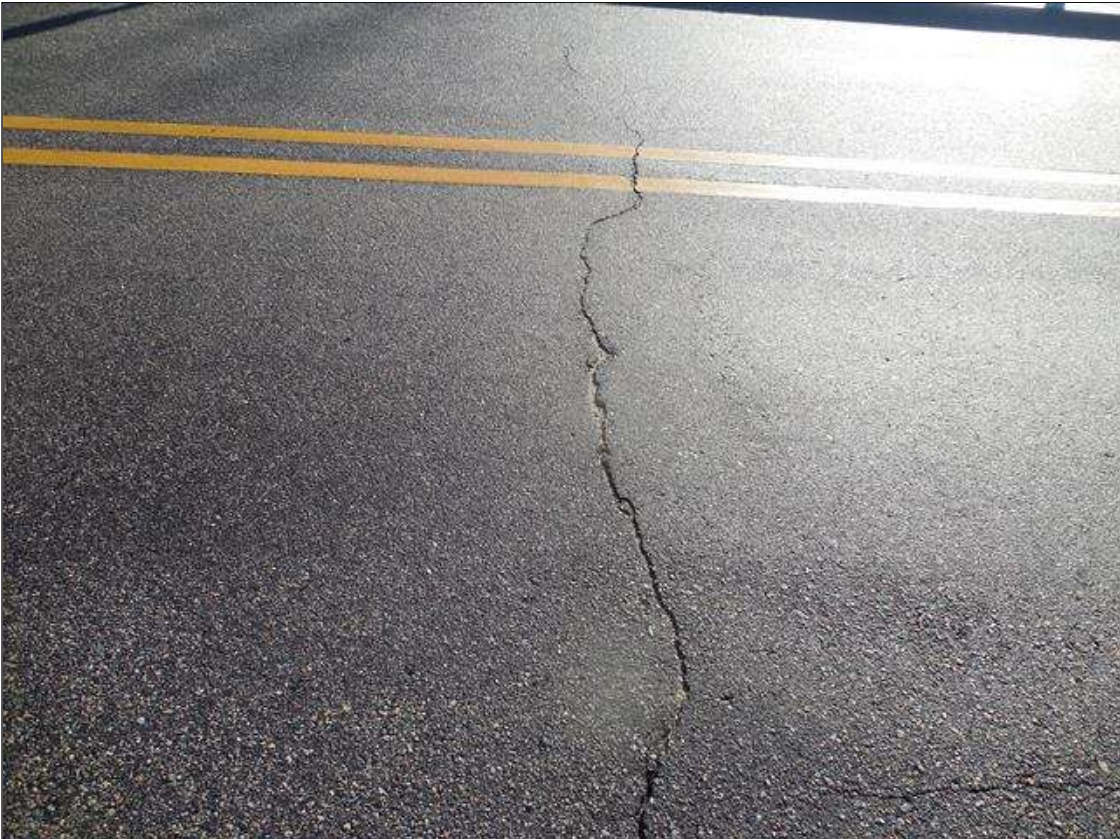
Span 3 Wearing Surface: 25 Square Feet of Crack (Wearing Surface): Width of more than 0.05 in. or spacing of less than 1.0 ft. 1/4" WIDE TRANSVERSE CRACK OVER END BENT 2

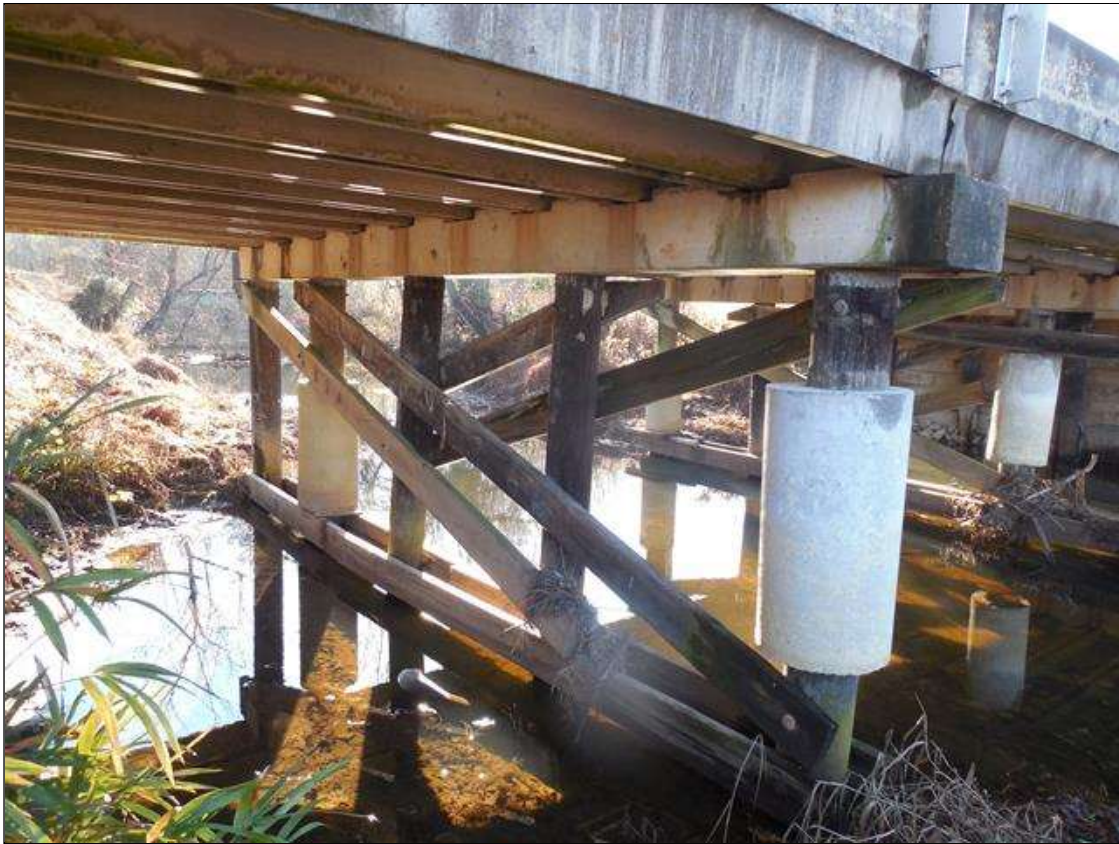
| <b>Details</b> | PILES 1 AND 4 ENCASED ( TEMPORARY REPAIRS ) AT BENT 2 |

PILES 1 AND 4 ENCASED ( TEMPORARY REPAIRS ) AT BENT 2

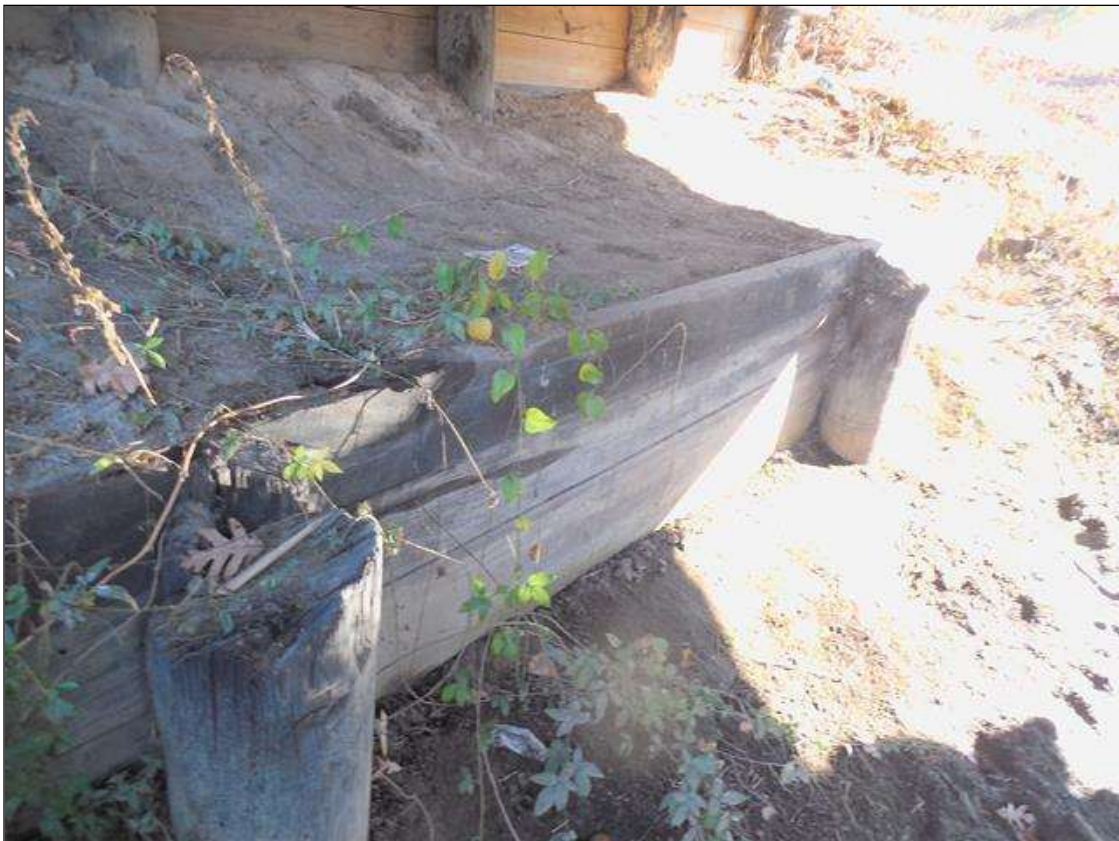
THERE IS AN OLD TIMBER BULKHEAD IN SPAN 3

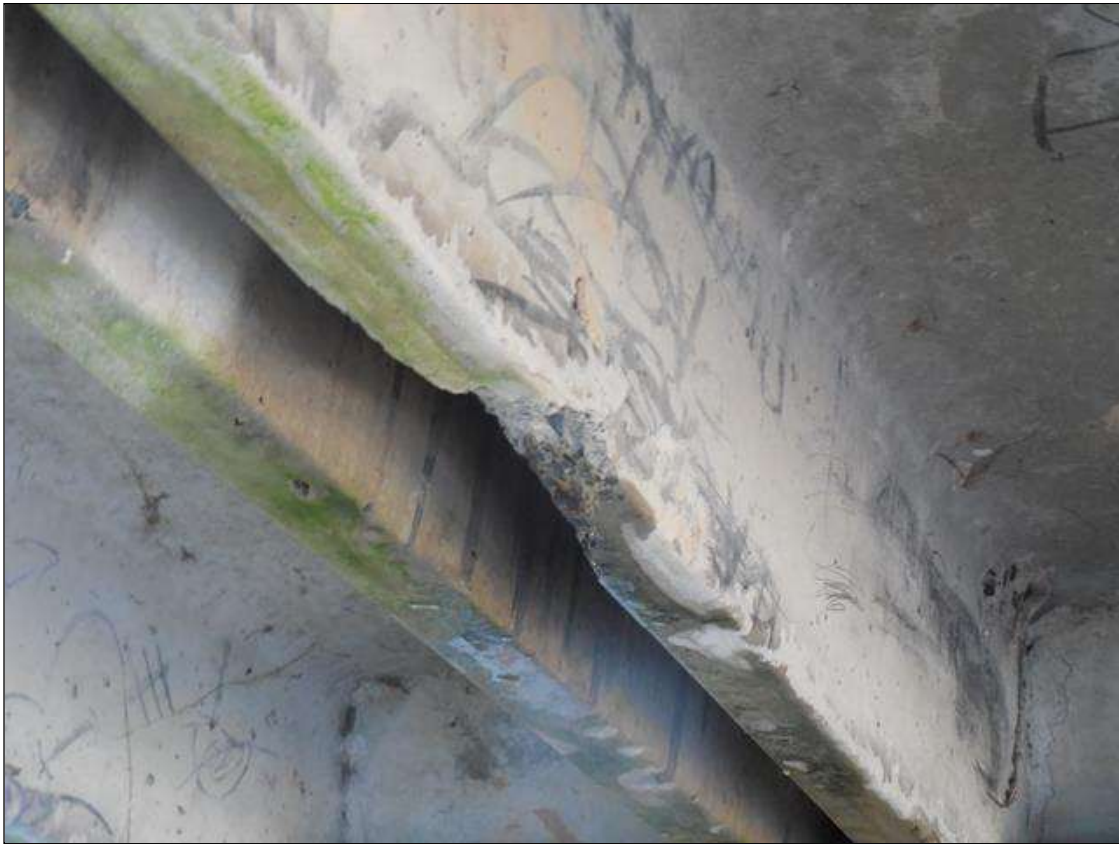
1 Feet of Delamination/Spall/Patched Area: Spall greater than 1 in. deep or greater than 6 in. diameter. Patched area that is unsound or showing distress. Does not warrant structural review. SPALL 12" WIDE X 3" HIGH IN LEFT LEG AT 3' FROM END BENT 2 CAP

Span 3 Channel/Slab 2: 1 Feet of Delamination/Spall/Patched Area: Spall greater than 1 in. deep or greater than 6 in. diameter. Patched area that is unsound or showing distress. Does not warrant structural review. SPALL 12" WIDE X 3" HIGH IN LEFT LEG AT 3' FROM END BENT 2 CAP

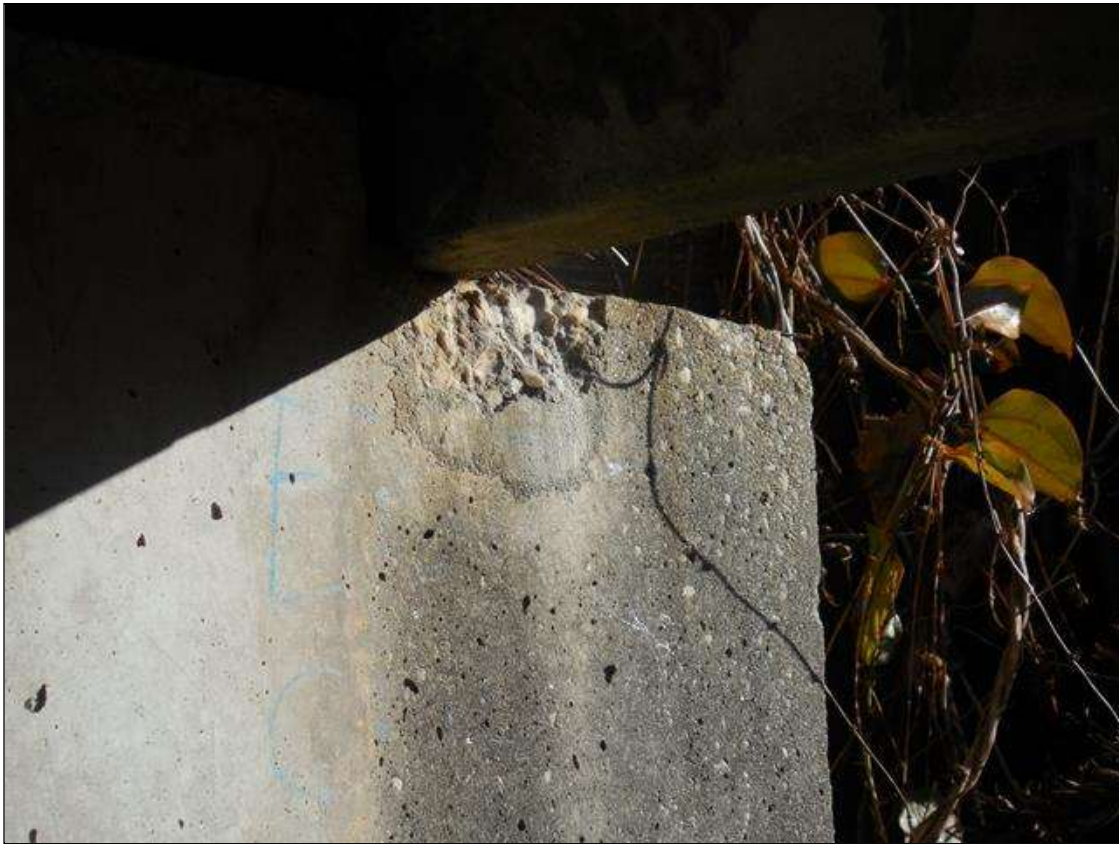
1 Feet of Delamination/Spall/Patched Area: Spall greater than 1 in. deep or greater than 6 in. diameter. Patched area that is unsound or showing distress. Does not warrant structural review. SPALL 8" WIDE X 3" HIGH X 3/4" DEEP UNDER CHANNEL 10 RIGHT LEG

End Bent 2 Cap : 1 Feet of Delamination/Spall/Patched Area: Spall greater than 1 in. deep or greater than 6 in. diameter. Patched area that is unsound or showing distress. Does not warrant structural review. SPALL 8" WIDE X 3" HIGH X 3/4" DEEP UNDER CHANNEL 10 RIGHT LEG

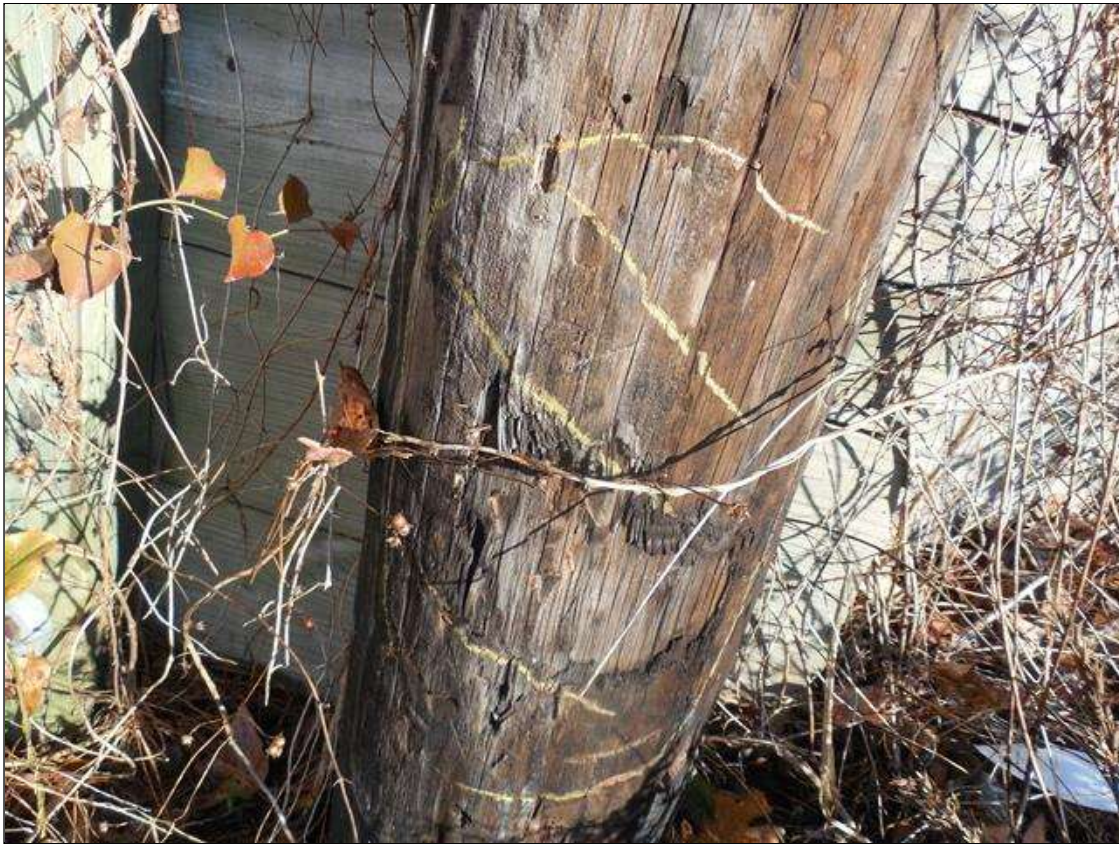
End Bent 2 Abutment/Backwall : 1 Feet of Split/Delamination (Timber): Length equal to or greater than the member depth but does not require structural review. TURNPILE AT NORTHEAST CORNER DELAMINATED 3' HIGH X 14" WIDE

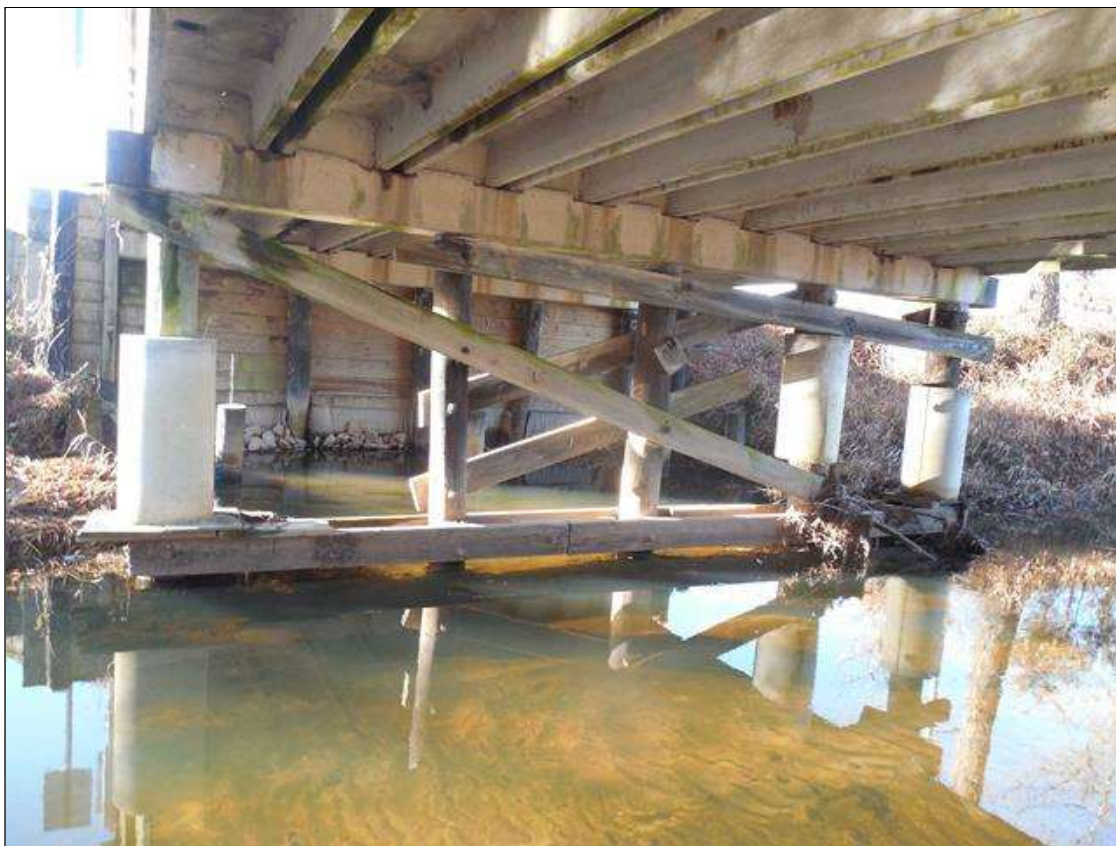
| | PILES 1, 2, AND 5 ENCASED ( TEMPORARY REPAIRS ) AT BENT 1 |

PILES 1, 2, AND 5 ENCASED ( TEMPORARY REPAIRS ) AT BENT 1

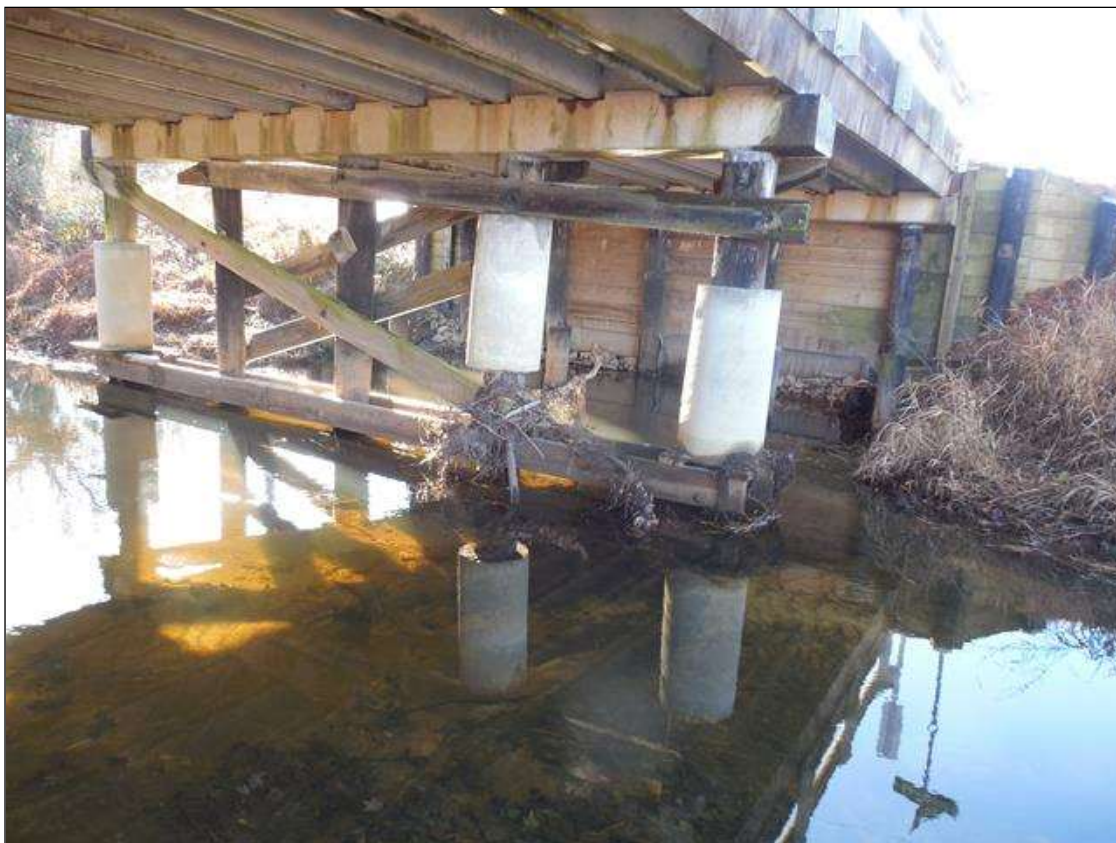
| <b>Details</b> | DRIFT COLLECTING AT BENT 1 PILES 1 AND 2 ( 10 HRS. ) |

DRIFT COLLECTING AT BENT 1 PILES 1 AND 2 ( 10 HRS. )

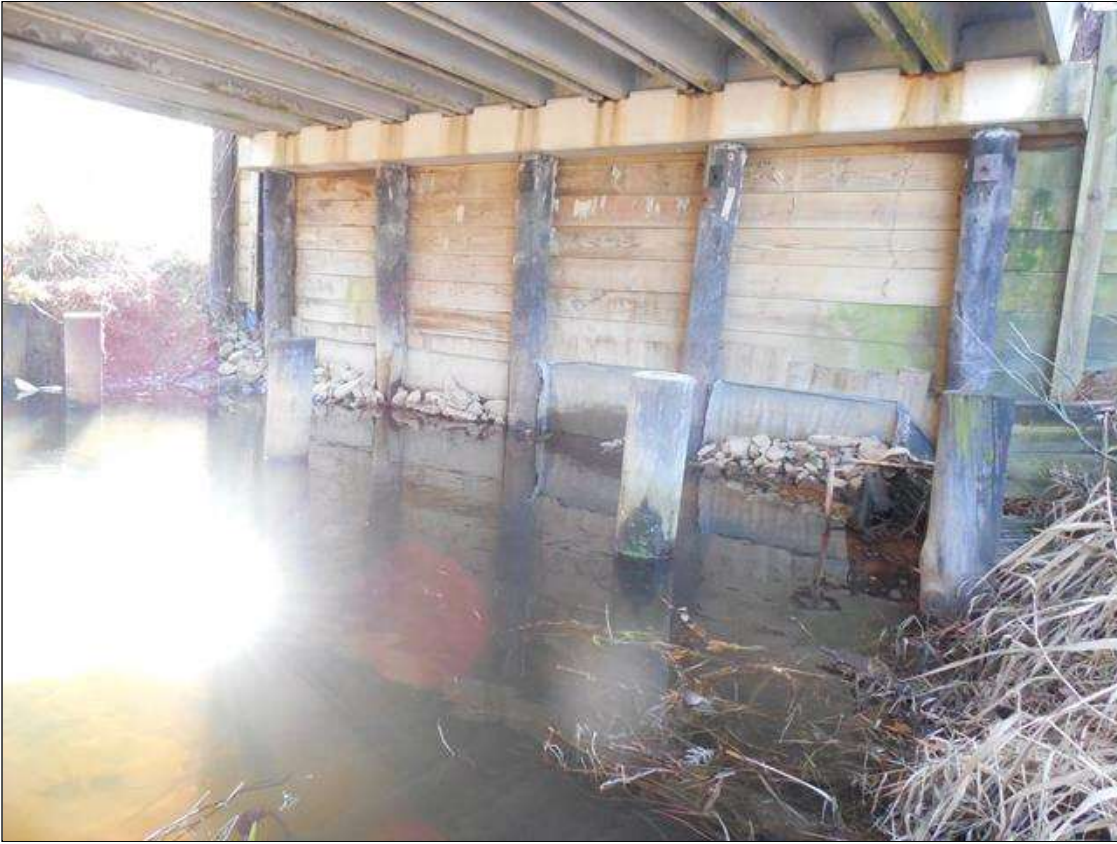
THERE ARE 5 CUT OFF PILES IN SPAN 1 WATERWAY

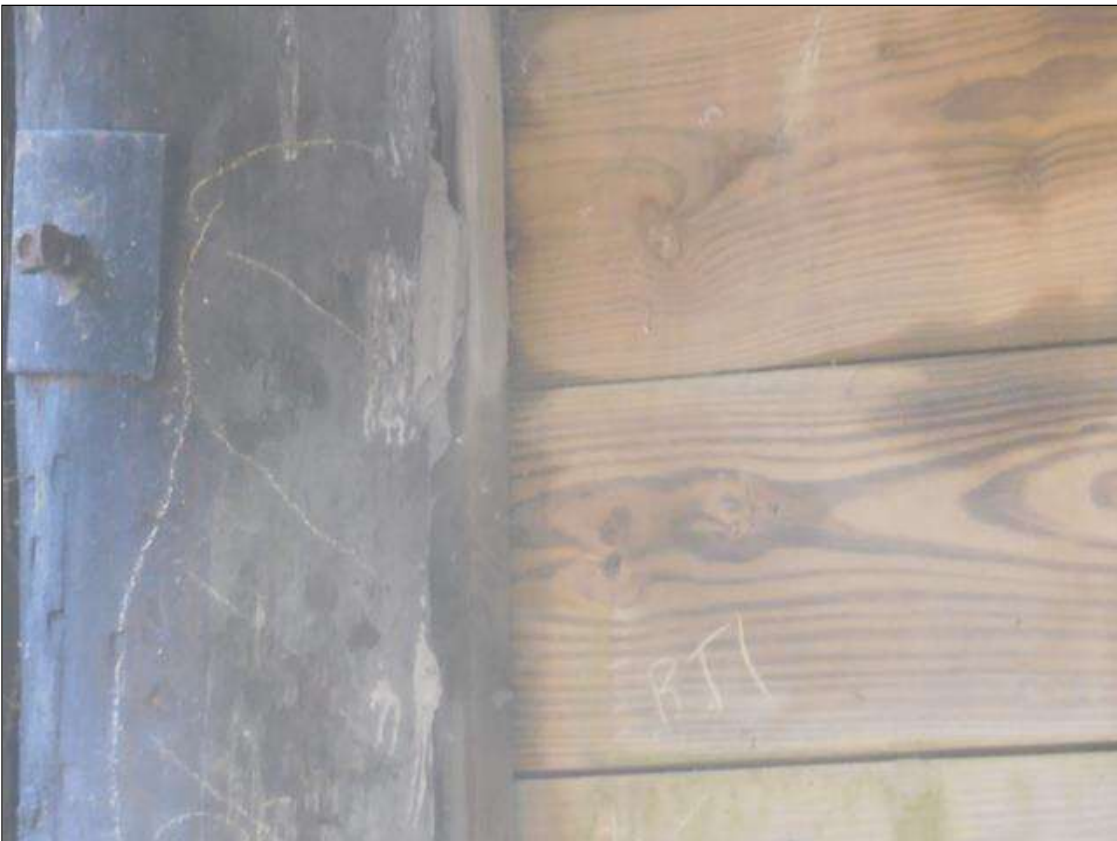
End Bent 1 Pile 5: 1 Each of Split/Delamination: Length less than the member depth or arrested with effective actions taken to mitigate. DELAMINATED 32" HIGH X 8" WIDE NEAR TOP OF PILE

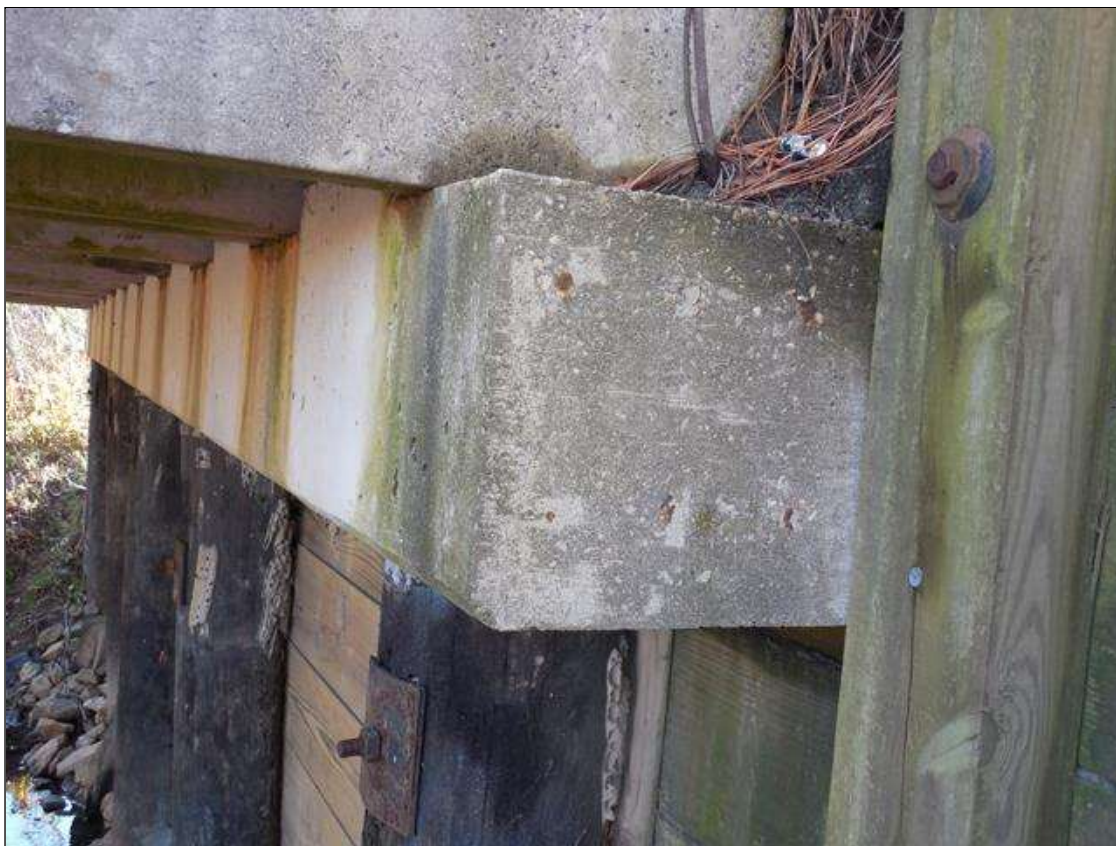
End Bent 1 Cap : 2 Feet of Exposed Prestressing: Present without section loss. ON WEST END

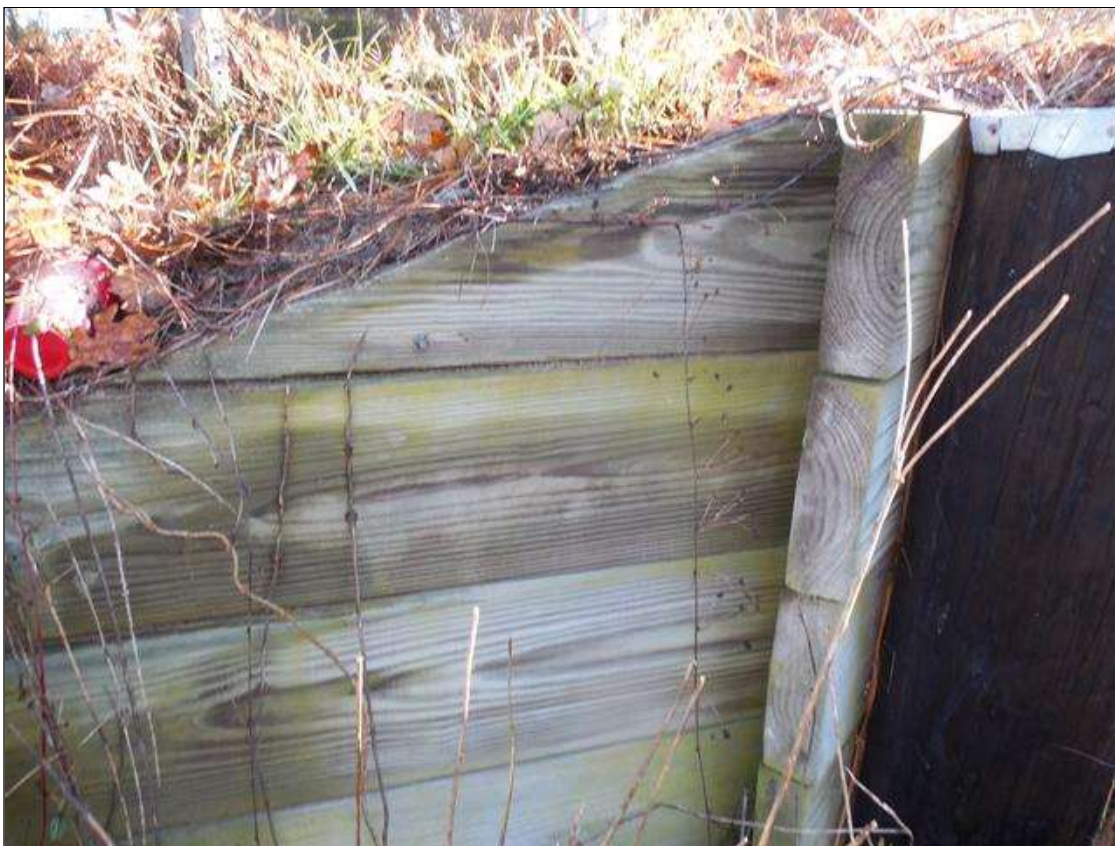
NEW WINGWALL AND BULKHEAD AT END BENT 2
