NC DEPARTMENT OF TRANSPORTATION  
DIVISION OF HIGHWAYS  
STRUCTURE MANAGEMENT UNIT

## Structure Safety Report

### Routine Element Inspection

COUNTY: ROBESON STRUCTURE NUMBER: 770172 FREQUENCY: 24 MONTHS

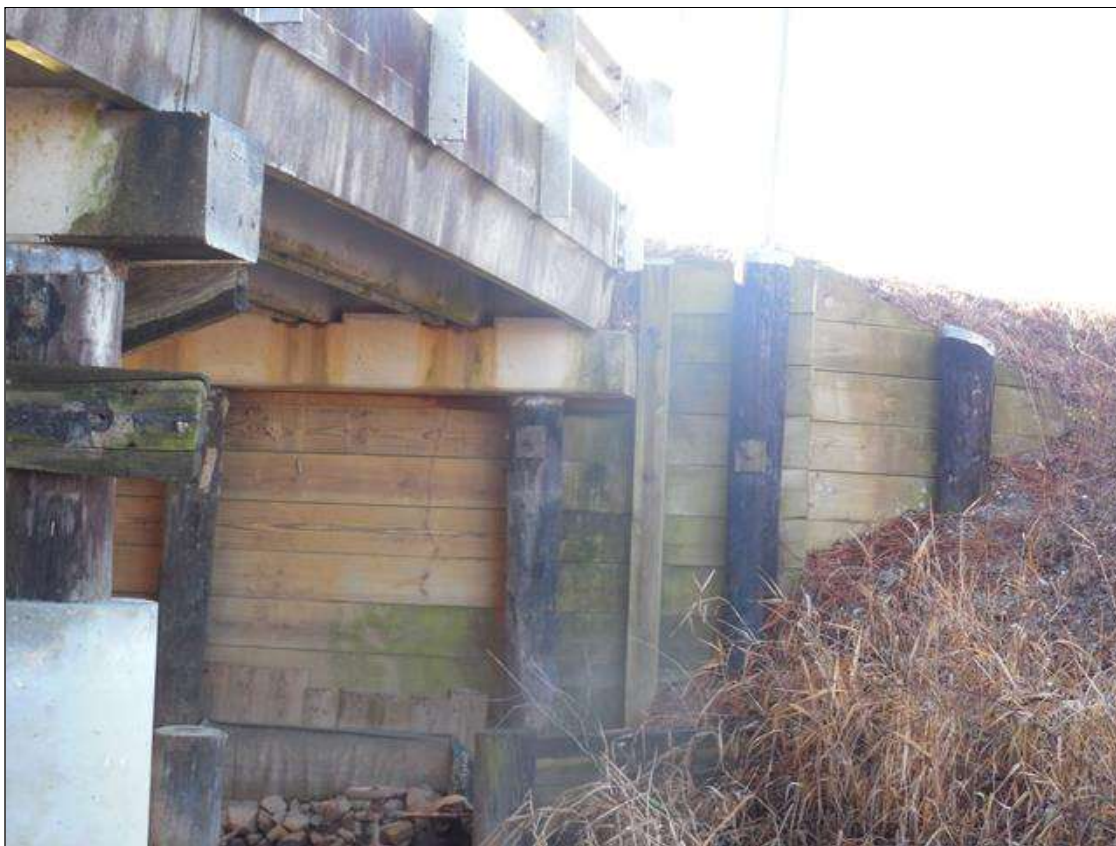
NEW WINGWALL AND BULKHEAD AT END BENT 1
