# Structure Safety Report

## Routine Element Inspection

COUNTY: WILKES STRUCTURE NUMBER: 960713 FREQUENCY: 24 MONTHSFACILITY CARRIED: SR2486 MILE POST: LOCATION: .8 MI.NE.JCT.SR2483FEATURE INTERSECTED: CUB CREEKLATITUDE: 36° 4' 53.93" LONGITUDE: 81° 9' 4.57"SUPERSTRUCTURE: TIMBER FLOOR ON SALAVAGE I-BEAMSSUBSTRUCTURE: E.BTS:TIMBER CAPS/TIMBER POST&SILLS @ VAR.CENTERSSPANS: 1 @ 40'-6"☐ FRACTURE CRITICAL ☐ TEMPORARY SHORING ☐ SCOUR CRITICAL ☐ SCOUR PLAN OF ACTIONPRESENT CONDITION: Fair INSPECTION DATE: 04/23/2015POSTED SV: 30 POSTED TTST: 30OTHER SIGNS PRESENT: 4 DEL

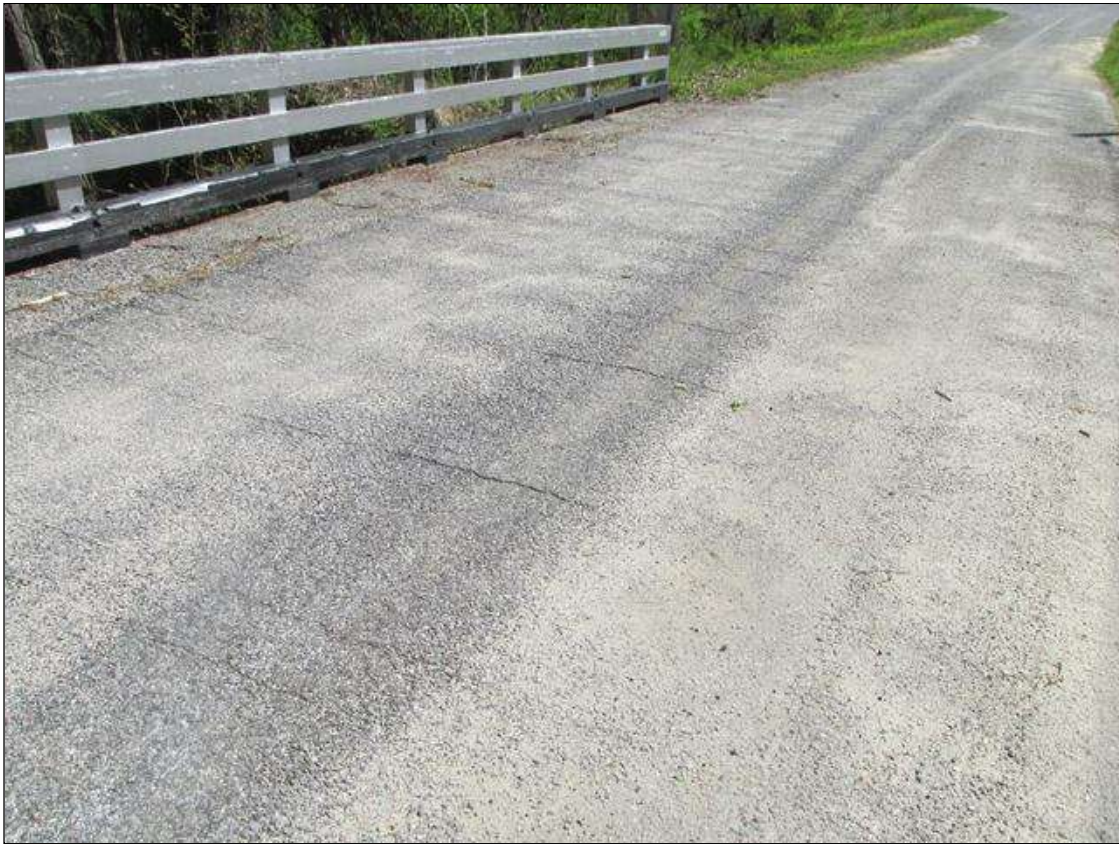
773 Square Feet of Crack (Wearing Surface): Width of more than 0.05 in. or spacing of less than 1.0 ft. ENTIRE WEARING SURFACE CRACKED FULL WIDTH AND LENGTH

Span 1 Wearing Surface: 773 Square Feet of Crack (Wearing Surface): Width of more than 0.05 in. or spacing of less than 1.0 ft. ENTIRE WEARING SURFACE CRACKED FULL WIDTH AND LENGTH

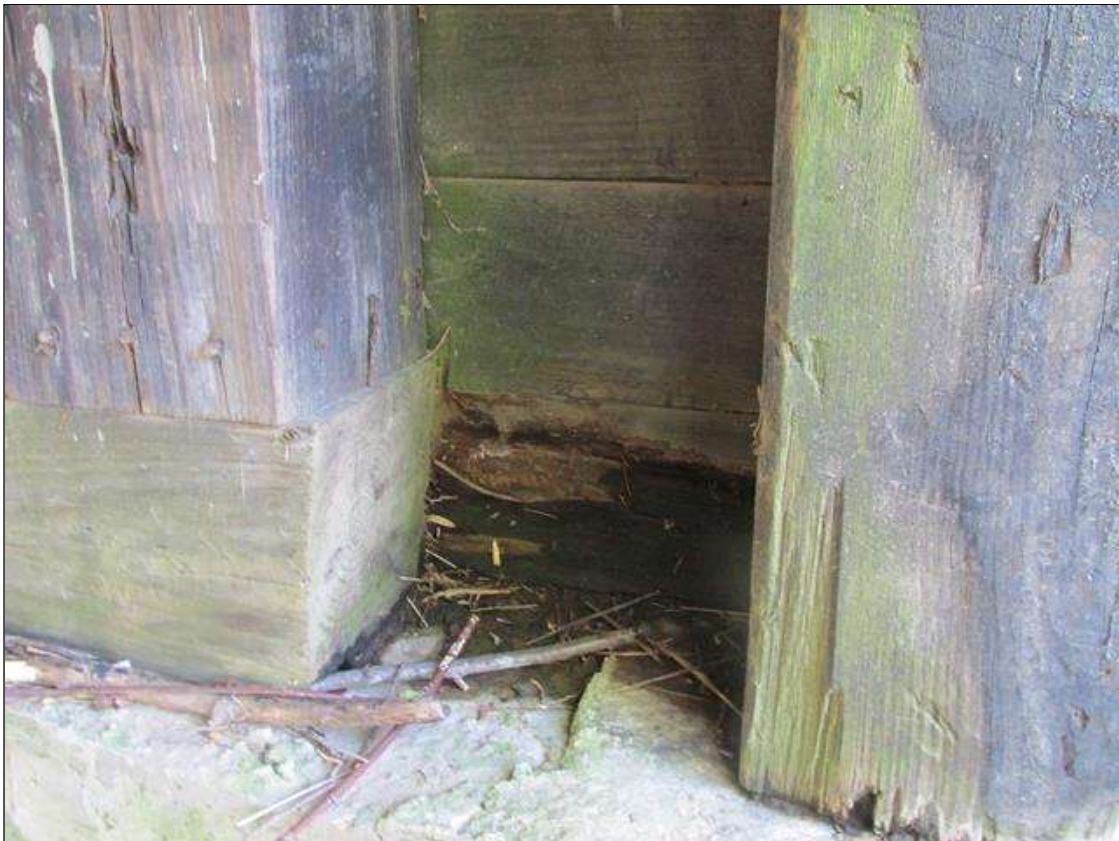
4 Feet of Decay/Section Loss: Affects less than 10% of the member section LEFT 4' OF ABUTMENT A BOTTOM BULKHEAD BOARD

End Bent 1 Abutment/Backwall : 4 Feet of Decay/Section Loss: Affects less than 10% of the member section LEFT 4' OF ABUTMENT A BOTTOM BULKHEAD BOARD

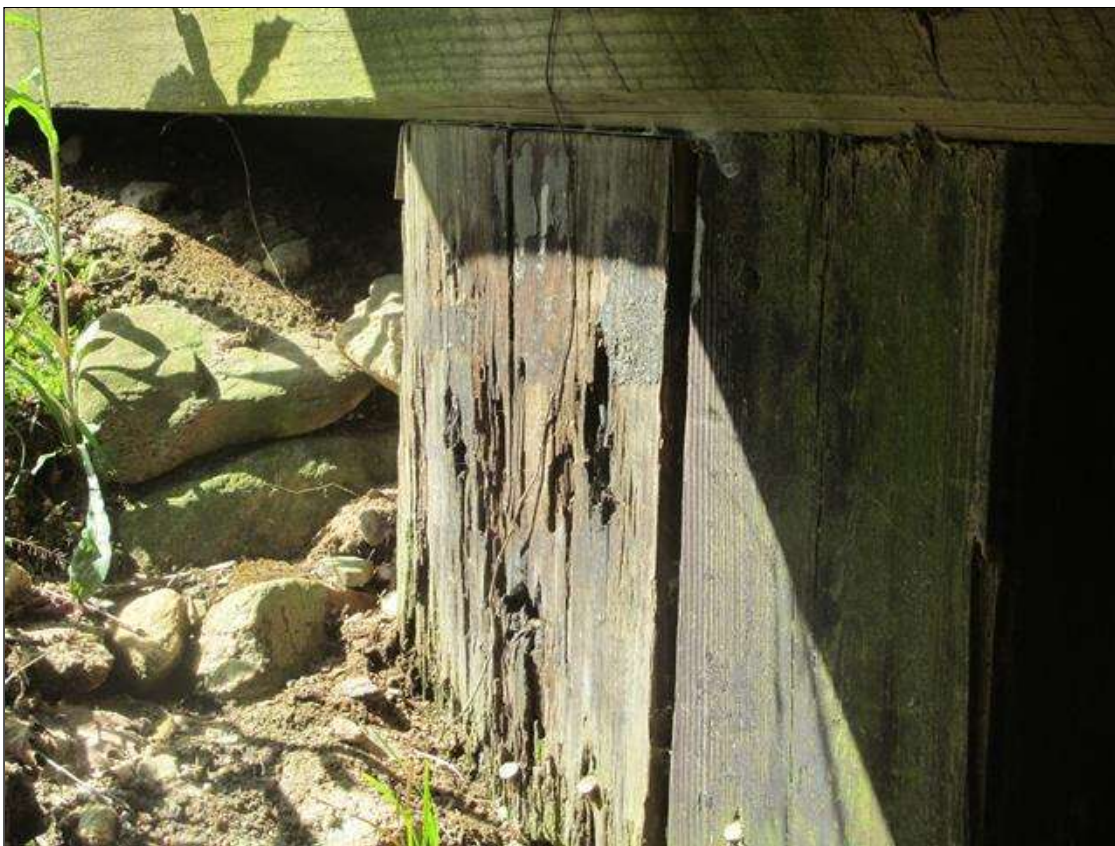
ABUTMENT A POST 6 DECAYED AND SUPPLIMENTED

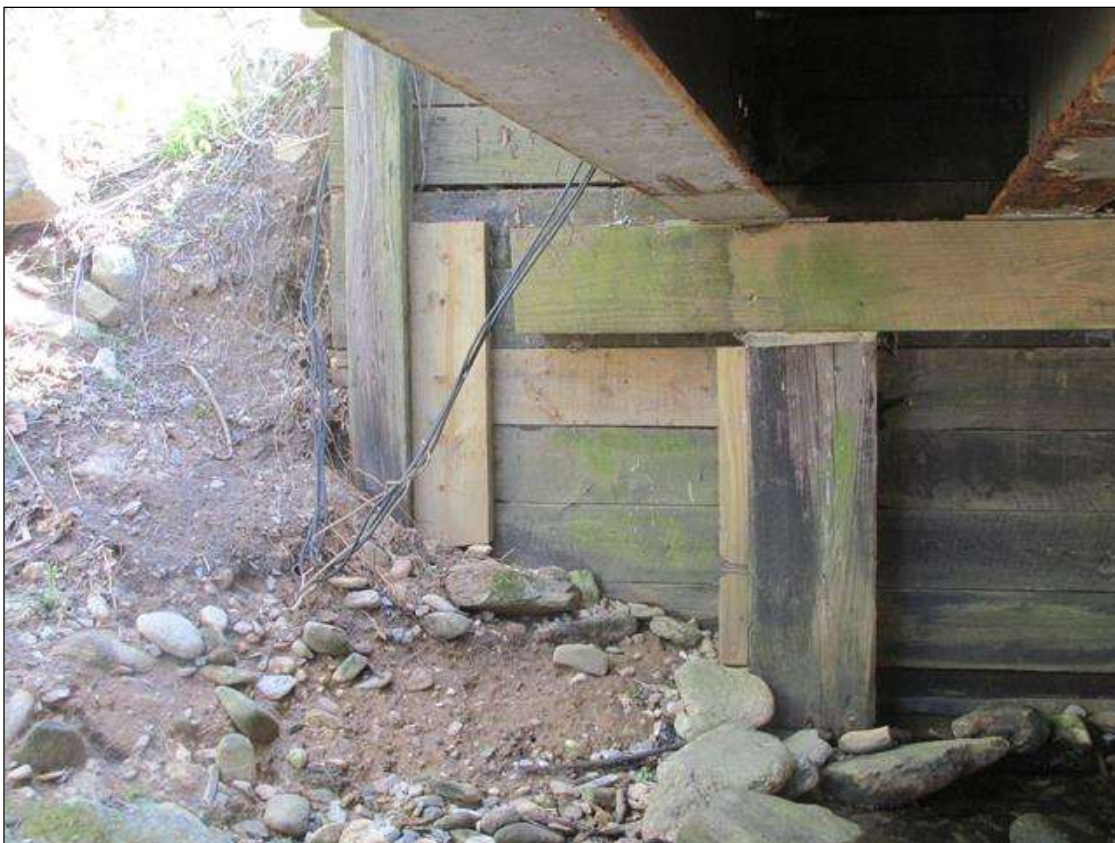
ABUTMENT B LEFT BULKHEAD TEMPORARY REPAIRS

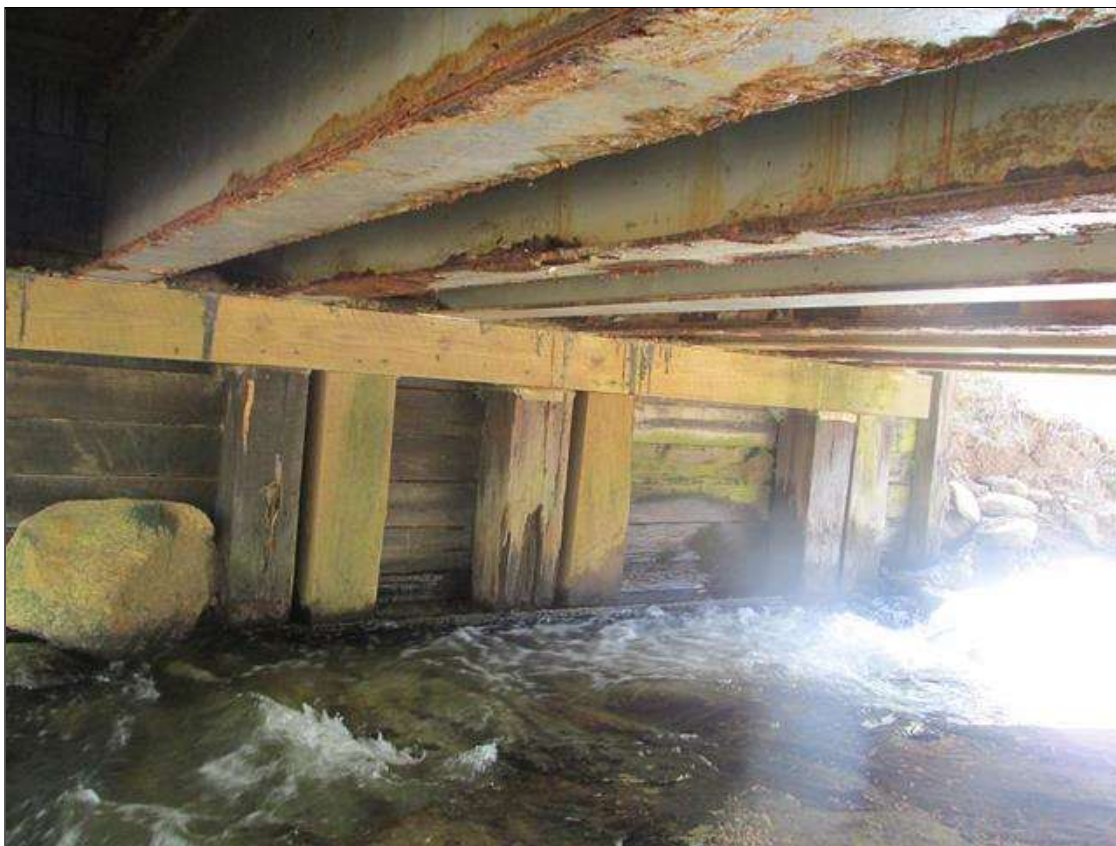
ABUTMENT B POSTS 2, 3, 5, DECAYED AND SUPPLIMENTED

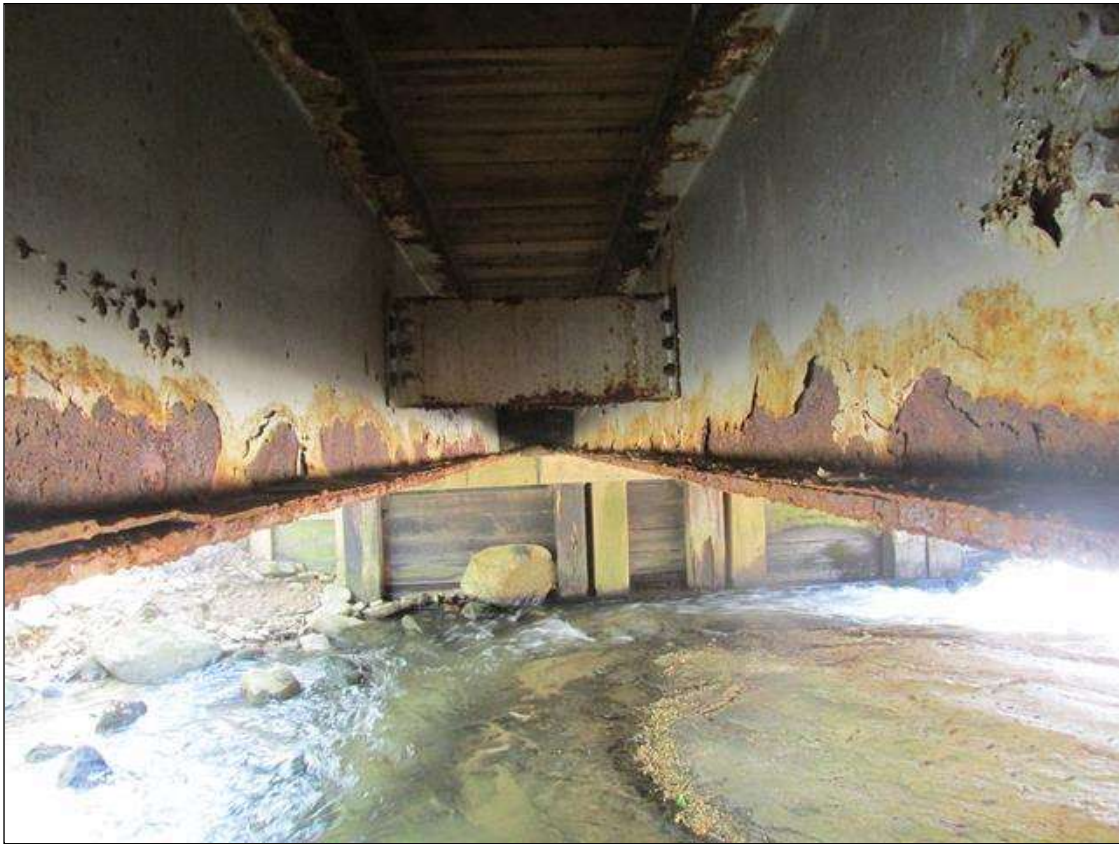
41 Feet of Corrosion: Section loss is evident or pack rust is present but does not warrant structural review. TOP AND BOTTOM FLANGE FULL LENGTH, 1/2 SECTION REMAINING, BOTTOM 6 INCHES OF WEB, NO SECTION LOSS AT THIS TIME ON WEB

281 Square Feet of Effectiveness (Steel Protective Coatings): Limited effectiveness. TOP AND BOTTOM FLANGE FULL LENGTH CORROSION, BOTTOM 6" OF WEB CORROSION

Span 1 Beam 3: 41 Feet of Corrosion: Section loss is evident or pack rust is present but does not warrant structural review. TOP AND BOTTOM FLANGE FULL LENGTH, 1/2 SECTION REMAINING, BOTTOM 6 INCHES OF WEB, NO SECTION LOSS AT THIS TIME ON WEB

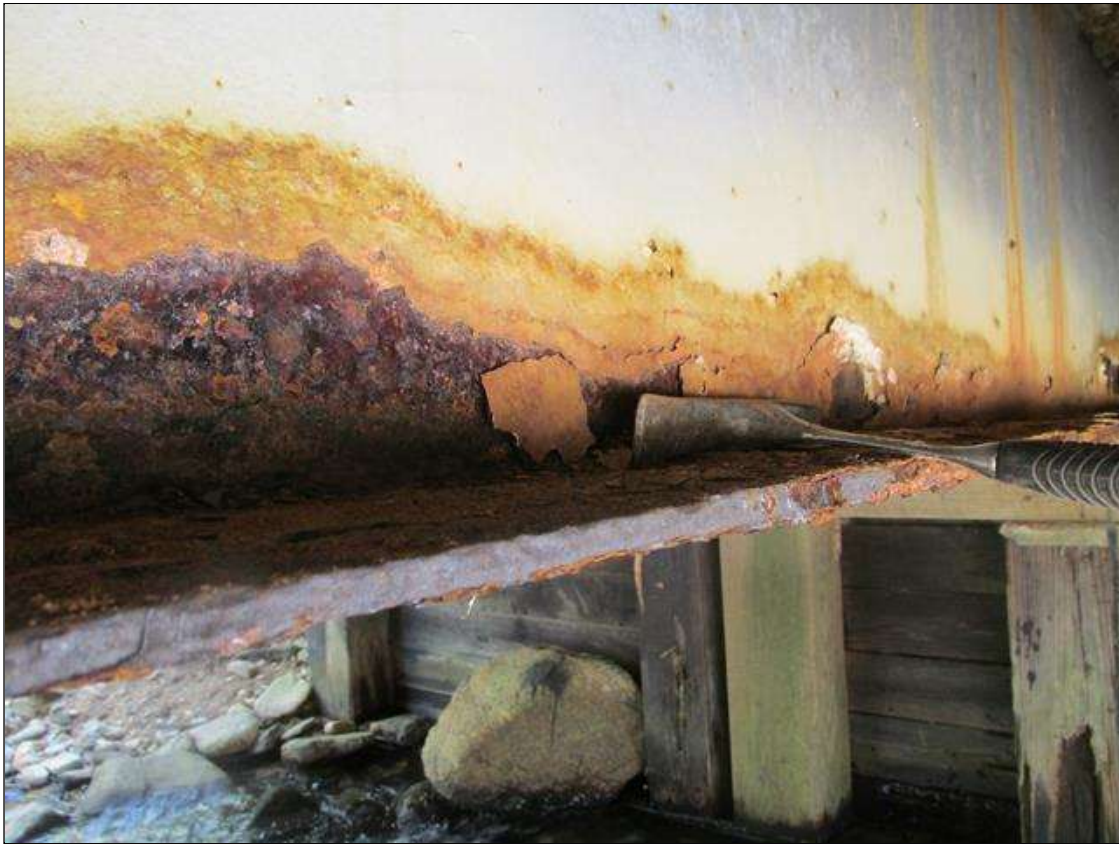
41 Feet of Corrosion: Section loss is evident or pack rust is present but does not warrant structural review. TOP AND BOTTOM FLANGE FULL LENGTH, 1/2 SECTION REMAINING, BOTTOM 6 INCHES OF WEB, NO SECTION LOSS AT THIS TIME ON WEB

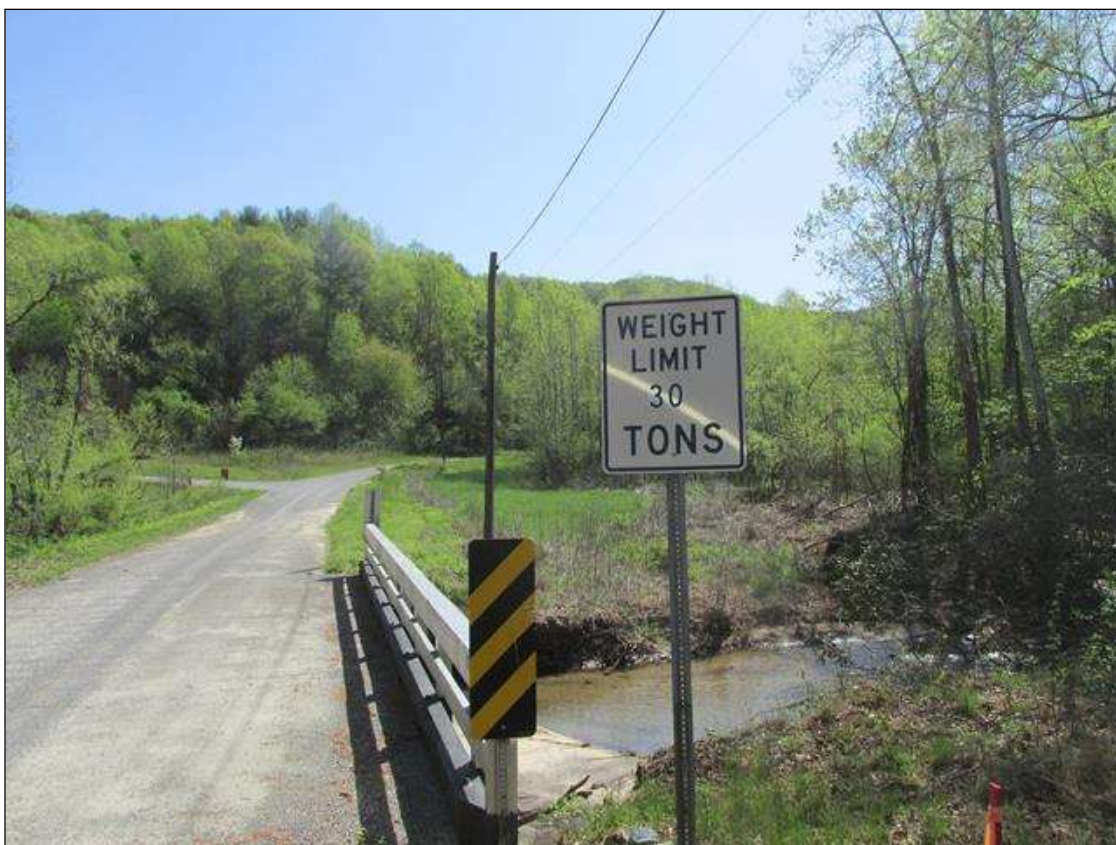
POSTING SIGN (30 TONS SV)
