NC DEPARTMENT OF TRANSPORTATION  
DIVISION OF HIGHWAYS  
BRIDGE MANAGEMENT UNIT

# BRIDGE INSPECTION REPORT

INSPECTION TYPE: Routine Inspection - Contract

COUNTY CALDWELL BRIDGE NUMBER 130123 INSPECTION CYCLE 0 YRS  
ROUTE SR1356 ACROSS ESTES MILL CREEK M.P. 0

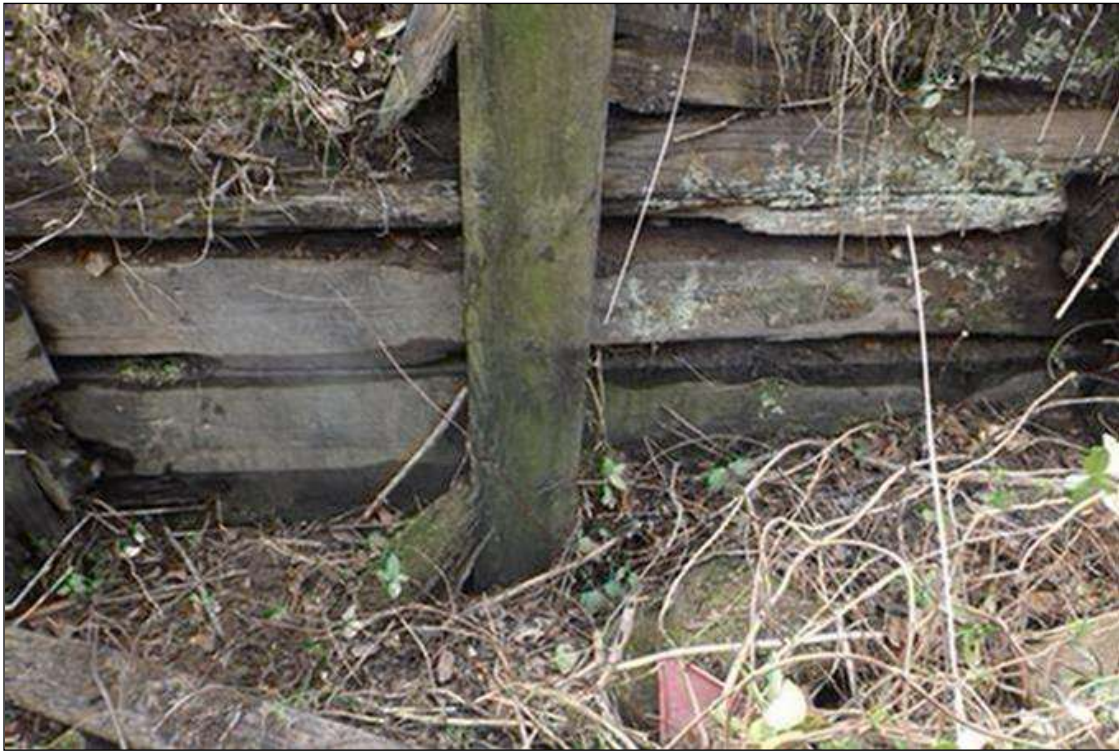
| 35c | P | <p>(3) UP TO 60" X 10" X 3" DEEP AREA OF DECAY IN SOUTHWEST WINGWALL.<br/> 26" X 8" X 3" DEEP AREA OF DECAY IN SOUTHWEST WINGWALL.<br/> 16" X 5 1/2" X 3" DEEP AREA OF DECAY IN WEST END OF ABUTMENT 1 BULKHEAD BOARDS.<br/> 7' X 6" X 3" DEEP AREA OF DECAY IN ABUTMENT 2 BULKHEAD BOARDS BEHIND PILE 5.<br/> 36" X 8" X 3" DEEP AREA OF DECAY IN WEST END OF ABUTMENT 2 BULKHEAD BOARDS.<br/> (2) 43" X 3 1/2" X 2" DEEP AREA OF DECAY IN WEST END OF ABUTMENT 1 BULKHEAD BOARDS.<br/> 9" X 2 1/2" X 3/4" DEEP AREA OF DECAY IN ABUTMENT 1 BULKHEAD BOARDS BETWEEN PILES 4 AND 5.<br/> VEGETATION GROWTH ON SOUTHEAST WINGWALL (ALL WINGWALLS SIMILAR).<br/> 3 1/2" X 7 1/2" X 3" DEEP AREA OF DECAY IN EAST END OF ABUTMENT 1 BULKHEAD BOARD.<br/> 19" X 3" X 3" DEEP AREA OF DECAY IN EAST END OF ABUTMENT 1 BULKHEAD BOARDS.<br/> 60" X 2 1/2" X 3" DEEP AREA OF DECAY IN SOUTHEAST WINGWALL.<br/> 27" X 3" X 3" DEEP AREA OF DECAY IN NORTHEAST WINGWALL.<br/> 11" X 4" X 3" DEEP AREA OF DECAY ON EAST END OF ABUTMENT 2 BULKHEAD BOARDS.<br/> 8 1/2" X 1 1/2" X 2" DEEP AREA OF DECAY ON EAST END OF ABUTMENT 2 BULKHEAD BOARDS.<br/> 72" X 17" X 3" DEEP AREA OF DECAY IN NORTHWEST WINGWALL.<br/> 12" X 10" X 3" DEEP AREA OF DECAY AND MISALIGNED BOARDS IN WEST END OF ABUTMENT 2 BULKHEAD BOARDS.</p> | |

(3) UP TO 60" X 10" X 3" DEEP AREA OF DECAY IN SOUTHWEST WINGWALL

| MMS Code | Description of Function | Unit | Quantity | Remarks | Est. Cost |
|---|---|---|---|---|---|
| 3346 | Repair / Maintain Timber Wings & Blkhds | SF | <del>14</del> TSE | (3) UP TO 60" X 10" X 3" DEEP AREA OF DECAY IN SOUTHWEST WINGWALL. 26" X 8" X 3" DEEP AREA OF DECAY IN SOUTHWEST WINGWALL | |

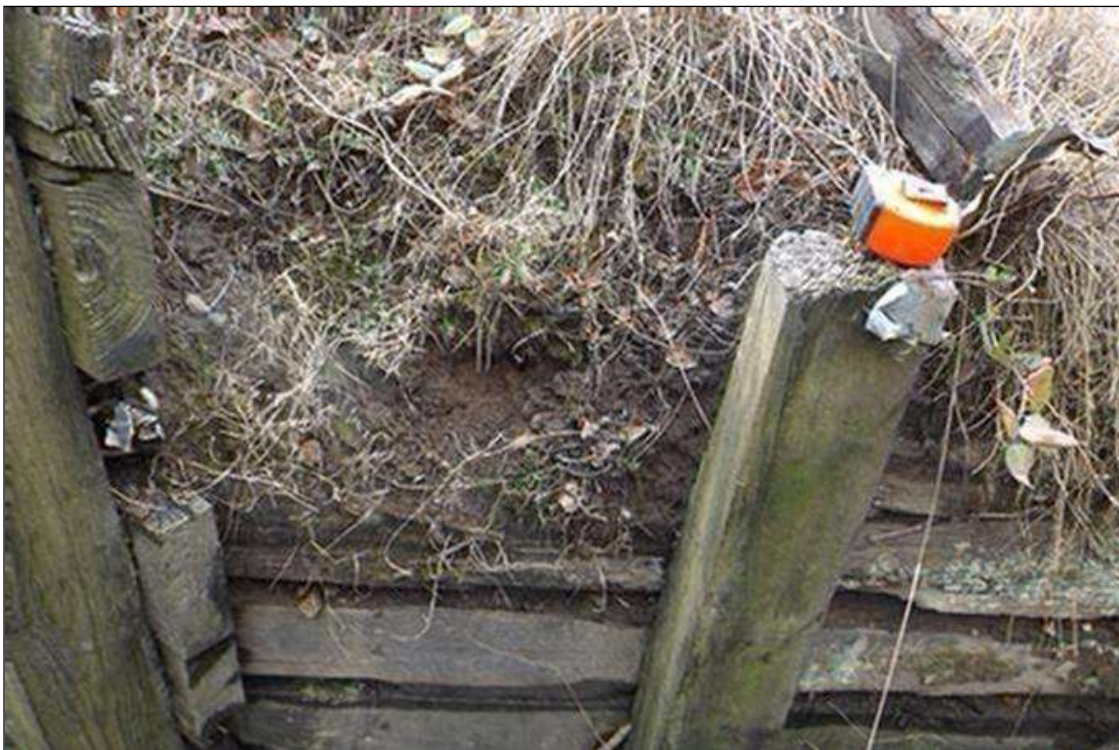
26" X 8" X 3" DEEP AREA OF DECAY IN SOUTHWEST WINGWALL

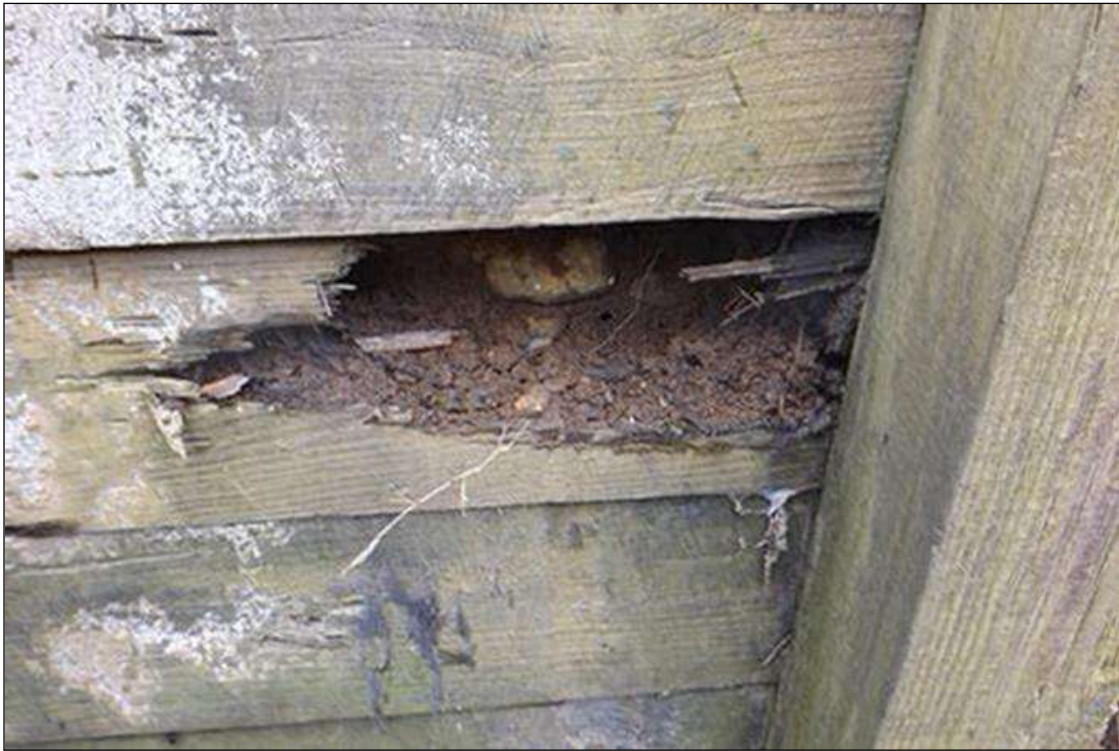
16" X 5 1/2" X 3" DEEP AREA OF DECAY IN WEST END OF ABUTMENT 1 BULKHEAD BOARDS

| MMS Code | Description of Function | Unit | Quantity | Remarks | Est. Cost |
|---|---|---|---|---|---|
| 3344 | Repair / Replace Timber Substructure Components | LF | <del>1</del> TSE | 16" X 5 1/2" X 3" DEEP AREA OF DECAY IN WEST END OF ABUTMENT 1 BULKHEAD BOARDS. | |

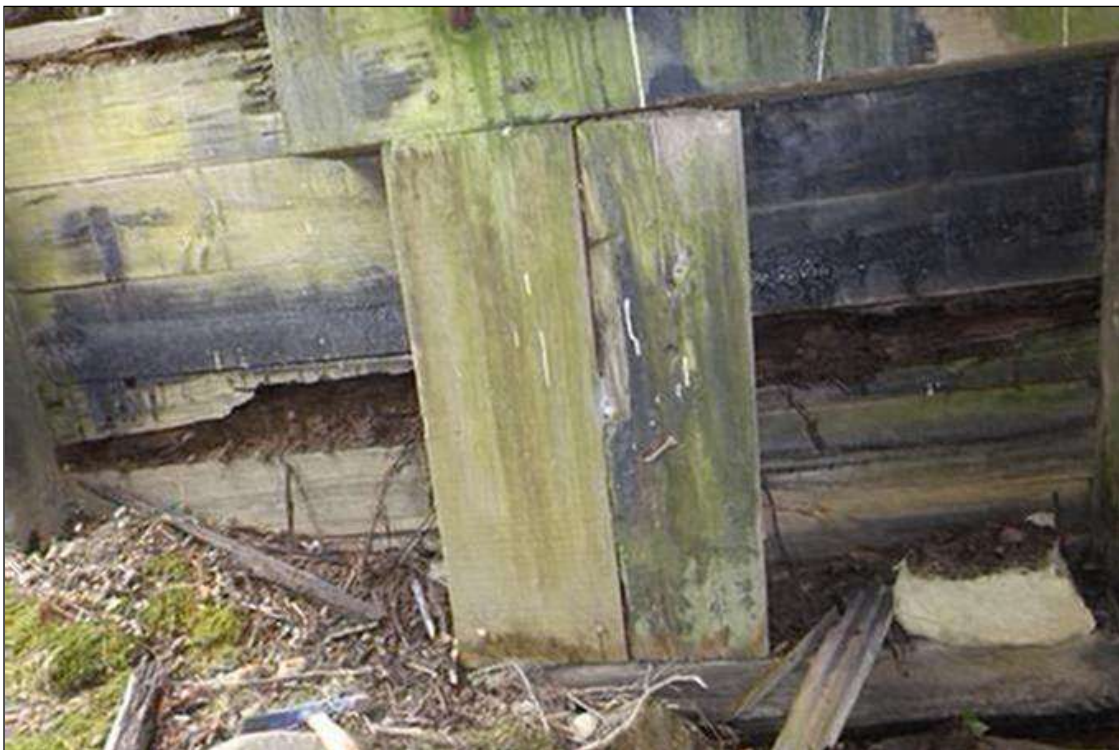
7' X 6" X 3" DEEP AREA OF DECAY IN ABUTMENT 2 BULKHEAD BOARDS BEHIND PILE 5

| MMS Code | Description of Function | Unit | Quantity | Remarks | Est. Cost |
|---|---|---|---|---|---|
| 3344 | Repair / Replace Timber Substructure Components | LF | <del>10</del><br>3/3/14 | 7' X 6" X 3" DEEP AREA OF DECAY IN ABUTMENT 2 BULKHEAD BOARDS BEHIND PILE 5. 36" X 8" X 3" DEEP AREA OF DECAY IN WEST END OF ABUTMENT 2 BULKHEAD BOARDS. | |

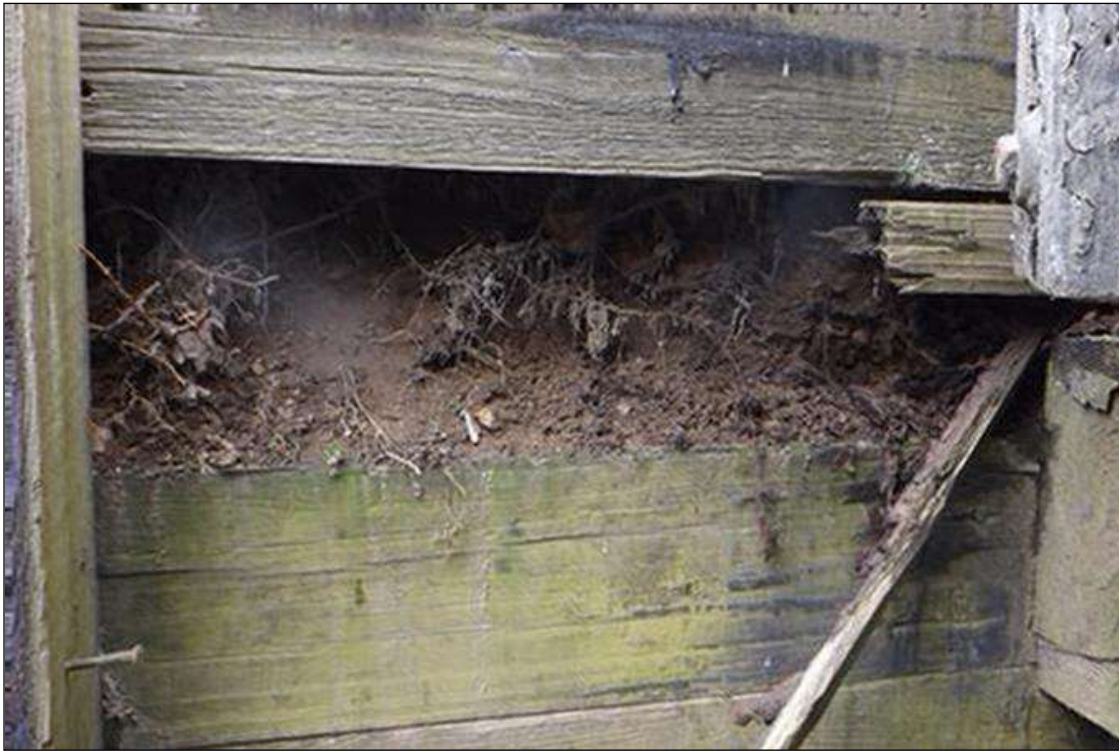
36" X 8" X 3" DEEP AREA OF DECAY IN WEST END OF ABUTMENT 2 BULKHEAD BOARDS

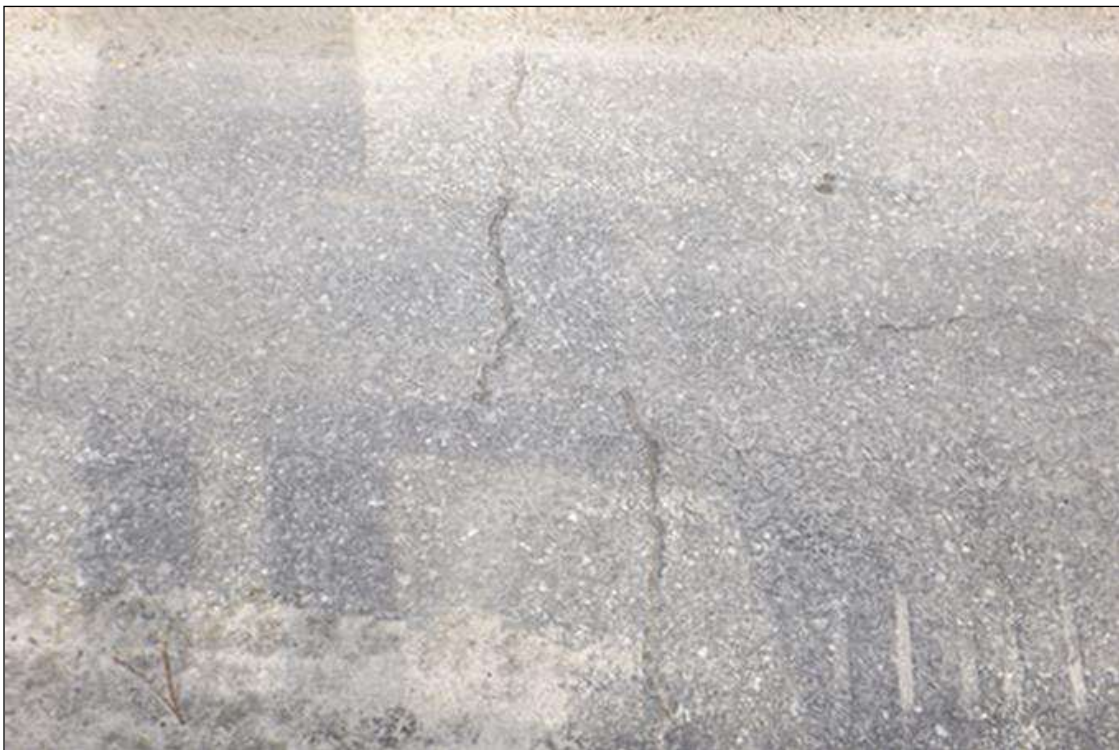
| Bridge I&A Form 1(82)H<br>State of North Carolina<br>Dept. of Transportation<br>Division of Highways | | <h1 style="text-align: center;">FIELD INSPECTION REPORT</h1> <p style="text-align: center;"><u>Bridge Inspeccion &amp; Analysis</u></p> | |
|---|---|---|--|
| 1 | G | UP TO 1/4" TRANSVERSE CRACKS IN TOP OF DECK ASPHALT WEARING SURFACE.<br>UP TO 1/16" LONGITUDINAL AND TRANSVERSE CRACKS IN DECK ASPHALT WEARING SURFACE. | |

UP TO 1/4" TRANSVERSE CRACKS IN TOP OF DECK ASPHALT WEARING SURFACE

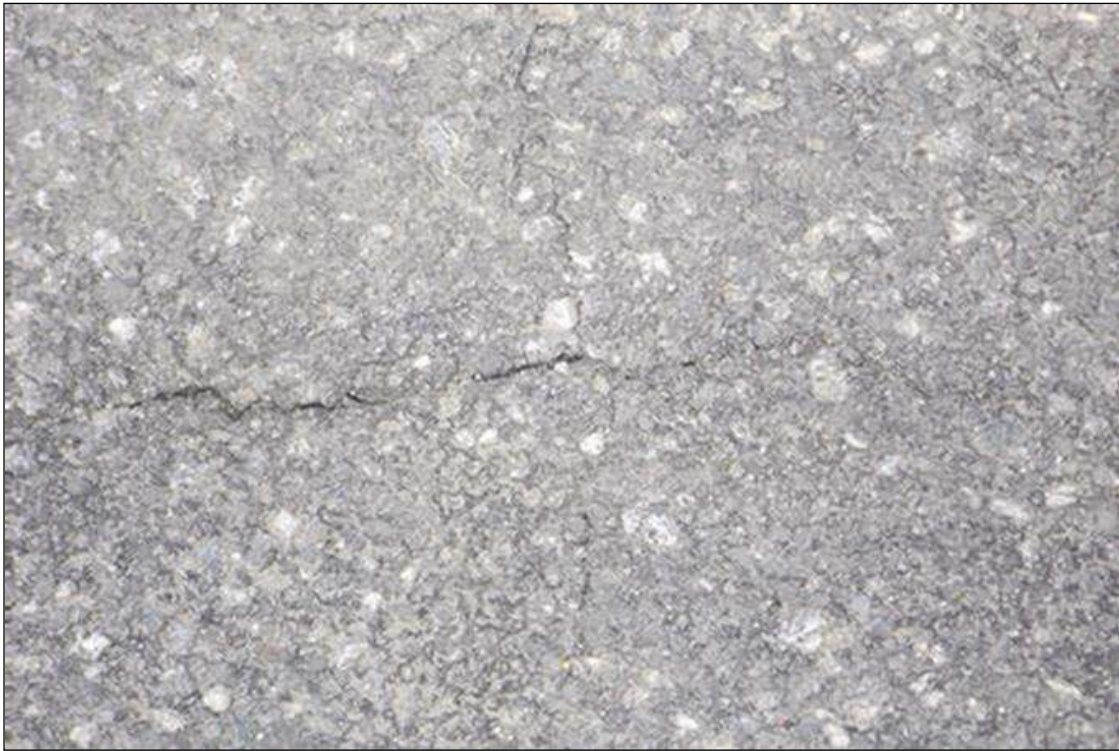
UP TO 1/16" LONGITUDINAL AND TRANSVERSE CRACKS IN DECK ASPHALT WEARING SURFACE

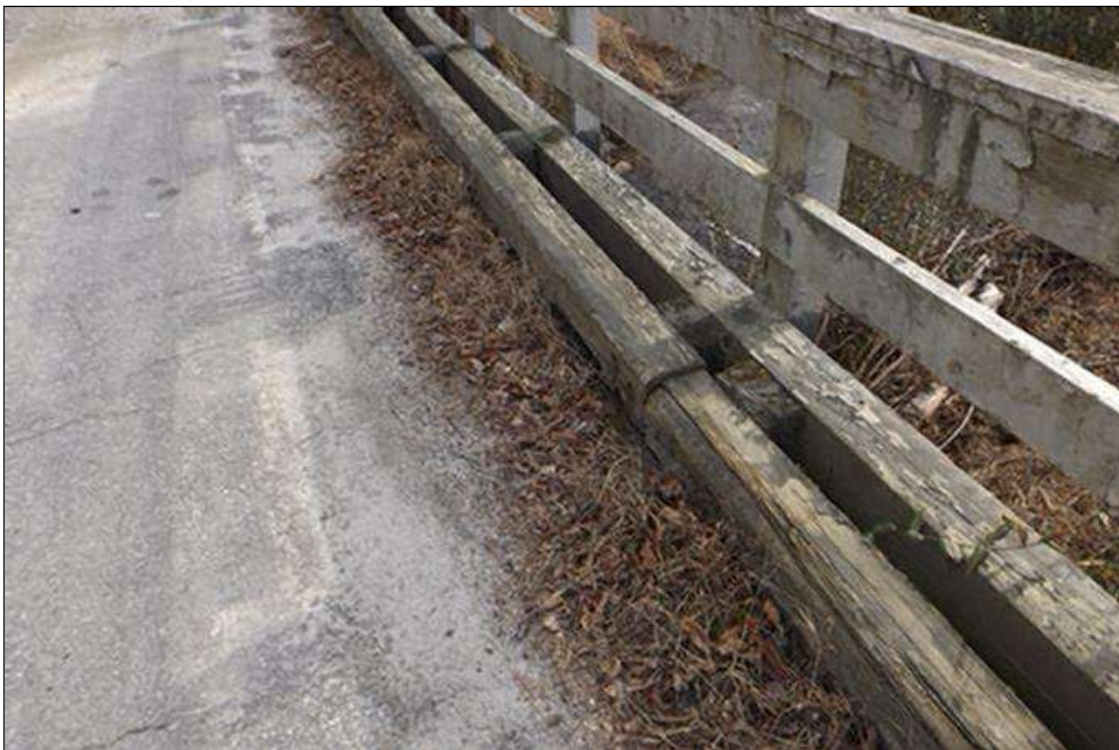
| Bridge I&A Form 1(82)H<br>State of North Carolina<br>Dept. of Transportation<br>Division of Highways | | <h1 style="text-align: center;">FIELD INSPECTION REPORT</h1> <p style="text-align: center;"><u>Bridge Inspeccion &amp; Analysis</u></p> | |
|---|---|---|--|
| 7 | F | VEGETATION GROWTH IN EAST GUTTER. | |

VEGETATION GROWTH IN EAST GUTTER

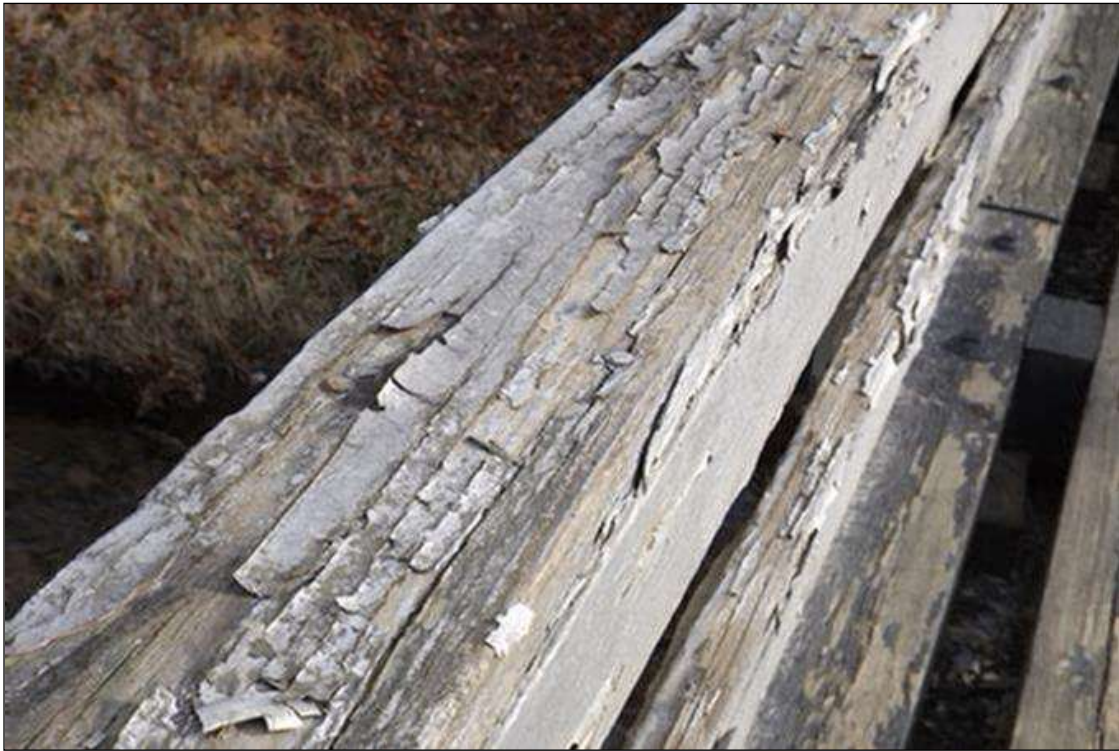
| Bridge I&A Form 1(82)H<br>State of North Carolina<br>Dept. of Transportation<br>Division of Highways | | <h1 style="text-align: center;">FIELD INSPECTION REPORT</h1> <p style="text-align: center;"><u>Bridge Inspeccion &amp; Analysis</u></p> | |
|---|---|---|--|
| 3b | F | 2 1/2" X 1 1/2" X 3 1/2" DEEP AREA OF DECAY IN WEST BRIDGE RAIL NEAR ABUTMENT 1.<br>PEELING PAINT WITH CHECKS ON WEST BRIDGE RAIL. | |

PEELING PAINT WITH CHECKS ON WEST BRIDGE RAIL

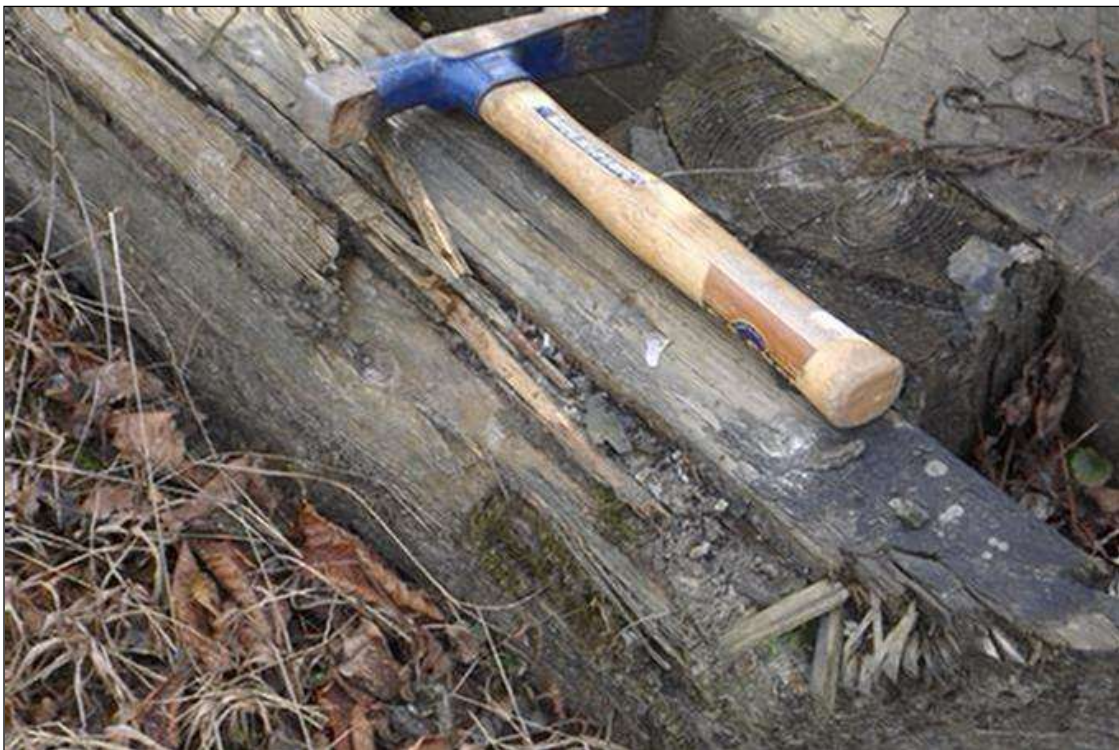
| Bridge I&A Form 1(82)H<br>State of North Carolina<br>Dept. of Transportation<br>Division of Highways | | <h1 style="text-align: center;">FIELD INSPECTION REPORT</h1> <p style="text-align: center;"><u>Bridge Inspeccion &amp; Analysis</u></p> | |
|---|---|---|--|
| 4 | G | 13" X 3" X 1" DEEP AREA OF DECAY IN SOUTH END OF EAST CURB.<br>CHECKS AND CRACKS IN EAST AND WEST CURBS. | |

13" X 3" X 1" DEEP AREA OF DECAY IN SOUTH END OF EAST CURB

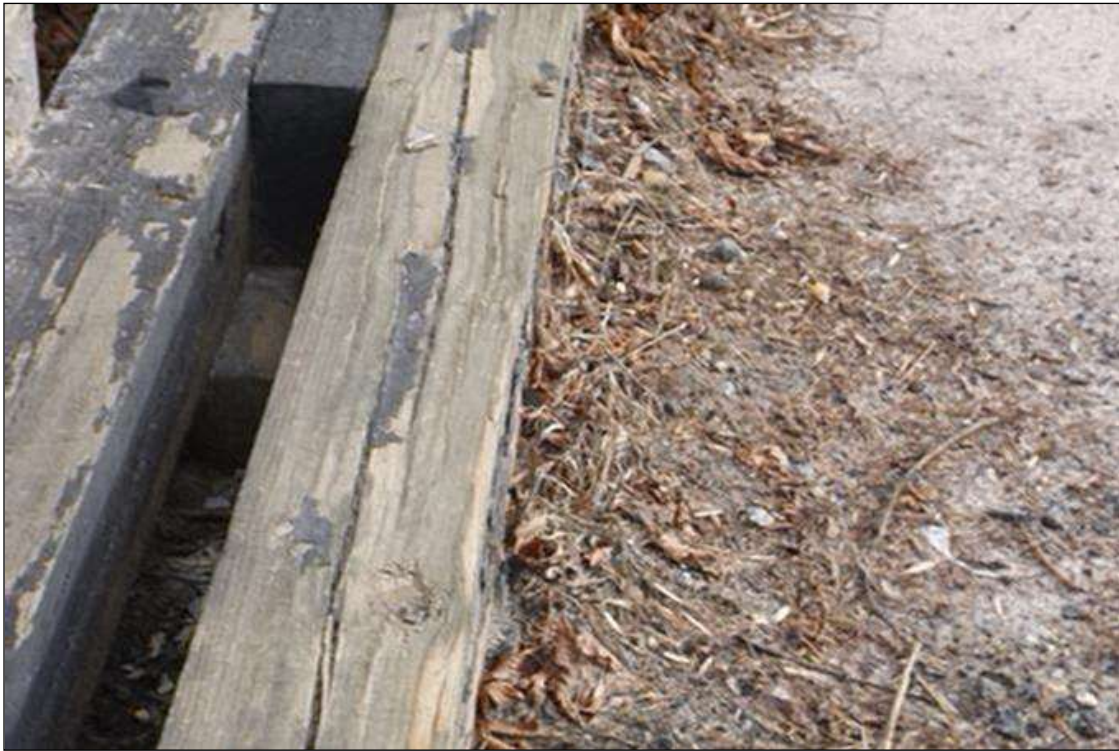
CHECKS AND CRACKS IN WEST CURB (EAST CURB SIMILAR)

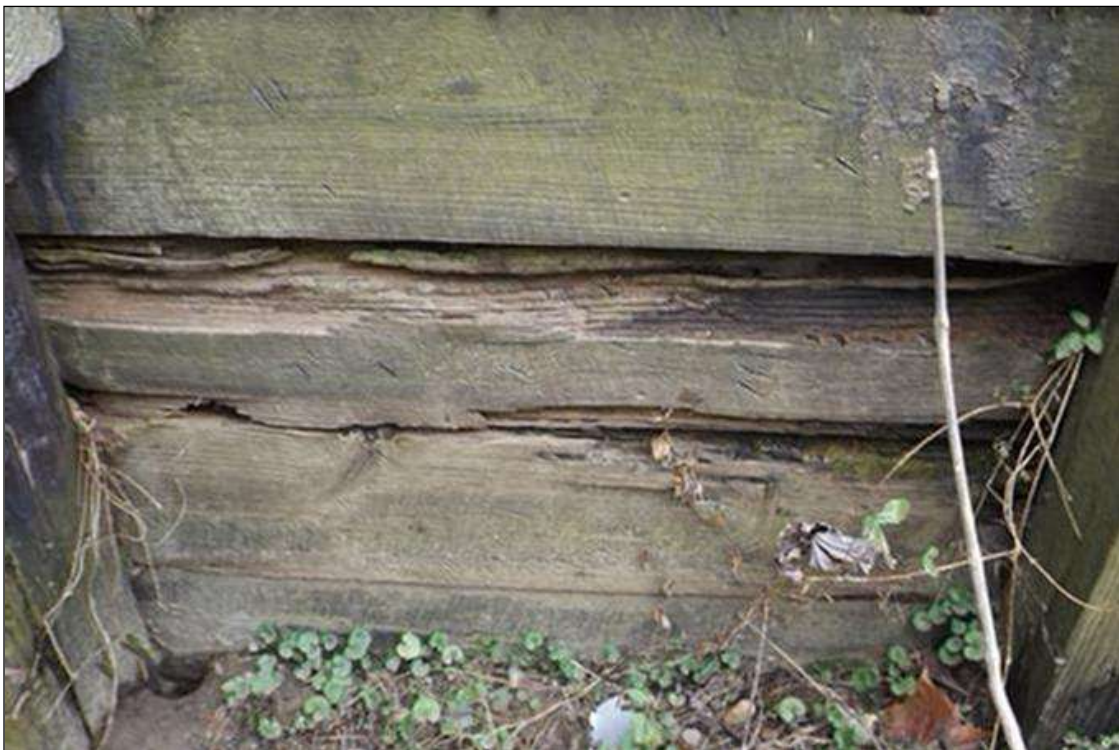
(2) 43" X 3 1/2" X 2" DEEP AREA OF DECAY IN WEST END OF ABUTMENT 1 BULKHEAD BOARDS

| MMS Code | Description of Function | Unit | Quantity | Remarks | Est. Cost |
|---|---|---|---|---|---|
| 3344 | Repair / Replace Timber Substructure Components | LF | 14 | (2) 43" X 3 1/2" X 2" DEEP AREA OF DECAY IN WEST END OF ABUTMENT 1 BULKHEAD BOARDS.<br>9" X 2 1/2" X 3/4" DEEP AREA OF DECAY IN ABUTMENT 1 BULKHEAD BOARDS BETWEEN PILES 4 AND 5.<br>3 1/2" X 7 1/2" X 3" DEEP AREA OF DECAY IN EAST END OF ABUTMENT 1 BULKHEAD BOARD.<br>19" X 3" X 3" DEEP AREA OF DECAY IN EAST END OF ABUTMENT 1 BULKHEAD BOARDS.<br>11" X 4" X 3" DEEP AREA OF DECAY ON EAST END OF ABUTMENT 2 BULKHEAD BOARDS.<br>8 1/2" X 1 1/2" X 2" DEEP AREA OF DECAY ON EAST END OF ABUTMENT 2 BULKHEAD BOARDS.<br>12" X 10" X 3" DEEP AREA OF DECAY AND MISALIGNED BOARDS IN WEST END OF ABUTMENT 2 BULKHEAD BOARDS.<br>UP TO 15" X 5" X 1 1/2" DEEP AREA OF DECAY IN BULKHEAD PILE ON WEST END OF ABUTMENT 1. | |

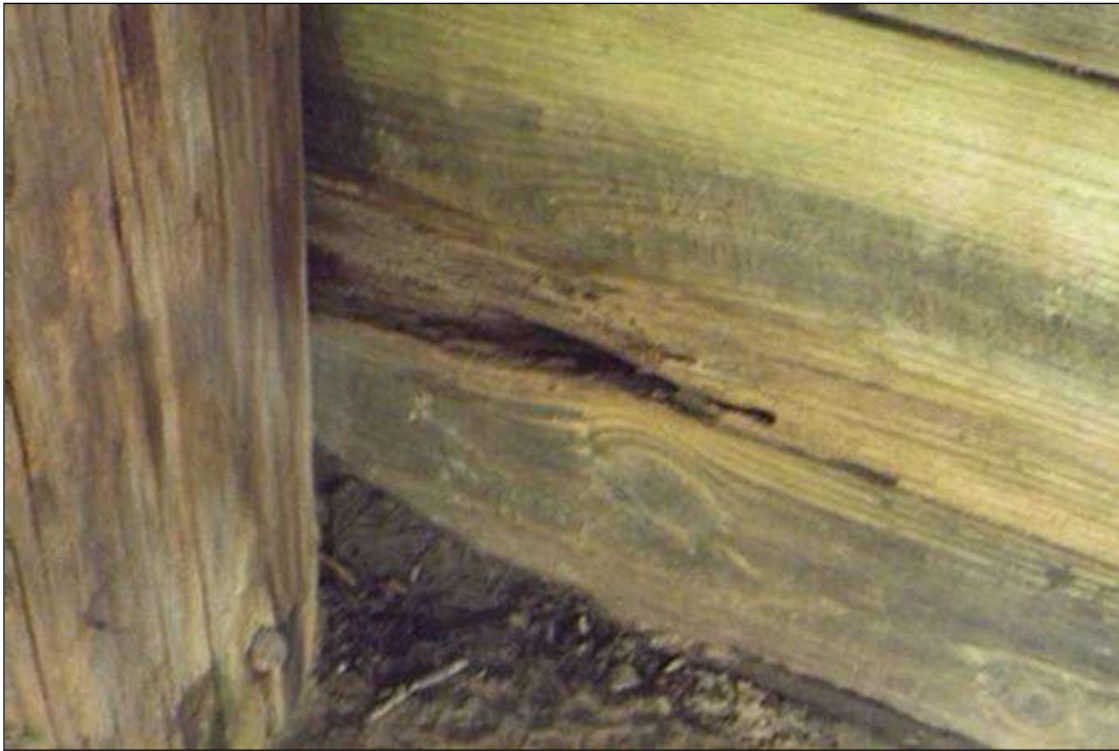
9" X 2 1/2" X 3/4" DEEP AREA OF DECAY IN ABUTMENT 1 BULKHEAD BOARDS BETWEEN PILES 4 AND 5

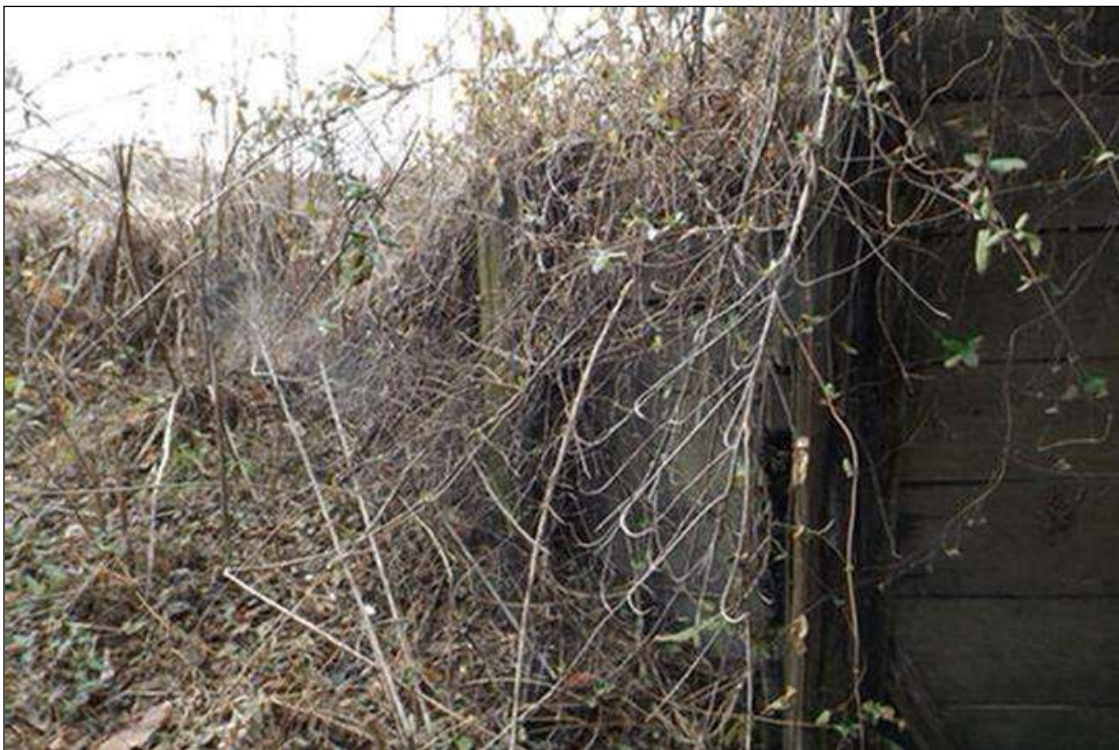
VEGETATION GROWTH ON SOUTHEAST WINGWALL (ALL WINGWALLS SIMILAR)

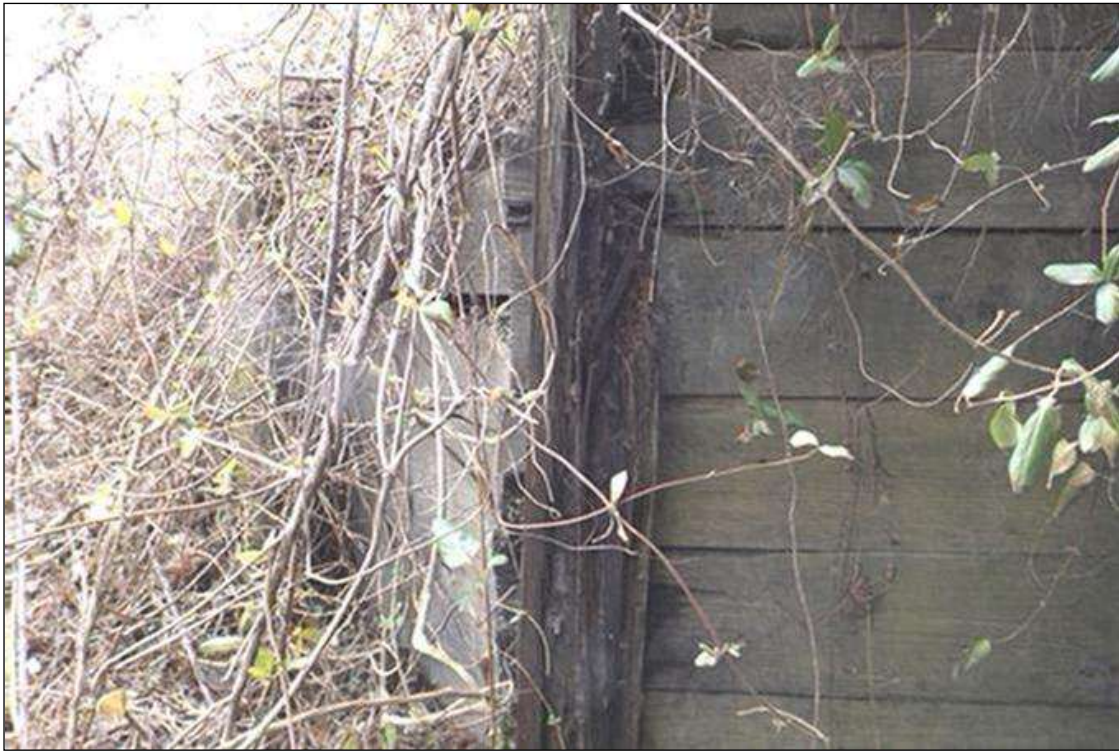
| Bridge I&A Form 1(82)H<br>State of North Carolina<br>Dept. of Transportation<br>Division of Highways | | <h1 style="text-align: center;">FIELD INSPECTION REPORT</h1> <p style="text-align: center;"><u>Bridge Inspeccion &amp; Analysis</u></p> | |
|---|---|---|--|
| 35b | F | 56" X 6" X 4" DEEP AREA OF DECAY IN BULKHEAD PILE AT EAST END OF ABUTMENT 1.<br>VERTICAL CRACK IN PILE 5 OF ABUTMENT 2 (ALL PILES SIMILAR).<br>LACK OF BEARING AT PILE 4 OF ABUTMENT 2 TEMPORARY REPAIR.<br>UP TO 15" X 5" X 1 1/2" DEEP AREA OF DECAY IN BULKHEAD PILE ON WEST END OF ABUTMENT 1. | |

56" X 6" X 4" DEEP AREA OF DECAY IN BULKHEAD PILE AT EAST END OF ABUTMENT 1

| MMS Code | Description of Function | Unit | Quantity | Remarks | Est. Cost |
|---|---|---|---|---|---|
| 3344 | Repair / Replace Timber Substructure Components | LF | <del>5</del> | 56" X 6" X 4" DEEP AREA OF DECAY IN BULKHEAD PILE AT EAST END OF ABUTMENT 1. | |

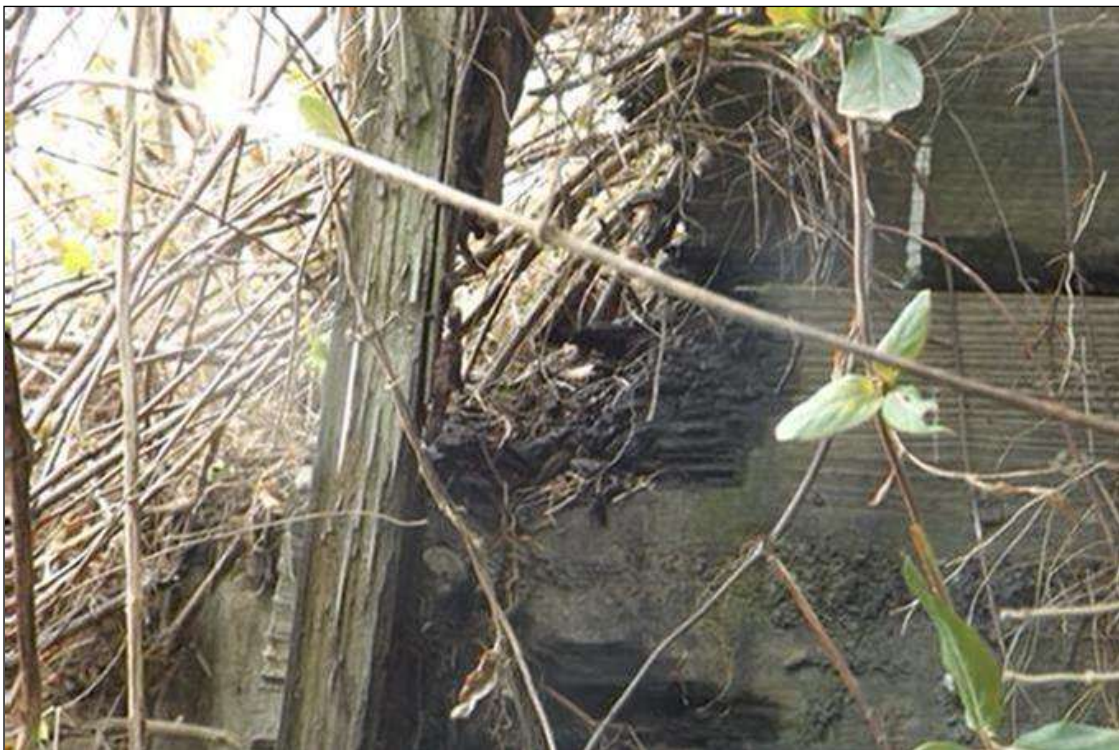
3 1/2" X 7 1/2" X 3" DEEP AREA OF DECAY IN EAST END OF ABUTMENT 1 BULKHEAD BOARD

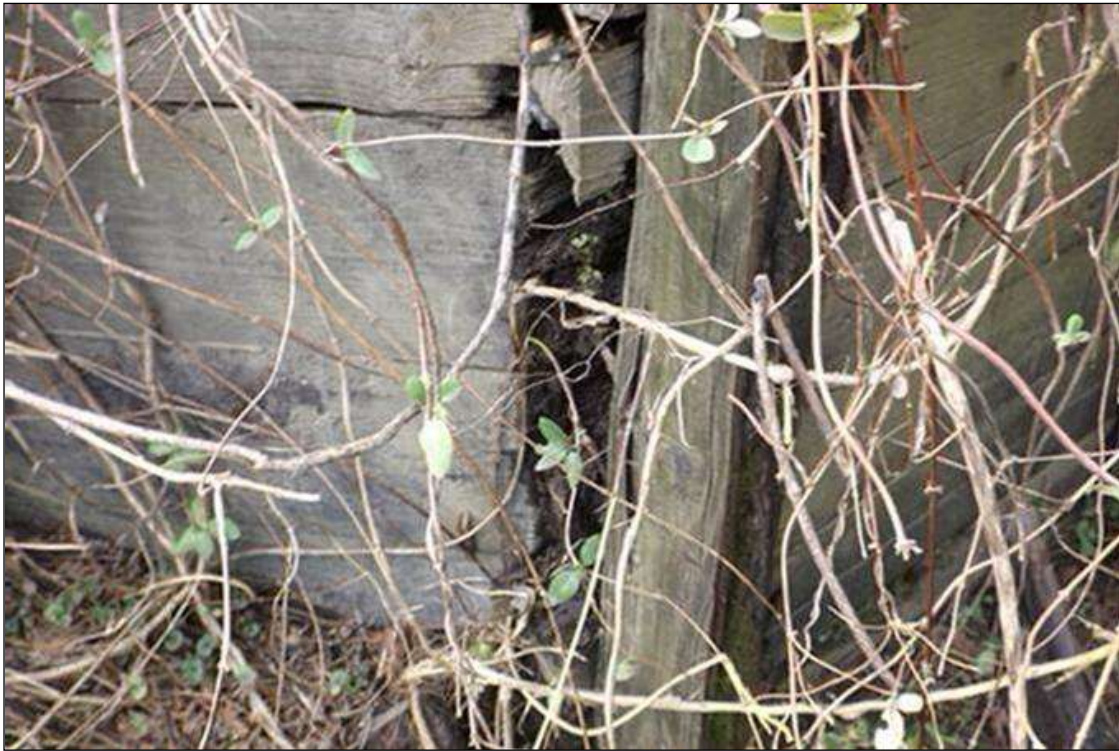
19" X 3" X 3" DEEP AREA OF DECAY IN EAST END OF ABUTMENT 1 BULKHEAD BOARDS

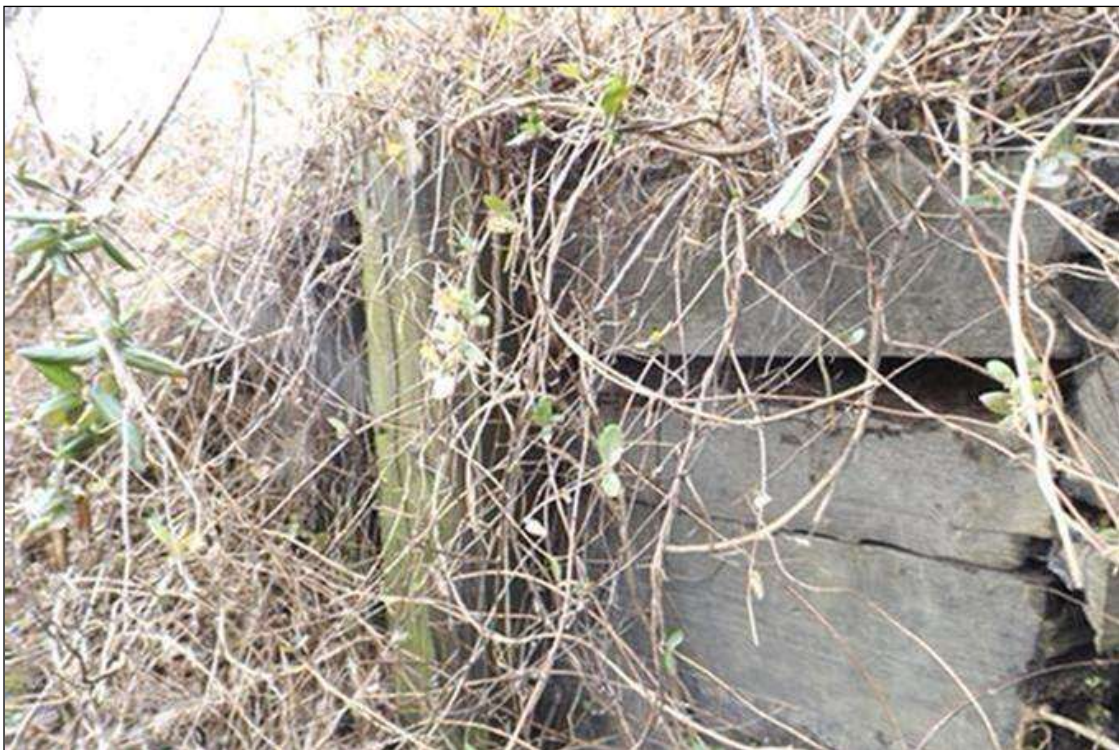
60" X 2 1/2" X 3" DEEP AREA OF DECAY IN SOUTHEAST WINGWALL

| MMS Code | Description of Function | Unit | Quantity | Remarks | Est. Cost |
|---|---|---|---|---|---|
| 3346 | Repair / Maintain Timber Wings & Blkhds | SF | 10 | 60" X 2 1/2" X 3" DEEP AREA OF DECAY IN SOUTHEAST WINGWALL.<br>27" X 3" X 3" DEEP AREA OF DECAY IN NORTHEAST WINGWALL.<br>72" X 17" X 3" DEEP AREA OF DECAY IN NORTHWEST WINGWALL. | |

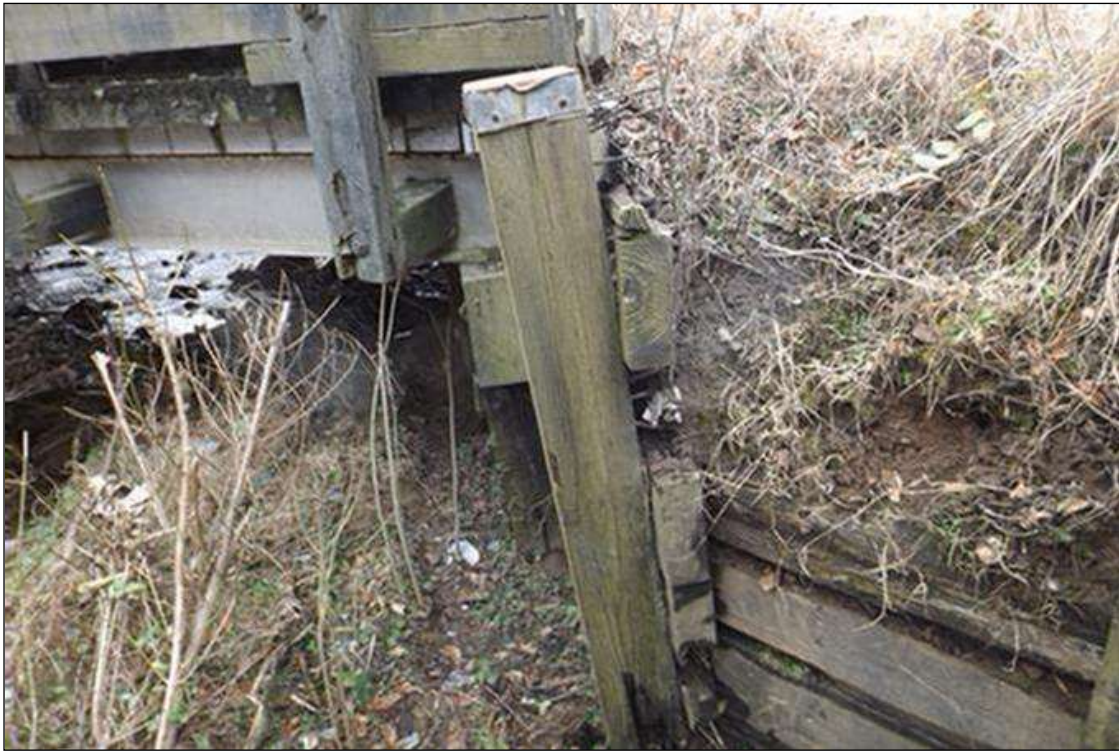
| Bridge I&A Form 1(82)H<br>State of North Carolina<br>Dept. of Transportation<br>Division of Highways | | <h1 style="text-align: center;">FIELD INSPECTION REPORT</h1> <p style="text-align: center;"><u>Bridge Inspeccion &amp; Analysis</u></p> | |
|---|---|---|--|
| 35a | F | 5" NORTHERN LEAN OF ABUTMENT 1<br>8" SOUTHERN LEAN OF ABUTMENT 2.<br>FULL LENGTH UP TO 1/8" HORIZONTAL CRACK IN ABUTMENT 2 CAP. | |

5" NORTHERN LEAN OF ABUTMENT 1

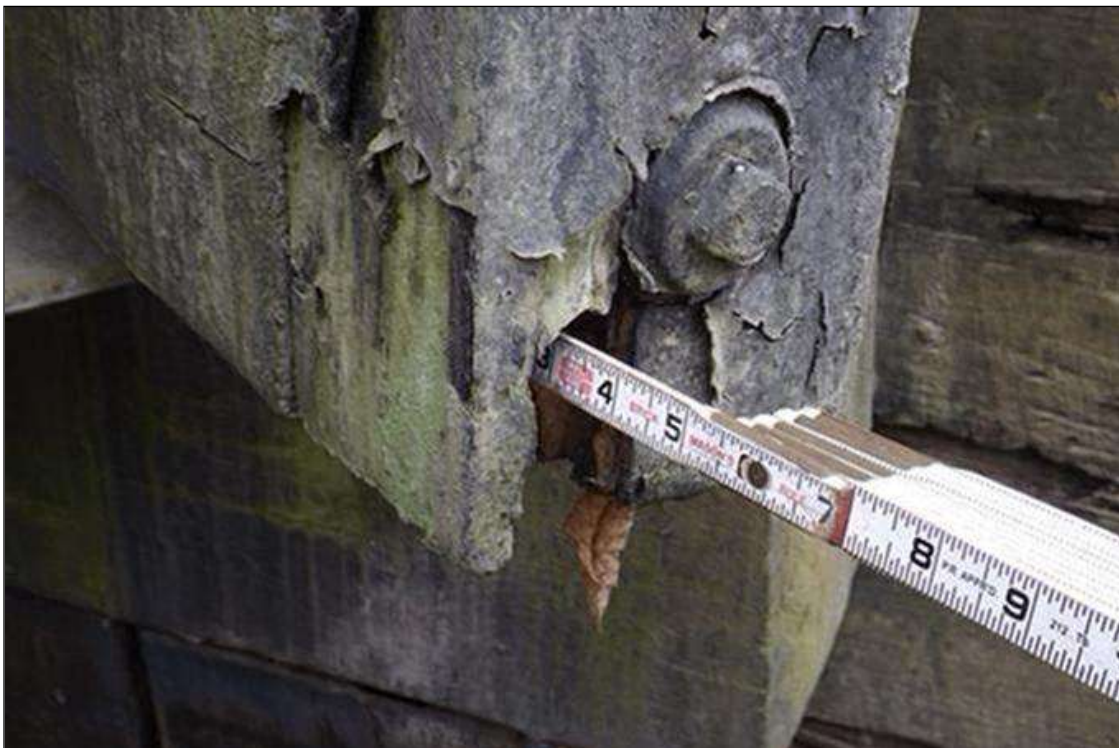
2 1/2" X 1 1/2" X 3 1/2" DEEP AREA OF DECAY IN WEST BRIDGE RAIL NEAR ABUTMENT 1

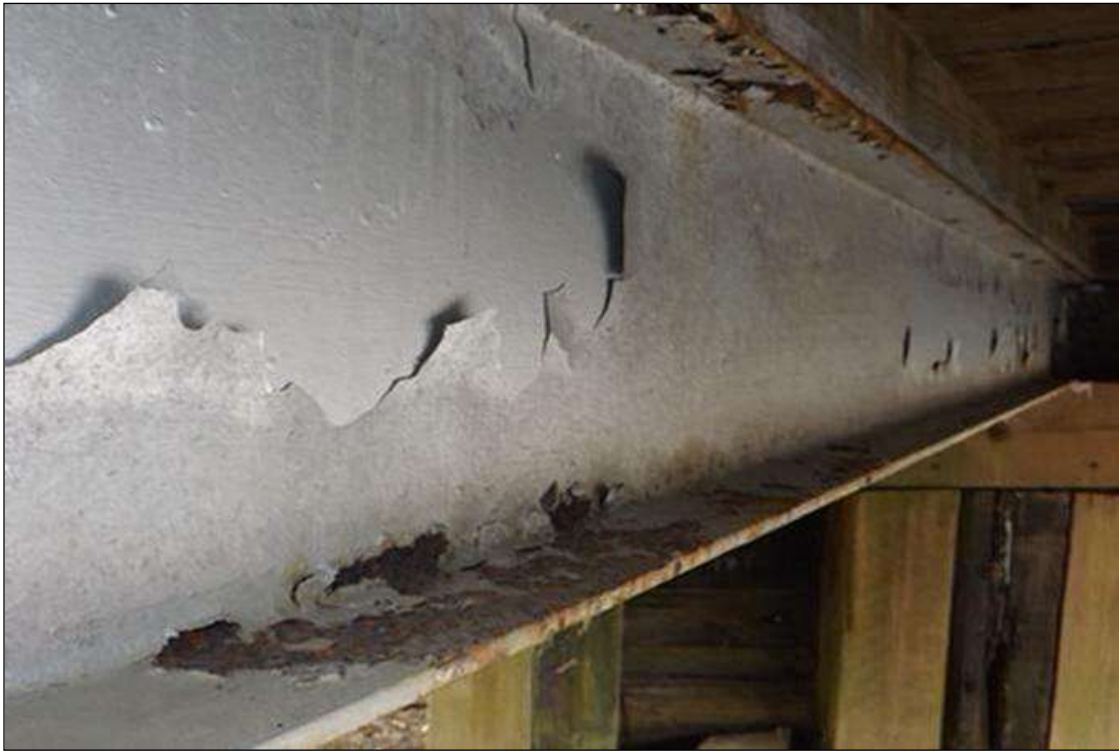
| Bridge I&A Form 1(82)H<br>State of North Carolina<br>Dept. of Transportation<br>Division of Highways | | <h1 style="text-align: center;">FIELD INSPECTION REPORT</h1> <p style="text-align: center;"><u>Bridge Inspeccion &amp; Analysis</u></p> | |
|---|---|---|--|
| 10 | G | PEELING PAINT WITH SURFACE RUST ON BOTH FLANGES OF EACH BEAM.<br>FLAKING RUST ON TOP FLANGE OF BEAM 1. | |

PEELING PAINT WITH SURFACE RUST ON BOTH FLANGES OF BEAM 3 (ALL BEAMS SIMILAR)

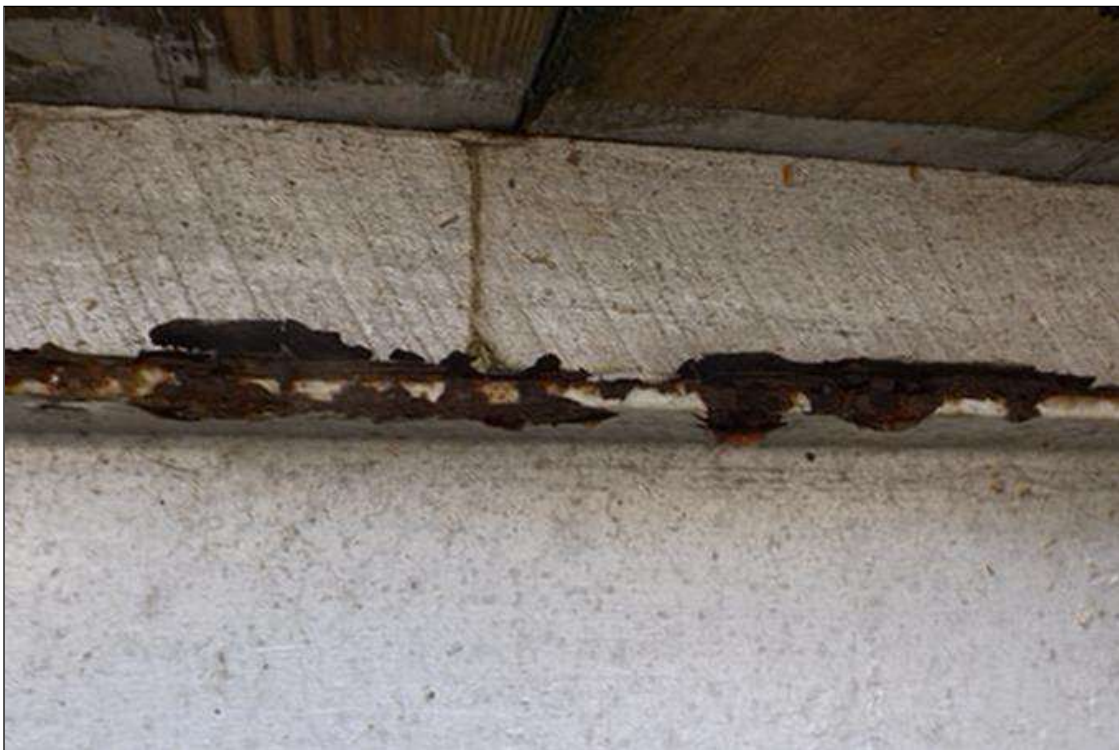
FLAKING RUST ON TOP FLANGE OF BEAM 1

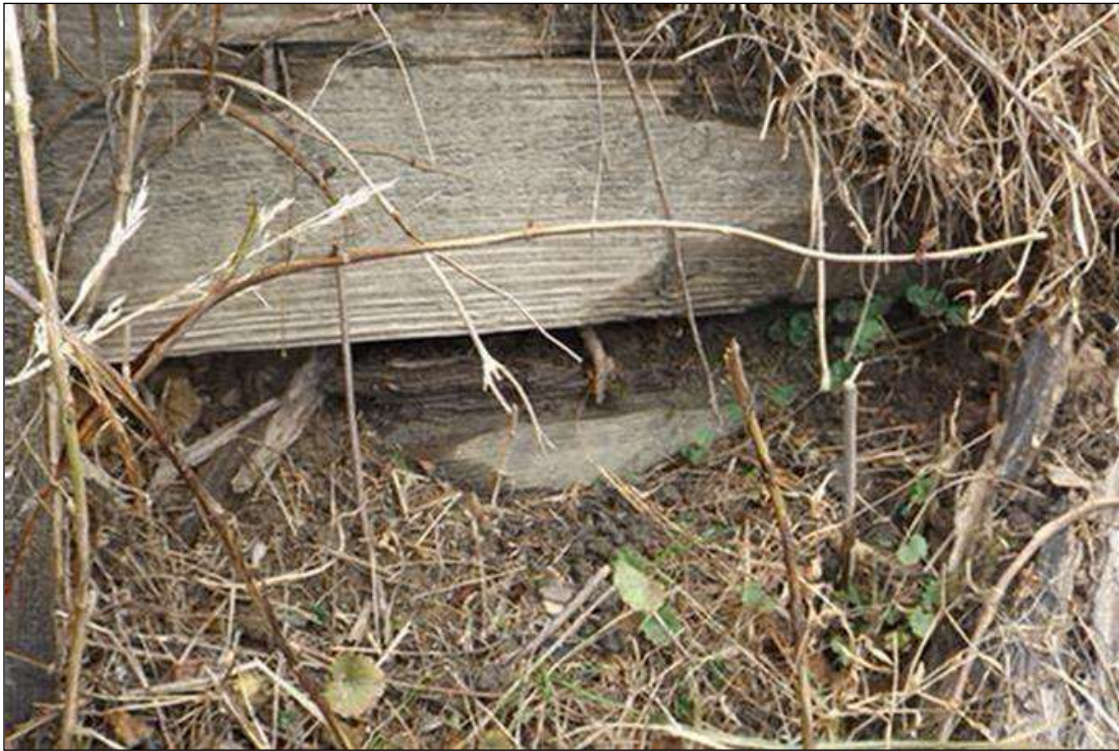
27" X 3" X 3" DEEP AREA OF DECAY IN NORTHEAST WINGWALL

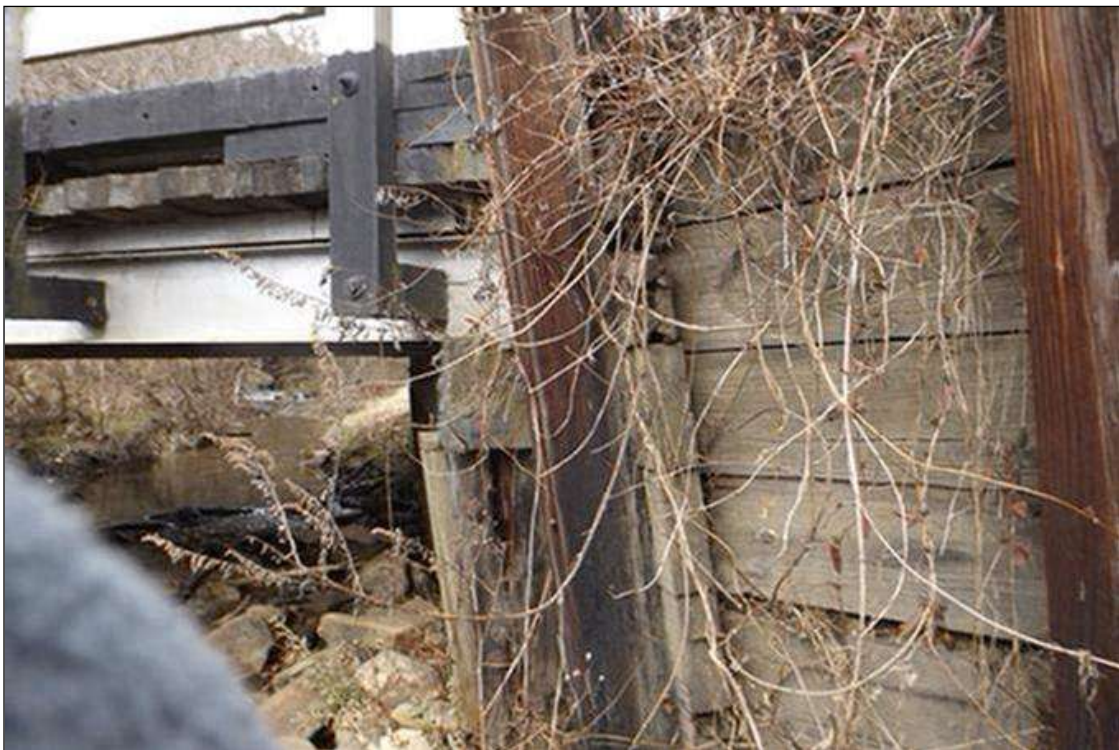
8" SOUTHERN LEAN OF ABUTMENT 2
