NC DEPARTMENT OF TRANSPORTATION  
DIVISION OF HIGHWAYS  
BRIDGE MANAGEMENT UNIT

# BRIDGE INSPECTION REPORT

INSPECTION TYPE: Routine Inspection - Contract

COUNTY CALDWELL BRIDGE NUMBER 130123 INSPECTION CYCLE 0 YRS  
ROUTE SR1356 ACROSS ESTES MILL CREEK M.P. 0

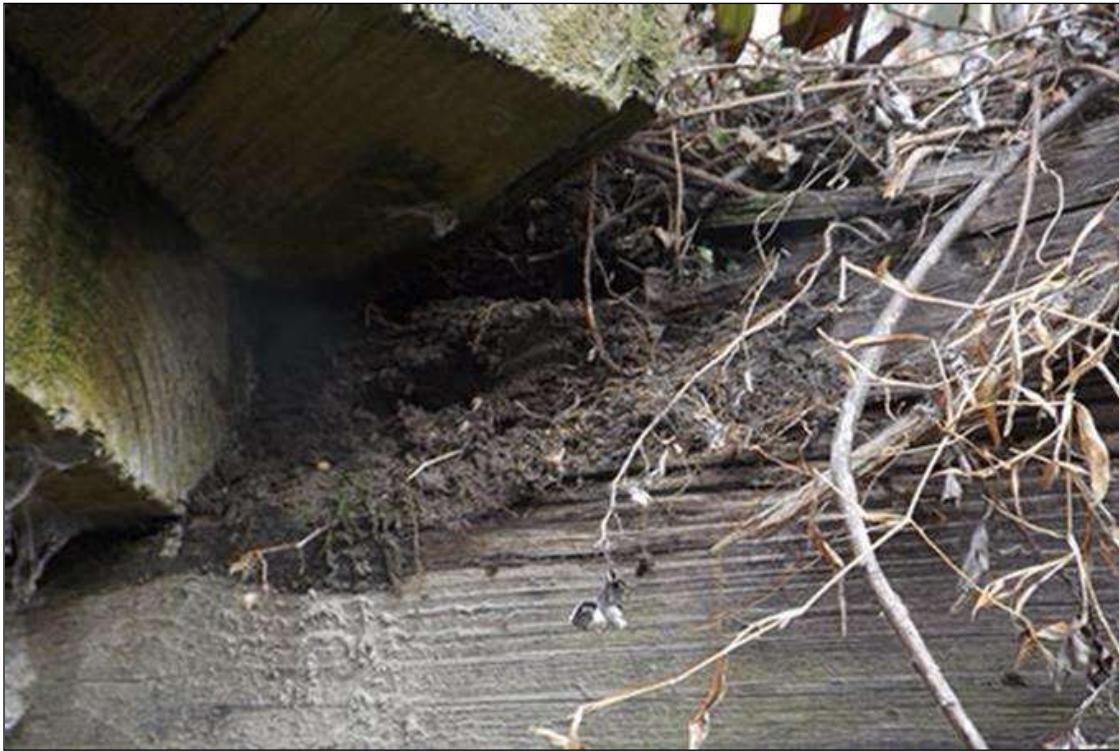
11" X 4" X 3" DEEP AREA OF DECAY ON EAST END OF ABUTMENT 2 BULKHEAD BOARDS

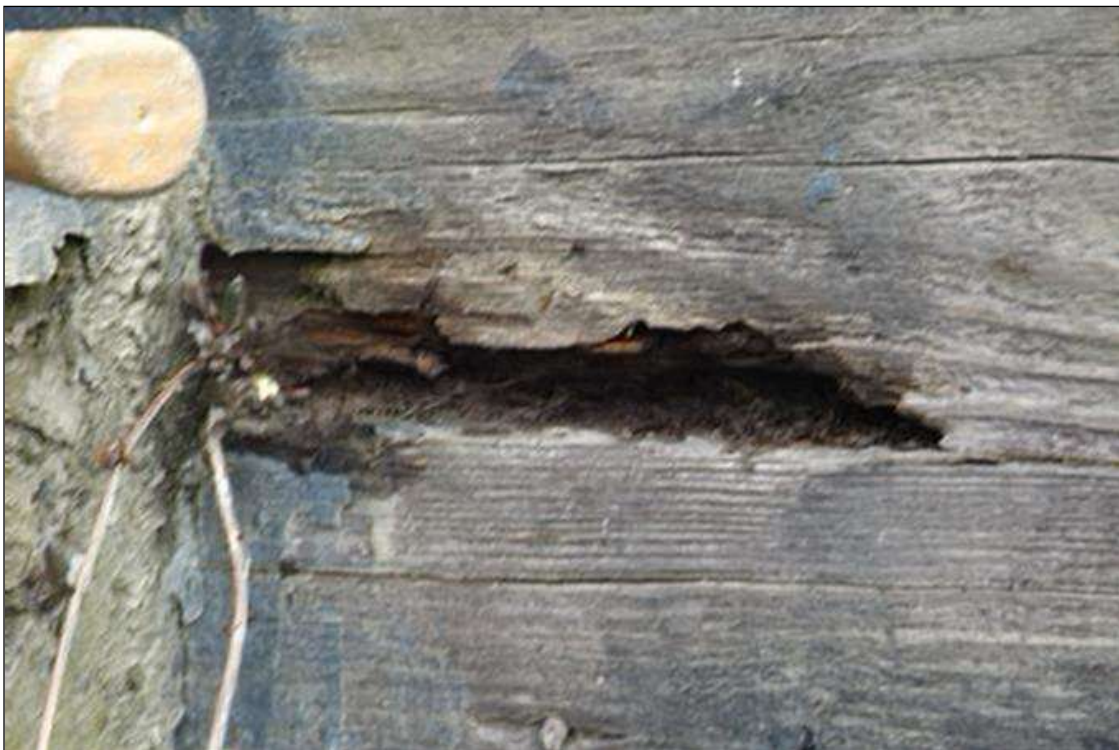
8 1/2" X 1 1/2" X 2" DEEP AREA OF DECAY ON EAST END OF ABUTMENT 2 BULKHEAD BOARDS

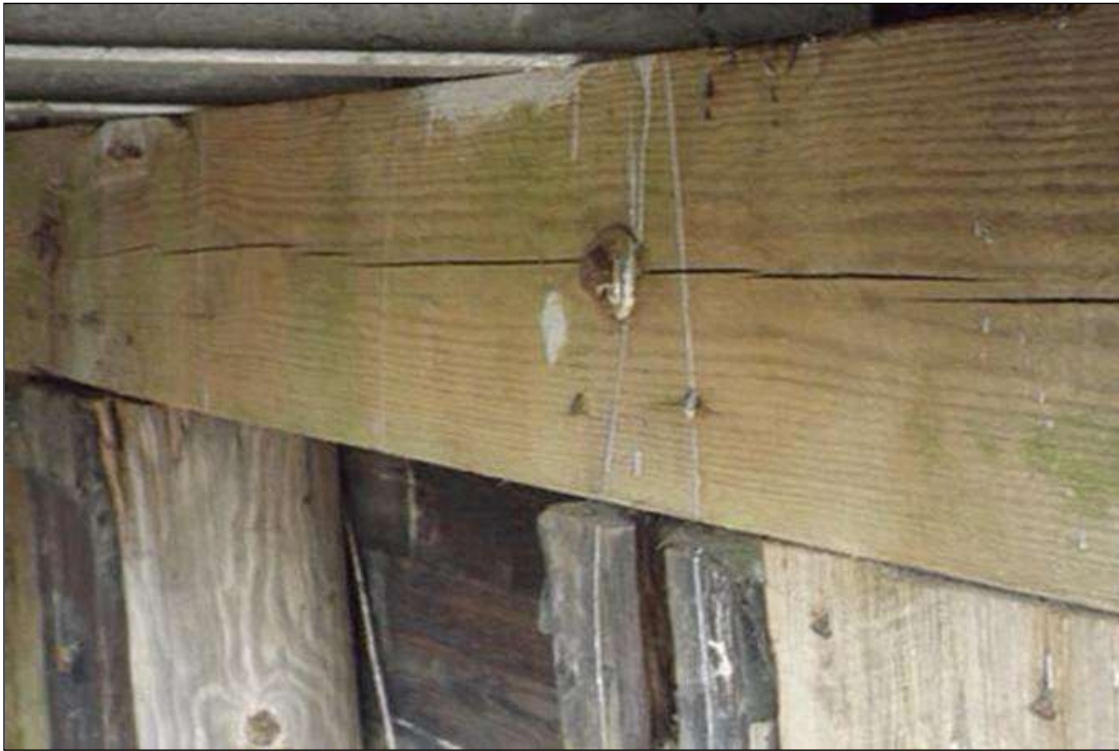
FULL LENGTH UP TO 1/8" HORIZONTAL CRACK IN ABUTMENT 2 CAP

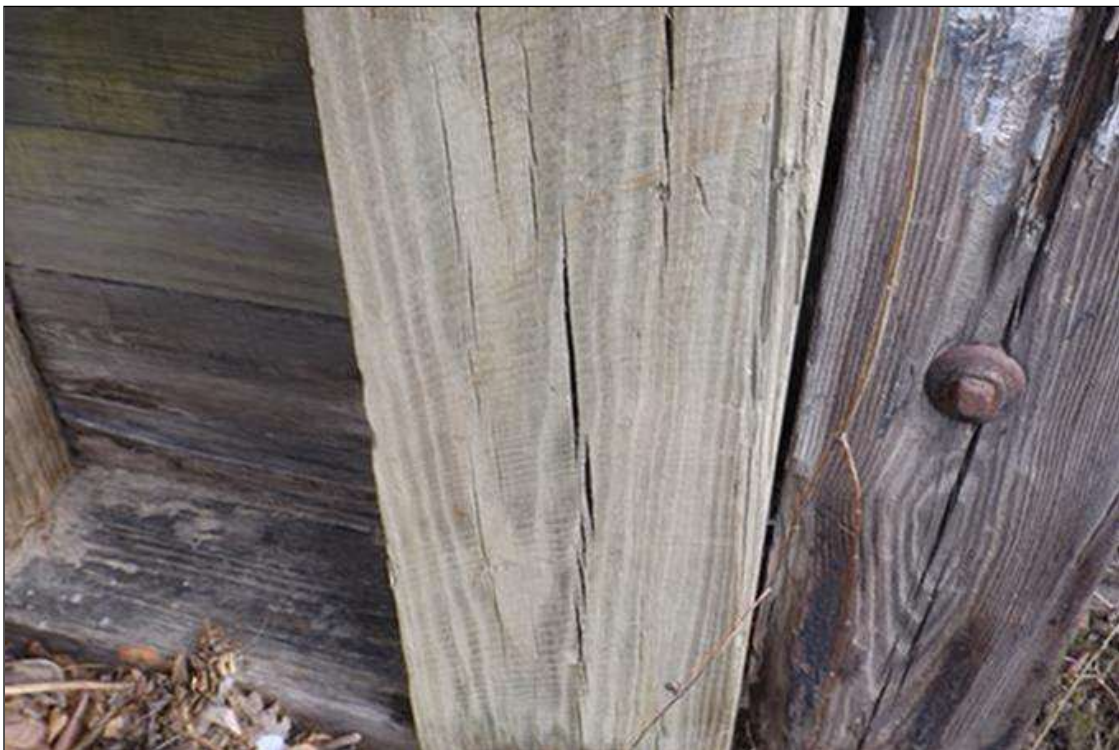
VERTICAL CRACK IN PILE 5 OF ABUTMENT 2 (ALL PILES SIMILAR)

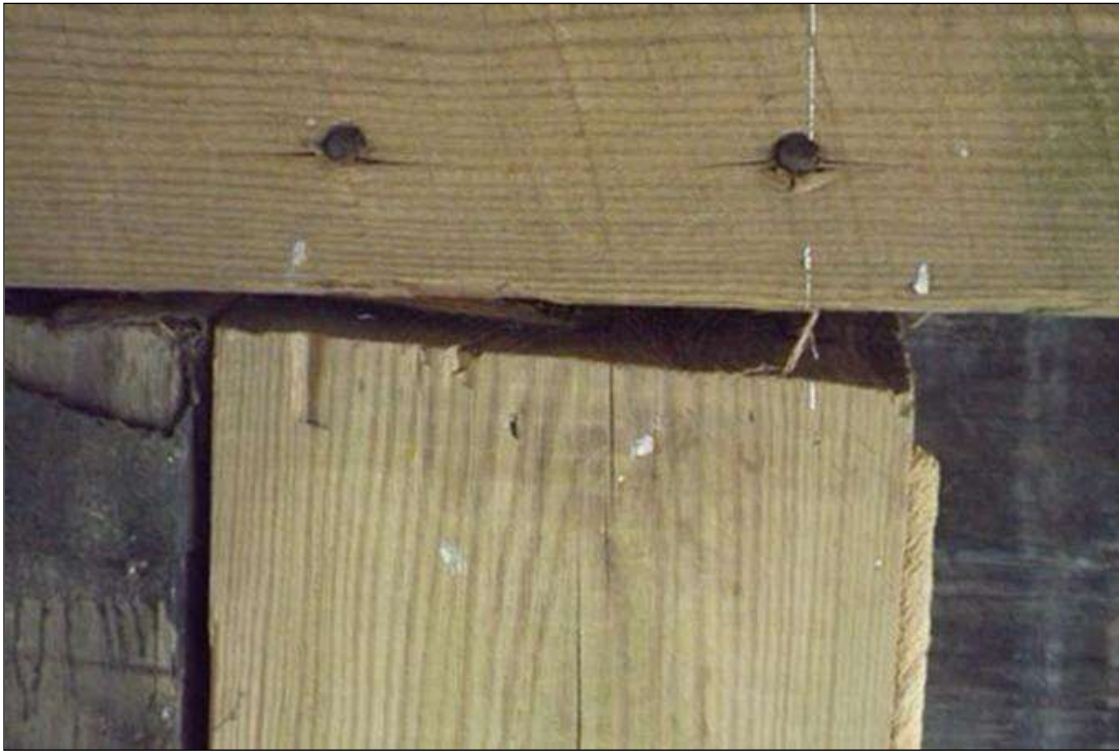
LACK OF BEARING AT PILE 4 OF ABUTMENT 2 TEMPORARY REPAIR

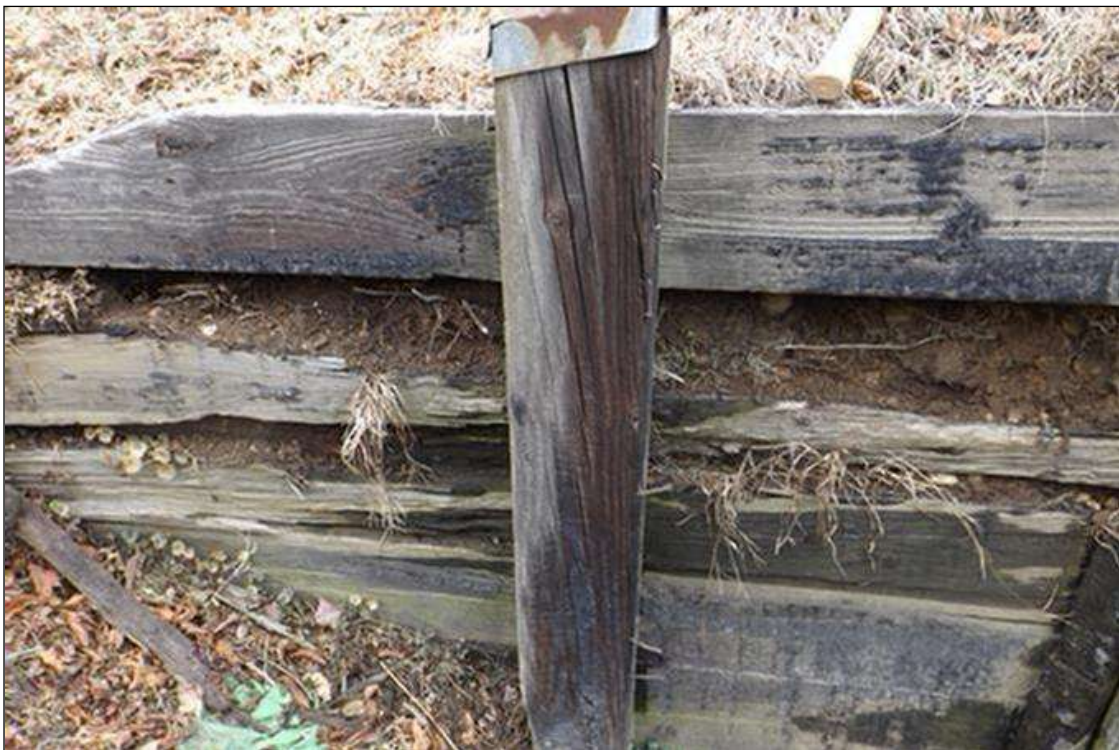
72" X 17" X 3" DEEP AREA OF DECAY IN NORTHWEST WINGWALL

| MMS Code | Description of Function | Unit | Quantity | Remarks | Est. Cost |
|---|---|---|---|---|---|
| 3346 | Repair / Maintain Timber Wings & Blkhds | SF | 10 | 60" X 2 1/2" X 3" DEEP AREA OF DECAY IN SOUTHEAST WINGWALL.<br>27" X 3" X 3" DEEP AREA OF DECAY IN NORTHEAST WINGWALL.<br>72" X 17" X 3" DEEP AREA OF DECAY IN NORTHWEST WINGWALL. | |

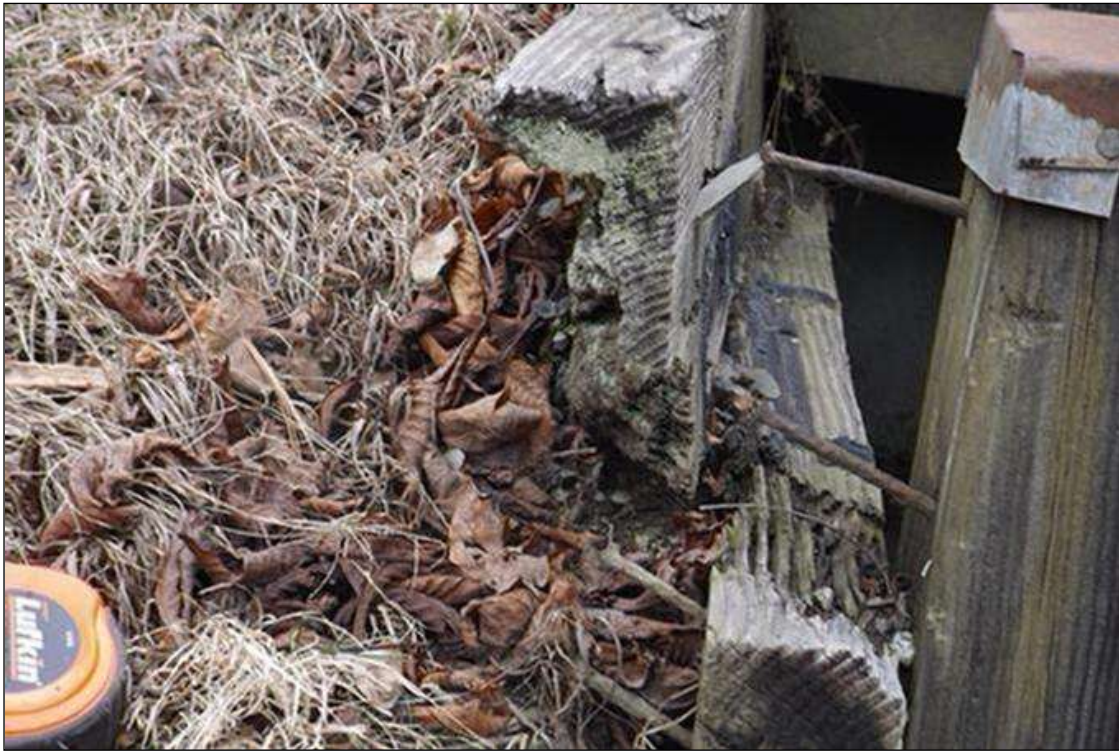
12" X 10" X 3" DEEP AREA OF DECAY AND MISALIGNED BOARDS IN WEST END OF ABUTMENT 2 BULKHEAD BOARDS

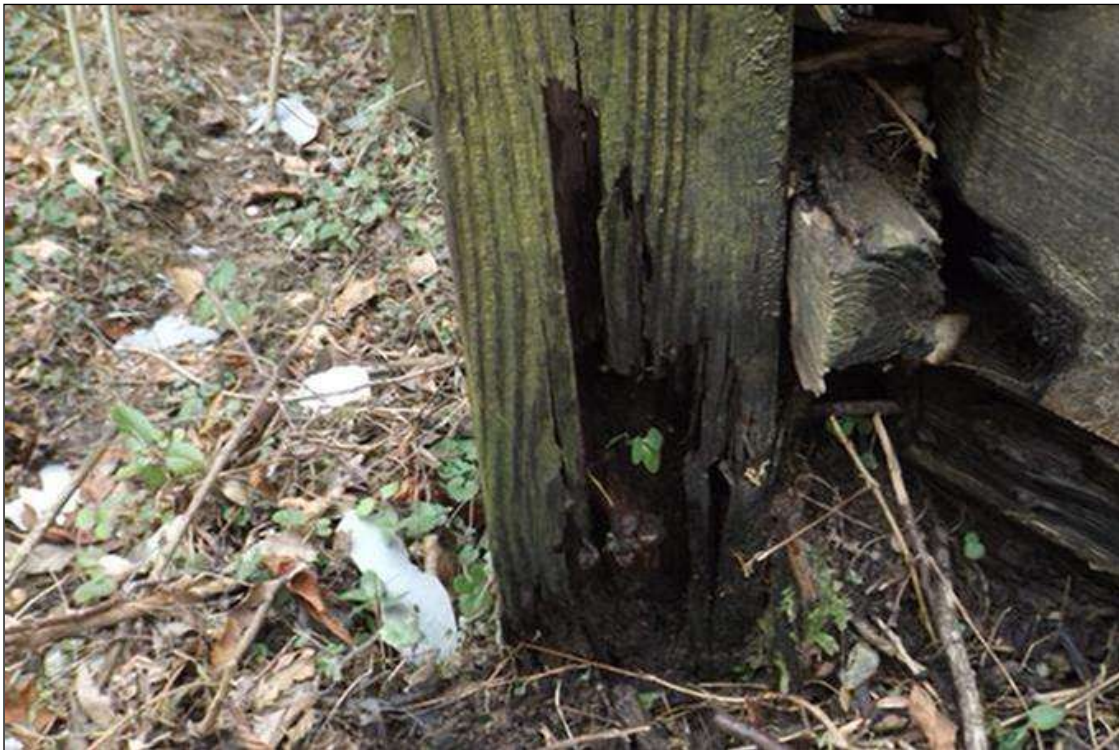
UP TO 15" X 5" X 1 1/2" DEEP AREA OF DECAY IN BULKHEAD PILE ON WEST END OF ABUTMENT 1

| MMS Code | Description of Function | Unit | Quantity | Remarks | Est. Cost |
|---|---|---|---|---|---|
| 3344 | Repair / Replace Timber Substructure Components | LF | 14 | (2) 43" X 3 1/2" X 2" DEEP AREA OF DECAY IN WEST END OF ABUTMENT 1 BULKHEAD BOARDS.<br>9" X 2 1/2" X 3/4" DEEP AREA OF DECAY IN ABUTMENT 1 BULKHEAD BOARDS BETWEEN PILES 4 AND 5.<br>3 1/2" X 7 1/2" X 3" DEEP AREA OF DECAY IN EAST END OF ABUTMENT 1 BULKHEAD BOARD.<br>19" X 3" X 3" DEEP AREA OF DECAY IN EAST END OF ABUTMENT 1 BULKHEAD BOARDS.<br>11" X 4" X 3" DEEP AREA OF DECAY ON EAST END OF ABUTMENT 2 BULKHEAD BOARDS.<br>8 1/2" X 1 1/2" X 2" DEEP AREA OF DECAY ON EAST END OF ABUTMENT 2 BULKHEAD BOARDS.<br>12" X 10" X 3" DEEP AREA OF DECAY AND MISALIGNED BOARDS IN WEST END OF ABUTMENT 2 BULKHEAD BOARDS.<br>UP TO 15" X 5" X 1 1/2" DEEP AREA OF DECAY IN BULKHEAD PILE ON WEST END OF ABUTMENT 1. | |

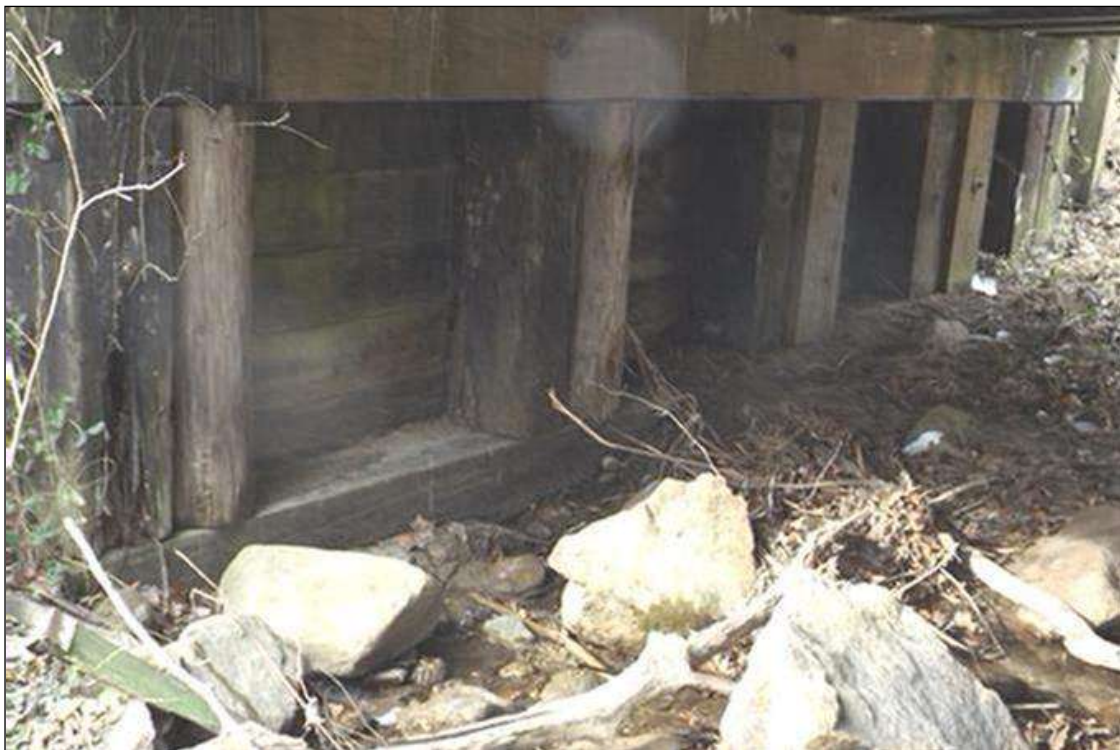
TEMPORARY REPAIRS:SOME OF THE POSTS ARE SUPPLIMENTED AT BOTH  
THE ABUTMENTS.

TEMPORARY REPAIR - ABUTMENT 1 PILES (ABUTMENT 2 SIMILAR)
