NC DEPARTMENT OF TRANSPORTATION  
DIVISION OF HIGHWAYS  
STRUCTURE MANAGEMENT UNIT

## Structure Safety Report

### 2 Year Complete Topside and Underwater Element Inspection

COUNTY: WILKES STRUCTURE NUMBER: 960150 FREQUENCY: 24 MONTHS

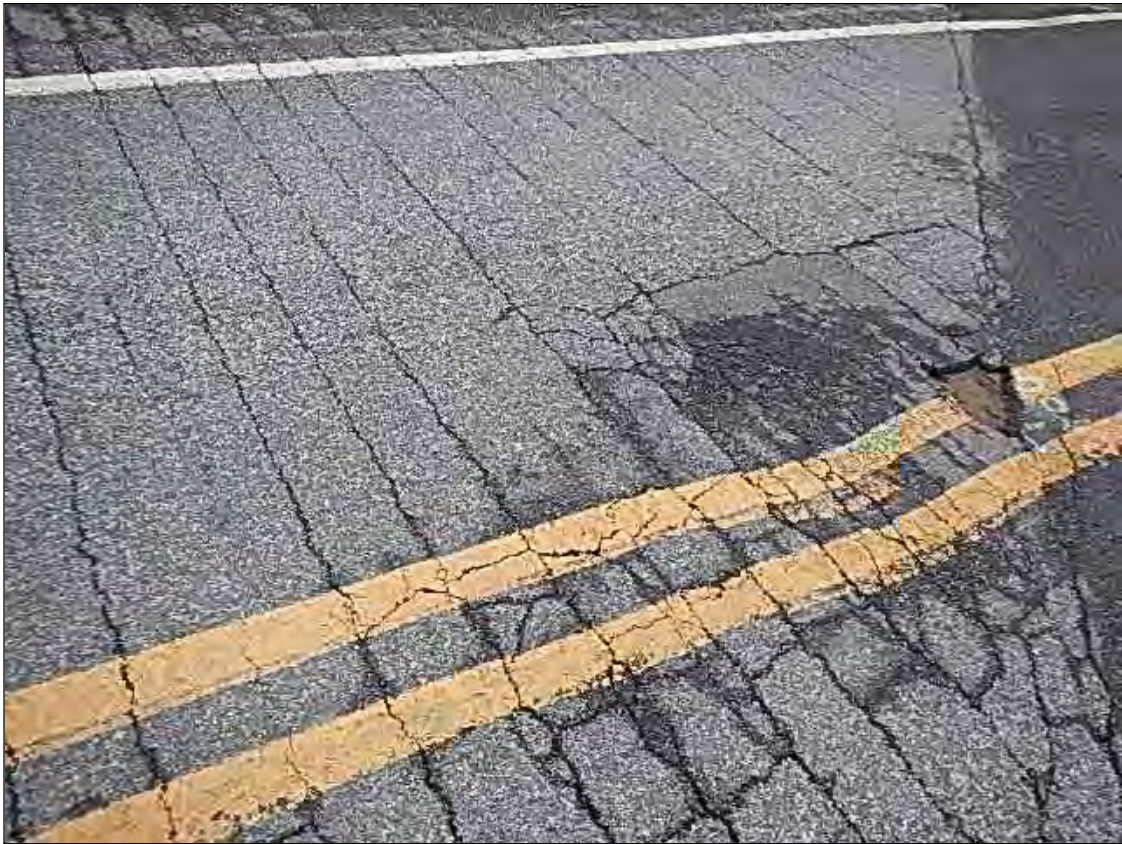
WEARING SURFACE

1 Square Feet of Effectiveness (Wearing Surface): The wearing surface is no longer effective. AREA MISSING AWS.  
646 Square Feet of Crack (Wearing Surface): Width of more than 0.05 in. or spacing of less than 1.0 ft. CRACKED ALONG DECK BOARD JOINTS.

| Details | DECK BOARDS SOFT TO 1/4" ON ENDS. AWS CRACKED ALONG DECK BOARDS. | | | | | |

| MMS Code | Description of Function | Unit | Quantity | Remarks | Est. Cost |
|---|---|---|---|---|---|
| 2816 | Asphalt Surface Repair or Replacement | SY | 72 | CRACKED ALONG ALL DECK BOARDS. 1 SQ FT WEST END MISSING. | |

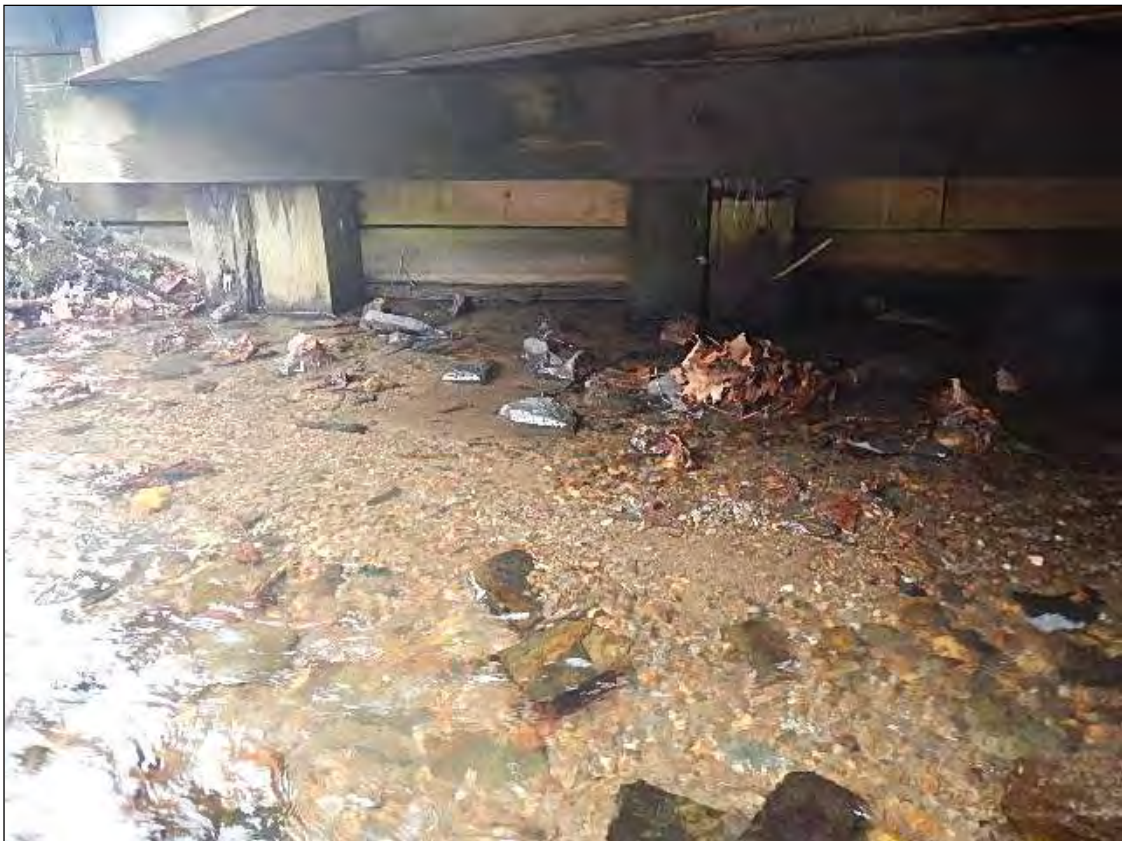
ABUTMENT 1 REPAIR

*Several posts @ abut #1 supplemented*

| Details | SOUTH WEST POST DECAYED 70%. PILES HAVE BEEN SUPPLEMENTED AT ABUTMENT 1. | | | | | |

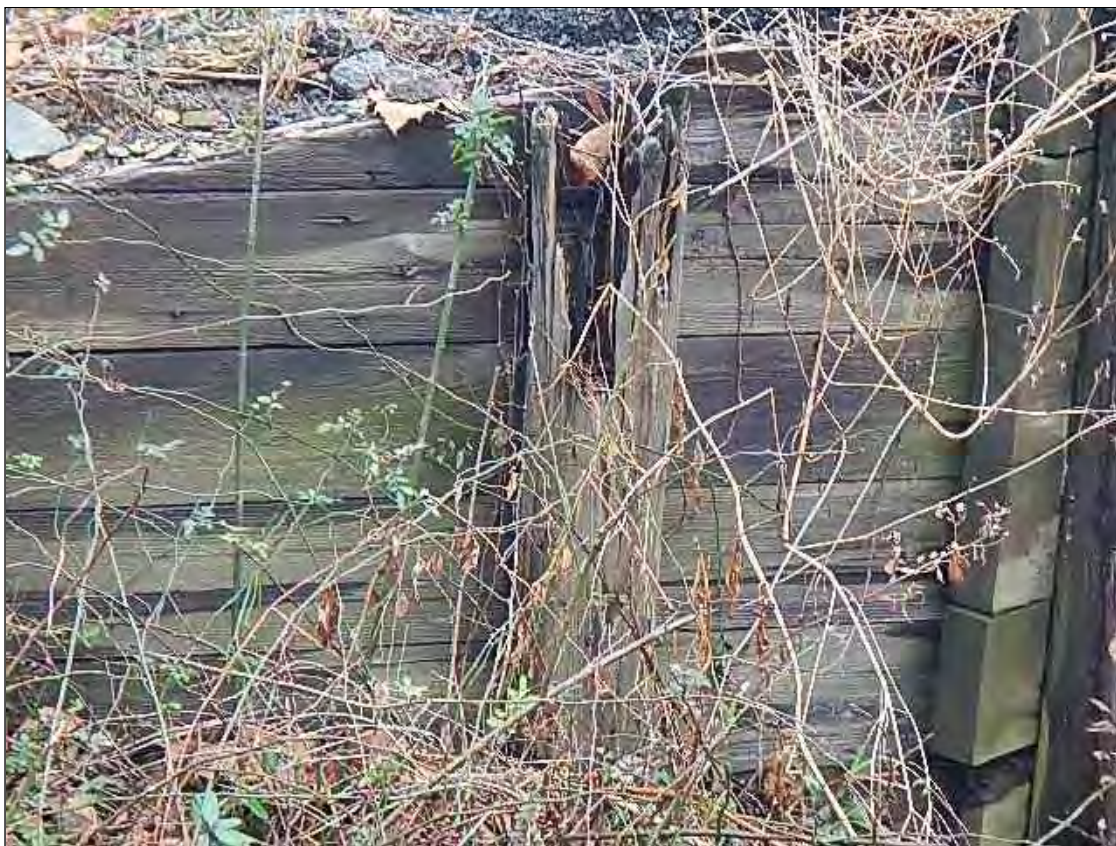
SOUTH WEST WINGWALL POST

1 Feet of Decay/Section Loss: Affects 10% or more of the member but does not warrant structural review. POST AT SOUTHWEST WING WALL DECAYED 70%.

| Details | SOUTH WEST POST AT ABUTMENT 1 DECAYED 70%. SEE PHOTO. | | | | | |

| MMS Code | Description of Function | Unit | Quantity | Remarks | Est. Cost |
|---|---|---|---|---|---|
| 3344 | Repair / Replace Timber Substructure Components | LF | 4 | SOUTH WEST WING POST 70% DECAYED. | |

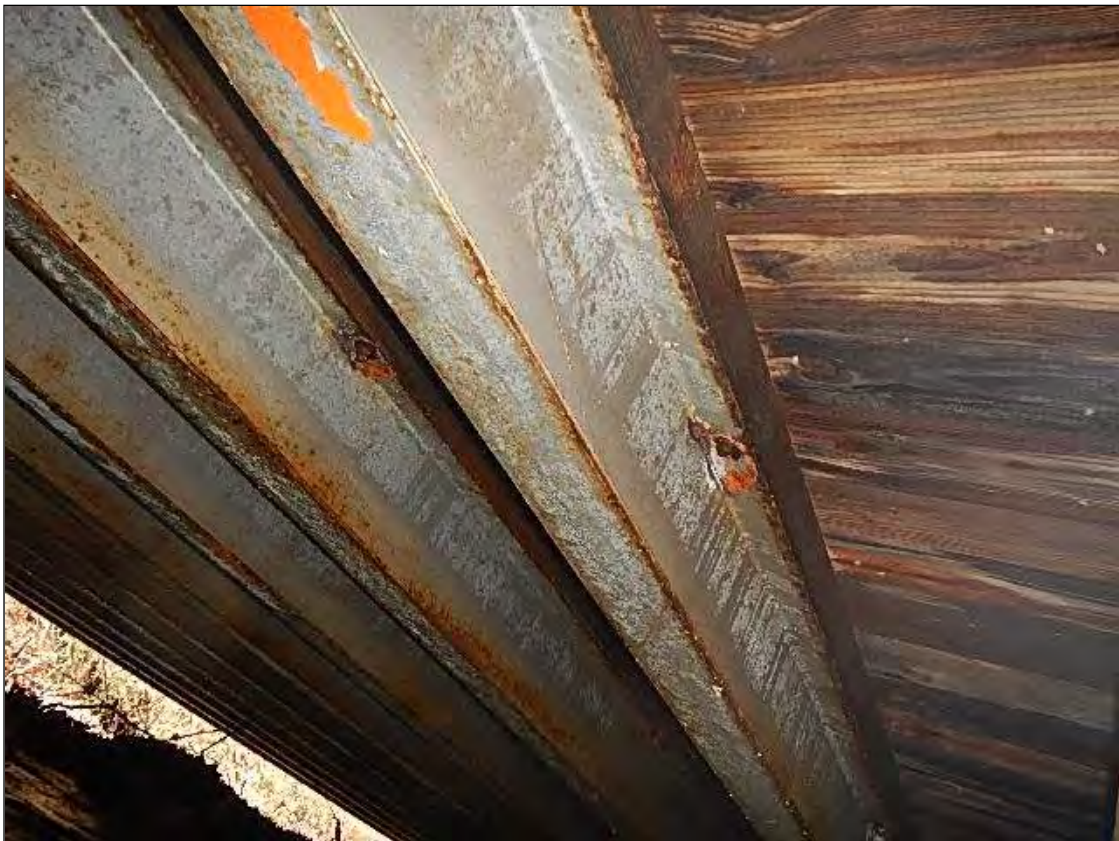
BEAMS

26 Feet of Corrosion: Freckled Rust. Corrosion of the steel has initiated. SURFACE RUST ALONG FLANGE EDGES.  
111 Square Feet of Effectiveness (Steel Protective Coatings): Substantially effective.

| Details | SURFACE RUST ON BEAMS. | | | | | |

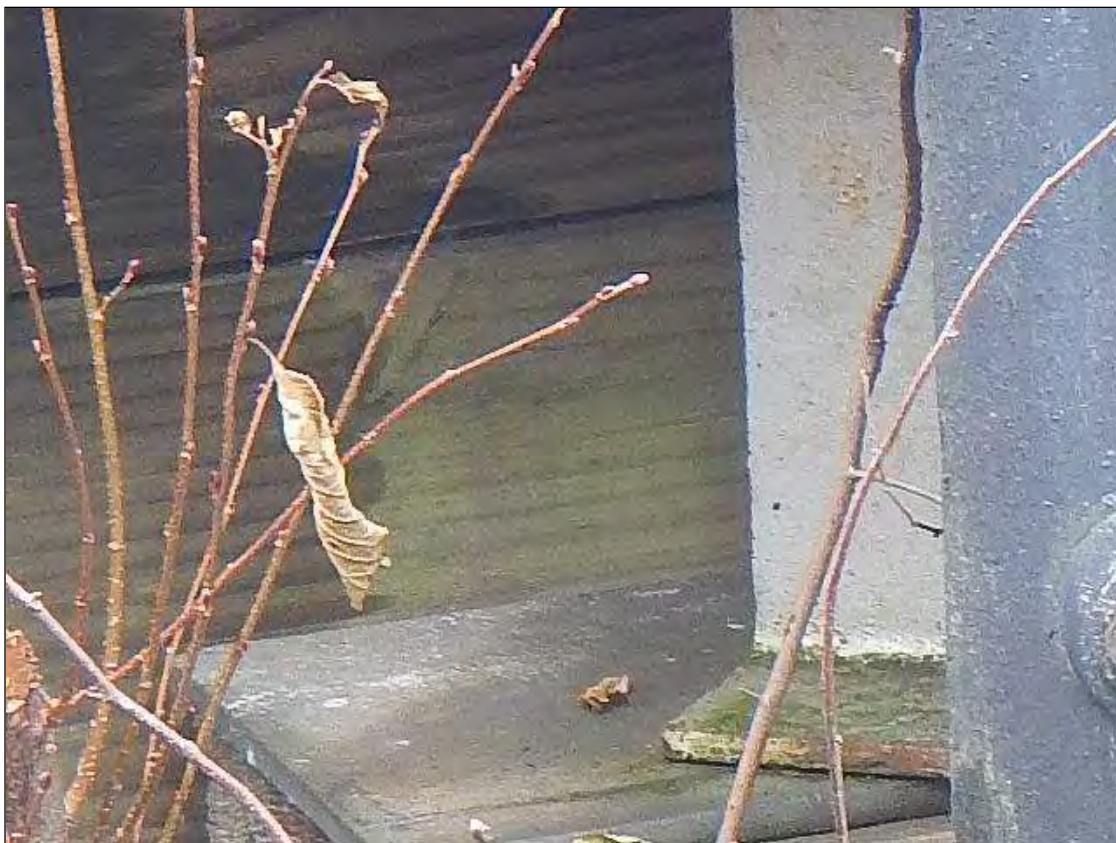
BEARINGS

1 Each of Corrosion: Freckled rust. Corrosion of the steel has initiated. RANDOM RUST BLISTERING.
