NC DEPARTMENT OF TRANSPORTATION  
DIVISION OF HIGHWAYS  
STRUCTURE MANAGEMENT UNIT

## Structure Safety Report

### Routine Element Inspection - Contract

COUNTY: WILKES STRUCTURE NUMBER: 960151 FREQUENCY: 24 MONTHS

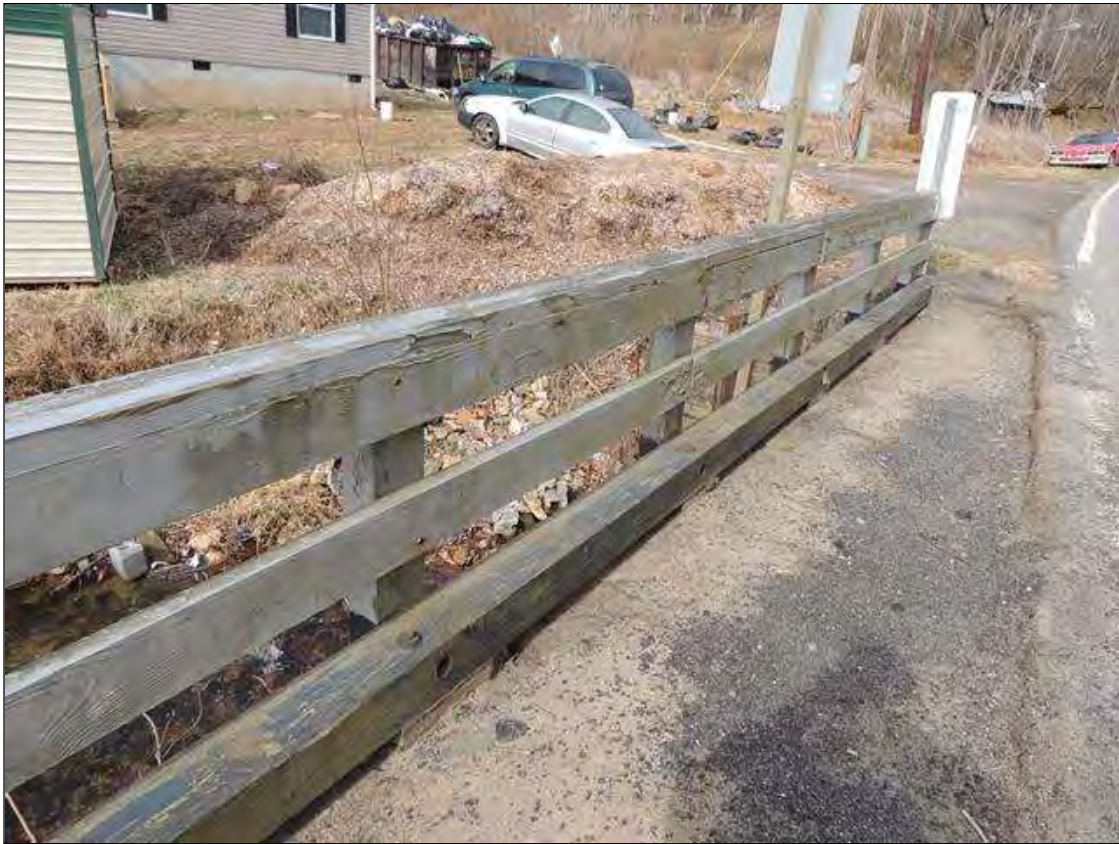
Span 1 Left Bridge Rail: 27 Feet of Crack (Timber): Identified crack that is not arrested but does not require structural review. rail is cracked and loose in spots through out.

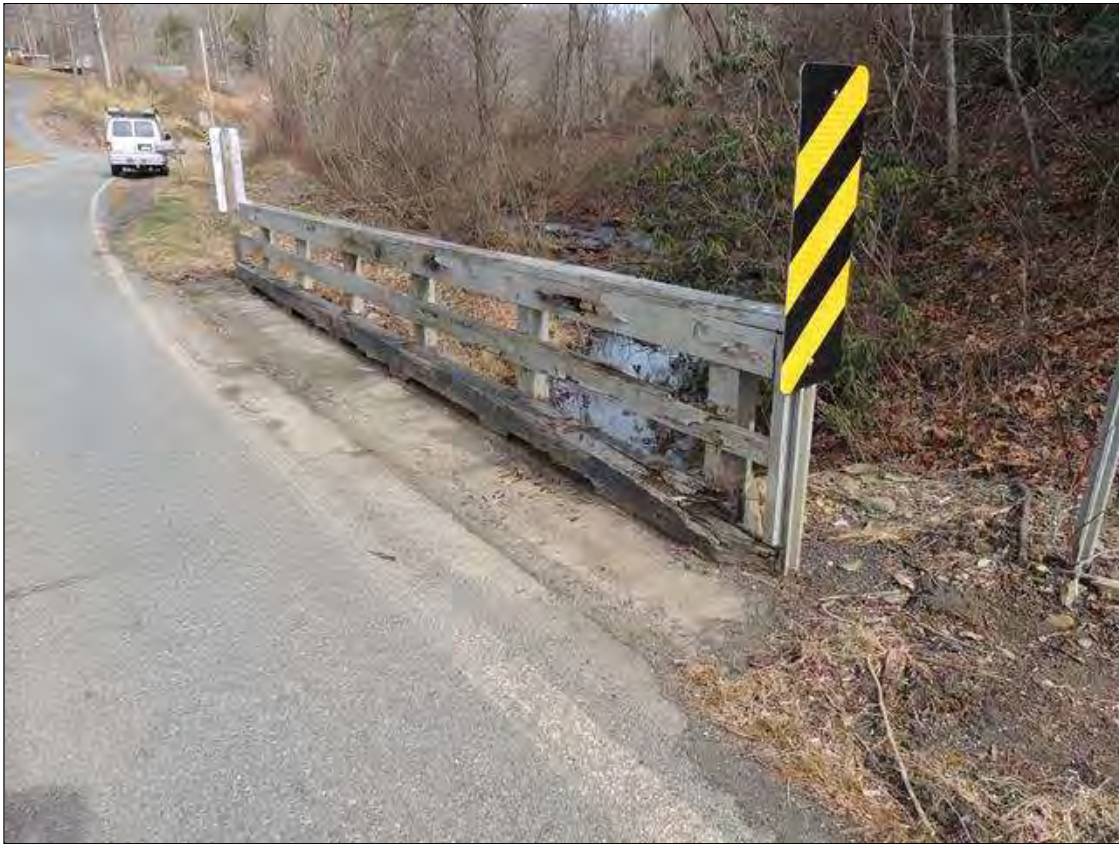
Span 1 Right Bridge Rail: 27 Feet of Decay/Section Loss: The condition warrants a structural review to determine the effect on strength or serviceability of the element or bridge; OR a structural review has been completed and the defects impact strength or serviceability of the element or bridge. rail is loose and cracked and decayed in spots

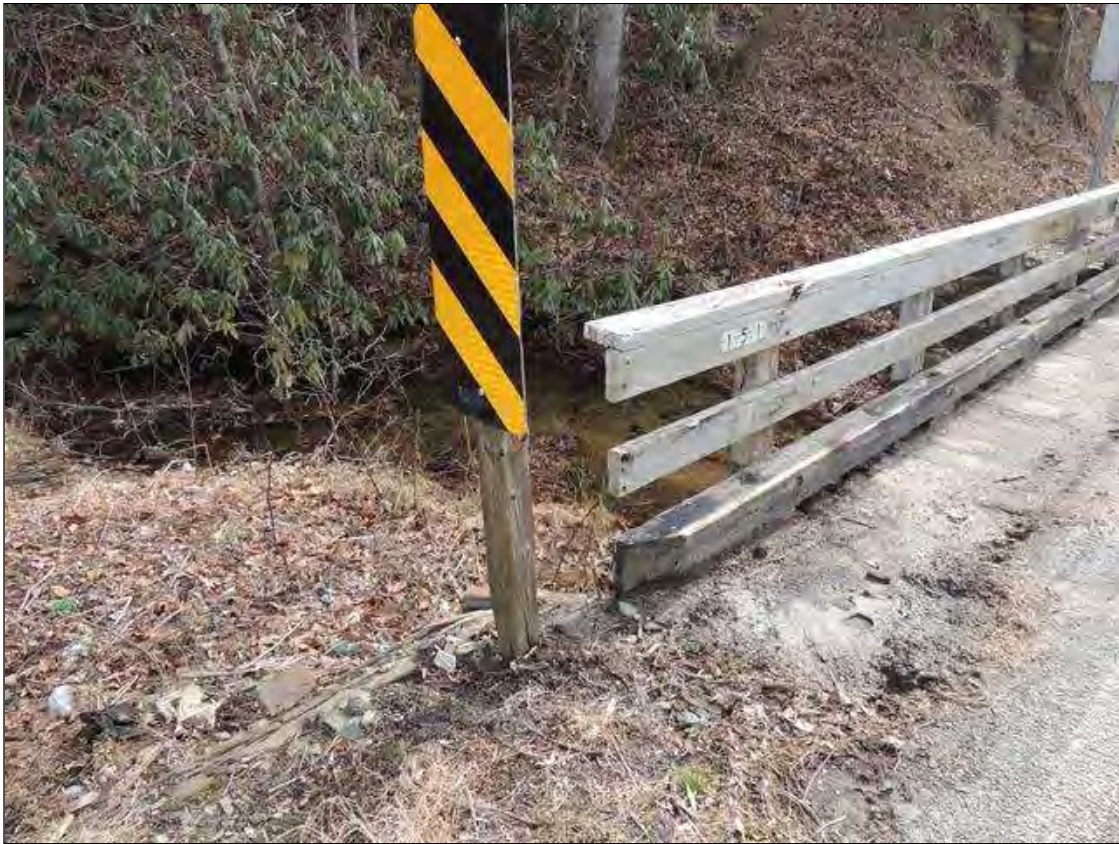
Span 1 Right Bridge Rail: 0 Feet of Connection: Missing bolts, rivets, or fasteners; broken welds; or pack rust with distortion but does not warrant a structural review. header board at the se corner is missing.

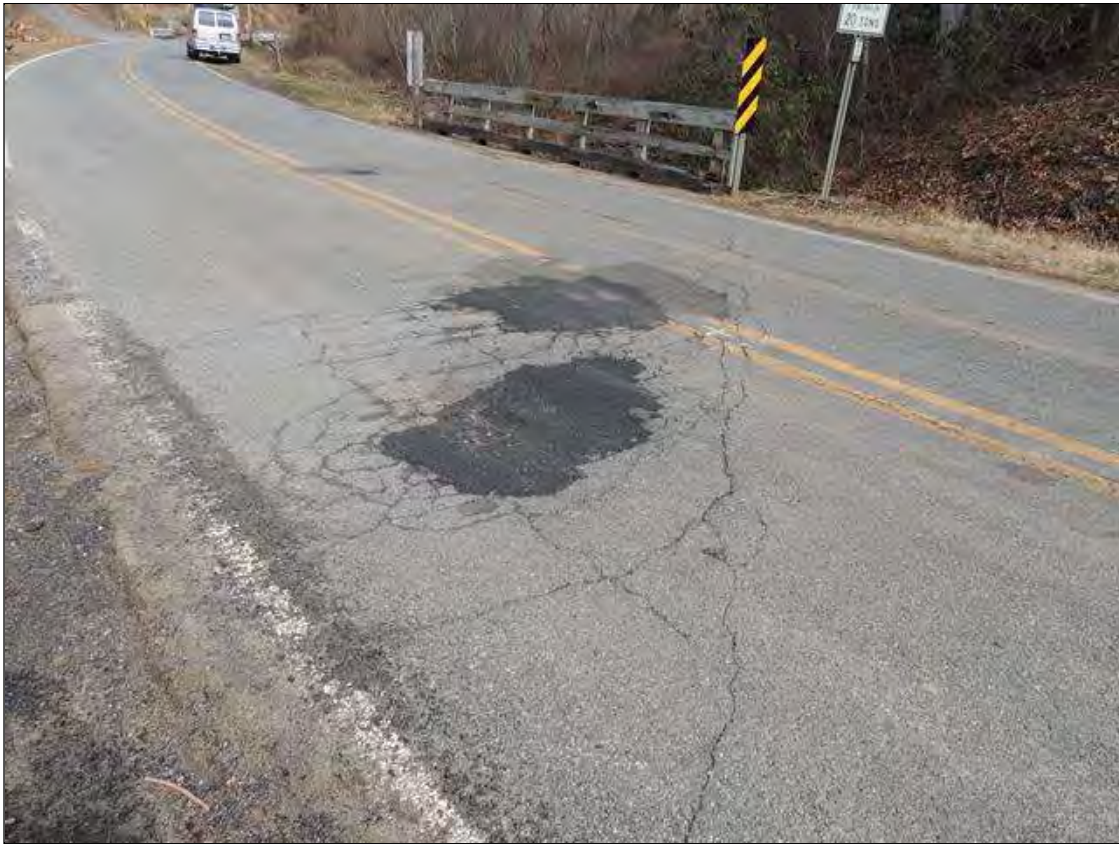
Span 1 Wearing Surface: 120 Square Feet of Delamination/Spall/Patched Area/Pothole (Wearing Surfaces): Spall 1 in. deep or greater or 6 in. diameter or greater. Patched area that is unsound or showing distress. Full depth pothole. top deck is patched over and breaking up and cracked over 10' x 12' area 1/2 lane at end bent 2

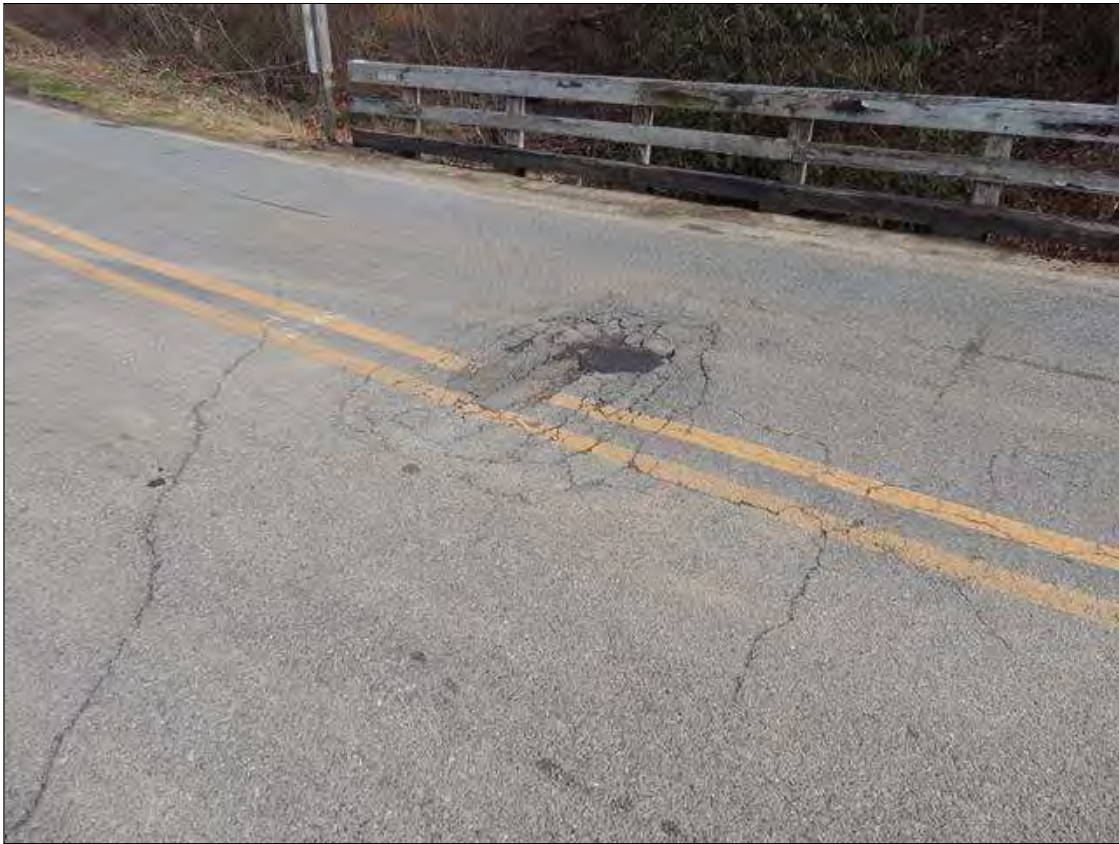
Span 1 Wearing Surface: 40 Square Feet of Delamination/Spall/Patched Area/Pothole (Wearing Surfaces): The wearing surface is no longer effective. top deck patch area breaking up in cl and rt lane

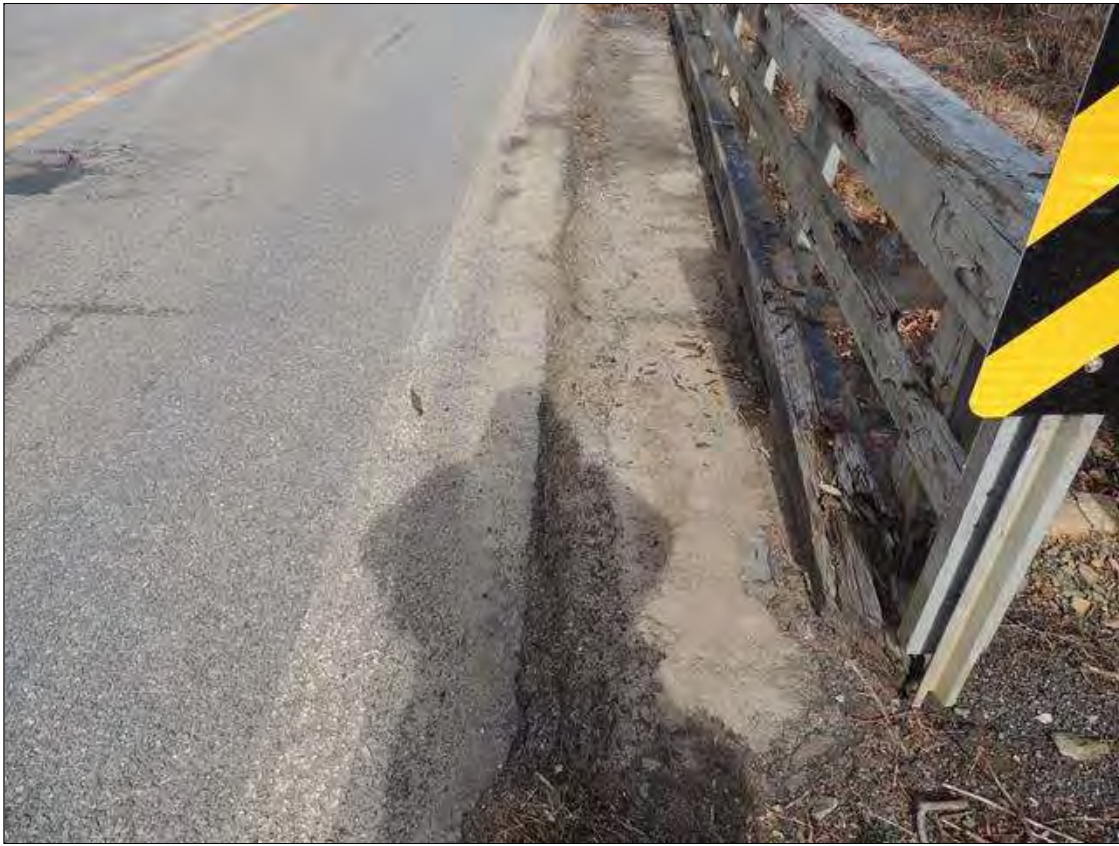
Span 1 Wearing Surface: 156 Square Feet of Delamination/Spall/Patched Area/Pothole (Wearing Surfaces): The wearing surface is no longer effective. rt side aws along curbline has been cut down 4" deep x 30" wide x length bridge and It curbline similar.

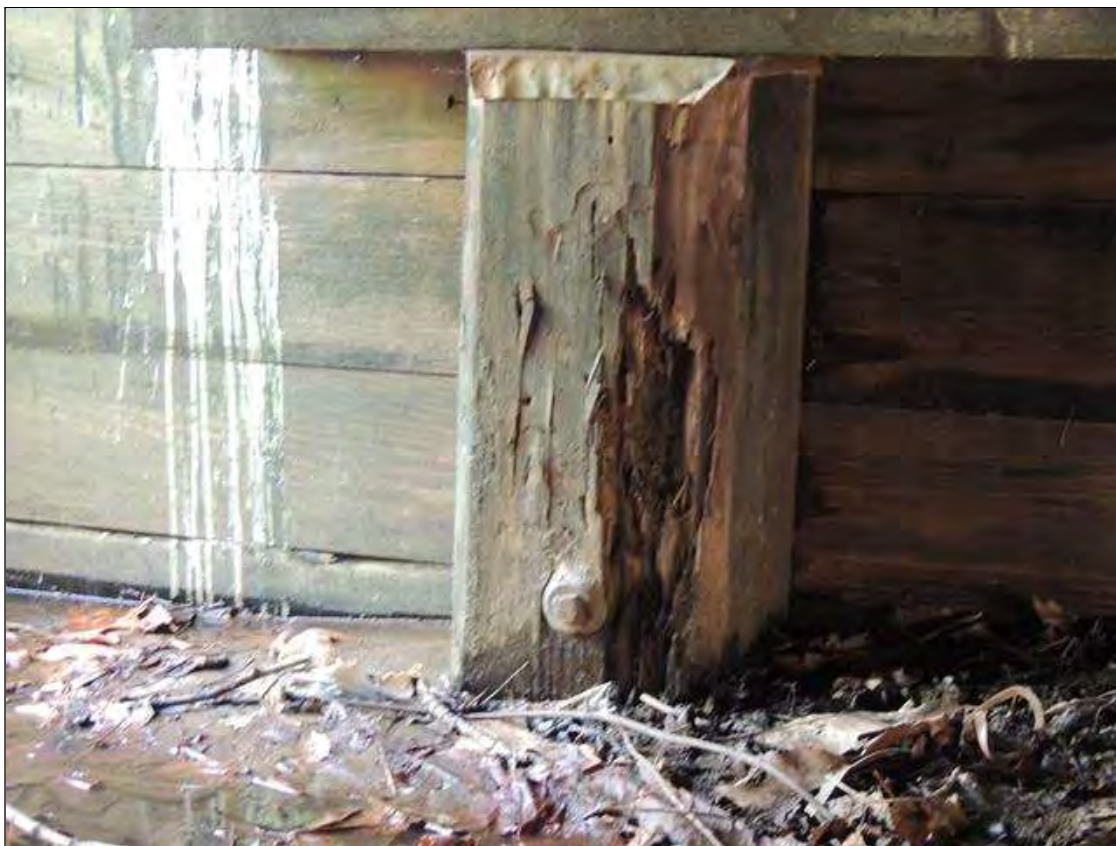
1 Each of Decay/Section Loss: Affects 10% or more of the member but does not warrant structural review. decayed near groundline 2" deep and 20" up

End Bent 1 Pile 7: 1 Each of Decay/Section Loss: Affects 10% or more of the member but does not warrant structural review.end bent 1 p7 decayed near ground line 2" deep and up 20"

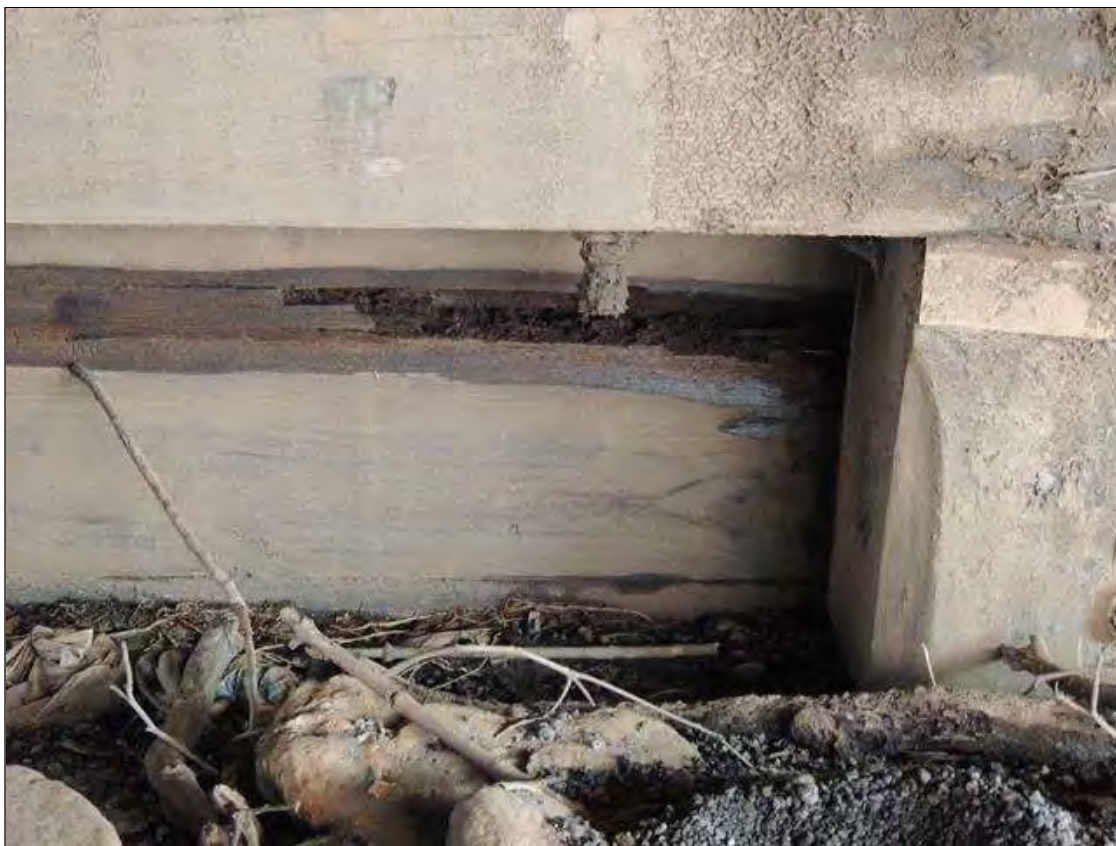
end bent 1 bulkhead boards decayed between p4 and p5 at ground line with fill exposed p5 and p6 similar rt side.

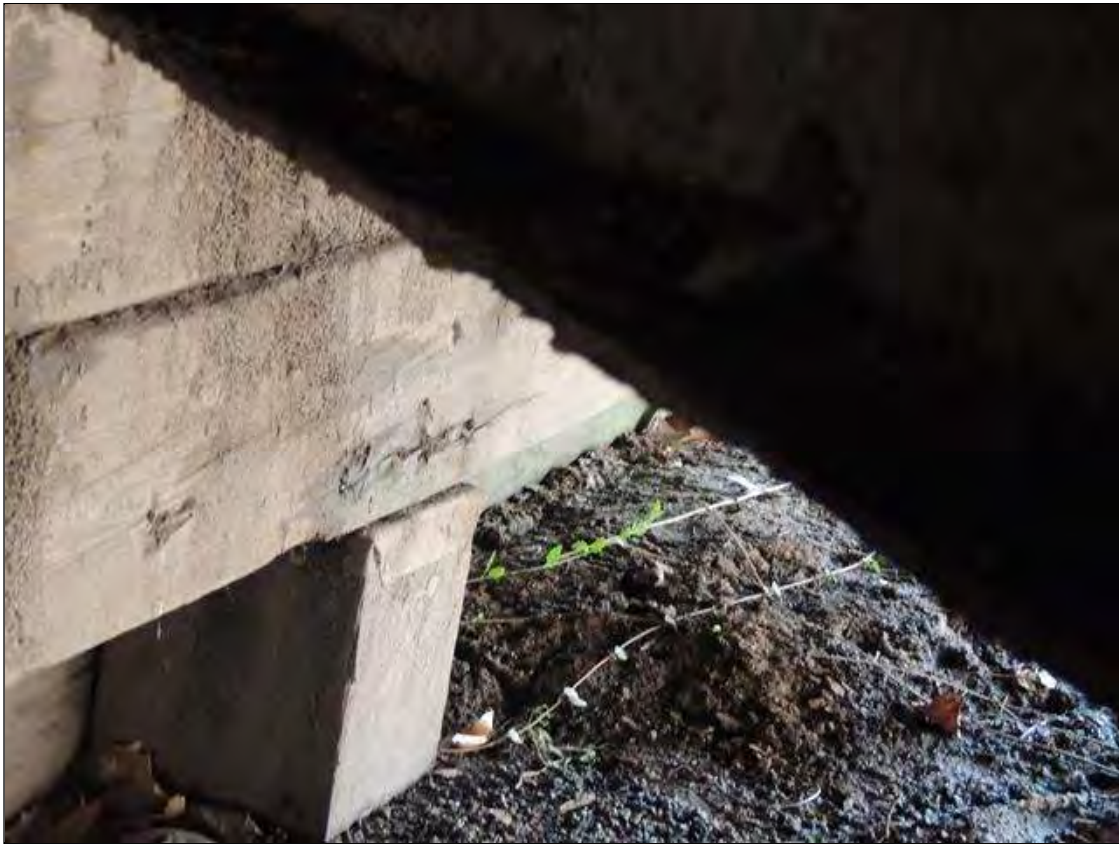
6 Feet of Corrosion: The condition warrants a structural review to determine the effect on strength or serviceability of the element or bridge; OR a structural review has been completed and the defects impact strength or serviceability of the element or bridge. 3/16" remaining along bottom flange 65" out from end bent 1

Span 1 Beam 5: 6 Feet of Corrosion: The condition warrants a structural review to determine the effect on strength or serviceability of the element or bridge; OR a structural review has been completed and the defects impact strength or serviceability of the element or bridge. 3/16" remaining along bottom flange 65" out from end bent 1

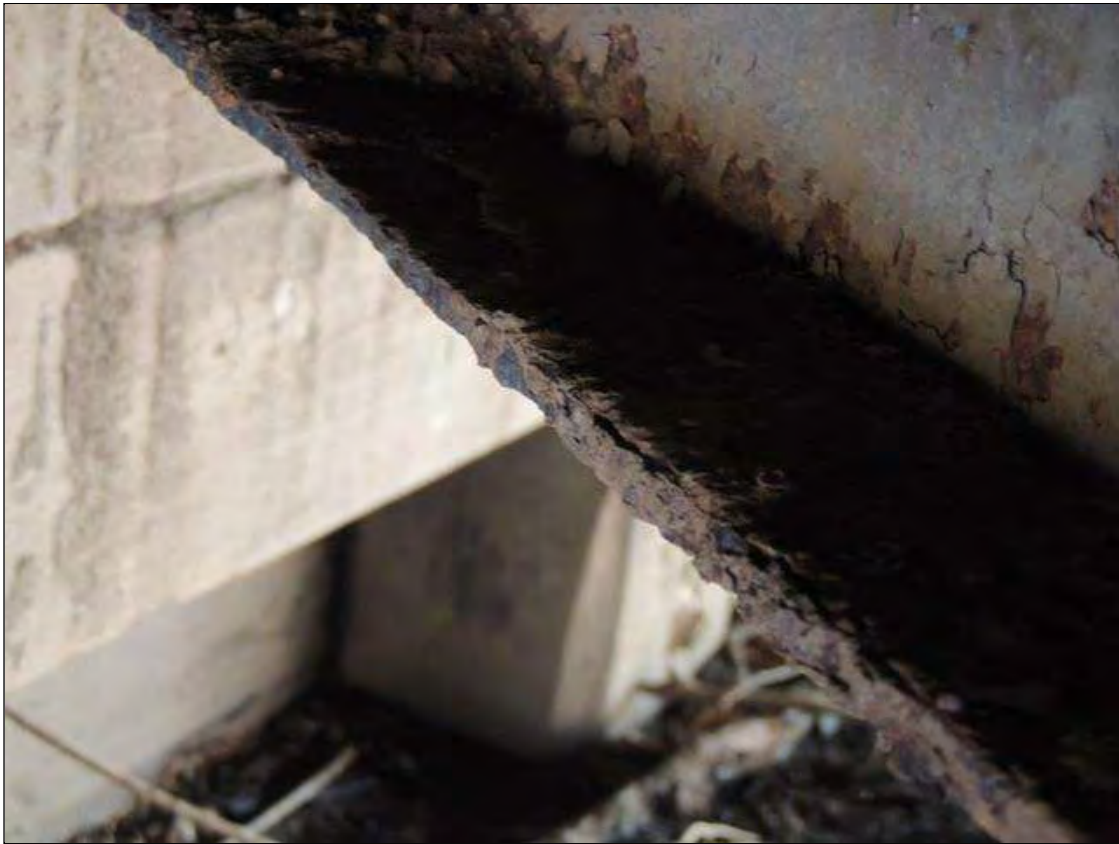
5 Feet of Corrosion: Section loss is evident or pack rust is present but does not warrant structural review. has 3/16" to 1/4" remaining along bottom flange 50" out from end bent 1

Span 1 Beam 7: 5 Feet of Corrosion: Section loss is evident or pack rust is present but does not warrant structural review.  
has 3/16" to 1/4" remaining along bottom flange 50" out from end bent 1

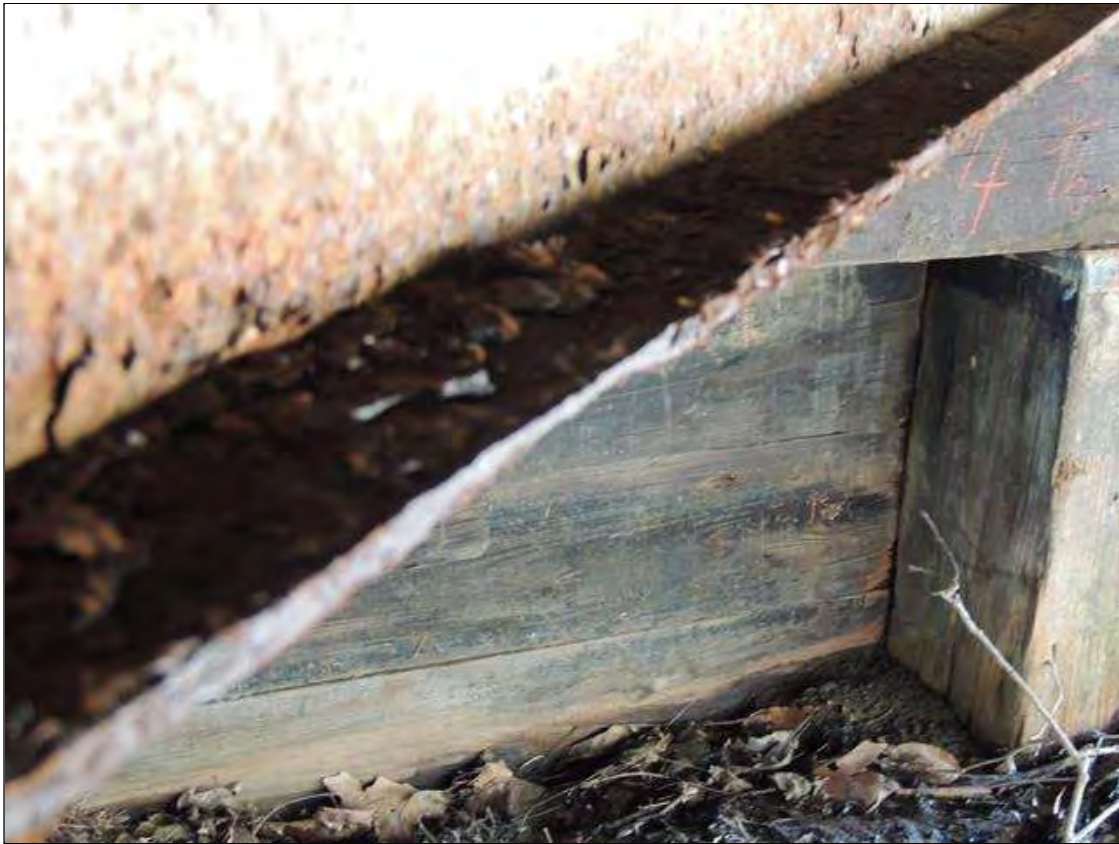
5 Feet of Corrosion: The condition warrants a structural review to determine the effect on strength or serviceability of the element or bridge; OR a structural review has been completed and the defects impact strength or serviceability of the element or bridge. bm 7 from 3/16" to 1/4" remaining along bottom flange from end bent 2 back 60"

Span 1 Beam 7: 5 Feet of Corrosion: The condition warrants a structural review to determine the effect on strength or serviceability of the element or bridge; OR a structural review has been completed and the defects impact strength or serviceability of the element or bridge. bm 7 from 3 /16" to 1/4" remaining along bottom flange from end bent 2 back 60"

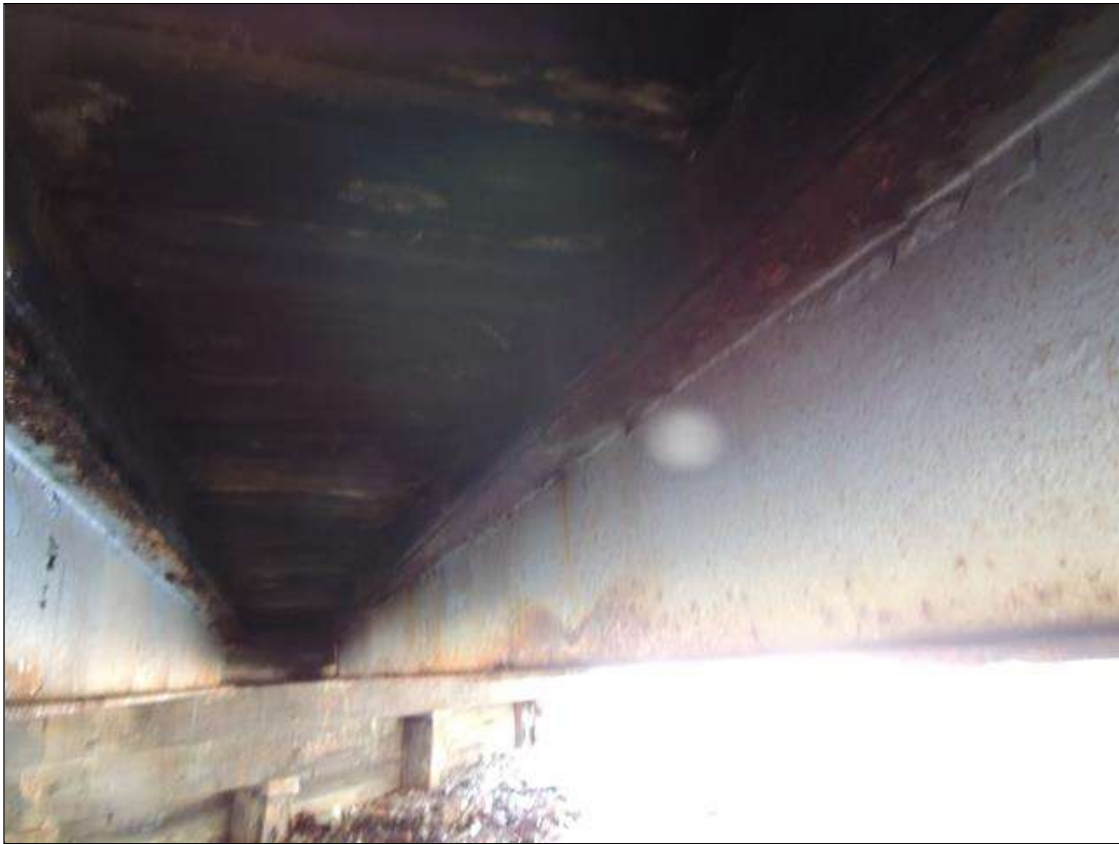
15 Feet of Corrosion: Section loss is evident or pack rust is present but does not warrant structural review. rusty and corrosion along top flange with 1/8" loss

Span 1 Beam 8: 15 Feet of Corrosion: Section loss is evident or pack rust is present but does not warrant structural review.  
rusty and corrosion along top flange with 1/8" loss

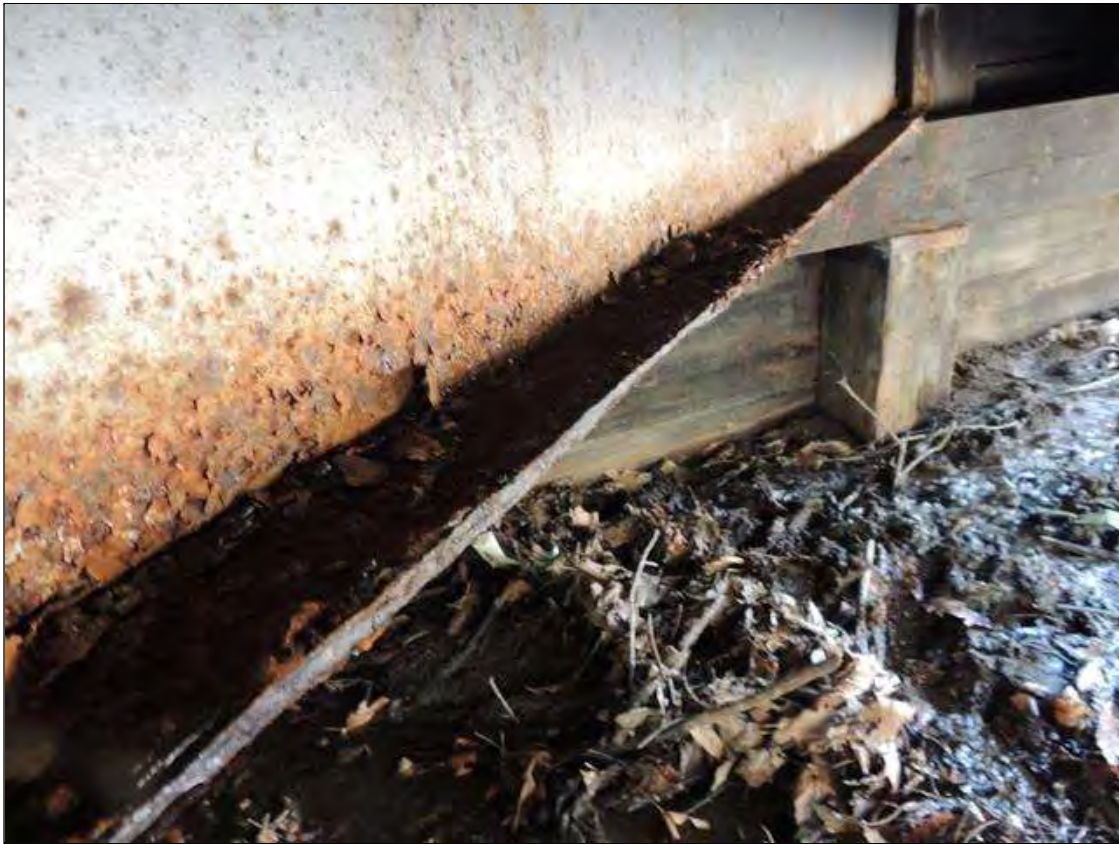
5 Feet of Corrosion: The condition warrants a structural review to determine the effect on strength or serviceability of the element or bridge; OR a structural review has been completed and the defects impact strength or serviceability of the element or bridge. rt side bm 8 along bottom flange 3/16" remaining from end bent 2 back 5'

Span 1 Beam 8: 5 Feet of Corrosion: The condition warrants a structural review to determine the effect on strength or serviceability of the element or bridge; OR a structural review has been completed and the defects impact strength or serviceability of the element or bridge. rt side bm 8 along bottom flange 3/16" remaining from end bent 2 back 5'

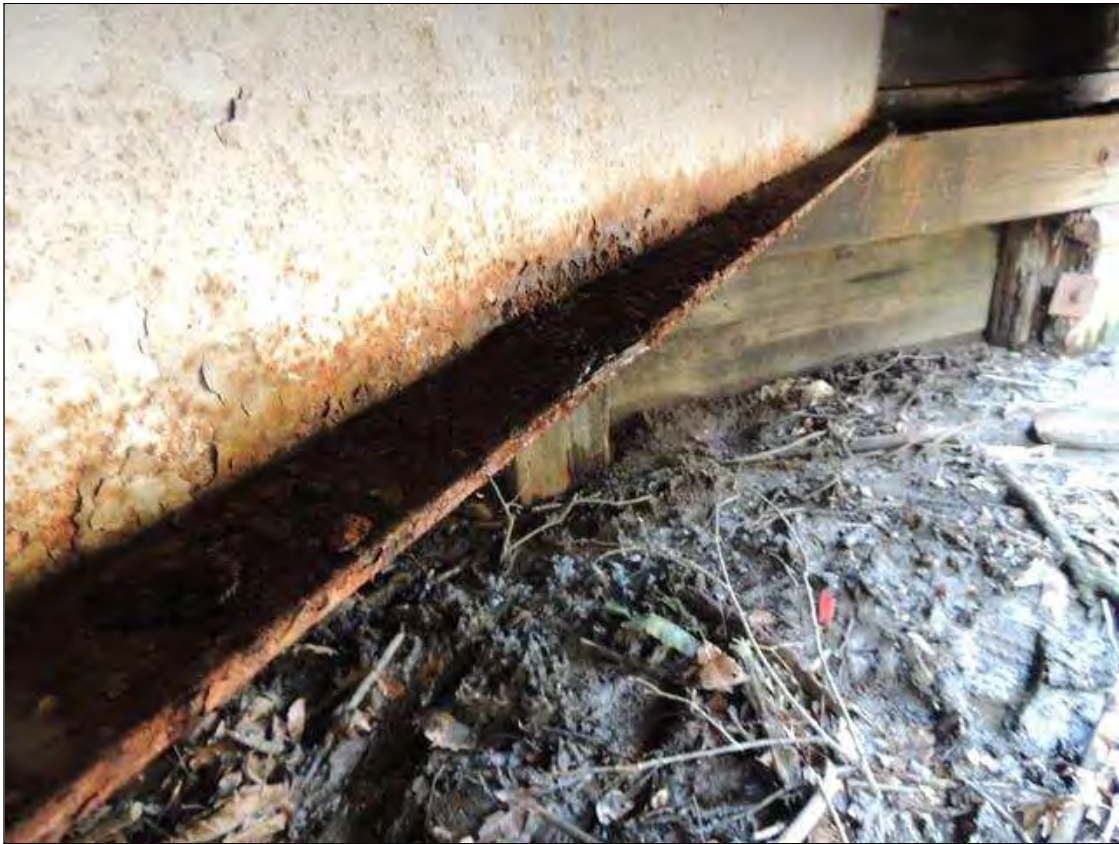
9 Feet of Corrosion: The condition warrants a structural review to determine the effect on strength or serviceability of the element or bridge; OR a structural review has been completed and the defects impact strength or serviceability of the element or bridge. bm 9

Span 1 Beam 9: 9 Feet of Corrosion: The condition warrants a structural review to determine the effect on strength or serviceability of the element or bridge; OR a structural review has been completed and the defects impact strength or serviceability of the element or bridge. bm 9

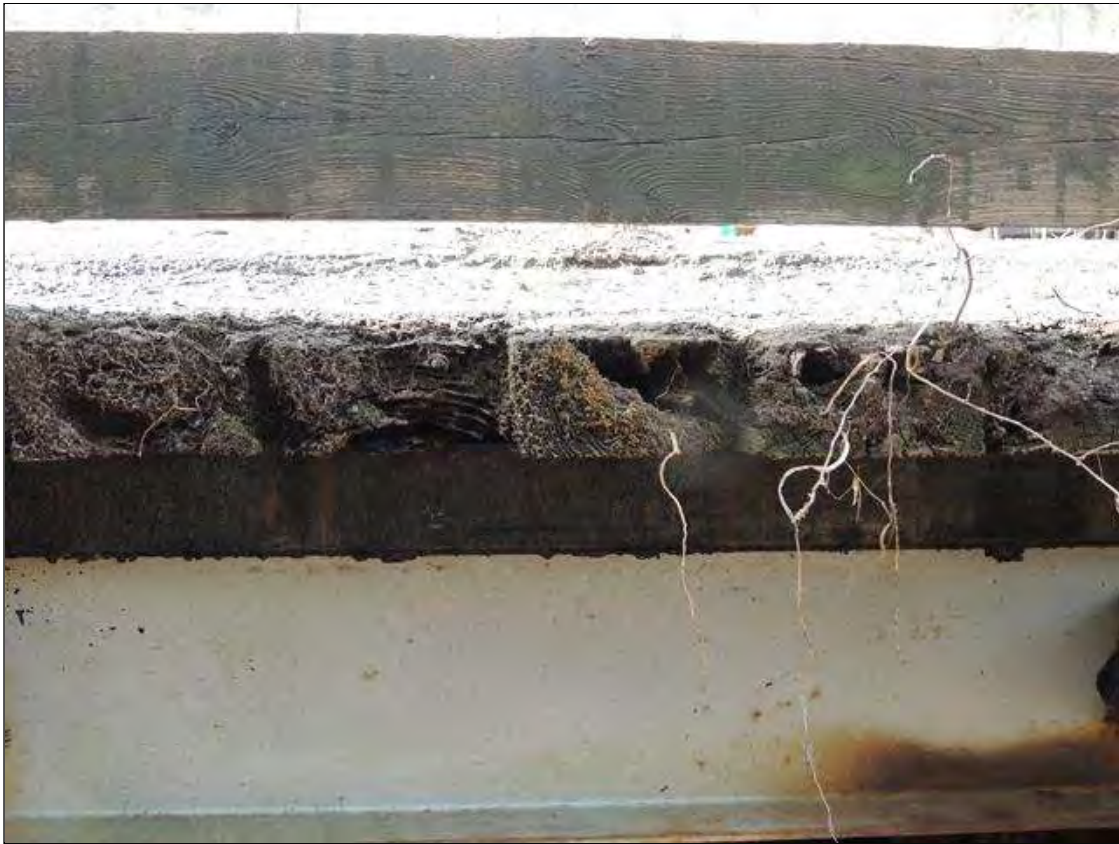
Span 1 Deck: 55 Square Feet of Decay/Section Loss: Affects 10% or more of the member but does not warrant structural review. timber floor boards decayed on ends

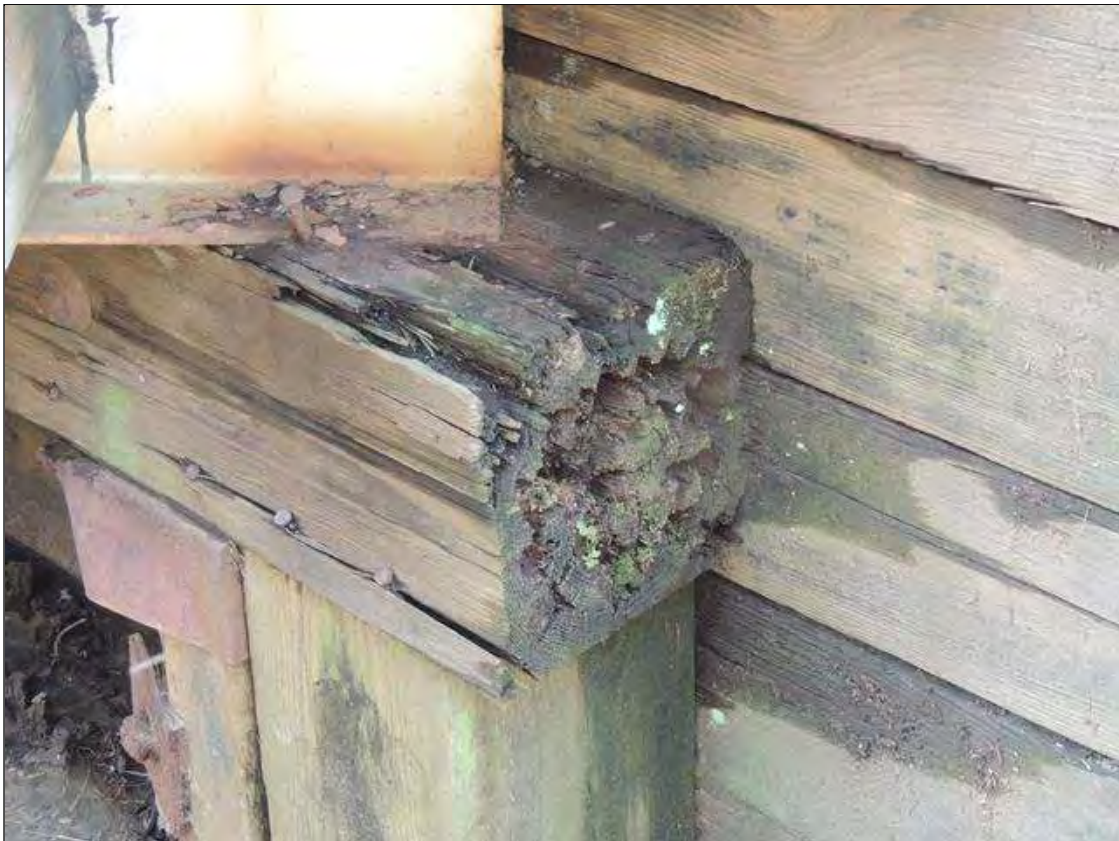
2 Feet of Decay/Section Loss: Affects 10% or more of the member but does not warrant structural review. rt end cap decayed top down 10" x 3" deep and 16" back

End Bent 2 Cap : 2 Feet of Decay/Section Loss: Affects 10% or more of the member but does not warrant structural review. cap segment 2 rt end cap decayed from end back 16" 10 1/2" w x top down 10" x 3" deep.

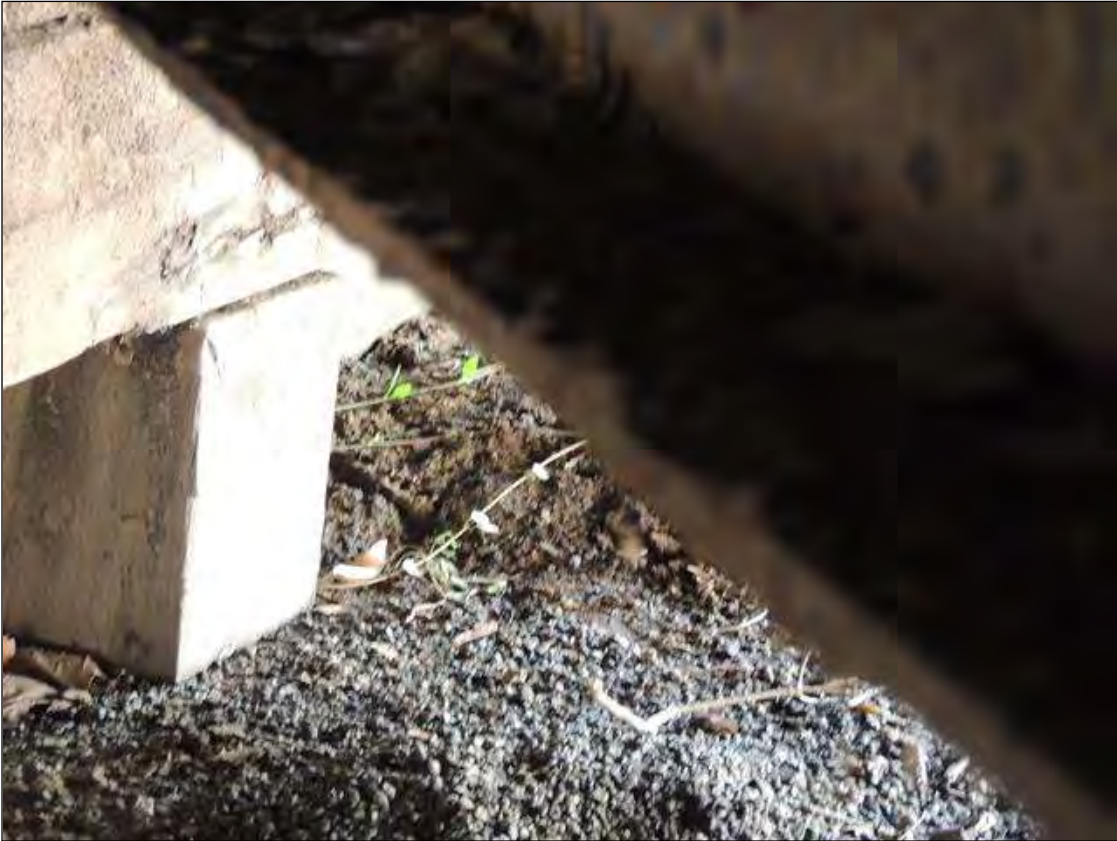
SPAN 1 BM 5  $5 \frac{3}{16}$ " REMAINING ALONG BOTTOM FLANGE FROM END BENT 1 OUT 65" AND  $\frac{1}{8}$ " LOSS IN TOP FLANGE

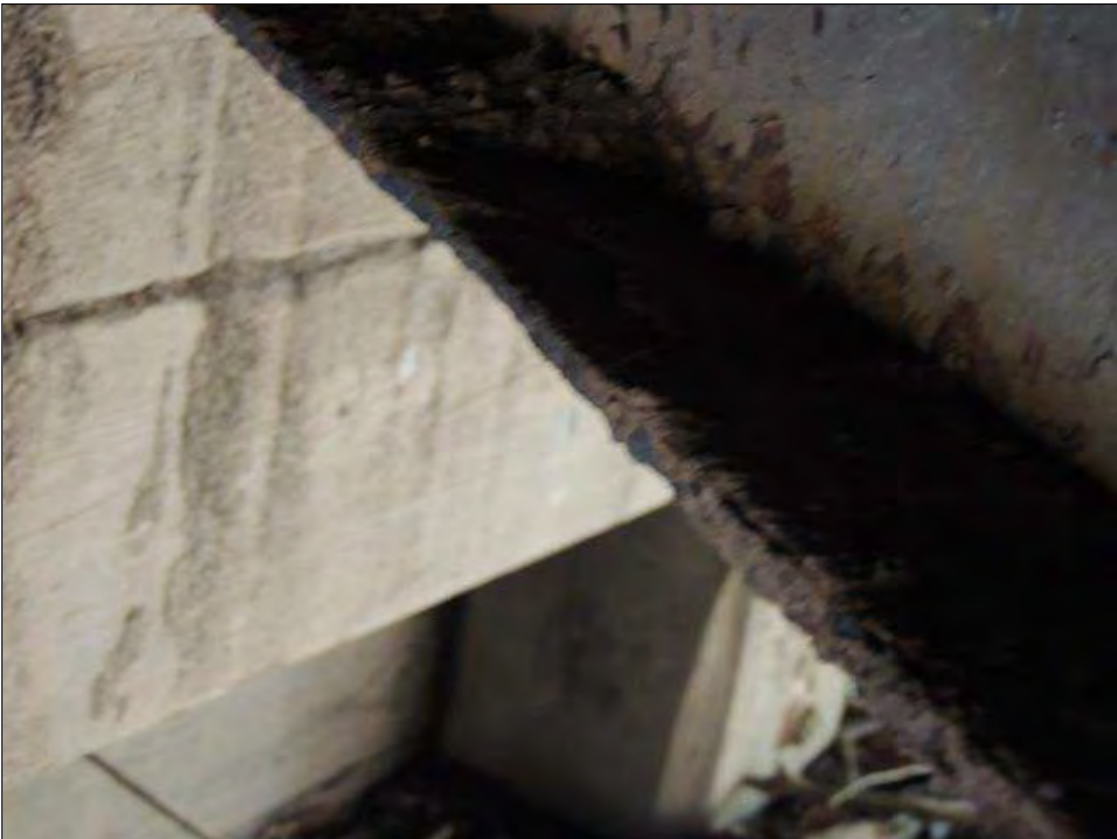
SPAN 1 BM 7 HAS  $\frac{3}{16}$ " REMAINING ALONG BOTTOM FLANGE FROM END BENT 1 OUT 50

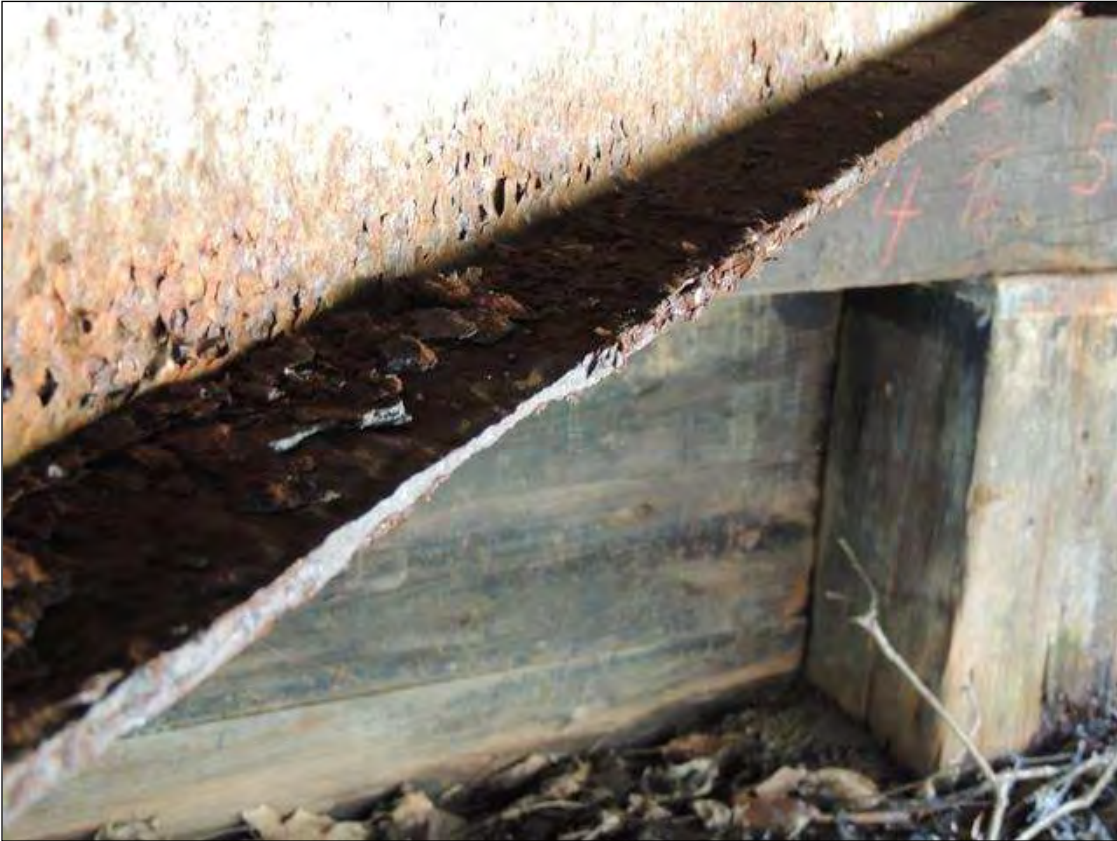
SPAN 1 BM 7 HAS 1/4" TO 3/16" REMAINING ALONG BOTTOM FLANGE FROM END BENT 2 BACK 60"

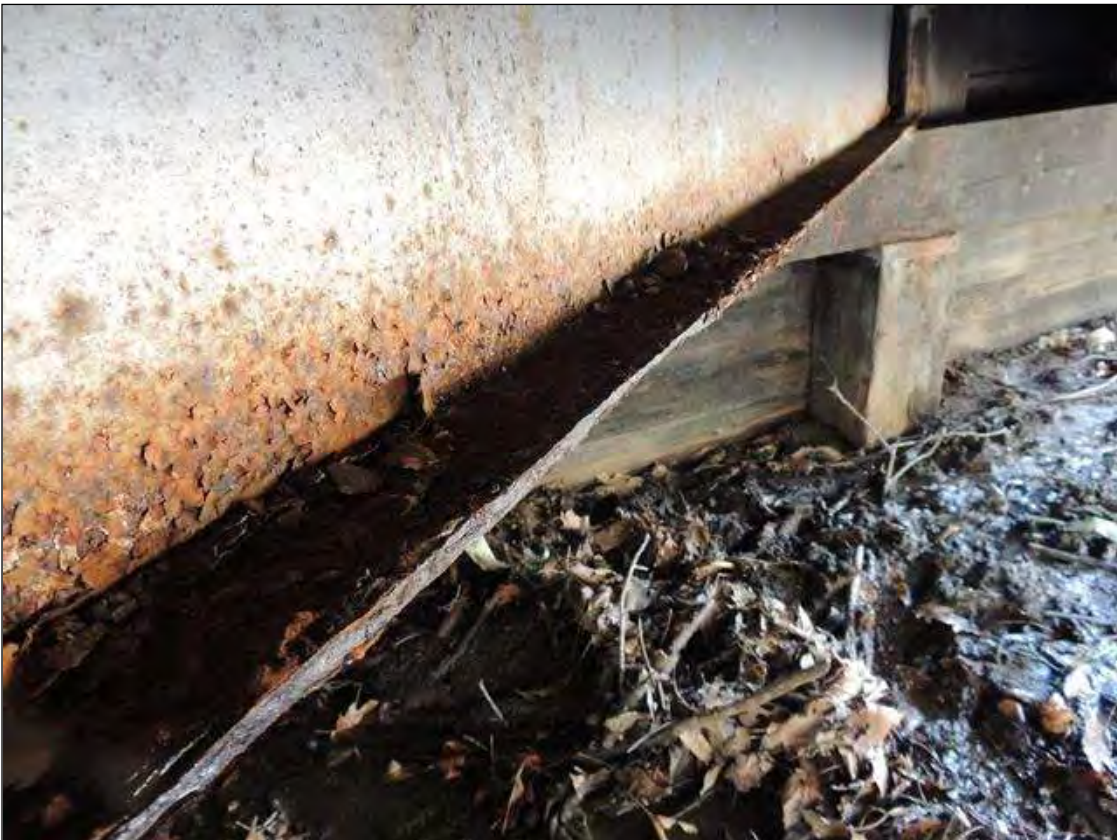
SPAN 1 BM 8 HAS 3/16" REMAINING ALONG BOTTOM FLANGE ON RT SIDE FROM END BENT 2 BACK 60".

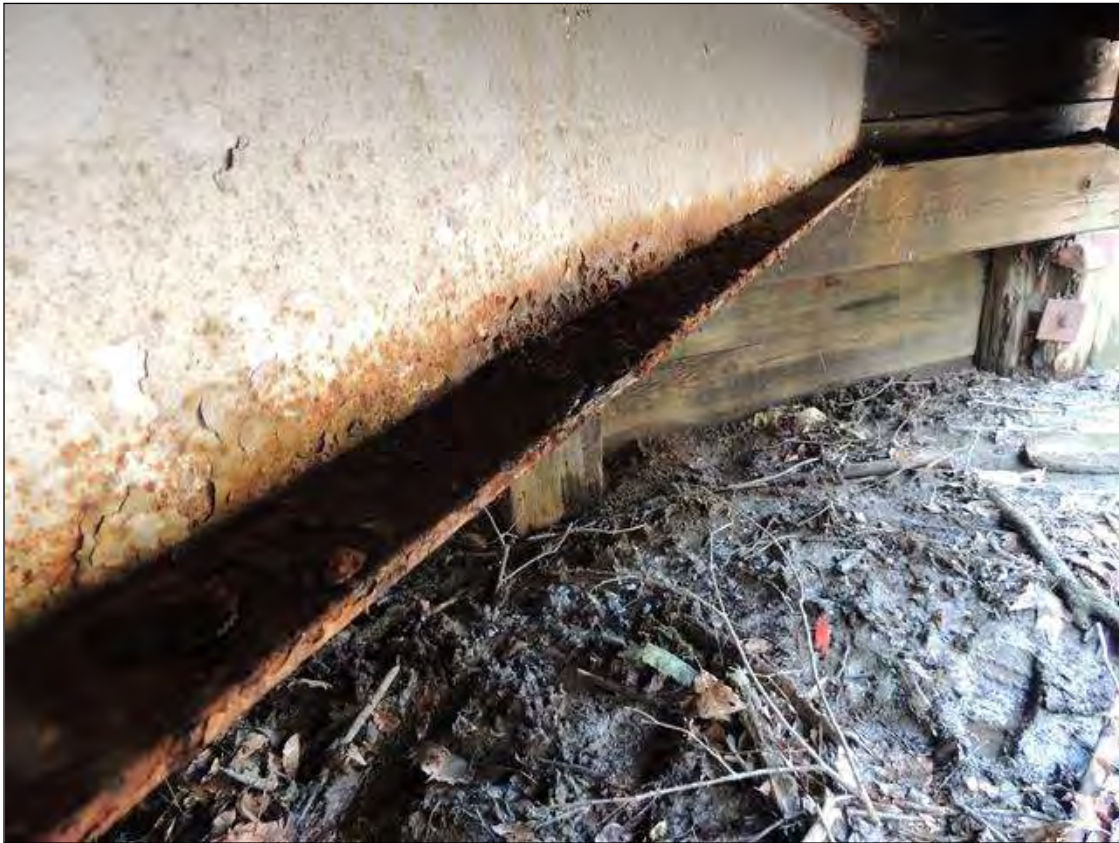
| MMS Code | MMS Description | Quantity |
|---|---|---|
| SPAN 1 BM 9 HAS 1/4" TO 3/16" REMAINING ALONG BOTTOM FLANGE FROM END BENT 2 BACK 9' AND 1/8" LOSS TOP FLANGE | | |

SPAN 1 BM 9 HAS 1/4" TO 3/16" REMAINING ALONG BOTTOM FLANGE FROM END BENT 2 BACK 9' AND 1/8" LOSS TOP FLANGE
