NC DEPARTMENT OF TRANSPORTATION  
DIVISION OF HIGHWAYS  
BRIDGE MANAGEMENT UNIT

# BRIDGE INSPECTION REPORT

INSPECTION TYPE: Routine Inspection - Contract

COUNTY WILKES BRIDGE NUMBER 960153 INSPECTION CYCLE 0 YRS  
ROUTE SR1728 ACROSS MULBERRY CREEK M.P. 0

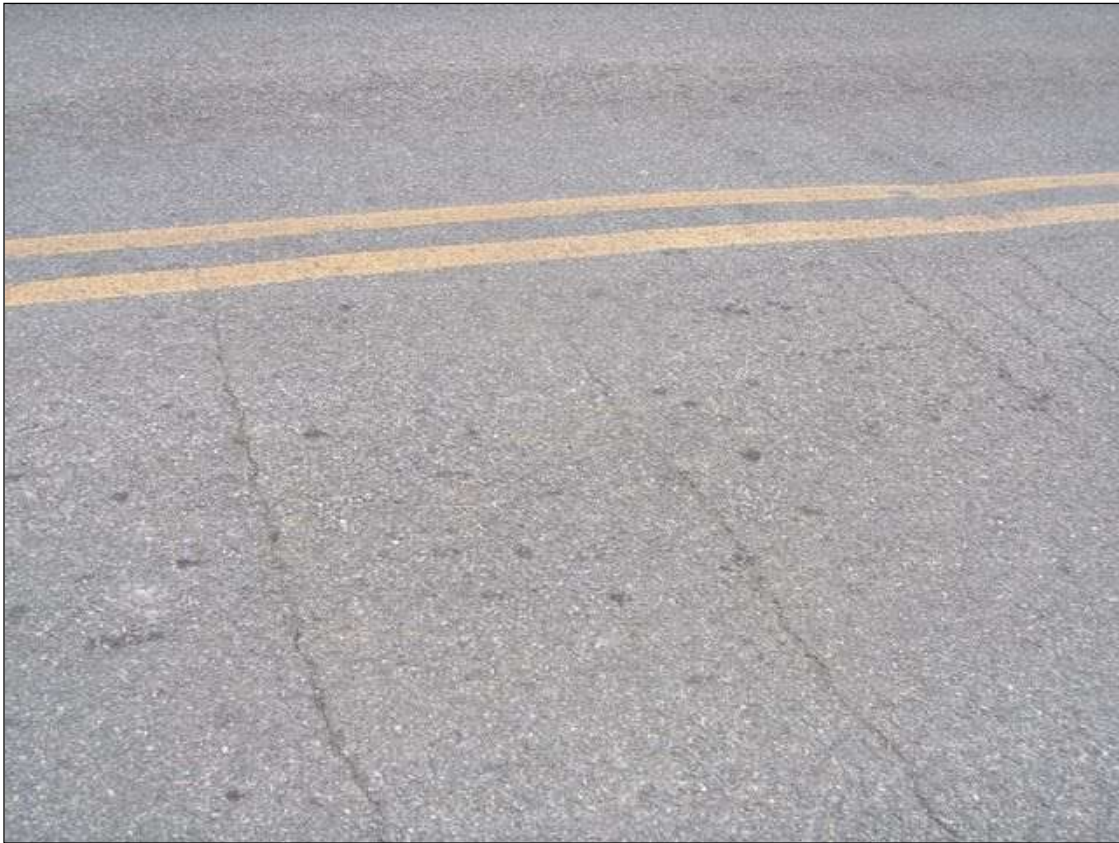
| Bridge I&A Form 1(82)H<br>State of North Carolina<br>Dept. of Transportation<br>Division of Highways | | <h1>FIELD INSPECTION REPORT</h1> <p><u>Bridge Inspeccion &amp; Analysis</u></p> | |
|---|---|---|--|
| 1 | G | TRANSVERSE CRACKS THROUGHOUT THE DECK ASPHALT WEARING SURFACE [SEE PHOTO]. | |

TRANSVERSE CRACKS THROUGHOUT THE DECK ASPHALT WEARING SURFACE

| MMS Code | Description of Function | Unit | Quantity | Remarks | Est. Cost |
|---|---|---|---|---|---|
| 2816 | Asphalt Surface Repair or Replacement | SY | 65 | TRANSVERSE CRACKS THROUGHOUT THE DECK ASPHALT WEARING SURFACE. | |

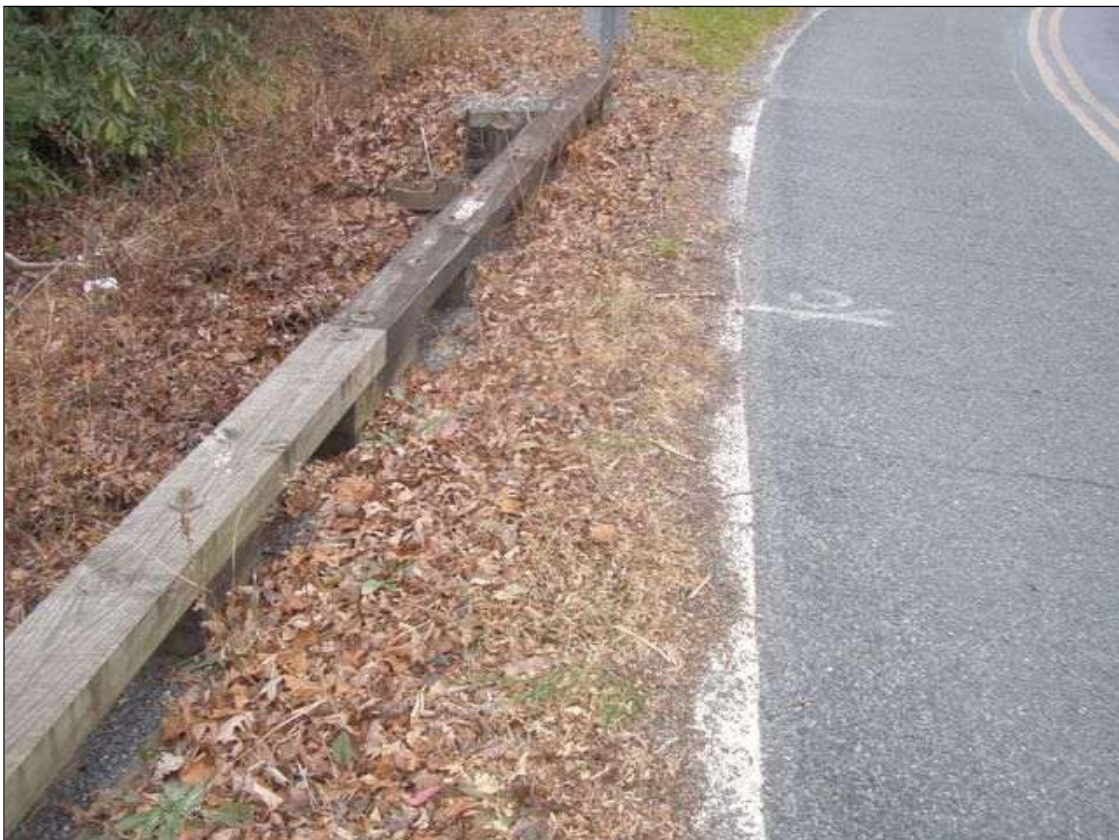
| Bridge I&A Form 1(82)H<br>State of North Carolina<br>Dept. of Transportation<br>Division of Highways | | <h1>FIELD INSPECTION REPORT</h1> <p><u>Bridge Inspeccion &amp; Analysis</u></p> | |
|---|---|---|--|
| 7 | F | VEGETATION DEBRIS ALONG BOTH BRIDGE RAILS [SEE PHOTO]. | |
| 16 | F | THERE IS DEBRIS ALONG BOTH BRIDGE RAILS [SEE PHOTO]. | |

VEGETATION DEBRIS ALONG THE NORTH BRIDGE RAIL (SOUTH SIMILAR)

| MMS Code | Description of Function | Unit | Quantity | Remarks | Est. Cost |
|---|---|---|---|---|---|
| 3366 | Drift and Debris Removal | HR | 8 | VEGETATION DEBRIS ALONG BOTH BRIDGE RAILS. | |

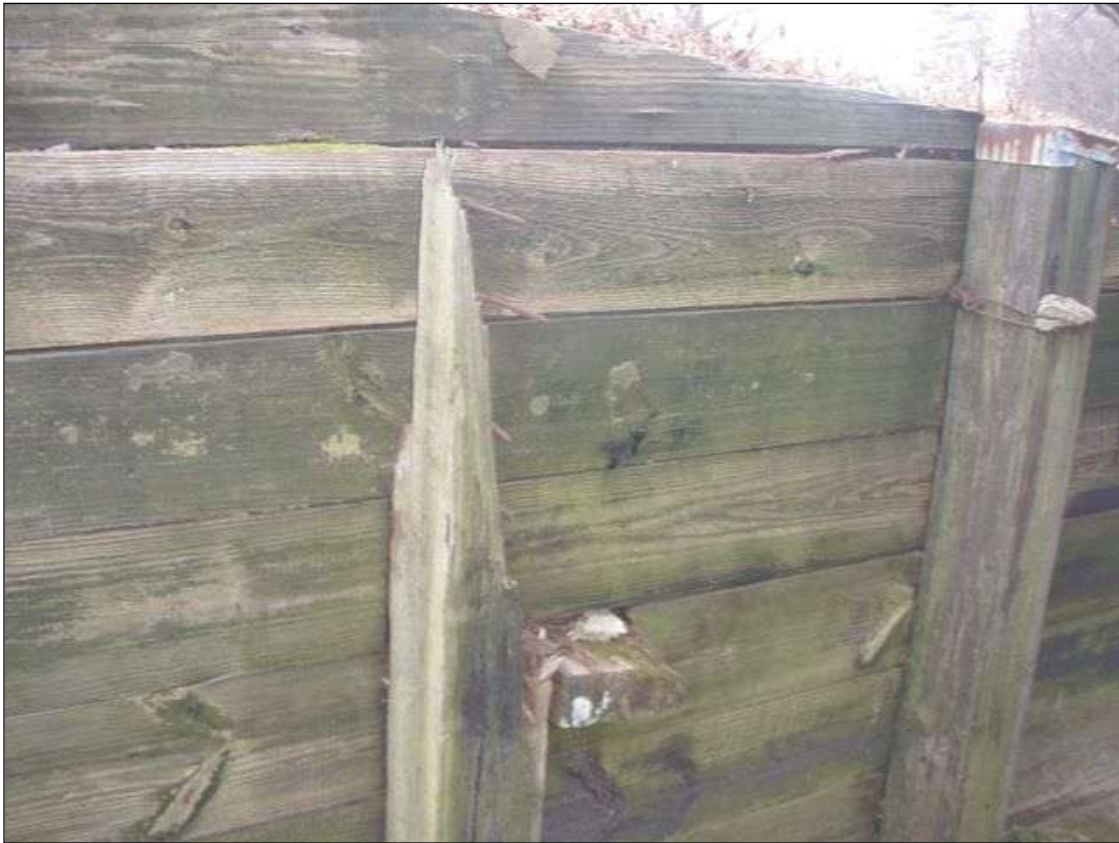
2'-2" HIGH X 6" WIDE X 6" DEEP FRACTURED SOLDIER PILE AT NORTHWEST WINGWALL

| MMS Code | Description of Function | Unit | Quantity | Remarks | Est. Cost |
|---|---|---|---|---|---|
| 3344 | Repair / Replace Timber Substructure Components | LF | 9 | 2'-2" HIGH X 6" WIDE X 6" DEEP FRACTURED SOLDIER PILE AT NORTHWEST WINGWALL. 4'-0" HIGH X 6" DEEP X 4" WIDE FRACTURED NORTH SOLDIER PILE AT ABUTMENT 1. 8" DIAMETER X 2" DEEP DECAYED AREA AT THE NORTH END OF ABUTMENT 1 CAP. 5" WIDE X 4" HIGH X 8" DEEP DECAYED AREA AT THE SOUTH END OF ABUTMENT 1 CAP AND AT NORTH END OF ABUTMENT 2. | |

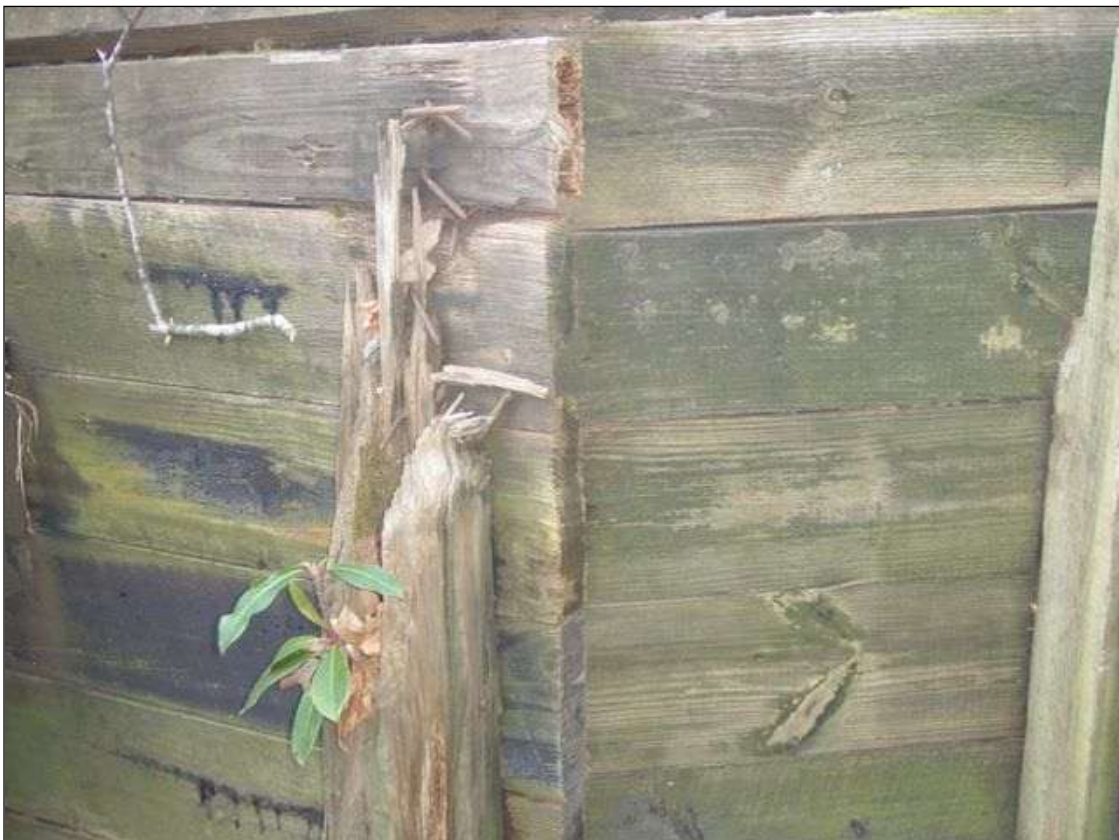
| Bridge I&A Form 1(82)H<br>State of North Carolina<br>Dept. of Transportation<br>Division of Highways | | <h1>FIELD INSPECTION REPORT</h1> <p><u>Bridge Inspeccion &amp; Analysis</u></p> | |
|---|---|---|--|
| 35b | F | THE NORTH SOLDIER PILE AT ABUTMENT 1 HAS A 4'-0" HIGH X 6" DEEP X 4" WIDE FRACTURED [SEE PHOTO]. THERE IS SURFACE DECAY AT PILE 9 OF ABUTMENT 2 AND A TEMPORARY REPAIR ADJACENT TO THE PILE [SEE PHOTO]. THE SOLDIER PILE OF THE NORTHWEST WINGWALL HAS A 2'-2" HIGH X 6" WIDE X 6" DEEP FRACTURED [SEE PHOTO]. THE SOLDIER PILE AT THE NORTHEAST WINGWALL IS MISSING [SEE PHOTO]. THE SOUTH SOLDIER PILE AT ABUTMENT 2 HAS ROTATED UP TO 5" AT THE TOP [SEE PHOTO]. | |

4'-0" HIGH X 6" DEEP X 4" WIDE FRACTURED NORTH SOLDIER PILE AT ABUTMENT 1

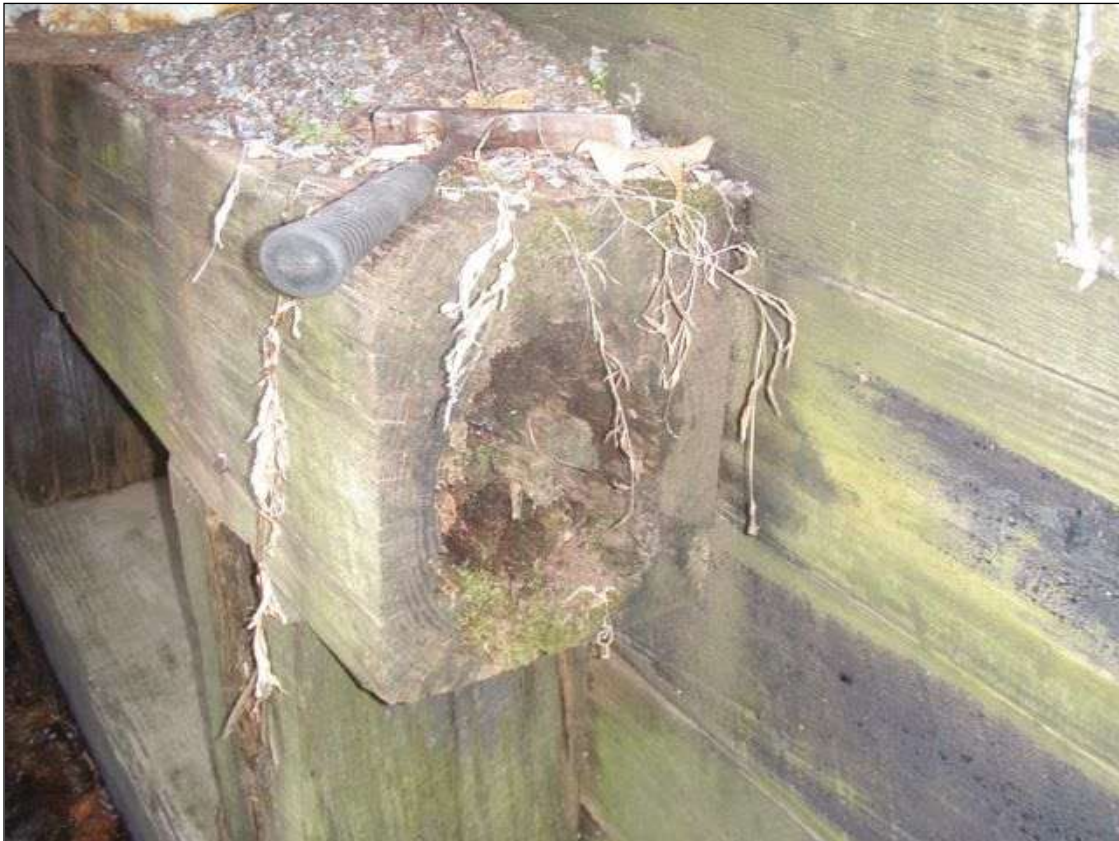
| Bridge I&A Form 1(82)H<br>State of North Carolina<br>Dept. of Transportation<br>Division of Highways | | <h1>FIELD INSPECTION REPORT</h1> <p><u>Bridge Inspeccion &amp; Analysis</u></p> | |
|---|---|---|--|
| 35a | F | THE NORTH END OF ABUTMENT 1 CAP HAS AN 8" DIAMETER X 2" DEEP DECAYED AREA [SEE PHOTO]. THE SOUTH END OF ABUTMENT 1 CAP AND THE NORTH END OF ABUTMENT 2 CAP HAVE A 5" WIDE X 4" HIGH X 8" DEEP DECAYED AREA [SEE PHOTO]. THERE IS A CUT OUT AREA IN ABUTMENT 1 CAP THAT HAS SURFACE DECAYED AROUND THE PERIMETER OF THE HOLE [SEE PHOTO]. | |

8" DIAMETER X 2" DEEP DECAYED AREA AT THE NORTH END OF ABUTMENT 1 CAP

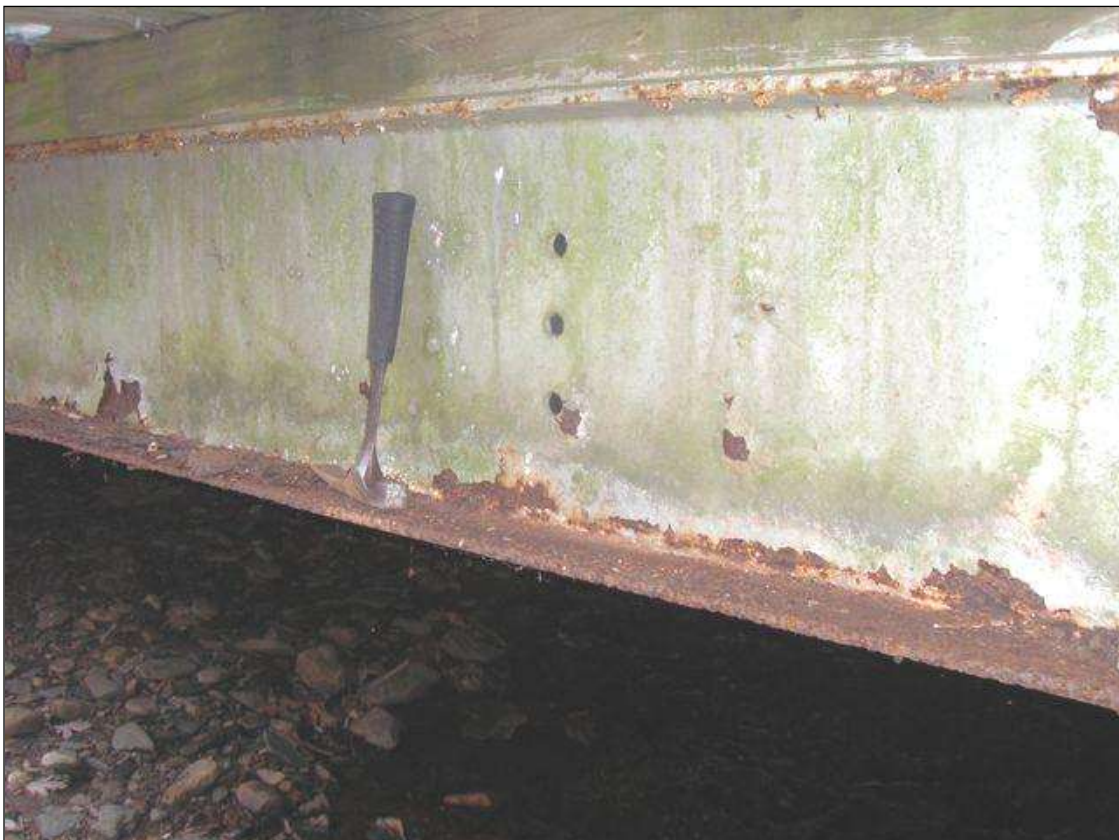
| Bridge I&A Form 1(82)H<br>State of North Carolina<br>Dept. of Transportation<br>Division of Highways | | <h1>FIELD INSPECTION REPORT</h1> <p><u>Bridge Inspeccion &amp; Analysis</u></p> | |
|---|---|---|--|
| 10 | F | DELAMINATED STEEL ALONG THE BOTTOM FLANGE OF ALL BEAMS WITHOUT WITH SECTION LOSS NOTED UP TO 1/16" AT BEAM ENDS [SEE PHOTO]. | |
| 52 | F | THERE IS PAINT LOSS ALONG THE BOTTOM FLANGE OF ALL BEAMS [SEE PHOTO]. | |

DELAMINATED STEEL IN BOTTOM FLANGE OF ALL BEAMS WITH UP TO 1/16" SECTION LOSS AT BEAM ENDS

| MMS Code | Description of Function | Unit | Quantity | Remarks | Est. Cost |
|---|---|---|---|---|---|
| 5603 | Partial Cleaning and Painting of Structural Steel | SF | 400 | DELAMINATED STEEL ALONG BOTTOM FLANGE OF ALL BEAMS WITH UP TO 1/16" SECTION LOSS AT BEAM ENDS. | |

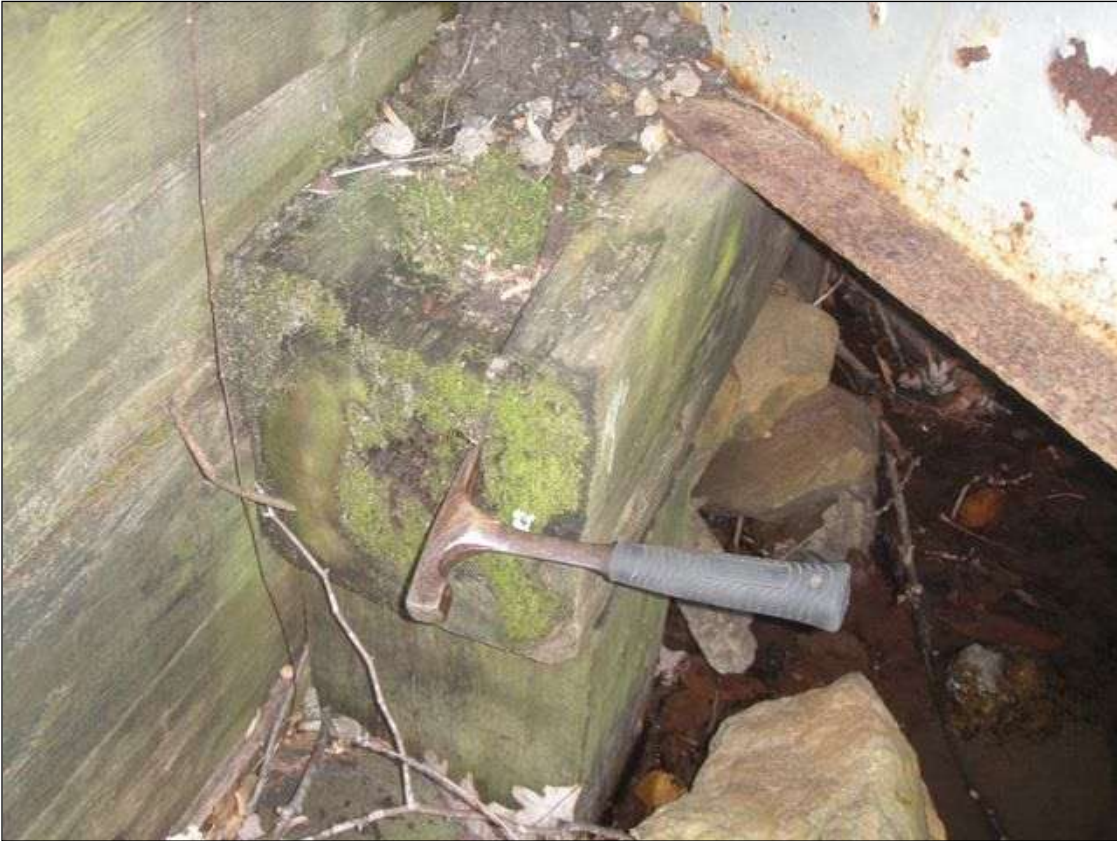
5" WIDE X 4" HIGH X 8" DEEP DECAYED AREA AT THE SOUTH END OF ABUTMENT 1 CAP (NORTH END OF ABUTMENT 2 SIMILAR)

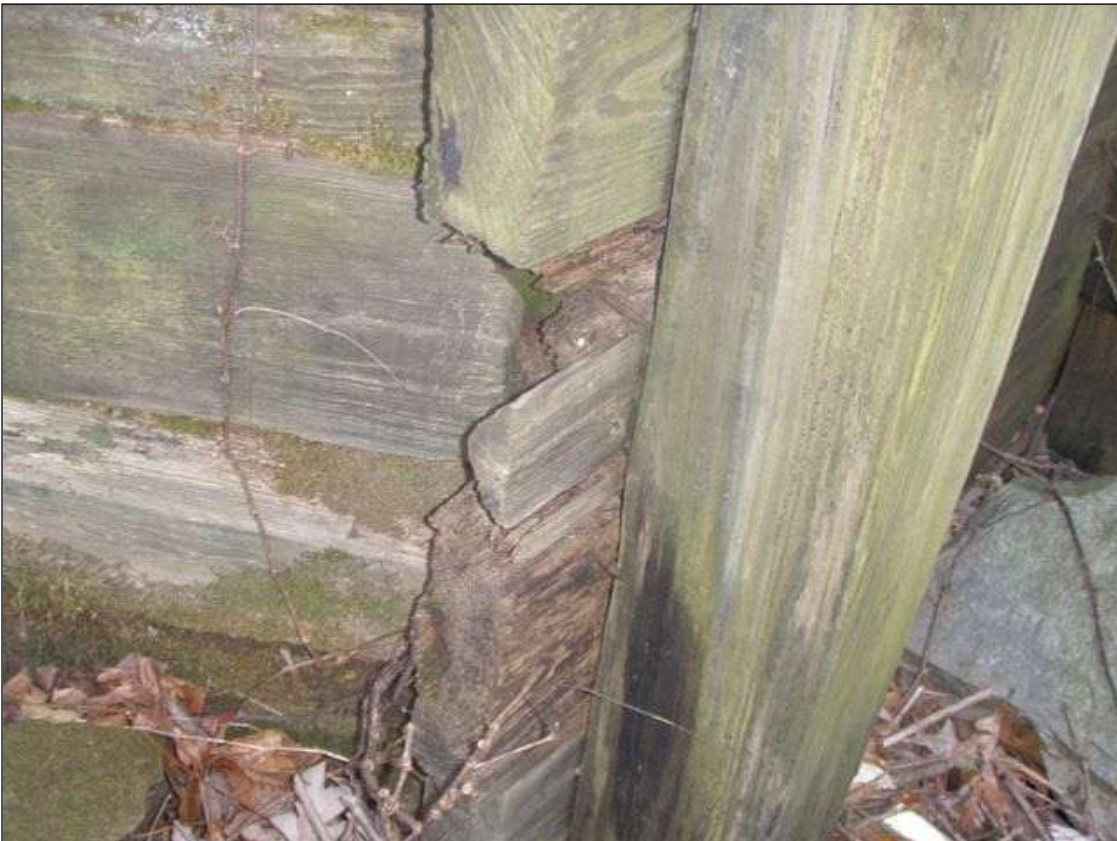
| Bridge I&A Form 1(82)H<br>State of North Carolina<br>Dept. of Transportation<br>Division of Highways | | <h1>FIELD INSPECTION REPORT</h1> <p><u>Bridge Inspeccion &amp; Analysis</u></p> | |
|---|---|---|--|
| 35c | F | THE SOUTH END OF ABUTMENT 1 BULKHEAD HAS A 9" HIGH X 5" WIDE X 3" DEEP DECAYED AREA [SEE PHOTO]. THE SOUTH END OF ABUTMENT 2 BULKHEAD HAS 4'-0" LONG X 4" HIGH X 3" DEEP DECAYED AREA [SEE PHOTO]. THE SOUTH END OF THE ABUTMENT 2 BACKWALL HAS AN UNDERMINED AREA UP TO 2'-6" LONG X 12" DEEP X 5" HIGH. THERE IS STONE BEHIND THE BACKWALL AND NO LOSS OF FILL IS NOTED [SEE PHOTOS]. THE SOUTHEAST MASONRY WINGWALL HAS AN UNDERMINED AREA UP TO 2'-6" LONG X 8" HIGH X 2'-4" DEEP WITH NO LOSS OF FILL NOTED [SEE PHOTO]. | |

9" HIGH X 5" WIDE X 3" DEEP DECAYED AREA AT SOUTH END OF ABUTMENT 1 BULKHEAD

| MMS Code | Description of Function | Unit | Quantity | Remarks | Est. Cost |
|---|---|---|---|---|---|
| 3346 | Repair / Maintain Timber Wings & Blkhds | SF | 3 | 9" HIGH X 5" WIDE X 3" DEEP DECAYED AREA AT SOUTH END OF ABUTMENT 1 BULKHEAD. 4'-0" LONG X 4" HIGH X 3" DEEP DECAYED AREA AT THE SOUTH END OF ABUTMENT 2 BULKHEAD. | |

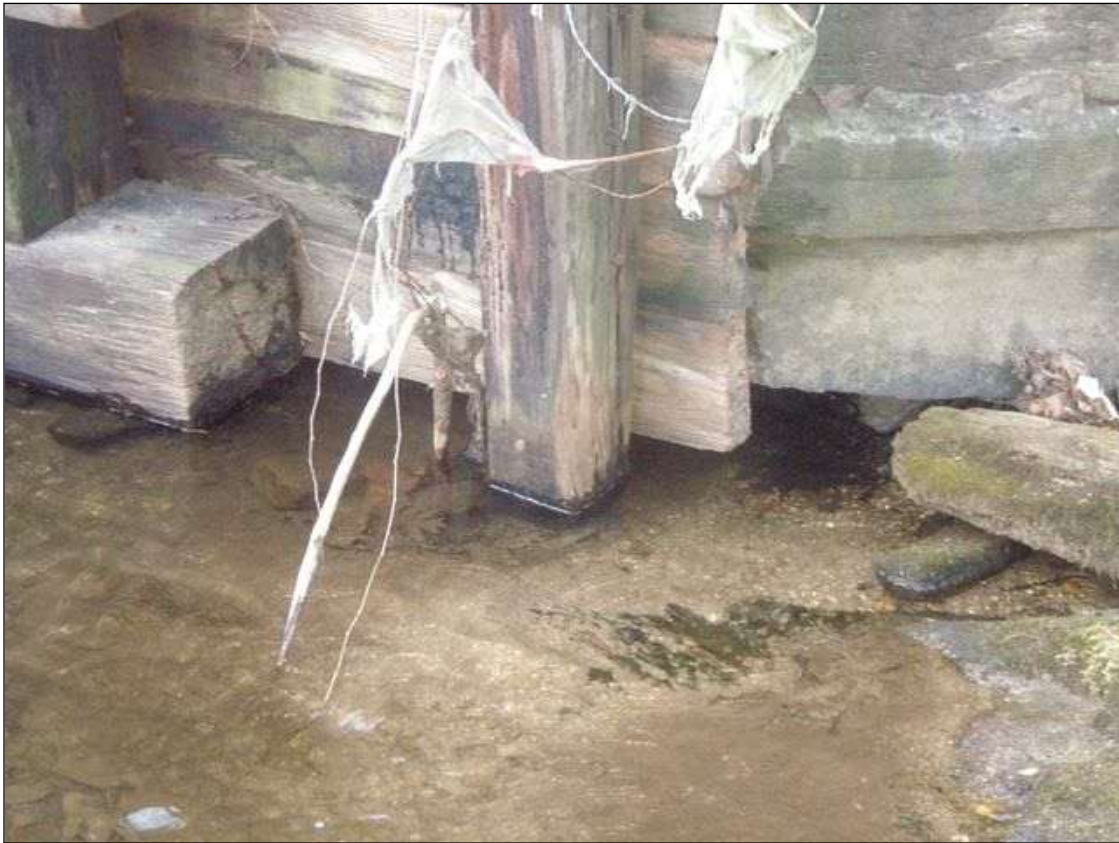
| 45b | F | THE CHANNEL FLOWS INTO THE SOUTHEAST WINGWALL AND AND ALONG ABUTMENT 1. | |

UNDERMINED AREA BELOW THE SOUTHEAST WINGWALL

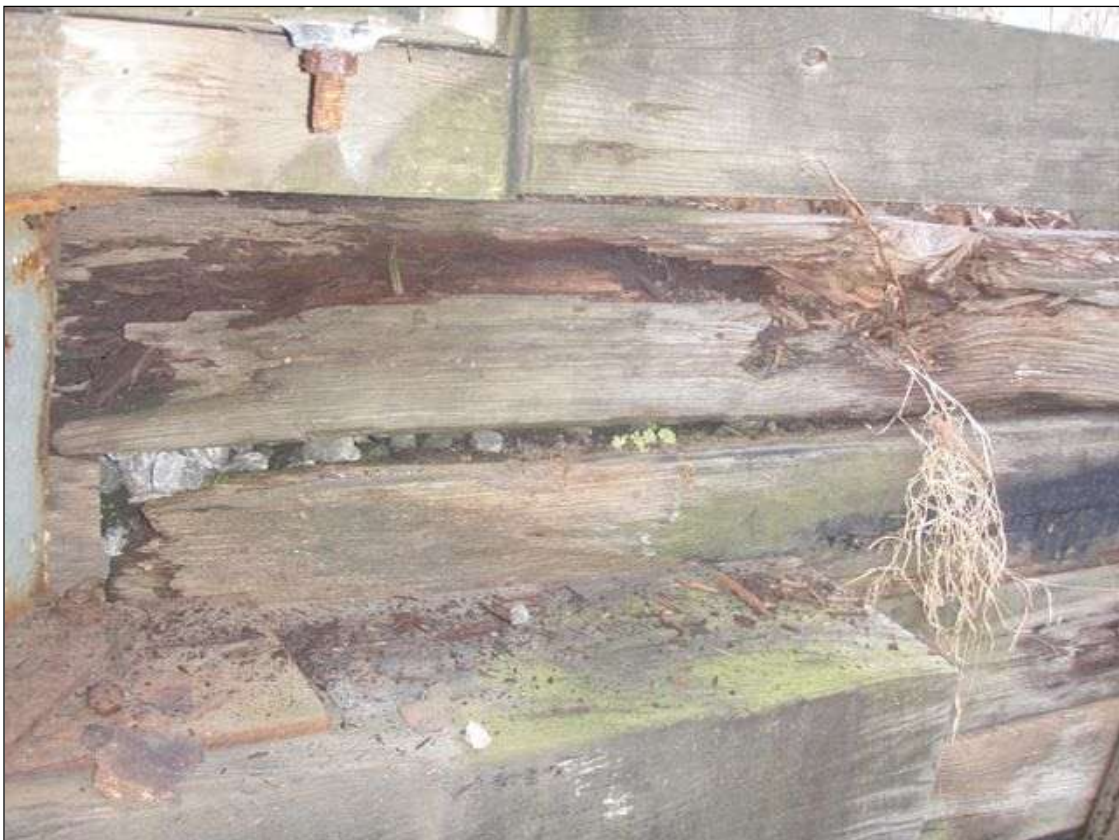
4'-0" LONG X 4" HIGH X 3" DEEP DECAYED AREA AT THE SOUTH END OF ABUTMENT 2 BULKHEAD

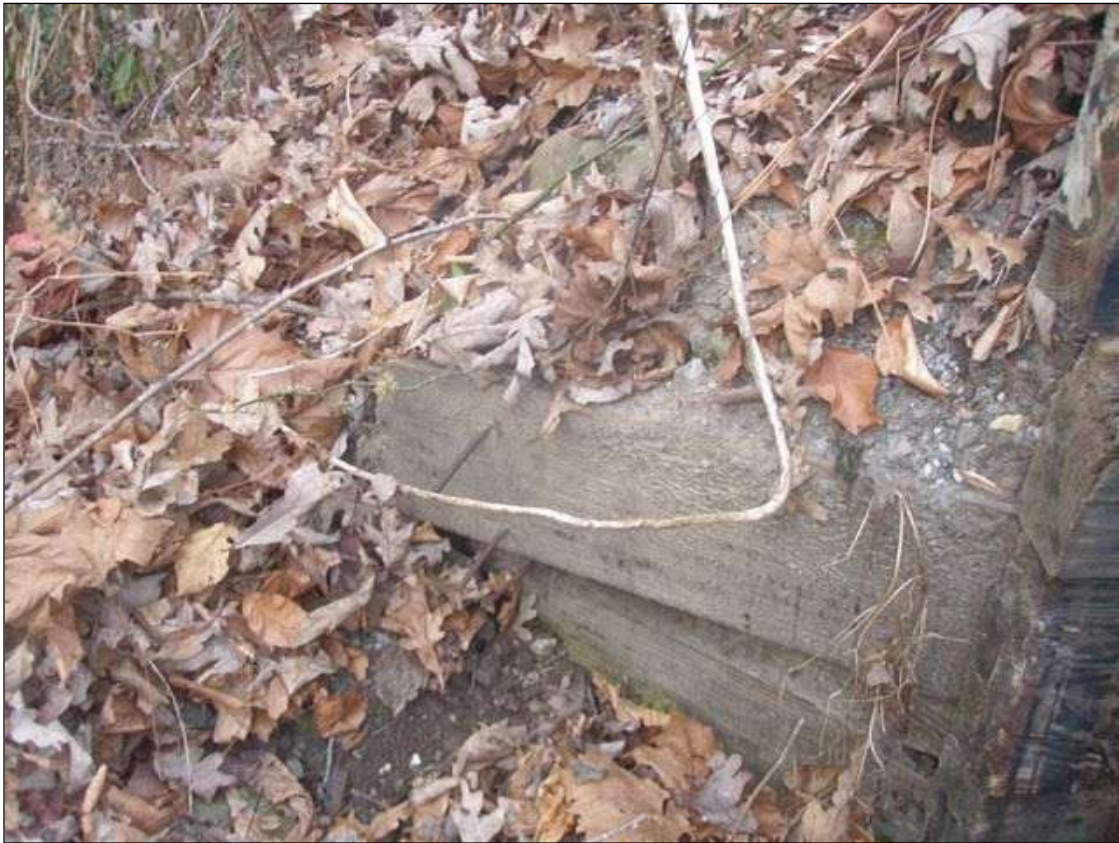
MISSING SOLDIER PILE AT THE NORTHEAST WINGWALL

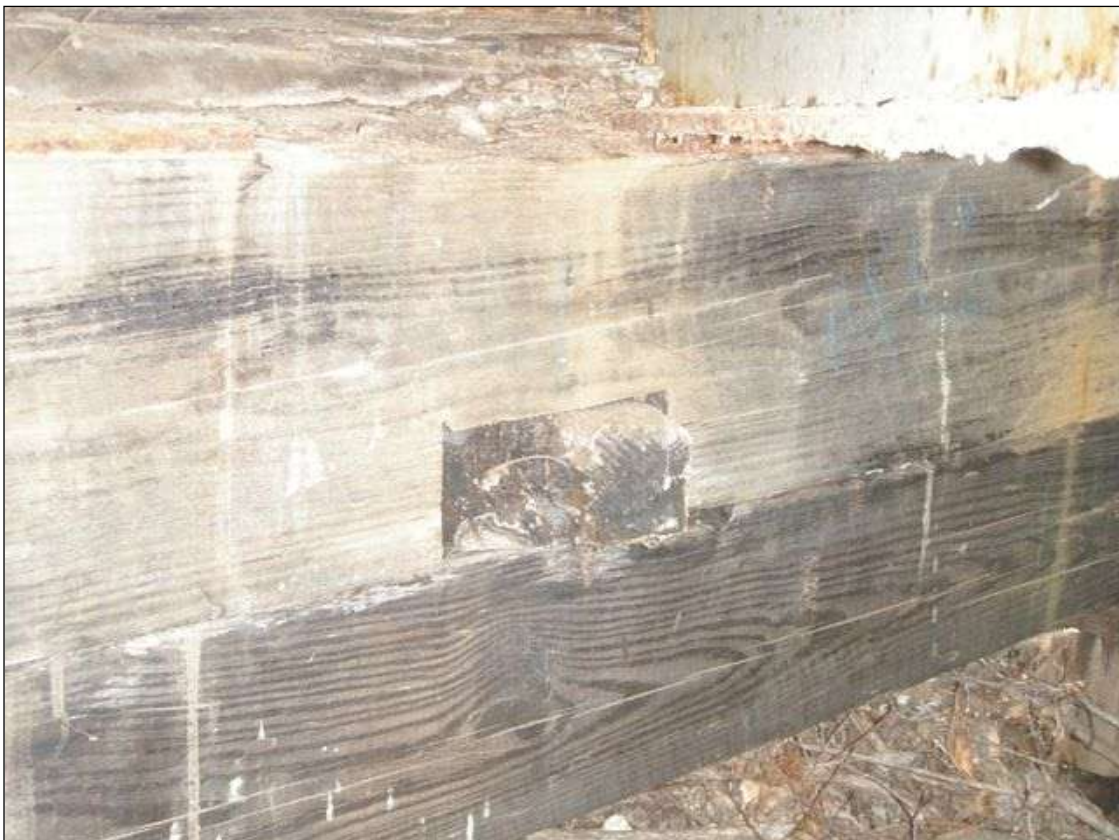
DECAYED AREA AROUND THE PERIMETER OF A CUT OUT AREA IN ABUTMENT 1 CAP

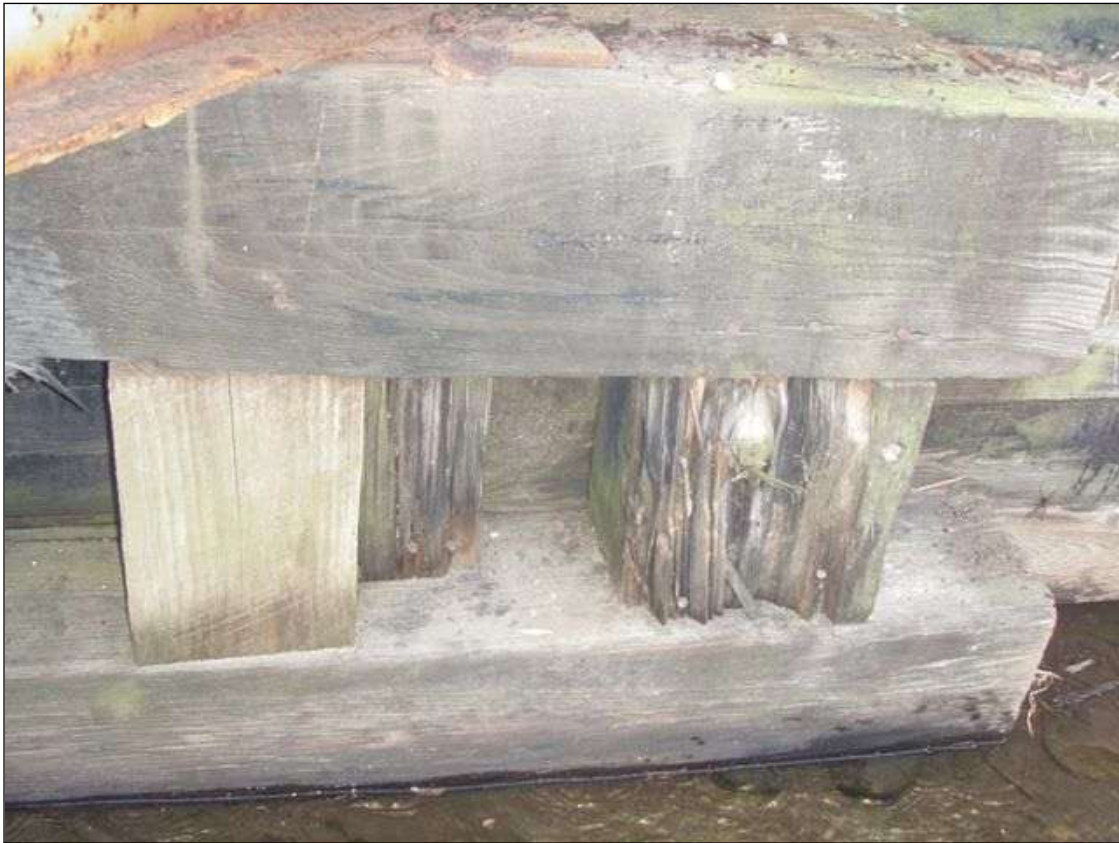
SURFACE DECAY IN PILE 9 WITH A TEMPORARY REPAIR AT ABUTMENT 2

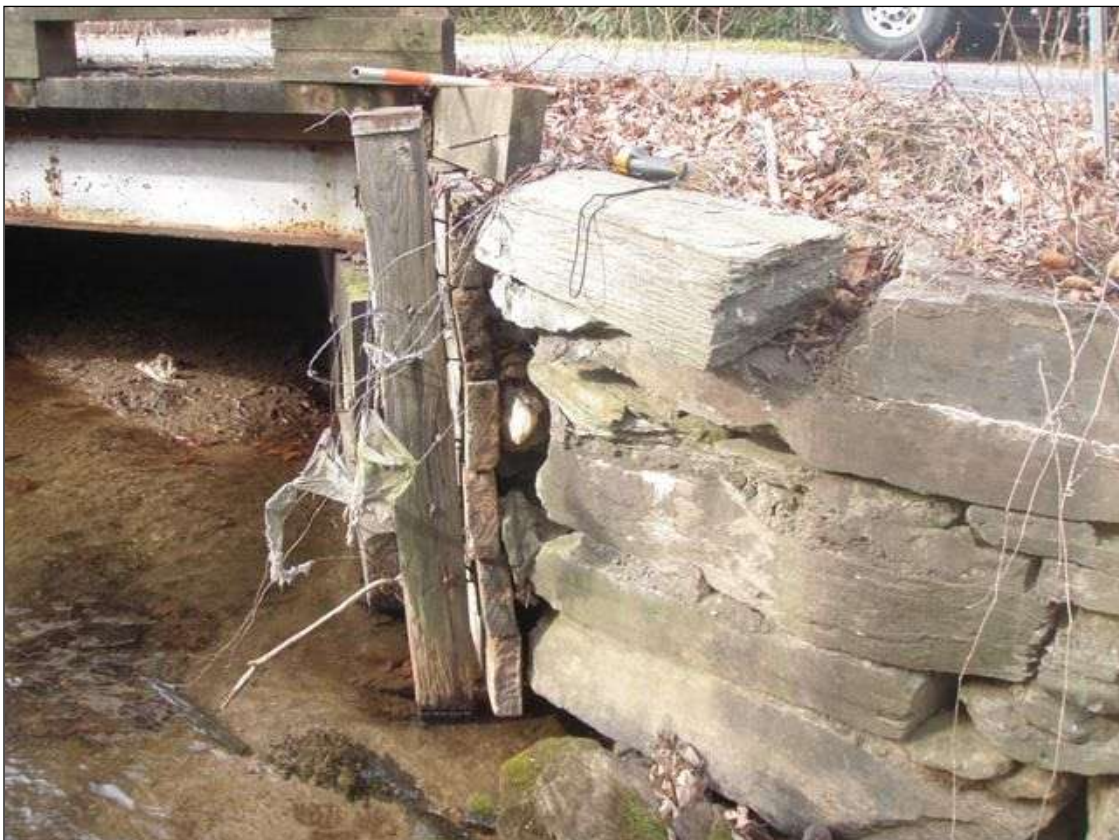
THE SOUTH SOLDIER PILE AT ABUTMENT 2 HAS ROTATED UP TO 5" AT THE TOP

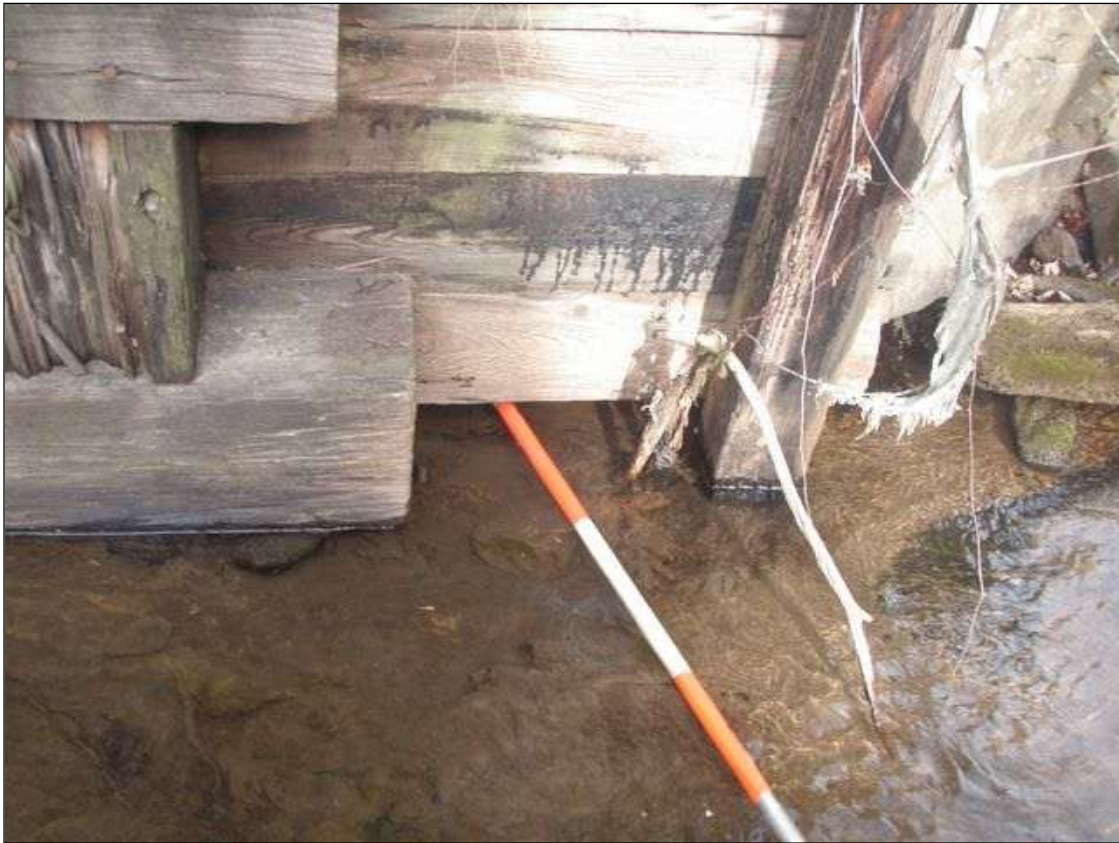
| 45c | F | THE SOUTH END OF THE ABUTMENT 2 BACKWALL HAS AN UNDERMINED AREA UP TO 2'-6" LONG X 12" DEEP X 5" HIGH. THERE IS STONE BEHIND THE BACKWALL AND NO LOSS OF FILL IS NOTED [SEE PHOTOS]. THE SOUTHEAST MASONRY WINGWALL HAS AN UNDERMINED AREA UP TO 2'-6" LONG X 8" HIGH X 2'-4" DEEP WITH NO LOSS OF FILL NOTED [SEE PHOTO]. | |

2'-6" LONG X 12" DEEP X 5" HIGH AREA OF UNDERMINING AT THE SOUTH END OF THE ABUTMENT 2 BACKWALL

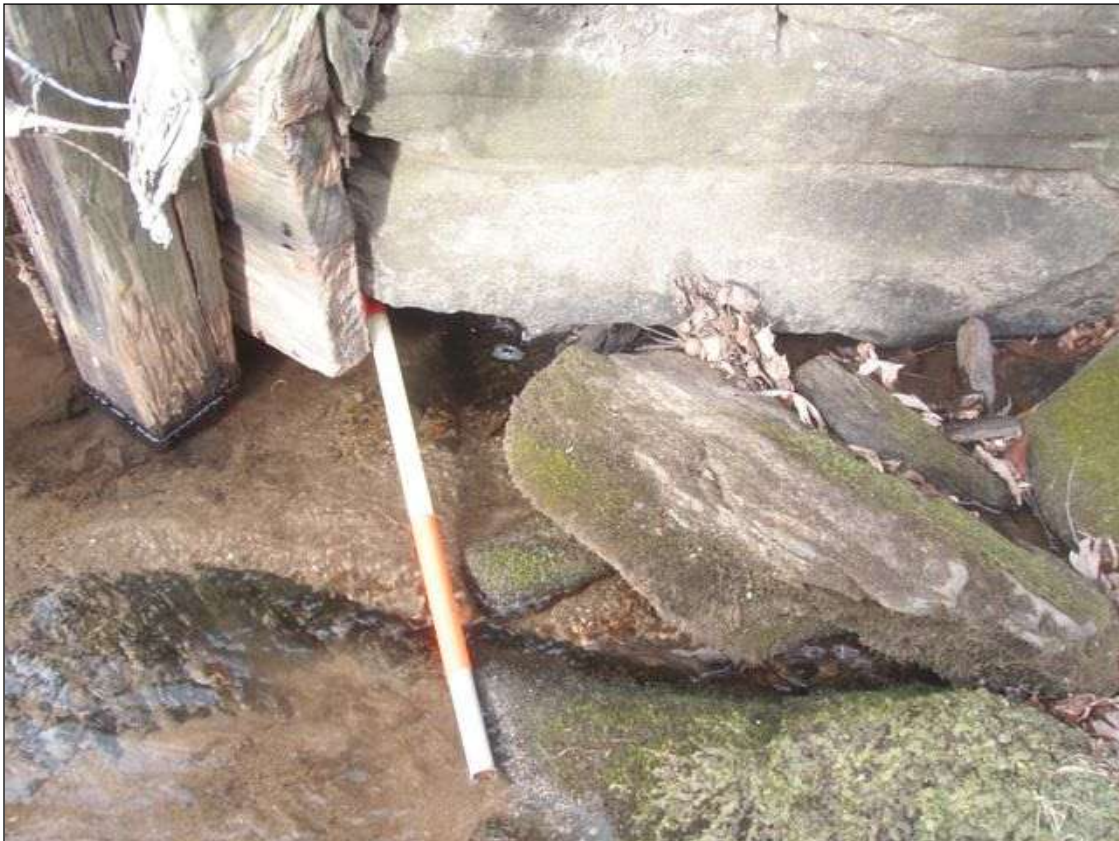
| Bridge I&A Form 1(82)H<br>State of North Carolina<br>Dept. of Transportation<br>Division of Highways | | <h1>FIELD INSPECTION REPORT</h1> <p><u>Bridge Inspeccion &amp; Analysis</u></p> | |
|---|---|---|--|
| 36d | F | 2'-6" LONG X 8" HIGH X 2'-4" DEEP AREA OF UNDERMINING ALONG THE SOUTHEAST MASONRY WINGWALL [SEE PHOTO]. | |

2'-6" LONG X 8" HIGH X 2'-4" DEEP AREA OF UNDERMINING ALONG THE SOUTHEAST MASONRY WINGWALL

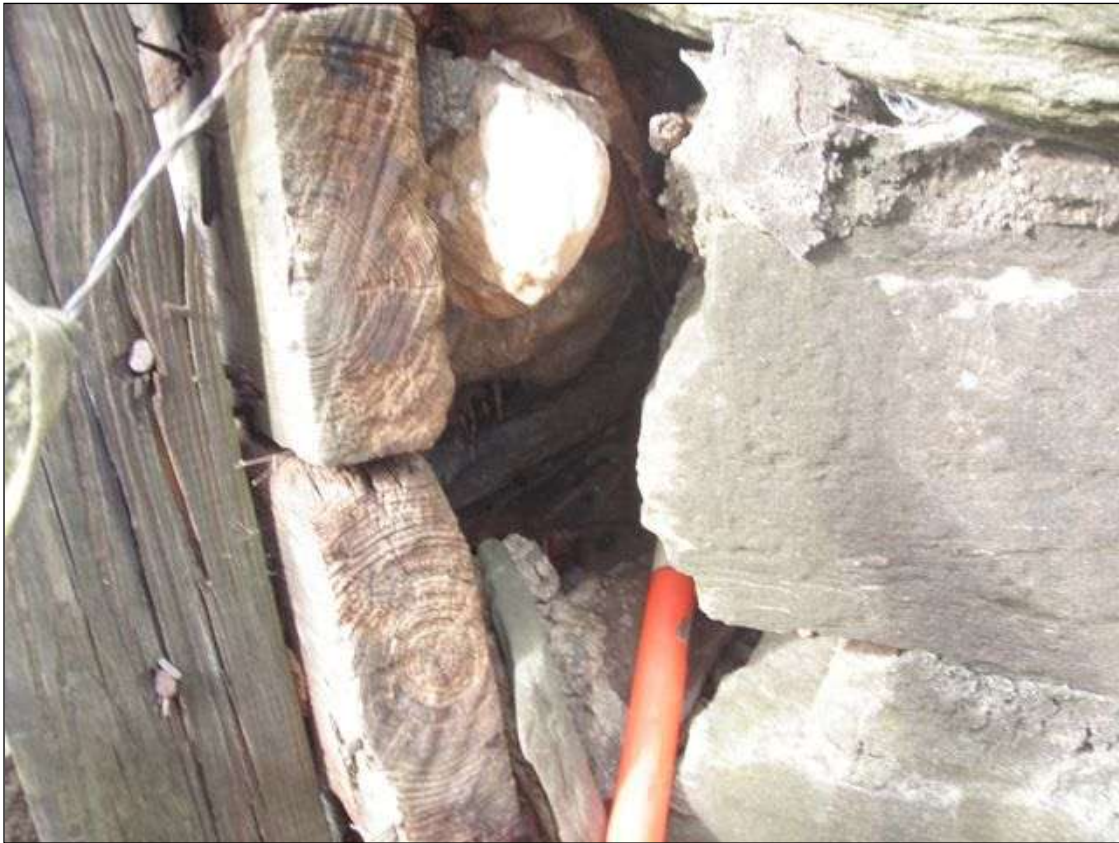
STONE FILL BEHIND THE SOUTH END OF THE ABUTMENT 2 BULKHEAD
