NC DEPARTMENT OF TRANSPORTATION  
DIVISION OF HIGHWAYS  
STRUCTURE MANAGEMENT UNIT

## Structure Safety Report

### Routine Element Inspection

COUNTY: WILKES STRUCTURE NUMBER: 960317 FREQUENCY: 24 MONTHS

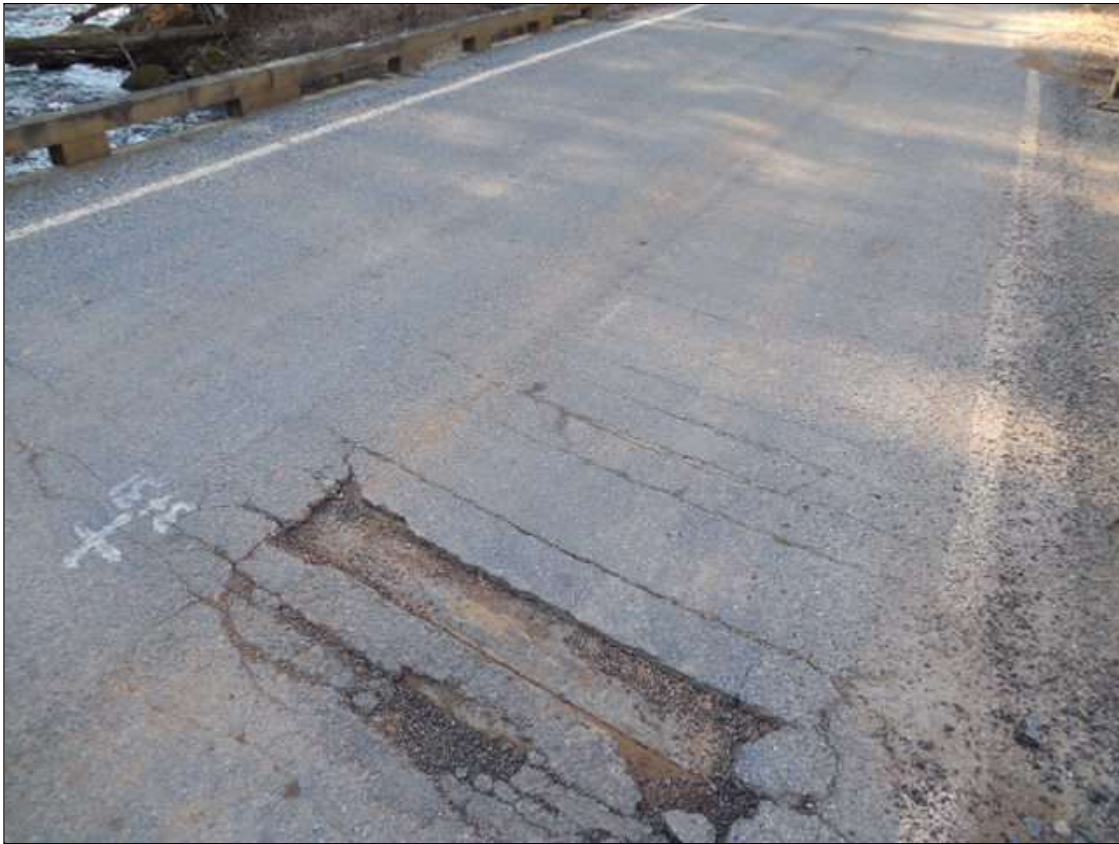
15 Square Feet of Delamination/Spall/Patched Area/Pothole (Wearing Surfaces): Spall 1 in. deep or greater or 6 in. diameter or greater. Patched area that is unsound or showing distress. Full depth pothole. POTHOLE ON DECK 7' X 2' DECK BOARDS EXPOSED AT ABUTMENT B

Span 1 Wearing Surface: 15 Square Feet of Delamination/Spall/Patched Area/Pothole (Wearing Surfaces): Spall 1 in. deep or greater or 6 in. diameter or greater. Patched area that is unsound or showing distress. Full depth pothole.  
POTHOLE ON DECK 7' X 2' DECK BOARDS EXPOSED AT ABUTMENT B

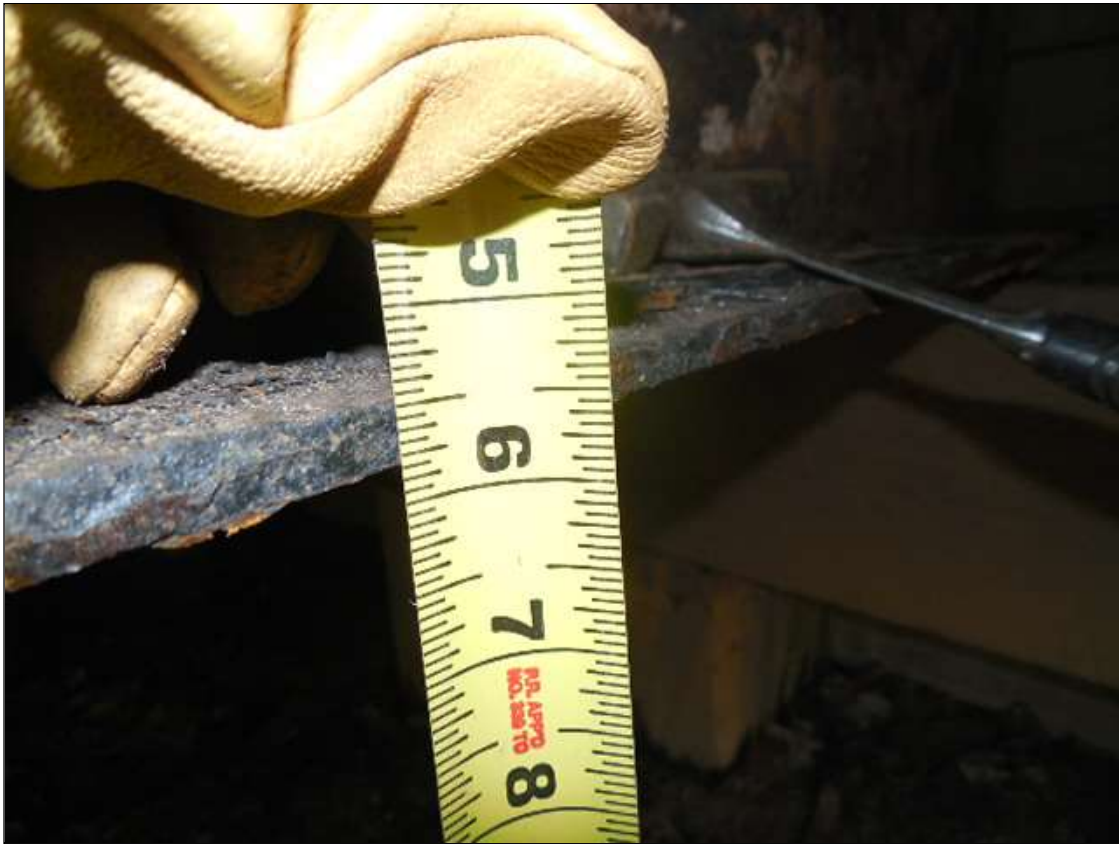
27 Feet of Corrosion: Section loss is evident or pack rust is present but does not warrant structural review. FROM ABUTMENT A EXTENDS 27' TOP AND BOTTOM FLANGE 1/4" REMAINING SECTION, BEAMS 2 AND 3 SIMILAR

Span 1 Beam 1: 27 Feet of Corrosion: Section loss is evident or pack rust is present but does not warrant structural review. FROM ABUTMENT A EXTENDS 27' TOP AND BOTTOM FLANGE 1/4" REMAINING SECTION, BEAMS 2 AND 3 SIMILAR

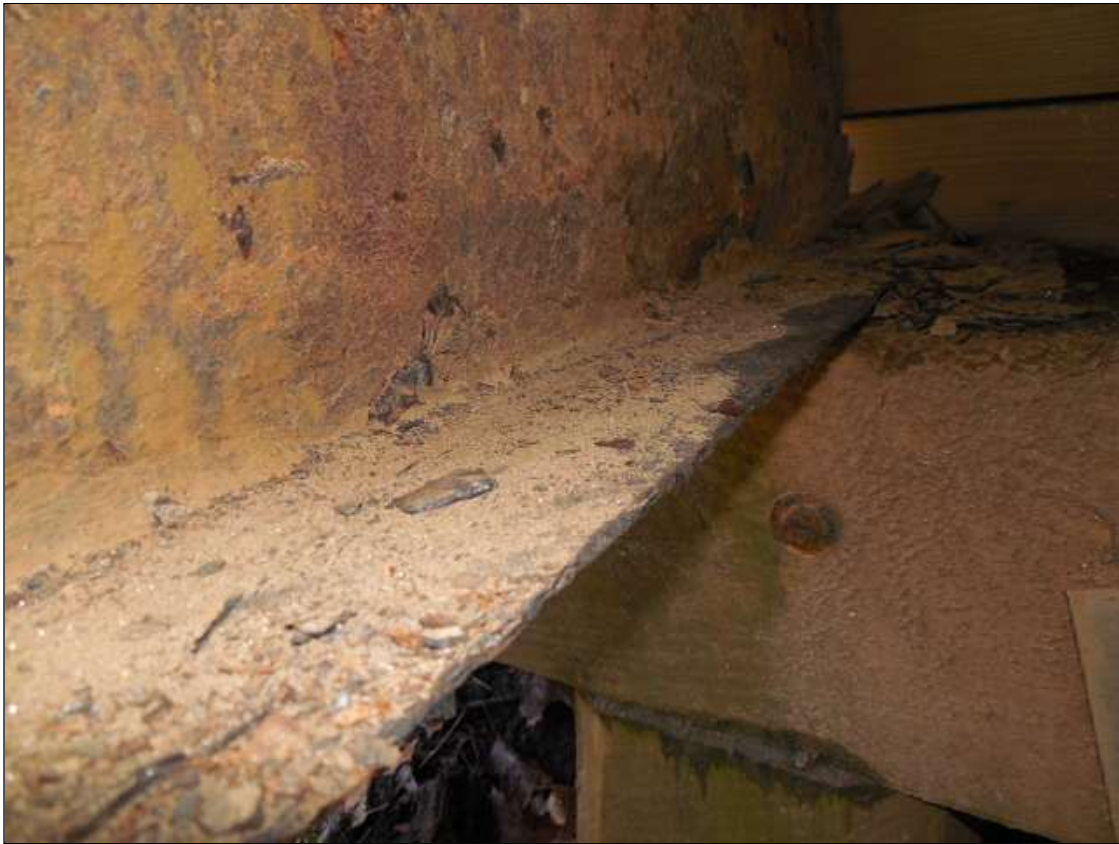
3 Feet of Corrosion: The condition warrants a structural review to determine the effect on strength or serviceability of the element or bridge; OR a structural review has been completed and the defects impact strength or serviceability of the element or bridge. BOTTOM RIGHT FLANGE FROM ABUTMENT B EXTENDING 3' KNIFE EDGE SECTION REMAINING

Span 1 Beam 1: 3 Feet of Corrosion: The condition warrants a structural review to determine the effect on strength or serviceability of the element or bridge; OR a structural review has been completed and the defects impact strength or serviceability of the element or bridge. BOTTOM RIGHT FLANGE FROM ABUTMENT B EXTENDING 3' KNIFE EDGE SECTION REMAINING

| MMS Code | Description of Function | Unit | Quantity | Remarks | Est. Cost |
|---|---|---|---|---|---|
| 3314 | Maintain Steel Superstructure Components | LF | 3 | BEAM 1 RT BOTTOM FLANGE KNIFE EDGE SECTION REMAINING, EXTENDS 3' FROM ABUTMENT B, END OF BEAM ALSO DISTORTED FROM FIRE DAMAGE | |

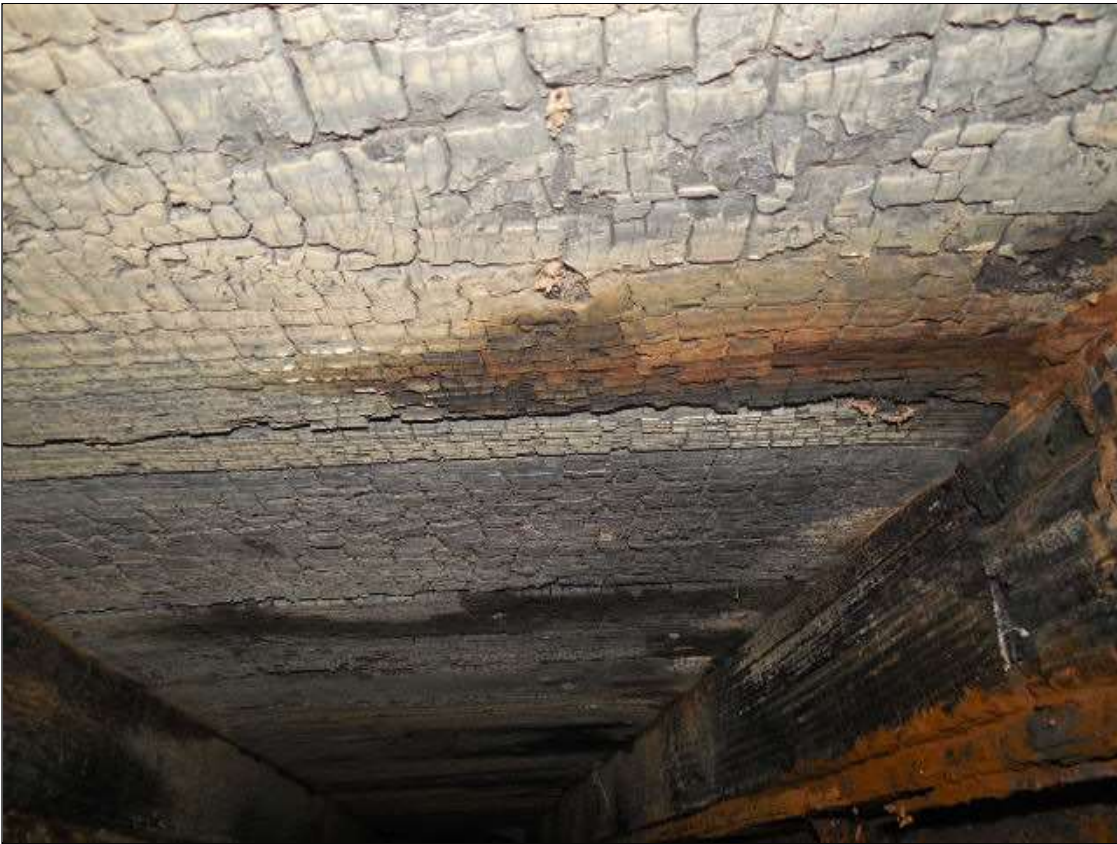
PMN ISSUED FOR SUPERSTRUCTURE, FIRE  
DAMAGE BEAMS 1,2,3. AND BOTTOM OF TIMBER  
DECK BAYS 1,2,3.

180 Square Feet of Decay/Section Loss: Affects 10% or more of the member but does not warrant structural review. FIRE DAMAGE BAY 1 AND 2 FULL LENGTH AND 15' OF BAY 3, 1/16" INCH SECTION LOSS TO BOTTOM OF DECK

Span 1 Deck: 180 Square Feet of Decay/Section Loss: Affects 10% or more of the member but does not warrant structural review. FIRE DAMAGE BAY 1 AND 2 FULL LENGTH AND 15' OF BAY 3, 1/16" INCH SECTION LOSS

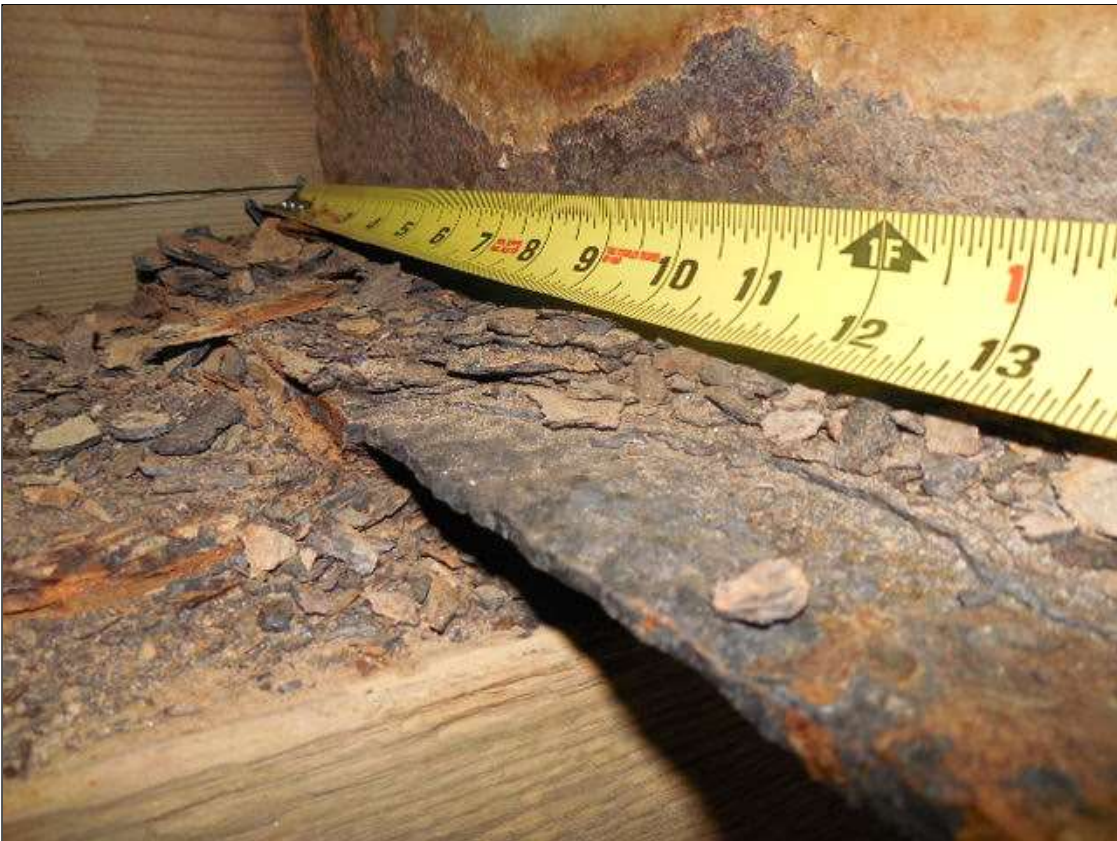
Span 1 Beam 7: 1 Feet of Corrosion: Section loss is evident or pack rust is present but does not warrant structural review. 1/8" REMAINING SECTION BOTTOM FLANGE FROM ABUTMENT A EXTENDS OUT 1'

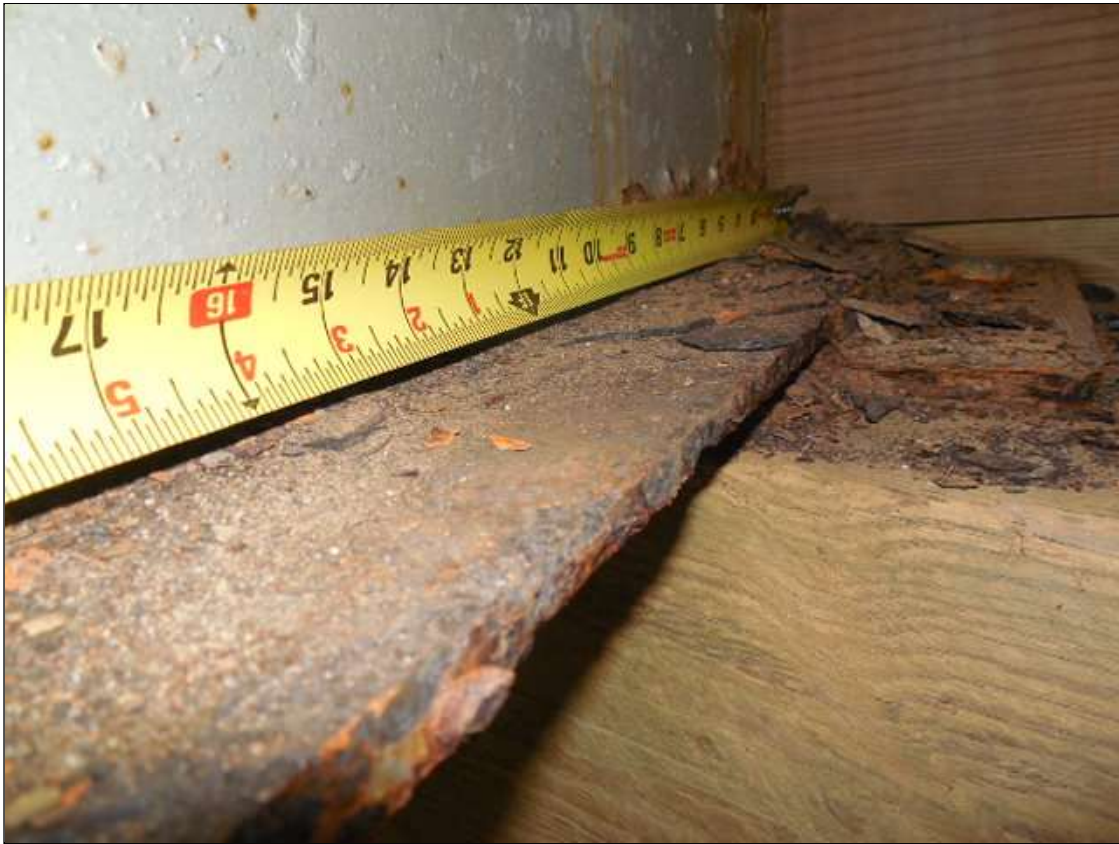
Span 1 Beam 8: 2 Feet of Corrosion: Section loss is evident or pack rust is present but does not warrant structural review. 3/8" REMAINING SECTION BOTTOM FLANGE EXTENDS FROM ABUTMENT A 2'

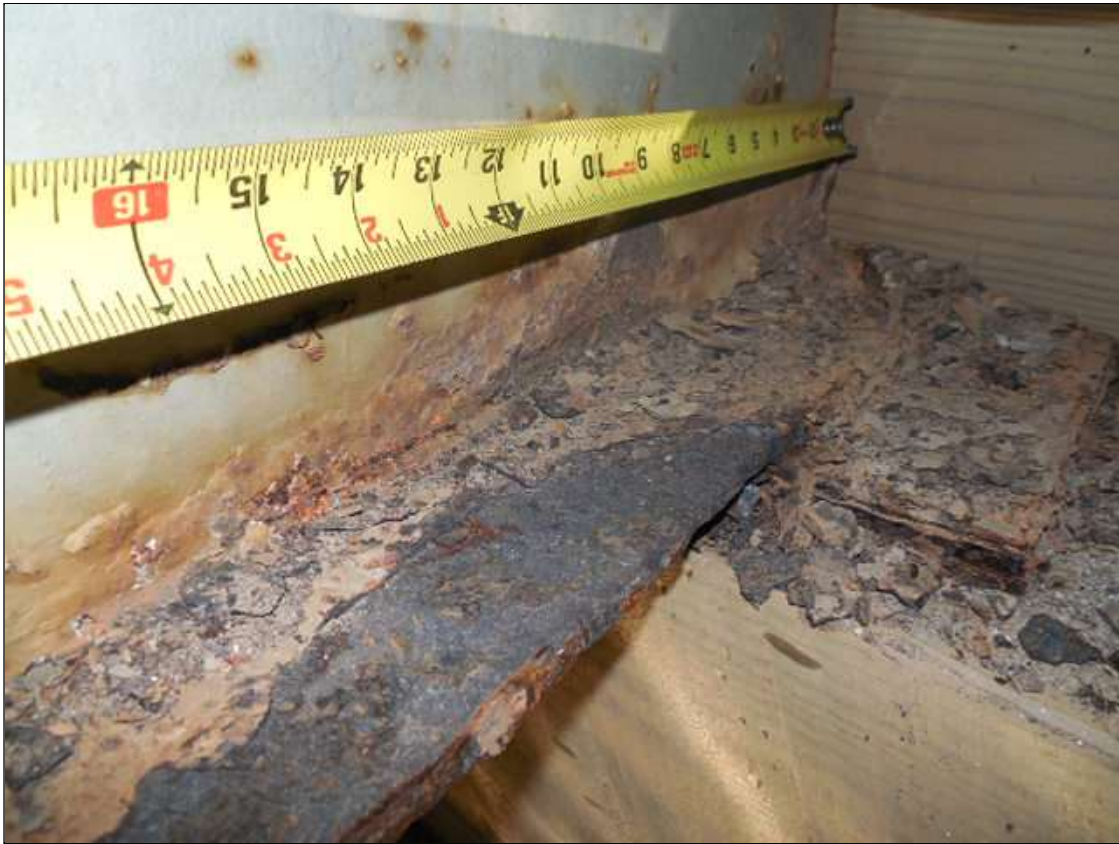
Span 1 Beam 7: 2 Feet of Corrosion: Section loss is evident or pack rust is present but does not warrant structural review. 1/8" SECTION REMAINING RT BOTTOM FLANGE, 3/8" REMAINING SECTION LT BOTTOM FLANGE, EXTENDS 2' FROM ABUTMENT B

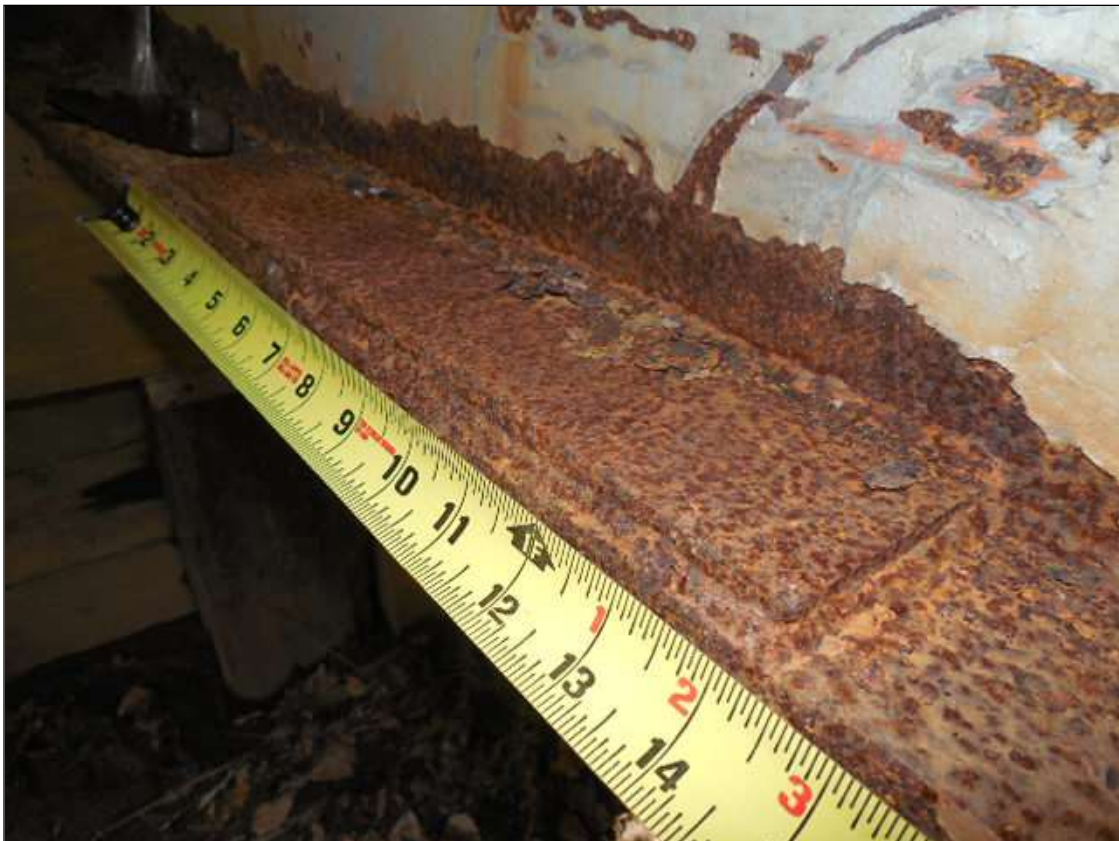
BEAM 9, BOTTOM FLANGE REMAINT RIGHT SIDE, BEGINS 31" FROM ABUTMENT A, REPAIR IS 14" L X 3" W X 3/8" THICK REPAIR IS GOOD

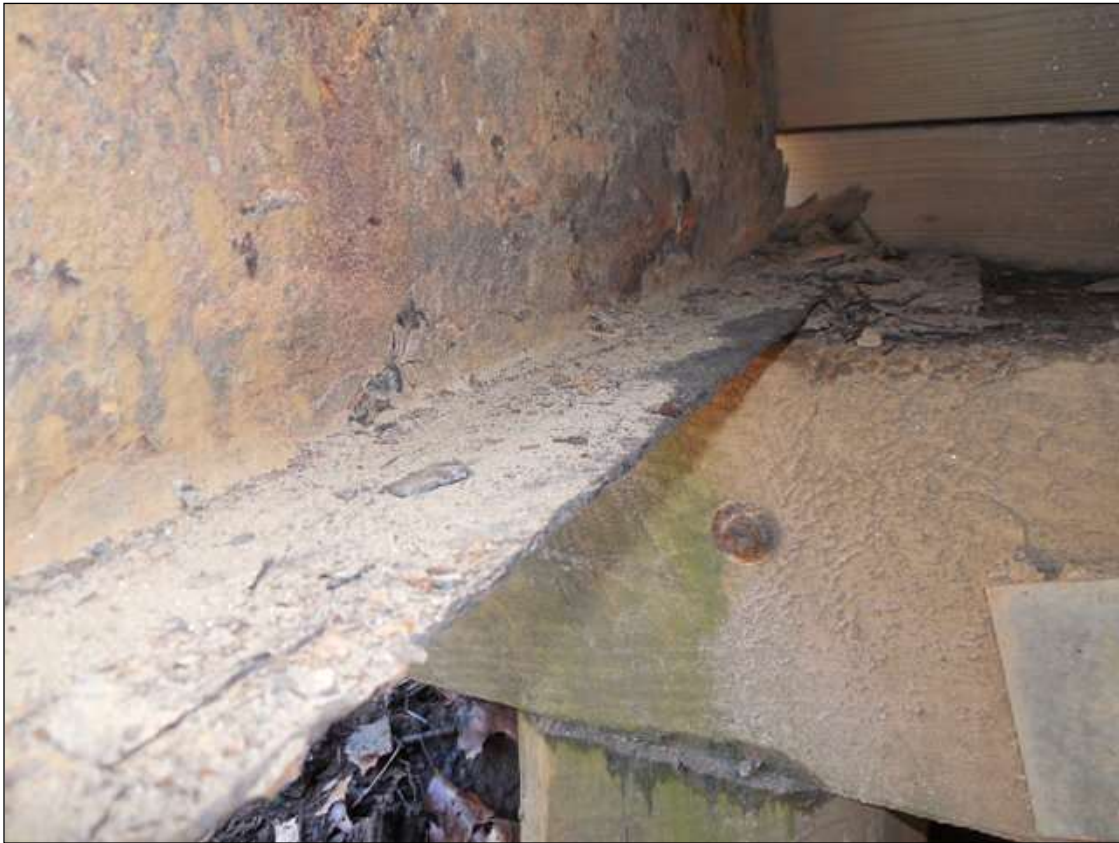
BEAM 1 RT BOTTOM FLANGE KNIFE EDGE SECTION REMAINING, EXTENDS 3' FROM ABUTMENT B, END OF BEAM ALSO DISTORTED FROM FIRE DAMAGE
