NC DEPARTMENT OF TRANSPORTATION  
DIVISION OF HIGHWAYS  
STRUCTURE MANAGEMENT UNIT

## Structure Safety Report

### 2 Year Complete Topside and Underwater Element Inspection

COUNTY: WILKES STRUCTURE NUMBER: 960403 FREQUENCY: 24 MONTHS

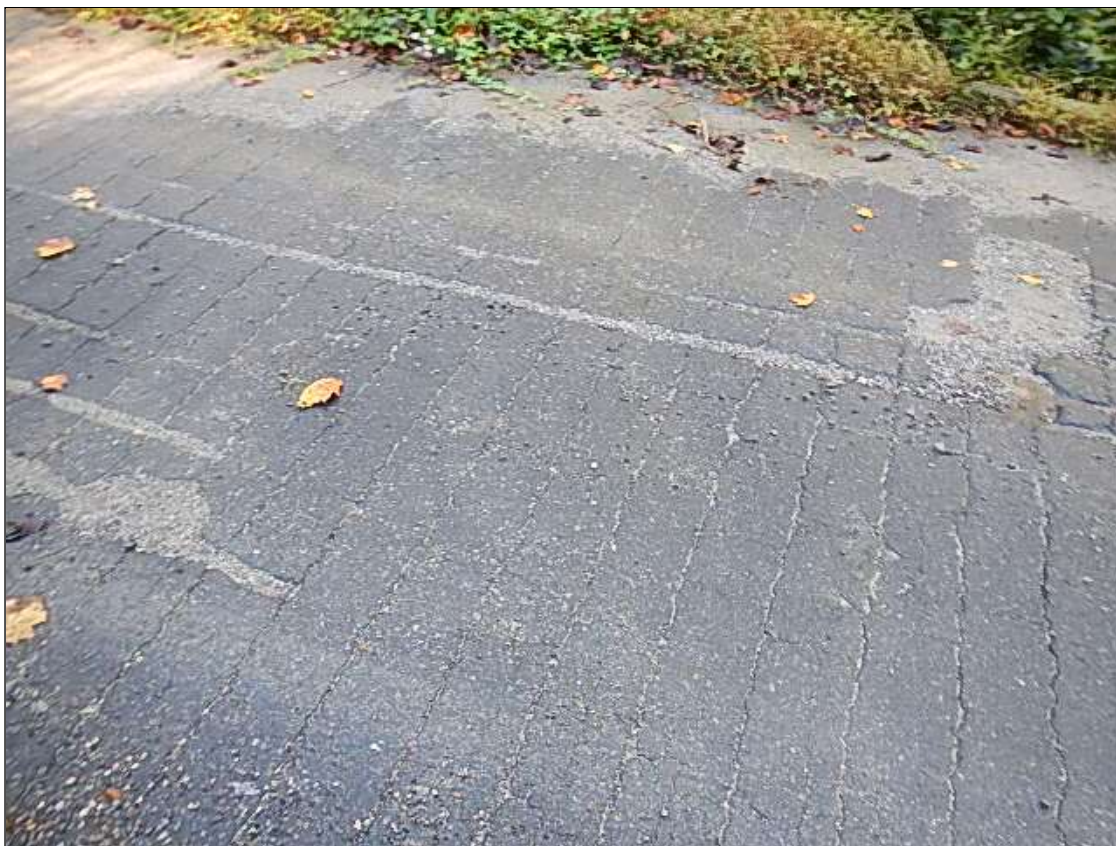
6 Square Feet MISSING AWS .Effectiveness (Wearing Surface): The wearing surface is no longer effective.

429 Square Feet of Crack (Wearing Surface): Width of more than 0.05 in. or spacing of less than 1.0 ft.

WEARING SURFACE

| MMS Code | Description of Function | Unit | Quantity | Remarks | Est. Cost |
|---|---|---|---|---|---|
| 2816 | Asphalt Surface Repair or Replacement | SY | 1 | MISSING AWS. | |

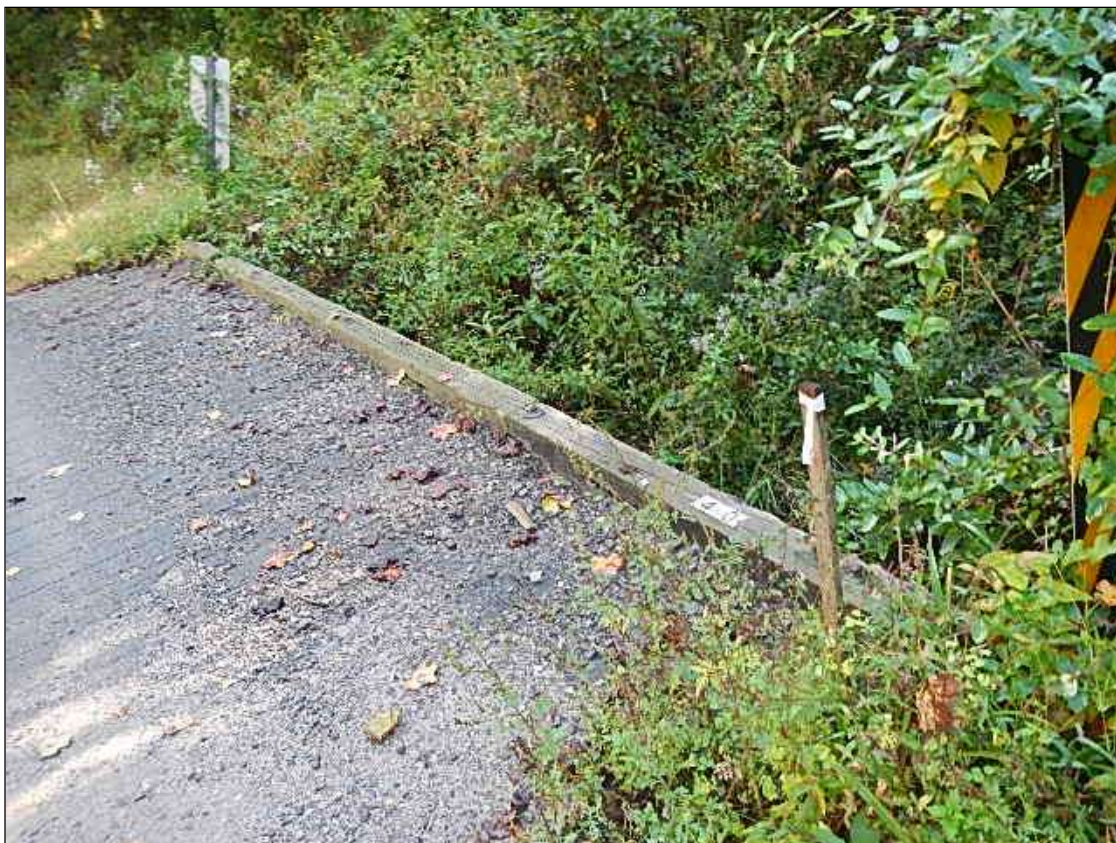
DEBRIS AND VEGETATION EAST side

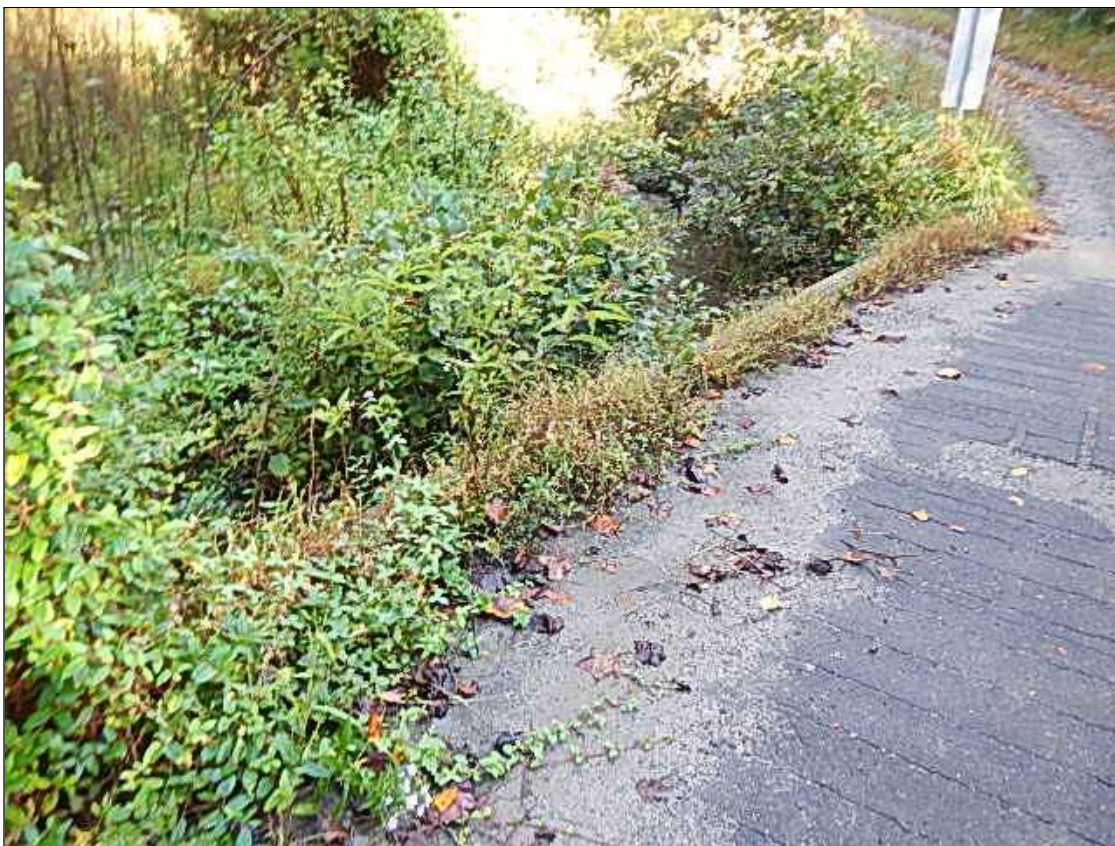
DEBRIS AND VEGETATION WEST SIDE

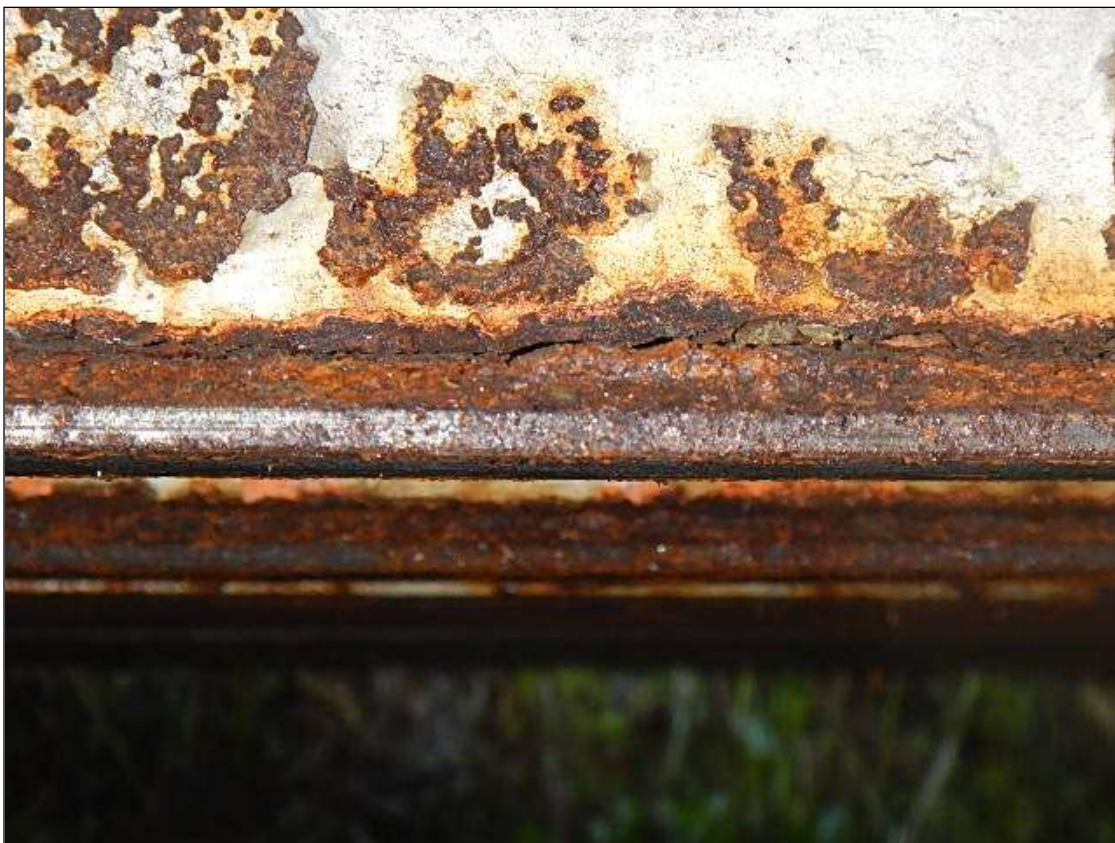
BEAMS SCALLING

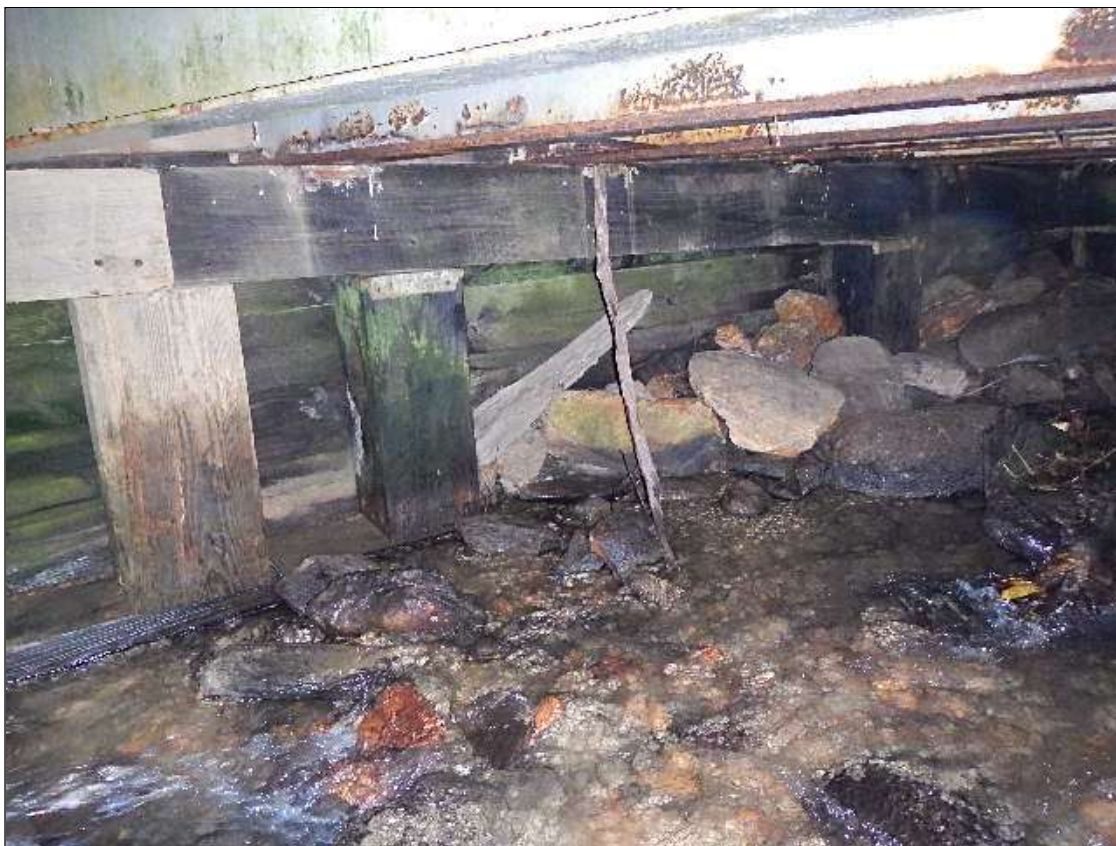
ABUTMENT 1

4 Feet of Decay/Section Loss: Affects less than 10% of the member section. SOFT TO 1/4".

17 Feet of Check/Shake: Penetrates 5%-50% of the thickness of the member and not in a tension zone. RANDOM CRACKING.

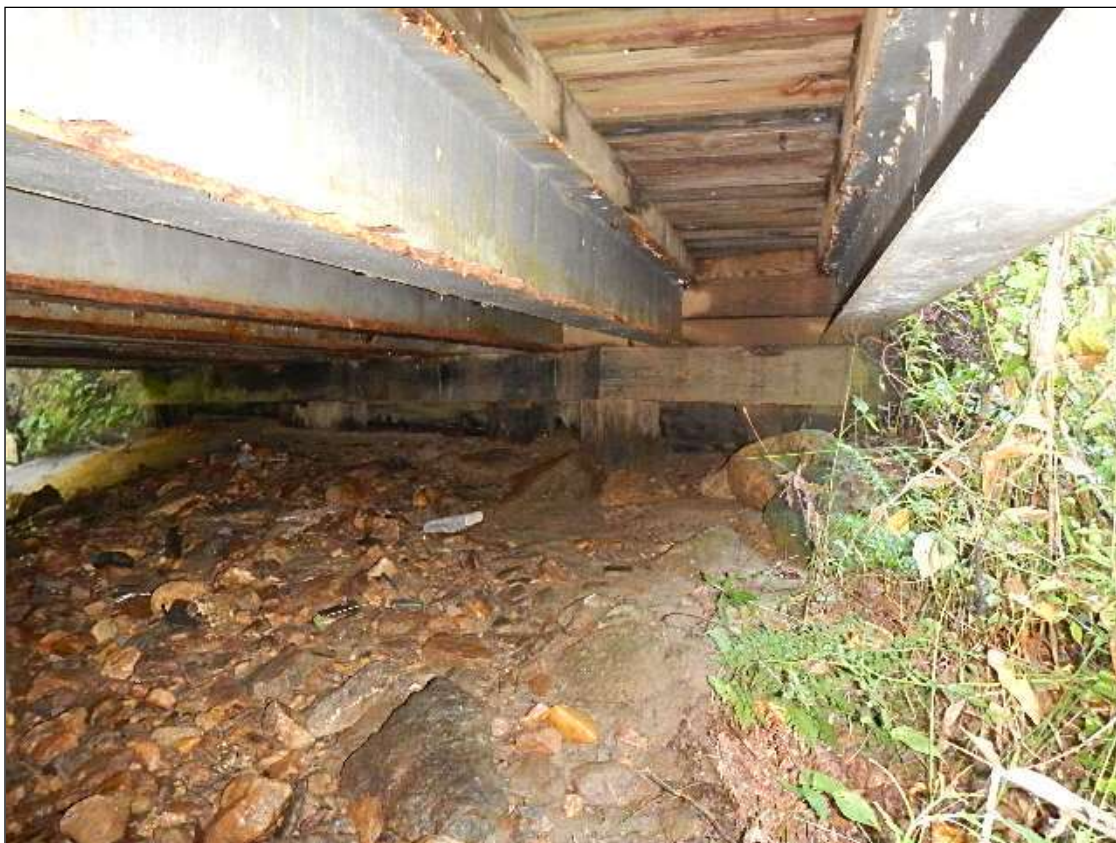
ABUTMENT 2

4 Feet of Decay/Section Loss: Affects less than 10% of the member section. SOFT TO 1/4".

17 Feet of Check/Shake: Penetrates 5%-50% of the thickness of the member and not in a tension zone. RANDOM CRACKING.

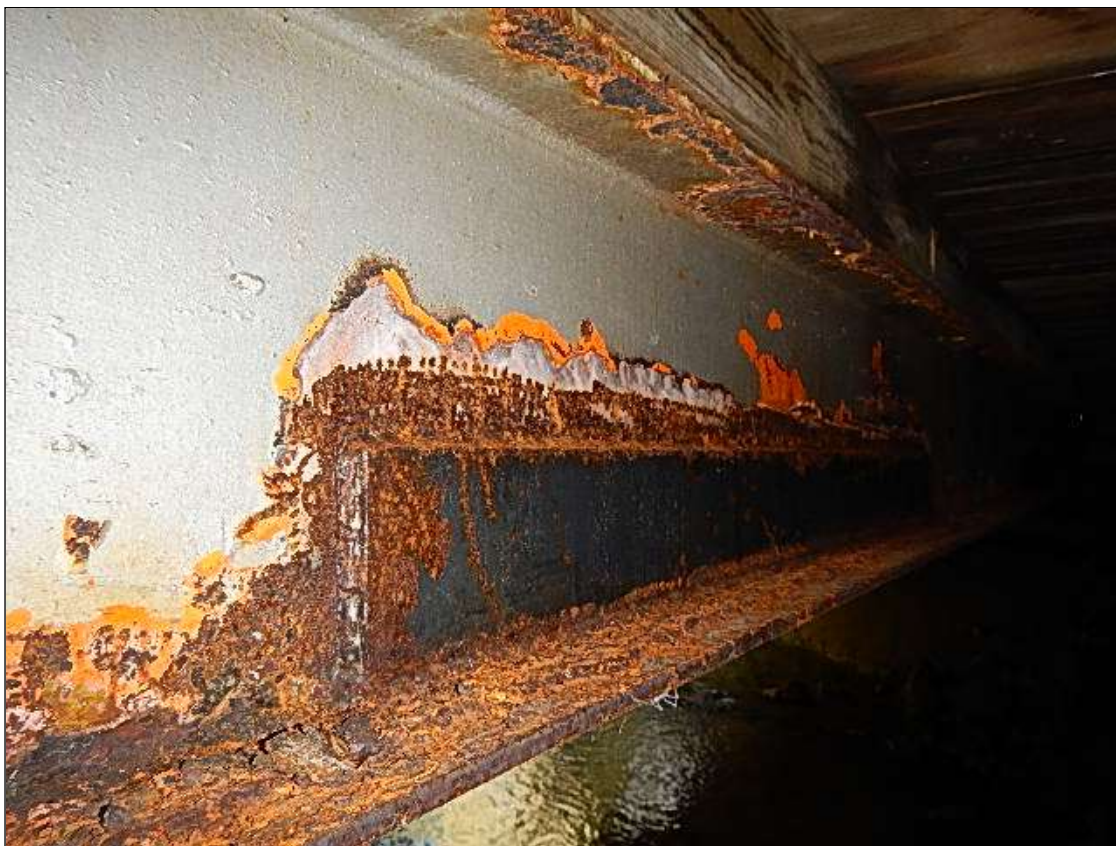
2 REPAIRS TO BEAM 3, 1 IS MID BEAM EAST FACE WELDED PLATE 47" LONG x 4" HIGH x 1/4" THICKNESS. 2ND IS NORTH END EAST FACE 36" LONG x 4" HIGH x 1/4" THICKNESS.

BEAM 3 MID EAST FACE

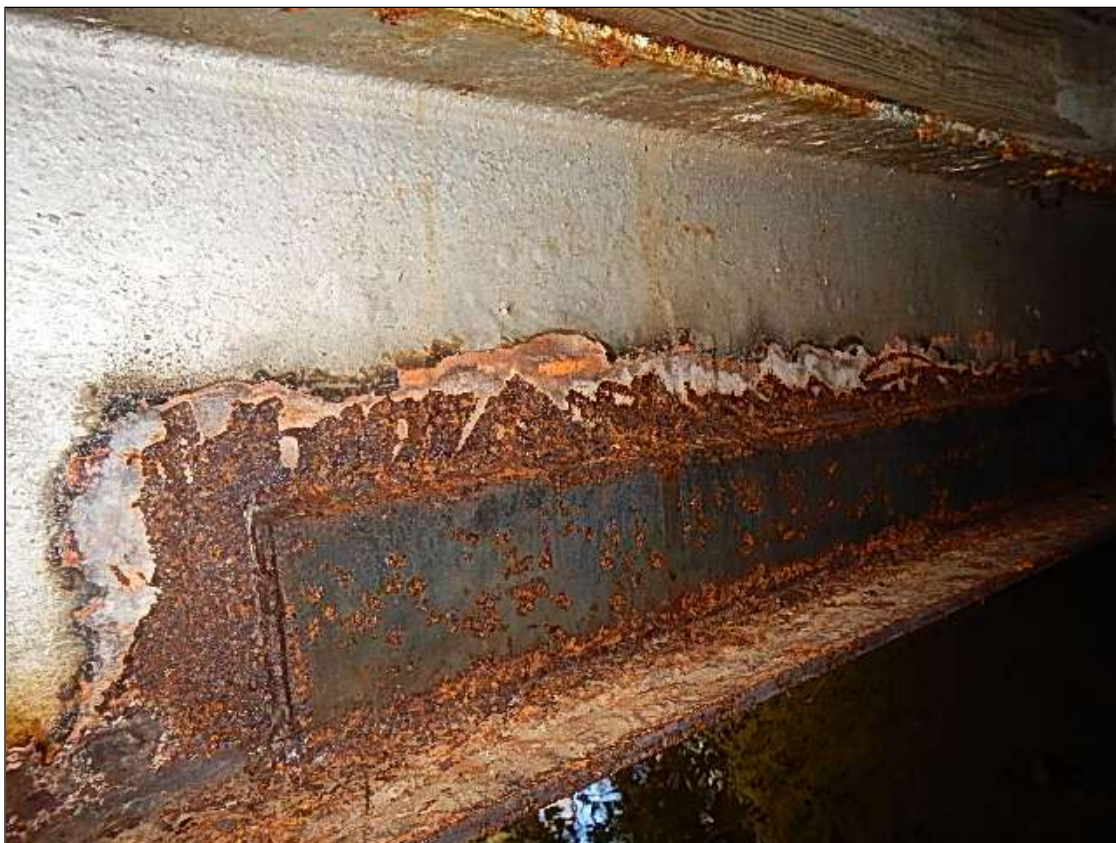
BEAM 3 NORTH END EAST FACE
