NC DEPARTMENT OF TRANSPORTATION  
DIVISION OF HIGHWAYS  
STRUCTURE MANAGEMENT UNIT

## Structure Safety Report

### Routine Element Inspection - Contract

COUNTY: WILKES STRUCTURE NUMBER: 960700 FREQUENCY: 24 MONTHS

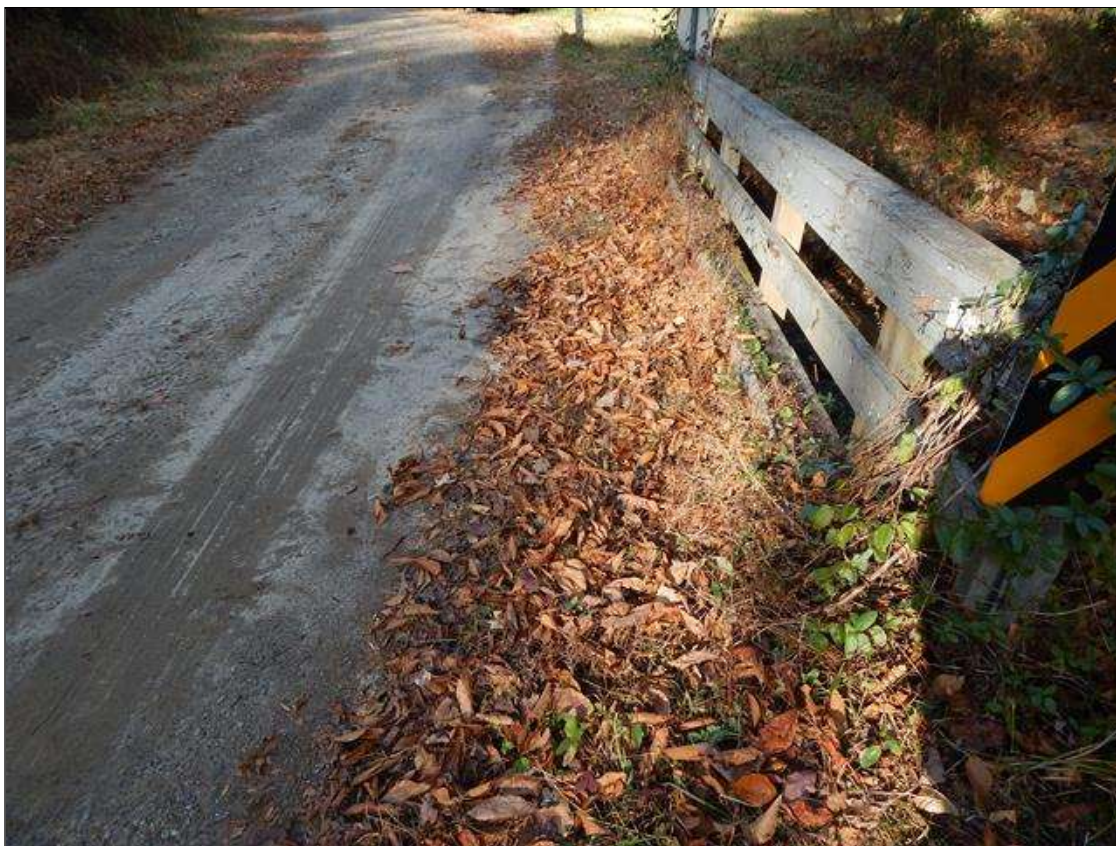
Details 3' of debris and vegetation in East gutter (West gutter similar).

3' of debris and vegetation in East gutter (West gutter similar)

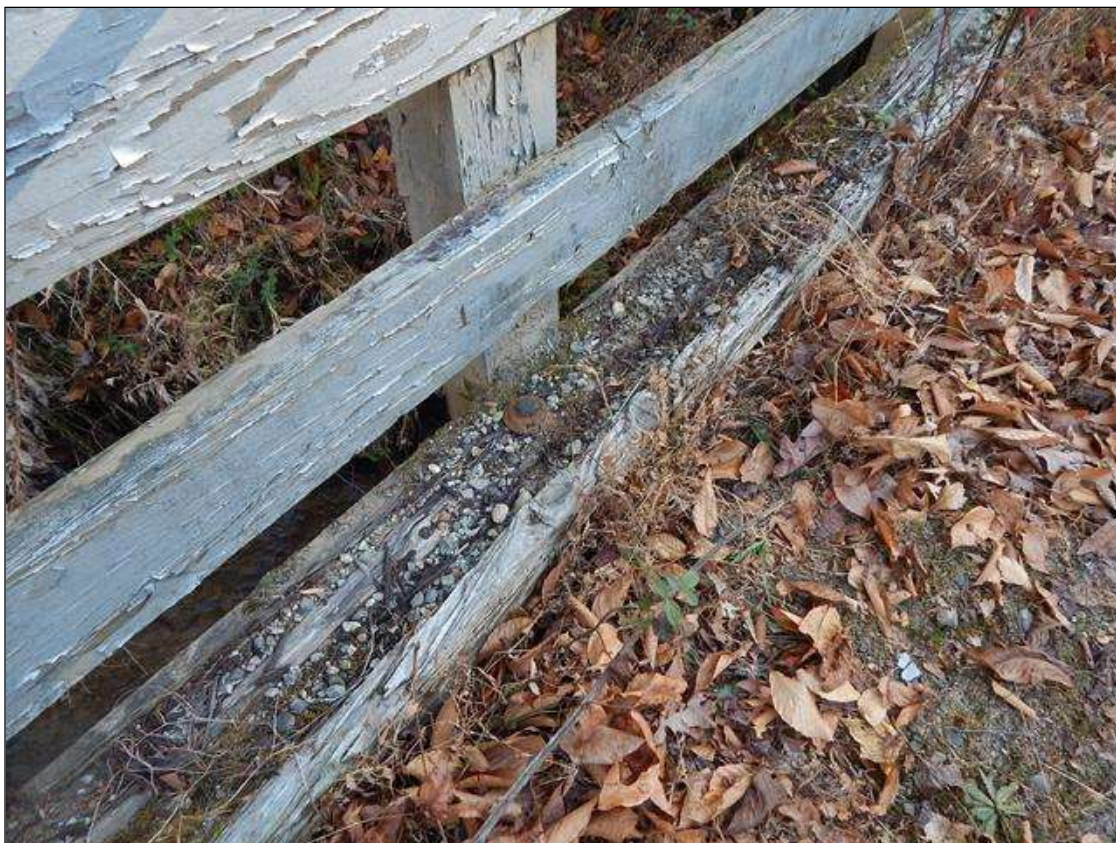
19' x up to 6" x 1" deep area of decay.

Span 1 Right Bridge Rail: 19' x up to 6" x 1" deep area of decay

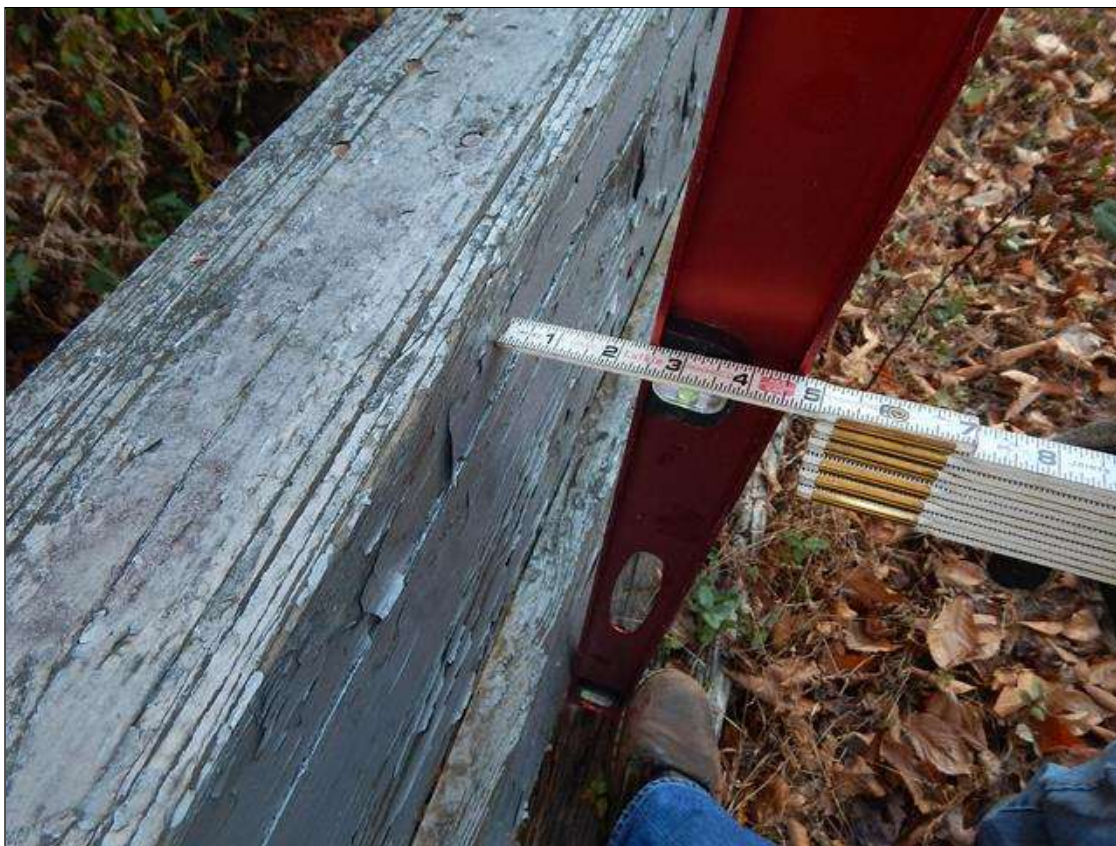
Up to 2 1/4" lean to the East.

Span 1 Right Bridge Rail: Up to 2 1/4" lean to the East

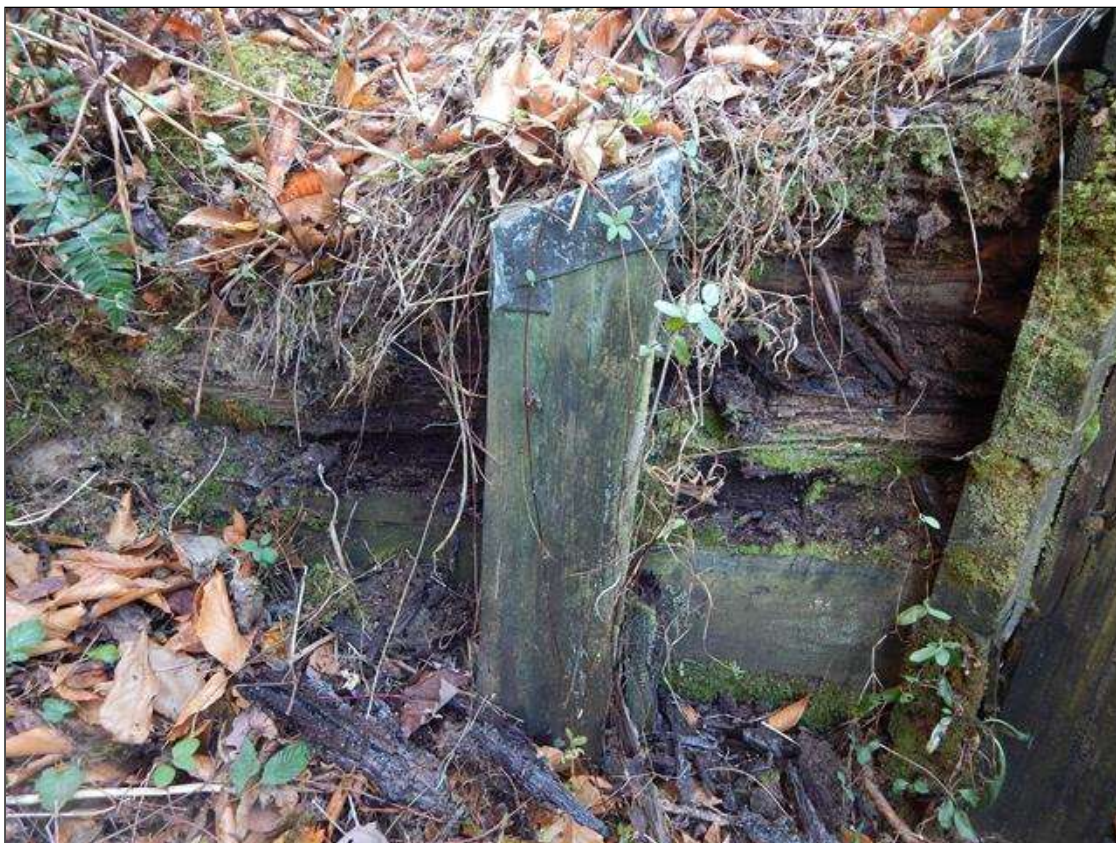
48" x 18" x 2" deep area of decay on Southeast wingwall.

4' x 18" x 2" deep area of decay on Southeast wingwall

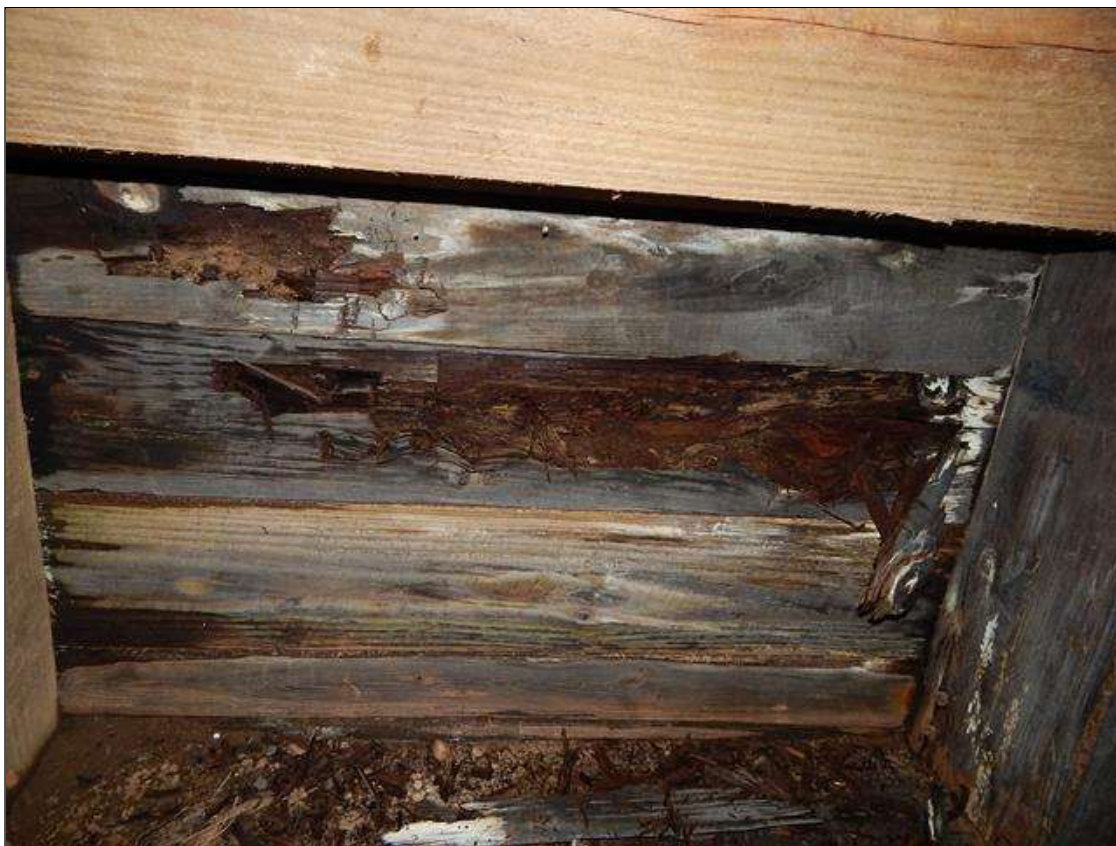
2' x 6" x 2" deep area of decay between piles 4 and 5.

End Bent 1 Abutment/Backwall : 2' x 6" x 2" deep area of decay between piles 4 and 5

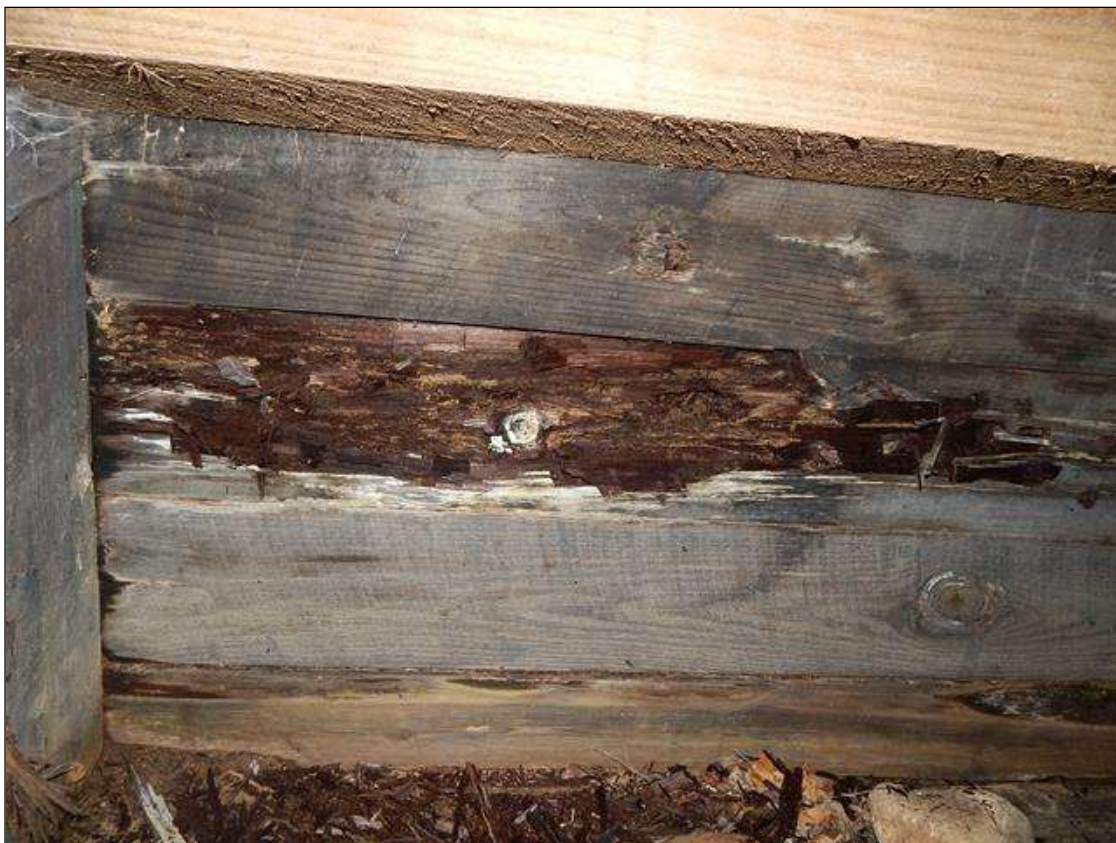
3' x 6" x 2" deep area of decay between piles 3 and 4.

End Bent 1 Abutment/Backwall : 36" x 6" x 2" deep area of decay between piles 3 and 4

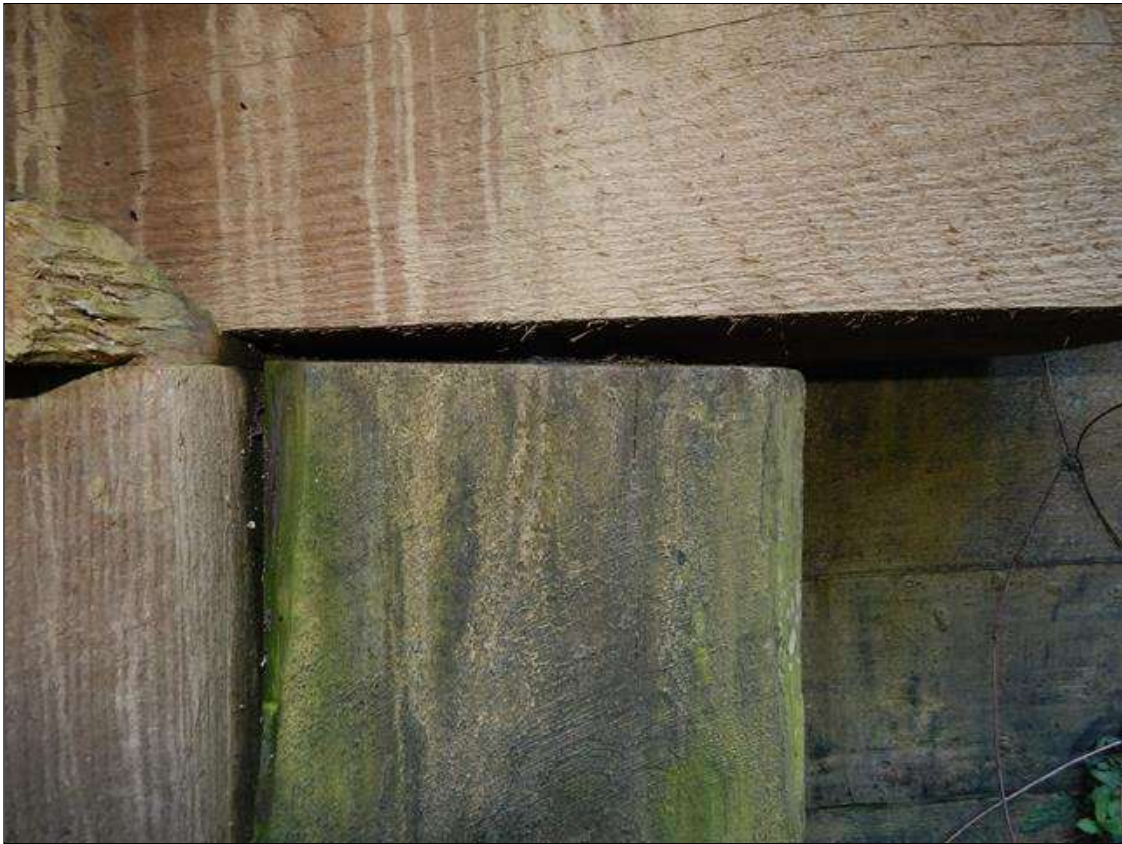
End Bent cap not bearing on pile 1.

End Bent 1 Pile 1: End Bent cap not bearing on pile 1

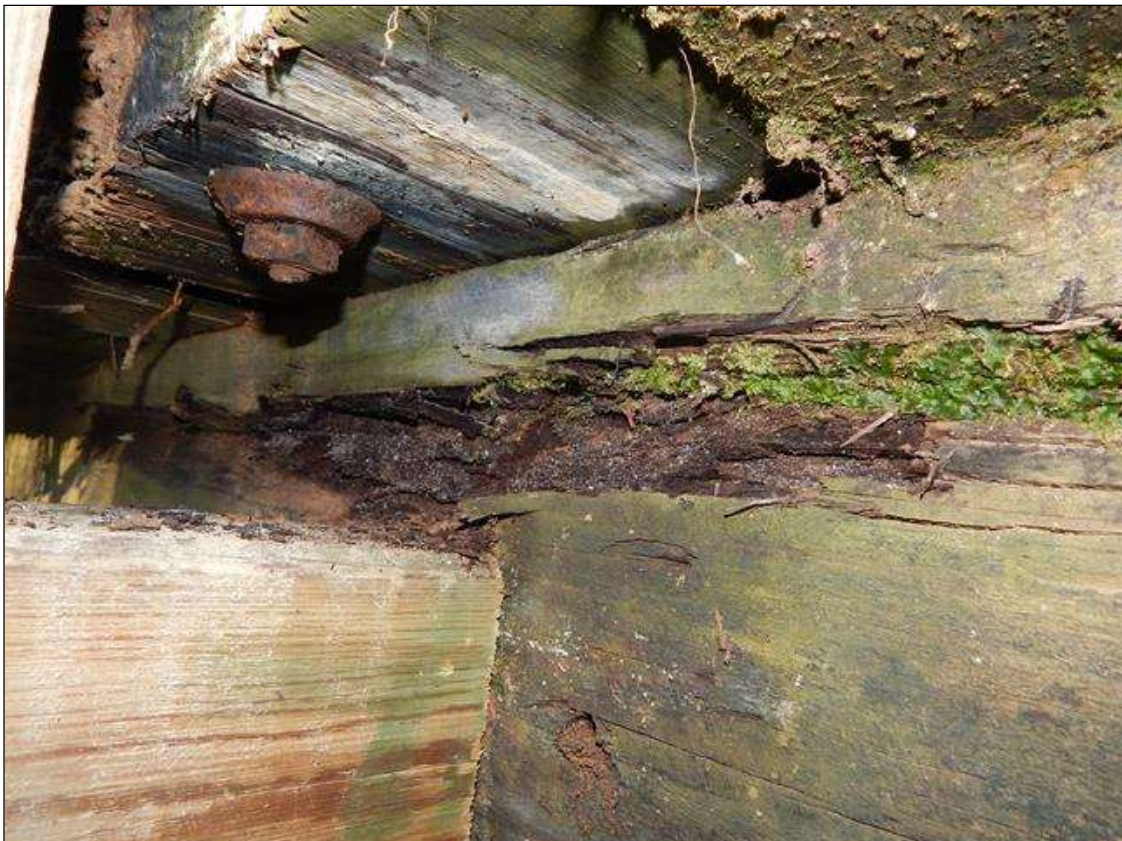
42" x 2" x 3/4" deep area of decay, 3' from End Bent 2.

Span 1 Beam 1: 42" x 2" x 3/4" deep area of decay, 3' from End Bent 2

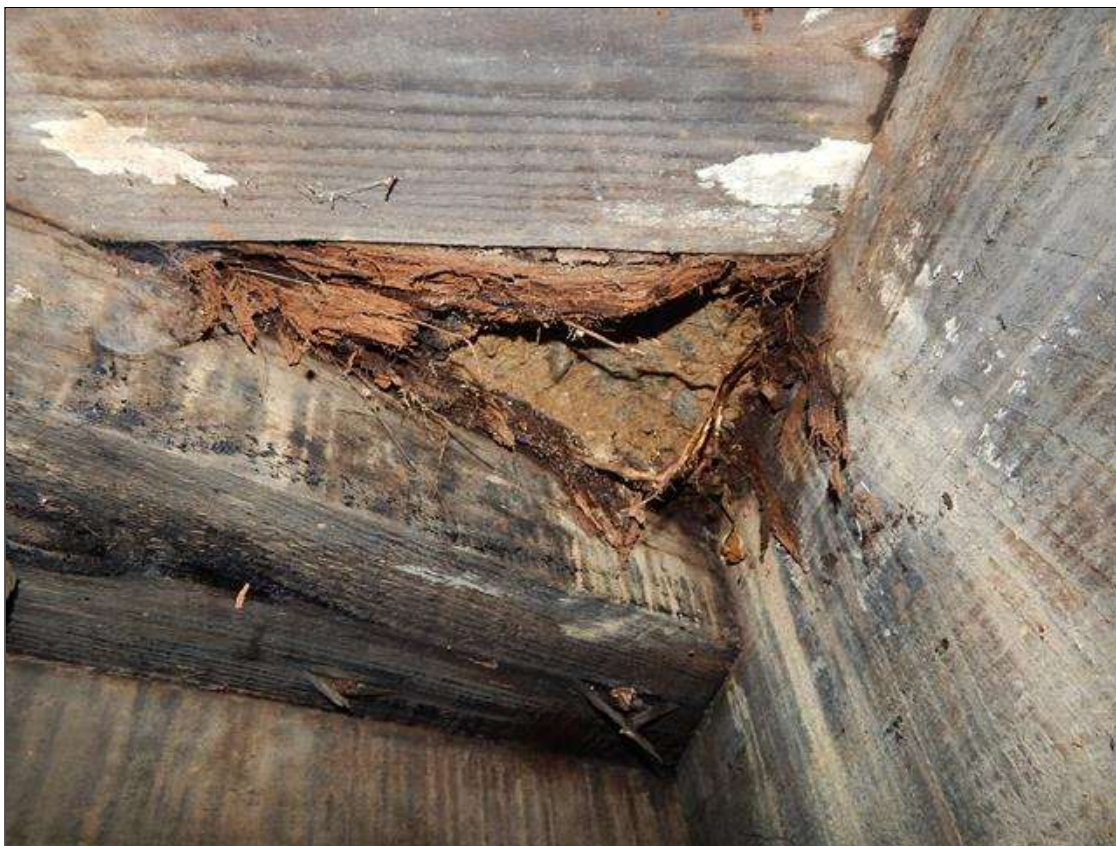
12" x 8" x 2" deep area of decay in bay 3 at End Bent 2.

Span 1 Deck: 12" x 8" x 2" deep area of decay in bay 3 at End Bent 2

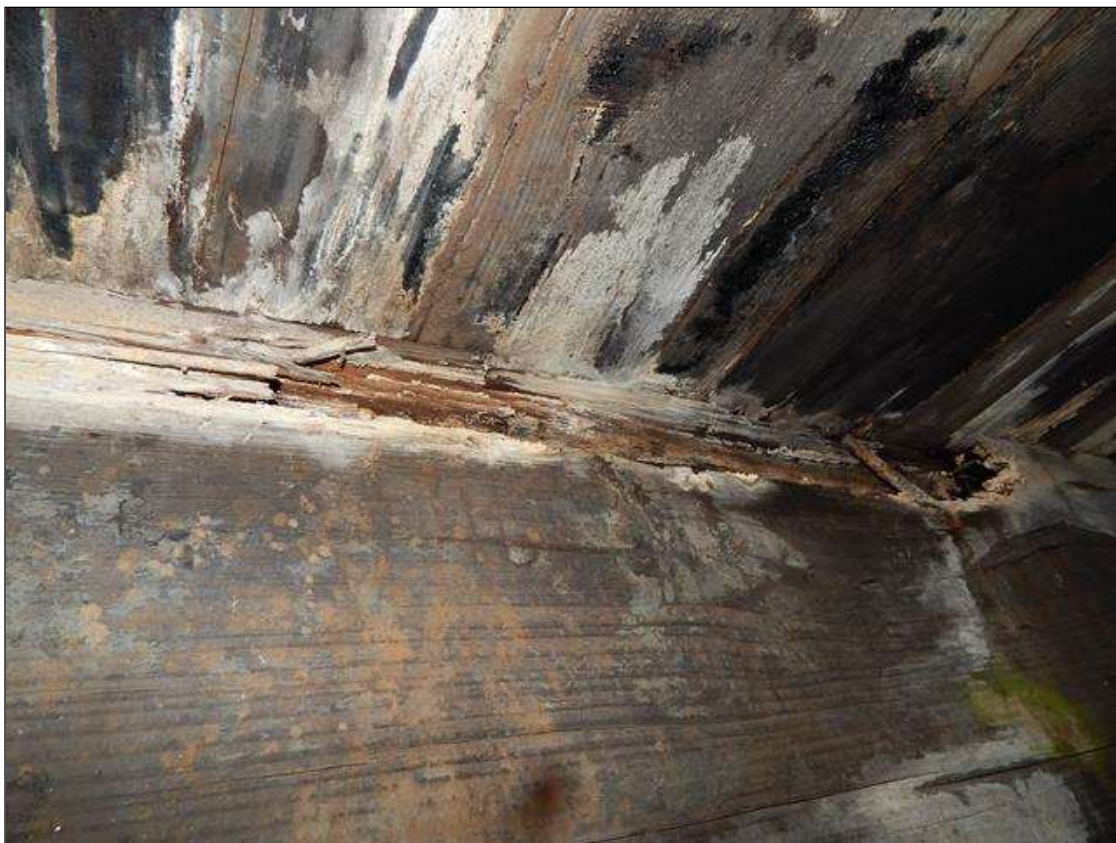
24" x 3" x 1" deep area of decay, 4' from End Bent 2.

Span 1 Beam 5: 24" x 3" x 1" deep area of decay, 4' from End Bent 2

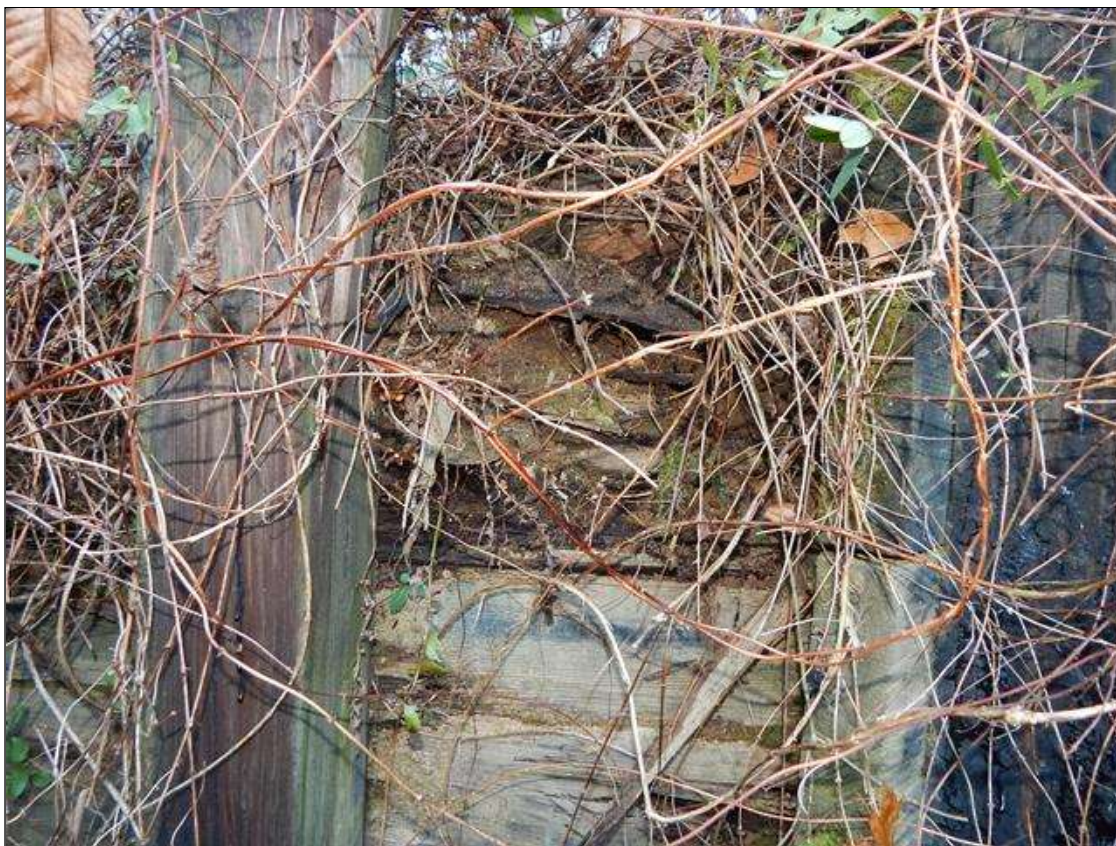
Details 36" x 15" x 2" deep area of decay on Northwest wingwall.

36" x 15" x 2" deep area of decay on Northwest wingwall

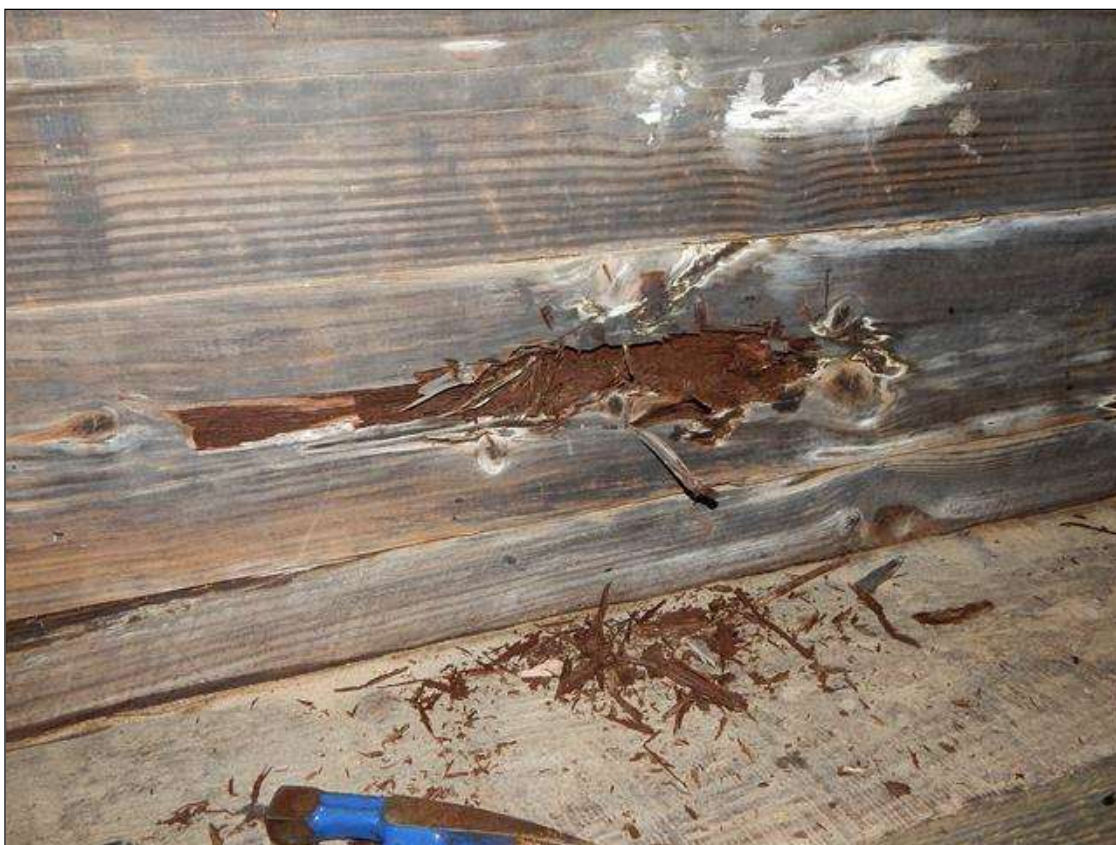
18" x 4" x 3/4" deep area of decay between piles 1 and 2.

End Bent 2 Abutment/Backwall : 18" x 4" x 3/4" deep area of decay between piles 1 and 2

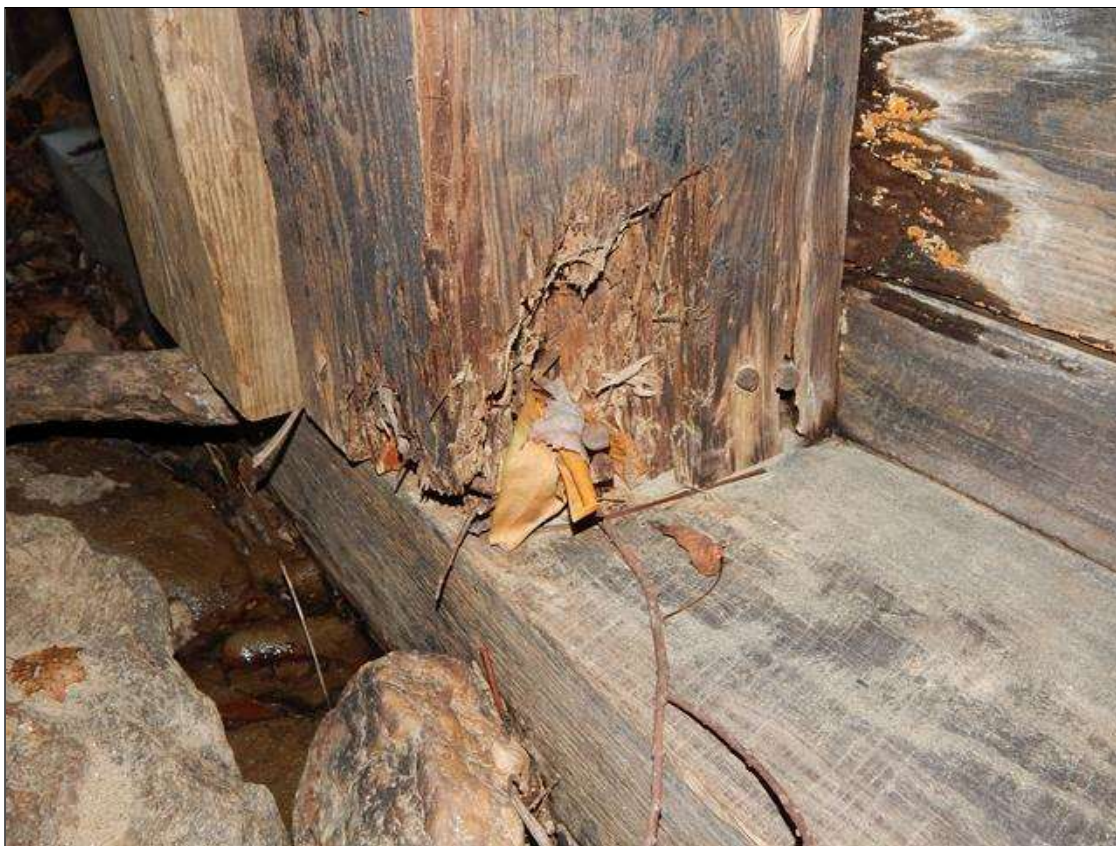
11" x 8" x up to 6" deep area of decay on Southeast corner.

End Bent 2 Pile 3: 11" x 8" x up to 6" deep area of decay on Southeast corner

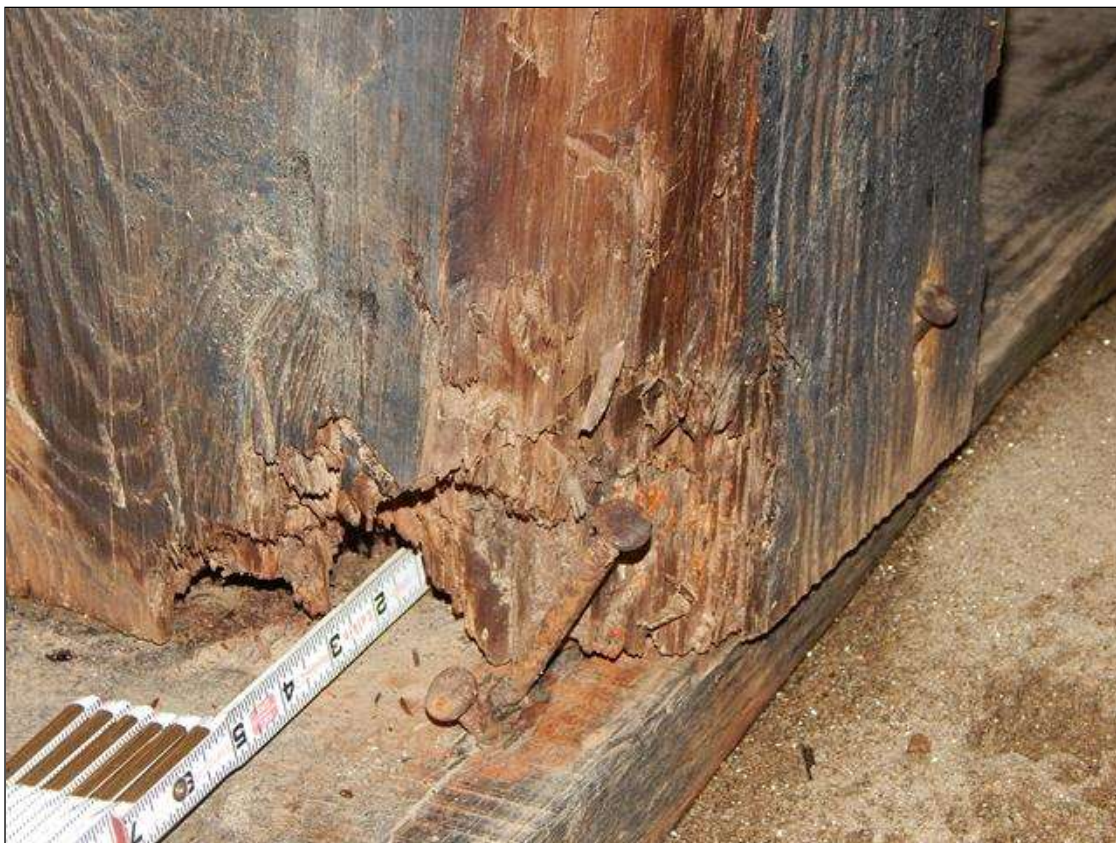
9" x 4" x 3" deep area of decay on Southwest corner.

End Bent 2 Pile 4: 9" x 4" x 3" deep area of decay on Southwest corner

| MMS Code | Description of Function | Unit | Quantity | Remarks | Est. Cost |
|---|---|---|---|---|---|
| 3344 | Repair / Replace Timber Substructure Components | LF | 10<br>BTH<br>8-3-15 | END BENT 2 PILE 4: 9" X 4" X 3" DEEP AREA OF DECAY ON SOUTHWEST CORNER. | |

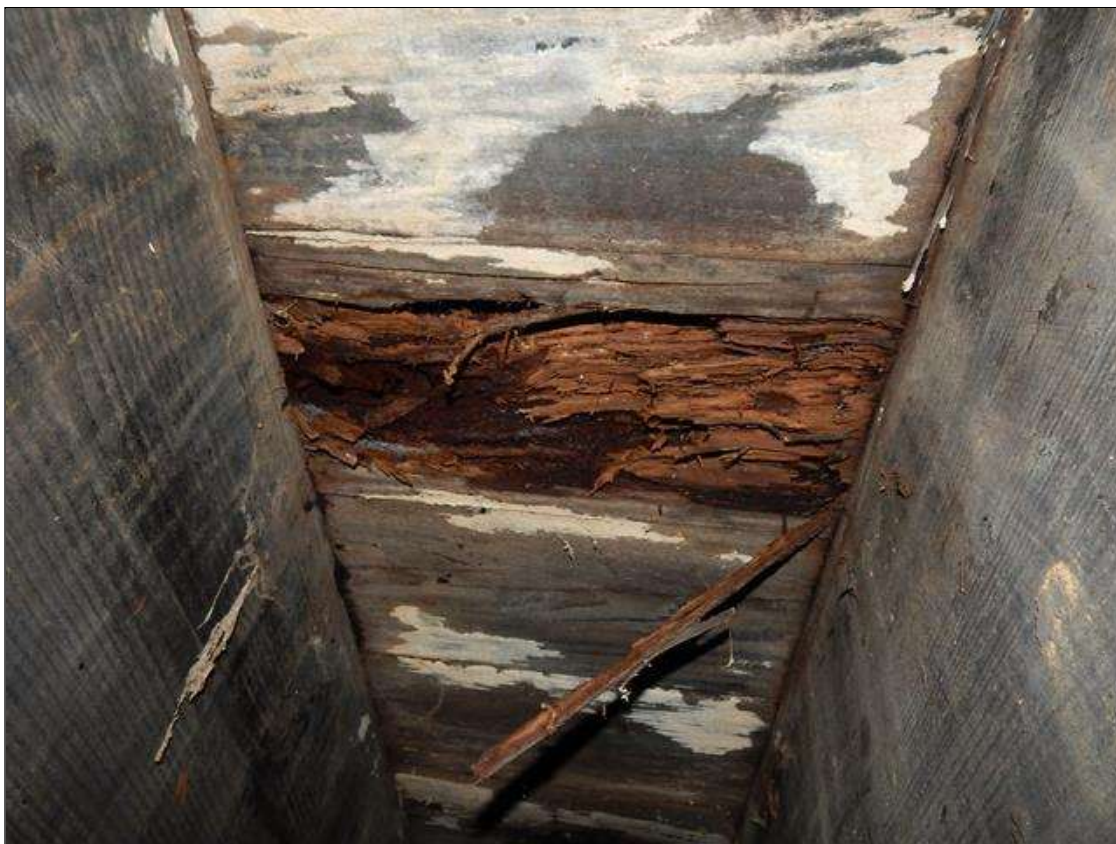
14" x 6" x 1 1/2" deep area of decay, 5' from End Bent 2.

Span 1 Deck: 14" x 6" x 1 1/2" deep area of decay, 5' from End Bent 2

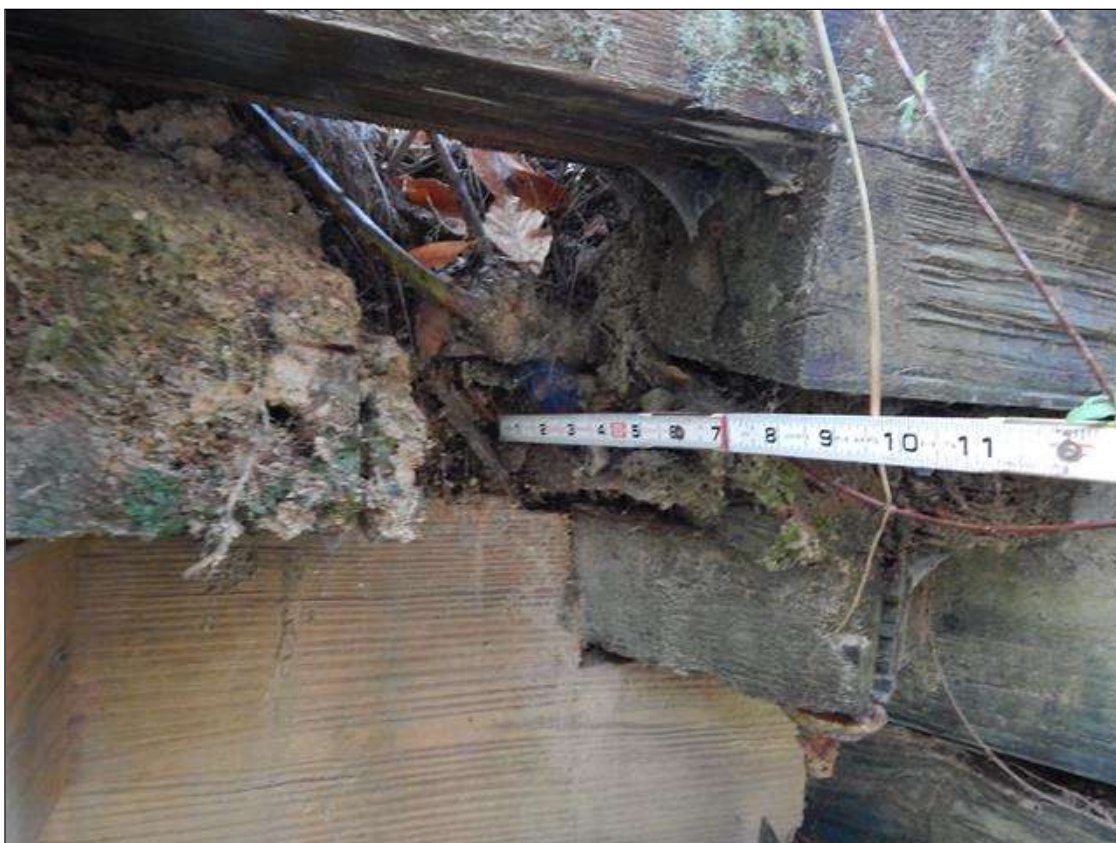
7" x 4" x 6" deep area of decay at End Bent 2 in East overhang.

Span 1 Deck: 7" x 4" x 6" deep area of decay at End Bent 2 in East overhang

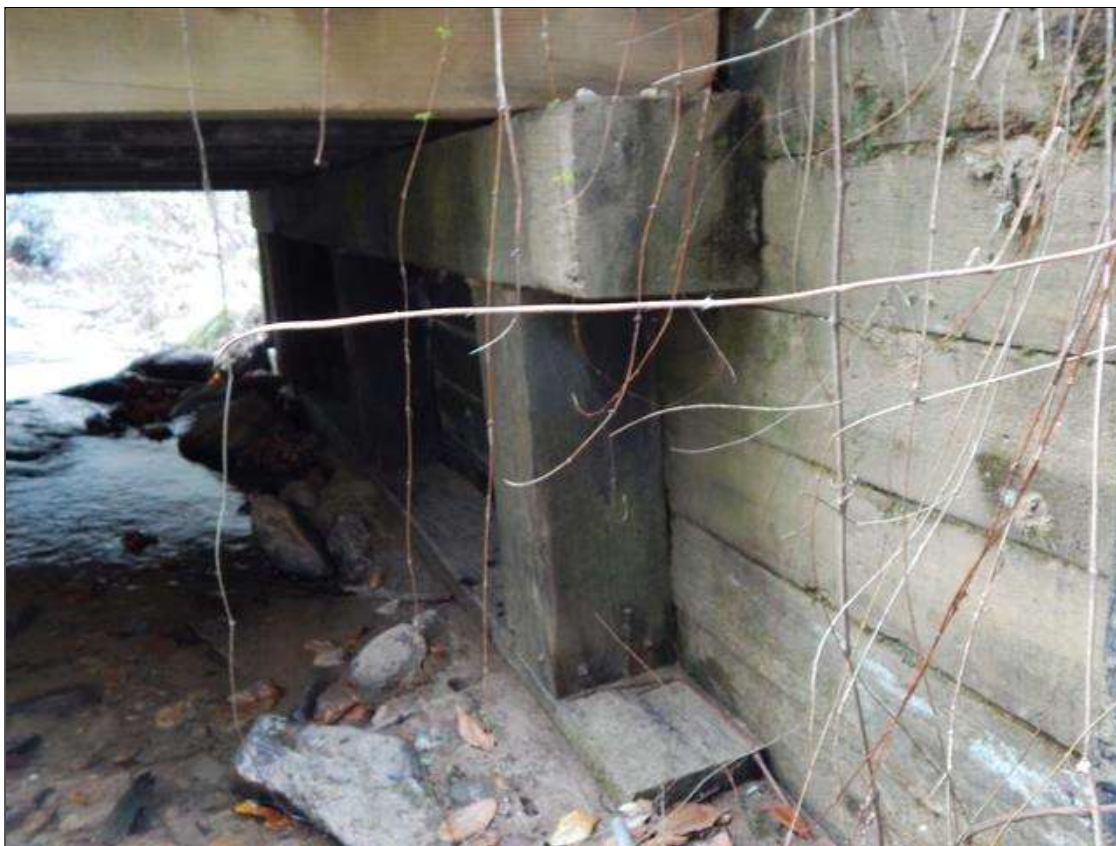
5" lean to the South.

5" lean to the South of End Bent 2

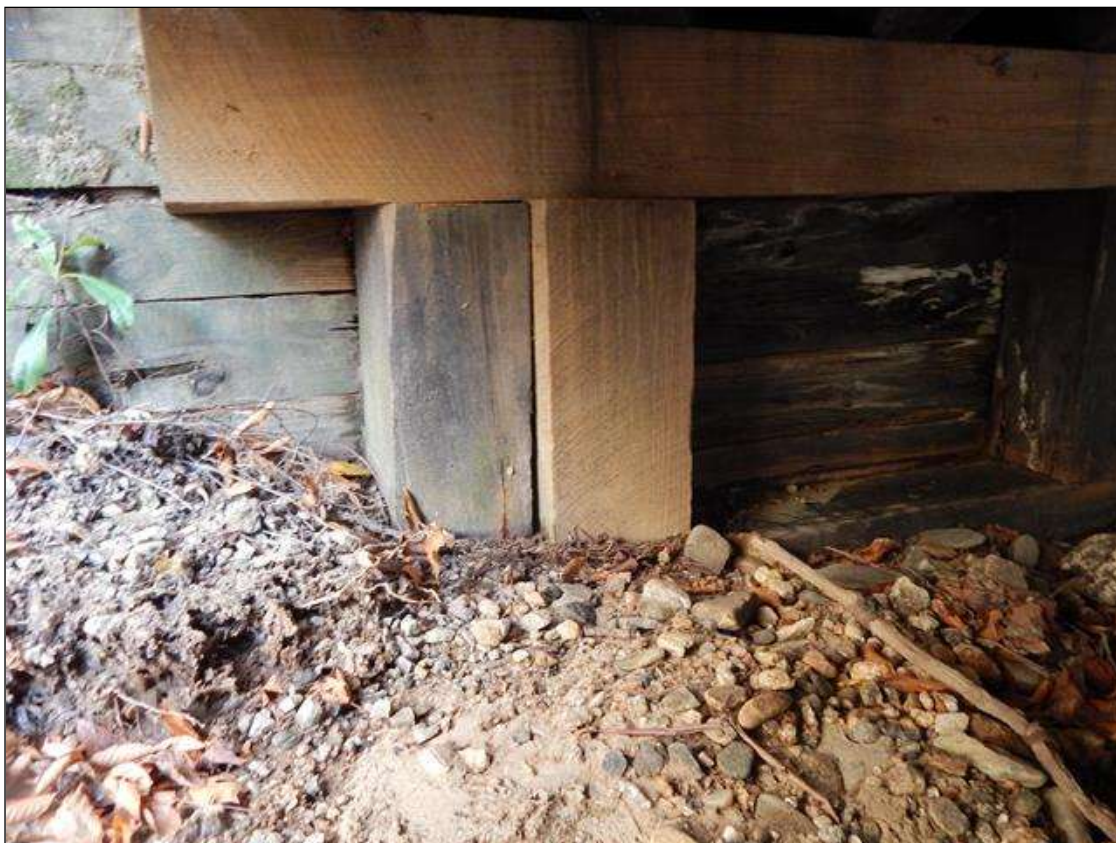
Temporary repair - Pile 5 at End Bent 1 (Pile 2 similar )

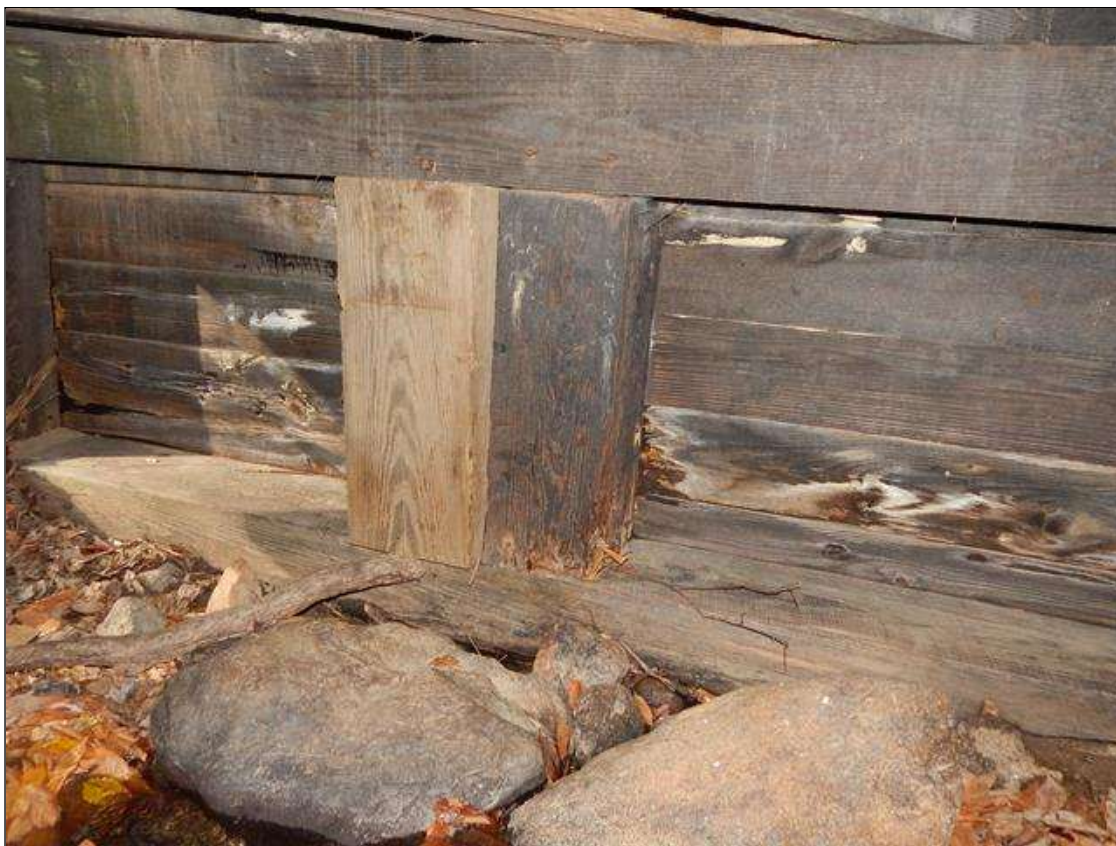
Temporary repair - Pile 2 at End Bent 2

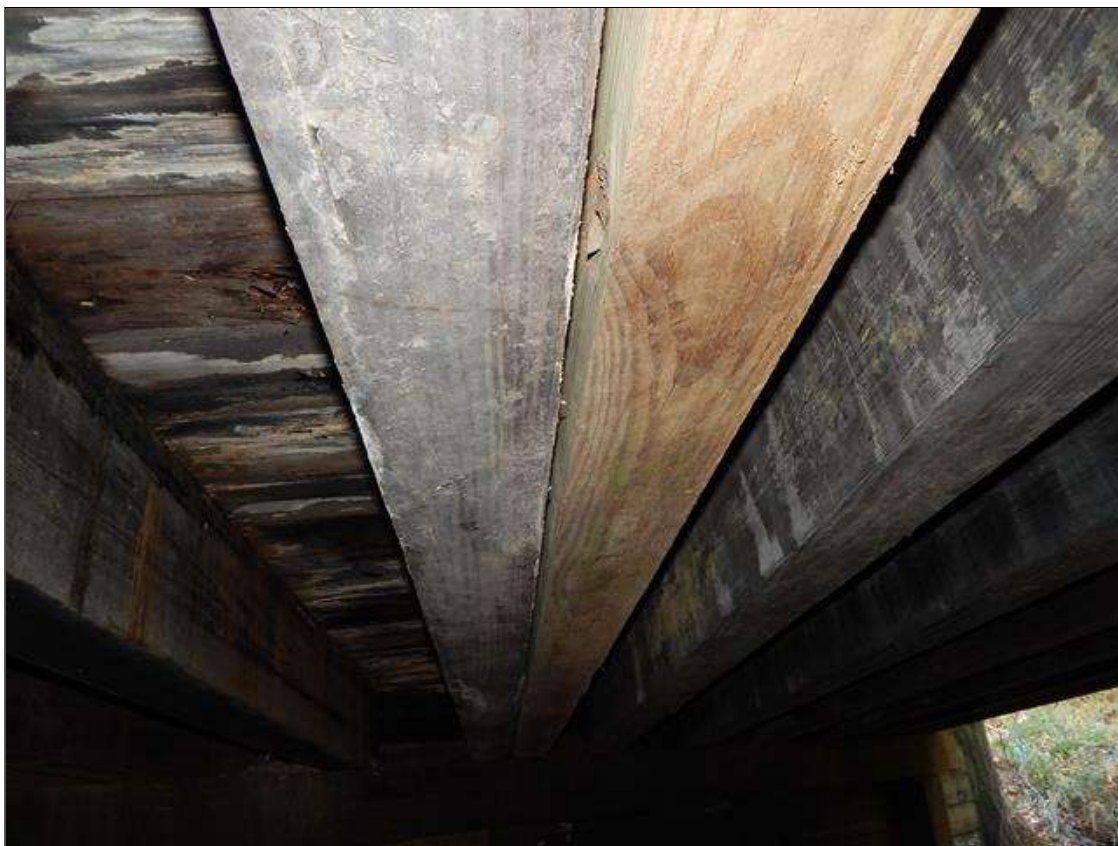
Temporary repair - Beam 6 (Beam 2 similar)

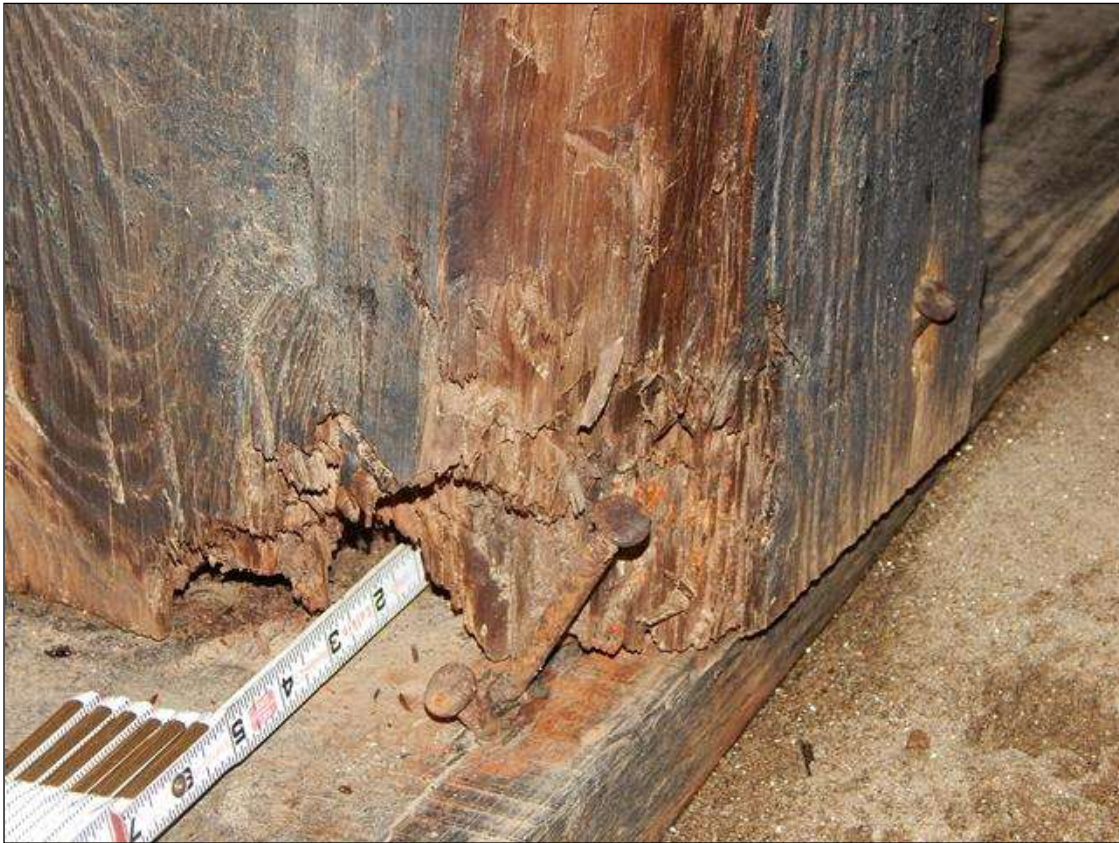
| MMS Code | MMS Description | Quantity |
|---|---|---|
| END BENT 2 PILE 4: 9" X 4" X 3" DEEP AREA OF DECAY ON SOUTHWEST CORNER. | | |

END BENT 2 PILE 4: 9" X 4" X 3" DEEP AREA OF DECAY ON SOUTHWEST CORNER

| MMS Code | MMS Description | Quantity |
|---|---|---|
| 3344 | Repair / Replace Timber Substructure Components | 1 LF |
