NC DEPARTMENT OF TRANSPORTATION  
DIVISION OF HIGHWAYS  
STRUCTURE MANAGEMENT UNIT

# Structure Safety Report

## Routine Element Inspection

COUNTY: CHOWAN STRUCTURE NUMBER: 200020 FREQUENCY: 24 MONTHS

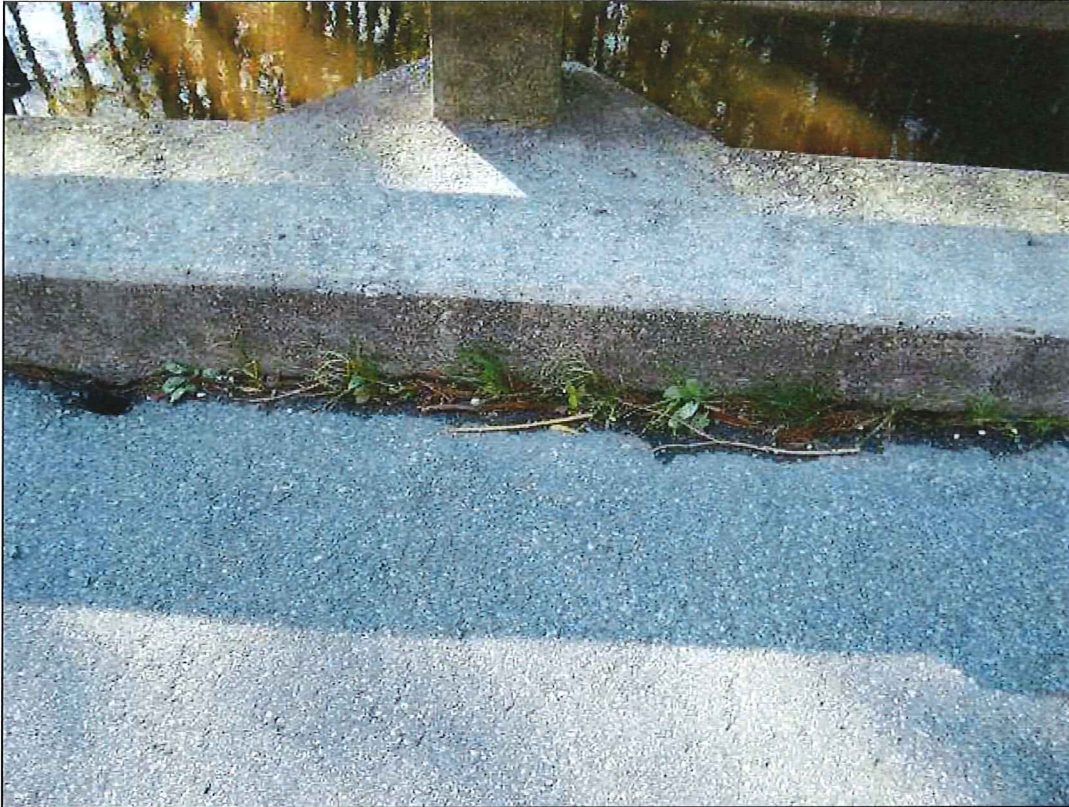
TRASH AND DEBRIS ADJACENT CURBS

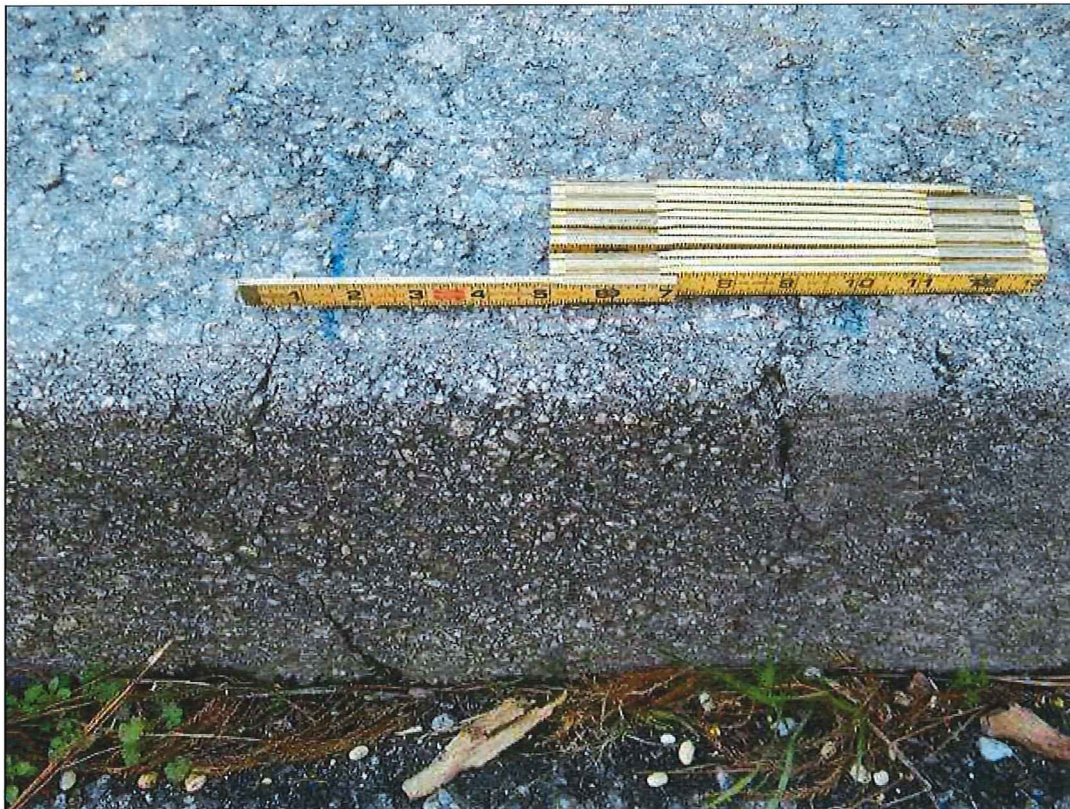
2 Feet of Cracking (RC and Other): Width greater than 0.05 in. or spacing of less than 1 ft.

Span 1 Left Bridge Rail: 2 Feet of Cracking (RC and Other): Width greater than 0.05 in. or spacing of less than 1 ft.

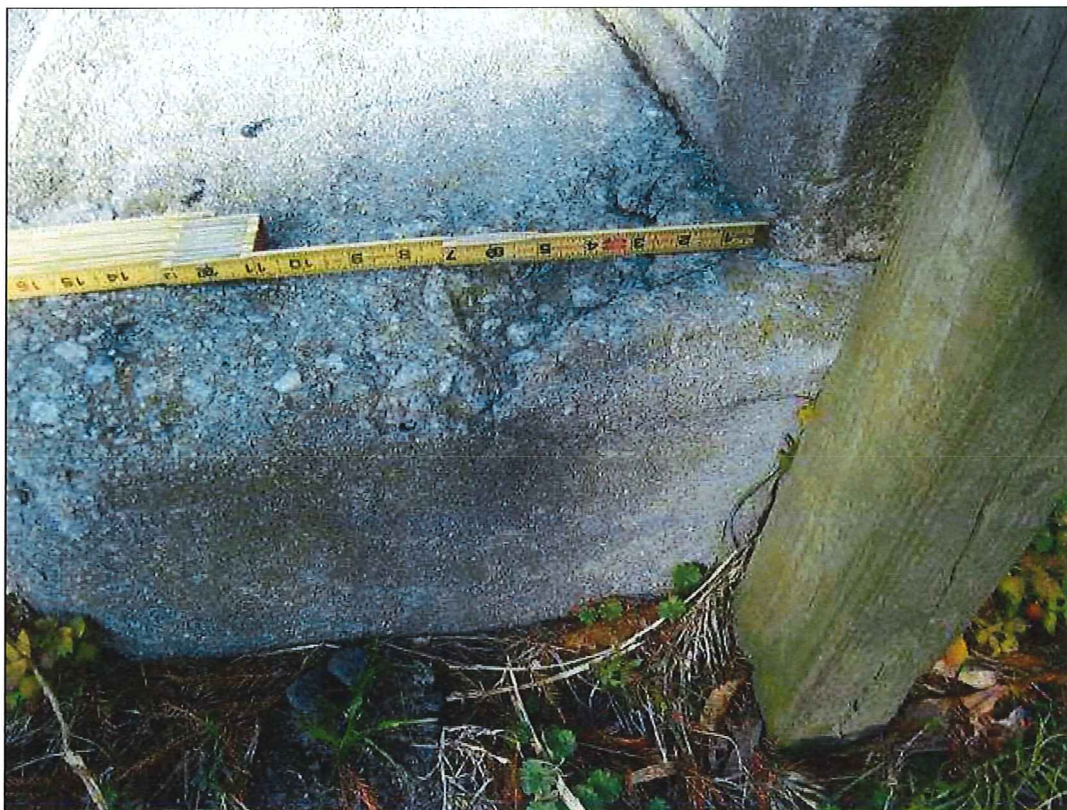
1 Foot of Spalled Area: Spall greater than 1 in. deep or greater than 6 in. diameter. Does not warrant structural review. on right side @ end bent 1.

Span 1 Right Bridge Rail: 1 Feet of Spalled Area: Spall greater than 1 in. deep or greater than 6 in. diameter. Does not warrant structural review. on right side @ end bent 1.

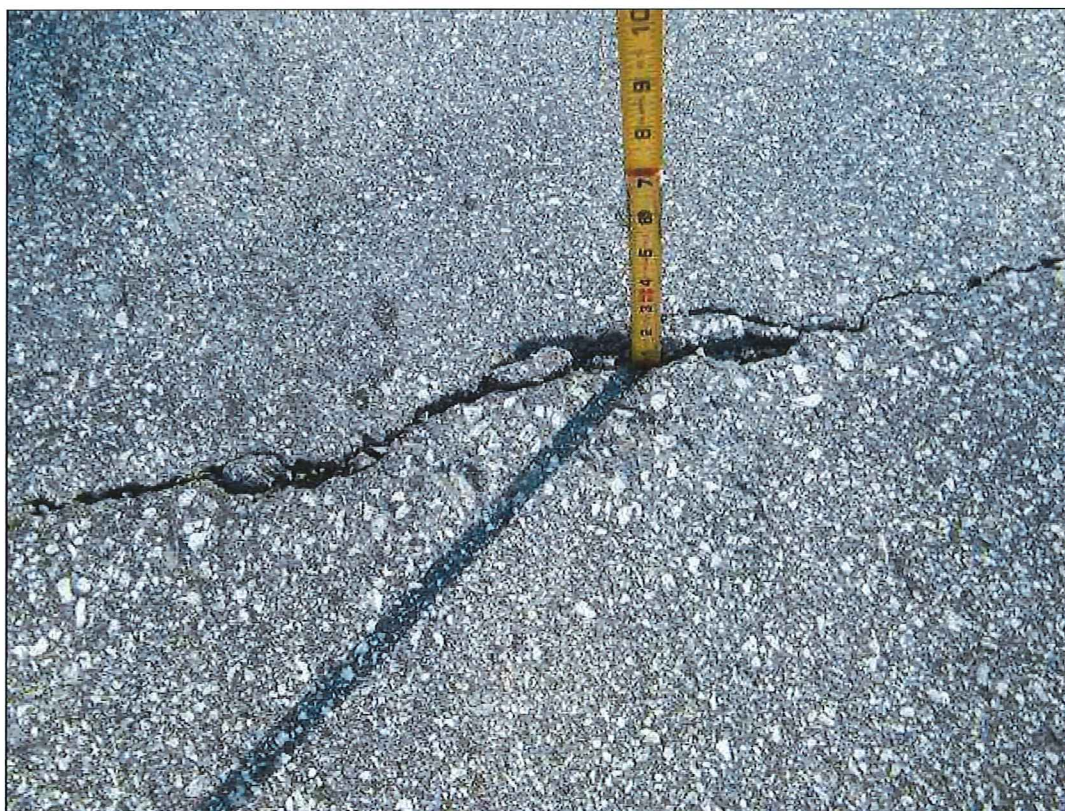
36 Square Feet of Crack (Wearing Surface): Width of more than 0.05 in. or spacing of less than 1.0 ft. in both lanes.

Span 1 Wearing Surface: 36 Square Feet of Crack (Wearing Surface): Width of more than 0.05 in. or spacing of less than 1.0 ft. in both lanes.

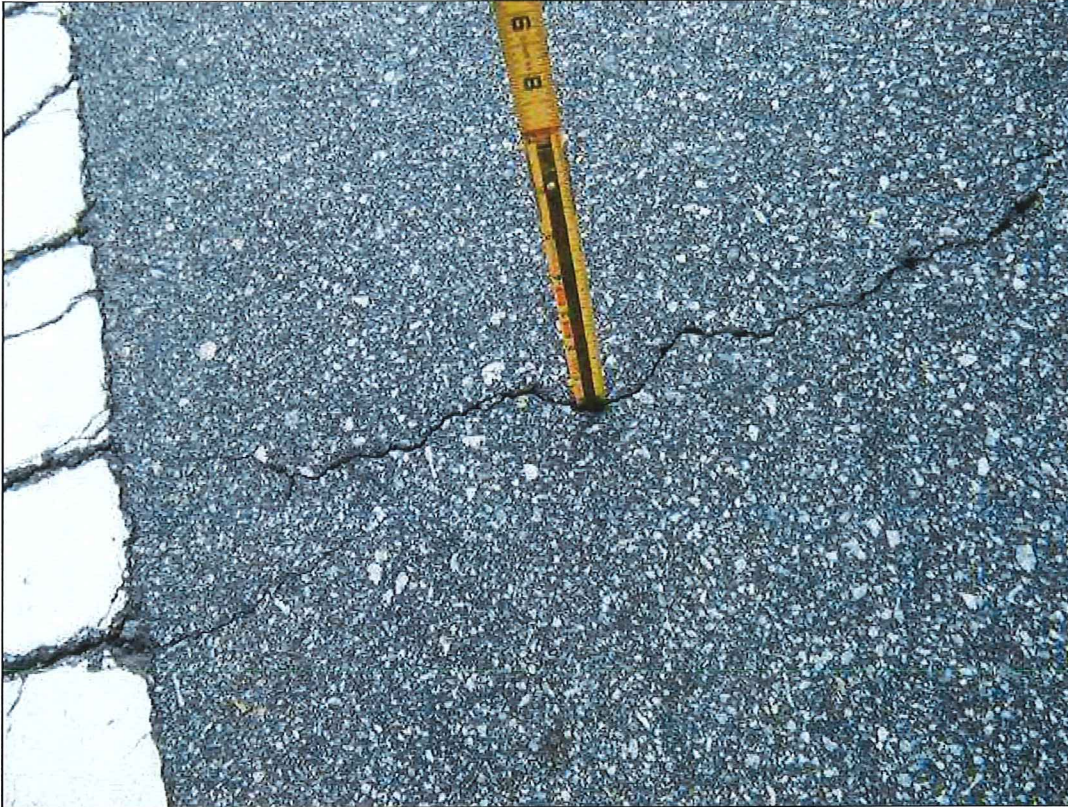
2 Square Feet of Crack (Wearing Surface): Width of more than 0.05 in. or spacing of less than 1.0 ft.

Span 2 Wearing Surface: 2 Square Feet of Crack (Wearing Surface): Width of more than 0.05 in. or spacing of less than 1.0 ft.

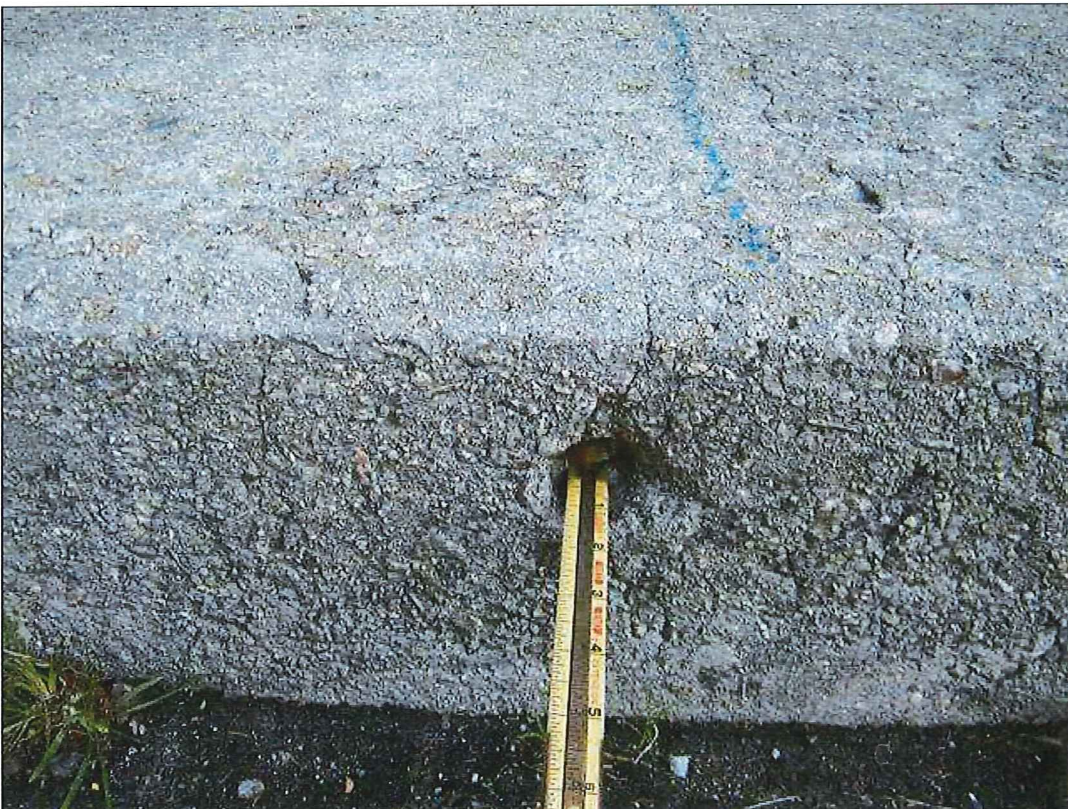
2 Feet of Spall Area: Spall greater than 1 in. deep or greater than 6 in. diameter. Does not warrant structural review. over bent 3.

Span 4 Right Bridge Rail: 2 Feet of Spall Area: Spall greater than 1 in. deep or greater than 6 in. diameter. Does not warrant structural review. over bent 3.

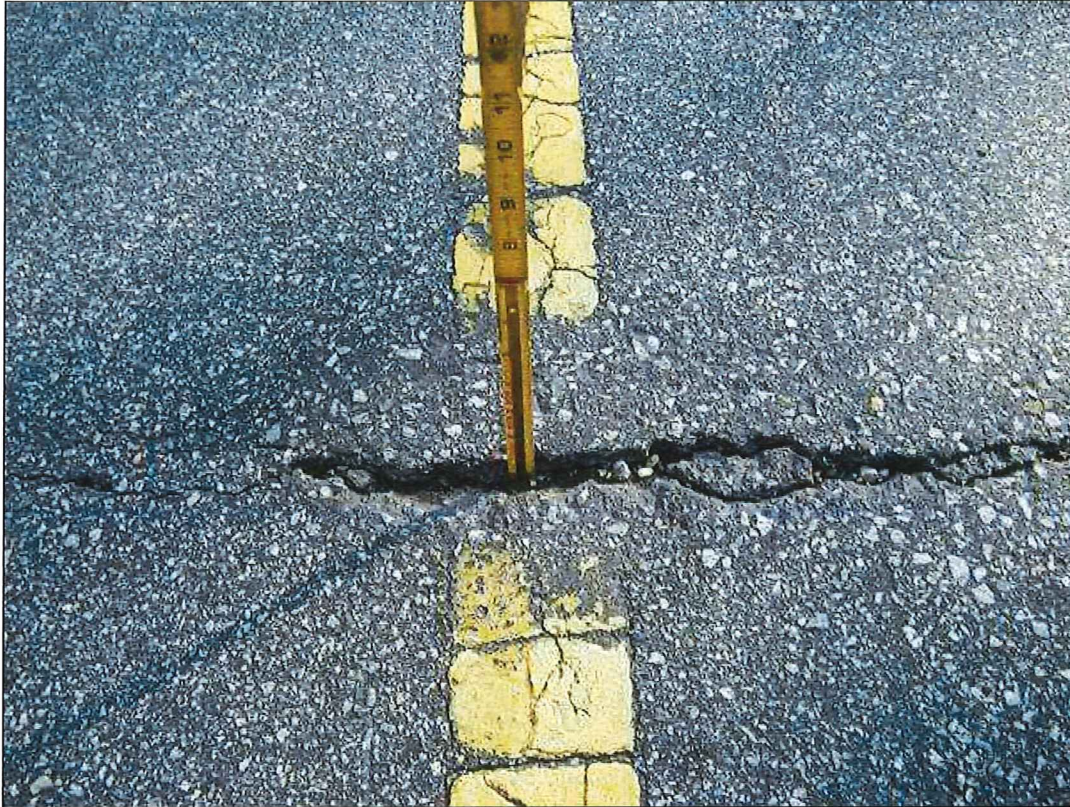
26 Square Feet of Crack (Wearing Surface): Width of more than 0.05 in. or spacing of less than 1.0 ft. in both lanes.

Span 4 Wearing Surface: 26 Square Feet of Crack (Wearing Surface): Width of more than 0.05 in. or spacing of less than 1.0 ft. in both lanes.

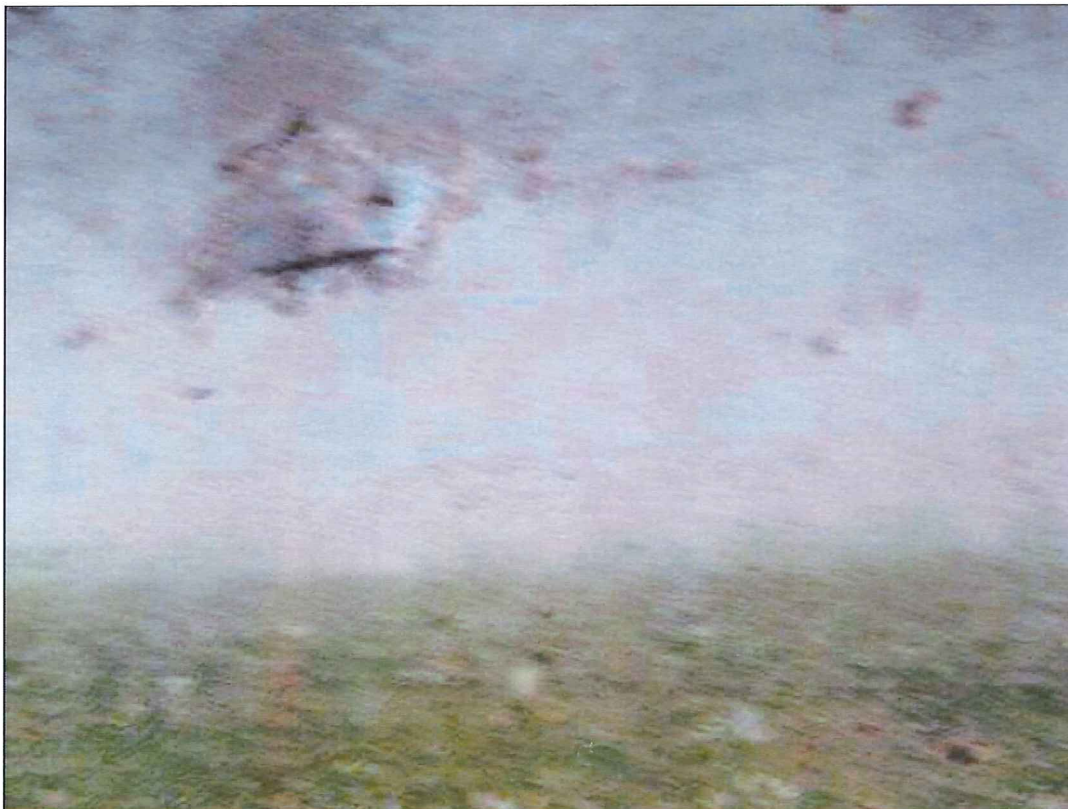
1 Feet of spalled Area: Spall greater than 1 in. deep or greater than 6 in. diameter. Area is 1' long, 20" below deck, and 1" deep. Does not warrant structural review.

End Bent 1 Abutment/Backwall : 1 Feet of spalled Area: Spall greater than 1 in. deep or greater than 6 in. diameter. Area is 1' long, 20" below deck, and 1" deep. Does not warrant structural review.

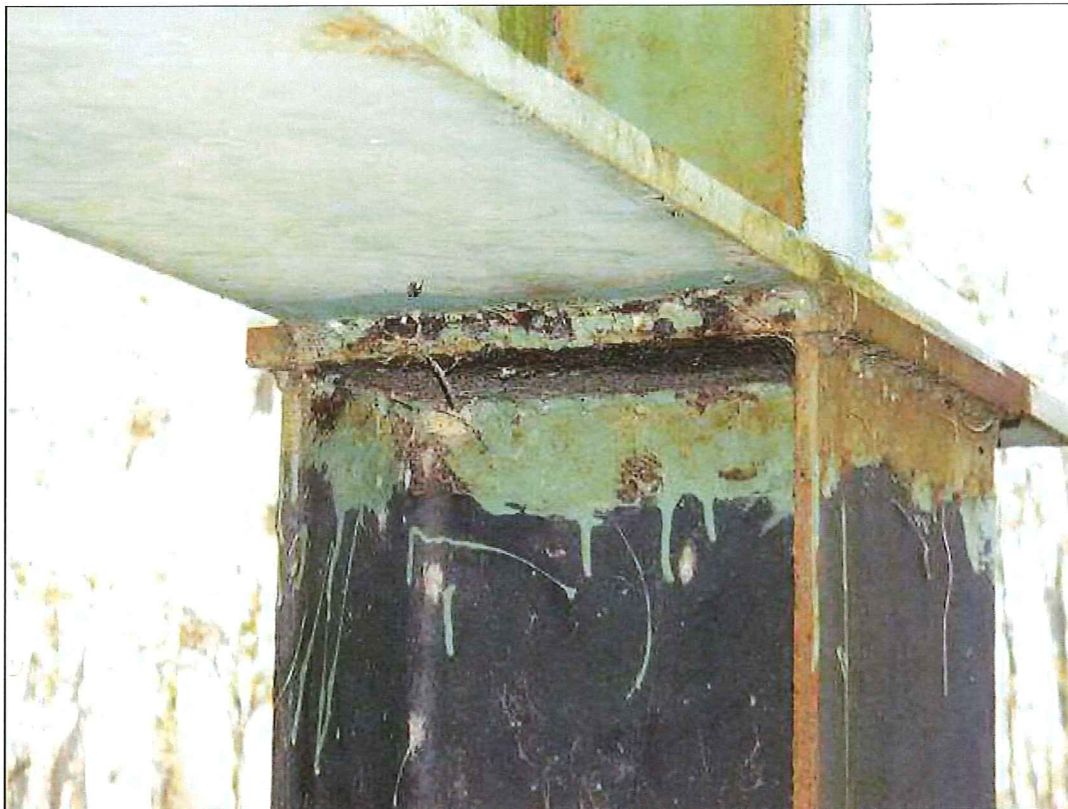
Bent 1 Pile 2: 1 Each of Corrosion: Corrosion of the steel has initiated.

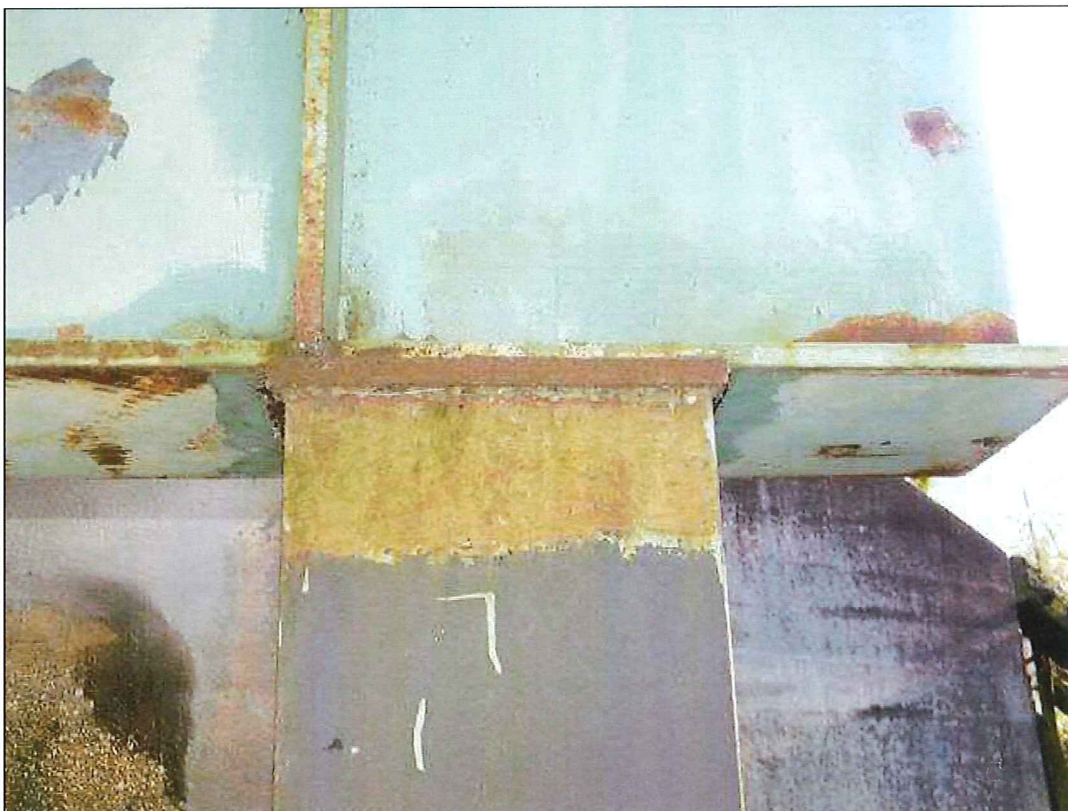
Bent 1 Pile 1: 1 Each of Corrosion: Corrosion of the steel has initiated at top of pile.

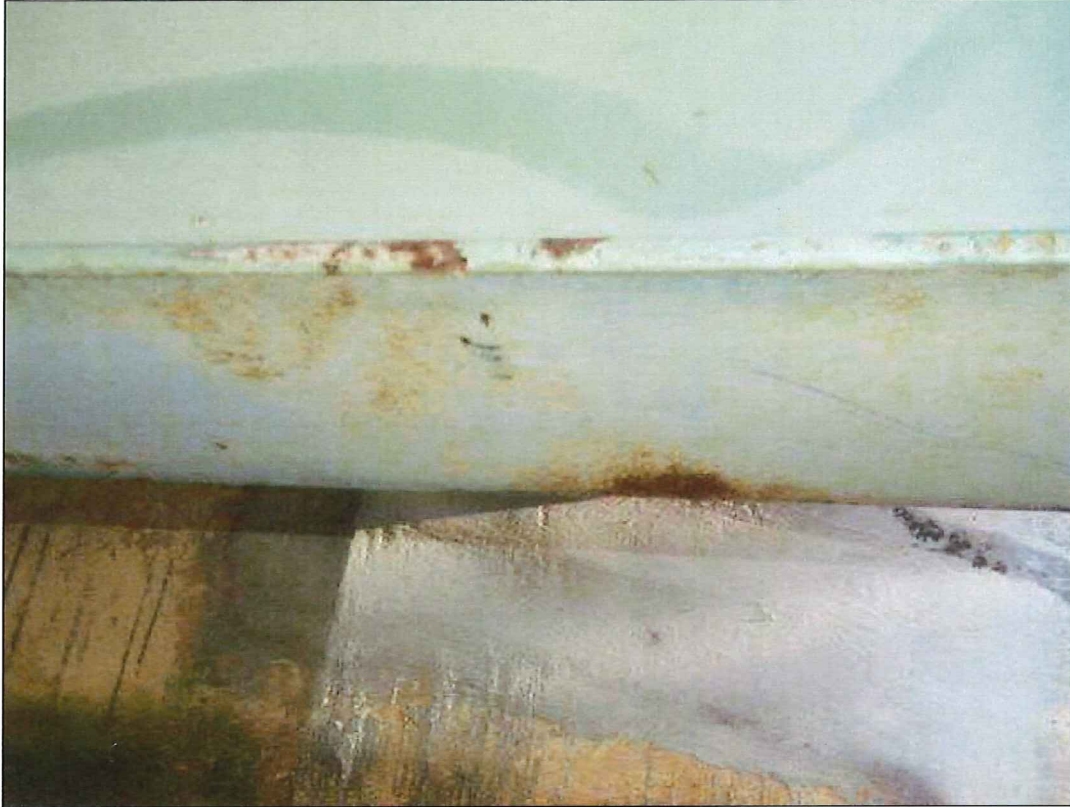
10 Feet of Corrosion: Corrosion of the steel has initiated.F

Bent 1 Cap : 10 Feet of Corrosion: Corrosion of the steel has initiated.F

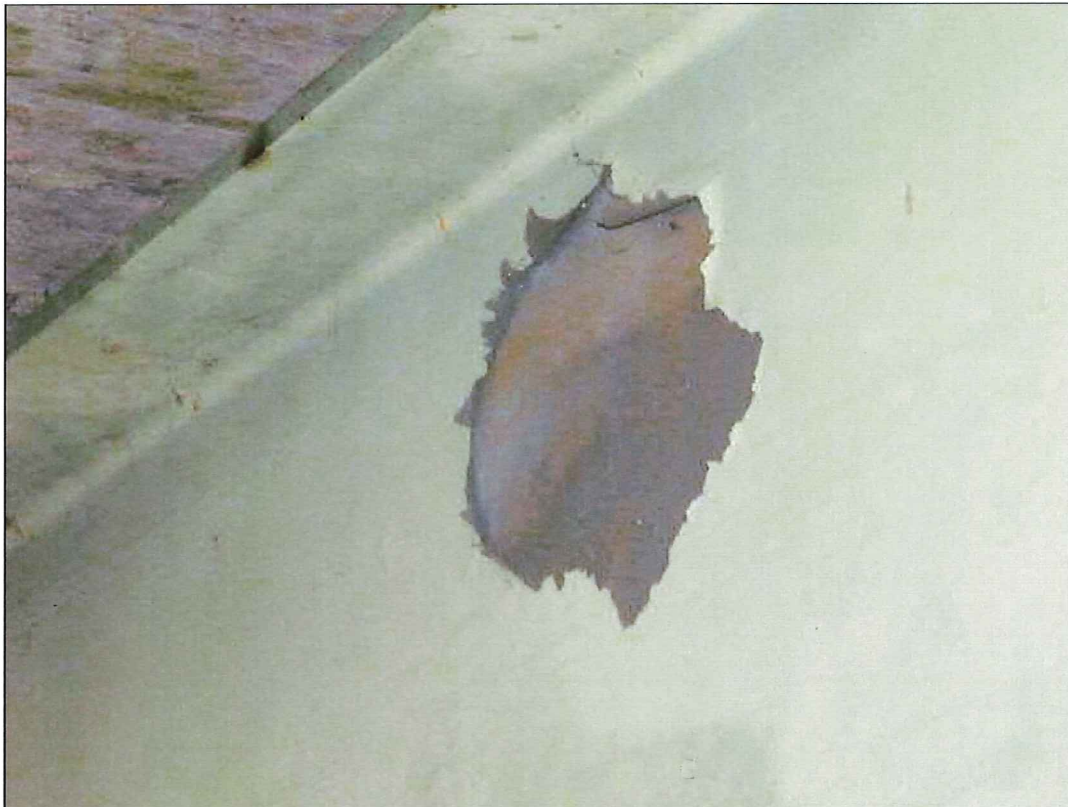
Bent 1 Cap : 12 Square Feet of Effectiveness (Steel Protective Coatings): Limited effectiveness.

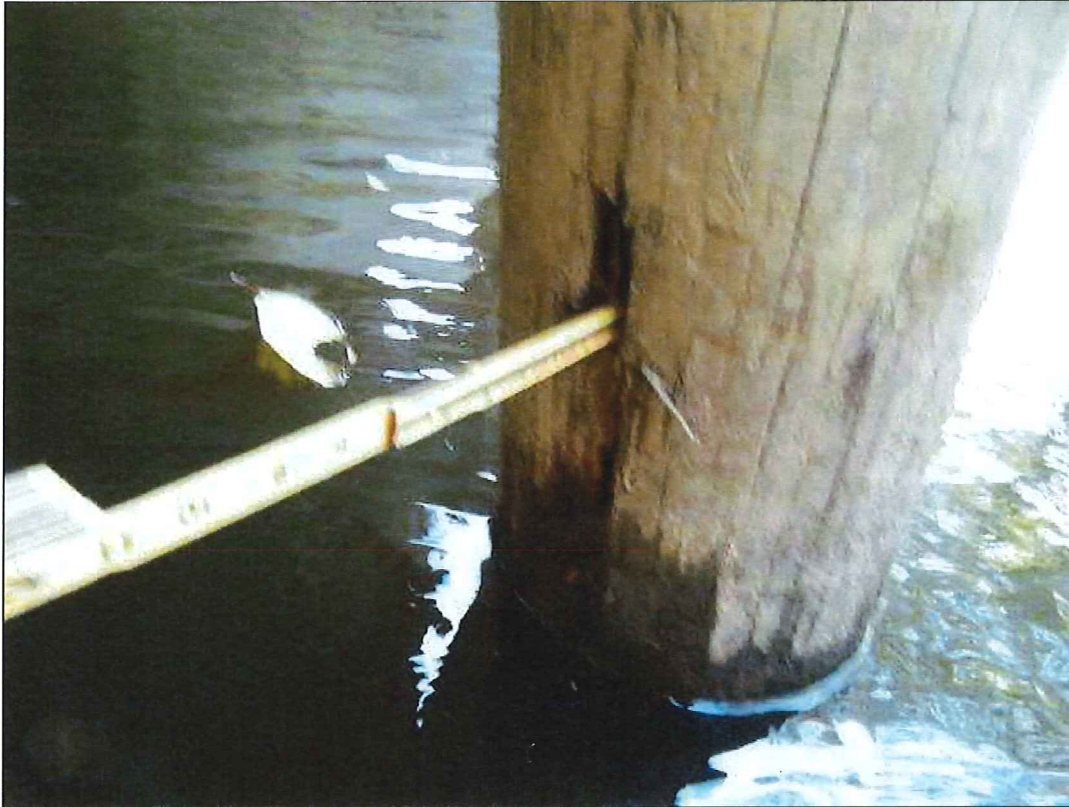
1 Each of Decay/Section Loss: Affects 10% or more of the member but does not warrant structural review. 5' from deck, 1' wide, 1.5" deep.

Bent 1 Pile 1: 1 Each of Decay/Section Loss: Affects 10% or more of the member but does not warrant structural review. 5' from deck, 1' wide, 1.5" deep.

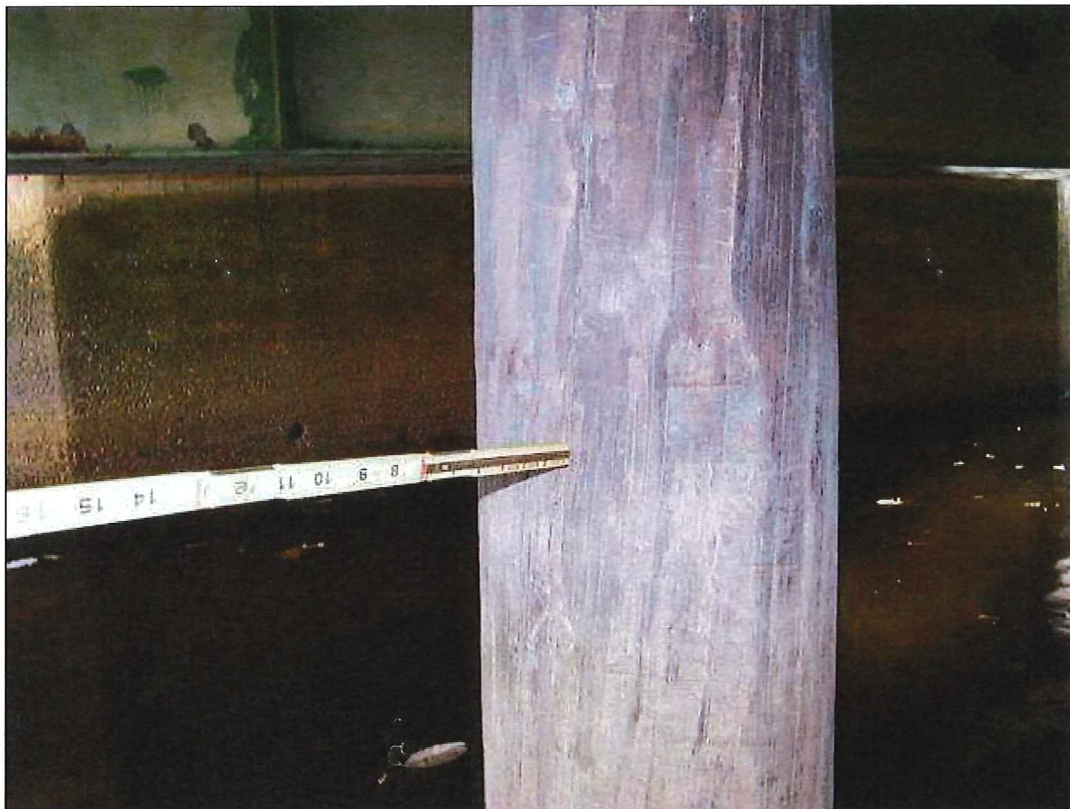
Bent 1 Pile 5: 1 Each of Check/Shake: Penetrates 5%-50% of the thickness of the member and not in the tension zone. 5' from bottom of cap down, 1" wide, and 1" deep.

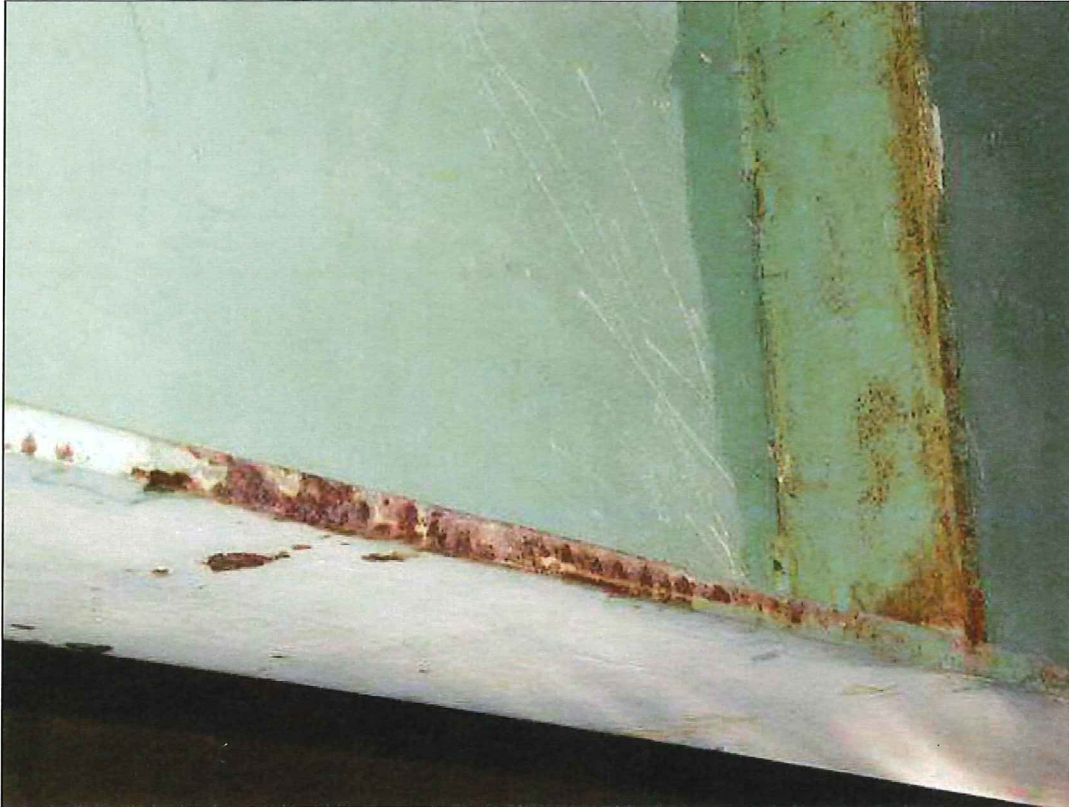
Bent 1 Cap : 4 Feet of Corrosion: Freckled Rust. Corrosion of the steel has initiated.

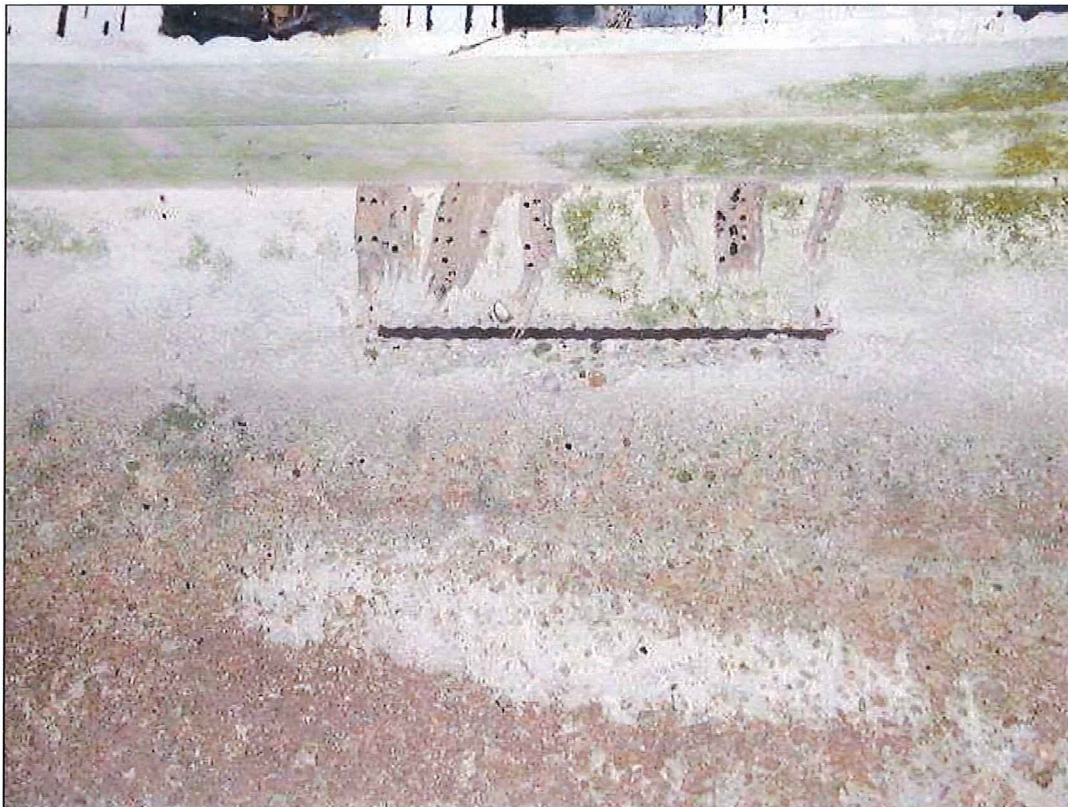
Bent 2 Cap : 2 Feet of Spall. Spall greater than 1 inch deep or greater than 6 inches in diameter. Condition does not warrant structural Review. 2' wide, 1" deep, 2' from deck down.

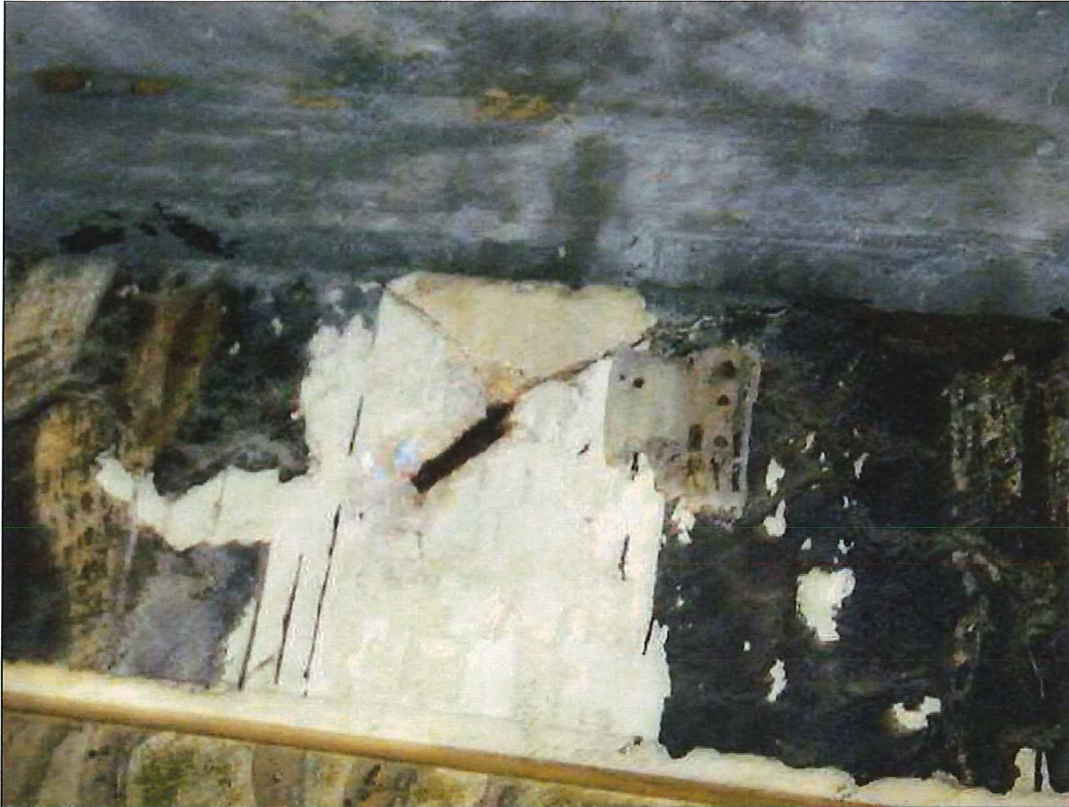
Bent 2 Cap : 1 Feet of Spall. Spall greater than 1 inch deep or greater than 6 inches in diameter. Condition does not warrant structural Review. 1' wide, 1" deep, at top of cap.

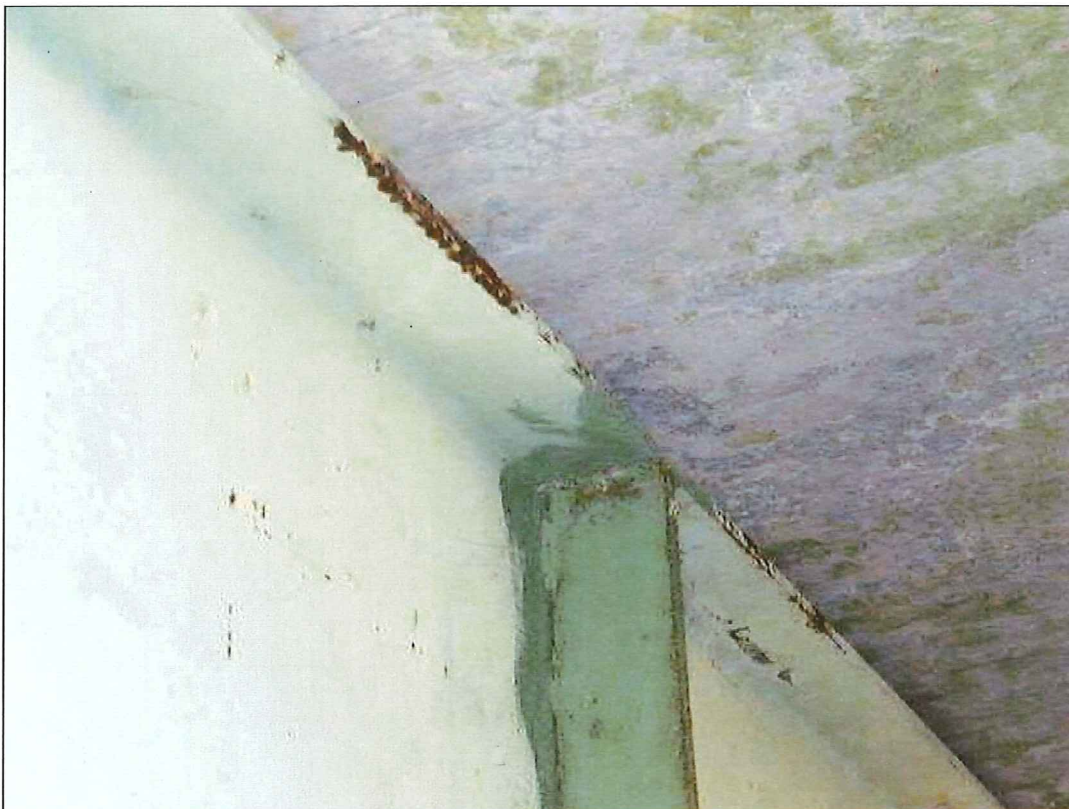
Bent 1 Cap : 10 Feet of Corrosion: Freckled Rust. Corrosion of the steel has initiated.

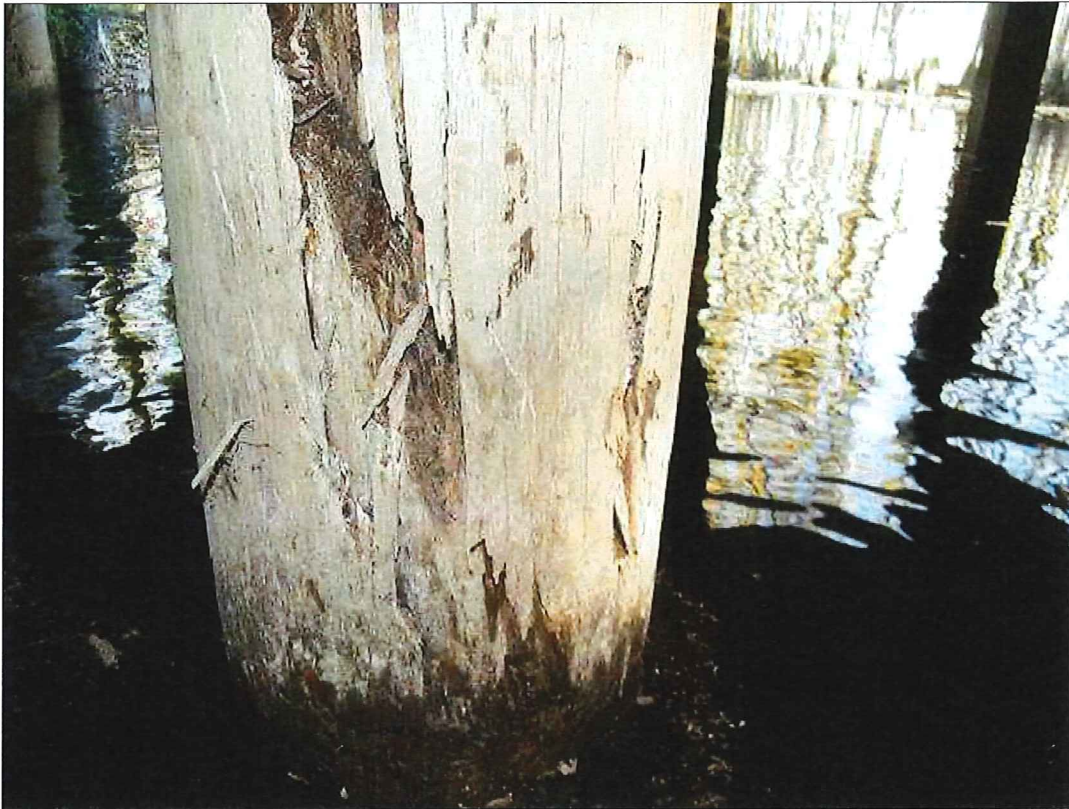
1 Each of Decay/Section Loss: Affects 10% or more of the member but does not warrant structural review. 2.5" deep, 10" wide, and 14" tall, starts 30" below cap. Outer shell starts 16" below cap, extends down 42" and 12" wide in northwest face.  
**PRIORITY MAINTENANCE ISSUED**

Bent 3 Pile 3: 1 Each of Decay/Section Loss: Affects 10% or more of the member but does not warrant structural review. 2.5" deep, 10" wide, and 14" tall, starts 30" below cap. Outer shell starts 16" below cap, extends down 42" and 12" wide in northwest face

| MMS Code | Description of Function | Unit | Quantity | Remarks | Est. Cost |
|---|---|---|---|---|---|
| 3344 | Repair / Replace Timber Substructure Components | LF | <del>4</del> <i>TSE</i><br><i>2/23/15</i> | PILE 3 AT BENT 3. 1 Each of Decay/Section Loss: Affects 10% or more of the member but does not warrant structural review. 2.5" deep, 10" wide, and 14" tall, starts 30" below cap. Outer shell starts 16" below cap, extends down 42" and 12" wide in northwest face. PRIORITY MAINTENANCE ISSUED | |

| MMS Code | MMS Description | Quantity |
|---|---|---|
| 3344 | Repair / Replace Timber Substructure Components | 4              LF |

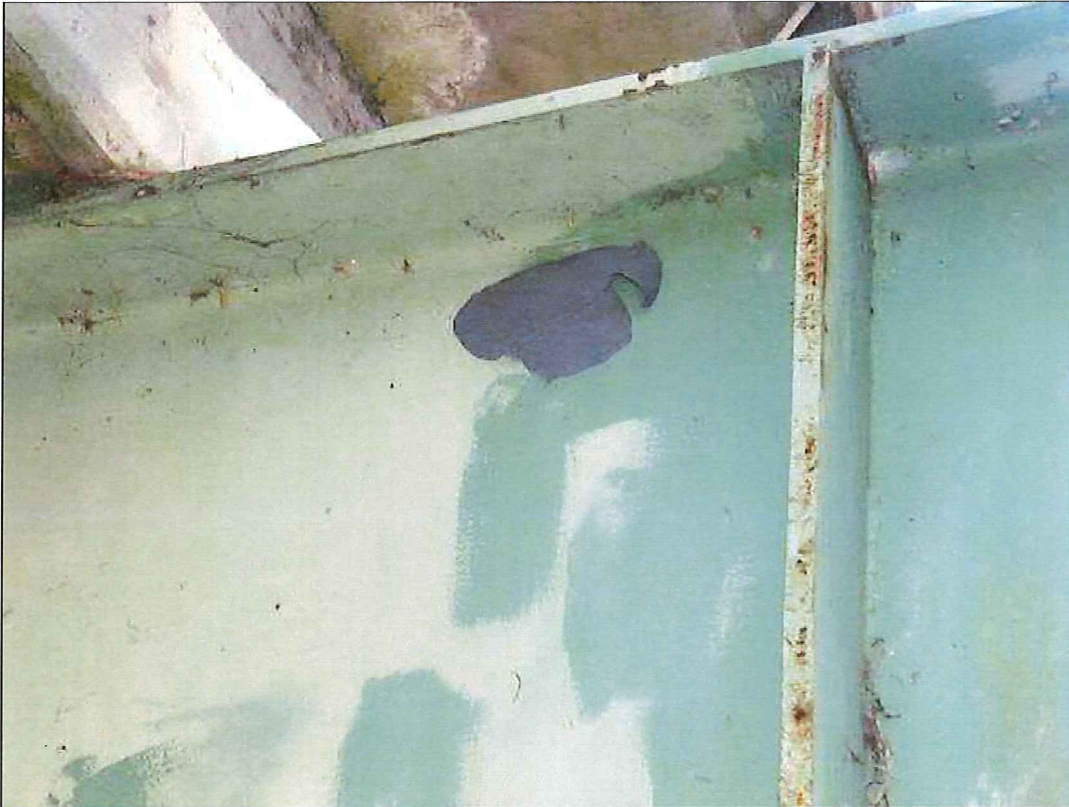
8 Feet of Corrosion: Freckled Rust. Corrosion of the steel has initiated. on left end  
4 Square Feet of Peeling/Bubbling/Cracking (steel Protective Coatings): Finish and primer coats.

Bent 1 Cap : 4 Square Feet of Peeling/Bubbling/Cracking (steel Protective Coatings): Finish and primer coats.

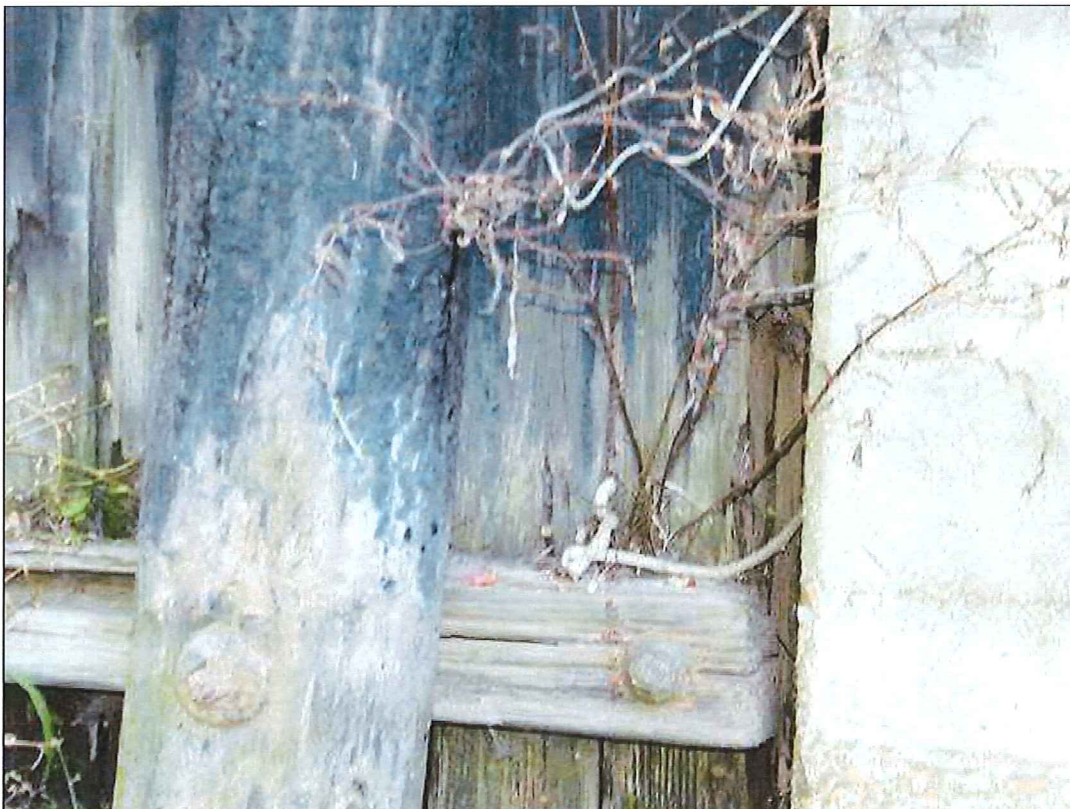
| Details | ALL WINGWALLS DECAYED. | | | | | |

decayed wings on all corners

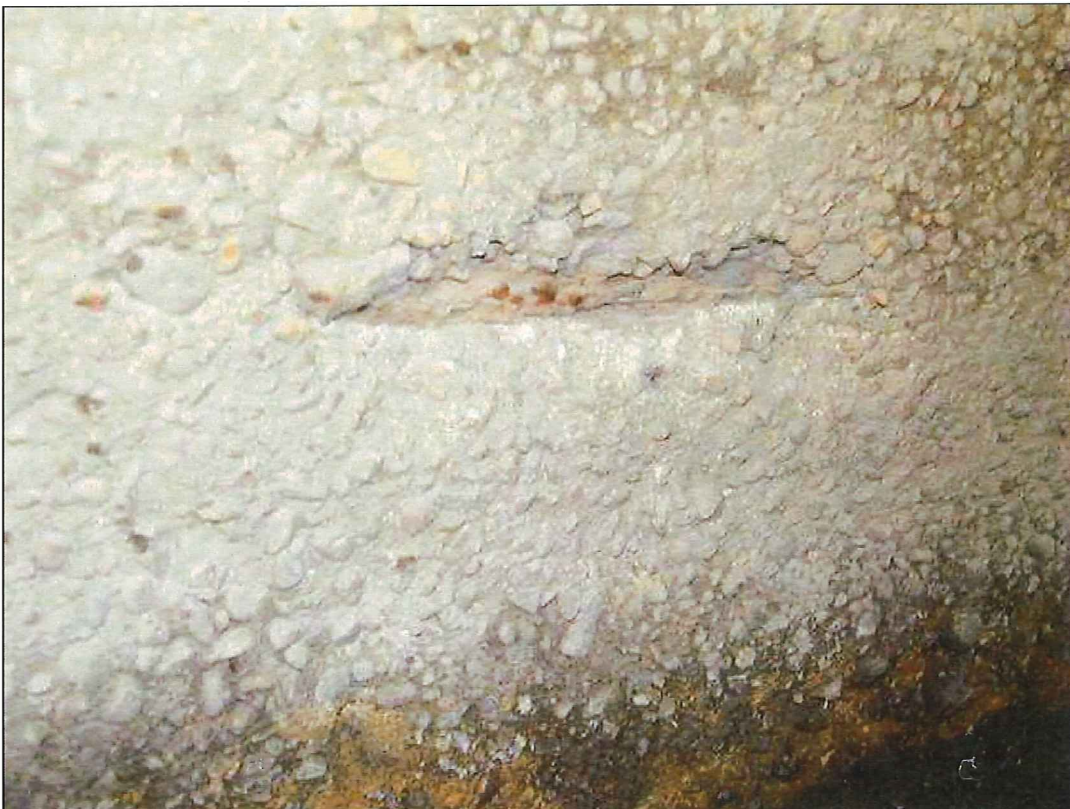
1 Feet of spalled Area: Spall greater than 1 in. deep or greater than 6 in. diameter. Area is 1' long, 84" below deck, and 1.5" deep. Does not warrant structural review.

End Bent 1:1 Feet of spalled Area: Spall greater than 1 in. deep or greater than 6 in. diameter. Area is 1' long, 84" below deck, and 1.5" deep. Does not warrant structural review.

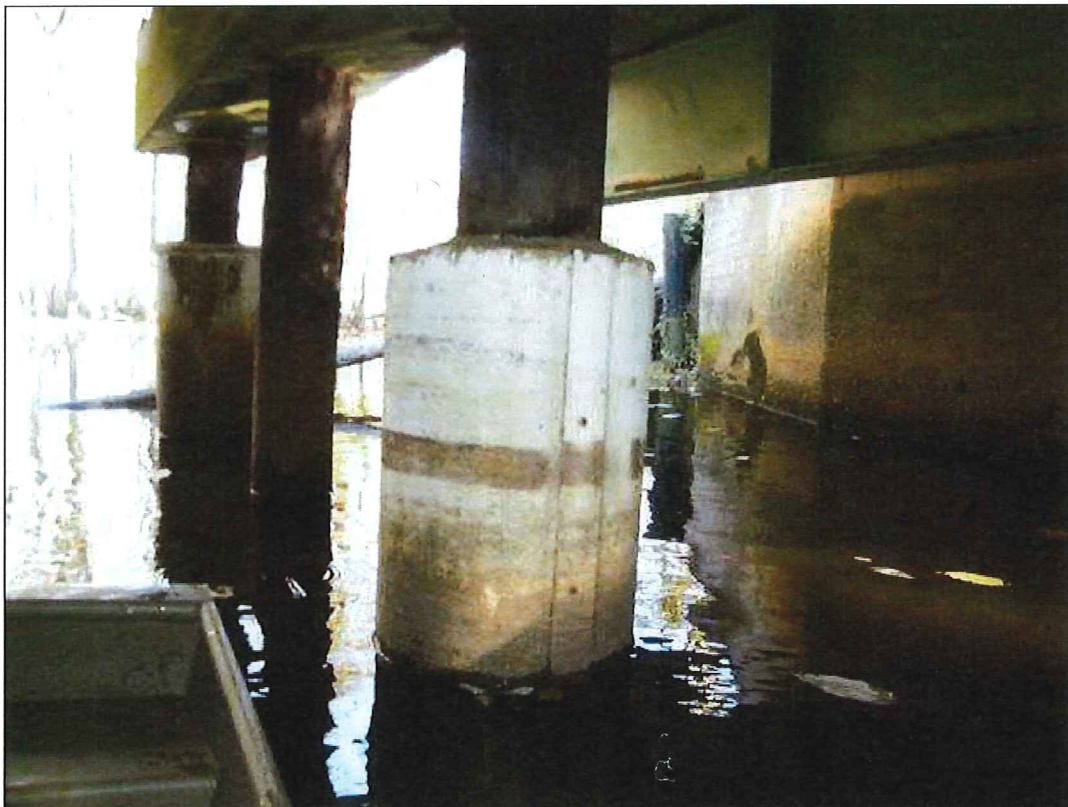
pile 4 at bent 1 encased, pile 6 is similar.

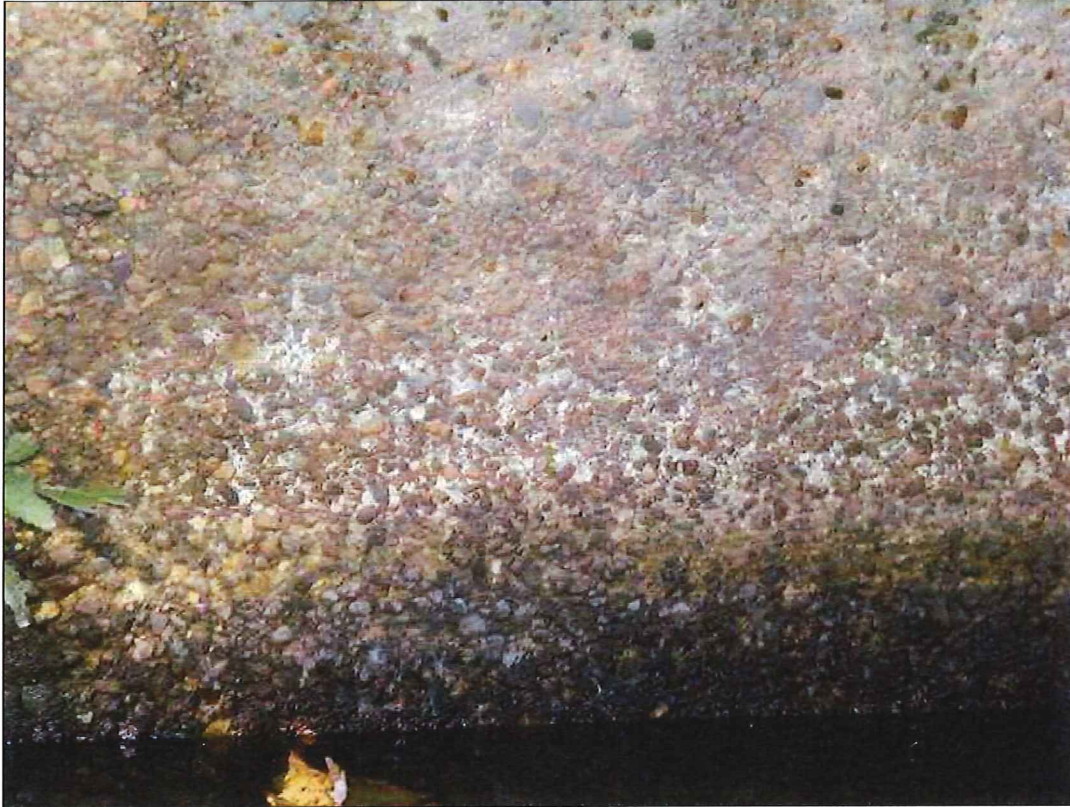
44 Feet of Abrasion/Wear (PSC/RC): Abrasion or wearing has exposed coarse aggregate but the aggregate remains secure in the concrete.

End Bent 2: 44 Feet of Abrasion/Wear (PSC/RC): Abrasion or wearing has exposed coarse aggregate but the aggregate remains secure in the concrete.
