NC DEPARTMENT OF TRANSPORTATION  
DIVISION OF HIGHWAYS  
STRUCTURE MANAGEMENT UNIT

# Structure Safety Report

## Routine Element Inspection

COUNTY: CHOWAN STRUCTURE NUMBER: 200020 FREQUENCY: 24 MONTHS

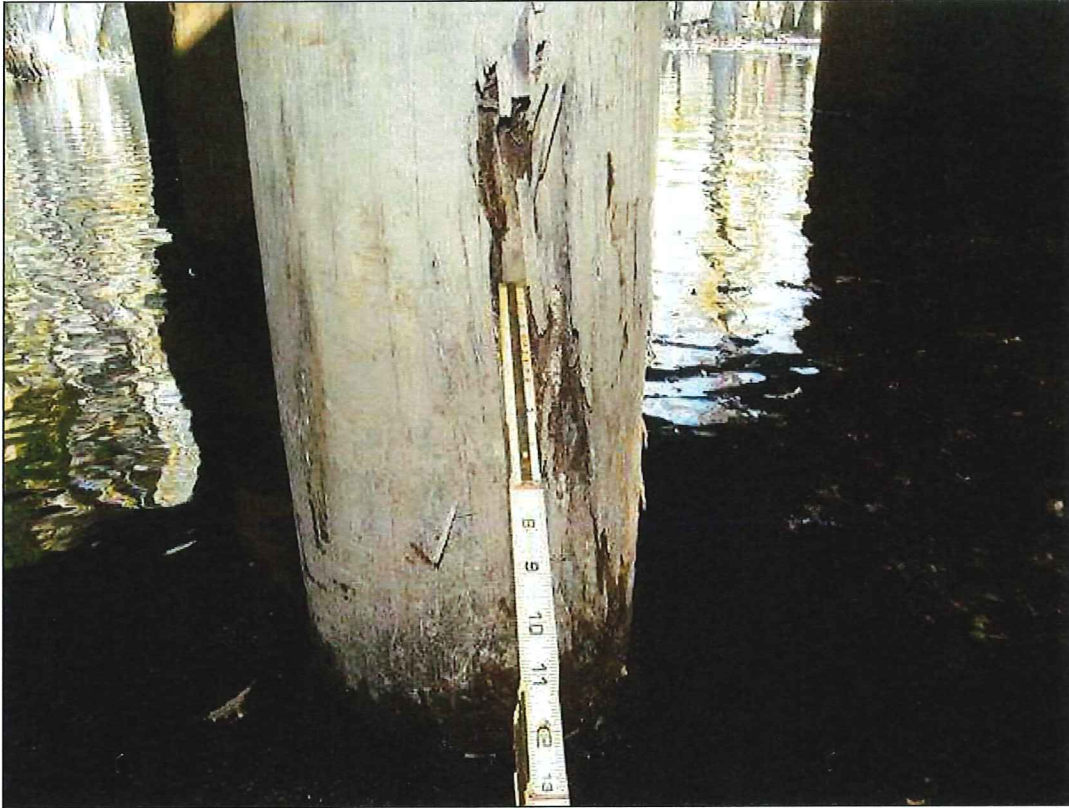
PILE 3 AT BENT 3. 1 EACH OF DECAY/SECTION LOSS: AFFECTS 10% OR MORE OF THE MEMBER BUT DOES NOT WARRANT STRUCTURAL REVIEW. 2.5" DEEP, 10" WIDE, AND 14"

| MMS Code | Description of Function | Unit | Quantity | Remarks | Est. Cost |
|---|---|---|---|---|---|
| 3344 | Repair / Replace Timber Substructure Components | LF | 4 | PILE 3 AT BENT 3. 1 Each of Decay/Section Loss: Affects 10% or more of the member but does not warrant structural review. 2.5" deep, 10" wide, and 14" tall, starts 30" below cap. Outer shell starts 16" below cap, extends down 42" and 12" wide in northwest face. PRIORITY MAINTENANCE ISSUED | |

| MMS Code | MMS Description | Quantity |
|---|---|---|
| 3344 | Repair / Replace Timber Substructure Components | 4              LF |
