NC DEPARTMENT OF TRANSPORTATION  
DIVISION OF HIGHWAYS  
STRUCTURE MANAGEMENT UNIT

## Structure Safety Report

### Routine Element Inspection

COUNTY: HALIFAX STRUCTURE NUMBER: 410015 FREQUENCY: 24 MONTHS

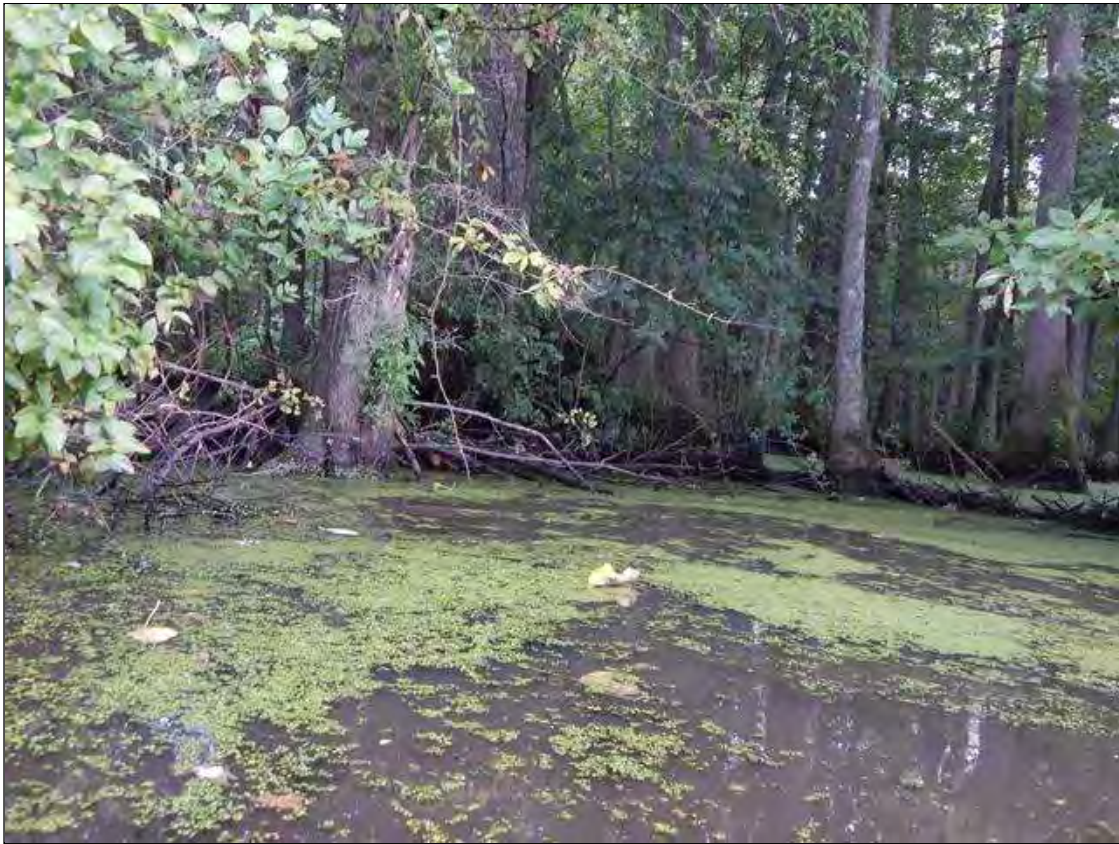
BEAVERDAM BLOCKING STREAM ON WEST SIDE, 50' FROM STRUCTURE.

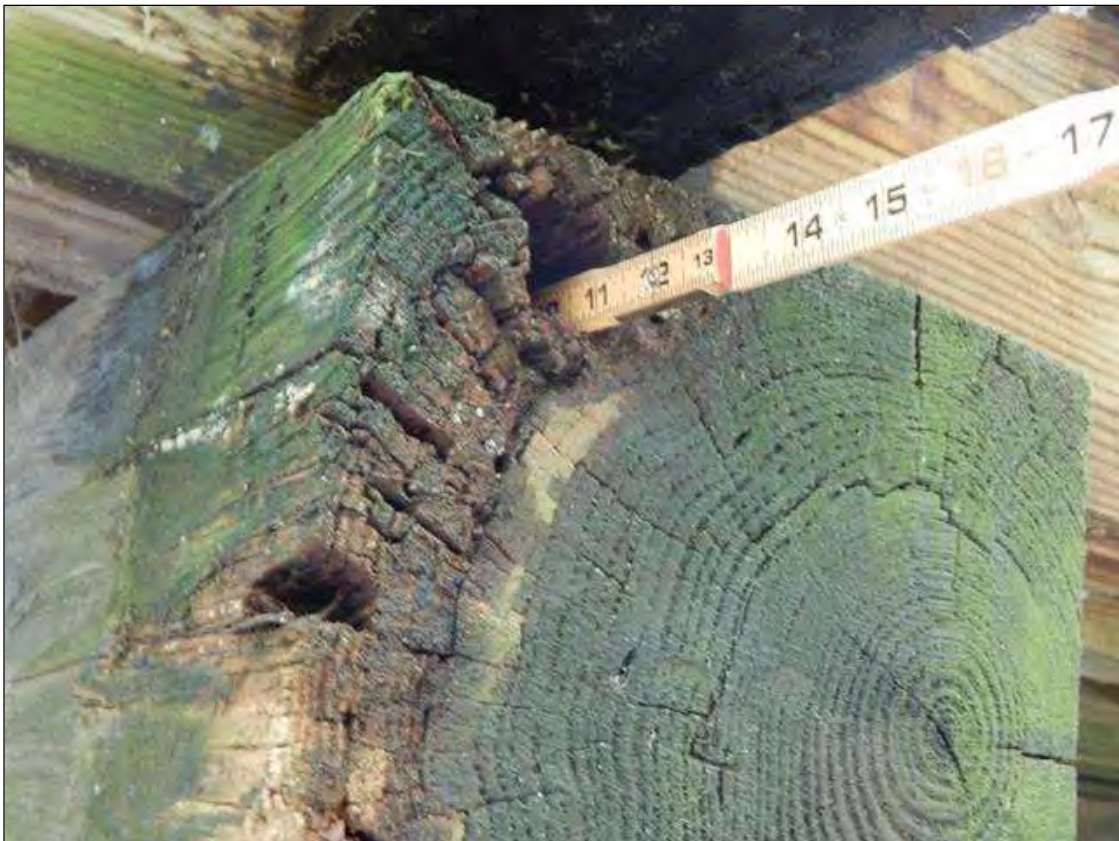
Bent 1 Cap : 1 Feet of Decay/Section Loss: AREA IS 11" DEEP, 12" TALL, AND 3" WIDE. Affects 10% or more of the member but does not warrant structural review.

| MMS Code | Description of Function | Unit | Quantity | Remarks | Est. Cost |
|---|---|---|---|---|---|
| 3344 | Repair / Replace Timber Substructure Components | LF | 1 | STRUCTURE HAS A POSTED WEIGHT LIMIT OF SV 24 TONS TTST 39 TONS. LEFT END OF BENT 1 CAP DECAYED, AREA IS 11" DEEP, 12" TALL, AND 3" WIDE. | |

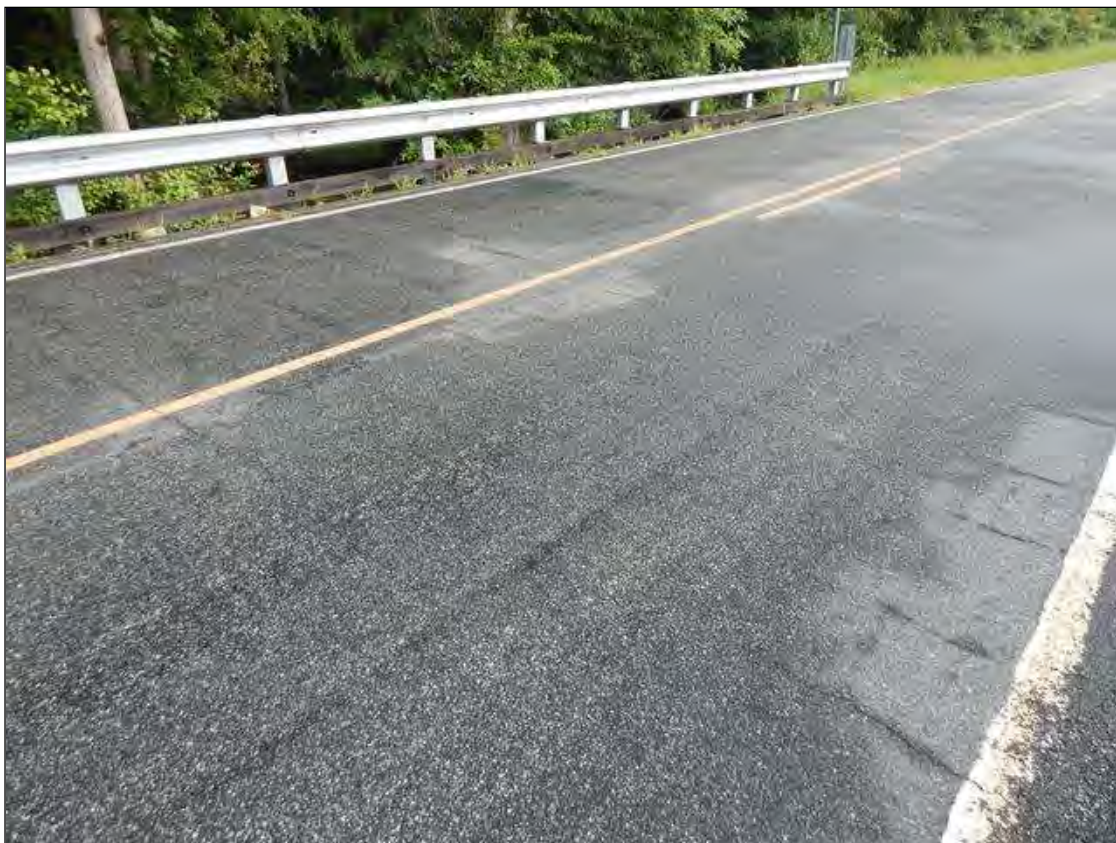
WEARING SURFACE

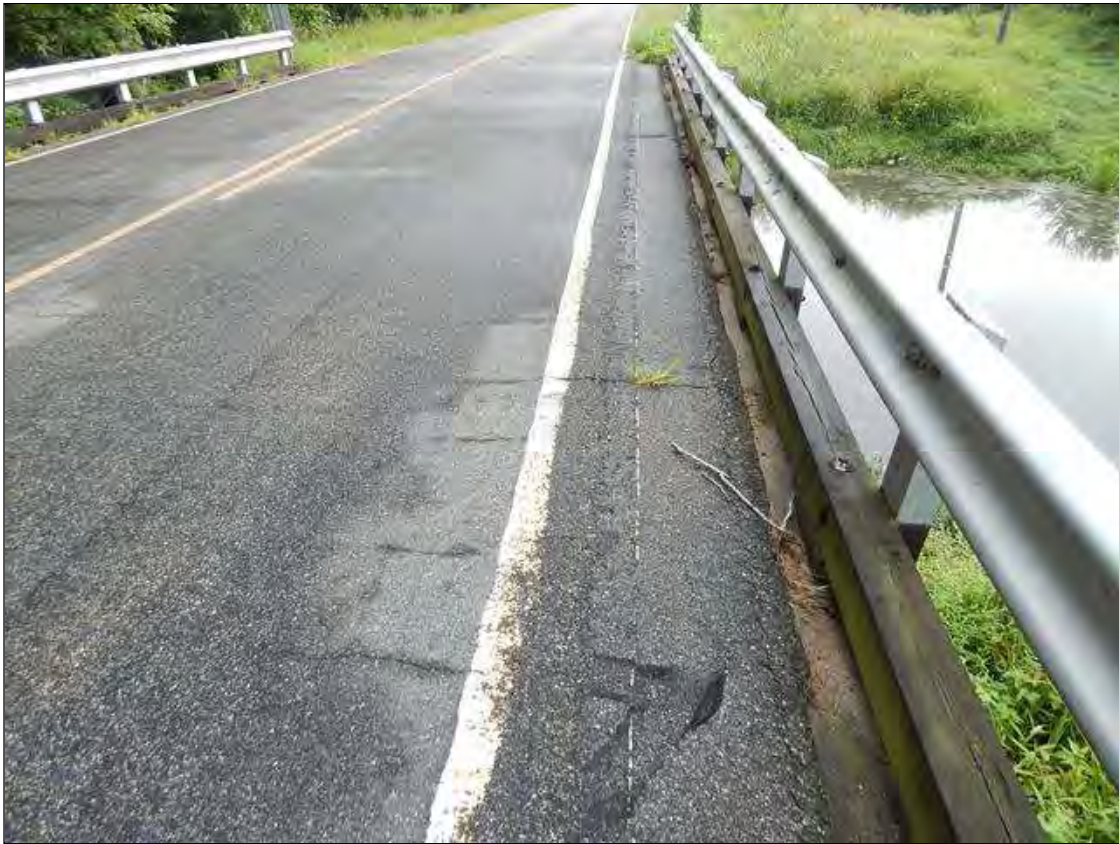
WEARING SURFACE

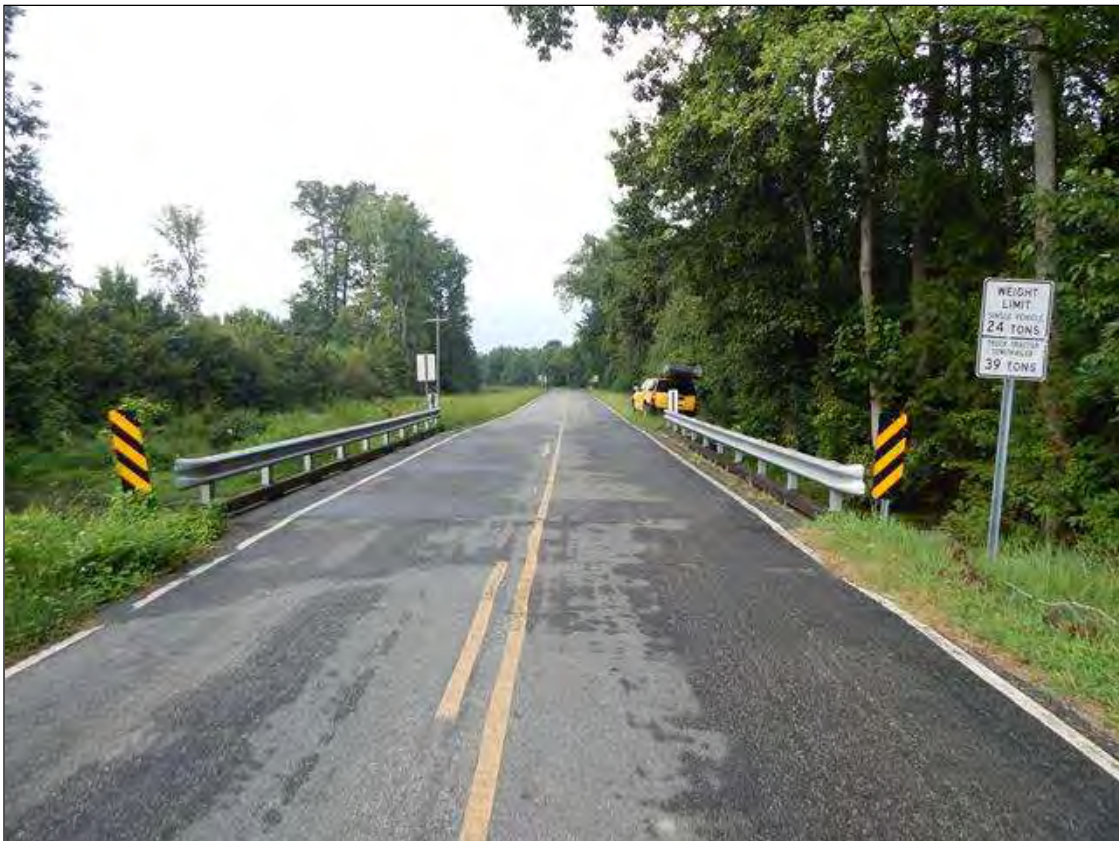
LOOKING SOUTH WEIGHT LIMIT SV 24 TTST 39 TONS

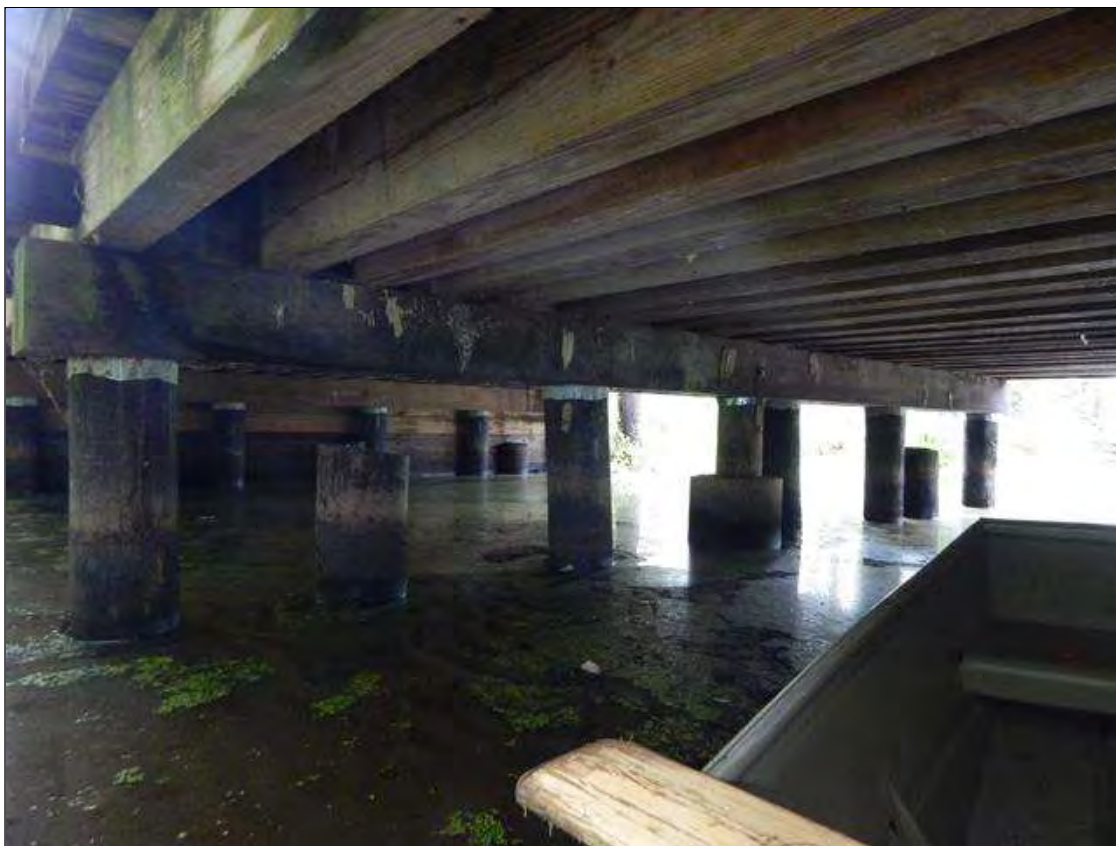
BENT 2 WITH PILE 3 ENCASED

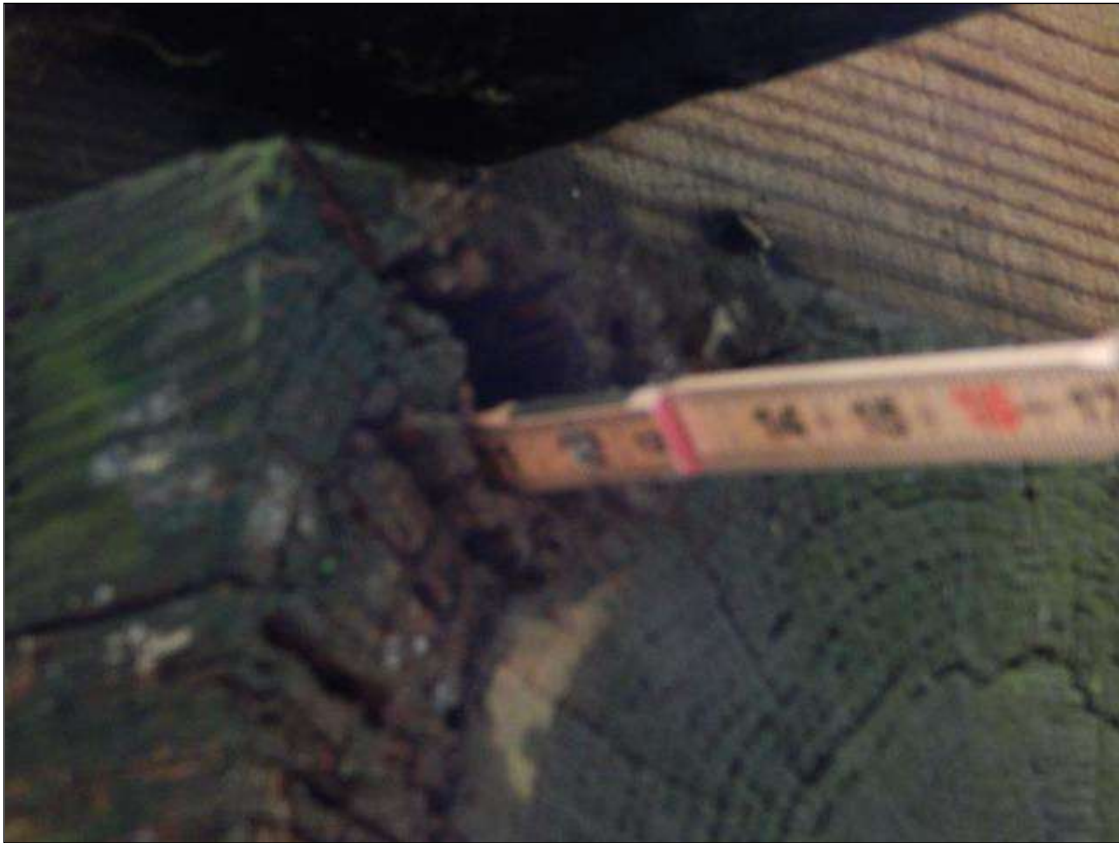
LEFT END OF BENT 1 CAP DECAYED, AREA IS 11" DEEP, 12" TALL, AND 3" WIDE.

| MMS Code | MMS Description | Quantity |
|---|---|---|
| 3344 | Repair / Replace Timber Substructure Components | 1 LF |

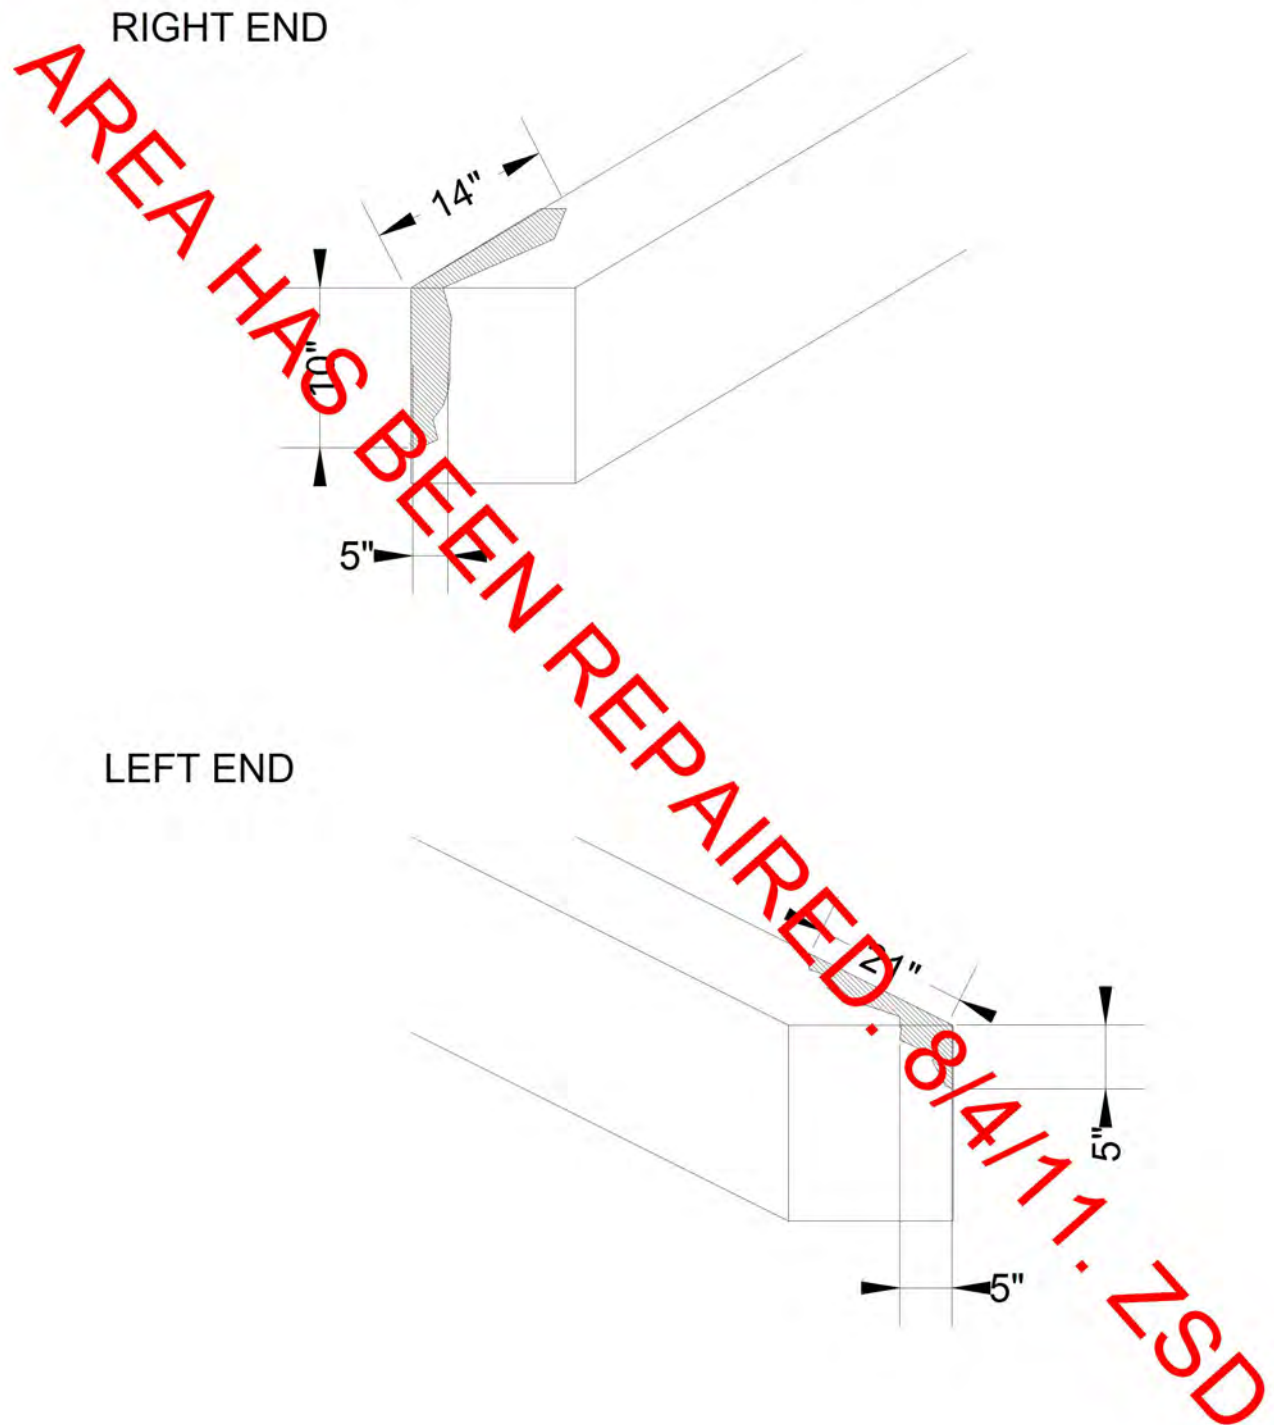
PRIORITY MAINTENANCE SKETCH 1

DECAYED AREAS IN ENDS OF END B  
ENT 1 CAP.

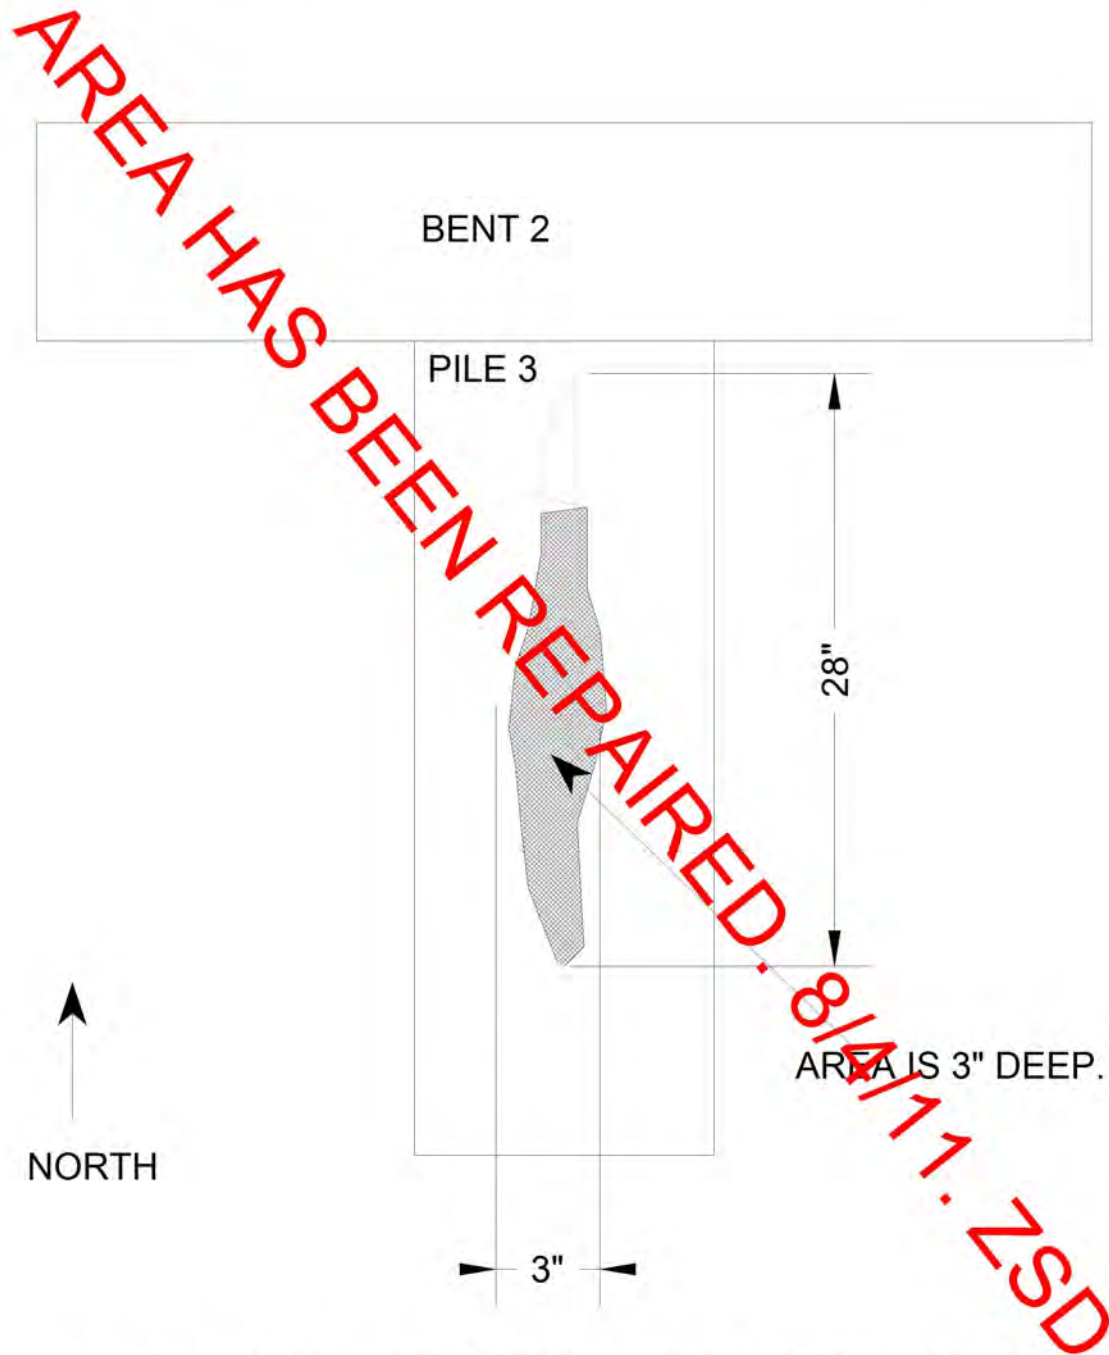
OUTER SHELL IS STILL INTACT OVER UPER PART OF DECAYED AREA.
