NC DEPARTMENT OF TRANSPORTATION  
DIVISION OF HIGHWAYS  
STRUCTURE MANAGEMENT UNIT

## Structure Safety Report

### Routine Element Inspection

COUNTY: HALIFAX STRUCTURE NUMBER: 410065 FREQUENCY: 24 MONTHS  
FACILITY CARRIED: SR1100 MILE POST: \_\_\_\_\_  
LOCATION: 1.0MI.W.NC125  
FEATURE INTERSECTED: DEEP CREEK  
LATITUDE: 36° 4' 26.05" LONGITUDE: 77° 26' 24.44"  
SUPERSTRUCTURE: STEEL PLANK FLOOR ON CONT I-BEAMS  
SUBSTRUCTURE: E.BTS&BTS:TIMBER CAPS/TIMBER PILES @ VAR CTS.  
SPANS: 1@20';1@20'-3;1@20'-9;1@19'-6;1@20';1@20'-3;CONT  
☐ FRACTURE CRITICAL ☐ TEMPORARY SHORING ☐ SCOUR CRITICAL ☒ SCOUR PLAN OF ACTION  
PRESENT CONDITION: Fair INSPECTION DATE: 08/24/2015  
POSTED SV: 39 POSTED TTST: 39  
OTHER SIGNS PRESENT: 4 DELINEATORS

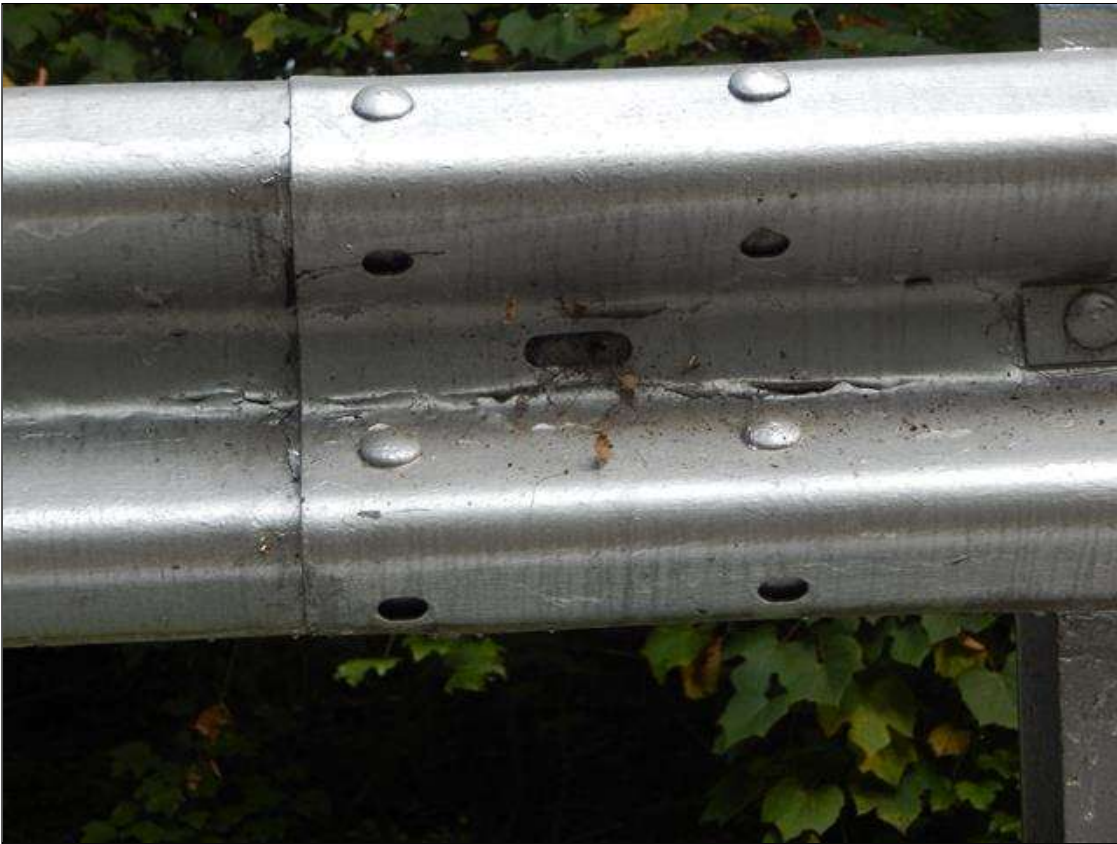
2 Feet of Connection: Missing bolts, rivets, or fasteners; broken welds; or pack rust with distortion but does not warrant a structural review.

Span 2 Left Bridge Rail: 2 Feet of Connection: Missing bolts, rivets, or fasteners; broken welds; or pack rust with distortion but does not warrant a structural review.

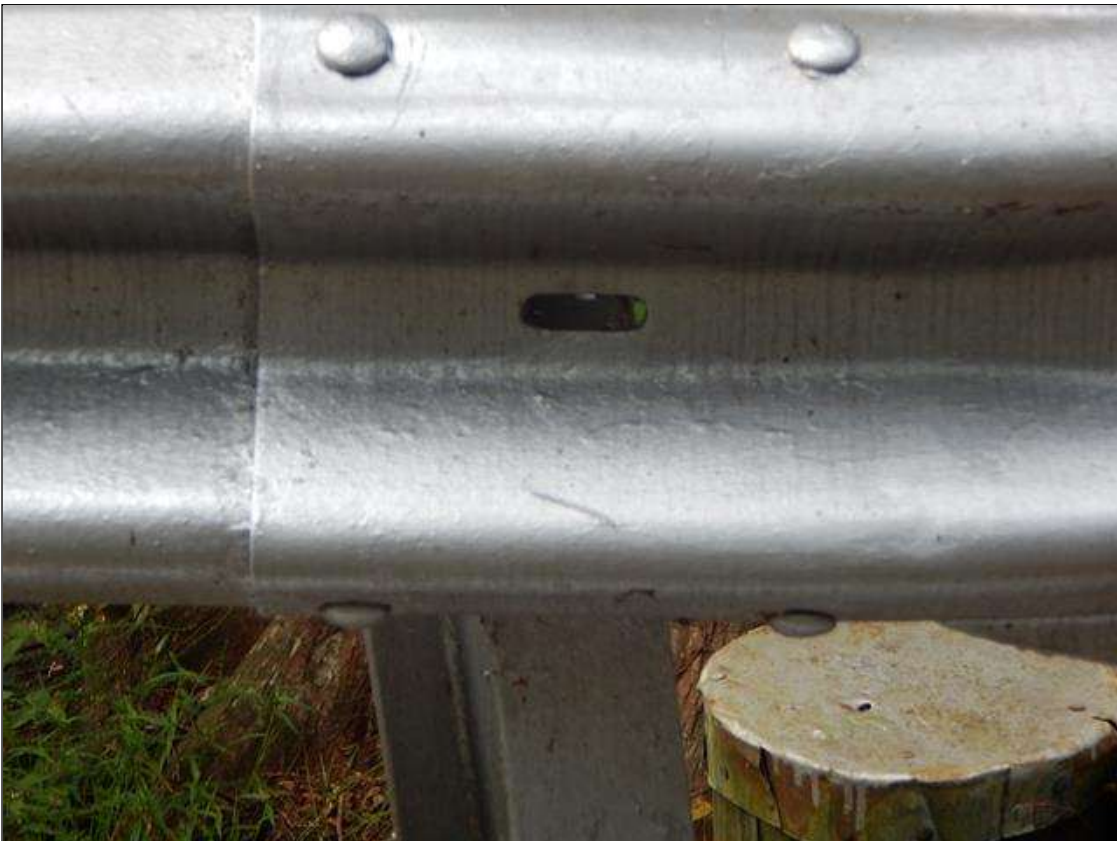
2 Feet of Connection: Missing bolts, rivets, or fasteners; broken welds; or pack rust with distortion but does not warrant a structural review.

Span 1 Right Bridge Rail: 2 Feet of Connection: Missing bolts, rivets, or fasteners; broken welds; or pack rust with distortion but does not warrant a structural review.

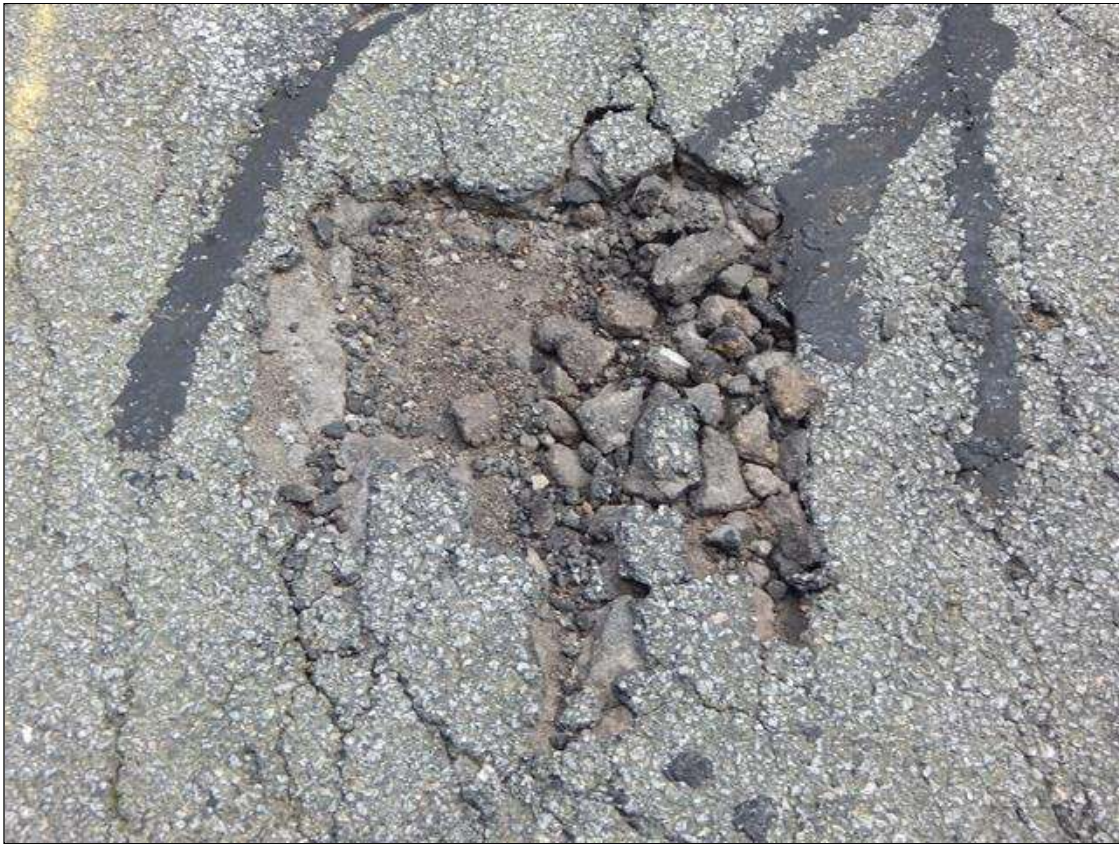
8 Square Feet of Spalled Area/Pothole (Wearing Surfaces): Spall 1 in. deep or greater or 6 in. diameter or greater. Patched area that is unsound or showing distress. Full depth pothole.

Span 2 Wearing Surface: 8 Square Feet of Spalled Area/Pothole (Wearing Surfaces): Spall 1 in. deep or greater or 6 in. diameter or greater. Patched area that is unsound or showing distress. Full depth pothole.

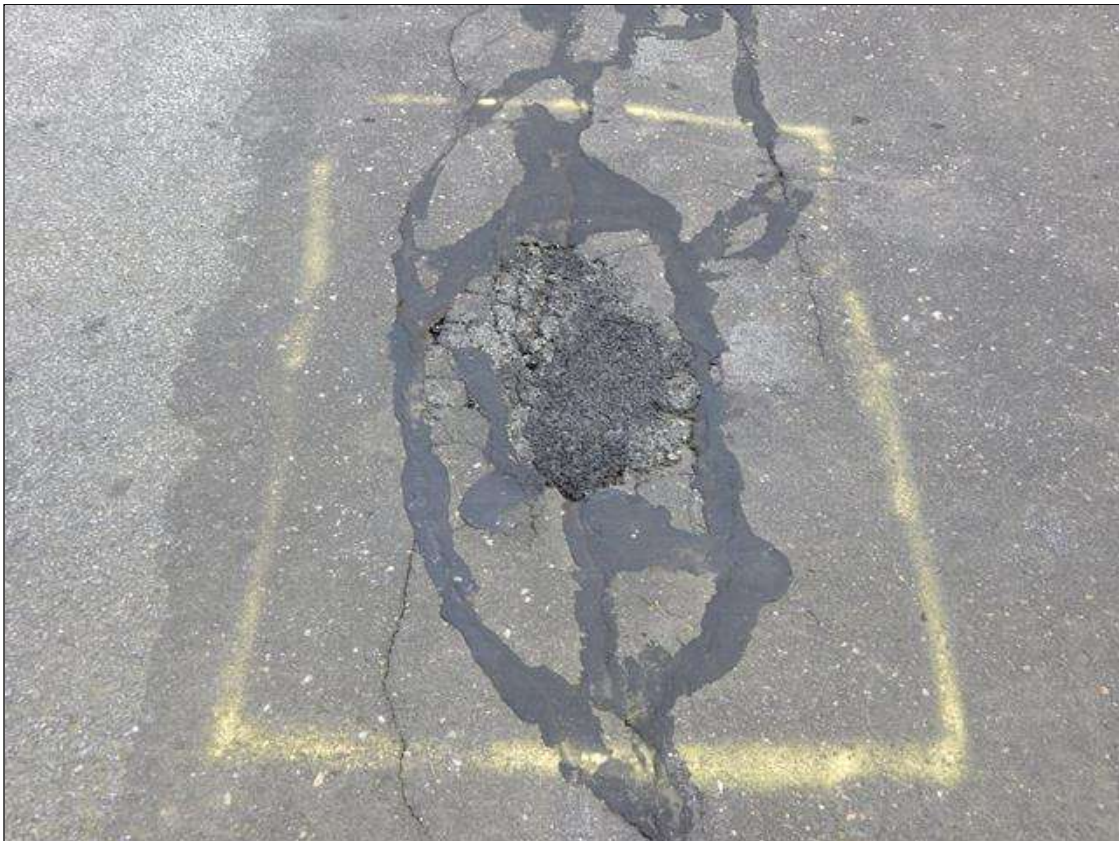
Span 6 Wearing Surface: 20 Square Feet of Crack (Wearing Surface): Width of more than 0.05 in. or spacing of less than 1.0 ft.

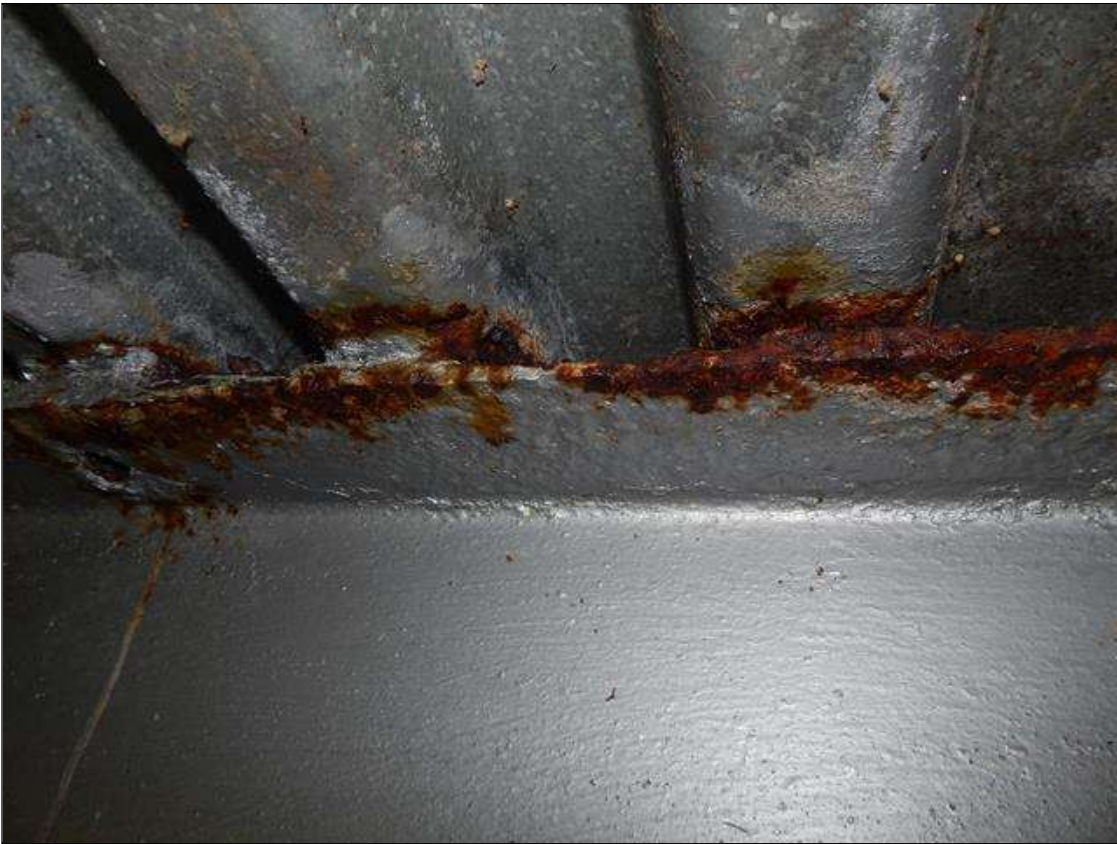
20 Feet of Corrosion IN TOP FLANGE, SPAN 2 WITH DOWN TO 1/8" REMAINING: Section loss is evident or pack rust is present but does not warrant structural review.  
20 Square Feet of Effectiveness (Steel Protective Coatings): Limited effectiveness.

Span 1 Beam 2: 20 Feet of Corrosion IN TOP FLANGE, SPAN 2 WITH DOWN TO 1/8" REMAINING: Section loss is evident or pack rust is present but does not warrant structural review.

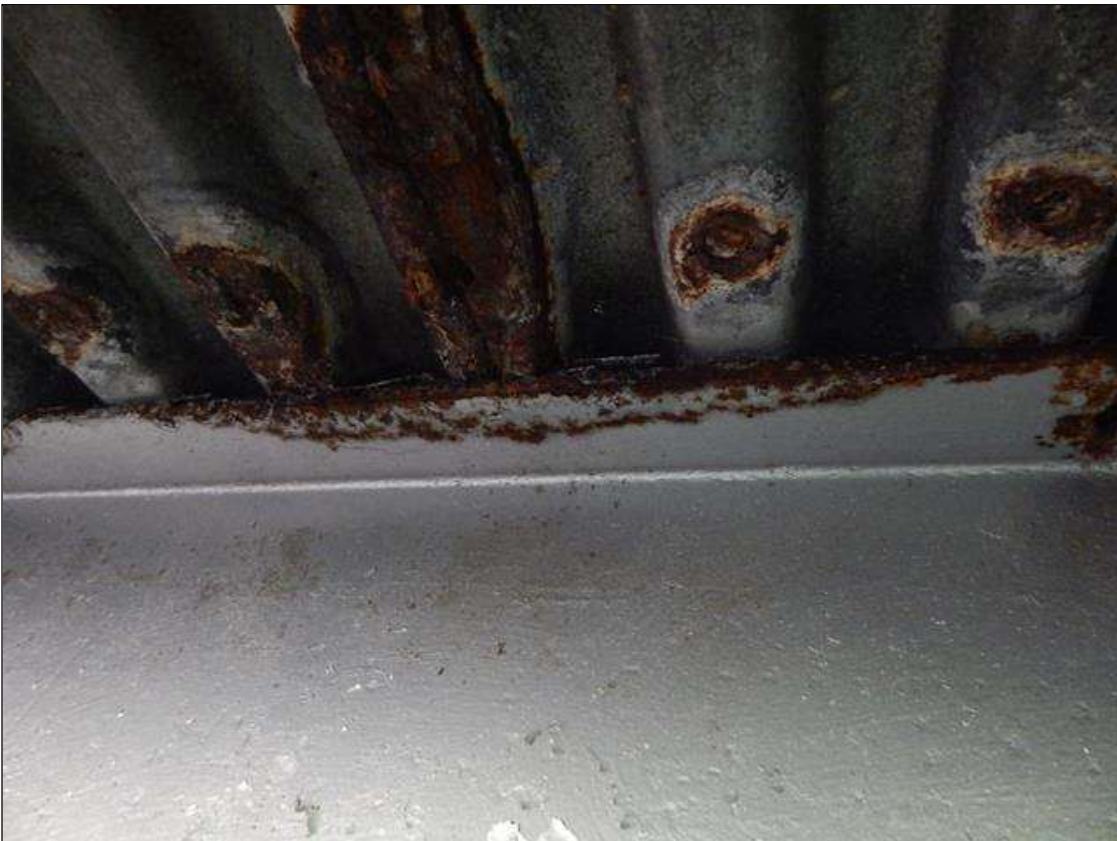
30 Feet of Corrosion: Section loss is present WITH 1/4" REMAINING. but does not warrant structural review.

SPAN 1, BEAM 3: 30 Feet of Corrosion: Section loss is present WITH 1/4" REMAINING. but does not warrant structural review

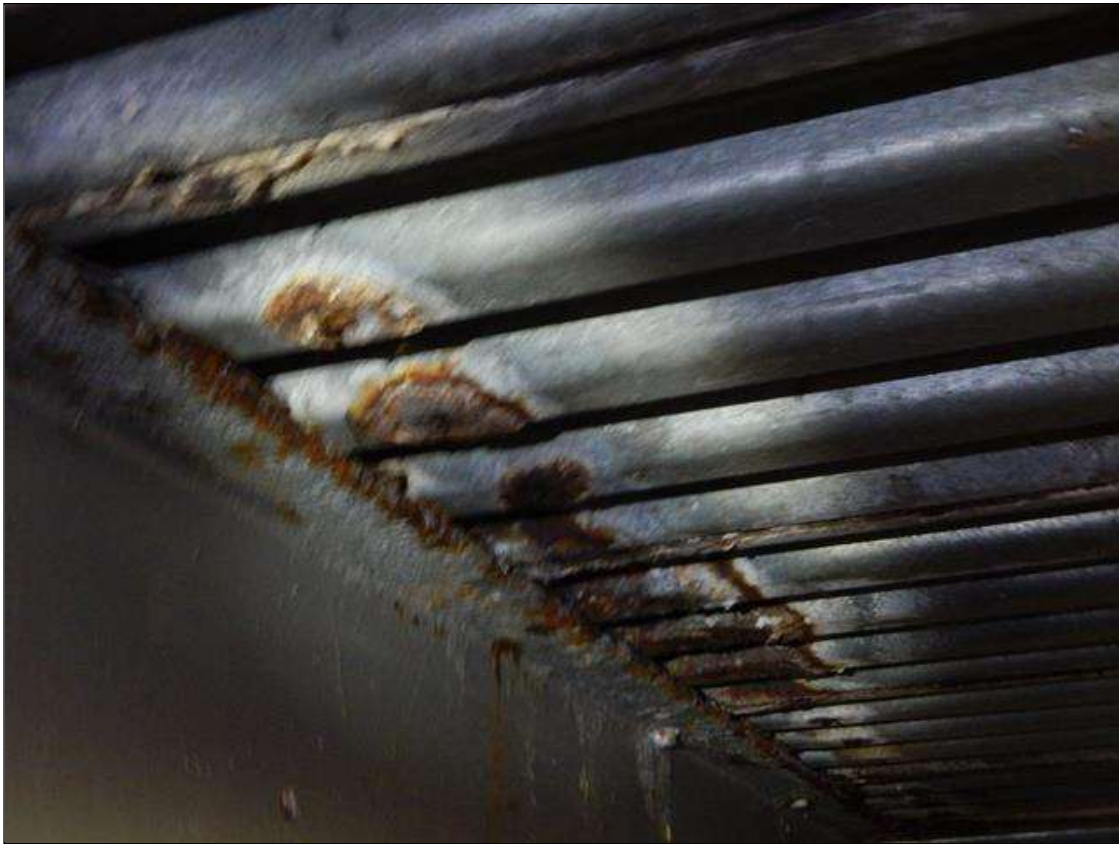
20 Feet of Corrosion: Section loss WITH 3/8" REMAINING IN TOP FLANGE AT MIDPOINT.is present but does not warrant structural review.

Span 1 Beam 5: 20 Feet of Corrosion: Section loss WITH 3/8" REMAINING IN TOP FLANGE AT MIDPOINT.is present but does not warrant structural review.

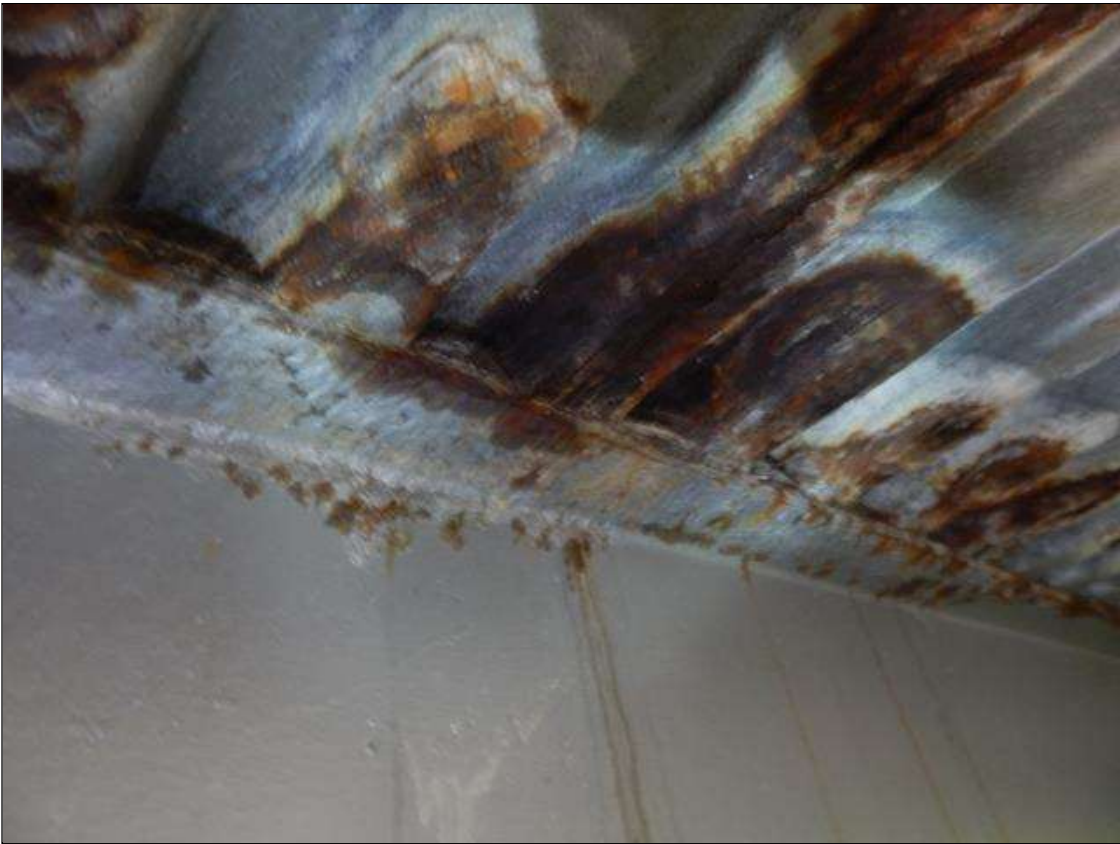
Span 1 Beam 7: 10 Feet of Corrosion: Section loss is evident or pack rust is present WITH 1/4" REMAINING IN TOP FLANGE IN SPAN 1, but does not warrant structural review.

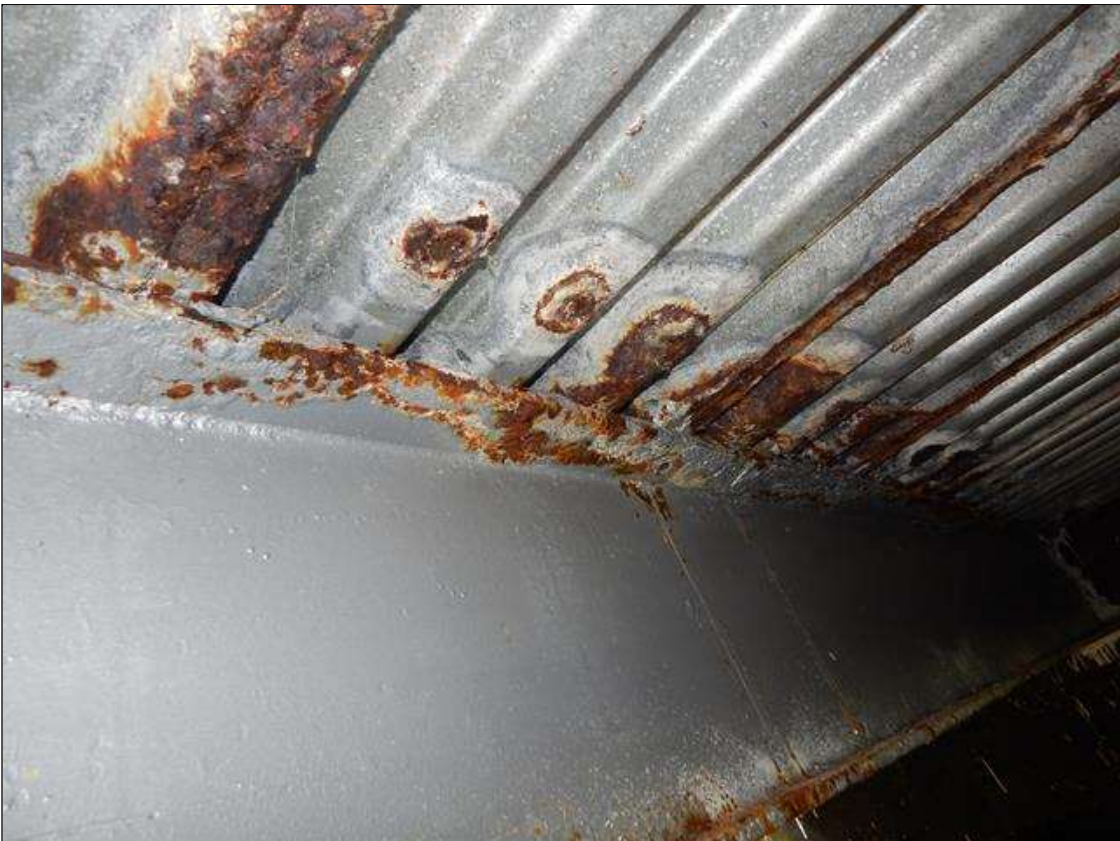
30 Feet of Corrosion: Section loss is evident or pack rust is present WITH 7/16" REMAINING IN TOP FLANGE IN SPAN 1, but does not warrant structural review.

Span 1 Beam 8: 30 Feet of Corrosion: Section loss is evident or pack rust is present WITH 7/16" REMAINING IN TOP FLANGE IN SPAN 1, but does not warrant structural review.

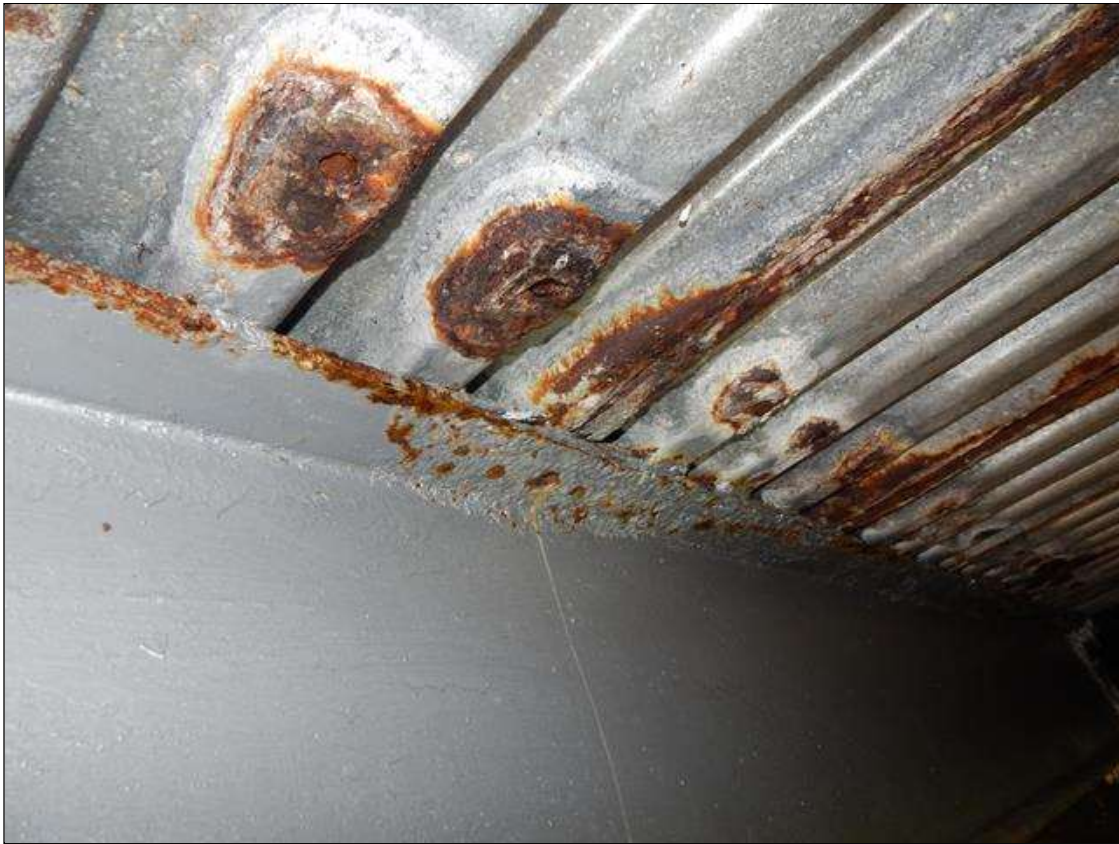
Span 1 Beam 9: 10 Feet of Corrosion: Section loss is evident or pack rust is present WITH 1/4" REMAINING IN TOP FLANGE IN SPAN 1, but does not warrant structural review.

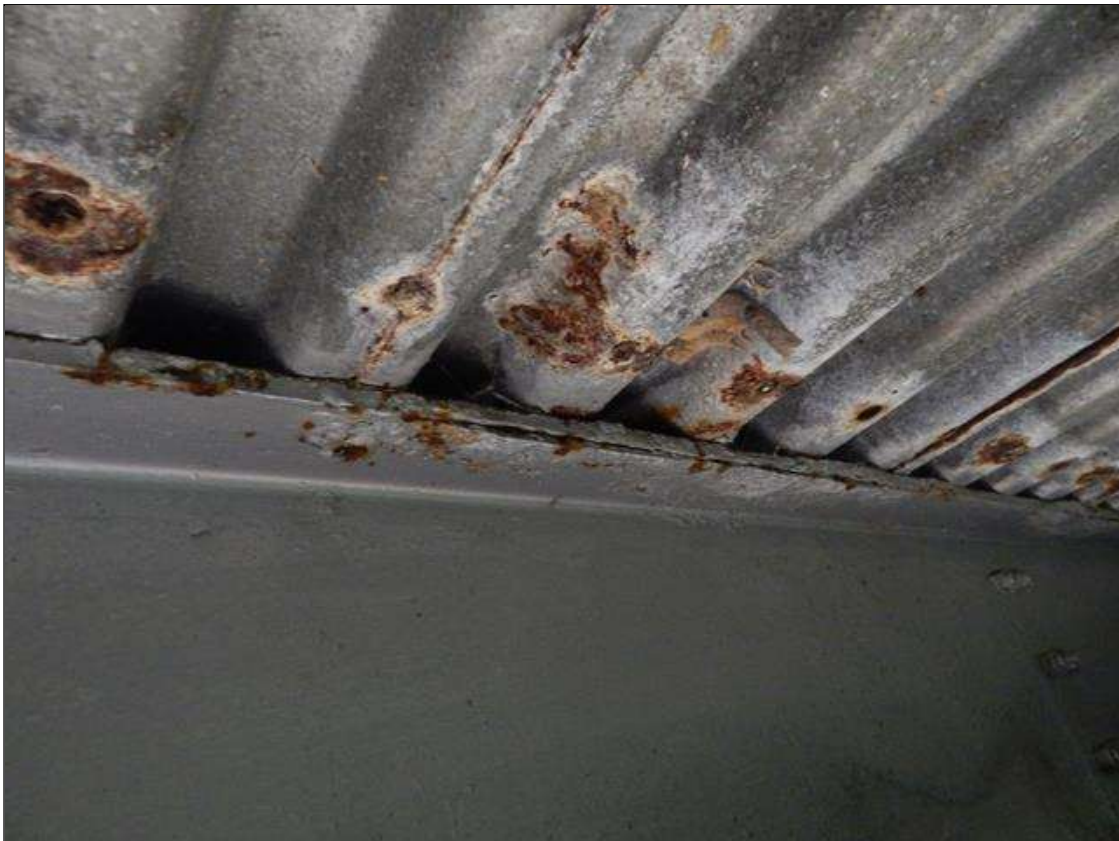
20 Feet of Corrosion: Section loss is evident or pack rust is present WITH 7/16" REMAINING IN TOP FLANGE, but does not warrant structural review.

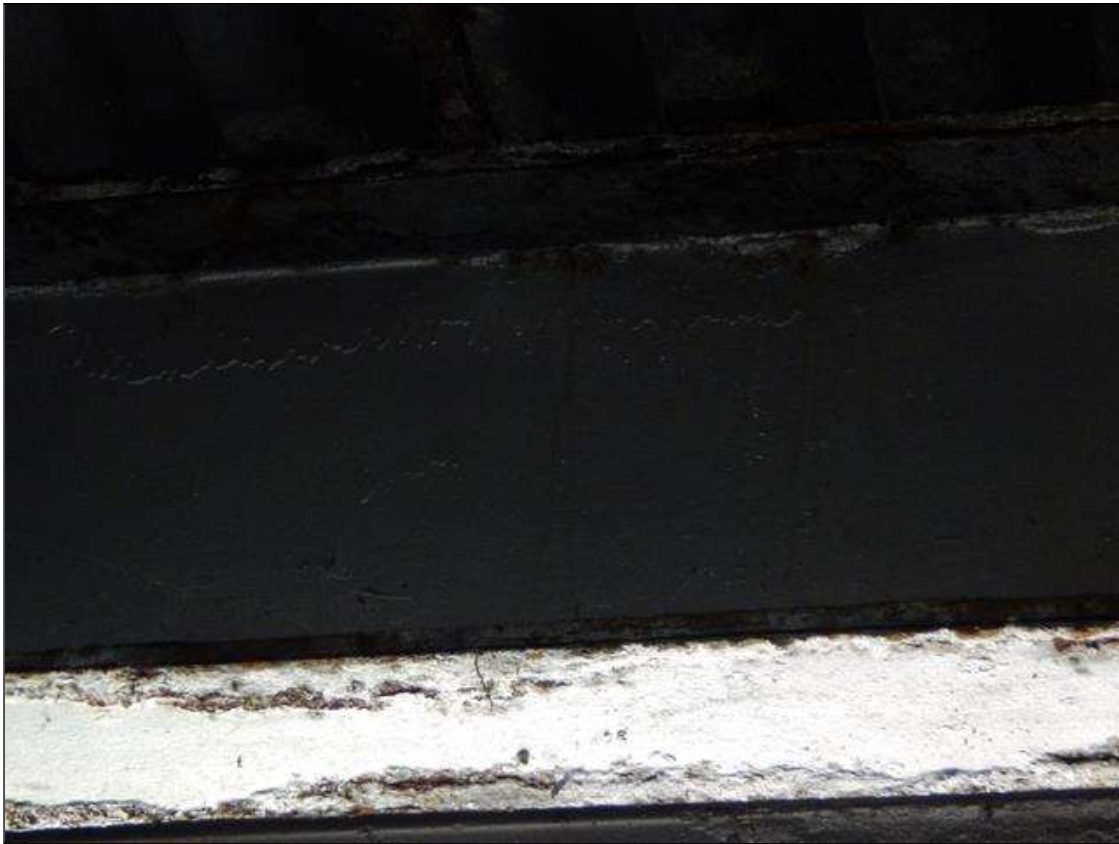
15 Feet of Corrosion: Section loss is evident or pack rust is present WITH 7/16" REMAINING IN TOP FLANGE, but does not warrant structural review.

Span 3 Beam 2: 15 Feet of Corrosion: Section loss is evident or pack rust is present WITH 7/16" REMAINING IN TOP FLANGE, but does not warrant structural review.

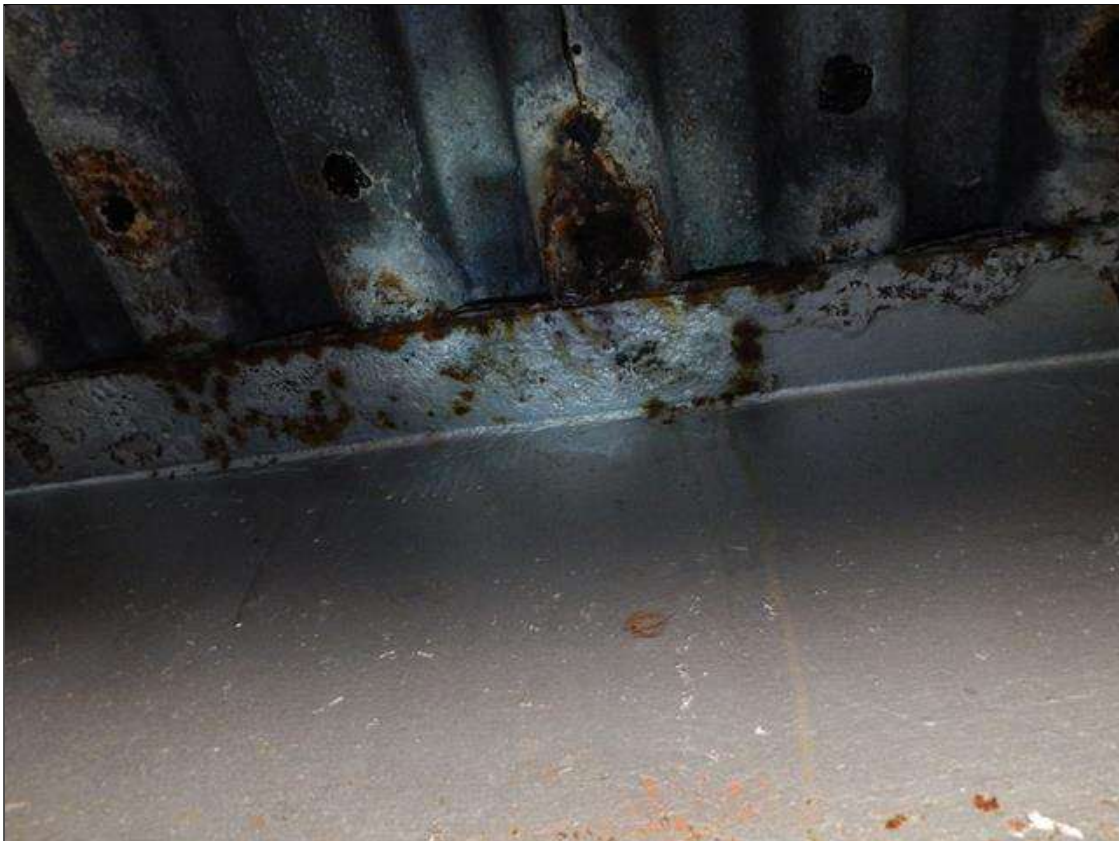
Span 3 Beam 6: 20 Feet of Corrosion: Section loss is evident or pack rust is present WITH 1/4" REMAINING IN TOP FLANGE, but does not warrant structural review.

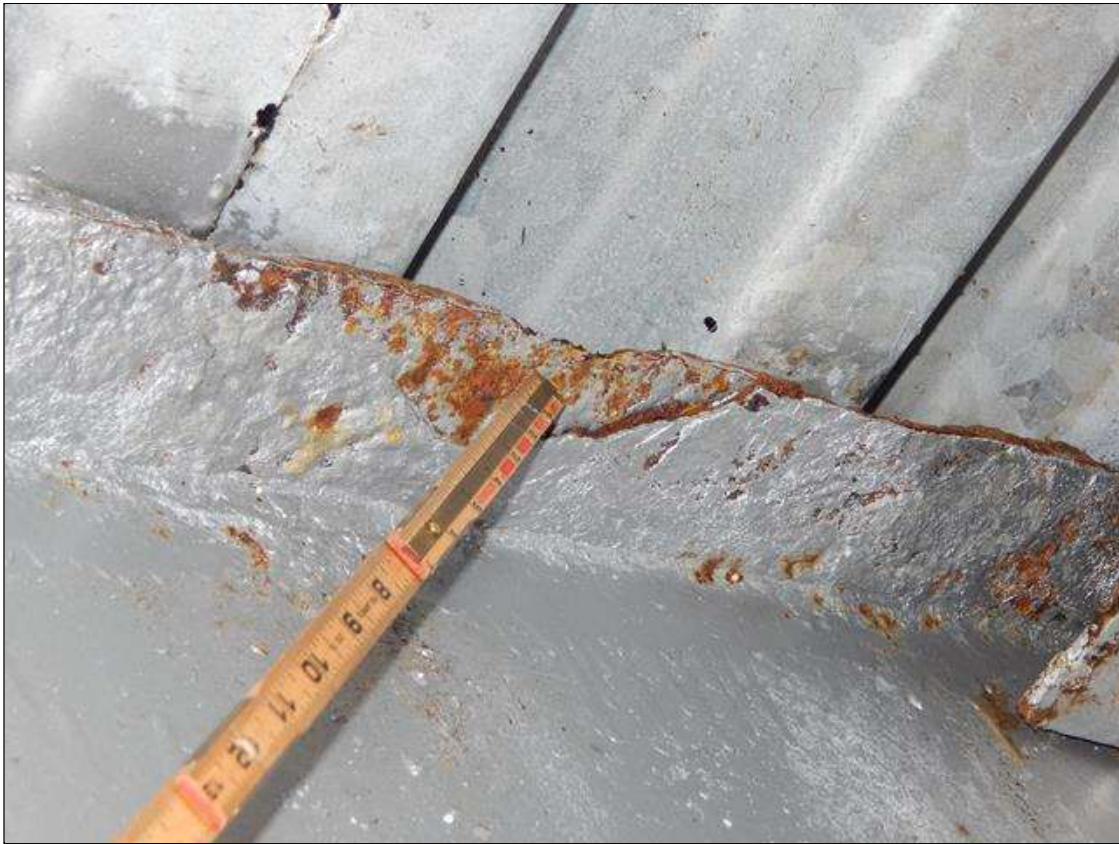
ATTENTION: PRIORITY MAINTENANCE ISSUED (BEAM 6, SPAN 3)

Span 3 Beam 6: 1 Feet of Corrosion: Section loss is DOWN TO KNIFE EDGE FOR 1/8" WIDE OVER INTERIOR DIAPHRAGM or pack rust is present but does not warrant structural review.

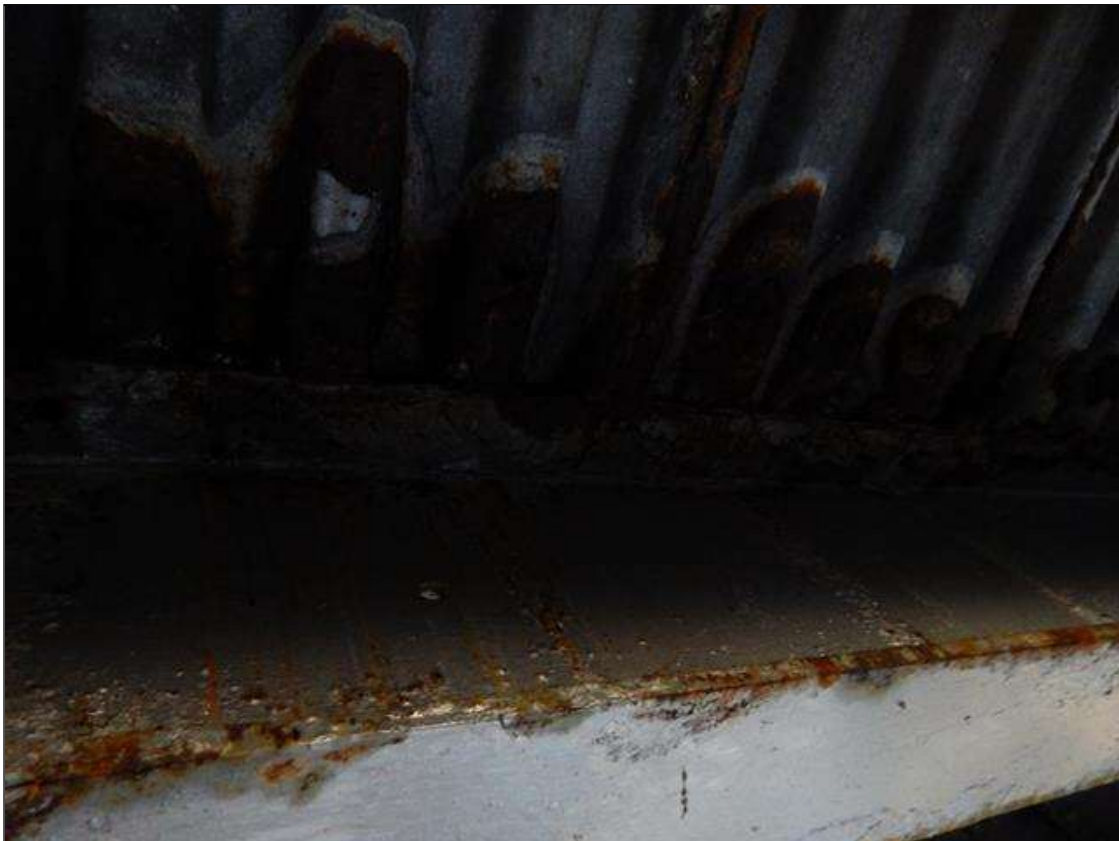
Span 3 Beam 9: 30 Feet of Corrosion: Section loss is evident with down to 1/8" remaining at midpoint, or pack rust is present but does not warrant structural review.

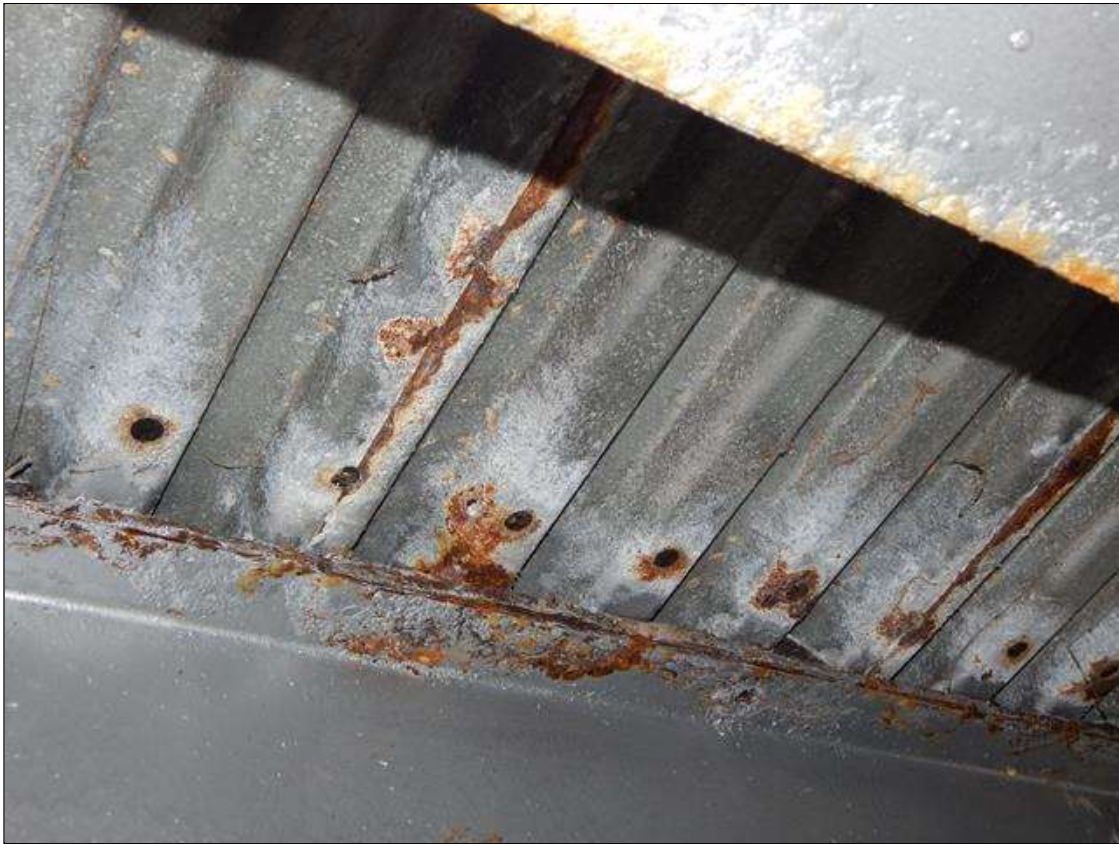
span 3 beam 10; 20 Feet of Corrosion: Section loss is evident with down to 1/4" remaining at midpoint, or pack rust is present but does not warrant structural review.

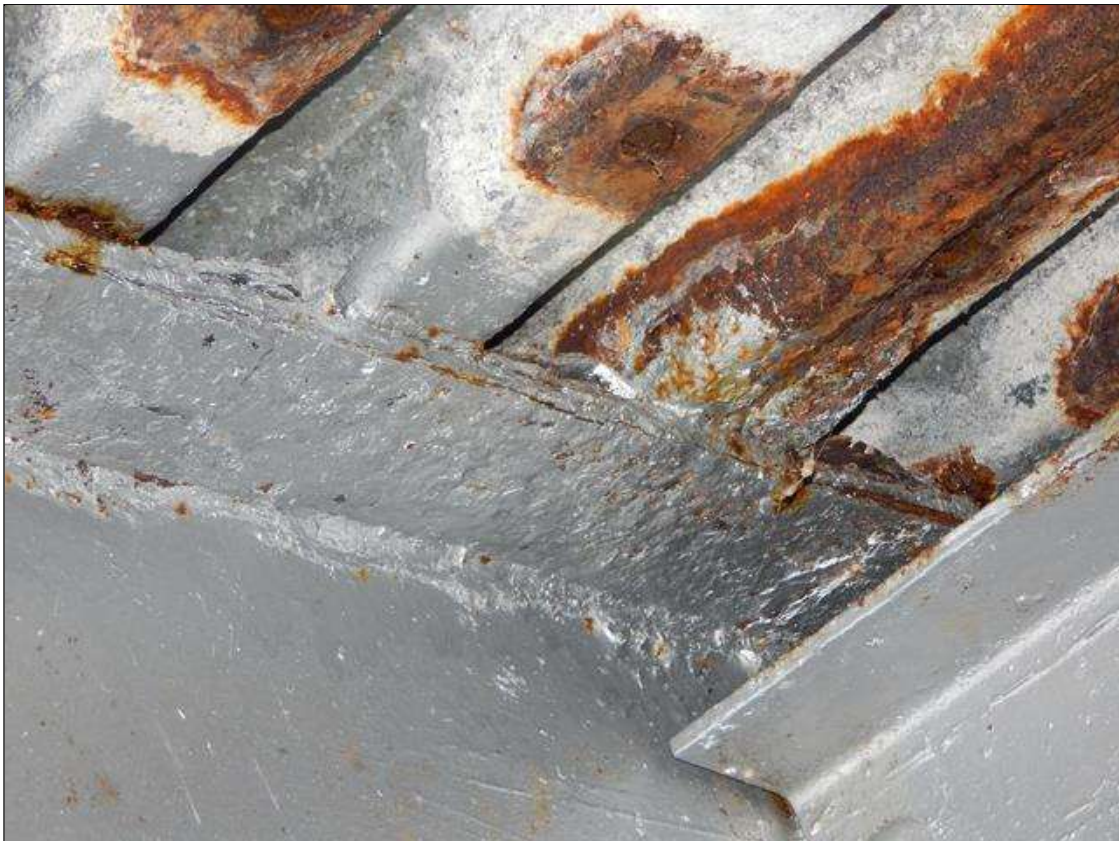
span 3 beam 8; 15 Feet of Corrosion: Section loss is evident with down to 1/4" remaining at midpoint, or pack rust is present but does not warrant structural review.

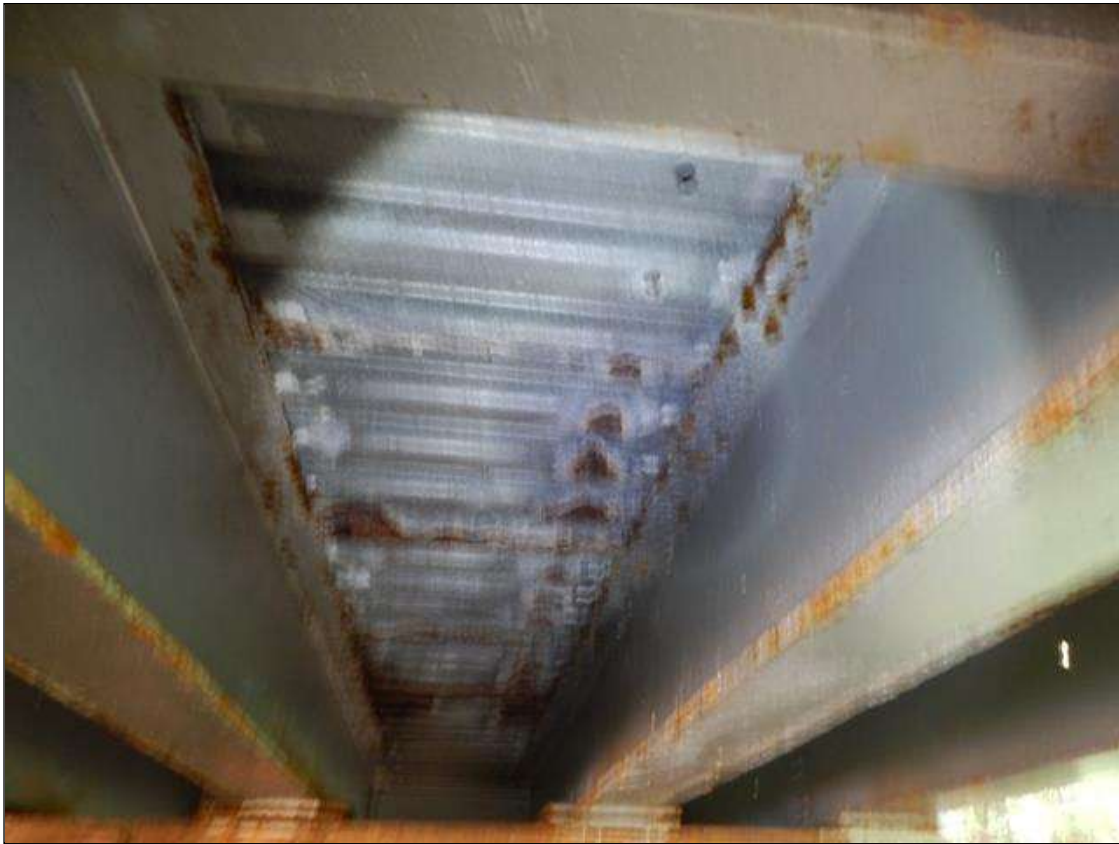
Span 5 Deck: 50 Square Feet of Corrosion: Section loss is evident or pack rust is present WITH DOWN TO 1/8" REMAINING, but does not warrant structural review.

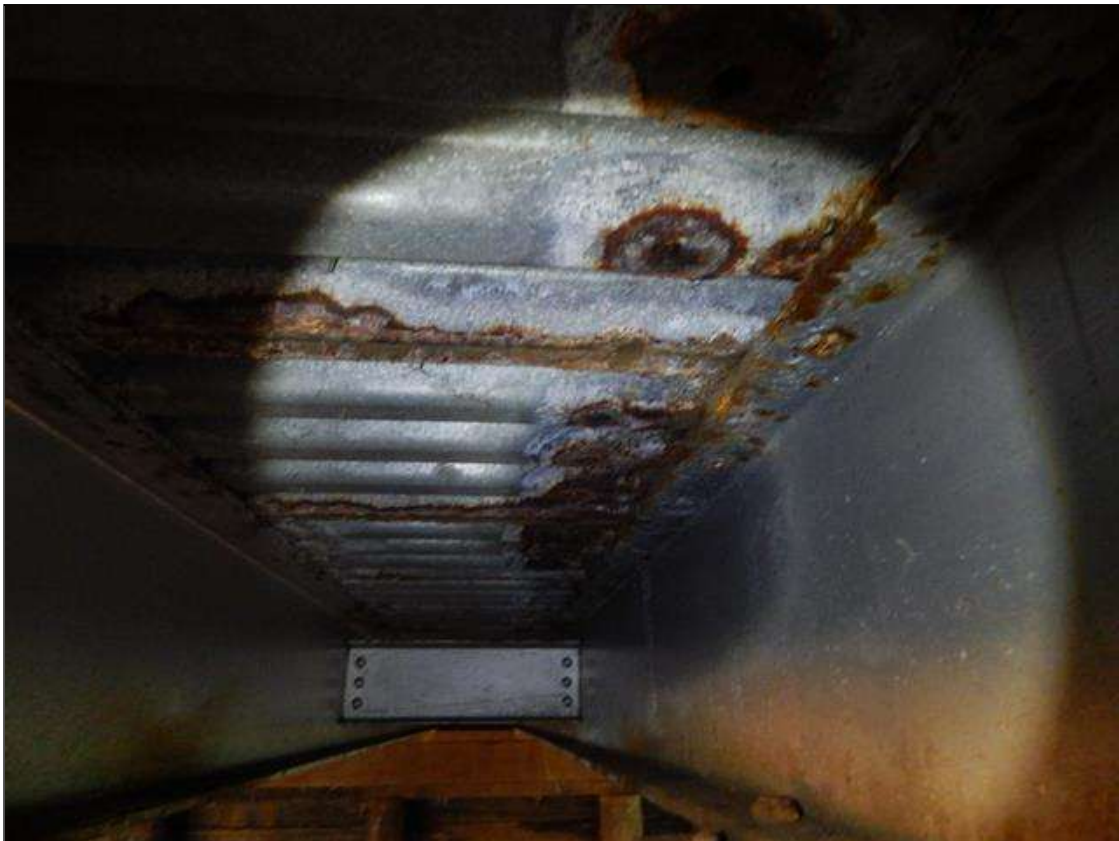
Span 6 Deck: 110 Square Feet of Corrosion: Section loss is evident WITH DOWN TO 1/8" REMAINING or pack rust is present but does not warrant structural review.

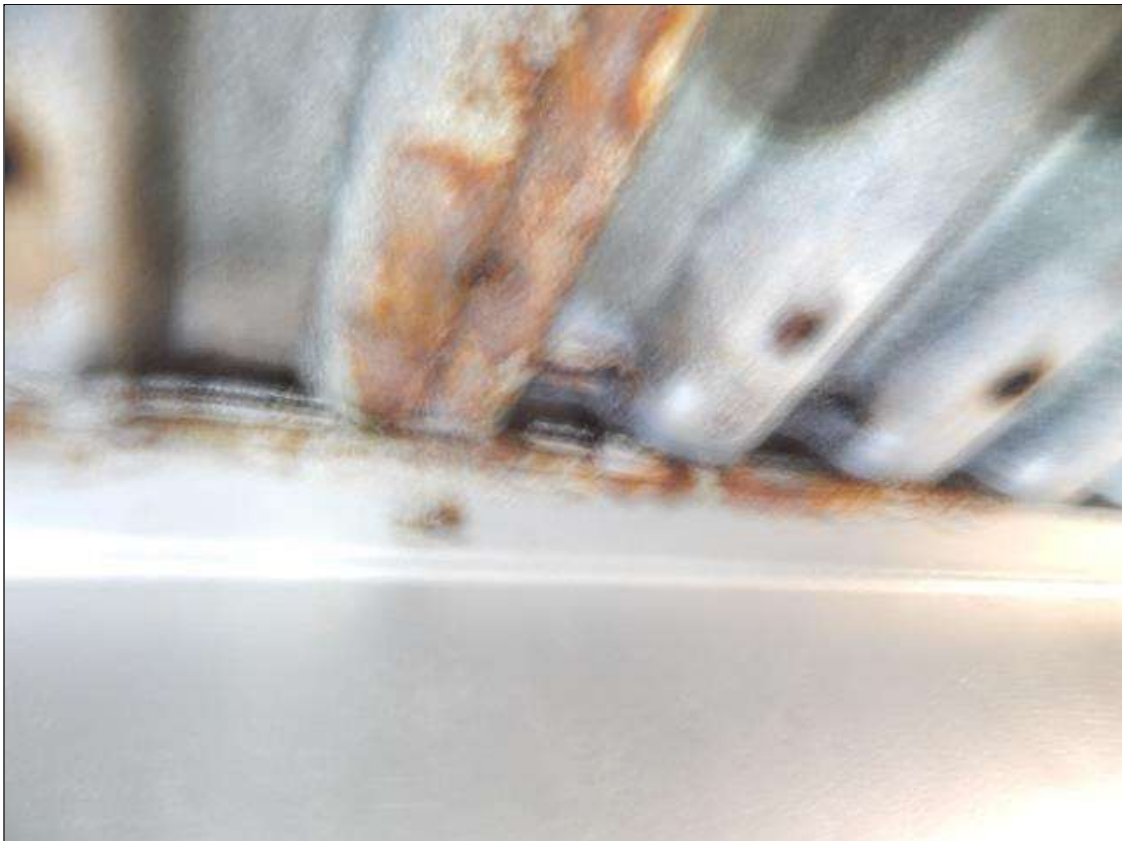
20 Feet of Corrosion: Section loss is evident WITH DOWN TO 7/16" REMAINING IN TOP FLANGE or pack rust is present but does not warrant structural review.

Span 5 Beam 3: 20 Feet of Corrosion: Section loss is evident WITH DOWN TO 7/16" REMAINING IN TOP FLANGE or pack rust is present but does not warrant structural review.

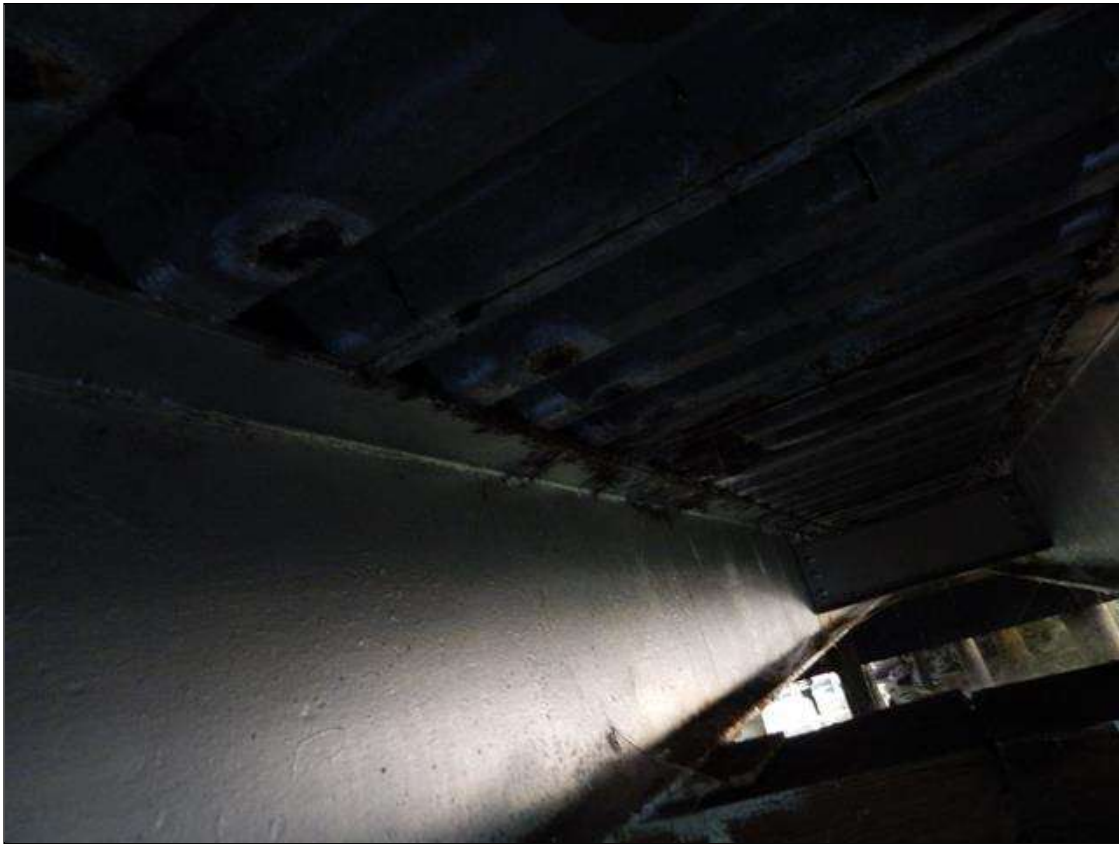
Span 5 Beam 6: 15 Feet of Corrosion: Section loss is evident WITH DOWN TO 7/16" REMAINING IN TOP FLANGE or pack rust is present but does not warrant structural review.

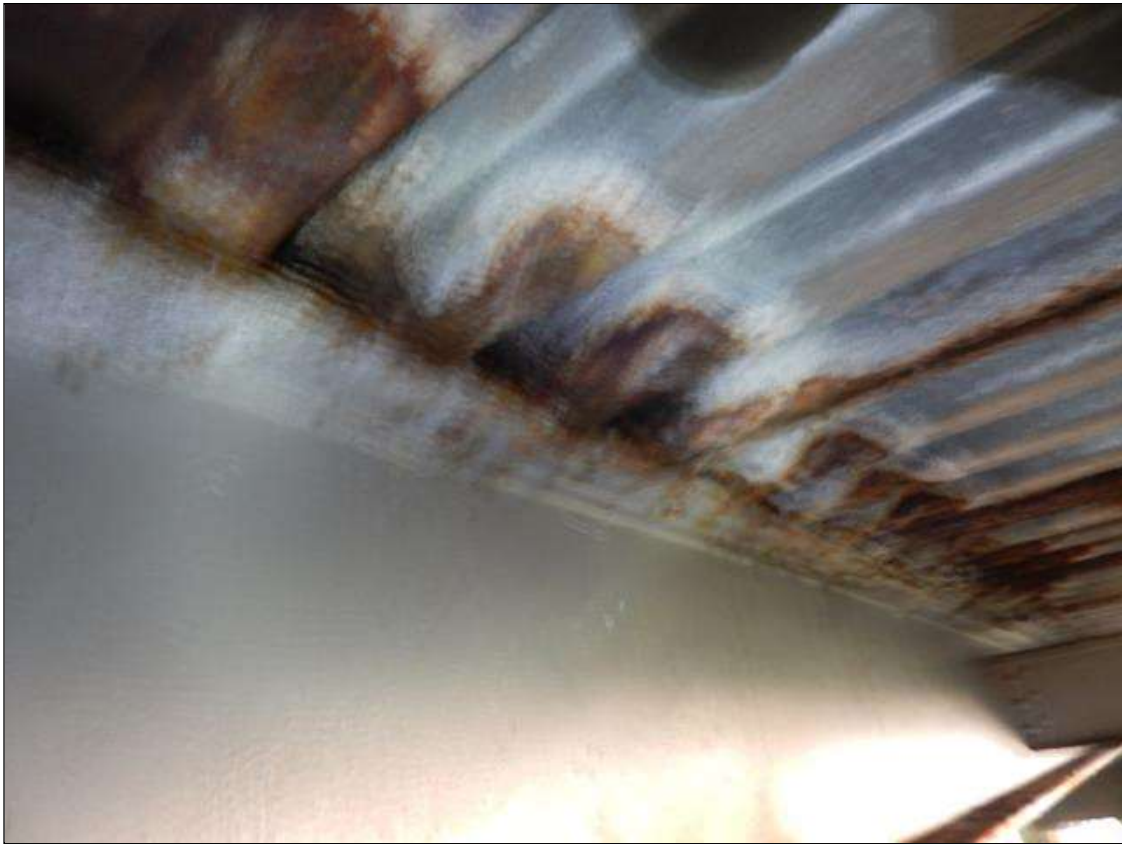
Span 5 Beam 8: 15 Feet of Corrosion: Section loss is evident WITH DOWN TO 1/4" REMAINING IN TOP FLANGE or pack rust is present but does not warrant structural review.
