NC DEPARTMENT OF TRANSPORTATION  
DIVISION OF HIGHWAYS  
STRUCTURE MANAGEMENT UNIT

## Structure Safety Report

### Routine Element Inspection

COUNTY: HALIFAX STRUCTURE NUMBER: 410065 FREQUENCY: 24 MONTHS  
FACILITY CARRIED: SR1100 MILE POST: \_\_\_\_\_  
LOCATION: 1.0MI.W.NC125  
FEATURE INTERSECTED: DEEP CREEK  
LATITUDE: 36° 4' 26.05" LONGITUDE: 77° 26' 24.44"  
SUPERSTRUCTURE: STEEL PLANK FLOOR ON CONT I-BEAMS  
SUBSTRUCTURE: E.BTS&BTS:TIMBER CAPS/TIMBER PILES @ VAR CTS.  
SPANS: 1@20';1@20'-3;1@20'-9;1@19'-6;1@20';1@20'-3;CONT  
☐ FRACTURE CRITICAL ☐ TEMPORARY SHORING ☐ SCOUR CRITICAL ☒ SCOUR PLAN OF ACTION  
PRESENT CONDITION: Fair INSPECTION DATE: 08/24/2015  
POSTED SV: 39 POSTED TTST: 39  
OTHER SIGNS PRESENT: 4 DELINEATORS

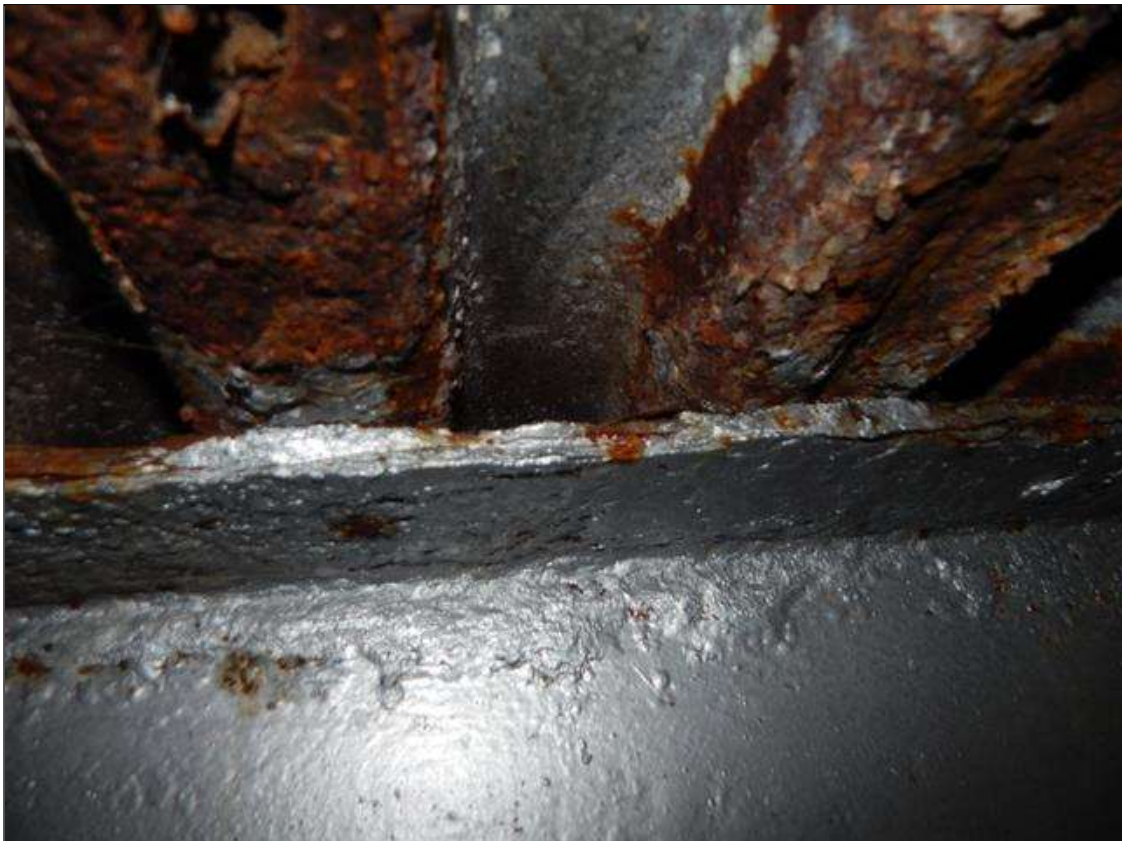
Span 5 Beam 9: 20 Feet of Corrosion: Section loss is evident WITH DOWN TO 1/4" REMAINING IN TOP FLANGE or pack rust is present but does not warrant structural review.

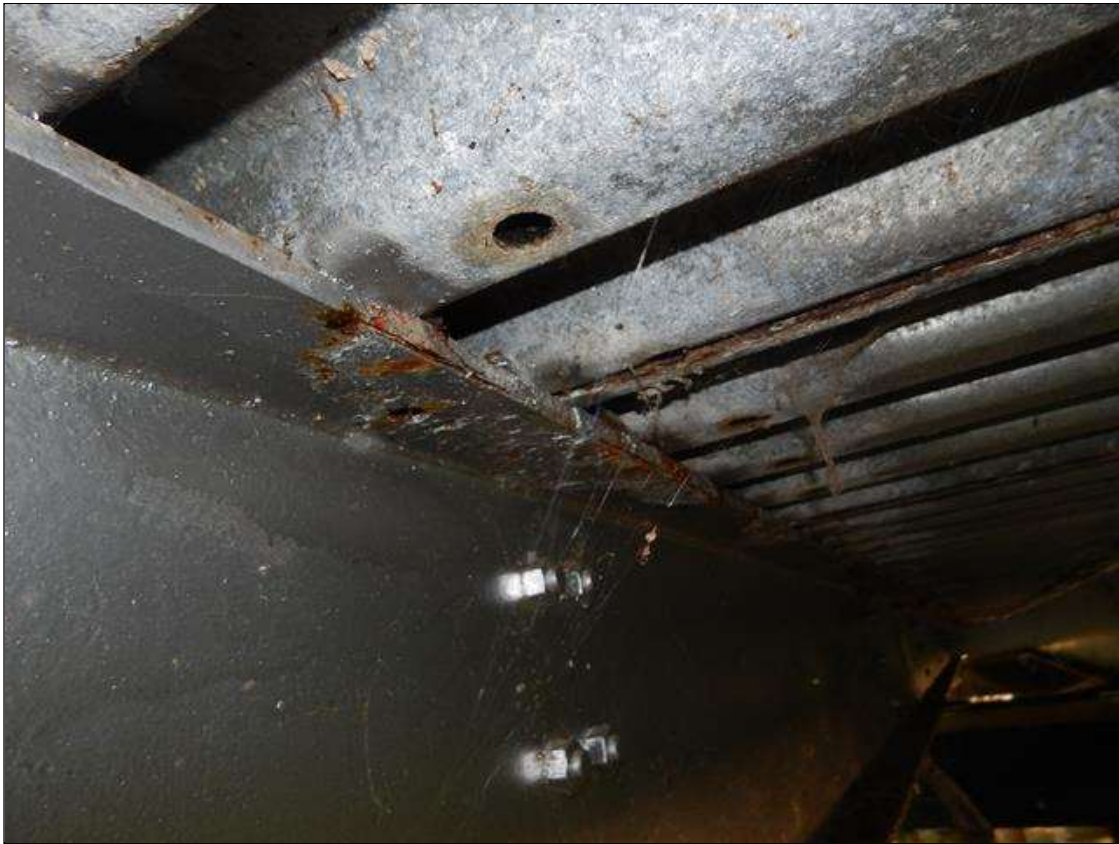
Span 5 Beam 10: 15 Feet of Corrosion: Section loss is evident WITH DOWN TO 7/16" REMAINING IN TOP FLANGE or pack rust is present but does not warrant structural review.

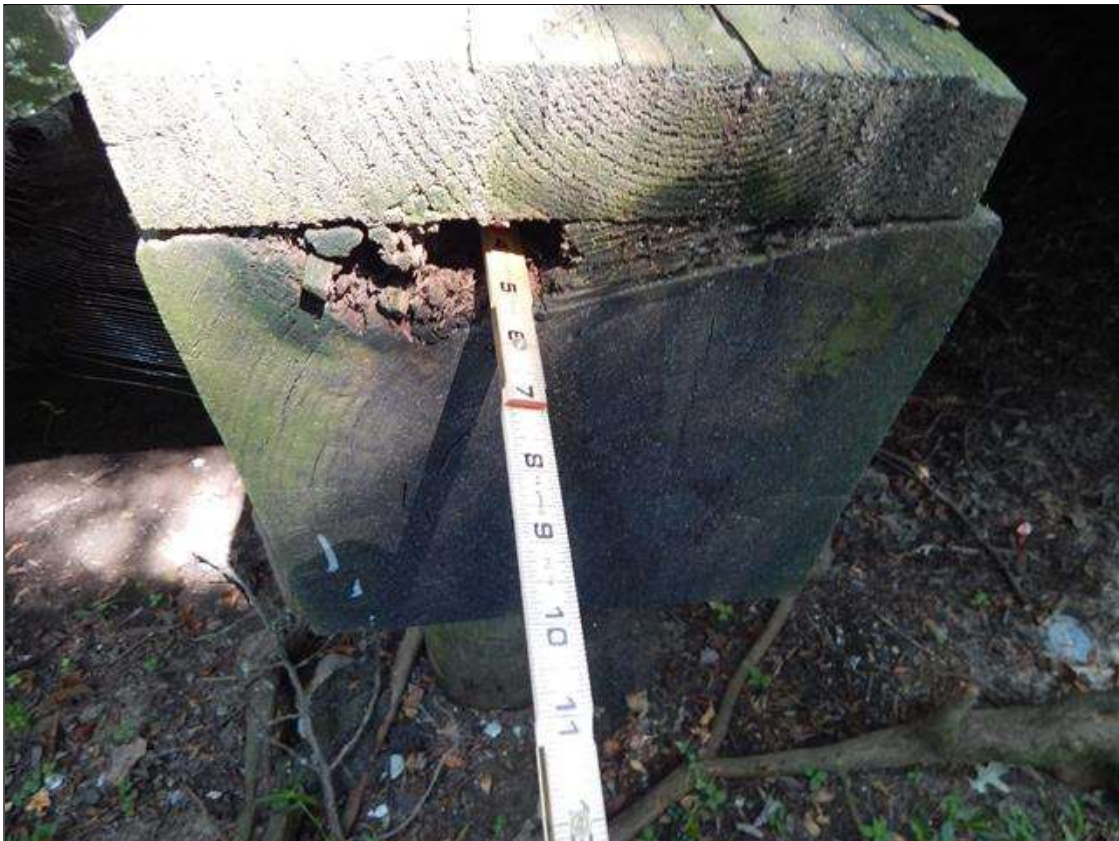
Bent 5 Cap : 1 Feet of Decay/Section Loss: Affects less than 10% of the member section. 5" DEEP, 4" WIDE, AND 2" TALL ON RIGHT END.

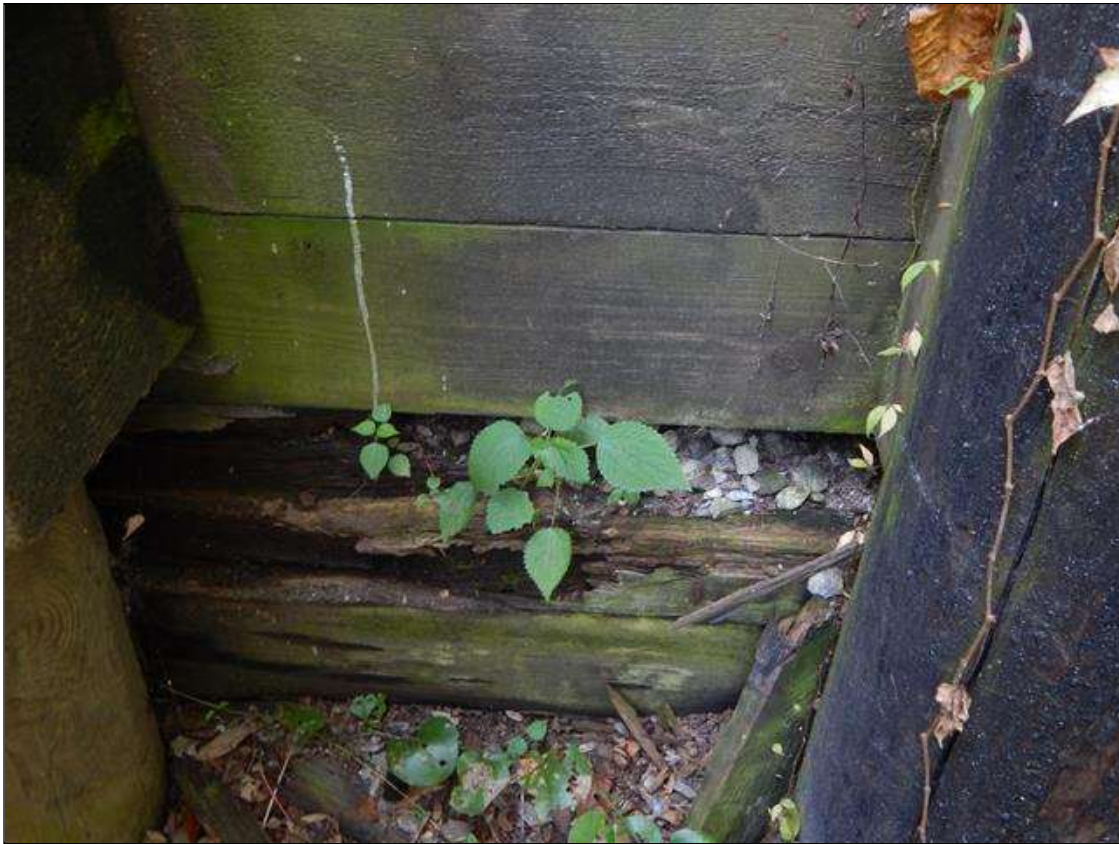
BULKHEAD DECAYED ON RIGHT SIDE AT END BENT 2 3' TOTAL

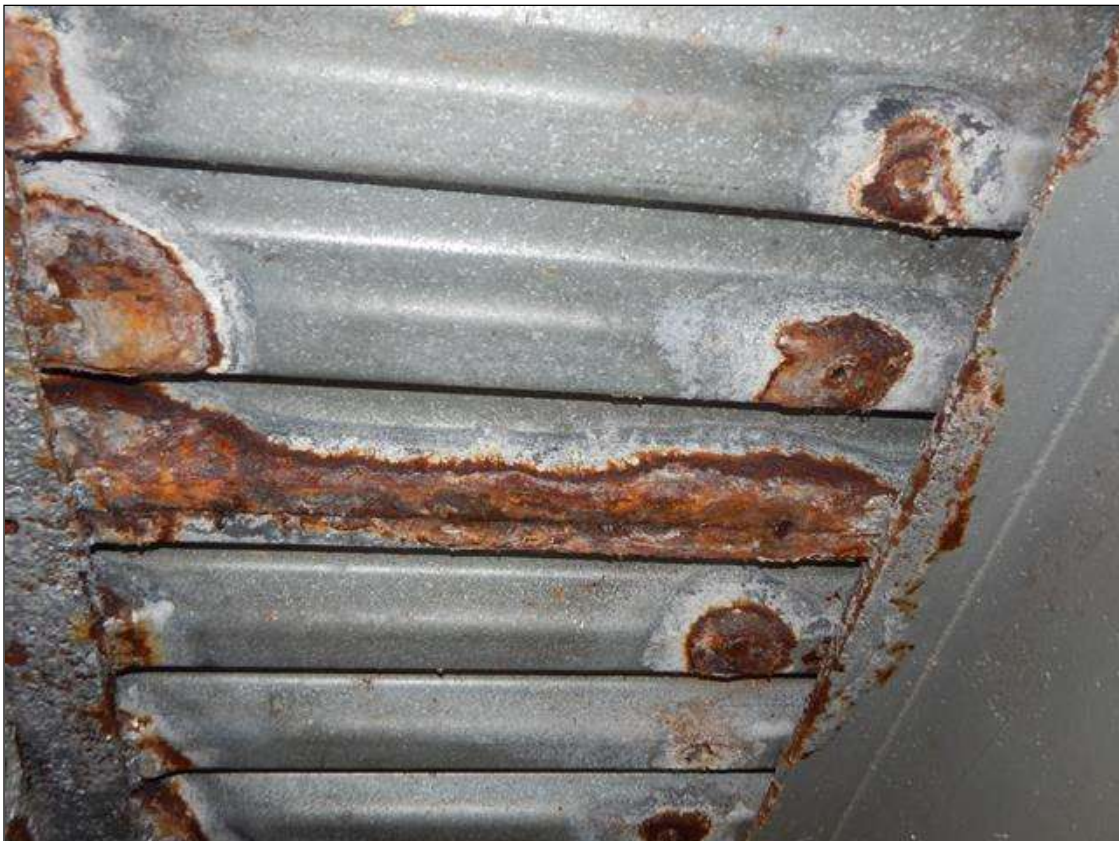
200 Square Feet of Corrosion: Section loss is evident WITH DOWN TO 1/8" REMAINING or pack rust is present but does not warrant structural review.

Span 2 Deck: 200 Square Feet of Corrosion: Section loss is evident WITH DOWN TO 1/8" REMAINING or pack rust is present but does not warrant structural review.

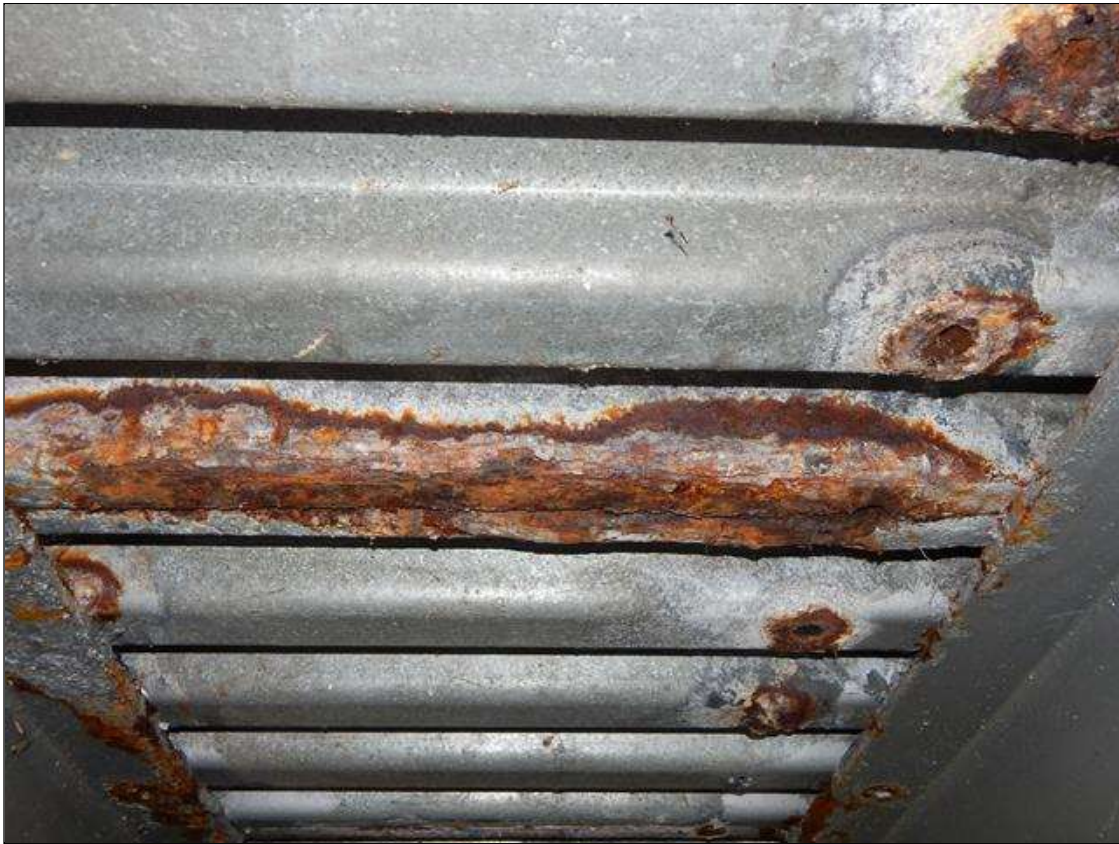
175 Square Feet of Corrosion: Section loss is evident WITH DOWN TO 1/8" REMAINING or pack rust is present but does not warrant structural review.

Span 1 Deck: 175 Square Feet of Corrosion: Section loss is evident WITH DOWN TO 1/8" REMAINING or pack rust is present but does not warrant structural review.

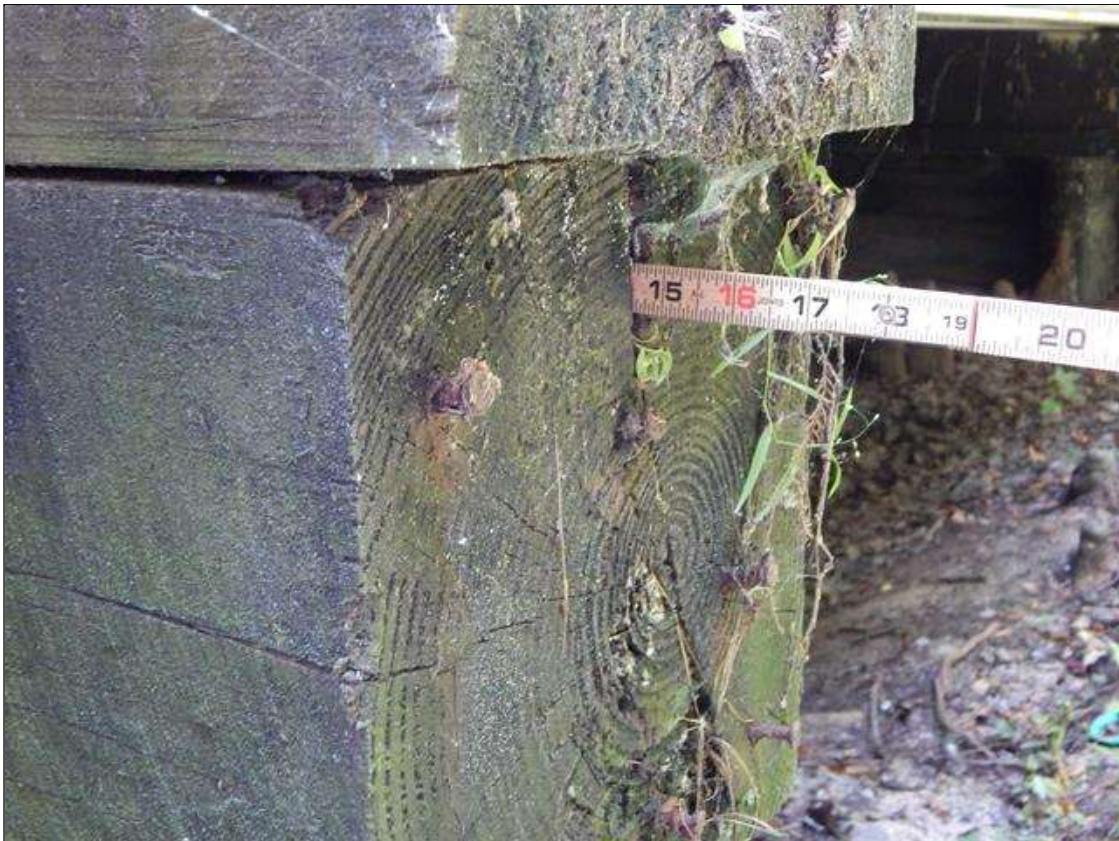
Bent 1 Cap : 1 Feet of Crack (Timber): Crack that has been arrested through effective measures. AREA IS 14" DEEP, AND FULL HEIGHT.

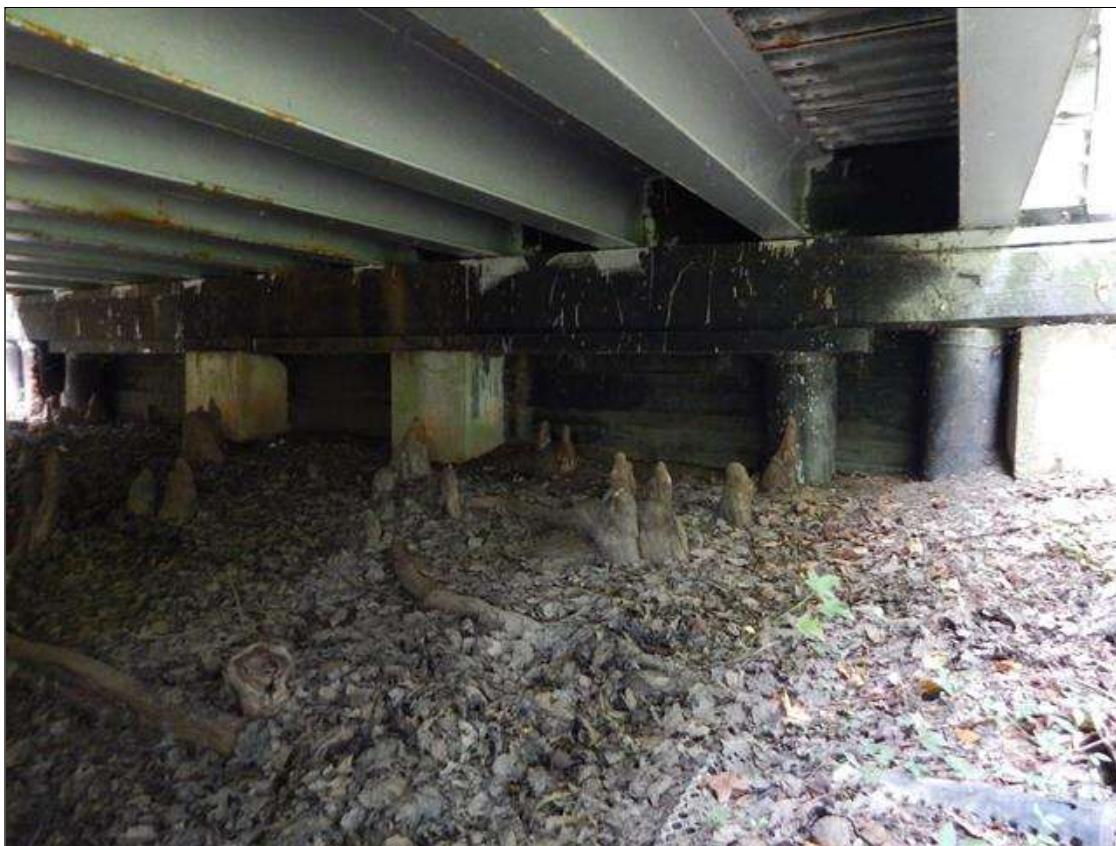
PILES 1, 4, AND 5 ENCASED AT END BENT 1

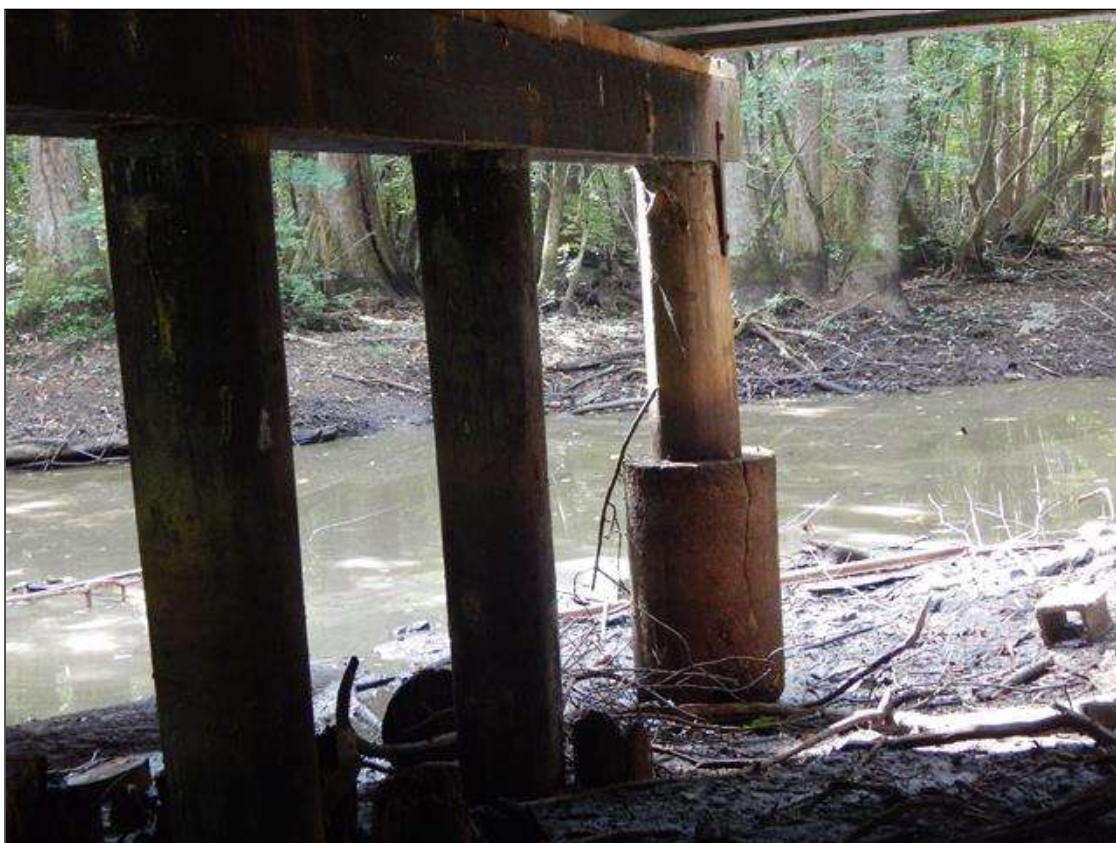
PILE 5 ENCASED AT BENT 1

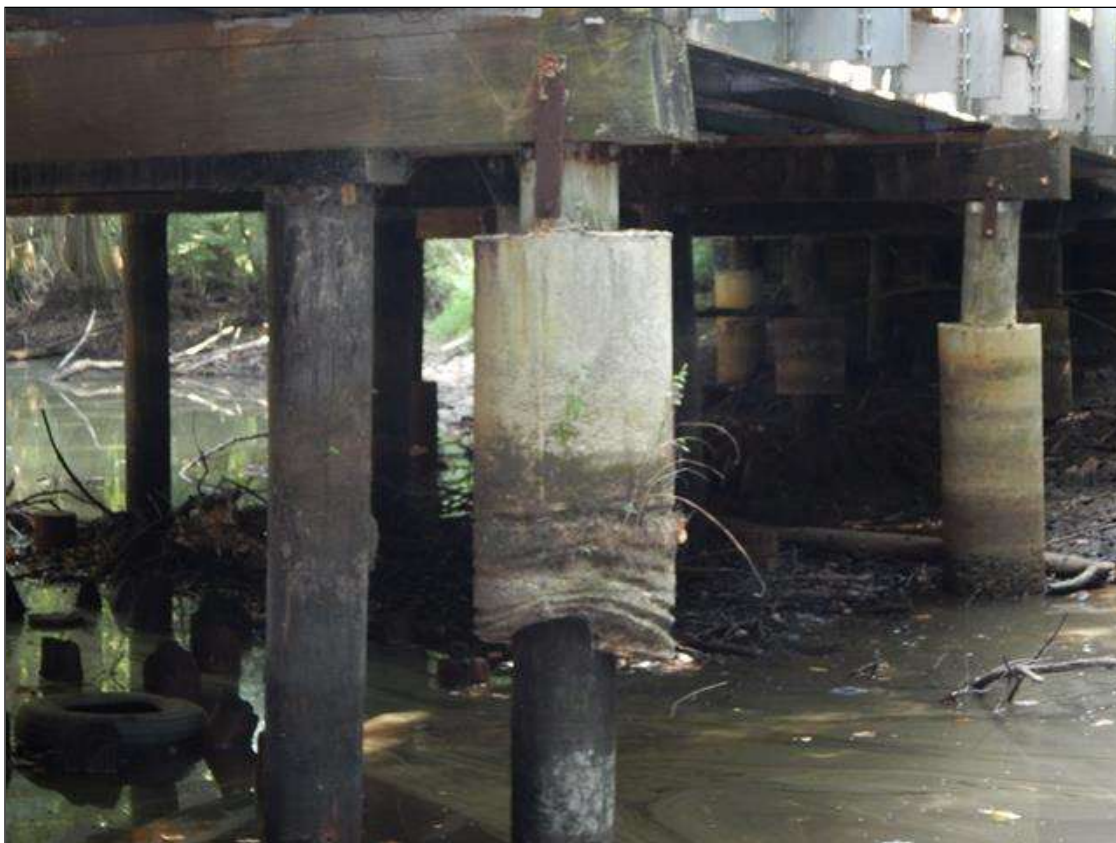
PILES 1,2,3, AND 6 ENCASED AT BENT 2

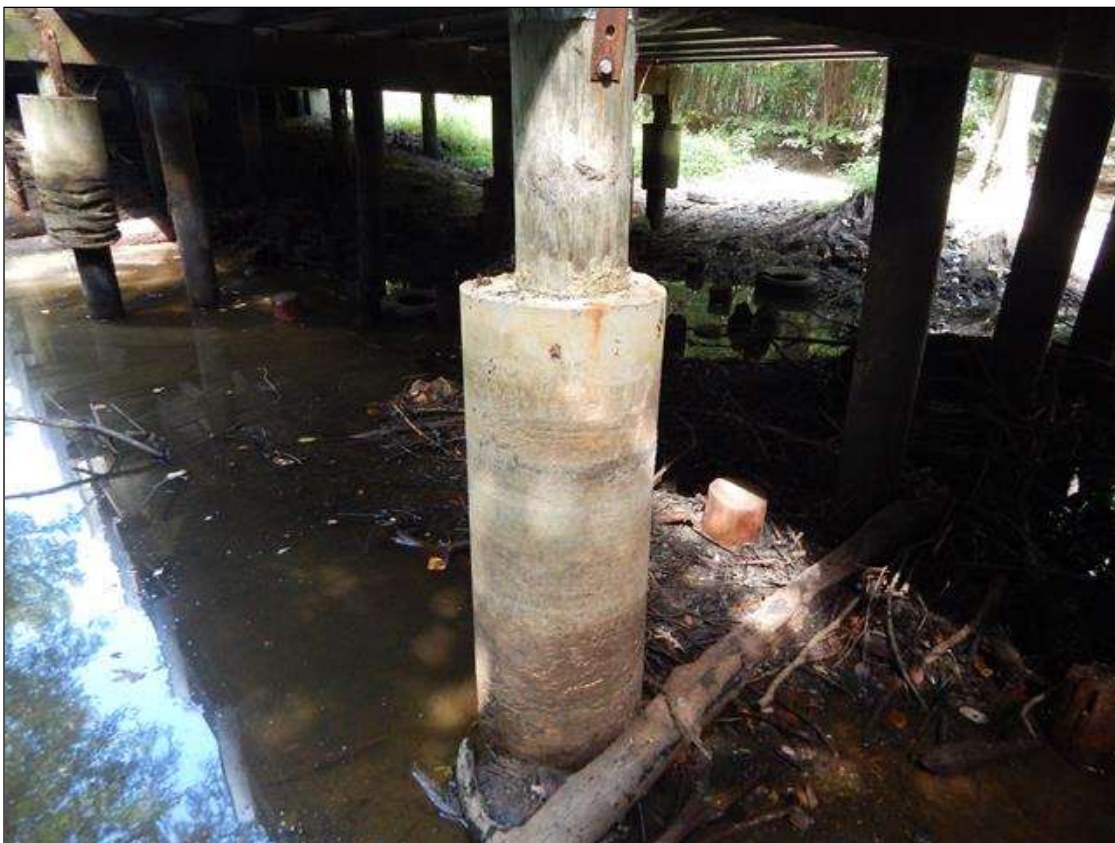
piles 1 and 5 encased at BENT 3

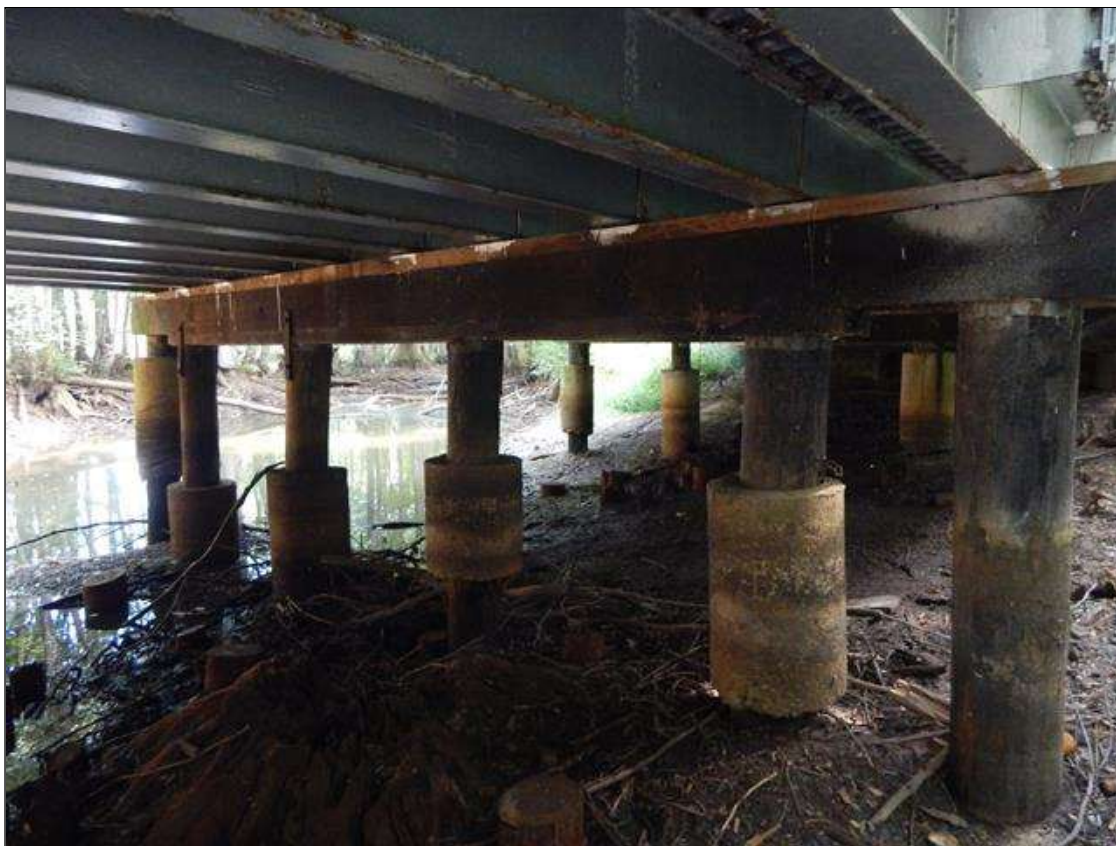
BENT 4, PILES 1-4 ENCASED

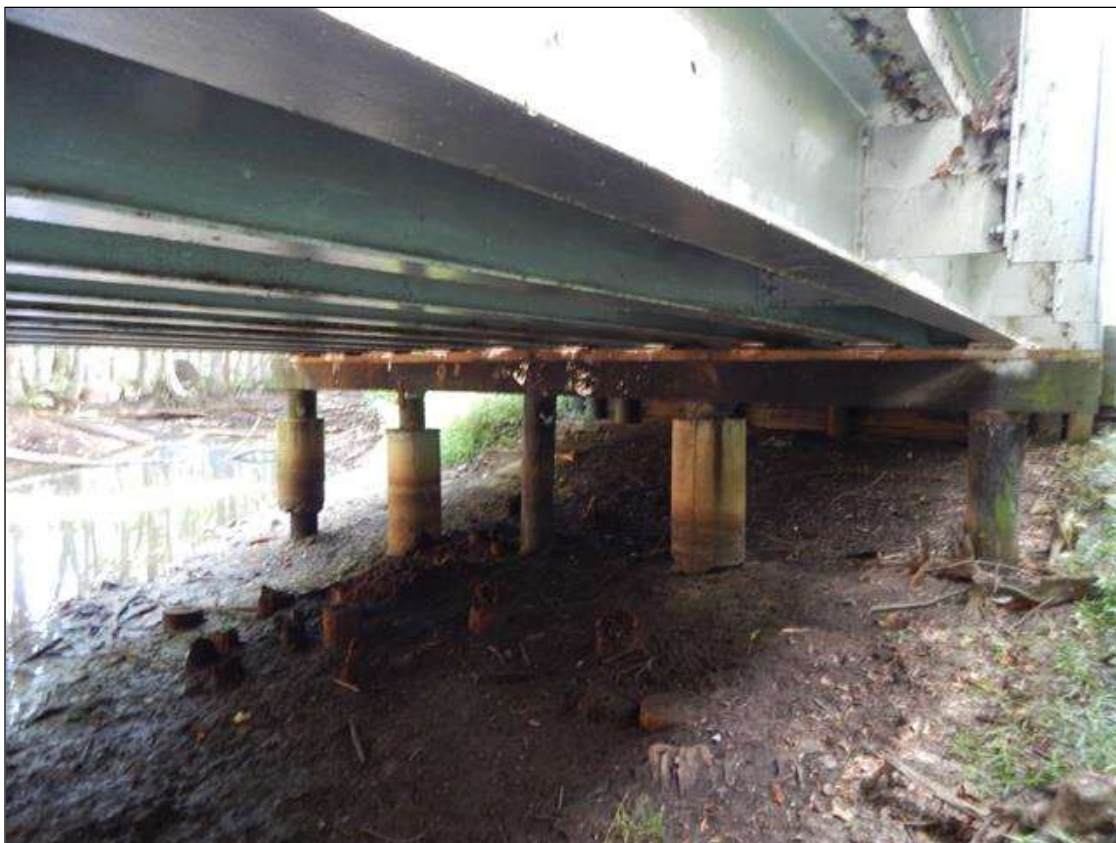
BENT 5 PILES 1,2, AND 4 ENCASED
