# Structure Safety Report

## Routine Element Inspection

COUNTY: HALIFAX STRUCTURE NUMBER: 410066 FREQUENCY: 24 MONTHSFACILITY CARRIED: SR1100 MILE POST: LOCATION: 0.9MI. W JCT NC125FEATURE INTERSECTED: DEEP CREEKLATITUDE: 36° 4' 27.26" LONGITUDE: 77° 26' 19.59"SUPERSTRUCTURE: STEEL PLANK FLOOR ON CONT. I-BEAMS.SUBSTRUCTURE: E.BTS&INT.BT:TIMBER CAP/TIMBER PILES @ 6' CTS.SPANS: 1@21';1@19'6 CONTINUOUS☐ FRACTURE CRITICAL ☐ TEMPORARY SHORING ☐ SCOUR CRITICAL ☒ SCOUR PLAN OF ACTIONPRESENT CONDITION: Fair INSPECTION DATE: 08/24/2015POSTED SV: 31 POSTED TTST: 34OTHER SIGNS PRESENT: 4 DELINEATORS

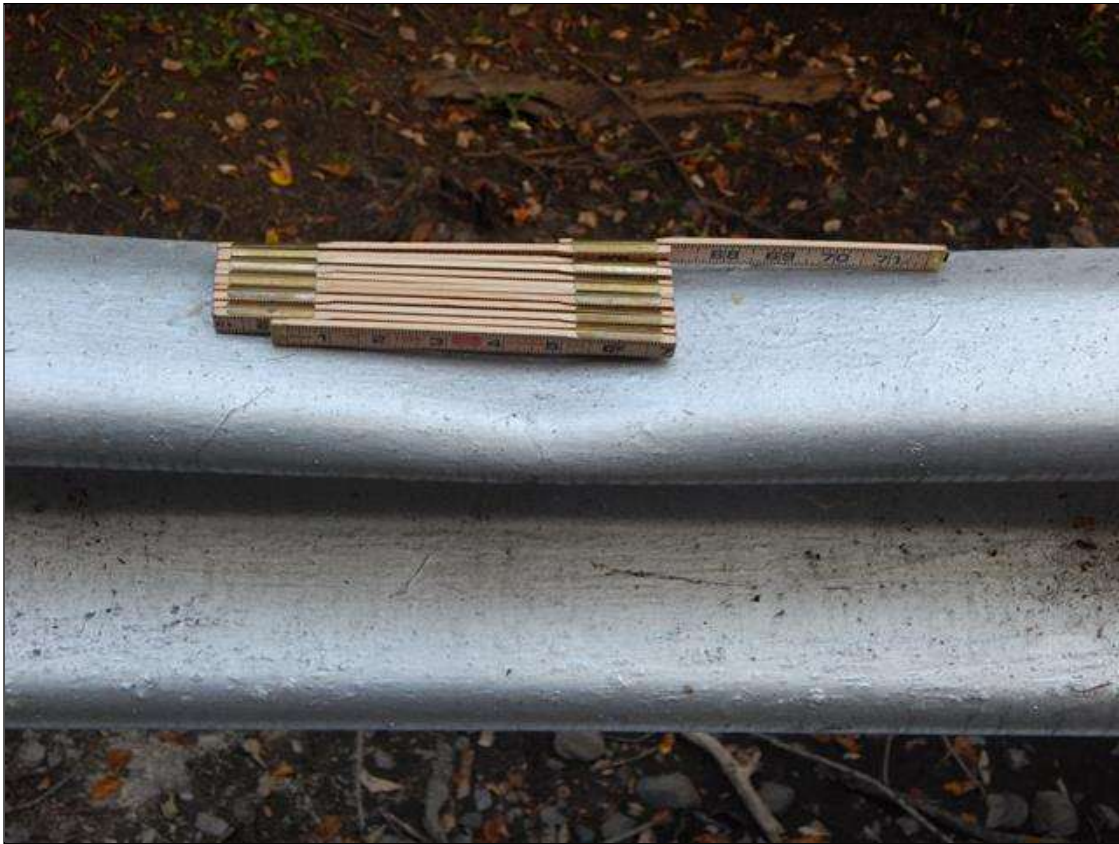
Span 2 Left Bridge Rail: 2 Feet of Damage: The element has impact damage. The specific damage caused by the impact has been captured in Condition State 2 under the appropriate material defect entry.

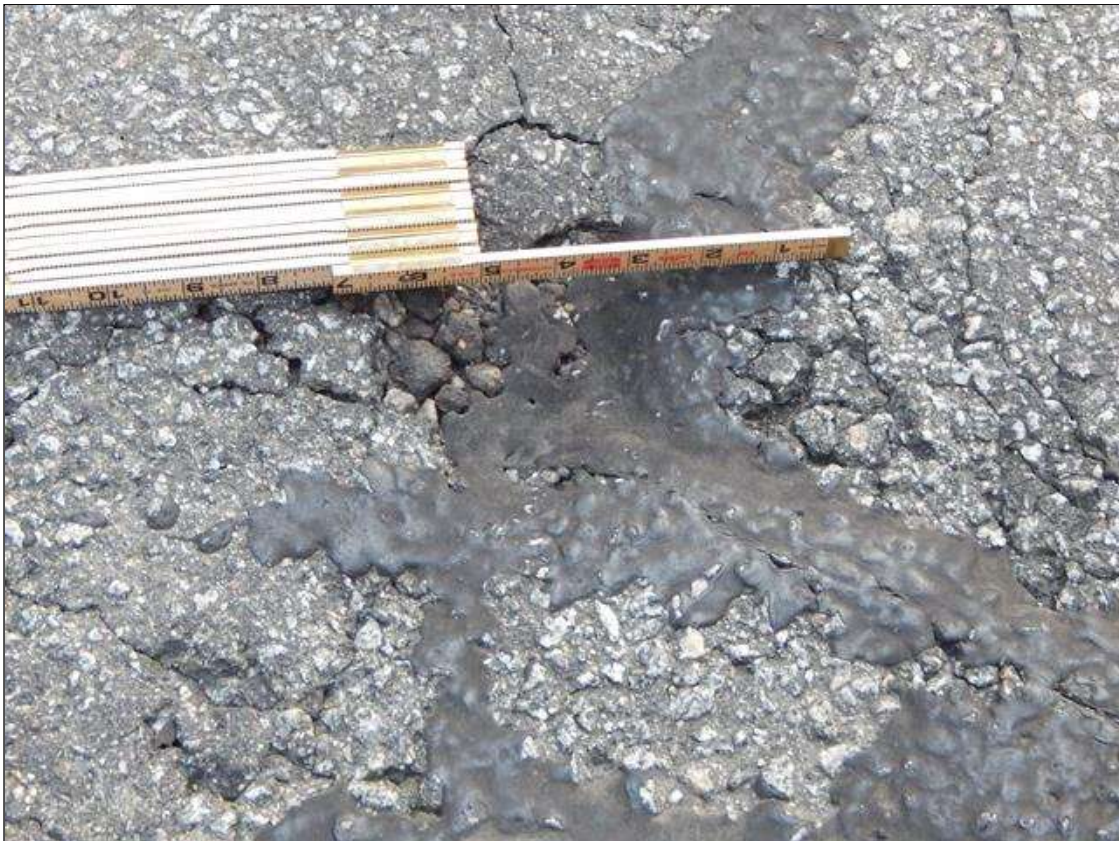
2 Square Feet of Crack OVER BENT 1.(Wearing Surface): Width of more than 0.05 in. or spacing of less than 1.0 ft.

Span 2 Wearing Surface: 2 Square Feet of Crack OVER BENT 1.(Wearing Surface): Width of more than 0.05 in. or spacing of less than 1.0 ft.

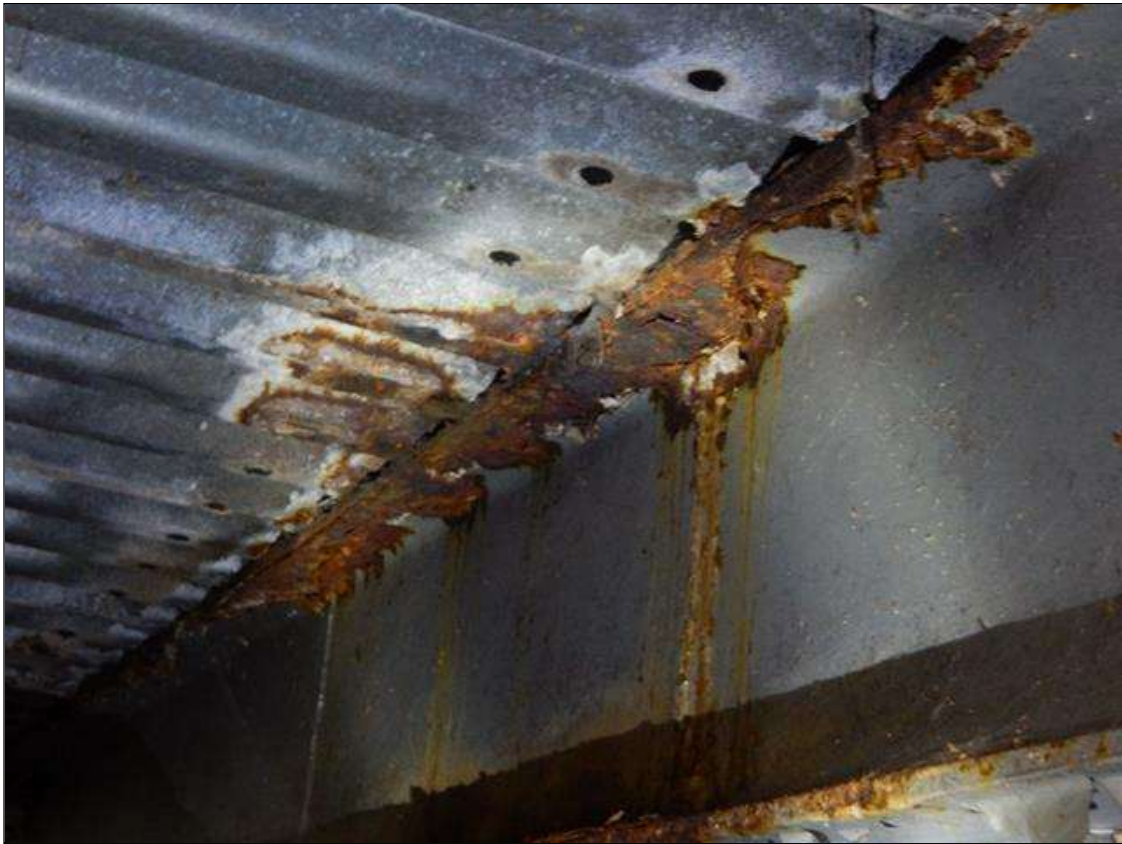
15 Feet of Corrosion OVER BENT 1, WITH DOWN TO 1/4" REMAINING.: Section loss is evident or pack rust is present but does not warrant structural review.

Span 1 Beam 5: 15 Feet of Corrosion OVER BENT 1, WITH DOWN TO 1/4" REMAINING.: Section loss is evident or pack rust is present but does not warrant structural review.

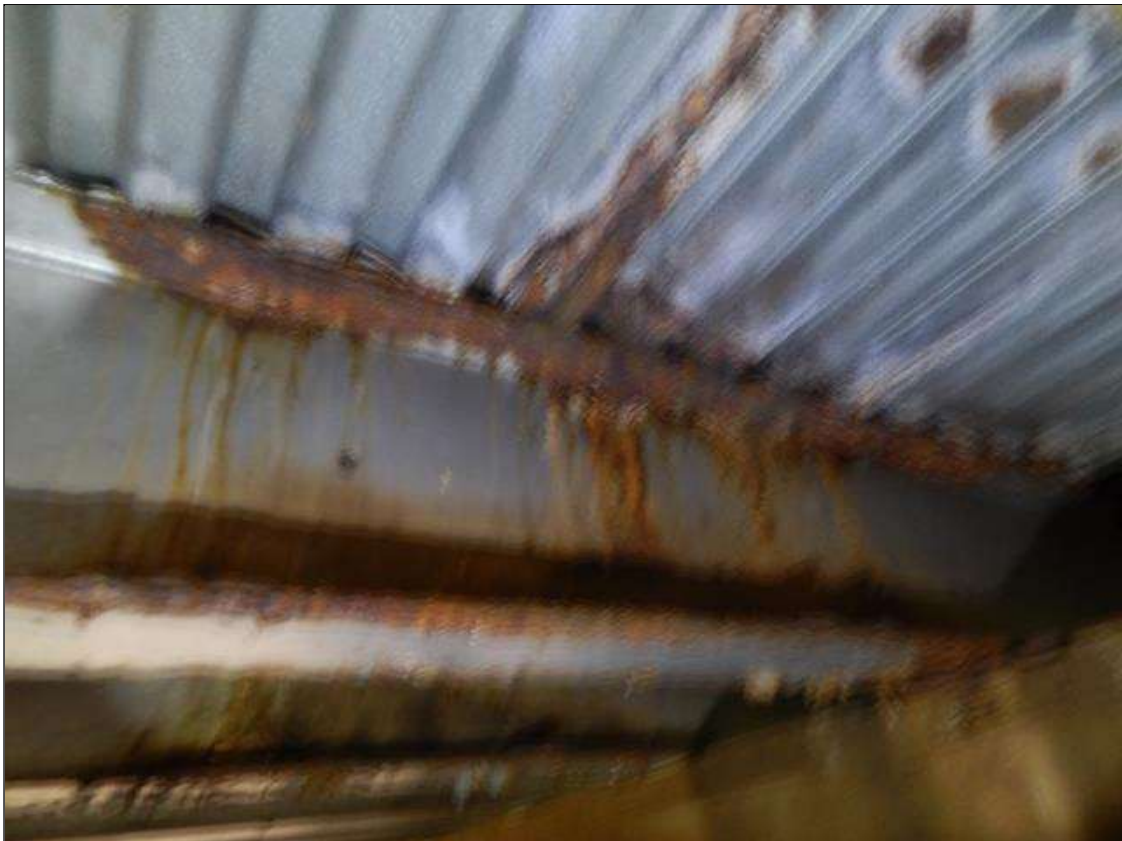
20 Feet of Corrosion OVER BENT 1 WITH DOWN TO 1/8" REMAINING IN FLANGES: Section loss is evident or pack rust is present but does not warrant structural review.

Span 1 Beam 6: 20 Feet of Corrosion OVER BENT 1 WITH DOWN TO 1/8" REMAINING: Section loss is evident or pack rust is present but does not warrant structural review.

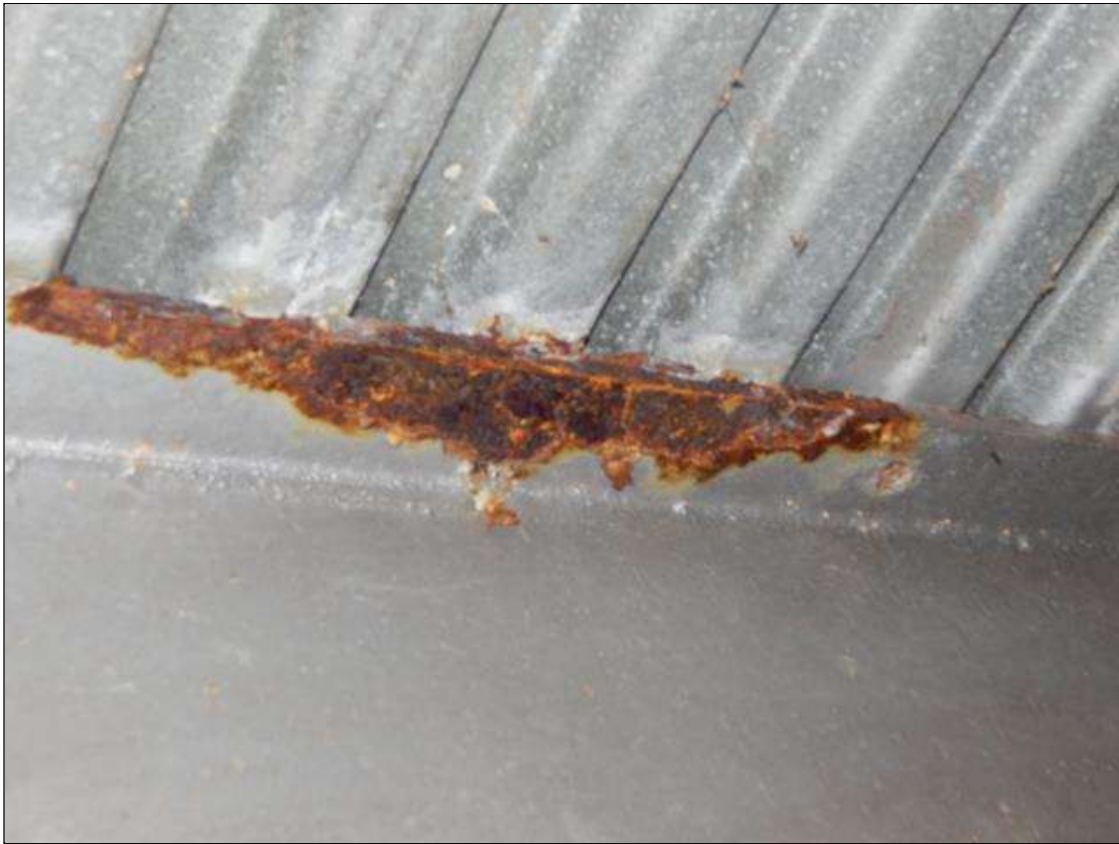
Span 1 Beam 7: 5 Feet of Corrosion: IN FLANGES OVER BENT 1 WITH 1/4" REMAIONING Section loss is evident or pack rust is present but does not warrant structural review.

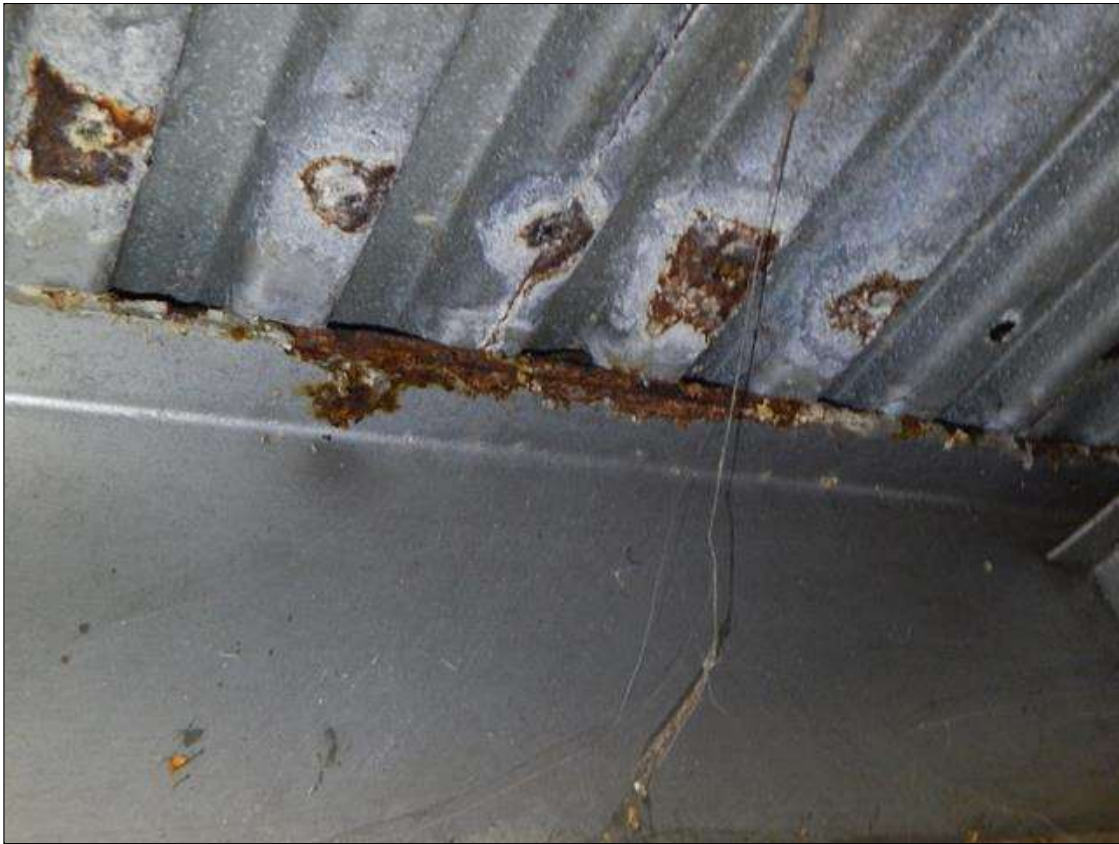
Span 1 Beam 9: 10 Feet of Corrosion IN FLANGES WITH 1/4" REMAINING: Section loss is evident or pack rust is present but does not warrant structural review.

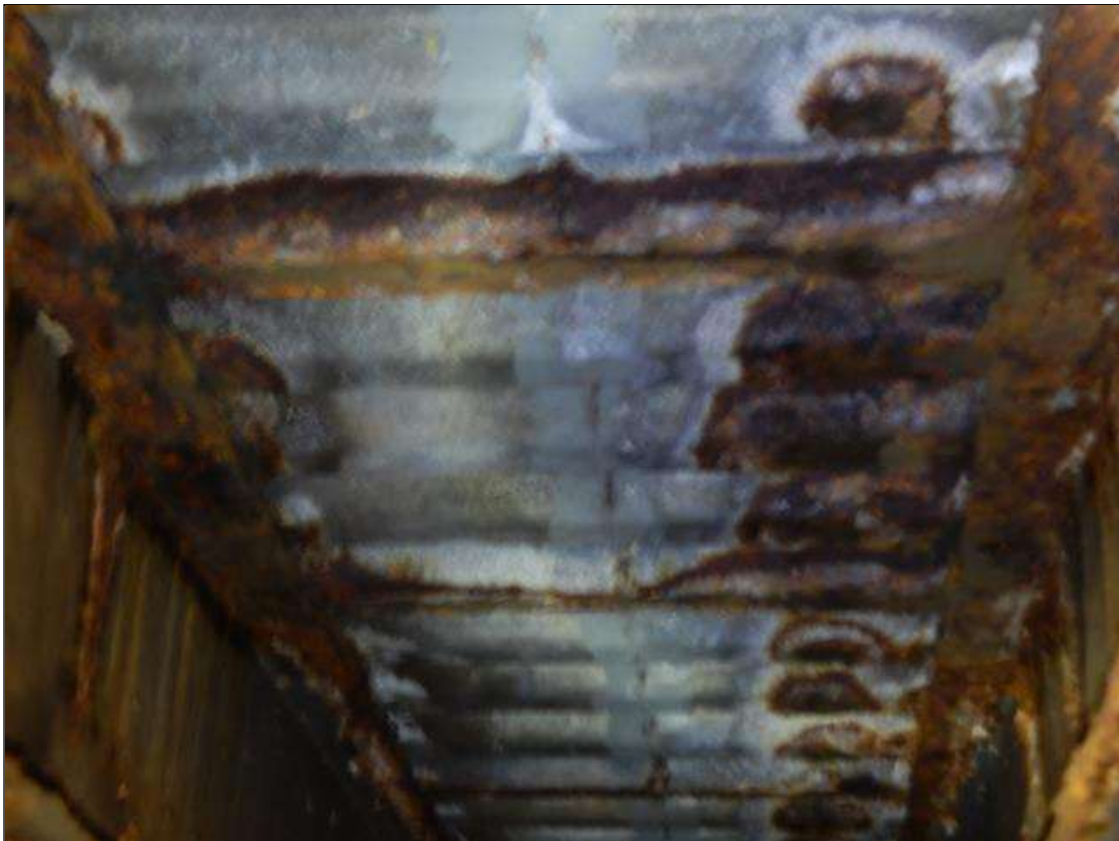
200 Square Feet of Corrosion: Section loss WITH DOWN TO 1/8" REMAINING is evident or pack rust is present but does not warrant structural review.

Span 1 Deck: 200 Square Feet of Corrosion: Section loss WITH DOWN TO 1/8" REMAINING is evident or pack rust is present but does not warrant structural review.

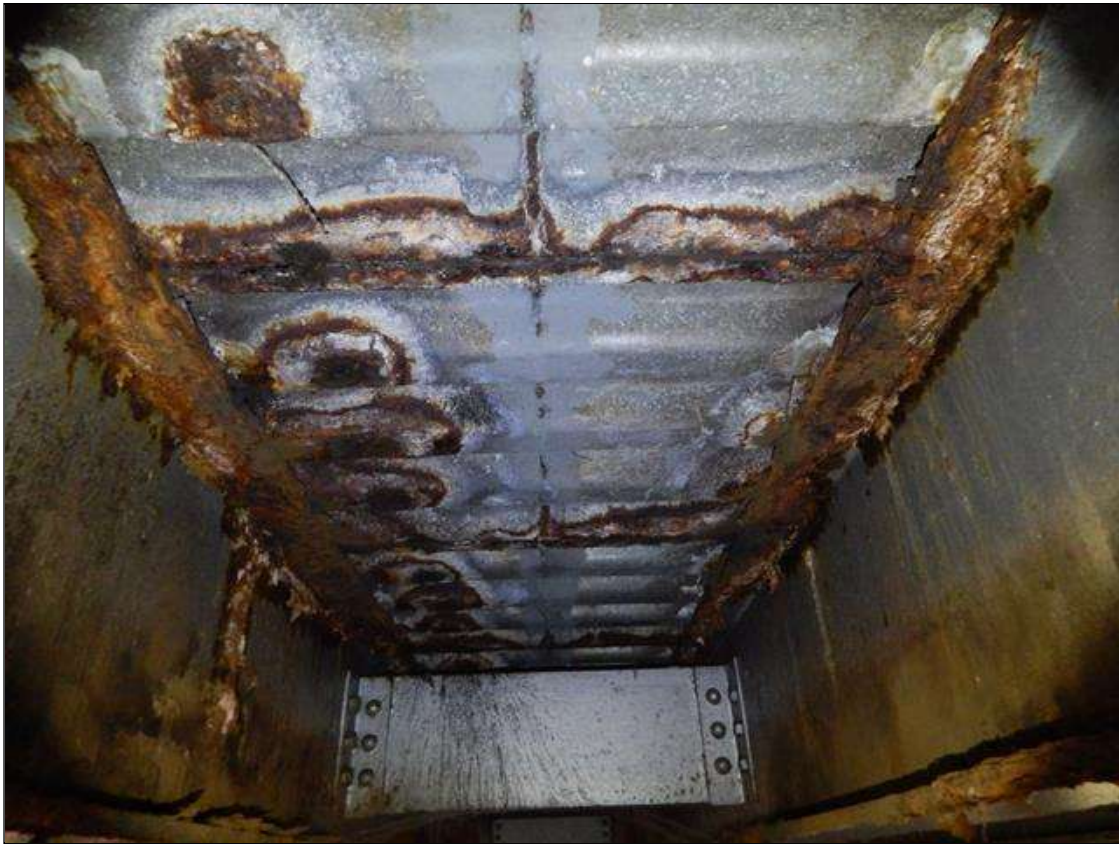
275 Square Feet of Corrosion: Section loss is evident or pack rust is present but does not warrant structural review.

Span 2 Deck: 275 Square Feet of Corrosion: Section loss is evident or pack rust is present but does not warrant structural review.

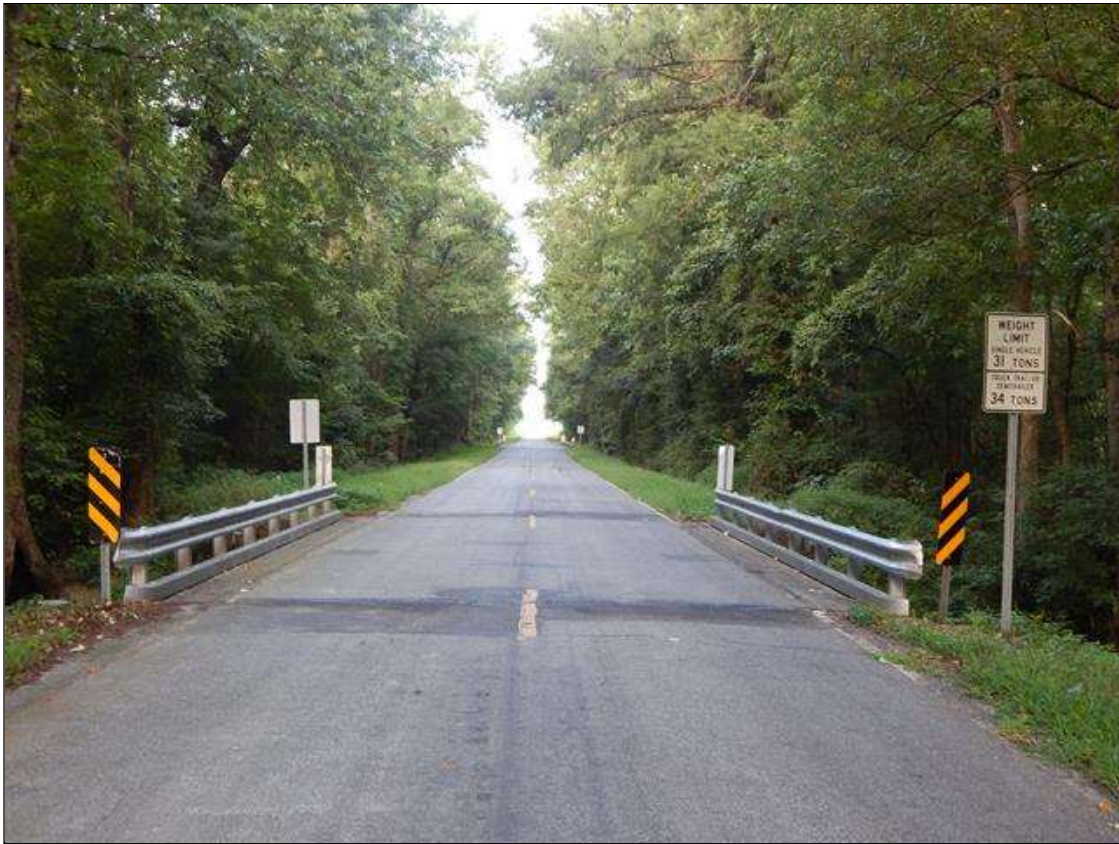
LOOKING WEST WEIGHT LIMIT SV 31 TONS, TTST 34 TONS
