NC DEPARTMENT OF TRANSPORTATION  
DIVISION OF HIGHWAYS  
STRUCTURE MANAGEMENT UNIT

## Structure Safety Report

### Routine Element Inspection - Contract

COUNTY: HALIFAX STRUCTURE NUMBER: 410134 FREQUENCY: 24 MONTHS

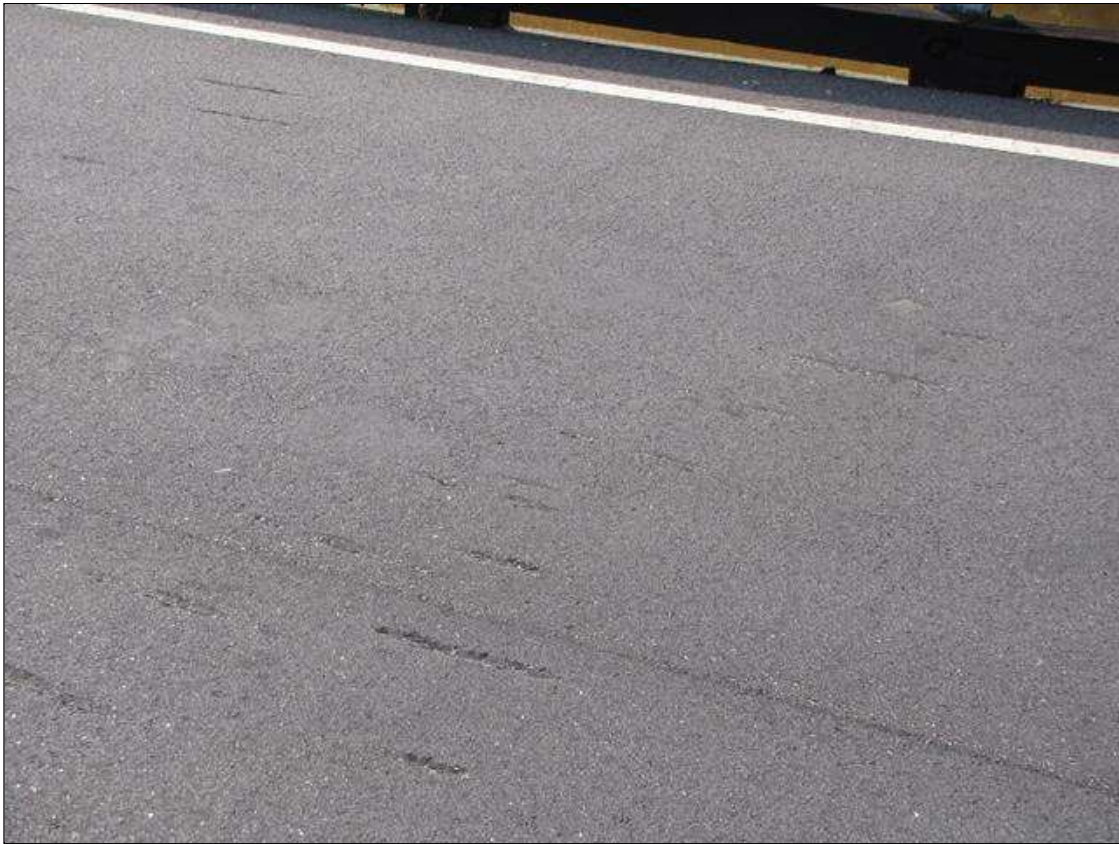
75 Square Feet of Damage (CS2): GOUGES UP TO 3/4 IN DEEP IN WEARING SURFACE OF EAST BOUND LANE.

Span 1 Wearing Surface: GOUGES UP TO 3/4 IN DEEP IN WEARING SURFACE IN EAST BOUND LANE.

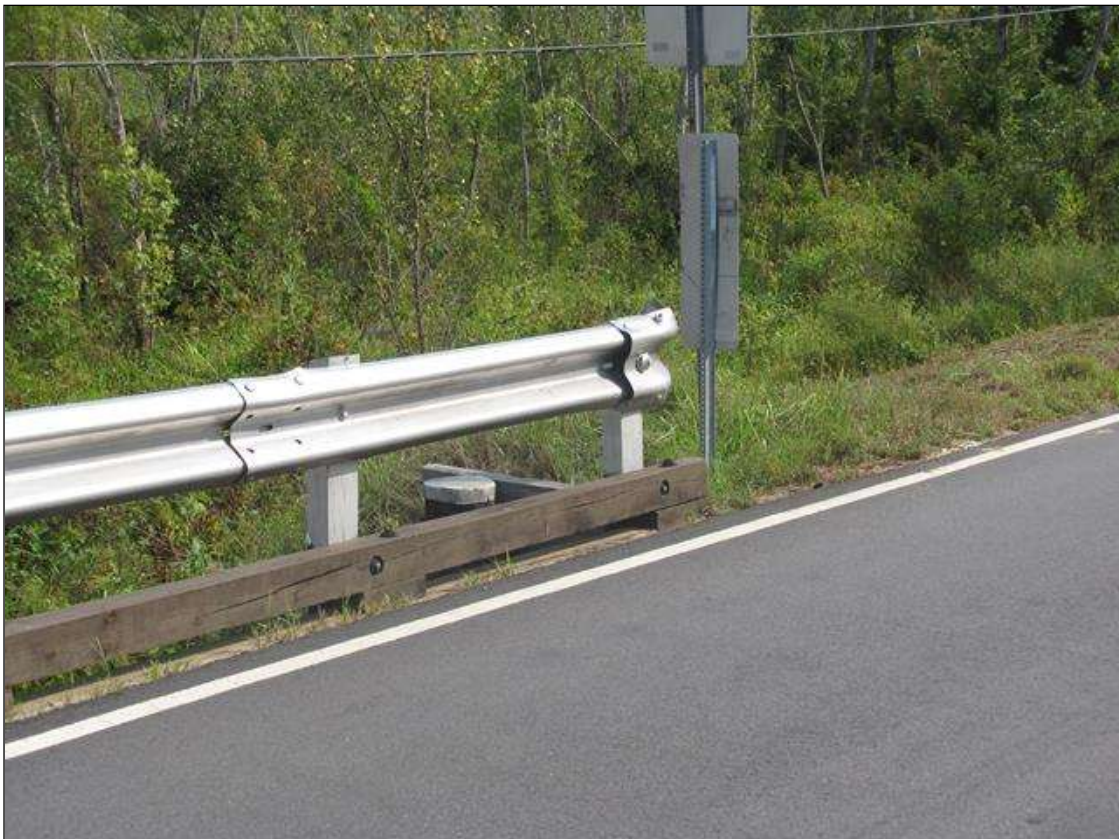
8 Feet of Damage (CS2): 8 FT OF IMPACT DAMAGE AT NORTHEAST CORNER.

Span 4 Left Bridge Rail: 8 FT OF IMPACT DAMAGE AT NORTHEAST CORNER.

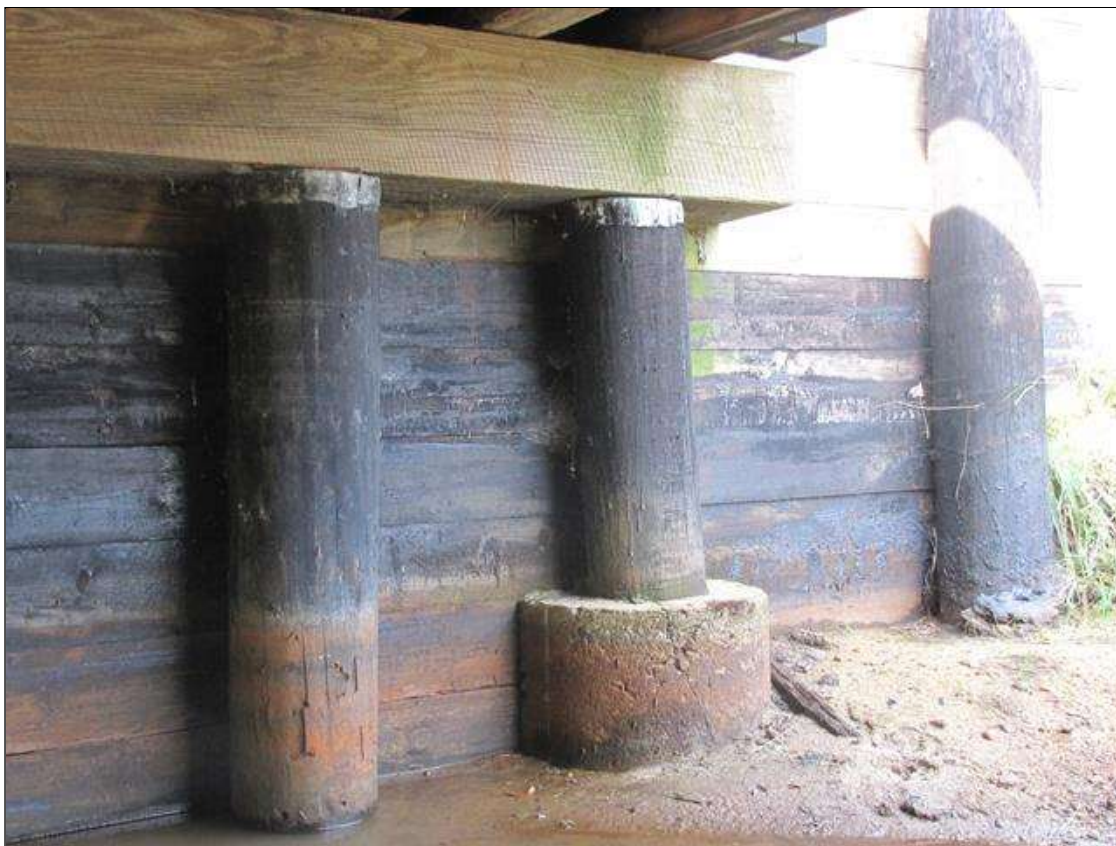
CONCRETE COLLAR AT PILE 1 AT END BENT 1.  
FULL HEIGHT VERTICAL CRACK UP TO 1/8 IN WIDE IN CONCRETE COLLAR.

End Bent 1 Pile 1: FULL HEIGHT VERTICAL CRACK UP TO 1/8 IN WIDE IN CONCRETE COLLAR.

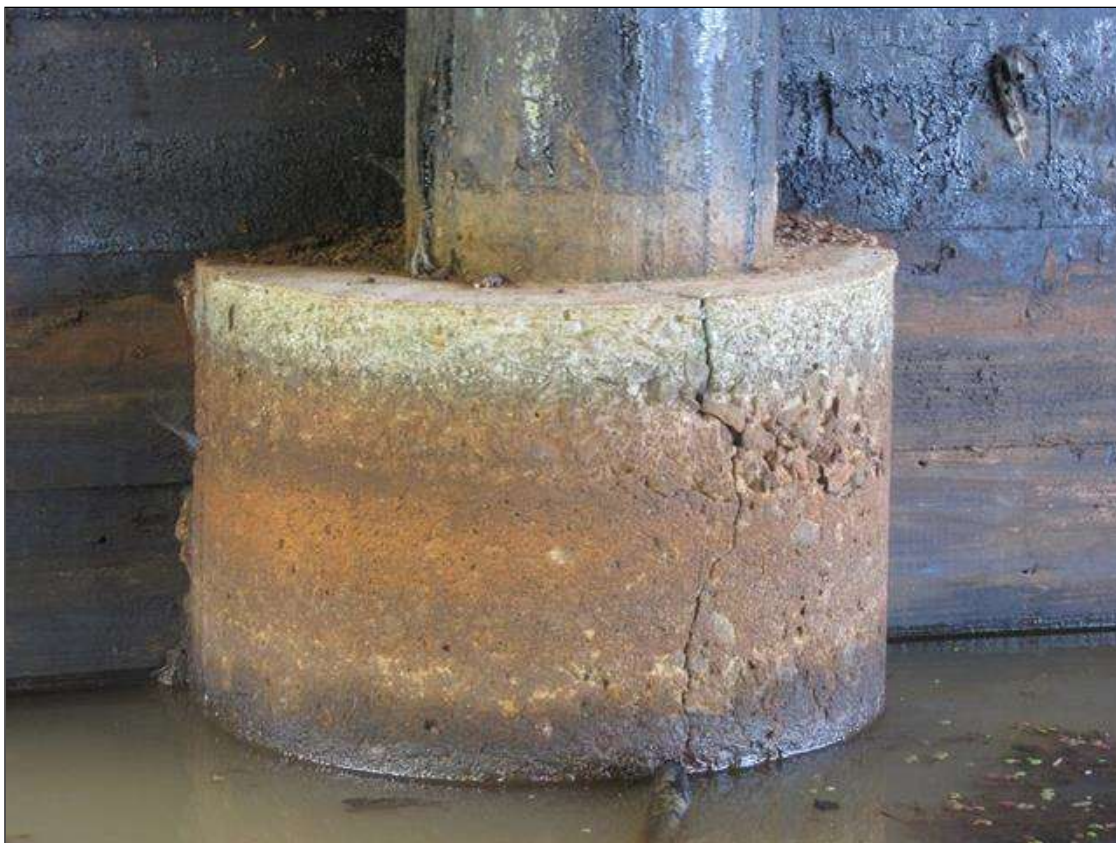
CONCRETE COLLAR AT PILE 4 AT END BENT 1.  
FULL HEIGHT VERTICAL CRACK UP TO 1/8 IN WIDE IN CONCRETE COLLAR.

End Bent 1 Pile 4: FULL HEIGHT VERTICAL CRACK UP TO 1/8 IN WIDE IN CONCRETE COLLAR.

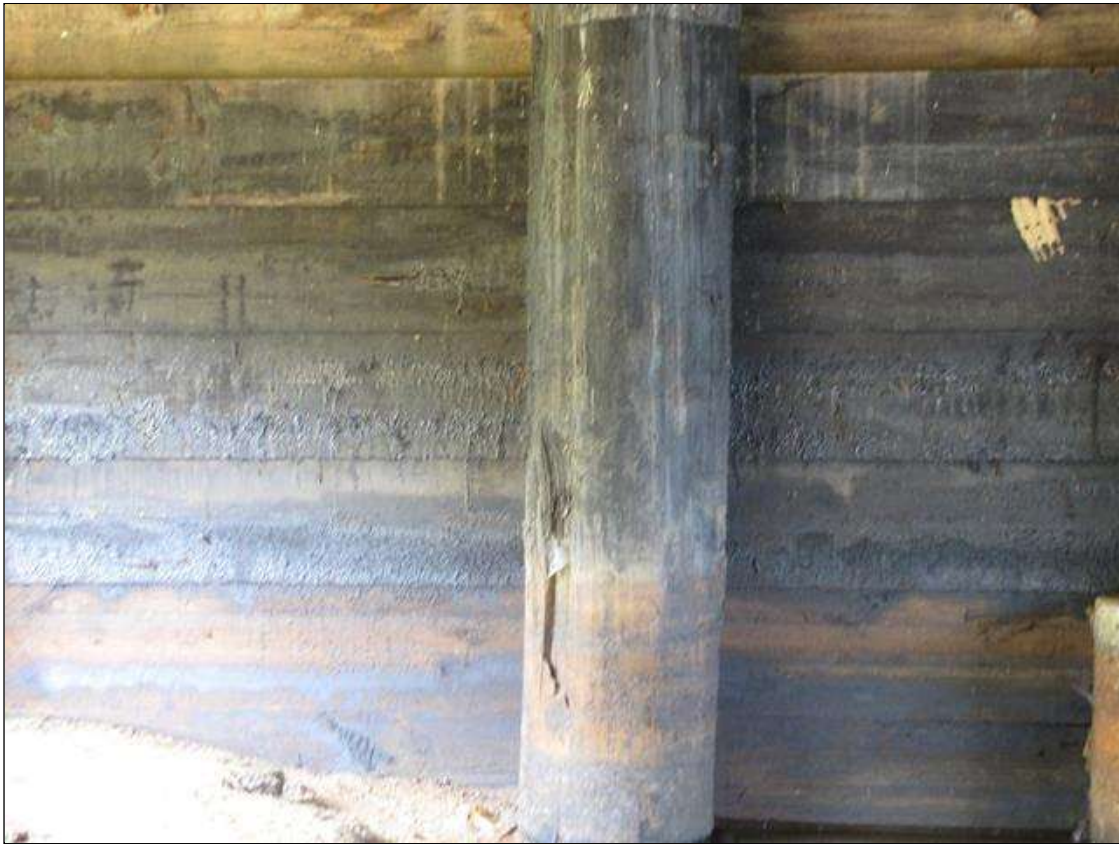
End Bent 1 Pile 5: 6 IN X 18 IN VERTICAL SPLIT IN EAST FACE, 1 FT FROM WATERLINE.

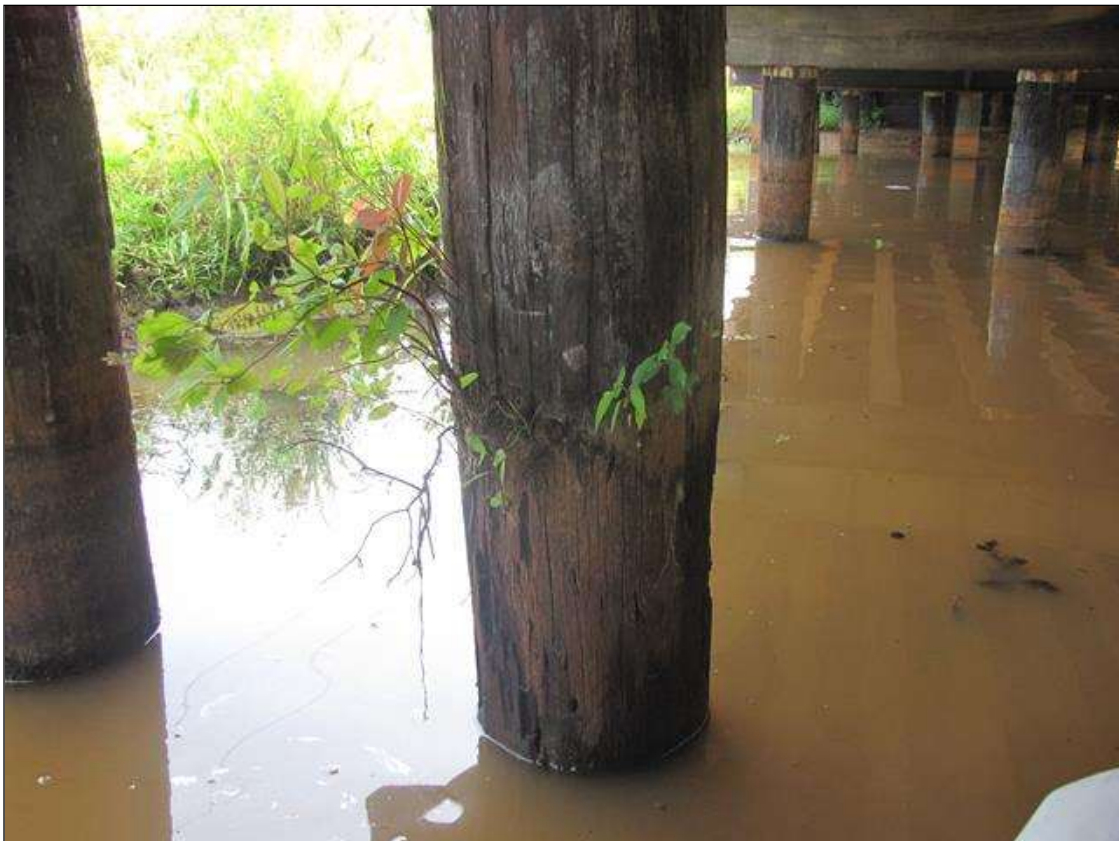
1 Each of Decay/Section Loss (CS3): 1 1/2 IN DEEP DECAY WITH VEGETATION GROWTH IN WEST FACE AT WATERLINE (PM). AREA OF DECAY WITH HOLLOW SOUND IN EAST FACE UP TO 3 FT ABOVE WATERLINE (PM).

Bent 1 Pile 2: 1 1/2 IN DEEP DECAY WITH VEGETATION GROWTH IN WEST FACE AT WATERLINE (PM).

| MMS Code | Description of Function | Unit | Quantity | Remarks | Est. Cost |
|---|---|---|---|---|---|
| 3344 | Repair / Replace Timber Substructure Components | LF | 4 | AREA OF DECAY WITH HOLLOW SOUND IN EAST FACE OF PILE 2, UP TO 3 FT ABOVE WATERLINE AND 1 1/2 IN DEEP DECAY WITH VEGETATION GROWTH IN WEST FACE OF PILE 2 AT WATERLINE AT BENT 1. | |

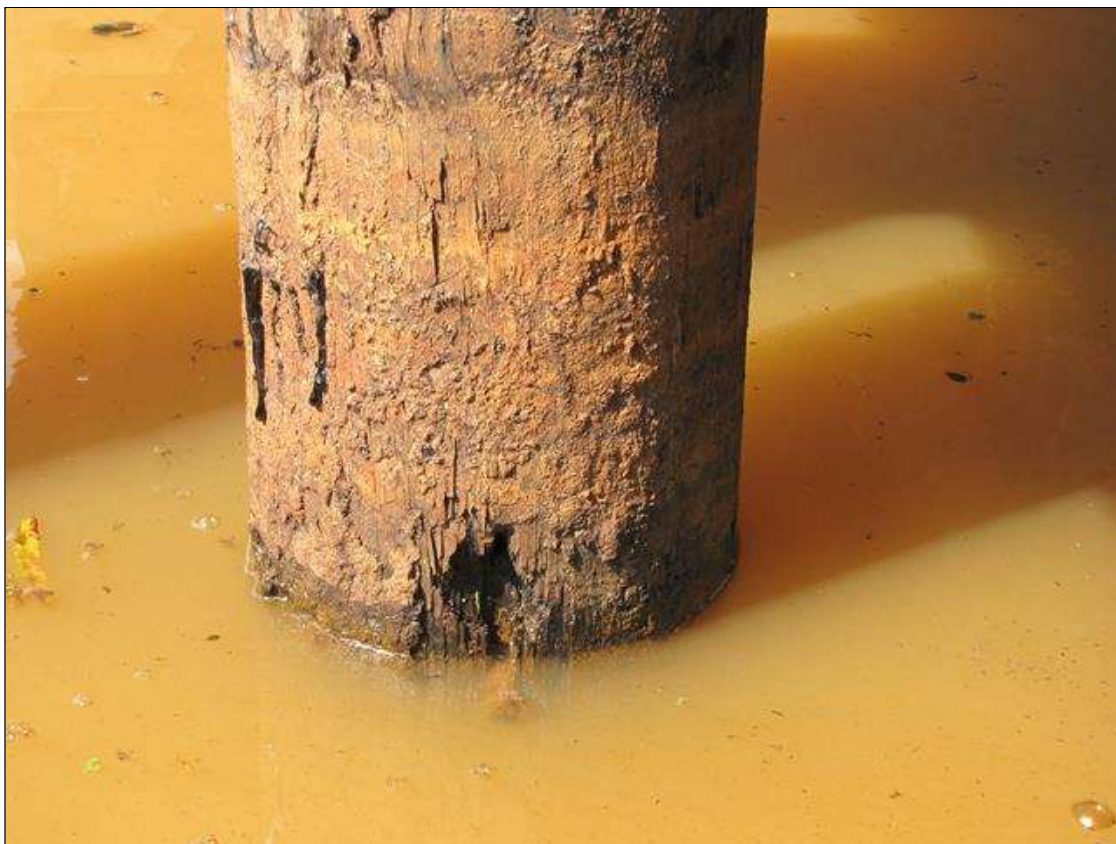
1 Each of Decay/Section Loss (CS3): 2 IN X 4 IN X 1 IN DEEP DECAY IN EAST FACE AT WATERLINE (PM).

Bent 1 Pile 6: 2 IN X 4 IN X 1 IN DEEP DECAY IN EAST FACE AT WATERLINE (PM).

| MMS Code | Description of Function | Unit | Quantity | Remarks | Est. Cost |
|---|---|---|---|---|---|
| 3344 | Repair / Replace Timber Substructure Components | LF | 1 | 2 IN X 4 IN X 1 IN DEEP DECAY IN EAST FACE OF PILE 6 AT WATERLINE AT BENT 1. | |

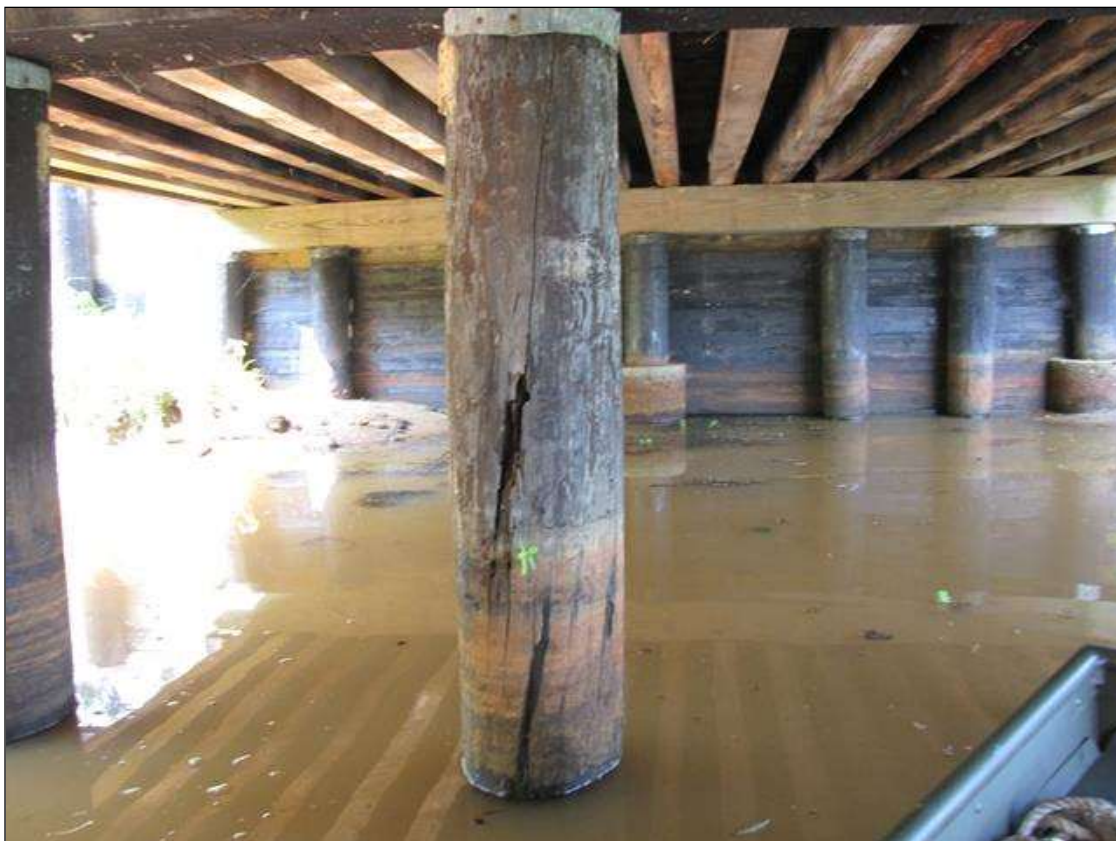
1 Each of Decay/Section Loss (CS3): 2 FT X 2 IN X 4 IN DEEP DECAY IN EAST FACE, 4 FT ABOVE WATERLINE (PM).

Bent 1 Pile 4: 2 FT X 2 IN X 4 IN DEEP DECAY IN EAST FACE, 4 FT ABOVE WATERLINE (PM).

| MMS Code | Description of Function | Unit | Quantity | Remarks | Est. Cost |
|---|---|---|---|---|---|
| 3344 | Repair / Replace Timber Substructure Components | LF | 2 | 2 FT X 2 IN X 4 IN DEEP DECAY IN EAST FACE OF PILE 4, 4 FT ABOVE WATERLINE AT BENT 1. | |

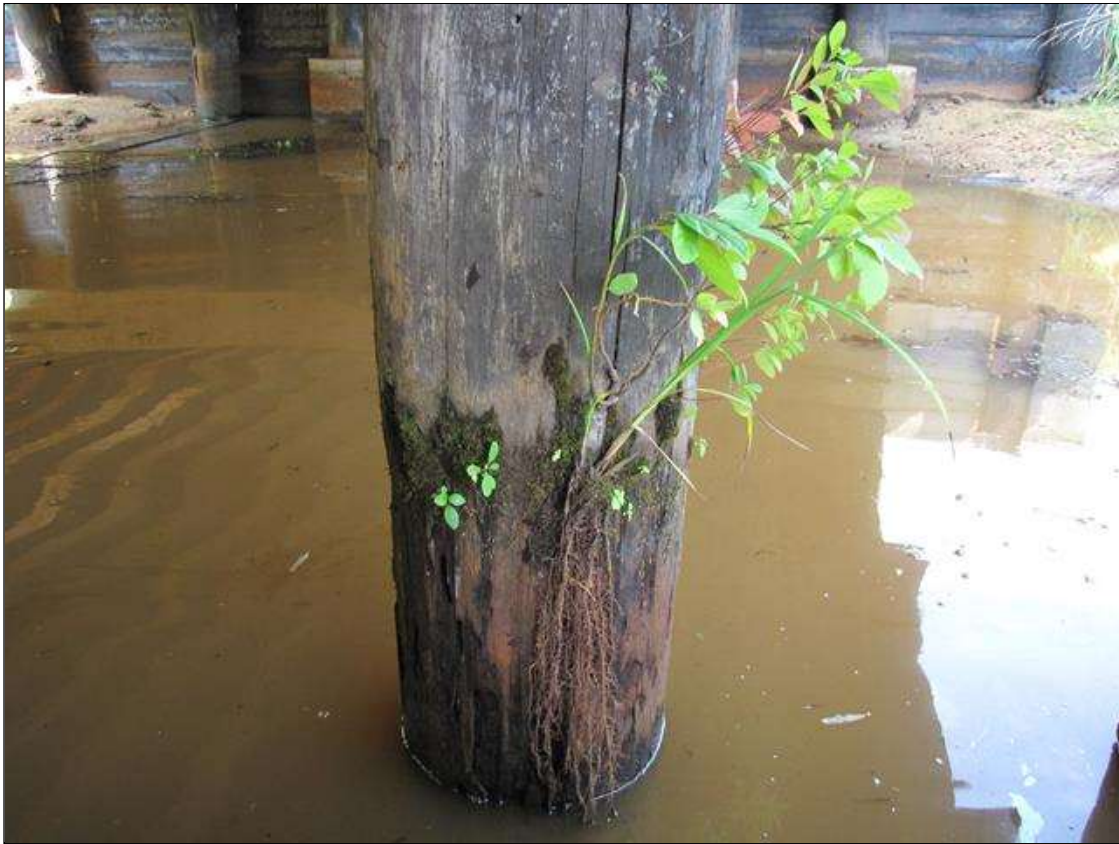
Bent 1 Pile 2: AREA OF DECAY WITH HOLLOW SOUND IN EAST FACE UP TO 3 FT ABOVE WATERLINE (PM).

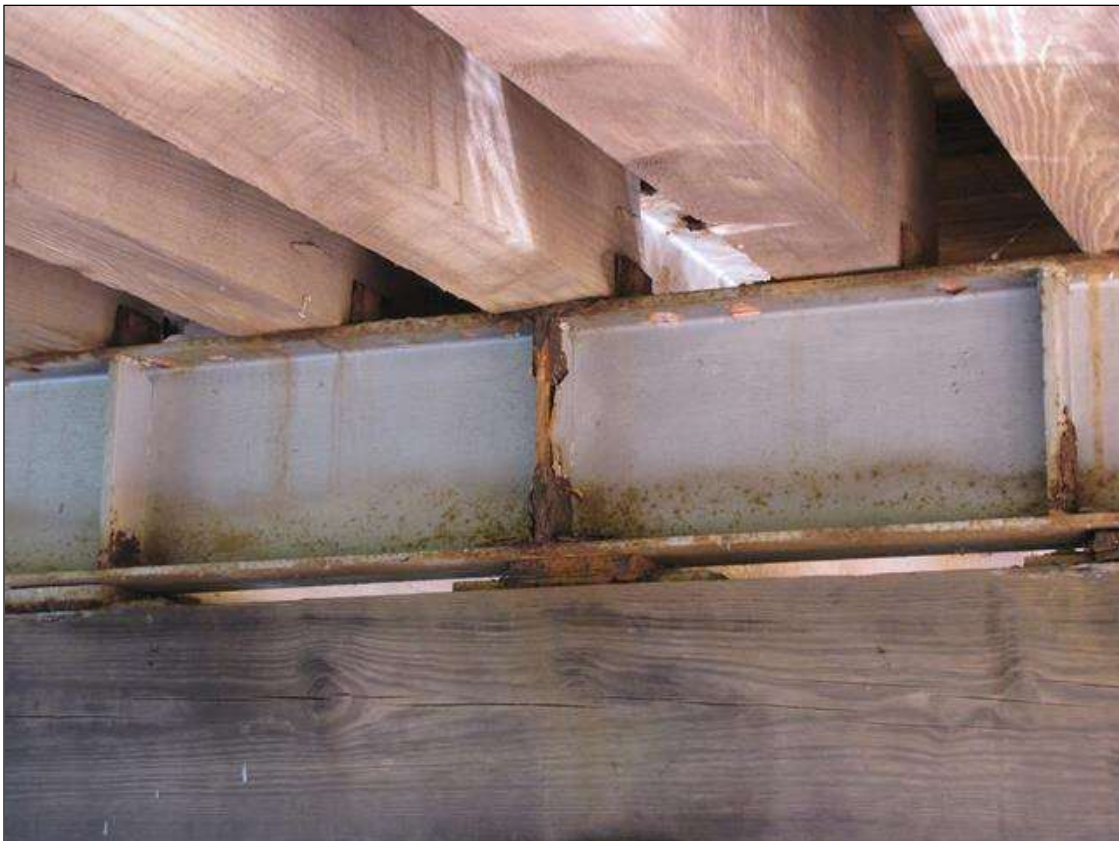
5 Feet of Corrosion (CS2): RANDOM FRECKLED RUST ALONG STEEL CAP, MOSTLY AT STIFFENER PLATES.

Bent 2 Steel Cap : RANDOM FRECKLED RUST, MOSTLY AT STIFFENER PLATES WITH LIMITED EFFECTIVENESS OF PROTECTIVE COATING.

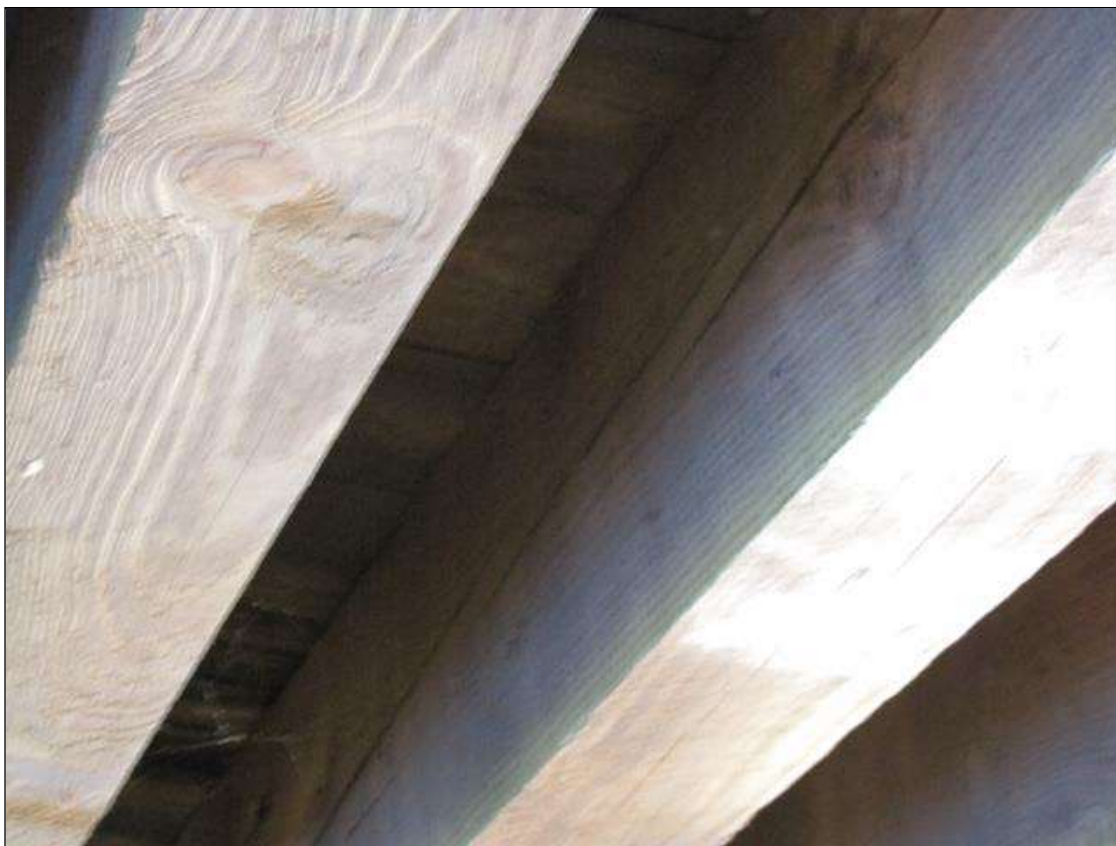
Span 2 Beam 13: FULL LENGTH HORIZONTAL SPLIT IN NORTH FACE.

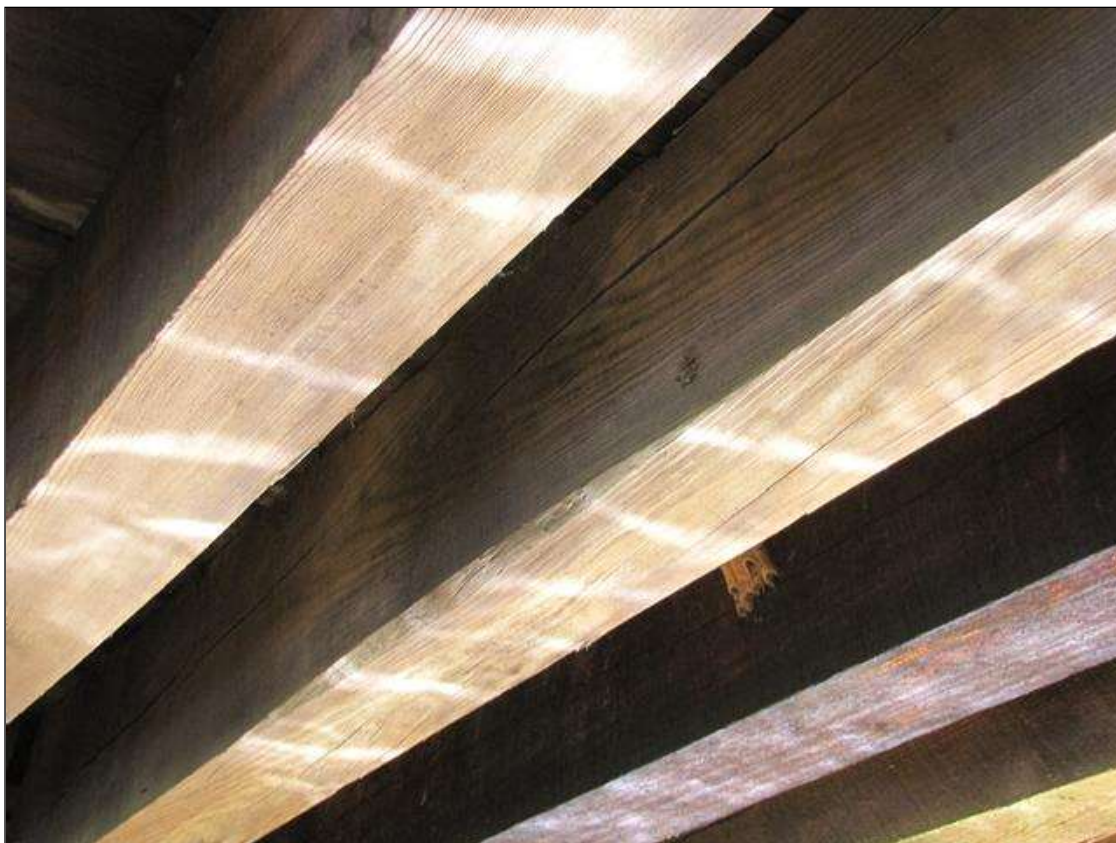
Span 2 Beam 15: FULL LENGTH HORIZONTAL SPLIT IN NORTH FACE.

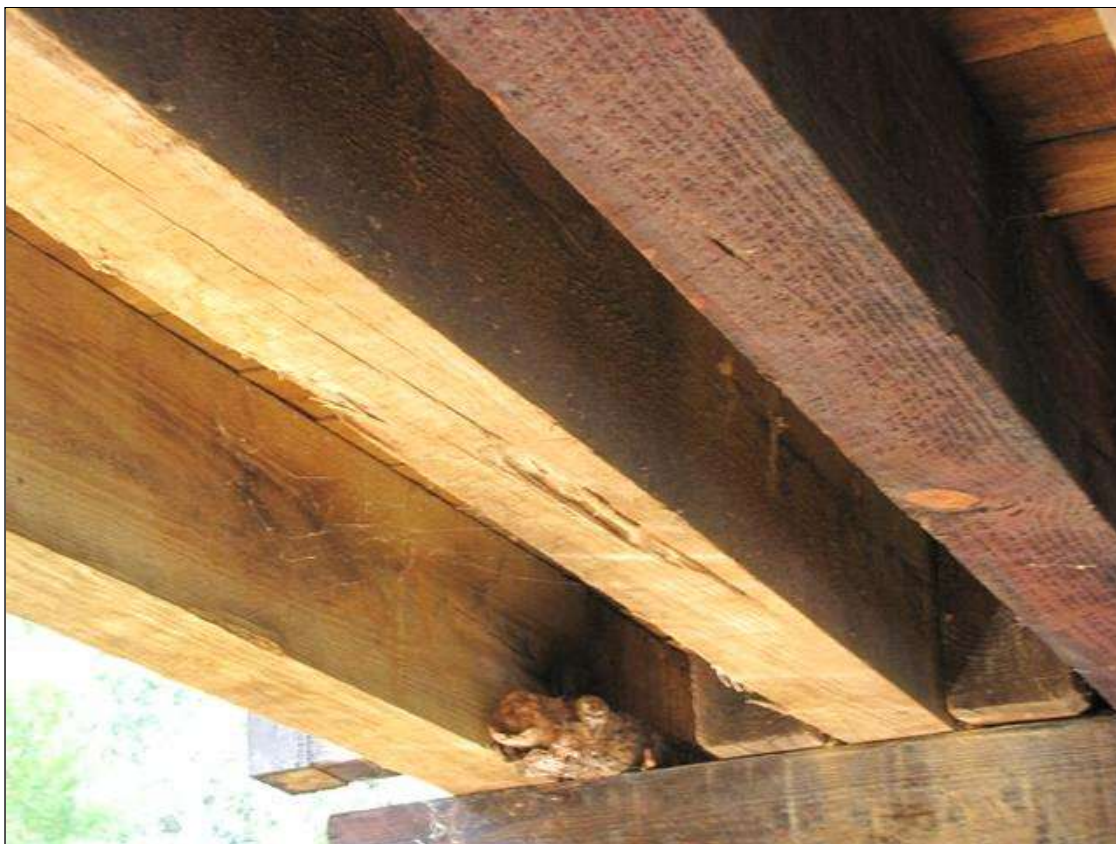
2 Feet of Damage (CS2): 3 IN X 2 FT X 1/2 IN DEEP LOSS OF SECTION IN BOTTOM FACE, 5 FT FROM BENT 1.

Span 2 Beam 17: 3 IN X 2 FT X 1/2 IN DEEP LOSS OF SECTION IN BOTTOM FACE, 5 FT FROM BENT 1.

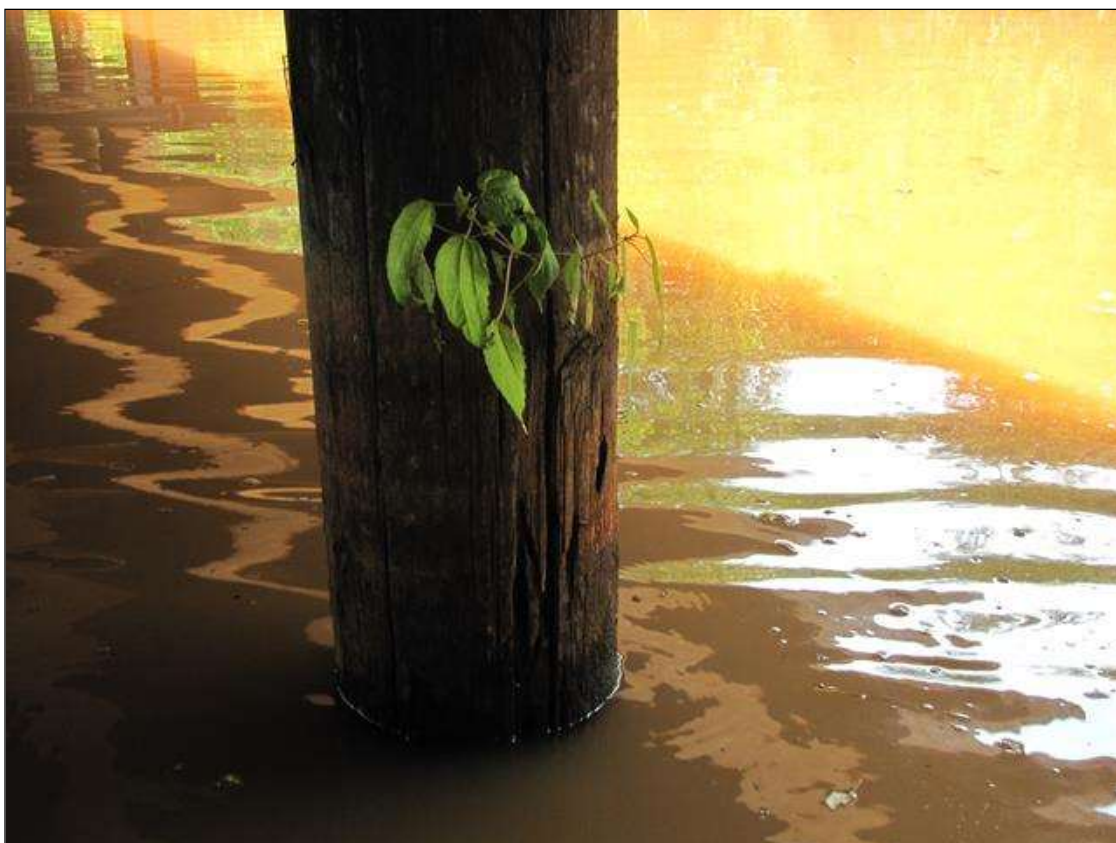
1 Each of Decay/Section Loss (CS3): 2 FT X 6 IN AREA OF DECAY WITH VEGETATION GROWTH IN WEST FACE AT WATERLINE (PM).

Bent 2 Pile 5: 2 FT X 6 IN AREA OF DECAY WITH VEGETATION GROWTH IN WEST FACE AT WATERLINE (PM).

| MMS Code | Description of Function | Unit | Quantity | Remarks | Est. Cost |
|---|---|---|---|---|---|
| 3344 | Repair / Replace Timber Substructure Components | LF | 2 | 2 FT X 6 IN AREA OF DECAY WITH VEGETATION GROWTH IN WEST FACE OF PILE 5 AT WATERLINE AT BENT 2. | |

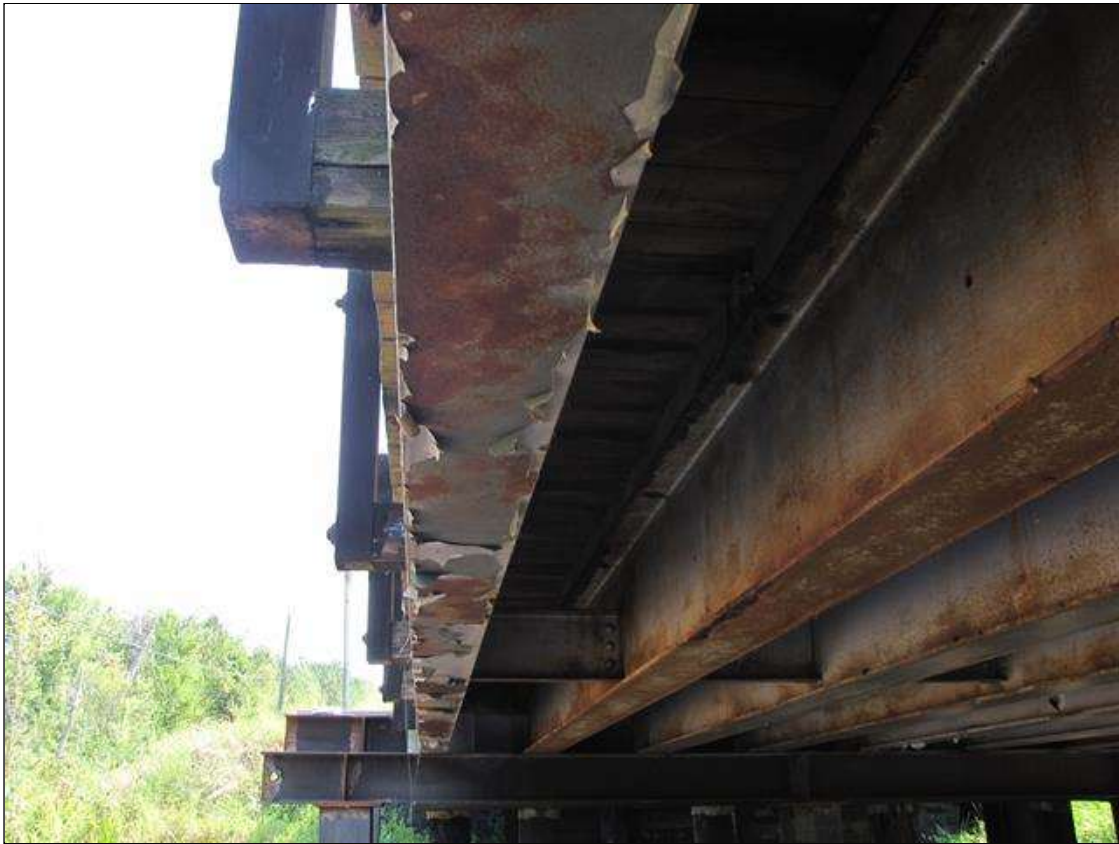
Span 3 Beam 1: PEELING PAINT ALONG BOTTOM FLANGE.

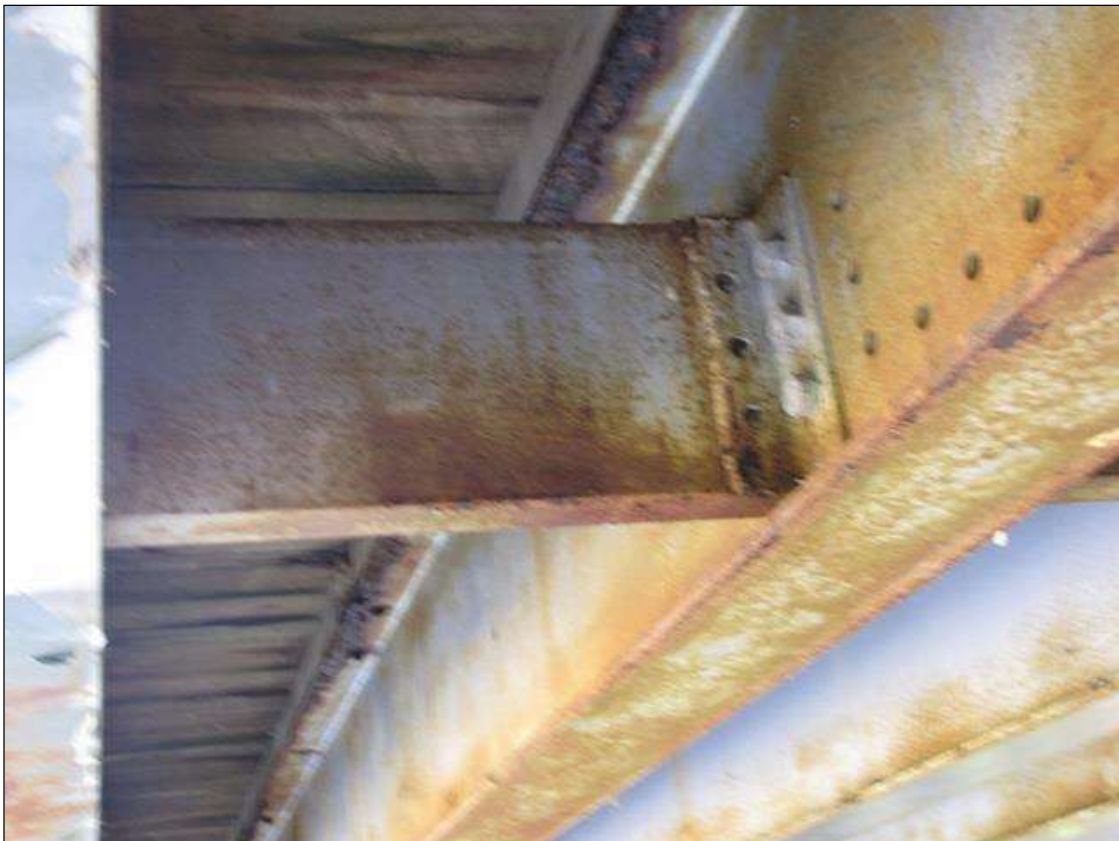
Span 3 Beam 2: CORROSION WITH LOSS OF SECTION TO KNIFE EDGE AT TOP FLANGE AND FRECKLED RUST AT RANDOM IN WEB AND BOTTOM FLANGE.

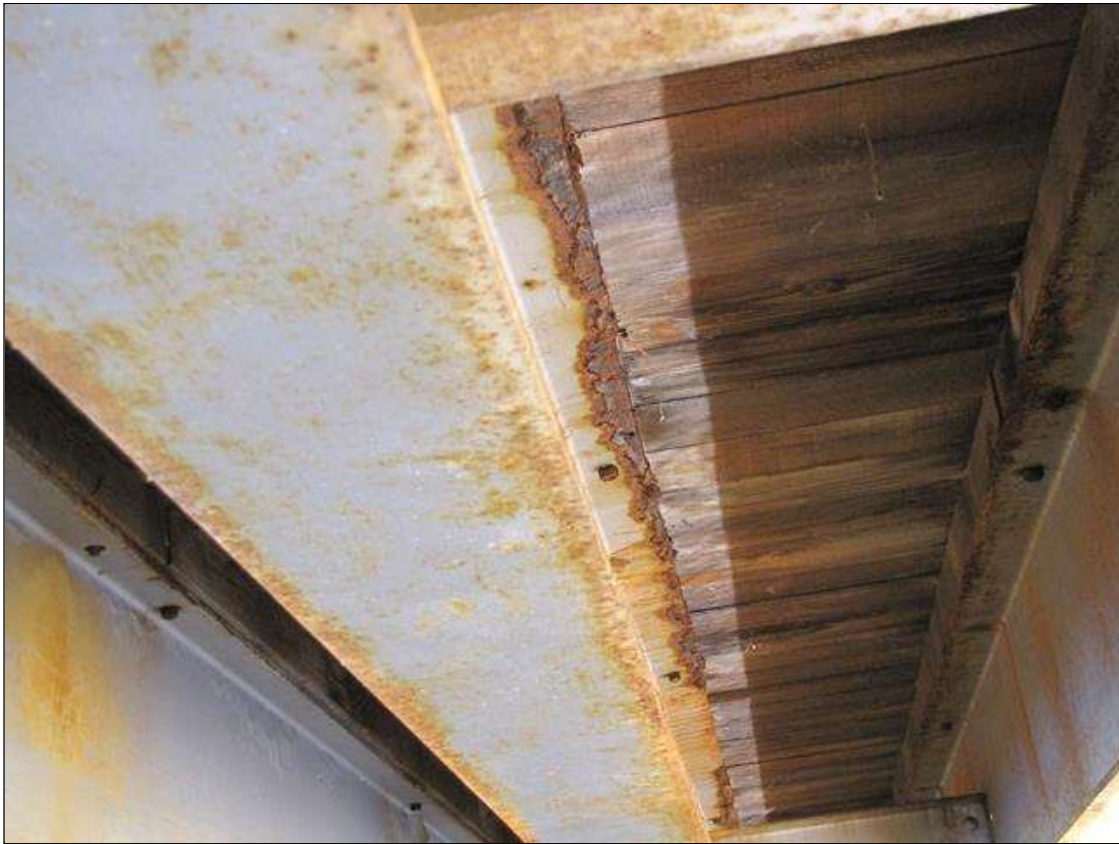
Span 3 Beam 2: CORROSION WITH LOSS OF SECTION TO KNIFE EDGE AT TOP FLANGE.

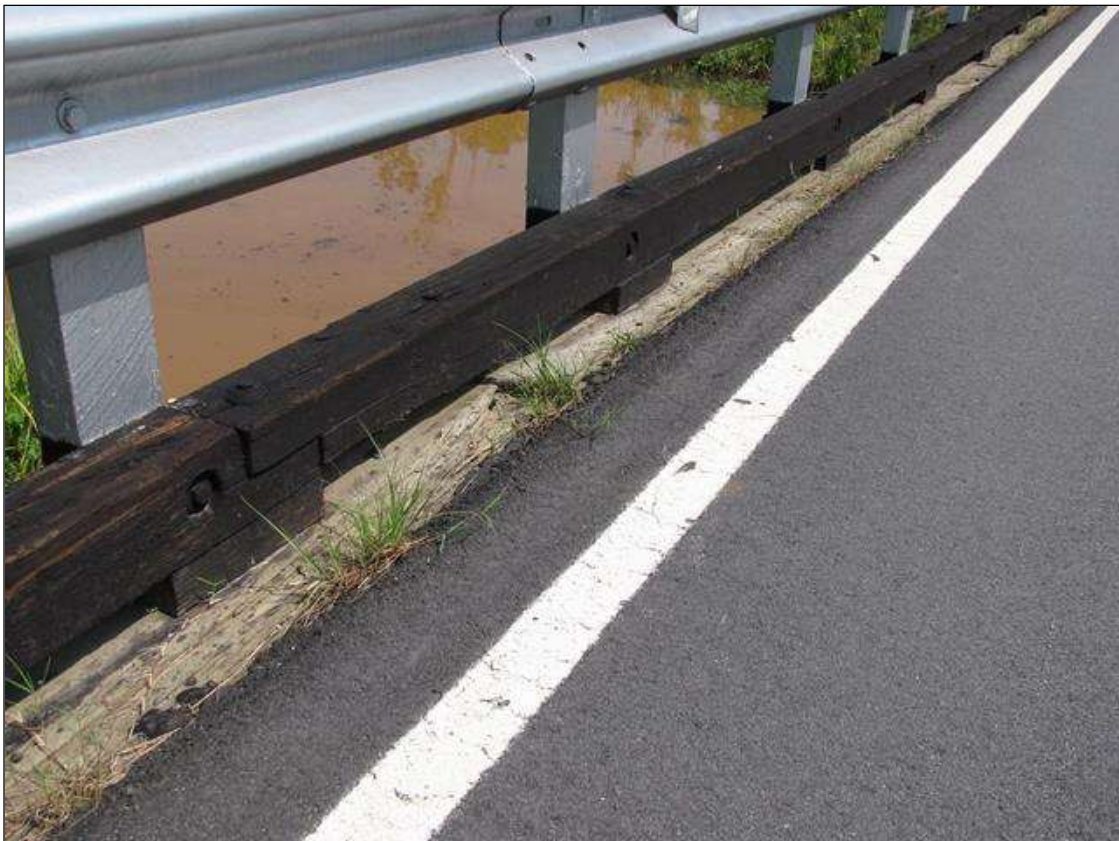
2 Square Feet of Split/Delamination (CS2): ASPHALT WEARING SURFACE TIMBER RETAINER IS WARPED AND SPLIT, AT LEFT GUTTER 3 FT FROM BENT 2.

Span 3 Deck: ASPHALT WEARING SURFACE TIMBER RETAINER IS WARPED AND SPLIT, AT LEFT GUTTER 3 FT FROM BENT 2.

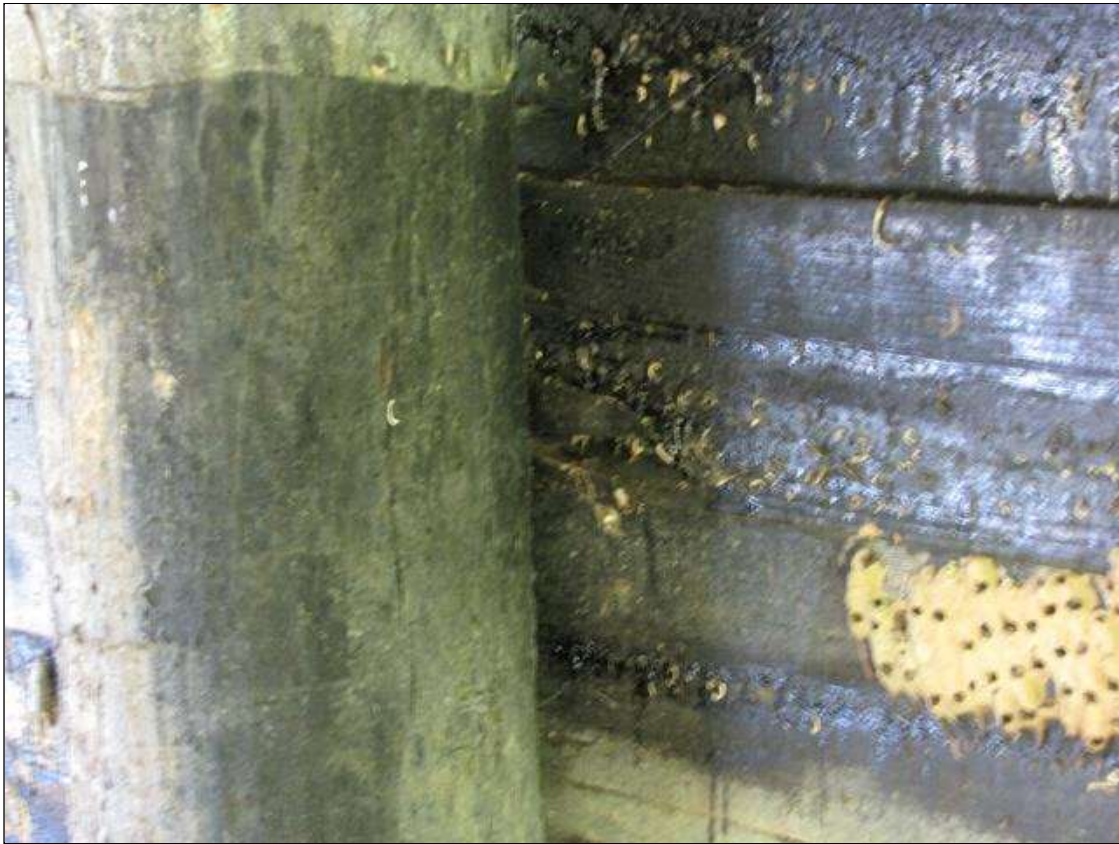
1 Feet of Decay/Section Loss (CS2): 12 IN X 5 IN X 1 1/2 IN DEEP DECAY BEHIND PILE 4.

End Bent 2 Abutment/Backwall : 12 IN X 5 IN X 1 1/2 IN DEEP DECAY BEHIND PILE 4.

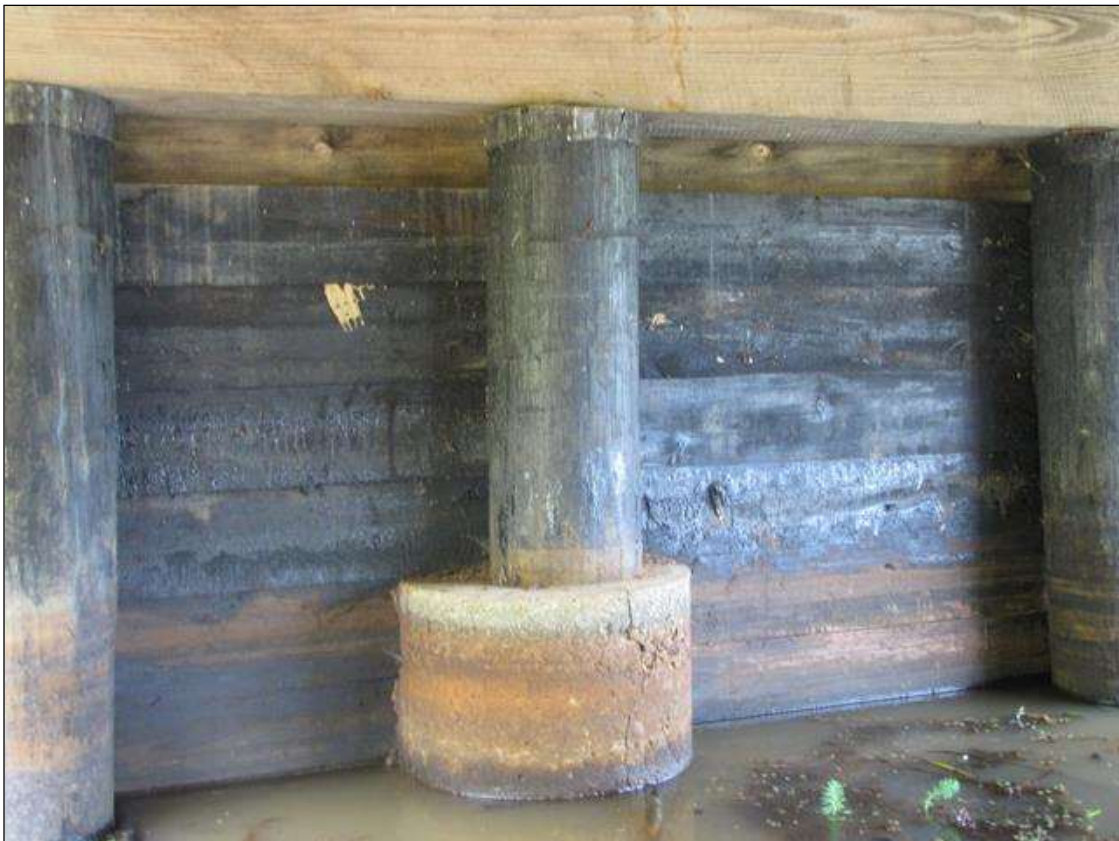
CONCRETE COLLAR AT PILE 4 AT END BENT 1.

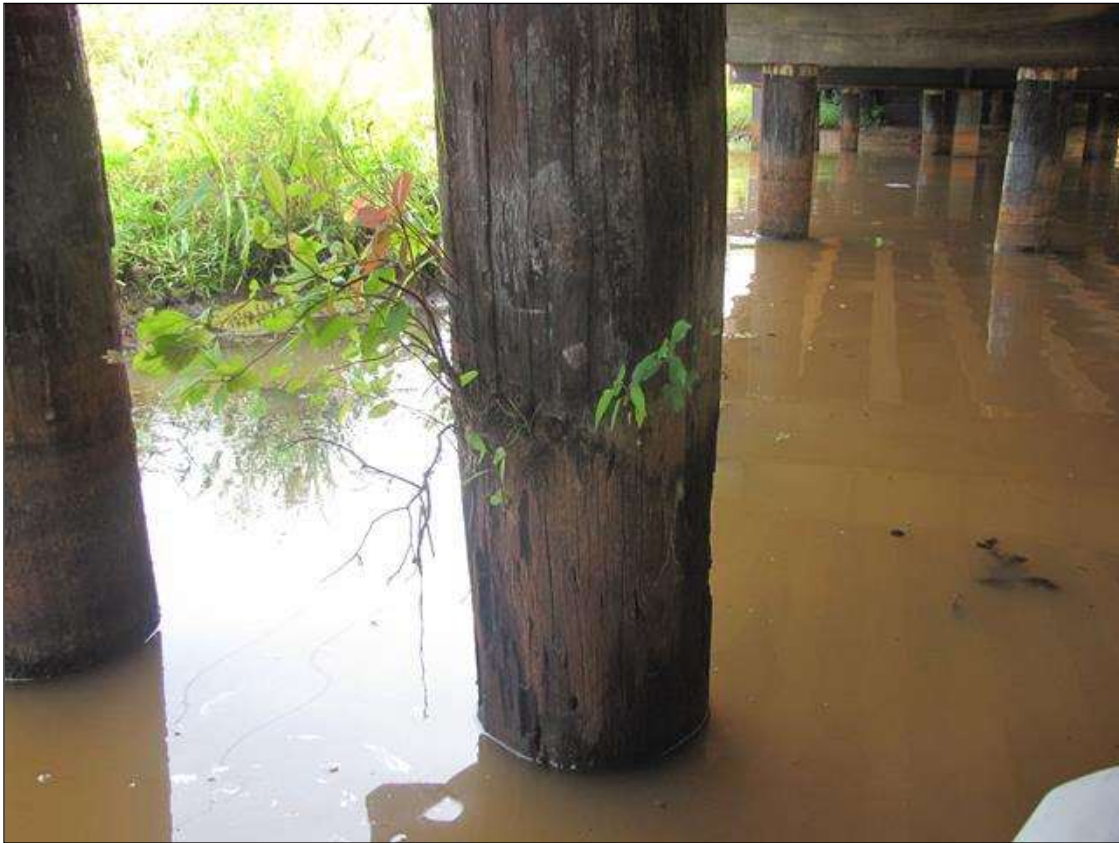
1 1/2 IN DEEP DECAY WITH VEGETATION GROWTH IN WEST FACE OF PILE 2 AT WATERLINE AT BENT 1.

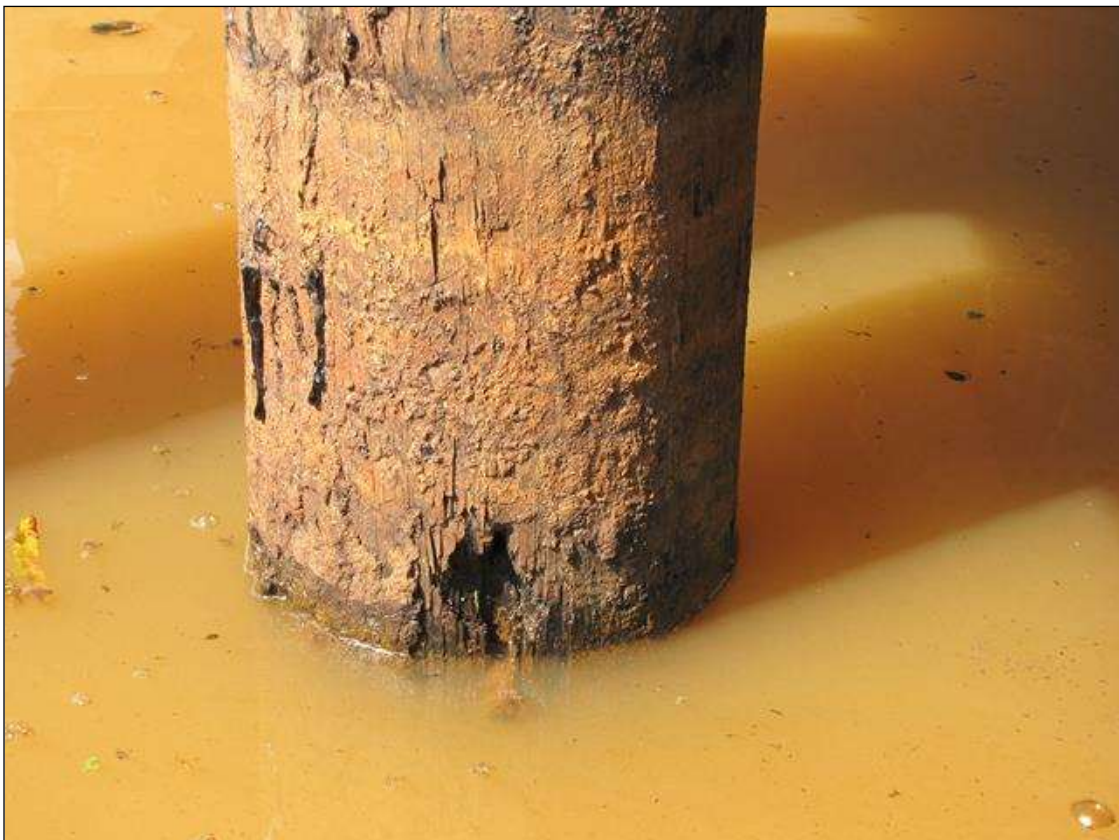
2 IN X 4 IN X 1 IN DEEP DECAY IN EAST FACE OF PILE 6 AT WATERLINE AT BENT 1.

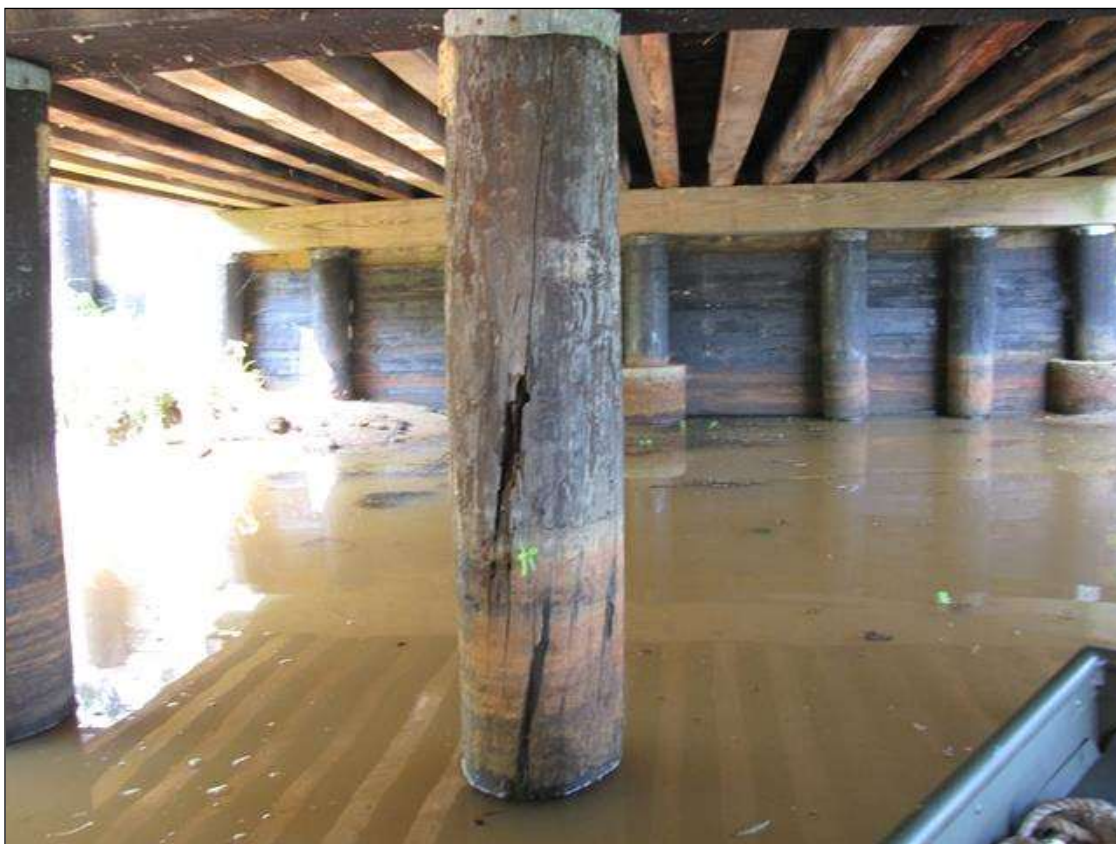
2 FT X 2 IN X 4 IN DEEP DECAY IN EAST FACE OF PILE 4, 4 FT ABOVE WATERLINE AT BENT 1.
