NC DEPARTMENT OF TRANSPORTATION  
DIVISION OF HIGHWAYS  
STRUCTURE MANAGEMENT UNIT

## Structure Safety Report

### Routine Element Inspection - Contract

COUNTY: HALIFAX STRUCTURE NUMBER: 410134 FREQUENCY: 24 MONTHS

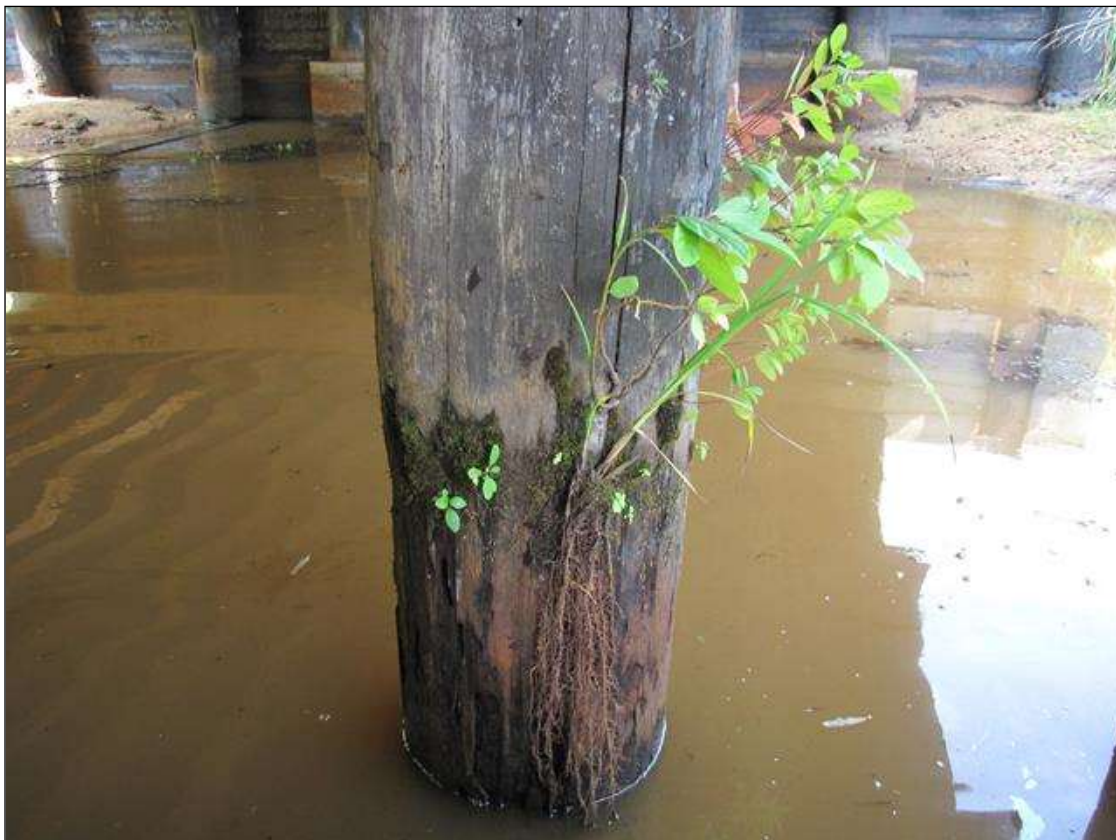
AREA OF DECAY WITH HOLLOW SOUND IN EAST FACE OF PILE 2, UP TO 3 FT ABOVE WATERLINE AT BENT 1.

| MMS Code | Description of Function | Unit | Quantity | Remarks | Est. Cost |
|---|---|---|---|---|---|
| 3344 | Repair / Replace Timber Substructure Components | LF | 4 | AREA OF DECAY WITH HOLLOW SOUND IN EAST FACE OF PILE 2, UP TO 3 FT ABOVE WATERLINE AND 1 1/2 IN DEEP DECAY WITH VEGETATION GROWTH IN WEST FACE OF PILE 2 AT WATERLINE AT BENT 1. | |

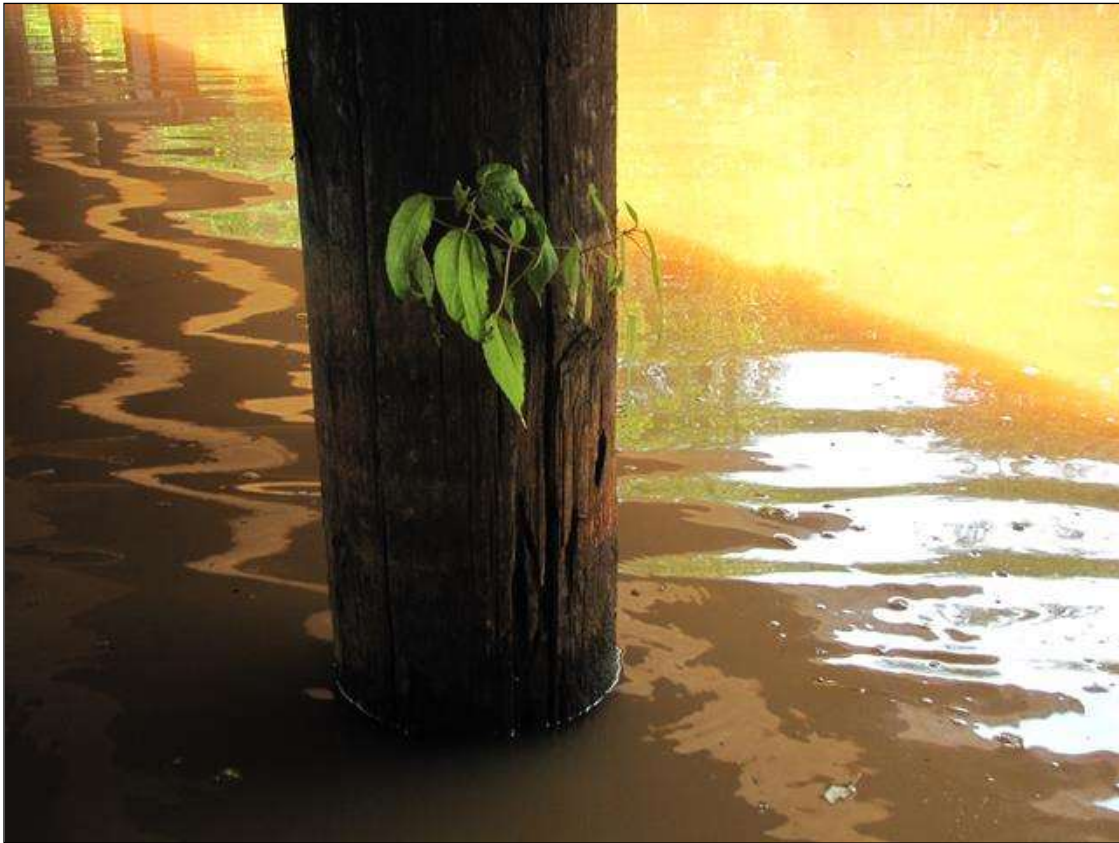
2 FT X 6 IN AREA OF DECAY WITH VEGETATION GROWTH IN WEST FACE OF PILE 5 AT WATERLINE AT BENT  
2.

| MMS Code | Description of Function | Unit | Quantity | Remarks | Est. Cost |
|---|---|---|---|---|---|
| 3344 | Repair / Replace Timber Substructure Components | LF | 2 | 2 FT X 6 IN AREA OF DECAY WITH VEGETATION GROWTH IN WEST FACE OF PILE 5 AT WATERLINE AT BENT 2. | |
